Issue Number 94

April 2002

Pack Rust on A-588 Weathering Steel Bridges Causes Safety Concerns

MDOT Investigation Helps Prevent Bridge-mounted Sign Failures

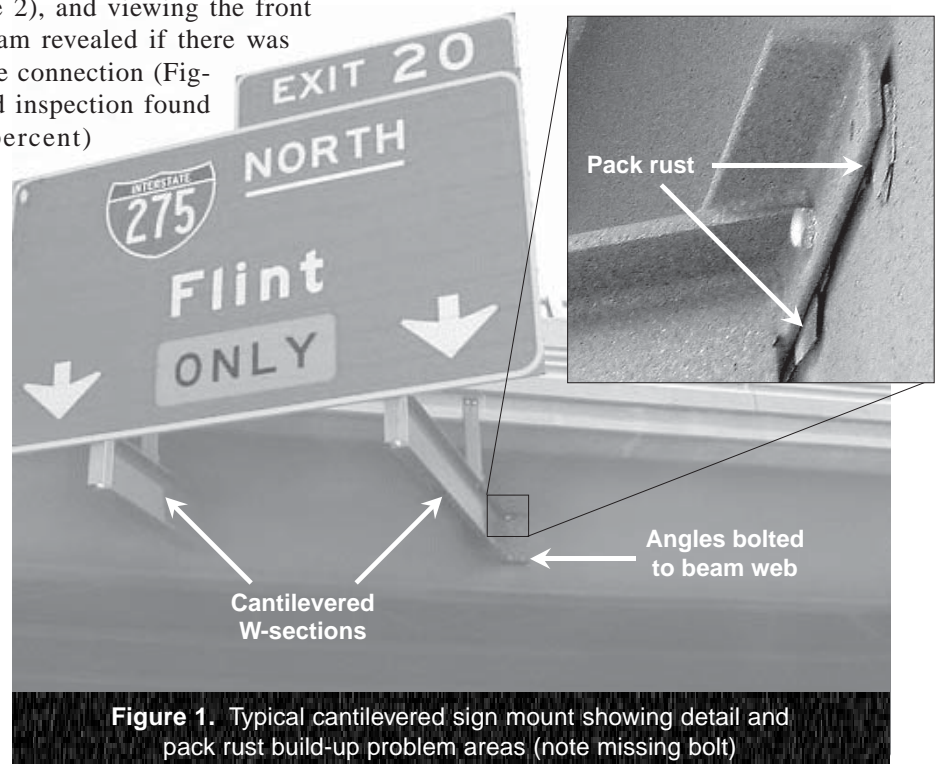
In the summer of 2001, MDOT's Structural Research Unit investigated problems found on signs mounted to ASTM A-588 weathering steel bridge beams. The investigators found broken, missing, short, and stripped bolts, and large build-ups of pack rust between the sign mounts and beam webs (Figure 1). The investigators suspected that the pack rust led to bolt failures, which would explain the missing bolts.

Figure 1. Typical cantilevered sign mount showing detail and pack rust build-up problem areas (note missing bolt)

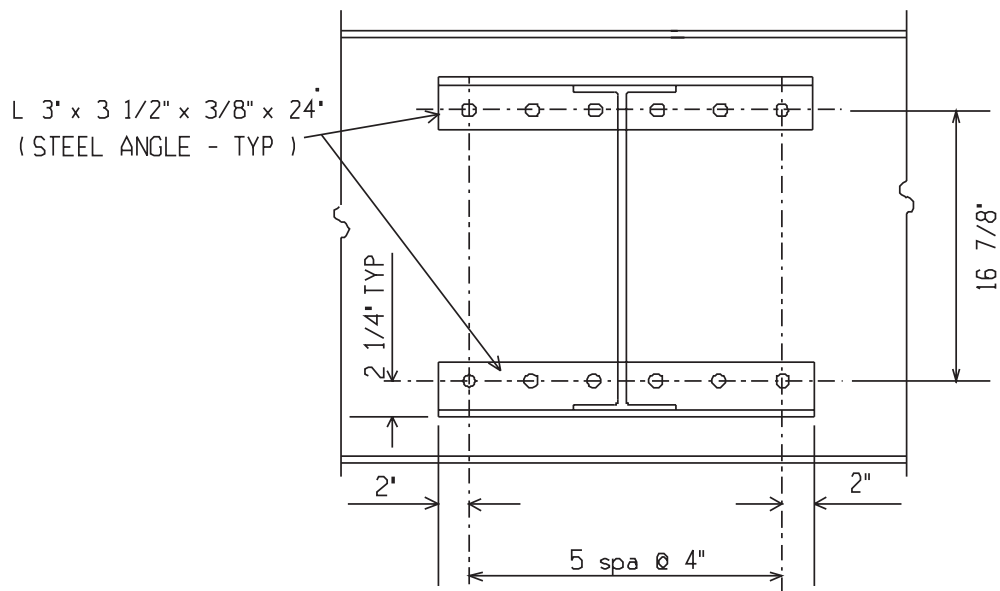
Figure E1. Sign mount detail changes

- E. Figure E1 shows recommended changes to Sign Standard Plans VIII-820E and VIII-830E. The redesign, which adds two additional bolts to each connection angle, satisfies AASHTO Standard Specifications for Highway Bridges, Sixteenth Edition, 1996, Subsection 10.24. 6.1, Sealing Against Moisture Penetration. The vertical leg of the angle is made longer to allow the bolt to be moved closer to the center of the connection, without interfering with the W-section/angle weld.

DRILL 11/16" DIA HOLES TO TEMPLATE FOR 2 1/2" x 5/8" DIA BOLTS, NUTS, FLAT WASHERS & LOCK WASHERS

- A. Replace all A-588 bridge-mounted sign supports with galvanized steel sign supports. Replacement/repair procedures are outlined in the following changes to the MDOT Sign Standard Plans VIII-820E and VIII-830E:

- i. The connection interface (faying surface on the beam web, and the support angle, if it is not galvanized) should be blast cleaned and primed with organic zinc-rich paint.

- ii. If the beam is unpainted A-588 steel, the paint color shall be "Brown Weathering Steel," Federal Code Number 10062, and the paint shall overlap the perimeter of the connection by 2 inches, otherwise blend the paint to the existing paint.

- iii. Bolts shall be long enough to extend beyond the top of the nut at least two thread pitches.
 - iv. The perimeter of the connection should be sealed with an approved silicone sealant in accordance to Subsection 713.03F of the Standard Specifications.

- v. High strength A-325 Type 3 bolts should be used when attaching a support to A-588 steel.
 - vi. The bolted connection of the sign support to the beam web shall be according to Subsection 707.03.D.9 of the Standard Specifications.

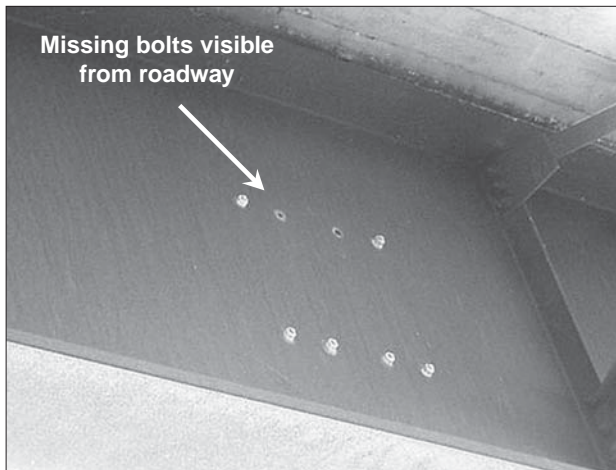
Figure 2. Example of what inspectors should look for during roadside inspections of bridge

- B. Bridge inspectors should inspect bridge-mounted sign supports for pack rust, missing bolts, short bolts (bolts that do not project completely through the nut), or impact damage.

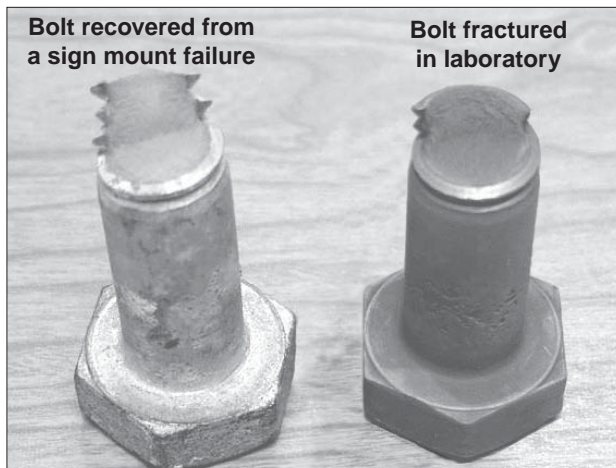
Figure 3. Recovered and Test Bolt Comparison

To confirm that the bolts used on the sign supports had adequate strength, and to demonstrate how pack rust could fracture the bolts, investigators tested bolts, comparing bolts fractured in the laboratory with fractured bolts found in the field. Bolts removed from a sign support were tested in accordance with ASTM A-

370, Section A3, "Mechanical Testing of Steel Products, Annex 3.2.1.5 - Tension Testing of Full Size Bolts with a Wedge." The bolts were 5/8-inch diameter, galvanized ASTM A-325 Type 2. Test results for the wedge test are shown in Table 1. All bolts met the required tensile strength of 27.1 kips. Figure 3 shows a bolt recovered from a sign mount and a bolt fractured by a wedge test in the laboratory. The failure surfaces are similar, indicating a similar wedge effect produced by the pack rust. Bolt head displacement for bolts subjected to tension tests in the laboratory (Table 2) show how far the test bolts stretch before failing. Investigators measured pack rust on the failed sign connection, finding build-up 0.225 inches thick, which is more than the 0.171 inches required to fracture a test bolt.

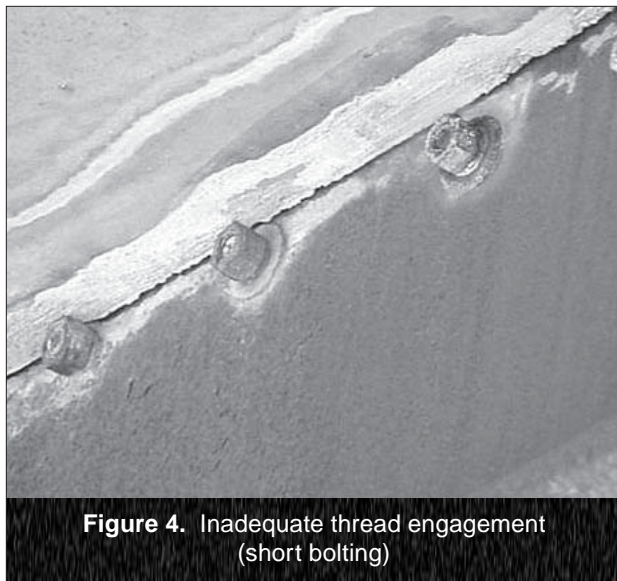
Figure 4. Inadequate thread engagement (short bolting)

Another problem found was short bolts. For a bolt and nut to offer full design strength, it must have full thread engagement with the end of the bolt, extending to at least flush with the face of the nut. Several sign support connections found during the investigation had improper thread engagement (Figure 4). Common industry practice specifies that two thread pitches protrude above the top of the nut to avoid chamfered threads at the bolt ends (Short Bolting).
