OFFICE MEMORANDUM

STATE HIGHWAY DEPARTMENT

February 24, 1964

Subject: Progress Report on the Experimental Transverse Joint Project:
I 96 from Meridian Rd to Wallace Rd. Research Project R-60 F-58.
Research Report No. R-452.

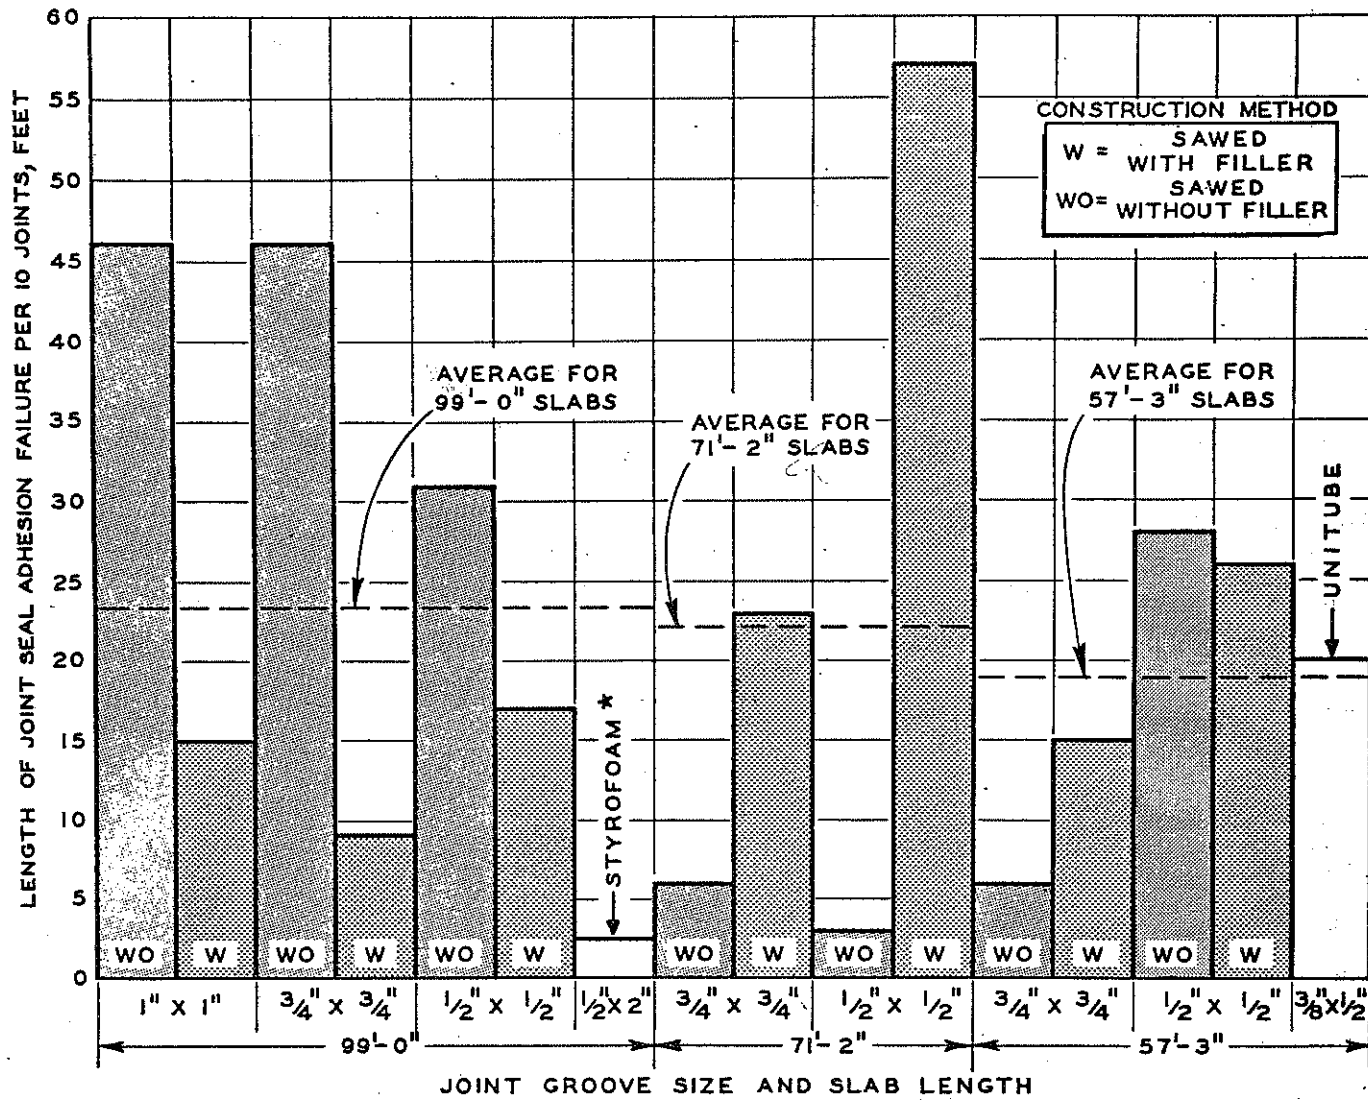
Figure 1. Effect of slab length, joint groove size, and joint crack forming method on joint seal adhesion failure.

Mr. MacDougall states that "they have reported that the sawed joints on I 96 near the Livingston County Line, which were sealed with your standard rubber asphalt compound, are in good-to-excellent condition with very little spalling." In a survey of joint seal performance by J. E. Simonsen and L. T. Oehler on February 10, 1964, the data in Fig. 1 on joint seal adhesion failure were obtained. In the first winter (1962-63), there was no appreciable amount of adhesion or cohesion failure on any section of the project. The hot-pour joint seal is currently hard and not very pliable. This winter the beginning of joint seal adhesion failures is readily apparent. Bond has not been completely lost, but pulling away of sections of the joint seal is apparent to a depth of 1/8 to 1/4 in. along the joint groove face (Fig. 2). The length of adhesion failure varies from 57 ft for one section to as little as 2 ft for another, involving a total of 10 joints, or 240 lin ft. The use of shorter slab lengths (57 ft 3 in. and 71 ft 2 in.) has not appreciably reduced the amount of adhesion failure.

With respect to joint groove size, the general appearance of sealants in the 1- by 1-in. and 3/4- by 3/4-in. grooves is better than in the 1/2- by 1/2-in. grooves, even though as Fig. 1 indicates the adhesion failure may be greater in some cases for the larger groove sizes. The reason for this is that the seal in the larger grooves has not subsided nearly as much as in grooves of the smallest size (1/2- by 1/2-in.), and thus it is easier to observe the adhesion failure in the larger grooves than in the smallest ones. This subsidence of the sealer in the 1/2- by 1/2-in. groove leaves only a small area of contact between the groove face and the seal, since most of it has receded into the plane of weakness crack below the groove. In the case of 1/2- by 2-in. joint grooves, the sealant has also subsided considerably, and in some cases is covered with dirt or small stones which occasionally have already penetrated into the sealing material. Of all the groove dimensions observed, sealants in this 1/2- by 2-in. groove size were most wrinkled and adulterated. Only in grooves of this size were appreciable cohesion failures found (Fig. 3), which might be considered a more serious deficiency than the minor adhesion failures discussed previously.

* The joint seal in these joints is depressed more than in any of the others and cohesion failure has occurred in the center of the depressed seal. A total length of 42 ft of cohesion failure per 10 joints was noted. Because of the depressed surface of the seal, sand and small stone infiltration appears more serious in these joints.

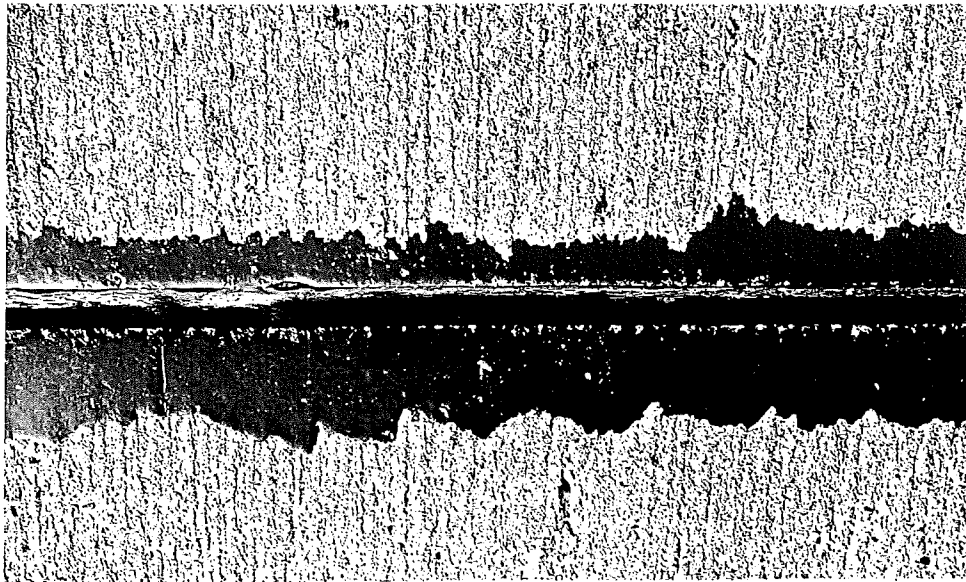
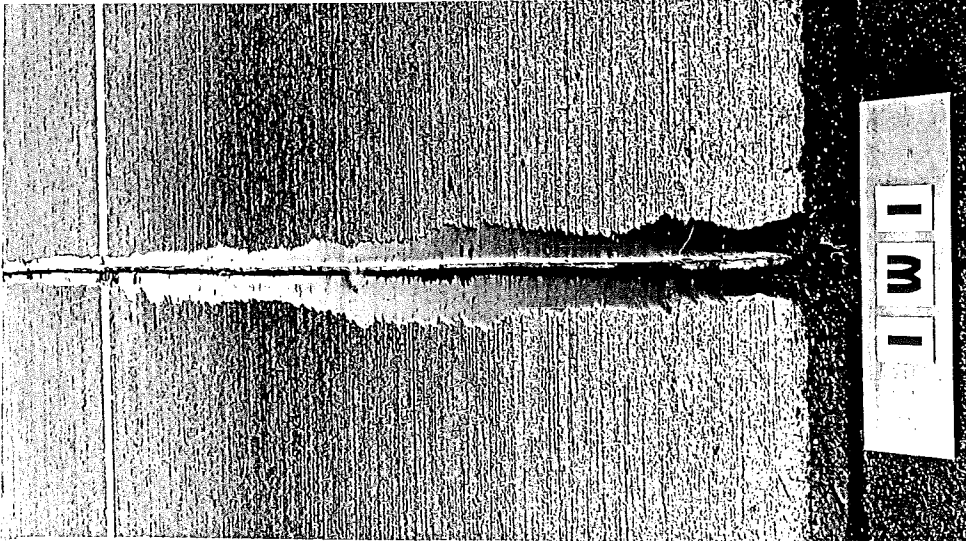
Figure 2. Overall view (left) and detailed view (right) of typical adhesion failure of joint seal.

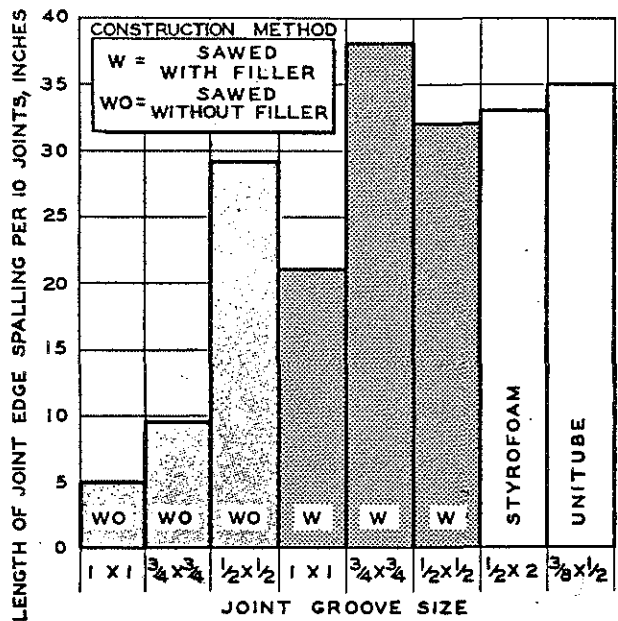
The amount of joint groove edge spalling on the various experimental sections is shown in Fig. 4. No distinction is made with respect to slab length, since that is not particularly pertinent to this performance item. It appears that sawing the joint groove, particularly for the wider grooves, resulted in less spalling than where the groove was formed by styrofoam or Unitube crimping. Since initial spalling occurs adjacent to the plane-of-weakness sawcut or bituminous filler, subsequent cutting of the wider joint groove obliterates or absorbs these initial spalls, resulting in an apparent reduction of overall edge spalling.

Figure 4 (left). Effect of joint groove size and joint crack-forming method on joint edge spalling.

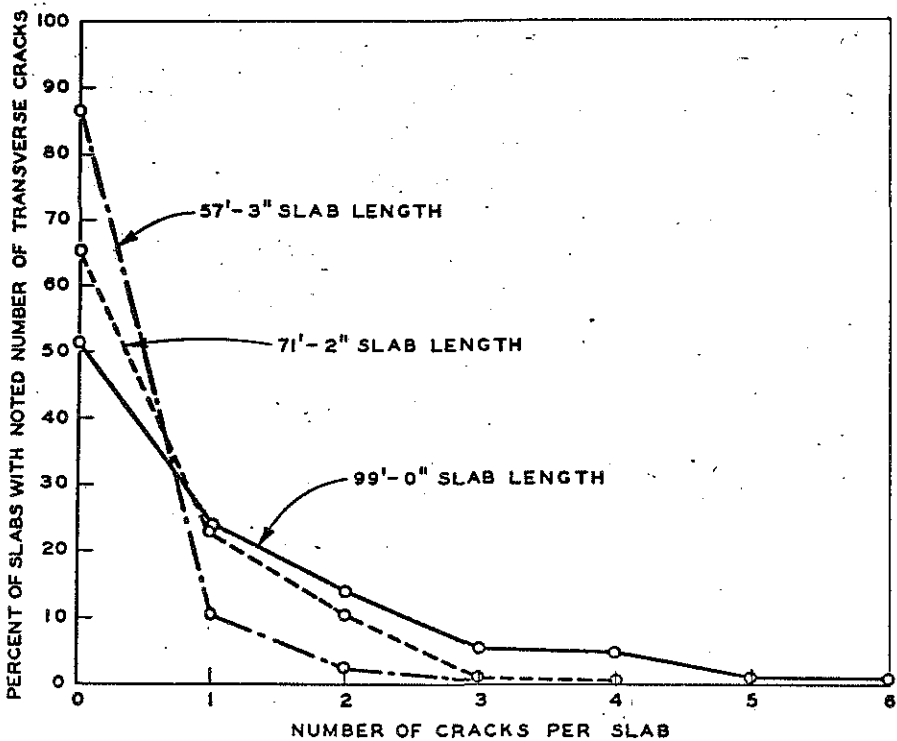
Mr. MacDougall states that "it was also their opinion that the reduction in slab cracking during the first two seasons would warrant serious consideration to a reduction in slab length on future work." It is to be expected that reduction in slab length will reduce transverse cracking and the Bureau's observations are confirmed by Figs. 5 and 6, where a frequency distribution of the percent of slabs with 0 to 6 cracks per slab is shown for the three different slab lengths. These observations were made during the 1963-64 winter condition survey of this project, but do not include the Unitube section so that the sample size is approximately the same for all slab lengths.

Figure 5 (lower left). Effect of slab length on frequency of transverse cracking (traffic lanes only).

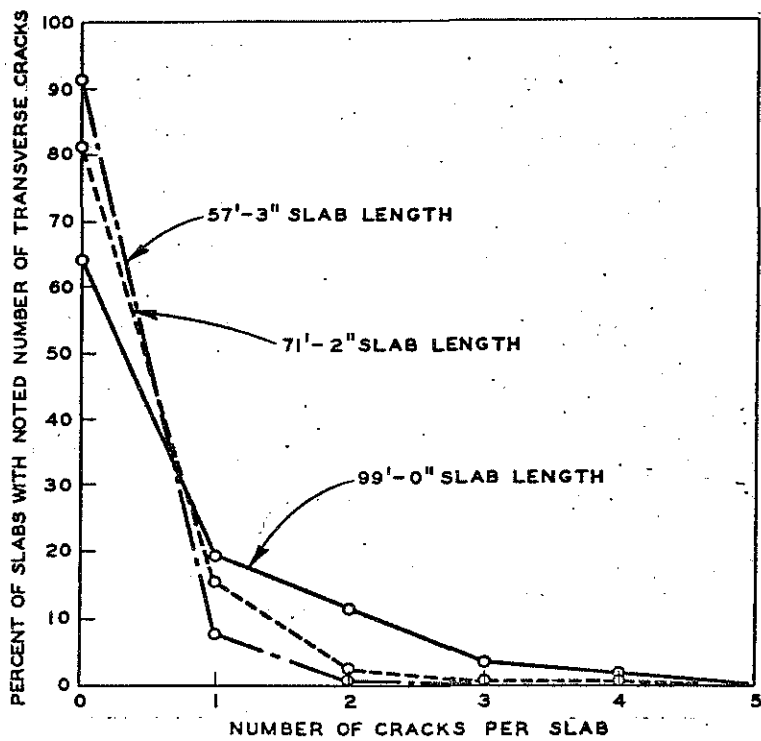
Figure 6 (lower right). Effect of slab length on frequency of transverse cracking (passing lanes only).

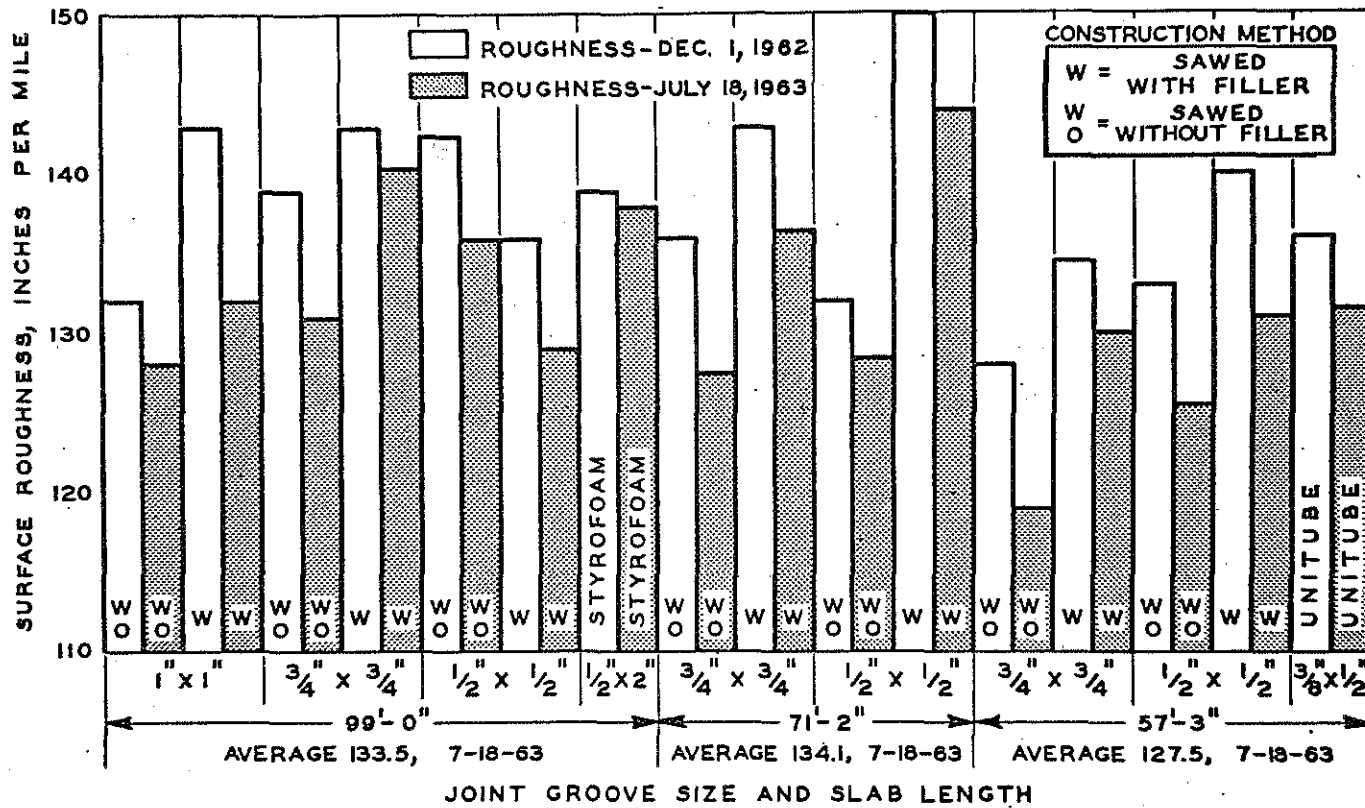
Another aspect of the experimental transverse joint study which is being followed is surface roughness. Fig. 7 indicates that two experimental features of this project appear to have no significant effect on surface roughness either as constructed or after approximately one year. One of these features is slab length; the latest roughness measurements give averages of 133.5, 134.1, and 127.5 in. per mi for 99-ft, 71-ft 2-in., and 57-ft 3-in. slab lengths, respectively. The other feature is joint groove width; it appears that the wider joint grooves do not contribute significantly to overall roughness.

Figure 7. Effect of slab length, joint groove size, and joint crack forming method on surface roughness.
