**CRASH TESTING OF MICHIGAN'S  
TYPE B (W-BEAM) GUARDRAIL SYSTEM**

**MIDWEST ROADSIDE SAFETY FACILITY**

MwRSF Research Report No. TRP-03-90-99

November 10, 1999

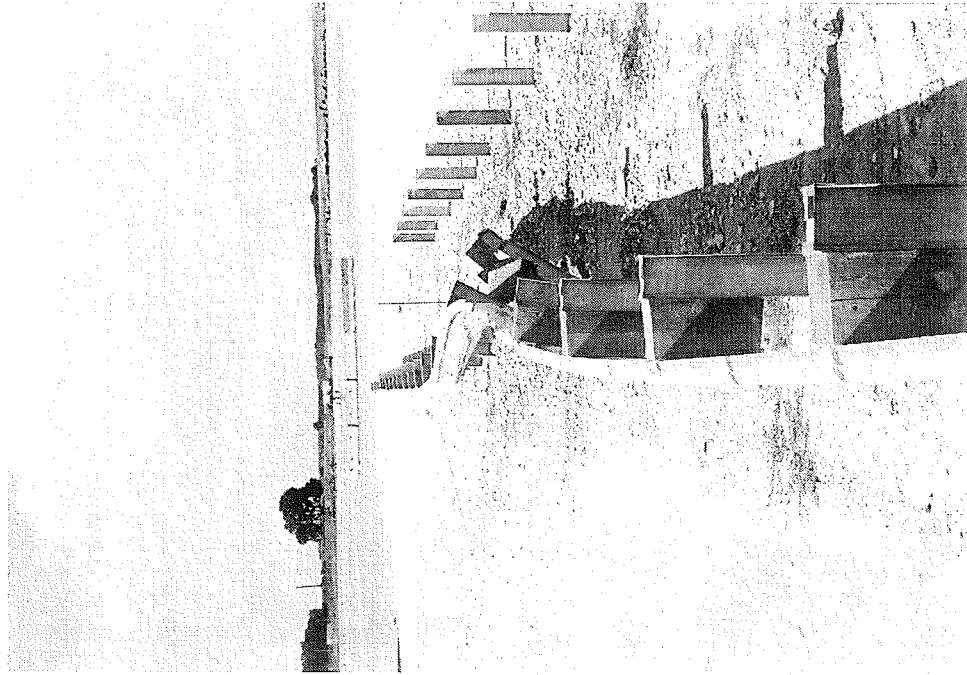
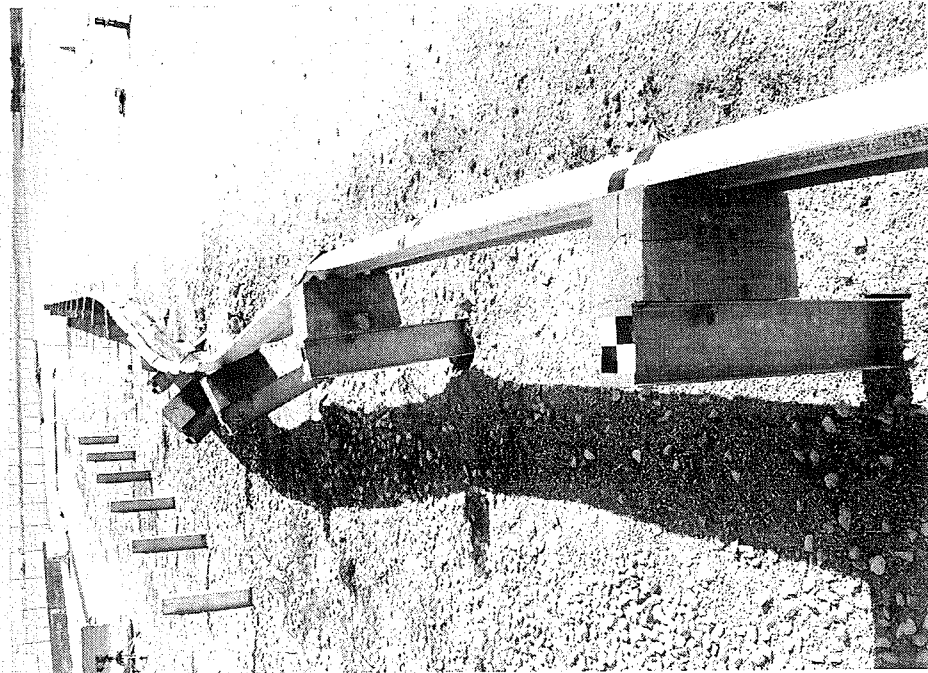
Figure 17. Type B Longitudinal Barrier Damage, Test MIW-1

Damage to the barrier was moderate, as shown in Figures 17 through 24. Barrier damage consisted mostly of deformed W-beam, contact marks on a guardrail section, and deformed guardrail posts. The W-beam damage consisted of moderate deformation and flattening of the lower portion of the impacted section between post nos. 13 and 14. Contact marks were found on the guardrail between post nos. 13 and 17. The W-beam rail at post nos. 13 through 15 was creased where the spacer block bears against the rail. The W-beam rail, 152-mm upstream of post no. 13, had a minor crease on the upper portion, while the W-beam rail's upper portion was creased 152-mm downstream of post no. 17. The W-beam rail was pulled off of post nos. 14 and 15.

Steel post nos. 3 through 10 and 19 through 27 moved backward slightly. Steel post nos. 11, 12, 17, and 18 were twisted and slightly rotated backward. Four steel posts, post nos. 13 through 16, were twisted and bent toward the ground. A 356-mm long tire contact mark was found along the upstream side of the front face of post no. 14. The lower-front face of post no. 15 was also slightly damaged. Both the upstream and downstream anchorage systems move slightly, but the posts were not damaged.

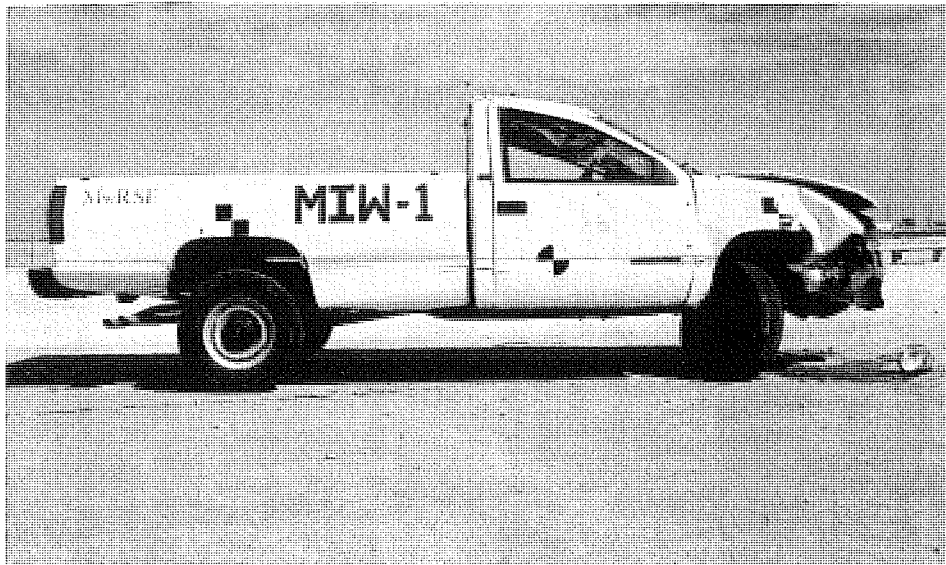
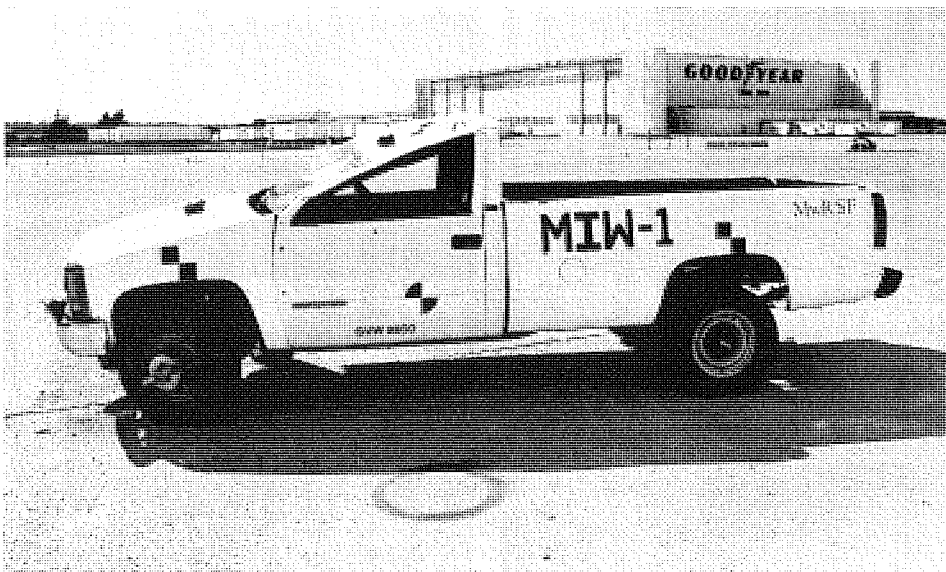
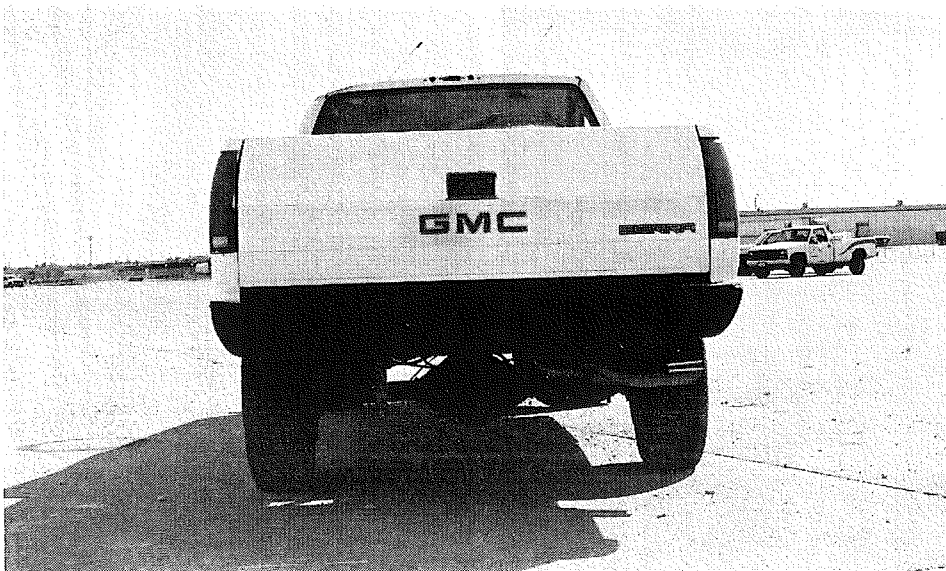
Figure 25. Vehicle Damage, Test MIW-1

Exterior vehicle damage was extensive, as shown in Figures 25 and 26. Interior occupant compartment deformations were determined to be negligible. The front bumper buckled at the centerline of the bumper and ripped at the right-front bumper attachment. The right-front quarter panel was crushed downward, and the right side of the front bumper was also bent back toward the engine compartment. The right-front wheel assembly was deformed to approximately a 90 degree bend and pushed into the frame. In addition, contact marks were observed on the rim as well as tie-rod disengagement. Small contact marks were found on the lower right side of the rear fender, the right-rear bumper, the outside surface of the right-rear tire, the lower right side of the truck box, and the right-side door. The roof, the A and B-pillars, and the left-front fender were crushed and deformed due to vehicle rollover. The windshield was cracked and deformed on the left side. Both the left- and right-side door windows were shattered. The rear window remained undamaged.
