WEATHERING STEEL GUARDRAIL
A MATERIALS PERFORMANCE EVALUATION

Research Laboratory Section
Testing and Research Division
Research Project 78 G-241
Research Report No. R-1155

Michigan Transportation Commission
Hannes Meyers, Jr., Chairman; Carl V. Pellonpaa,
Vice-Chairman; Weston E. Vivian, Rodger D. Young,
Lawrence C. Patrick, Jr., William C. Marshall
John P. Woodford, Director
Lansing, November 1980

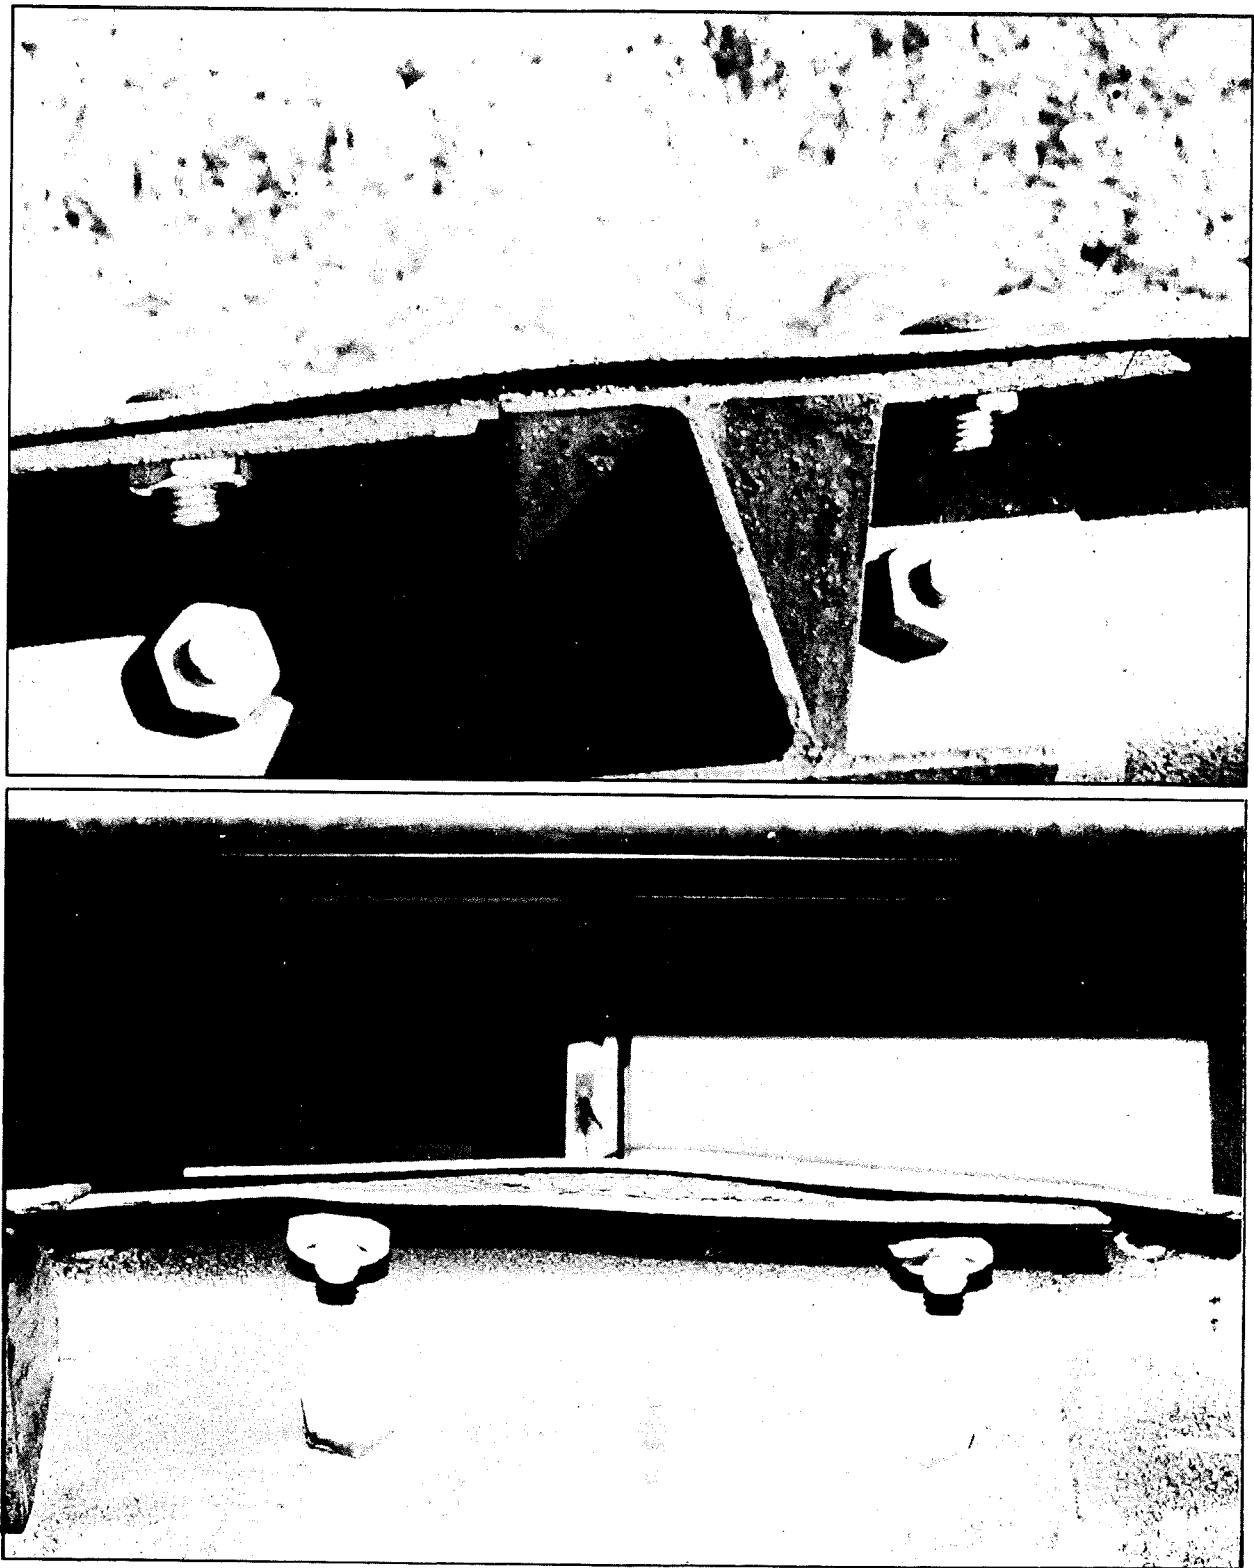
Among the oldest weathering steel structures in Michigan is a test stretch of guardrail installed in February 1963. A cursory examination of this test site in 1978 revealed bulging lapped joints, expanding outward from the internal pressure of the corrosion products (Fig. 1). Ultrasonic thickness gage measurements indicated that some areas in the joint had lost up to 40 percent of their original thickness. Further testing and evaluation seemed definitely in order.

Figure 1. Weathering steel guardrail lapped joint after 15 years of exposure.

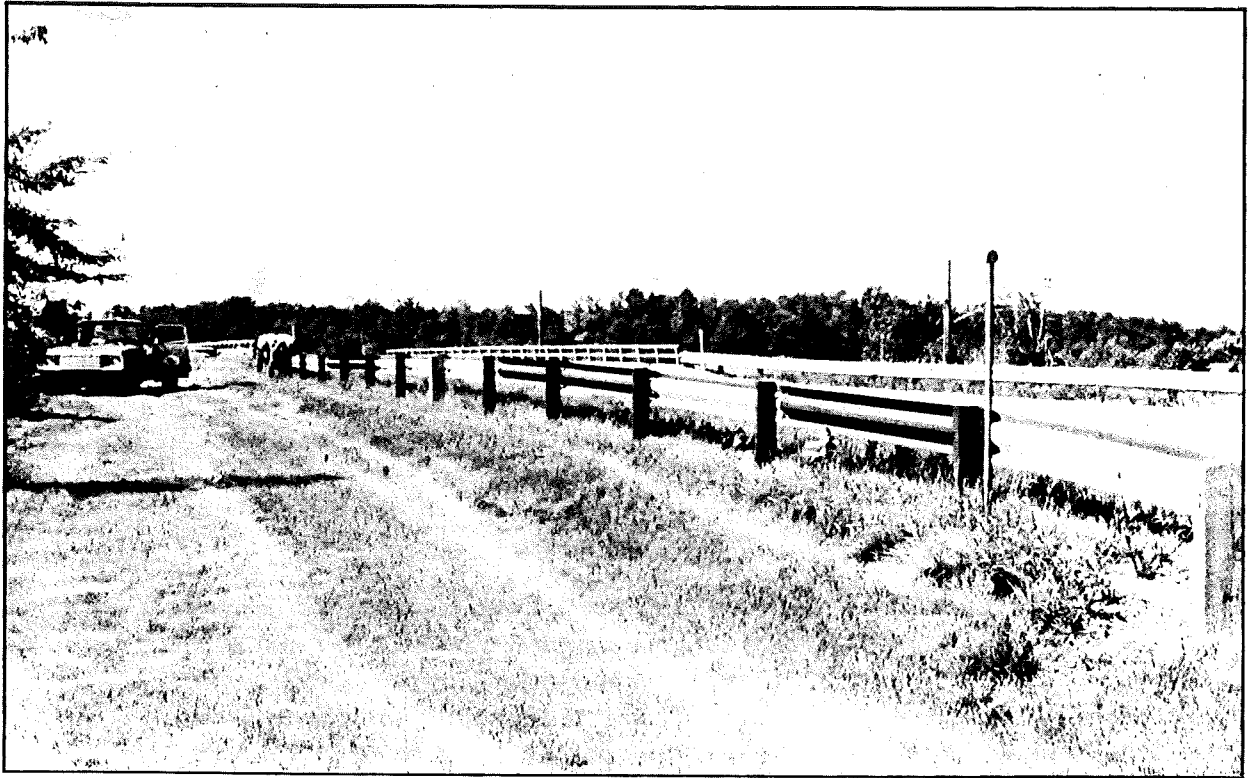
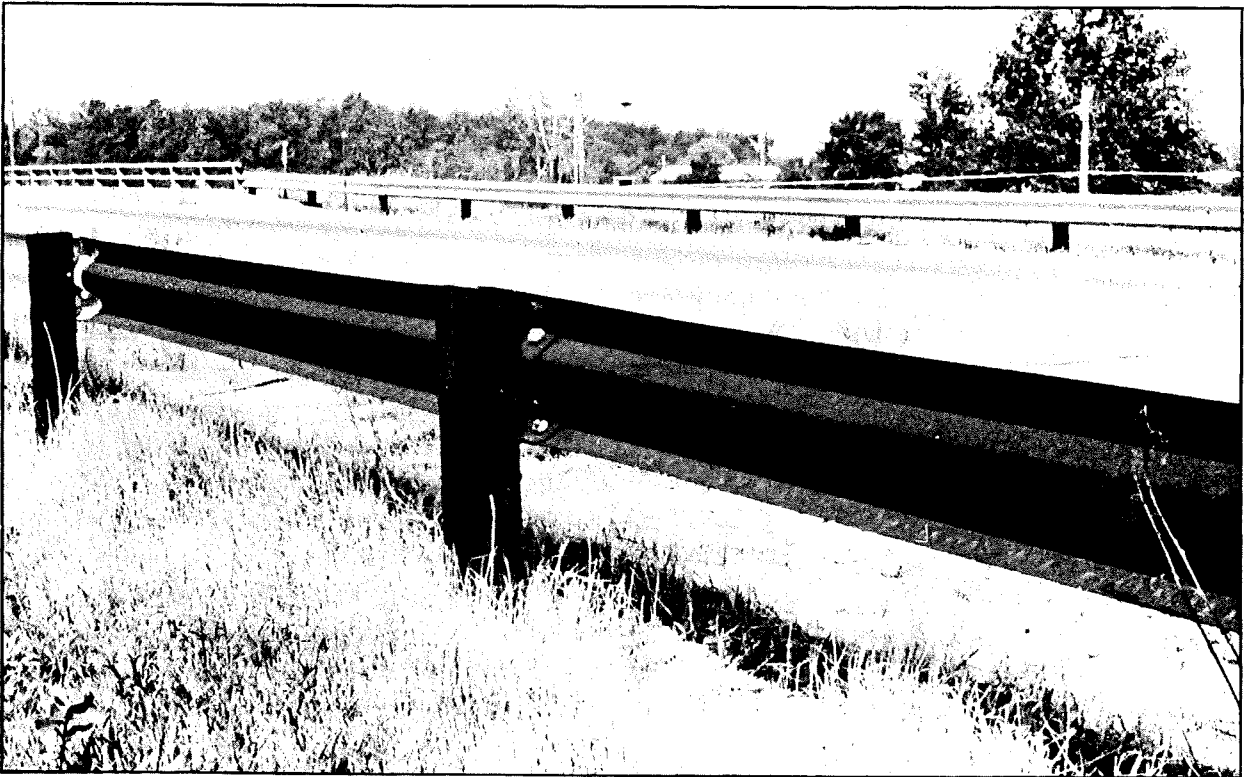
Old WSG was obtained from several very different service environments. Guardrail sections were removed from a Lansing area test site in mid-1979 after 15-1/2 years of service (Fig. 2). Sections from this same site had also been removed and tested by A. J. Permoda in early 1970 after seven years of service. This site is situated on a freeway around the outskirts of Lansing. While situated close to the city limits, the Lansing site is still three to five miles from areas of industrial activity and other major sources of pollution. This section of freeway, with a moderately heavy traffic volume, is representative of an environment roughly intermediate between rural and urban. Guardrail at this site is freely exposed so that alternate wetting and drying should be easily obtained (except in lapped joints). While the guardrail is sufficiently close to traffic lanes that the beams were exposed to salt-laden vehicle spray, the boldly exposed nature of the site allows for periodic washing by rainwater thus minimizing the time interval and the concentration in which pollutants can act.

Figure 2. Lansing site—typical highway environment.

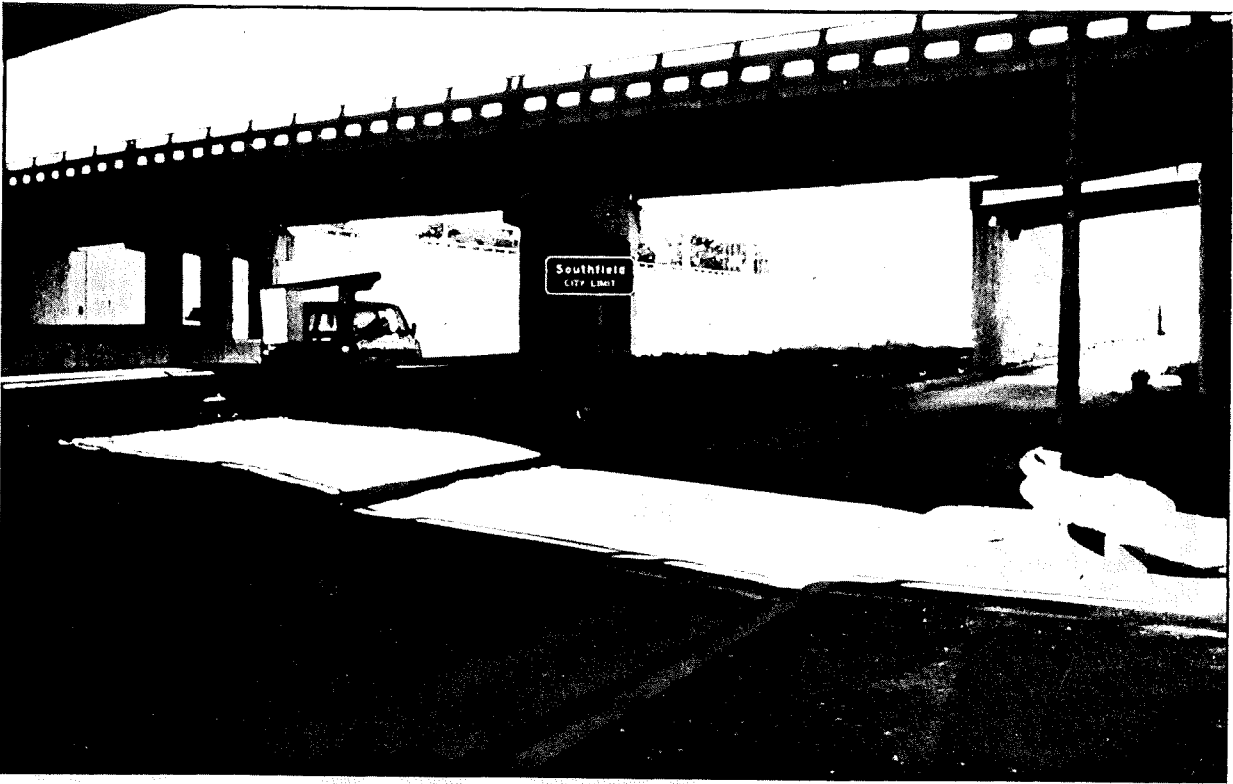
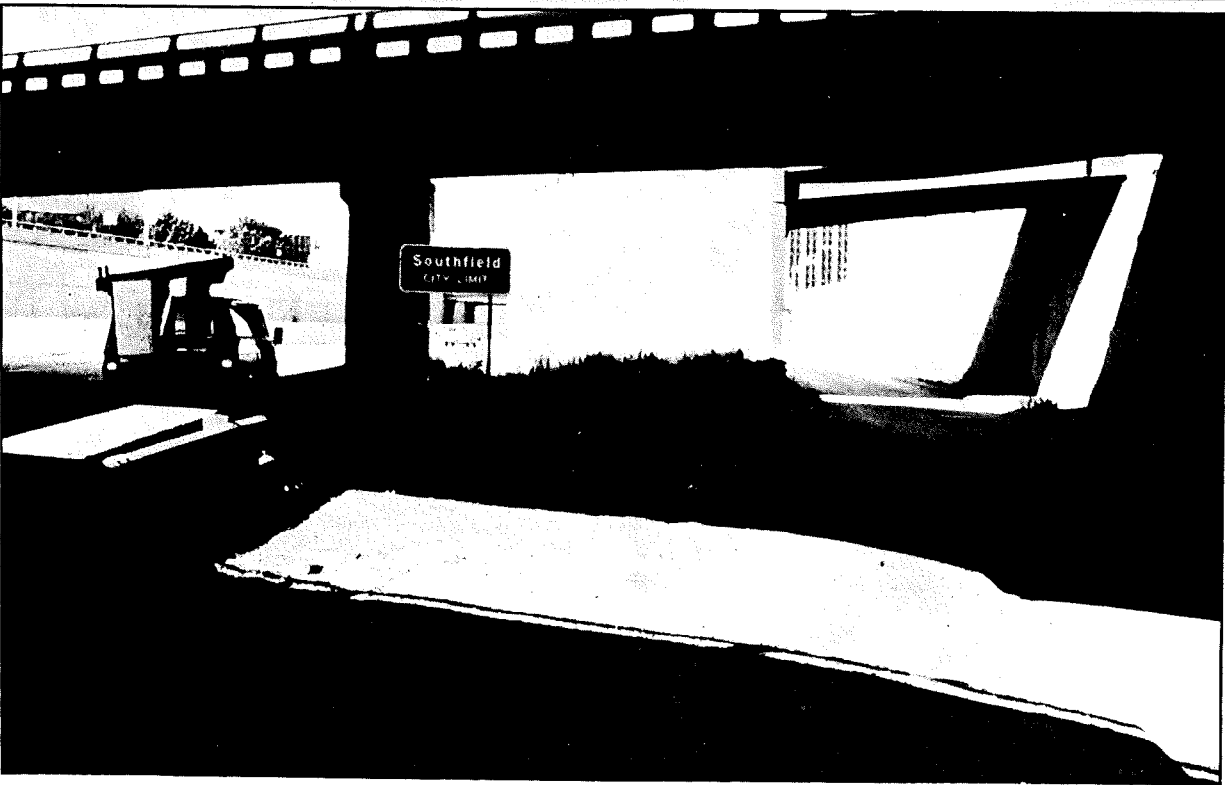
Figure 3. Detroit site—highly corrosive highway environment.

traveled urban site should be representative of what can be expected under extremely poor conditions. Of the two beams taken from this 'tunneled' freeway site, one was partially covered with trash and debris. Both were located under overhead bridges such that neither rain nor direct sunlight was allowed to aid in creating the alternate wetting and drying cycle deemed necessary to create a protective oxide coating. The WSG beams were also subject to all manner of roadway pollutants (most notably salt—the other major detrimental condition for weathering steels) distributed by passing vehicles. Without rainwater to wash the guardrail beams, pollutant deposits continue to build up (Fig. 4) and act in higher concentrations when moisture is present (dew, traffic spray, etc.).

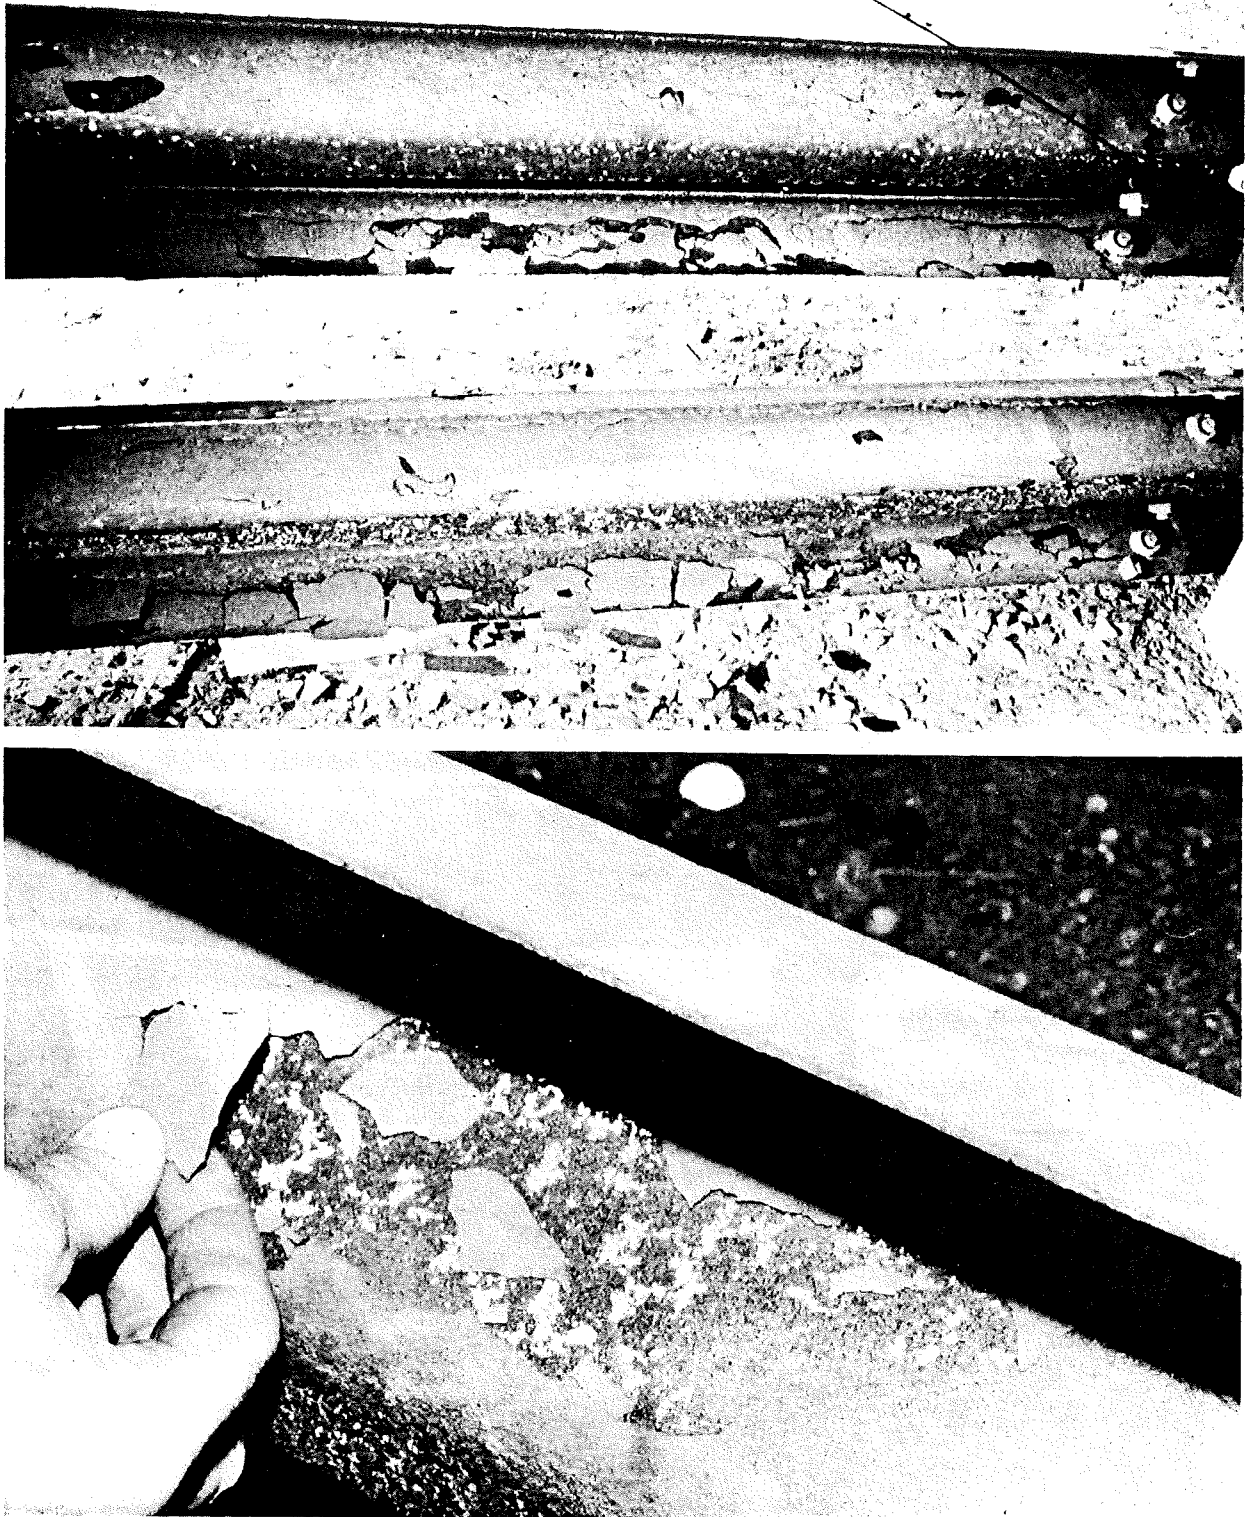
Figure 4. Close-up of weathering steel guardrail at Detroit site.

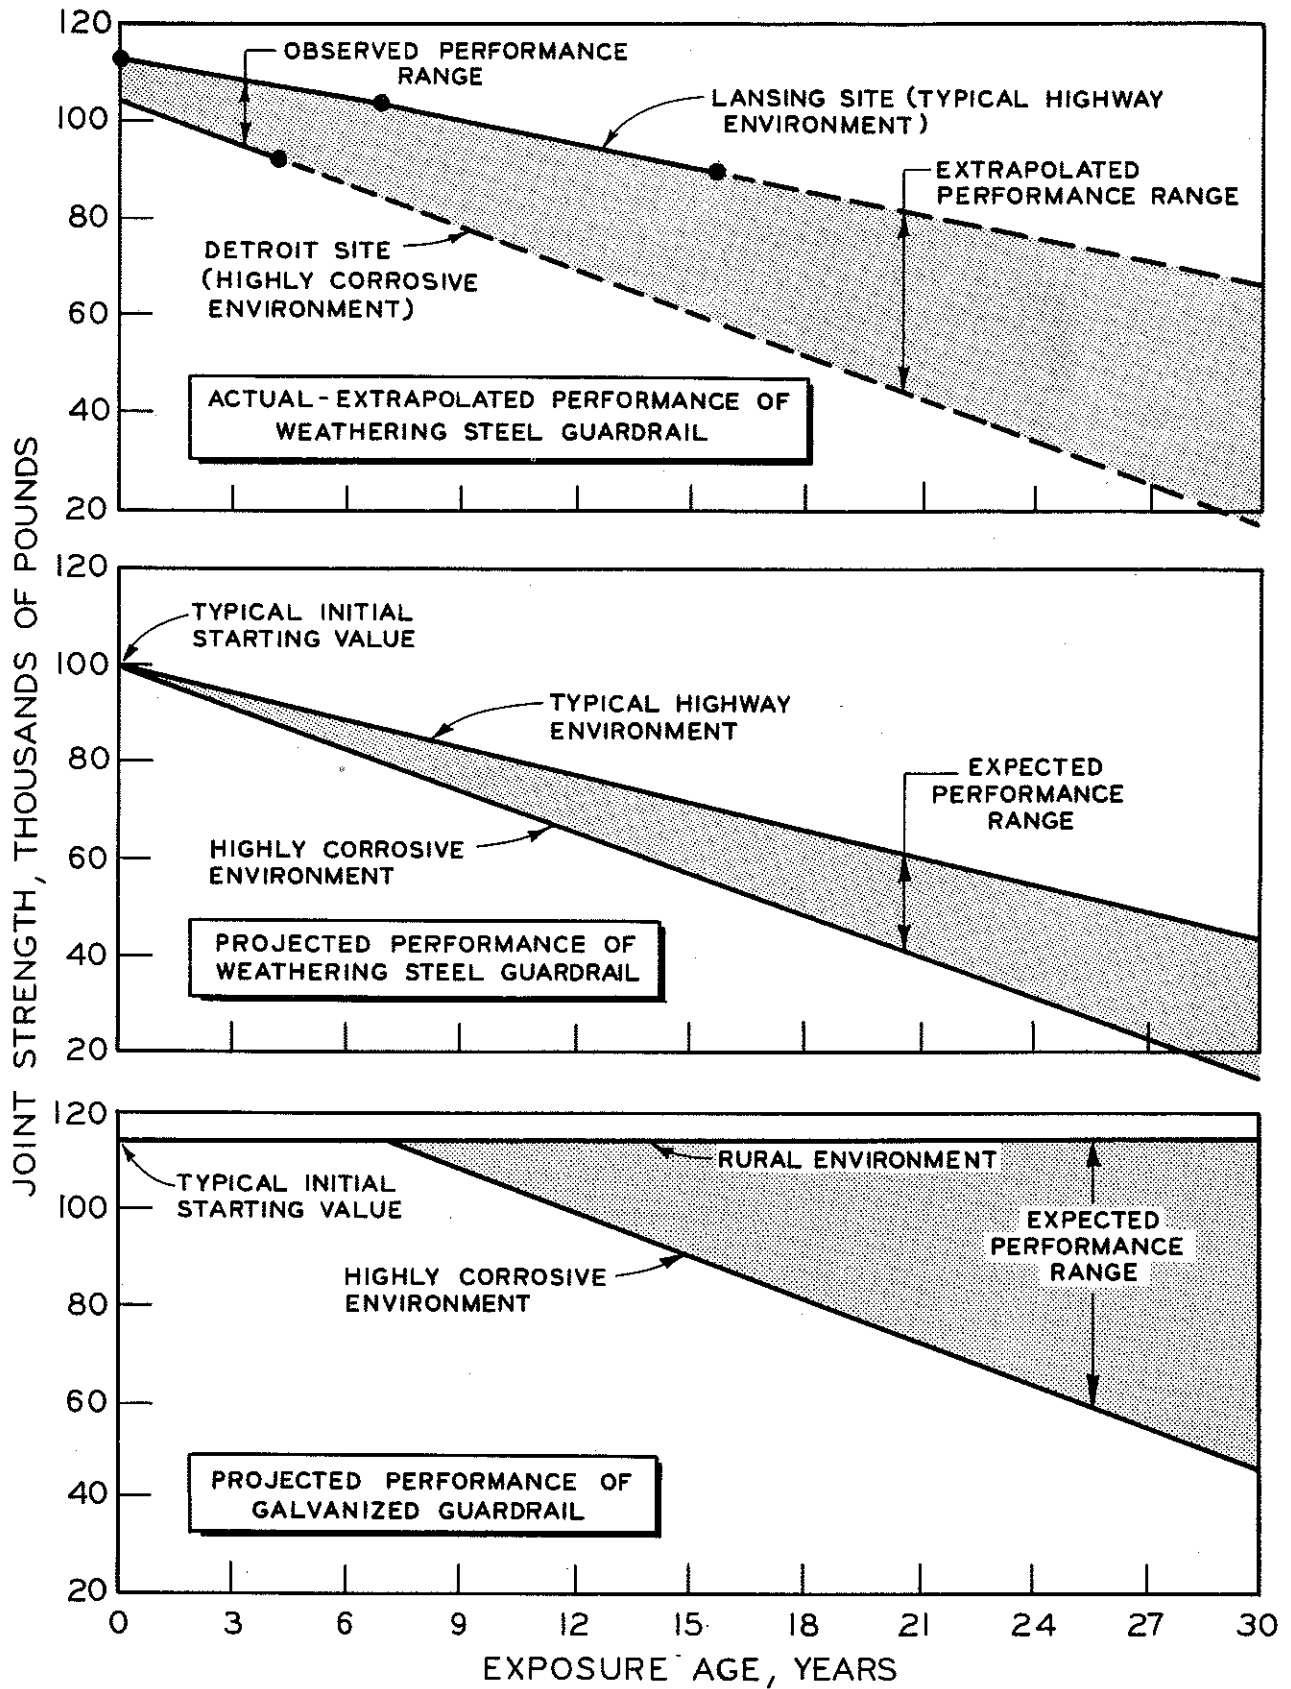
Figure 6. Guardrail joint strength actual and projected vs. exposure age.

Also very noticeable is the difference in corrosion rate between a 'typical' (Lansing site) environment and a highly corrosive (Detroit site) environment. These differences can be used to establish estimates of the limits of joint strength performance for the possible range of corrosion rates that can be expected to occur in our multitude of service environments (Fig. 6).

The major results of this investigation are summarized in Figure 6. In these graphs, joint strength deterioration vs. age is plotted for both a typical highway environment and a highly corrosive environment. In this manner, a representative performance range is established by upper and lower boundaries. The uppermost graph of Figure 6 depicts and extrapolates results actually observed for WSG. In the middle graph the observed deterioration rates for WSG are projected from a current typical initial joint strength.

Figure 6 establishes the same type of performance boundaries for typical GG as currently used in Michigan (AASHTO M 180-74, Class A, Type 2, 3.6 oz zinc coating). The upper limit is established by extrapolating a rural environment case, where the galvanized coating should remain intact for the full 30 years. The lower limit is developed for a severe industrial environment where the galvanized coating should be starting to spot with red rust after approximately seven years, (based on the American Society for Metals, predicted coating corrosion rate for a severe industrial environment). From this point on, the deterioration rate of the joint strength is assumed to approximate that of the WSG from the Detroit site—an extremely corrosive environment. This would appear to be a reasonable assumption. Studies have been performed by one of the major steel companies on weathering steel and plain carbon steel corrosion specimen suspended under the same bridges that sheltered the Detroit site guardrail (1, 2). For this particular highly corrosive environment, weathering steels

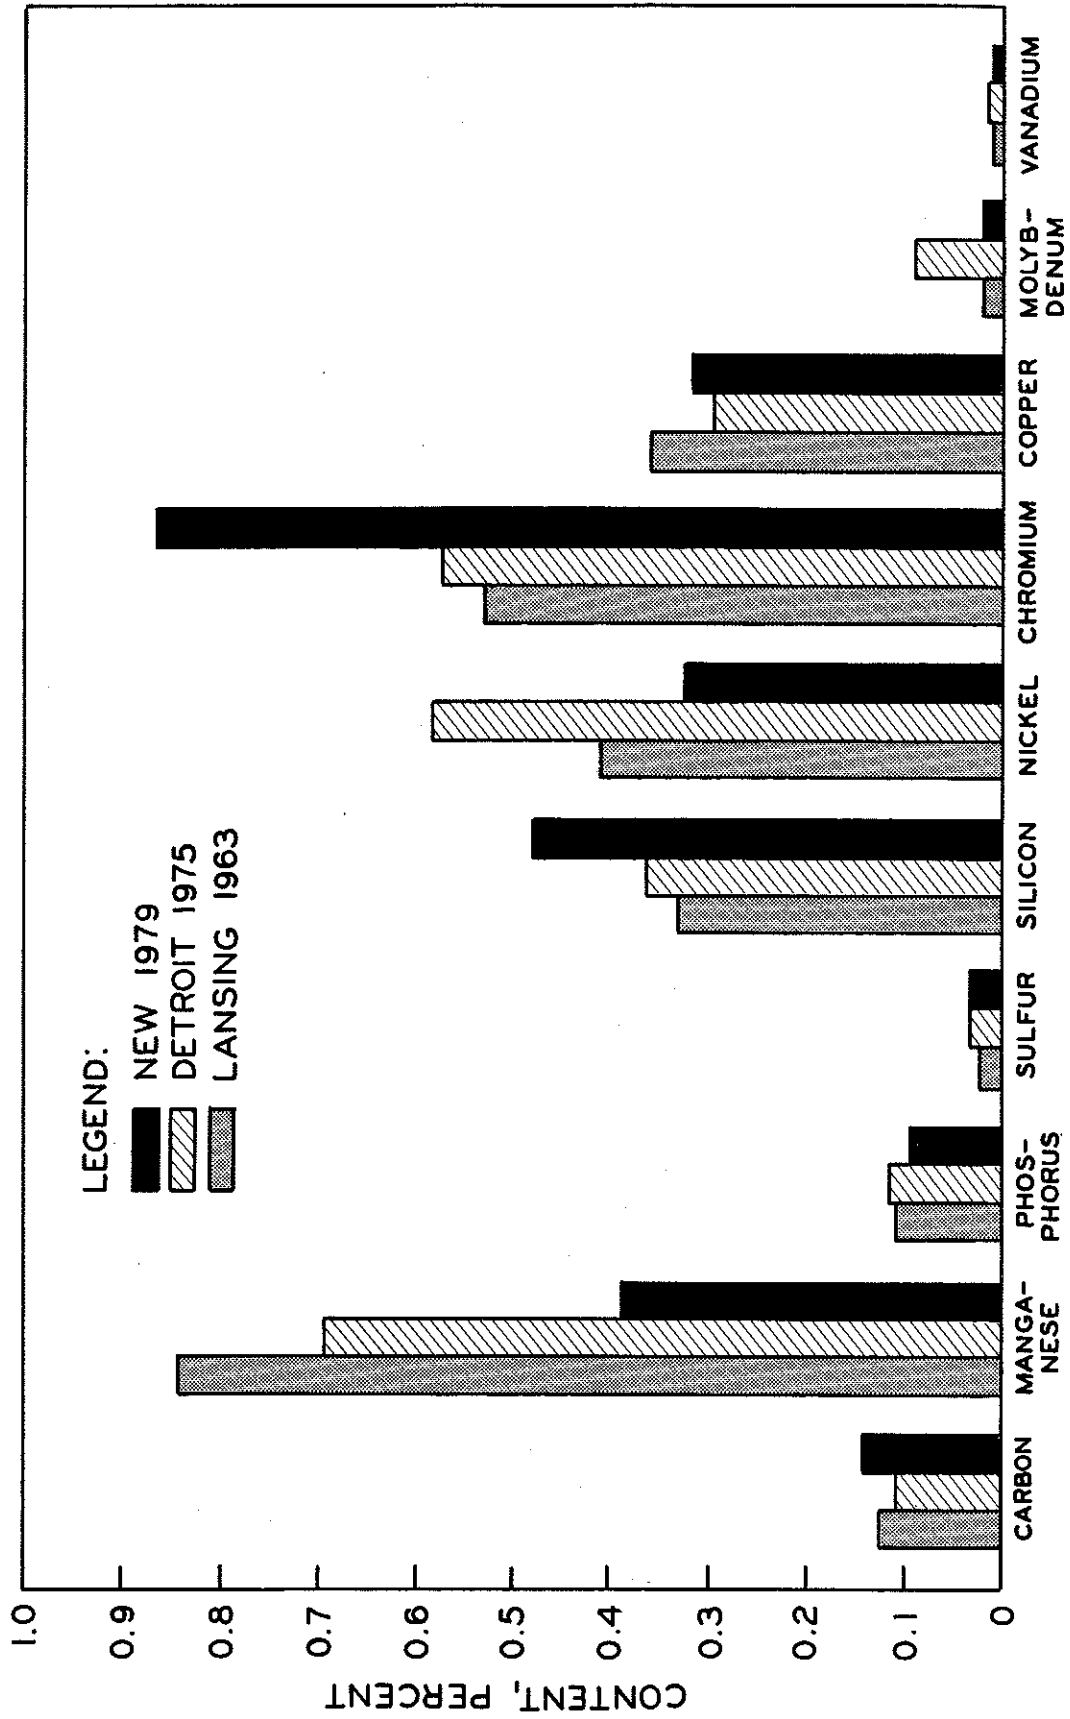
Figure 7. Chemical analysis of weathering steel guardrail (WSG).

Chemical analysis was performed for all of the major groups of guardrail. The results of these analyses are shown in Figure 7. The primary item of interest here is the difference in composition between the three groups (new; Detroit site, 4-1/4 years; and Lansing site, 15-1/2 years) of WSG. While it is very likely that the composition plays some role in influencing the corrosion rate of the freely exposed surface, there is reason to doubt that this same influence would be as significant in the lapped joint areas.

Since the beneficial metallic elements can be leached away in long term aqueous environments, the moisture retention abilities of the joint area would minimize, if not eliminate, the beneficial effects of the corrosion resistant elements. In other words, the performance of the section of the guardrail beam most likely to fail is possibly independent, or nearly so, of the weathering characteristics of the component steel (at least for the inner contact surfaces) within the limits of variation in chemistry that are present in these steels.
