MICHIGAN DEPARTMENT OF TRANSPORTATION
MDOT

CONCRETE PAVEMENT RESTORATION
Final Report

Research and Technology Section
Materials and Technology Division
Research Project 86 G-267
Research Report No. R-1327

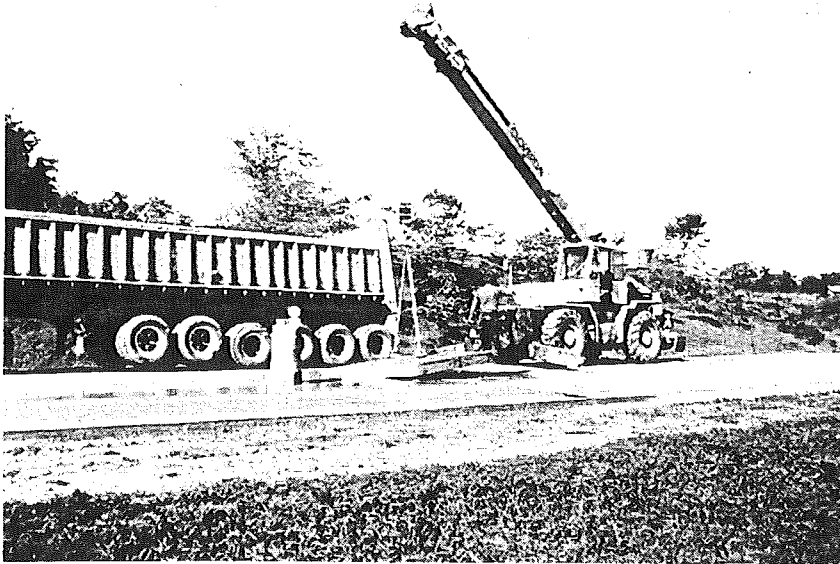
◀ Figure 1. Removing distressed pavement section.

The end limits of the repairs were sawed full-depth using a diamond segmented saw blade and the larger sections of the distressed concrete slab were lifted out without disturbing the base material (Fig. 1). After hand clean out of the repair area, the dowel holes were machine drilled. Two groups of five dowels, spaced 12 in. apart, are used in each end of a lane repair. Each dowel group is centered in each half-lane width, resulting in the first dowel being 12 in. from the lane edge and in a 24 in. spacing in the center of the 12-ft lane. The contractor used a five-gang drilling machine, hydraulically powered, to drill the holes. The dimensions of the holes were 1-3/8 in. diameter with a nominal depth of 7-1/2 in.

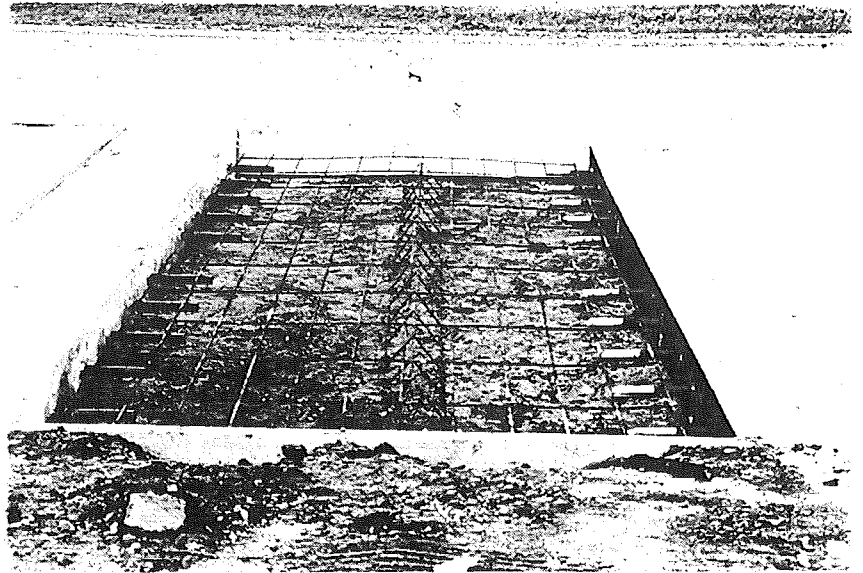
Figure 2. Repair area ready for concrete placement. (Contraction joint on the left, expansion joint on the right). ▶

Once the treatment of the dowels or deformed bars was completed, the repair area was formed and the reinforcement installed (Fig. 2). A 9-sack ready mixed concrete was used and consolidated using a hand-held immersible vibrator, screeded off, floated, broomed, and a curing compound applied. The transverse joint grooves were formed using a 1 by 1-in. wood strip inserted in the fresh concrete just prior to screeding the concrete surface. The joint grooves were sandblasted and cleaned with oil-free compressed air just prior to sealing with a low-modulus hot-poured sealant. Figure 3 shows a typical finished repair.

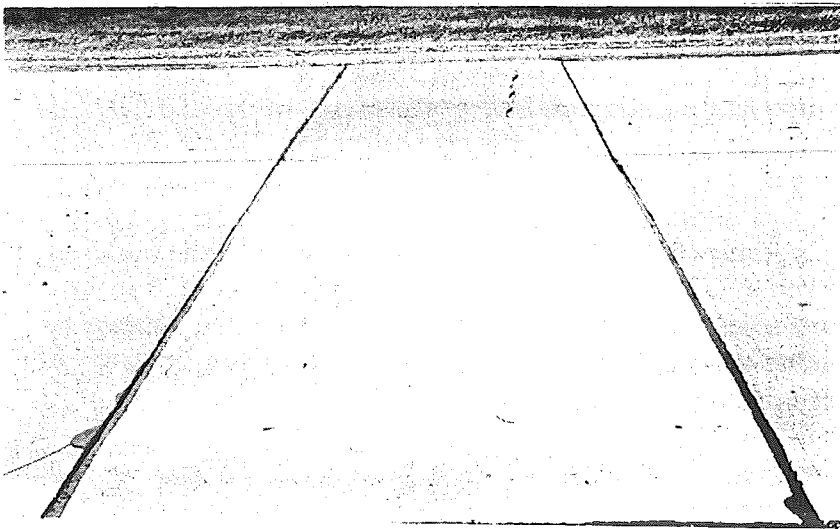
◀ Figure 3. Finished concrete repair.

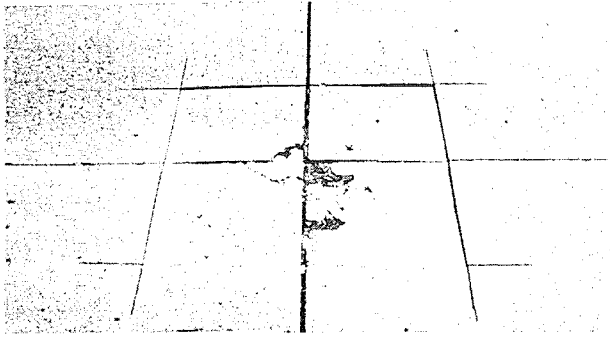
Figure 4. Sawed perimeter of a typical deteriorated joint intersection.

As previously mentioned, cores taken at the intersection of the transverse and longitudinal joints indicated that removal of a 2-ft wide by 4-ft long area of the slab would be sufficient to remove the deteriorated concrete. During construction it was found that in the majority of cases this area was adequate in size, but in a few cases it was necessary to increase the area by resawing to remove all the unsound concrete. Figure 4 shows a sawed deteriorated joint intersection.

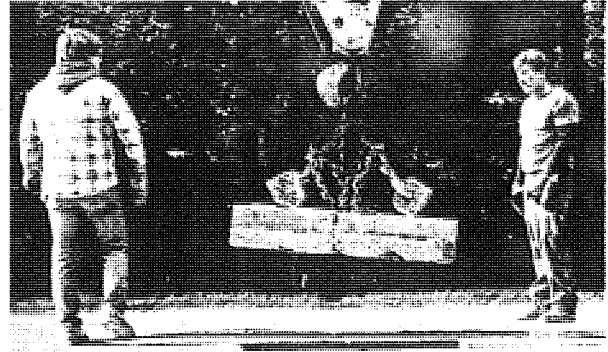
Figure 5. Lifting out distressed concrete at joint intersection.

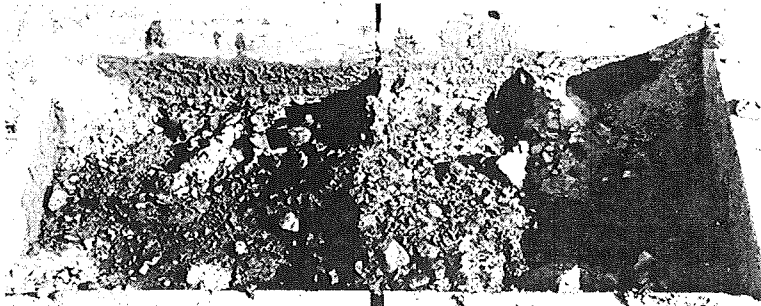
Figure 6. Deteriorated concrete in bottom of repair area.

bottom of the corners by drilling holes through the areas that were not sawed (due to inaccessibility of the saw blade) and then lifted out the section. In both cases, the debris in the repair area was cleaned out by hand (Fig. 6). The new concrete was tied into the existing concrete using 24-in. epoxy coated No. 5 deformed bars epoxy grouted into 3/4 in. diameter holes 6 in. deep (Fig. 7). The bars were located 4 in. from the surface of the slab. Four bars were used in the transverse direction and four in the longitudinal direction. The transverse bars were a nominal 10 in. from the ends of the repair and the longitudinal ones were 6 in. from each side. The holes were drilled by hand-held drills, downward at about a 20° angle to allow drilling in the confined space. Once the bars were in place, they were bent down so as to be approximately parallel to the surface. The dowels removed with the concrete were not replaced, but a 3/4 in. thick full-depth filler board was installed in line with the transverse joint to ensure that the new concrete would not be subjected to excessive compression. Figure 8 shows a finished repair before sealing.

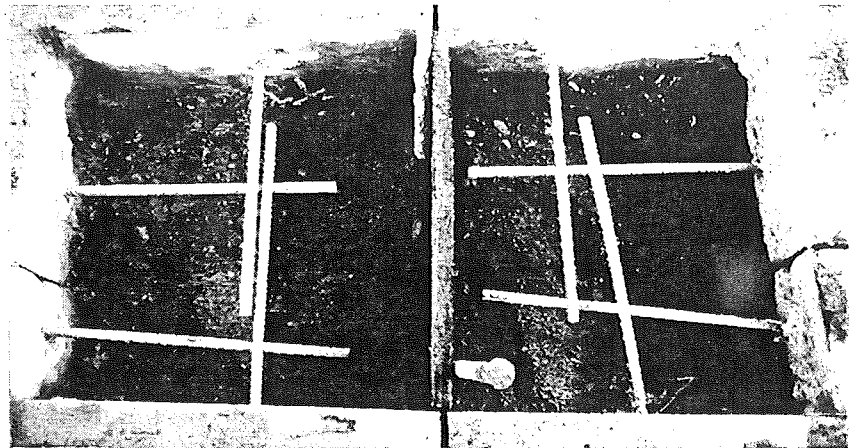
Figure 7. Joint intersection ready for concrete placement.

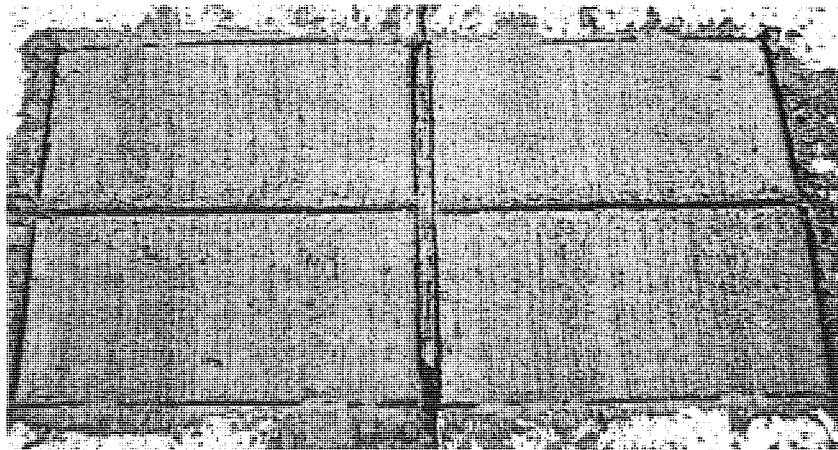
Figure 8. Finished repair before sealing joints.

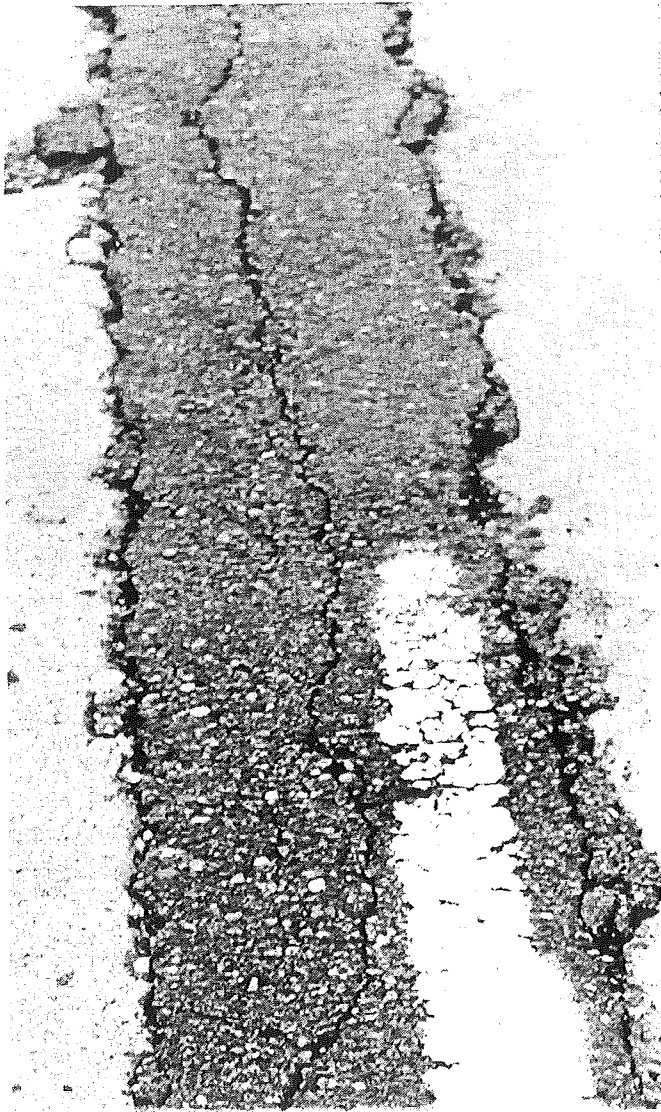
Figure 22. Typical 1988 condition of centerline joint on I 69 repaired with bituminous materials in 1984. ▶

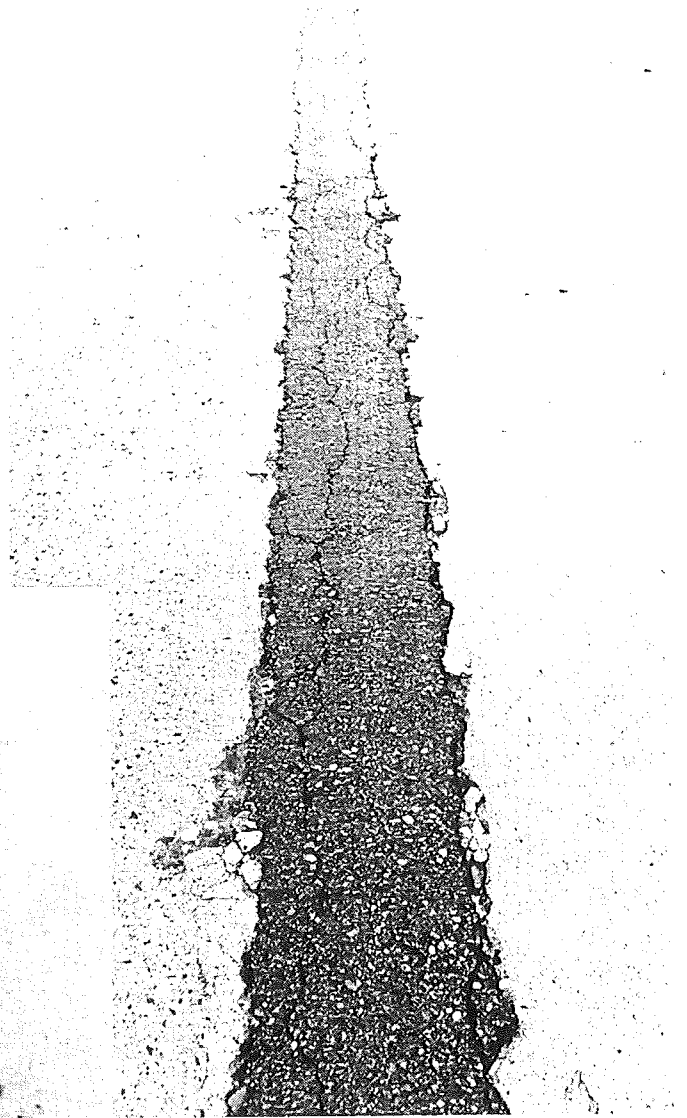
◀ Figure 23. Ravelling along edges and cracking over plane-of-weakness crack--4 years of service.

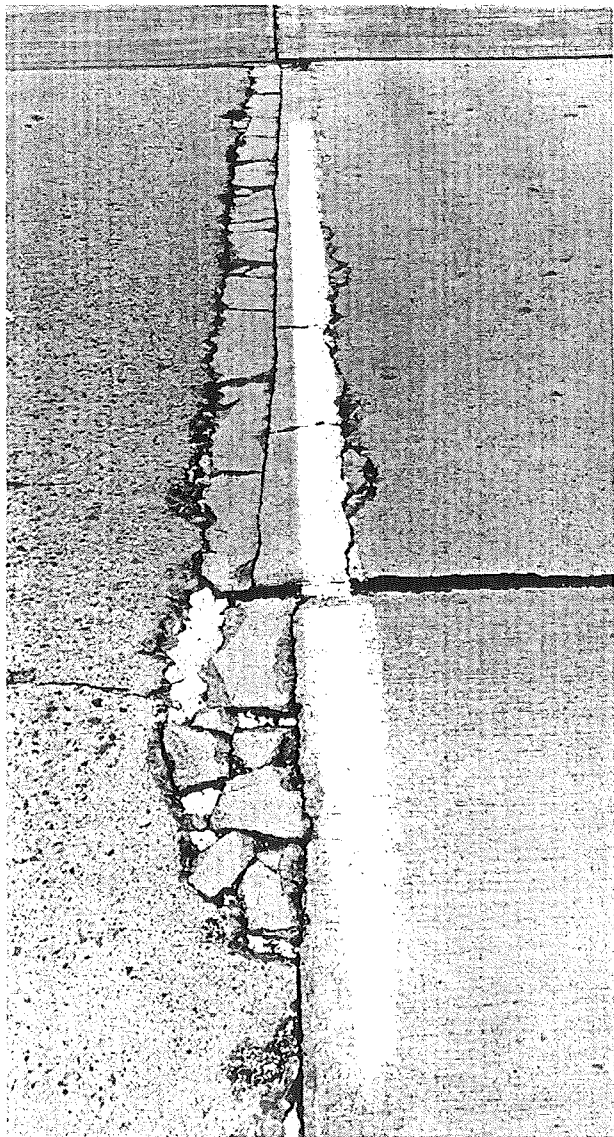
Figure 24. Typical condition in 1988 of centerline joint repaired in 1984 on I 69 using concrete.

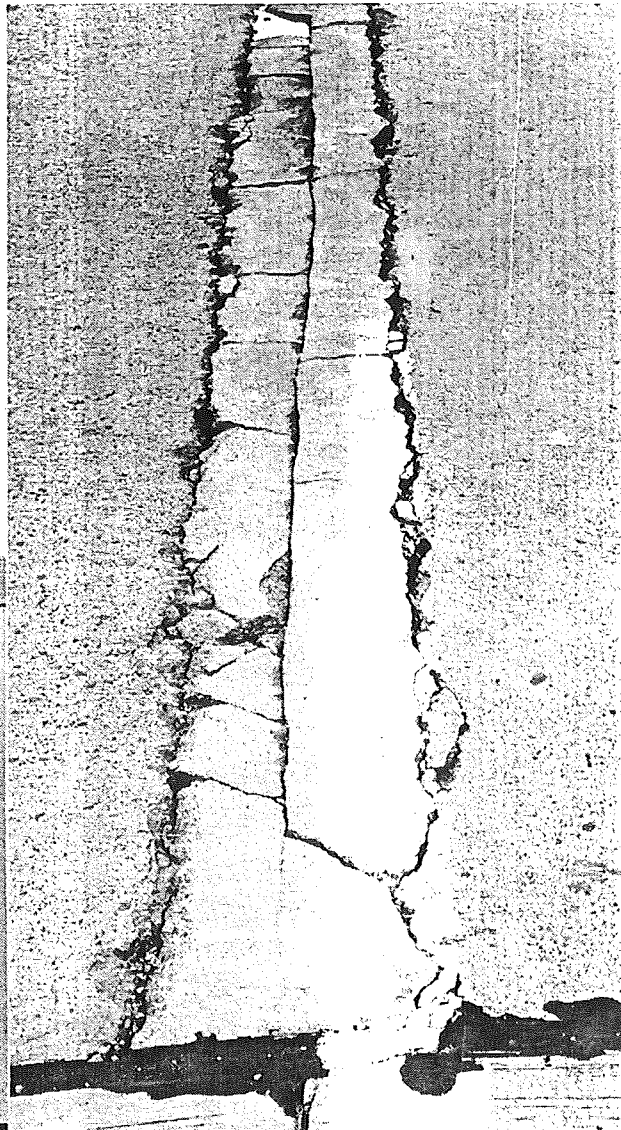
Figure 25. Severe cracking has occurred. Some of the concrete pieces are missing.

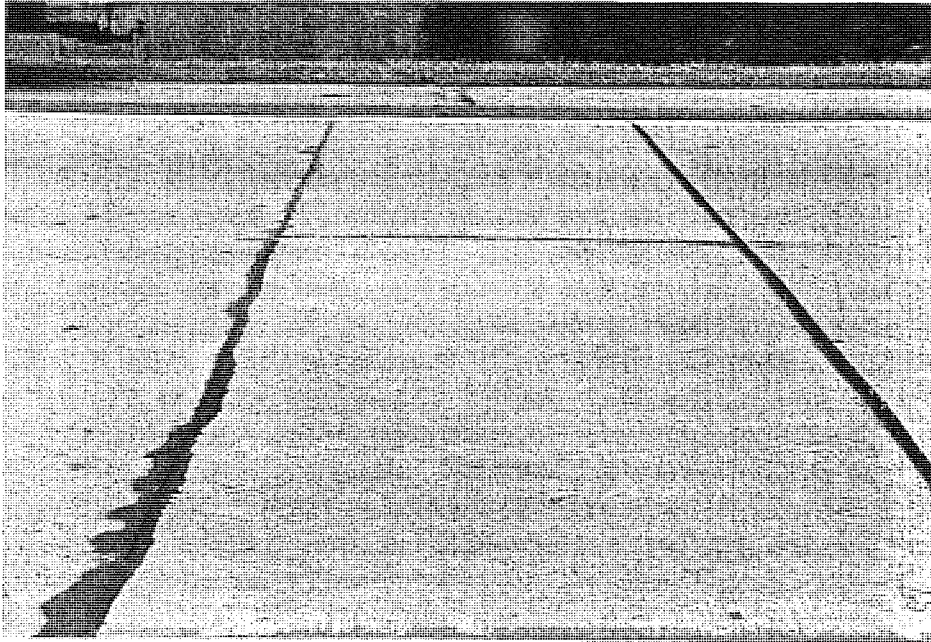
After six years of service, all full-depth repairs remain structurally sound with a minimum of spalling (Figure 26). It had been planned to use a Falling Weight Deflectometer to measure the load transfer capability of the grouted-in-place dowels. However, the unit was not available in time for this project. Vertical measurements do indicate that the load transfer has been achieved. Vertical differences (faulting) of only 0-1/8 in. were recorded. This small amount allows for acceptable levels of traffic noise and ride quality.

▲
Figure 26. Full-depth repair
in good condition.

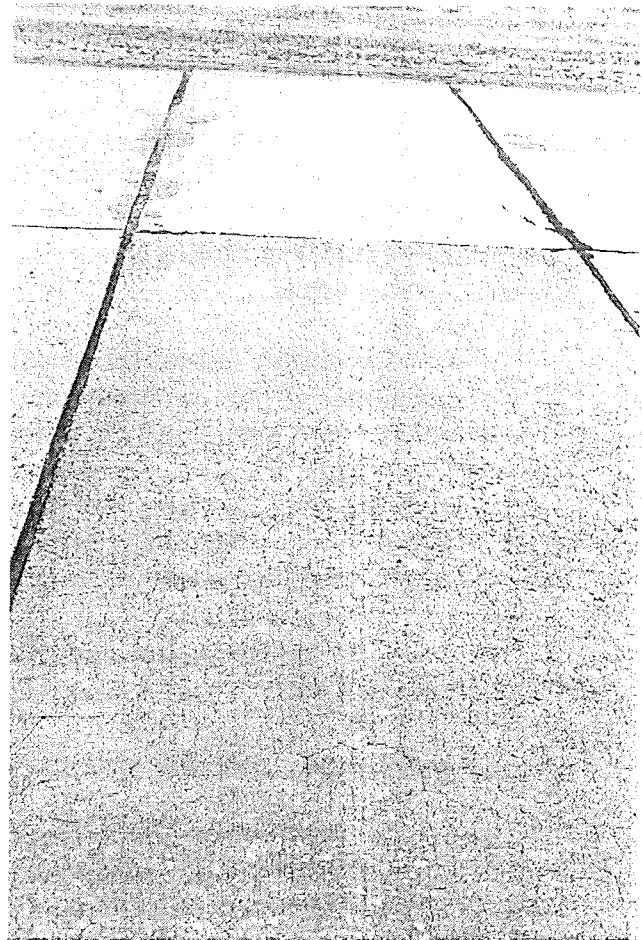
The problem most frequently observed was the presence of severe map cracking. This condition is described on page ten of the "Condition Survey Manual" and is rated as Severity Level 2 for previous repair distress. A less severely map cracked repair is shown in Figure 27. This problem is associated with shrinkage due to the heat generated from rapidly curing concrete. The problem is exacerbated by the addition of more chloride to accelerate hydration in cold weather. Unless slower cures can be tolerated, this problem,

▶
Figure 27. Moderate level
of map cracking.

at least to some degree, appears to be unavoidable. Surface spalling and scaling over the next few years can be expected requiring some maintenance repairs.

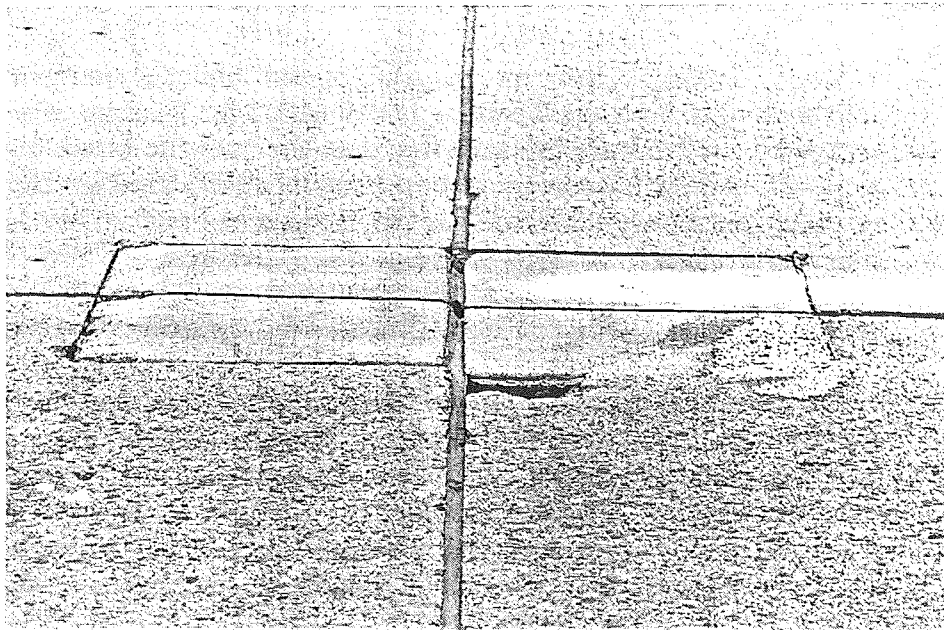
Figure 28. Settled full-depth centerline repair with spalling and cracking.

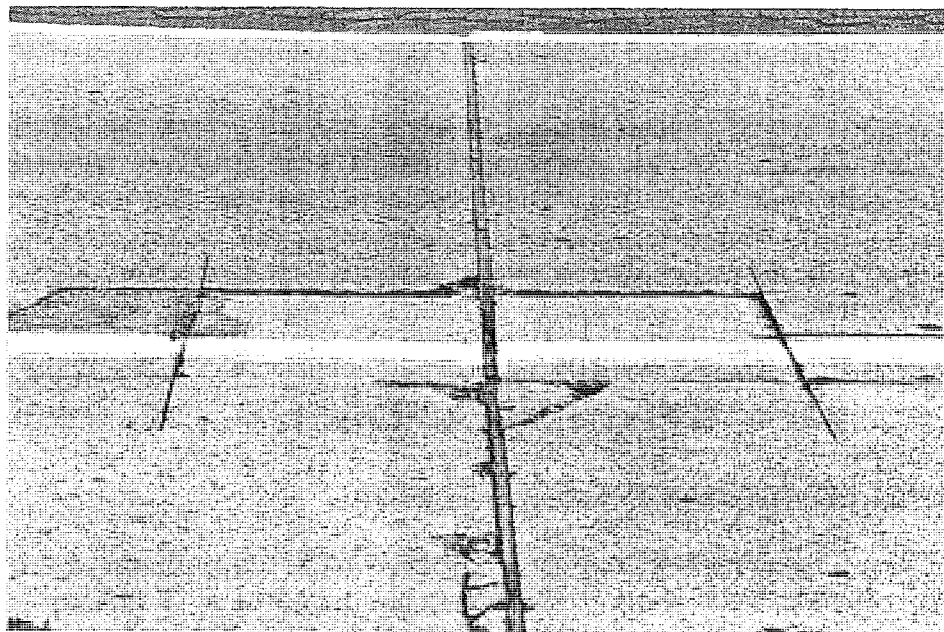
Figure 29. Damage to roadway concrete adjacent to patch.

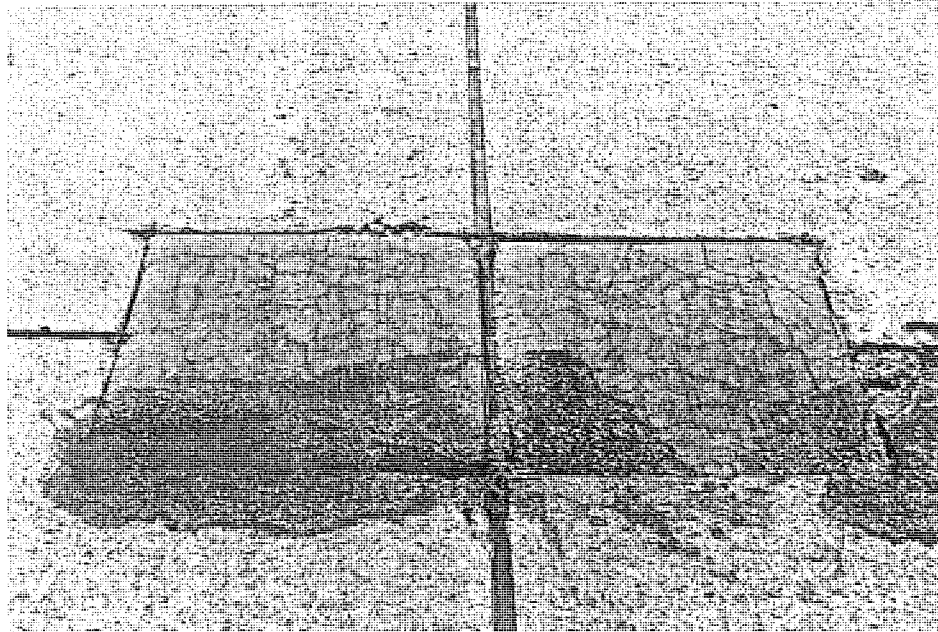
Figure 30. Severe map cracking.

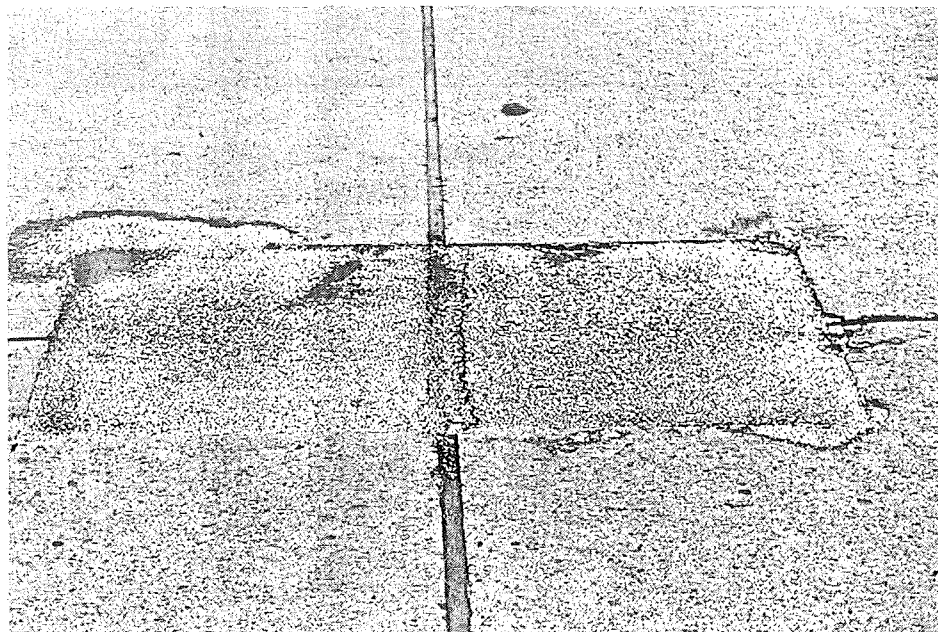
Figure 31. Bituminous repair of full-depth centerline repair.

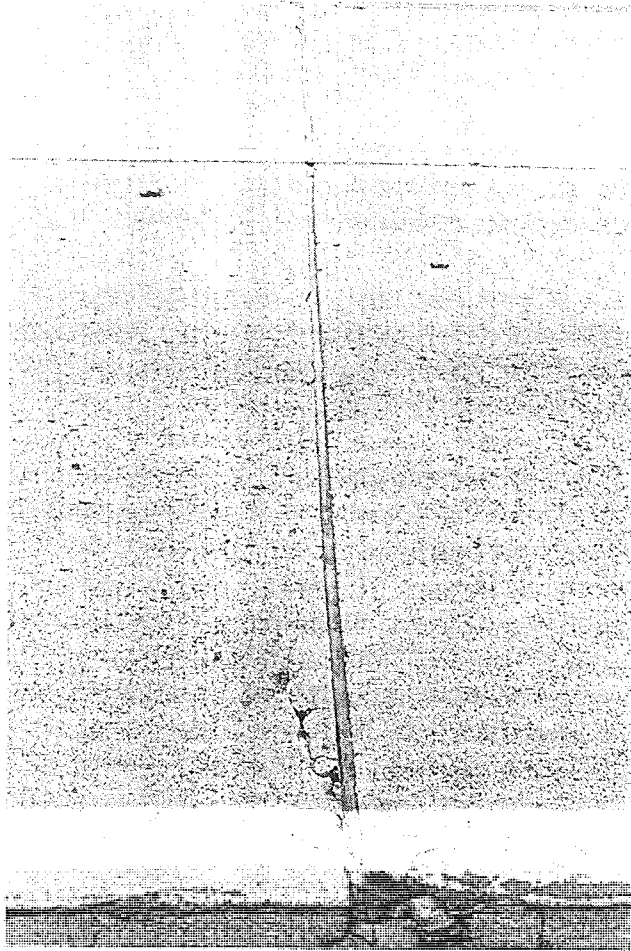
◀ Figure 32. Transverse joint resealed with silicone is rated as having slight problems.

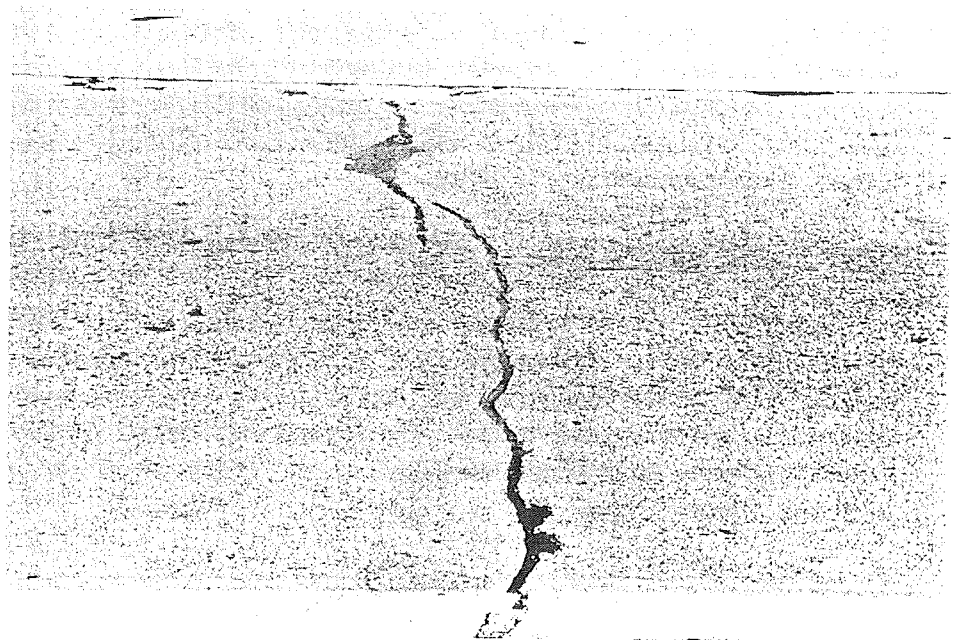
Performance of the low-modulus hot pour was highly variable. Cracks that were basically "fixed" (less than 0.01 inches of movement) were rated a four since only slight problems were observed (Figure 33). As the measured crack

Figure 33. Low-modulus hot-pour sealed crack with a 4 rating.

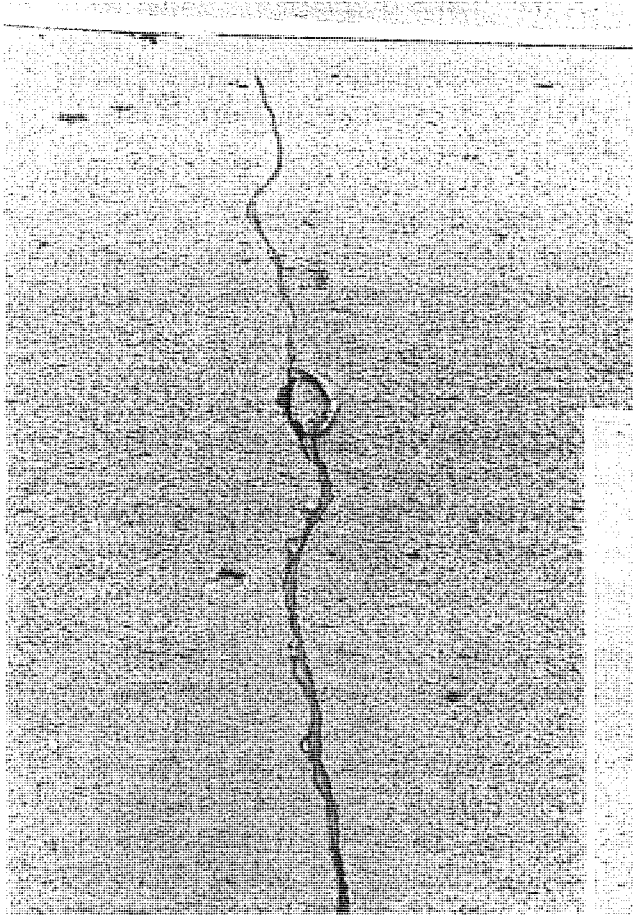
◀ Figure 34. Moderately performing silicone crack sealant.

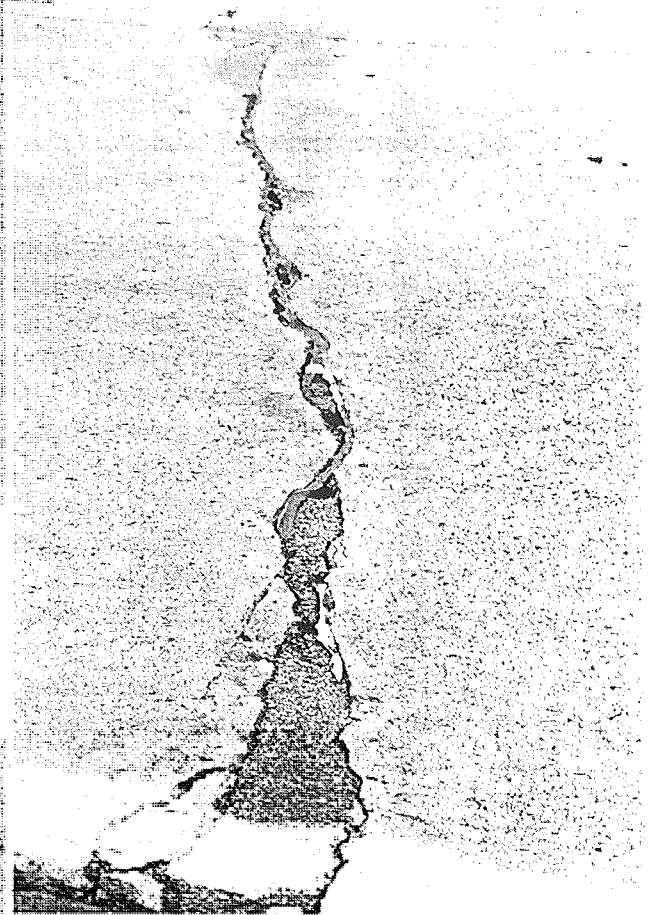
movements increased towards 0.06 inches, the ratings decreased to a one or two (deteriorated or severe problems observed). These results are consistent with results from many other projects utilizing a low-modulus hot pour. The sealant consistently failed in adhesion whenever movements in sealed cracks or joints exceeded the 5-10 percent range.

Figure 35. Crack has developed into a "moving crack" with severe spalling.

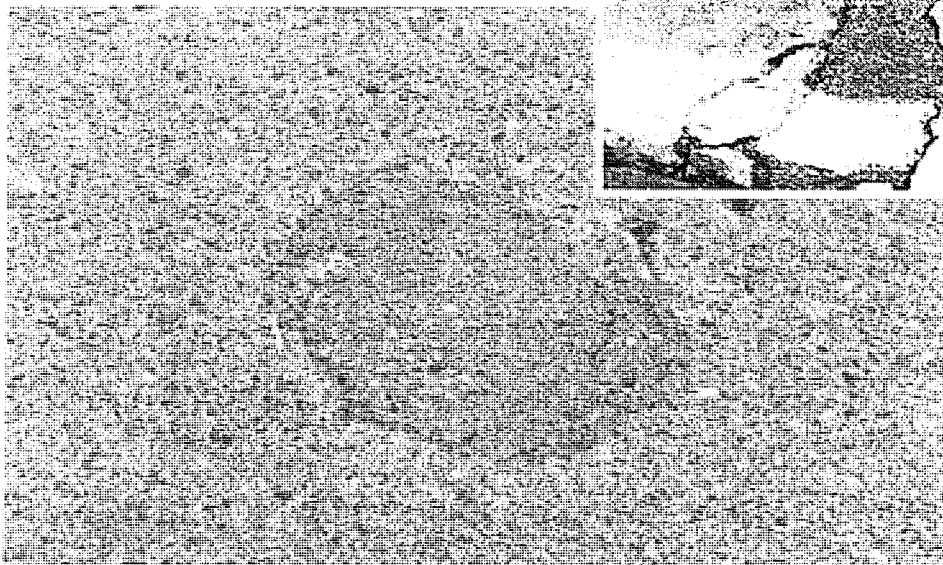
The restoration technique for repairing large size surface pop-outs, caused by expansive coarse aggregate, was very successful. Figure 36 shows a typical repair looking the same now as when repaired. The success of these repairs was something of a surprise for two reasons.

Figure 36. Surface pop-out repair is in excellent condition.

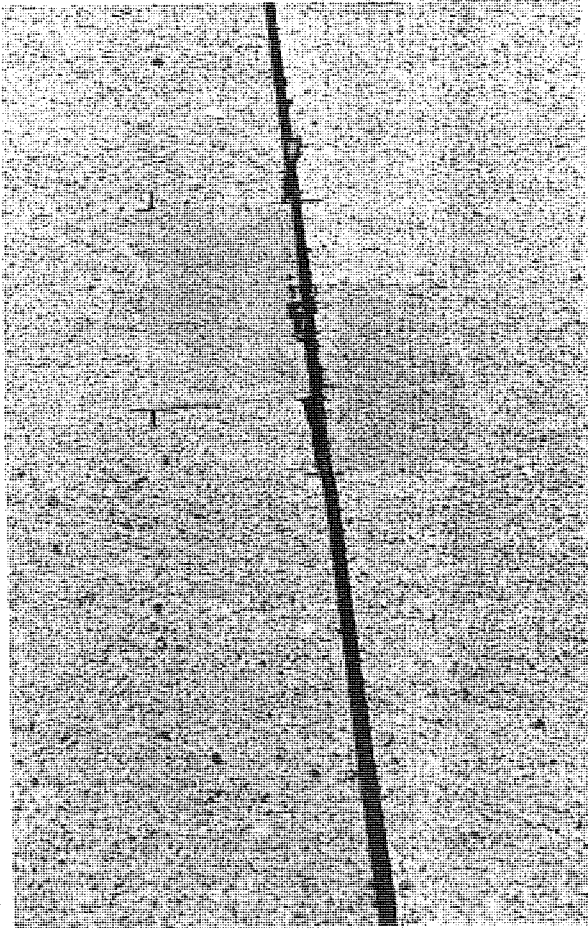
▲
Figure 37. Shallow-depth joint spall repairs in good condition after 6 years of service.

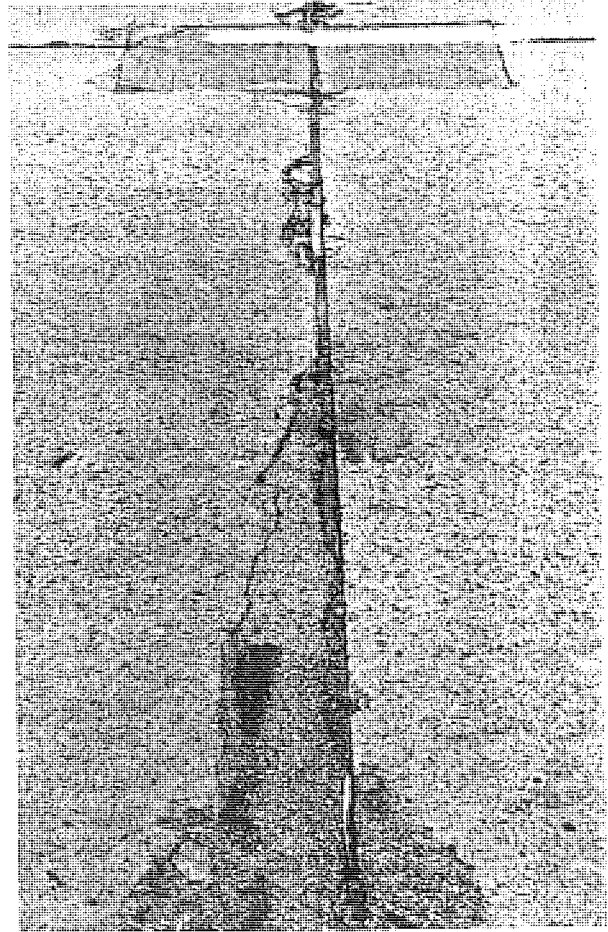
▲
Figure 38. Cracks along joint faces developed into significant distress.

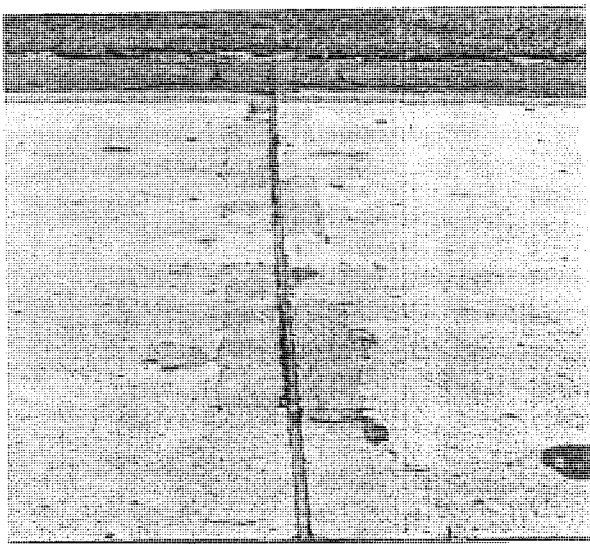
◀
Figure 39. Level of distress along transverse joint with partial-depth repairs has remained low.

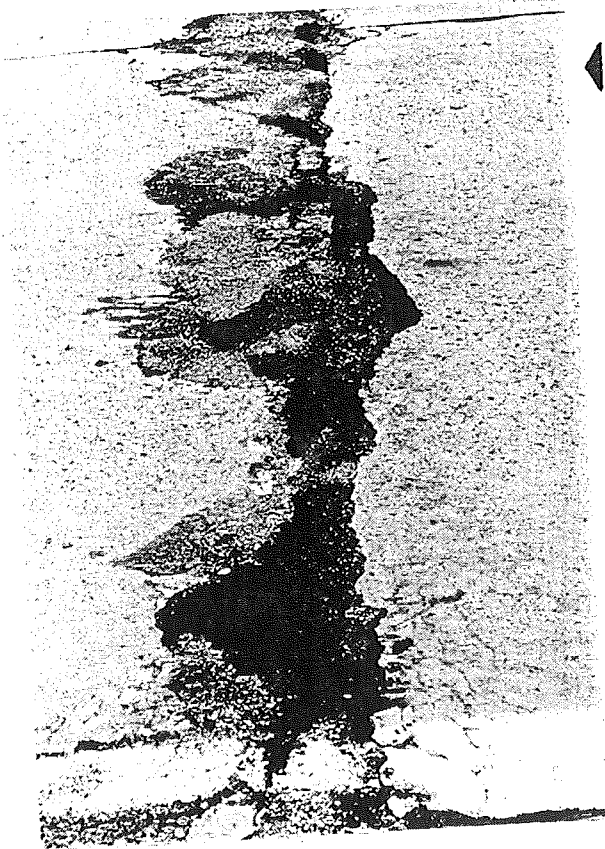
◀ Figure 1A. Transverse joint compression failure.

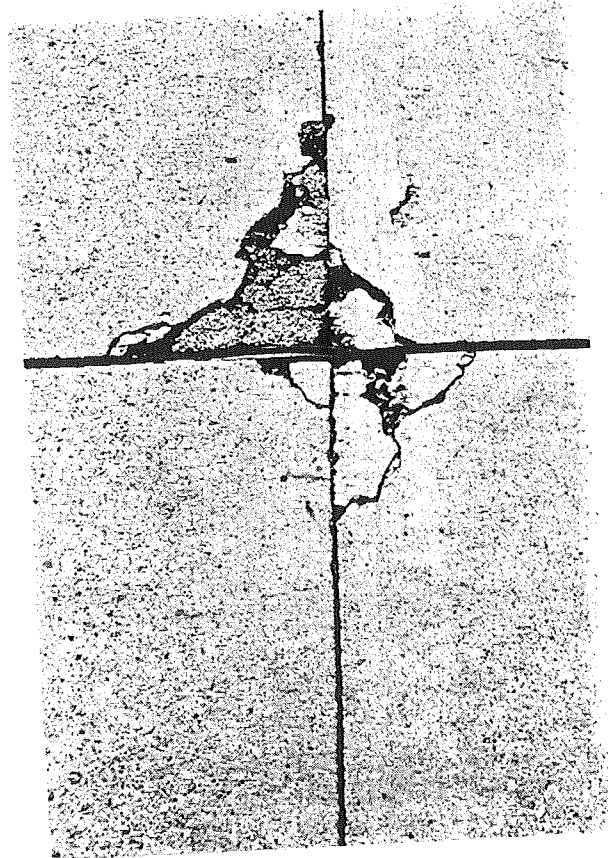
▲ Figure 2A. Failure at intersection of the transverse and longitudinal joint.

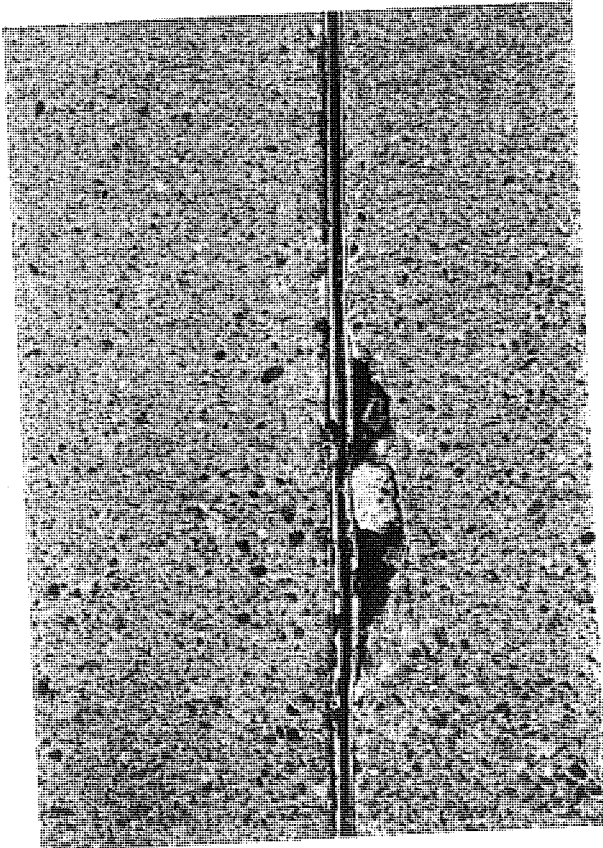
◀ Figure 3A. Joint groove spall.

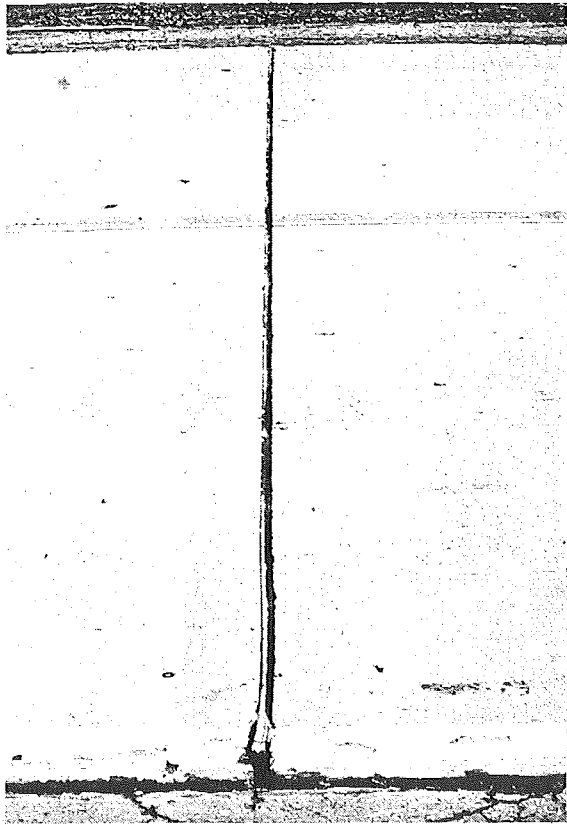
Figure 5A. Transverse crack with fractured steel.

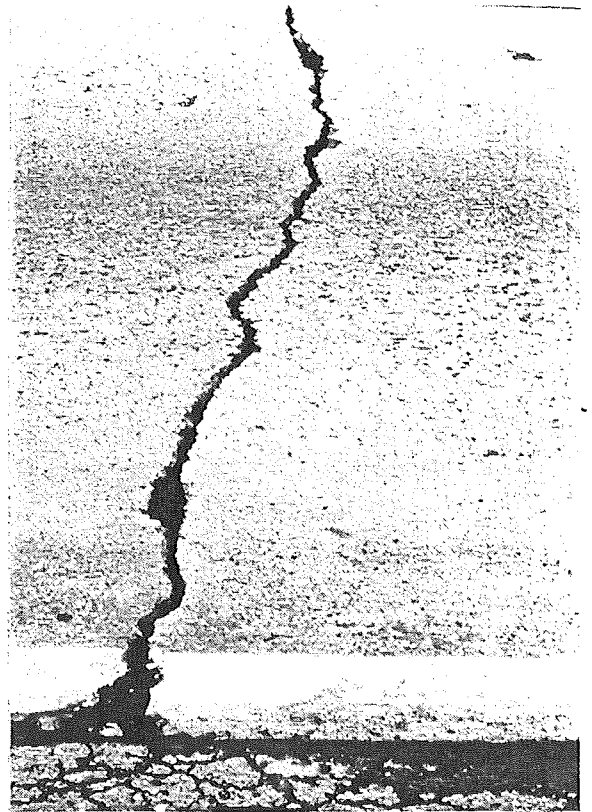
Figure 6A. Transverse crack with reinforcement intact.
