OFFICE MEMORANDUM

MICHIGAN
STATE HIGHWAY DEPARTMENT

December 3, 1962

Subject: Placement of Steel: I 75 North of St. Ignace (Project No. BI 49025E, C18). Research Project 39 F-7. Report No. R-405.

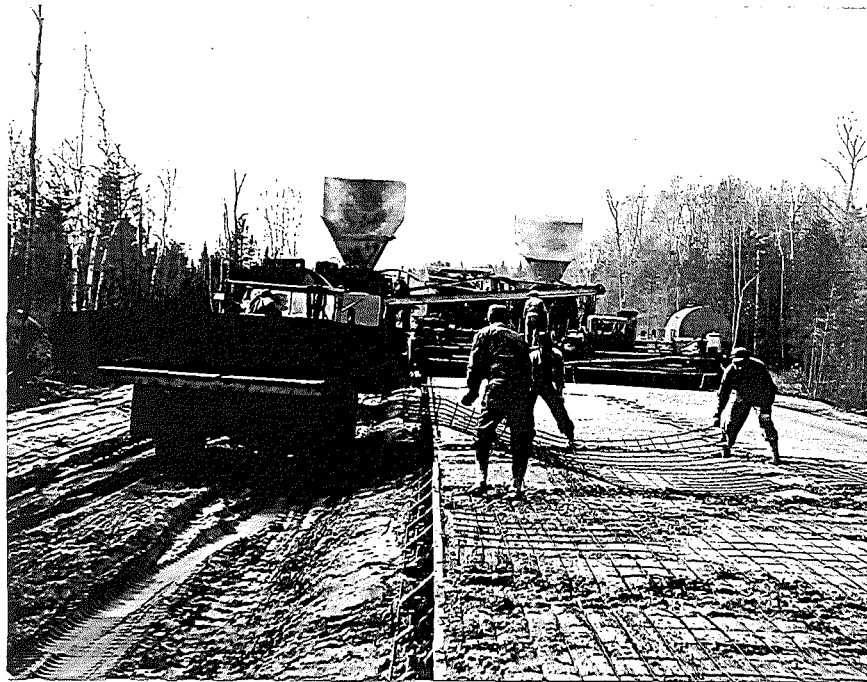
Figure 1. (upper left) Steel being placed on top of 9 inches of concrete.

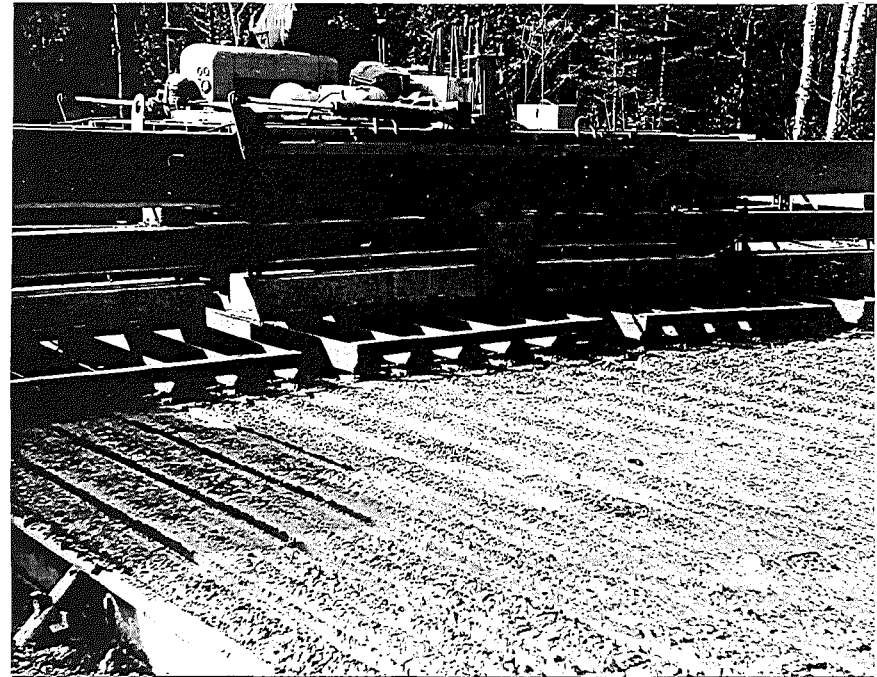
Figure 2. (above) Machine with vibrating gangs raised.

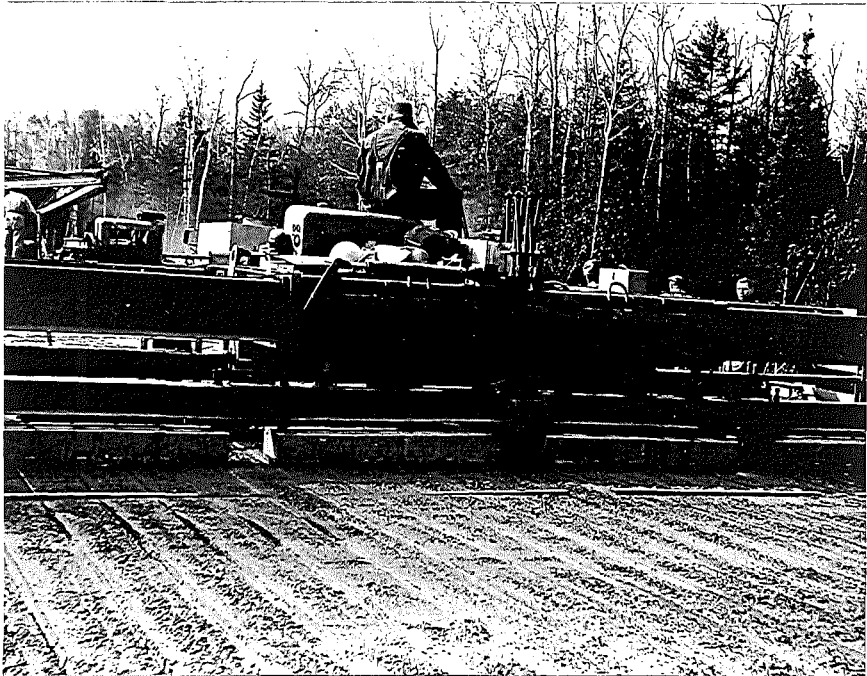
Figure 3. (left) Machine with vibrators at lowest point of stroke.

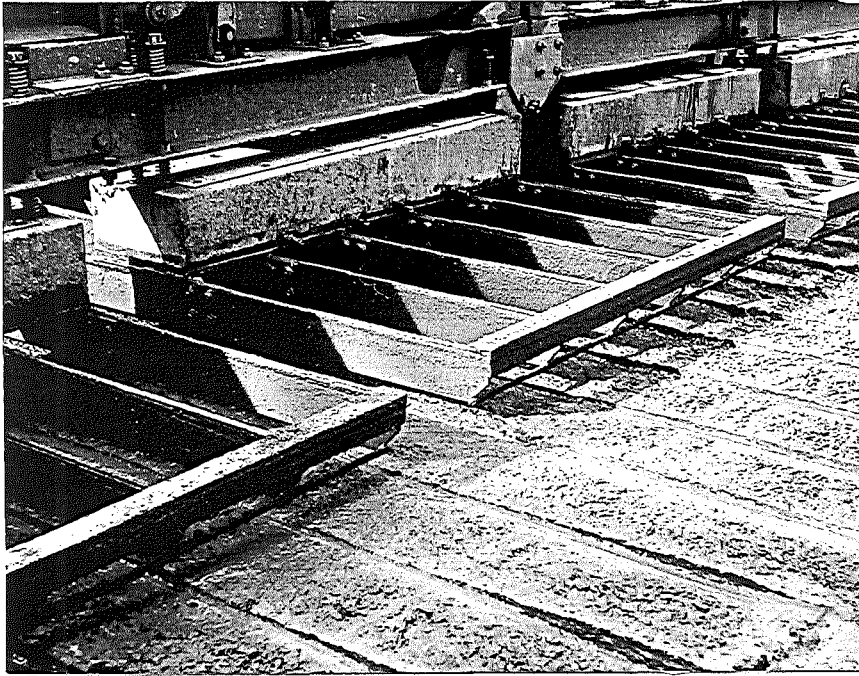
Figure 4. (upper left) Vibrator plates and framework.

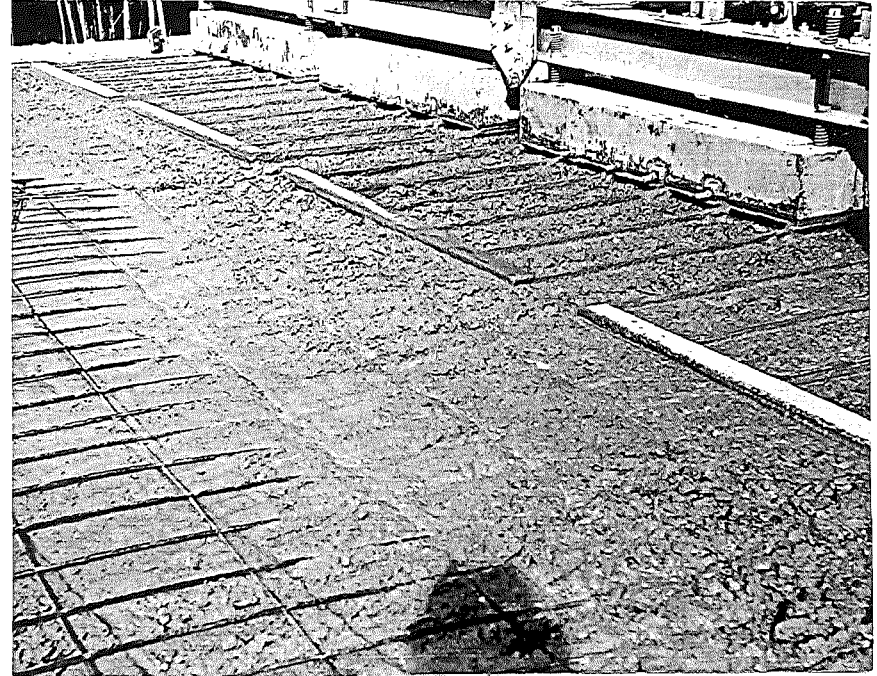
Figure 5. (above) Front gangs at lowered position, showing next mat in place.

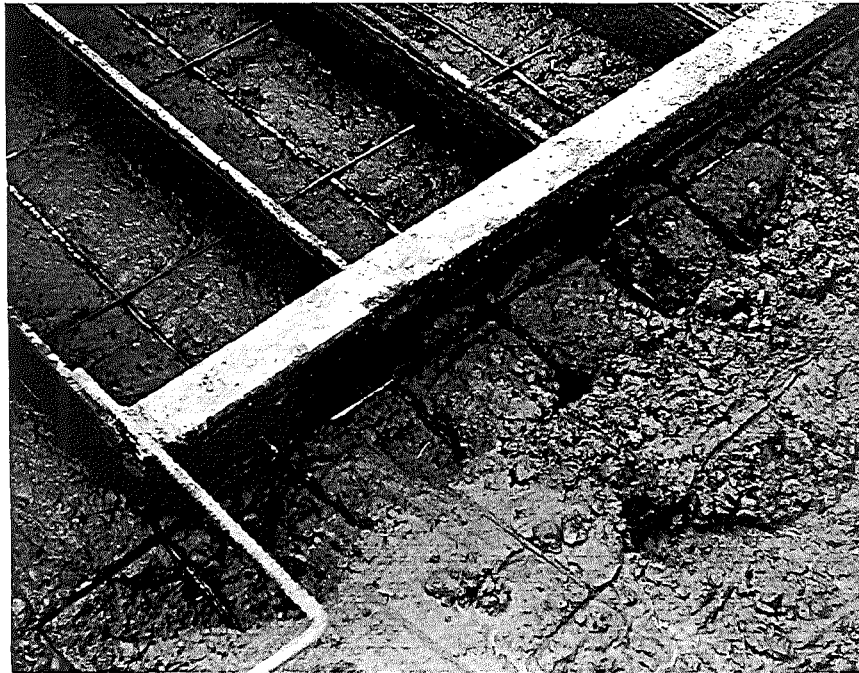
Figure 6. (left) Placement of vibrator plates over steel mesh.

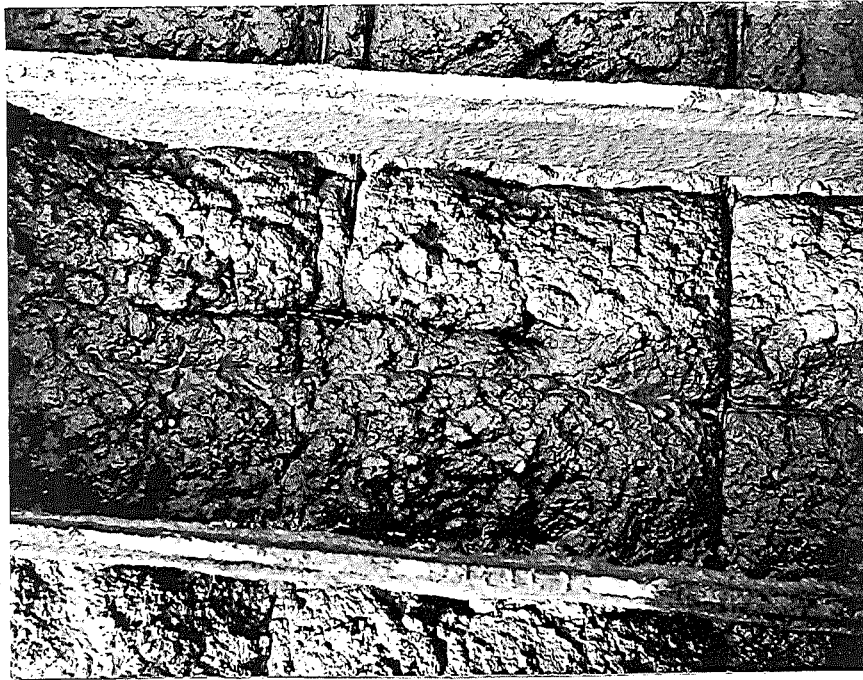
Figure 7. (upper left) Concrete being displaced as steel starts downward.

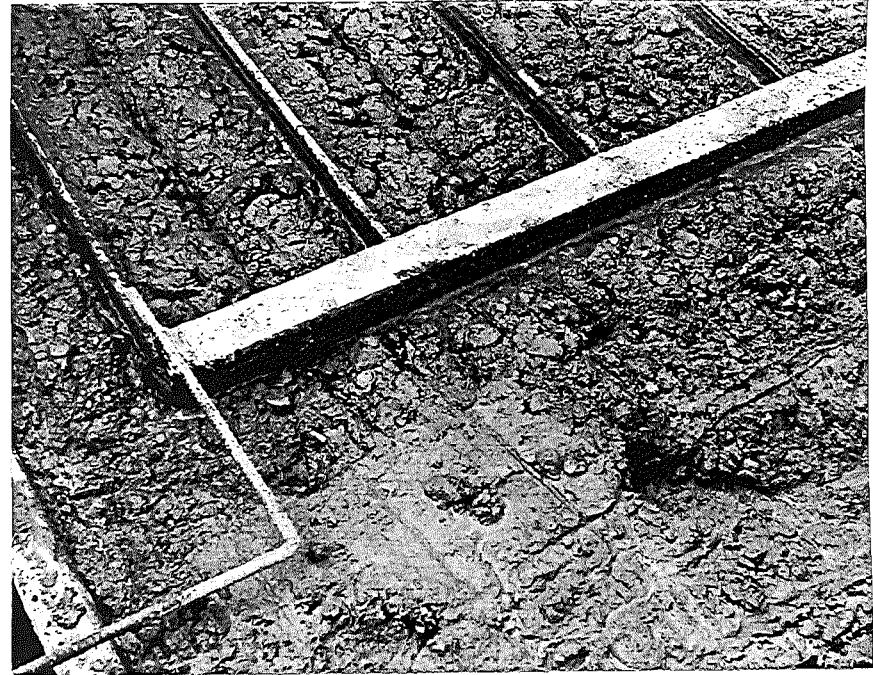
Figure 8. (above) Close-up of Vibrator at bottom of stroke.

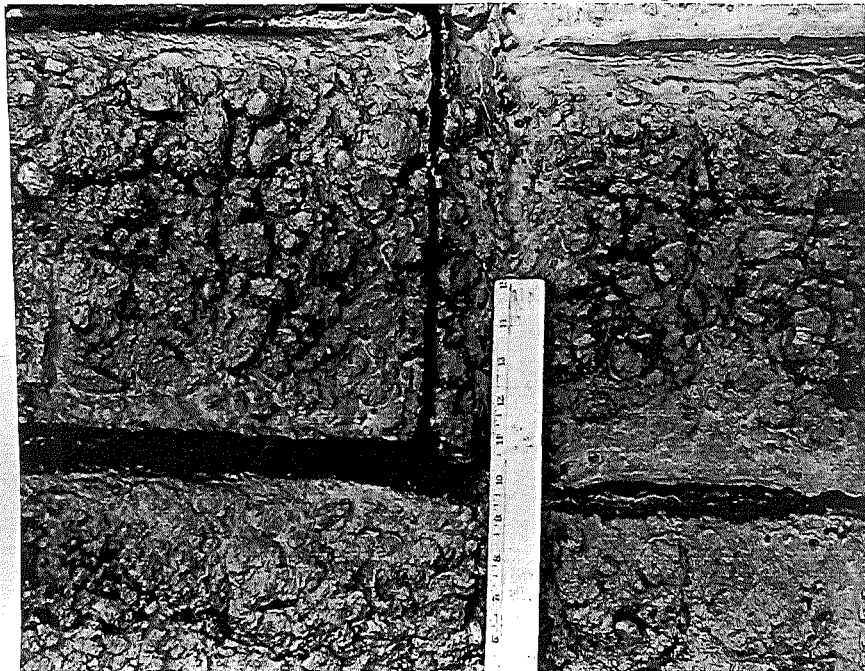
The machine is driven over a section of the mesh and the gangs lowered onto the steel as shown in Fig. 6. The plates are then started vibrating and force downward to the required depth. Concrete is displaced by steel and plates as shown in Fig. 7. The plates continue to vibrate for a short time at the bottom of the stoke, Fig. 8, and while being withdrawn. Fig. 9 was taken shortly after the plates were withdrawn, showing apparent flow of fines to the vibrator and the void left by the plates.

The finisher apparently does little to remove the segregation of aggregate, since the wooden ruler could still be pushed easily into the area where the plates had

been, after the finisher had passed. This would seem to indicate absence of coarse aggregate. The paving inspector has taken measurements of the locations of some of these longitudinal lines of possible segregation formed by the vibrating plates, and cores will be taken at these critical points to establish whether segregation has occurred.

Figure 9. (left) Void left by vibrator when it is withdrawn.

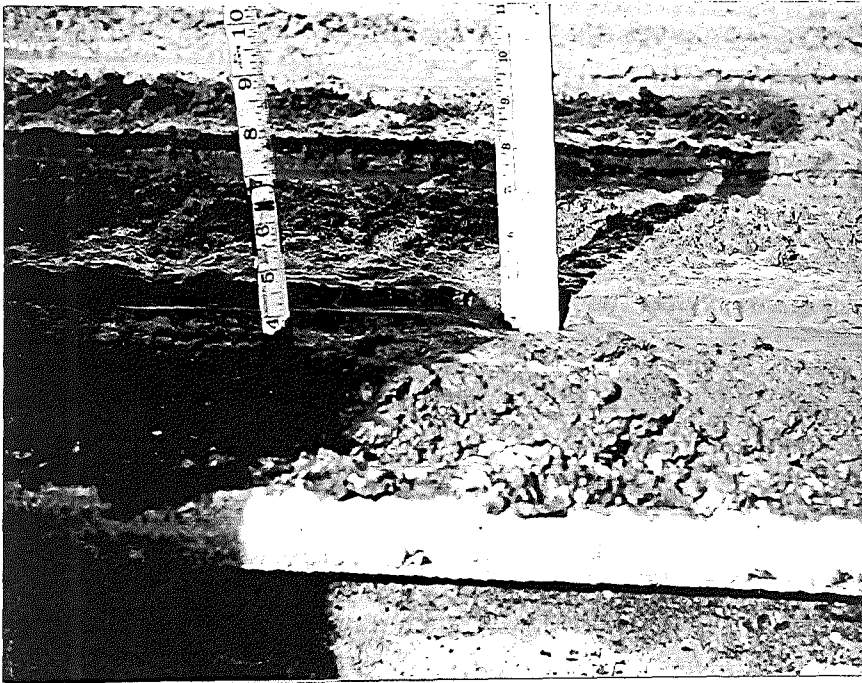
A dozen random measurements taken of the final depth of reinforcement found it to be within $\pm 1/4$ in. of the required 3 in. Fig. 10 shows a narrow scale on the steel and a wider scale in the vibrator groove.

Figure 10. (upper left) Narrow ruler on steel, wider ruler in vibrator groove.

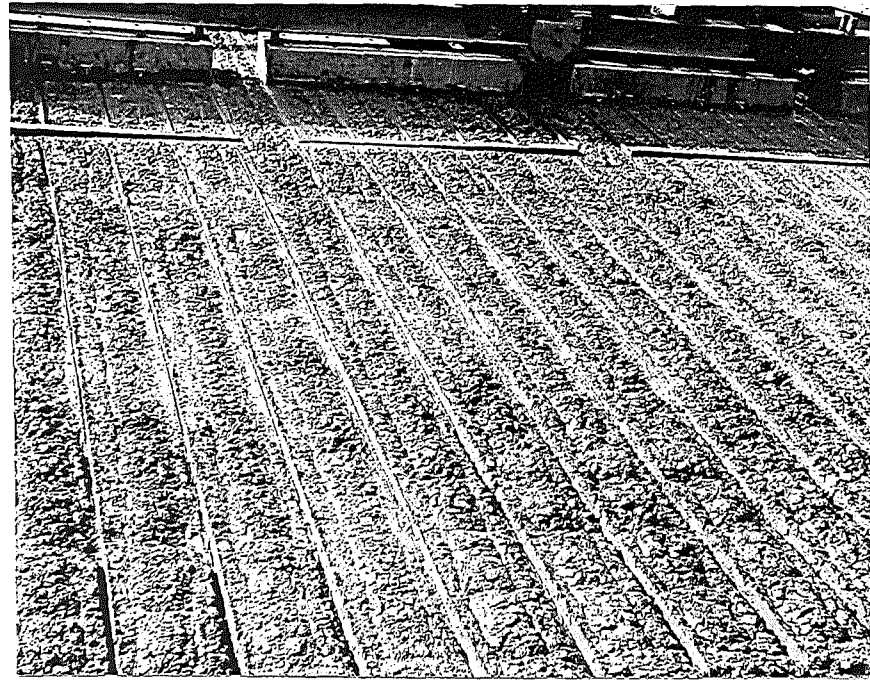
Figure 11. (above) Surface of slab between vibrator and first finisher.

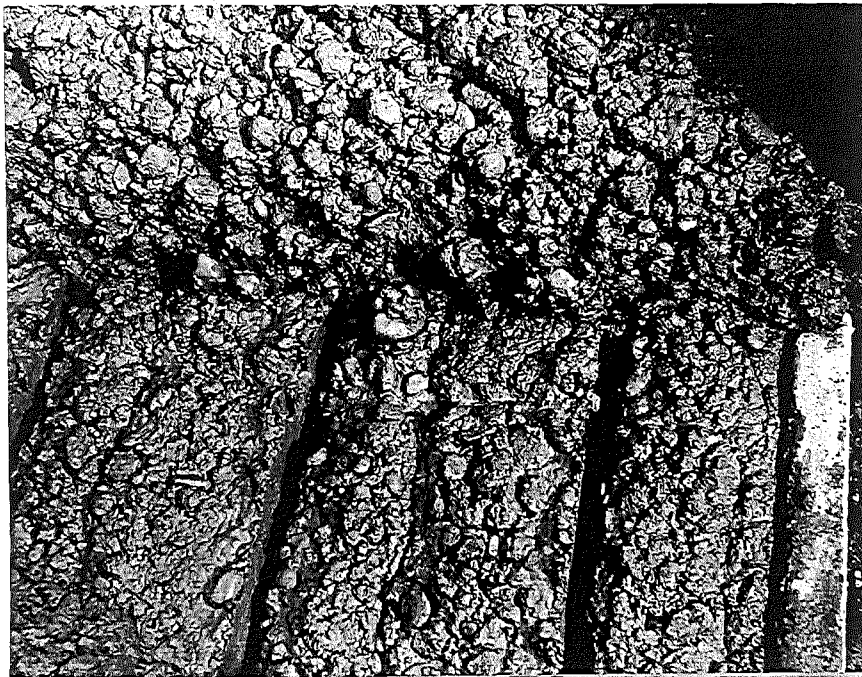
Figure 12. (left) First finisher approaching.
