MICHIGAN
STATE HIGHWAY DEPARTMENT
Charles M. Ziegler
State Highway Commissioner

INVESTIGATION OF BLOW-UP ON M-47
CONSTRUCTION PROJECT 73-46, C4
SOUTH OF ST. CHARLES

Research Project 39 F-7 (14)
Evaluation of Post War Pavements

Research Laboratory
Testing and Research Division
Report No. 239a
October 1, 1955

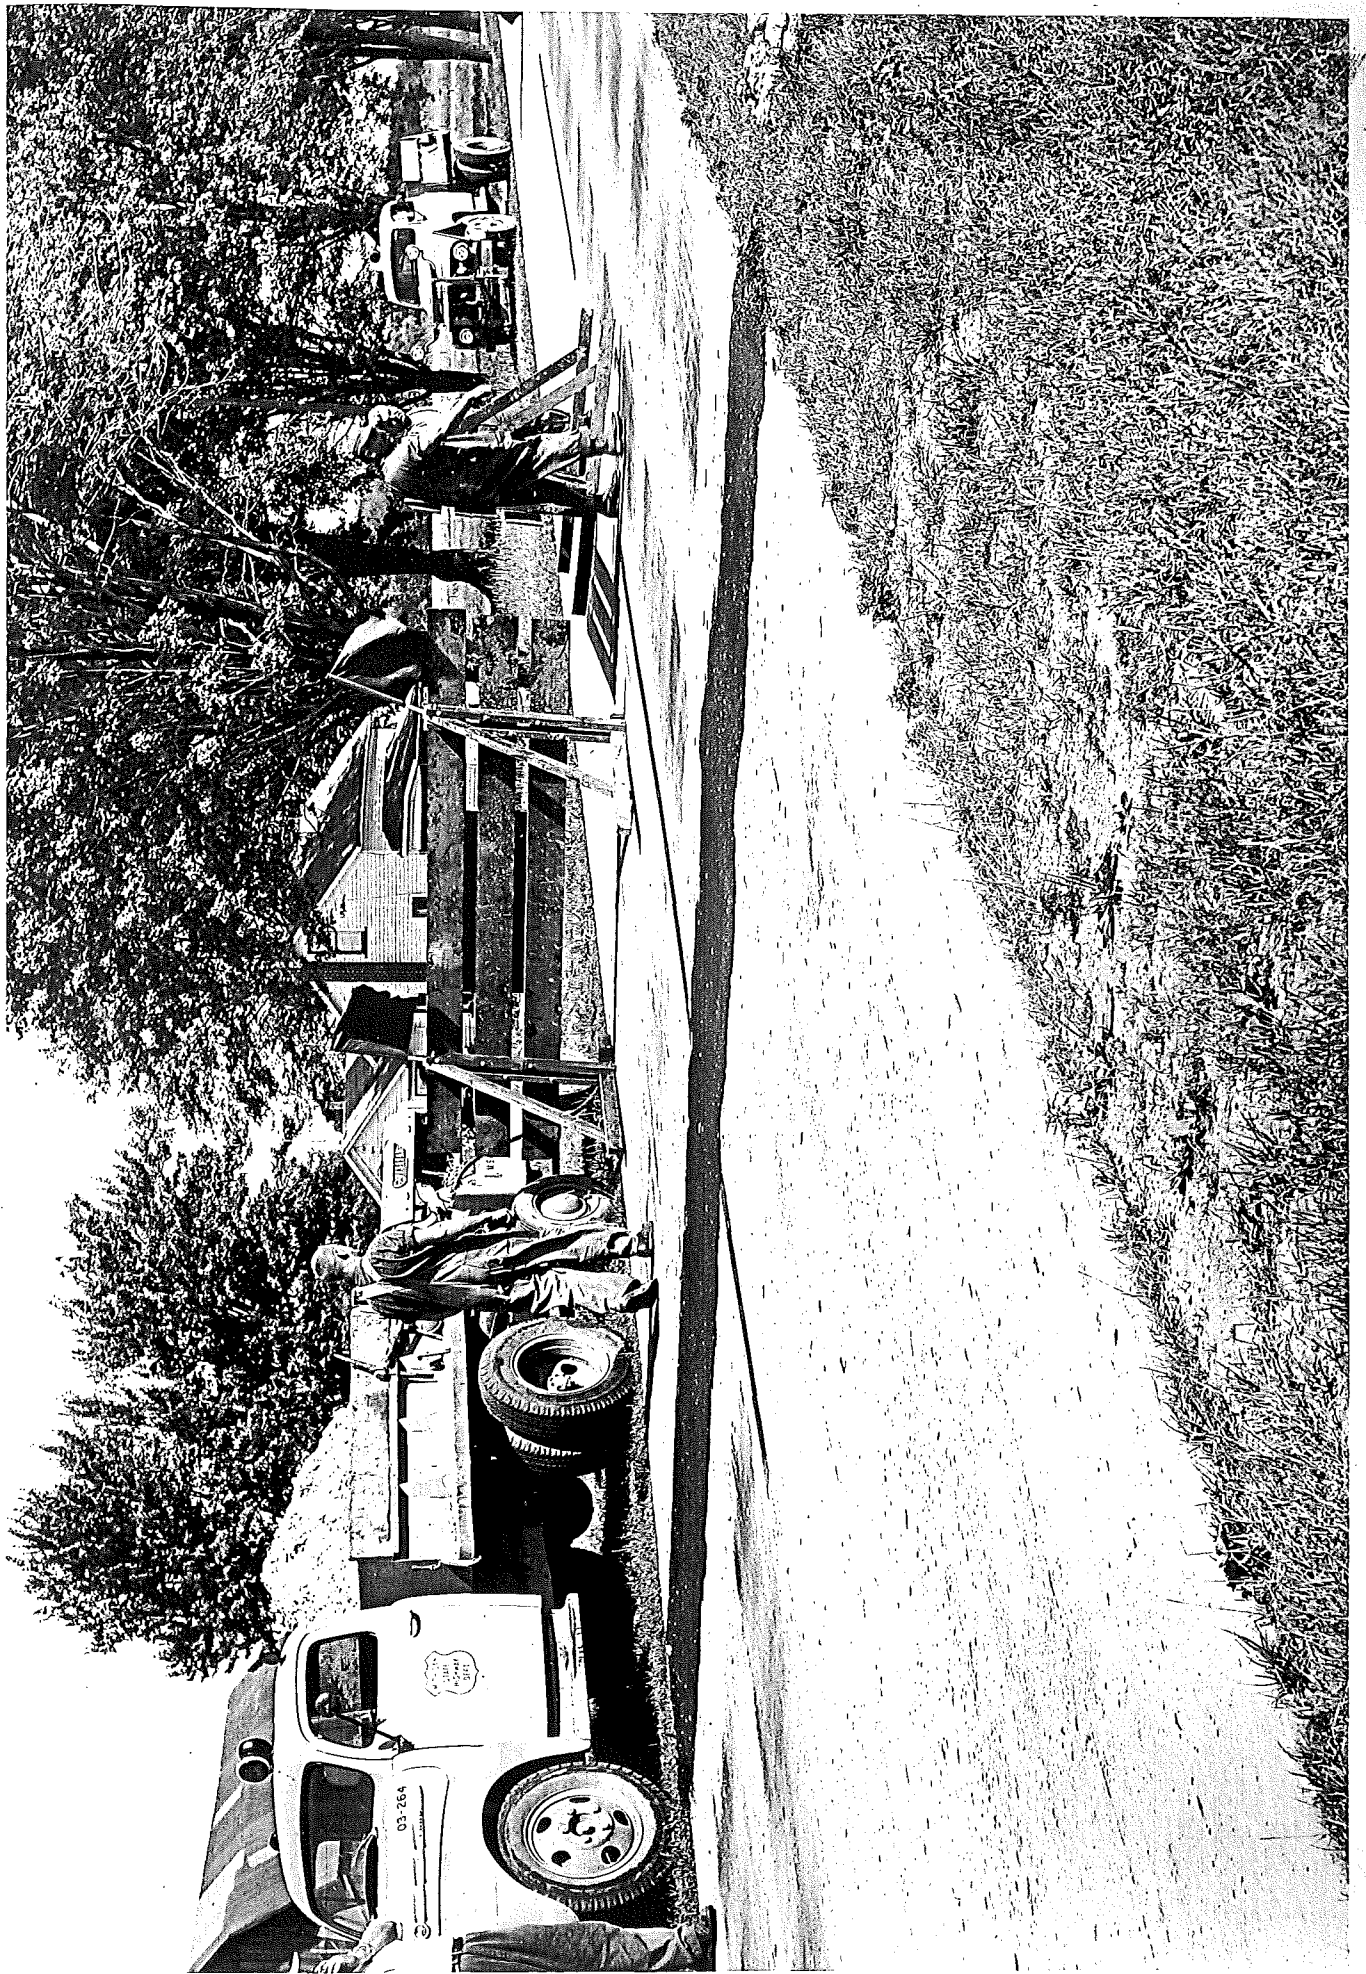
The picture in Figure 1 on the adjacent page shows the blow-up area prior to starting permanent repairs. The broken concrete had been removed previously and the hole temporarily filled with a bituminous material.

The concrete slab on the north side of the joint (in background) was raised approximately 2 inches above the surface of the pavement on the south side of the joint. The concrete on the north side of the joint was not broken. The top portion of the south slab was shattered and pulverized for a distance of 4 feet from the joint.

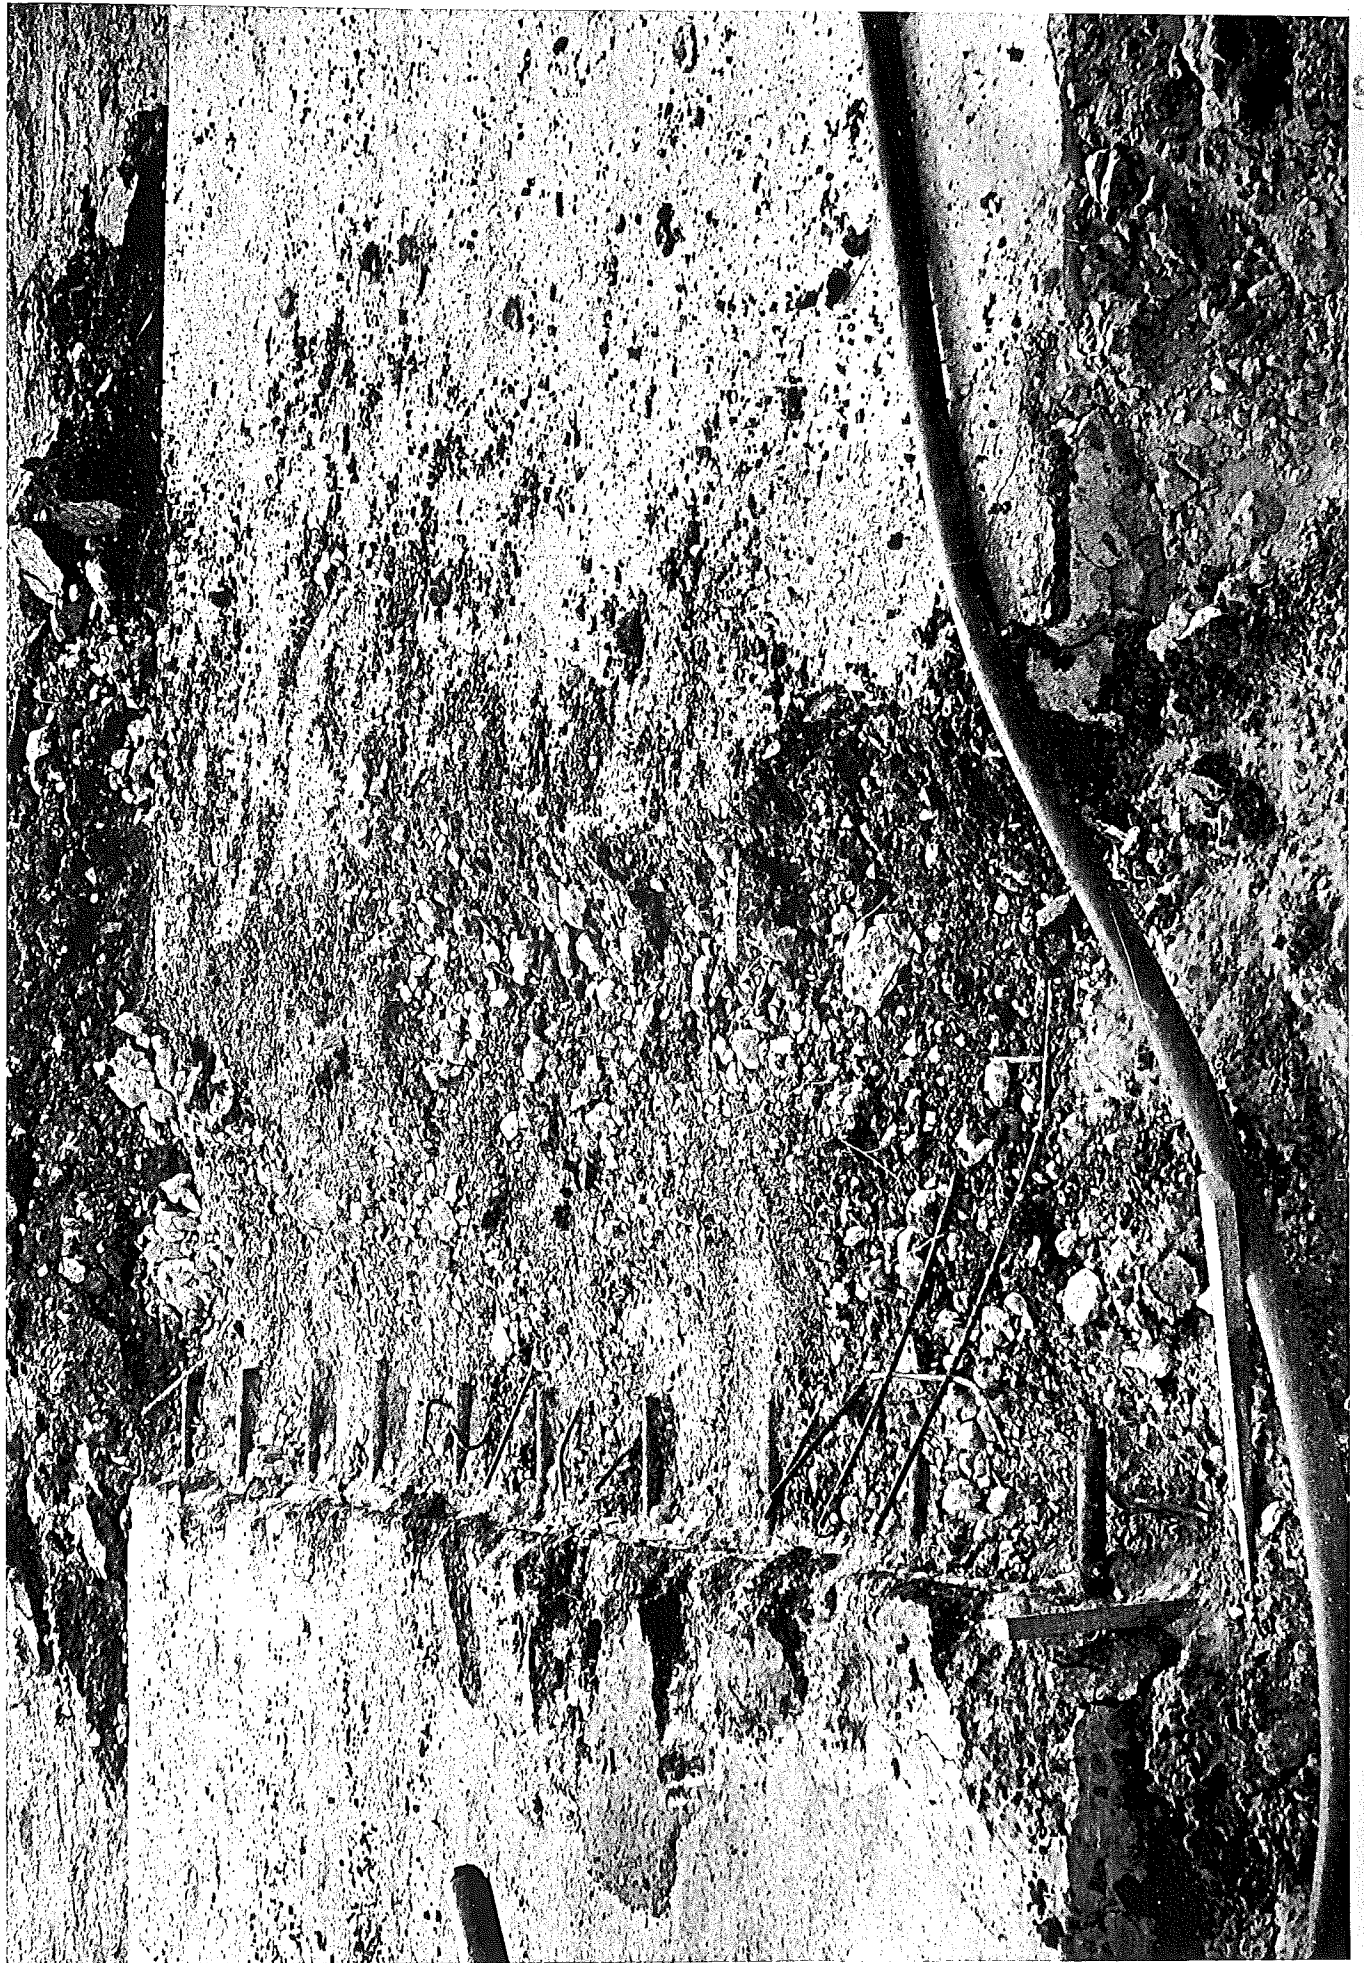
Typical Condition of Dowel System

Figure 2 on the adjacent page shows the condition in which the dowels were found upon removal of the concrete. Note sound condition of slab on left side of joint (north) and shattered condition of concrete on south side.

It may be seen in the picture that the south end of the dowels had been forced out of the dowel basket assembly clips. Note dowel in foreground. The dowels were found to be displaced upward as much as 1-3/4 inches to 2-5/8 inches.

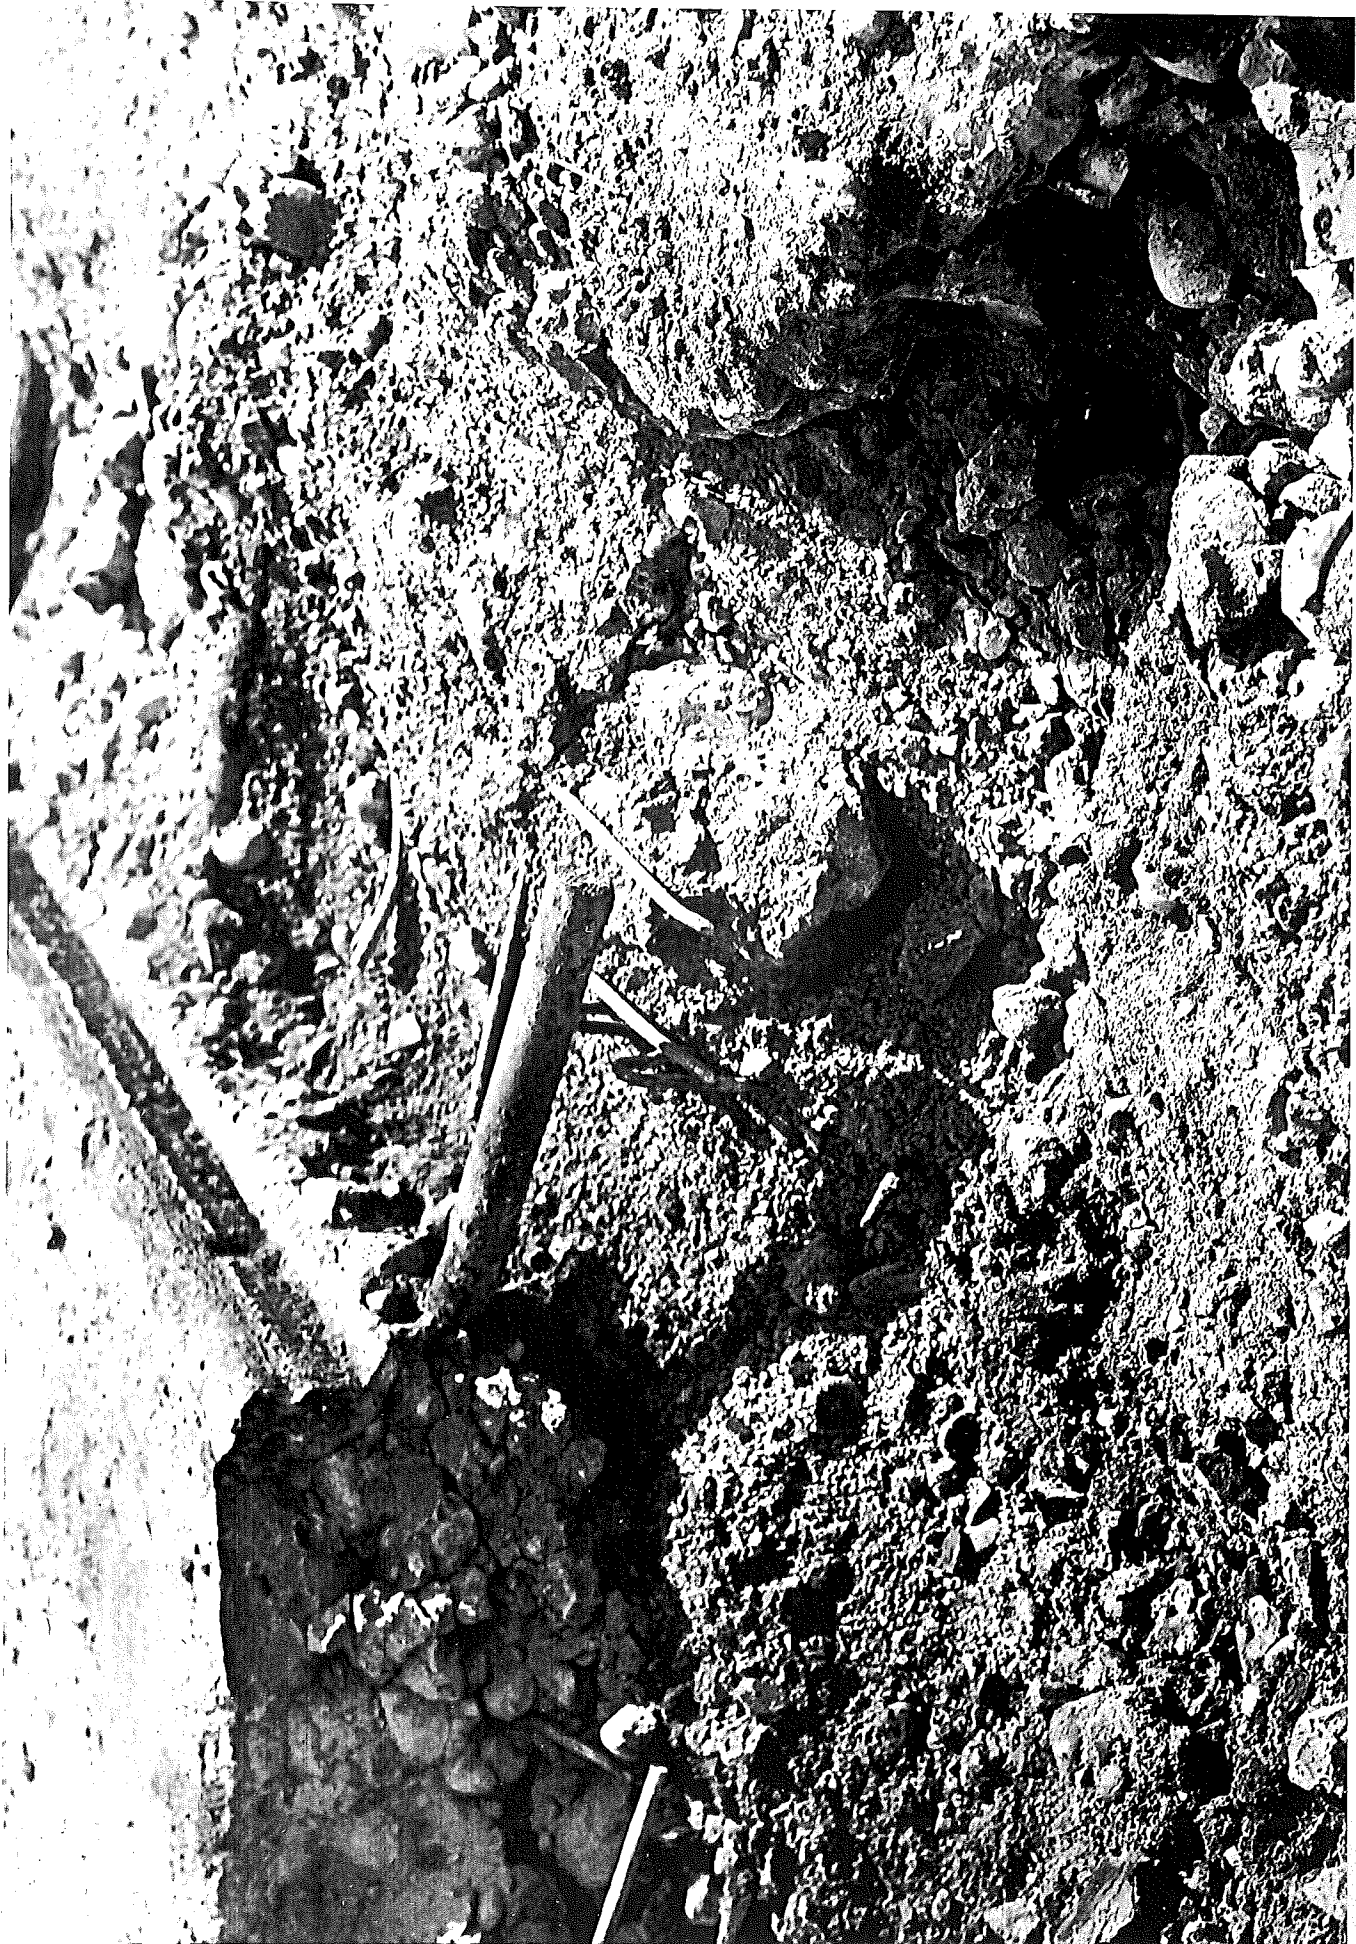
Typical Position of Dowels

Figure 3 on the adjacent page is a close view of a dowel which clearly illustrates how the dowels were moved upward out of the dowel clips by the blow-up action.

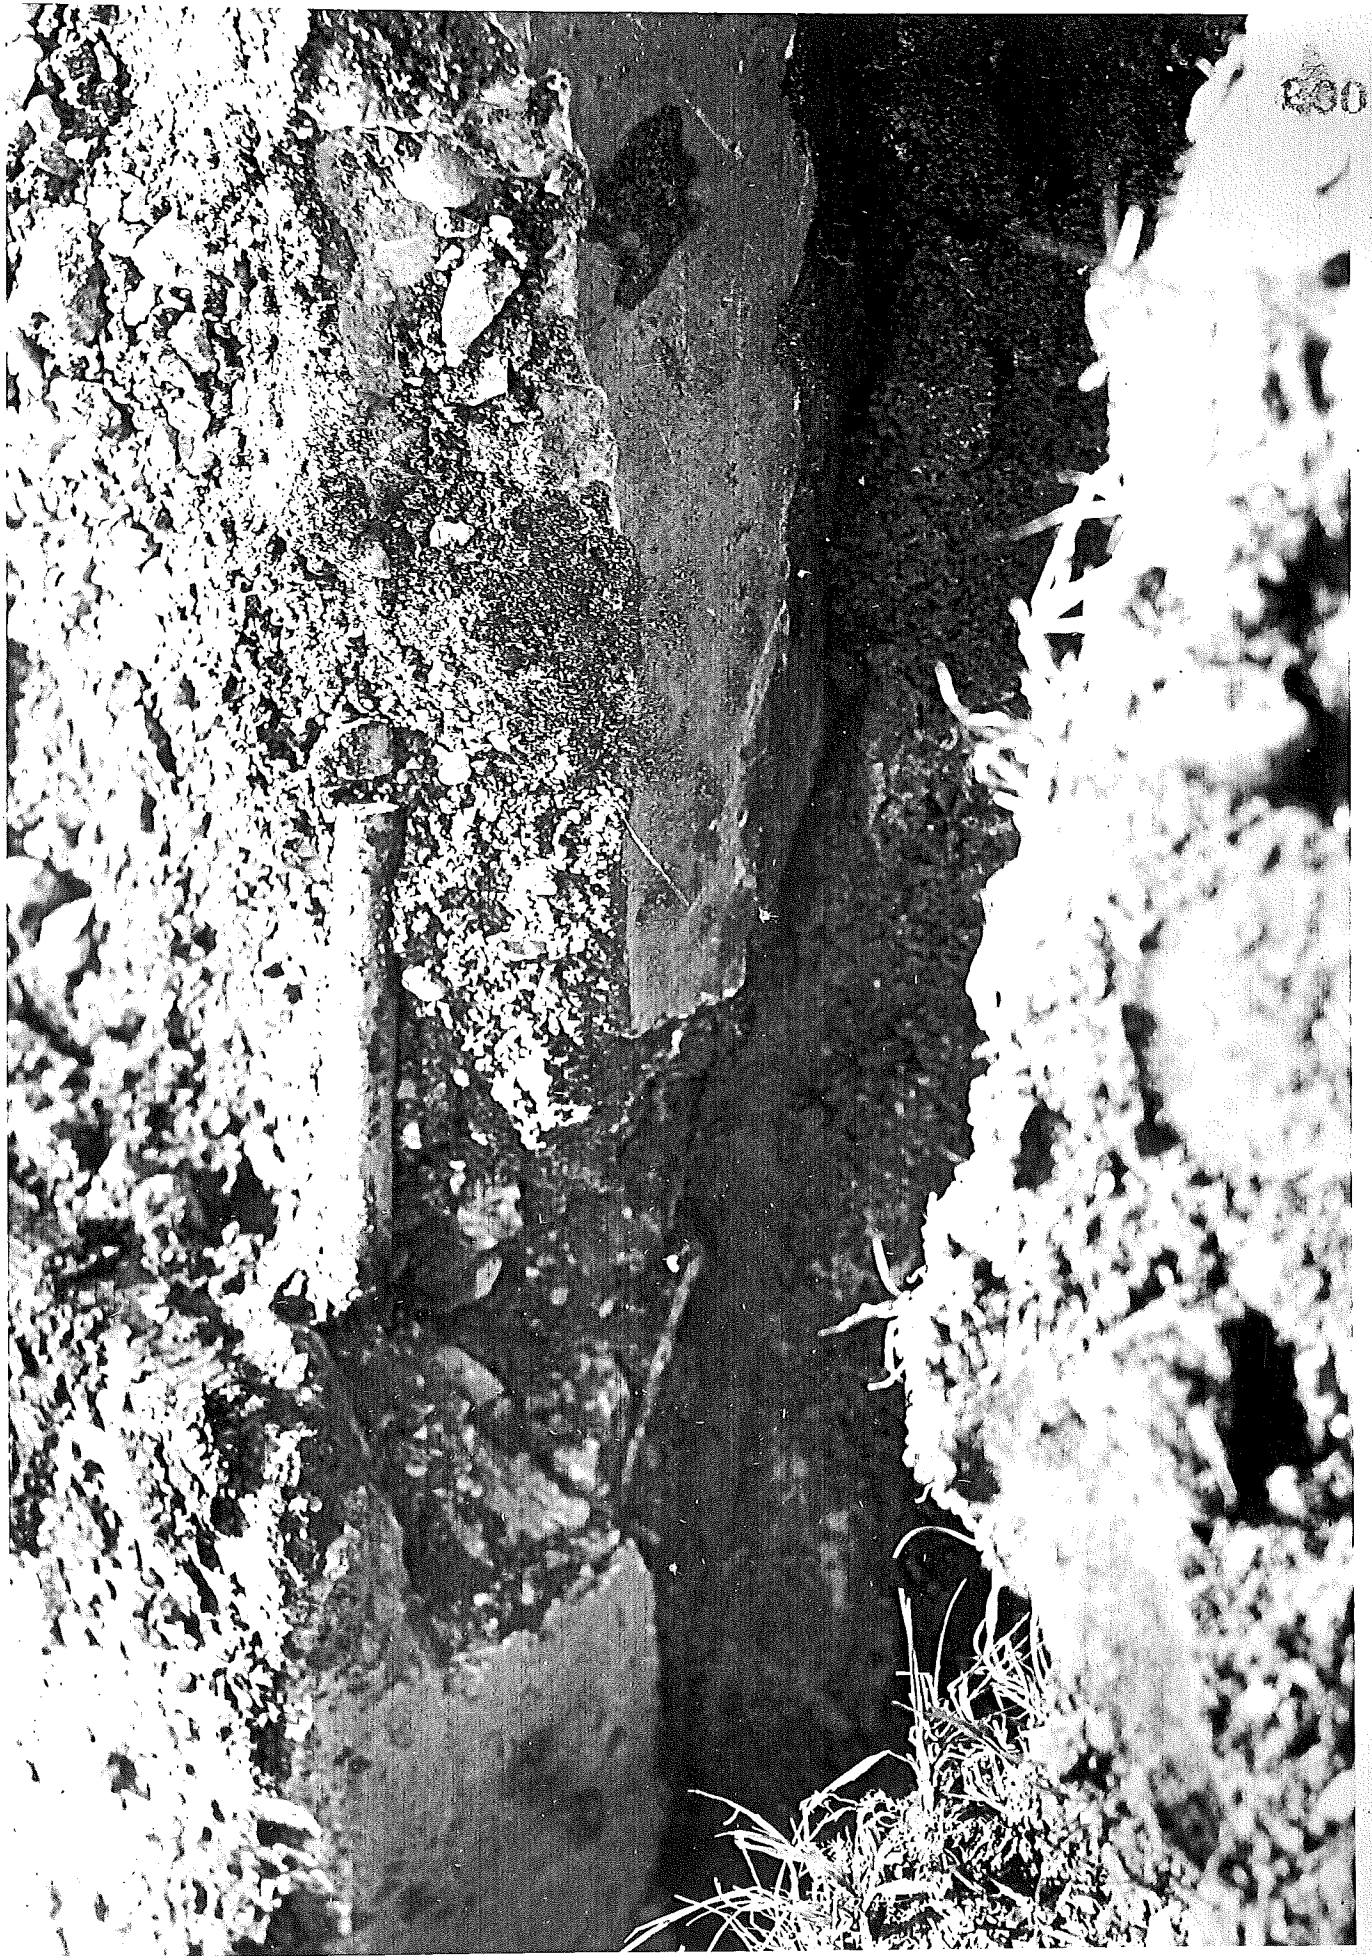
Condition of Concrete at Edge of Pavement

Figure 4 illustrates the spalled condition of concrete at edge of pavement.

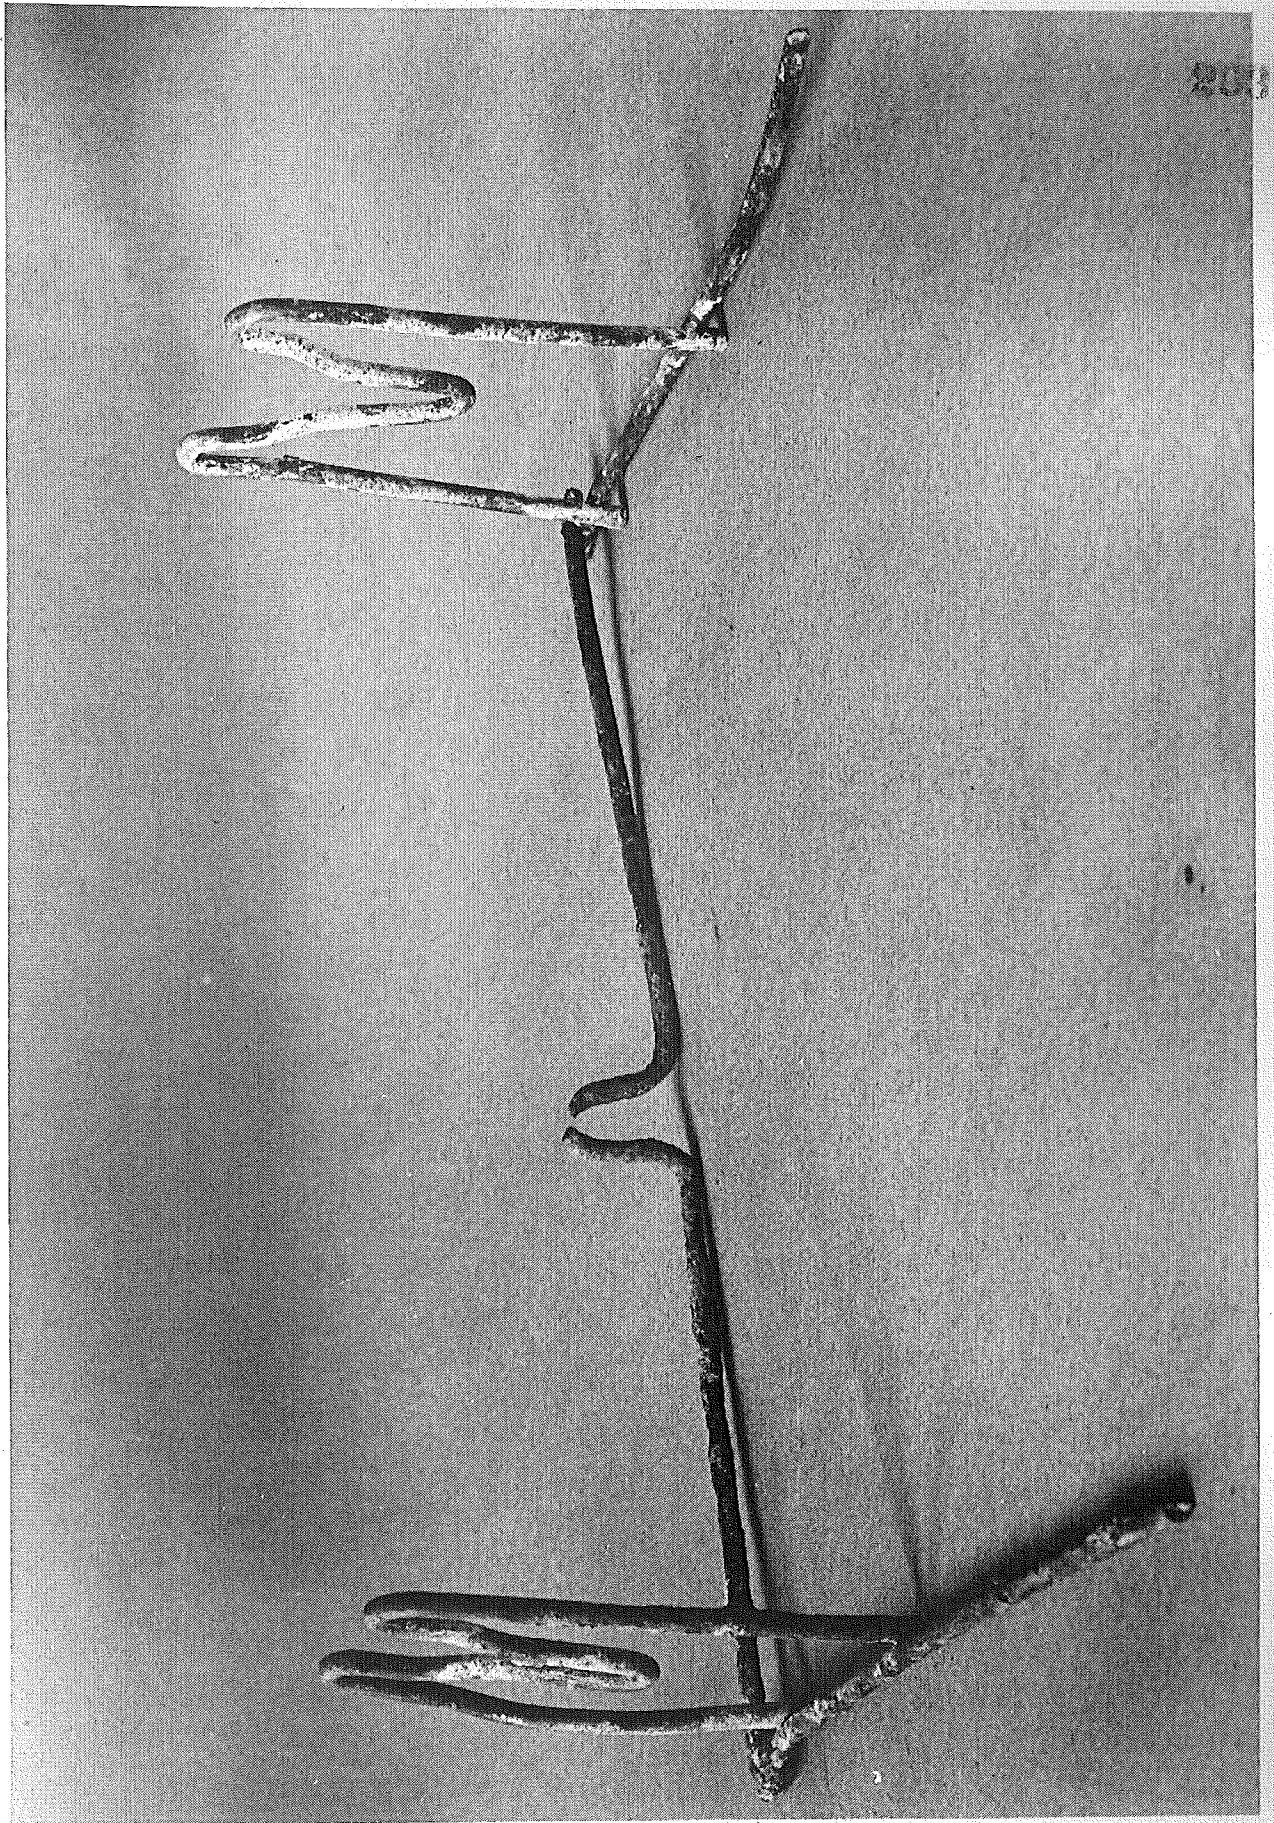
Condition of Dowel Bar Basket

Figure 7, page 15, illustrates the condition of a section of dowel bar basket as removed from pavement.

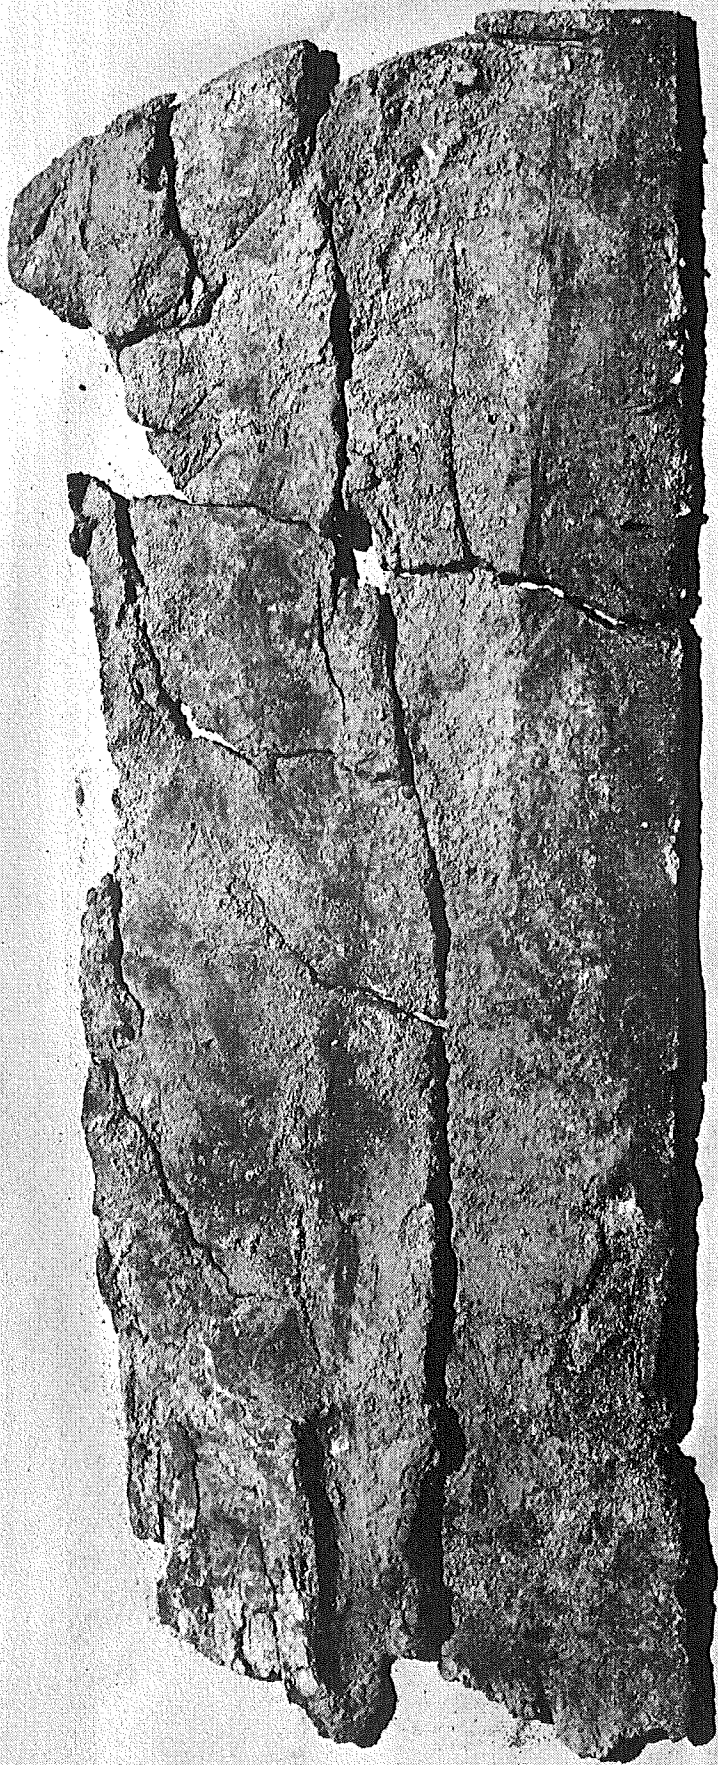
Bituminous Base Plate

A section of the bituminous base plate was carefully removed for examination. Figure 8, next page, shows the cracked condition of the plate as it was found under the pavement. The longitudinal crack was under this joint.

The material was found to be soft and brittle with but little structural strength.

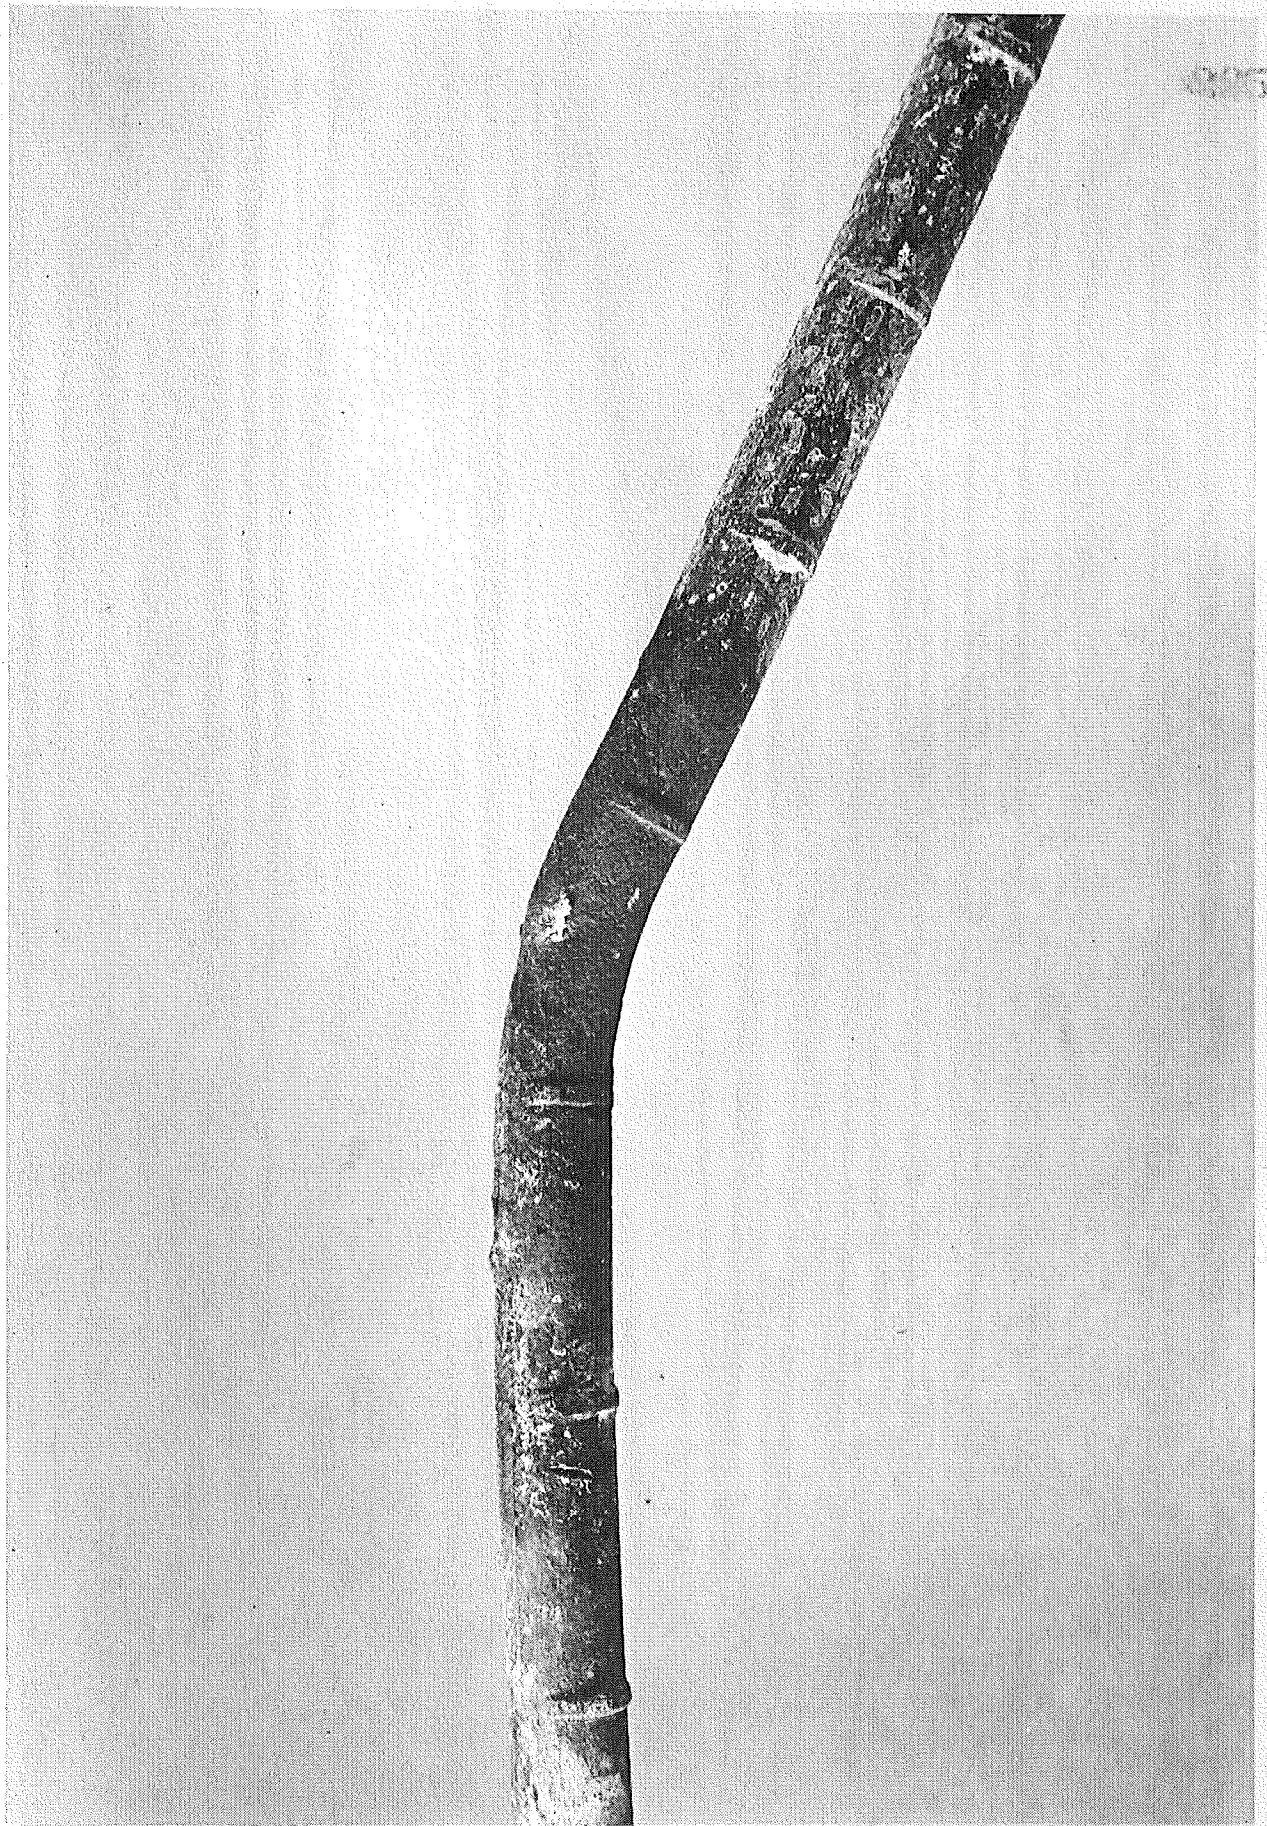
Condition of Tie Bars

One tie bar was received and examined for rusting. Rusting occurred for a distance of about 2 inches on each side of center. See Figure 9, next page. Note deep pitting at center of bar.

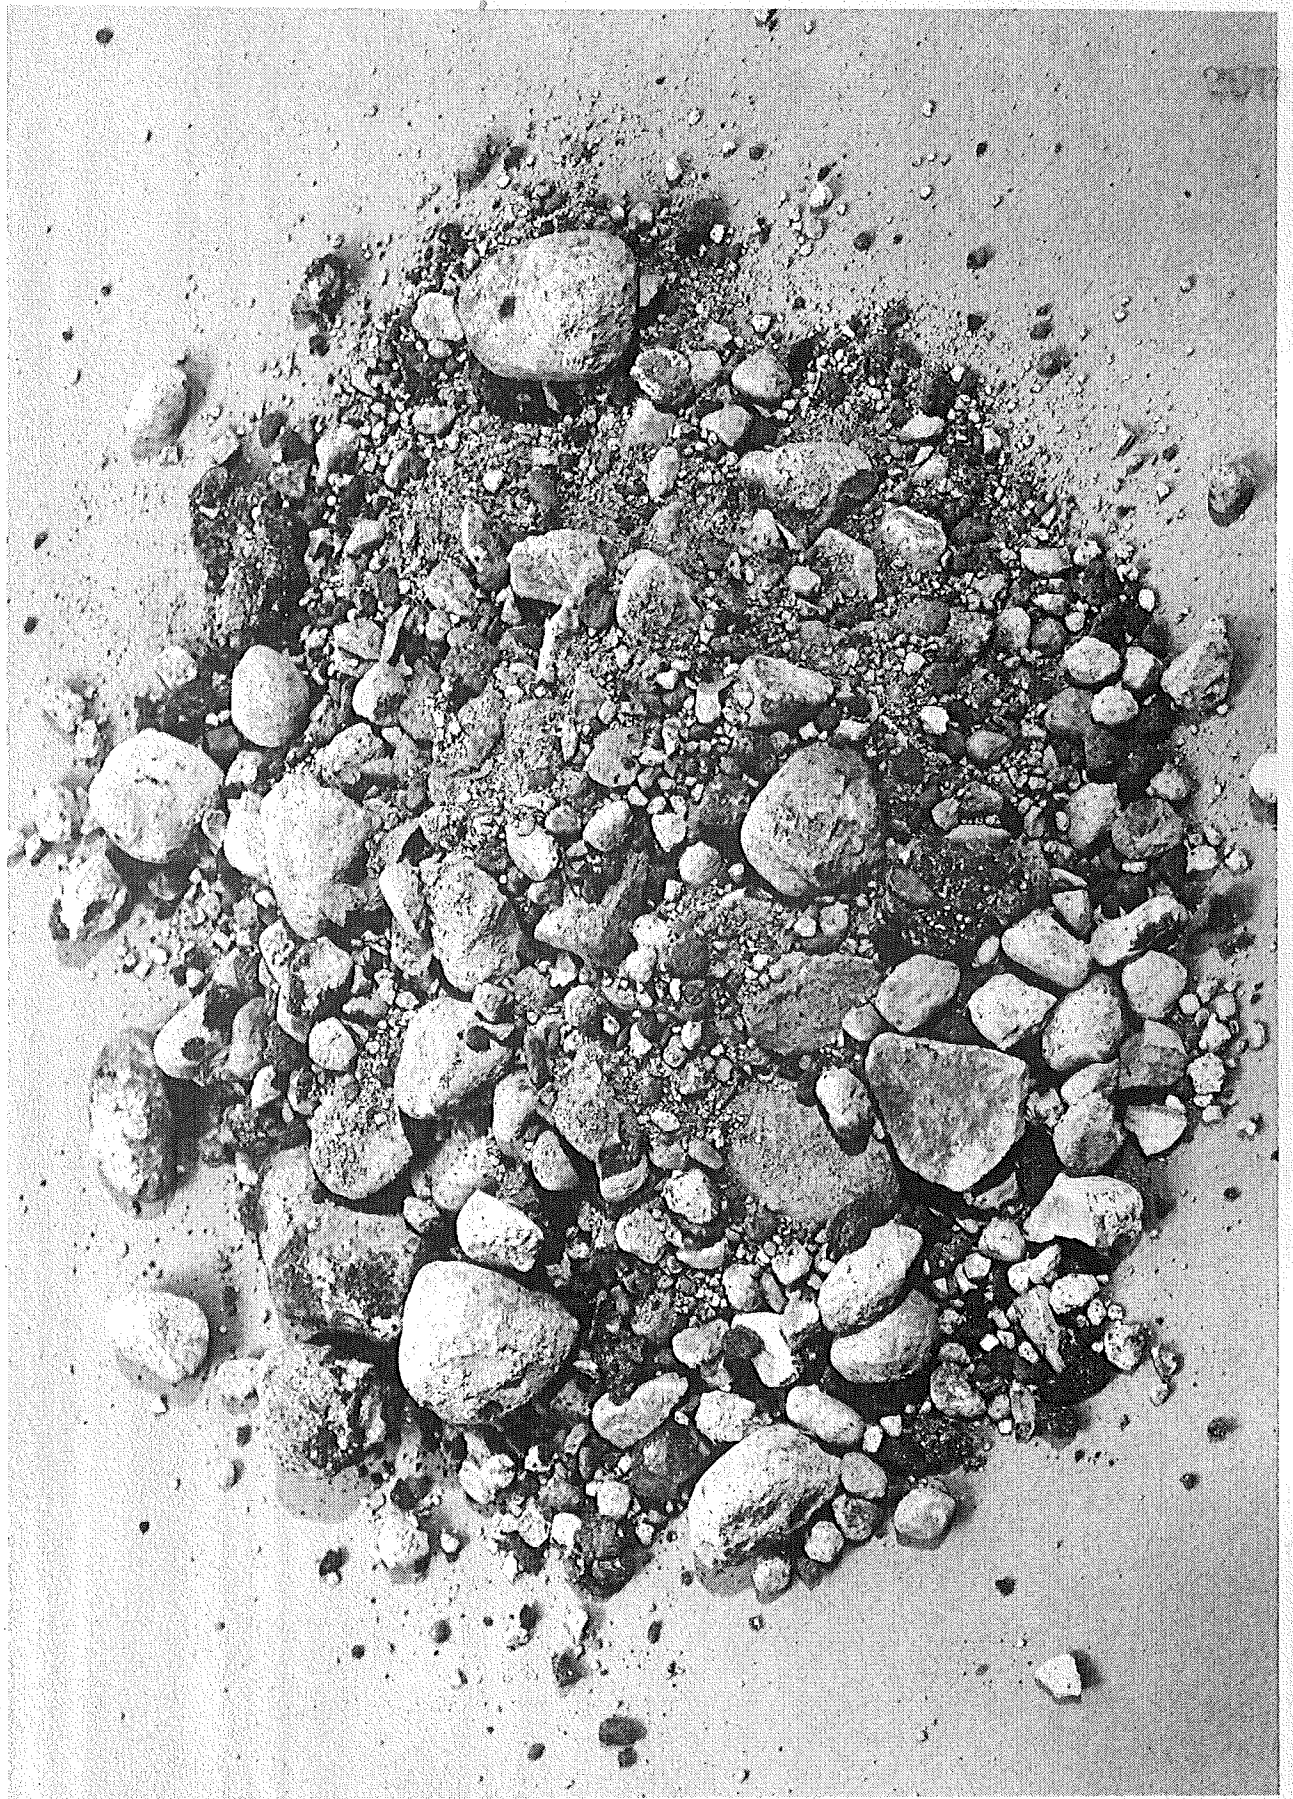
Condition of Concrete

In the blow-up area there was considerable concrete in the condition as shown in Figure 10. Note poor binding properties between course aggregates and cement mortar.

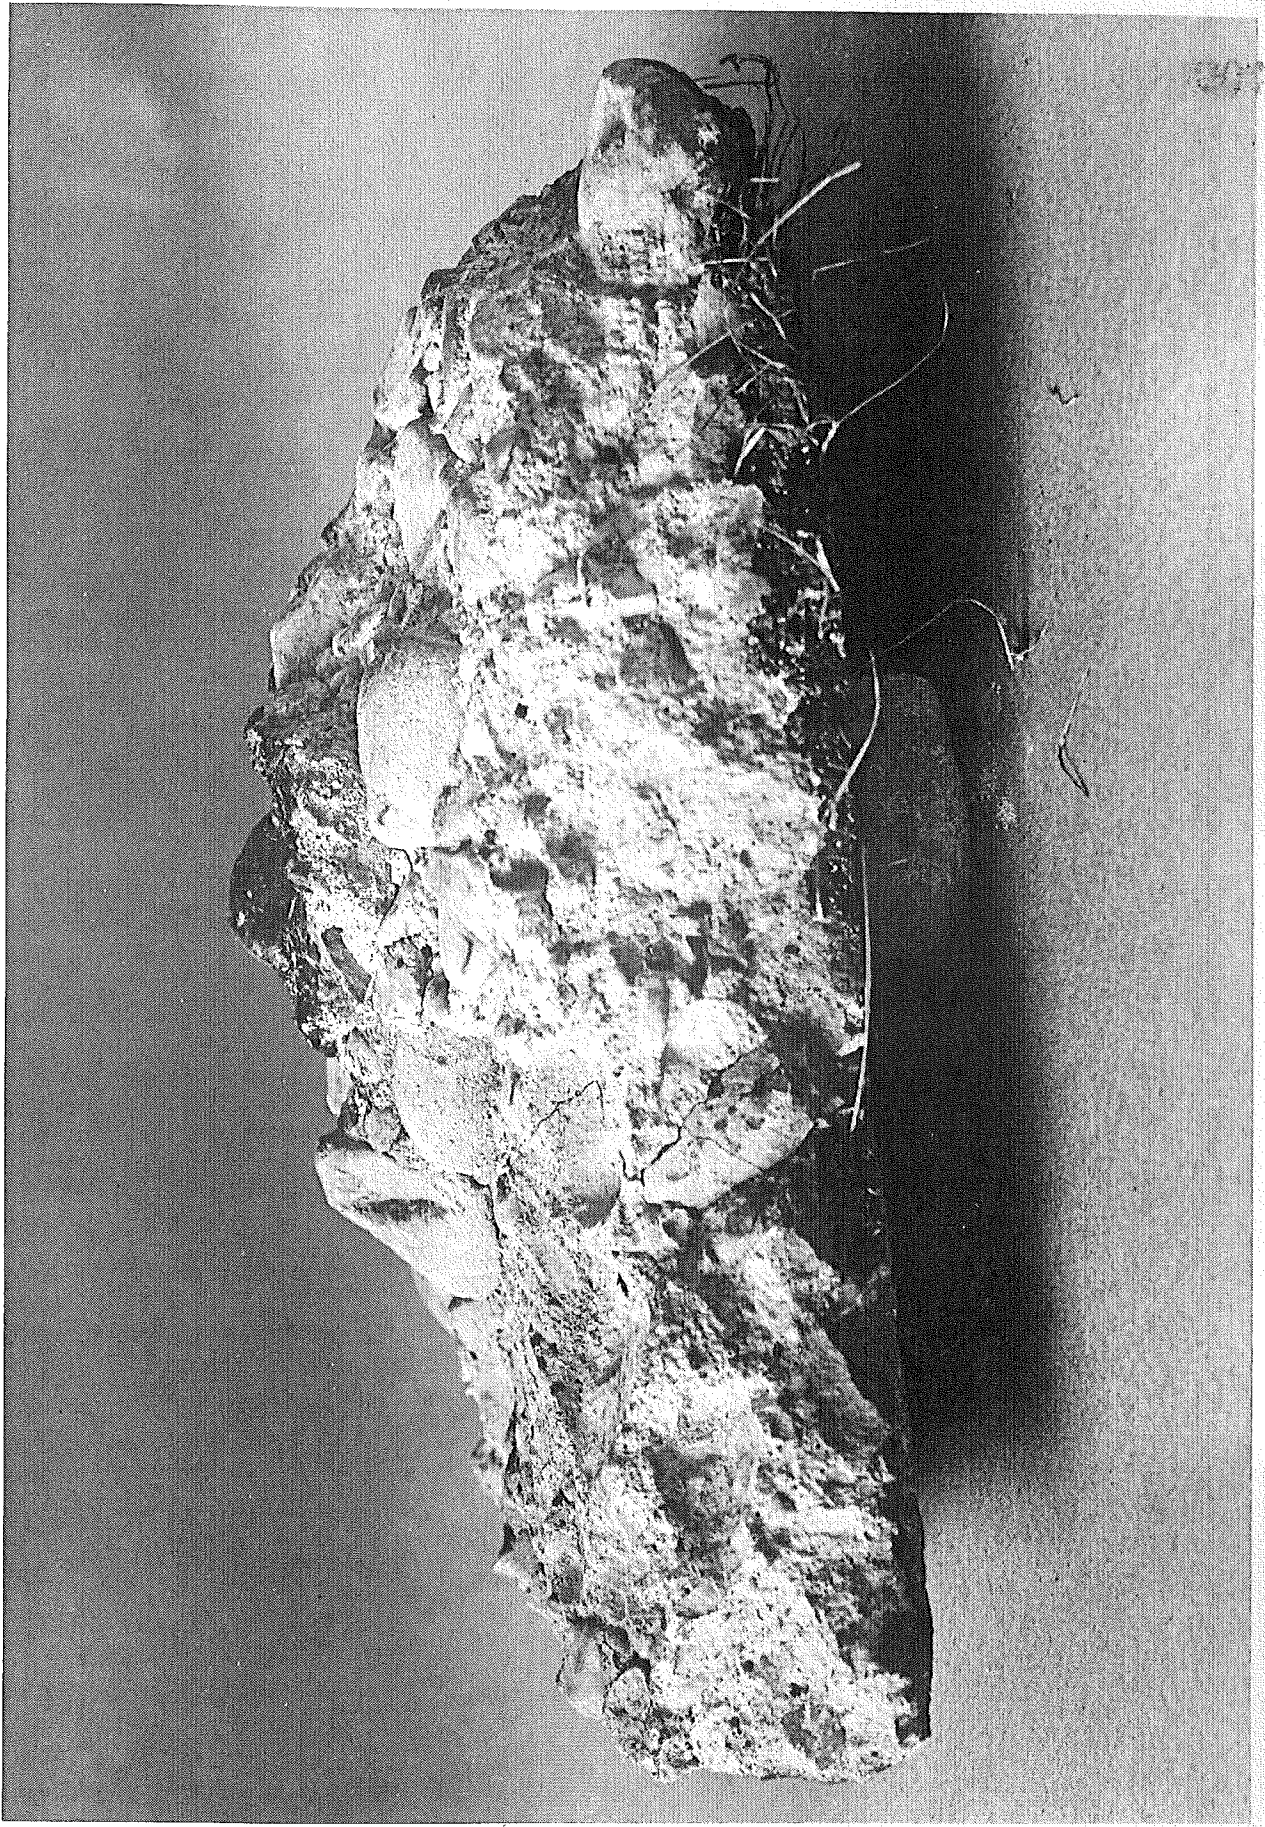
Compressive strength tests were made with a Swiss Hammer on the pavement and on specimens taken from blow-up area.

Sample 1.	3300 psi.	Sample A.	4200 psi.
Sample 2.	3450 psi.	Sample B.	4450 psi.

Figure 11 shows specimen of spalled concrete taken from blow-up area.

Note poor bonding conditions between coarse aggregate and mortar.
