PERFORMANCE OF SEVERAL TYPES OF
CORROSION RESISTANT LOAD TRANSFER
BARS, FOR AS MUCH AS 21 YEARS OF
SERVICE IN CONCRETE PAVEMENTS

Research Laboratory Section
Testing and Research Division
Research Projects 70 F-116
and 73 F-136
Research Report No. R-1151

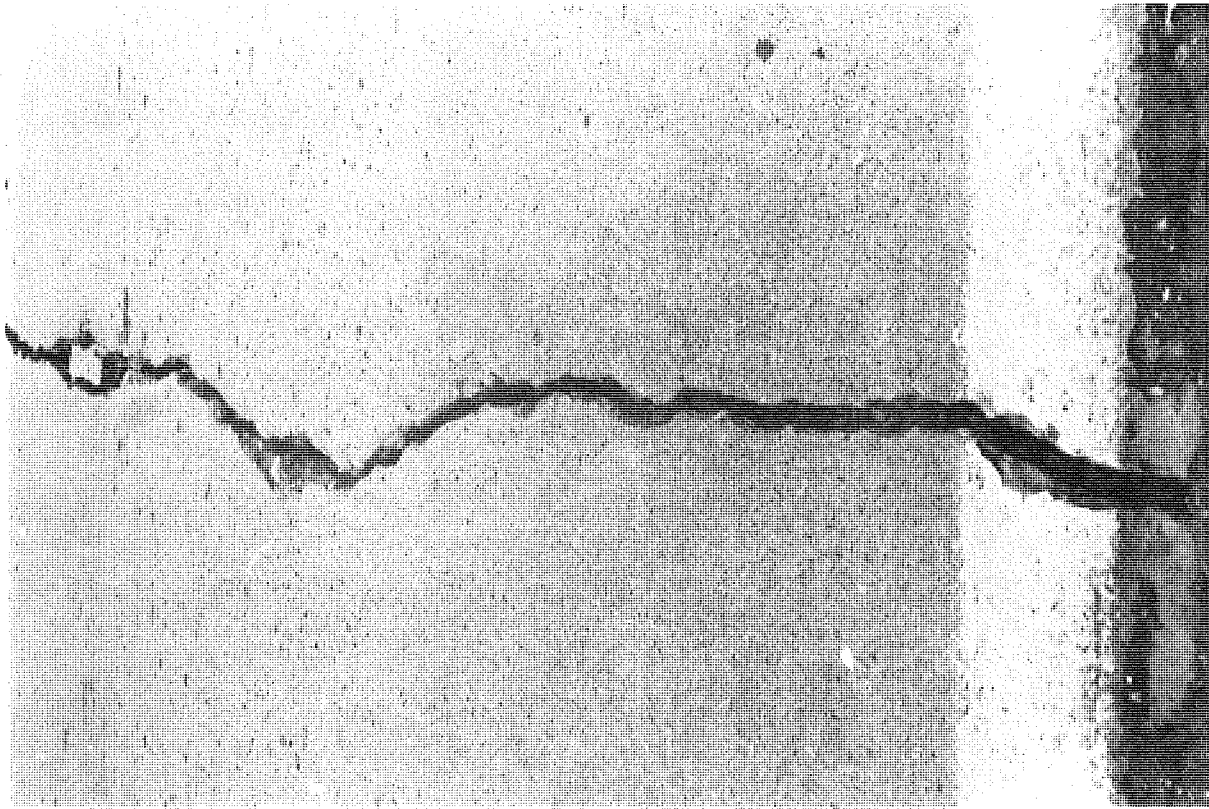
Figure 1. Open crack fills with incompressible material and causes extra pressure on adjacent joints when pavement expands in the spring.

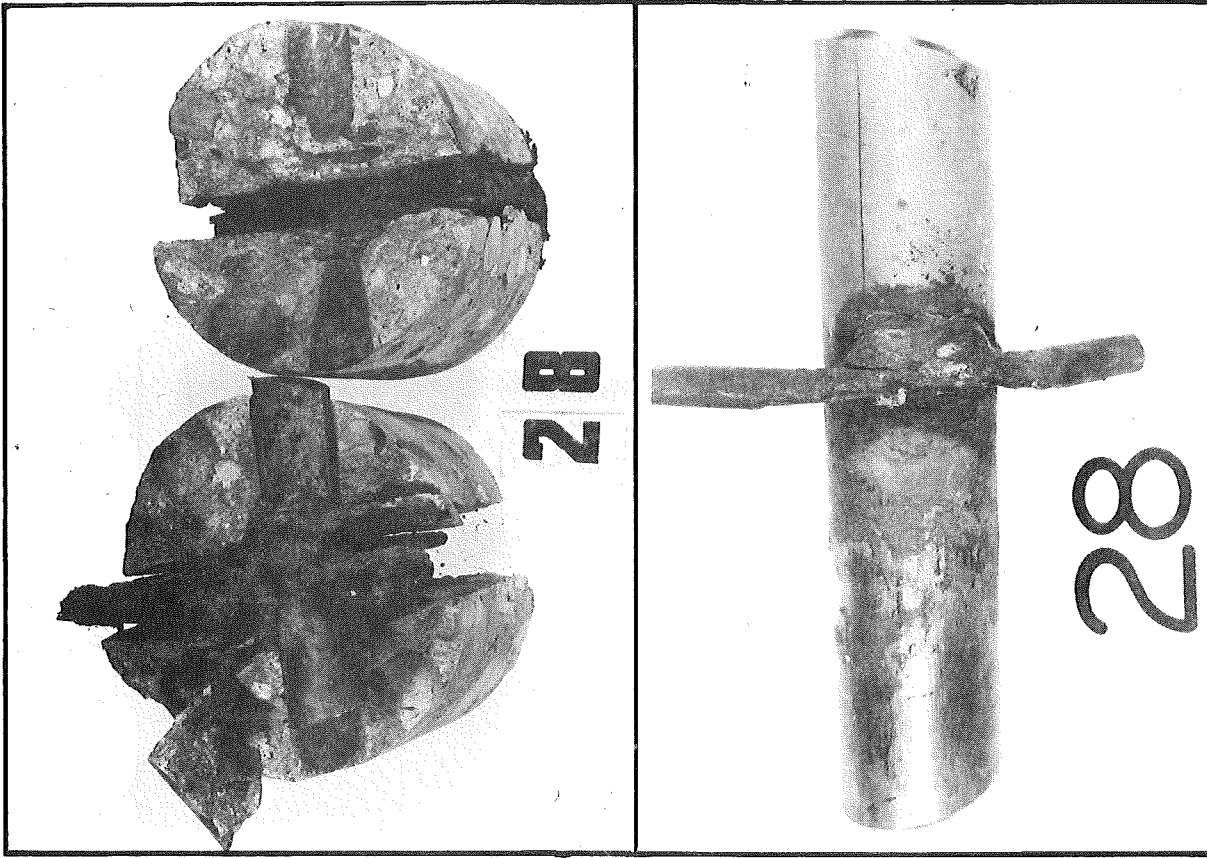
Figure 2. Stainless surfaced dowel (Type 304) from an expansion joint in I 96 near Portland; constructed 1958, 50-ft slab. Surface stained but in excellent condition after 21 years' service. Coating is 0.023 in. thick.

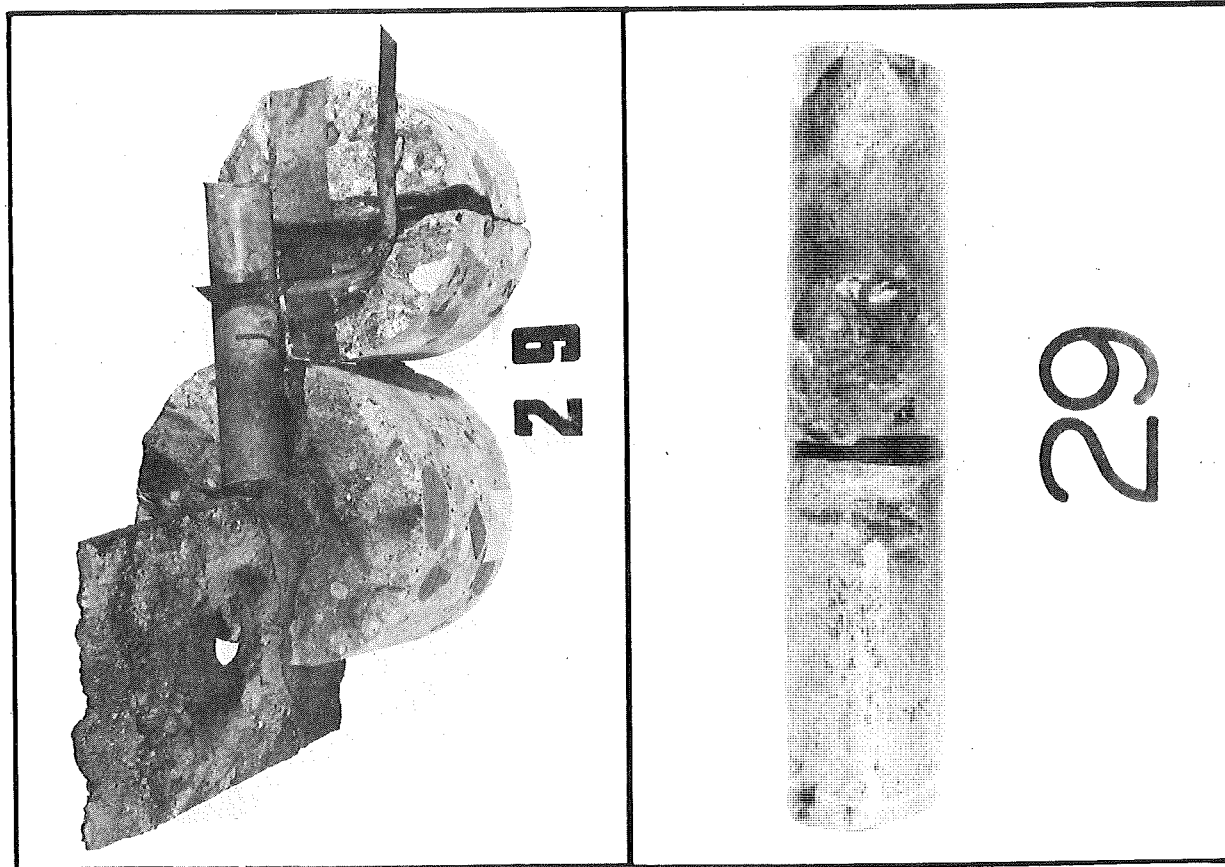
Figures 3 through 6 show the stainless steel and Monel surfaced bars, and the nickel clad bars removed from the I 96 pavement near Portland after 21 and 21-1/2 years of service. The only places where the stainless or Monel surfaces are disrupted are where the uncoated transverse wire was tack welded through the coating. Otherwise, although the surfaces are stained and have mineral deposits on them, the bars are in excellent condition. These old stainless steel and Monel surfaced bars were located in expansion joints while the newer stainless sleeves, the old nickel clad, and all other coated bars shown were removed from contraction joints. Generally speaking, the old stainless, Monel surfaced, and nickel clad bars are in remarkably good condition after having been in service for 21 or more years on an Interstate route. The location is rural, and therefore does not get salted as heavily as some urban sites, but with Michigan's climate and the bare roads policy of recent years, salting obviously has been considerable. The heavy corrosion of the attached uncoated wires shows evidence of the adverse environment to which the bars were exposed. Figures 7 and 8 show uncoated bars from nearby contraction and expansion joints, for comparison. Benefits of the coatings are obvious.

Figure 3. Stainless surfaced dowel (Type 316) from an expansion joint in I 96 near Portland; constructed 1958, 50-ft slab. Surface stained but in excellent condition after 21 years' service. Coating is 0.023 in. thick.

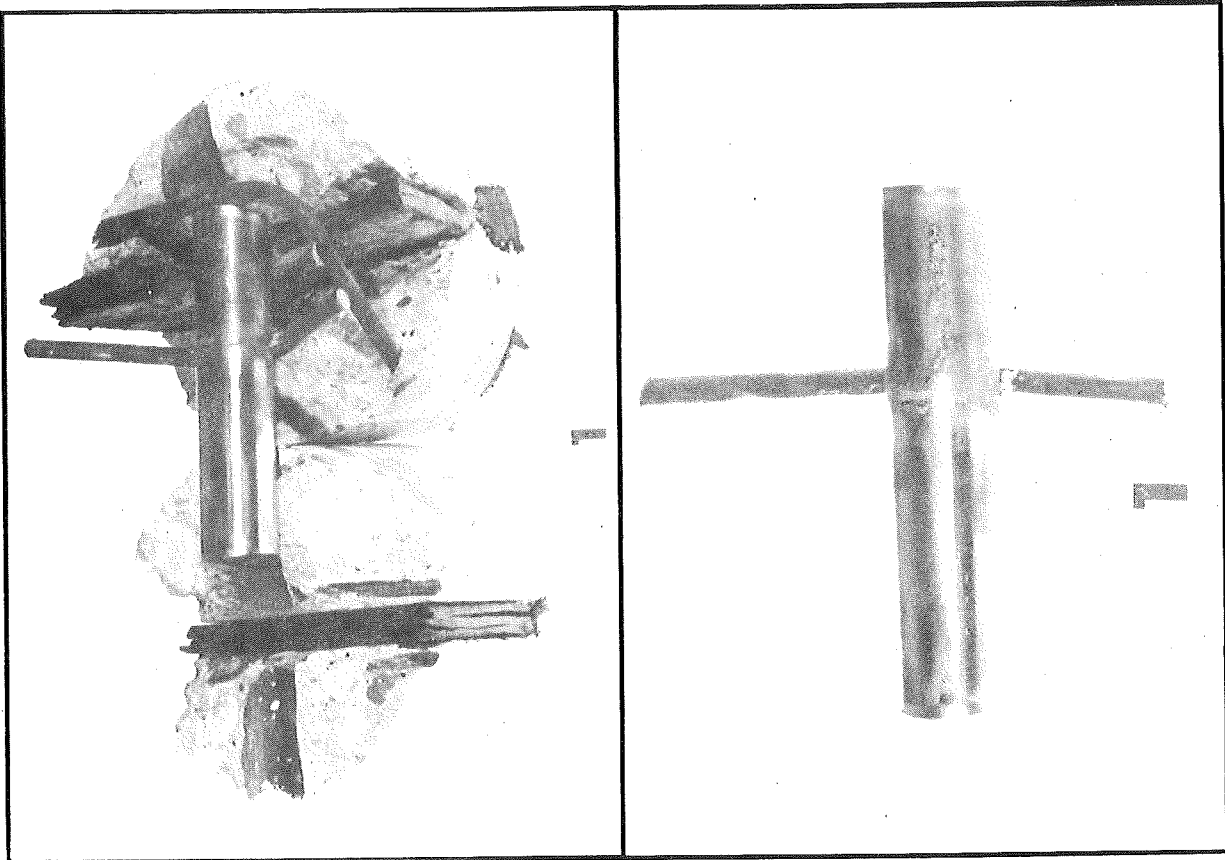
Figure 4. Monel surfaced dowel from an expansion joint in I 96 near Portland; constructed 1958, 50-ft slab. Surface stained but in excellent condition after 21-1/2 years' service. Coating is 0.026 in. thick.

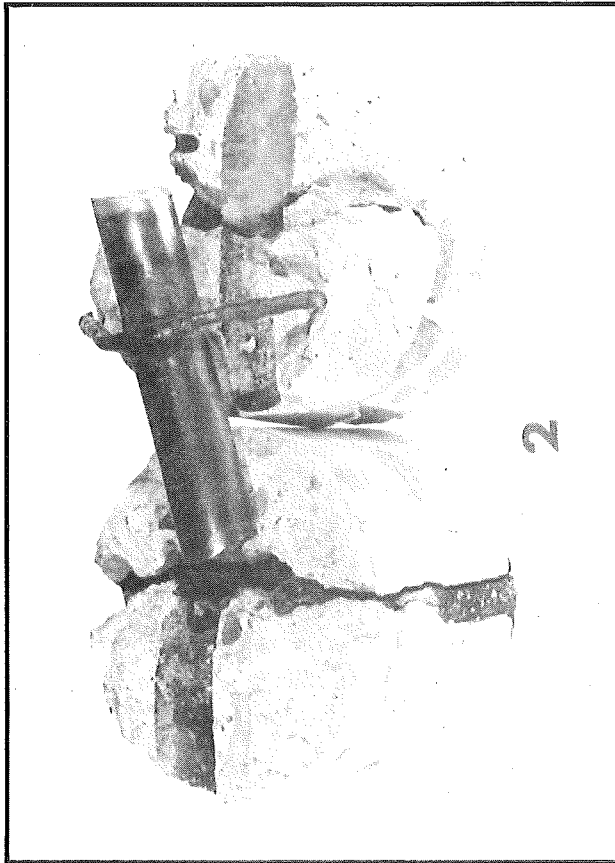
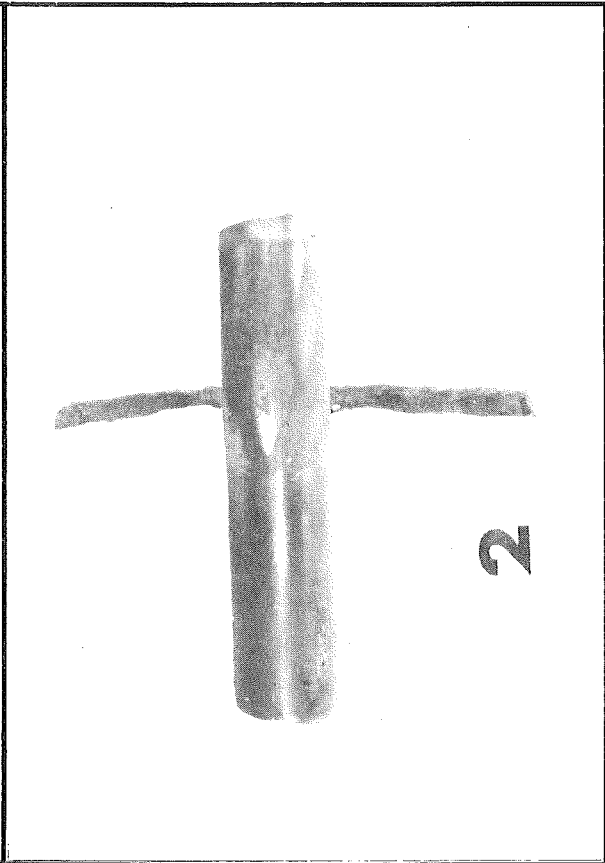
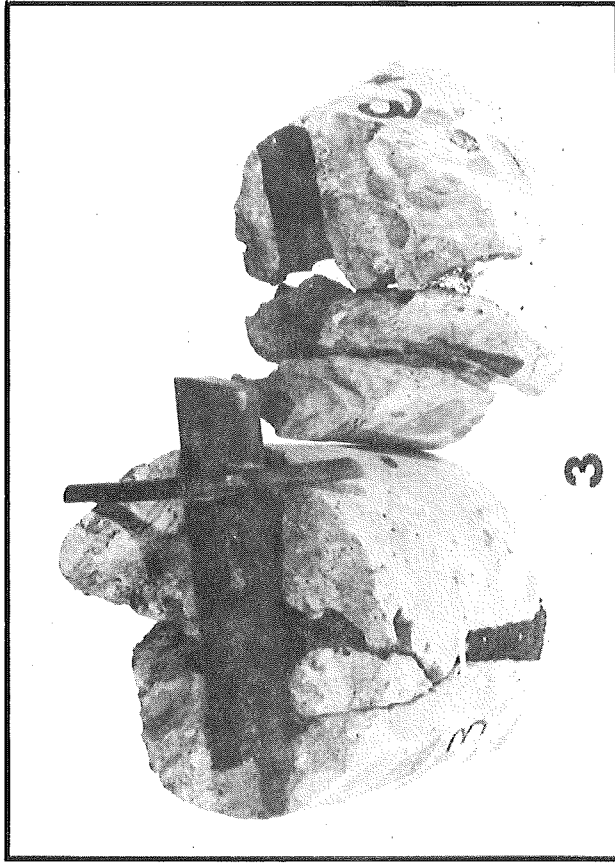
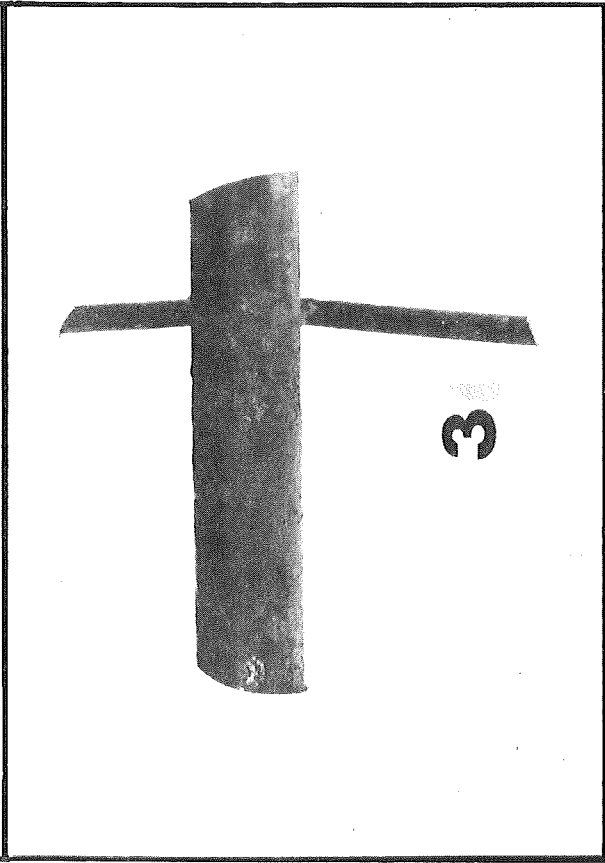
Figure 5. Nickel clad dowels from contraction joints in I 96 near Portland; constructed 1958, 99-ft slabs. The one at left has a variable thickness mill-rolled nickel coating 0.007 to 0.018 in. thick, still in place and in very good condition with some pitting. The other has no coating remaining but has not yet deteriorated badly for 21-1/2 years' service. It appears to have been protected to some extent during early service, perhaps by a thinner coating.

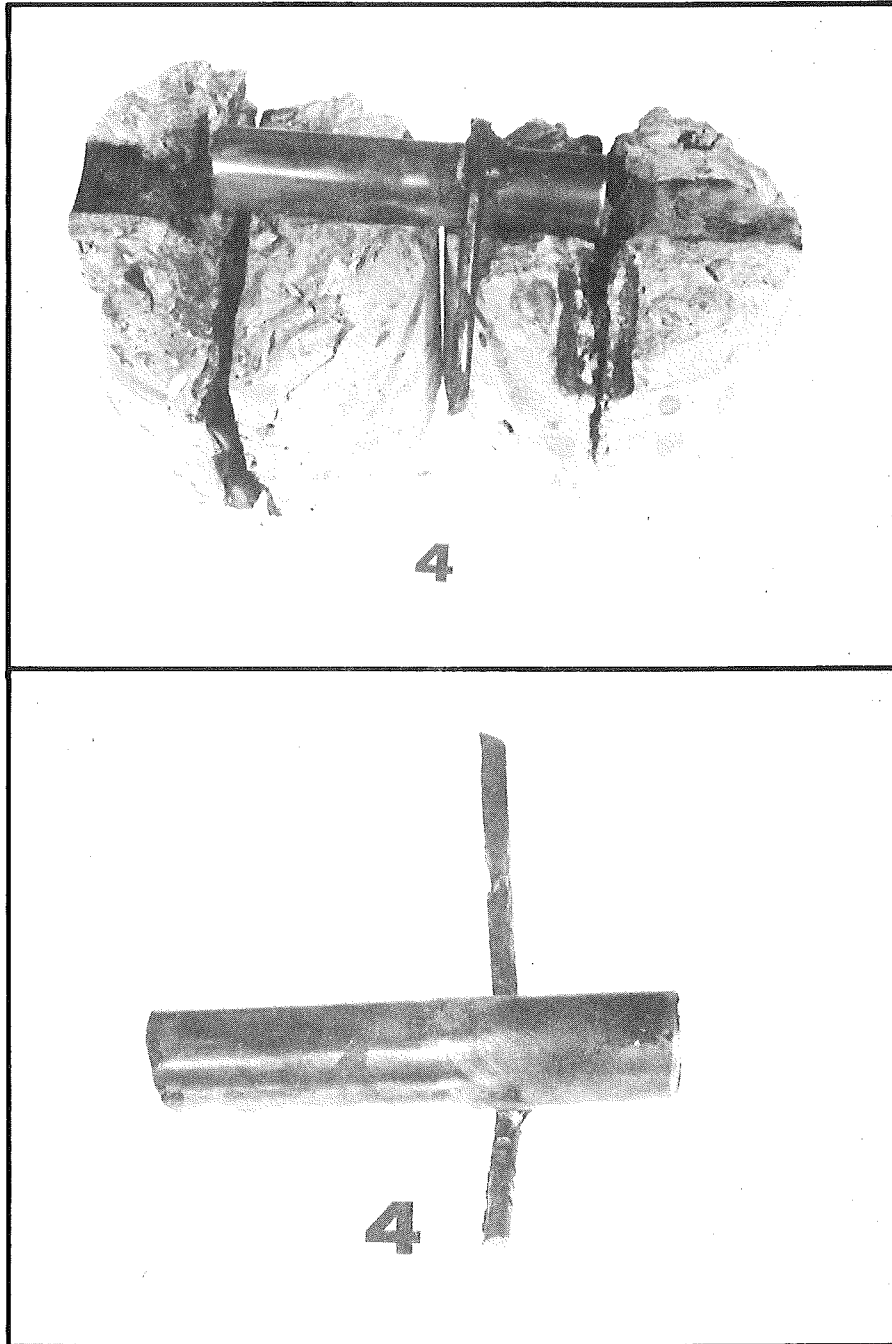
Figure 6. Stainless surfaced dowel (Type 430) from an expansion joint in I 96 near Portland; constructed 1958, 50-ft slab. Surface stained but in excellent condition after 21-1/2 years' service. Coating is 0.026 in. thick.

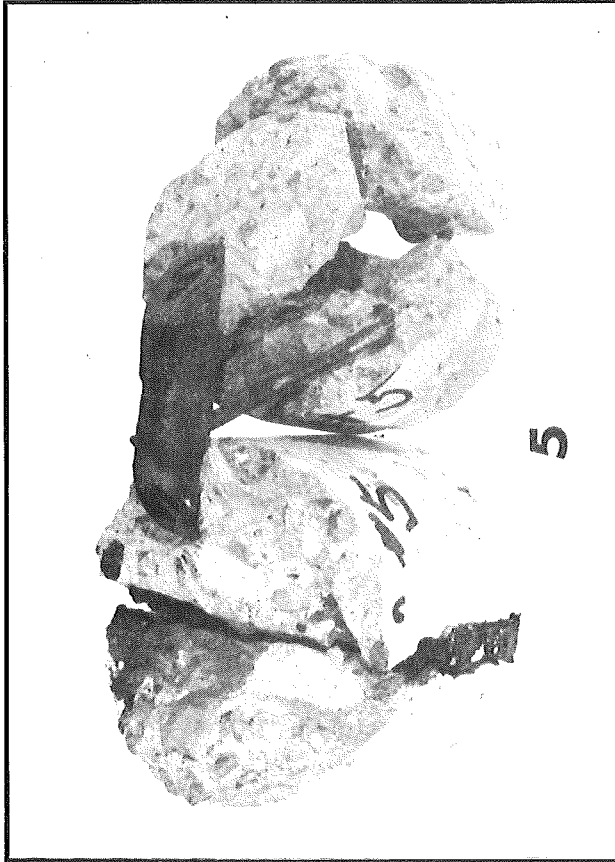
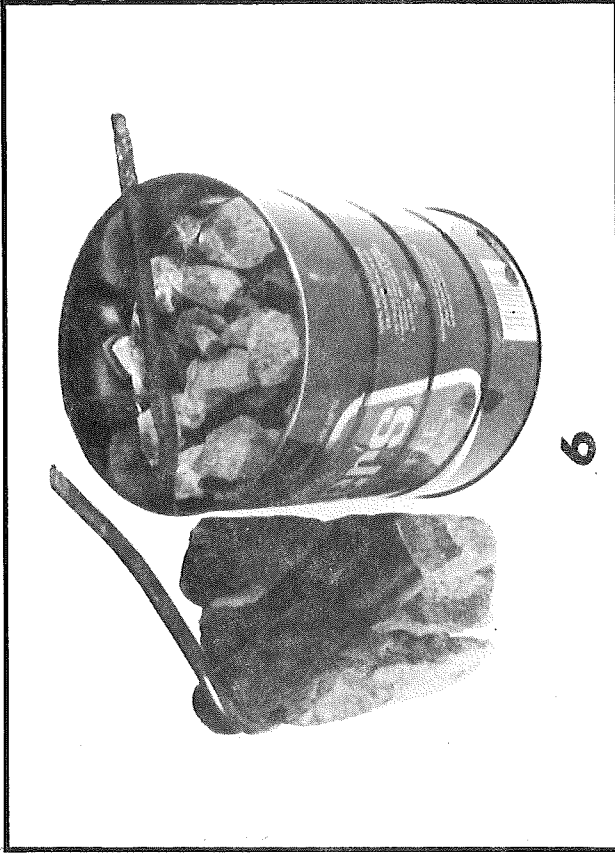
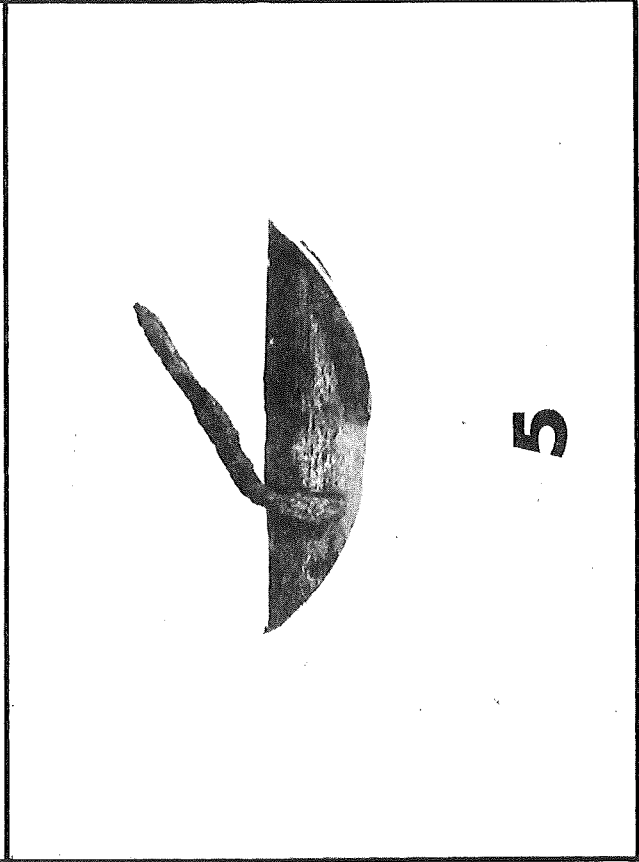
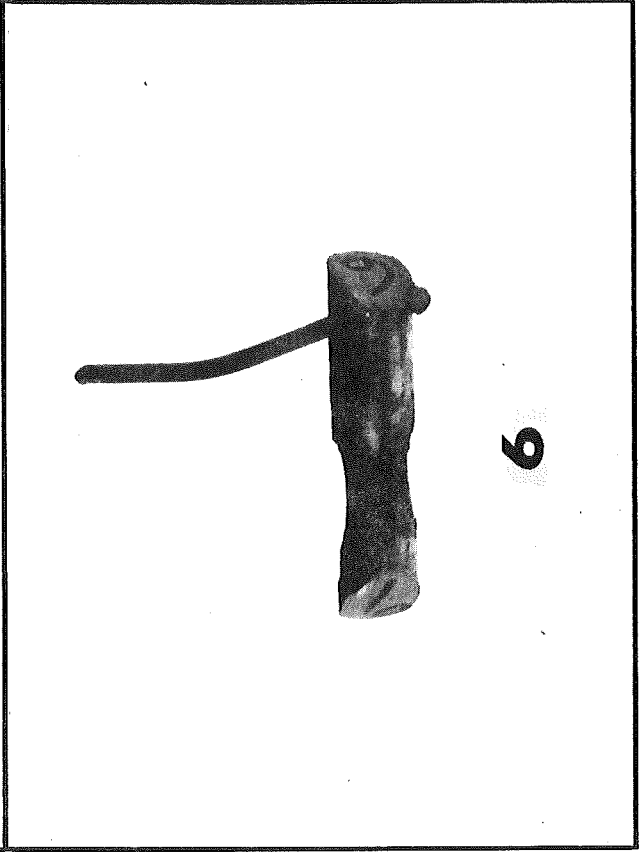
Figure 7. Standard, uncoated dowels from contraction joints in I 96 near Portland; constructed 1958, 99-ft slab length. These bars are from 'better' joints in the area; both show severe attack and metal loss after 21-1/2 years' service.

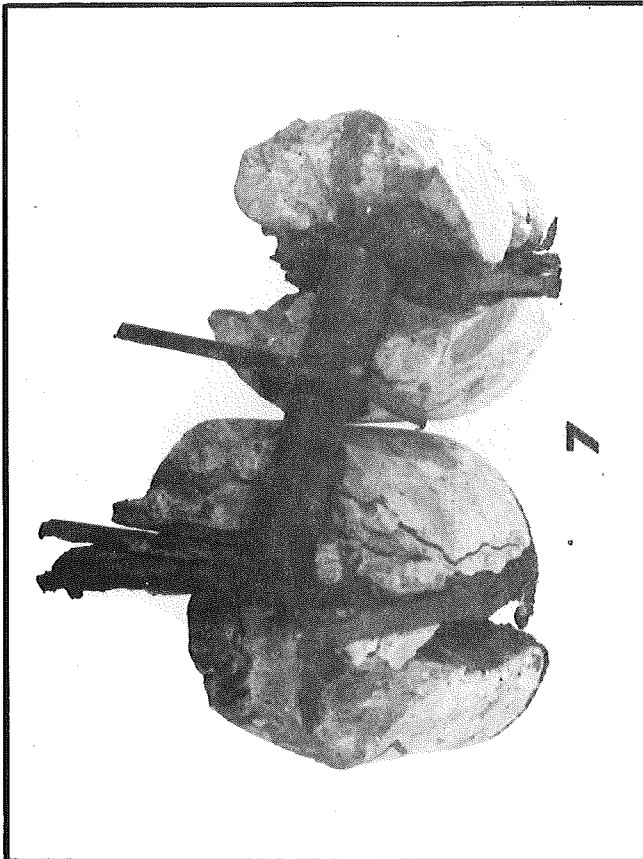
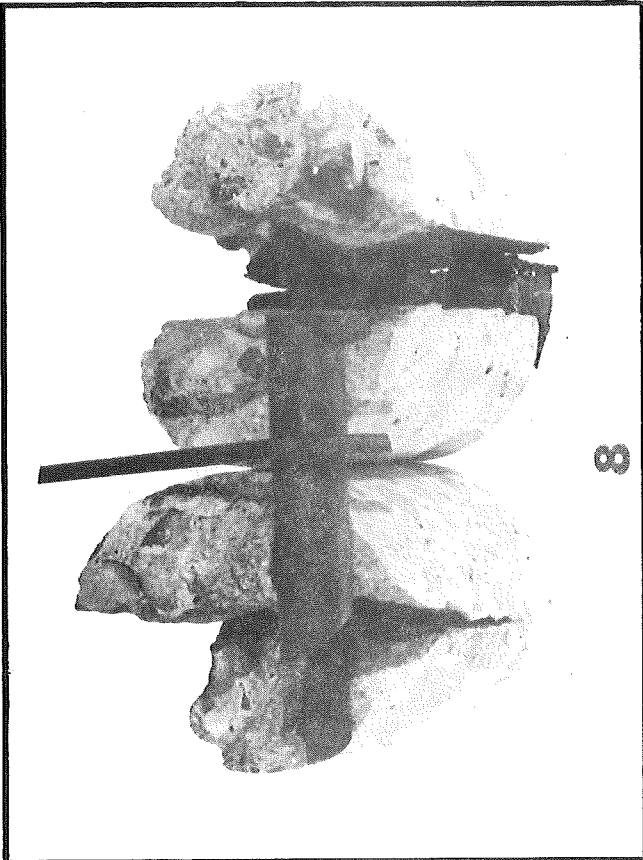
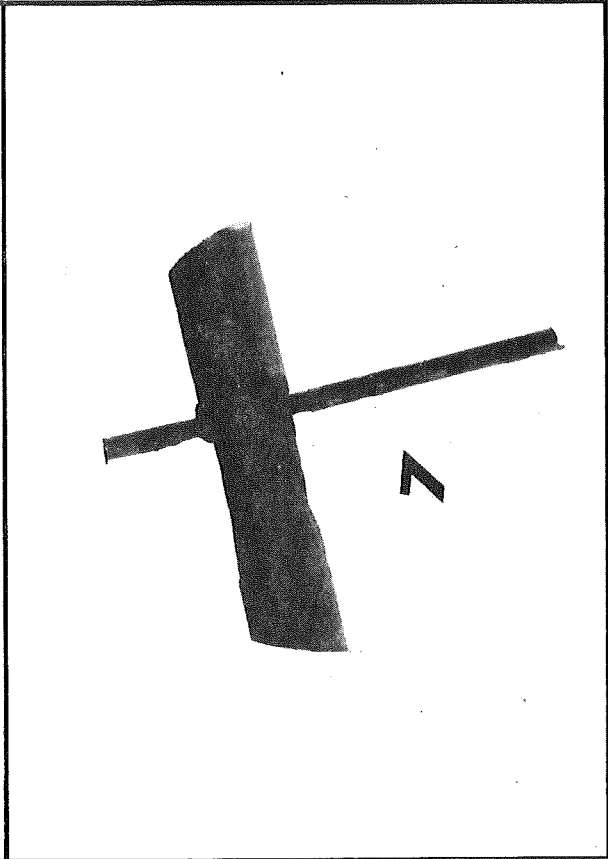
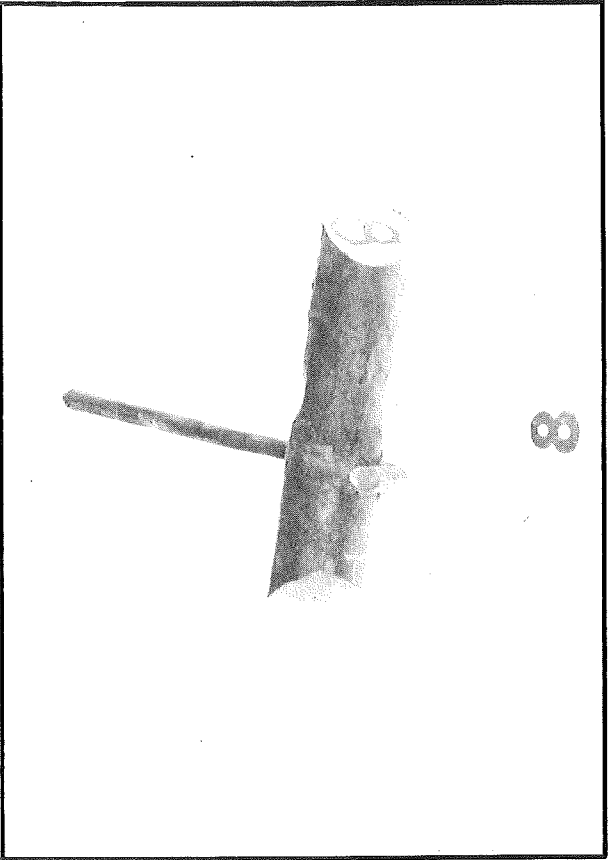
Figure 8. Standard, uncoated dowels from expansion joints in I 96 near Portland; constructed 1958, 99-ft slab lengths on one side, 16-ft on the other (bridge approach). Heavily corroded but somewhat better than those from the contraction joints after 21-1/2 years' service.

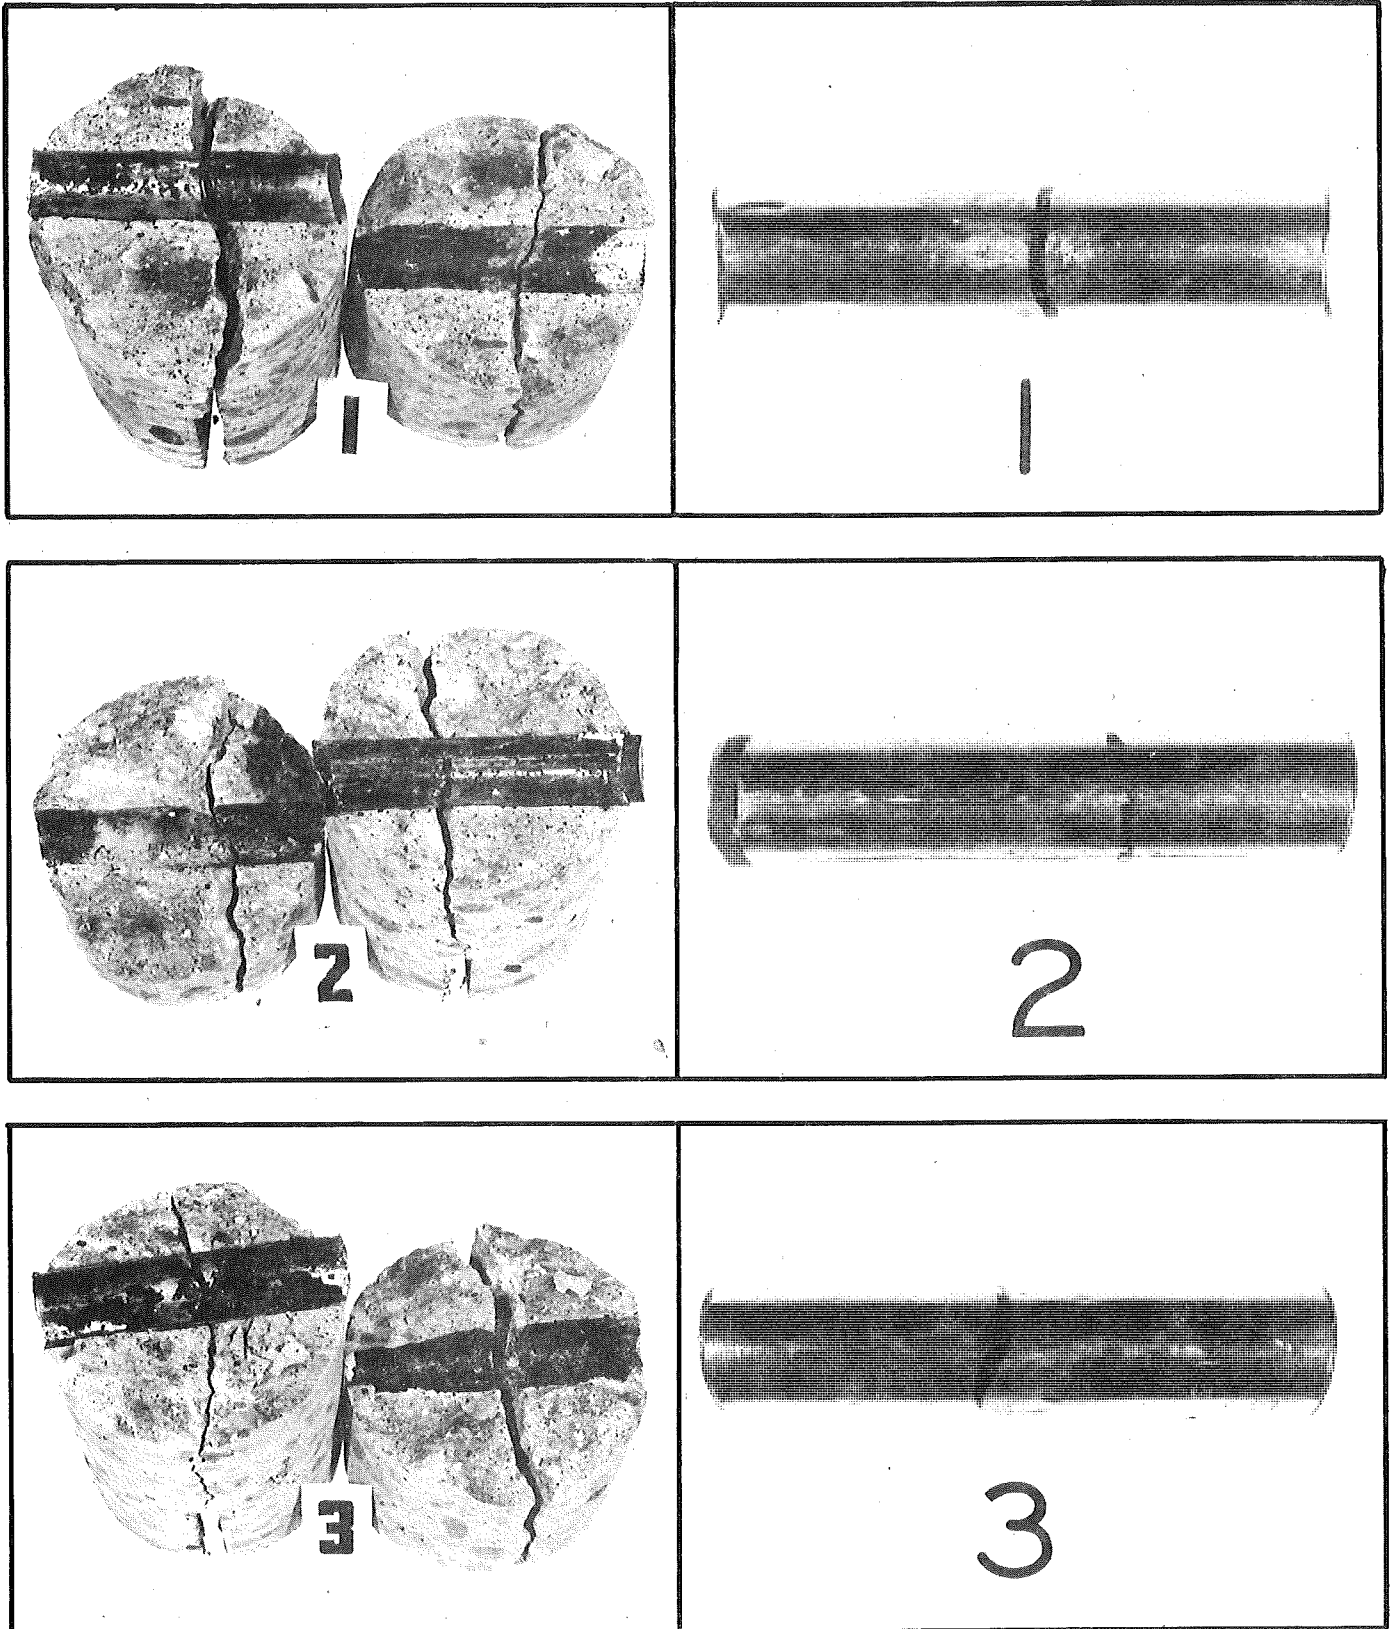
The bars in Figure 9 are from an early 1977 installation where sleeves were fitted to the bars and spot welded by hand, resulting in a very loose fit. At the time of construction, this was the only source available. There was some concern that the loosely fitting sleeves might buckle in service. Later projects had bars from another source that developed a machine operation with a rolled seam that fitted much better. The bars shown in Figure 10 are from one of the later projects. A close look at Figure 10 shows that even these sleeves are loose enough to allow denting of the sleeve by the operations used to remove the bar from the core. Although no load transfer tests have been made on those roadways, previous work would indicate the probability that load transfer would be reduced by increased clearance between the bar and sleeve, since relative deflections normally are very small for tight fitting uncoated dowels. The possibility of impact as the bar moves within the sleeve also seems evident. Long-term possibilities of the build-up of corrosion products between the bar and sleeve also must be considered. At the present time, the outside surfaces of the bars themselves inside the sleeves show evidence of having been wet, probably during placement of concrete, but do not appear to have been repeatedly

Figure 9. Stainless sleeves from contraction joints in I 96 near Detroit; constructed 1977, 40-ft slabs. Sleeves are loose fitting, but in very good condition after two years' service. Black stain in top views is bituminous bond-breaker. Sleeves are 0.011 in. thick, '300 Series' type stainless, hand formed and spot-welded.

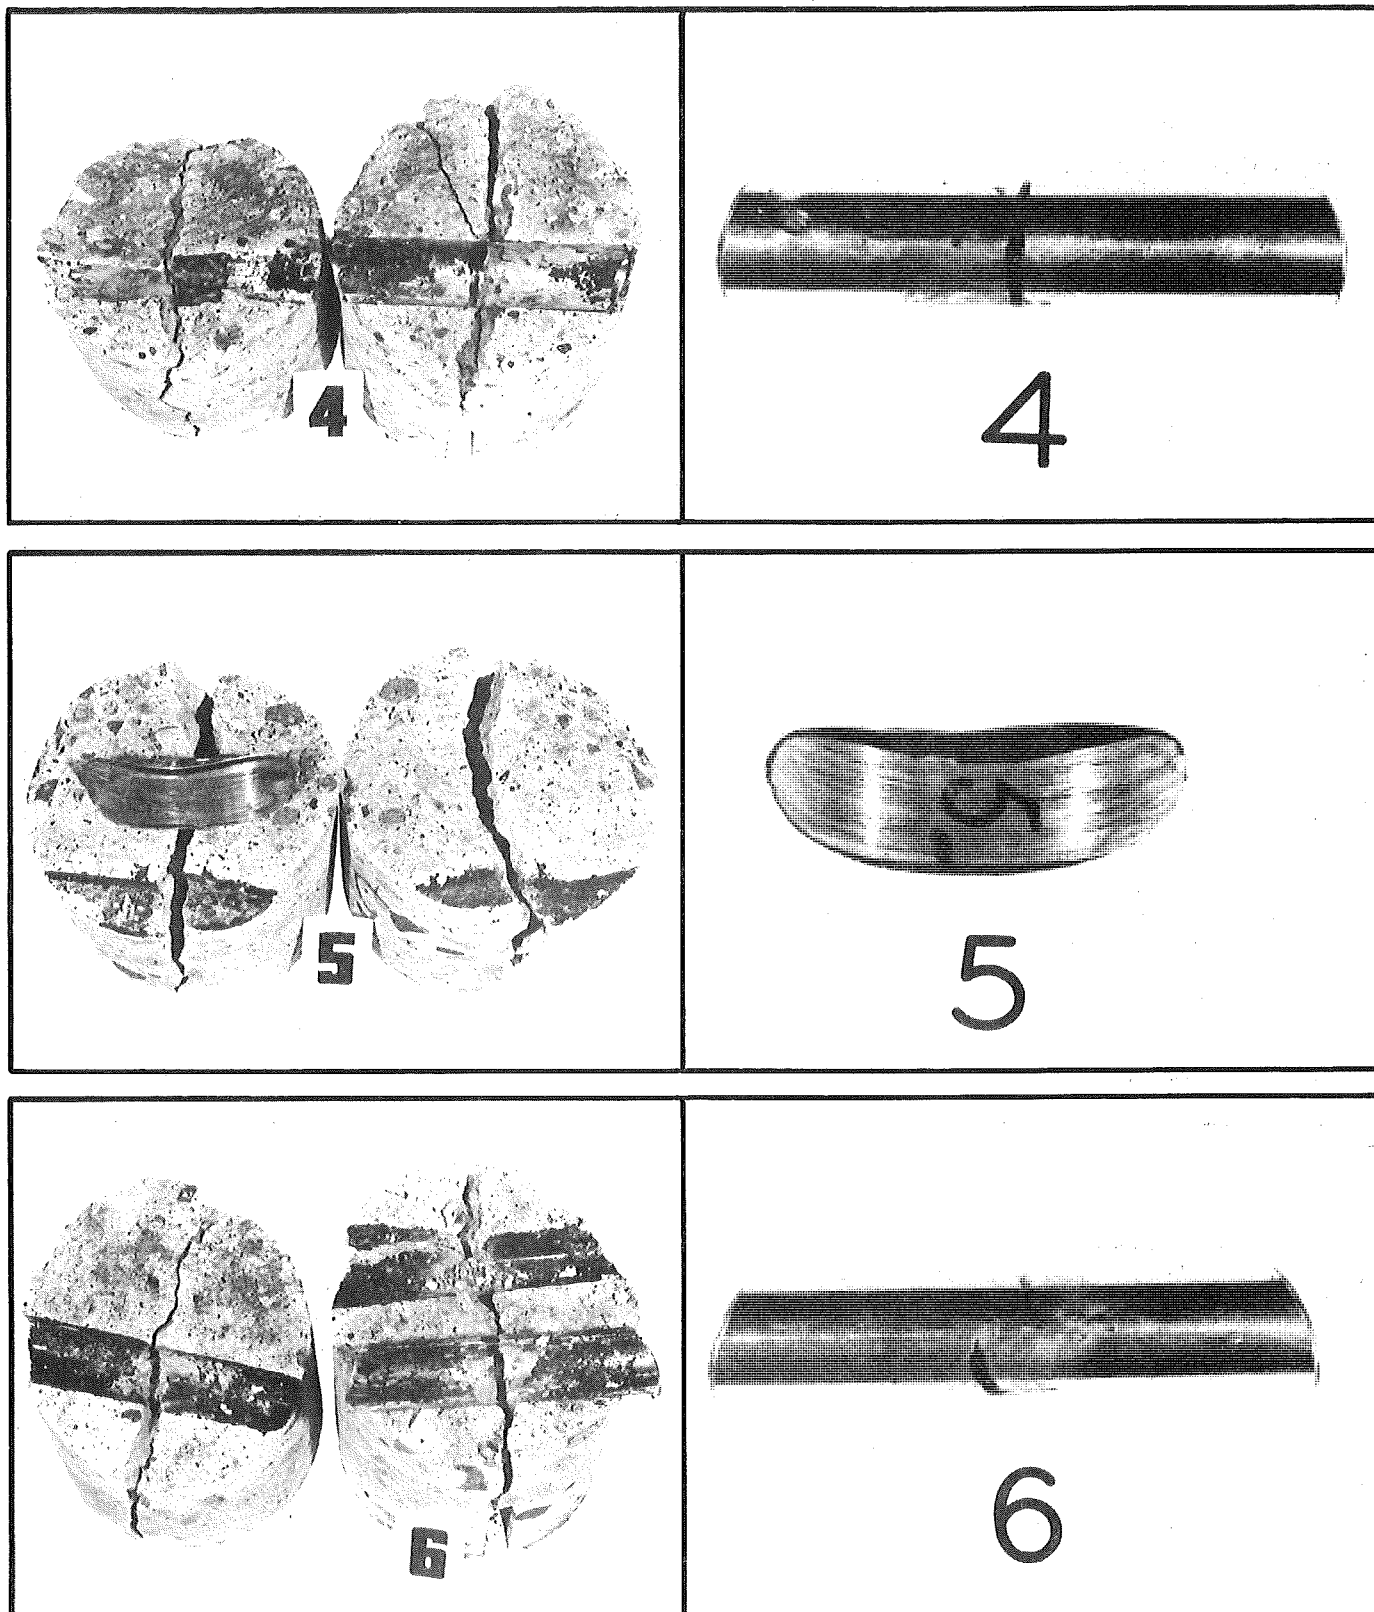
Figure 10. Stainless sleeves from contraction joints in I 96 near Detroit; constructed 1977, 40-ft slabs. Sleeves are tighter fitting than those in Figure 9 and are in very good condition after two years' service. Dents were caused by removal operations. Black stain in upper views is bituminous bond-breaker. Sleeves are 0.011 in. thick, '300 Series' type stainless, seam welded.

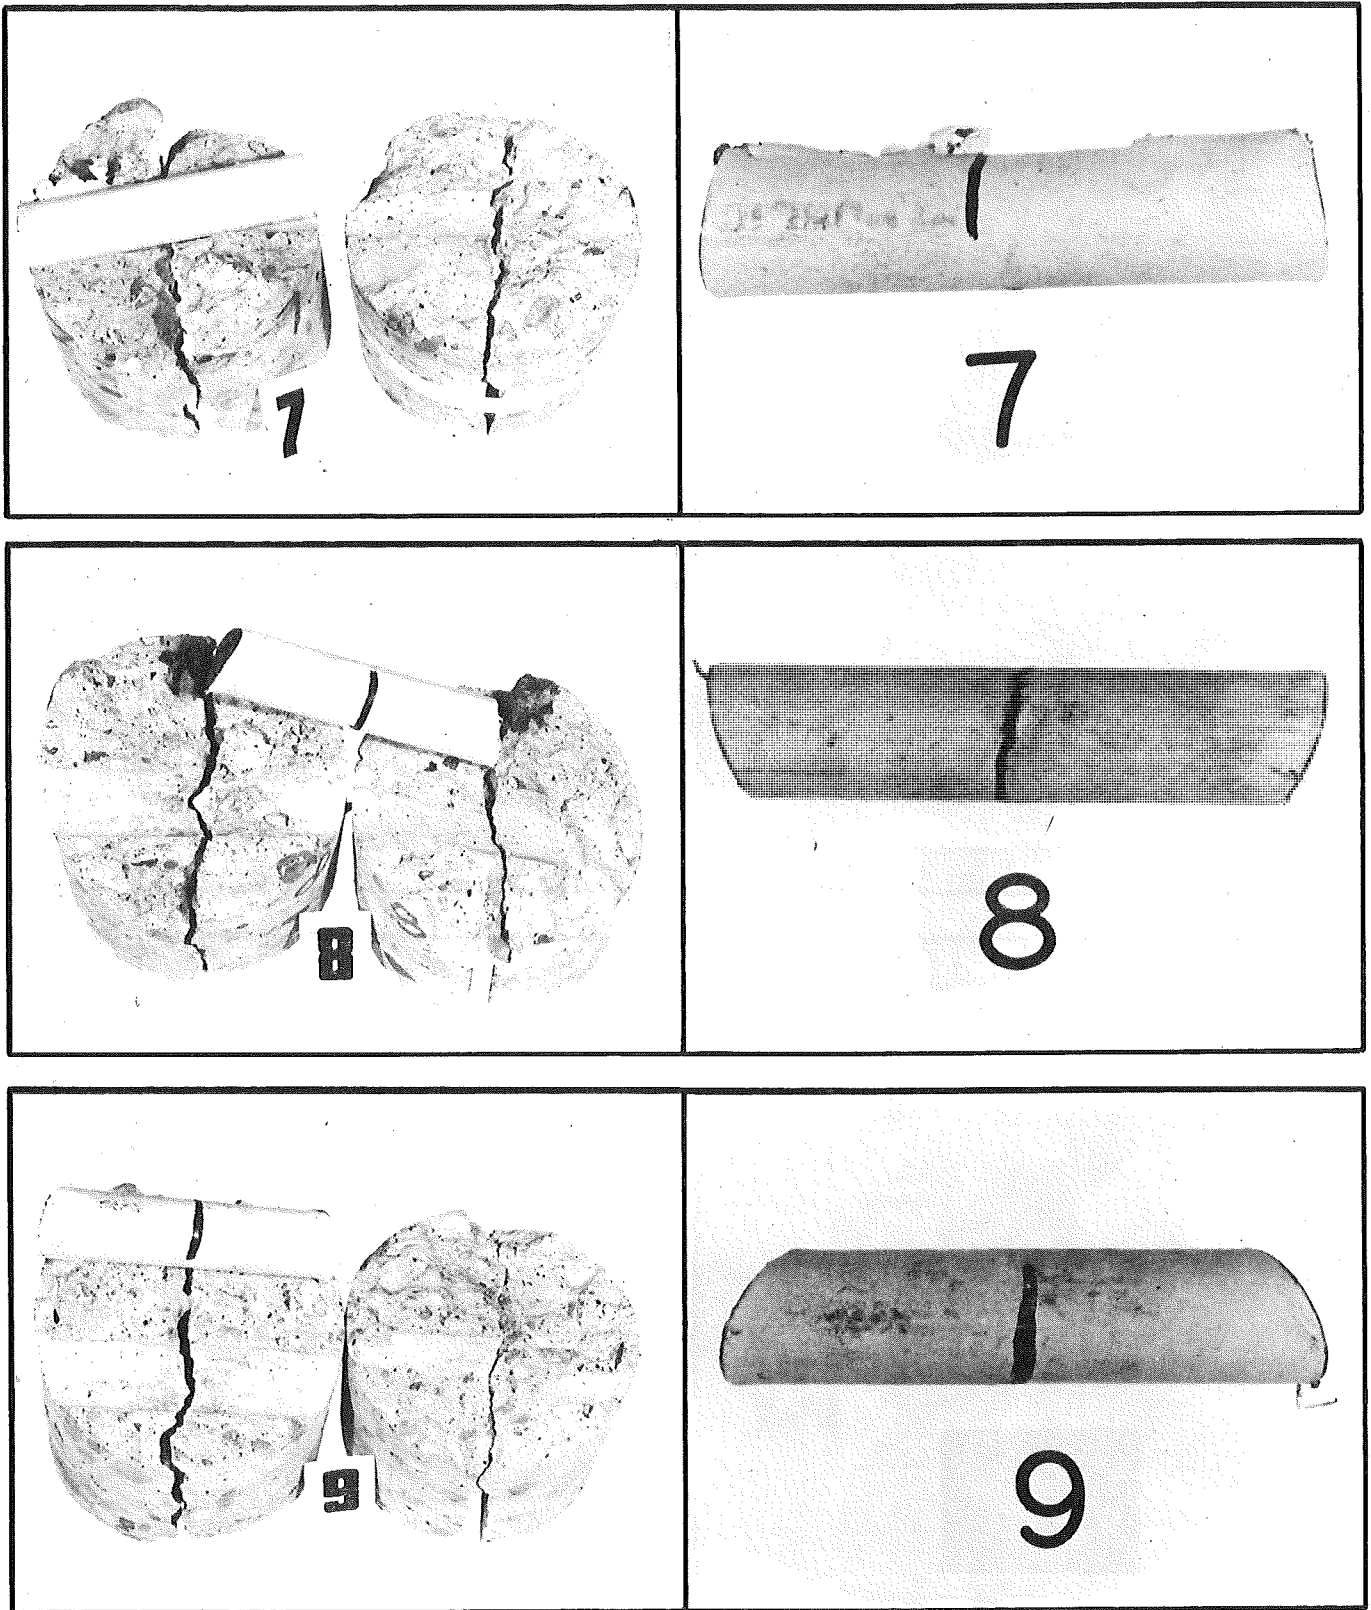
Figure 11 shows the excellent performance of the coatings on the plastic coated dowels installed on M 52 south of Owosso in 1969. Note on sample No. 7 that the damaged coating was caused during removal of the core. Measured polyethylene thickness on these particular bars was nearly 0.030-in. In a final report on the experimental project from which these bars were removed, Simonsen (3) concluded the following:

Figure 11. Plastic coated dowels from contraction joints in M 52 near Owosso, constructed 1969, 71-ft slabs. Coatings are in excellent condition after 10 years' service. Note that the damage on specimen No. 7 was caused by the coring operation. The polyethylene coating is nearly 0.030 in. thick.

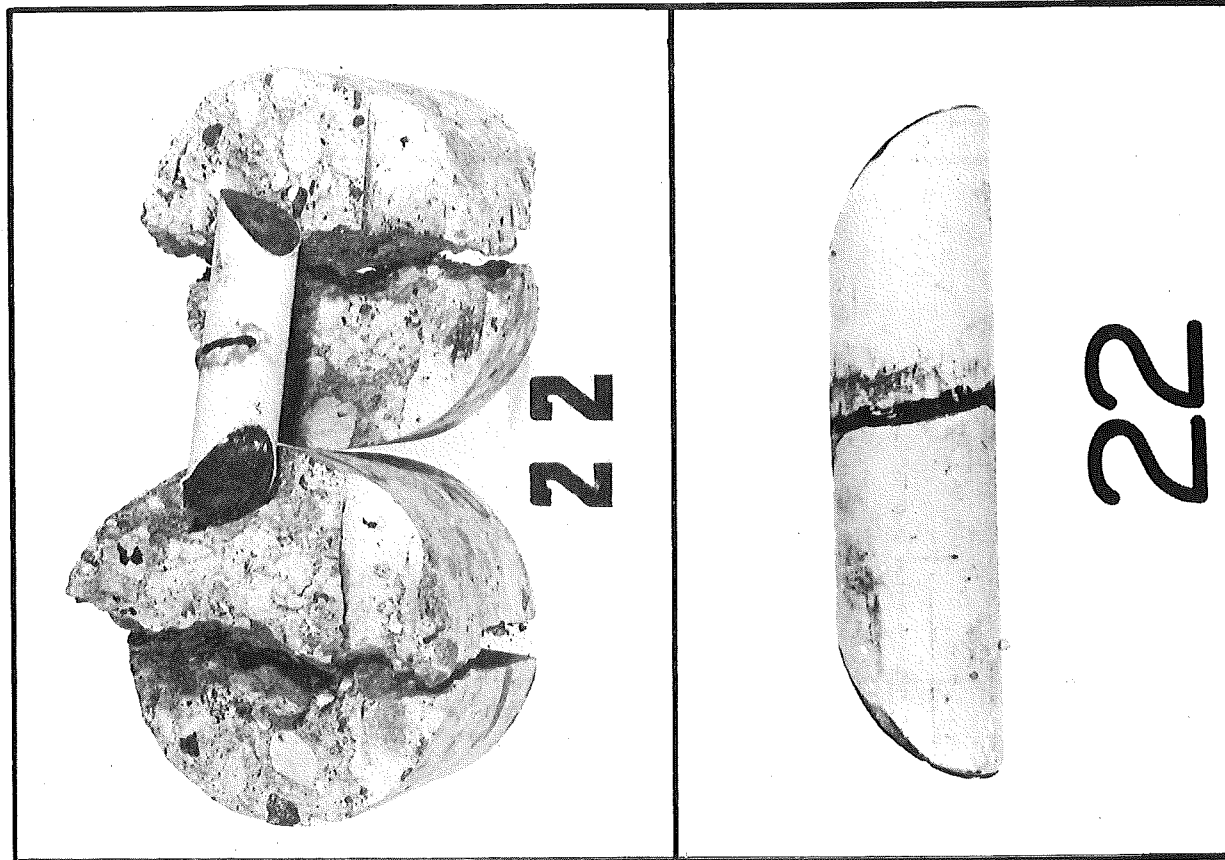
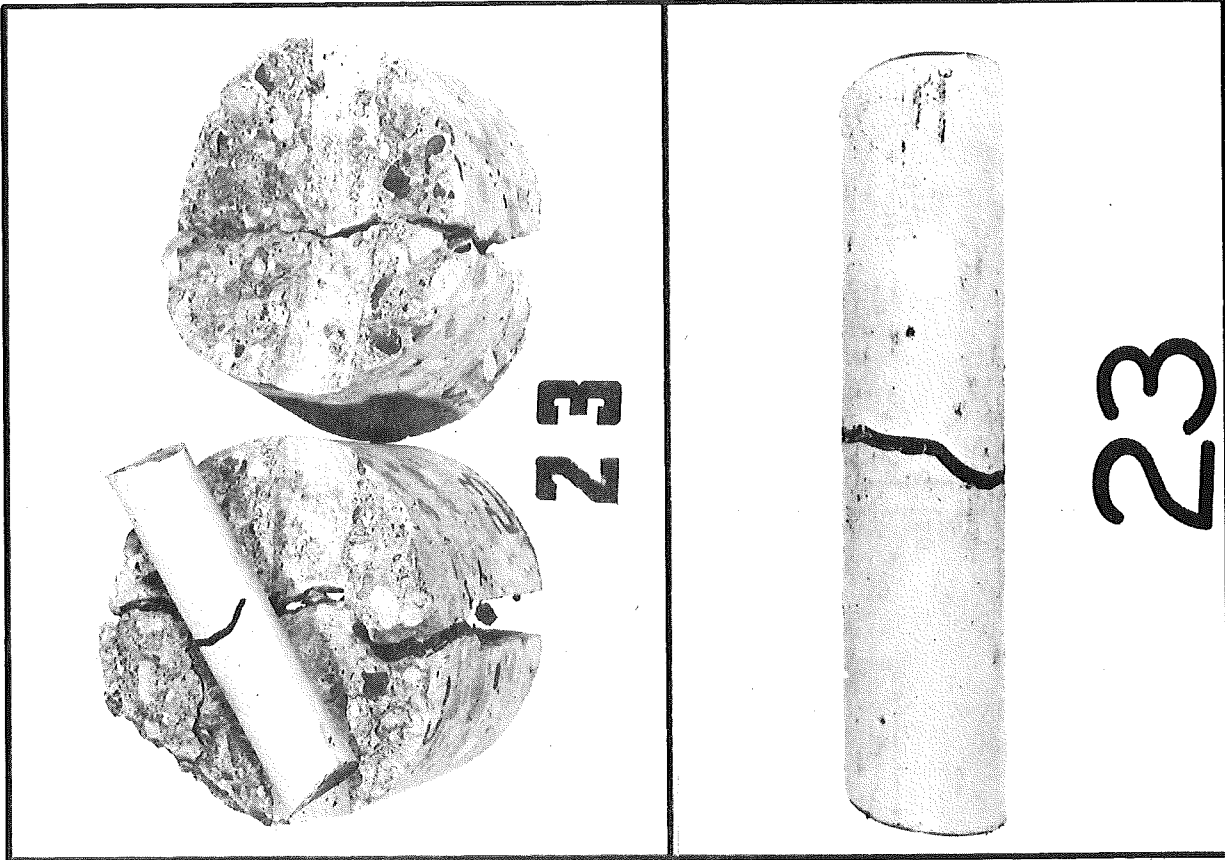
Figure 12, taken from the more extensive installation made on I 75 west of West Branch during 1973, confirms the excellent performance of the plastic coatings. While there are some small dents and stains on the surface, the coating is intact and in good condition after six years' service at the rural freeway location. Measured polyethylene thickness was 0.023-in. Comparison with the uncoated bars from the same project shown in Figure 13 shows the corrosive attack that would have occurred without the coating.

Figure 12. Plastic coated dowels from contraction joints in I 75 near West Branch; constructed 1973, sample Nos. 22 and 23 are from 71-ft slabs, No. 24 is from 57-ft slabs, and No. 27 is from 43-ft slabs. Coatings are in very good condition after six years' service. Discoloration is surface abrasion and staining. Polyethylene coating is 0.023 in. thick.
