PERFORMANCE OF SEVERAL TYPES OF
CORROSION RESISTANT LOAD TRANSFER
BARS, FOR AS MUCH AS 21 YEARS OF
SERVICE IN CONCRETE PAVEMENTS

Research Laboratory Section
Testing and Research Division
Research Projects 70 F-116
and 73 F-136
Research Report No. R-1151

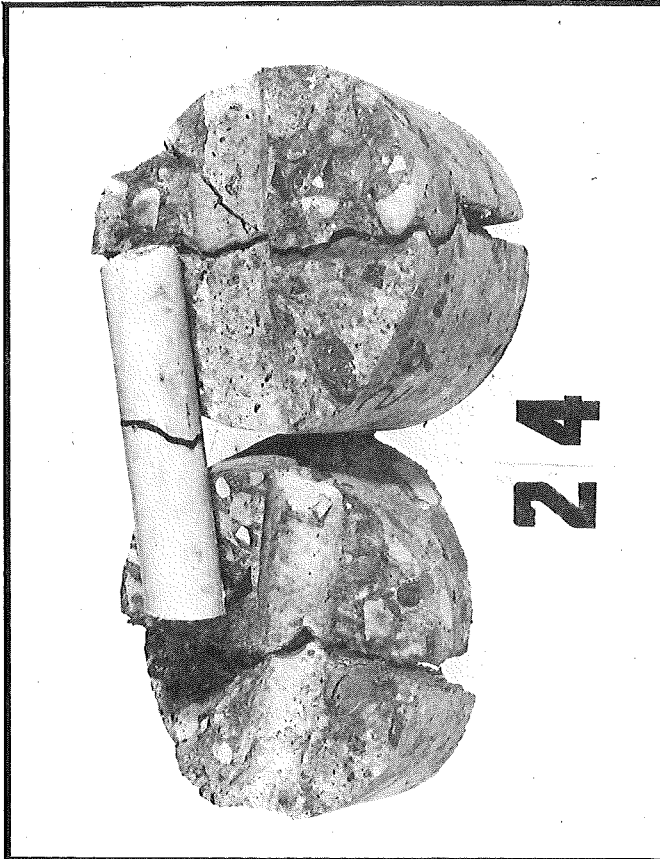
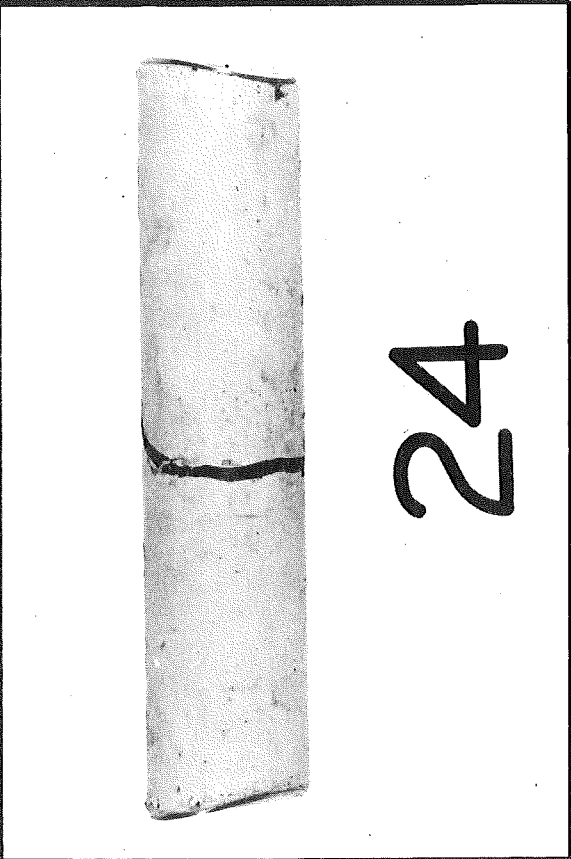
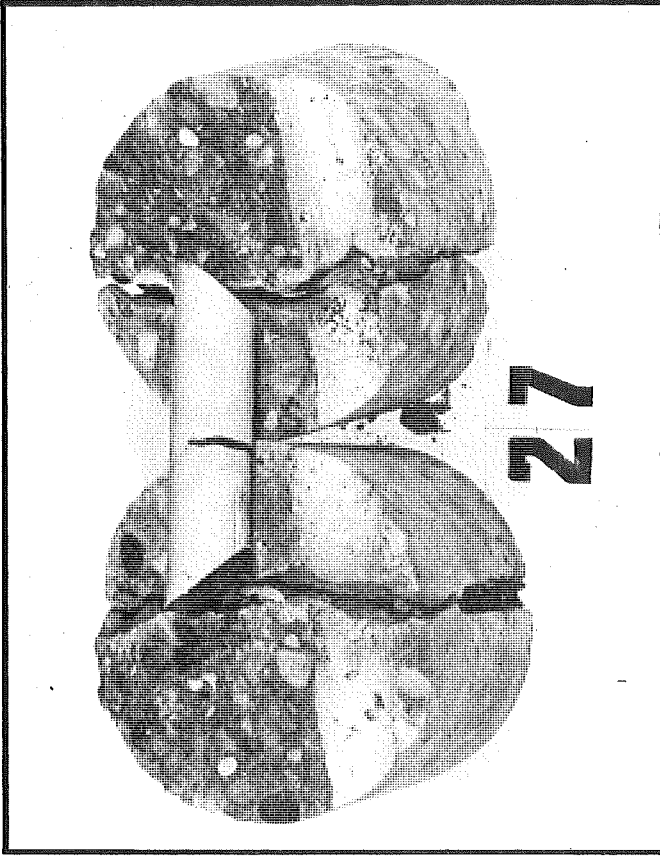
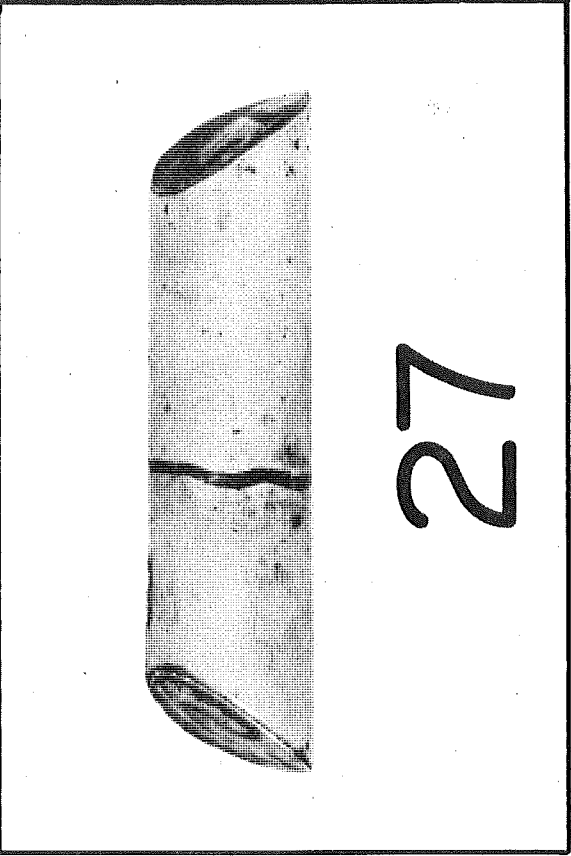
Figure 12 (Cont.). Plastic coated dowels from contraction joints in I 75 near West Branch; constructed 1973, sample Nos. 22 and 23 are from 71-ft slabs, No. 24 is from 57-ft slabs, and No. 27 is from 43-ft slabs. Coatings are in very good condition after six years' service. Discoloration is surface abrasion and staining. Polyethylene coating is 0.023 in. thick.

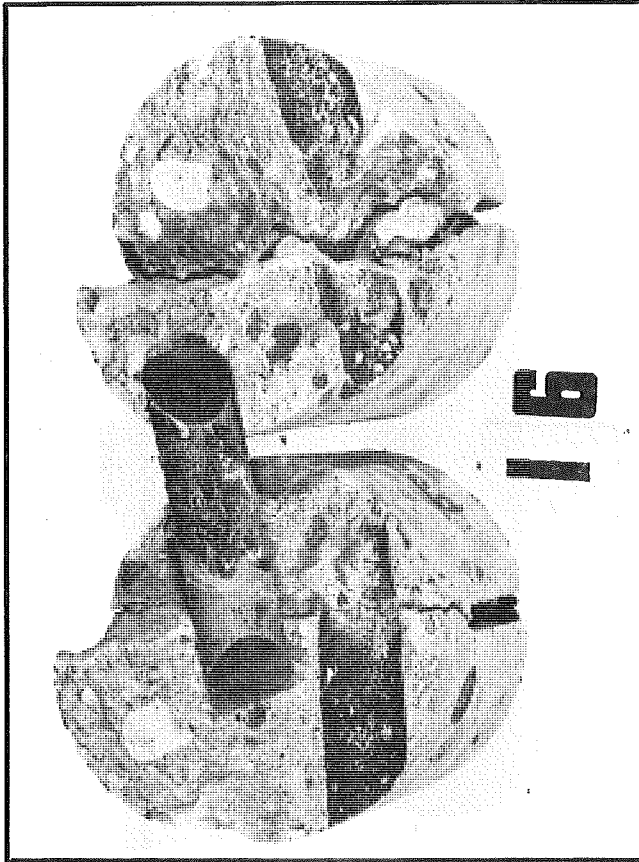
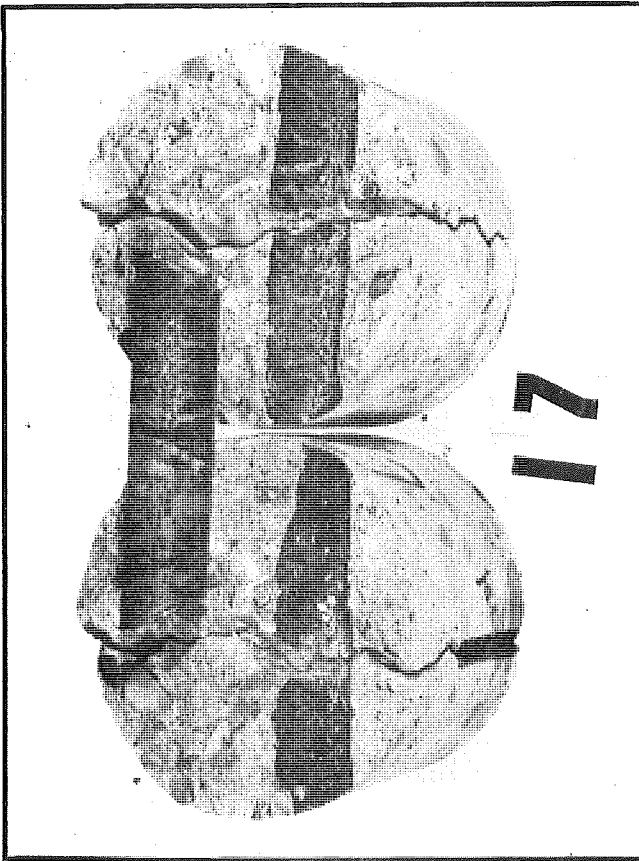
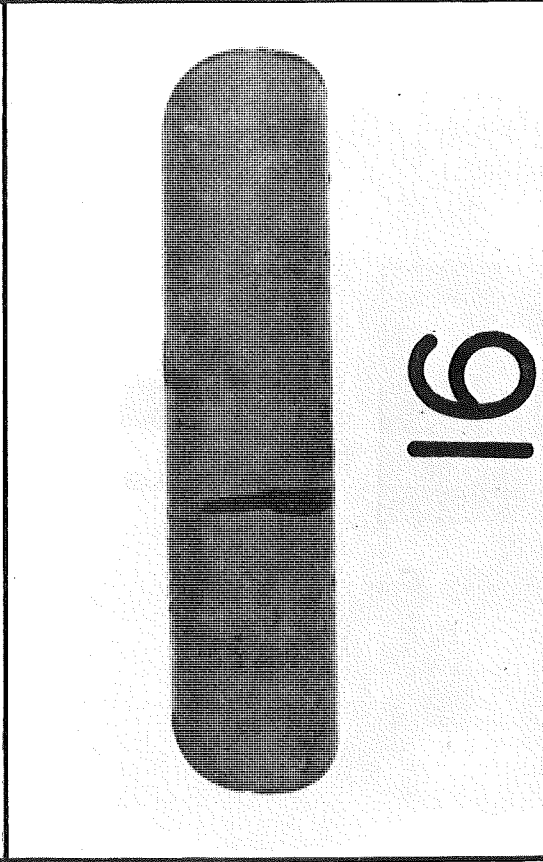
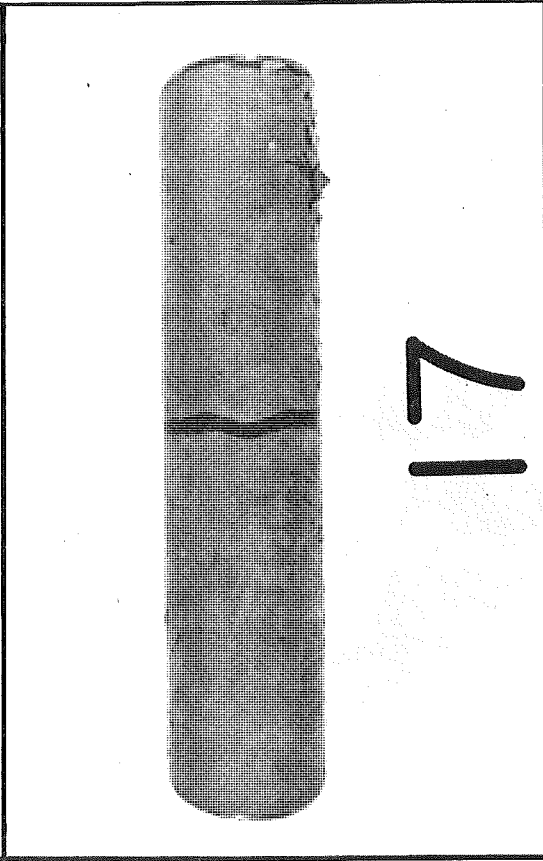
Epoxy coatings for dowel bars have been used extensively throughout the state since 1975. Figure 14 shows the bars removed from the US 10 experimental pavement north of Clare which was one of the earlier installations. The bars were removed four years after the pavement was opened to traffic. Several different epoxy materials now are approved as alternates. Specifications for this type of coating call for coating thicknesses to be a minimum average of 0.010-in. on any bar, with individual measurements within a tolerance of ± 0.004 -in. The bars shown were within the specified thickness averaging 0.008 to 0.010-in. Although the four bars shown were taken from the same project, there is an obvious difference in appearance of the coatings. The basic formulation appears to be the same, but the coating shown on sample Nos. 16 and 19 have a different shade of color than those on Nos. 17 and 18. Note, also, the brittle type failure and lack of bond on the lower surface of No. 17; there also is a break in the coating at the joint location with associated corrosion. The dark spots on No. 18 are surface stain only, but there are several areas on the bar showing corrosion beneath the coating without breaks in the coating. The appearance suggests that these two bars were not adequately prepared and quality controlled during preparation, coating application, and curing. Sample Nos. 16 and 19 show no such defects, and are in very good condition. Figure 15 shows uncoated dowels from an adjacent project for comparison with the epoxy coated bars. The uncoated specimens had been installed a year earlier than the others, but the project was not open to traffic until 1975, at the same time as the experimental project.

The short-term performance of the four epoxy coated bars seems to underscore the importance of quality control during coating application.

Figure 14. Epoxy coated bars from contraction joints in experimental pavement, US 10 north of Clare, constructed 1975, sample Nos. 16 and 17 were from 13 to 17-ft slabs. Note the brittle coating failure and lack of bond on specimen No. 17; there is also a break in the coating at the joint location with associated corrosion of the bar. No. 16 is stained but in very good condition. Coating thickness averaged 0.008 to 0.010 in. Dark stains in top views are bituminous bond-breaker. These have been in service four years.

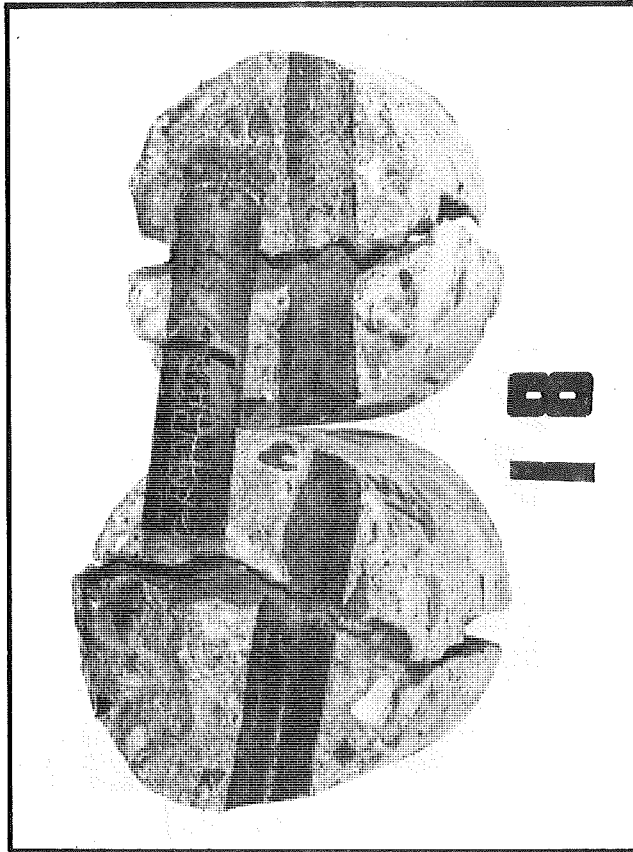
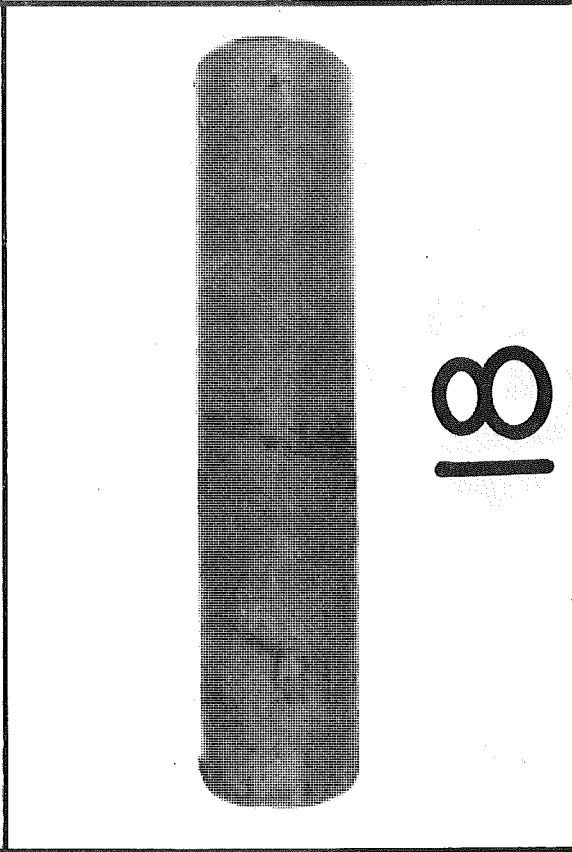
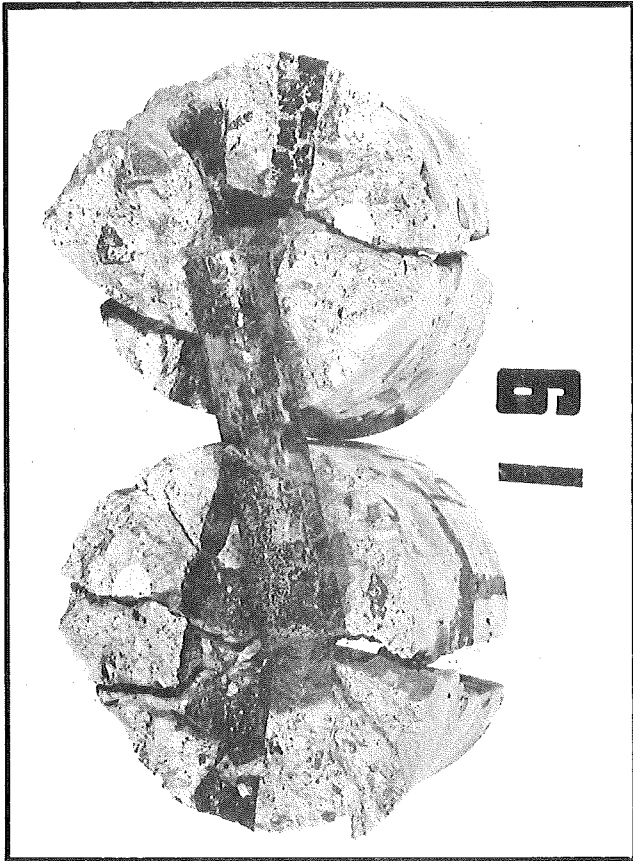
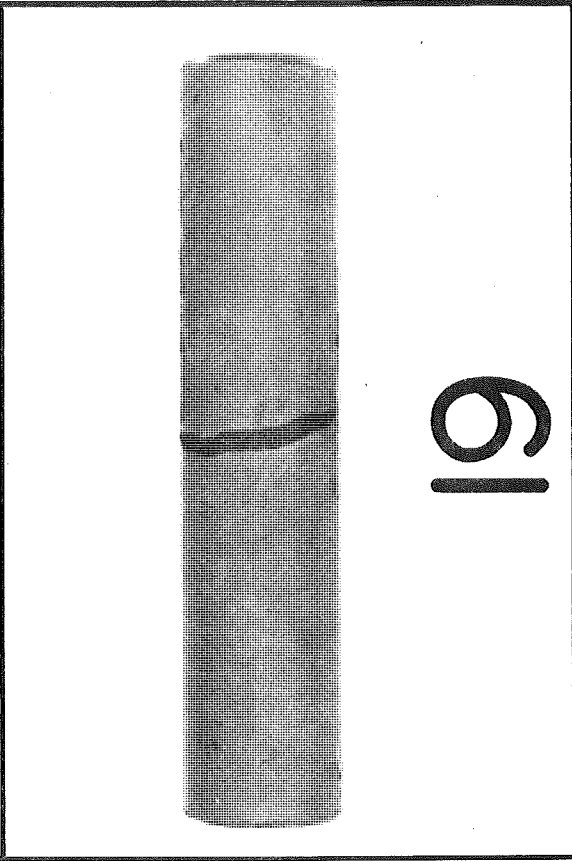
Figure 14 (Cont.). Epoxy coated bars from contraction joints in the Clare test road; constructed 1975, sample Nos. 18 and 19 were from 71-ft slabs. Dark spots on specimen No. 18 are surface stains, but there are several areas of rust beneath the coating without breaks in the coating. Coating thickness averaged 0.008 to 0.010 in. Dark stains in top views are bituminous bond-breaker. These have been in service four years.

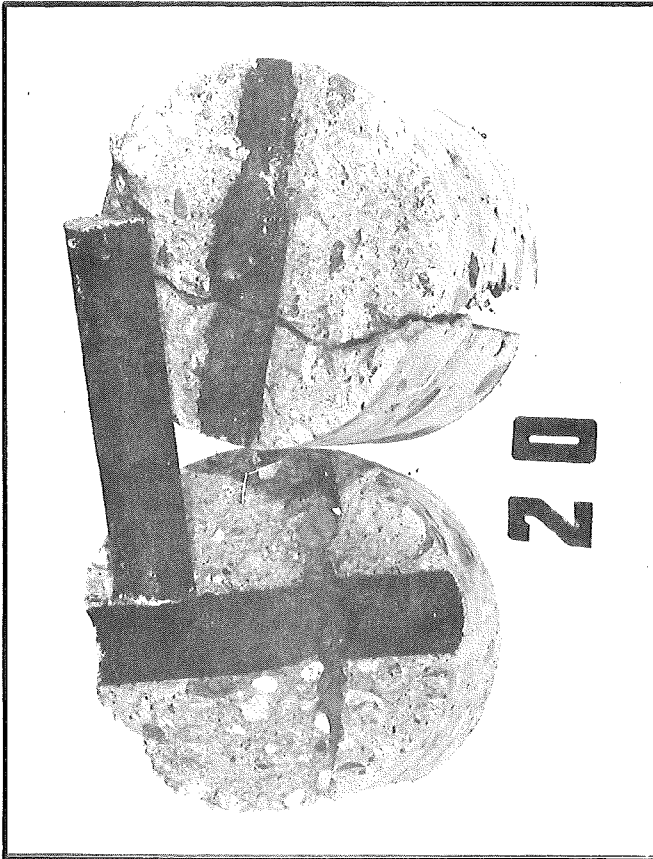
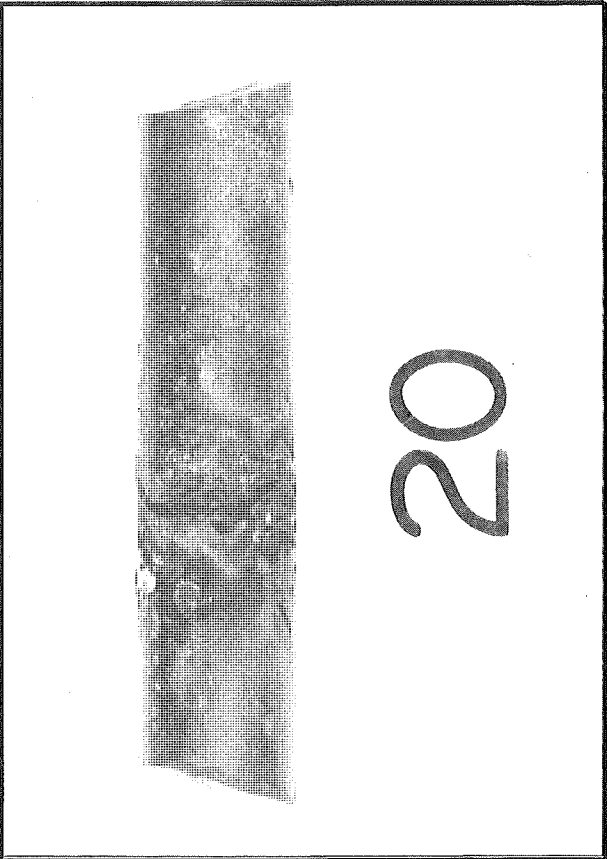
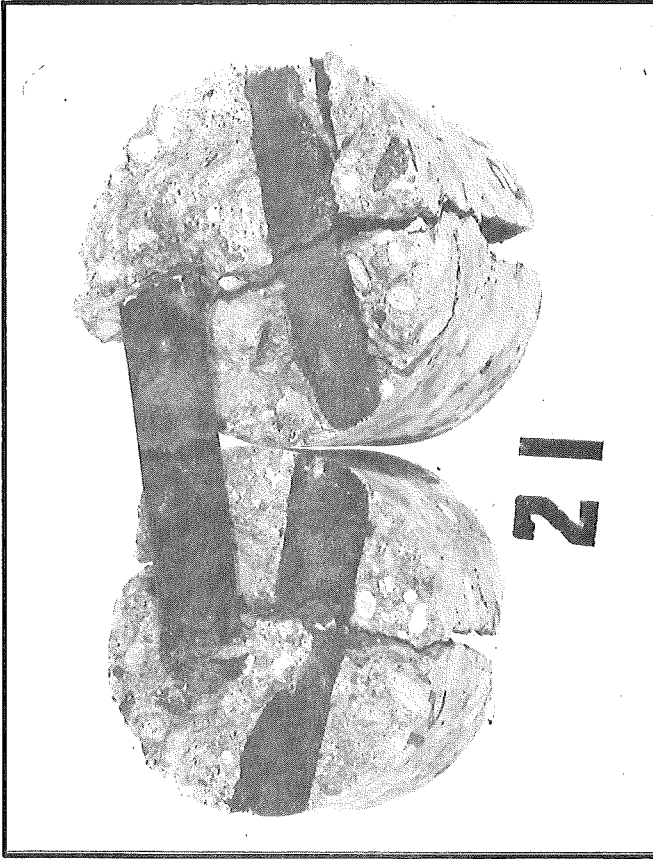
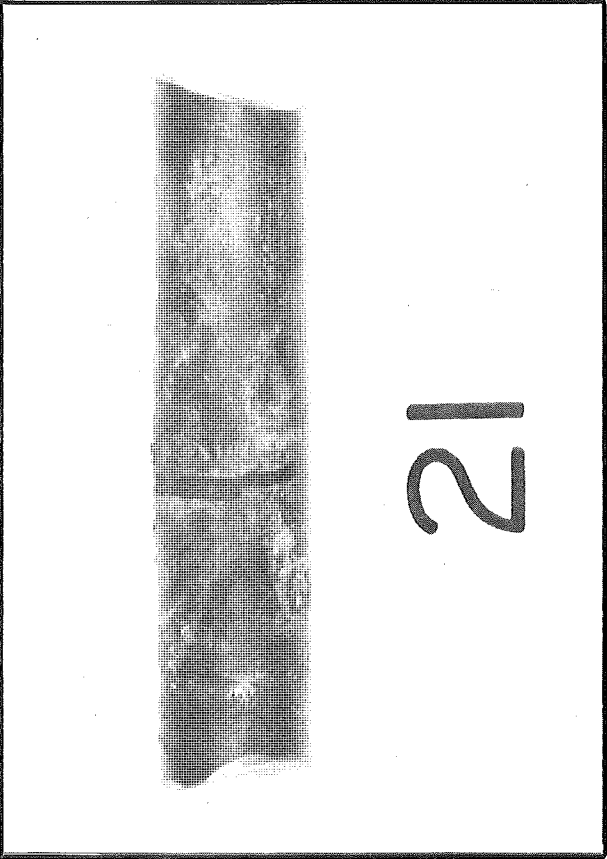
Figure 15. Uncoated bars from contraction joints in the adjoining project, US 10 north of Clare; constructed 1974 but only in service four years, 71-ft slab length. Rusting of the bar near the joint opening is evident.
