DURABILITY OF BRIDGE CONCRETE
I 75 - US 23 Over the Flint River (B1 of 25-7-3)

Research Laboratory Division
Office of Testing and Research
Report No. 351
Research Project 59 B-47

Michigan State Highway Department
John C. Mackie, Commissioner
Lansing, March 1961

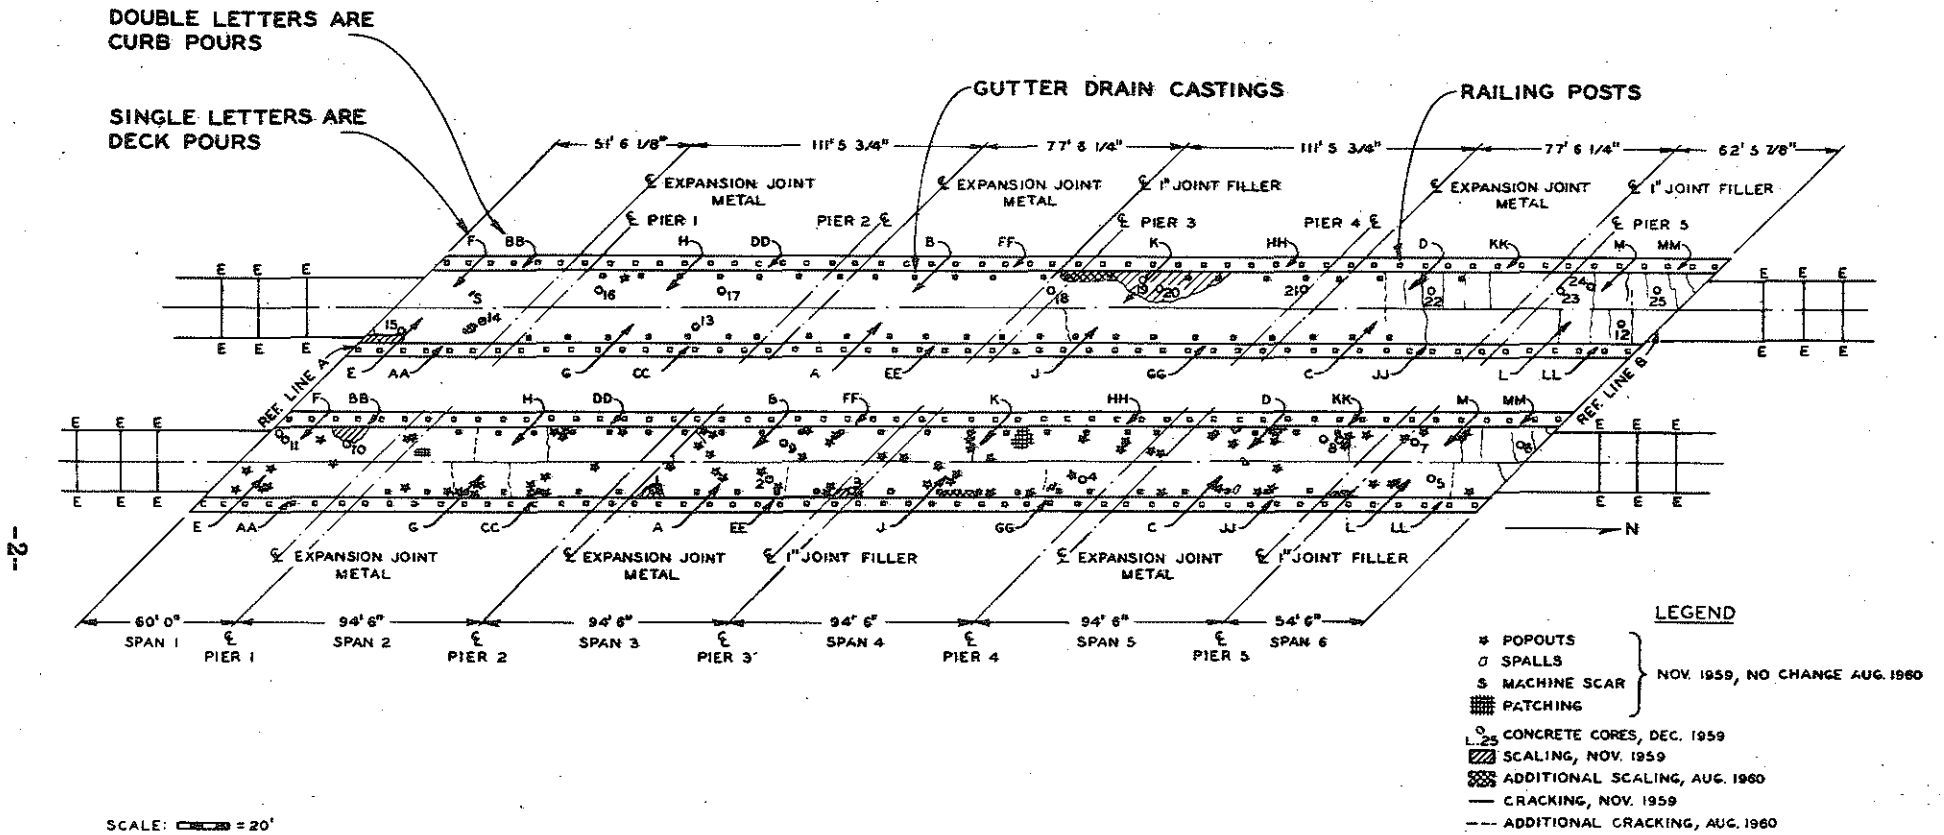
The plan view of the superstructure in Fig. 1 shows the deterioration observed in the 1959 condition survey, along with further scaling, cracking, and spalling through the survey of August 1960. In the following discussion of bridge concrete condition, the superstructure and substructure are each considered in turn, with special attention to such subjects as scaling, cracking, and popouts.

Figure 1. Plan view and condition survey of superstructure of B1 of 25-7-3.

Cracking. The most extensive cracking of the bridge deck has occurred on Spans 5 and 6 of the southbound roadway and Span 6 of the northbound roadway (Fig. 1). In all three areas, there are six or more cracks per span (Fig. 10). Winter maintenance chemicals entering these cracks are passing completely through the deck, in large enough quantities to stain the deck bottom surface.

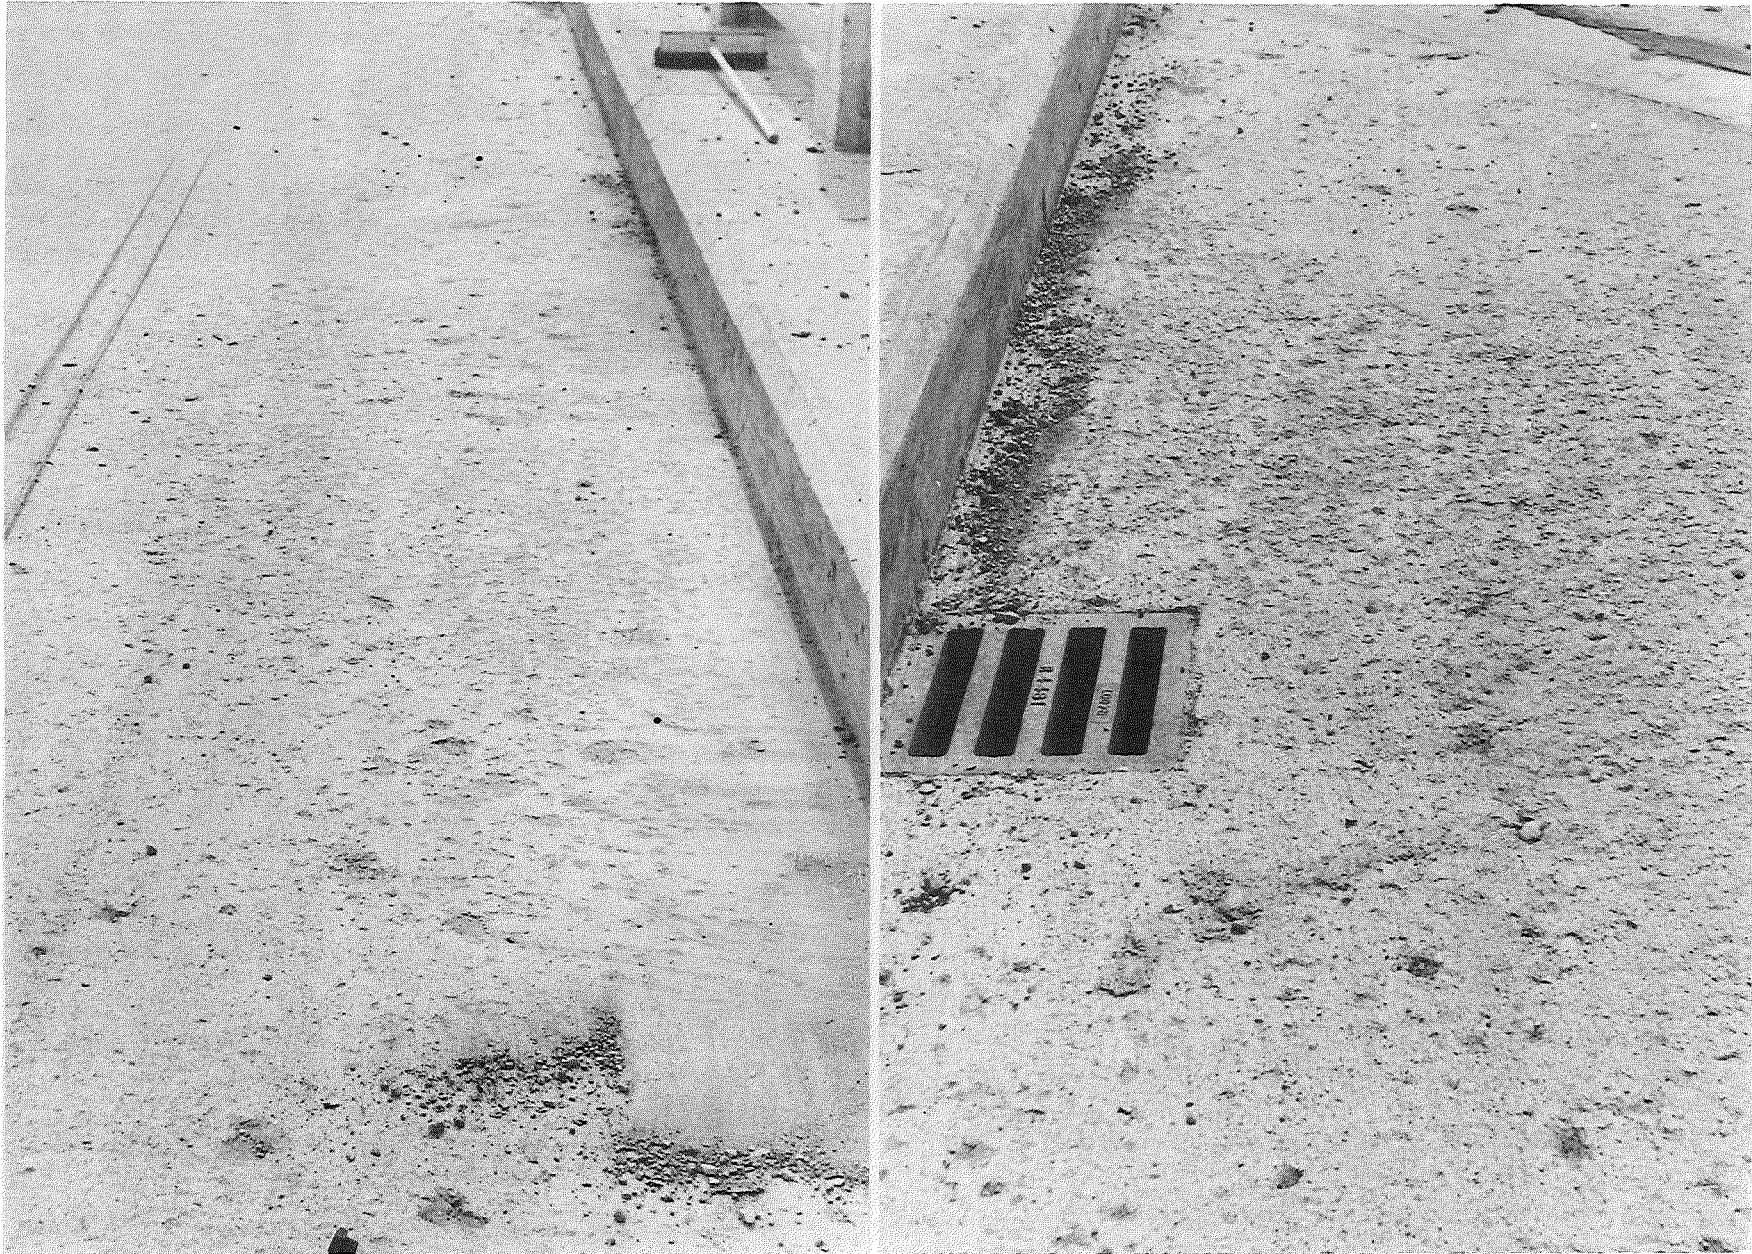
Scaling and Patching. The extent of scaling for the various pours is summarized in Table 1. On the northbound roadway, the surfaces of five of the six spans have scaled (Figs. 2-4), generally in limited areas near the curbs. Some additional scaling developed in the 1959-60 winter, but the original scaling does not appear to be progressive--most seems to have occurred in the first months after the structure was completed.

Figure 2. Scaled deck pavement on northbound roadway -- passing lane at center of Span 1 (left) and traffic lane at south end of Span 3 (right). Sept. 1960.

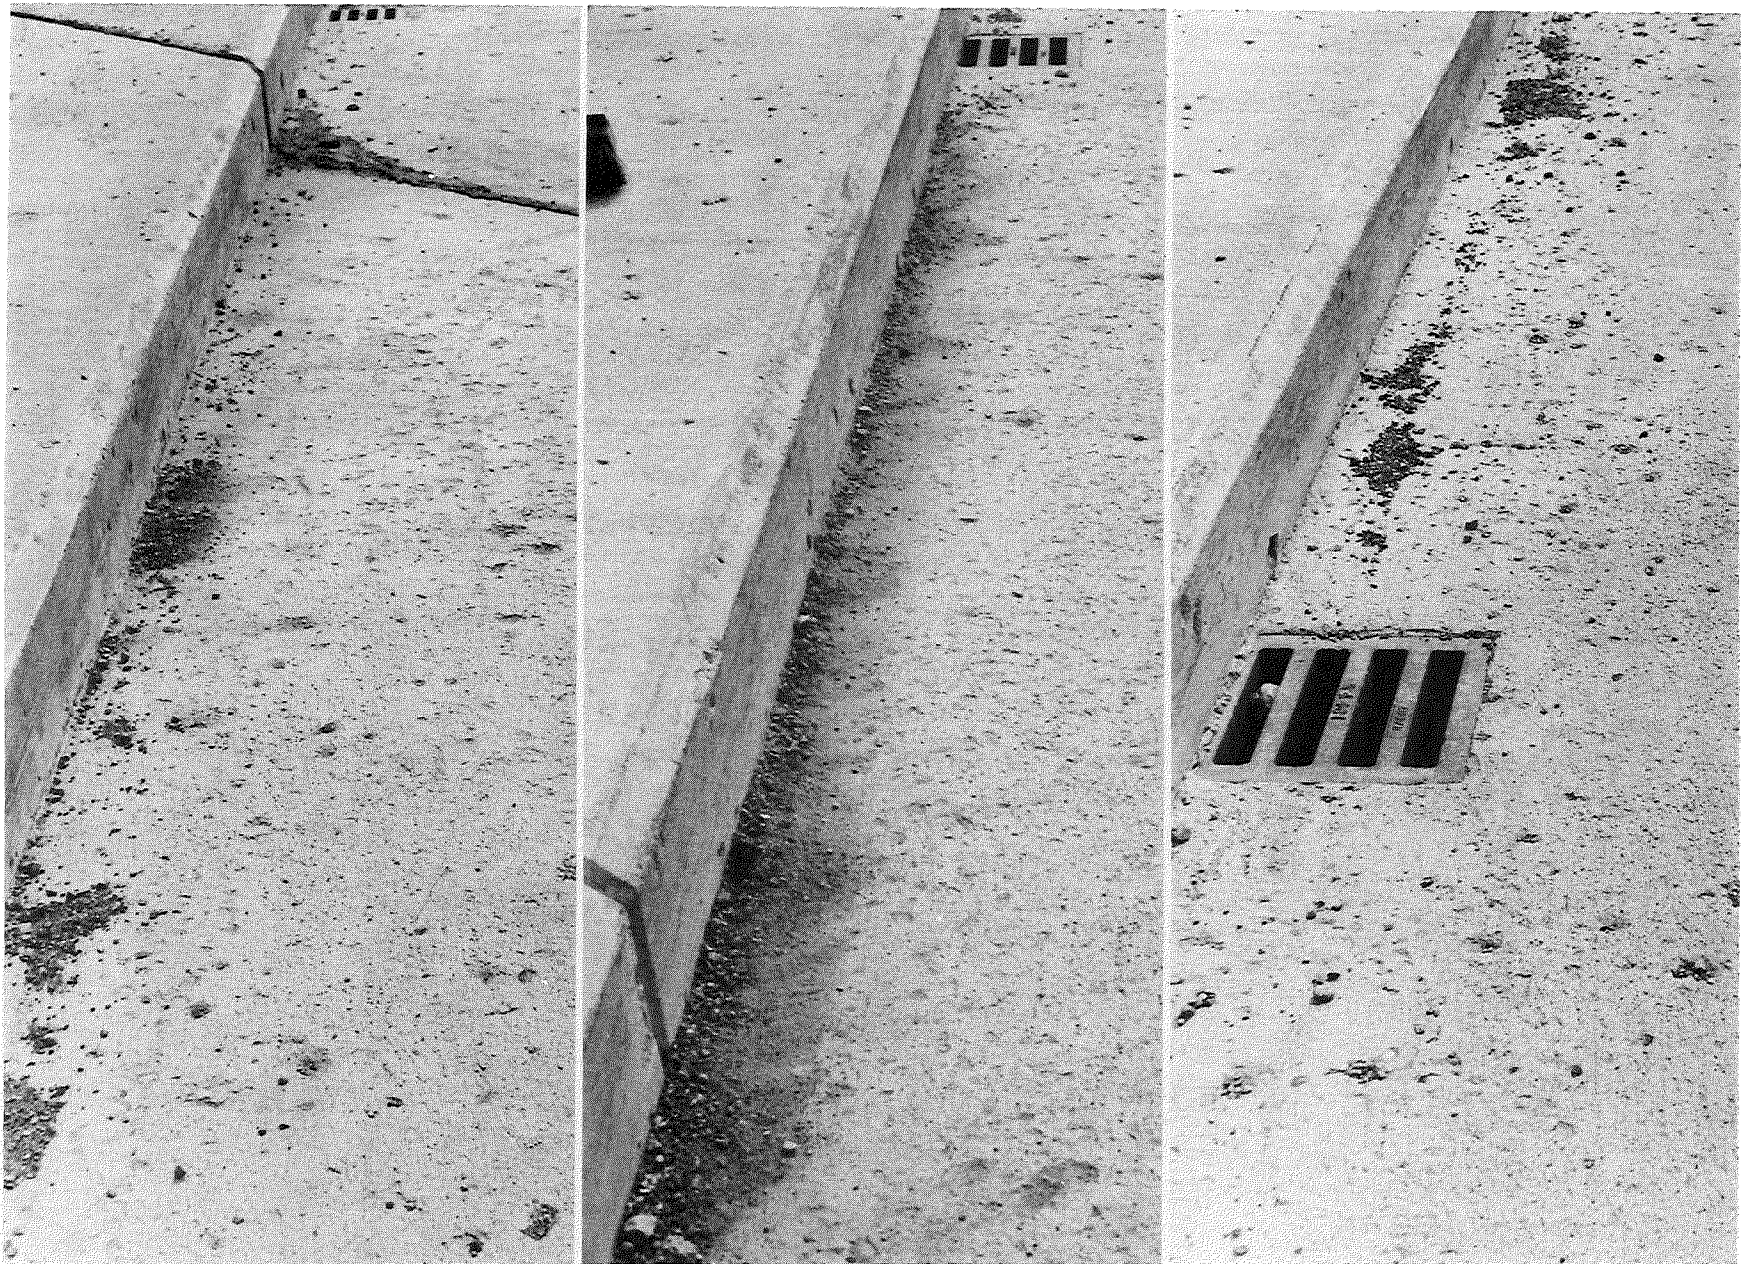
Figure 3. Scaled deck pavement on Span 4, northbound roadway traffic lane -- south end (left), center (center) and north end (right).
Sept. 1960.

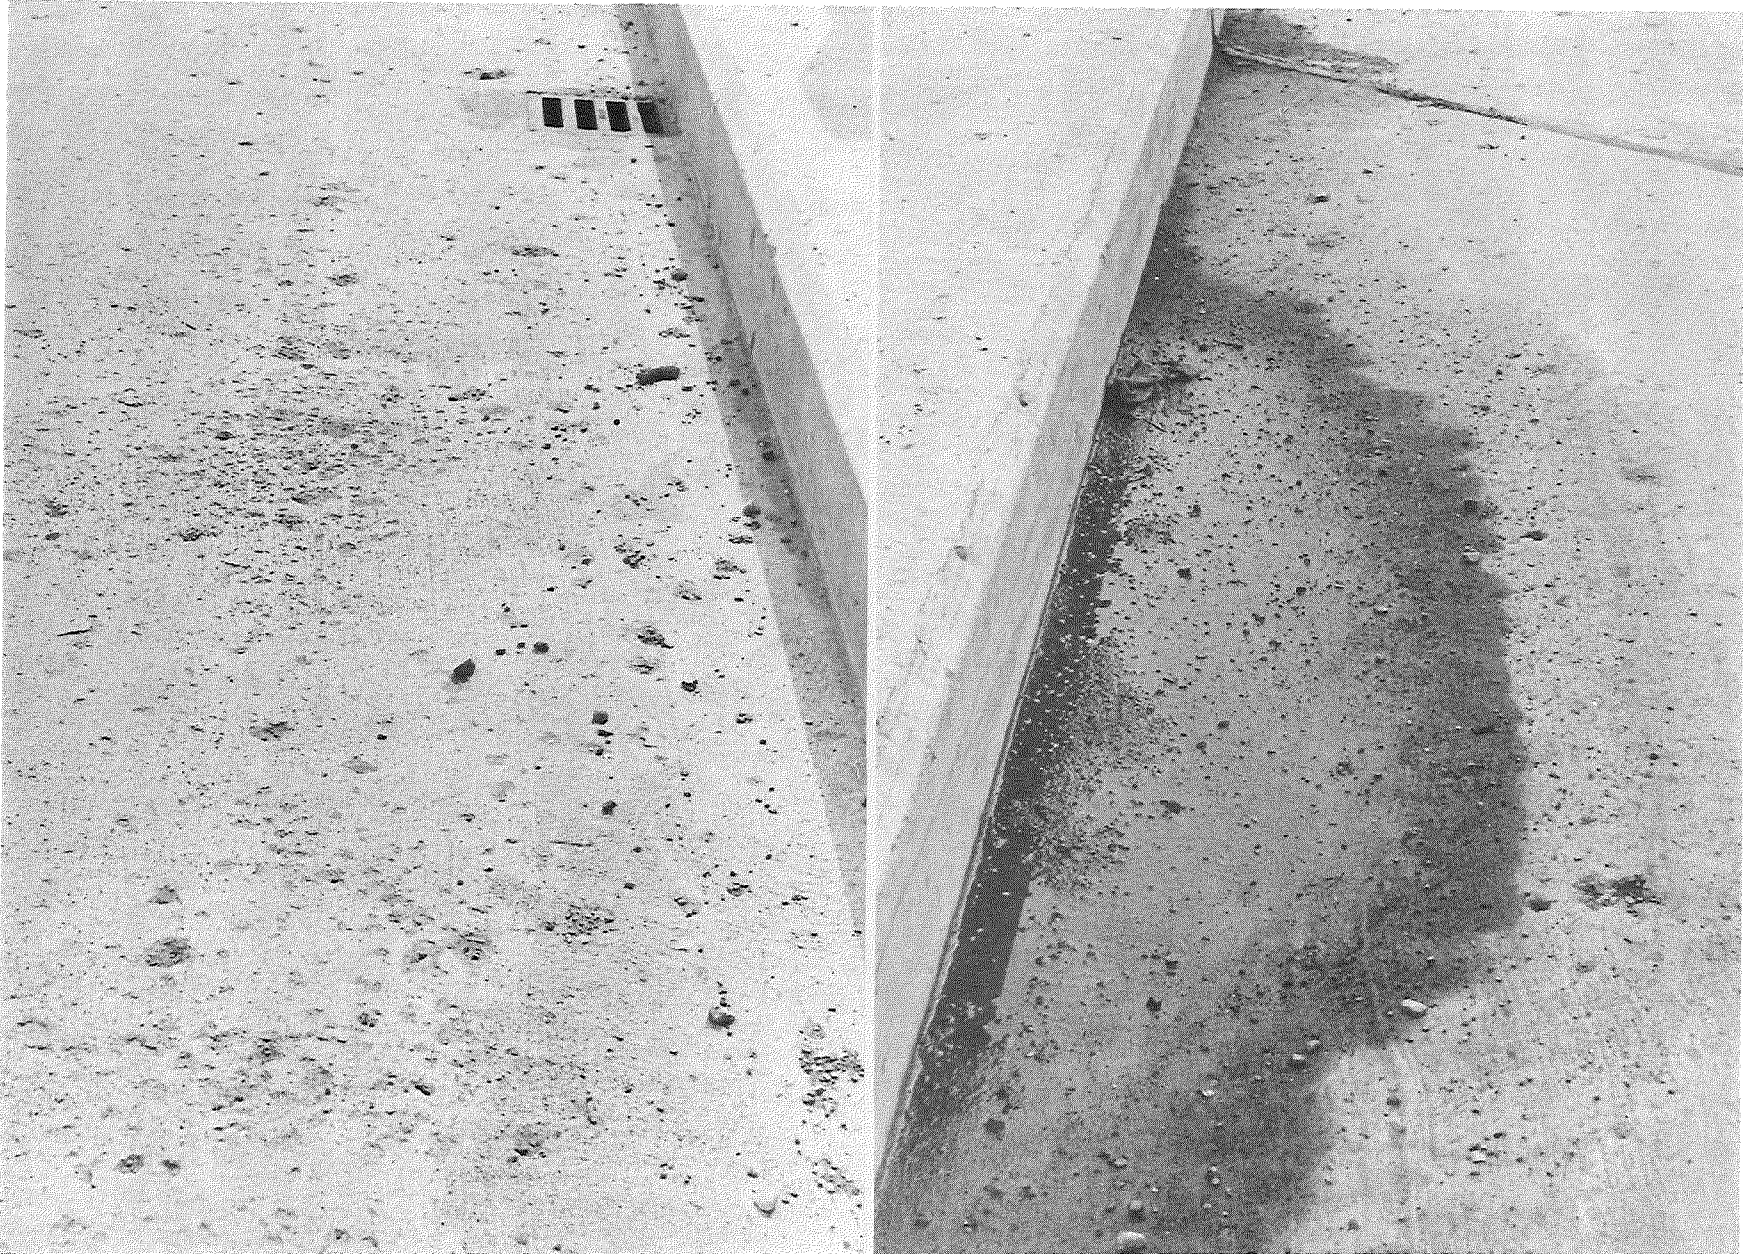
Figure 4. Scaled deck pavement on northbound roadway--passing lane at center of Span 5 (left) and traffic lane at south end of Span 6 (right). Sept. 1960.

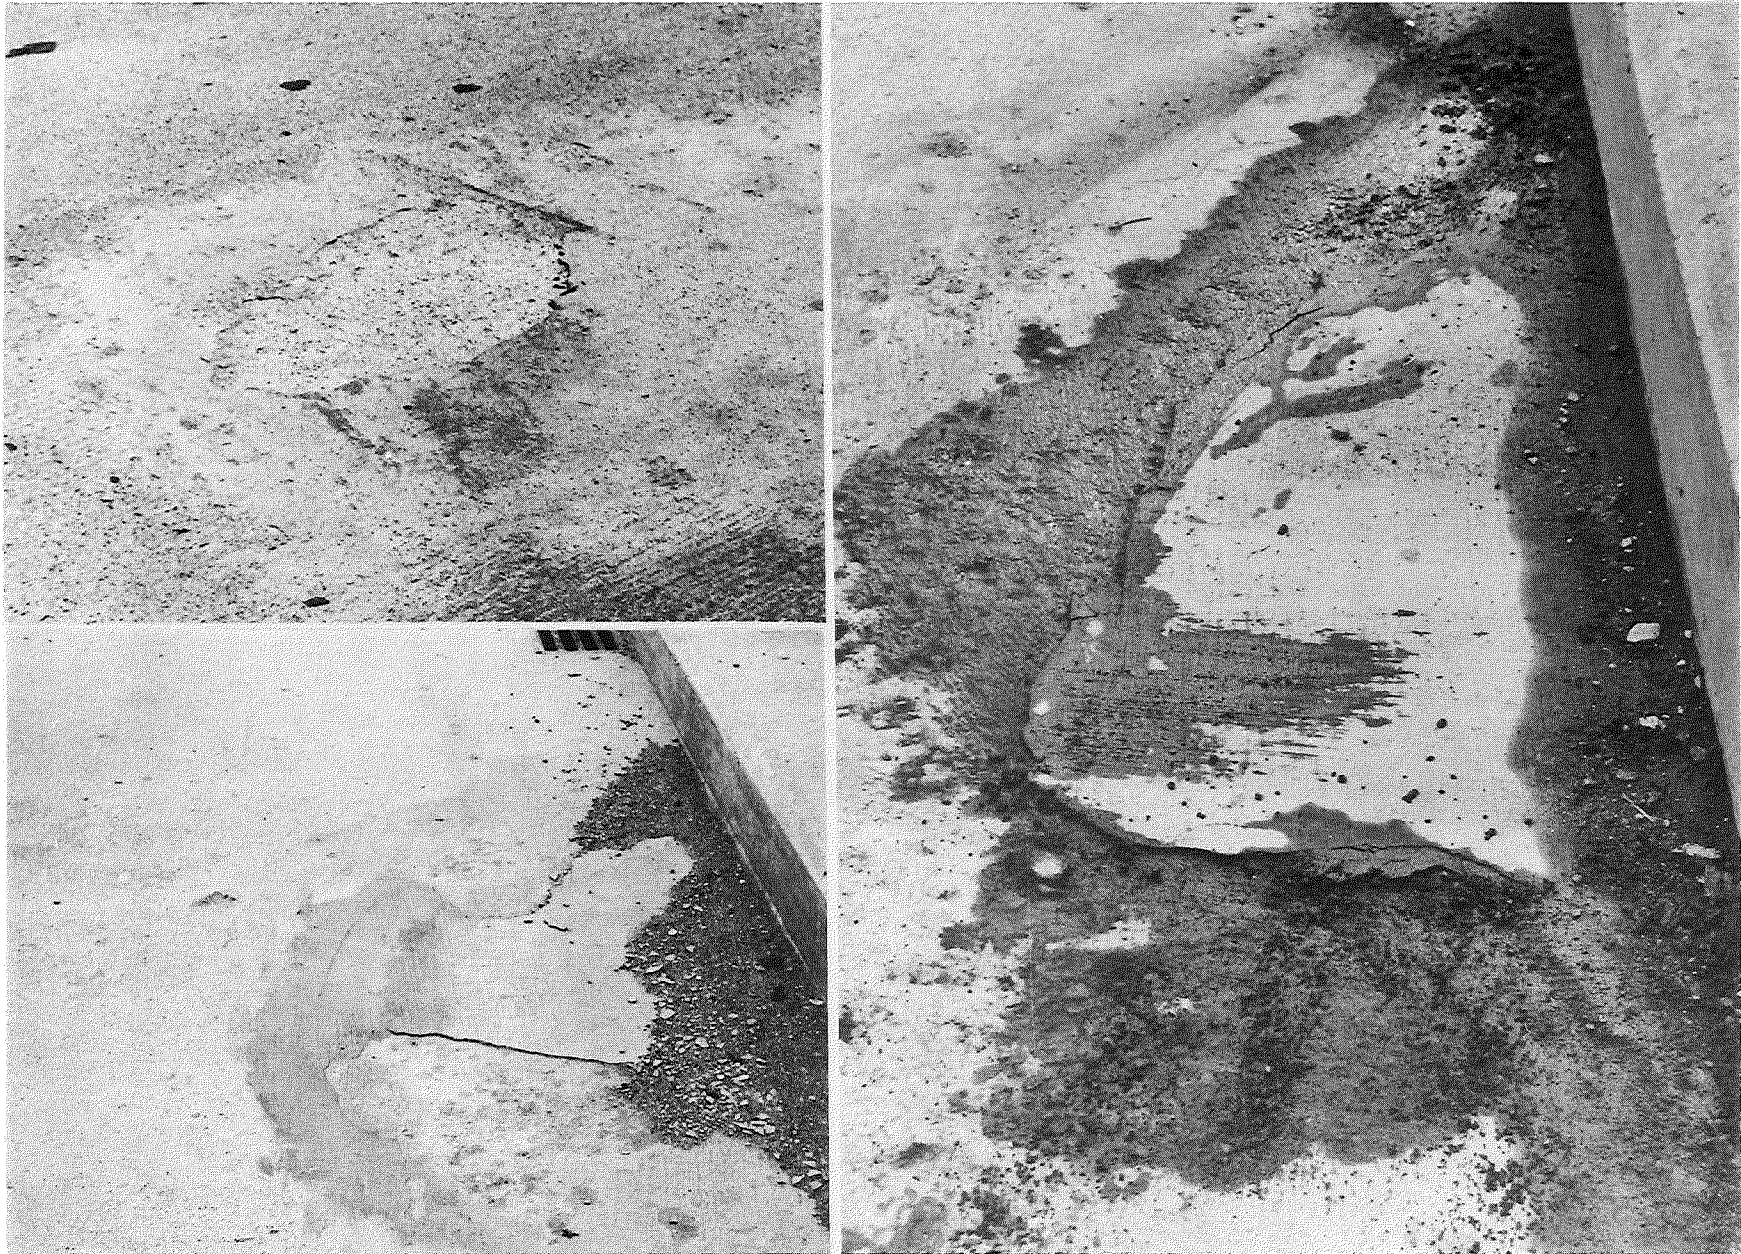
Some concrete patching or concrete mortar spillage appears on the deck surface of the northbound roadway. Fig. 5 shows that some of this material has broken away from the underlying concrete.

Figure 5. At three locations in the passing lane of the northbound roadway, local concrete patching or mortar spillage has broken away from the original pavement surface -- south end of Span 2 (top left -- Sept. 1960), center of Span 4 (lower left -- Nov. 1959), and center of Span 5 (right -- Sept. 1960).

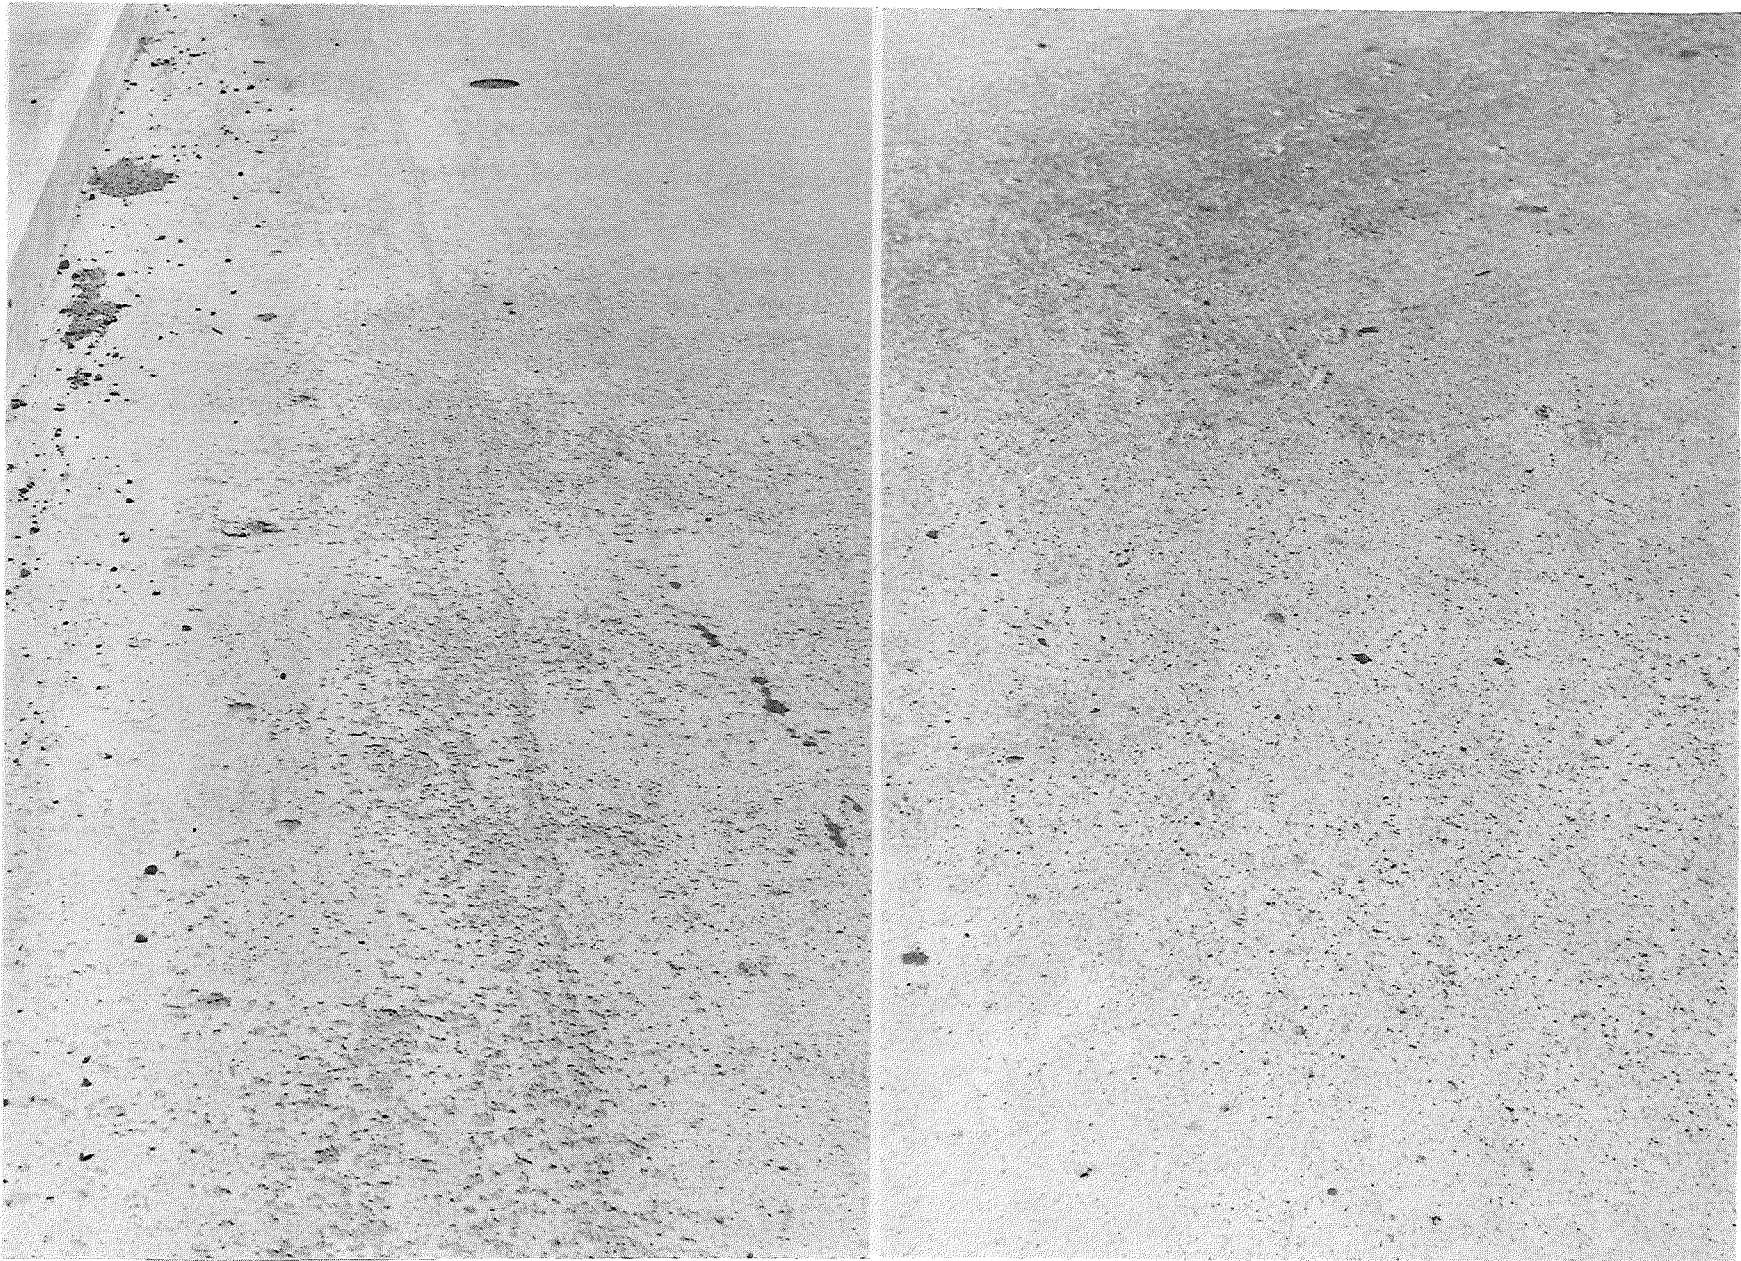
Figure 6. Scaled deck pavement on Span 1 southbound roadway passing lane -- south end (left) and center (right). Sept. 1960.

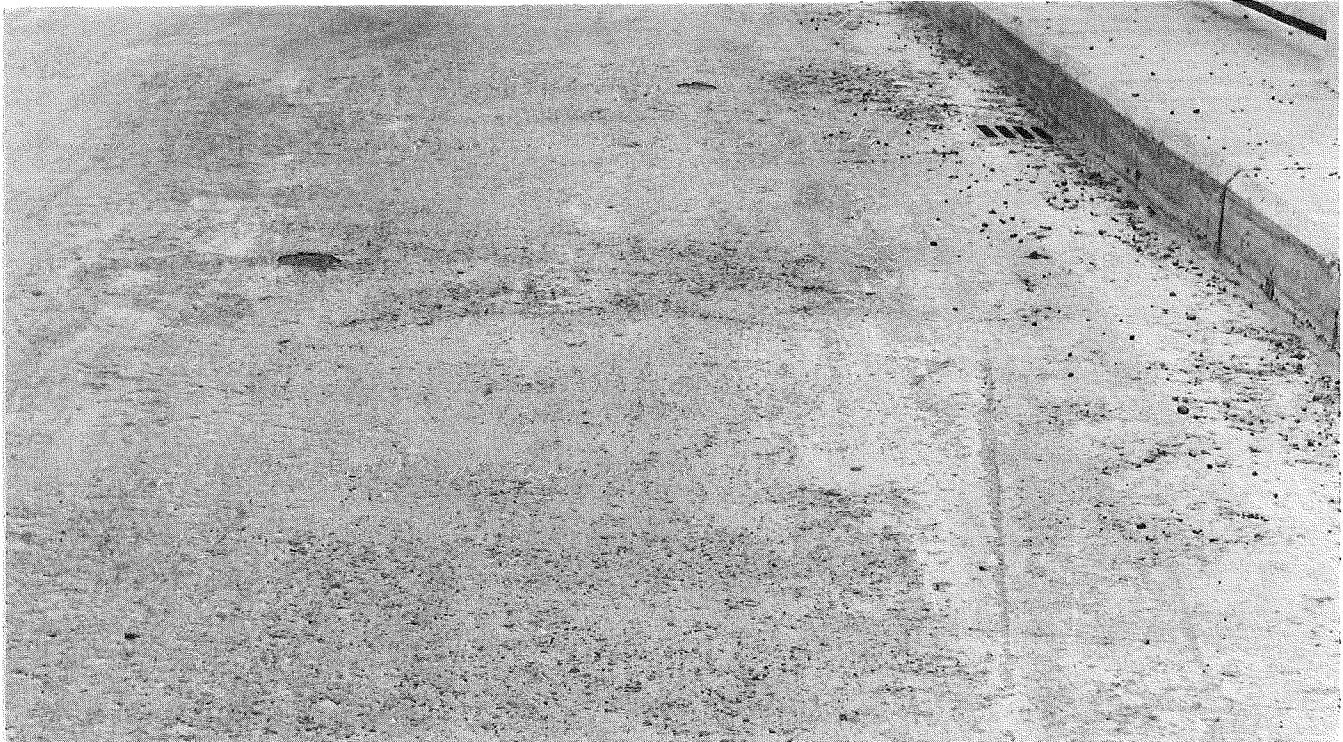
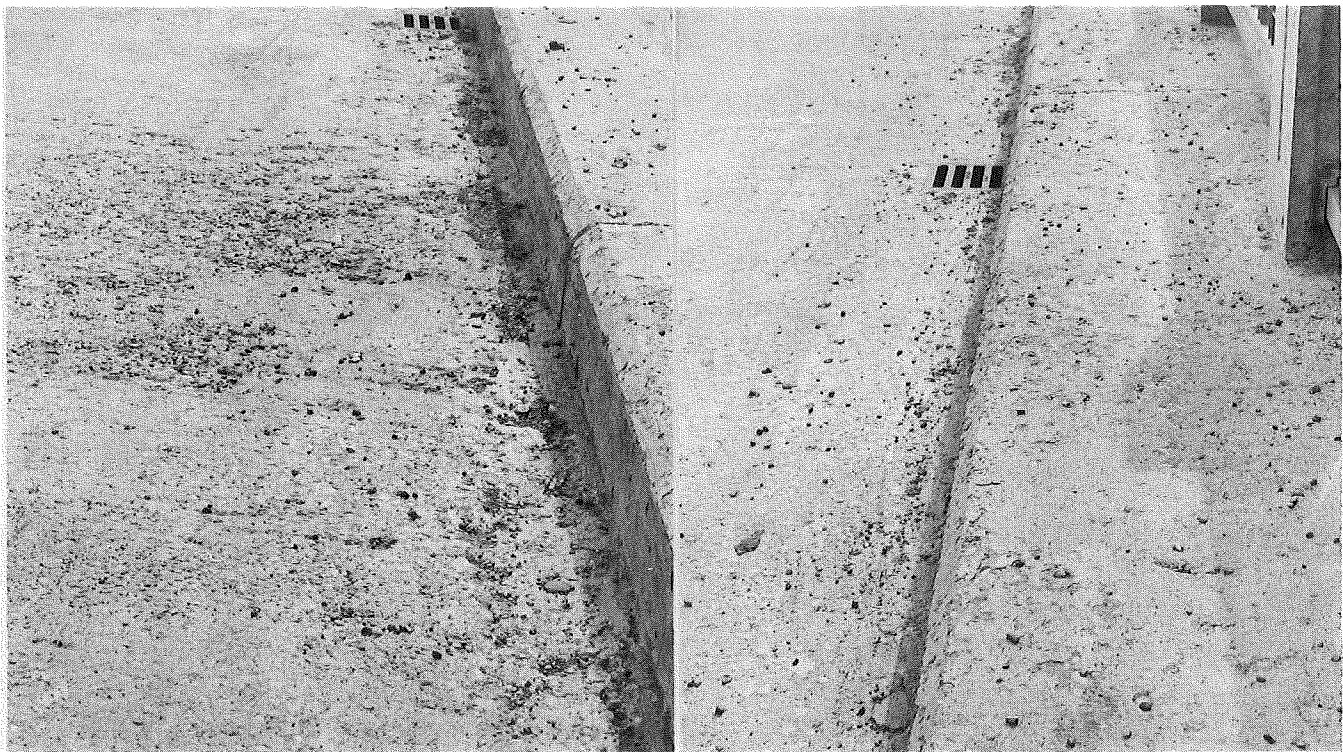
On the southbound roadway, some scale appears on Span 1 (Fig. 6), and the most extensive and severe scaling on the project is found in the traffic lane of Span 4 (Pour K). Although scaling here is deeper than at any other point on the bridge, penetration is not so severe that any large coarse aggregate has been dislodged (Fig. 7). There appears to be no prospect of any substantial future increase in depth of scaling on Pour K.

In the area of most extensive and severe scaling, Pour K in the traffic lane of the southbound roadway on Span 4, the cores were checked for air content both at the 3/4-in. level and at 1-1/2-in. by the linear traverse method. It was known that heavy rain fell as this pour was in progress and the double check of the Pour K cores was intended to determine if air content close to the surface had been specially affected by this rain. At the 3/4-in. level, average air content was 3.6 percent, as compared to 5.6 percent at the 1-1/2-in. level. This indicates a loss of air near the surface, with satisfactory air content at the lower level. Scaling did not deepen significantly during the third winter. It appears that the poor surface condition on this span is due to the high fluidity of the concrete--estimated slump: 5 in. according to Testing and Research field reports--and to the heavy rain during pouring and finishing operations.

Figure 7. Scaled deck pavement and curb of Span 4 southbound roadway traffic lane--the region of most severe and extensive scaling on the project (Sept. 1960).

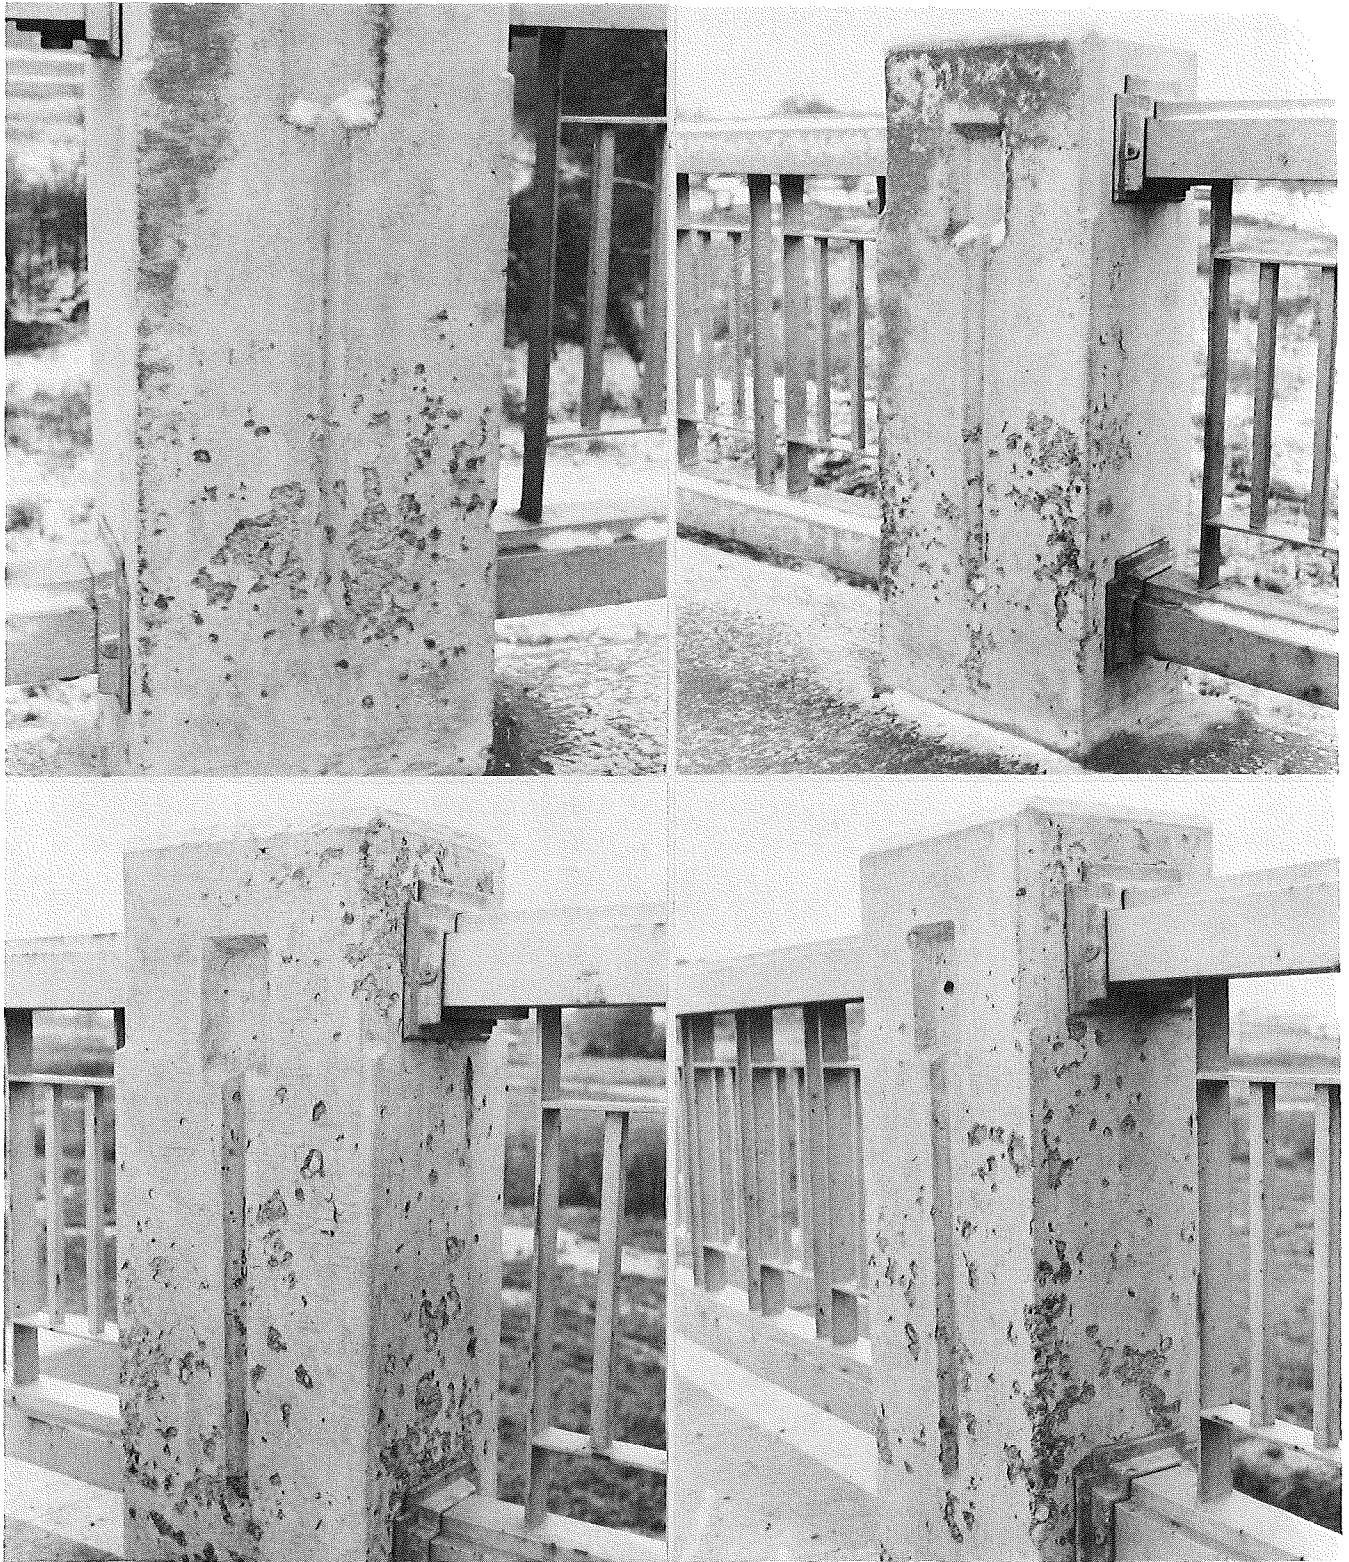
Eight railing posts on Span 4 of the northbound roadway, all on the traffic lane side, have fairly extensive pitting and scaling on their approach and traffic faces, first noted in the inspection of November 1959 (Fig. 8). In addition, similar scaling has developed since then on two posts on Span 1 of the southbound roadway (Fig. 8). Some other posts have small areas of scaling, but these are less extensive than on the ten posts mentioned. Fig. 9 illustrates the marked difference in the separate faces of

Scaling of particular railing posts cannot be explained specifically since construction records do not show which posts were constructed from a given pour. However, records do show that all railing posts were poured on eight days: October 29, November 4, 5, 7, 15, 20, 25, 27, and December 3. During the first three days after each of these pours, low air temperatures dropped to freezing or below. After each of the final four post-pour days, daily low temperatures dropped considerably below freezing--24, 24, 15, and 20 F, respectively--so that surface weakening of the concrete mortar might be expected, even when protected by construction forms.

Figure 8. In November 1959, two of the posts on Span 4, northbound roadway (top), showed considerable exfoliation and scale from splashed winter maintenance chemicals; note snow or slush deposits remaining on post faces. In September 1960, two posts on Span 1, southbound roadway (bottom), show similar deterioration which developed during the 1959-1960 winter.

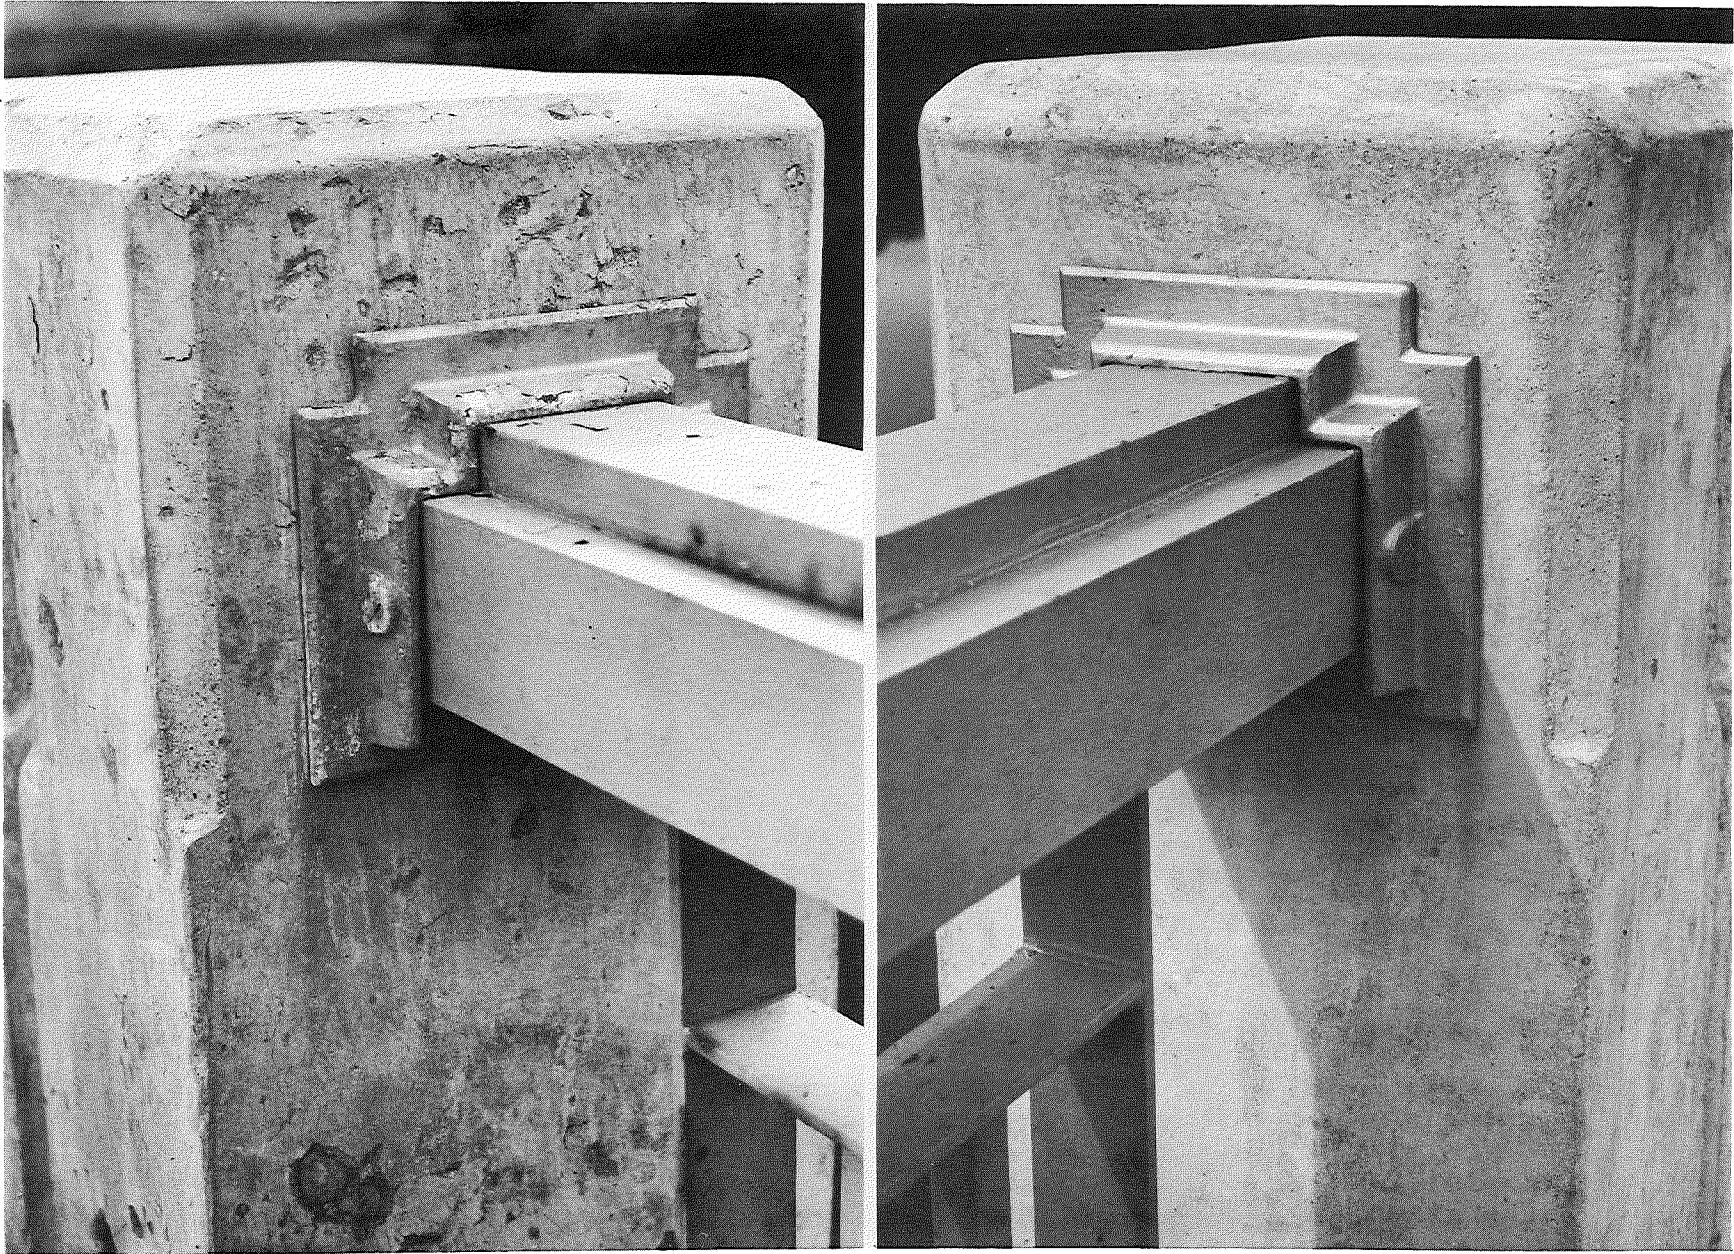
deteriorated railing posts, with most marking on the traffic and approach faces.

Figure 9. Marked difference in performance was noted on various faces of the railing posts. On a typical post the approach and traffic faces (left) have deteriorated, while the trailing face (right) has a clear, unmarked surface. Note railing corrosion on the approach side and uncorroded coating on the other side (Sept. 1960).

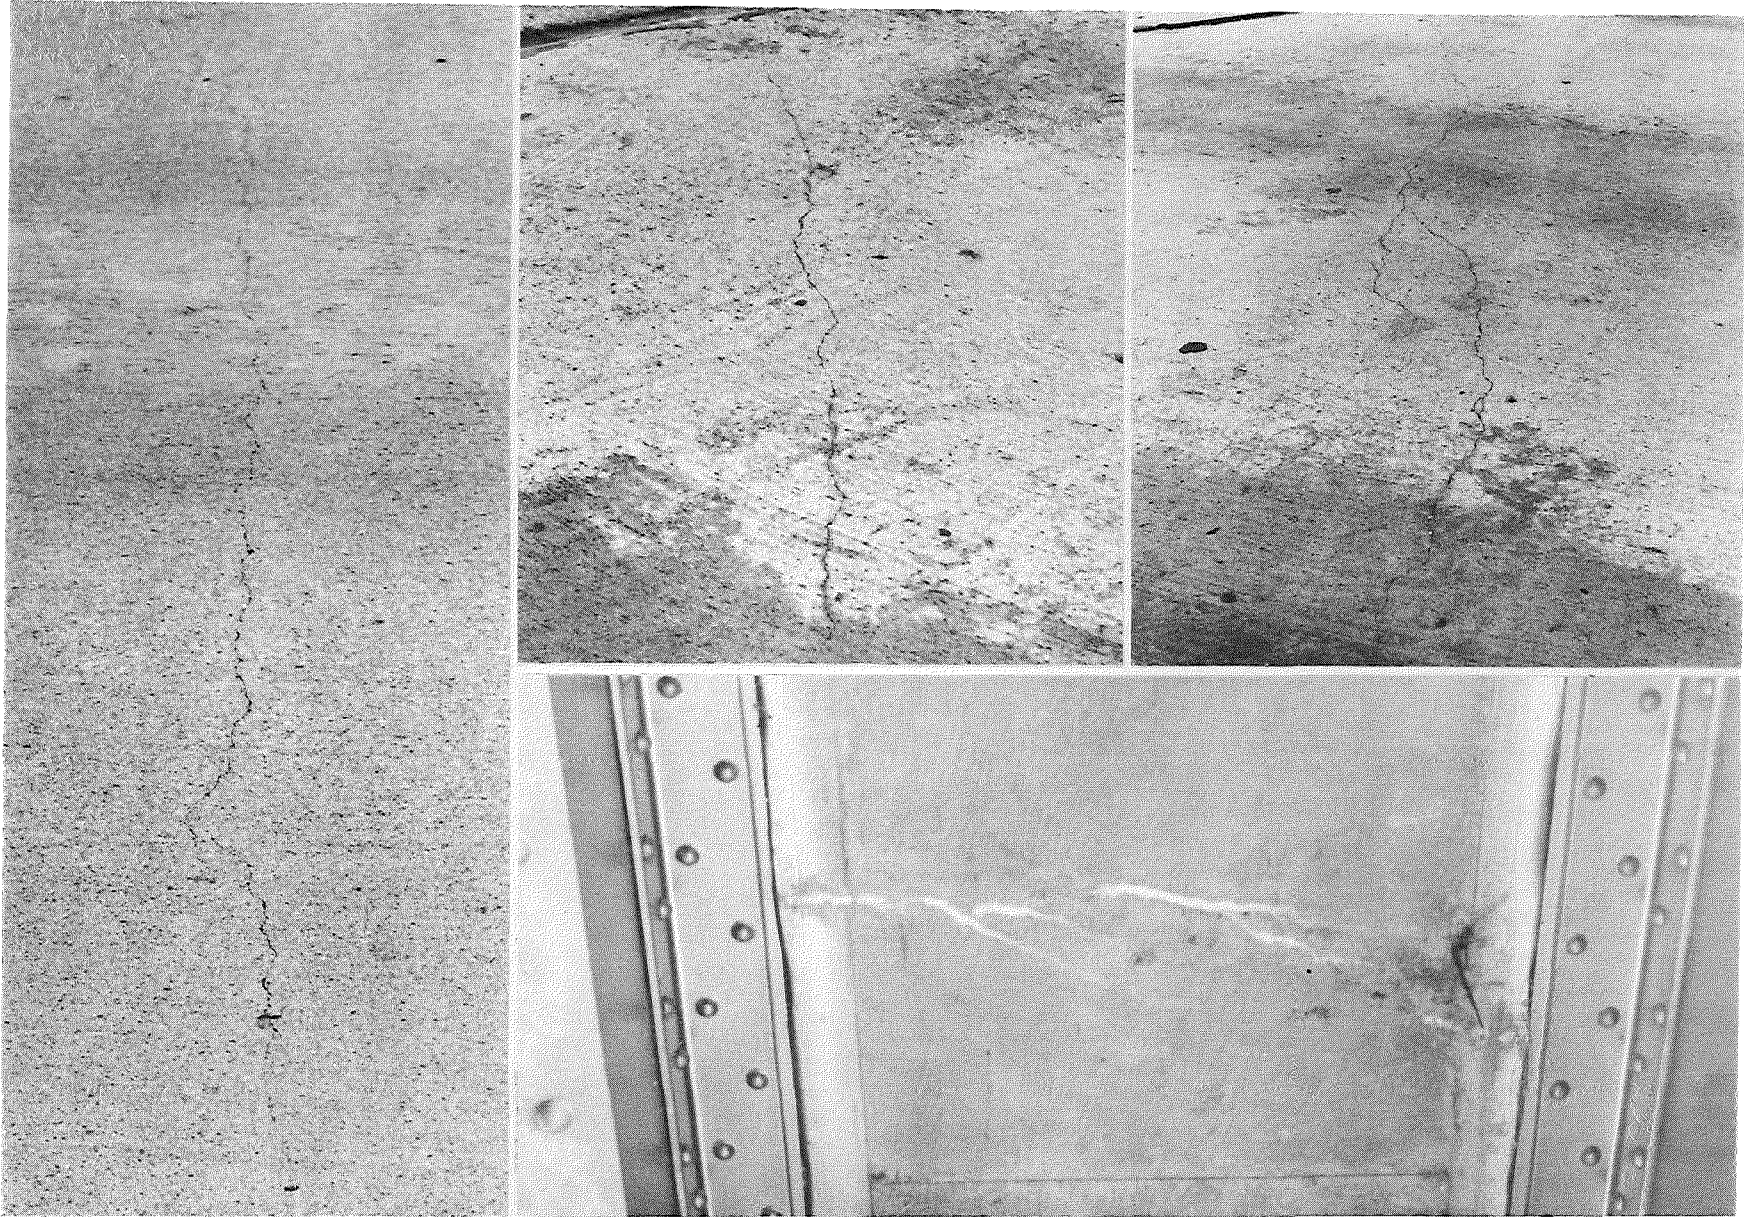
Figure 10. Cracking in the traffic lane of the southbound roadway. The deck undersurface (lower right) is marked by ice removal and chemicals leaching through deck cracks--center of Span 5 (left), north end of Span 6 (top center and right), and undersurface at north end of Span 6 (lower right). Nov. 1959.
