DURABILITY OF BRIDGE CONCRETE
I 75 - US 23 Over the Flint River (B1 of 25-7-3)

Research Laboratory Division
Office of Testing and Research
Report No. 351
Research Project 59 B-47

Michigan State Highway Department
John C. Mackie, Commissioner
Lansing, March 1961

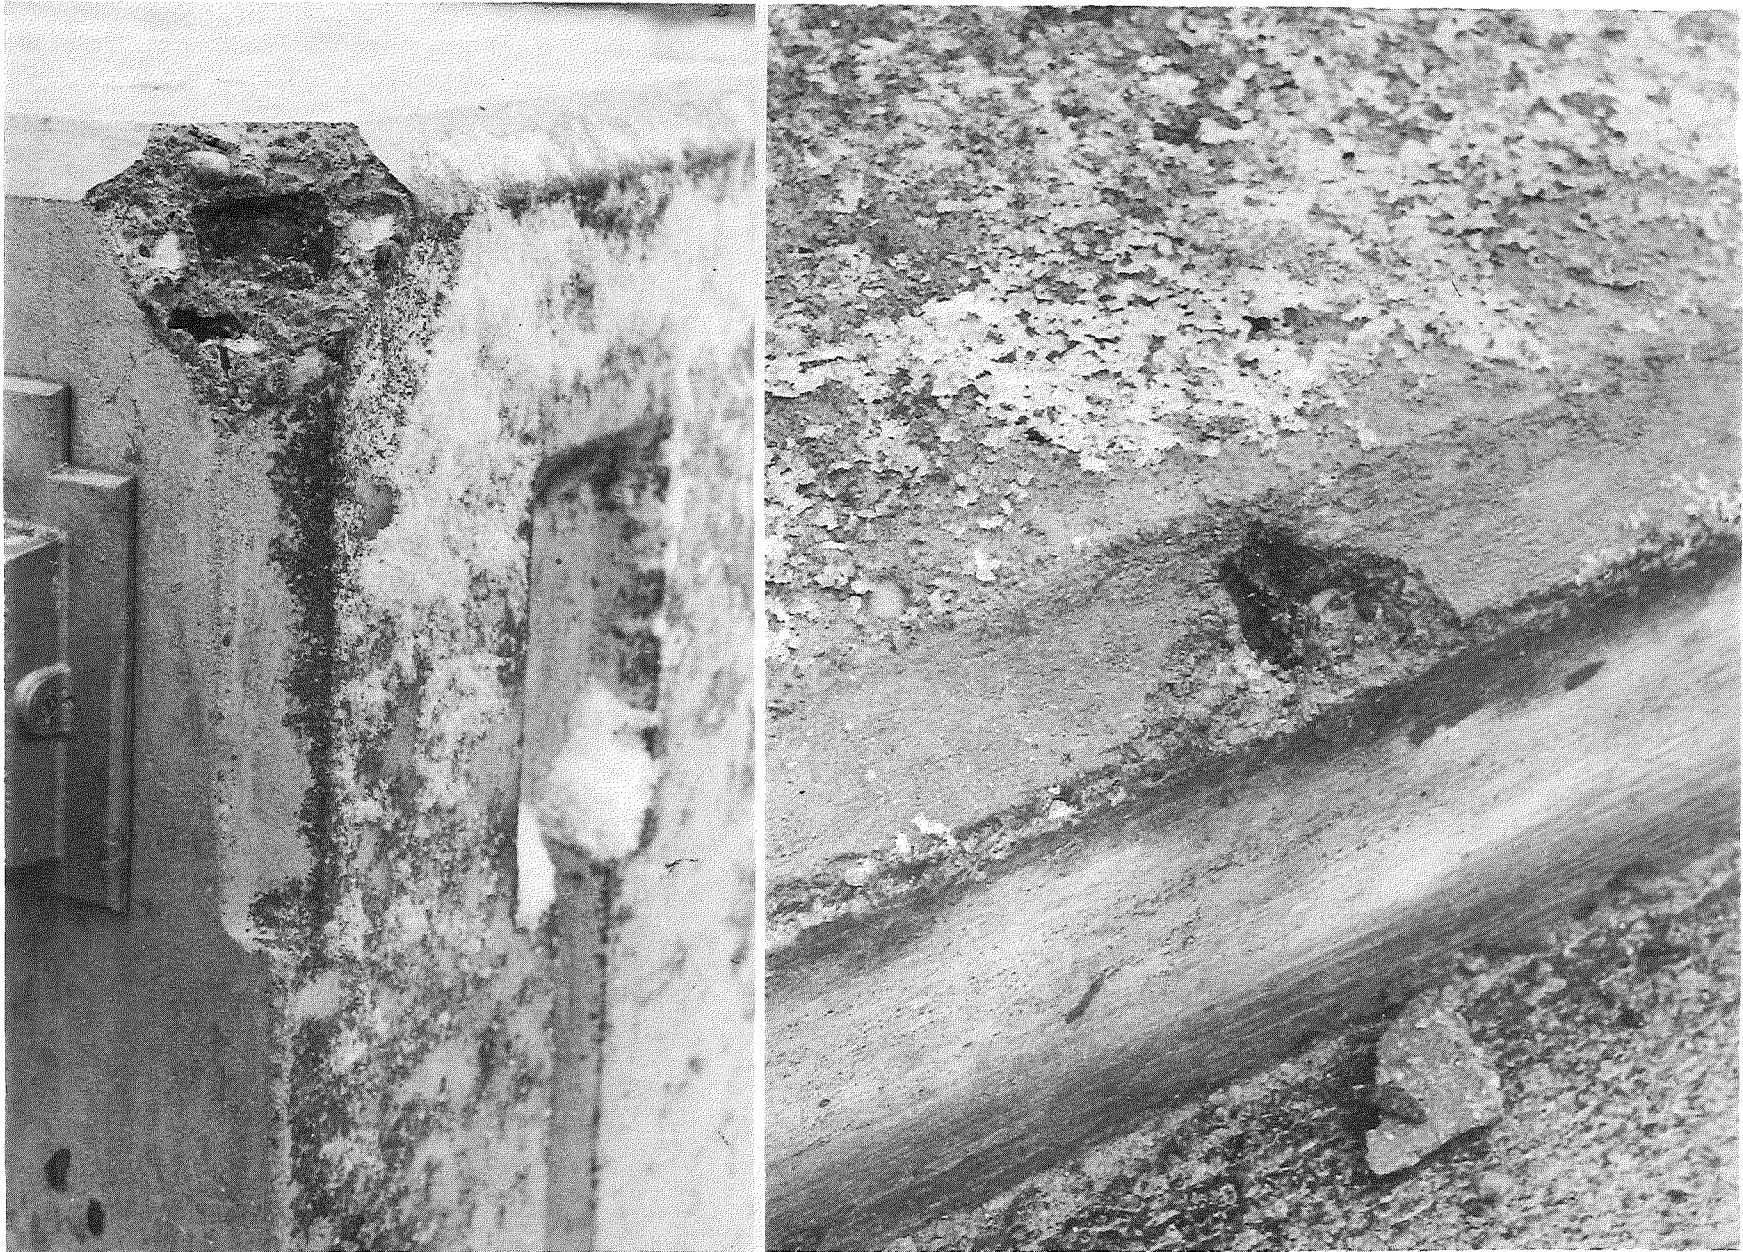
Popouts. The northbound roadway has numerous large popouts of the deck, curbs, and railing posts of all six spans (Fig. 11). The southbound roadway, however, is relatively free of popouts. This difference in frequency and its relation to materials changes is discussed later.

Study of the materials used in the various pours (Table 2) helps explain why aggregate popouts are numerous in the northbound roadway and infrequent in the southbound roadway. The coarse aggregate on the northbound deck was Groveland 6A, except for Green Oak 6B on Pour L (Span 6). On the southbound, it was 6B, either from American Aggregates Green Oak or from Killins, with the exception of Pour K, Span 4--the worst scaled area--where Groveland 6A was used. The difference between allowable percentages of deleterious materials in the 6A and 6B, according to MSHD specifications for gravel aggregate, is as follows:

The specification for 6A coarse aggregate permits a higher percent of poorer aggregate constituents with results which are apparent in the much greater frequency of aggregate popouts on the northbound roadway. However, use of 6A aggregate was in accordance with the specifications for this bridge.

Figure 11. Aggregate popouts on a railing post (Span 2, southbound roadway) and on a curb edge (Span 3, northbound roadway).
Nov. 1959.

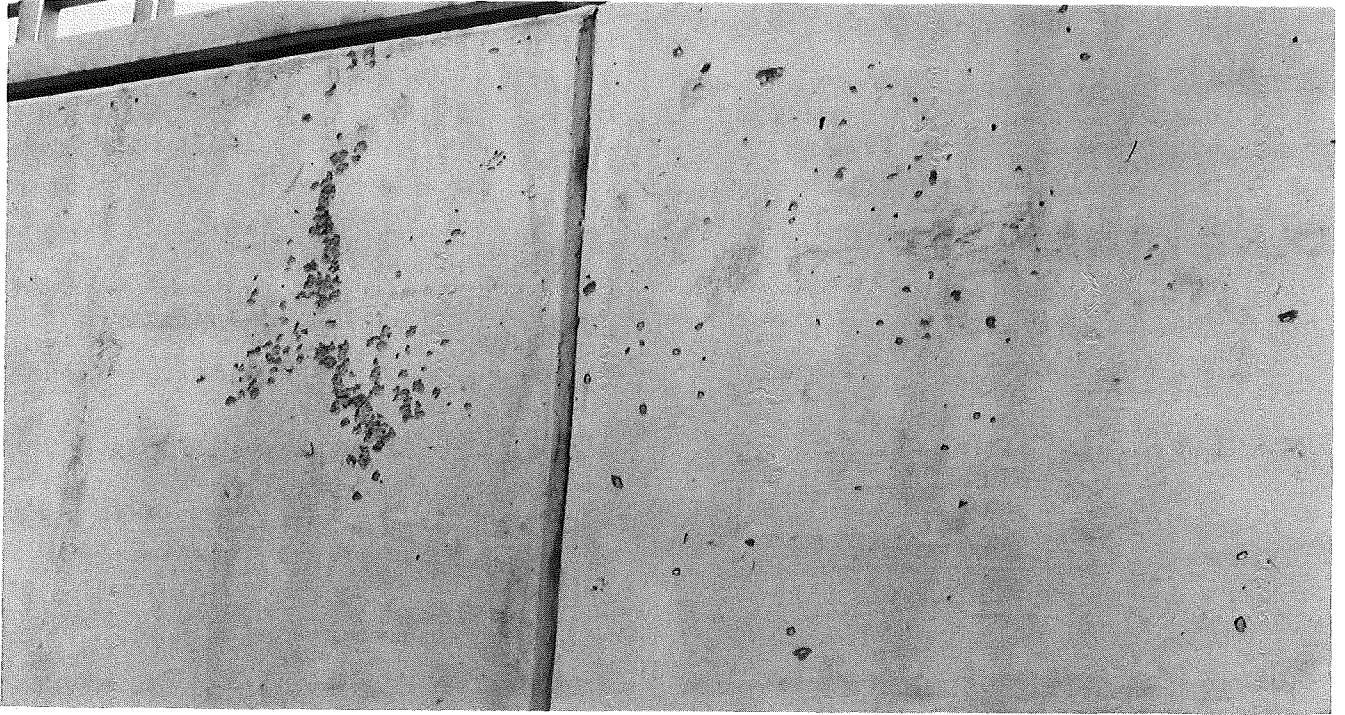
The only scaling found on the substructure concrete surfaces is between the roadways on the south parapet wall (Fig. 12). This scale seems to have resulted from splashing of chemical-laden slush and snow from the decks above.

Figure 12. Scaling or pitting similar to that on the railing posts has occurred on the south retaining wall between the separate roadways, probably due to splashing of chemical-laden slush and snow by passing vehicles and winter maintenance operations. Sept. 1960.

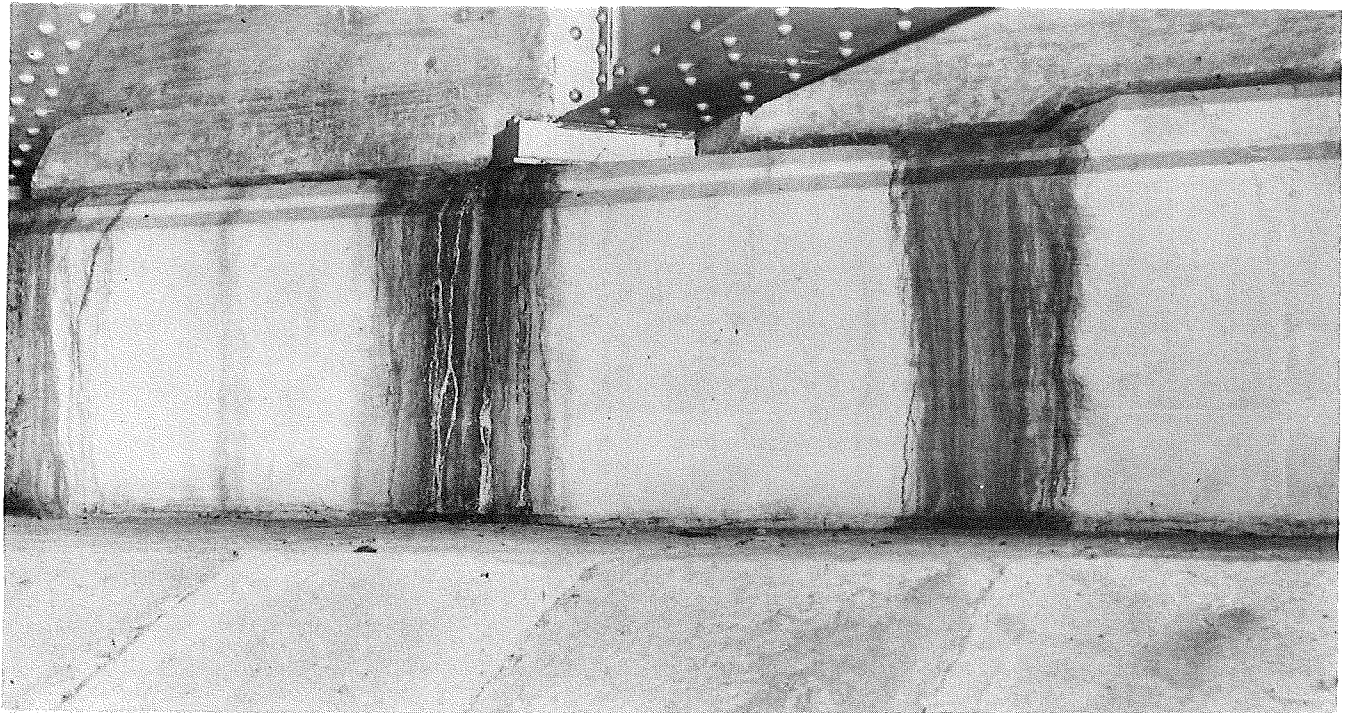
Water leakage through the north abutment wall has left extensive stains on the inside face. This leakage is occurring along vertical cracks in the stub abutment and through the bridge seat construction joint between the back wall and the abutment pour (Fig. 13). The latter leakage may be the result of failure of joint waterproofing material at certain points along this joint.

Figure 13. Water leakage has stained concrete on the inside face of the north abutment through cracks in the abutment wall and at various points along the bridge seat construction joint. Sept. 1960.

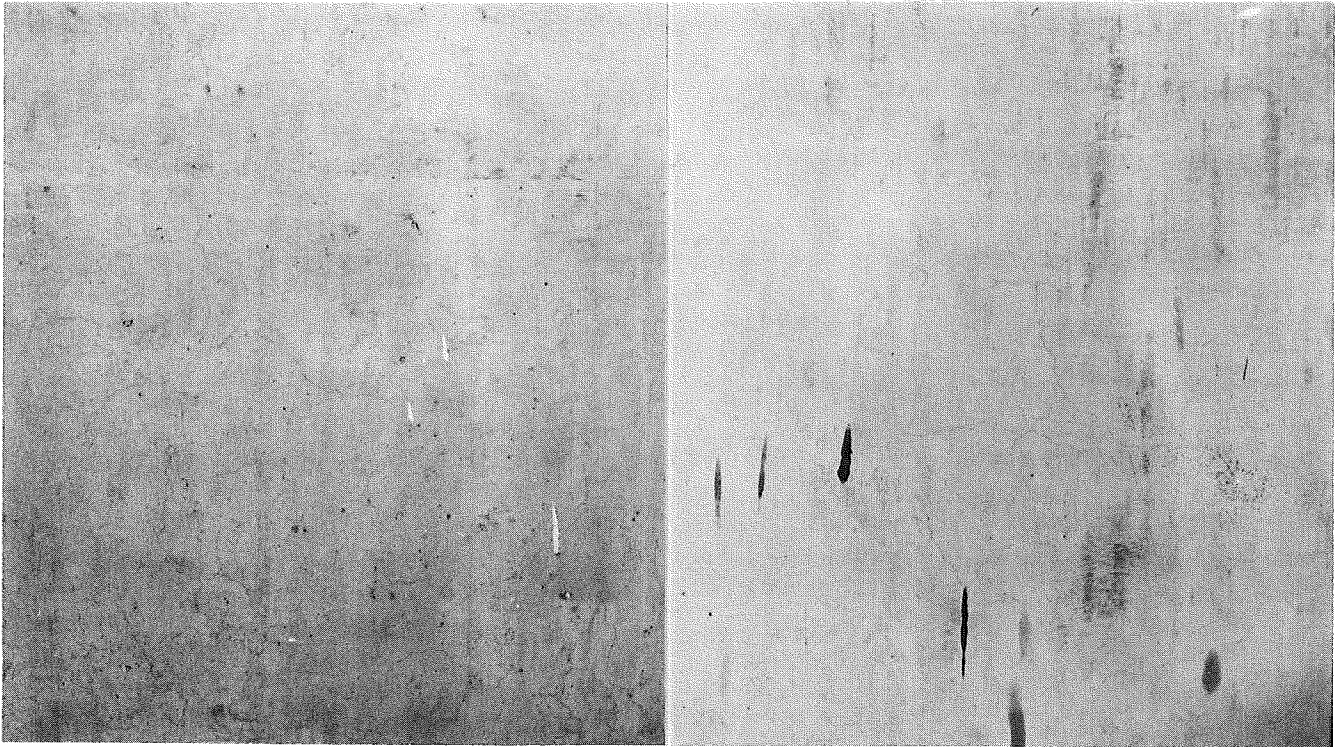
Another minor imperfection noted in the substructure was extensive, fine hairline cracking (Fig. 14). This deterioration was most pronounced on the Pier 4 pedestal, but was also noted on some columns of Pier 1. This type of cracking has also been noted on other structures, particularly on pier columns, and does not appear to be a serious defect.

The hairline cracking, most prevalent on the Pier 4 pedestal wall (Fig. 14), also appears to be associated with cold temperature pouring. The Pier 4 pours were made on March 23, 27, and 28. All other exposed substructure concrete was poured after April 10, when temperatures were generally more moderate.

Figure 14. Hairline cracking of concrete surfaces on Pier 4 pedestal wall. Nov. 1959.

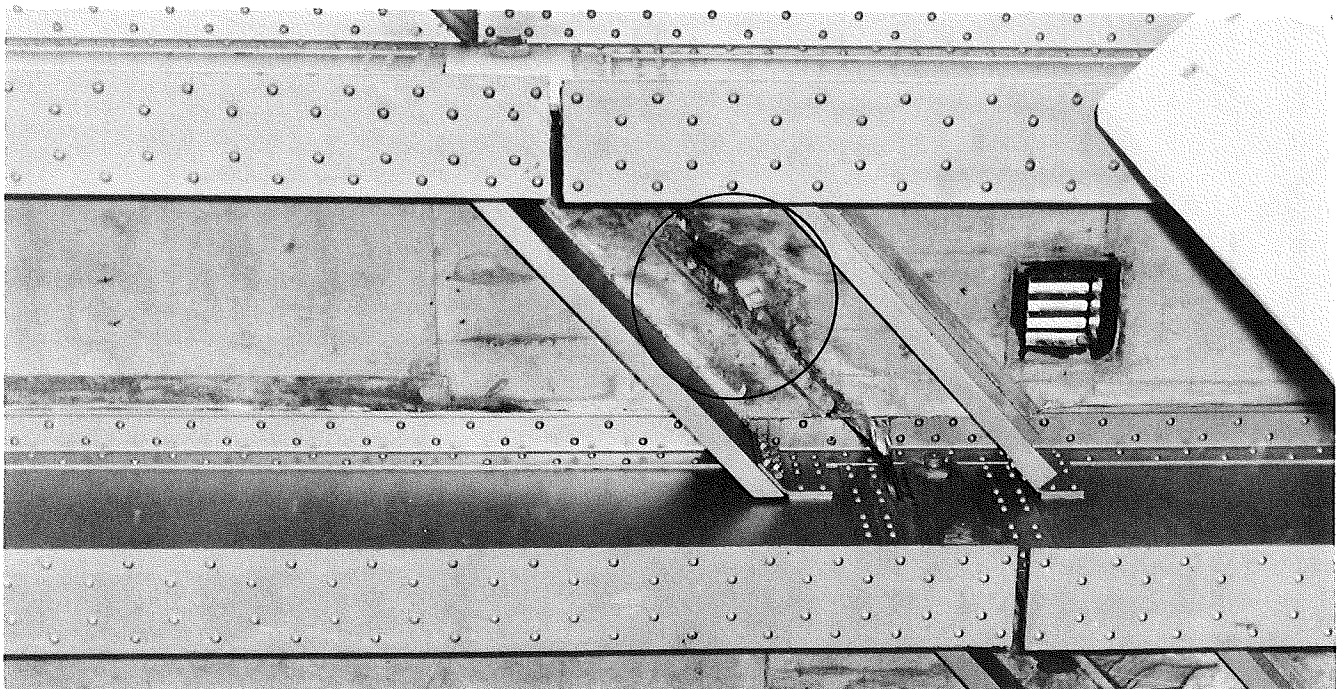
A large concrete spall was found on the deck undersurface at the expansion joint at the south end of Span 5 on the southbound roadway (Fig. 15).

Figure 15. Concrete spall at expansion joint at the south end of Span 5 on the southbound roadway Nov. 1959.
