EXPERIMENTAL SHOULDER STABILIZATION
US 23 North of Alpena (Mn 04032, C6)
First Progress Report

Research Laboratory Division
Office of Testing and Research
Research Project R-62 E-25
Report No. R-415R

Michigan State Highway Department
John C. Mackie, Commissioner
Lansing, May 1963

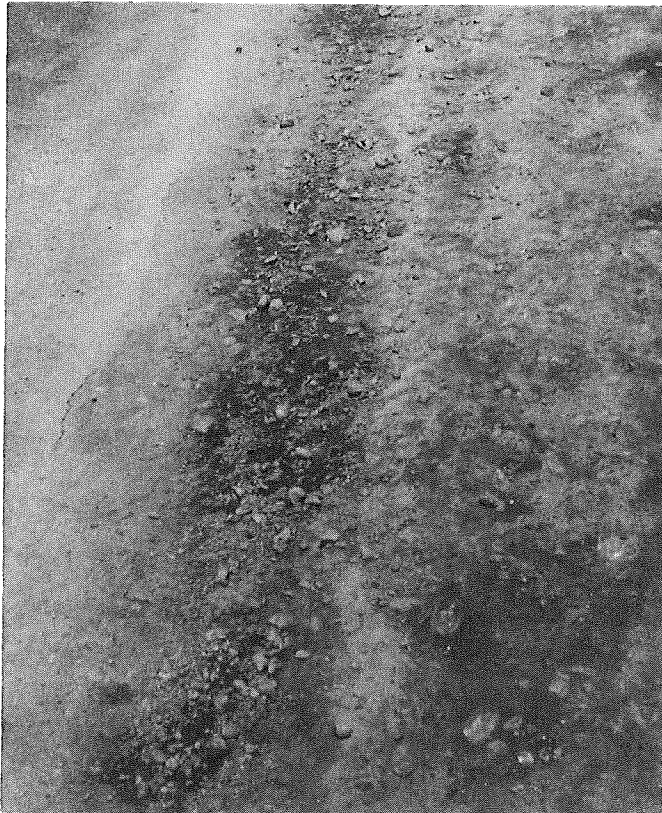
The portland cement sections were in good shape at the time of sealing. However, as shown in Fig. 6, there were many loose stones on the surface at this time. Fig. 7 shows a general view of the 6-percent soil-cement section after two days of moist curing.

Figure 6. Loose condition of soil cement surface before sealing. Note presence of stones.

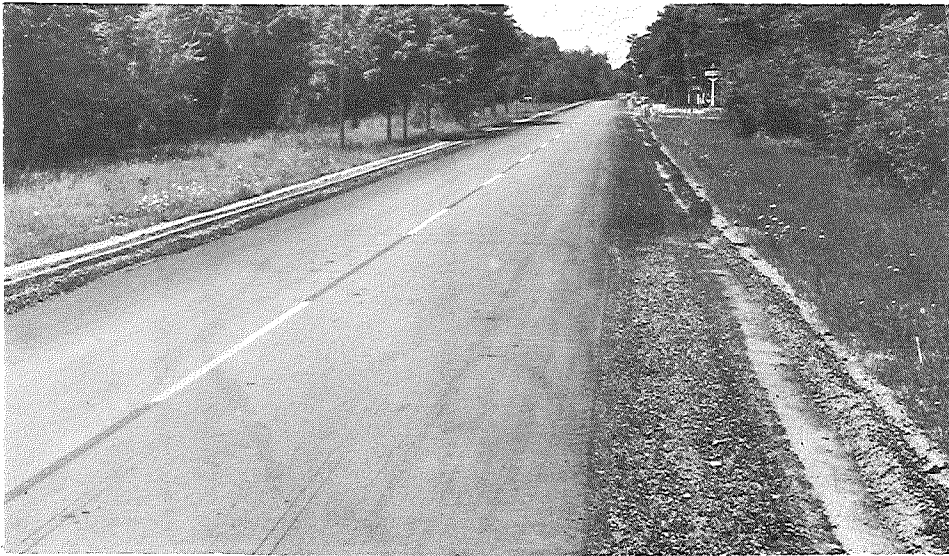
The Duo-Stabilizer equipment used for applying the asphalt depends upon a positive displacement pump and a constant forward speed to produce a uniform application. Unfortunately, uniform speed could not always be maintained and there were indications that the pump output was erratic. When it became apparent that either too much or too little asphalt was being applied (by observing the liquid level in the truck in comparison with the distance traveled), the pumping rate or the speed of the equipment was changed. The result of such modification is shown in Fig. 11 where a pronounced change is apparent in the quantity of asphalt in the 2.3 percent SC-3 section. This may also be observed in Fig. 12 where molded samples are shown which were obtained in about a 100-ft length of the 2.3 gal section.

Figure 11. Visible variation in asphalt content in slow curing asphalt section.

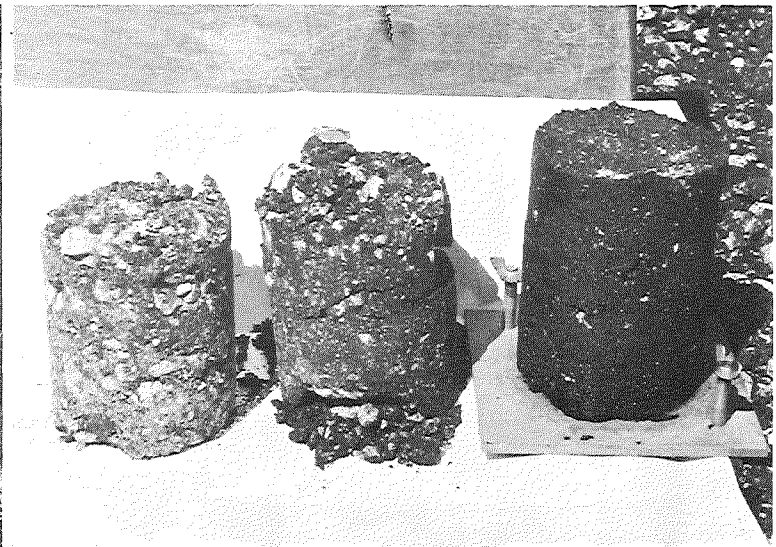
Figure 12. Molded samples showing variable asphalt content in slow curing asphalt section.

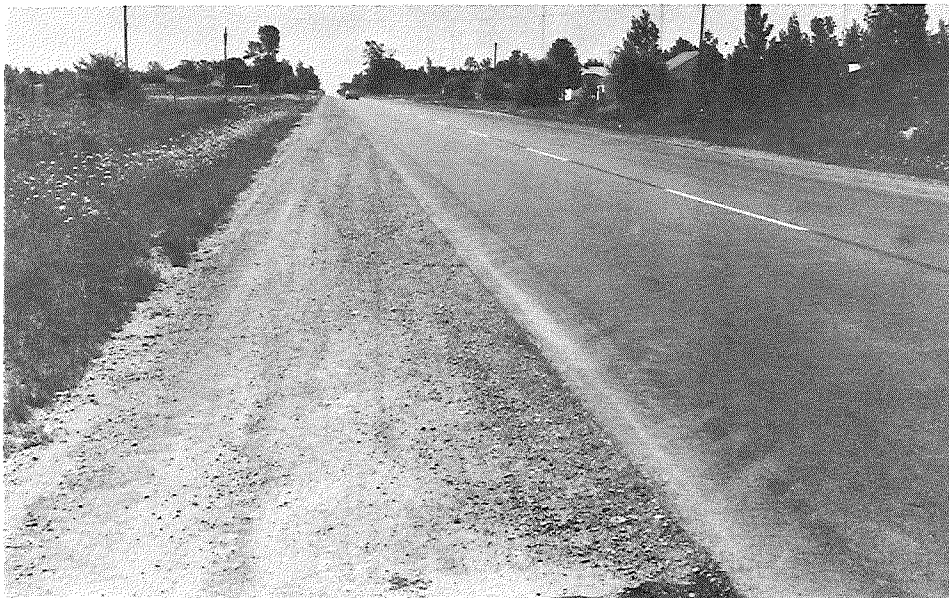
All the asphalt emulsion sections appeared to be lean in asphalt content, particularly the 2.0 gal per sq yd areas. Fig. 13 shows a typical section of this treatment. The surface gravel is quite loose. The 2.6 gal per sq yd section contained only small areas where loose stones were present. There was no bleeding in the low emulsion area and only about 5-percent bleeding in the area of higher treatment. Asphalt emulsion did not appear to adhere to the aggregate as readily as did the slow curing asphalt.

Figure 13. Appearance of the 2-percent asphalt emulsion section.

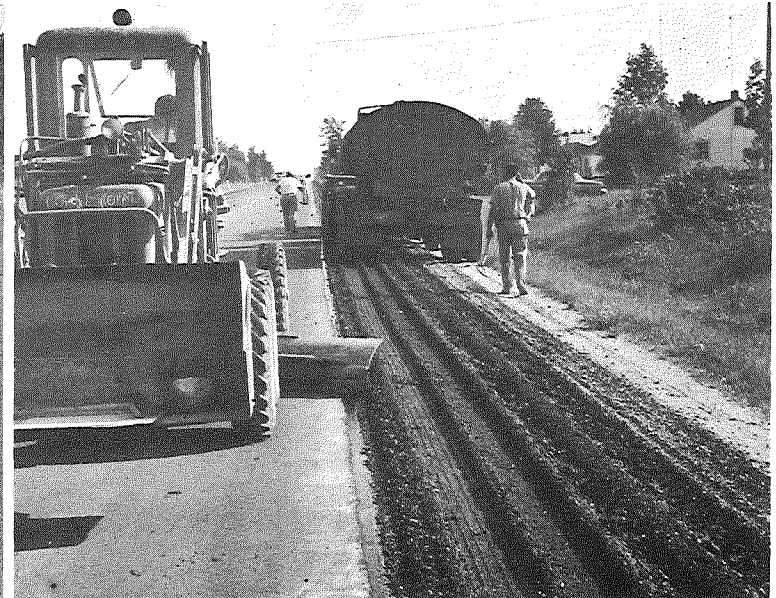
A potential traffic hazard is created by the long time required for curing of an asphalt shoulder prior to obtaining density. Fig. 14 shows the typical loose condition of the shoulder material during the curing period.

Figure 14. Loose shoulder material during curing of asphalt-aggregate mixture.

4. Asphalt stabilization required an unusual amount of mixing and aeration in order to place the asphalt in a proper manner. The time required for curing, prior to compaction, was excessive and during this time the uncompacted shoulders were a potential traffic hazard. The use of a more rapid curing asphalt might help improve this situation.

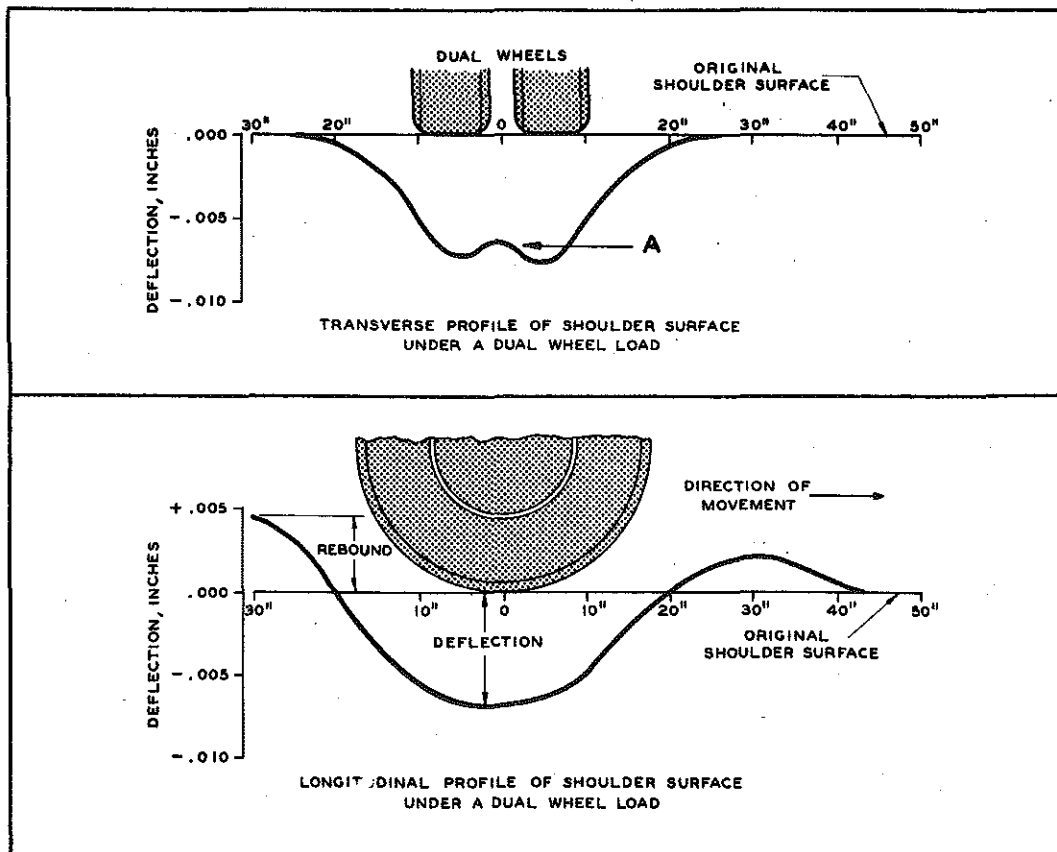
Figure 17. Typical surface distortion for asphalt-treated gravel under dual wheel load of 5300 lb.
