PERFORMANCE EVALUATION OF  
CONCRETE PAVEMENT OVERLAYS  
(CONSTRUCTION REPORT)

J. E. Simonsen  
A. W. Price

Technology Laboratory Section  
Materials and Technology Division  
Research Project 83 F-162  
Research Report No. R-1262

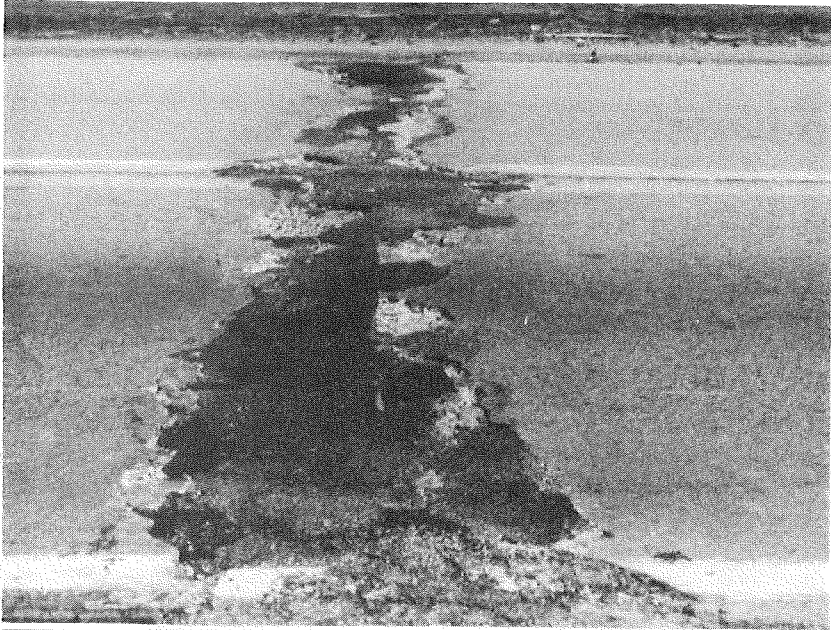
Description: Failure of the transverse joints is the spalling, breaking, or buckling of the concrete along one or both edges of the joint groove for a total width of 4 in. or more. Failures normally occur gradually and are maintained by temporary bituminous patching.

Severity Level 1-From 6 to 12 ft of spall or bituminous patching.

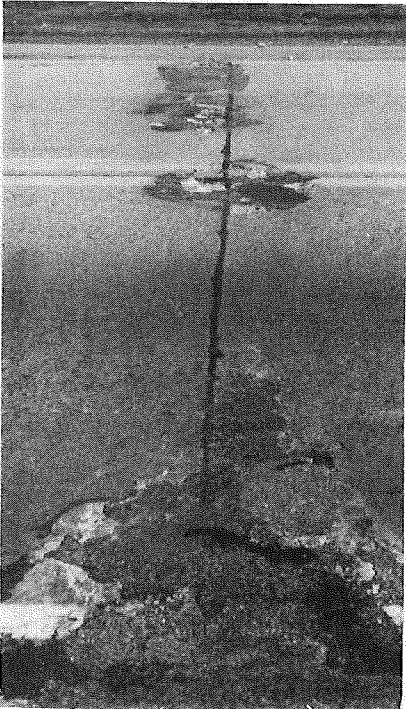
Severity Level 2-From 3 to 6 ft of spall or bituminous patching.

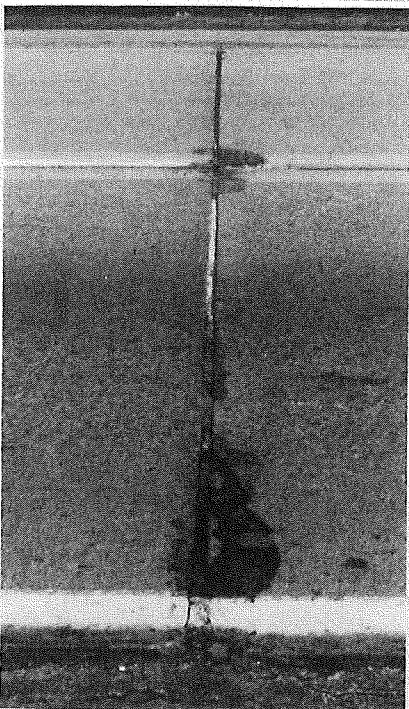
Severity Level 3-From 1 to 3 ft of spall or bituminous patching.

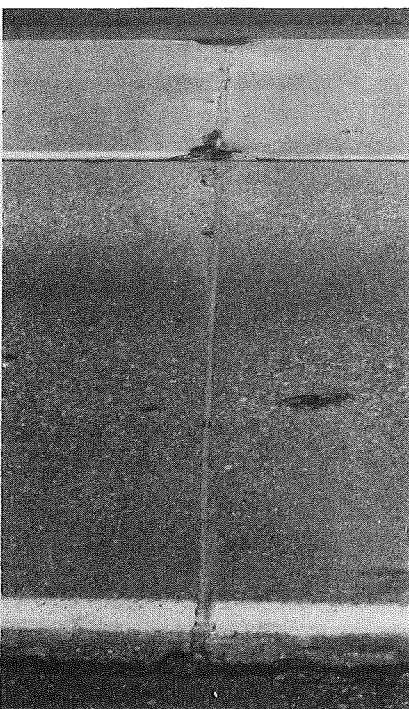
Severity Level 4-From 0 to 1 ft of spall or bituminous patching.

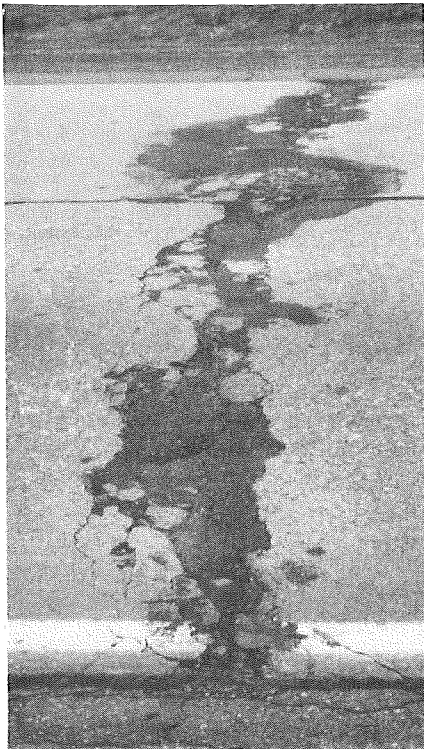
Description: An open transverse crack is a small gap in the pavement slab between joints. The reinforcement has fractured and the crack acts as a joint. Normally the width of the crack must be 1/4 in. or more to be considered open. Spalling, bituminous patching, and faulting may have occurred.

Severity Level 1-From 6 to 12 ft of spall or bituminous patching. Faulting may have occurred.

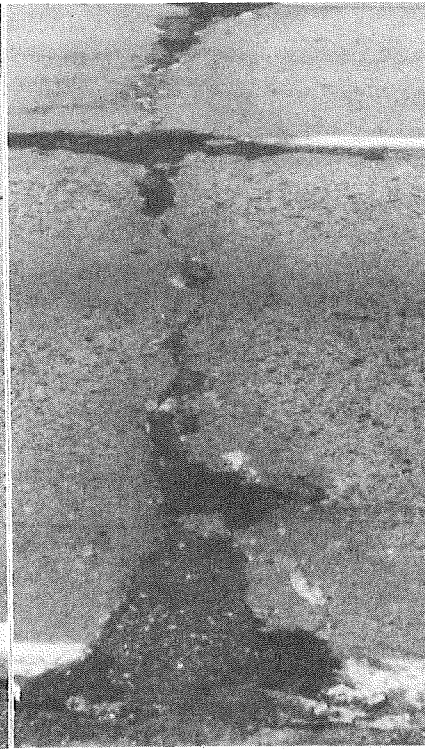
Severity Level 2-From 3 to 6 ft of spall or bituminous patching. Faulting may have occurred.

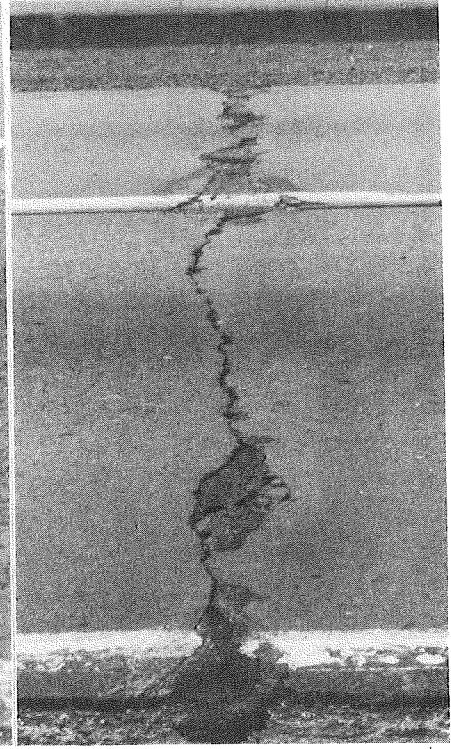
Severity Level 3-From 1 to 3 ft of spall or bituminous patching. Faulting may have occurred.

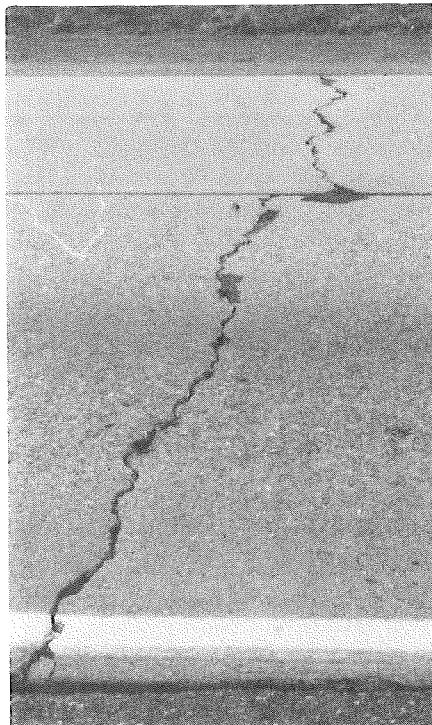
Severity Level 4-From 0 to 1 ft of spall or bituminous patching. Faulting may have occurred.

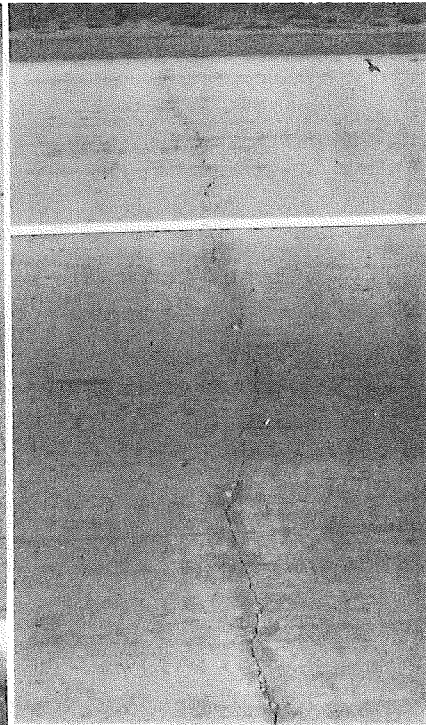
Severity Level 5-Transverse cracks with only minor spalls and reinforcement still intact.

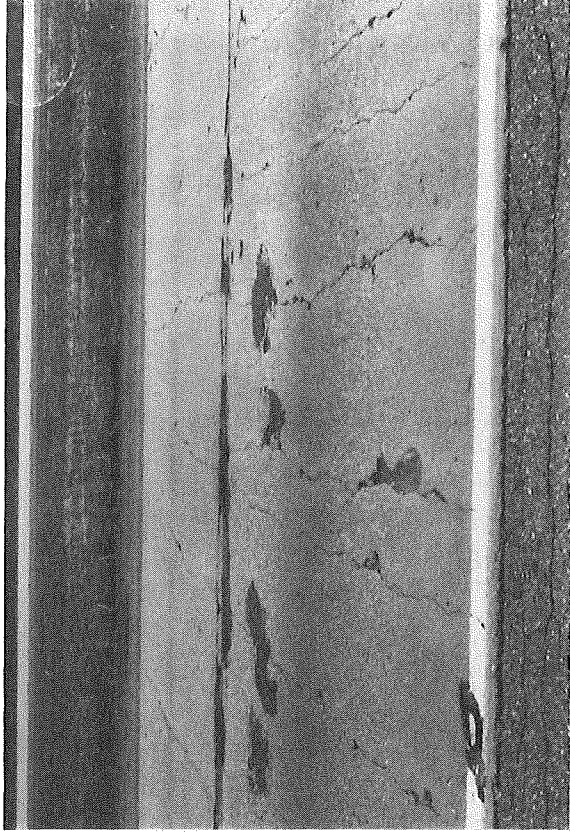
In addition to locating joints and cracks in the test sections, previous repairs and pressure relief joints were also located. Since the joints at repairs and the relief joints were basically free of deterioration they were not rated with respect to current condition. A typical repair condition is shown in Figure 9. The deteriorated condition of joints and cracks for test sections in the jointed pavement is summarized in Table 1. As can be seen, the US 23 test sections show more deterioration than the I 96 sections. However, it should be noted that Section D on I 96 had previously been extensively repaired which would reduce the severity of the rated surface defects.

Figure 9. Typical condition of undoweled repairs located within the test section limits.

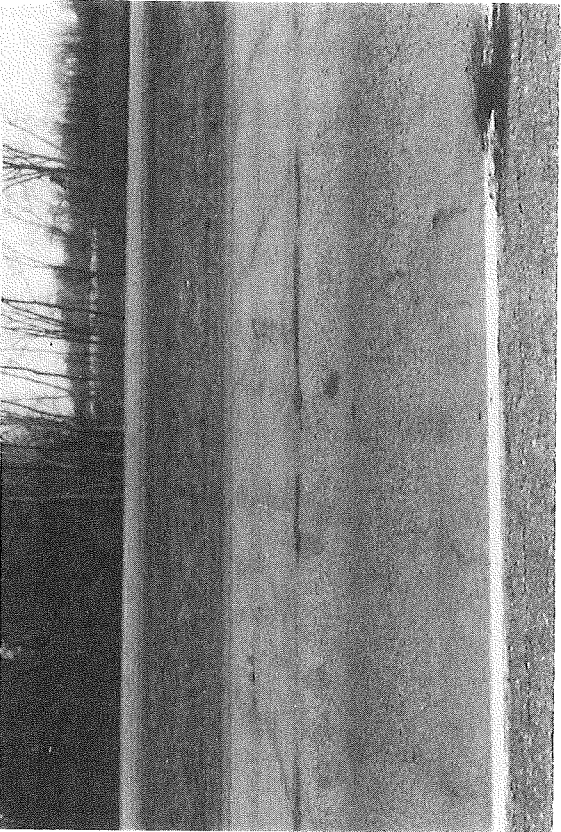
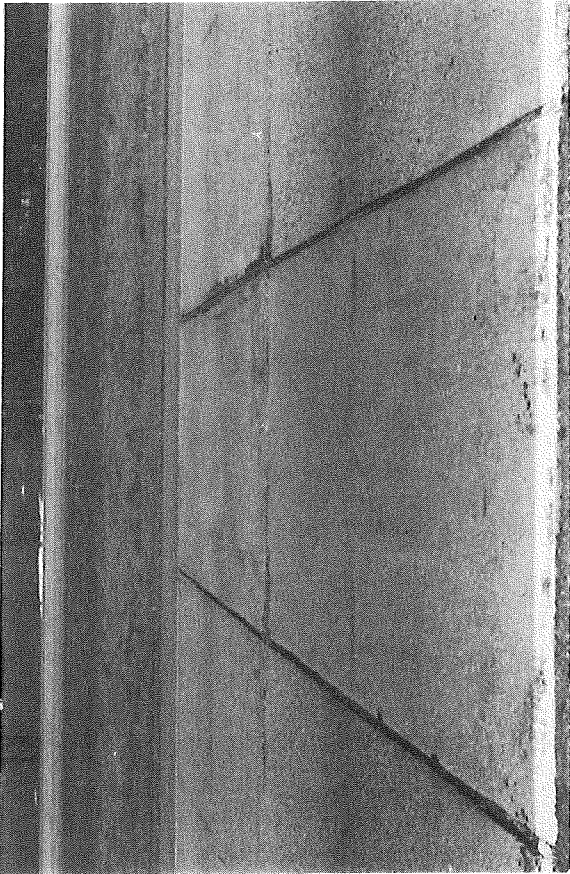
The condition of the CRC pavement in test sections B and C is shown in Figures 10 and 11. As shown in Figure 10, the transverse cracks exhibited medium to heavy spalling and patching in some areas and only minor spalling and patching at other locations. Six failed areas were previously repaired with undowelled joints in Section B and seven areas in Section C. The condition of the centerline joint, Figure 11, in the CRC sections was generally good with only minor patching. The condition of the centerline joint on the sections in the jointed pavement (Fig. 12) varied from minor to medium to heavy patching and fracture of the tie bars was evident because of separation of the slabs.

Figure 10. The condition of the I 96 CRC pavement ranged from medium (top) to minor spalling and patching of the transverse cracks (bottom).

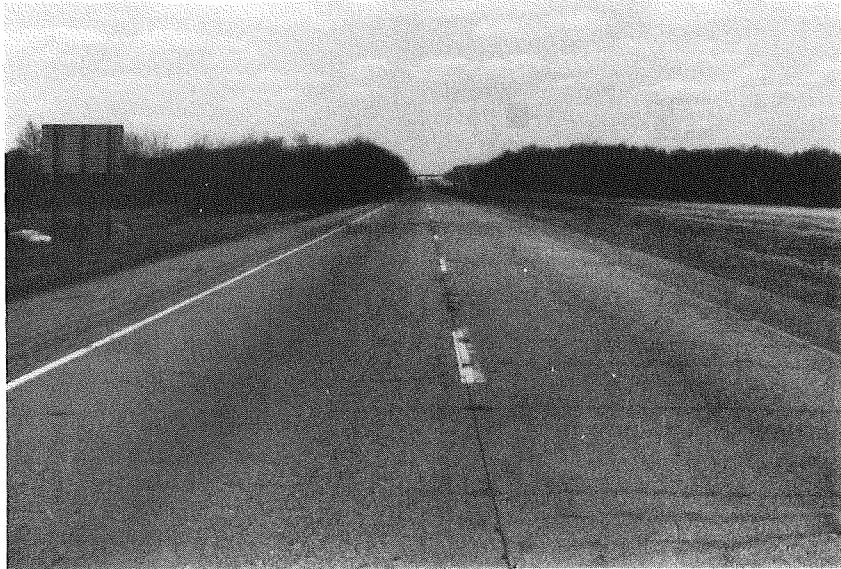
Figure 11. The longitudinal joint in the CRCP test sections exhibited only minor to moderate spalling and patching and only occasional areas where the joint had separated.

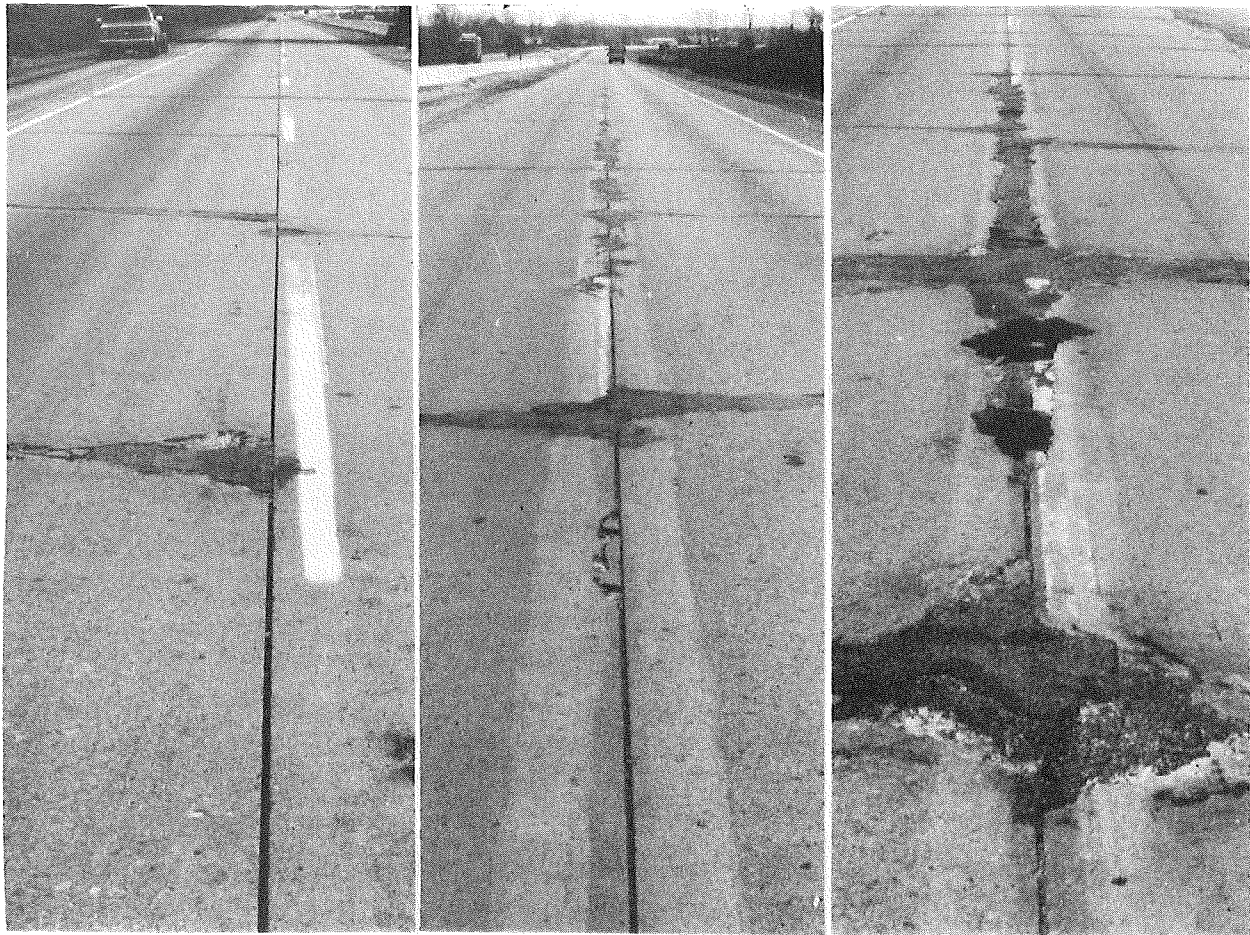
Figure 12. Condition of the longitudinal joint varied from basically no spalling (left) to medium spalling and patching (center) to heavy spalling and patching (right). Throughout most of the test sections' lengths separation of the joint had occurred indicating that the tie bars had fractured.
