MICHIGAN
STATE HIGHWAY DEPARTMENT
Charles M. Ziegler
State Highway Commissioner

EXPERIMENTAL PATCHING OF BROKEN CONCRETE
AT EXPANSION JOINTS

US-16 - Nunica to Fruitport

Research Laboratory
Testing and Research Division
Report 197A
Dec. 4, 1953

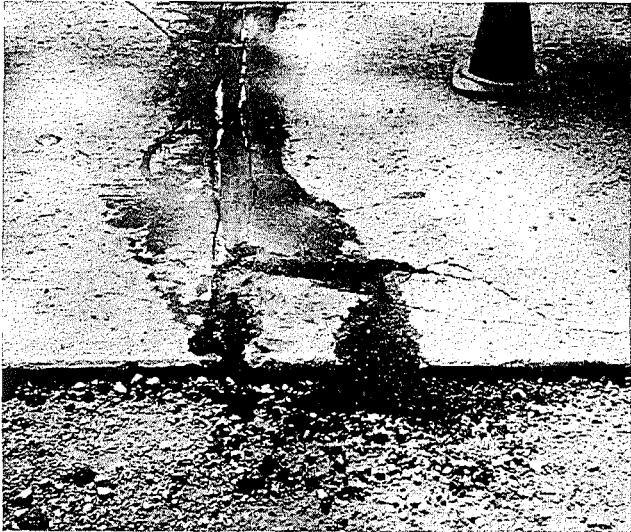
▲ Figure 1. A corner break typical in appearance, having received routine county maintenance treatment.

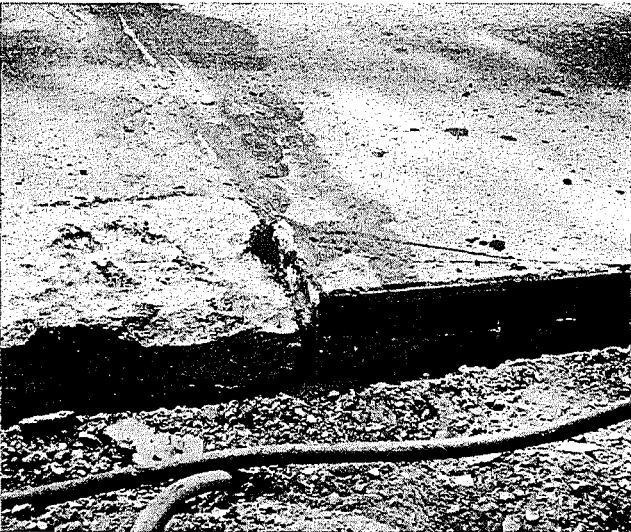
It was found that usually only one corner break was apparent at the junction of an expansion joint and the pavement edge. Removal of a section of the shoulder always indicated, however, that the other corner was broken too. It appeared that compressive stress at the joint caused the upper corner of one slab and the lower corner of the other to shear off at an angle of about 30 degrees to the horizontal. This condition is apparent in Figure 2 and is typical of all corner breaks examined

▲ Figure 2. A typical corner break with shoulder excavated to show details. First in a series showing steps in repair method.

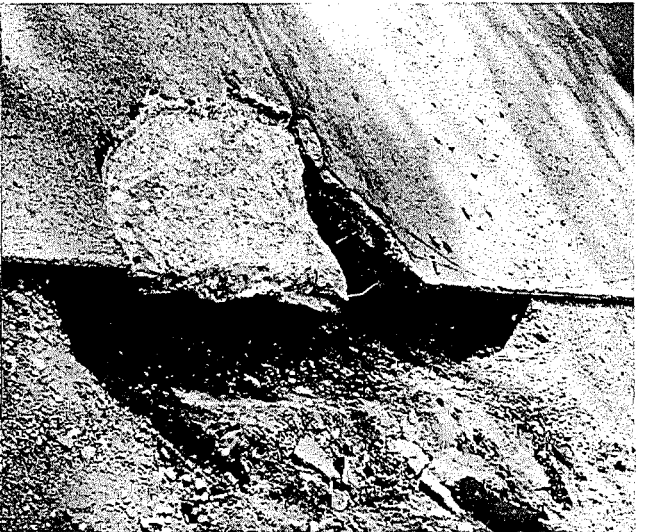
▲ Figure 3. Close-up of lower break in Figure 2 with loose and decomposed material removed.

Figures 2 through 11 show the various steps used in making these repairs. The loose and decomposed concrete was removed with an air hammer (Figures 3 and 4) and the joint felt and groove form set in place (Figure 5). A wide board was used as a form for the pavement edge. A very thin water slurry of cement containing 10 percent by weight of Embeco was brushed into the faces of the old concrete for a bond coat (Figures 5 and 7). A grout made of 60 volumes of 1-inch maximum gravel, 40 volumes No. 8 sand, and 33-1/3 volumes of cement containing 10 percent by weight of Embeco was then packed into the cavity by hand and consolidated by tamping in with the end of a small board (Figures 6 and 8). This grout mixture was unusually dry, containing just enough water to retain its shape when squeezed into a ball in the hand. A 1/2-inch surface coat, in which the gravel was replaced by No. 8 sand, was used to finish off the patch (Figures 9 through 11). The patch was covered overnight with Sisalkraft paper (Figure 12) and then alternately wetted and dried for several hours in order to rust the iron in the Embeco. Figures 13, 14, and 15 show various finished patches and Figure 16 shows a general view of the barricades set up around a series of patches. These barricades were illuminated at night with flares and red lanterns.

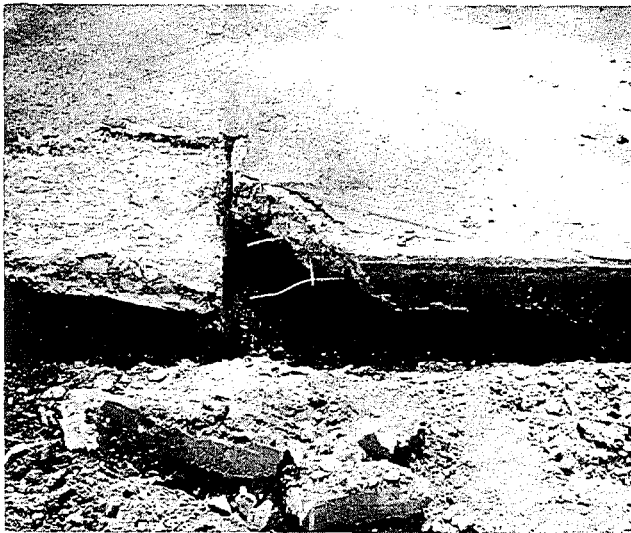
▲ Figure 4. Close-up of top break in Figure 2 with loose and decomposed material removed.

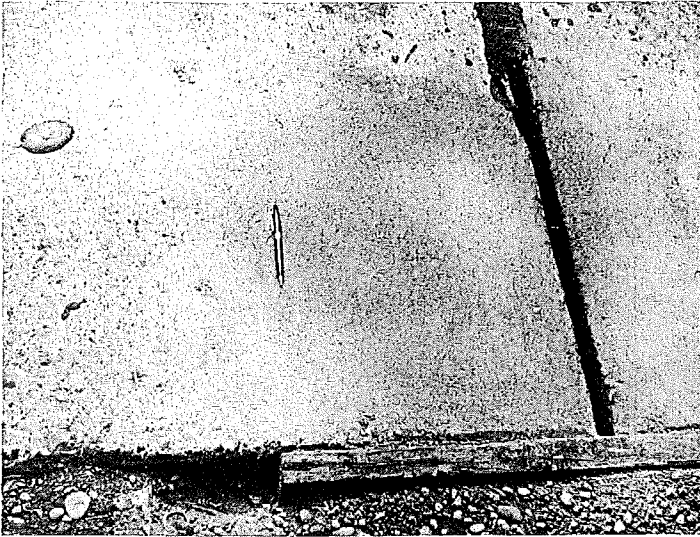
Figure 13. A typical repaired corner break.

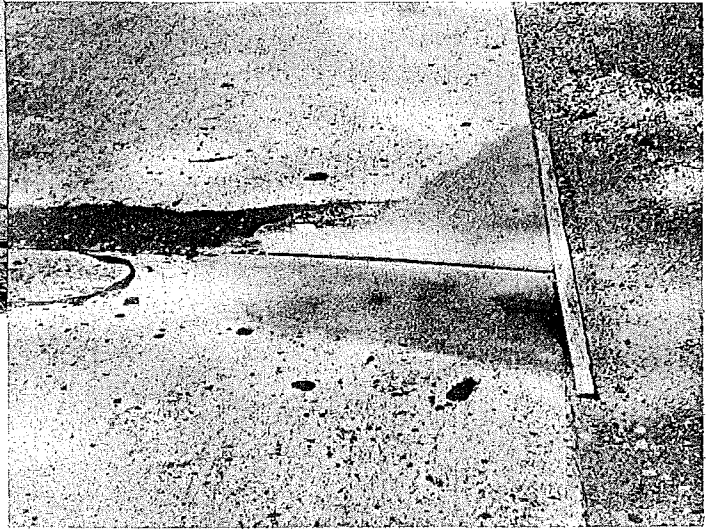
Figure 14. Another repaired corner break.

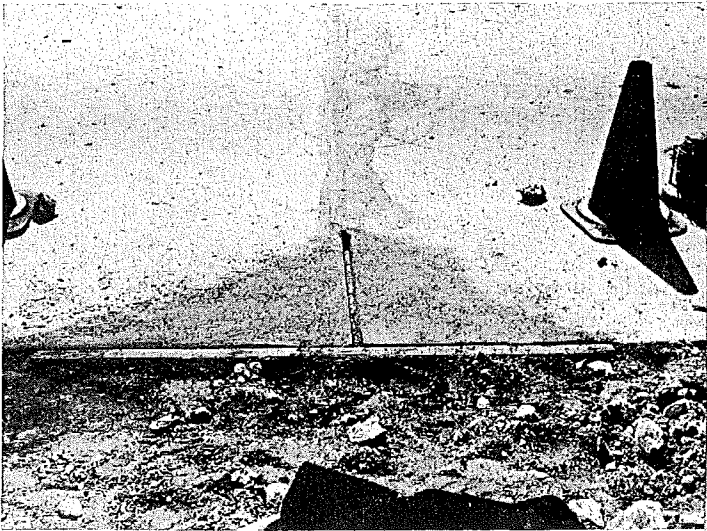
Figure 15. A corner break repair with traffic barrier in place.

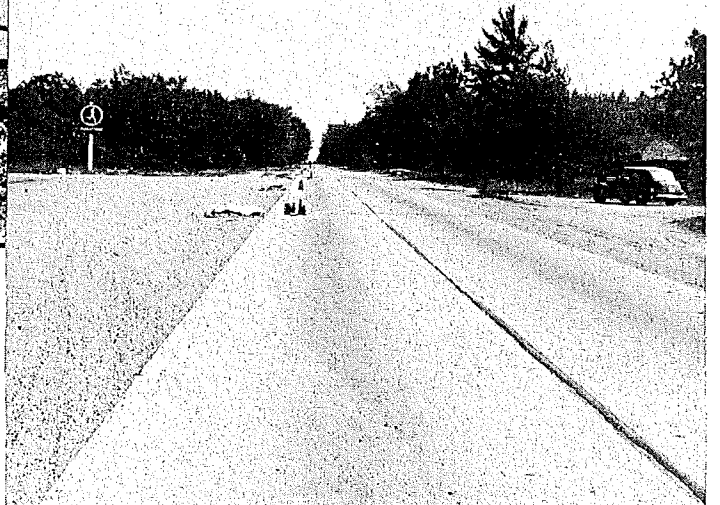
Figure 16. A general view of repairs showing method of protection from traffic.
