METHODS FOR EVALUATING DETERIORATION
OF IN-SERVICE REFLECTIVE SHEETING SIGNS

M. H. Janson
G. M. Smith

Research Laboratory Section
Testing and Research Division
Research Project 68 G-160
Research Report No. R-692

State of Michigan
Department of State Highways
Lansing, April 1969

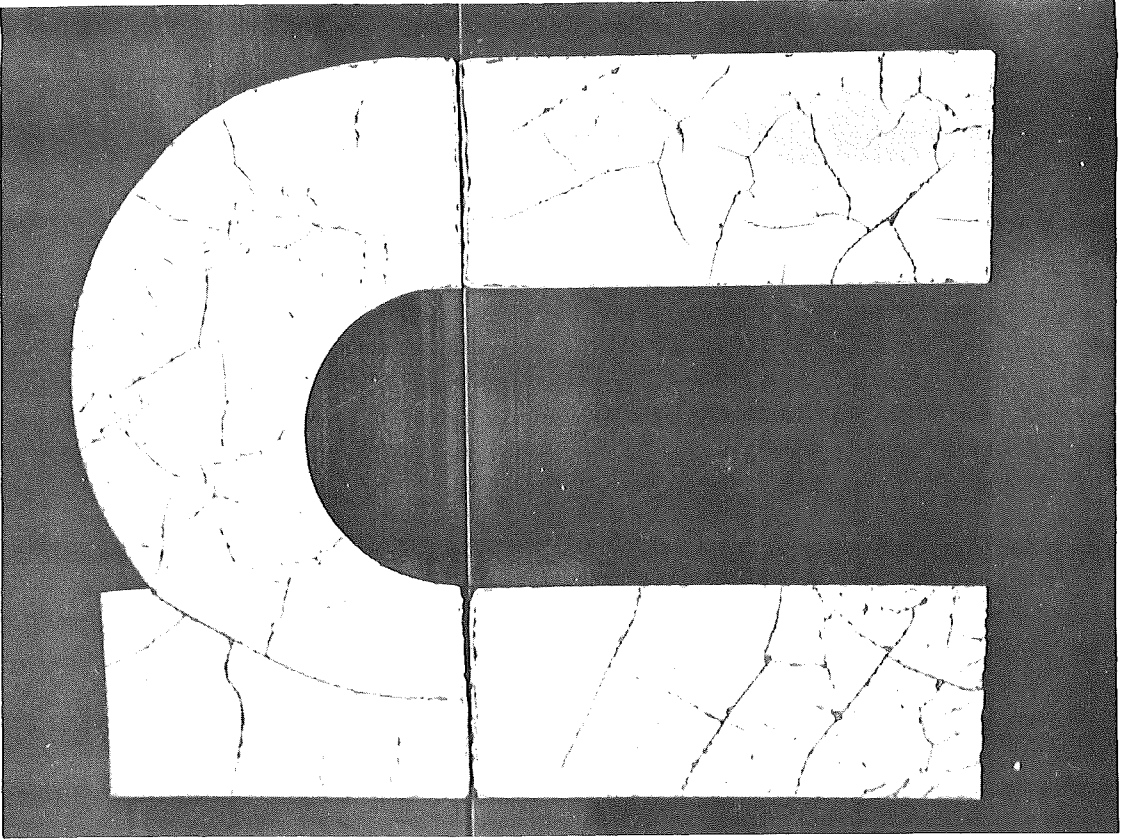
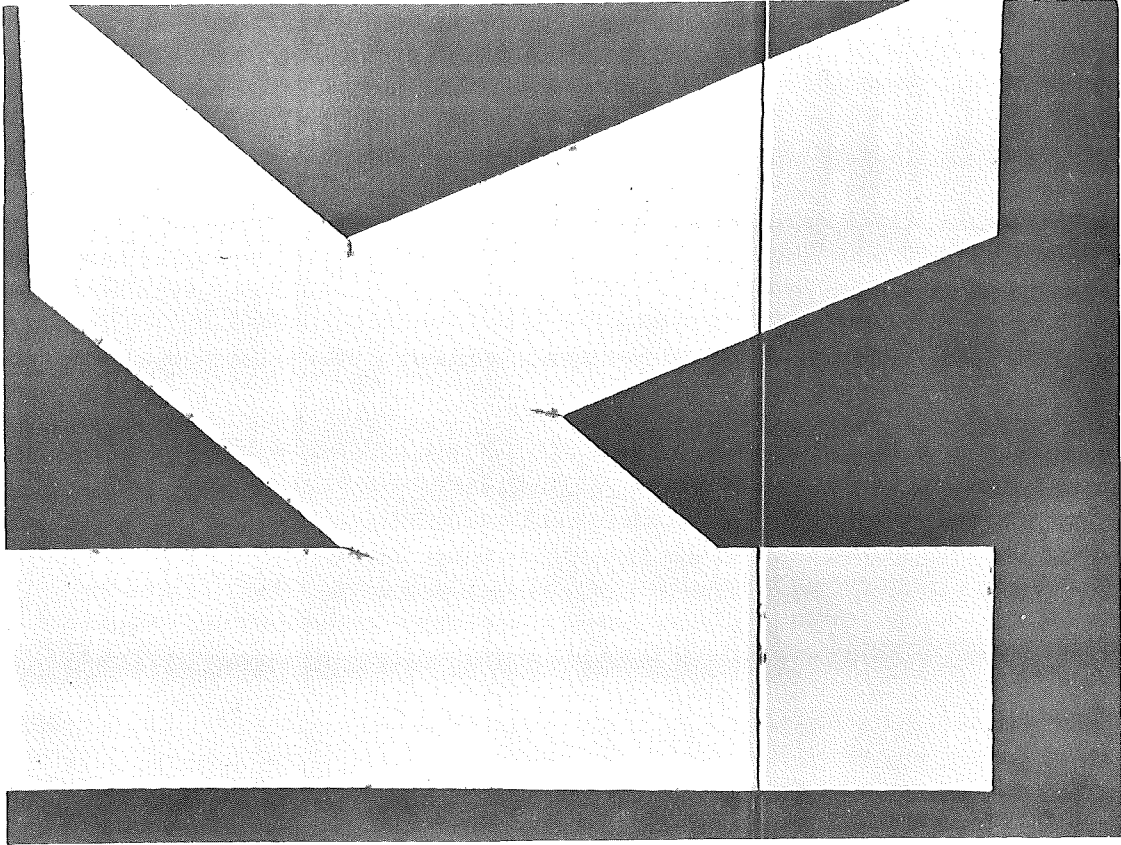
Figure 2 shows the luminance values for the I 96 signs and new reflective sheeting as a comparison. Figure 3 depicts typical "New" and "Intermediate" signs on I 96. It was found that even though the I 96 "Intermediate" signs had cracks in the legend sheeting, legend and background luminances were not significantly lower than those of the "New" signs on I 96. Figure 4(a) shows a typical letter from "Old" signs on I 96. Luminances for these "Old" signs are numbered 1, 2, and 3, in Figure 2. Figure 4(b) shows a letter typical of the other "Old" signs on I 96, numbered

Figure 3. Typical condition of "New" (left) and "Intermediate" (right) signs on I 96.

3. Signs classed as "Intermediate" or signs beginning to show evidence of deterioration appeared brighter than the reference, however, the signs showed a characteristic discoloration. Clearcoating is recommended.

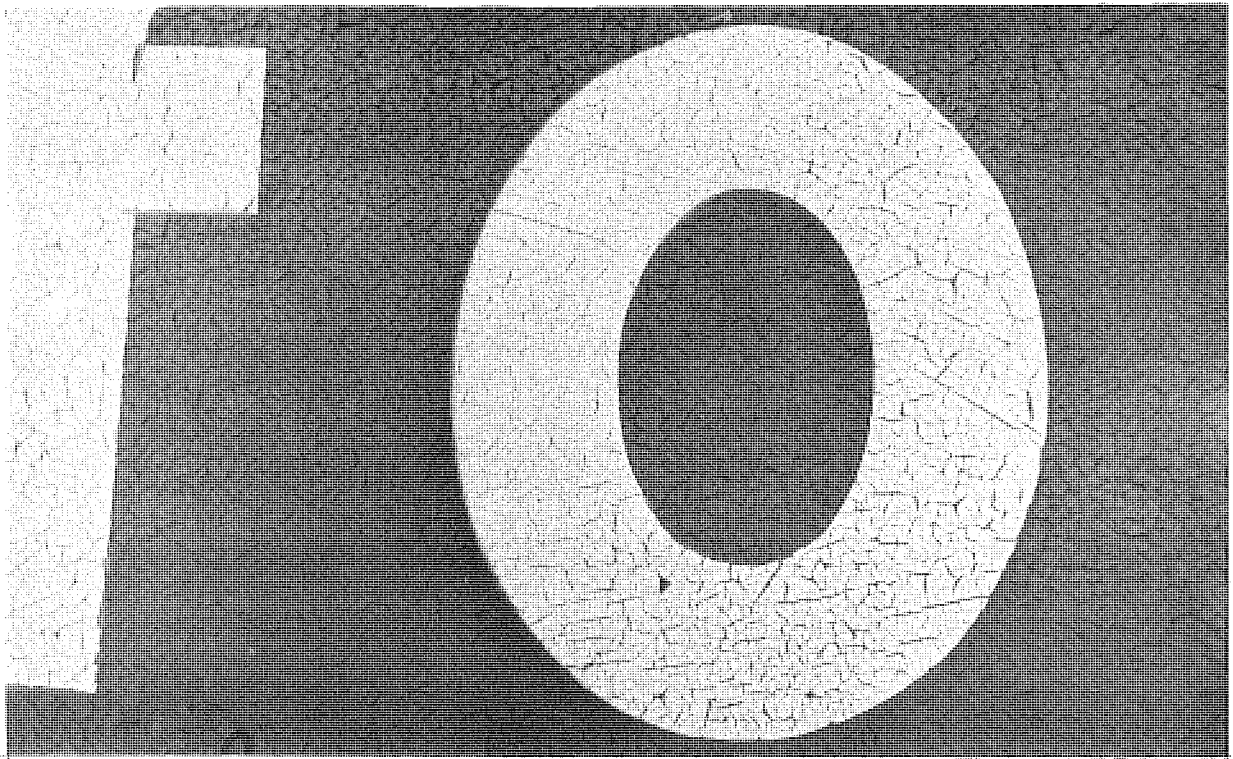
Figure 4a. Typical section of "Old" I 96 signs. Nos. 1, 2, and 3.

4 and 5 in Figure 2. The legend and background luminance values of the above numbered 1, 2, and 3, "Old" signs were approximately 5 to 40 percent of the values for "New" and "Intermediate" signs. These luminances were considered too low for nighttime legibility. The luminance values of the above signs numbered 4 and 5 were as high as values for "New" signs.

1. Comparison observations showed that the "Old" signs on I 96 and the "Very Old" signs on I 94 had luminances well below the reference panel and, therefore, well below levels acceptable for adequate legibility distance. Sign replacement is recommended.

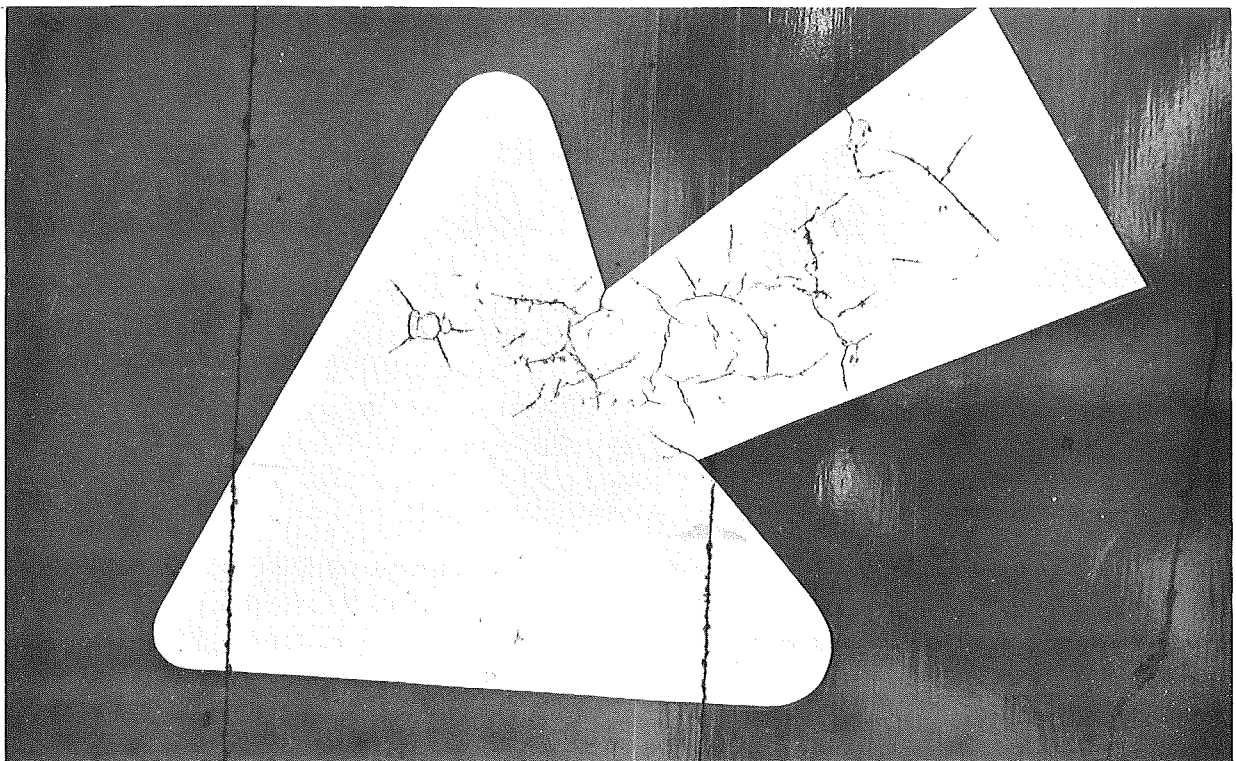
Figure 4b. Typical section of "Old" I 96 signs. Nos. 4 and 5.

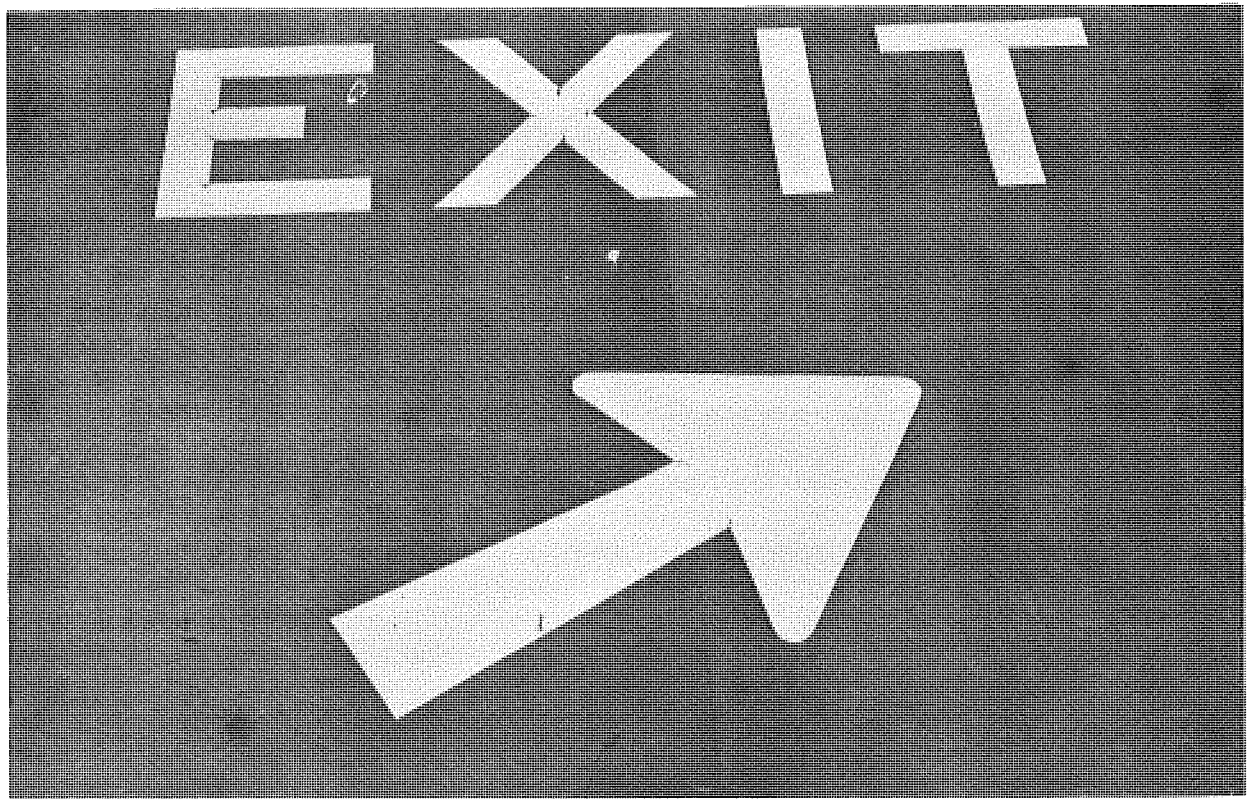
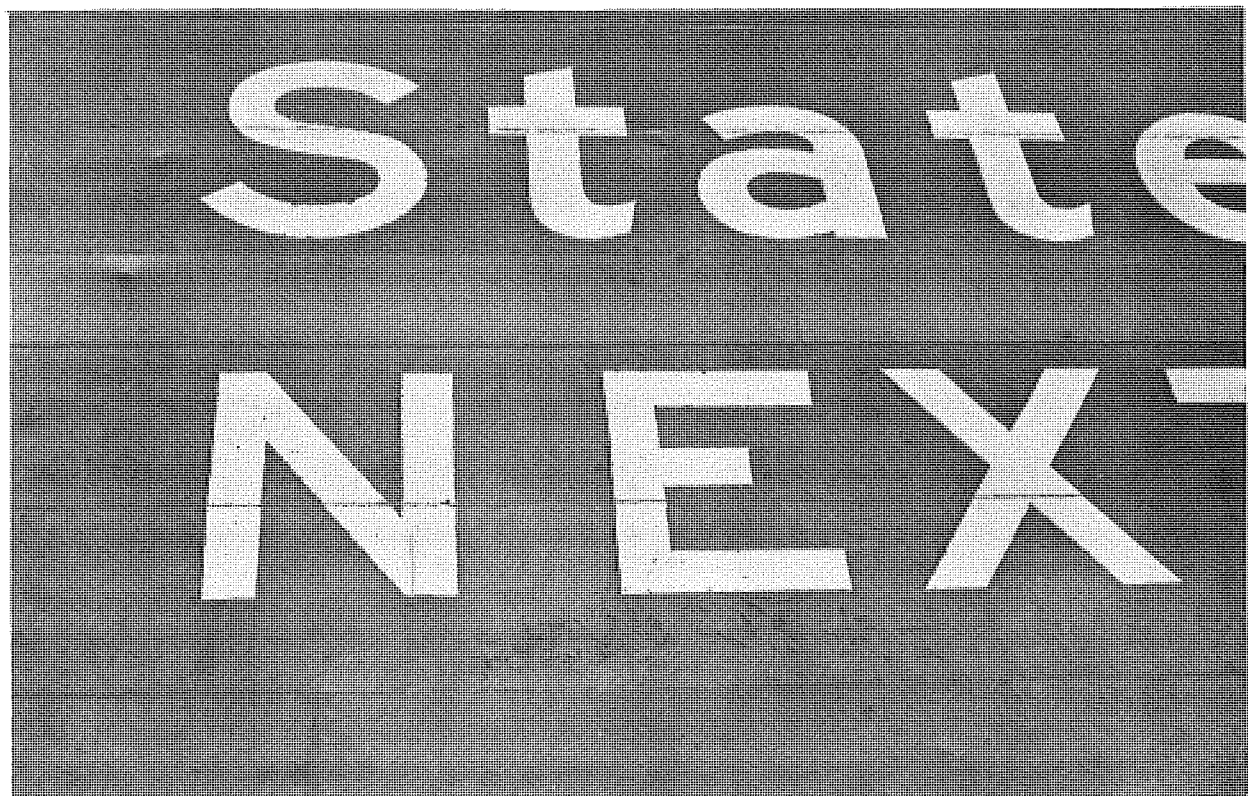
Of the signs on I 94 classified by nighttime appearance, the "Intermediate" signs were nearly as bright as the "New" signs even though the "Intermediate" sign surfaces exhibited occasional cracks and some discoloration. Figure 5 shows the luminance values for the I 94 signs as compared to new reflective sheeting. Typical examples of "New" and "Intermediate" I 94 signs are shown in Figure 6. Two stages of severe surface deterioration were identified and classified as "Old" and "Very Old" (Fig. 7). Figure 8 shows a detailed view of surfaces classified as "Very Old." The luminance values for the "Old" and "Very Old" signs ranged from 20 to 50 percent of the luminance values for "New" and "Intermediate" signs.

Figure 6. Typical condition of "New" (above) and "Intermediate" (below) signs on I 94.

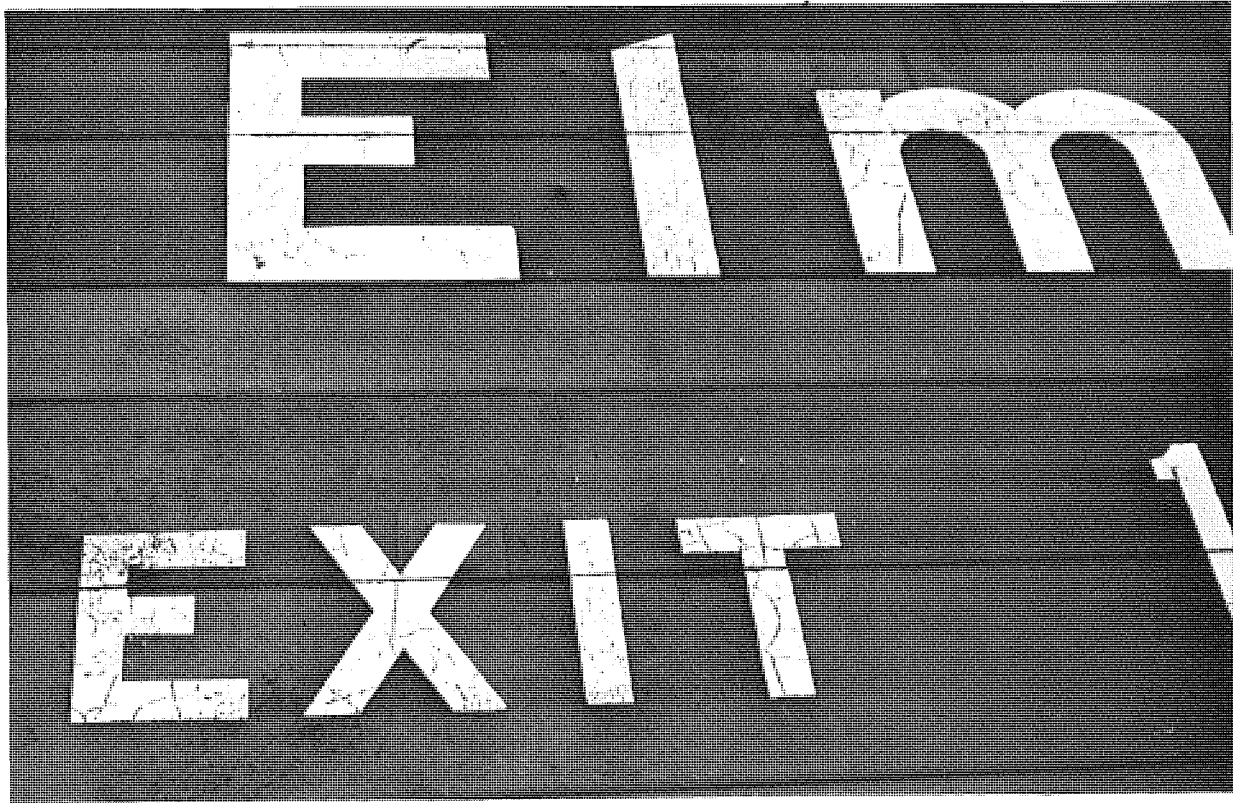
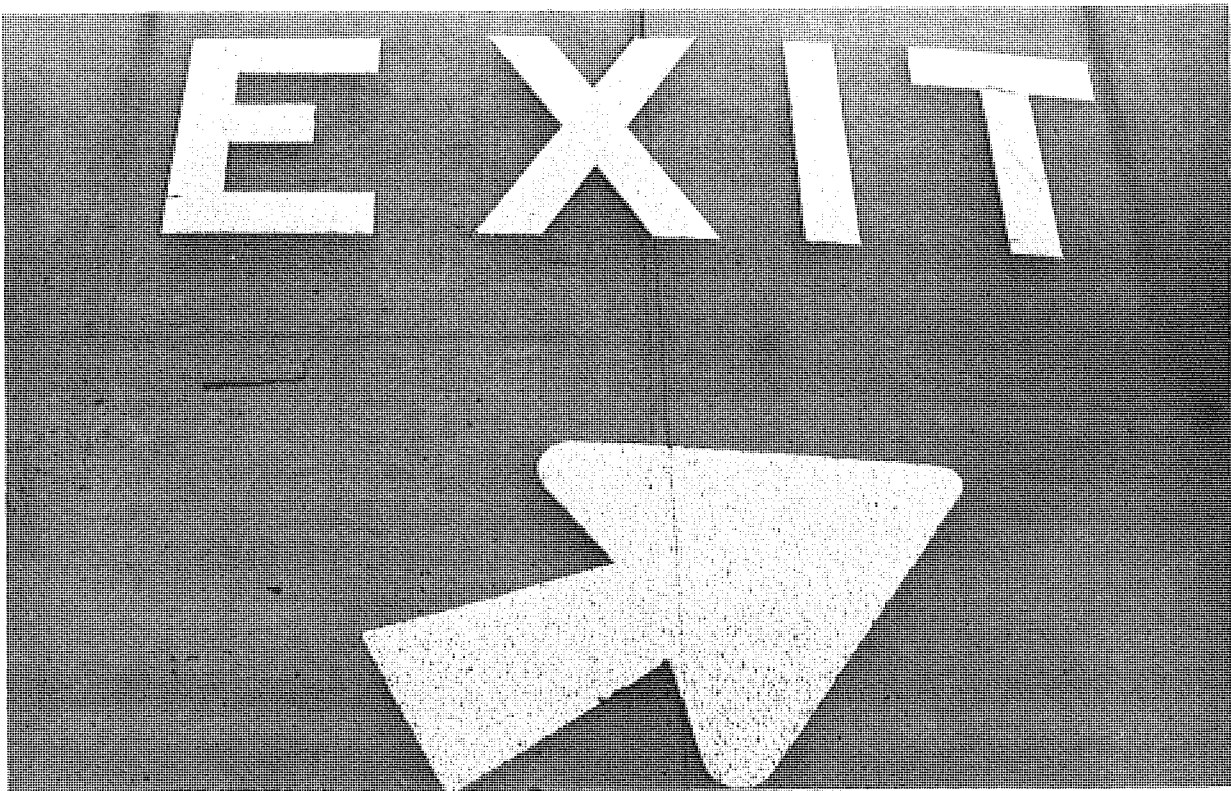
The luminance of the "Very Old" signs was too low for legibility at an adequate distance (greater than 300 ft). The condition of the "Very Old" signs on I 94 was similar to the "Old" signs on I 96, that is, they exhibited numerous and extensive cracks on both the legend and background.

Figure 7. Typical condition of "Old" (above) and "Very Old" (below) signs on I 94.

2. The "Old" signs on I 94 appeared to be similar in luminance to the reference panel. Clearcoating is recommended and sign replacement in one to two years is indicated.

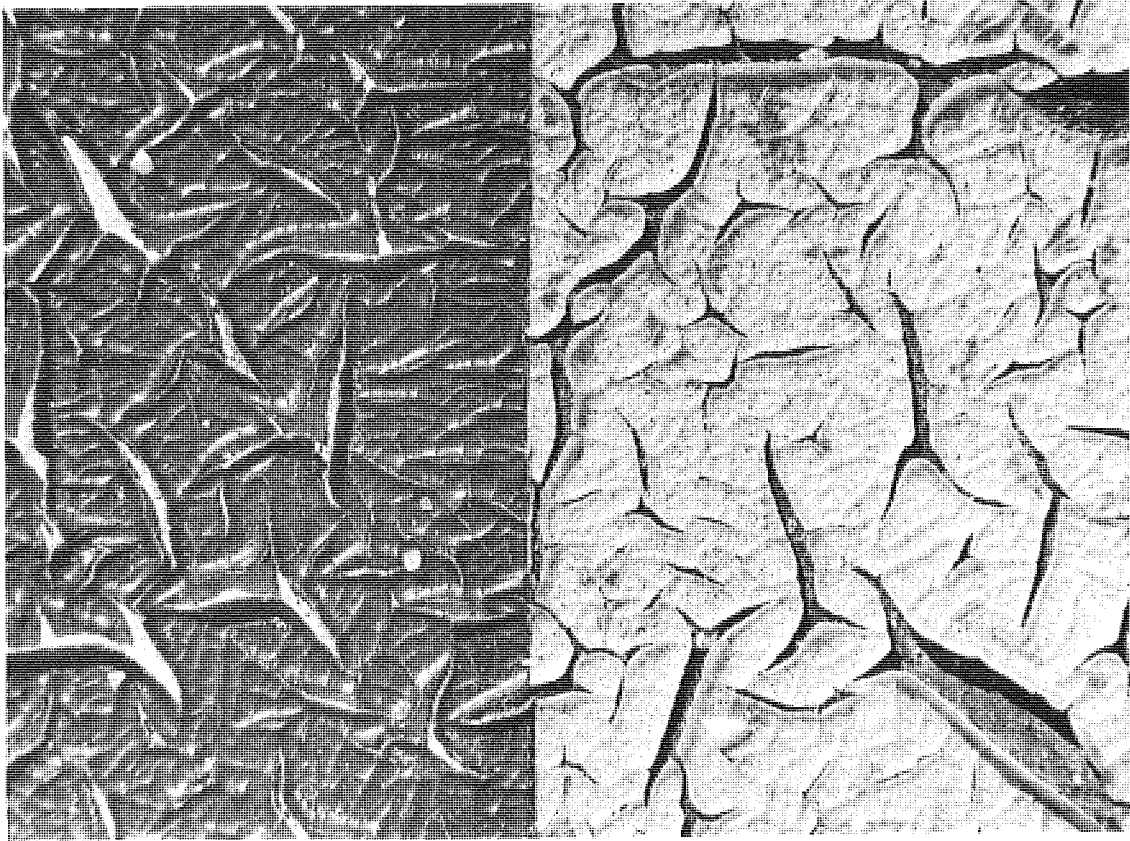
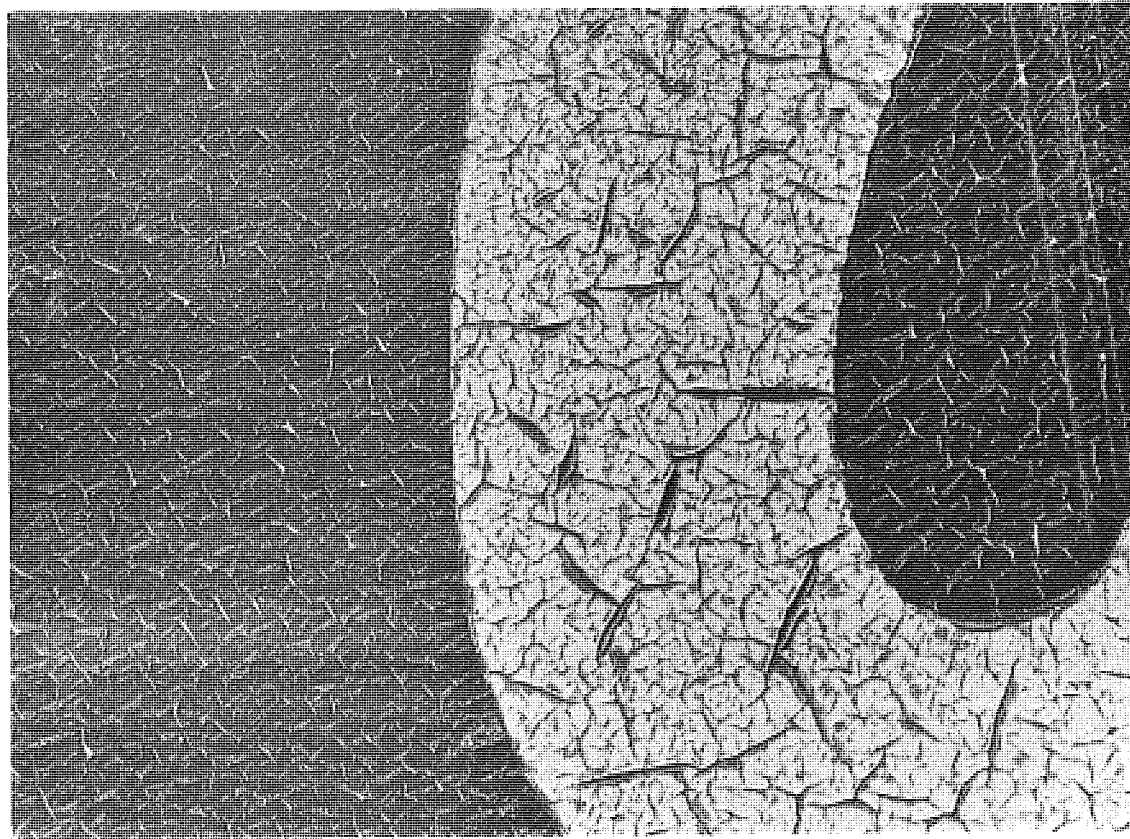
Figure 8. Detail of "Very Old" signs, I 94, showing extreme deterioration.

3. Signs which can readily be evaluated and categorized by daytime observation such as the "Old" on I 96 or "Very Old" on I 94 be replaced. These signs are not legible at night.
