CRASH TESTS OF R4 RETROFIT
AND OPEN PARAPET BRIDGE RAILS

MICHIGAN DEPARTMENT OF TRANSPORTATION CONTRACT
88-0815-DAB

FINAL REPORT

February 1992

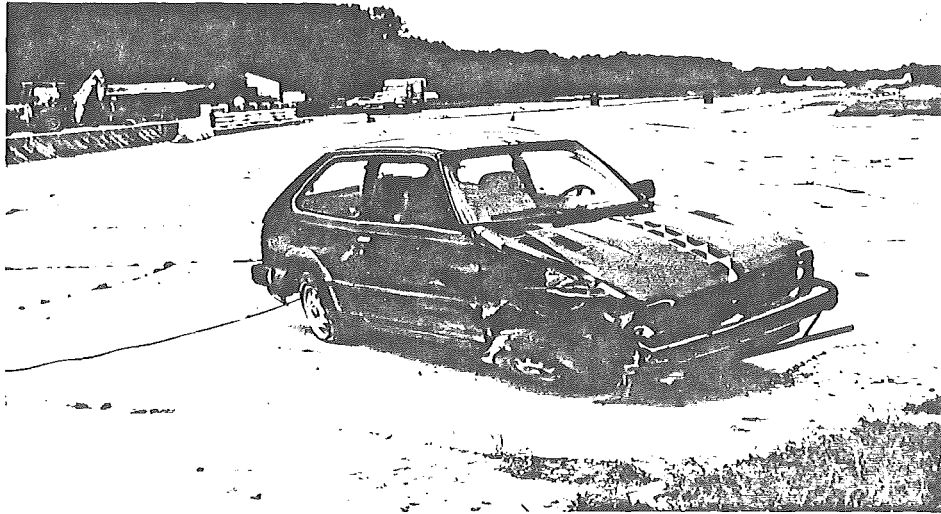
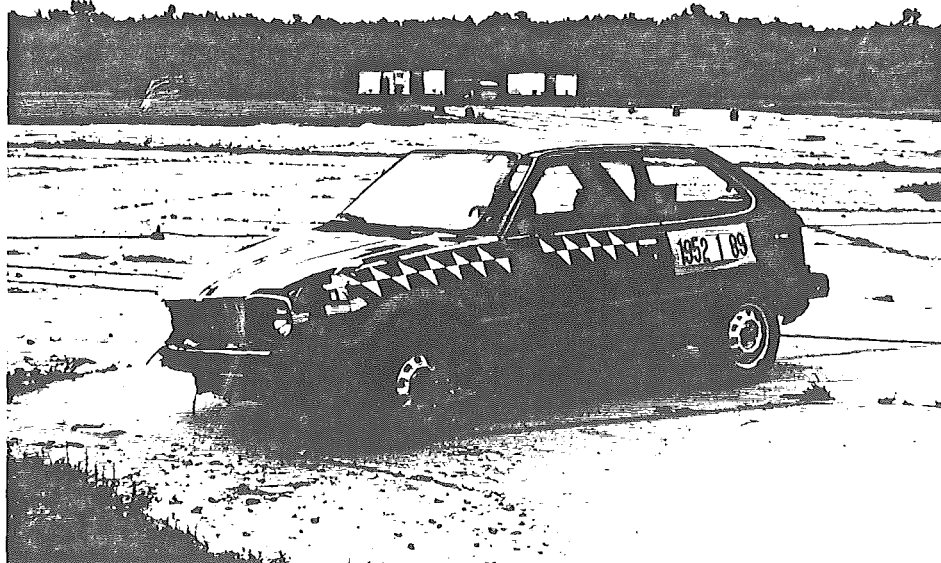
Figure 8. Posttest photographs of test vehicle, test 1952-1-89.

Damage occurred to the right front wheel and suspension, the right rear wheel, hood, bumper and entire right side of the vehicle. The passenger side door window was broken and the door was wedged out 2 to 3 in by the dummy impact. Posttest photographs of the vehicle are shown in figure 8.

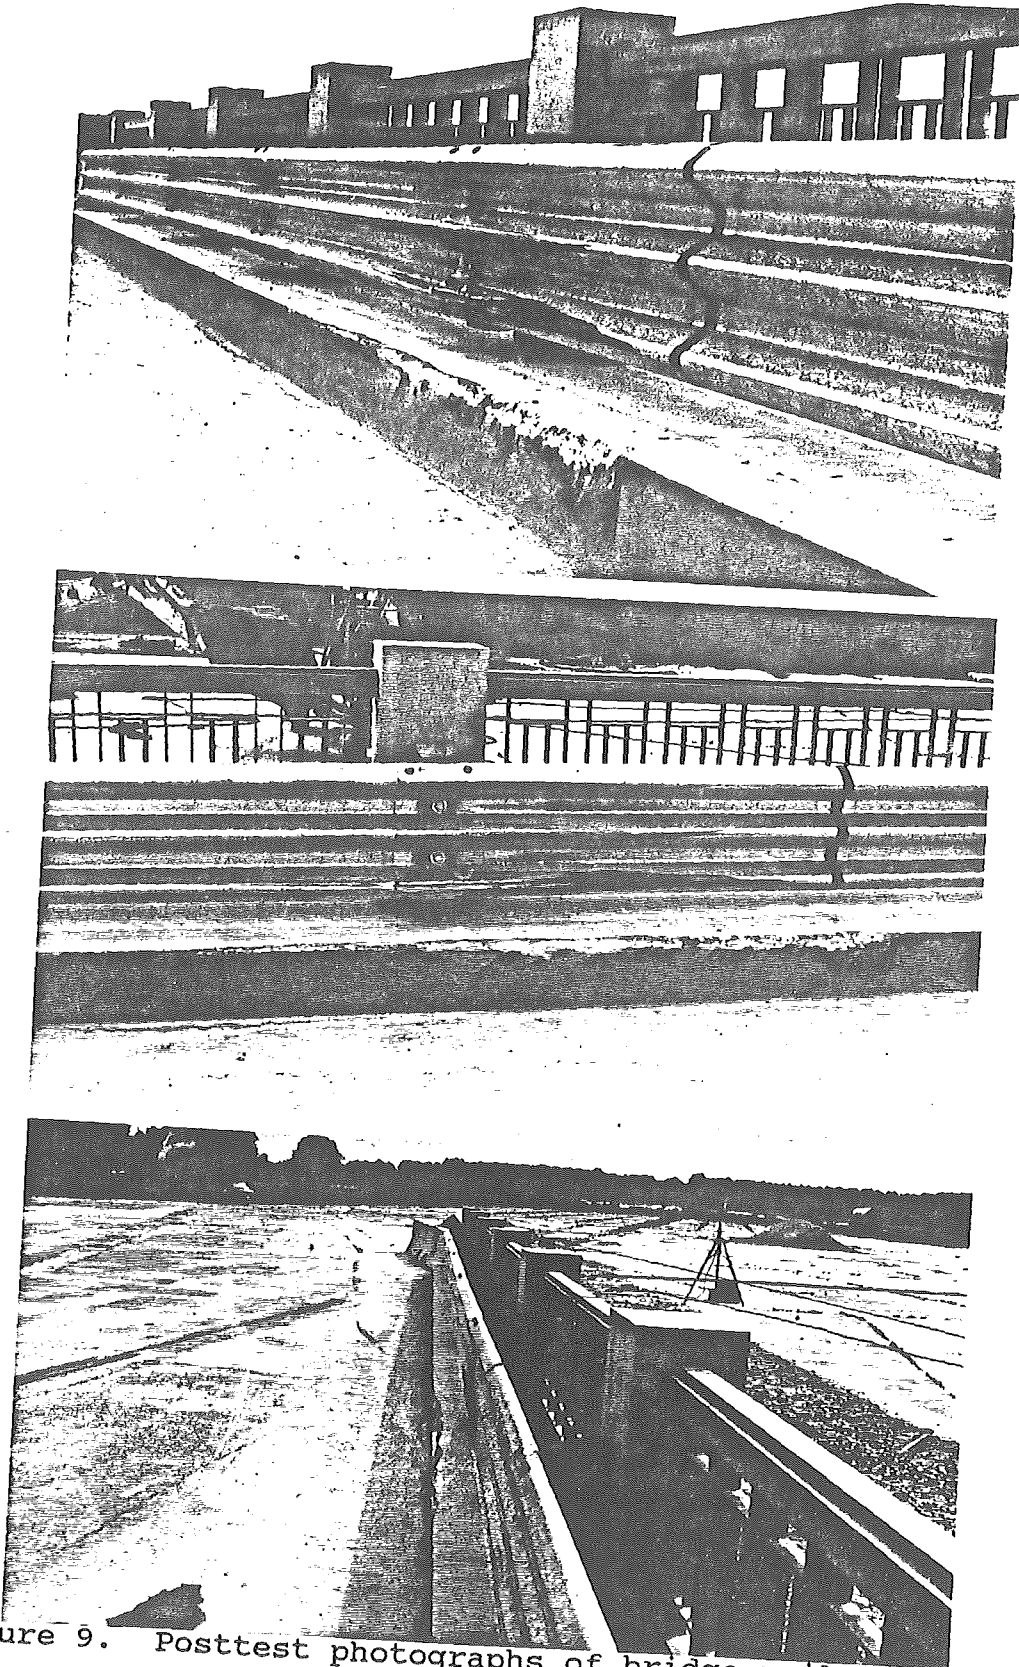
Figure 9. Posttest photographs of bridge rail system, test 1952-1-89.

The bridge rail suffered very little damage. There were tire marks on the thrie beam for 101 in starting 5 in past the target impact line (see subsection c). There was tire scuff on the brushblock for 161 in starting 13 in prior to the target impact line. Minor spalling of the brushblock occurred for 106 in starting 6 in prior to the target impact line. There was no measurable deflection of the rail. Posttest photographs of the bridge rail are shown in figure 9.

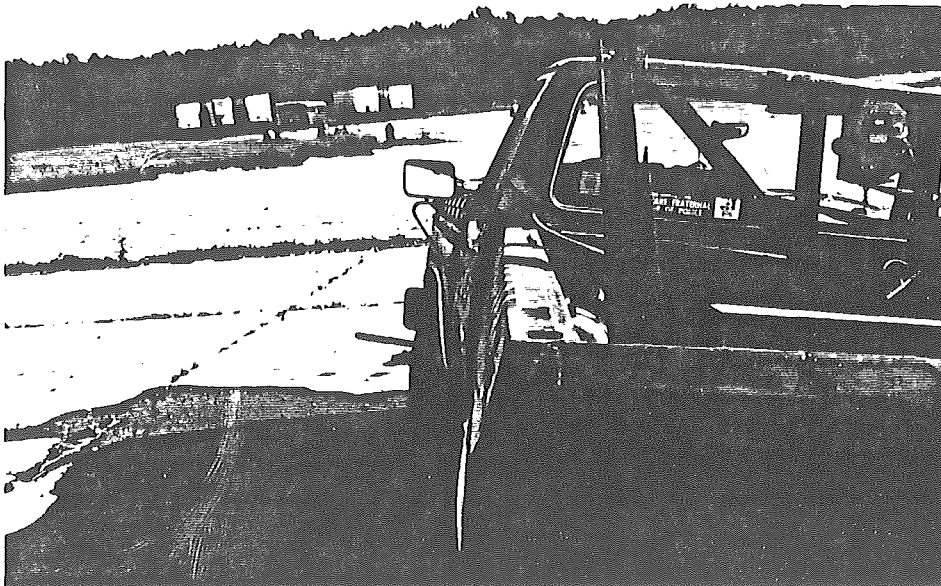
Figure 15. Posttest photographs of test vehicle,
test 1952-2-89.

vehicle. The passenger side door window was broken and the door was wedged out by the dummy impact. The impact caused the vehicle to bend toward the driver side. The front of the truck was pushed 17 in out of line. Posttest photographs of the truck are shown in figure 15.

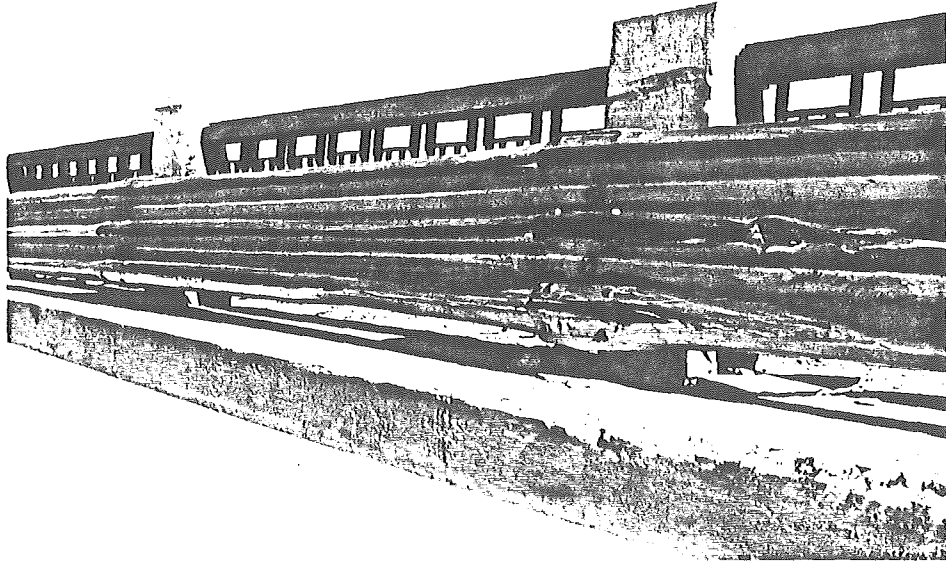
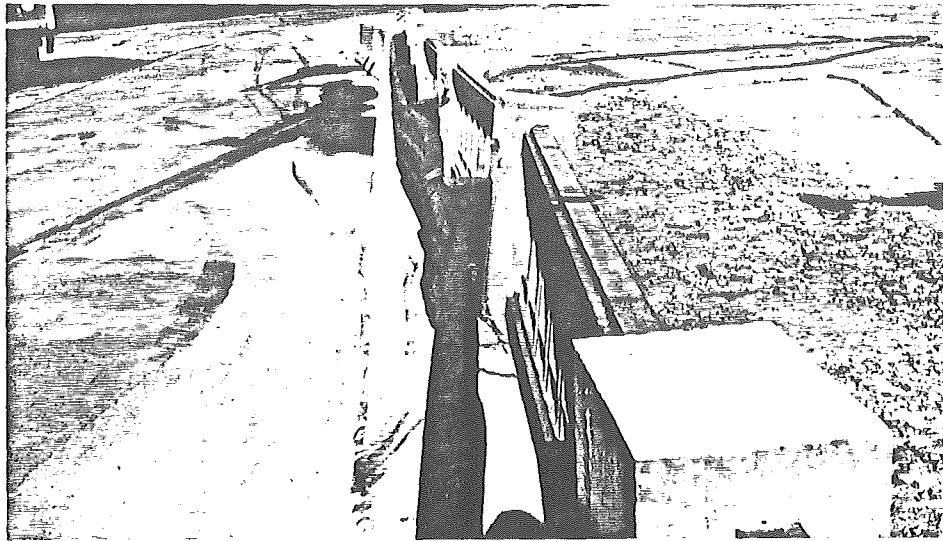
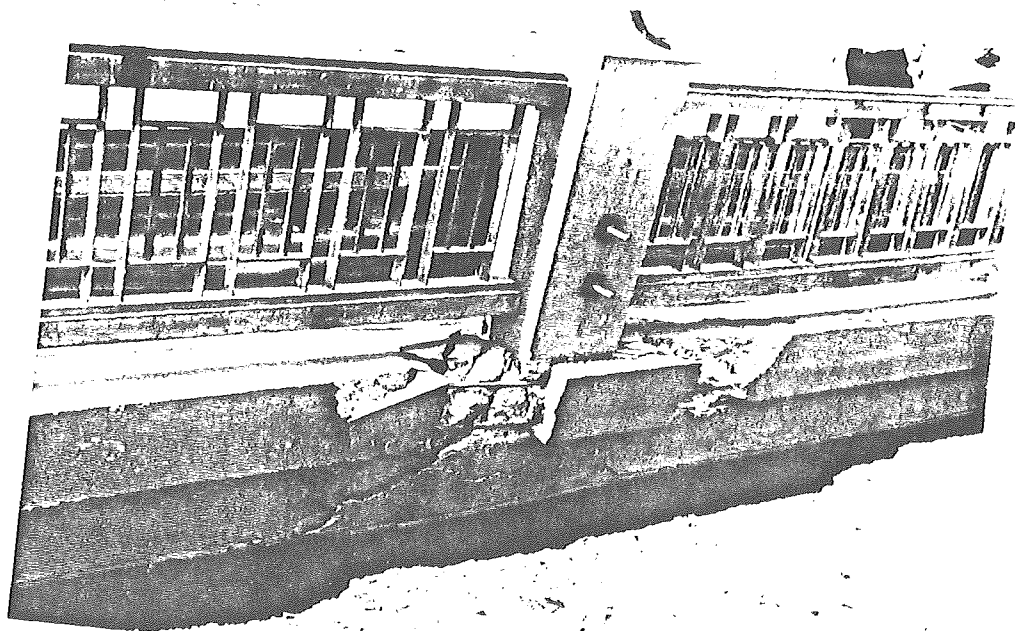
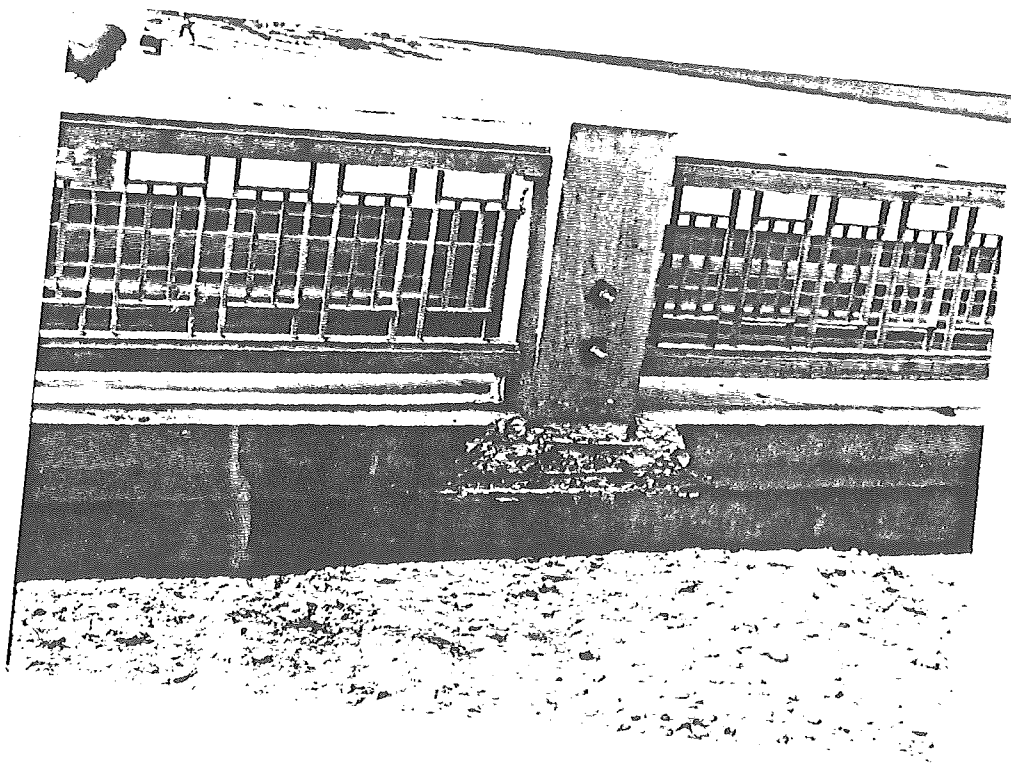
Figure 16. Posttest photographs of bridge rail system, test 1952-2-89.

The bridge rail suffered major structural damage during this impact. Posts 3 and 4 were pushed back approximately 8 and 4 in, respectively, at the top of the post. Damage to the brushblock and deck occurred at post 3 and damage occurred to the brushblock at post 4. In both cases, the damage pattern was semicircular around the post.

The damage at post 3 consisted of cracking in the brushblock and deck. The brushblock was damaged 30 in before and 35 in past the post. The deck suffered damage 30 in before and 6 in after the post. The deck was cracked for 6 in back under the edge.

The damage at post 4 was less severe and only occurred in the brushblock and the post. The brushblock was damaged 18 in before and after the post. Another crack ran from the upstream corner of the post to 32 in before the post on the edge of the brushblock.

Spalling occurred to the top portions of posts 3 and 4 above the top of the guardrail. The maximum permanent guardrail deflection occurred 8 ft past post 2 and was 7.5 in.

This damage was repaired in preparation for the next test. When the damaged areas were removed, it was discovered that post 2 also had hairline cracks near the base of the post and was also removed.

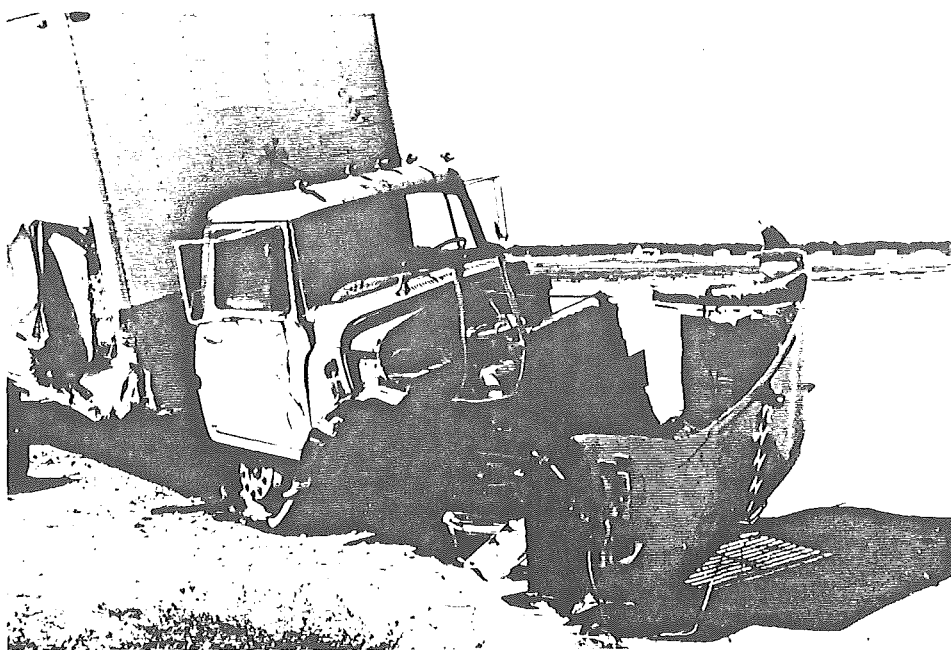
Figure 22. Posttest photographs of test vehicle,
test 1952-3-89.

The chassis at the front of the truck was damaged and twisted. The hood came open and the front axle was torn from the frame and pushed under the truck. However, the occupant compartment was not intruded. The rail side of the vehicle was damaged from impacting the rail, posts and blockouts during the impact event. A 4-ft by 4-ft hole was torn in the impact side corner of the box of the truck. Minor truck parts, ballast and debris were wedged between the posts, blockouts and rail. All tires on the impact side were deflated from contact with the brushblock and the wheels were damaged. Posttest photographs of the truck are shown in figure 22.

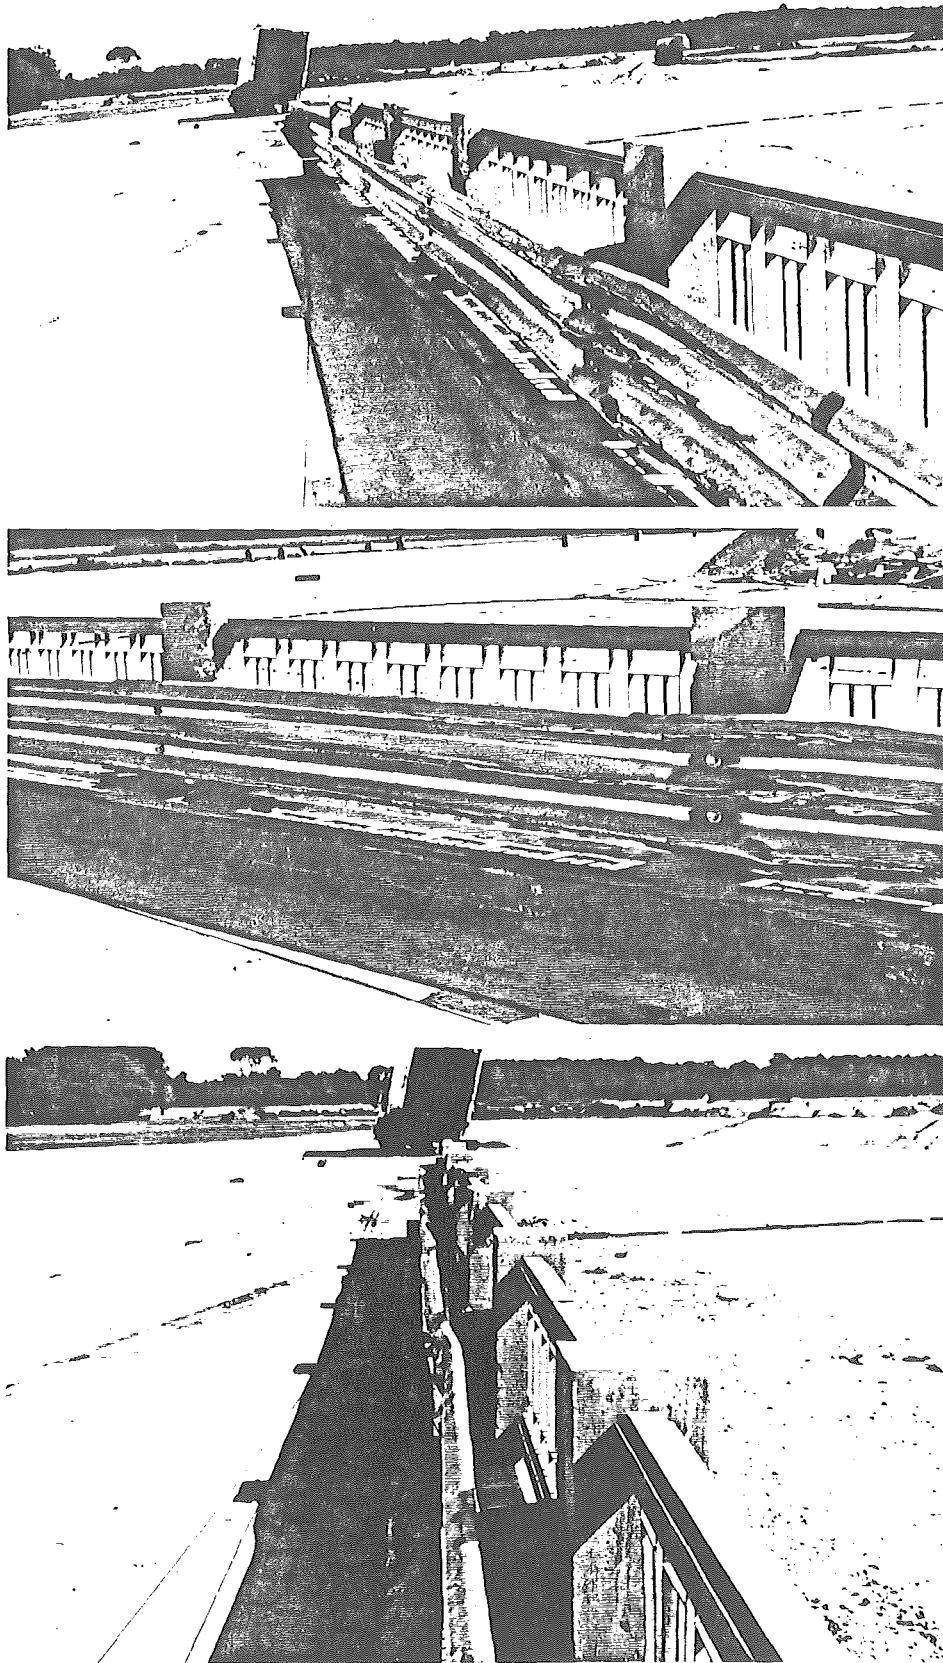
Figure 23. Posttest photographs of bridge rail system, test 1952-3-89.

The bridge rail was damaged from the impact point downstream 45 ft. Four blockouts were damaged from impacts with the truck box. Posts 3 and 4 were damaged and showed cracks. Post 3 was cracked around the bottom and in a cone extending to the back of the brushblock. Post 4 was cracked around the bottom and through the post in two other places. The cracks did not extend into the brushblock. Post 4 also was spalled at the top from the impact with the truck box. The deck was not damaged. The maximum permanent thrie beam rail deflection was 3 in. Posttest photographs of the bridge rail are shown in figure 23.

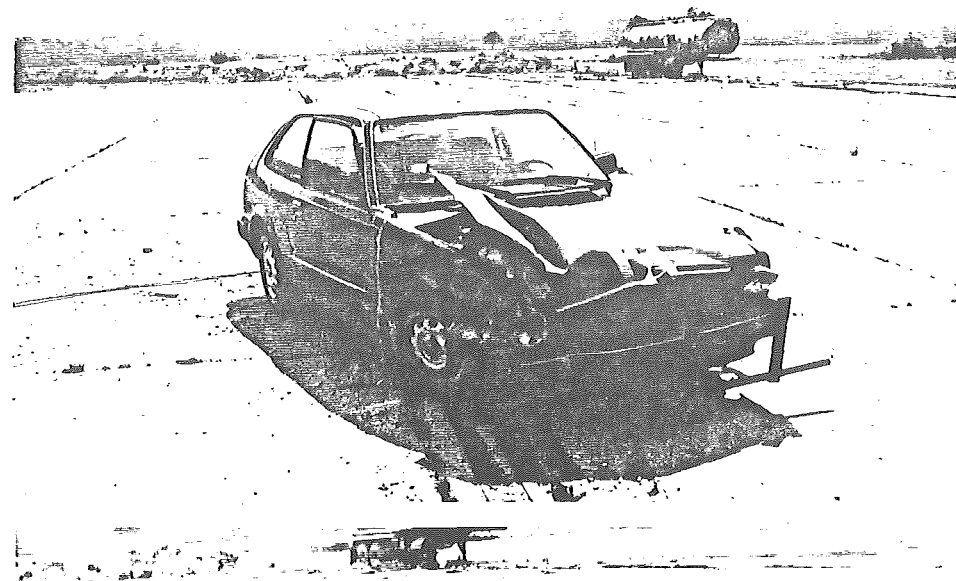
Figure 30. Posttest photographs of test vehicle,
test 1952-4-90.

Damage occurred to the right front wheel and suspension, the hood, bumper and entire right side of the vehicle. The passenger side door was wedged out by the dummy impact. Posttest photographs of the vehicle are shown in figure 30.

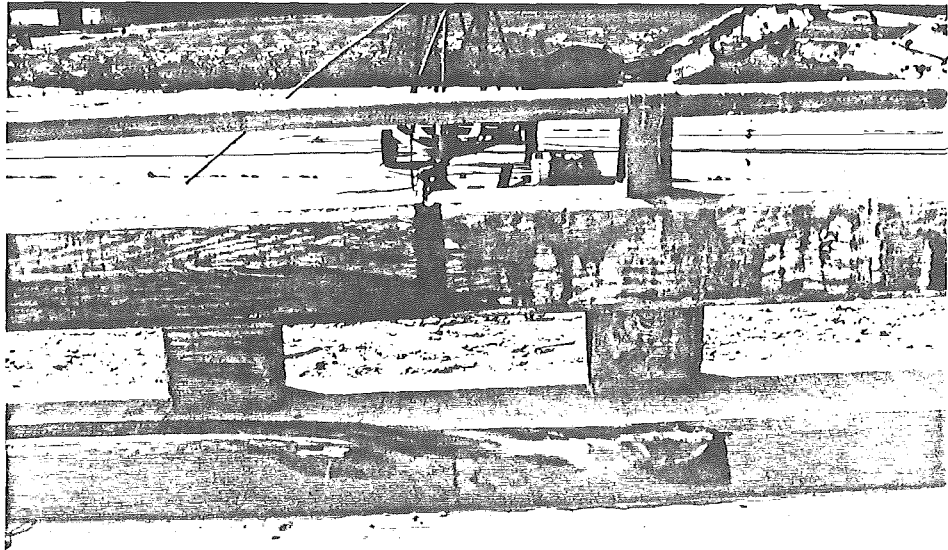
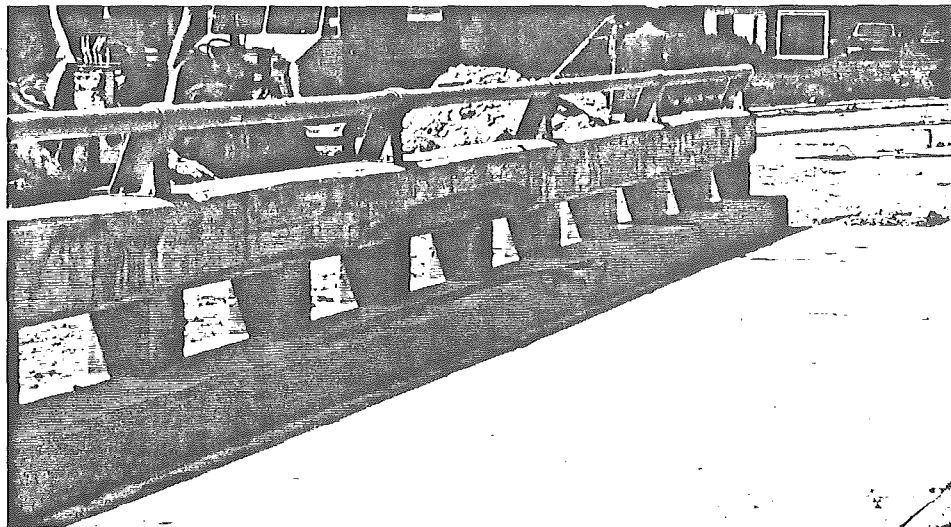
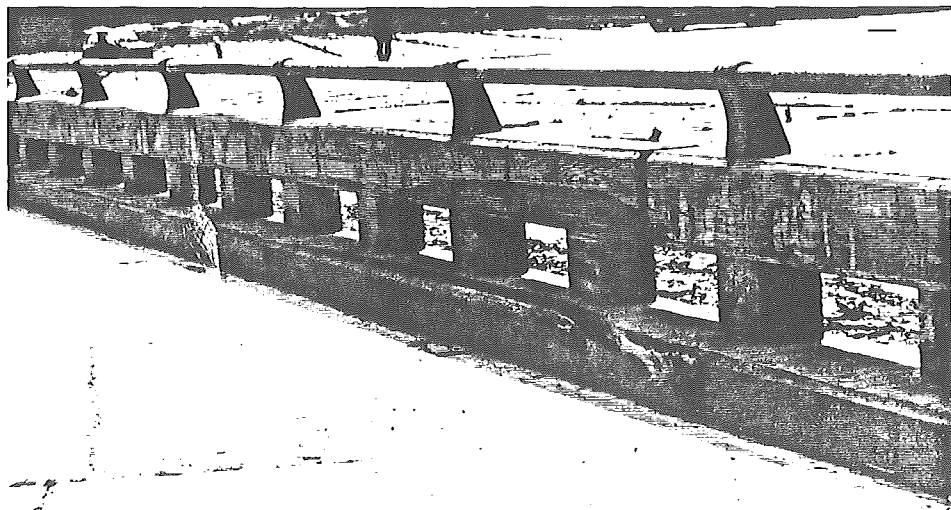
Figure 31. Posttest photographs of bridge rail system, test 1952-4-90.

The bridge rail suffered very little damage. There was vehicle paint, tire and wheel scrub on the rail for 16.5 ft, starting 1.5 ft before the impact point (see subsection 3). There was tire

scrub on the brushblock for 20 ft, starting 3 ft before the impact point. There were scrub marks on posts 6 and 7. From the tire marks, it can be concluded that the right front tire was completely on the brushblock. Scrub on the rail covered the entire face of the rail (up to the level of the top bevel). There was no damage other than minor spalling of the brushblock and posts 6 and 7. There was no measurable deflection of the rail. Posttest photographs of the bridge rail are shown in figure 31.

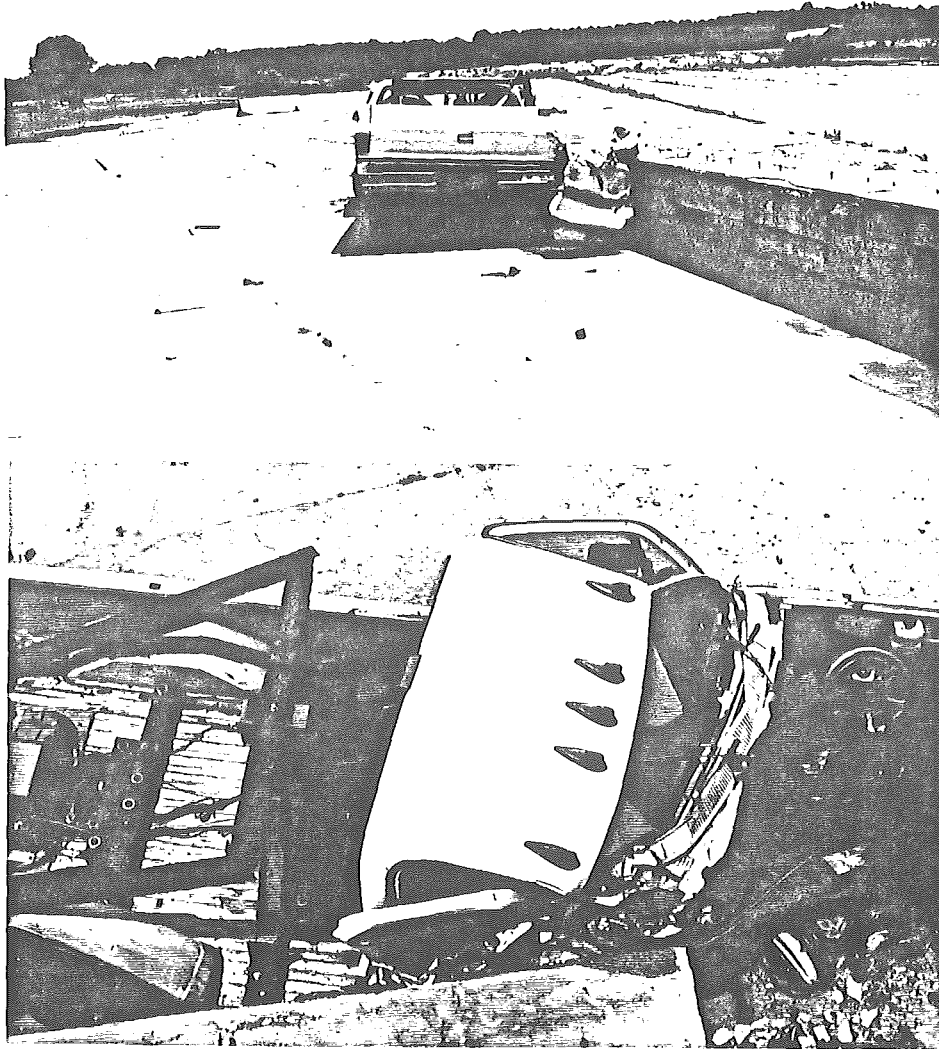
Figure 37 (continued). Posttest photographs of test vehicle, test 1952-5-90.

Damage occurred to the front and entire right side of the vehicle. The hood was pushed into the occupant compartment. The occupant compartment was severely deformed. The right front fender was torn from the truck. The passenger side door was deformed. The right panel of the truck box was torn from its welds and wrapped around the rear of the vehicle. The front suspension was damaged. The truck buckled at the front of the bed due to the loss of structural integrity. Posttest photographs of the truck are shown in figure 37.

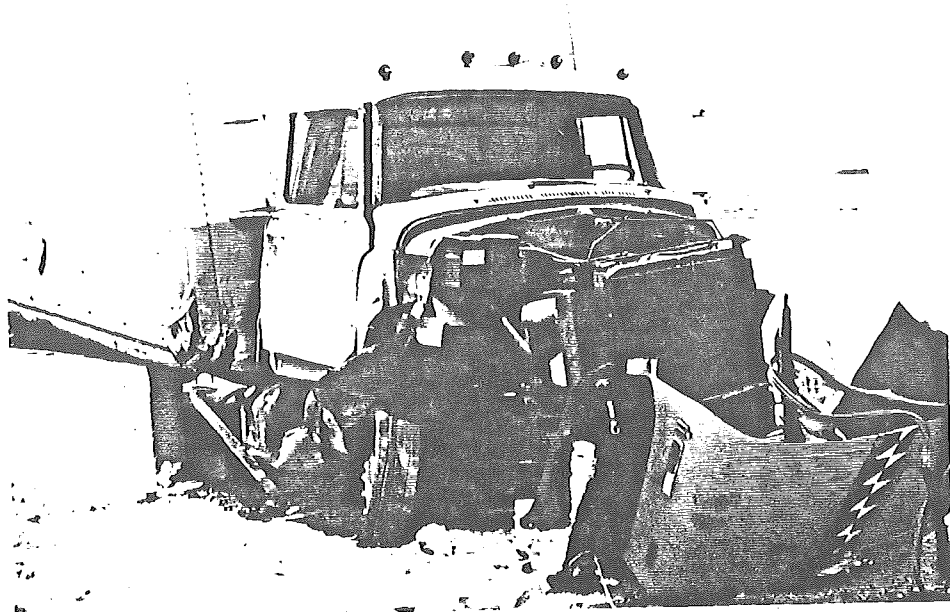
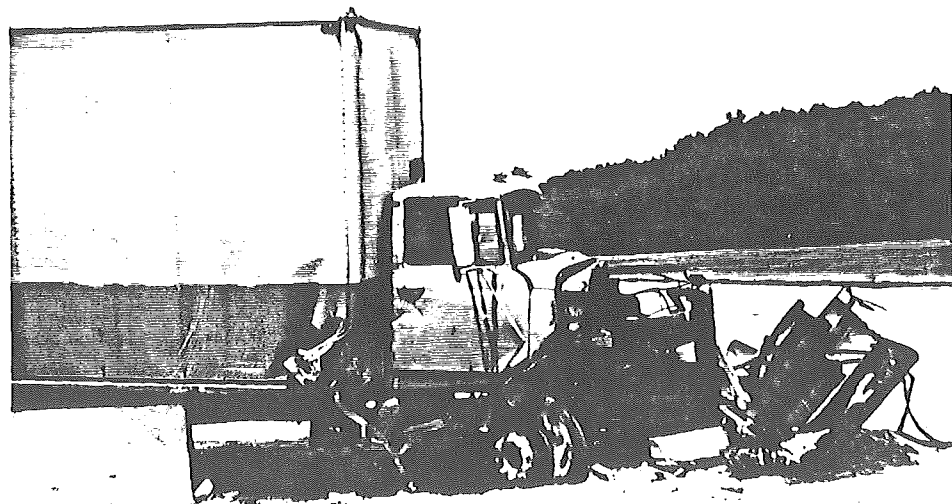
Figure 44. Posttest photographs of test vehicle,
test 1952-6-90.

The chassis at the front of the truck was damaged and twisted. The hood came open and the windshield popped out. The right front wheel and tire were damaged and the front axle was pushed under the truck. However, the occupant compartment was not intruded. The rail side of the vehicle was damaged from impacting the concrete and aluminum tube rails. The impact side

front corner of the box was damaged due to impacts with the tube railing posts. Posttest photographs of the truck are shown in figure 44.

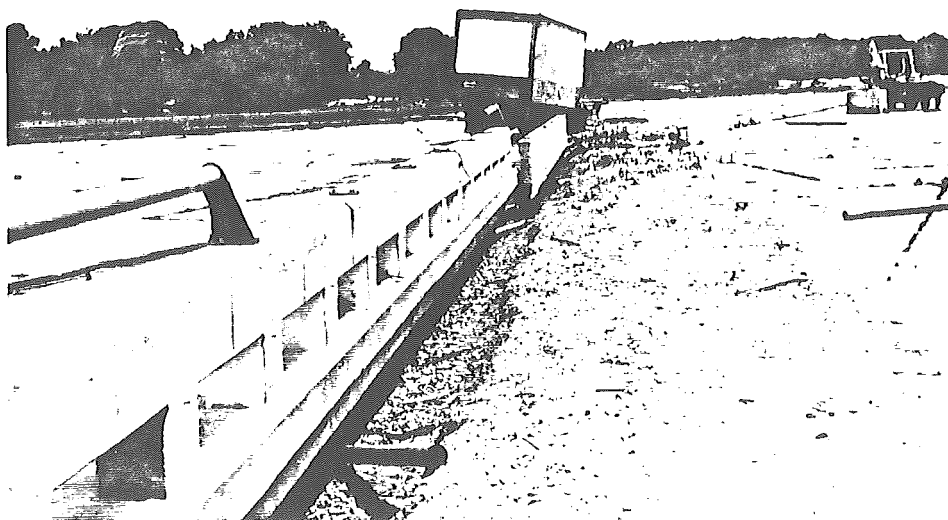
Figure 45. Posttest photographs of bridge rail system, test 1952-6-90.

The bridge rail suffered major spalling for 7 ft beginning at the impact point. One 30-lb chunk was spalled from the bottom of the rail between the impact point and post 7. The aluminum tube railing was mostly destroyed. Tube railing posts 4 through 8 were sheared off above the bolts and tubes 3 through 7 were scattered away from the bridge rail. Other than the major spalling and the destruction of the tube railing, the remaining damage was cosmetic in nature. There was scrub on the brushblock from 2 ft prior to impact to the downstream end. There was scrub on the rail for 17 ft beginning at impact and minor spalling occurred between posts 7 and 8. There was scrub on and spalling occurred to concrete posts 7 and 8. Slight spalling also occurred to the brushblock prior to impact. Posttest photographs of the bridge rail are shown in figure 45.

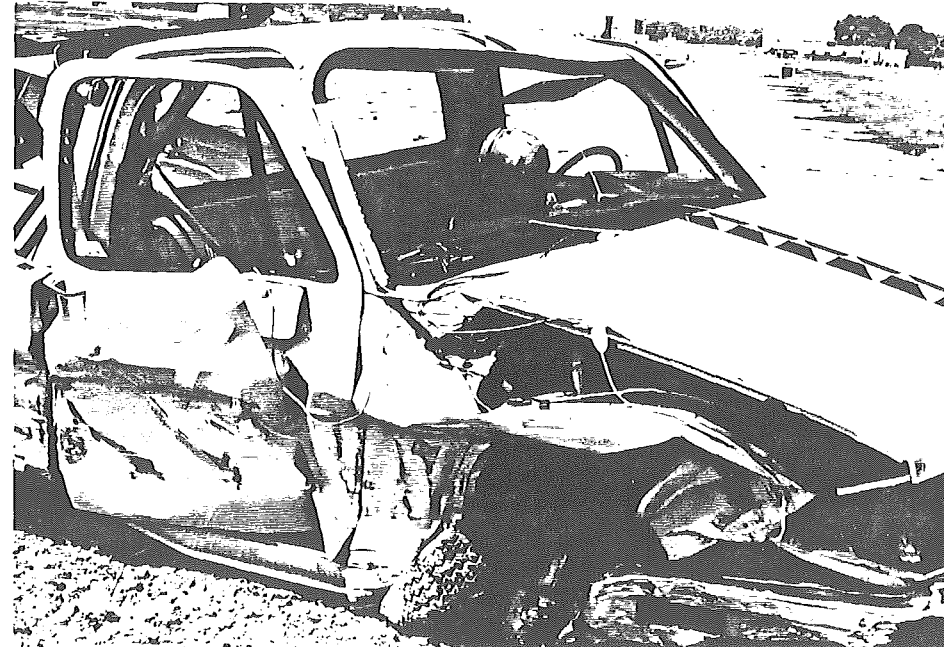
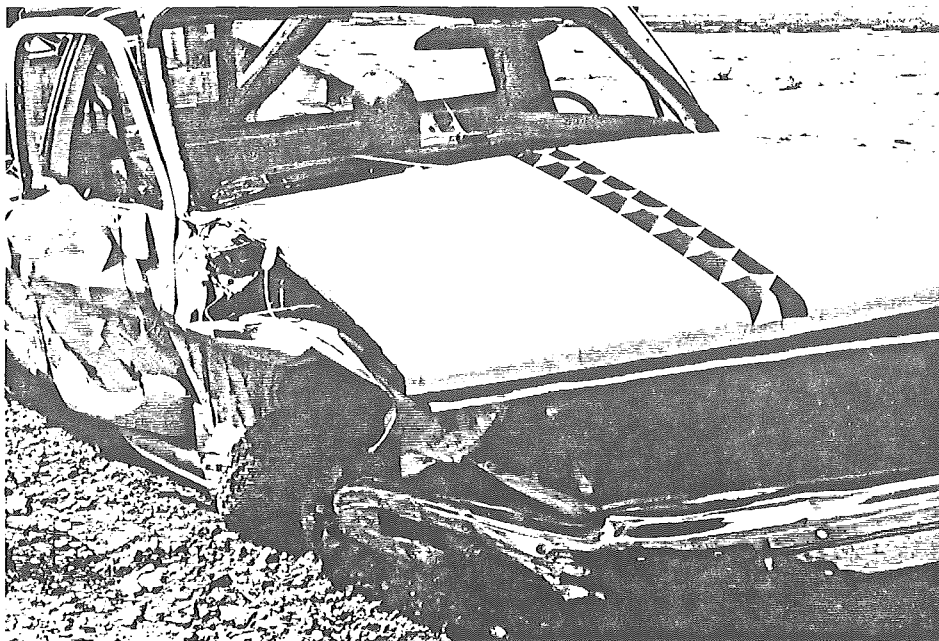
Figure 51. Posttest photographs of test vehicle,
test 1952-7-91.

Damage occurred to the front and entire right side of the vehicle. The bumper and front fender were pushed into the engine compartment. The front suspension and wheel/tire were pushed back and deformed the occupant compartment. The windshield had popped out due to deformation of the cab. The passenger side door was deformed and the passenger side window had been punched out by the impact of the dummy's head. Posttest photographs of the truck are shown in figure 51.

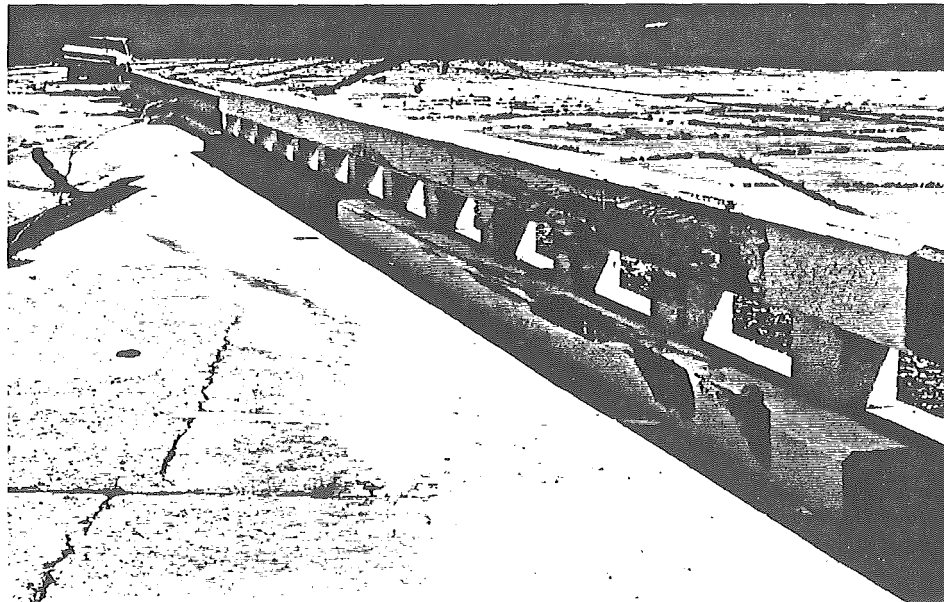
Figure 52. Posttest photographs of bridge rail system, test 1952-7-91.

The bridge rail suffered some cosmetic damage but no structural damage during this impact. There was scrub on the brushblock for 40 ft beginning 2.5 ft before impact. There was major scrub on the rail for 15 ft beginning 1.5 ft upstream of impact. Minor scrub on the rail continued for another 30 ft. There was major scrub on posts 6 through 8. Spalling occurred to the brushblock, rail and posts 6 through 8. The patch on the underside of the midspan posts 7 and 8 rail was spalled off in this impact. Posttest photographs of the bridge rail are shown in figure 52.
