## OFFICE MEMORANDUM

October 18, 1963

Subject: Concrete Durability on Bridge Deck Widening: I 94 - Edsel Ford Expressway Structure over DeQuindre Yards (EBBI X01 of 82024B, C5). Research Project R-63 B-70. Research Report No. R-441.

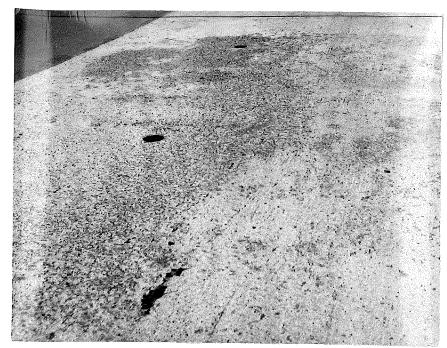
Figure 1. Variable scaling pattern at east end of Span 24 (cores 10 and 11).

The roadway and refuge walk pours might have been given added resistance to scaling if a double application of a linseed oil-naphtha mixture or penetration epoxy could have been applied prior to early salt applications. It is recommended that the more severely scaled roadway areas be restored with a thin, bonded mortar coating, and that the entire roadway and walk pours be coated with a penetrating epoxy to give the air-deficient areas added protection against de-icing salts this coming winter.

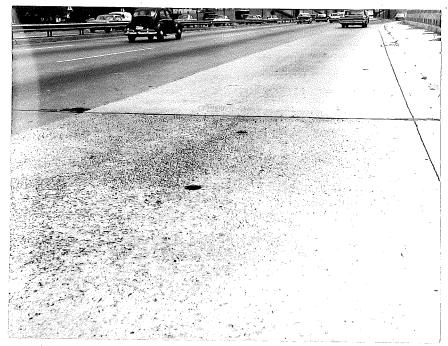
Figure 2. Heavy scaling at east end of Span 28 (cores 8 and 9). Lightly scaled surface of Span 29 in background.

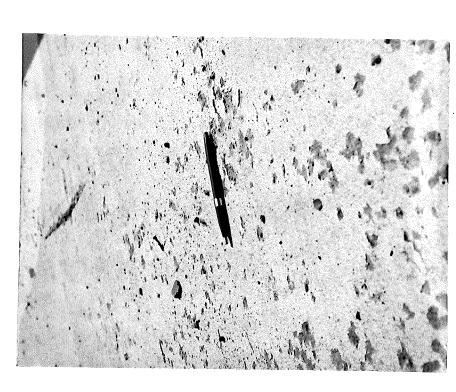
Figure 3. Typical pitting or light scale found on portions of refuge sidewalk pours.

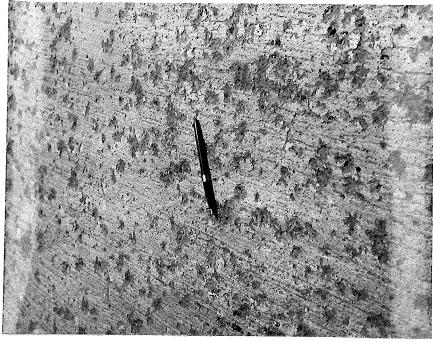
Figure 4. Typical light scale found in some roadway surface areas.
