CONSTRUCTION
OF
EXPERIMENTAL SOIL-CEMENT STABILIZATION
ROAD SURFACE
STOCKBRIDGE, MICHIGAN

Research Project 36 E-5 (2)

Research Laboratory
Testing and Research Division
Report No. 30
April 1, 1942

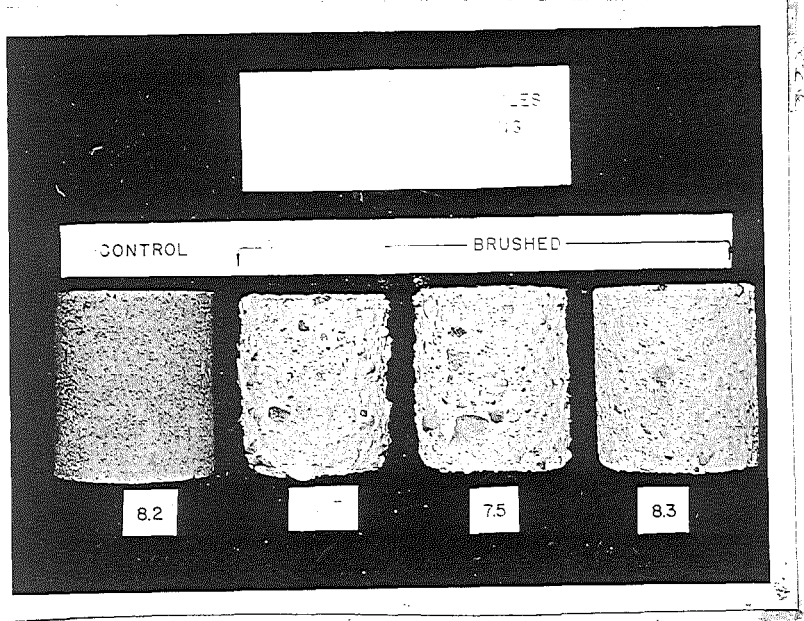
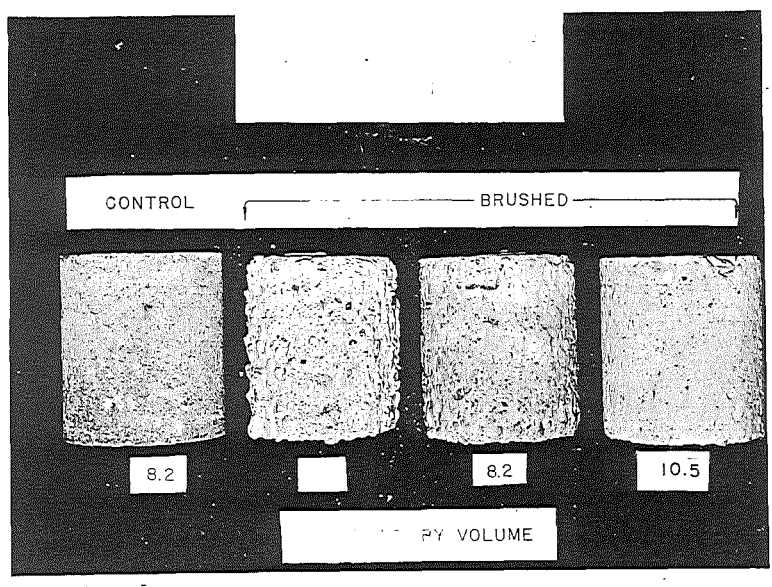
Soil No. 1-Durability Specimens after 12 cycles of (a) wetting and drying, and (b) freezing and thawing

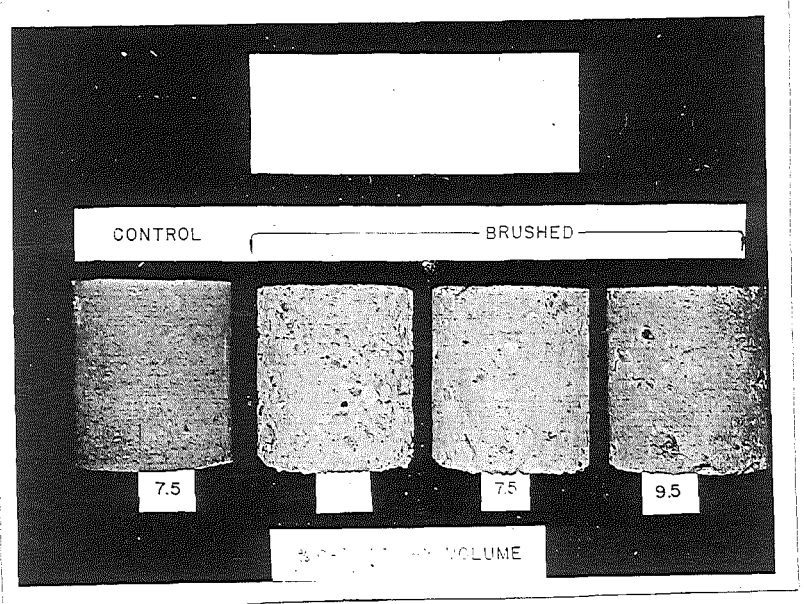
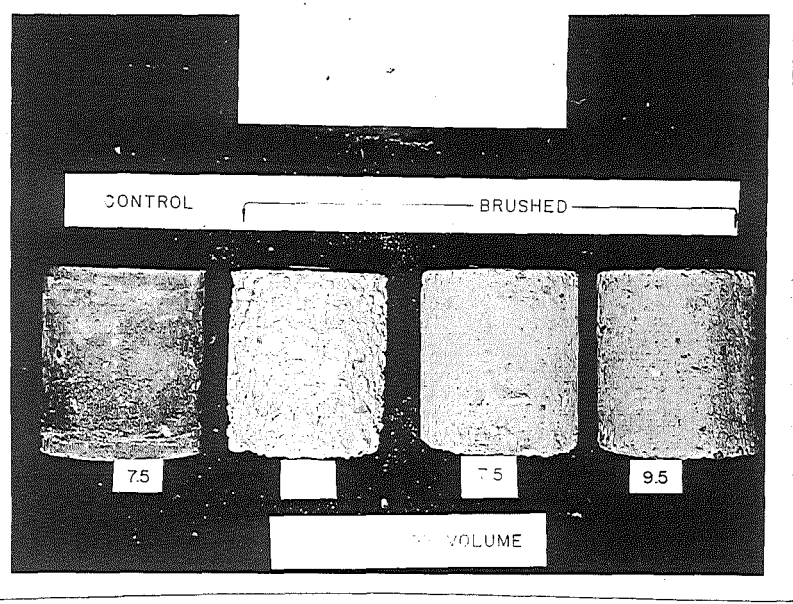
Soil No. 2-Durability Specimens after 12 cycles of (a) wetting and drying, and (b) freezing and thawing

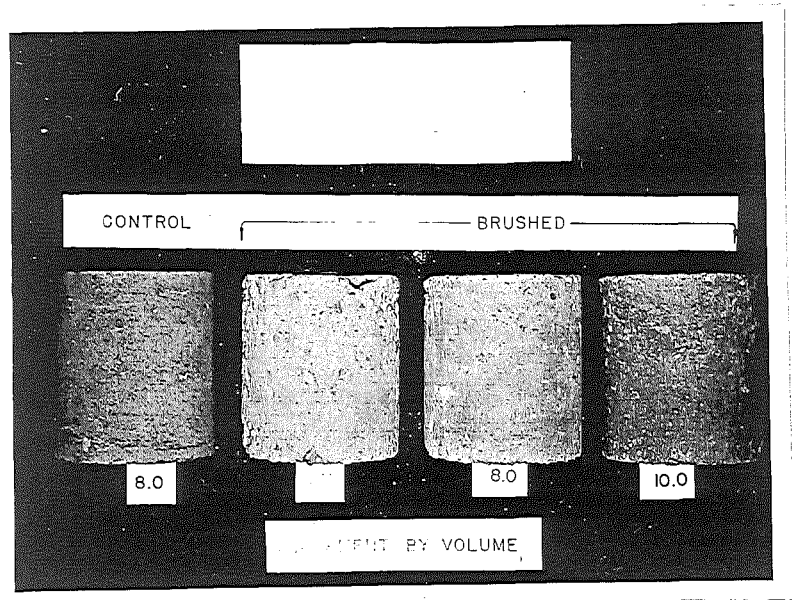
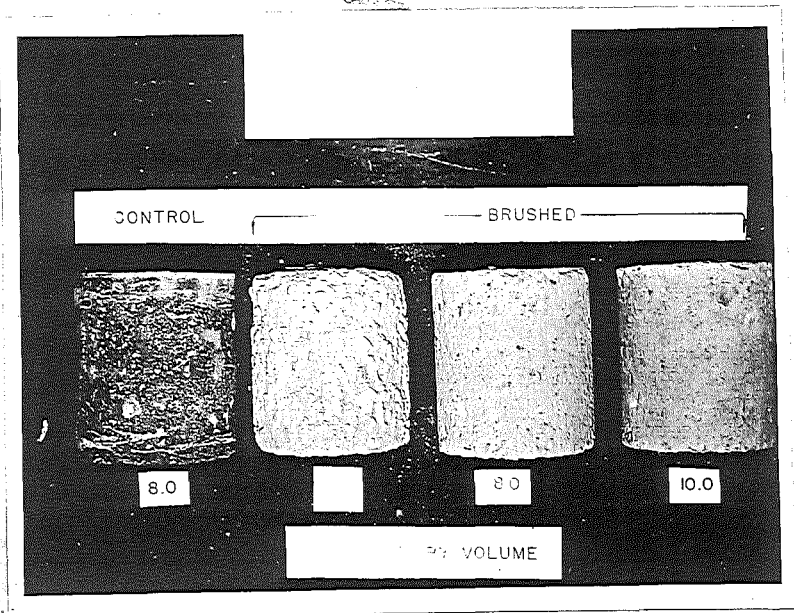
Soil No. 4-Durability Specimens after 12 cycles of (a) wetting and drying, and (b) freezing and thawing

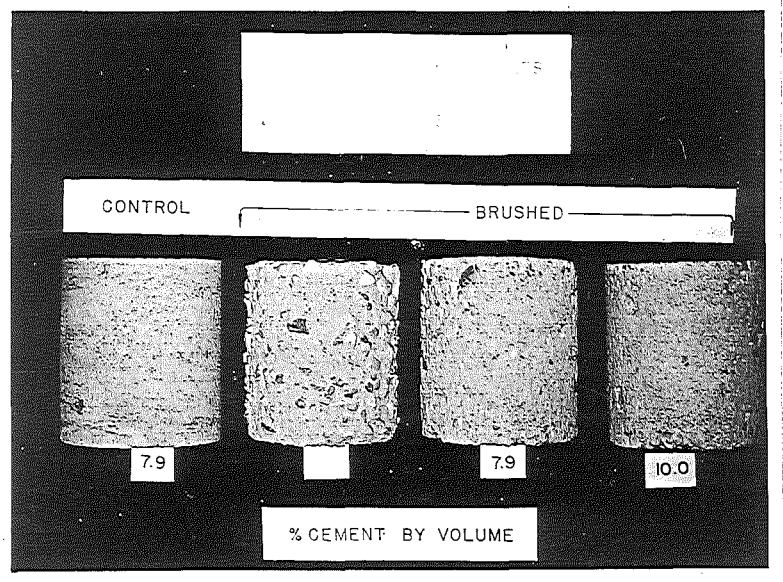
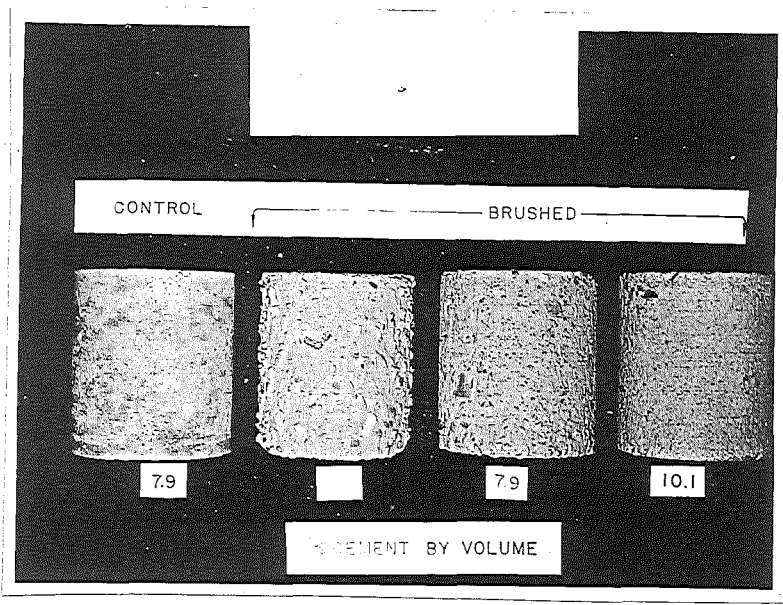
Soil No. 6-Durability Specimens after 12 cycles of (a) wetting and drying, and (b) freezing and thawing

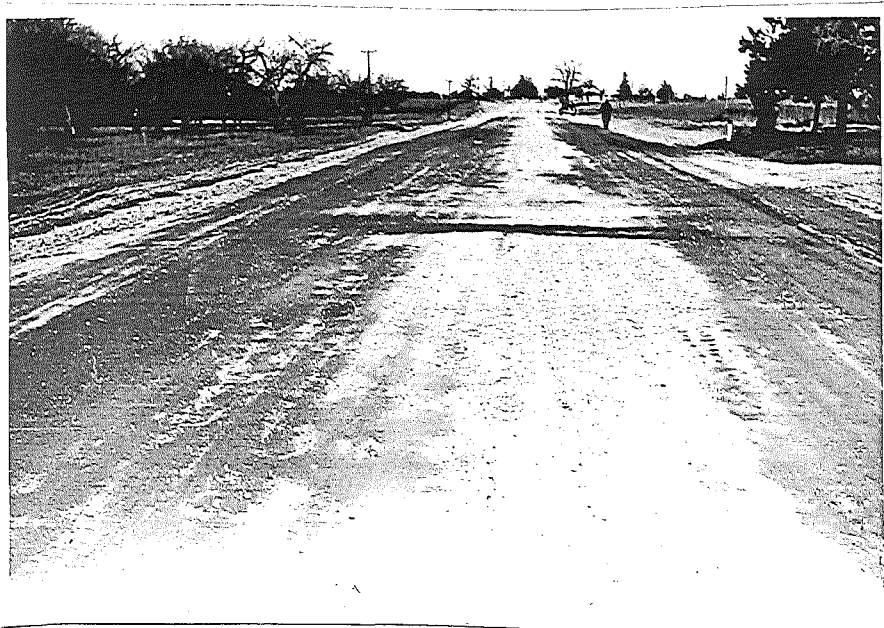
a. General surface condition Station 193+00
Dark areas badly rutted.

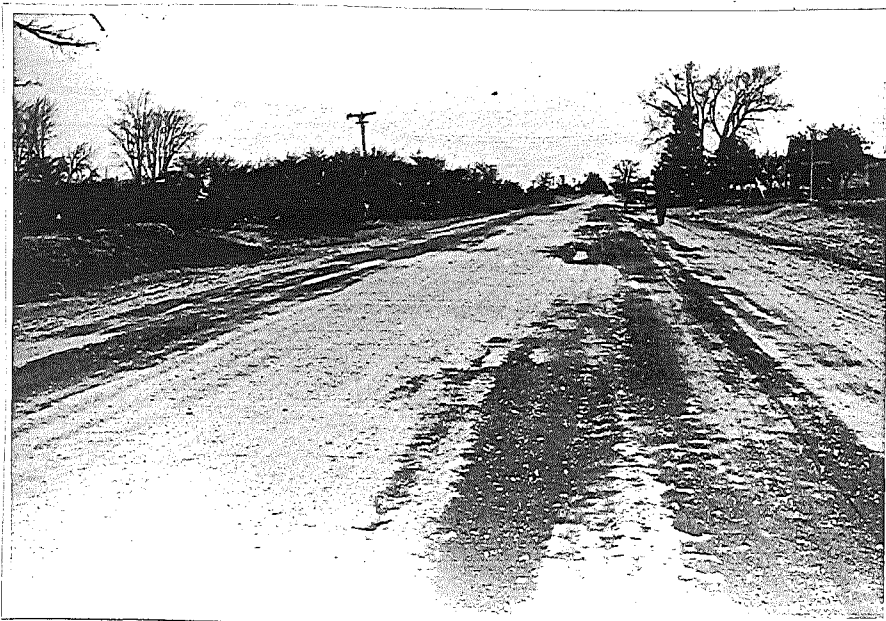
b. General surface condition Station 191+00
Dark areas badly rutted.

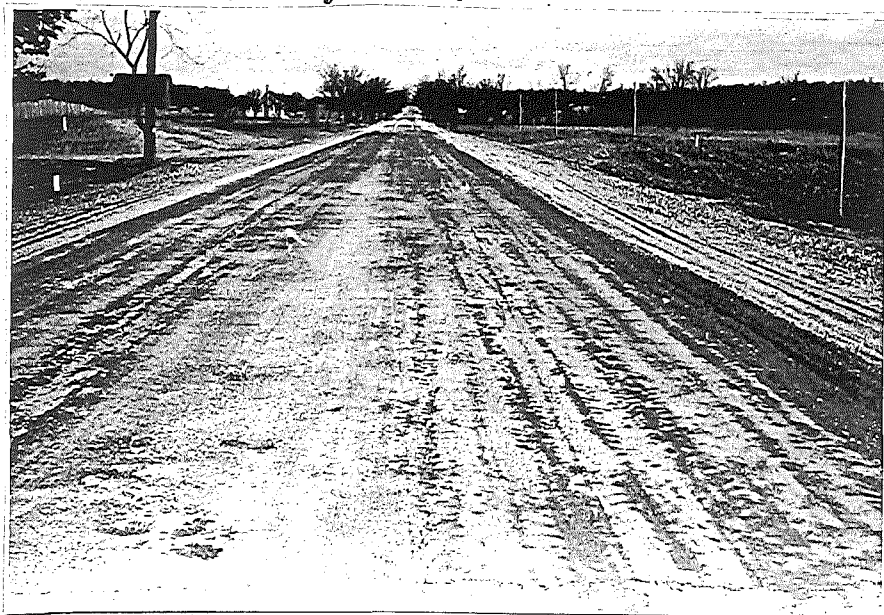
c. General surface condition Station 95+00
Surface in good condition.

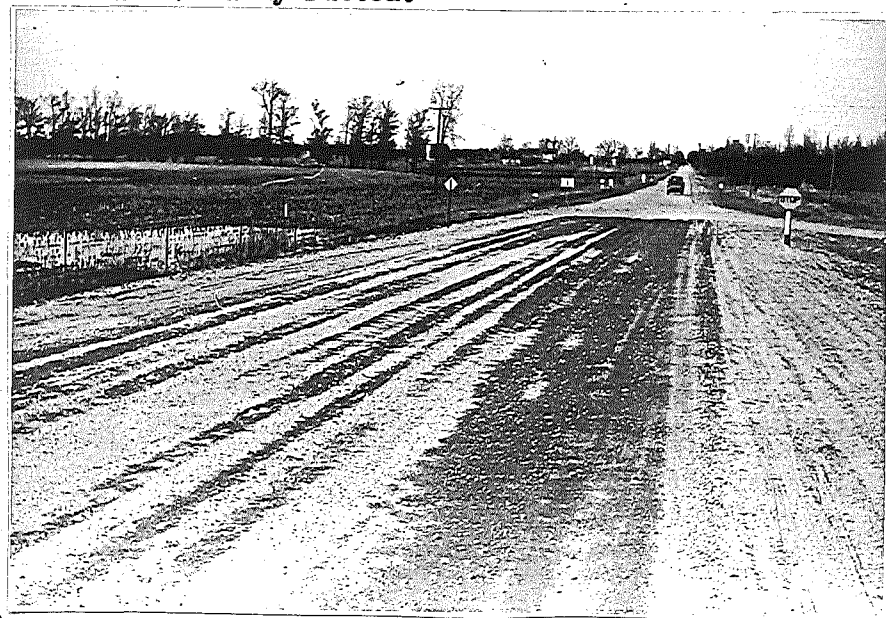
d. General surface condition at Station 248+00
Dark areas slightly rutted.

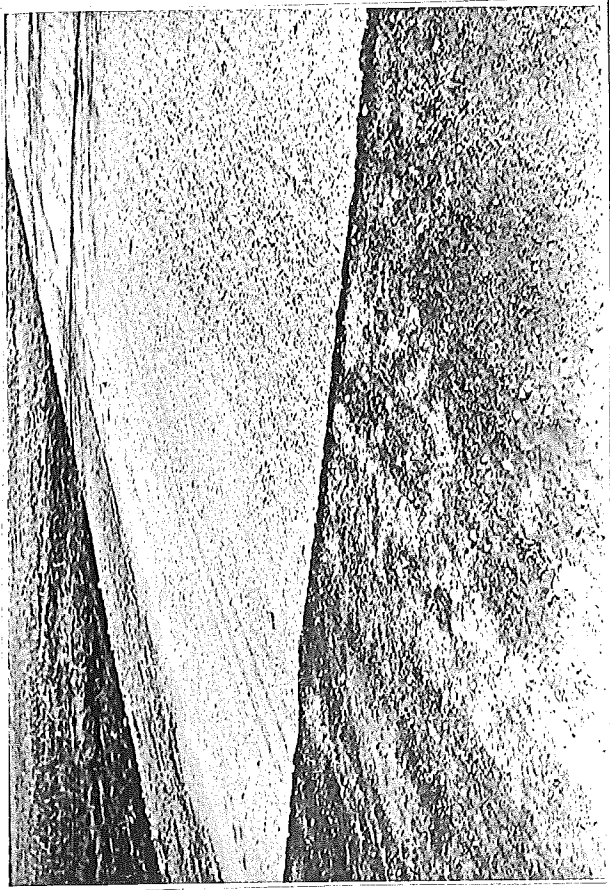
Structurally the slab is in excellent condition. Some of the joints between daily runs need patching. Traffic has caused some surface abrasion.

b. Station 144+00
Typical Joint Condition

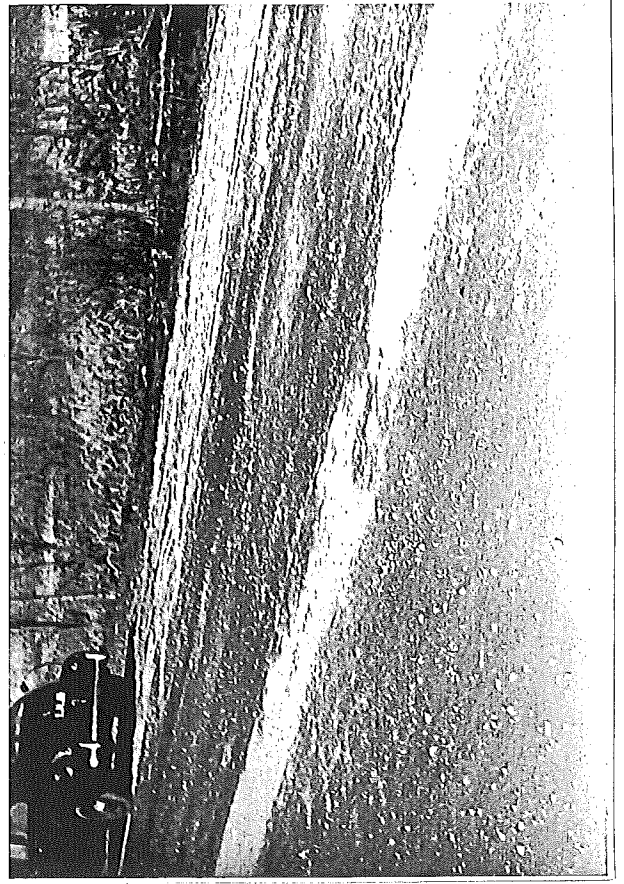
This section is in good condition showing some local pitting and some raveling along the edge. General surface abrasion caused by traffic. Fill settlement at the culvert Sta. 130 and peat swamp Sta. 131, has also caused some weakening of the soil cement. Some patching will be necessary.

Rain during finishing. Sheepfooted 1 hr. 5 min. Rubber tire rolled before spike tooth and broom. Settlement at Culvert Sta. 130 - broken S-C. Section built 6th, rain 7th, covered 8th October. South hill slope shows somewhat inferior S-C with about 1" accumulated loose material on surface. Edges appear to be depressed just outside 1/4 line. Apparently some existing soil in treatment. Hill top portion good. Balance of section like hill slope with some maximum 2" ruts and pocket ravel. End joint slightly low.

d. Subbase failure at culvert, Station 130+00
