OFFICE MEMORANDUM

STATE HIGHWAY DEPARTMENT

February 20, 1967

Subject: Investigation of Concrete Pavement Cracking on the Southbound I 75
Fisher Freeway (Sta. 987+00 to 990+00, Construction Project
BI 82194E, C4). Research Project 66 B-81. Research Report
No. R-623.

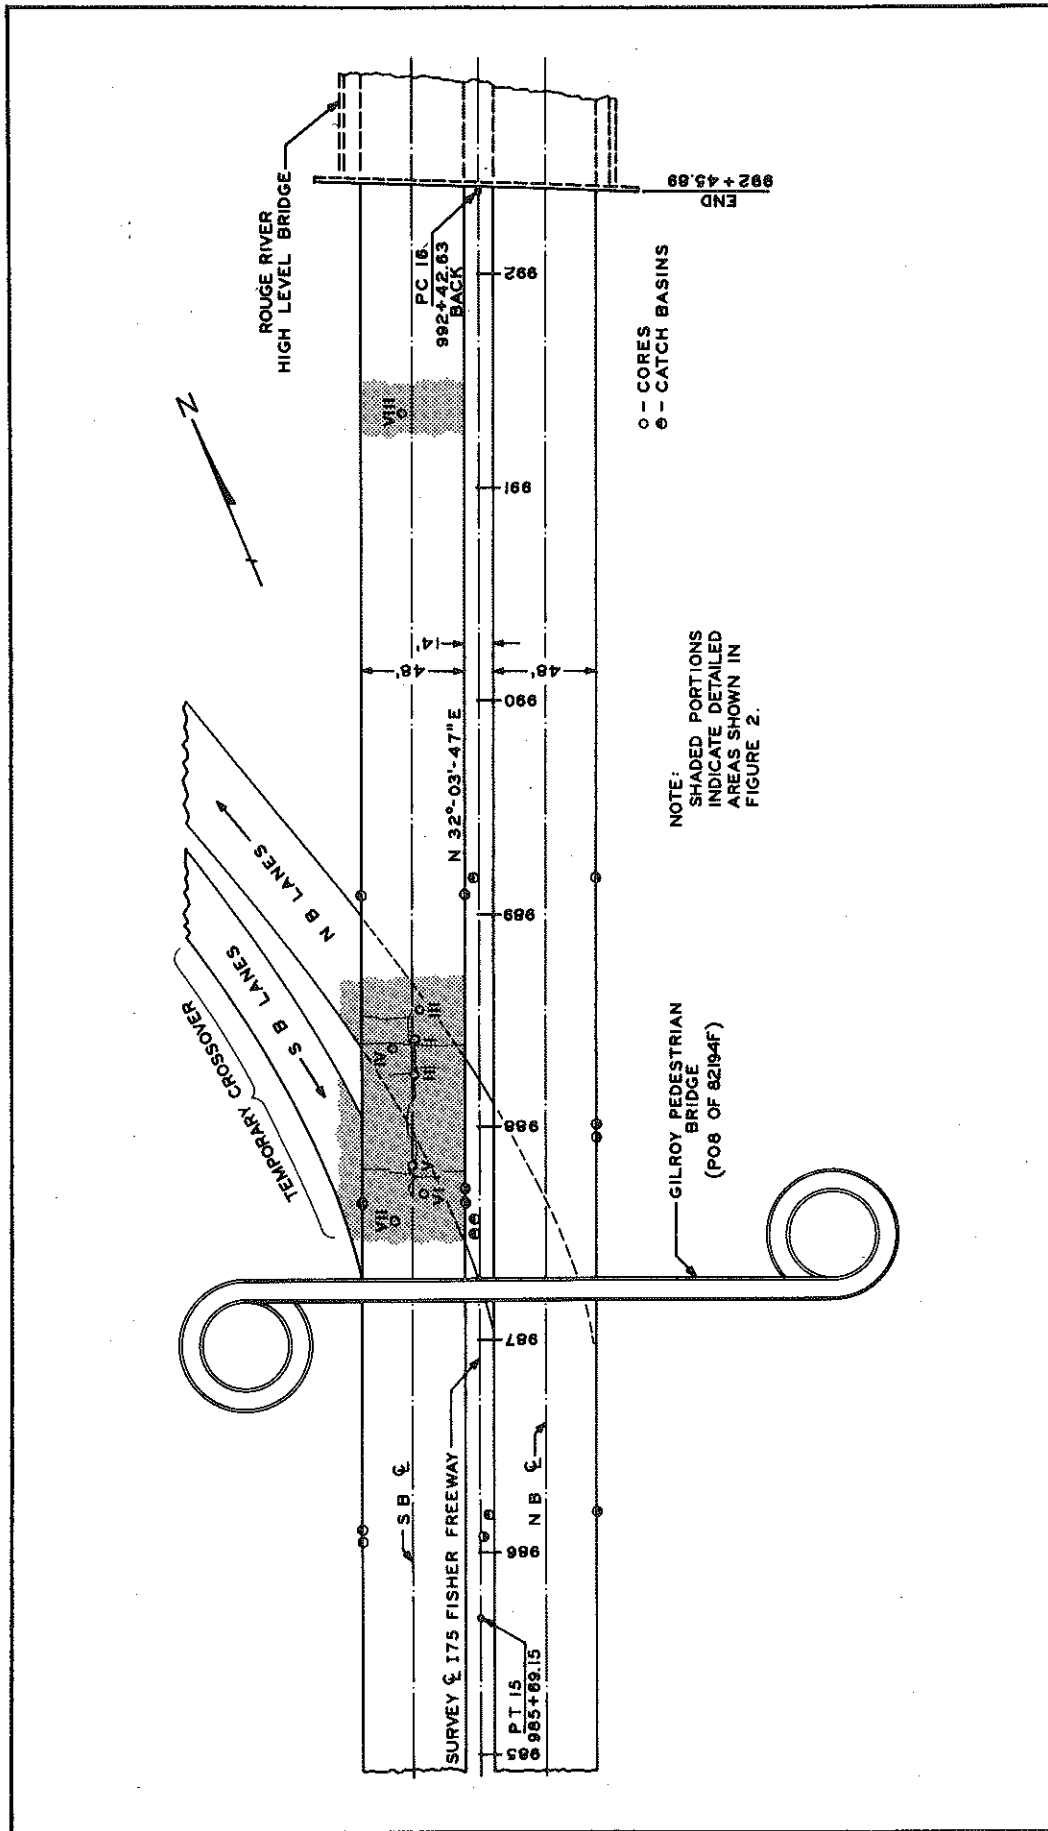
Figure 1. General location plan of cracked pavement.

In a letter to W. W. McLaughlin dated October 17, 1966, D. L. Wickham, Assistant to the Chief Construction Engineer, requested that four cores be taken from the southbound I 75 pavement south of the Rouge River Bridge, between Stations 987+00 and 990+00. A number of unexplained cracks had occurred in the center 24-ft section of this 48-ft roadway, poured June 18, 1966. These included one long longitudinal crack at the centerline and several transverse cracks. Figure 1 gives a general plan of the area involved.

In Figure 1, the cracks in the southbound pavement occur where the cross-over roadway connects the northbound and southbound I 75 freeway lanes to Fort Street. It is probable that construction vehicles crossing over this area in

August and September, combined with subgrade settlement, have caused this cracking. During the November inspection, large dump trucks were using the southbound freeway and cross-over to Fort Street.

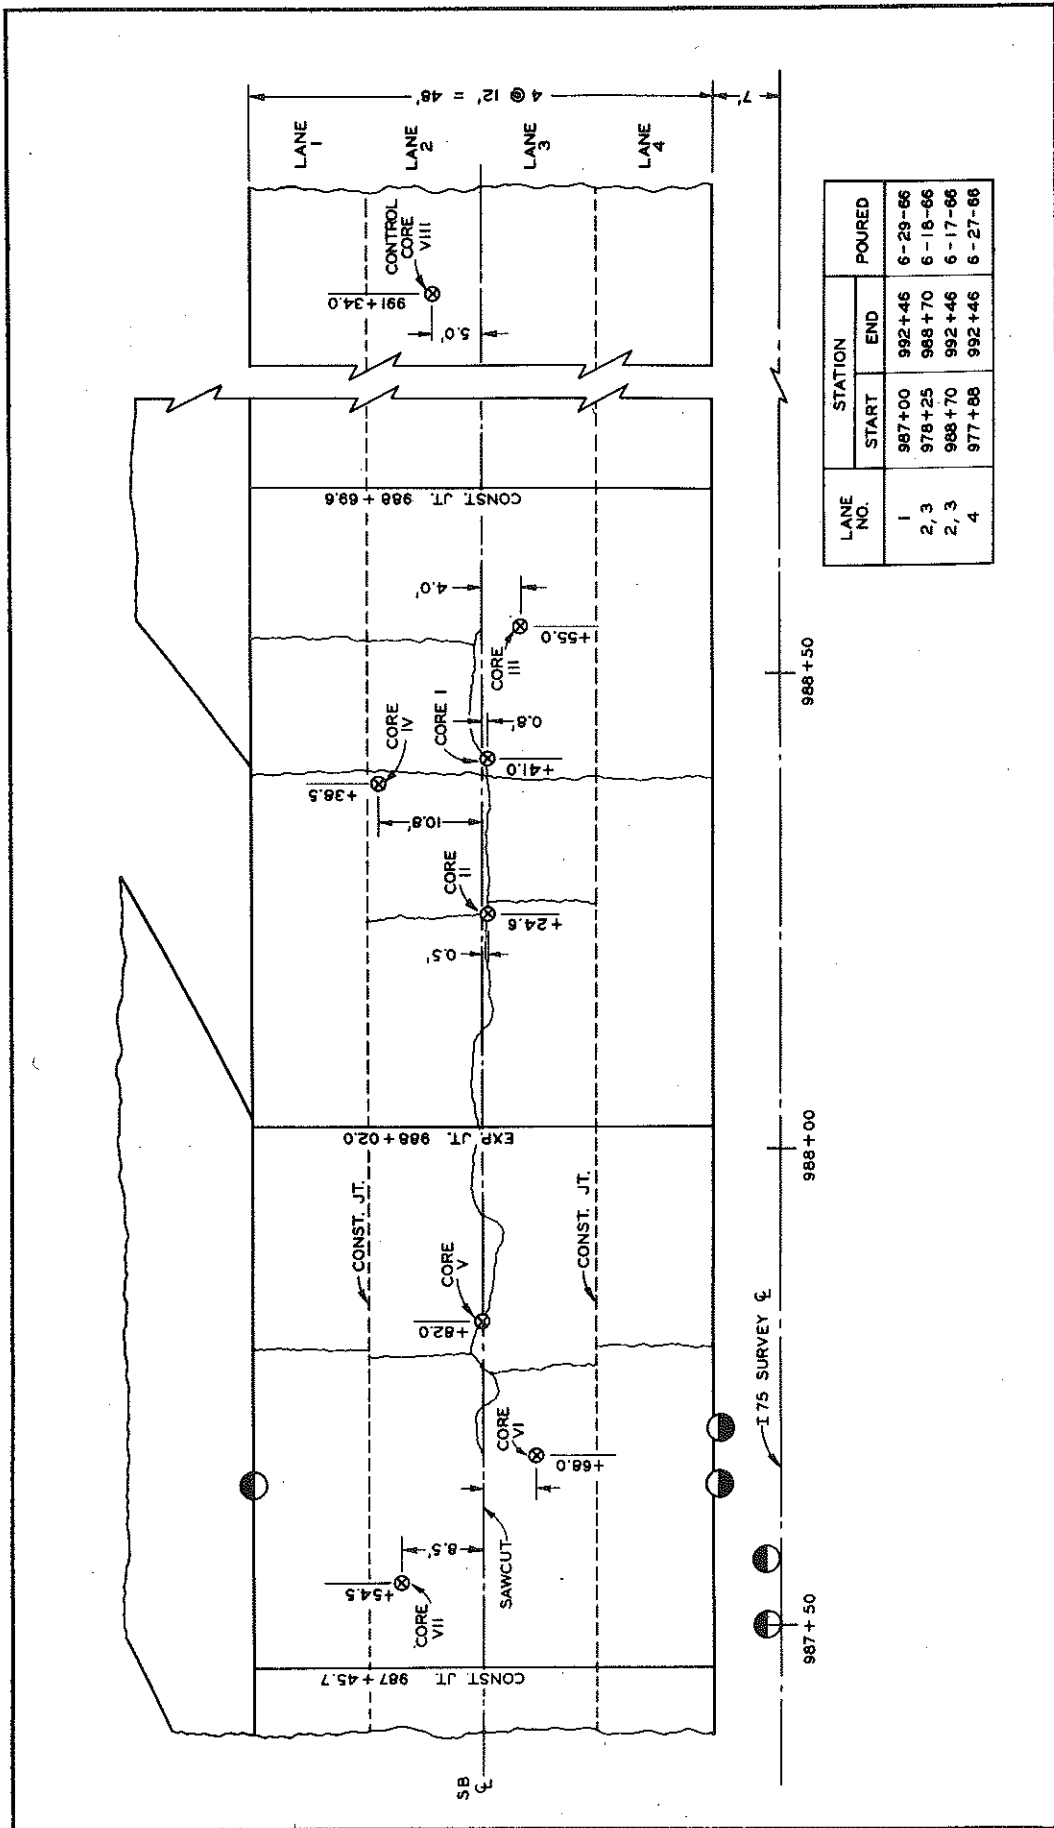
Figure 2. Detail plan of cracked pavement.

Mr. Sypitkowski selected eight locations for cores--seven from the cracked area and the eighth from the previous day's pour. This eighth core was included as a control core, as a basis for comparison with the other seven. For further control, he sent the Research Laboratory sample bags of portland cement, sand, and slag coarse aggregate used in the pavement concrete, along with the required mix proportions. To assist further in the investigation, a diagram of the roadway was included, showing the crack patterns and locations where cores were cut.

This diagram, with additions, is shown in Figure 2. Of the seven cores, two were taken through cracked areas, and one broke in two during drilling. Thus, four cores (in addition to the control core) were suitable for testing. Figure 3 shows Cores II and V cut through cracks.

During the course of the laboratory study and at the suggestion of Mr. Wickham, the site was visited on two occasions. The first was on October 26, 1966, at which time the two cracked center lanes (poured 6-18-66) were observed. Corresponding transverse cracks were also noted in the two outside lanes (Fig. 2), which were poured later (June 27 and 29). The second visit was on November 15. The pavement in the center two lanes had been replaced. The crack pattern in the two outside lanes was measured, however, to complete the record of all original cracks in this area (Fig. 2). Appearance of the southbound roadway after this repair is shown in Figure 4.

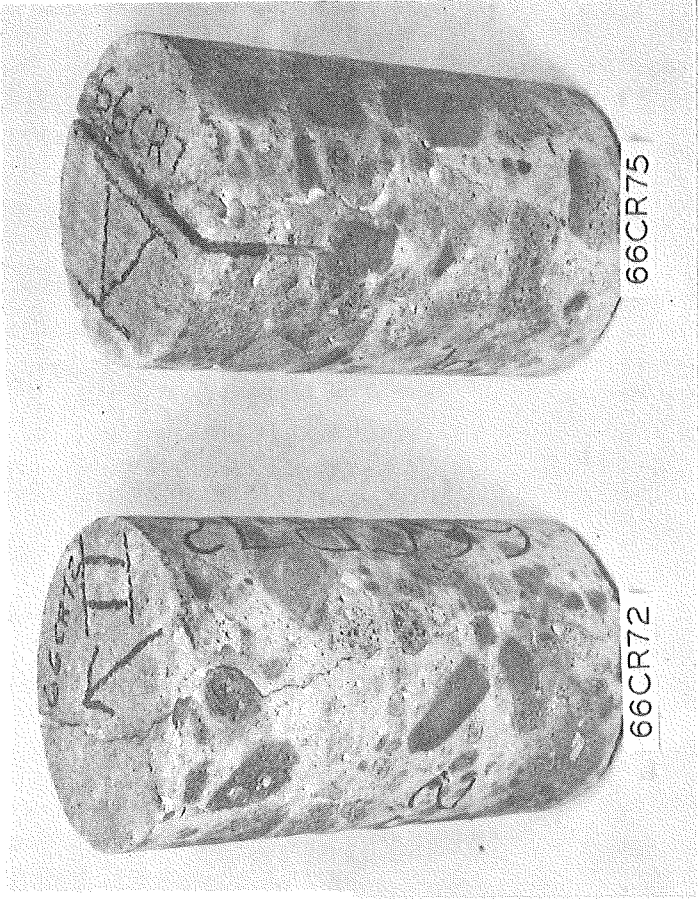
Figure 3 (right). Cores II and V (not tested), showing full depth cracks.

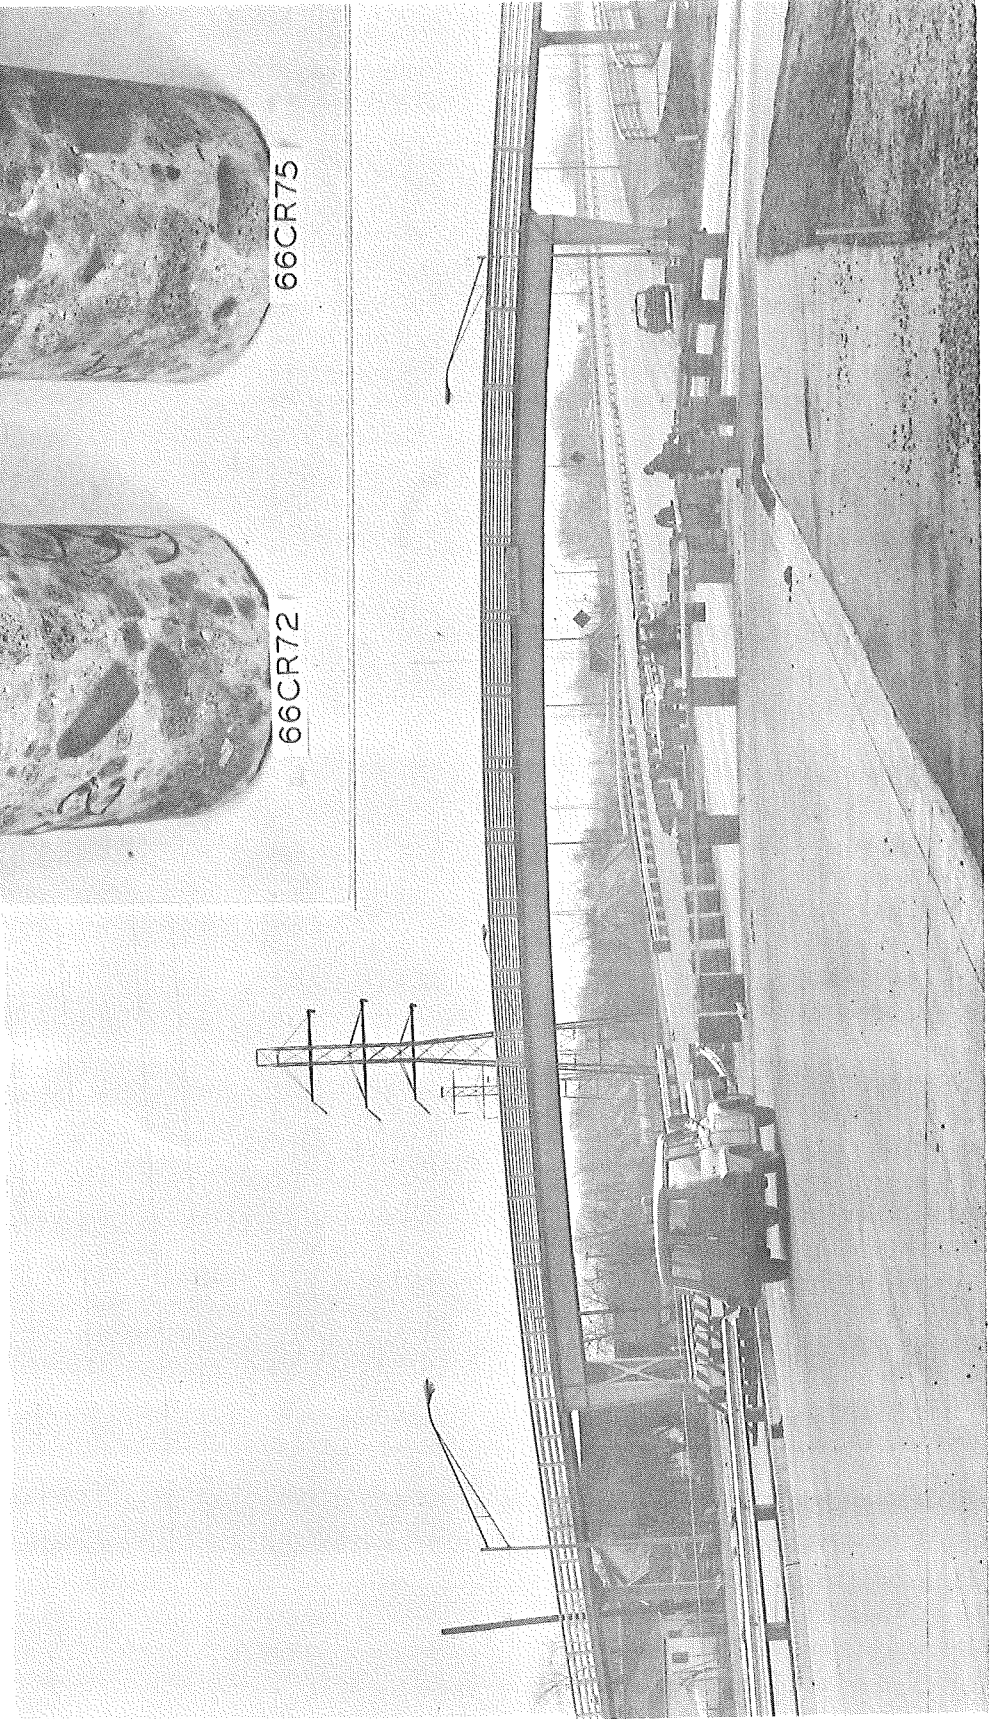
Figure 4 (below). General view of area looking south (November 15, 1966).
