FAILURE OF CENTER-MOUNT DELINEATORS  
A Summary of Research Laboratory Observations

Research Laboratory Division  
Office of Testing and Research  
Research Project 51 G-54(4)  
Research Report No. R-627

State of Michigan  
Department of State Highways  
Lansing, May 1967

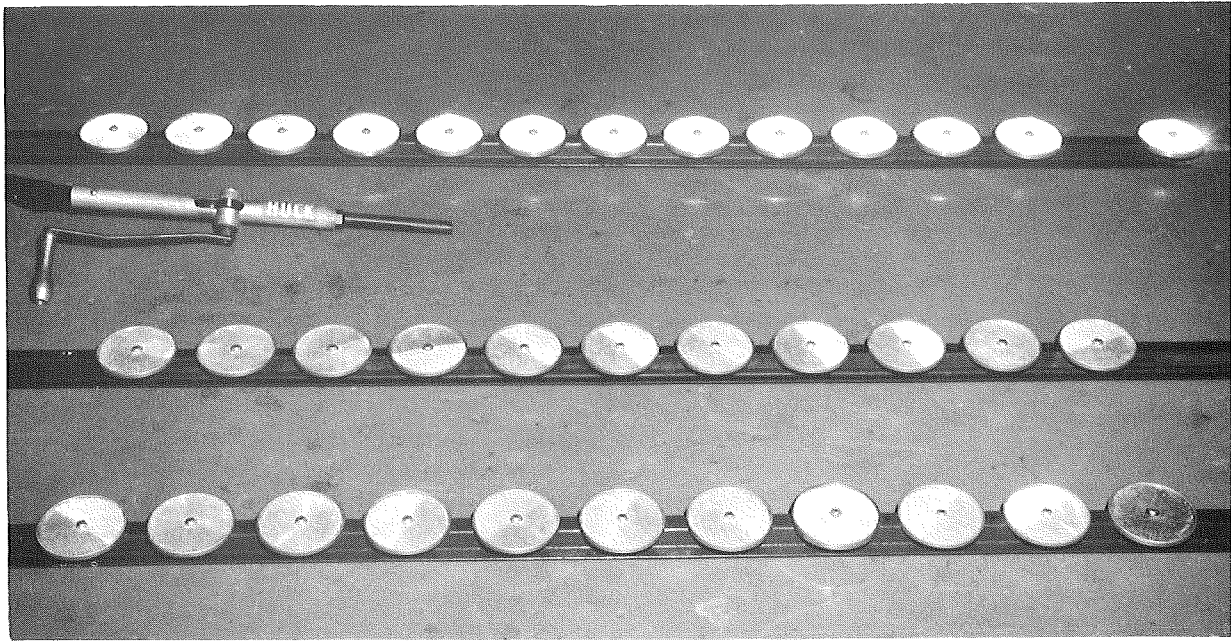
A. Based on results of a laboratory test where delineators were fastened to posts, according to Departmental standards, riveting did not cause any cracks in the 35 delineators tested (Figs. 1 and 2).

Figure 1. Typical delineators mounted on posts with the necessary riveting gun.

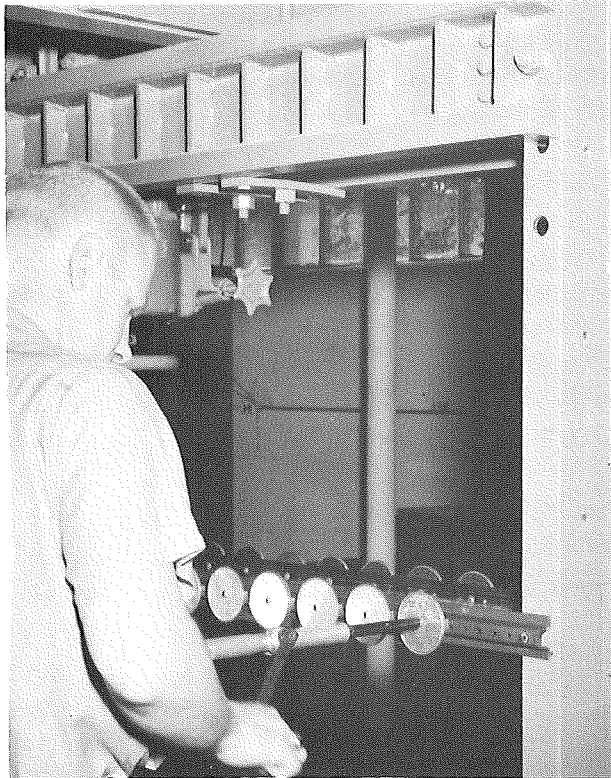
Figure 2. Riveting operation.

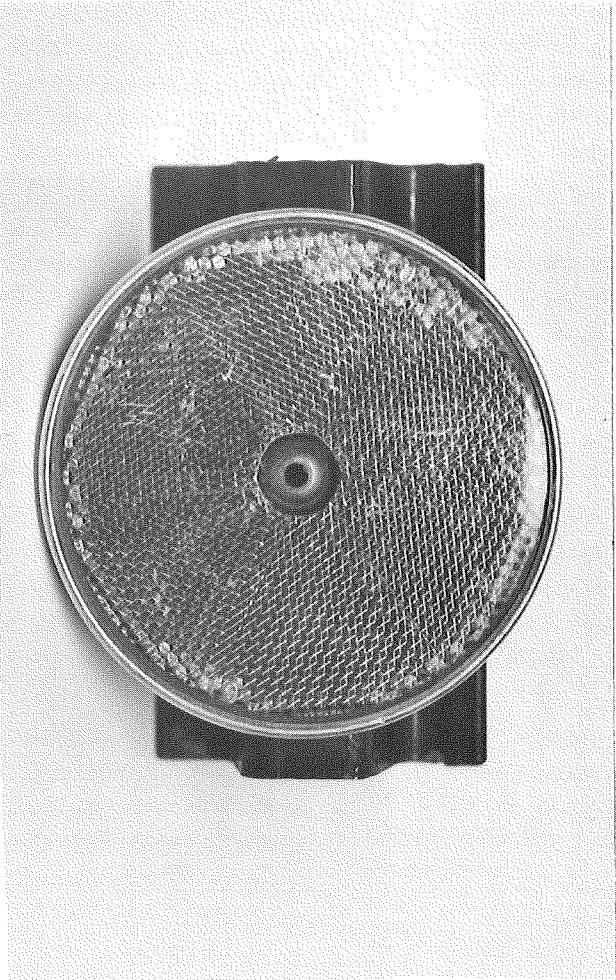
B. 17 delineators riveted to posts were subjected to a heat shock test with no evidence of cracking, warping, or water inclusion (Fig. 3).

Figure 3 (right). Reflector button after completion of specified heat shock test.

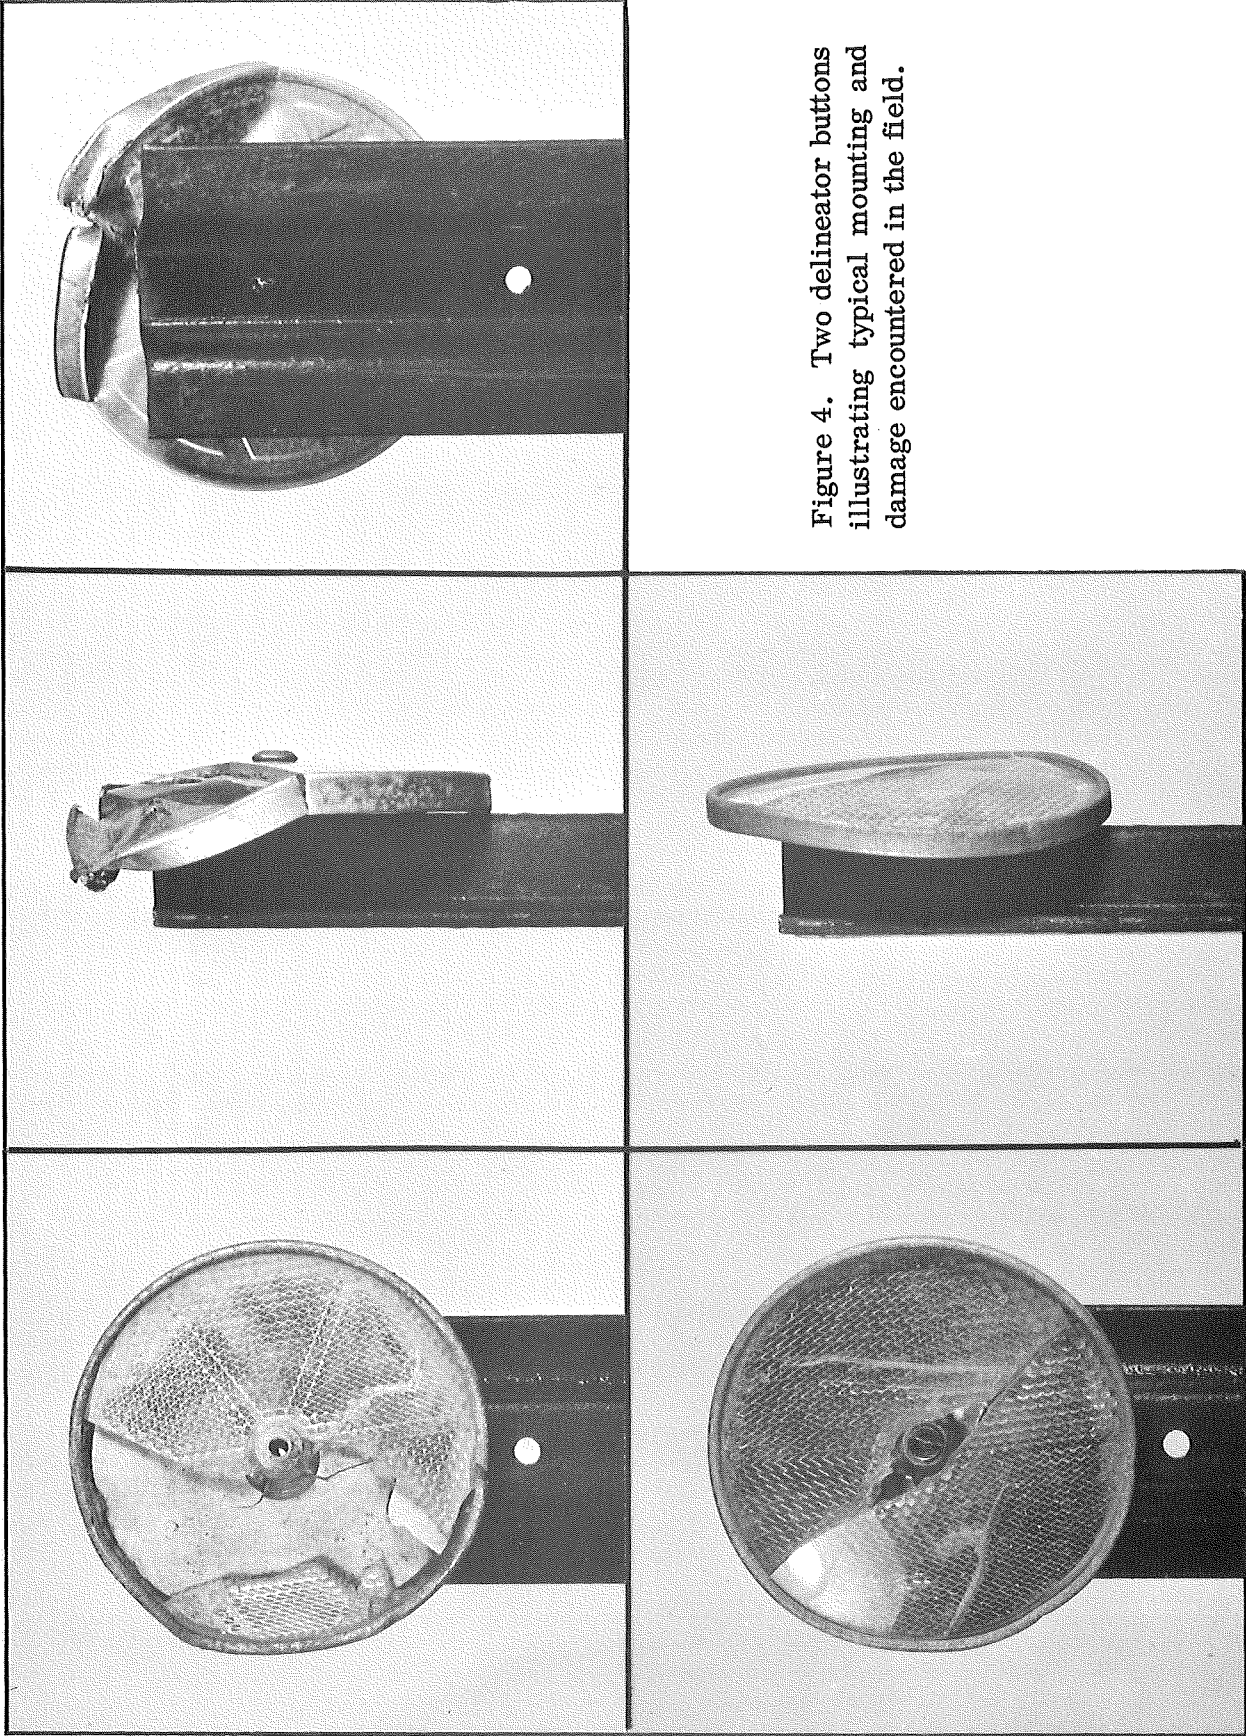
C. "I concur with Mr. Harvey that most failures of center-mount delineators should be attributed to direct blading damage by snow removal equipment, rather than the riveting operation. However, another direct factor, in my opinion, is impact resulting from flying ice, snow, and frozen shoulder material" (Fig. 4).

Figure 4. Two delineator buttons illustrating typical mounting and damage encountered in the field.

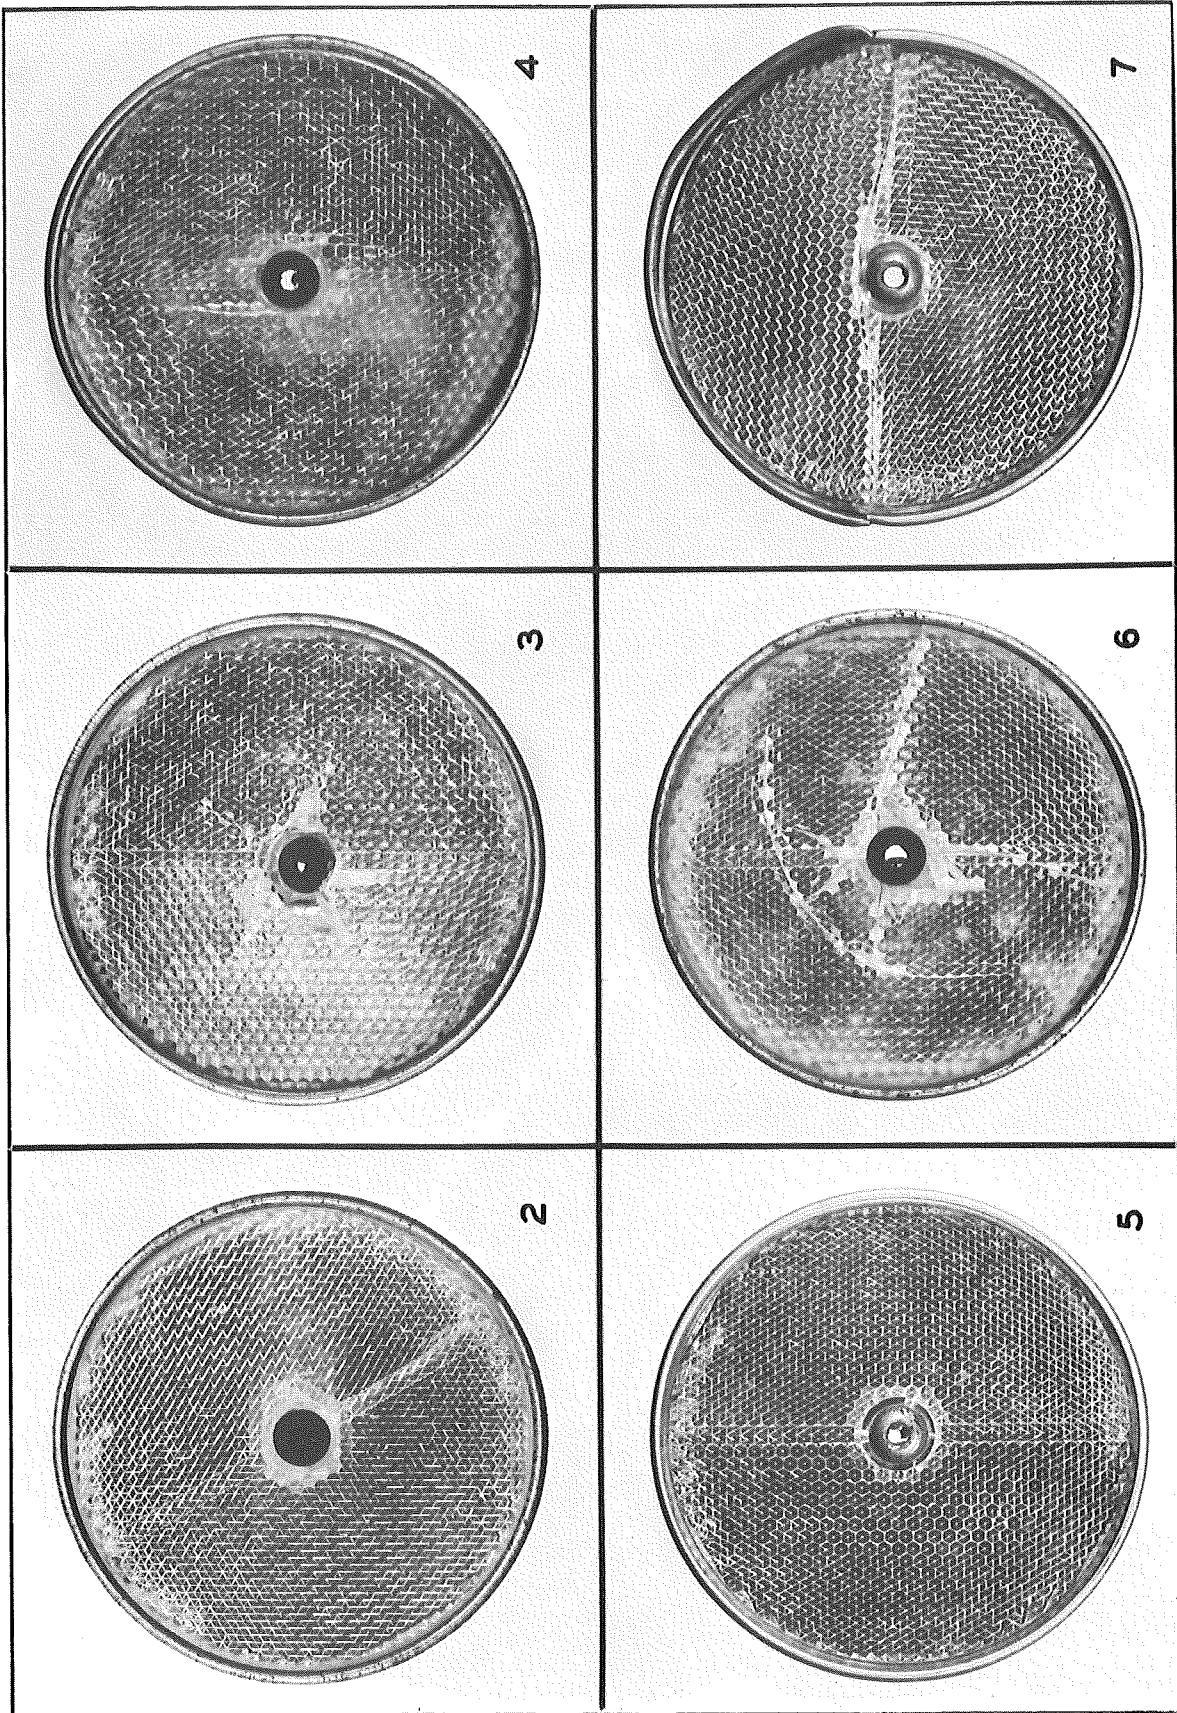
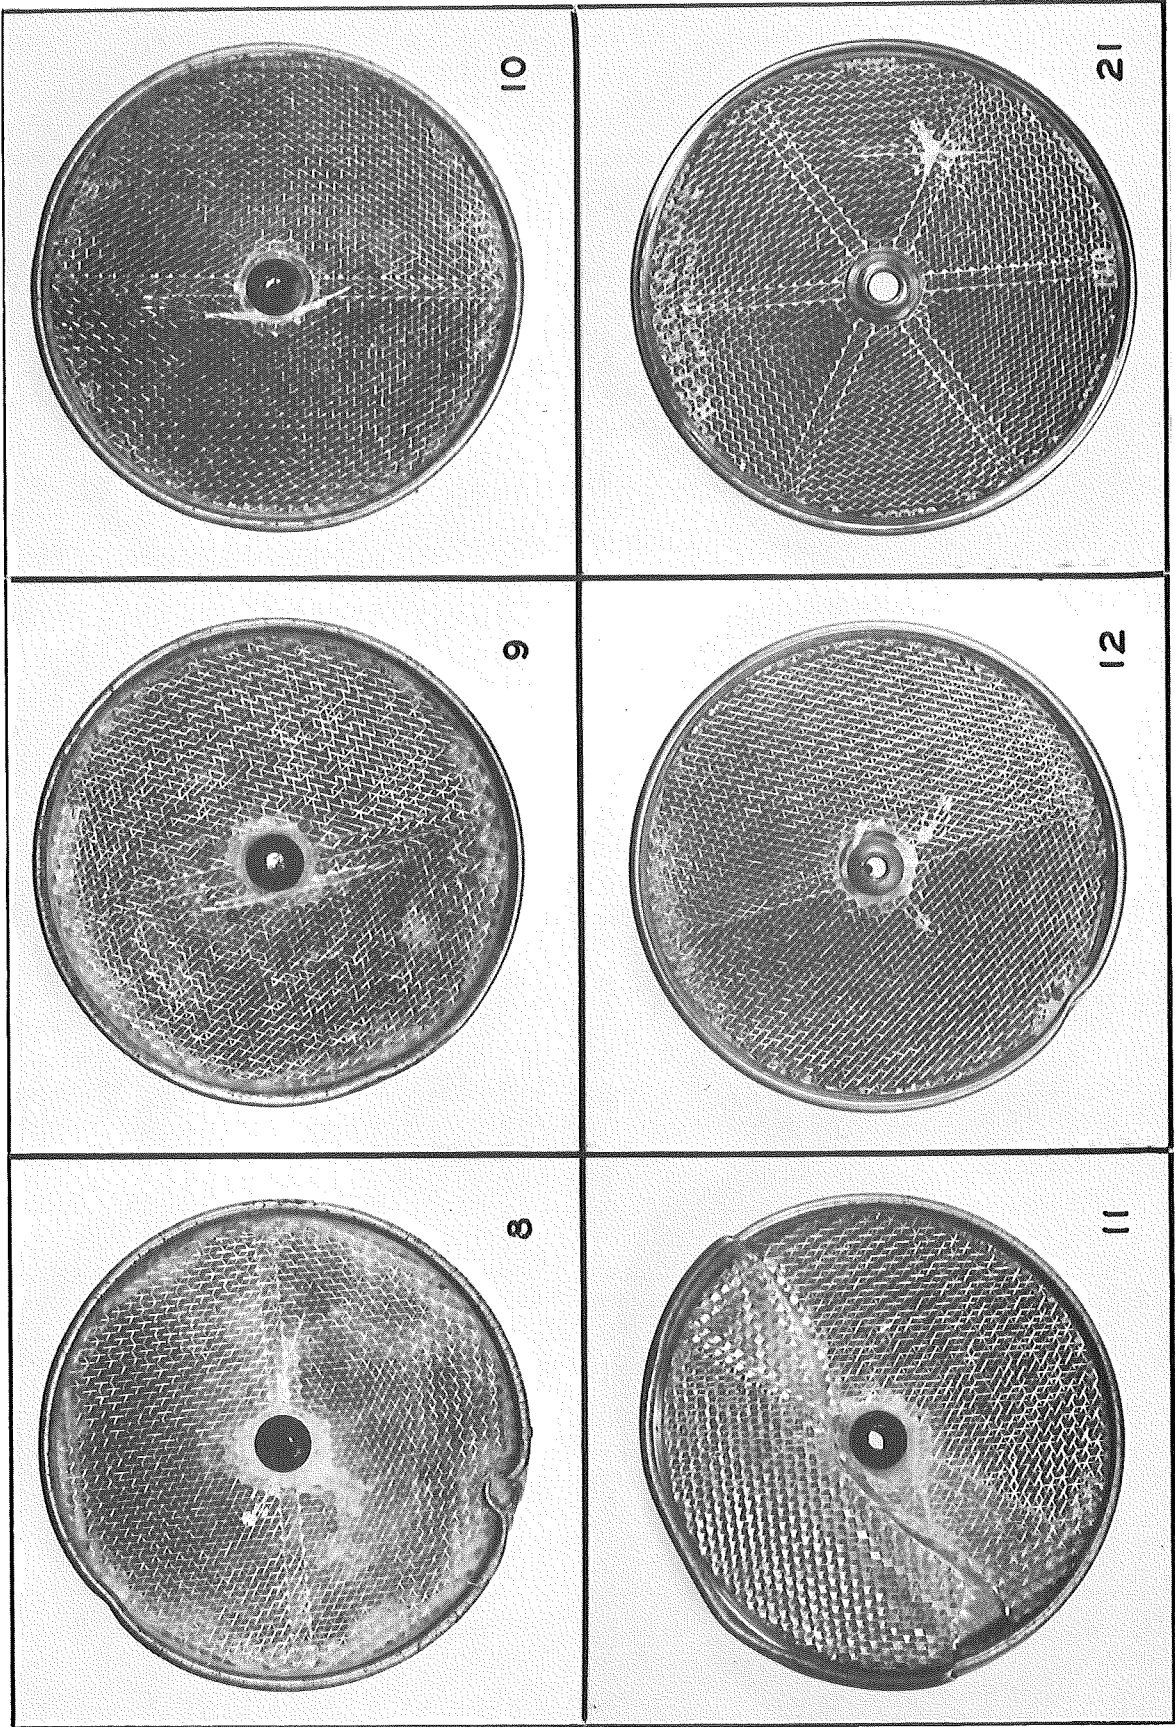
1. Inspection results are recorded in Table 1 and samples shown in Figures 5 and 6:
  - a. All delineators were mounted on the narrow side of the post.
  - b. Approximately 54 percent of the delineators inspected were damaged.
2. All new delineators, used to replace the sampled ones, cracked curing replacement riveting. A laboratory examination of the riveting process (Fig. 7) revealed:
  - a. Huck rivets are 0.187-in. diam before riveting but expand up to 0.255-in. diam during fastening.
  - b. Diameter of the hole in the plastic delineator is 0.240 in. Maximum inside diameter of the grommet mounting hole is 0.220 in.
  - c. The examination shows the rivet can expand to a diameter 0.035-in. greater than can be accepted by the delineator.

TABLE 1  
 SUMMARY OF DELINEATOR BUTTON PERFORMANCE SURVEY  
 (Sample Nos. refer to Figs. 5 and 6)

Figure 5. US 27 button samples.

Figure 6. US 27 button samples.

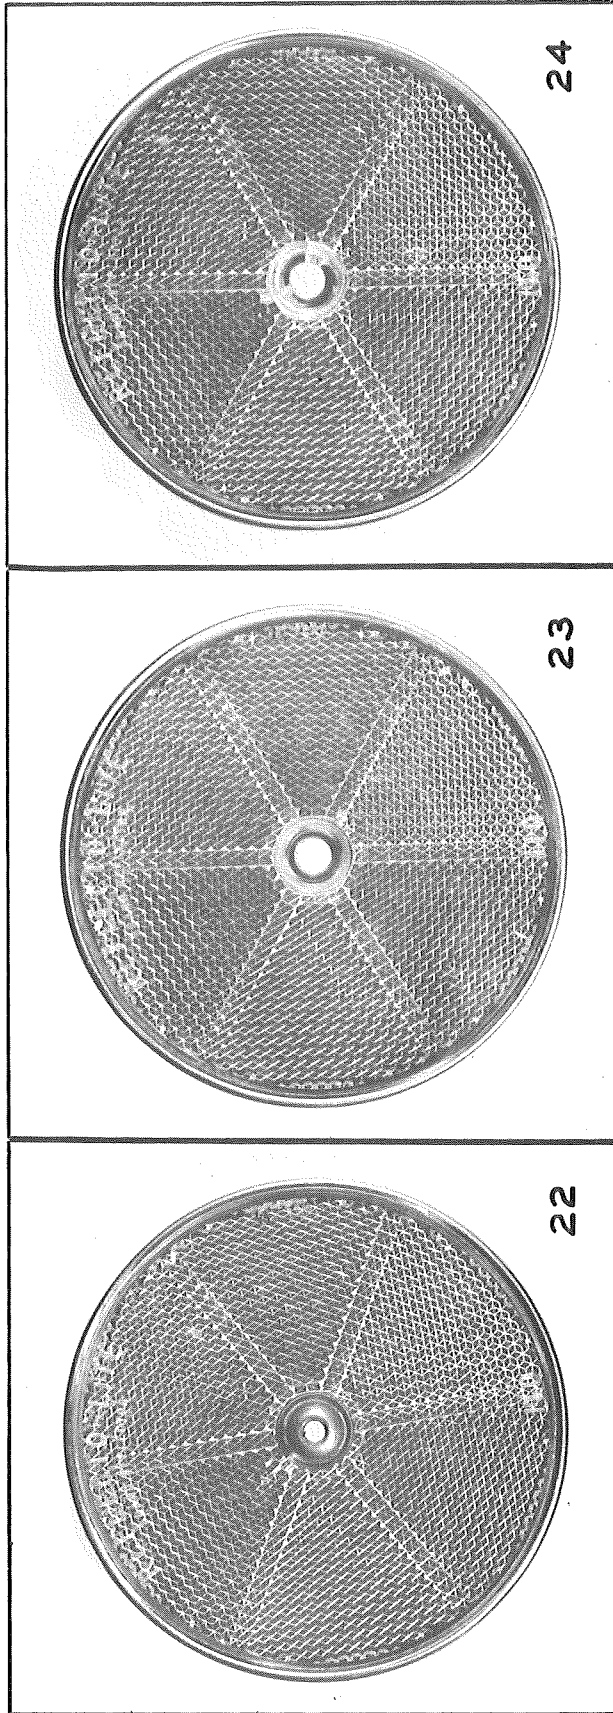
Delineator cracked at center, with rivet in place.

Normal delineator with grommet removed.

Delineator cracked at center, with rivet and grommet removed.

Figure 7. Condition of new delineators after laboratory riveting.

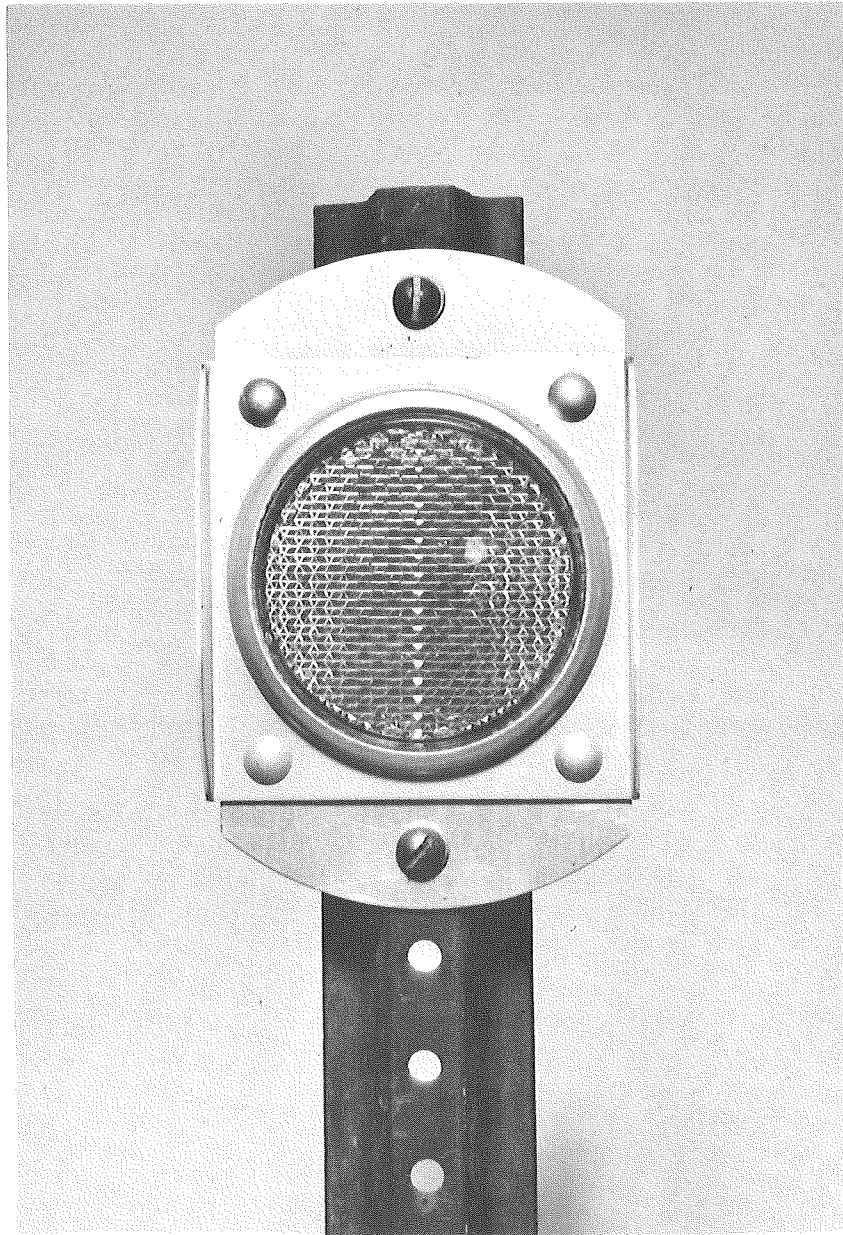
Figure 8. Delineator type used on short length of road-  
way in Ottawa County.

1. Two controllable factors responsible for cracking delineators are the fastening device and the mounting.
2. It is recommended that pull-through rivets be discontinued as fasteners for center-mount delineators.
3. It is recommended that the Physical Research Section investigate the use of other fasteners and revise present specifications to agree with investigation results.
4. The plugging-type rivet is considered more satisfactory and is recommended for use during the investigation.
5. The use of backing-plates or a more satisfactory method of providing support for the delineators is also recommended (Fig. 8).
