PARCLO TERMINAL STUDY

Evaluation of driver errors and turning movements

TSD-G-110-69

#### I-196 at Coloma Road Hagar Township, Berrien County

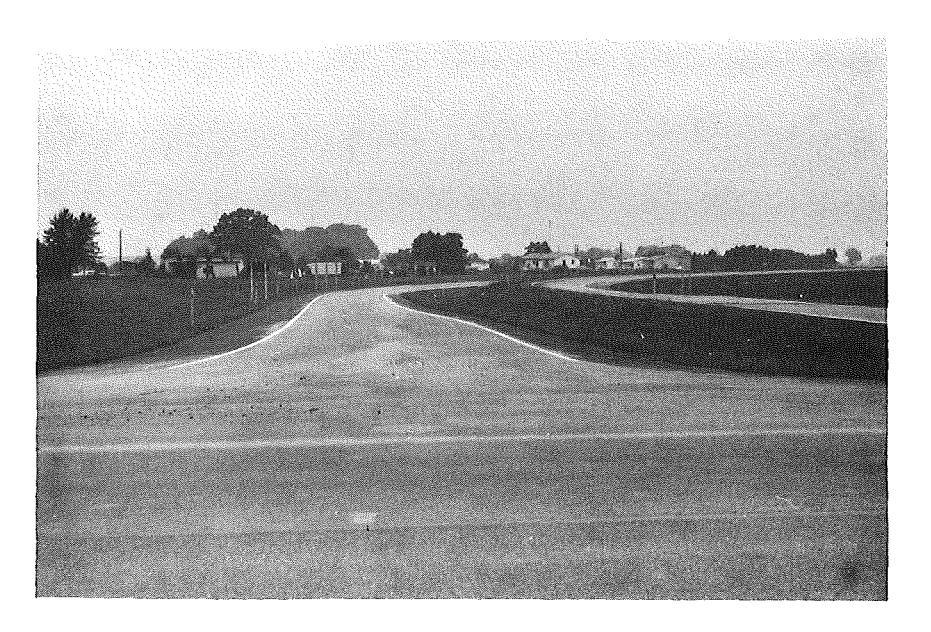
Photo 1

### Before Reconstruction

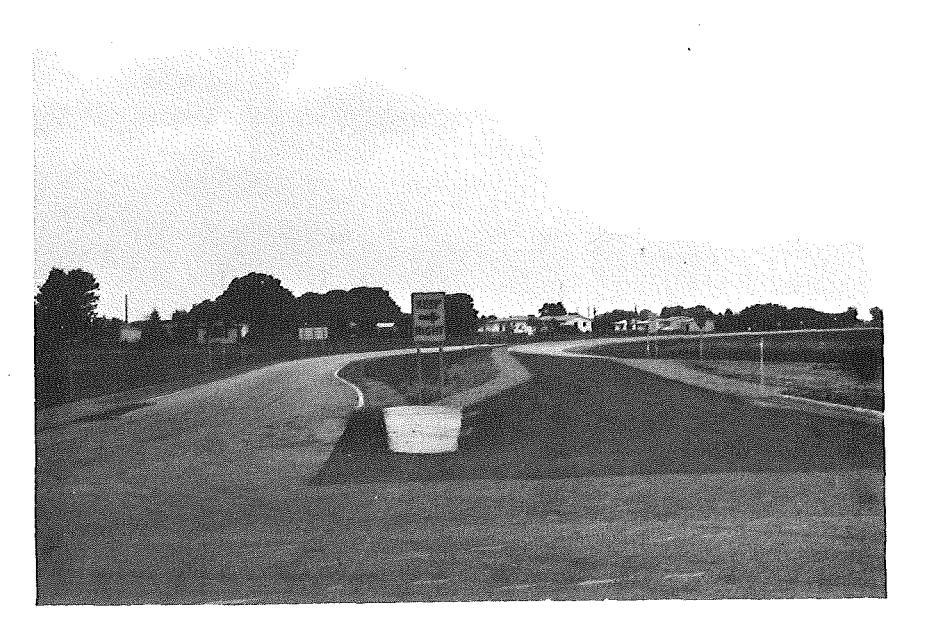
Photo 2

After Reconstruction

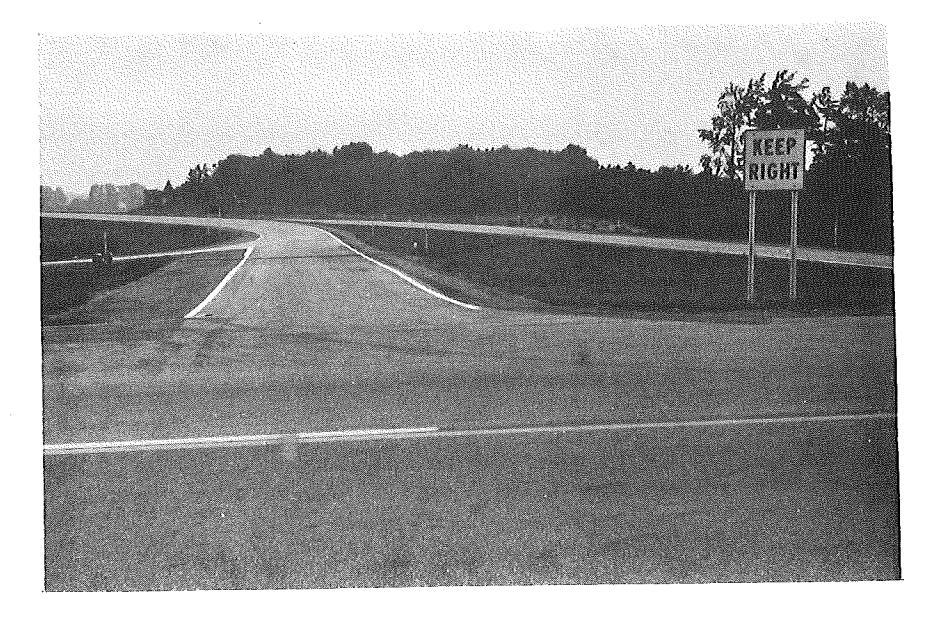
Photo 3

## Before Reconstruction

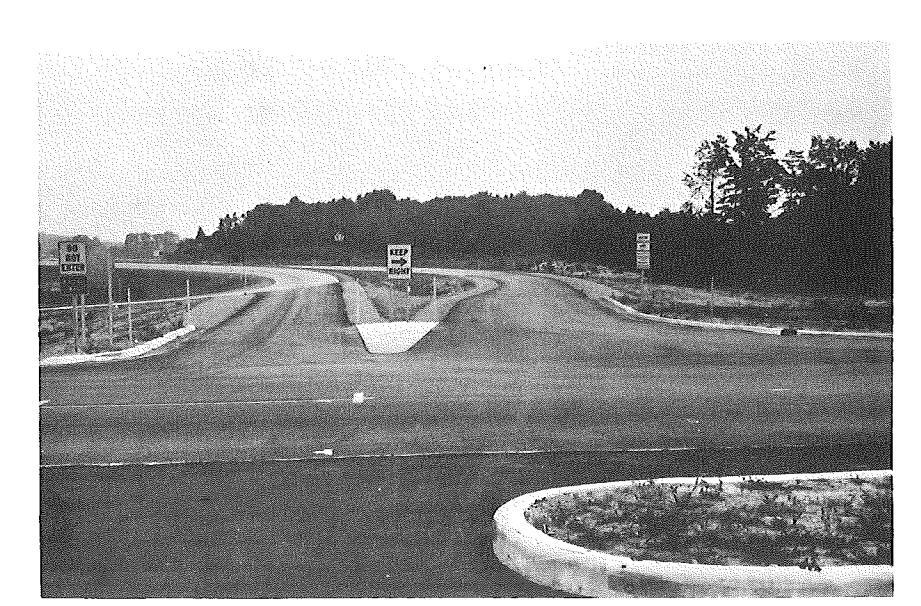
Photo 4

## After Reconstruction

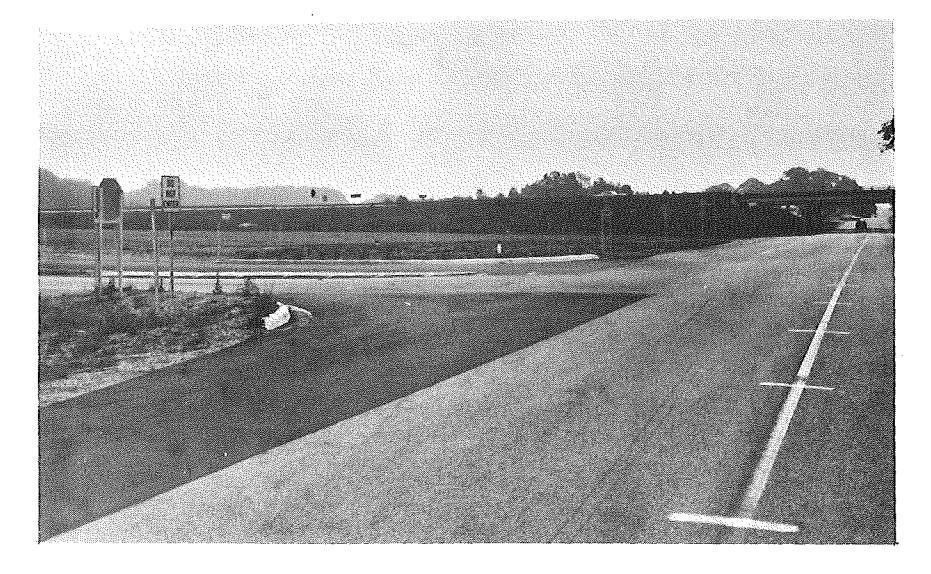
Photo 5

During the first study in August and September of 1965 before the terminals were reconstructed, errors were committed by 10.4% of the vehicles entering the ramps at this interchange. After reconstruction of the ramps, the study was repeated in August of 1967, and the errors dropped to 5.8%. In further breaking down the errors, before reconstruction, the east terminal experienced 10.0% errors; after reconstruction, only 0.2% errors were observed, a rather remarkable improvement. The western terminal originally experienced 10.5% errors, whereas after reconstruction 7.4% errors were observed with all but one of these errors being misses (where the driver went past the ramp terminal and made a U-turn into the free-flow diverge ramp connection, as shown on Exhibit #4). On close inspection of this terminal, it appeared that some of these misses might possibly be attributed to signing deficiencies since the route signs labeling the entrance ramp were across Coloma Road and were obscured by trees. In addition, the "Do Not Enter" and "Keep Right" signs were situated so they appeared to pertain to the whole terminal, rather than just the exit ramp. Thus it appeared that the variations in errors between the eastern and western ramp terminals (since the terminals are similar in geometric design) might be largely attributable to the variation in signing, in addition to limited visibility of the sign opposite the western terminal.

Before Sign Changes

Therefore, the signing at the western terminal was changed to conform with that of the eastern terminal (see Appendix -Photos 5 and 6), and the study was repeated in August 1968. The errors committed by vehicles entering the western ramp dropped from 7.4% to 2.9%, with only one vehicle making the previously-described U-turn movement into the free-flow connection. The overall rate of errors for vehicles entering both ramps dropped to 1.9%.

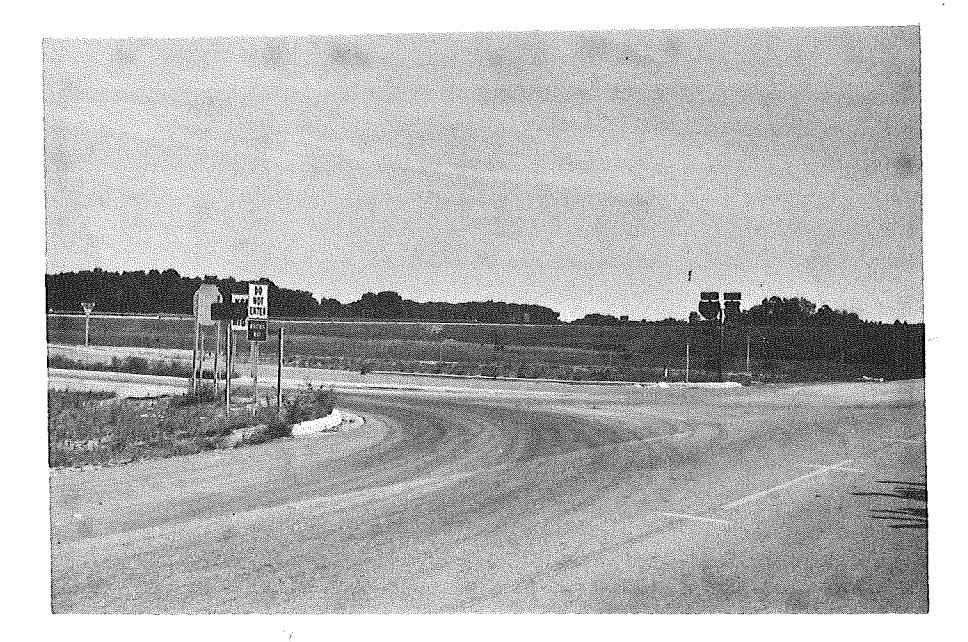
Photo 6

After Sign Changes
