Distress Identification and Scoping of Concrete Pavements

Andy Bennett Materials Technology Group Construction Field Services

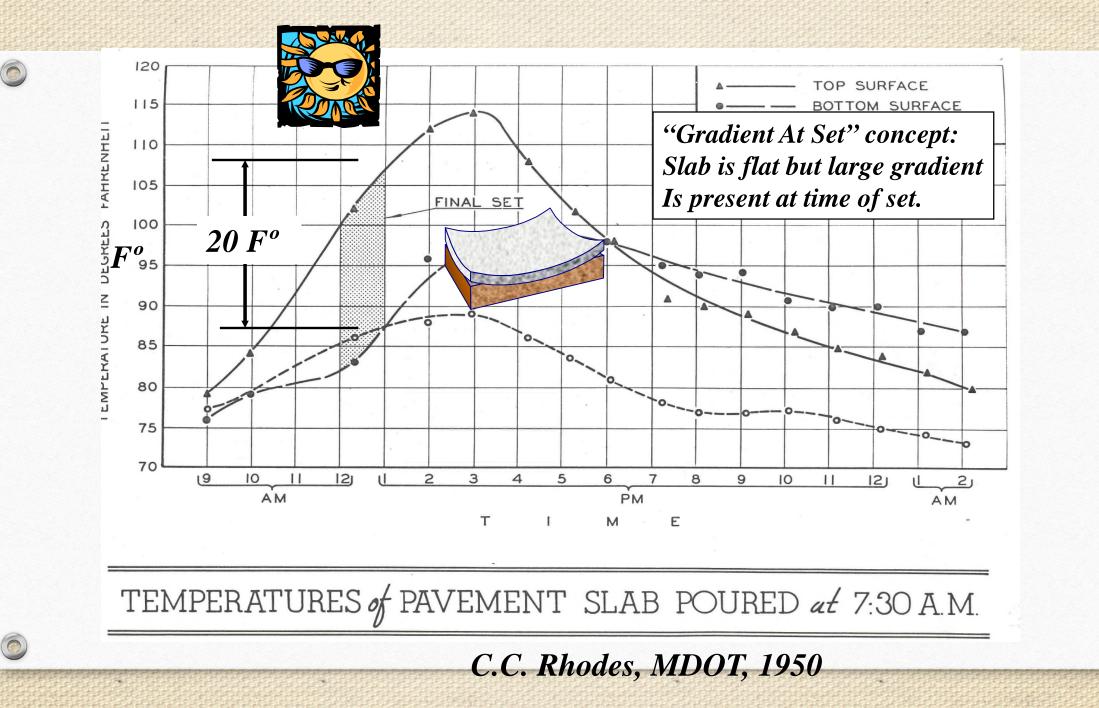
Curling and Warping

JPCP, 7 Years after construction: extensive mid-slab cracking and dowel bar looseness due to moisture warping

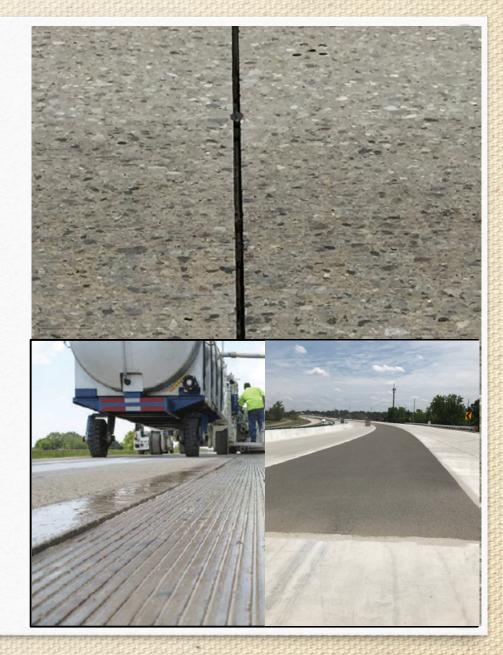
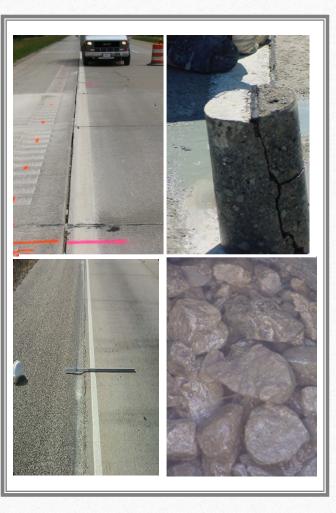
POLISHED AGGREGATE

Older pavements where surface texture has been removed by traffic over time.

Newer pavements that have been diamond ground for initial ride quality requirements that have been worn smooth by traffic.

Check friction numbers, traffic speed, and wet weather accident information for project selection.

Diamond Grooving is a selection option to increase macrotexture, channel water, and improve lateral tire stability.

High Friction Surface Treatment is another selection option that will greatly improve friction numbers.

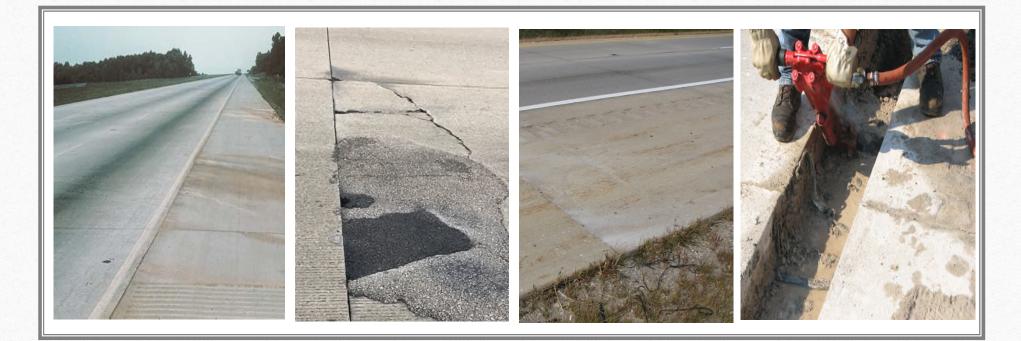
EDGE DROP

•Poor Load Transfer across the shoulder.

- •Increased surface water entering the shoulder joint.
- •Reduces resilient modulus of base at the edge of pavement leading to non-uniform support.
- •JRCP and JPCP constructed from on open-graded unbound base.
- •Movement of fines from the unbound base.
- •UBCOC from pumping erosion of the asphalt interlayer.

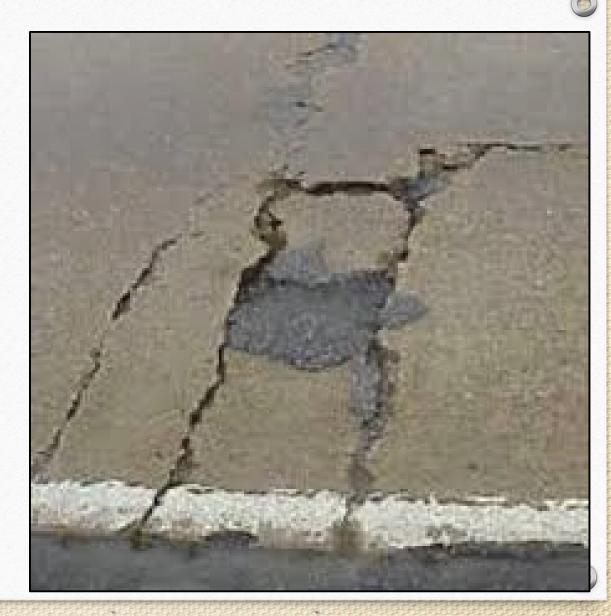
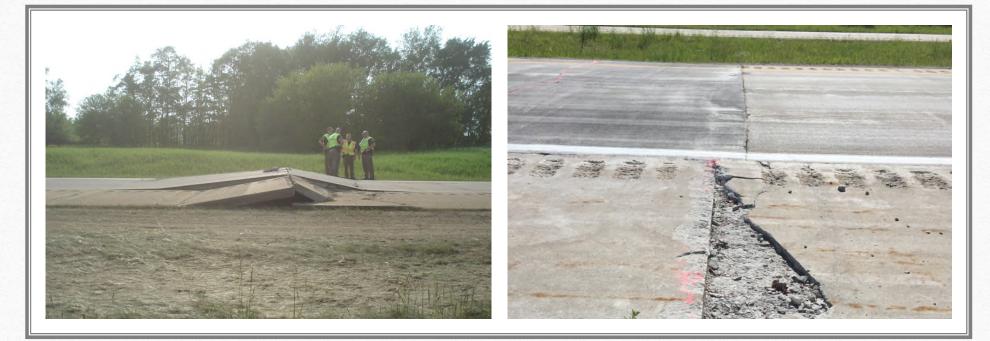
PUNCHOUTS

CRCP constructed on unbound base (all sections remaining are composite pavements).

JRCP constructed from 1983 to 1990 with very open-graded base with no geotextile separator.

Full Depth Repair is recommended.
