# Culvert Inspection/Maintenance

Erik Carlson, PE  
Hydraulic Unit Supervisor

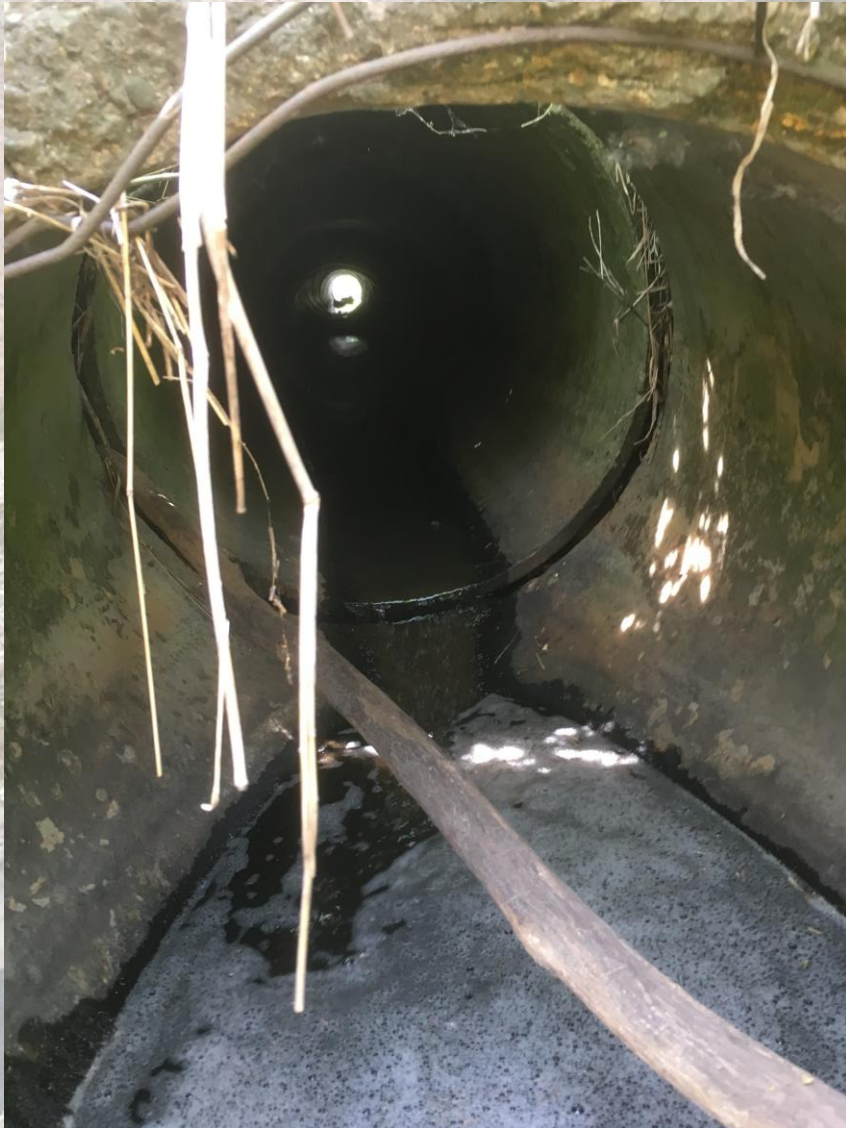
- Critical component of culvert inspection, particularly concrete
- Soil displacement can lead to voids around the pipe, eventually leading to problems at the surface (pavement).
- Voids are often hard to find and fix once they start.
- Joint problems near the inlet and outlet of the pipes can be an indicator that the culvert is undersized.

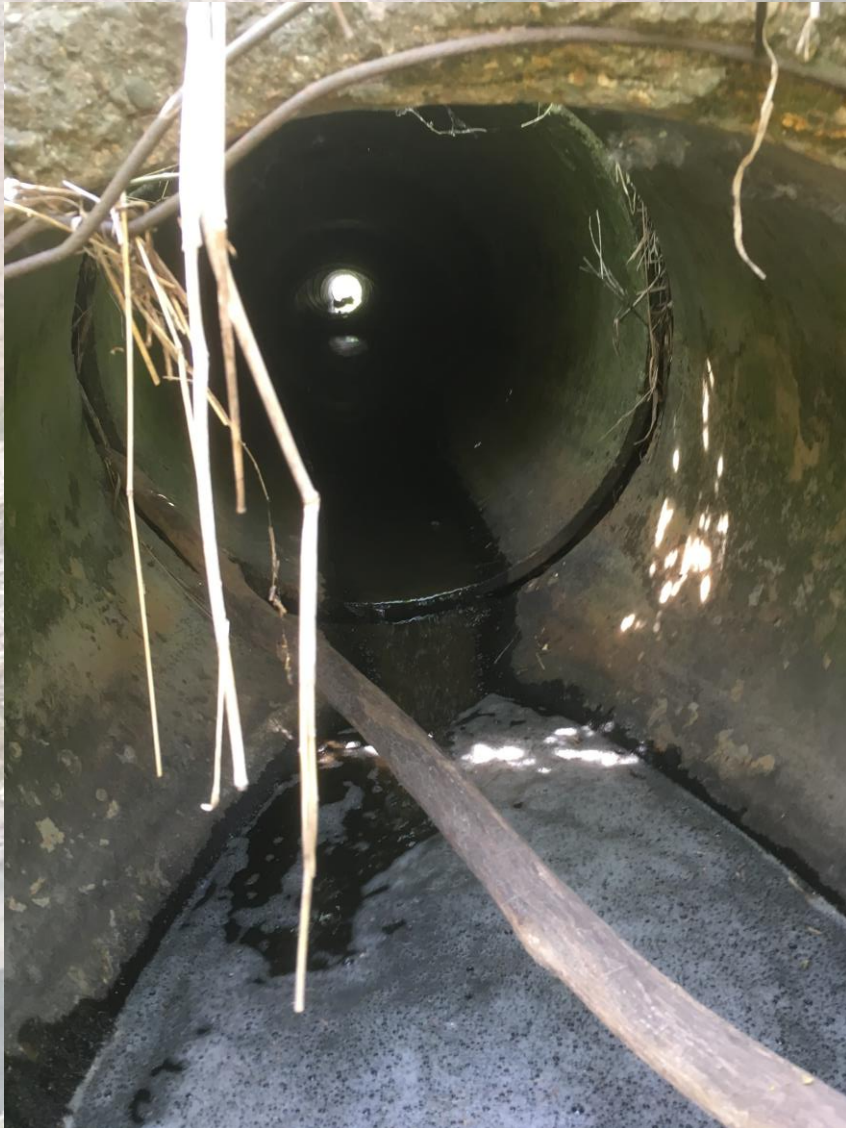
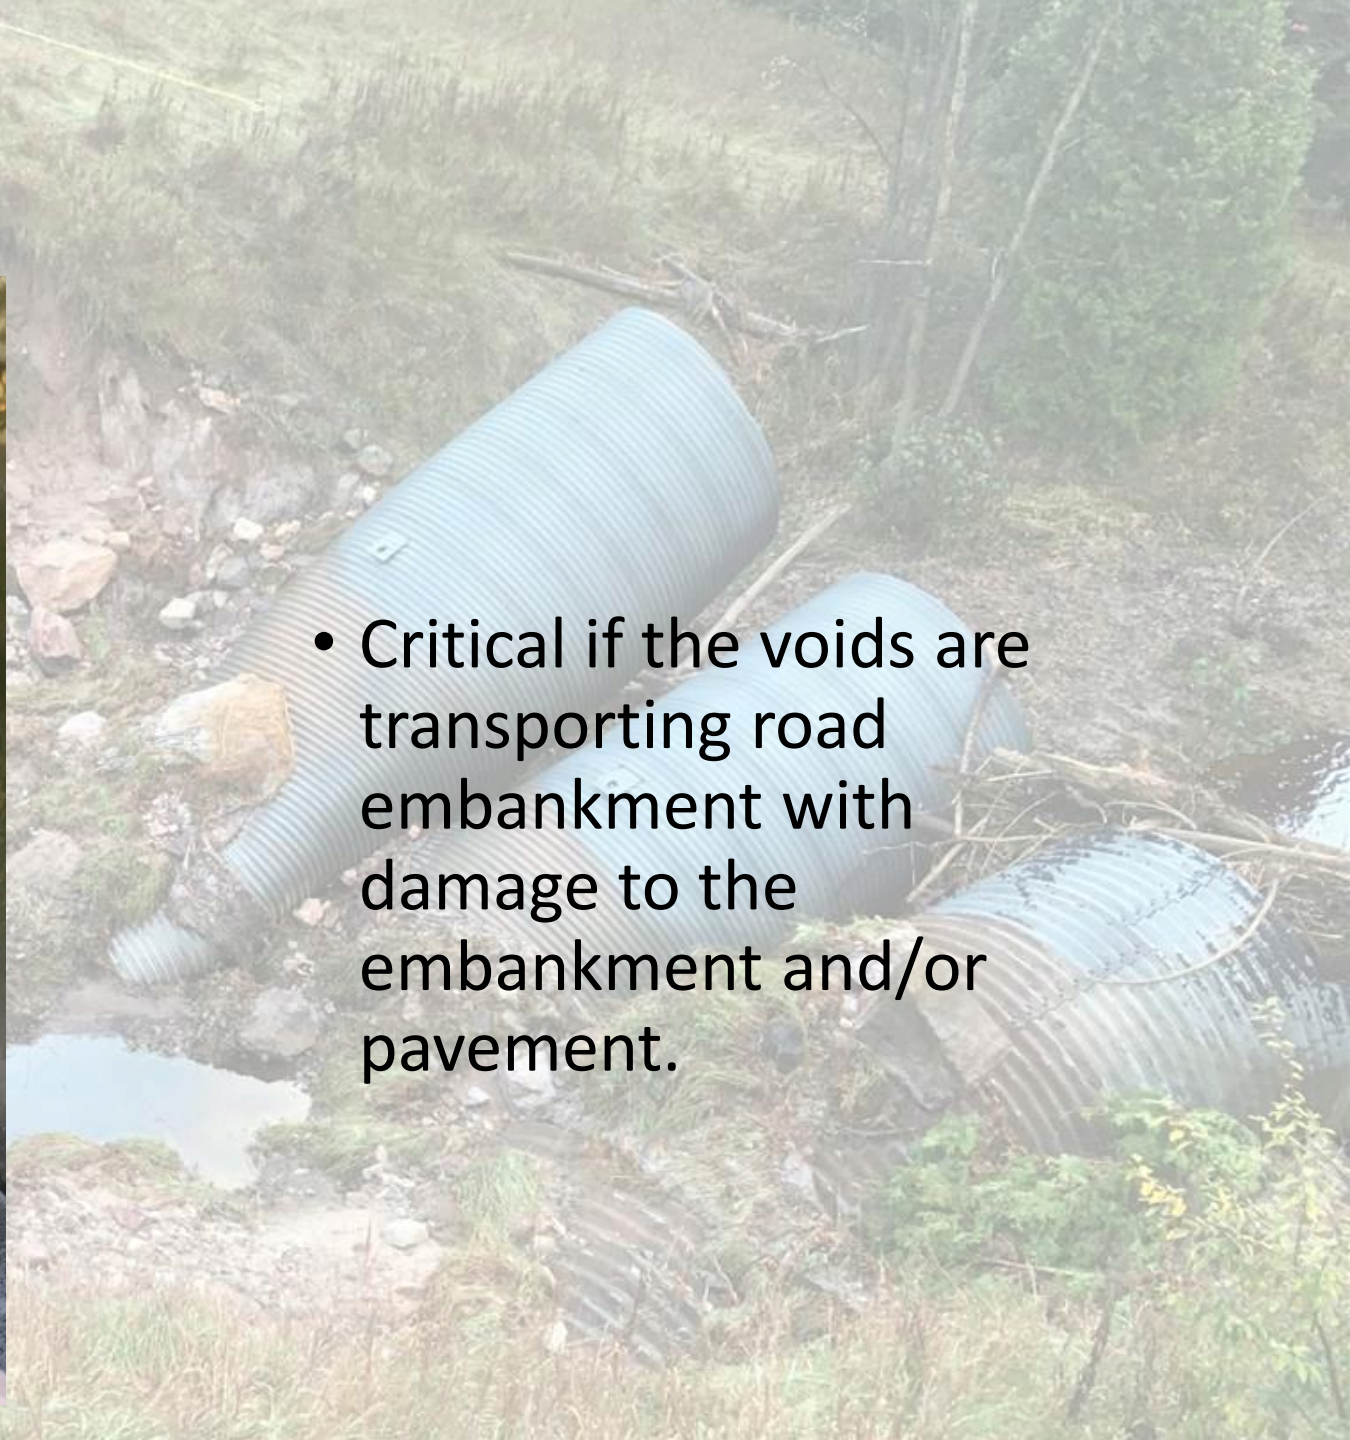
- Critical if the voids are transporting road embankment with damage to the embankment and/or pavement.

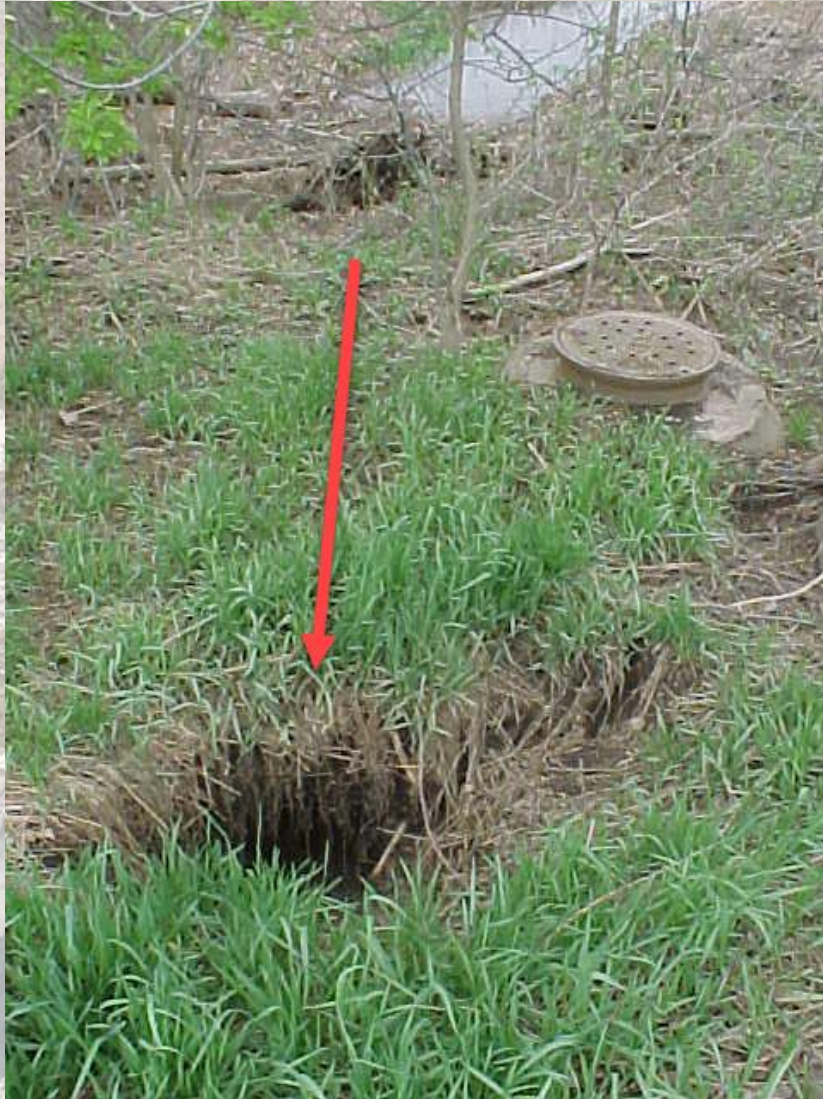
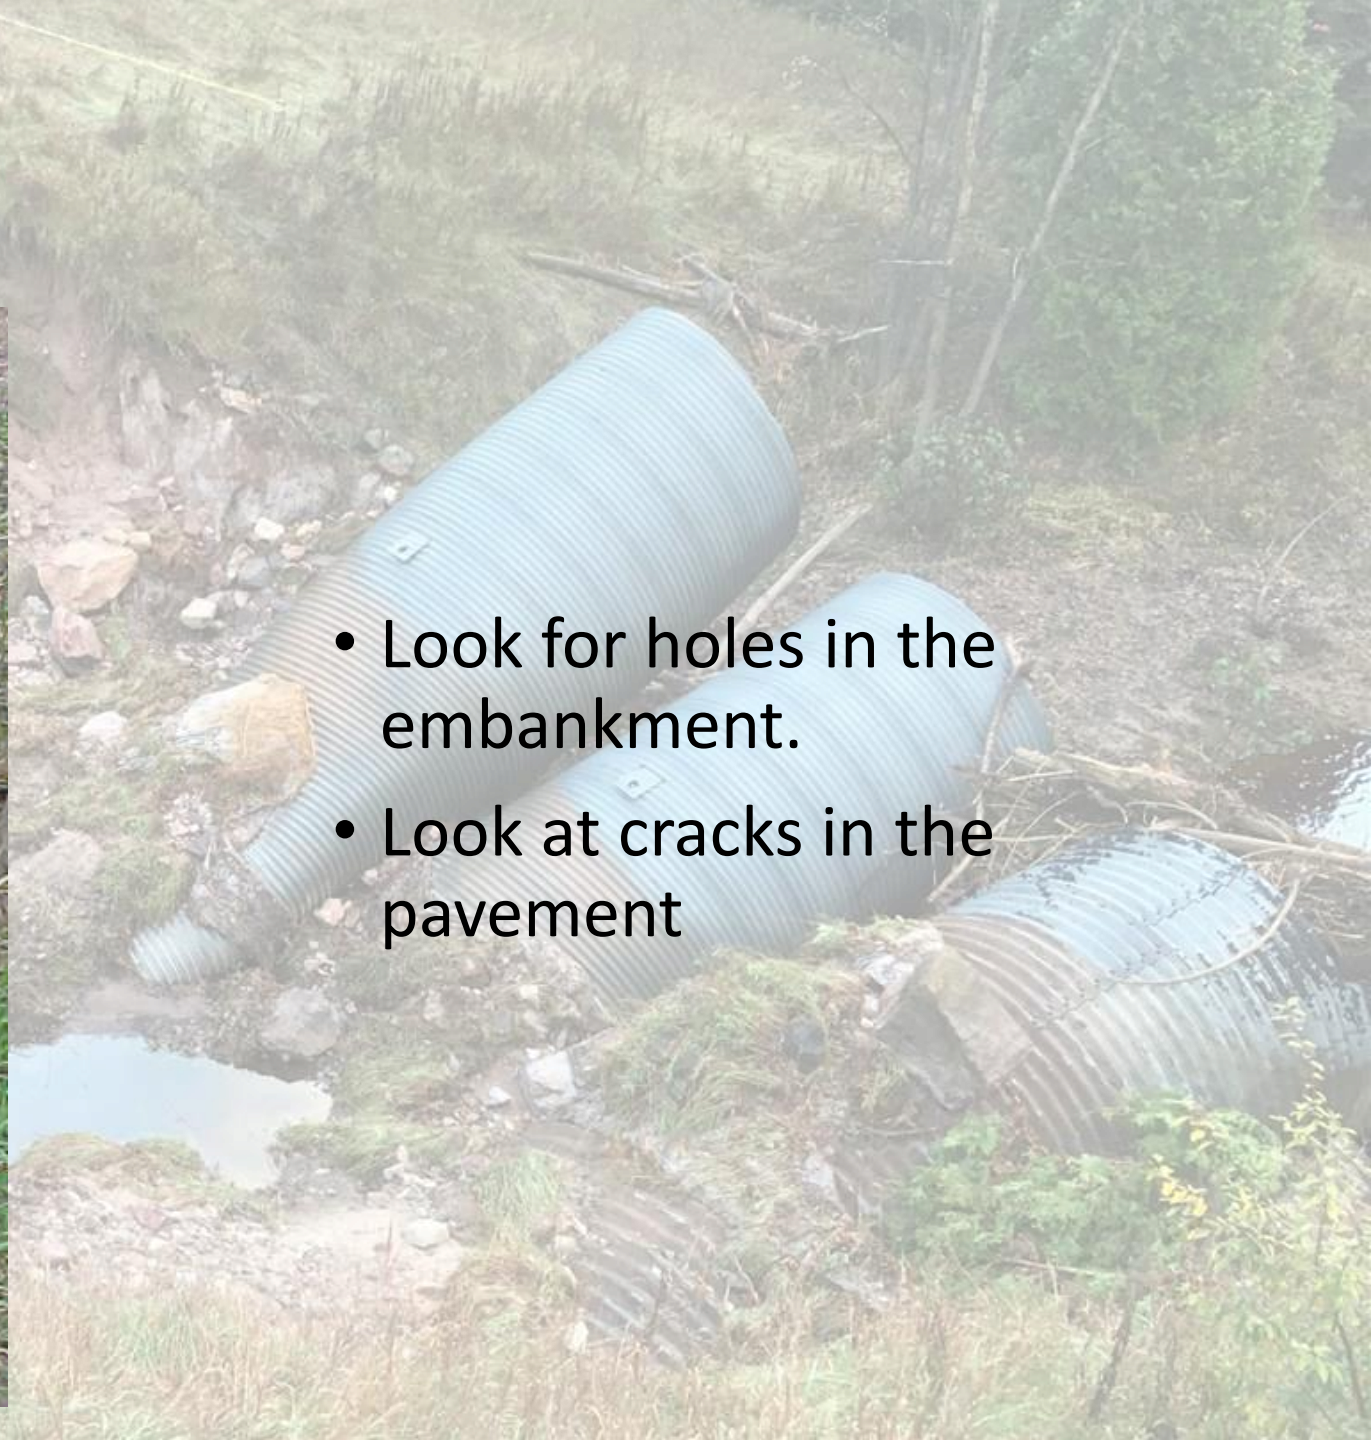
- Look for holes in the embankment.
- Look at cracks in the pavement

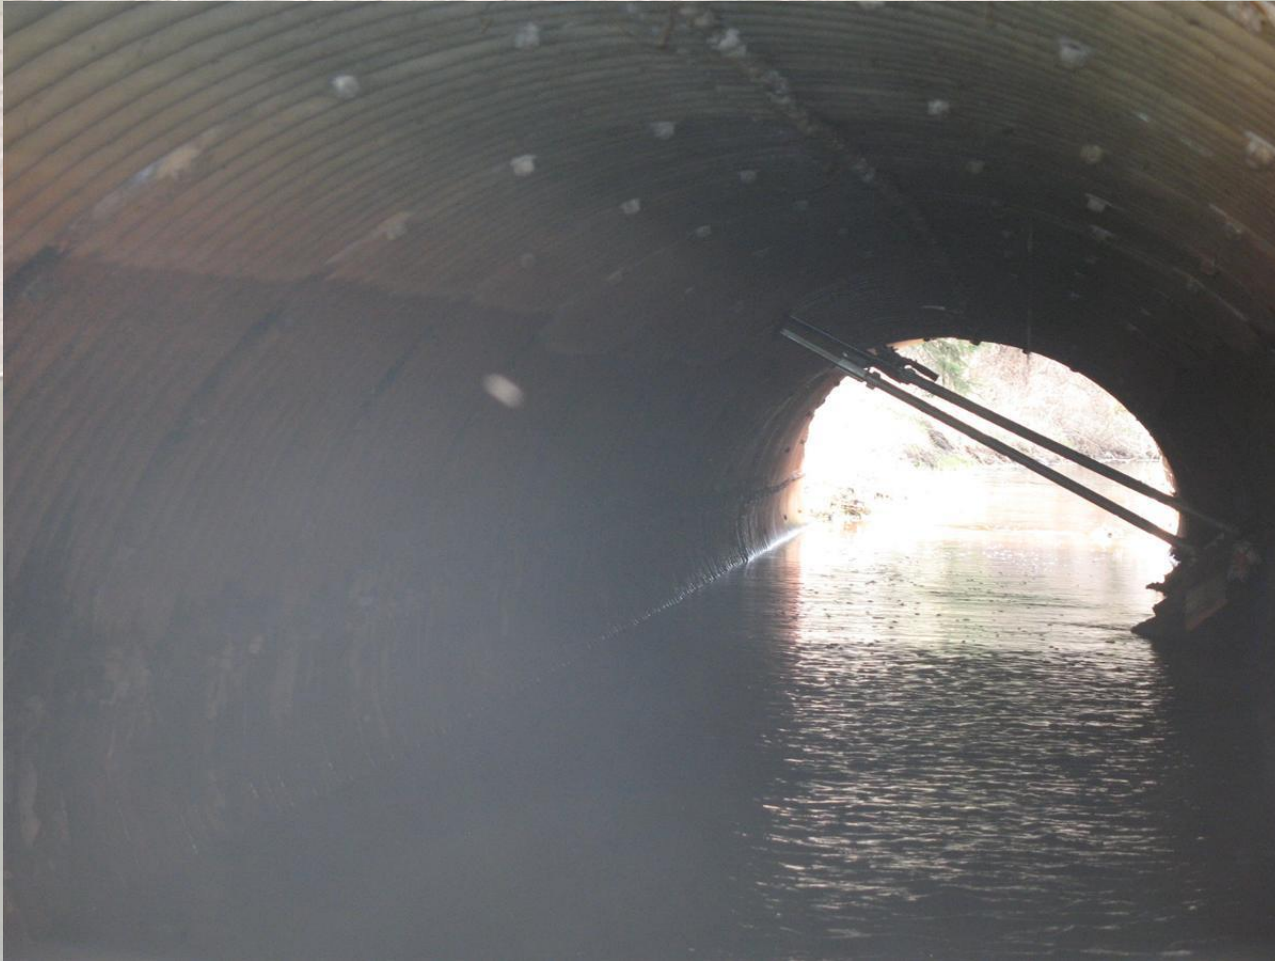
- Typically more of a concern with flexible pipe (metal or plastic)
- Bulging on the bottom half of the culvert may be an indicator of high groundwater table (referred to as a “boil”).

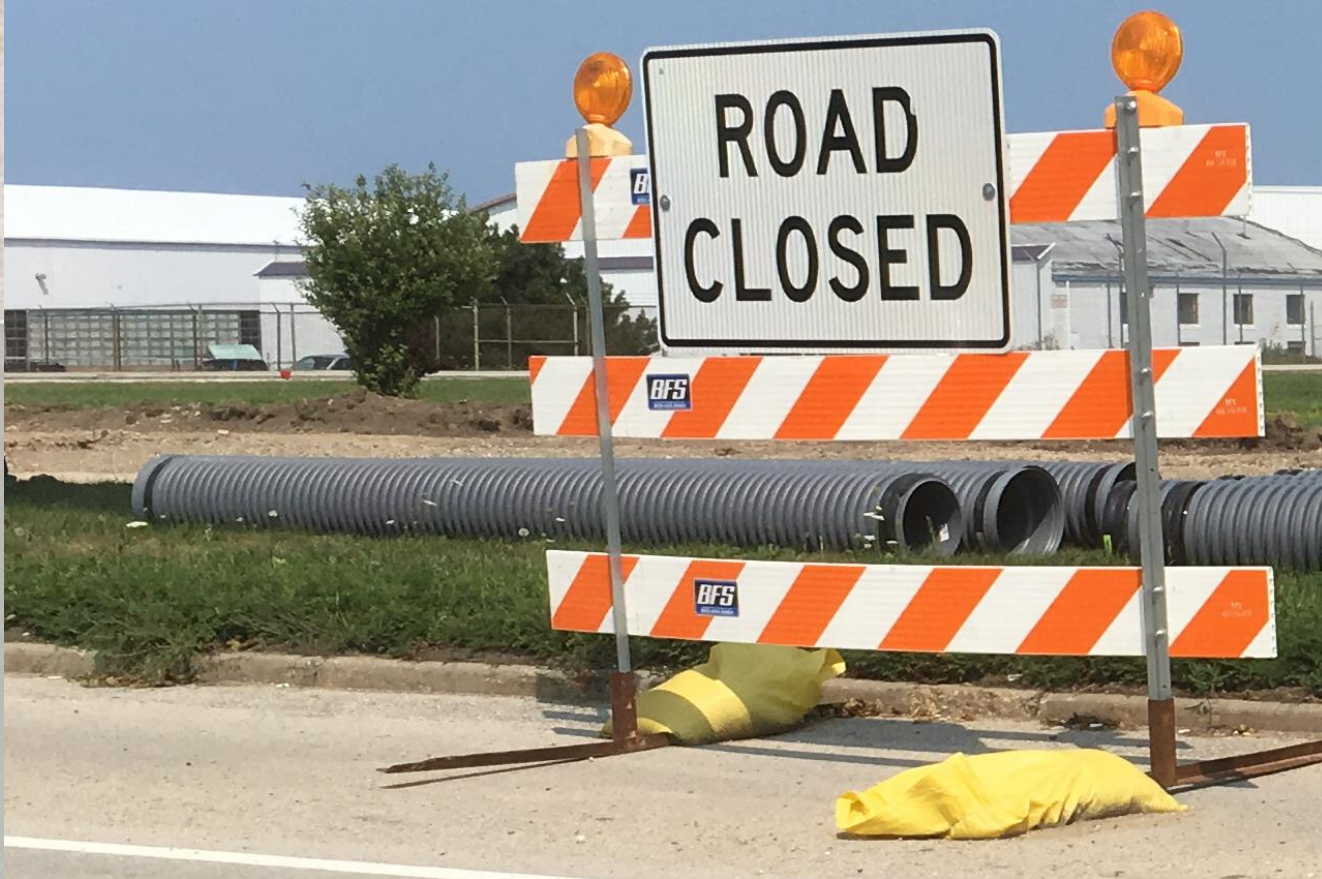
- Multiple forms of “plastic” pipe (HDPE, polyethylene, polypropylene).
- Department to track polypropylene pipe installations.

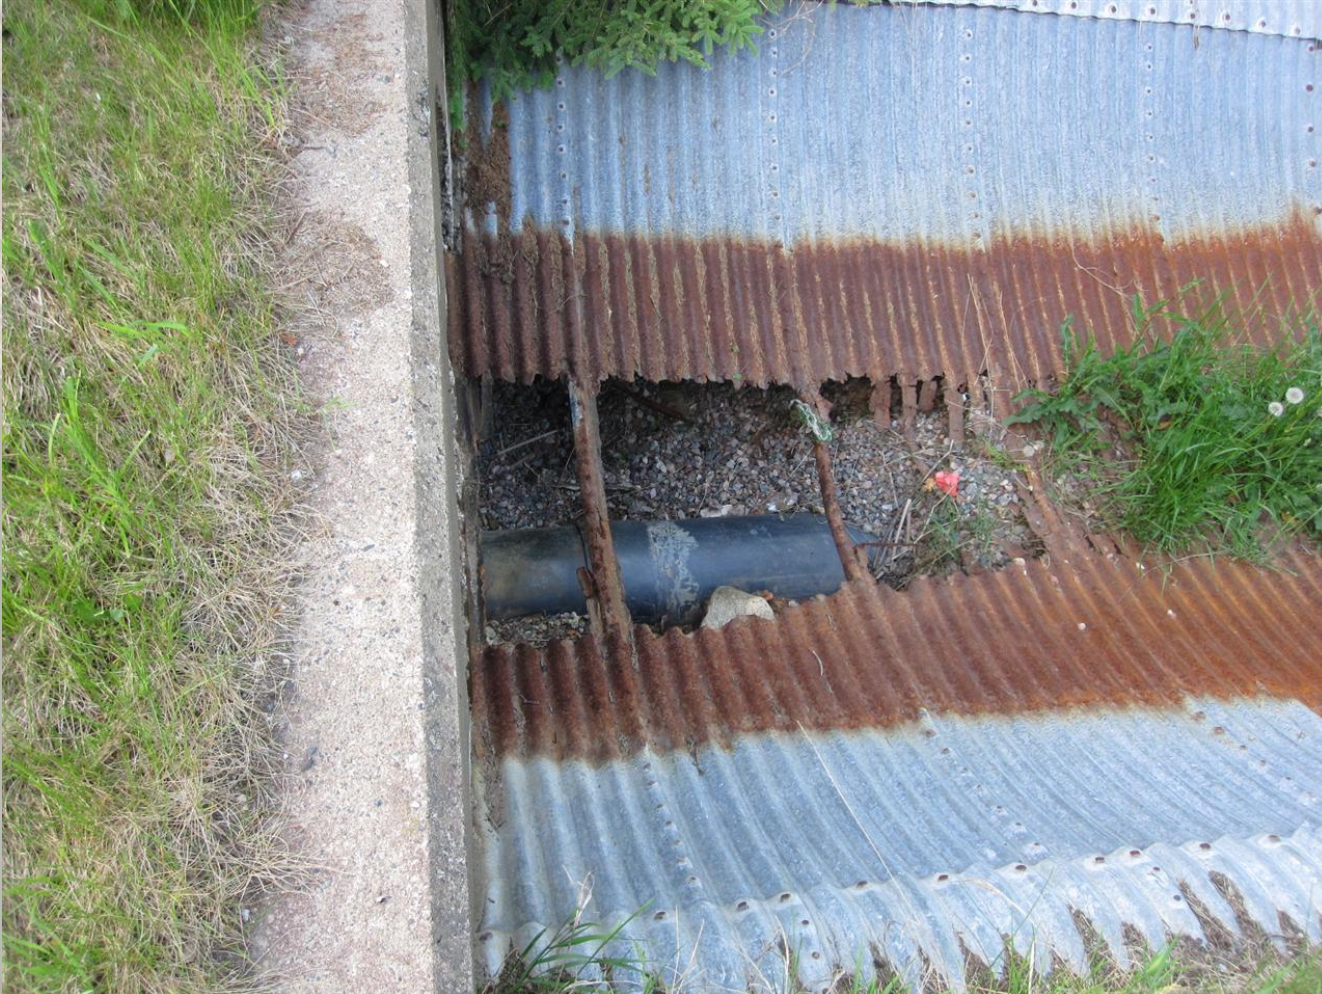
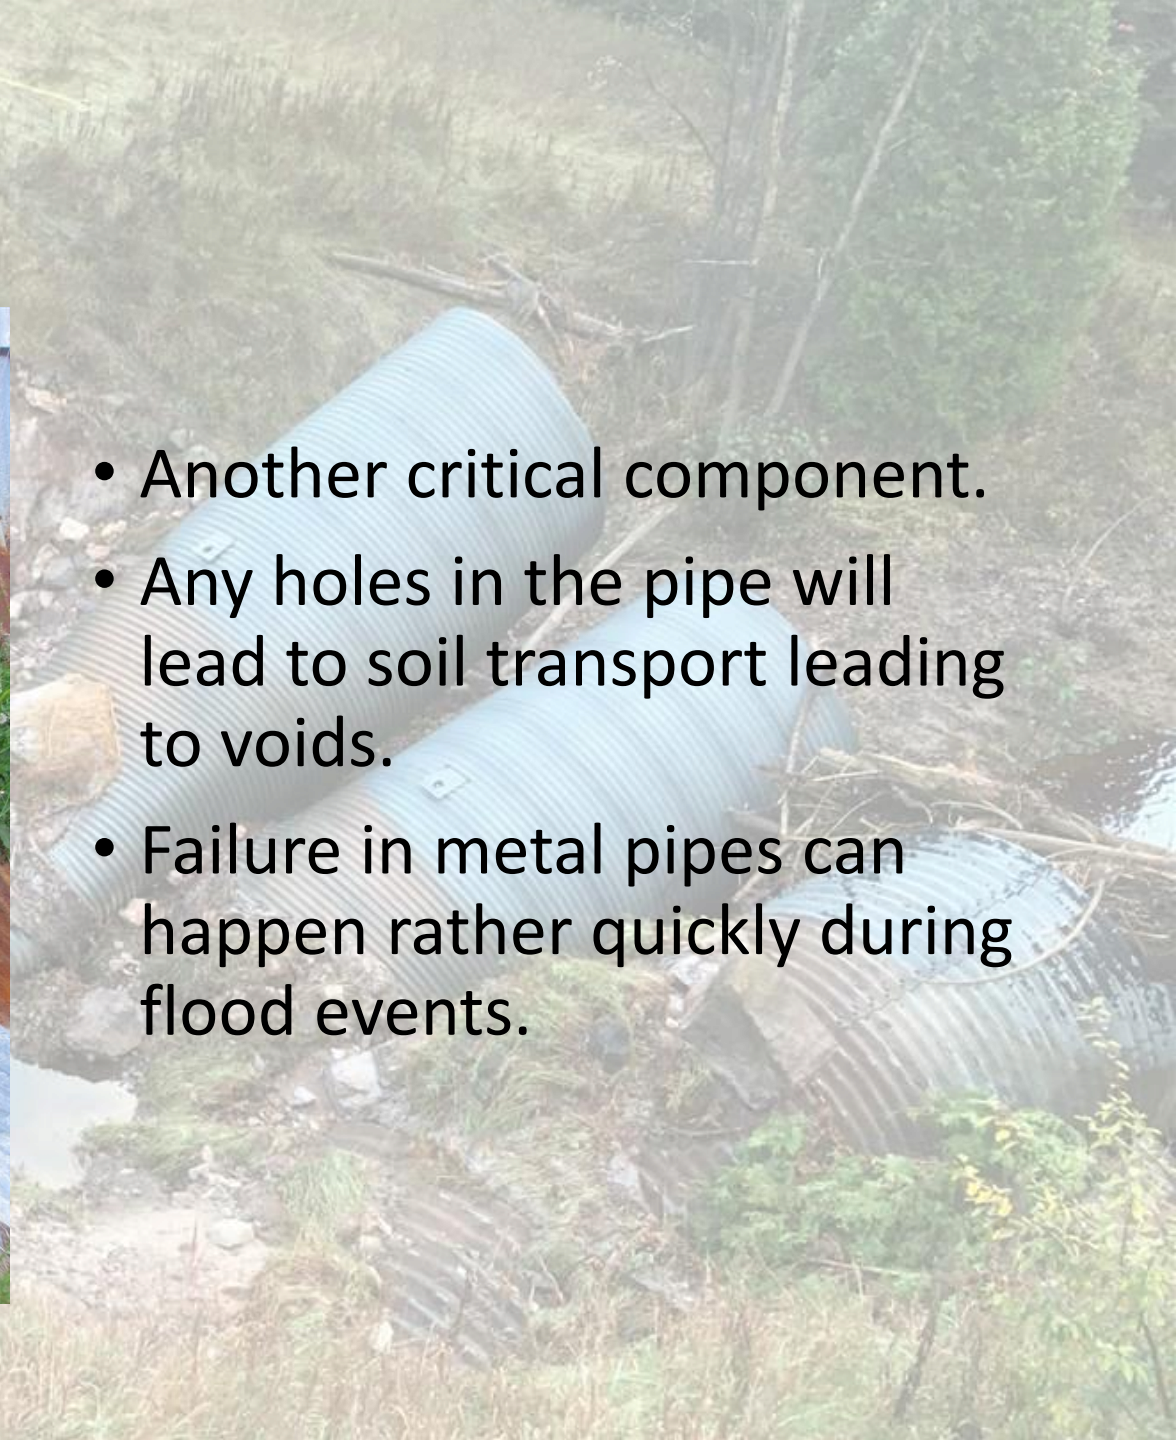
- Another critical component.
- Any holes in the pipe will lead to soil transport leading to voids.
- Failure in metal pipes can happen rather quickly during flood events.

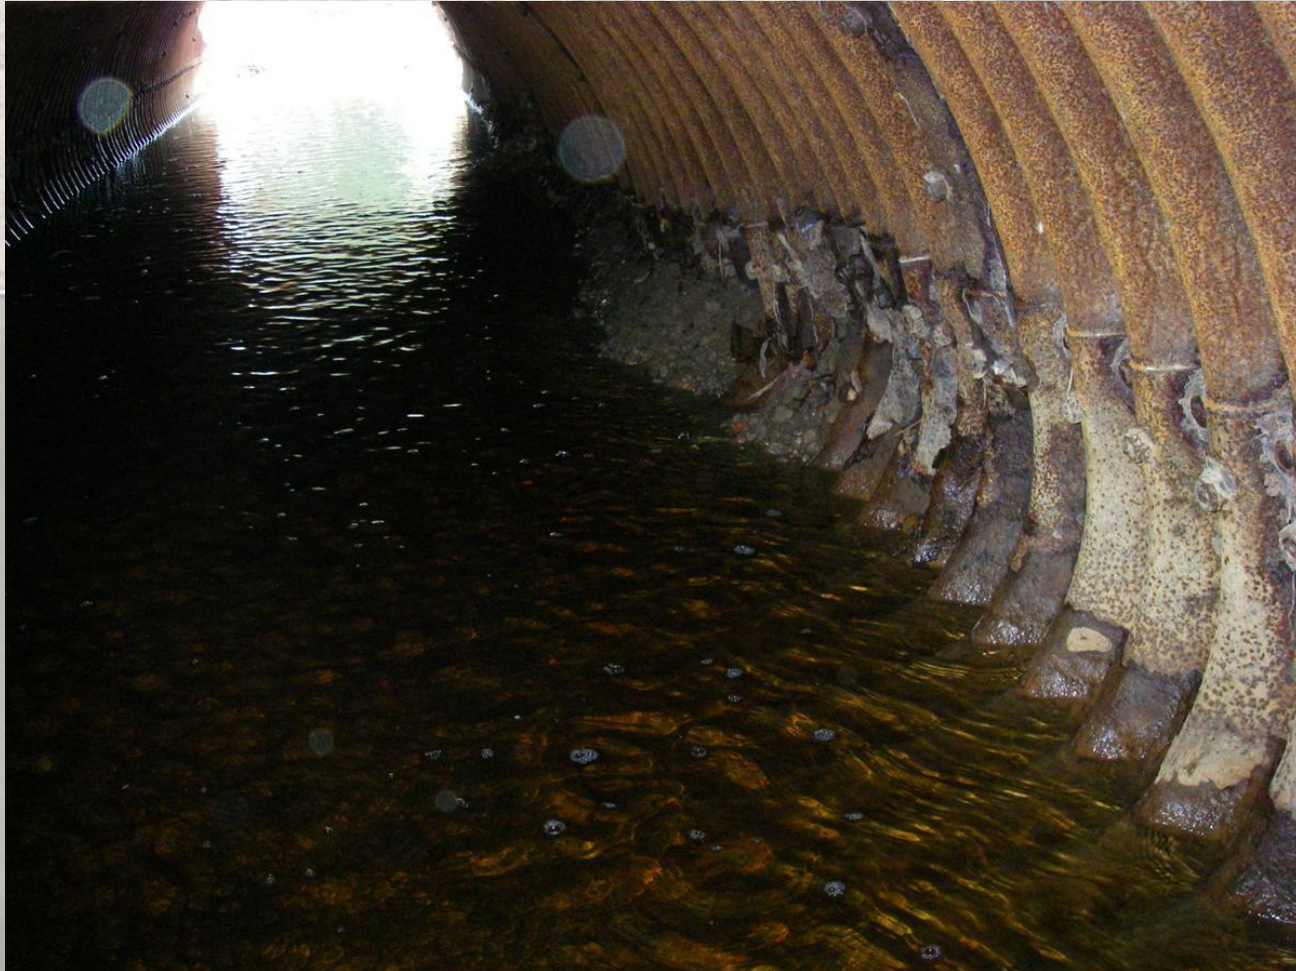
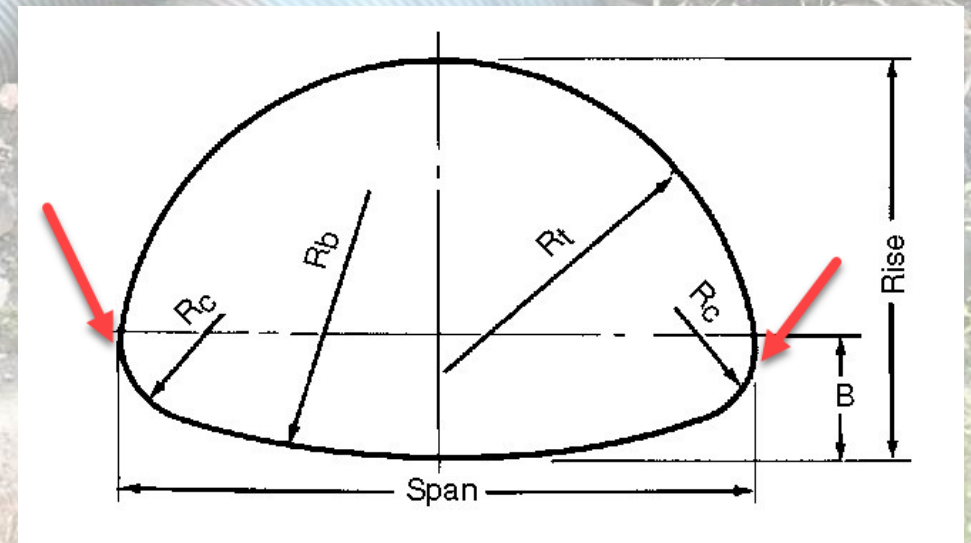
- Corrosion at the lower hinge point of arch pipe can be problematic

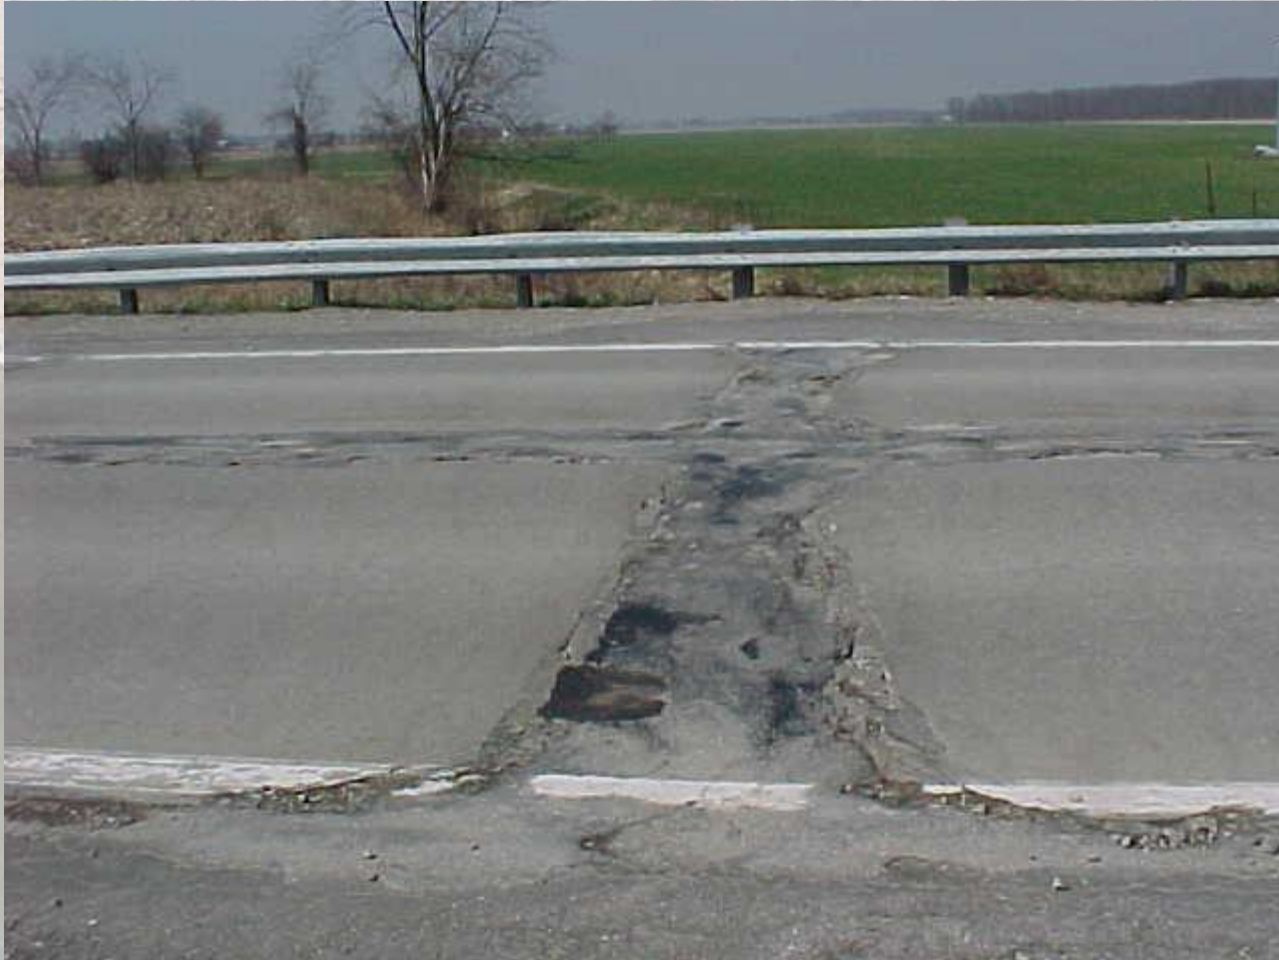
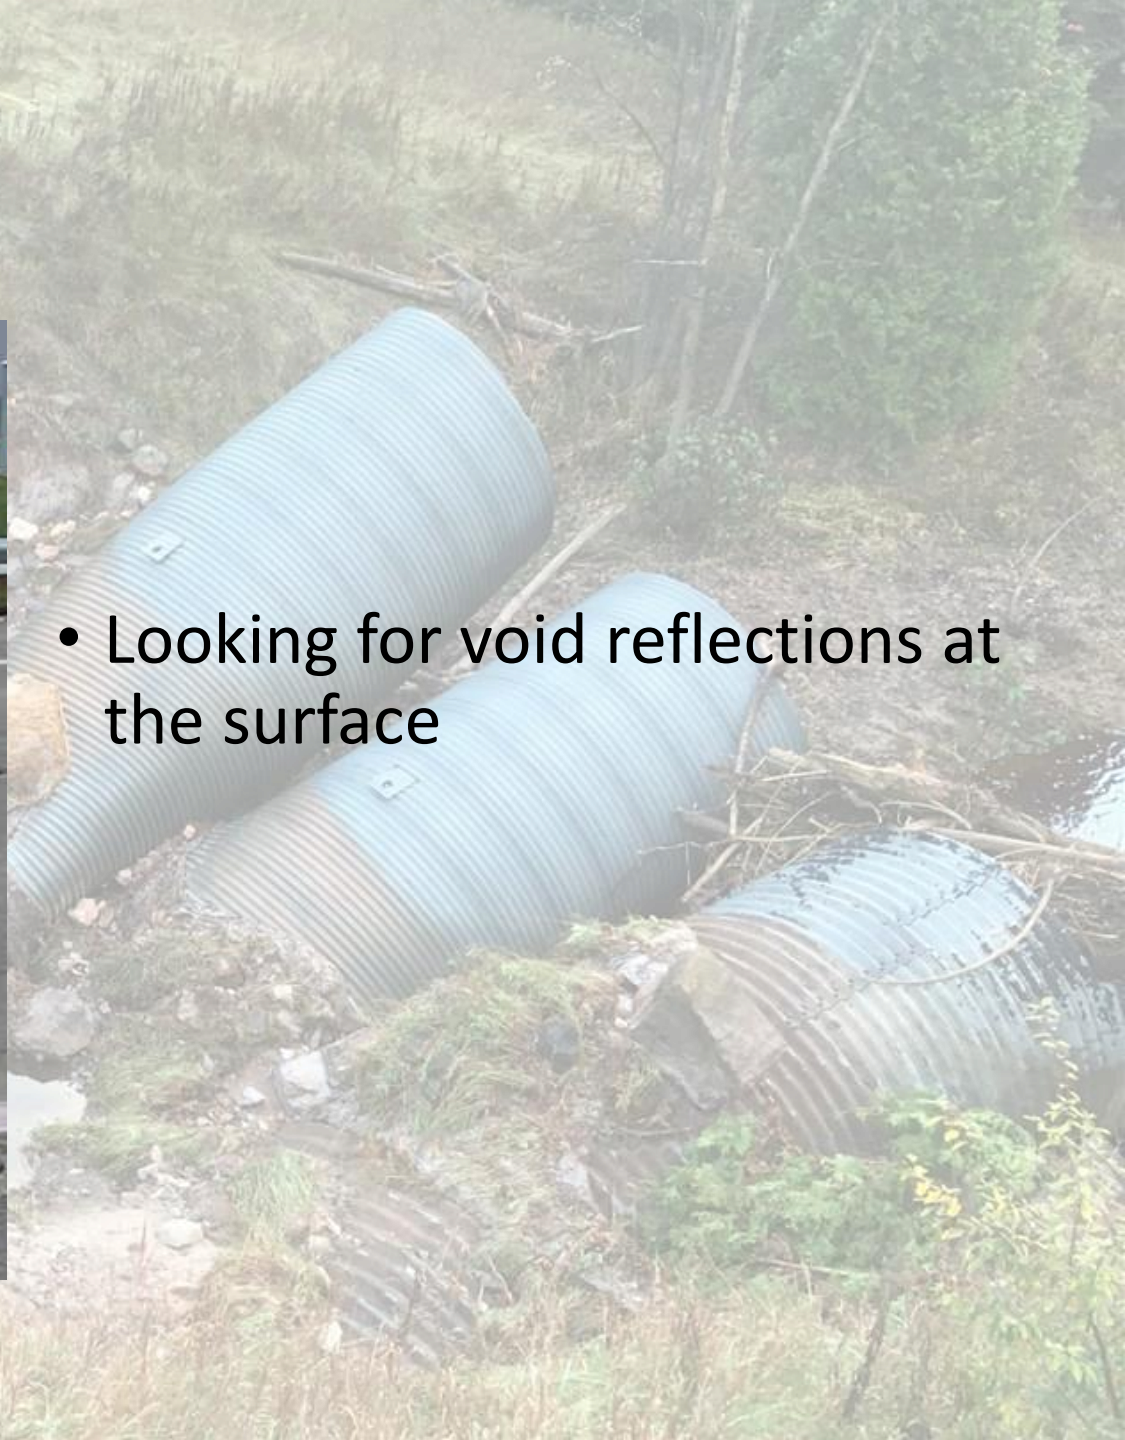
- Looking for void reflections at the surface

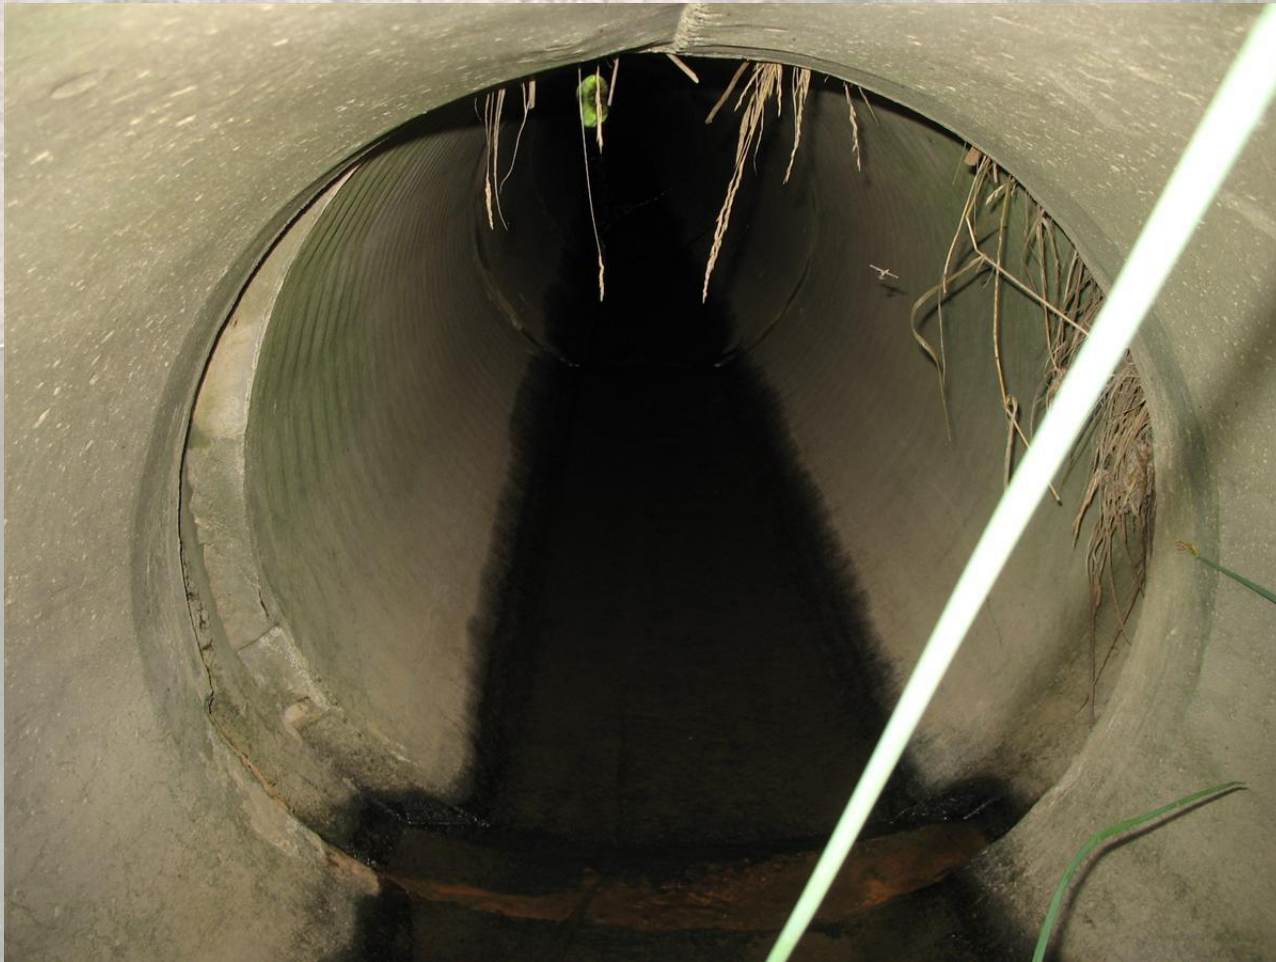
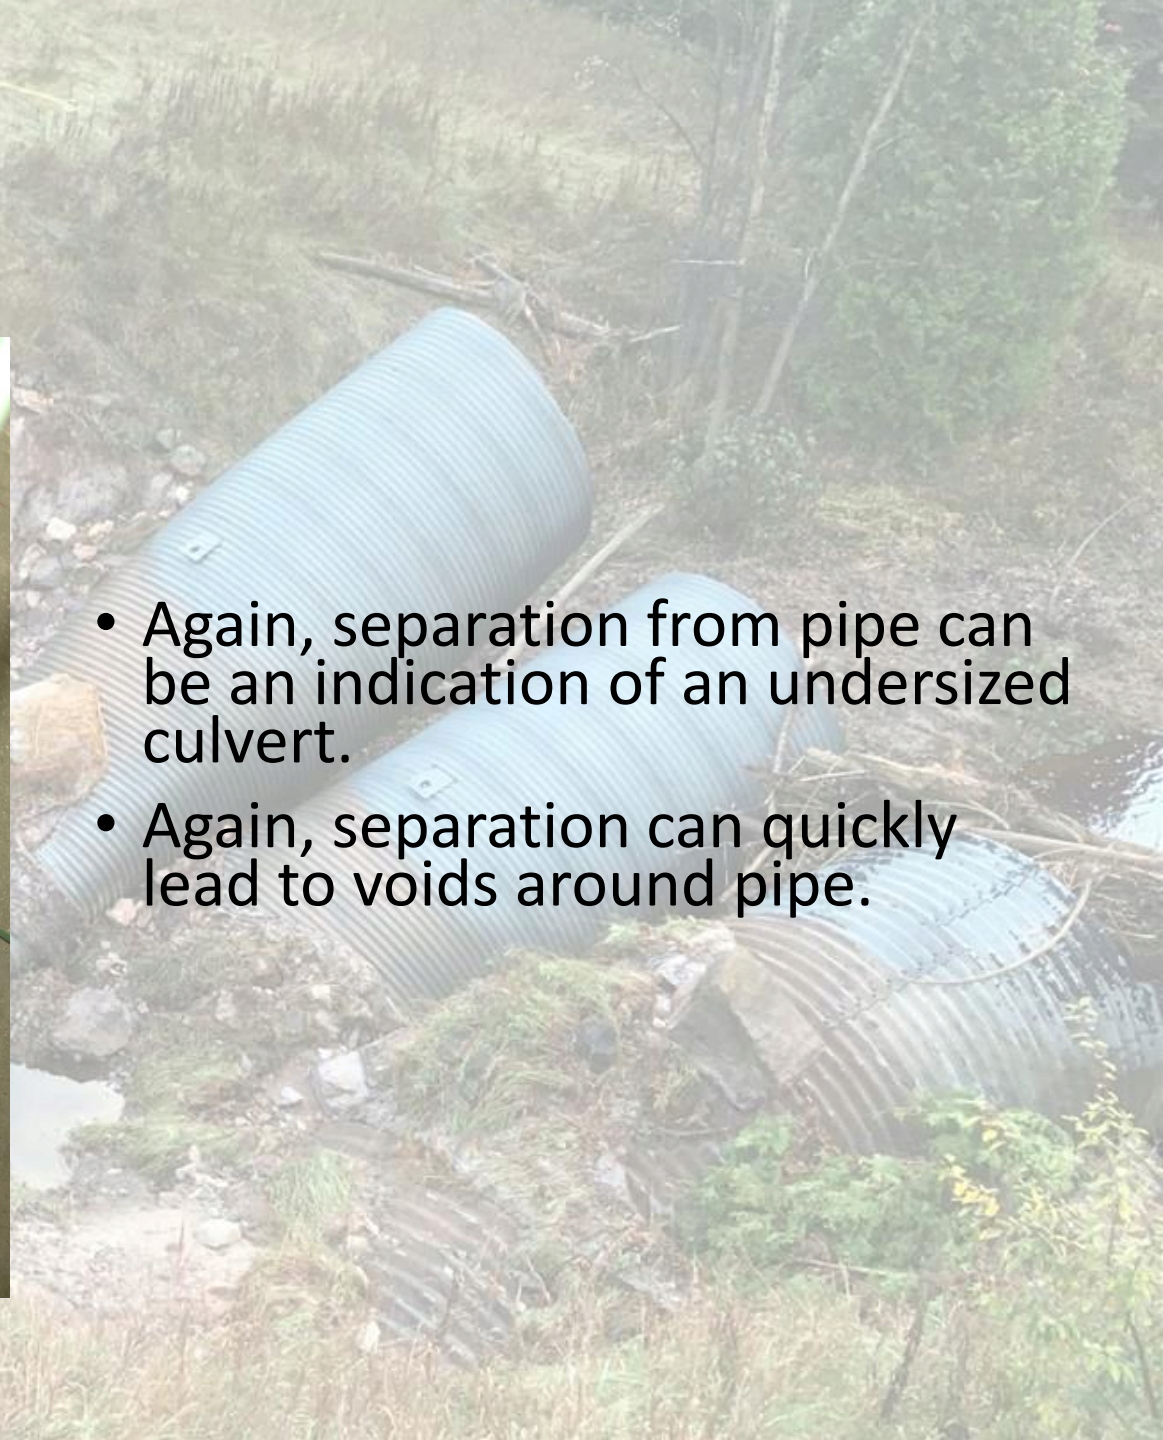
- Again, separation from pipe can be an indication of an undersized culvert.
- Again, separation can quickly lead to voids around pipe.

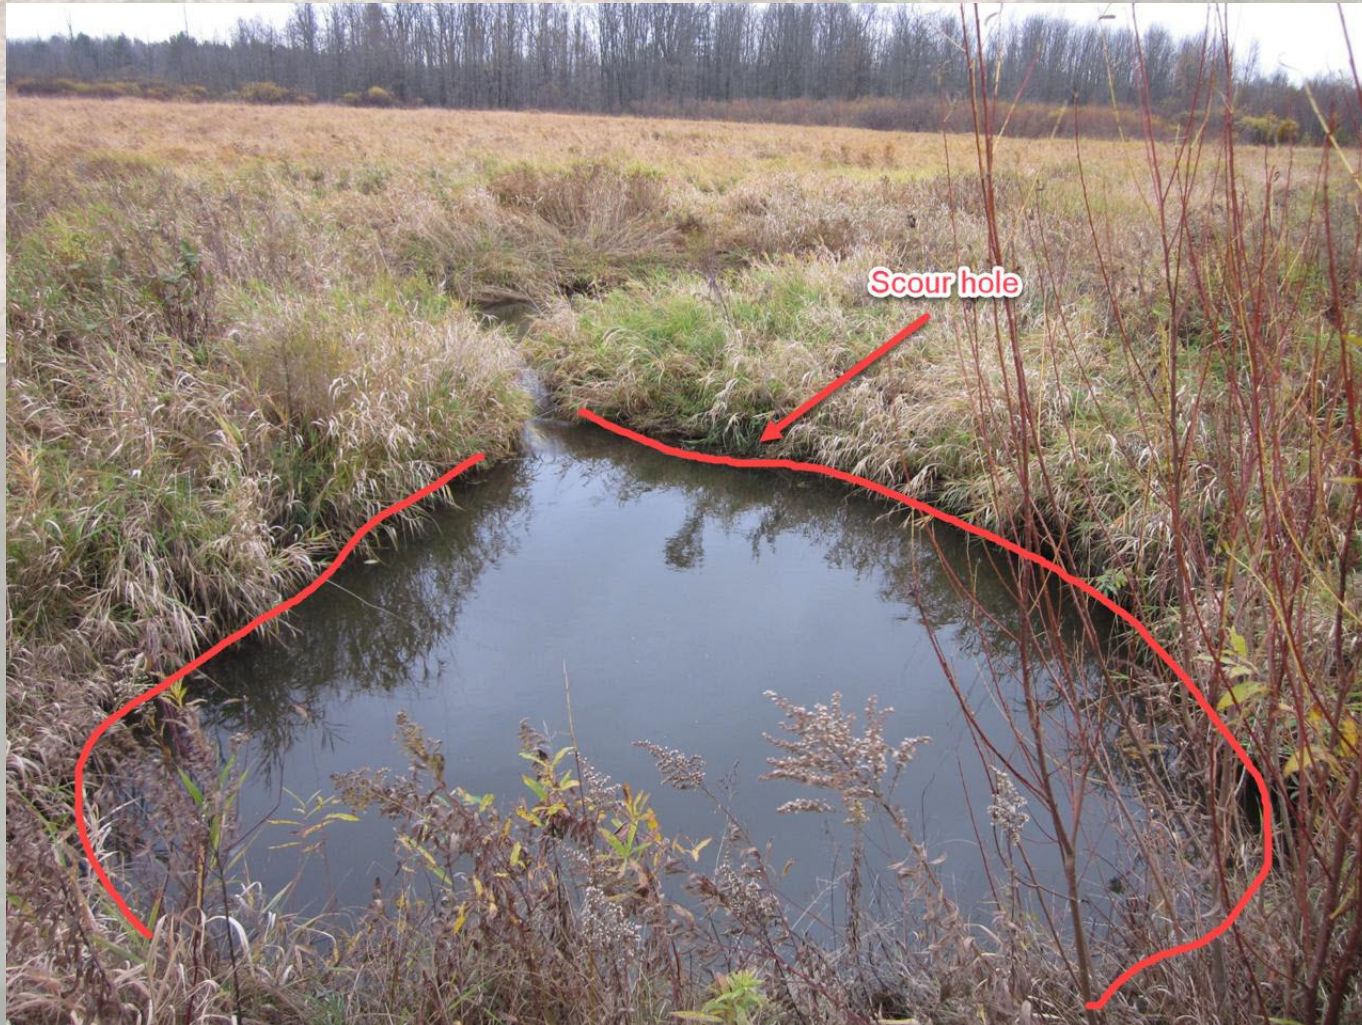
- Usually an indicator of an undersized pipe.
- Can lead to end section separation at the outlet.
- Can lead to piping underneath culvert, leading to voids
