# Culvert Inspection/Maintenance

Erik Carlson, PE  
Hydraulic Unit Supervisor

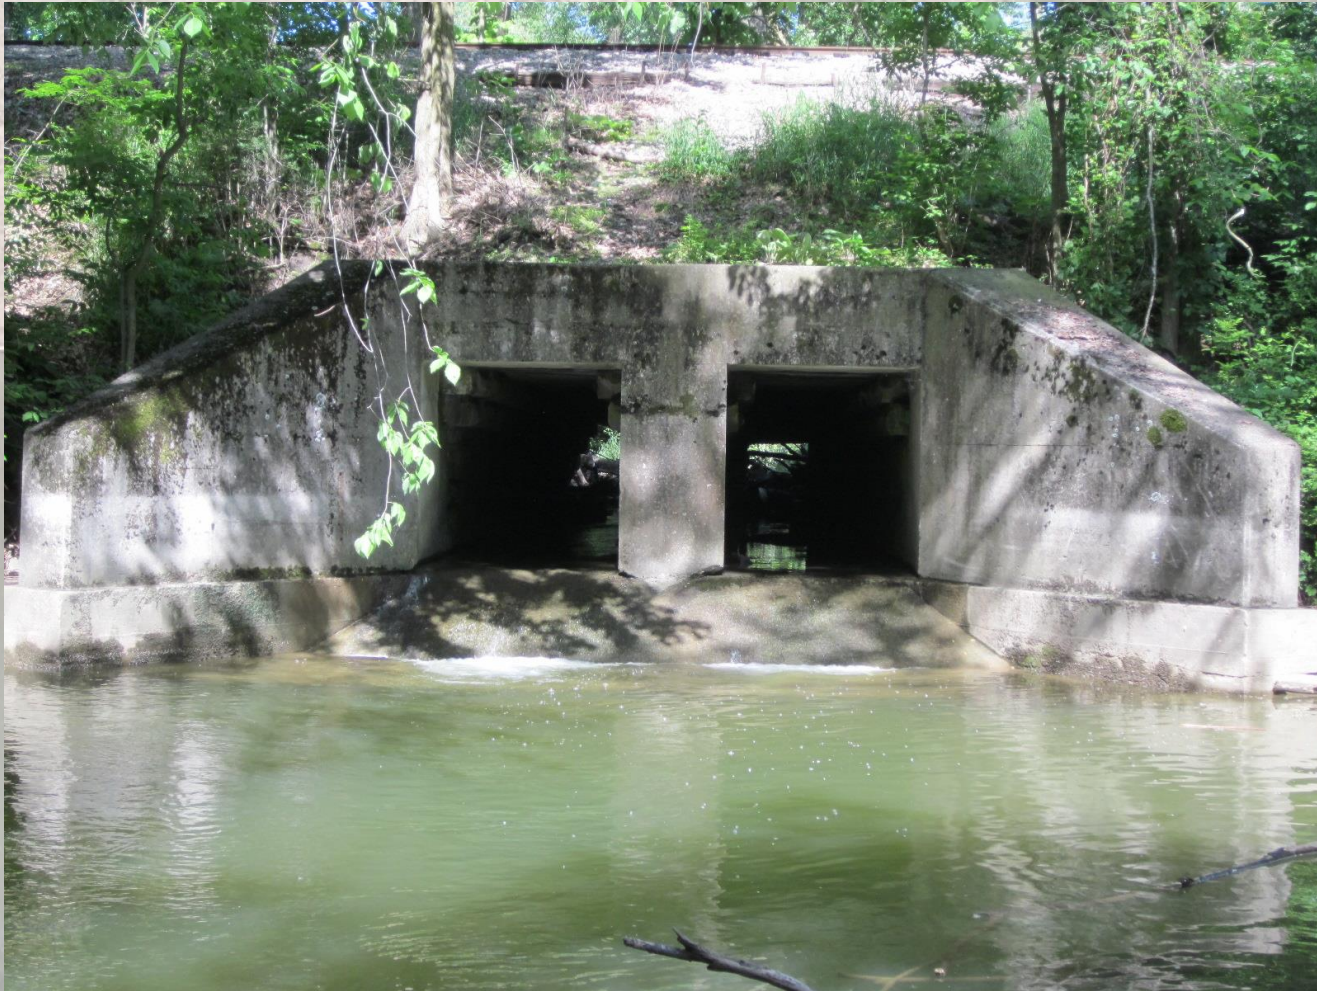
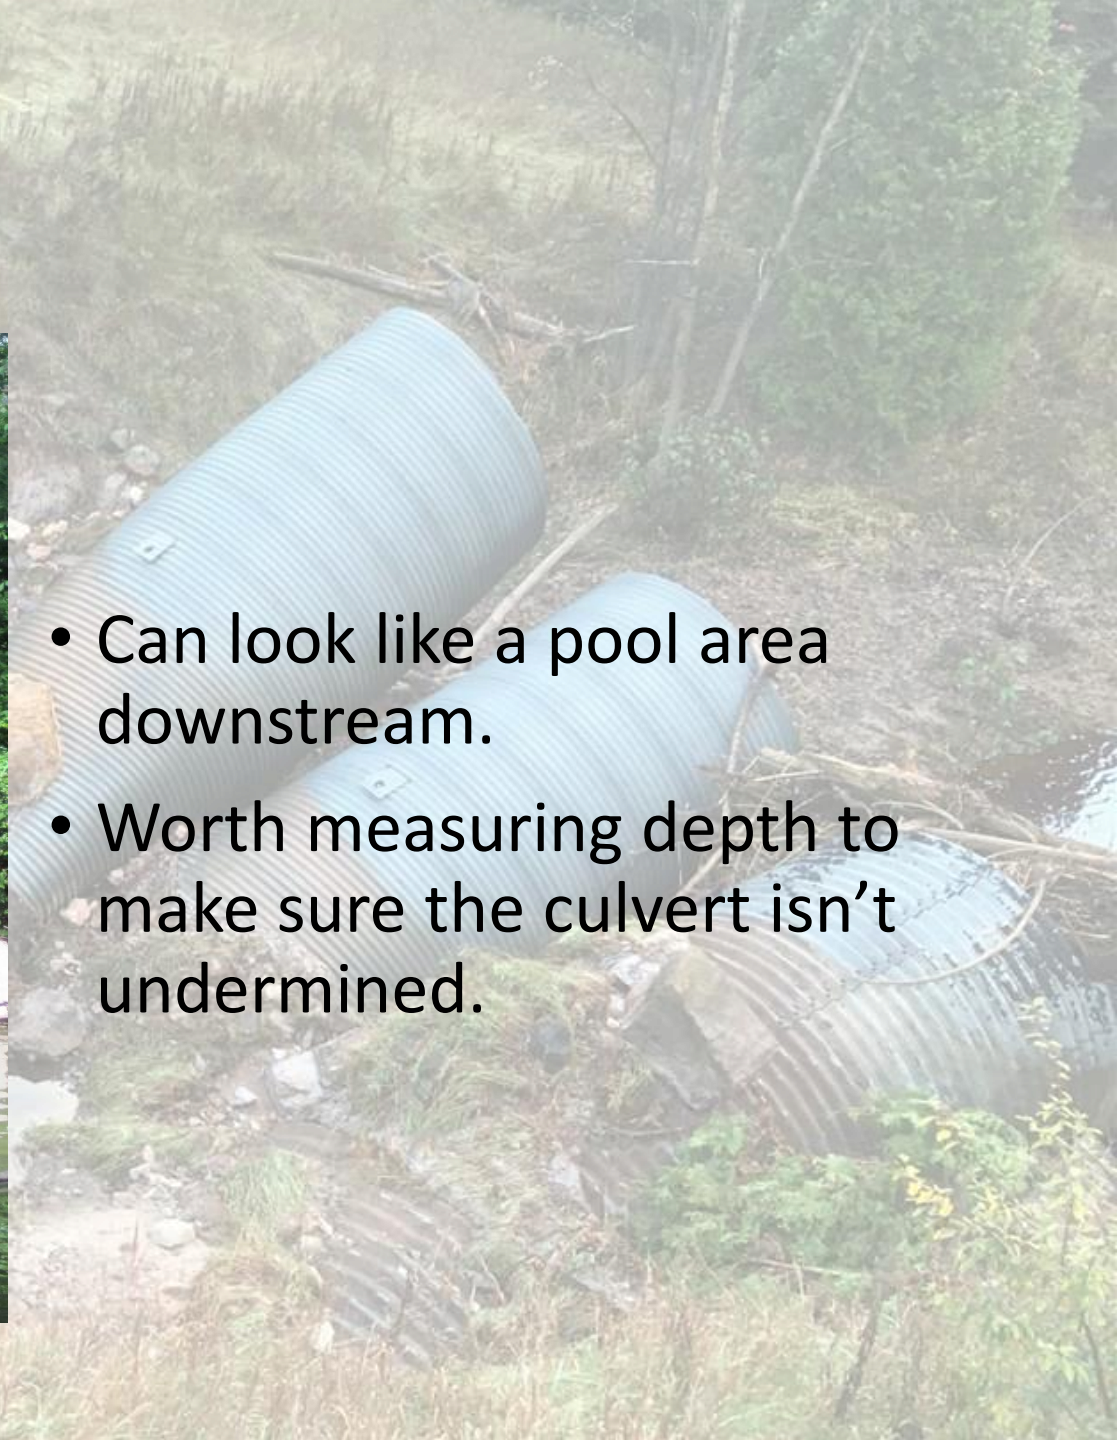
- Can look like a pool area downstream.
- Worth measuring depth to make sure the culvert isn't undermined.

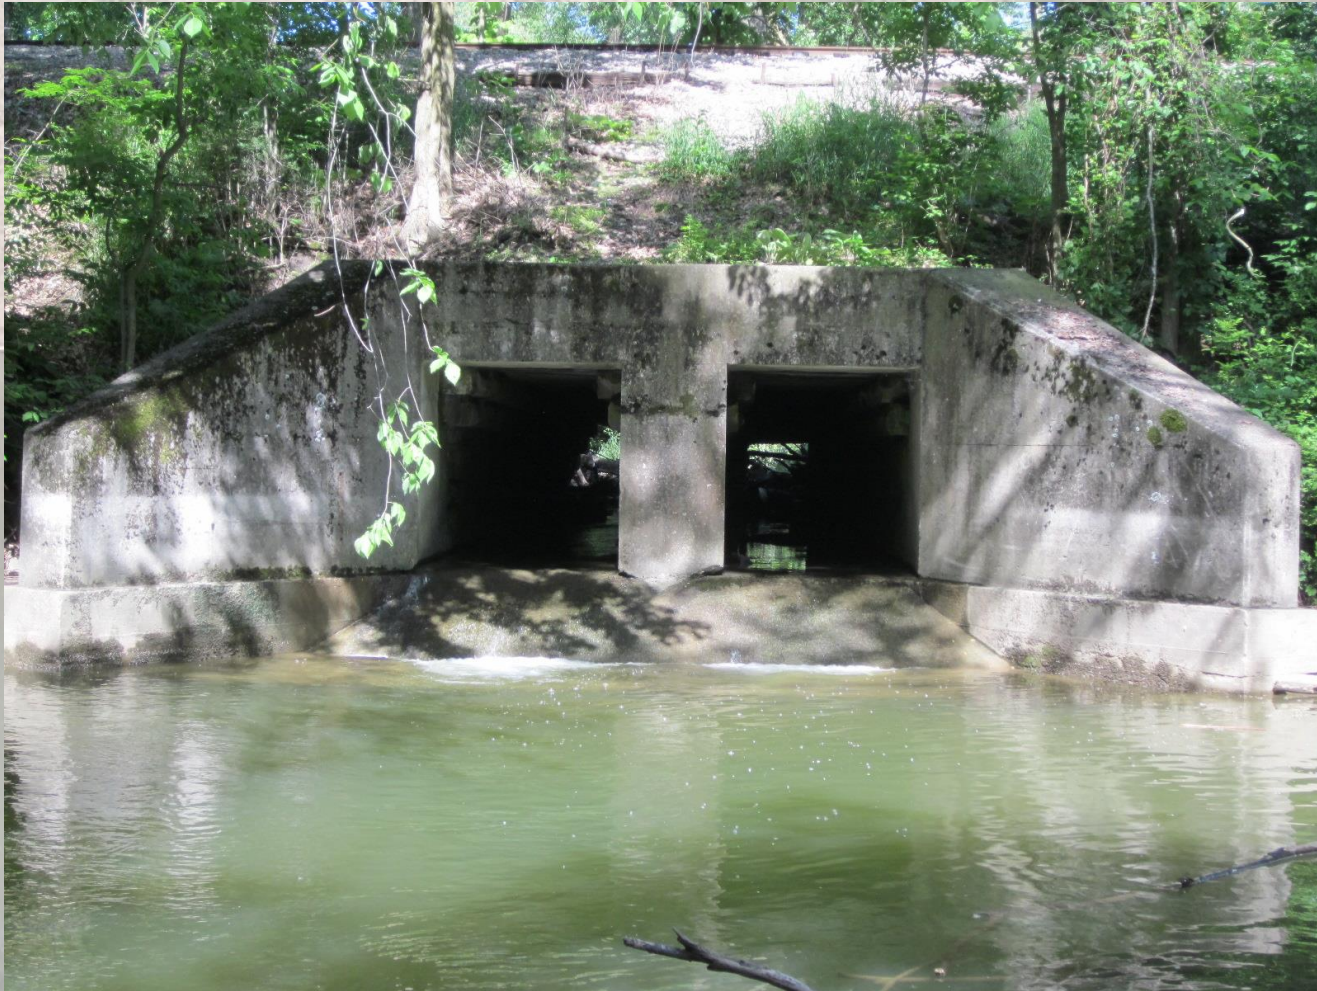
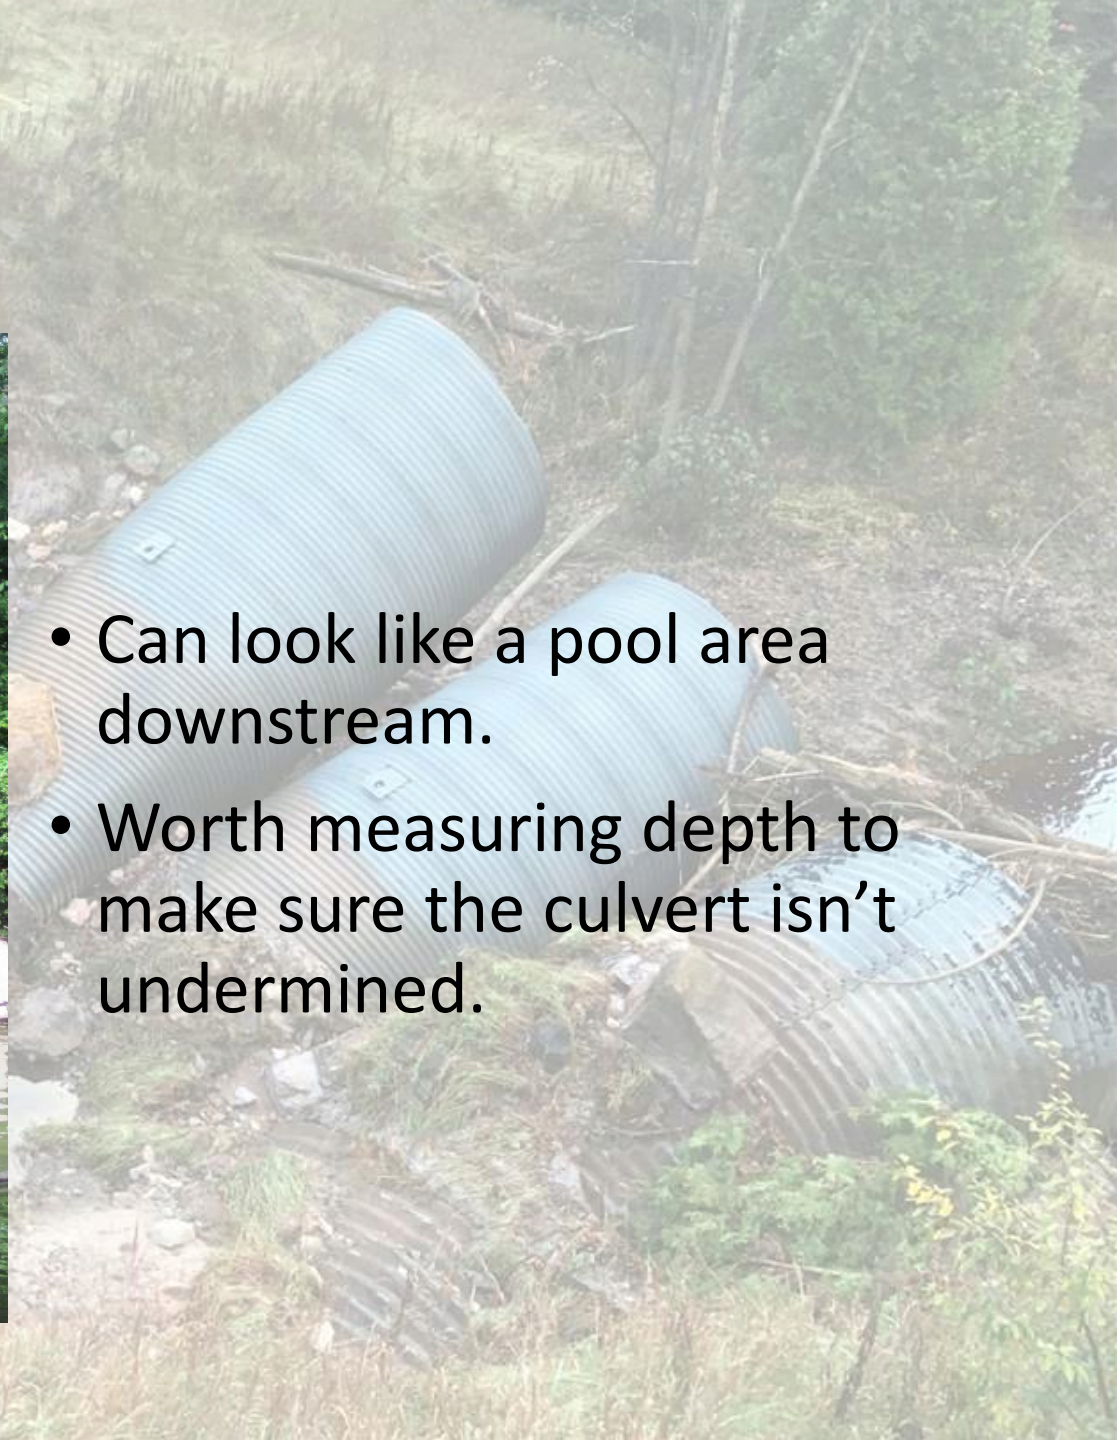
- Can look like a pool area downstream.
- Worth measuring depth to make sure the culvert isn't undermined.

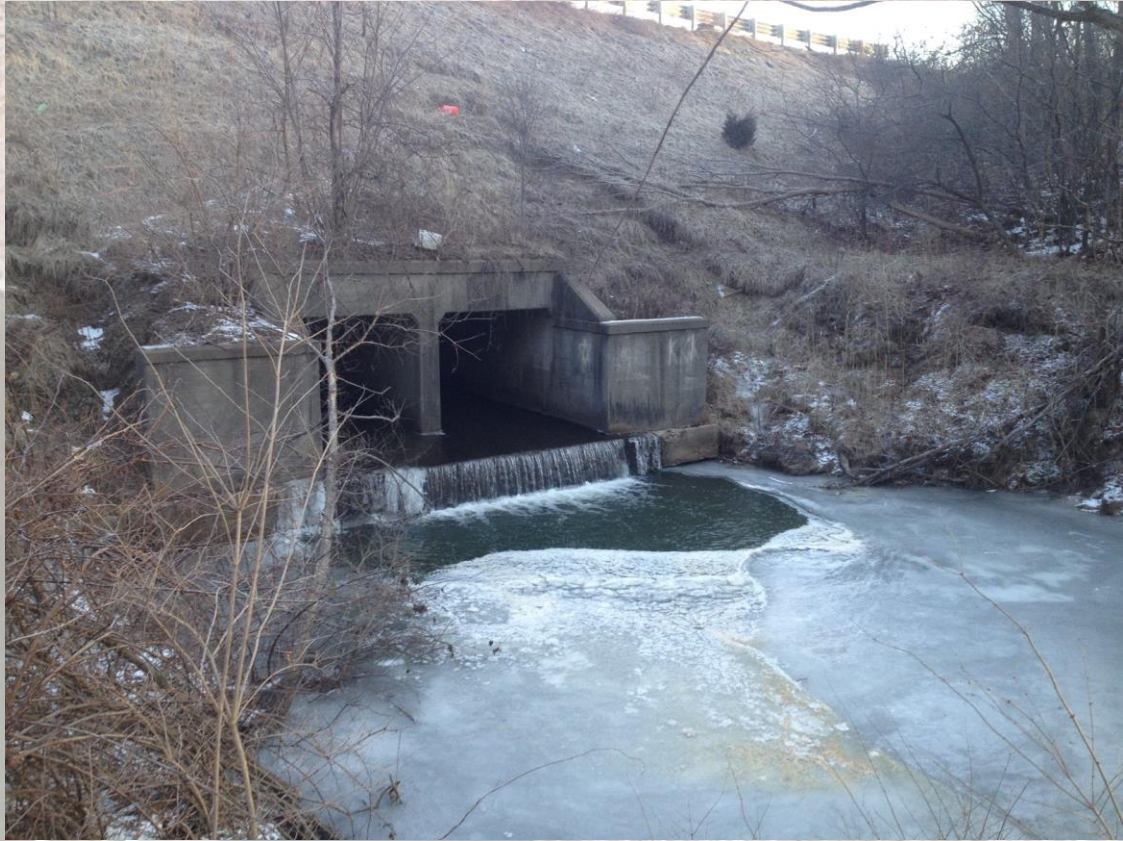
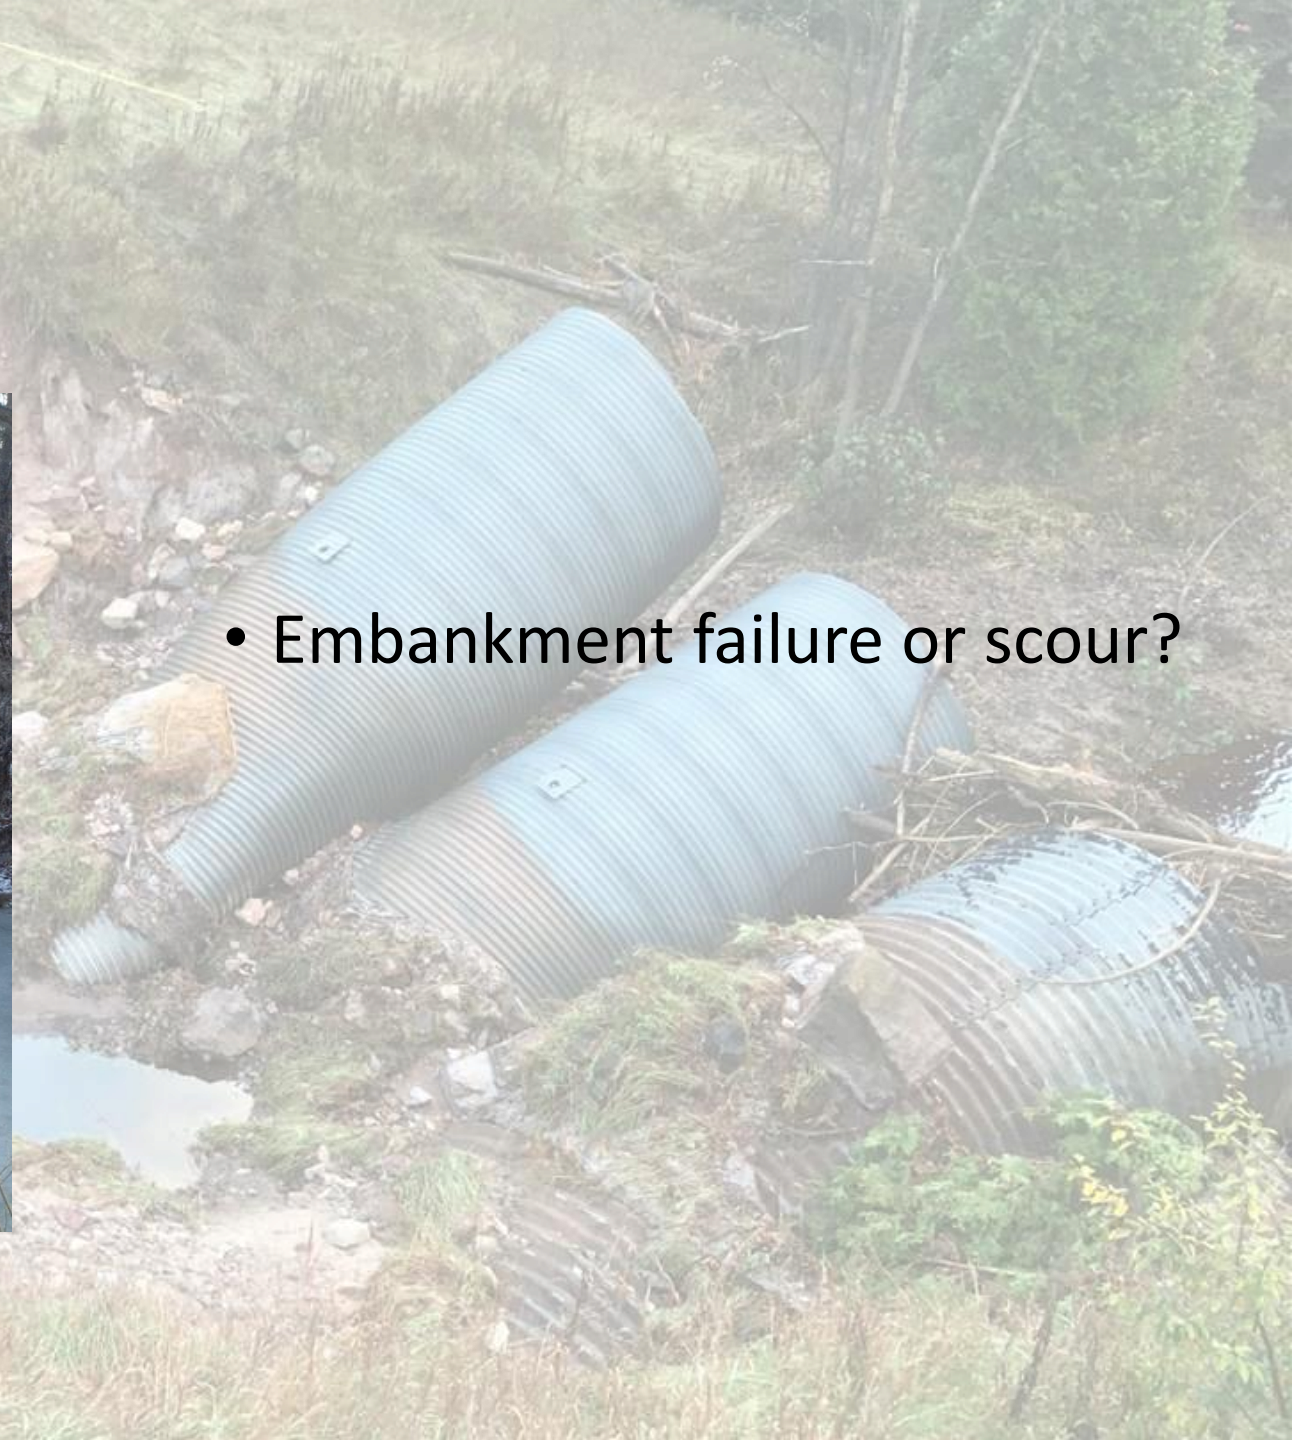
- Embankment failure or scour?

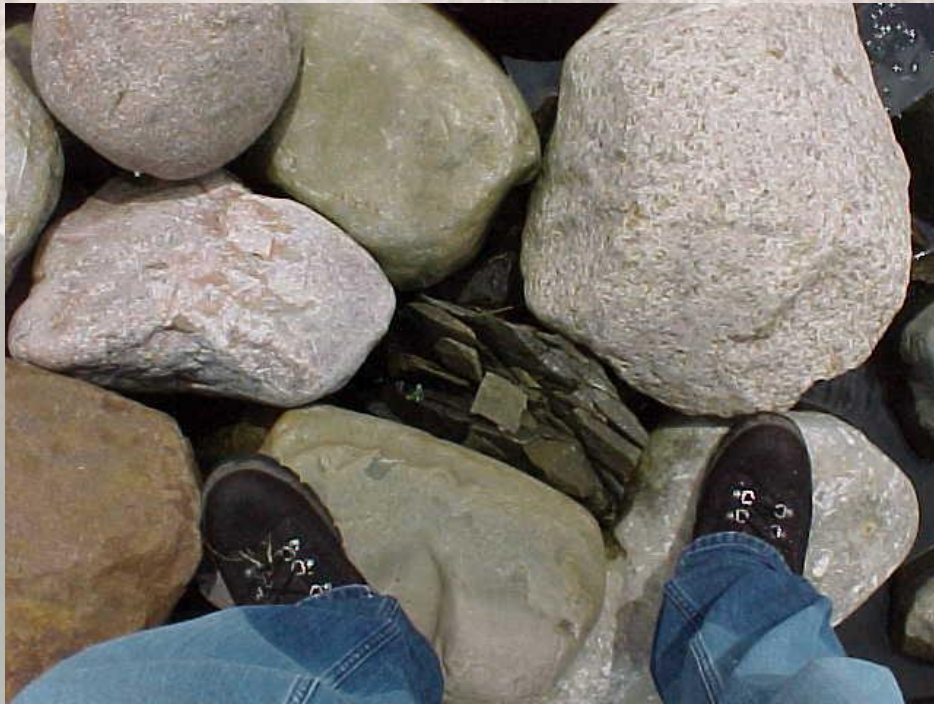
- Multiple failure methods (toe failure, shear failure, winnowing, dissolution).
- Sometimes the riprap is still in place, but overgrown with vegetation (need to probe).
- Can be critical inspection item for slab culverts.
- Need filter (i.e. geotextile) for success.
- Ideally riprap would extend min. 10 feet in all directions around culvert end section, and up road embankment above top of end section.

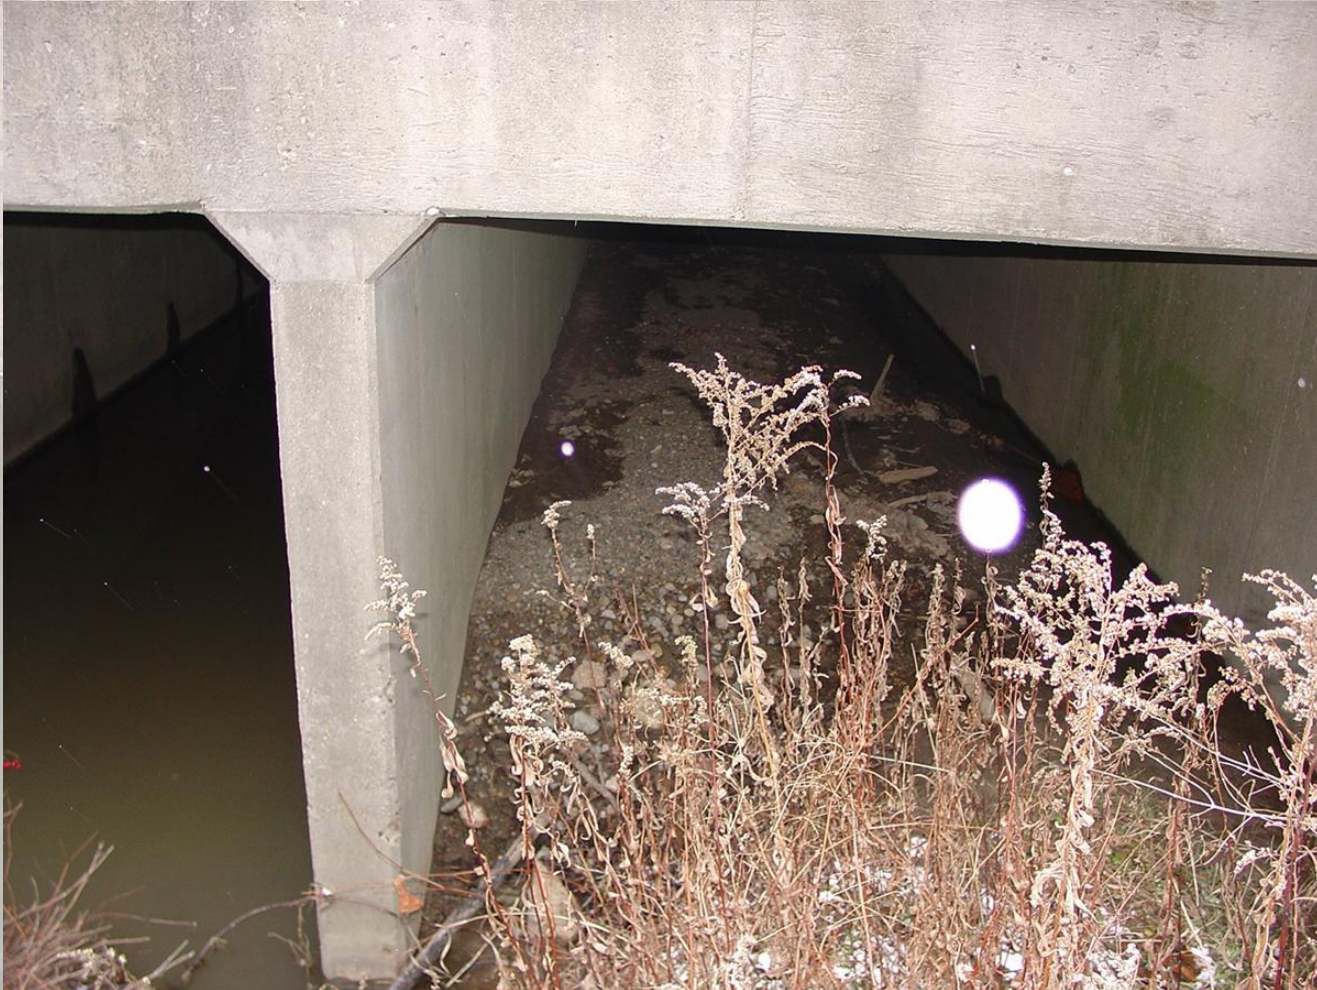
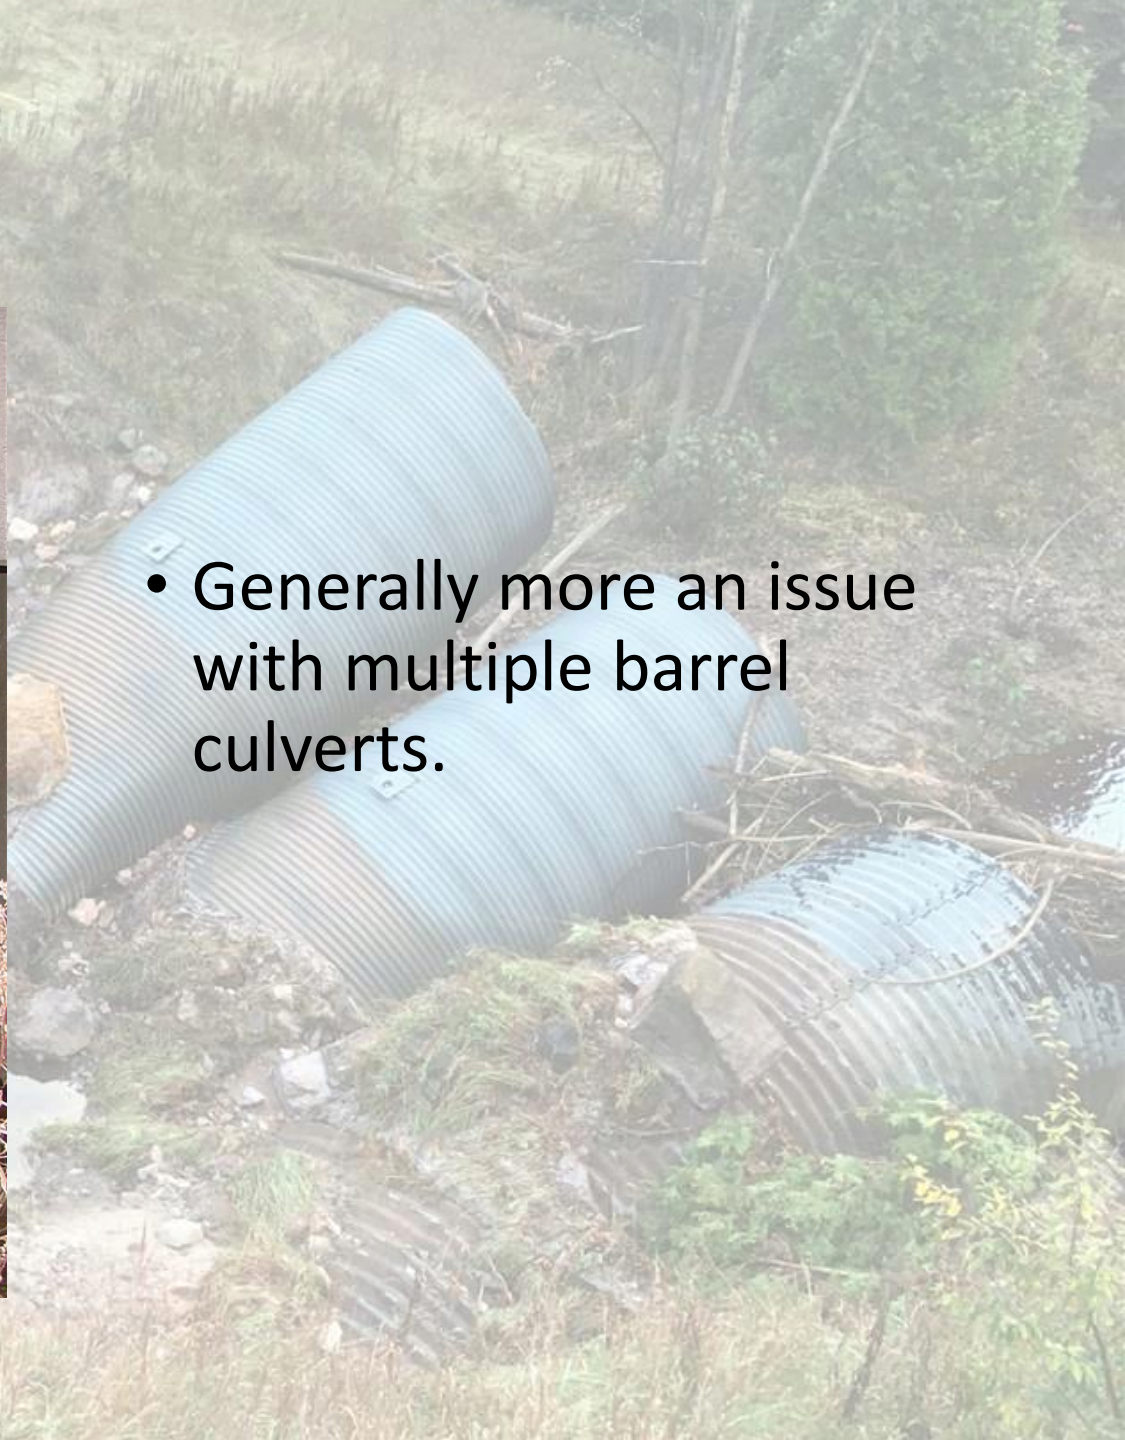
- Generally more an issue with multiple barrel culverts.

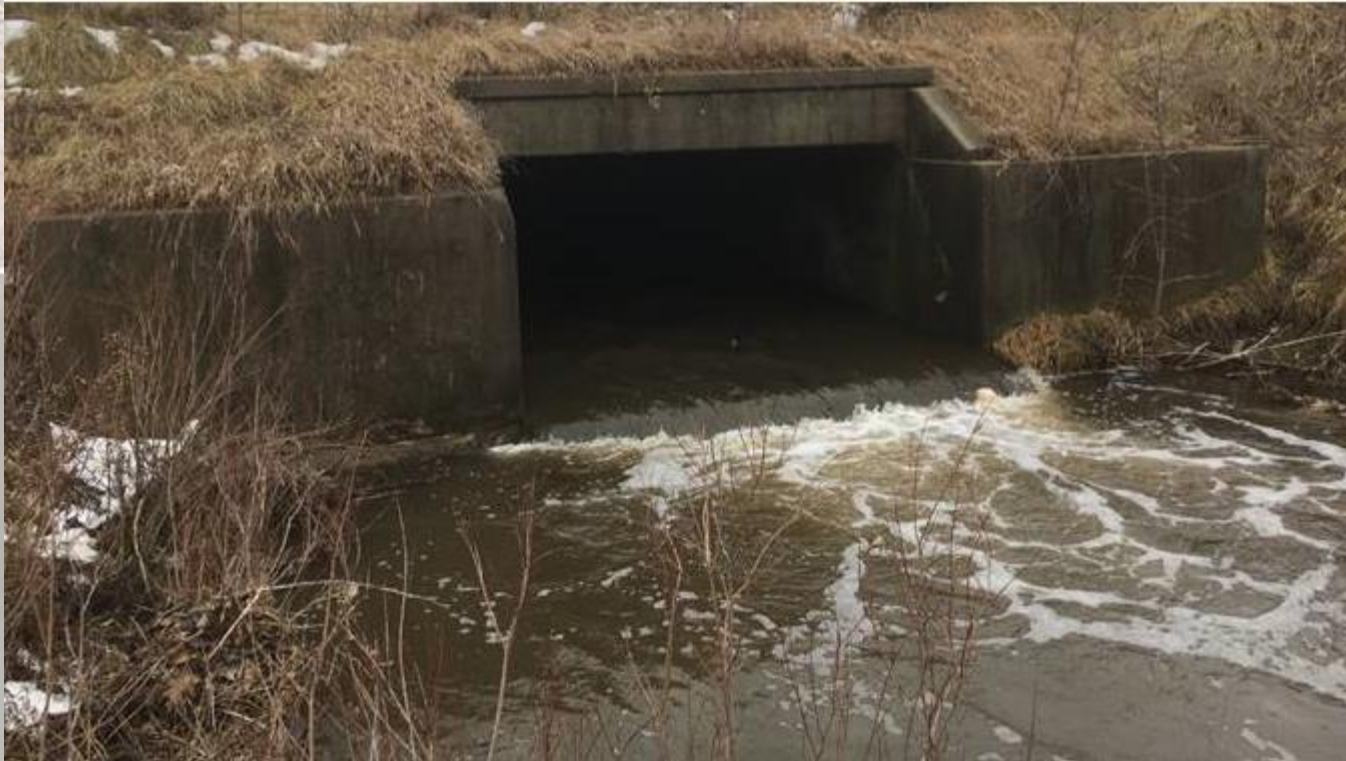
- Perched culverts can lead to piping underneath the barrel.
- Can be caused by stream degradation, drain cleanouts, and scour.
- Can be a critical component, as it can lead to voids around the culvert.

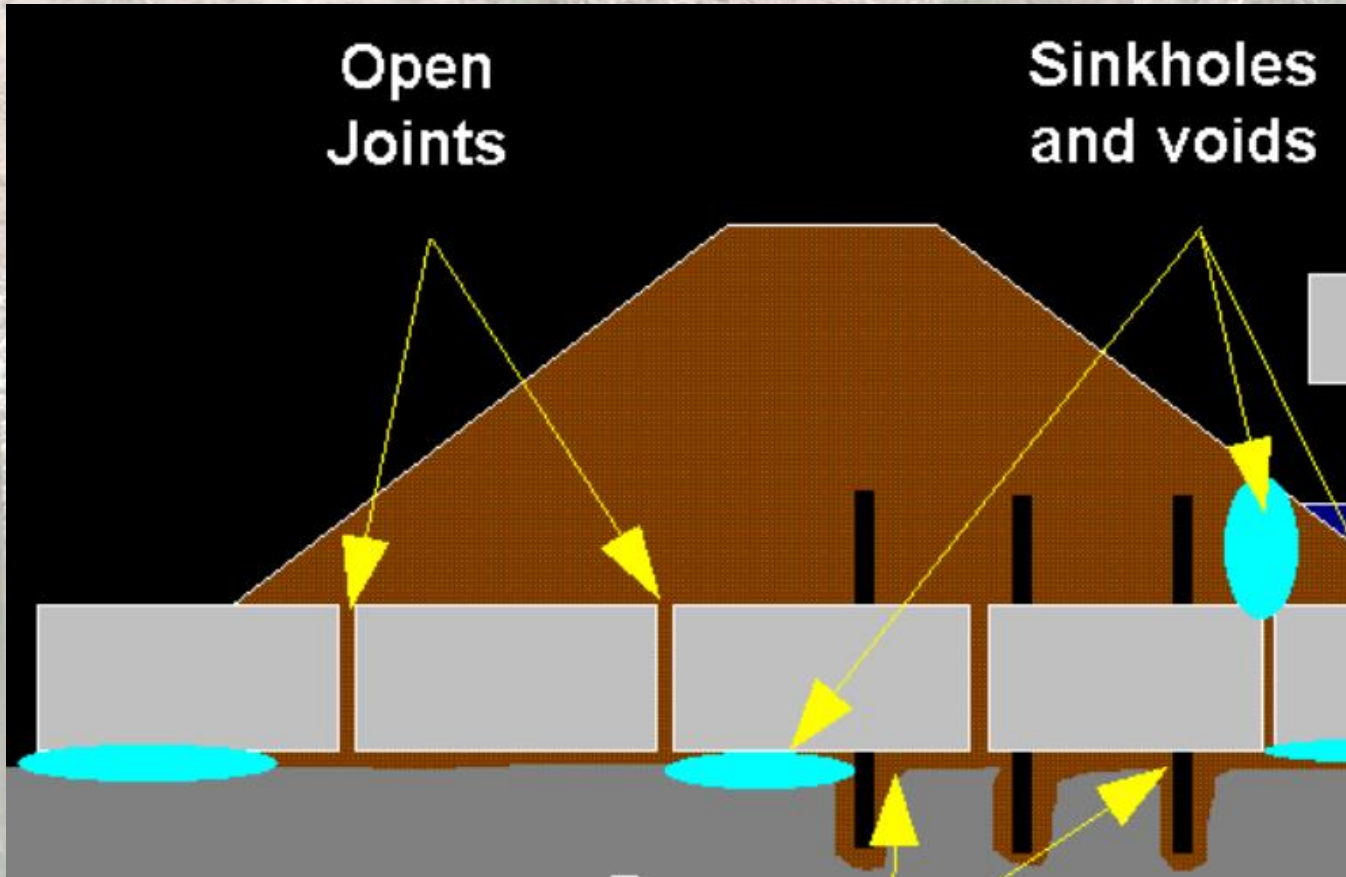
- Commercial end sections often don't have anti seep protection (i.e. curtainwalls). Without protection, the piping can occur rapidly.
- If culvert perched below anti seep device, it must be classified as critical (3 – 1).

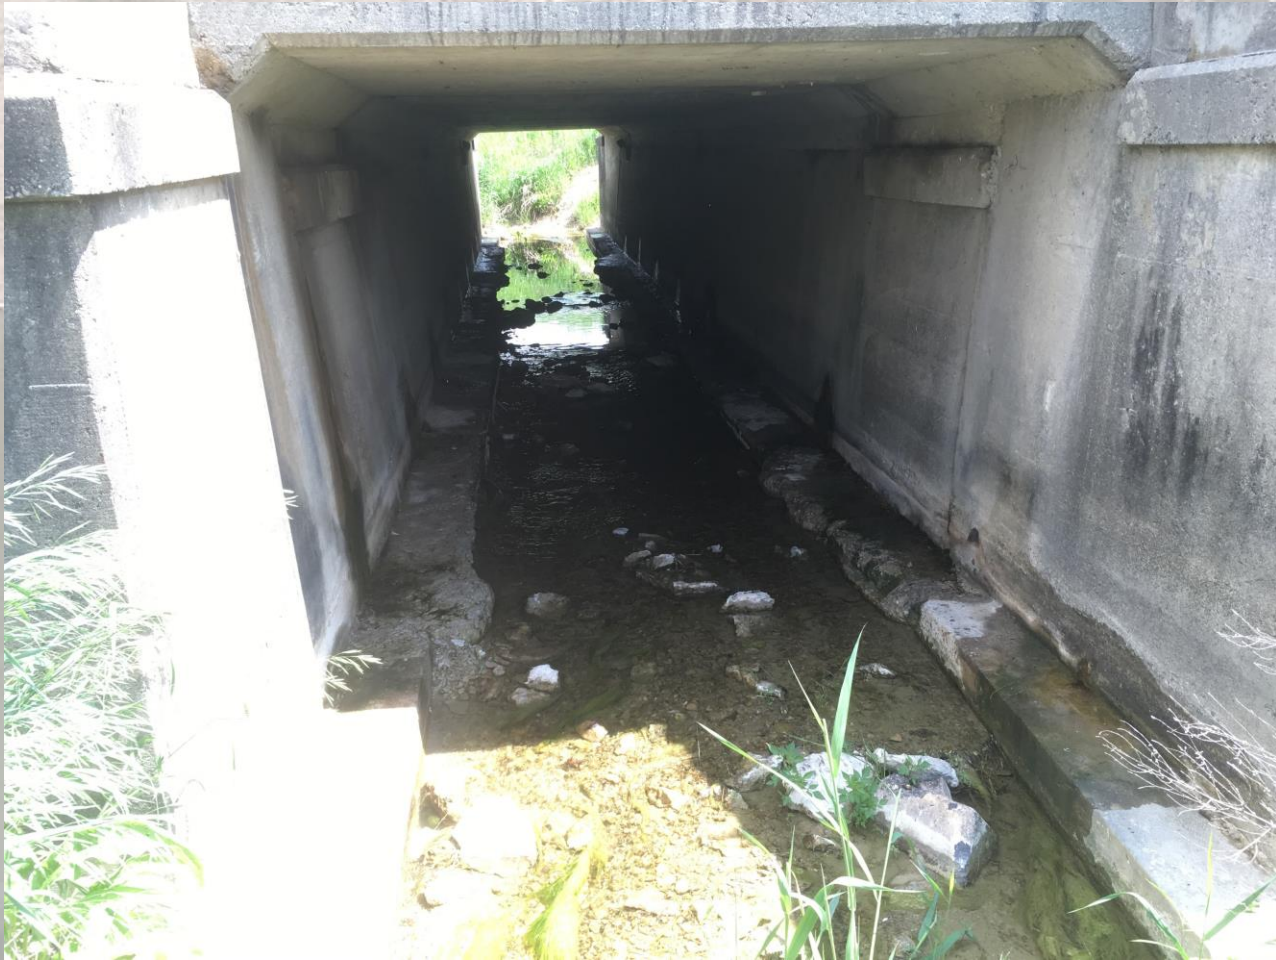
- Critical inspection component.
- Slab culverts can be like mini scour critical bridges.
- Many slab installations in the state, as was once a standard plan.
- Slabs often get mistaken for boxes.

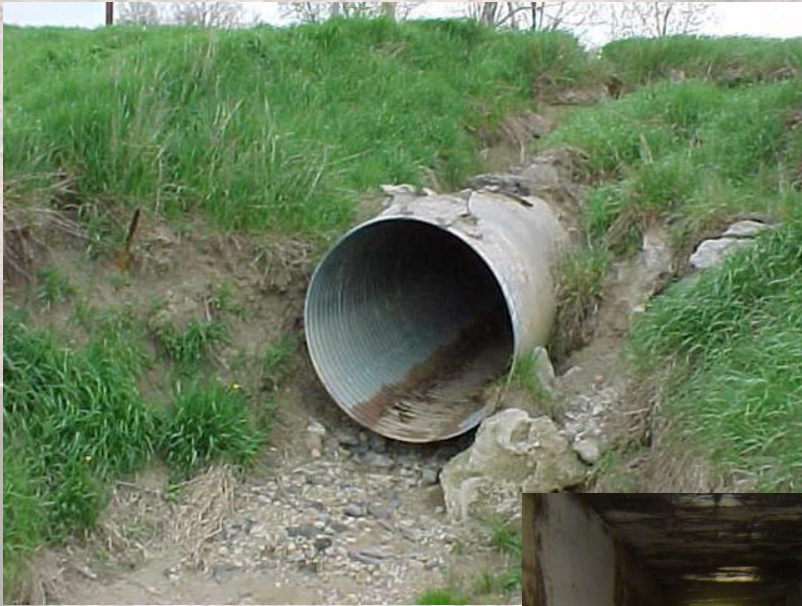
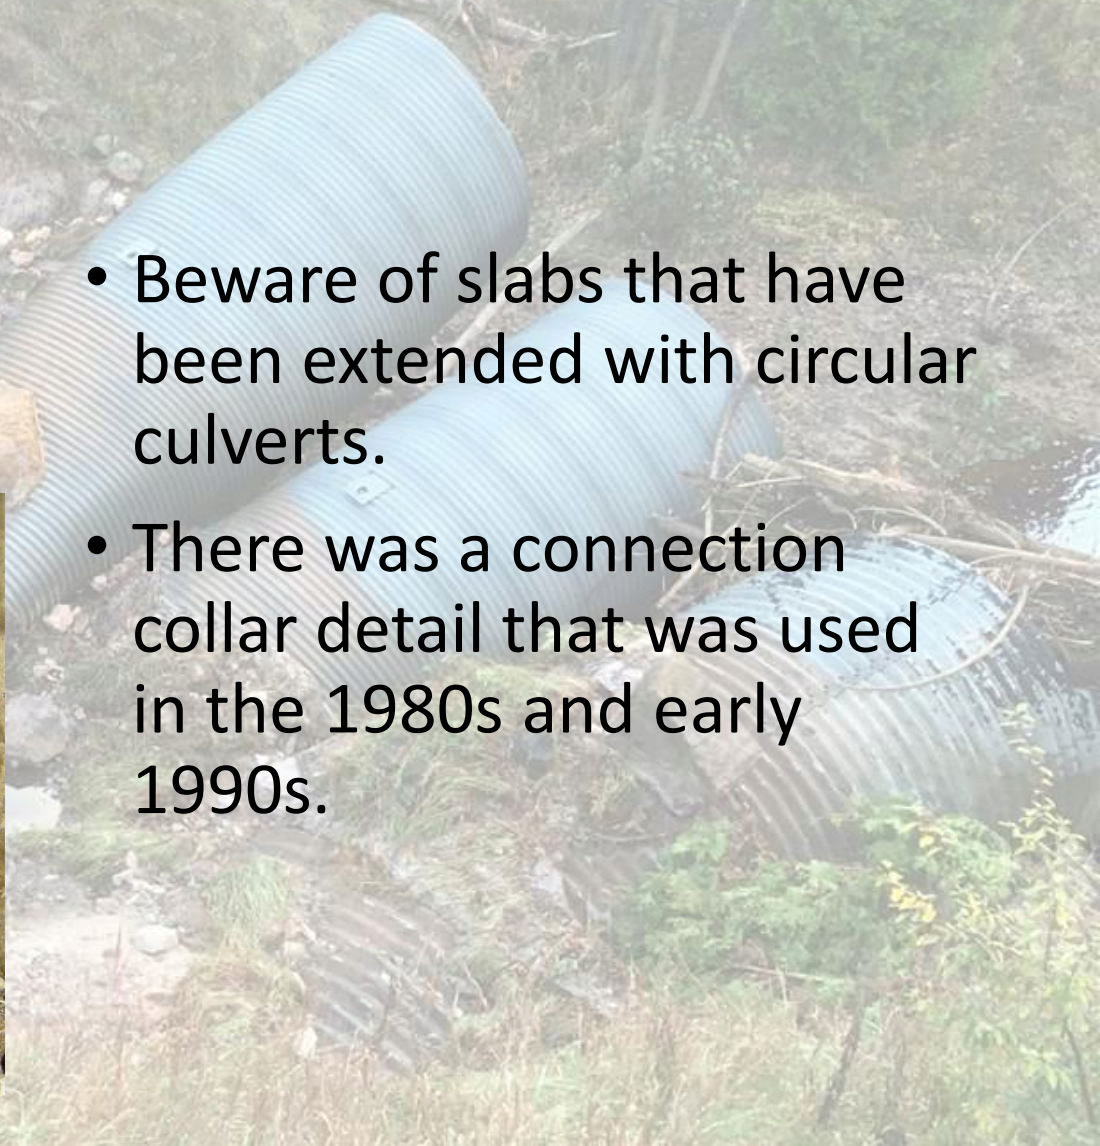
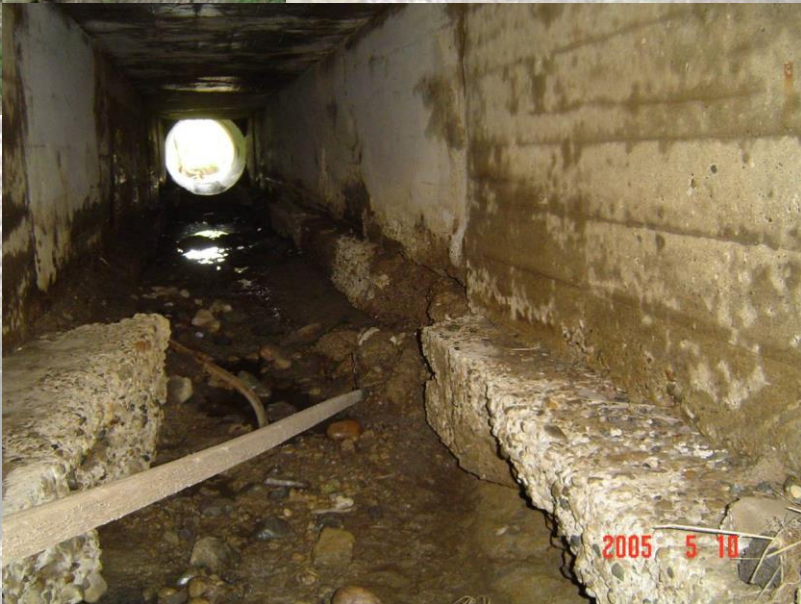
- Beware of slabs that have been extended with circular culverts.
- There was a connection collar detail that was used in the 1980s and early 1990s.

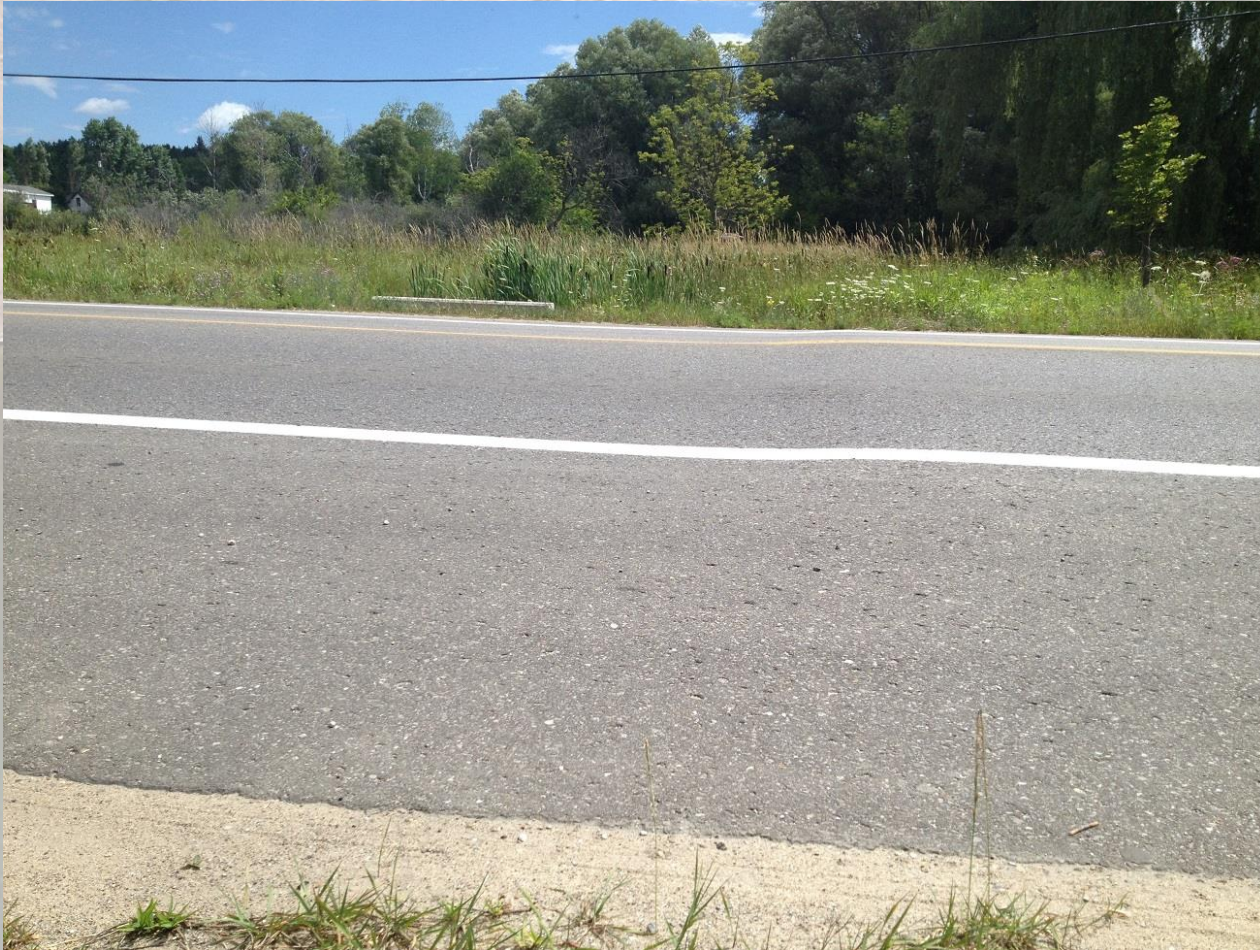
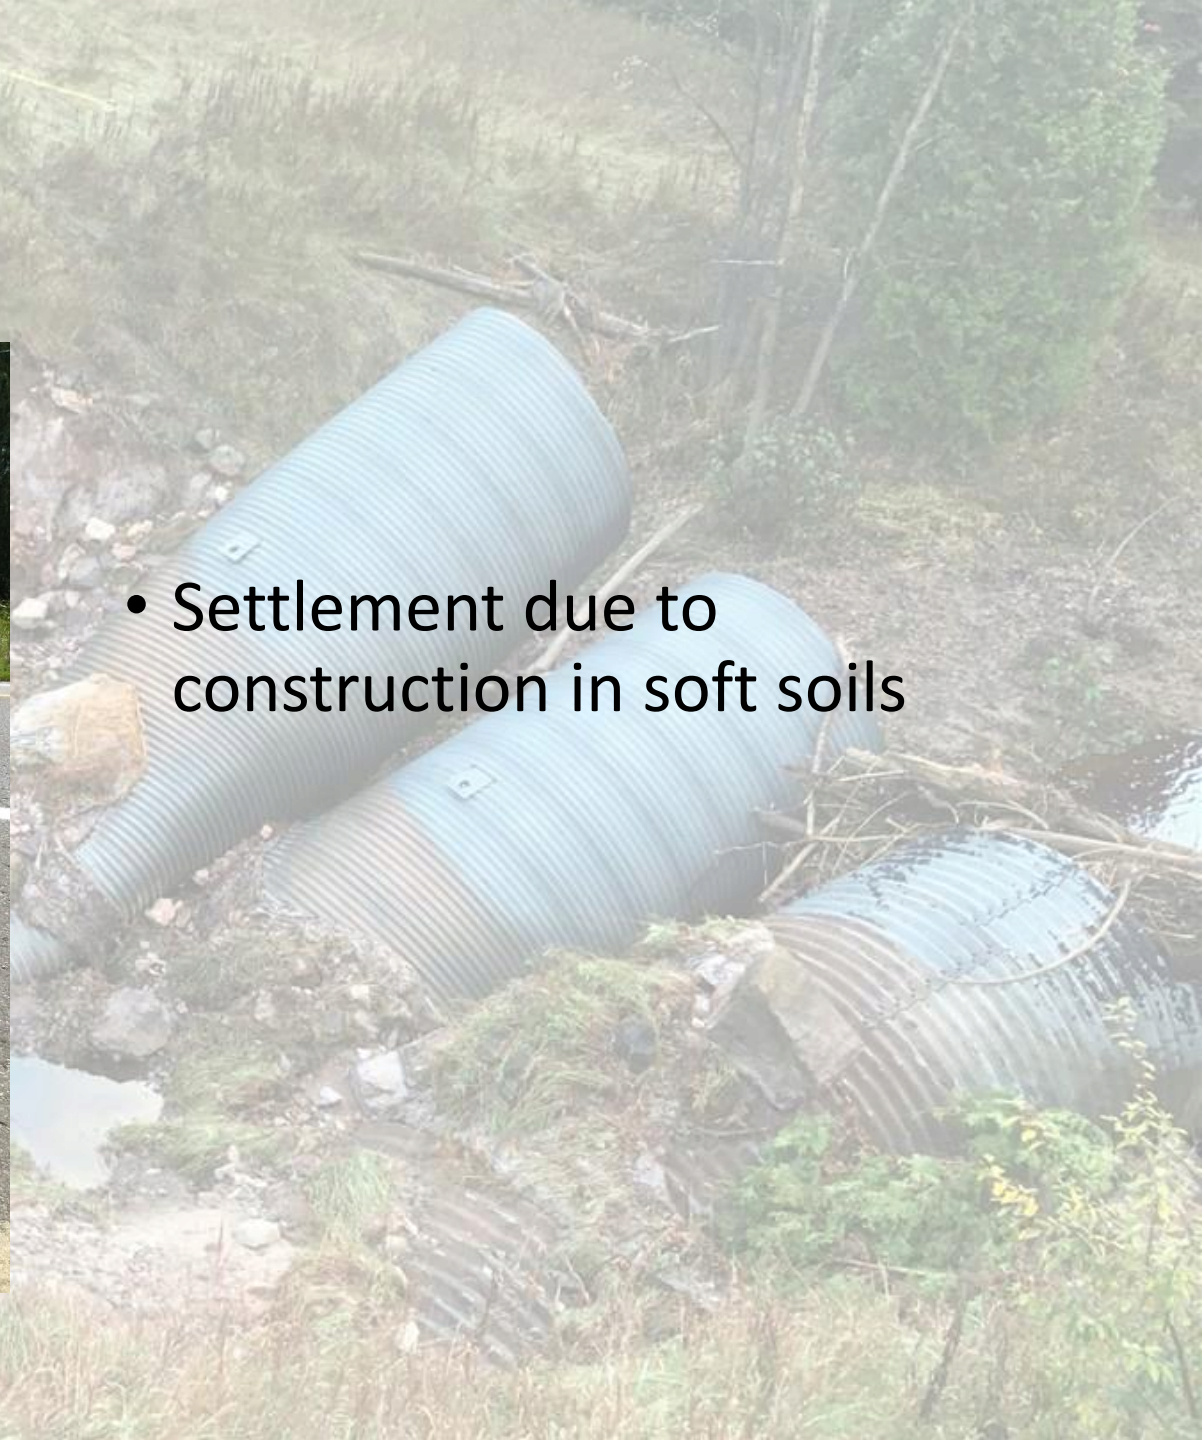
- Settlement due to construction in soft soils
