# Culvert Inspection/Maintenance

Erik Carlson, PE  
Hydraulic Unit Supervisor

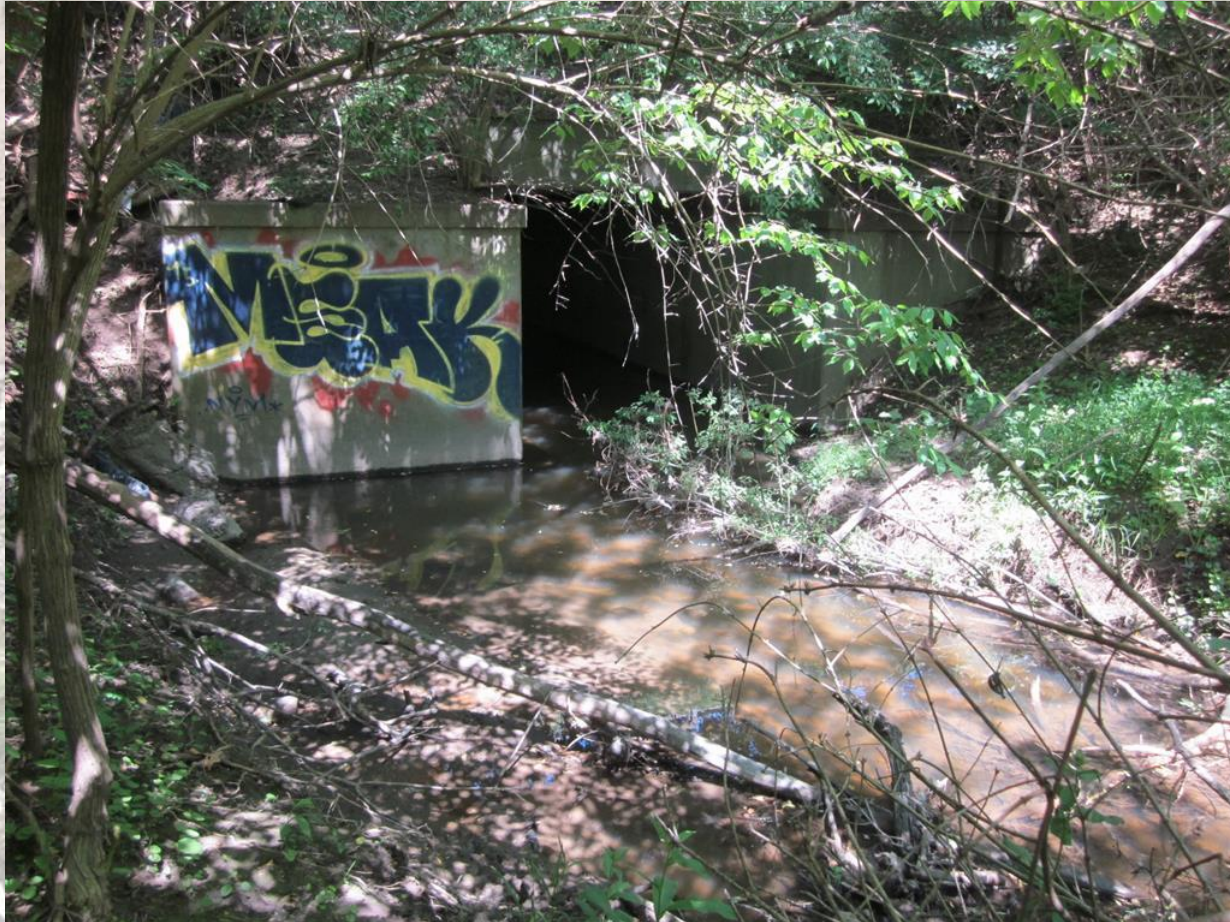
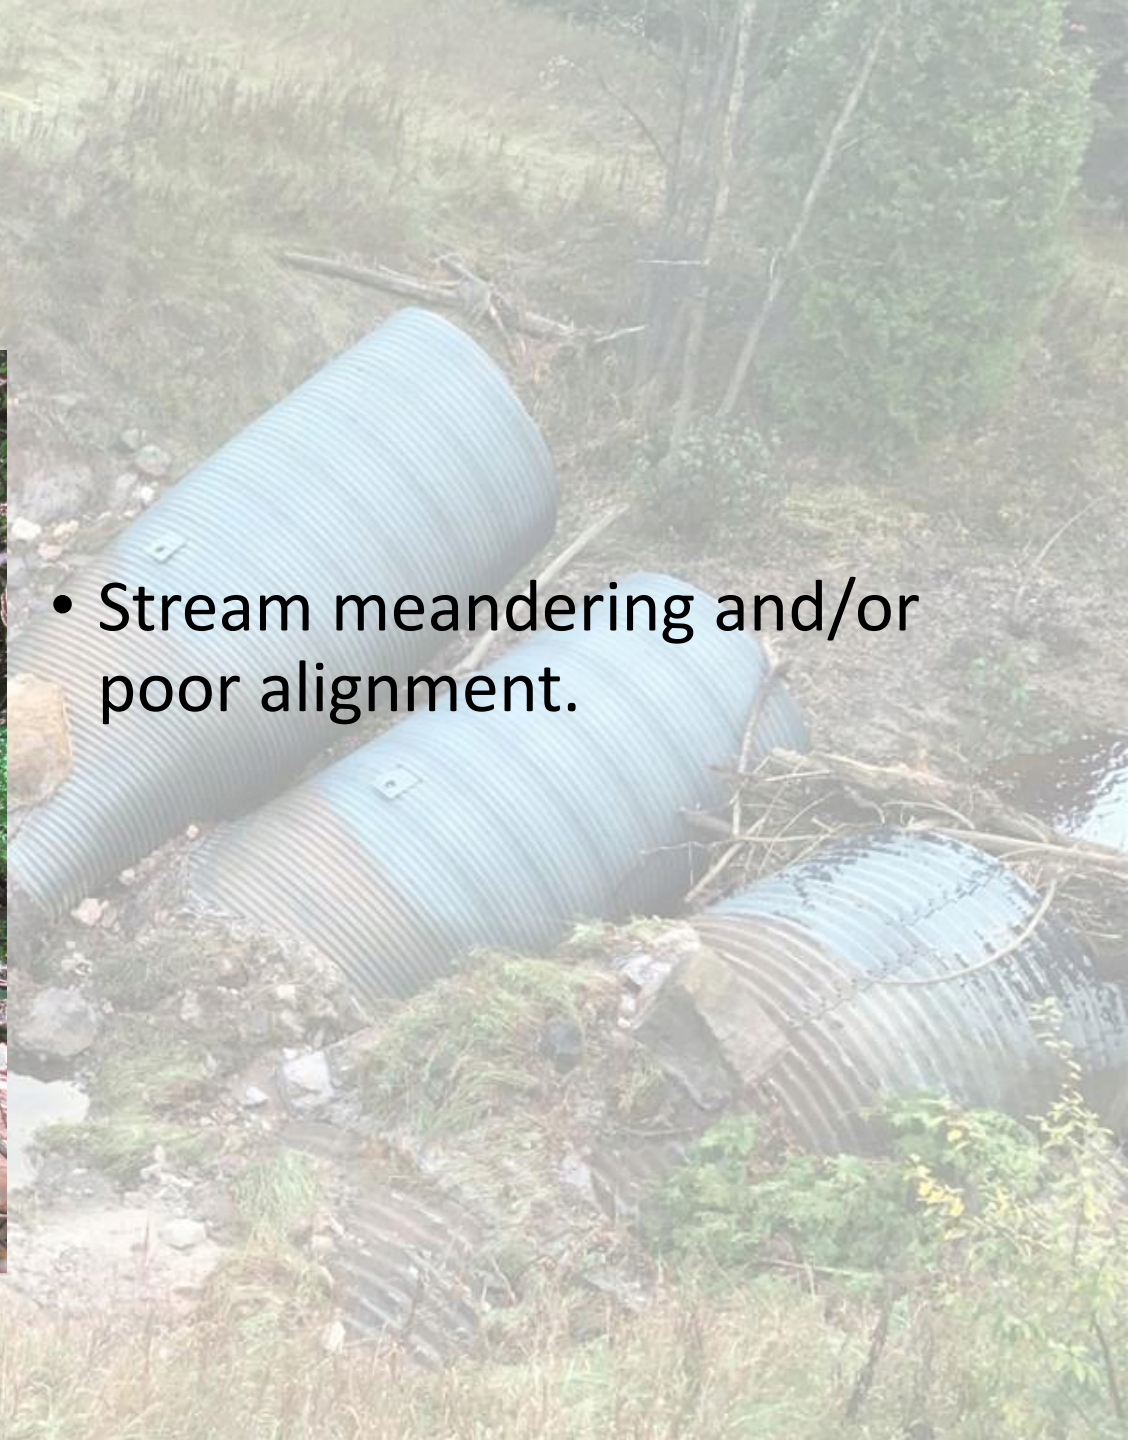
- Stream meandering and/or poor alignment.

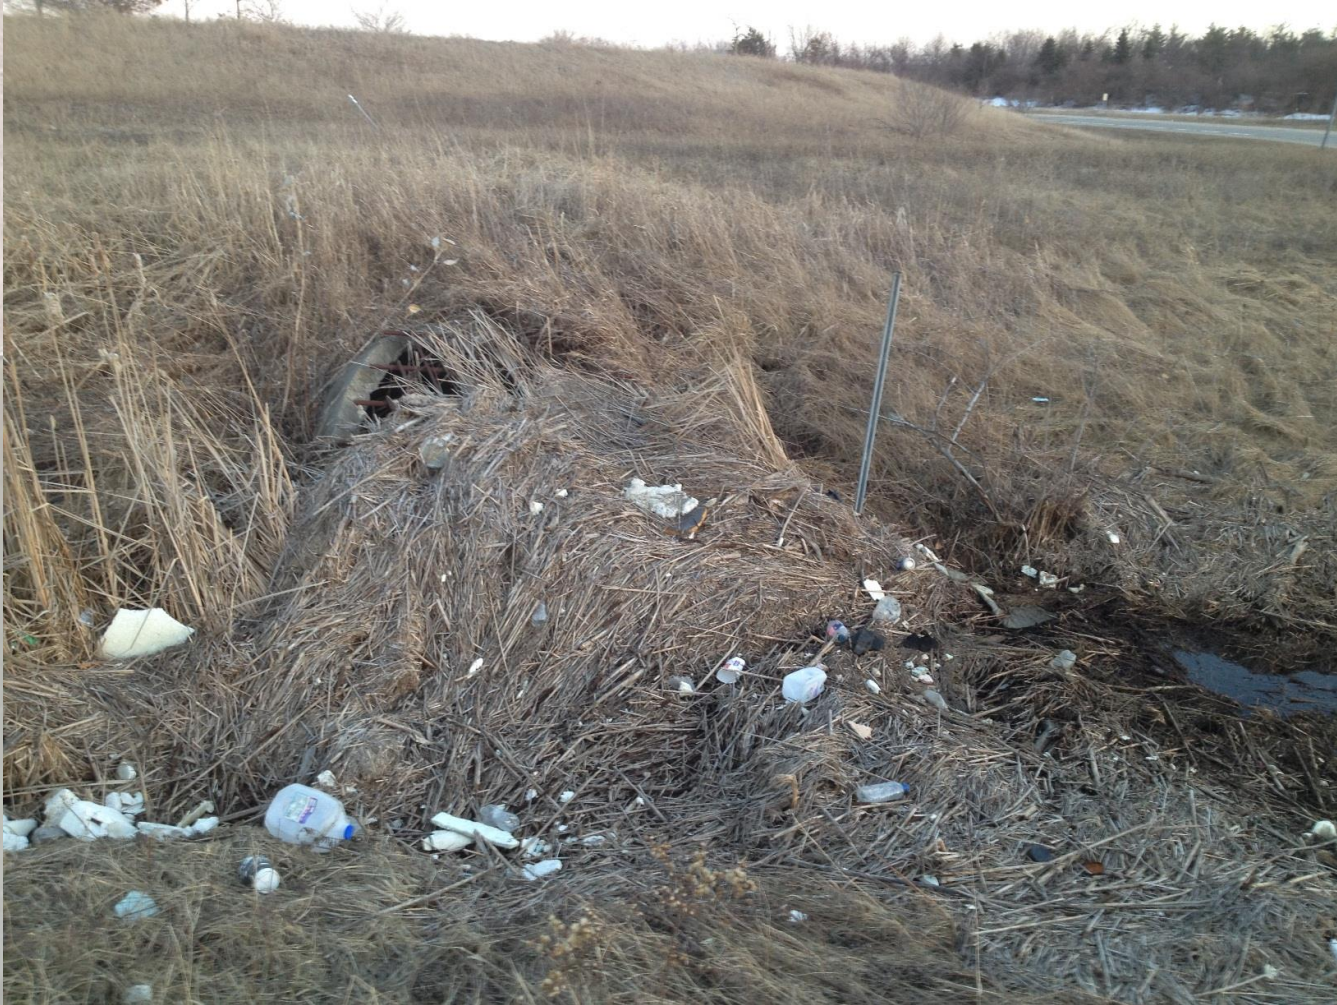
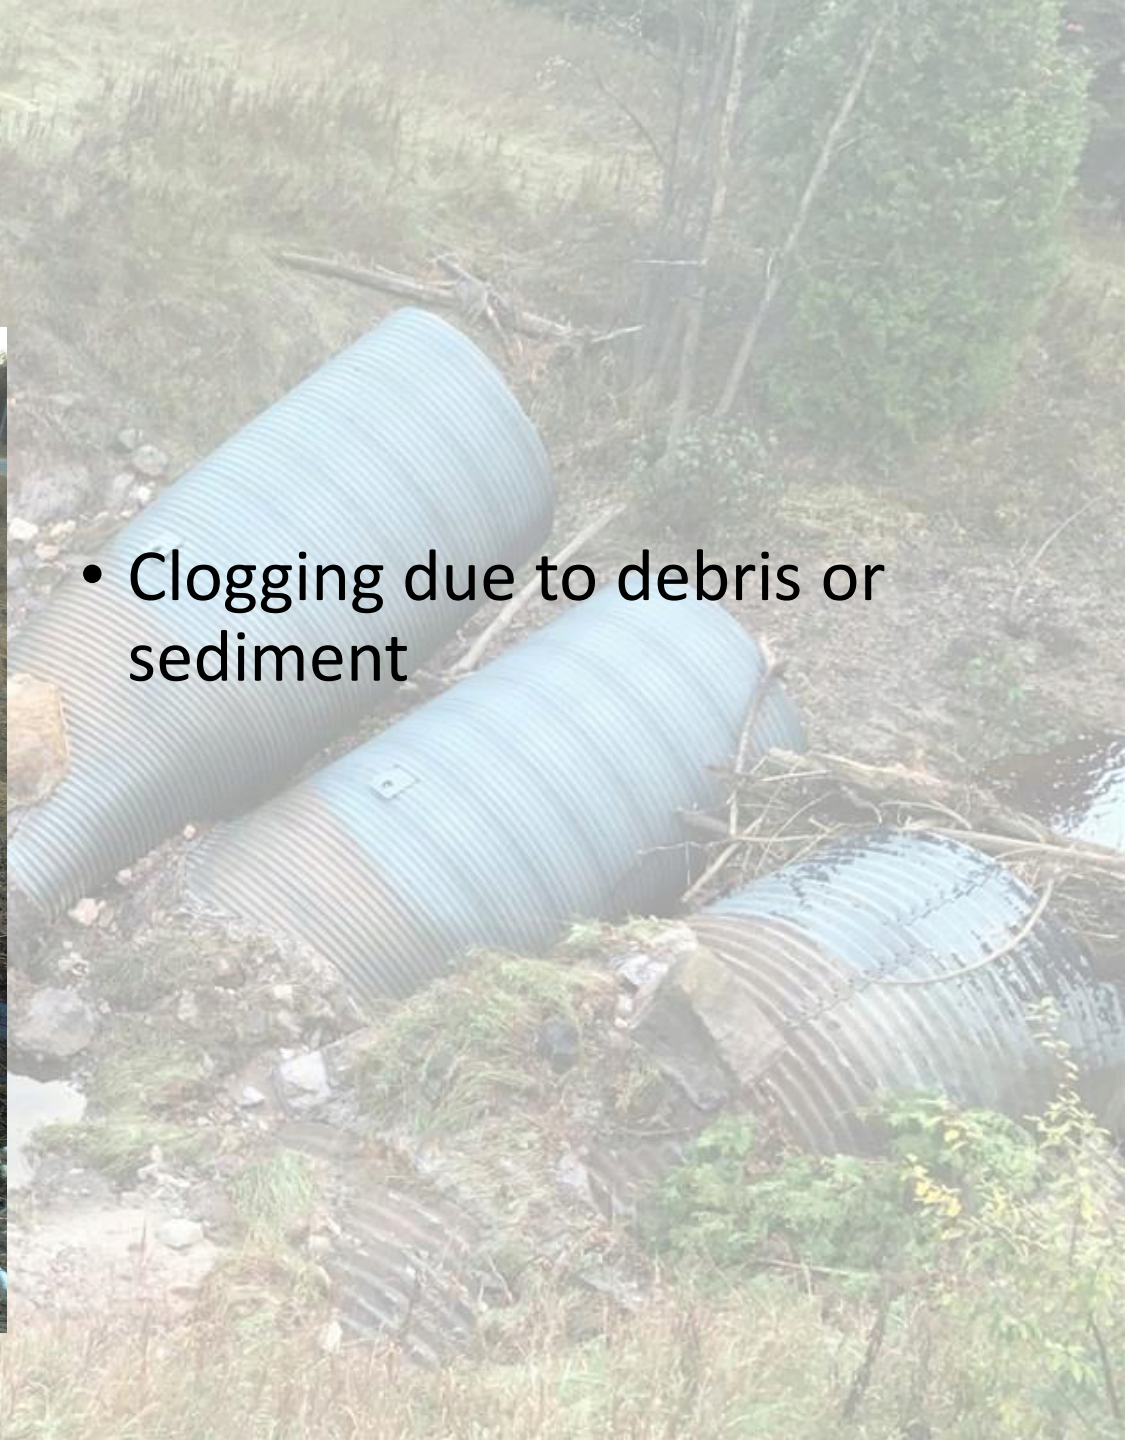
- Clogging due to debris or sediment
