Pavement Demonstration Program Project Finalization Thin Unbonded Concrete Overlay Projects – M-3 & M-1 (MDOT Job Numbers 72407 & 79673)

Final Technical Report

Report No. OR23-304, A

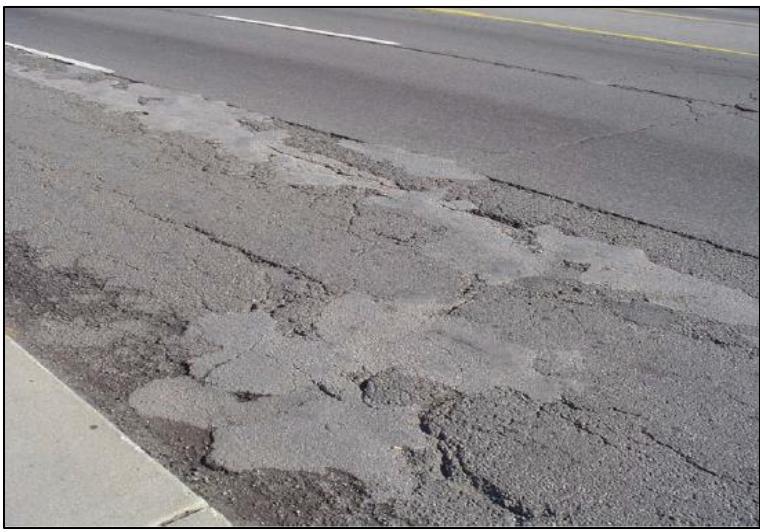
Before construction in 2010, pavement distresses such as rutting, cracking (reflection and alligator cracking), and localized settlements were present on M-1. These distresses were predominant in intersections, parking lanes, stops, and around utility structures (manholes), as seen in Figures 4 to 7. Both M-3 and M-1 were rehabilitated before the placement of the unbonded concrete layer. The brick pavers were removed, and the distressed sections were cold-milled and resurfaced.

Figure 4. Deteriorated Pavement in the Outside Lane from MDOT Field Investigation Report for M-1

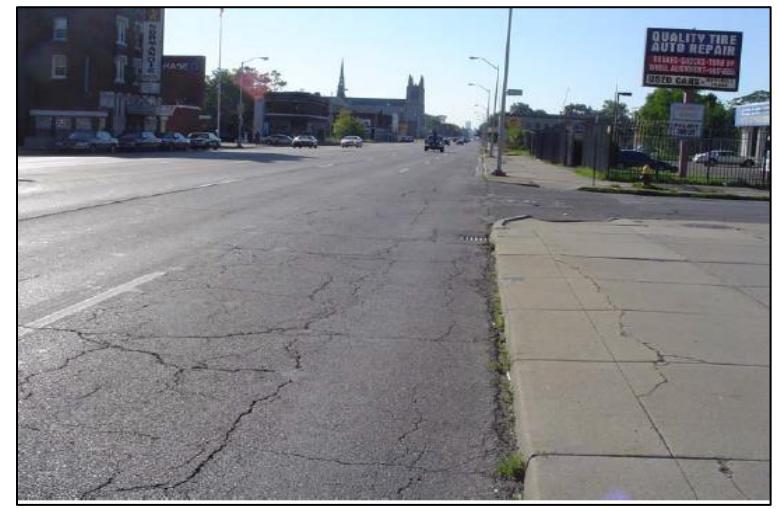
Figure 5. Cracking in Outside Lane from MDOT Field Investigation Report for M-1

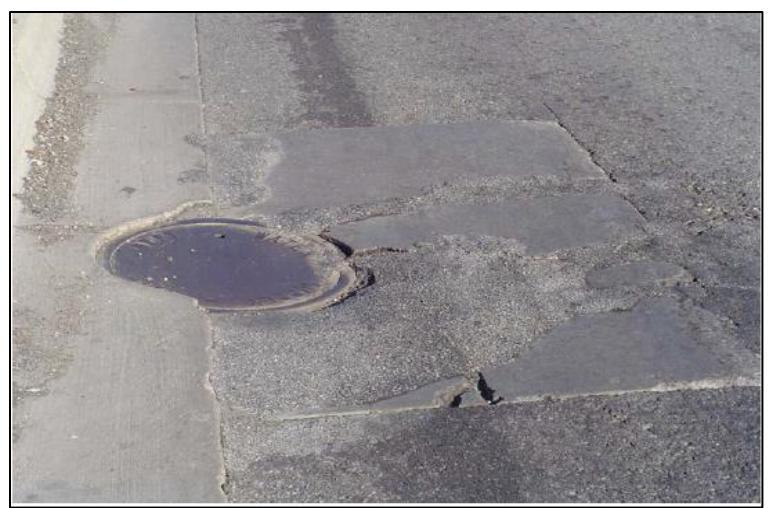
Figure 6. Distress Around Utility Mains from MDOT Field Investigation Report for M-1

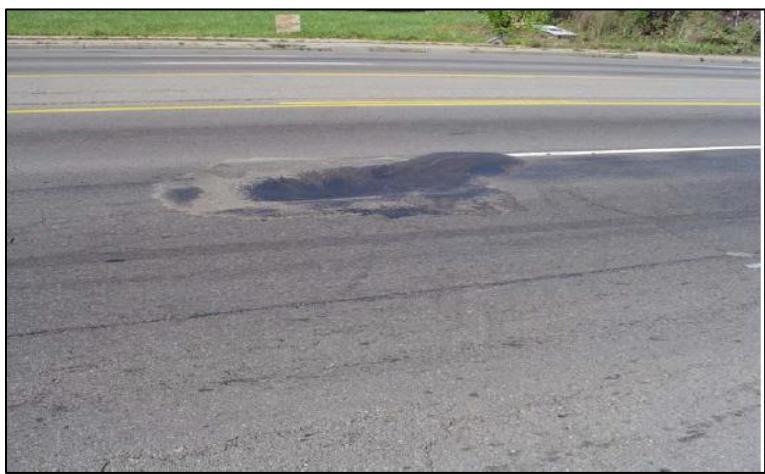
Figure 7. Localized Settlement in Middle Lane from MDOT Field Investigation Report for M-1

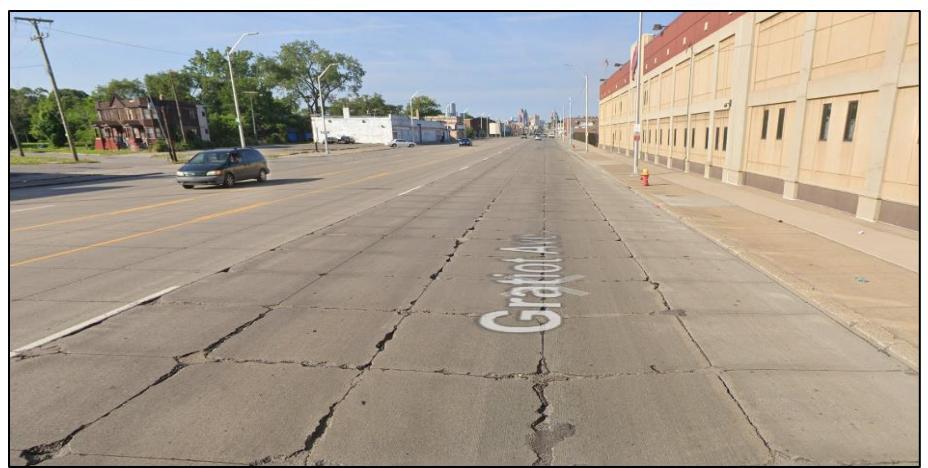
Most distressed, cracked, or repaired panels appear at or near areas with a business presence. For example, the outermost lane of M-3 has excessive spalling close to a Faygo Beverages business site, as shown in Figure 19. This location was completely replaced sometime after 2019, as shown in Figure 20. Clogged drains shown in Figure 21 could have also accelerated the deterioration of these sections. Furthermore, distribution trucks traveling or parking along this section likely exacerbated the distress.

Figure 19. Distressed Panels on M-3 near Faygo Property Site, Google Maps Image 2019

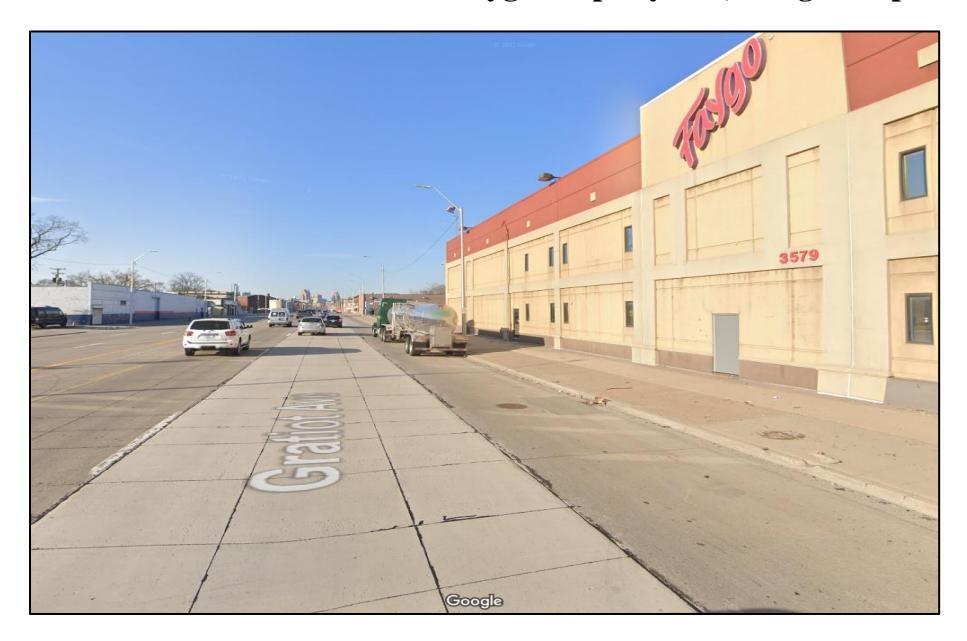
Figure 20. Repaired Panel on M-3 near Faygo Property Site, Google Maps Image 2022

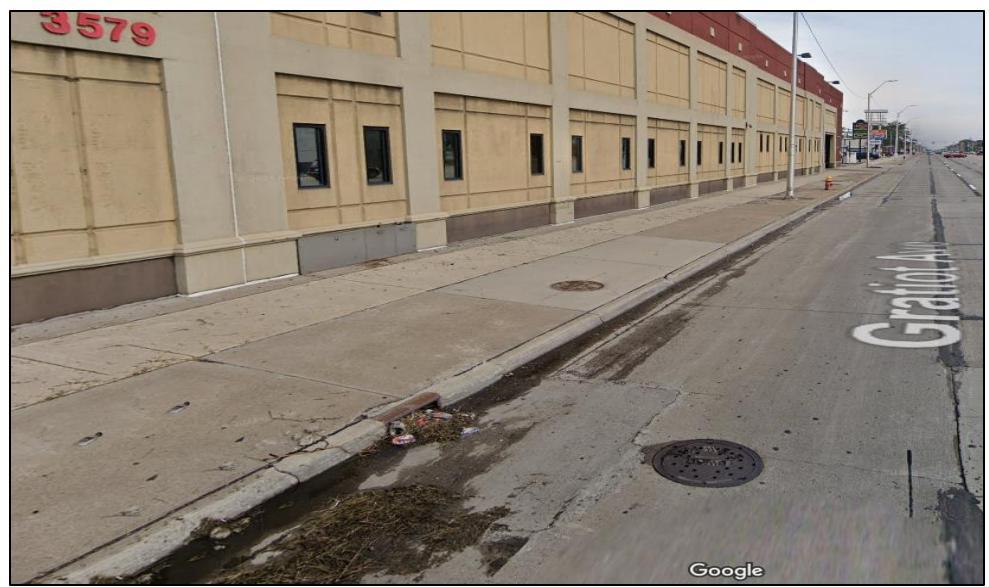
Figure 21. Clogged Drains on M-3, Google Maps Image 2021

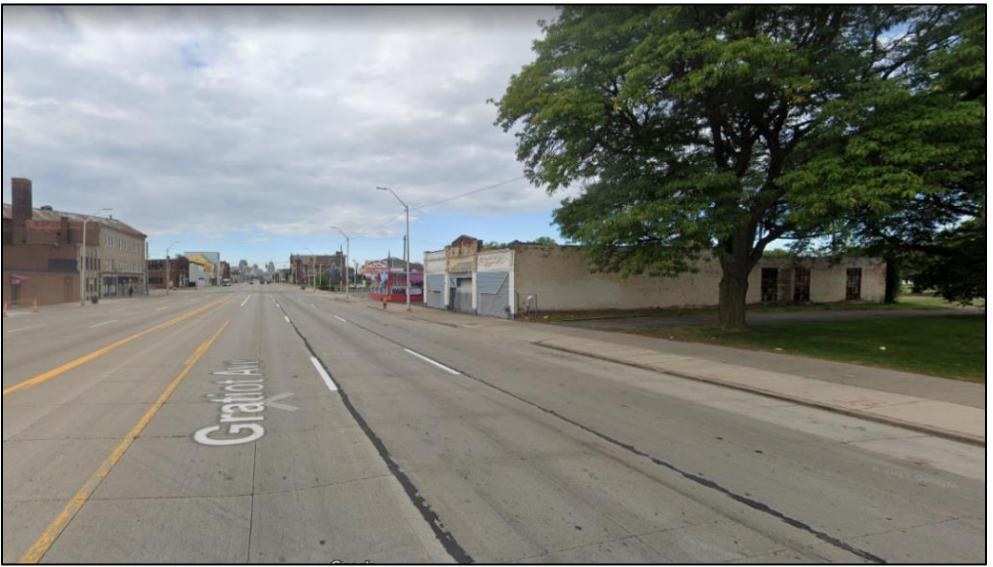
In comparison, areas with less business presence appear to have better-performing pavement, as shown by the example in Figure 22. This spalling distress is less prevalent on the M-1 project compared with M-3 at the same age. M-1 joints are holding much more tightly, so their distress is more due to panel cracking and faulting. Therefore, as poor panels are replaced and distress is mitigated, the DI progression for M-1 may slow to perform like the M-3 demonstration project.

Figure 22. Good Pavement on M-3 near Mack Avenue, Google Maps Image 2022

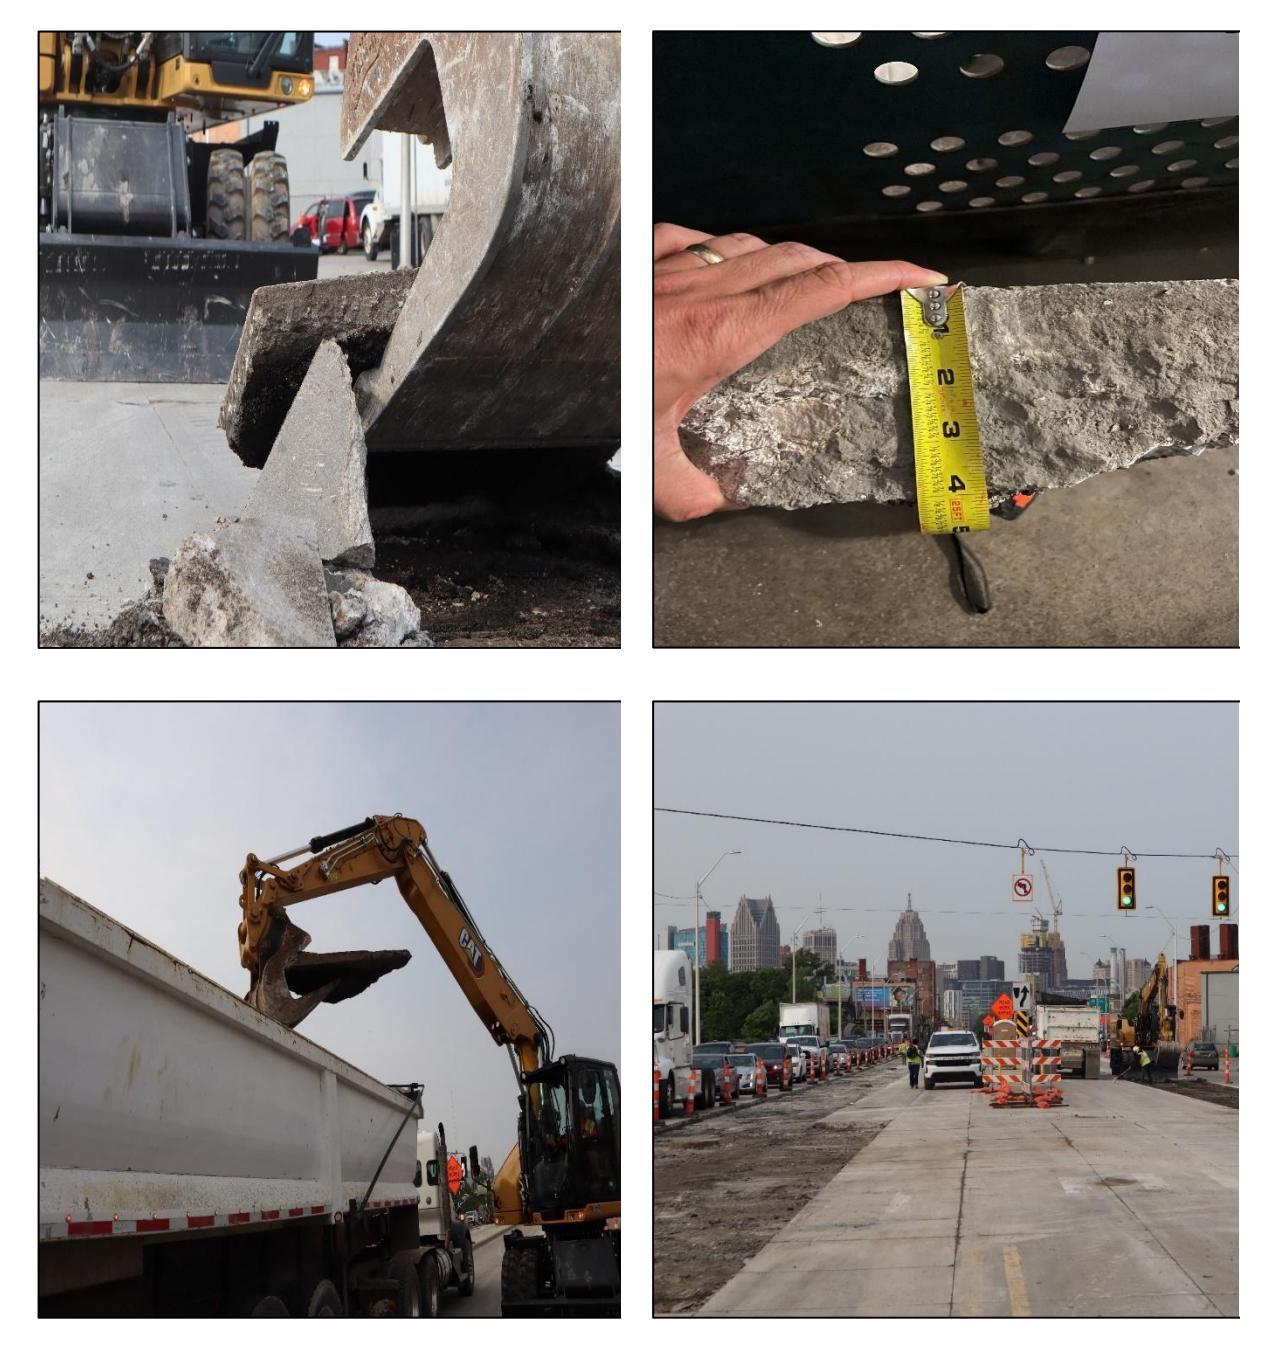
To further evaluate the potential of trapped moisture beneath the surface concrete as indicated by observed surface black staining at the joints, MDOT personnel, who have conducted past maintenance work, were consulted regarding any indications of water observed during repairs for both projects. They have not observed any evidence of water throughout any past repair work, and this is further supported by recent maintenance work on M-3 in June 2023, shown in Figure 23. Subsequent to removal of the existing surface concrete, no noticeable water or moisture-related issues were found. However, it appeared that the joints were filled with trapped fines, which could be a contributing factor to the observed joint spalling.

Figure 23. June 2023 Maintenance Repair Work on M-3

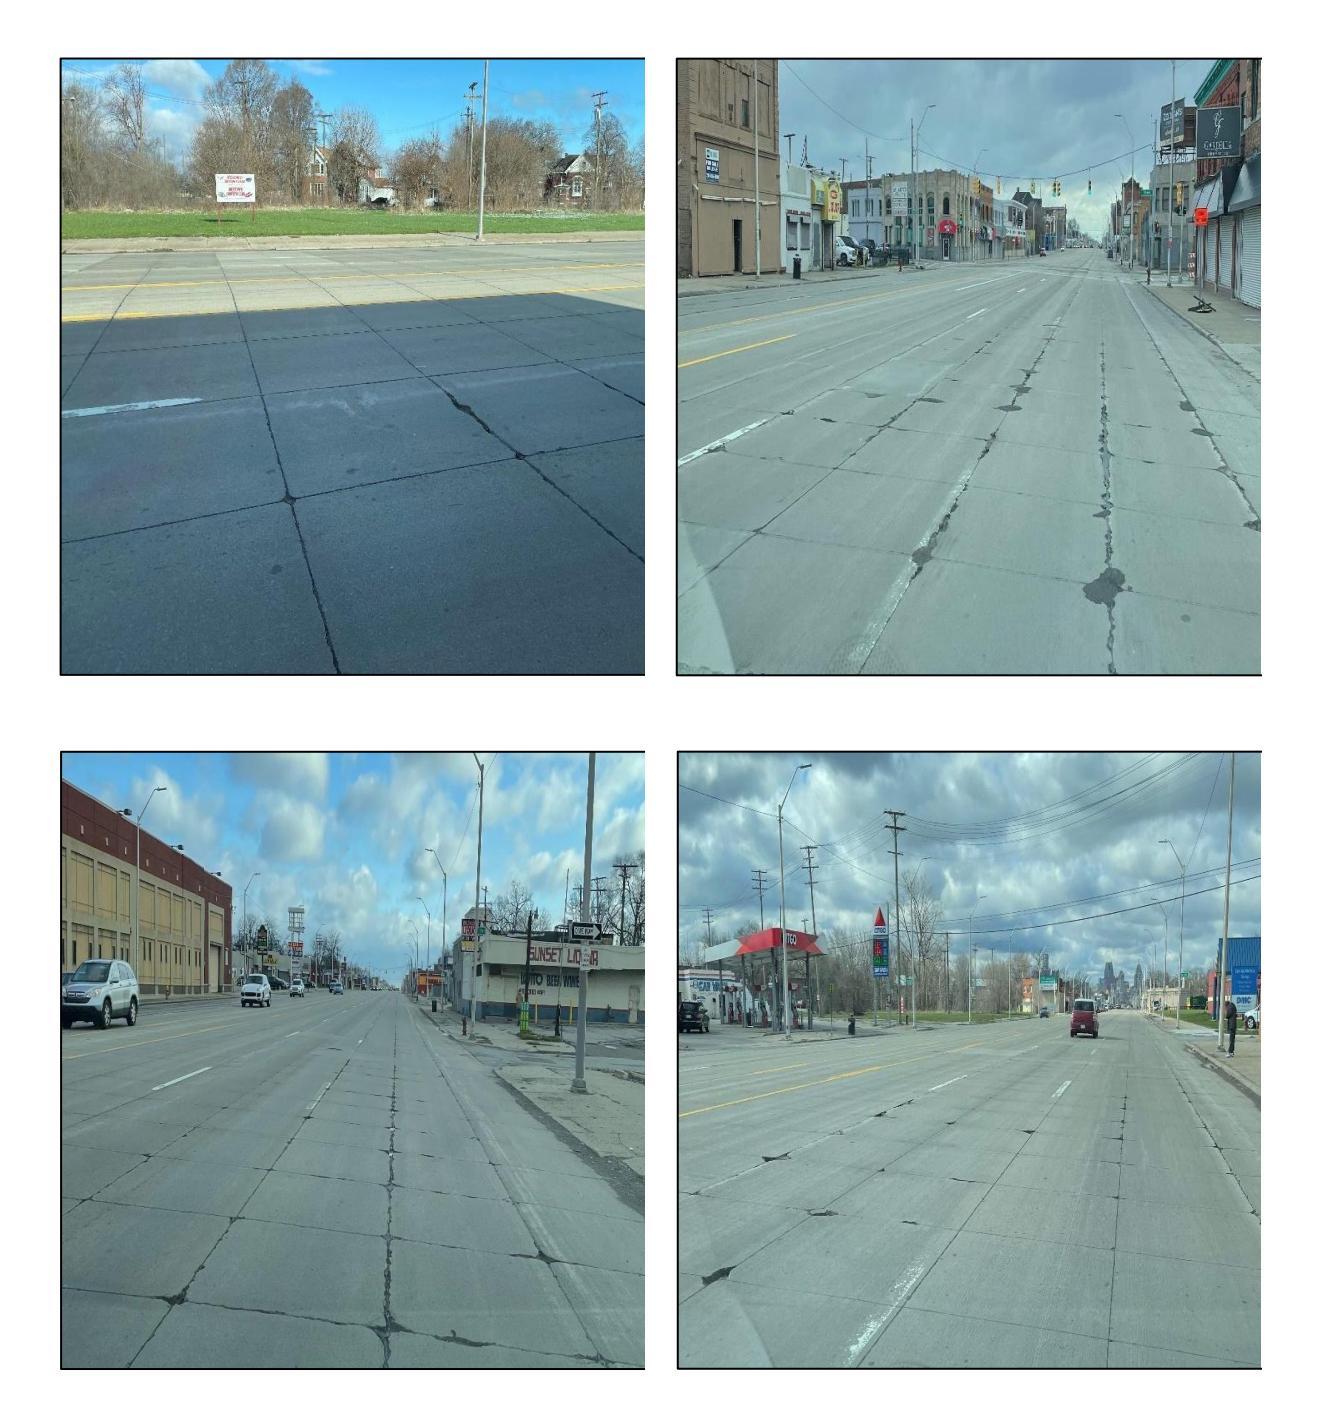
Each year, as the pavement has continued to age, an increase in distresses like raveling, cracking, and spalling has been observed throughout the project. Specifically, sections 2 and 3 of the northbound outside lanes have experienced significant spalling in their middle longitudinal joint. The highest distress concentration is observed at intersections, bus lanes, transitions, and manholes. To address this, maintenance and repair work has been conducted, and about 87% of the remaining panels do not exhibit cracking as of 2022. Pictures of the current pavement condition on M-3 are shown in Appendix Figure A10. The field visit summary notes described the pavement's overall performance as fair*.

Figure A 10. April 2022 Field Evaluation Pictures of M-3

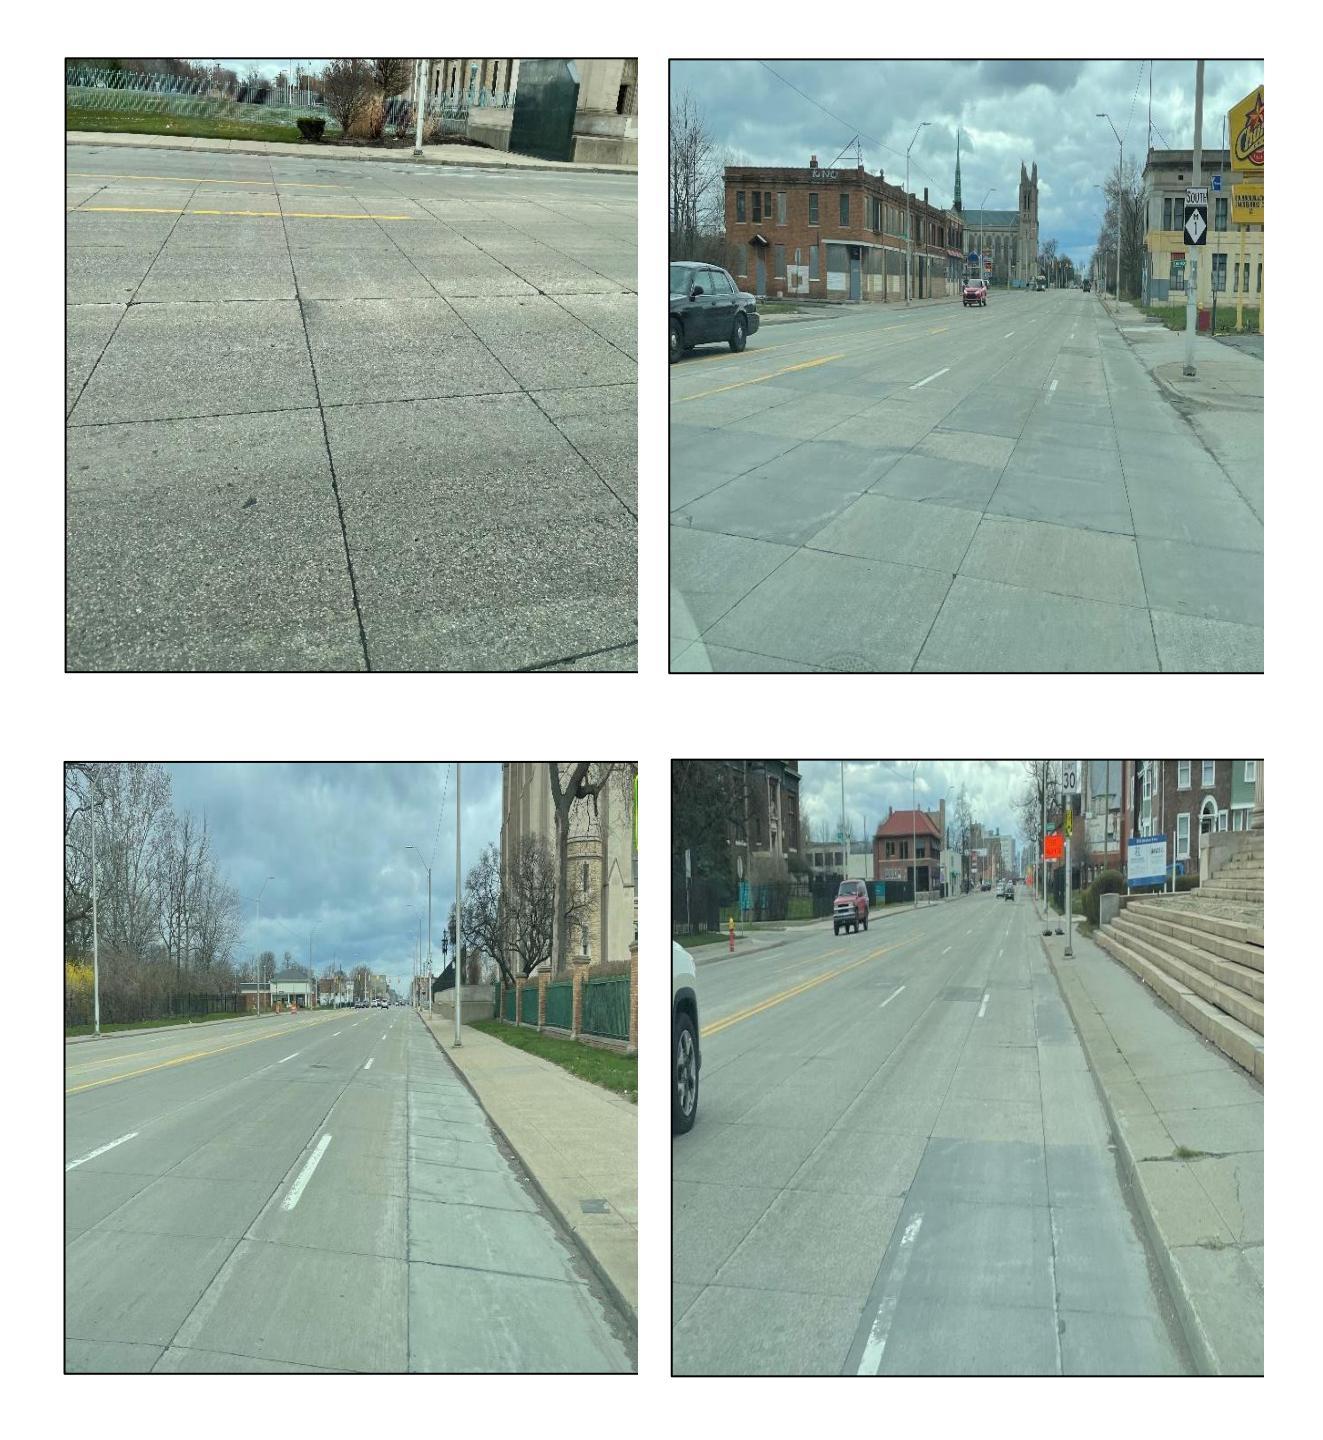
The annual visit for M-1 in April 2022 noted that after 12 years in service (2022), 9.1% of panels have been cracked and repaired. Additionally, intermittent black staining was observed on either side of the transverse and longitudinal joints. This may be attributed to pumping of water at the HMA interlayer, but as is noted in the following section, no moisture was found to be present during slab replacement repairs. Accordingly, the panels where the staining occurs do not exhibit much distress, and the corresponding joints are in fair to good condition. Of the panels cracked/repaired, about 73% occurred in the middle travel lanes (next to the outside lanes). The high presence of distress in the middle lane may also be due to the propagation of distress from the outside lane. While not included in the counts, most panels in the outside lanes have been repaired due to many being faulted or shattered. Throughout the project length, annual maintenance has been performed over the past 4 years to repair localized areas of distressed panels. The field visit summary notes described the performance of this section as fair*.

Figure A 11. April 2022 Field Evaluation Pictures of M-1

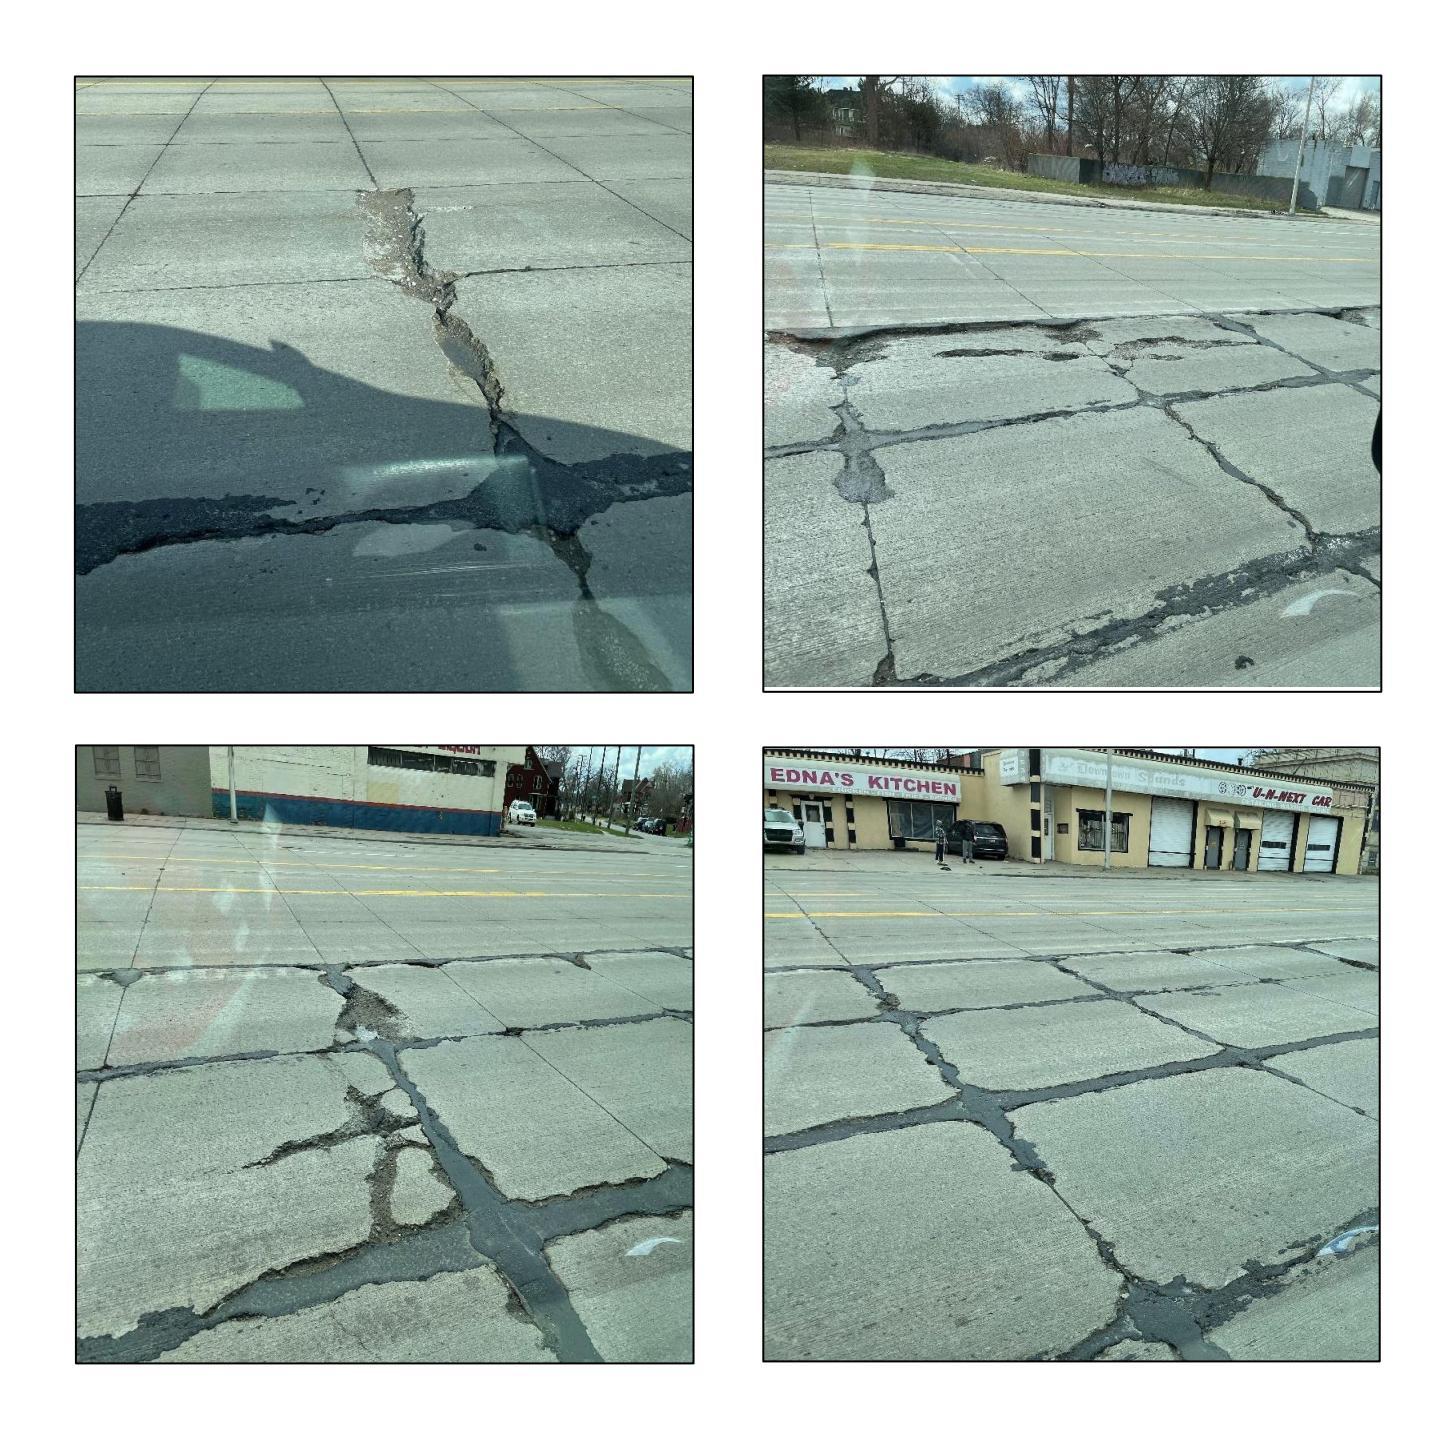
Figure A 12. April 2022 Field Evaluation Picture Examples of Joint Spalling and Raveling in Sections 2 and 3 on M-3

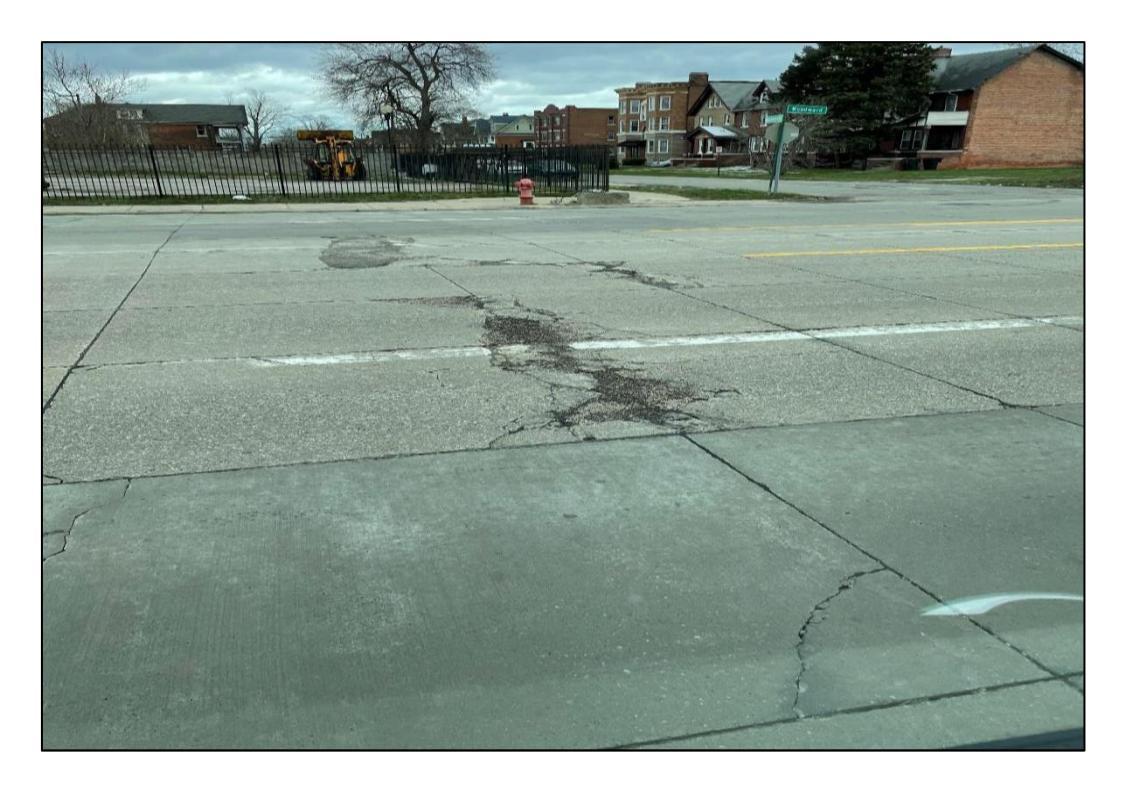
Figure A 13. April 2022 Field Evaluation Picture Example of Corner Cracking and Raveling on M-1

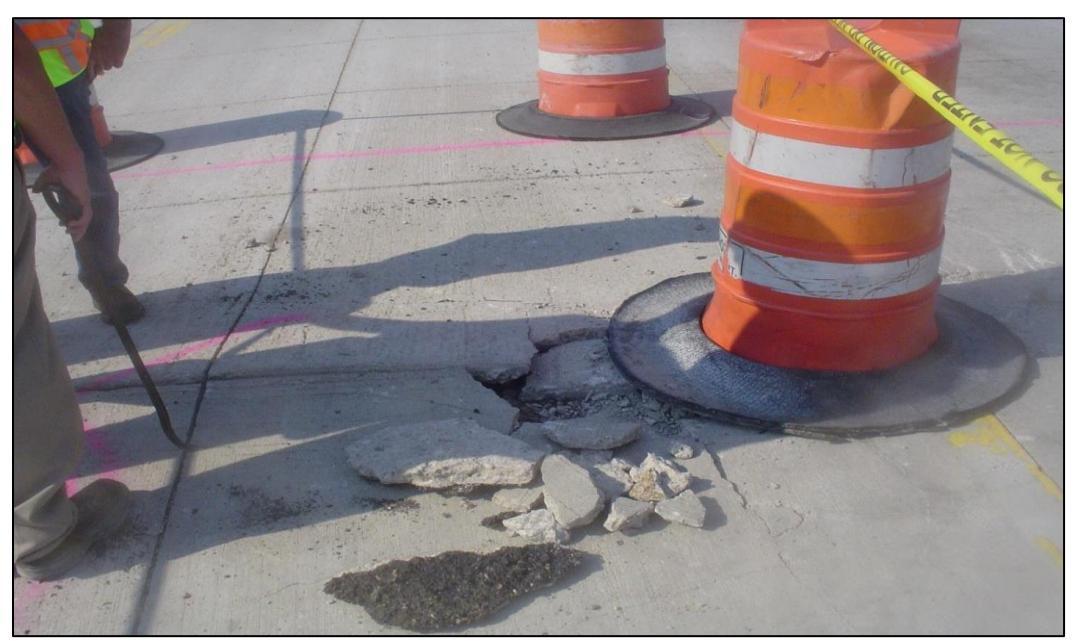
For M-3, some panels at an intersection were repaired in 2008 due to premature failure. These panels exhibited distresses like blowups, cracking, and spalling, as shown in Appendix Figures A12 and A14. Cores were extracted to better understand the cause of the failure, as shown in Figures A15 and A17 of the Appendix. It was observed that sections with severe failure had a concrete overlay thickness less than the design thickness of 4 inches. In general, the causes of failure of the thin unbonded concrete overlay were due to variability in construction rather than poor performance of the designed thin overlay.

Figure A 14. April 2008 Concrete Pavement Blowup North of Van Dyke Street on M-3

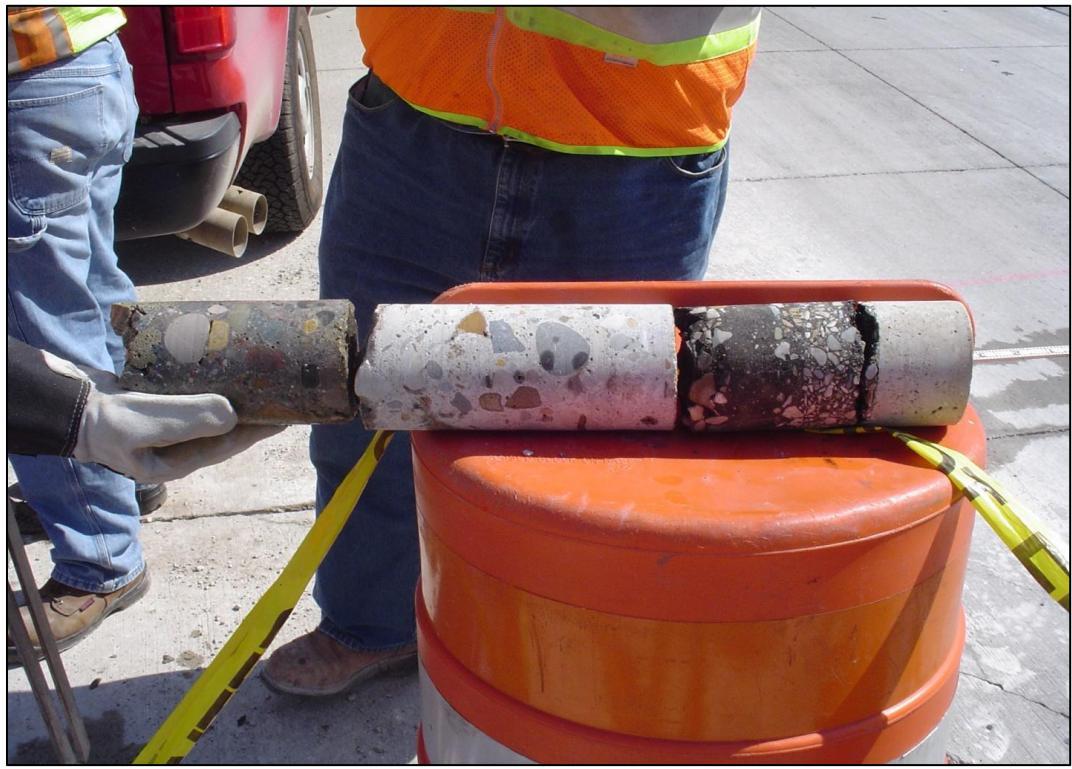
Figure A 15. April 2008 Core from M-3 Blowup Location (overlay is about 3.5")

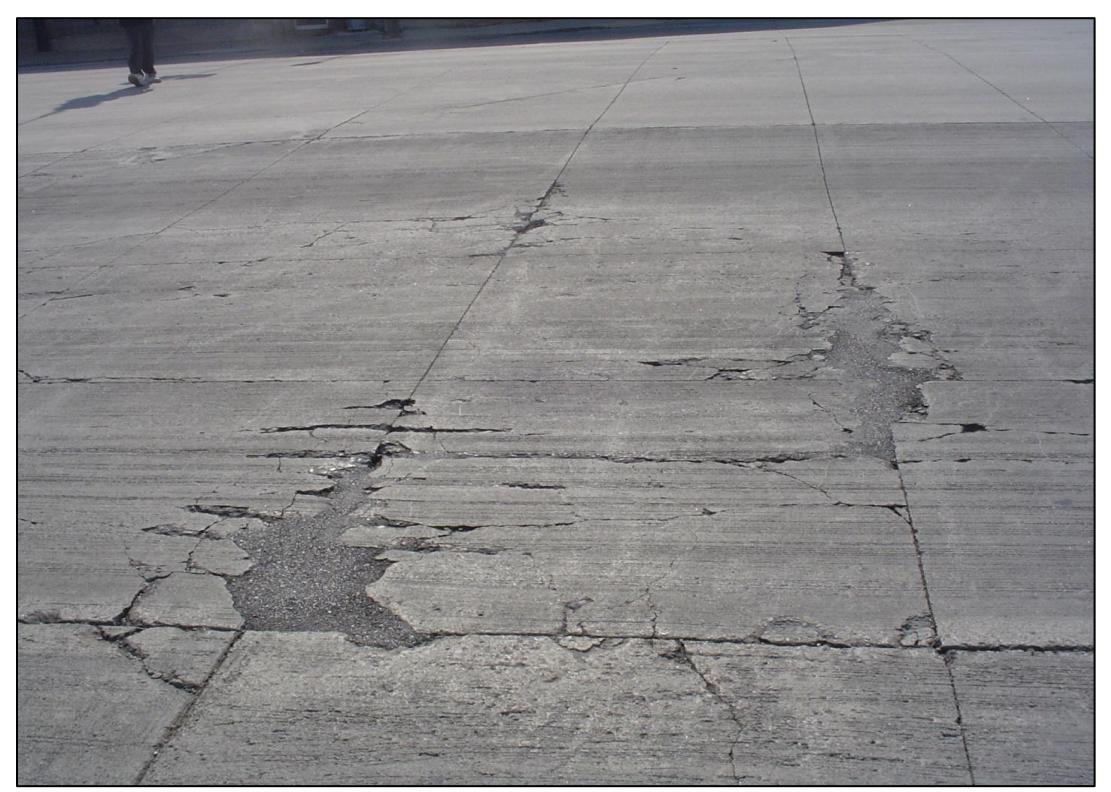
Figure A 16. April 2008 Deteriorated Panel at the Intersection of McDougal and M-3

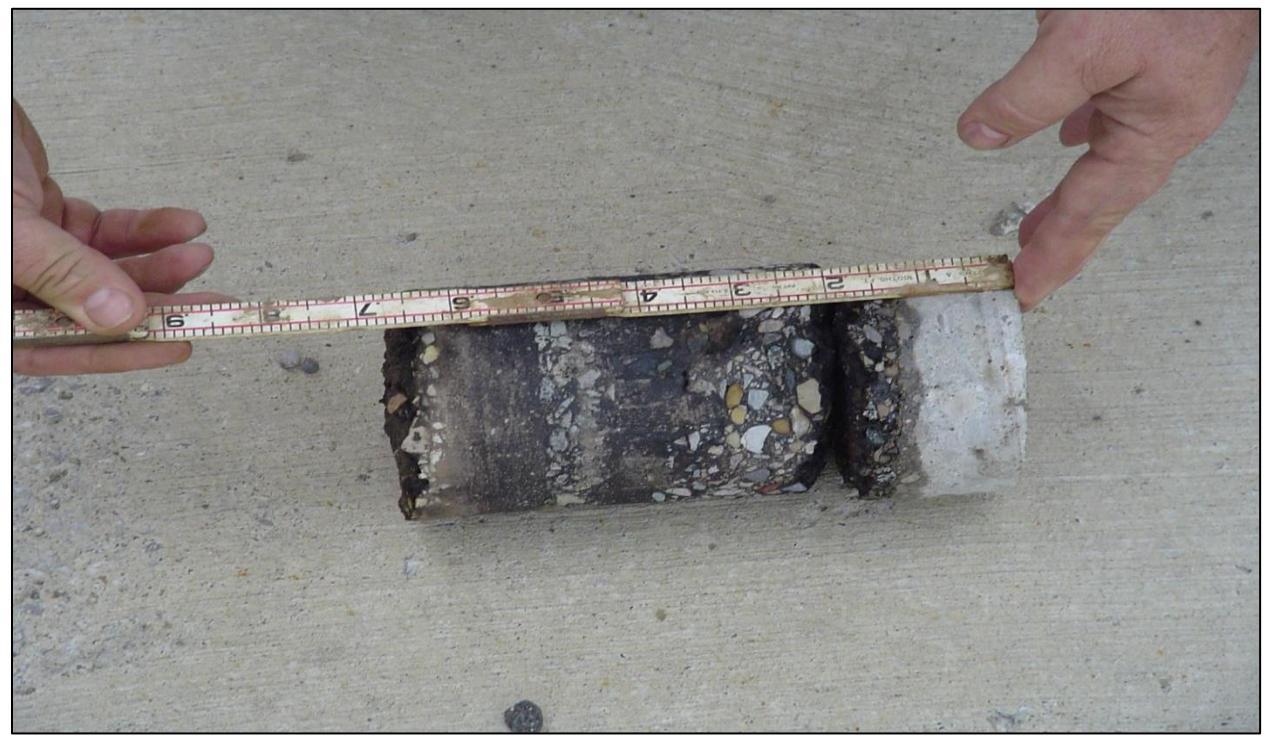
Figure A 17. April 2008 Core from M-3 Deteriorated Panel Location (overlay is about 1.5")

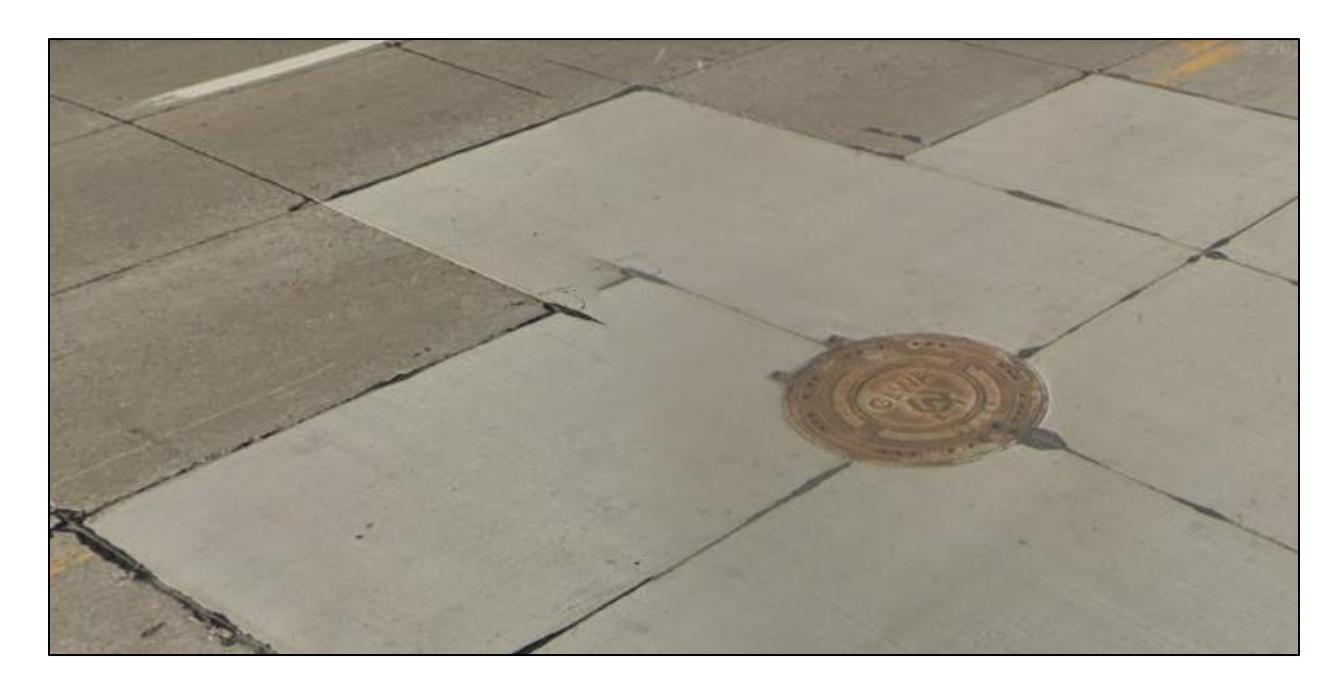
Figure A 18. Repaired Panels on M-1 at Manhole, Google Maps Image 2022

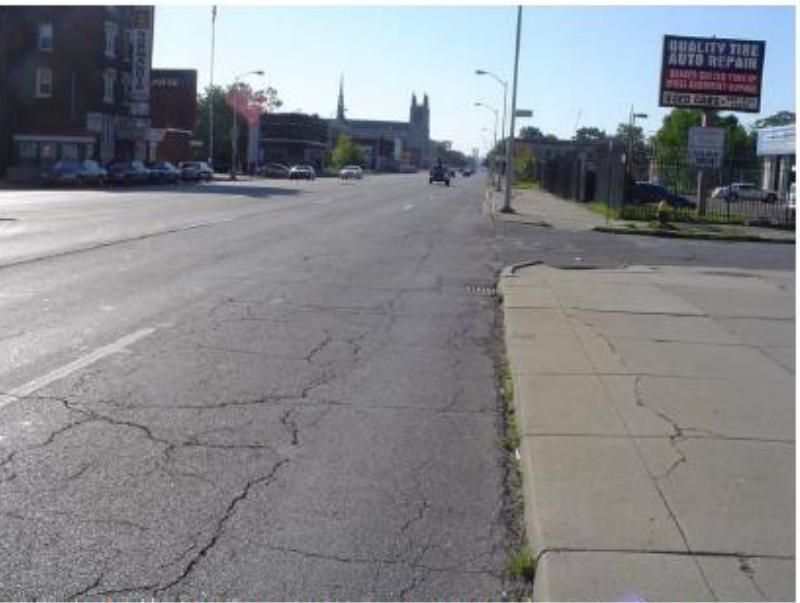
Figure 1: General View of M-1 Showing Cracking

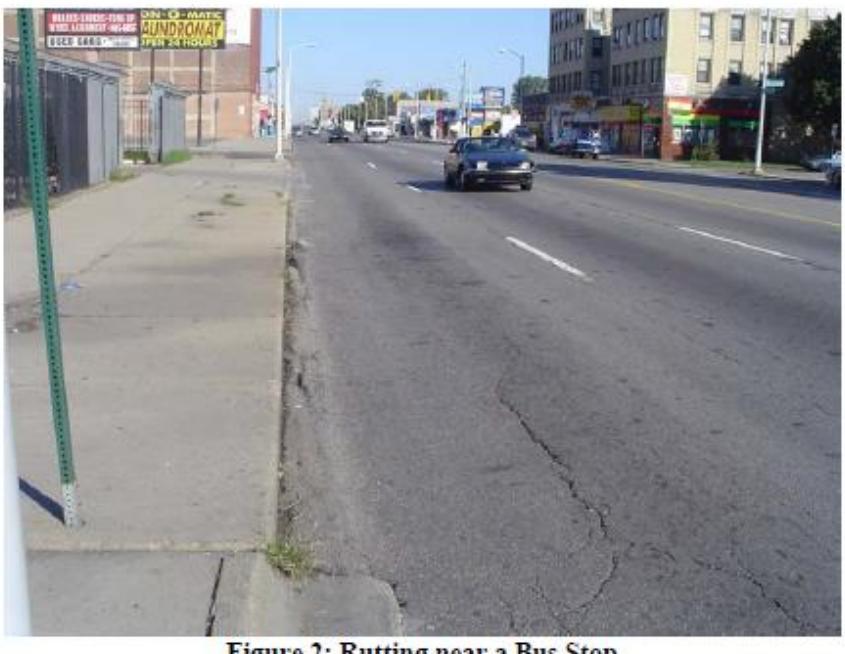
Figure 2: Rutting near a Bus Stop

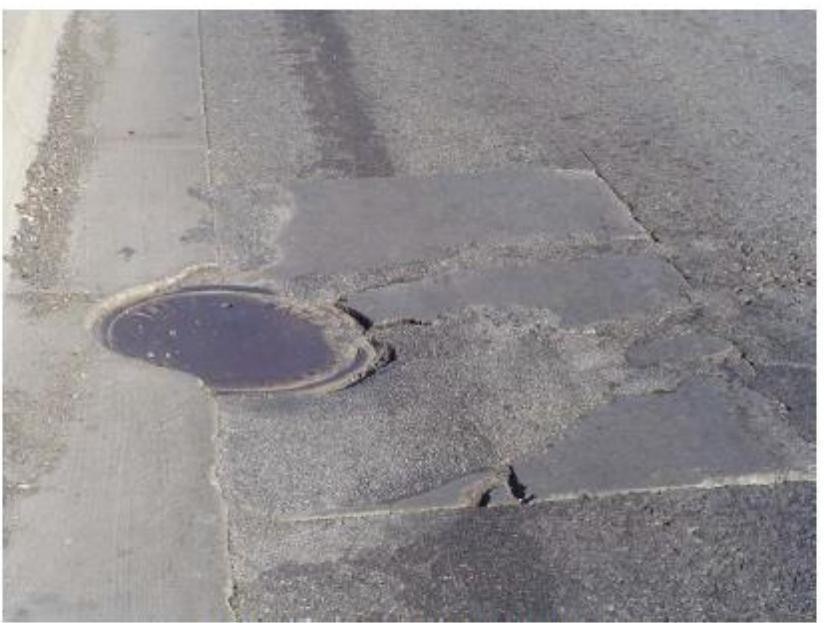
Figure 3: Failures around Structures

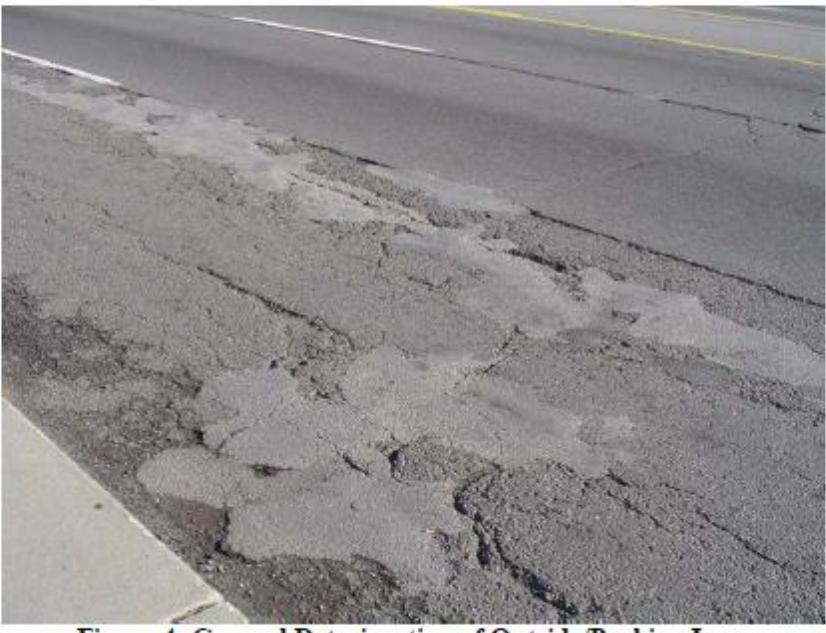
Figure 4: General Deterioration of Outside/Parking Lane

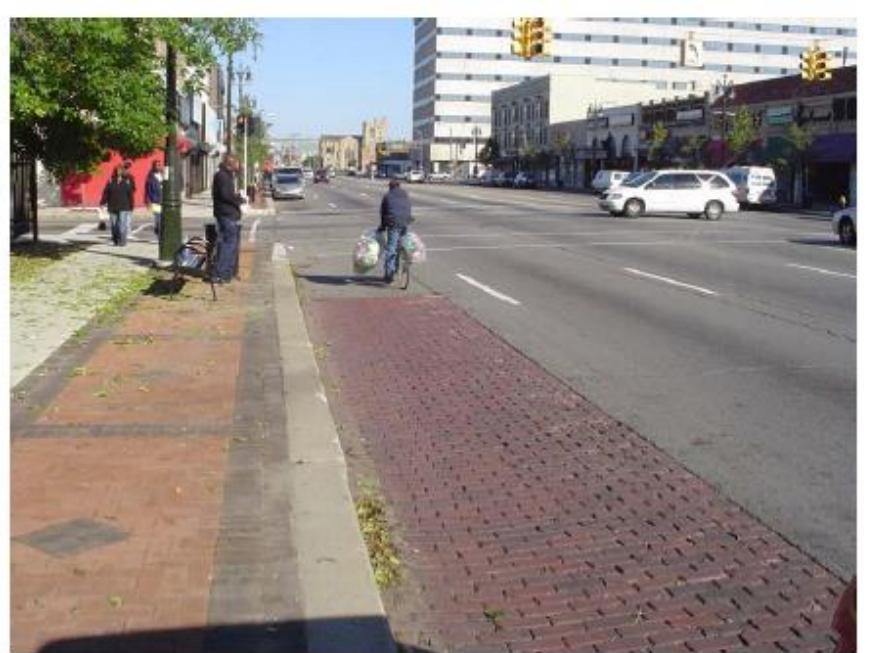
Figure 5: Brick Pavers on the Parking Lane (South of Grand Blvd.)

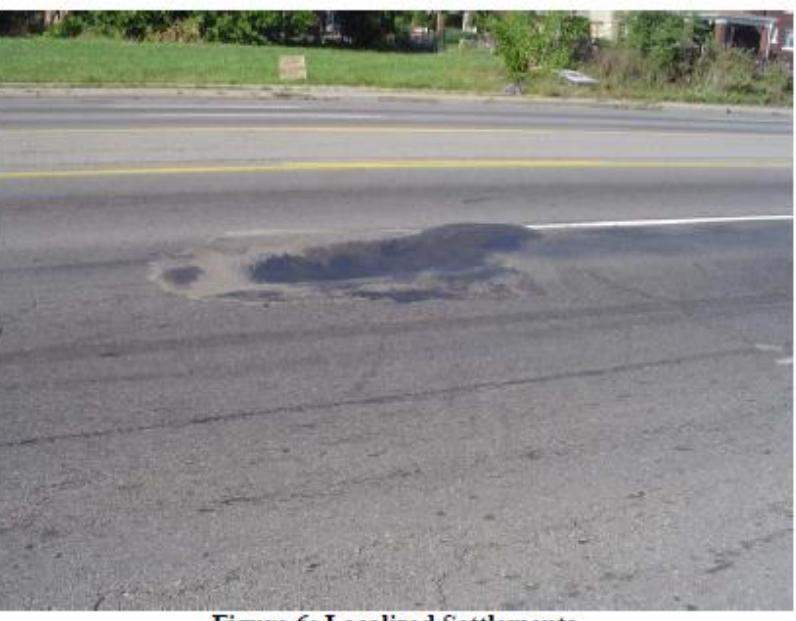
Figure 6: Localized Settlements
