LAWRENCE TECHNOLOGICAL UNIVERSITY

**INSPECTION AND DETERIORATION OF BRIDGE DECKS
CONSTRUCTED USING STAY-IN-PLACE METAL FORMS
AND EPOXY-COATED REINFORCEMENT**

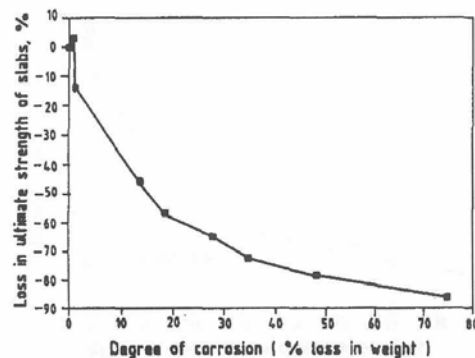
Figure 2.1. Loss in ultimate strength of slabs with varying degrees of corrosion (Almusallam et al. 1996)

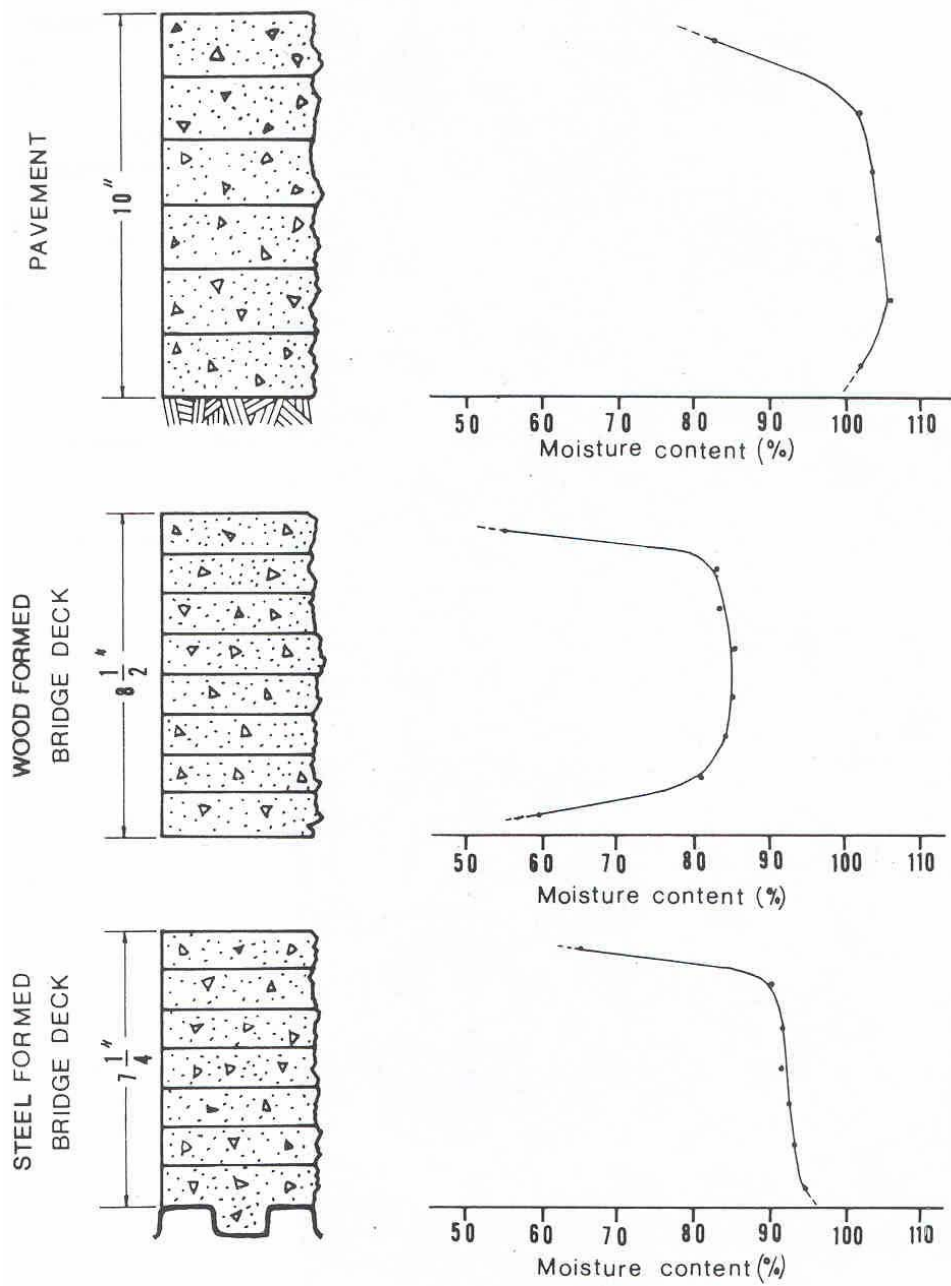
Figure 2.2. Moisture Distribution in a Pavement and Bridge Decks (Cady and Renton 1975)

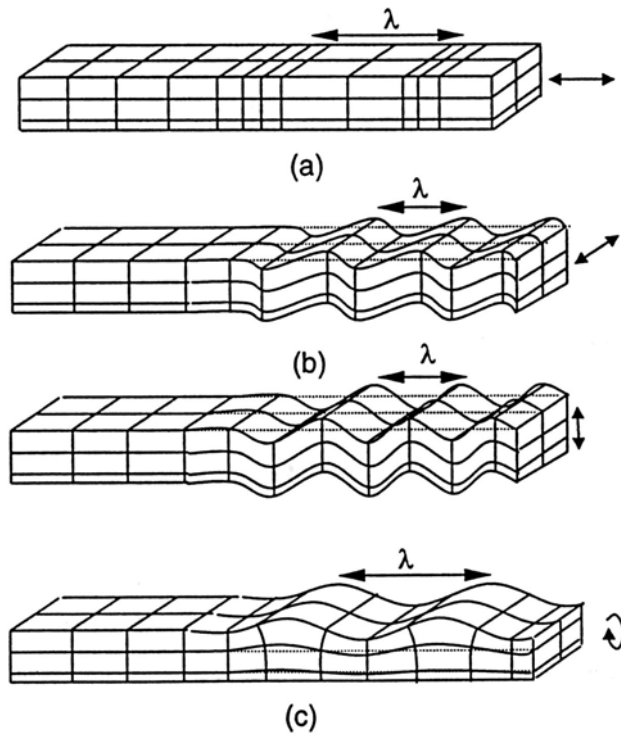
Figure 2.3. Ultrasonic Waveforms (a) Primary Waves, (b) Shear Waves (two polarizations), (c) Rayleigh Waves (Inci 2001)

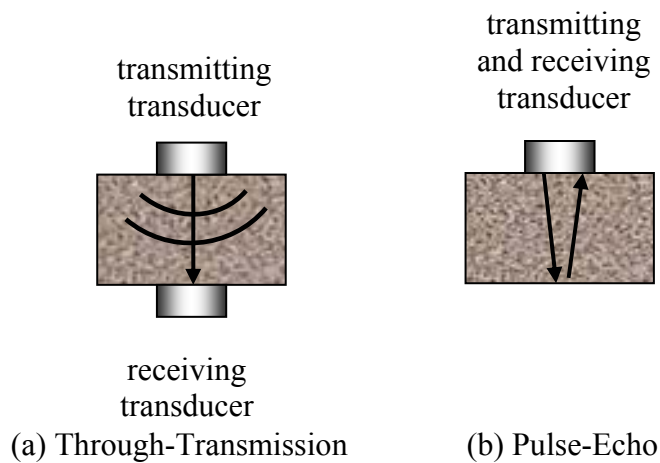
Figure 2.4. Ultrasonic Wave Propagation for (a) Through-Transmission and (b) Pulse-Echo Arrangement

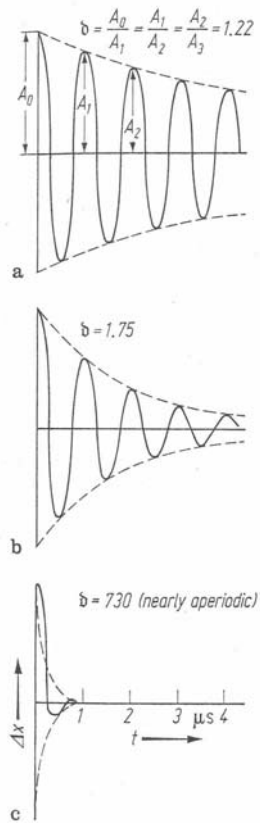
Figure 2.5. Attenuation of ultrasonic wave in various materials (Krautkramer and Krautkramer 1990)

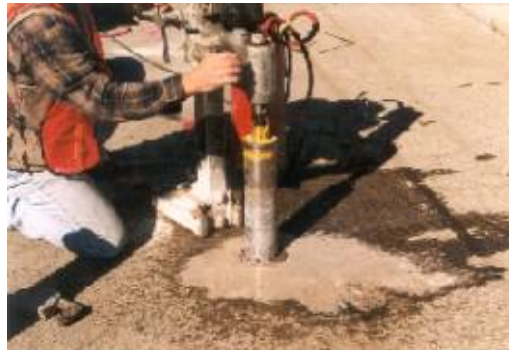
The reinforced hole was then plugged using ready-mix concrete “DURAPATCH HIWAY” (which sets in 10 minutes). The concrete for the plug was rodded after placement.

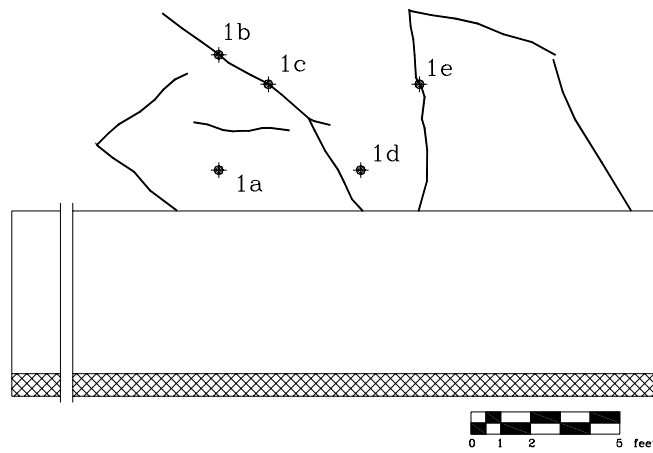
Figure 3.4. Coring locations for Bridge Deck Number 1 (Structure No. R01-13012)

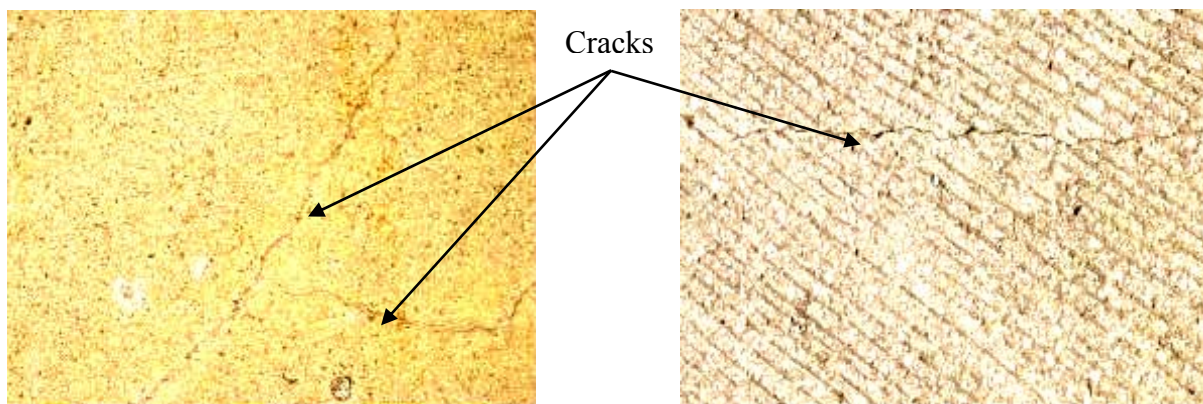
a. Longitudinal and transverse cracks

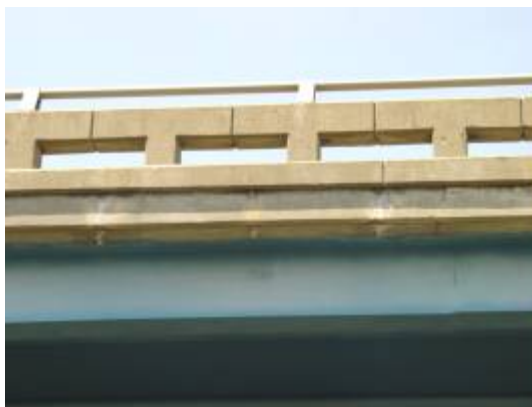
Figure 3.7. Cracks propagated through the sides

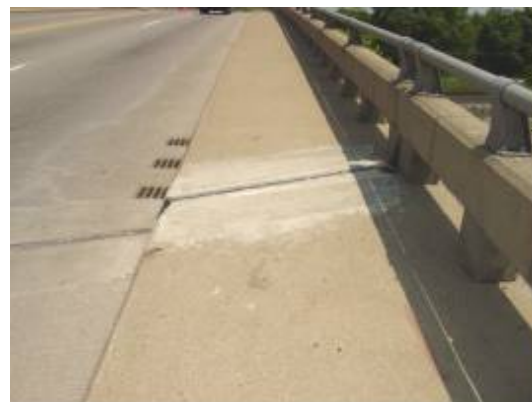
Figure 3.8. Different types of concrete around the joints

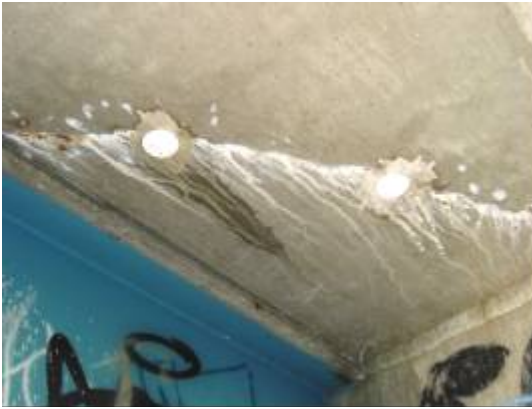
a. Diagonal cracks with white traces

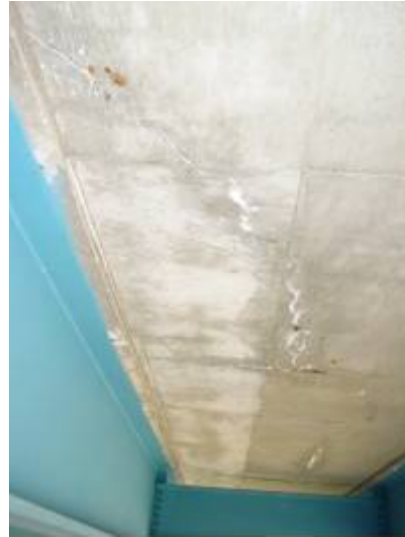
b. Longitudinal cracks with white traces

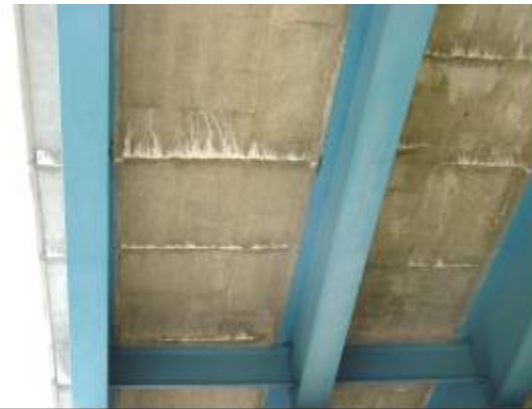
c. Transverse cracks with white traces

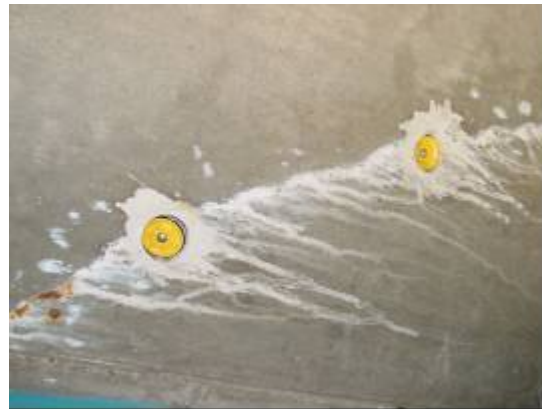
d. Cracks with corrosion and white traces in the direction of slope

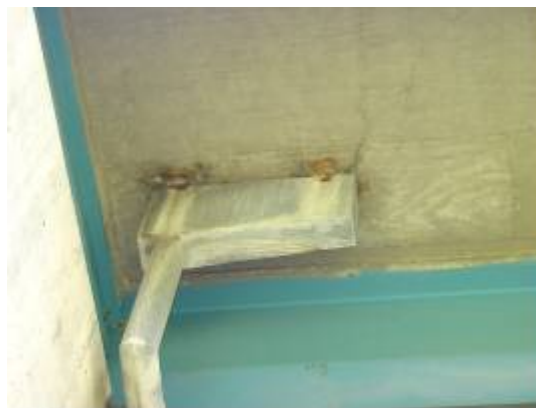
e. Rust traces from reinforcement around the drainage holes

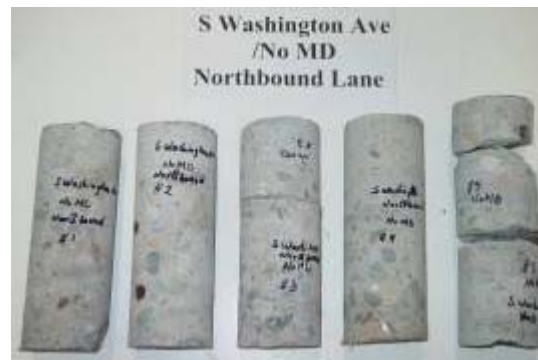
Figure 3.10. The 5 cores taken from Bridge Deck Number 1 (Structure No. R01-13012)

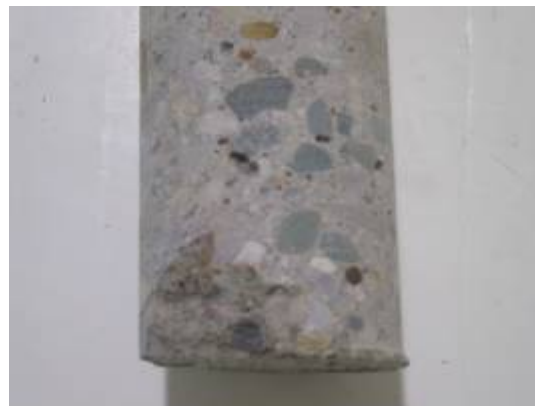
Figure 3.11. Core 1a shows large region of honeycombing

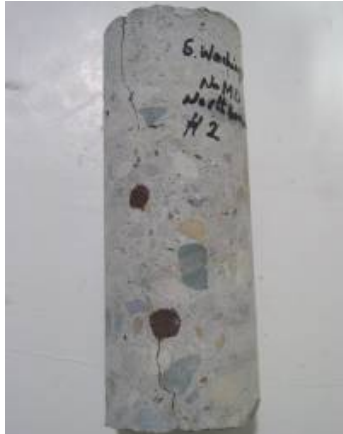
Figure 3.12. Core 1b shows rust in reinforcement

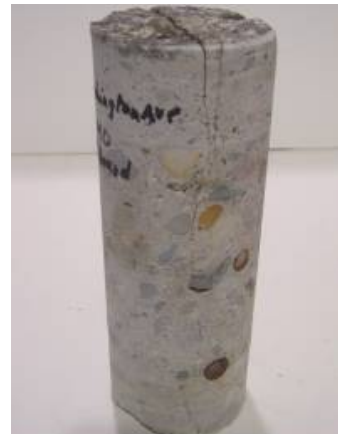
Figure 3.13. Core 1b longitudinal crack

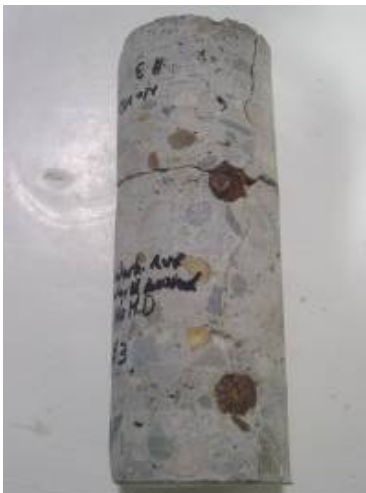
Figure 3.14. Core 1c transverse and longitudinal cracks

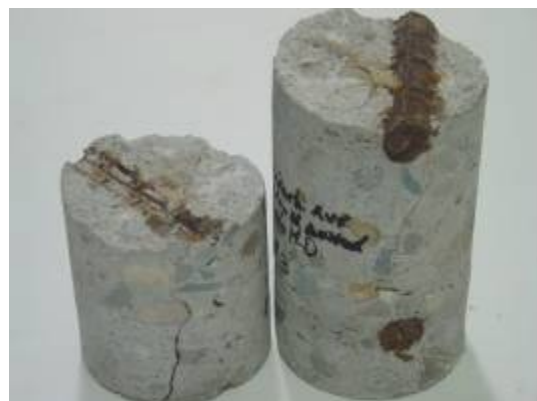
Figure 3.15. Core 1c rust in steel

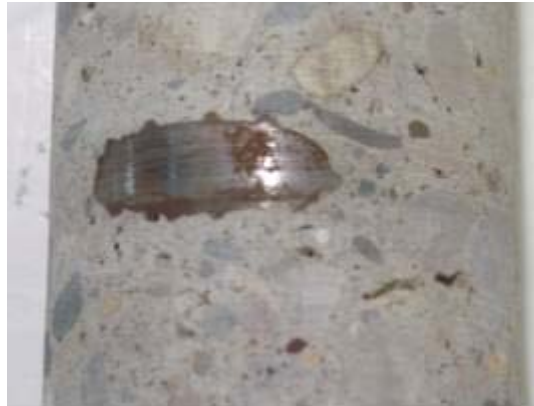
Figure 3.16. Core 1d

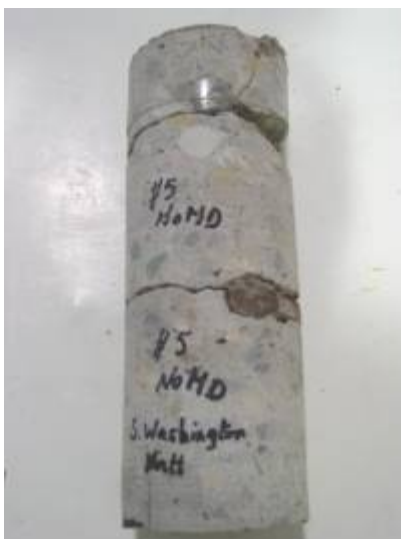
Figure 3.17. Core 1e cracks at the reinforcement bars

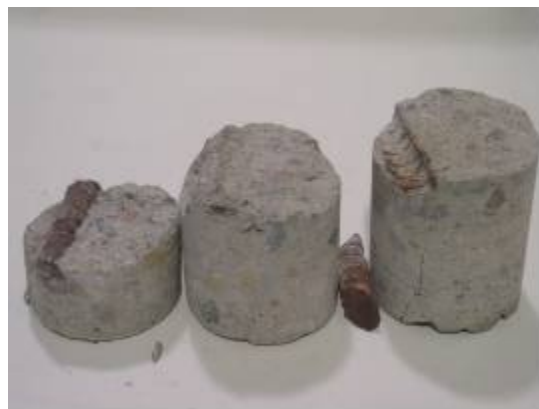
Figure 3.18. Core 1e rust in the reinforcement bar

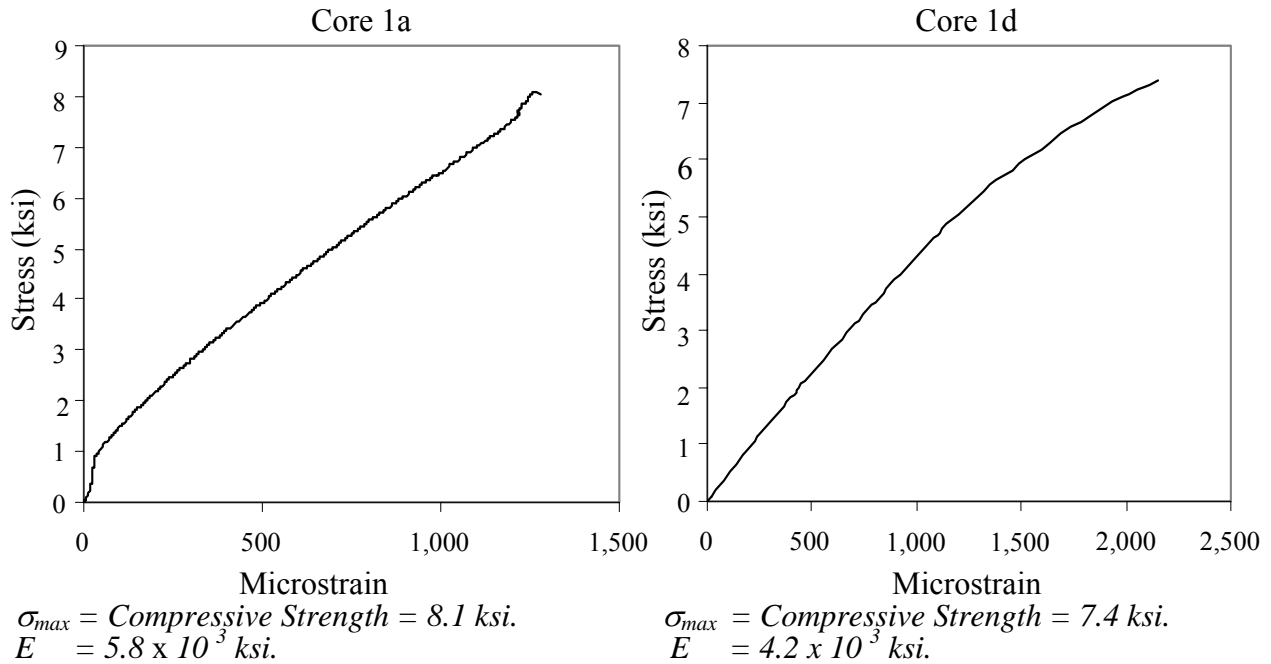
Figure 3.19. Compressive strength test results for Cores 1a and 1d (S. Washington Ave., Bridge Deck Number 1, Structure No. R01-13012, No SIPMF)

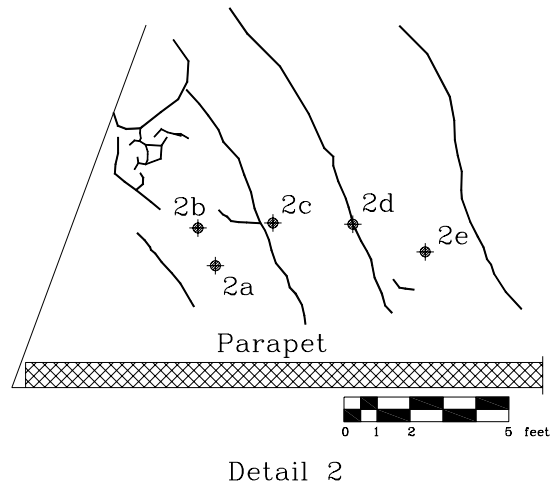
Figure 3.22. Map of cracks at coring locations for Bridge Deck Number 2 (Structure No. S03-81041)

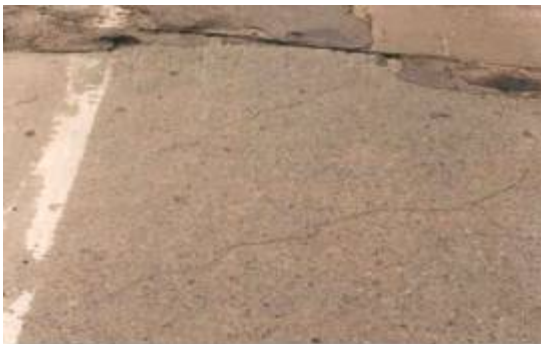
Major cracks were found at the top surface of the concrete slabs at the first and fourth spans (Figure 3.23). These cracks penetrated the entire slab thickness (Figure 3.24). In many locations along the bridge, the concrete curbs were deteriorated and the steel reinforcement bars were uncovered (Figure 3.25). White and rust traces were observed underneath the concrete slab, along the side of the bridge, and at the location of the steel hanger rods supporting PVC conduit for telephone wires (Figures 3.26 to 3.29). Traces of corrosion existed at the location of the first and second joints (Figure 3.30). For the abutment located at the north of the bridge, cracks, white traces and traces of corrosion in steel reinforcements existed at the middle and extreme bays (Figure 3.31).

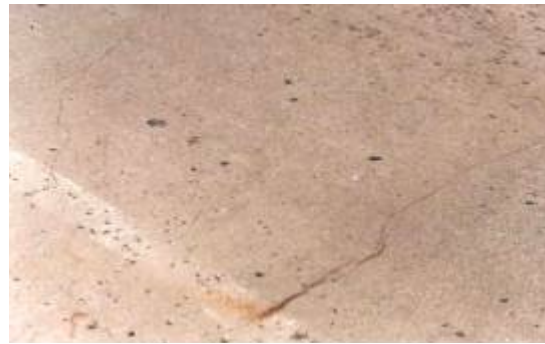
b. Transverse cracks with rust traces

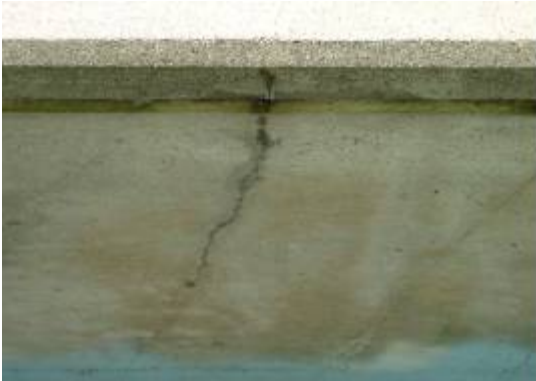
Figure 3.24. Cracks through the slab thickness

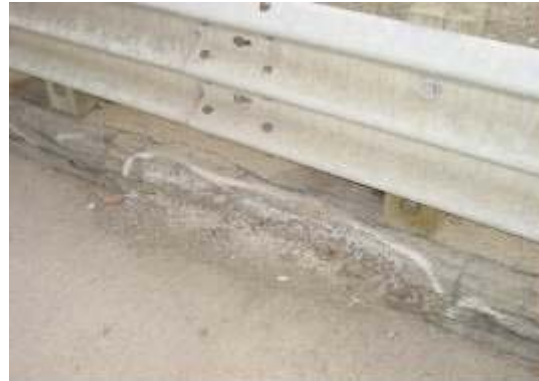
Figure 3.25. Severe deterioration of the curb

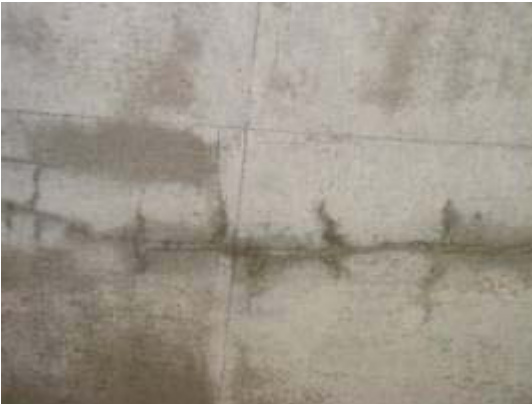
a. Longitudinal crack

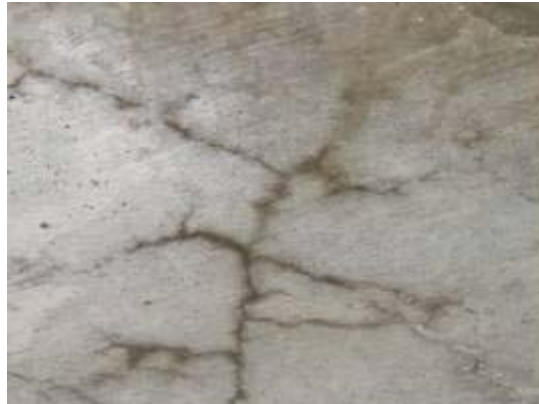
b. Diagonal and Transverse cracks

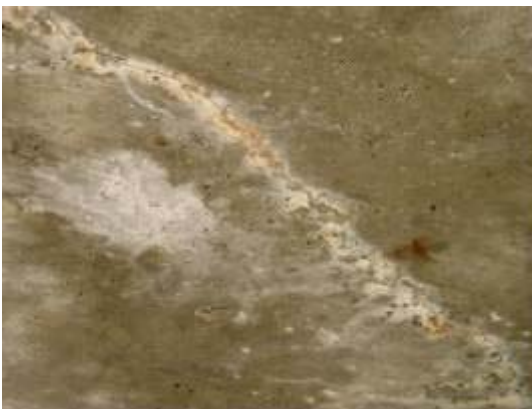
Figure 3.27. White traces on the bottom surface

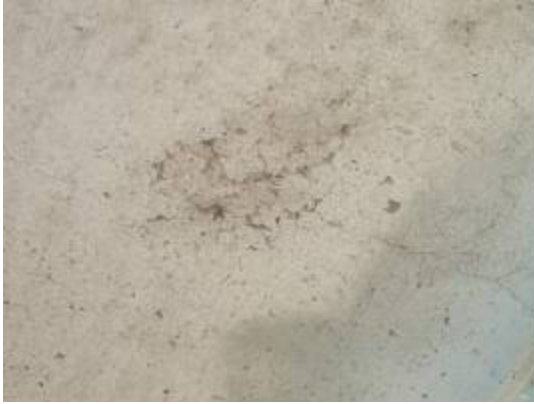
Figure 3.29. Honeycombing at the bottom surface of the slab

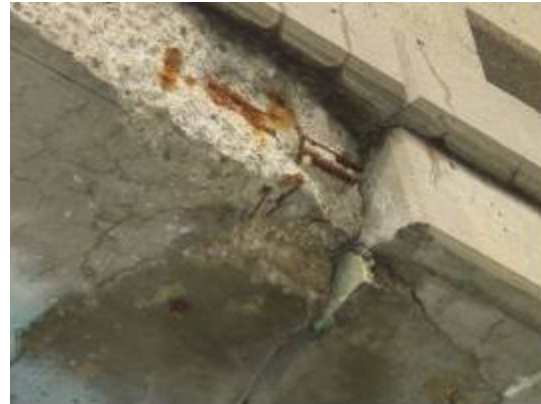
Figure 3.30. Deterioration of the concrete cover and rust traces at the joint

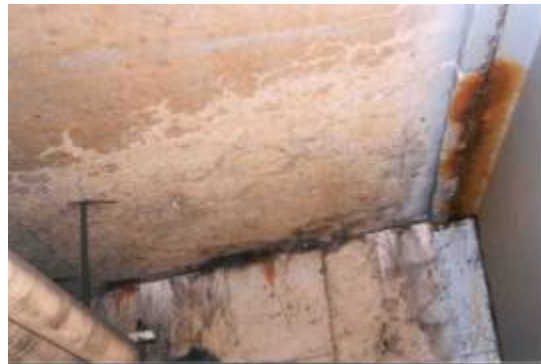
b. Cracks and rust traces

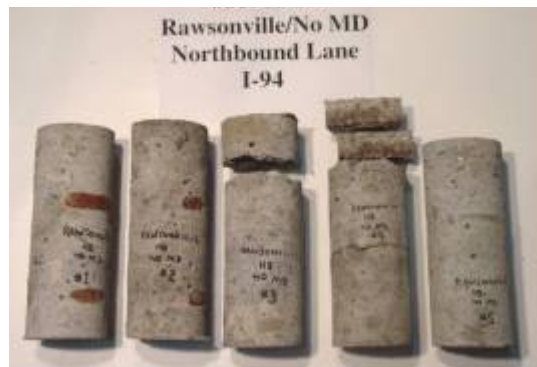
Figure 3.32. The 5 cores taken from Bridge Deck Number 2 (Structure No. S03-81041)

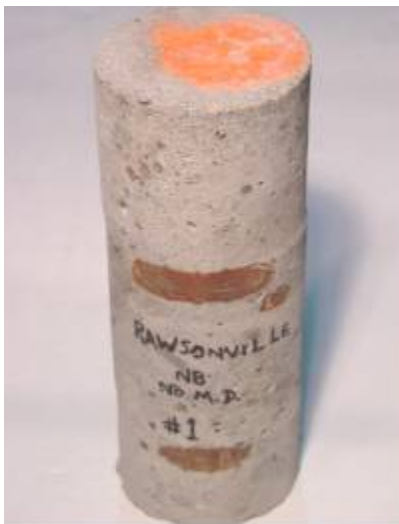
Figure 3.33. Core 2a reinforcement bars are rusted

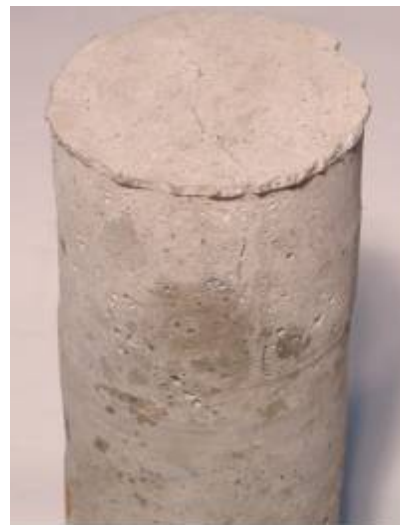
Figure 3.34. Core 2a crack propagated through the depth of the core

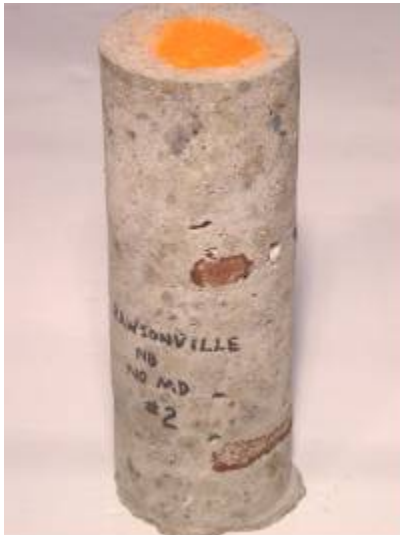
Figure 3.35. Core 2b

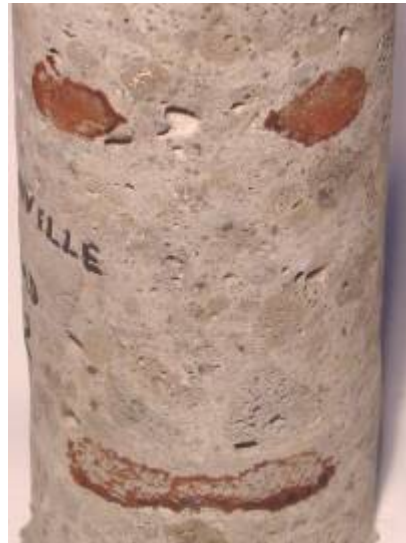
Figure 3.36. Core 2b rust in the reinforcement bars

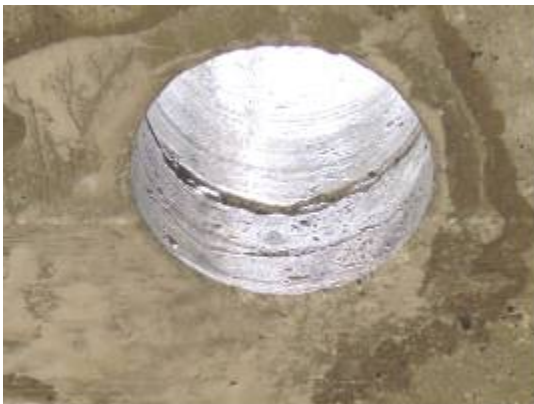
Figure 3.37. Crack in the thickness of the slab (Core 2c location)

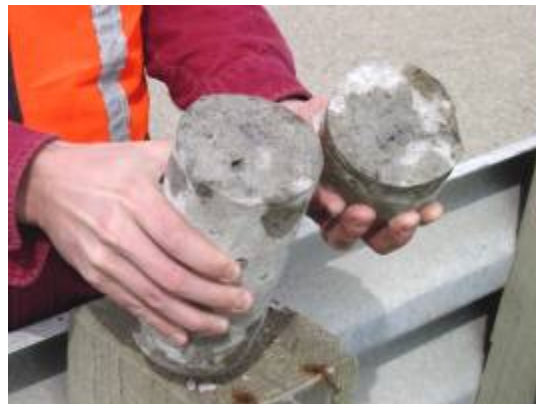
Figure 3.38. Presence of horizontal crack in Core 2c

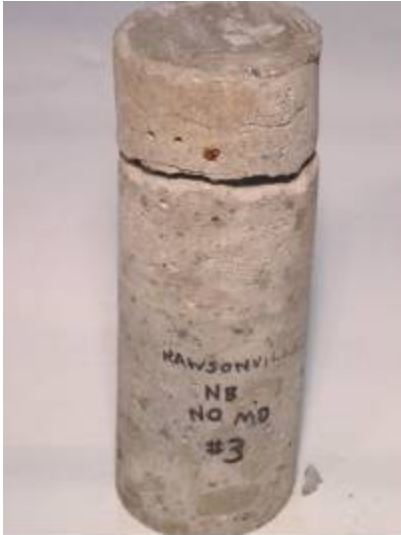
Figure 3.39. Core 2c

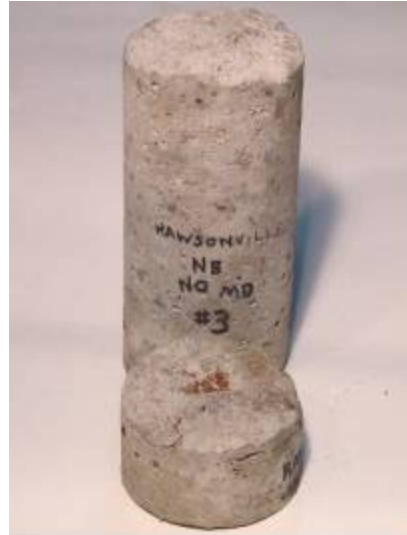
Figure 3.40. Core 2c rust traces

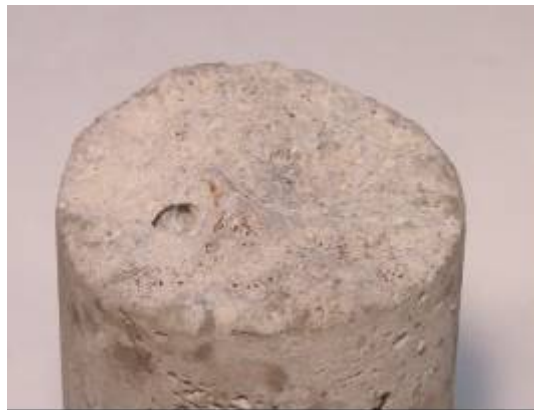
Figure 3.41. Core 2c honeycombing in the concrete

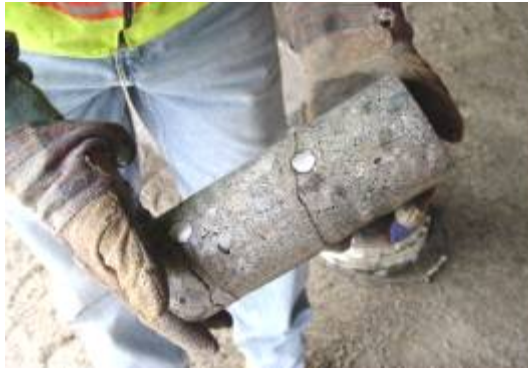
Figure 3.42. Core 2d after collecting it

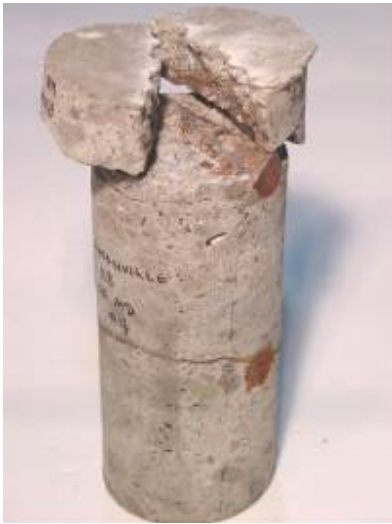
a. Core was broken at the bottom

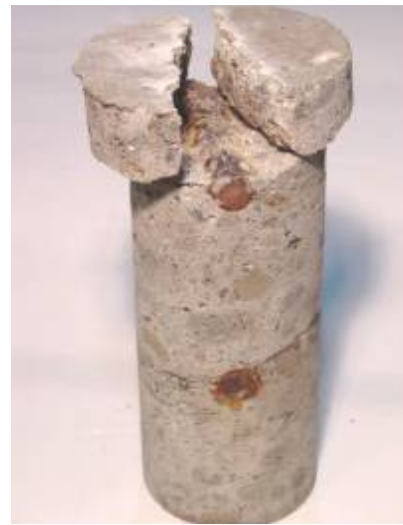
b. Reinforcement bars are rusted

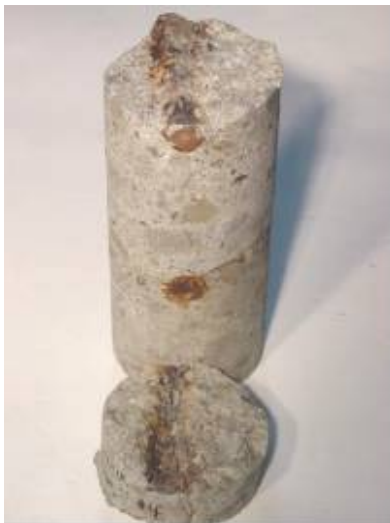
Figure 3.43. Deterioration of Core 2d

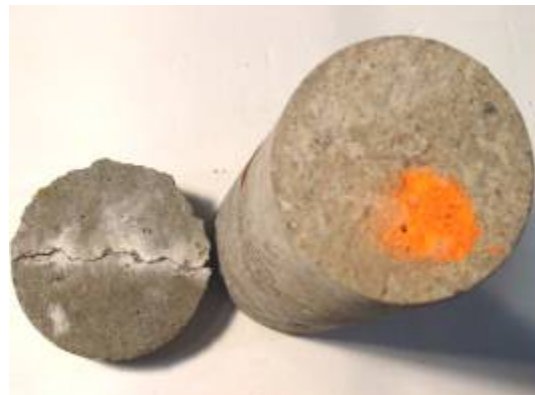
b. White traces on the bottom surface

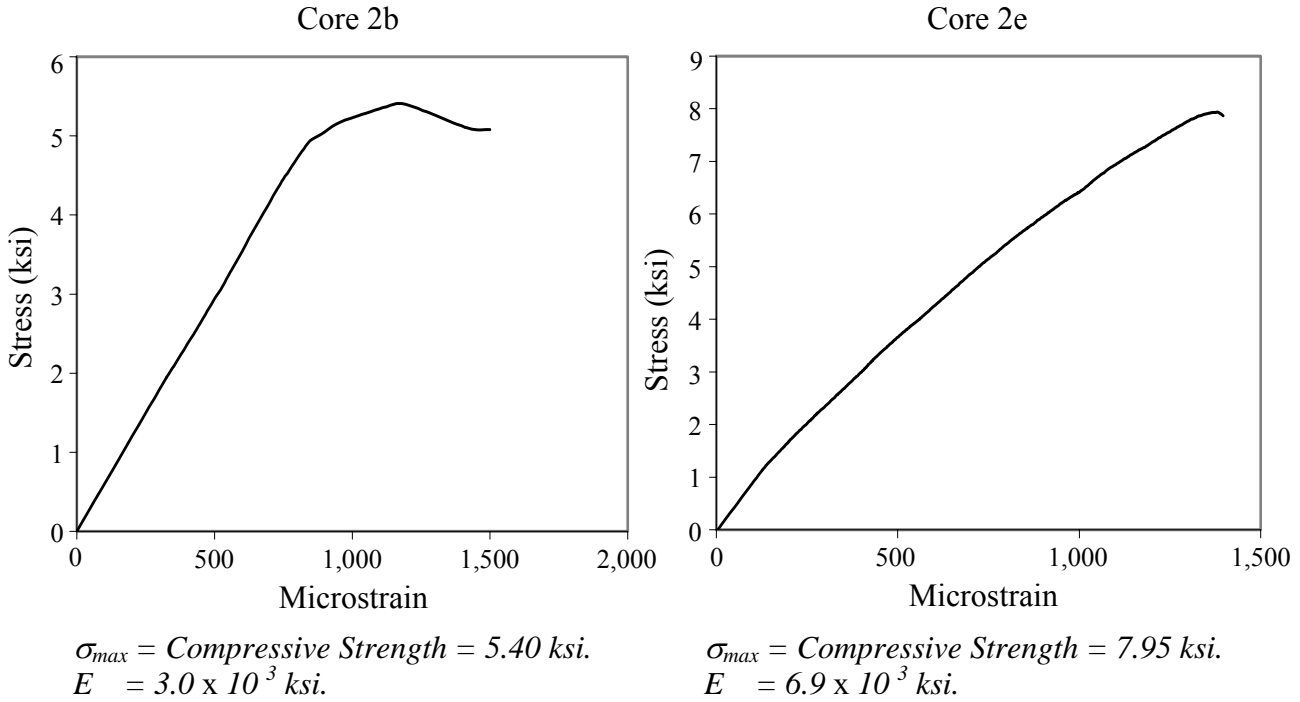
Figure 3.46. Compressive strength test results for Cores 2b and 2e (Rawsonville Rd., Bridge Deck Number 2, Structure No. S03-81041, No SIPMF)

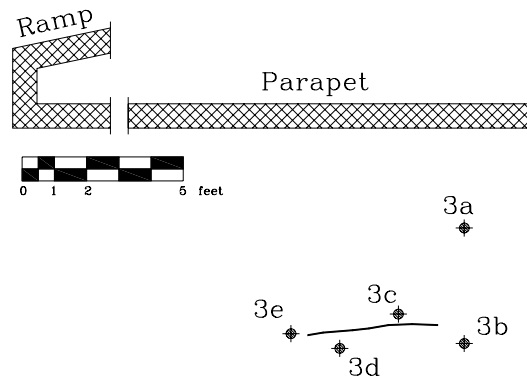
Figure 3.48. Coring locations for Bridge Deck Number 3 (Structure No. B01-82194)

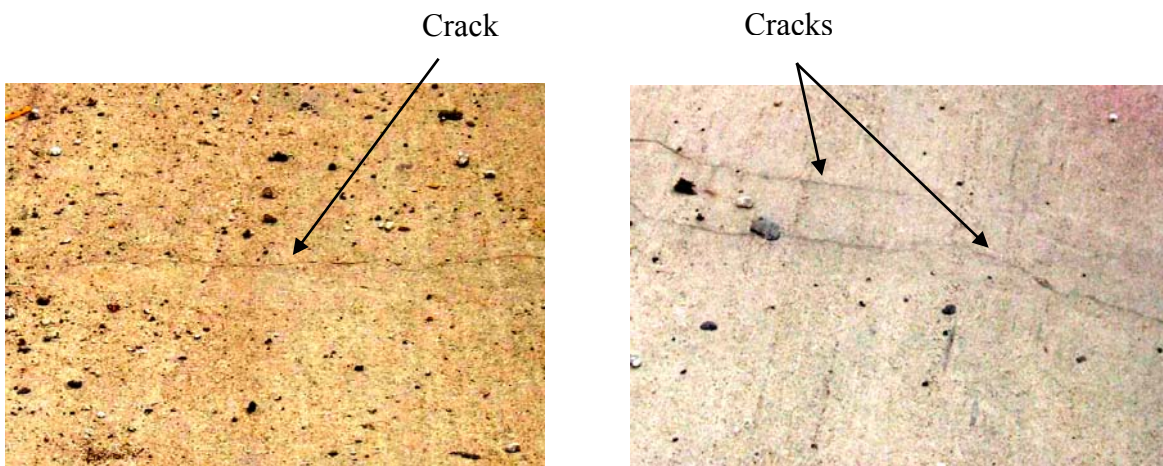
An inspection of the bridge was conducted for the top and bottom surfaces of the deck slab, steel beams and piers. Cracks were observed at the top surface of the concrete slabs (Figure 3.50). Cracks propagated transversely and longitudinally dividing the surface into small rectangles (approximately one square foot each) as shown in Figure 3.51. White and rust traces were encountered underneath the concrete slab (Figure 3.51). White traces were also encountered around the drainage pipe at the bottom surface (Figure 3.51). In some locations, the concrete cover was deteriorated and the steel reinforcement bars were exposed and rusted (Figure 3.52). The bottom surface of the cantilever deck slabs had white traces and the reinforcement bars had corrosion traces (Figure 3.53).

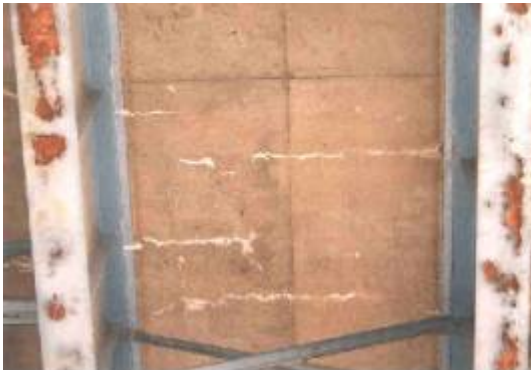
a. Transverse cracks and white traces

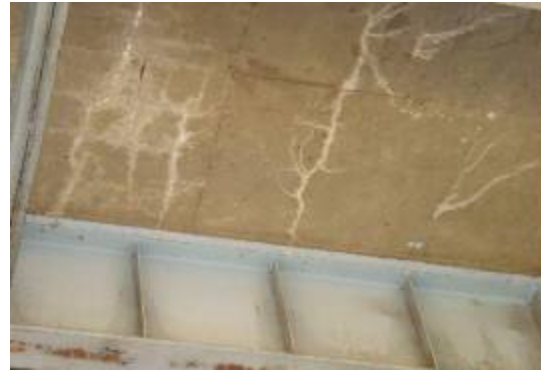
b. Transverse and longitudinal cracks

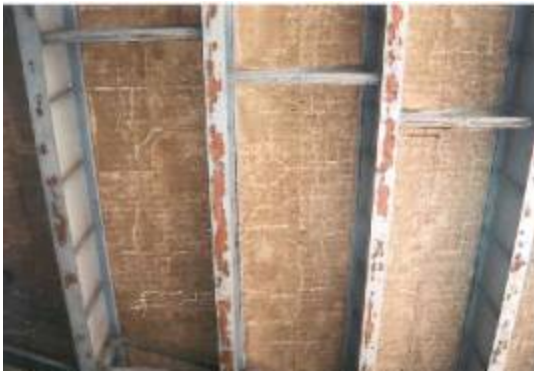
c. Cracks and white traces (small rectangles)

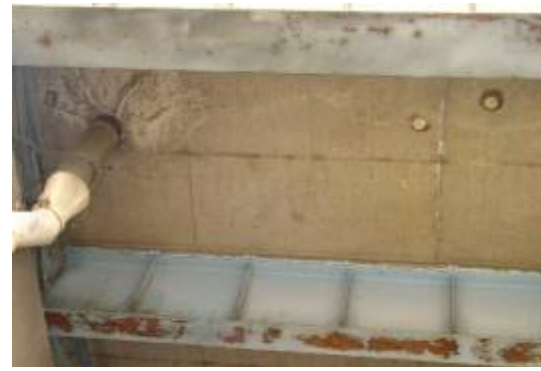
d. White traces around drainage opening

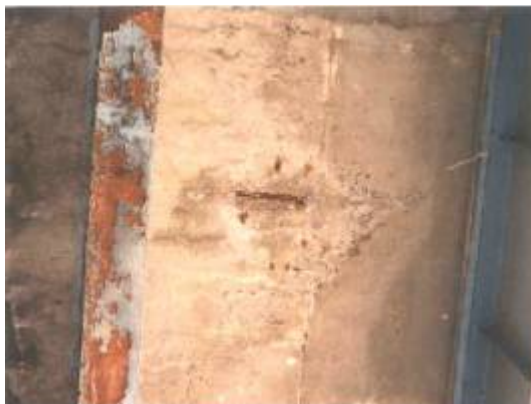
a. Deteriorated concrete cover and rust traces

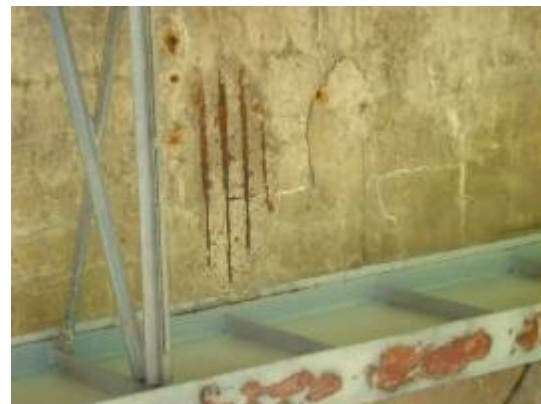
b. Reinforcement bars rusted

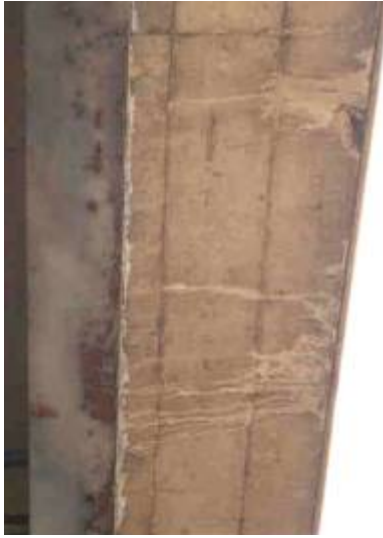
Figure 3.52. Corrosion in the reinforcement bars at the bottom surface of the slab

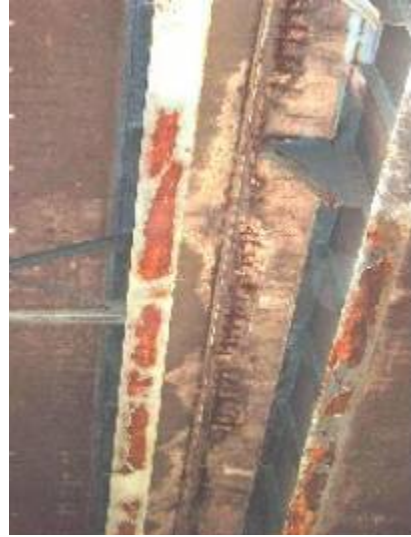
b. Rust and white traces

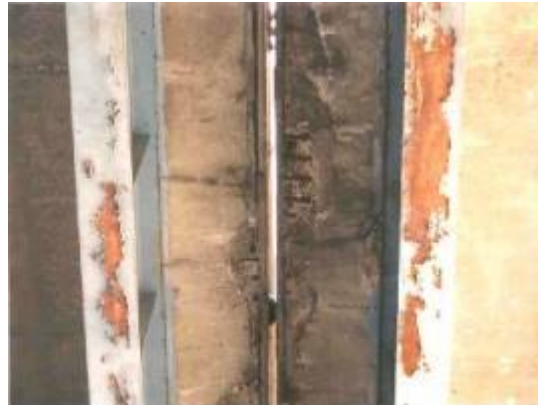
c. Rust and white traces

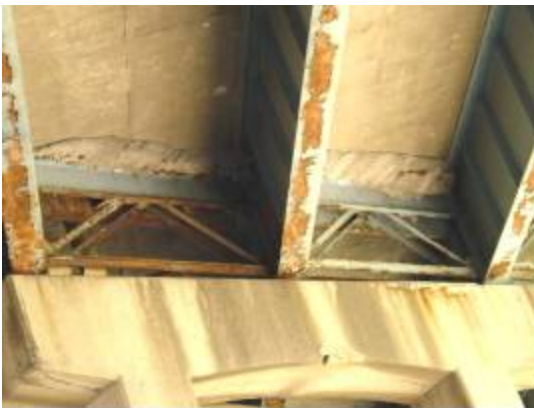
a. Deteriorated concrete cover

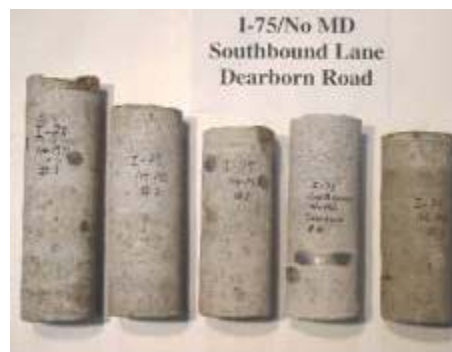
Figure 3.55. The 5 cores that were taken from Bridge Deck Number 3 (Structure No. B01-82194)

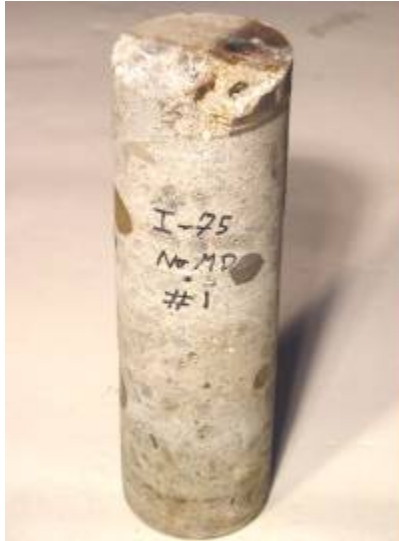
- 12.3 in. height.
- Part of the connection between the steel beam and the slab was cut and there were traces of corrosion on it.
- Six axial cuts located 4.8, 8.0 and 9.0 in. from top.
- One longitudinal cut located 3.8 in. from top.
- Five locations of honeycombing of average diameter of 0.2 in. located 5.0, 5.5, 6.0 and 8.0 in. from top.
- There was a large void of diameter 0.4 in. and depth of 3.5 in. located the bottom of the core at the location of the connection with the steel beam.
- Slag as well as conventional aggregates were used.

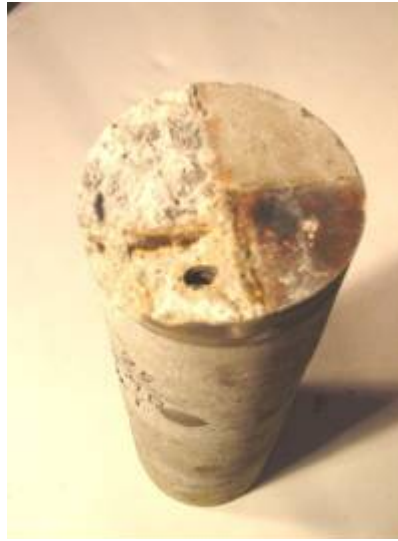
b. Large void and rust at the bottom

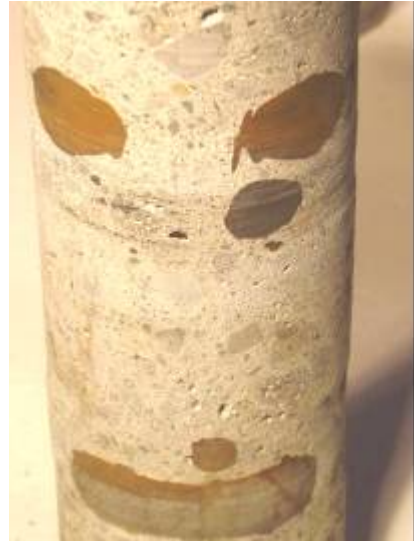
c. Rusted reinforcement bars

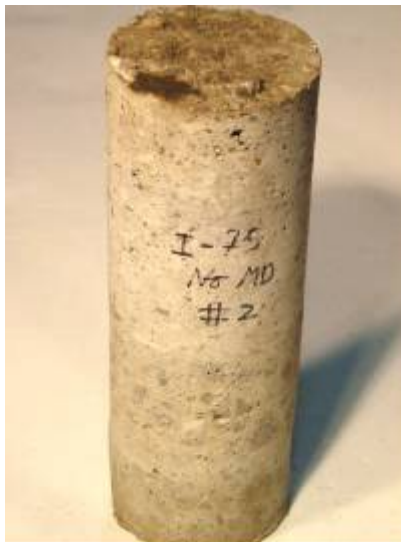
Figure 3.57. Core 3b

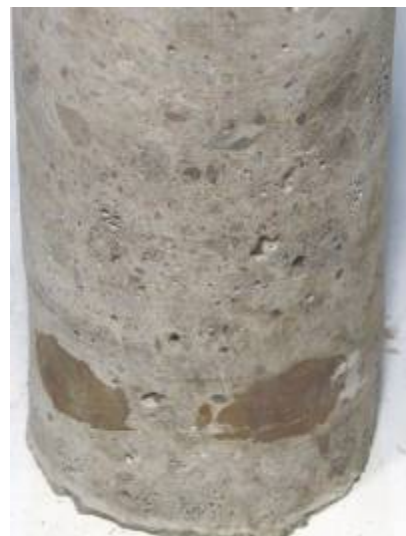
Figure 3.58. Core 3b voids and rust in the reinforcement

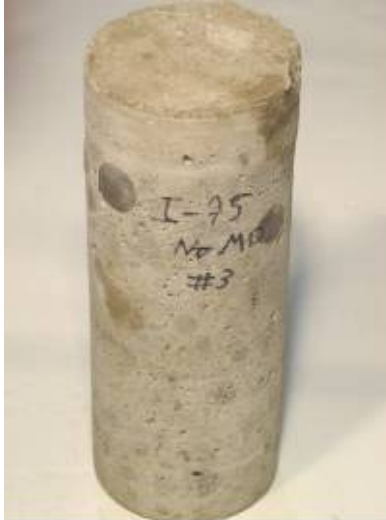
Figure 3.59. Core 3c

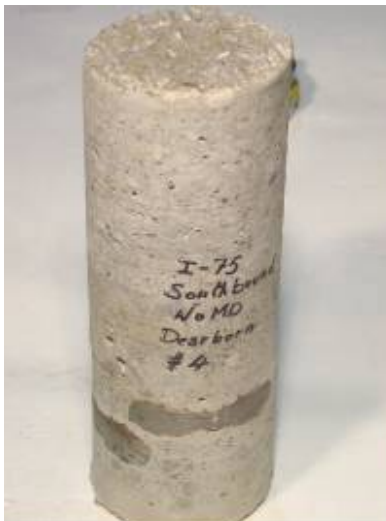
Figure 3.61. Core 3d

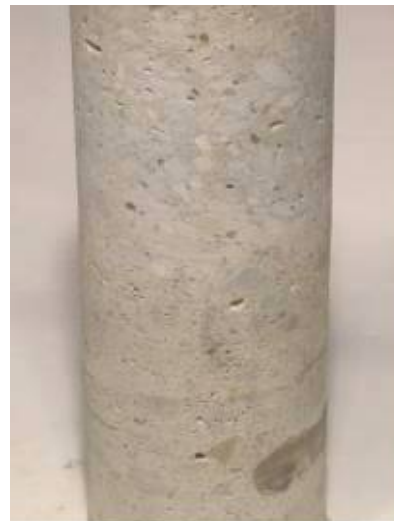
Figure 3.62. Core 3d wearing surface

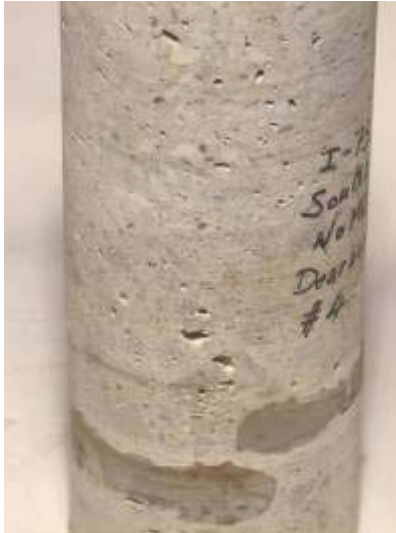
Figure 3.63. Voids in Core 3d

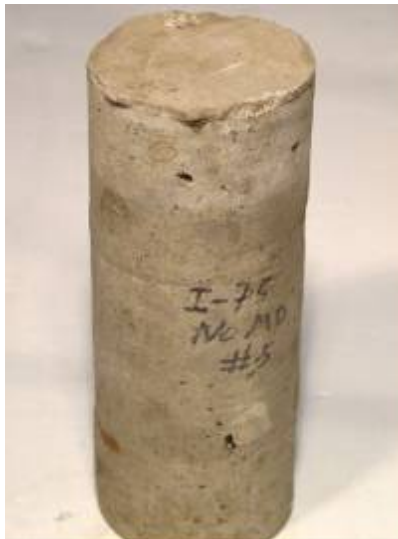
Figure 3.64. Wearing surface
Core 3e

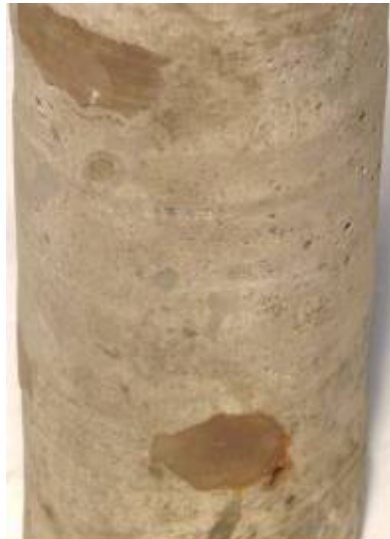
Figure 3.65. Rust in steel bars
Core 3e

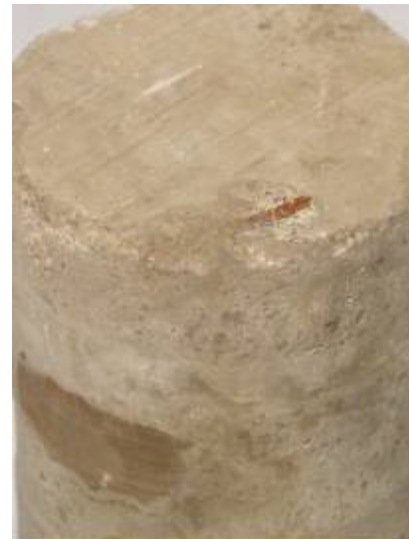
Figure 3.66. Pop-out in concrete
Core 3e

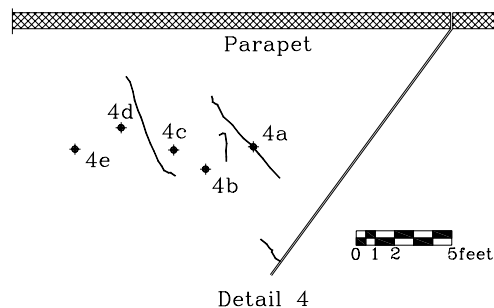
Figure 3.70. Map of cracks at coring location for Bridge Deck Number 4 (Structure No. S11-82022)

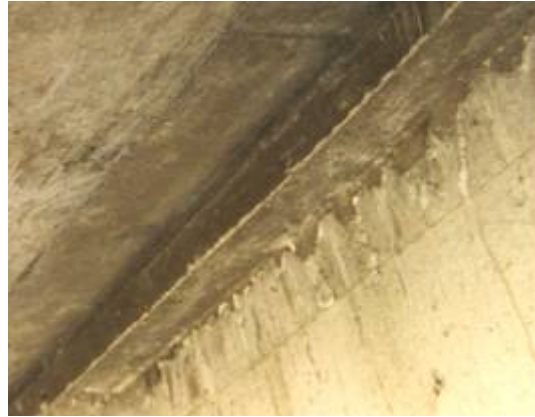
Figure 3.71. Good concrete condition

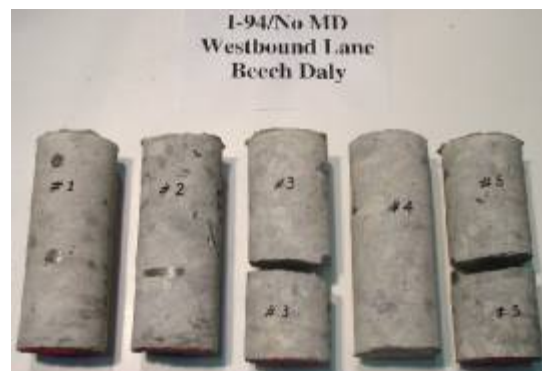
Figure 3.72. The 5 cores that were taken from Bridge Deck Number 4 (Structure No. S11-82022)

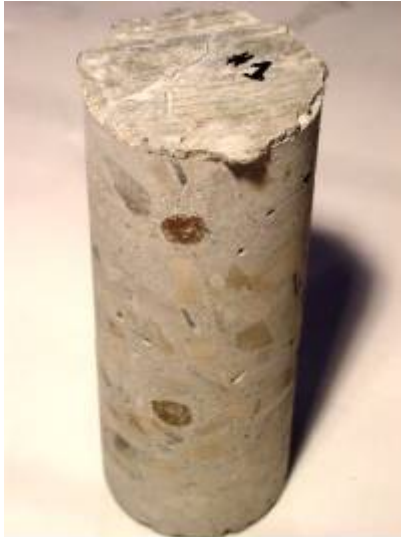
a. Reinforcement bars

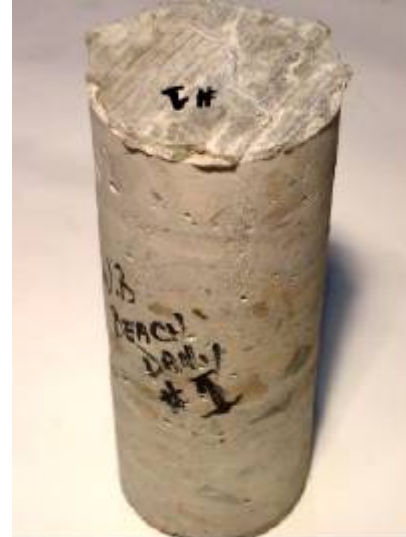
b. Crack propagated through the height

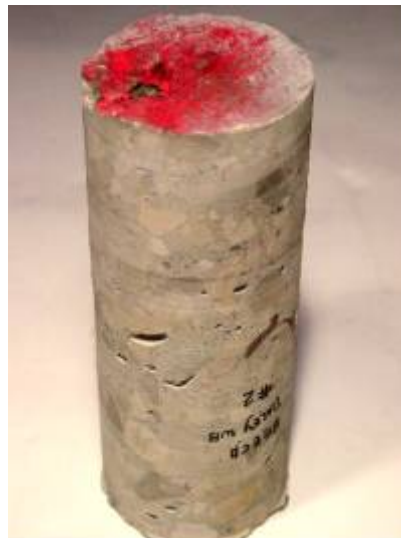
Figure 3.74. A few large voids near the mid-height and reinforcing steel were observed in Core 4b

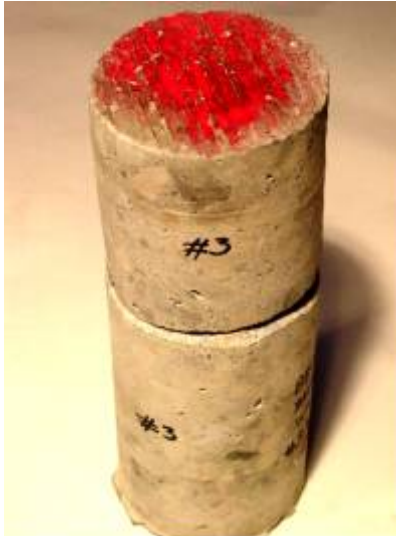
Figure 3.75. Core 4c fractured at the reinforcement location

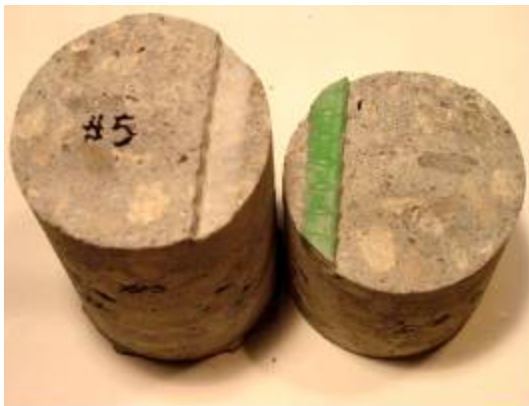
Figure 3.77. Exposed reinforcement where core fractured in Core 4e

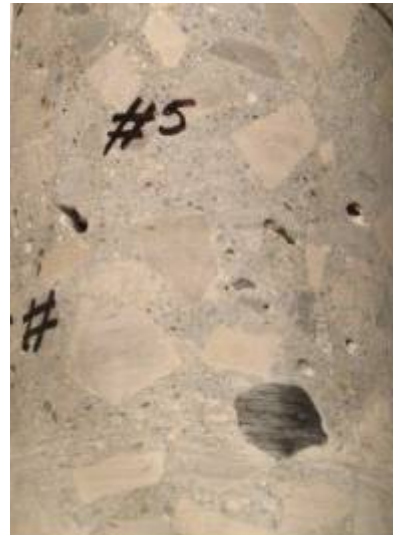
Figure 3.78. Voids observed in Core 4e
