LAWRENCE TECHNOLOGICAL UNIVERSITY

**INSPECTION AND DETERIORATION OF BRIDGE DECKS
CONSTRUCTED USING STAY-IN-PLACE METAL FORMS
AND EPOXY-COATED REINFORCEMENT**

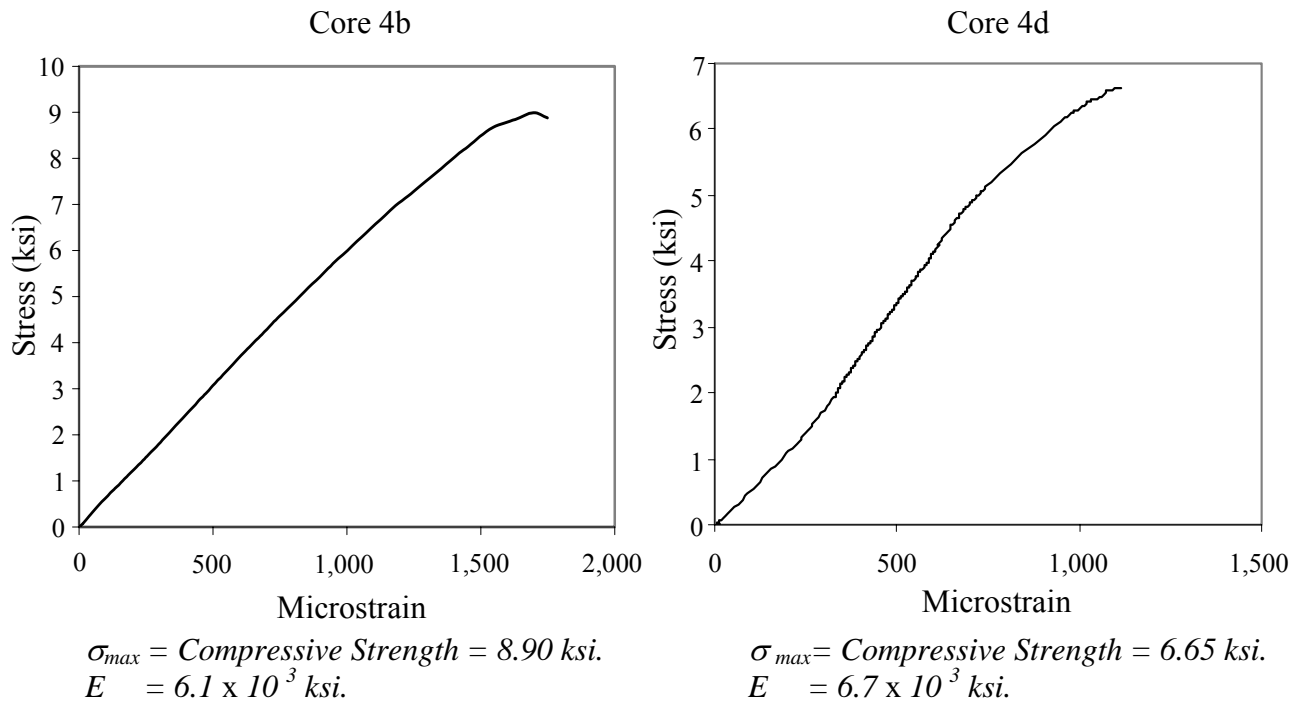
Figure 3.79. Compressive strength test results for Cores 4b and 4d (I-94, Bridge Deck Number 4, Structure No. S11-82022, No SIPMF)

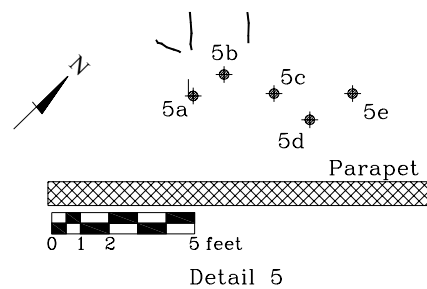
Figure 3.82. Map of cracks at coring locations for Bridge Deck Number 5 (Structure No. S09-82022)

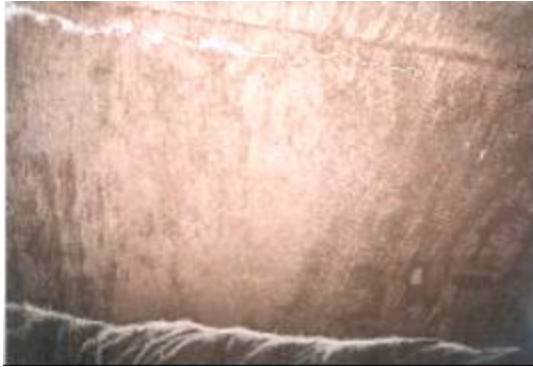
a. White traces at approximately 4 ft

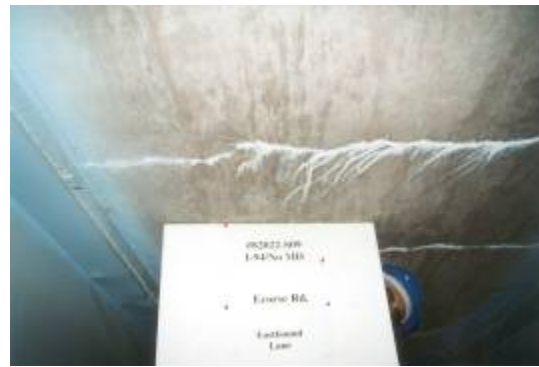
b. White traces with transverse crack

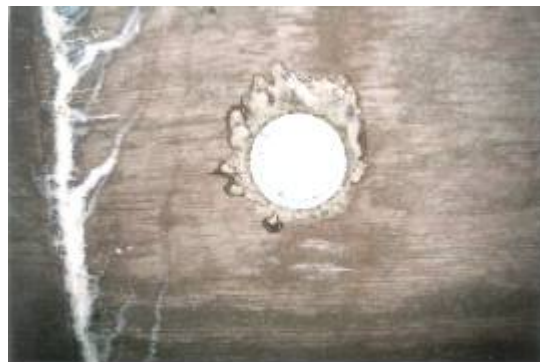
Figure 3.84. White traces near coring location

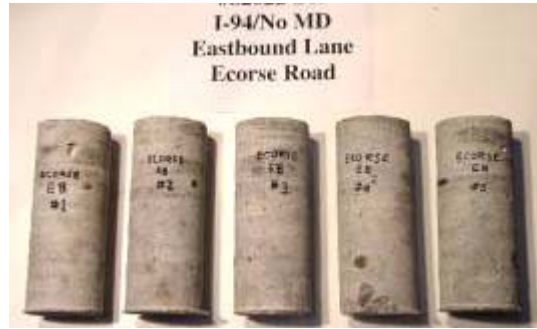
Figure 3.85. The 5 cores that were taken from Bridge Deck Number 5 (Structure No. S09-82022)

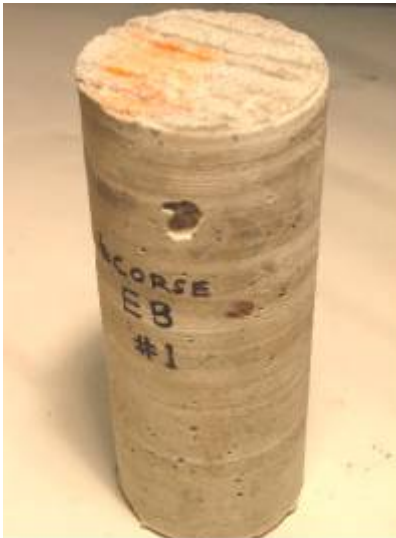
Figure 3.86. Core 5a with a large void

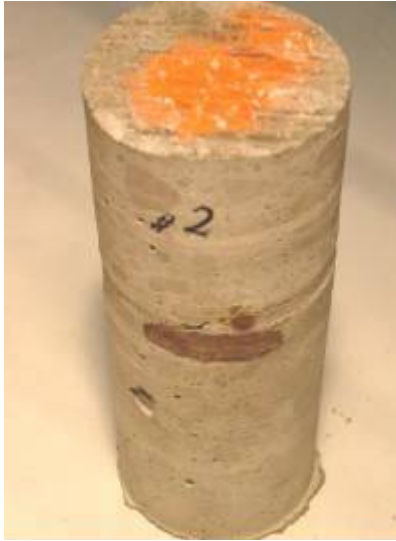
Figure 3.87. Core 5b with a large void and rust in the reinforcement

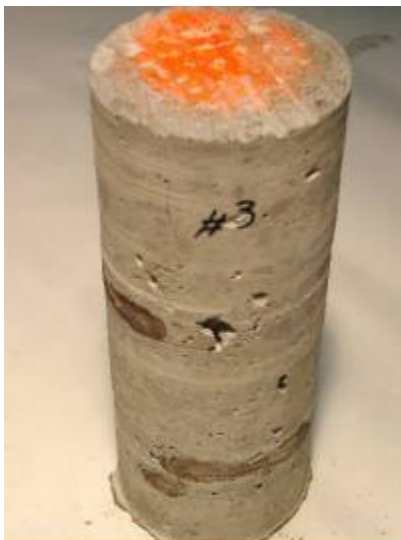
Figure 3.88. Presence of honeycombing in Core 5c

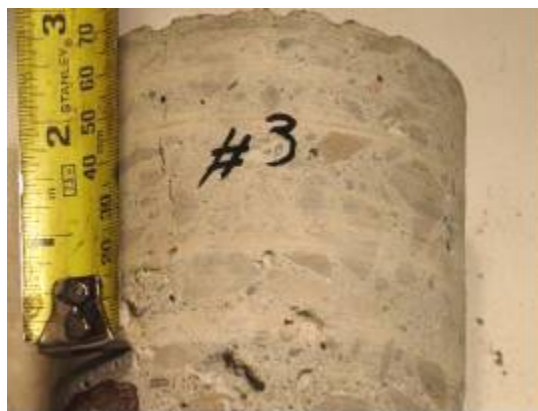
Figure 3.89. Hairline crack along surface of core in Core 5c

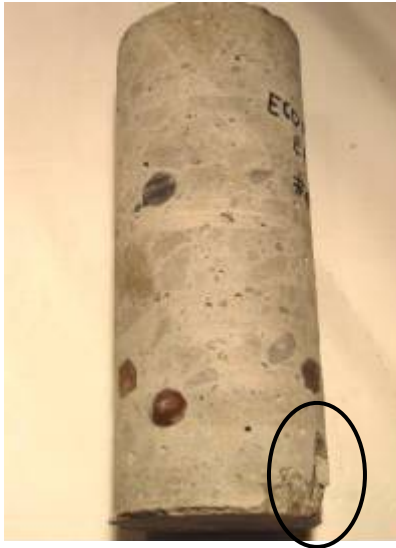
Figure 3.90. Damage of bottom region of Core 5d

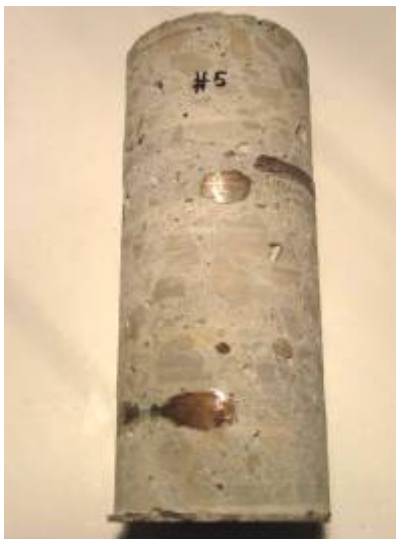
Figure 3.91. Core 5e with rust traces in reinforcement bars

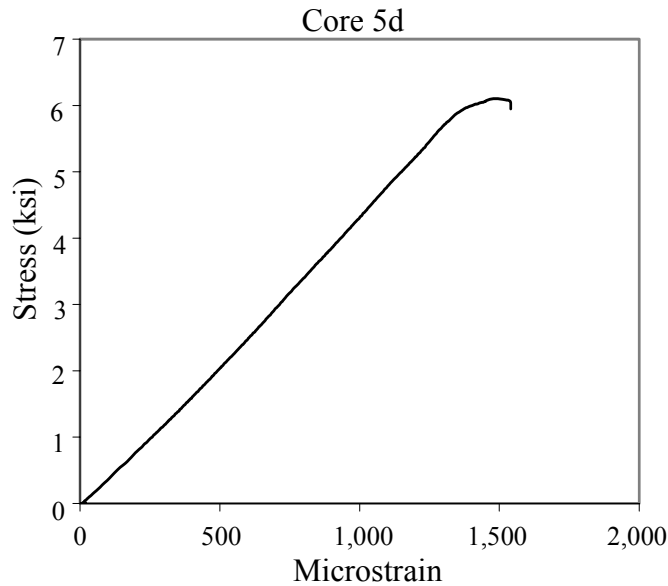
$$\sigma_{max} = \text{Compressive Strength} = 6.10 \text{ ksi.}$$

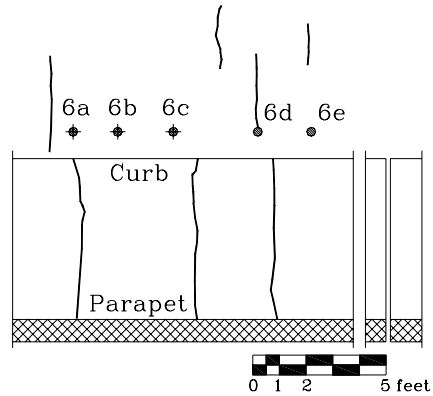
Figure 3.94. Coring locations for Bridge Deck Number 6 (Structure No. R01-13012)

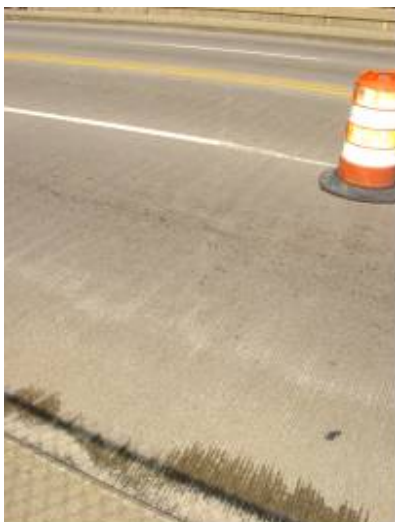
Figure 3.96. Cracks propagated on the top surface of the deck slab

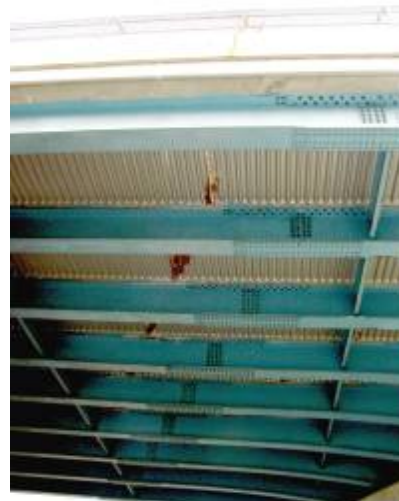
Figure 3.97. Corrosion at the SIPMF

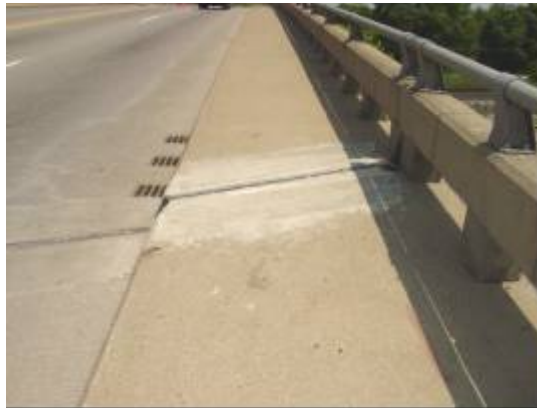
Figure 3.98. Different types of concrete around the joints

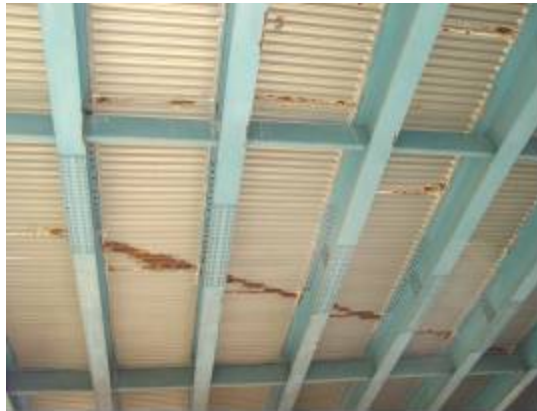
a. Corrosion in the SIPMF oriented diagonally

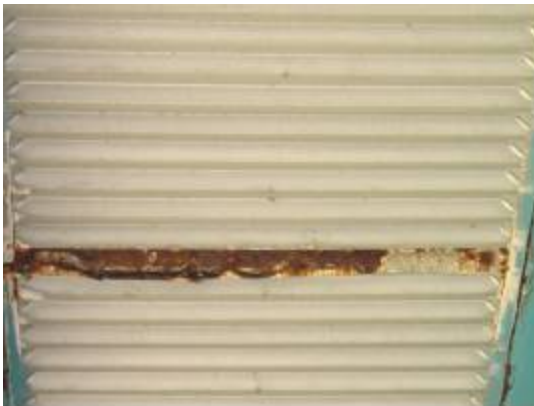
b. Corrosion in the SIPMF oriented transversely

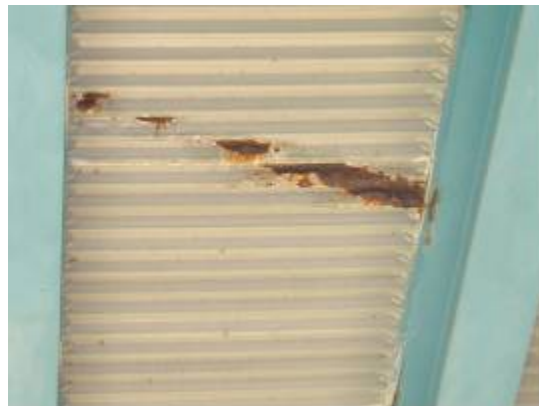
c. Corrosion and white traces in the SIPMF

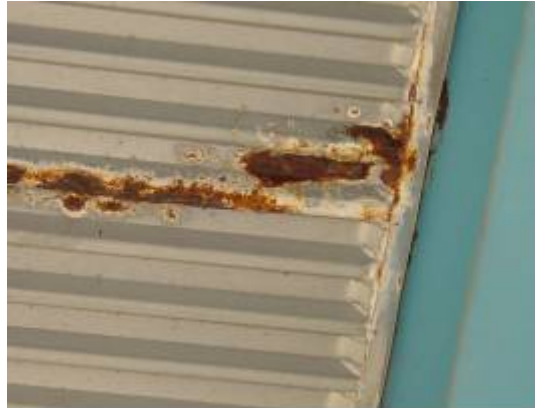
a. Corrosion and white traces near the connection

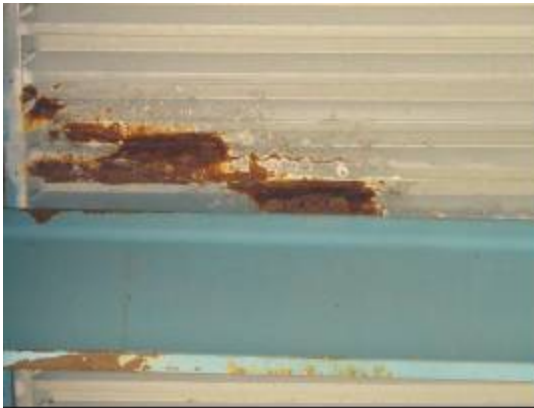
b. Corrosion in SIPMF near connection between main and bracing beams

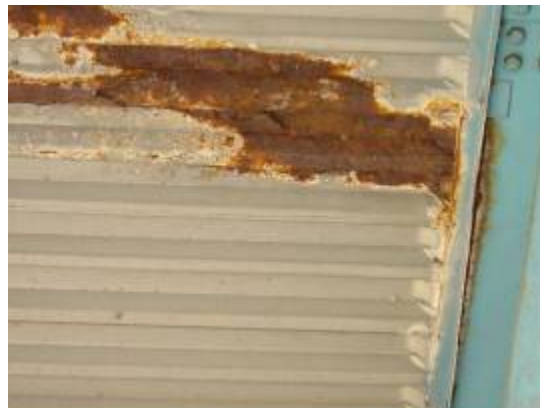
c. Corrosion in SIPMF and steel beam at the connection

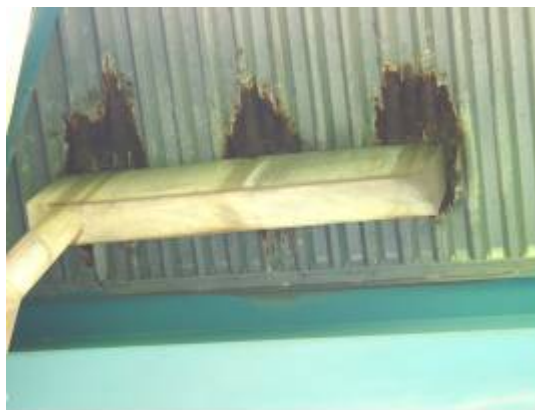
Figure 3.101. Corrosion around the hole in the deck with SIPMF

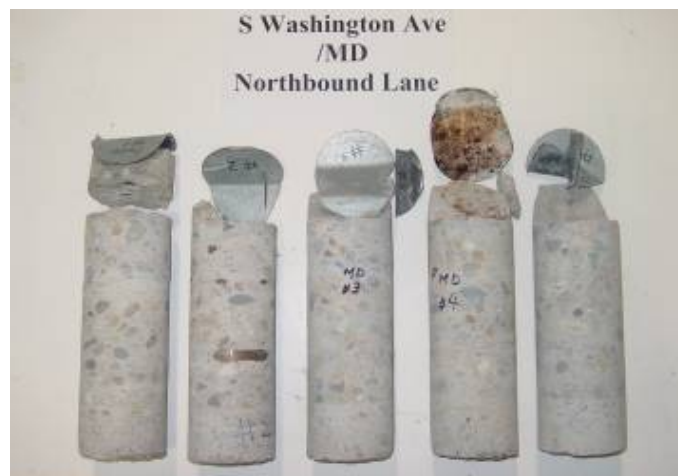
Figure 3.102. The 5 cores that were taken from Bridge Deck Number 6 (Structure No. R01-13012)

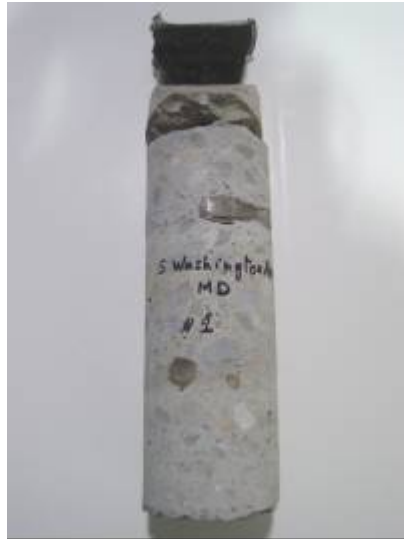
Figure 3.103. Core 6a broken concrete in the region of the valley of the SIPMF and separated SIPMF

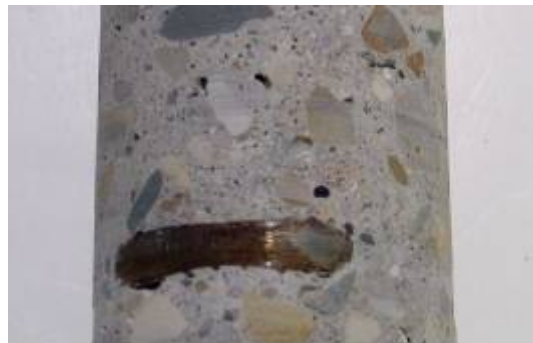
Figure 3.104. Core 6b many honeycombing and rust in the reinforcement bars

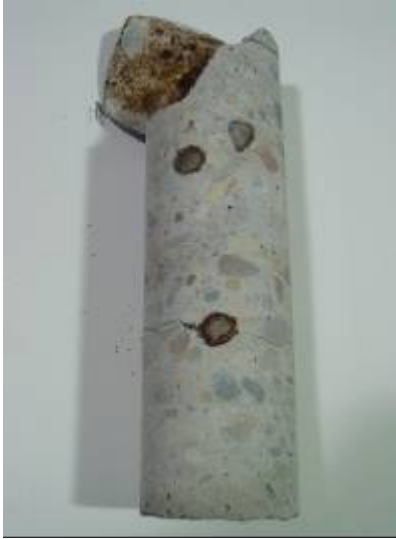
Figure 3.105. Core 6c crack at the reinforcement

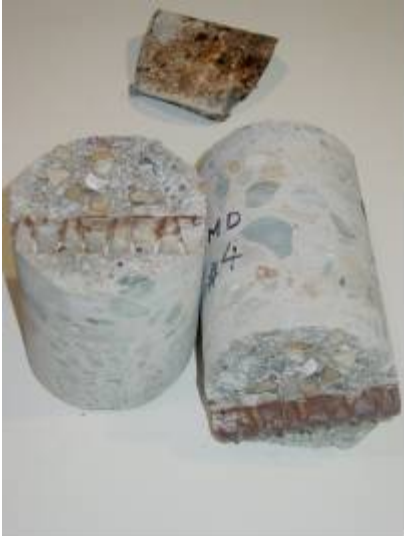
Figure 3.106. Core 6d rust at the reinforcement bar

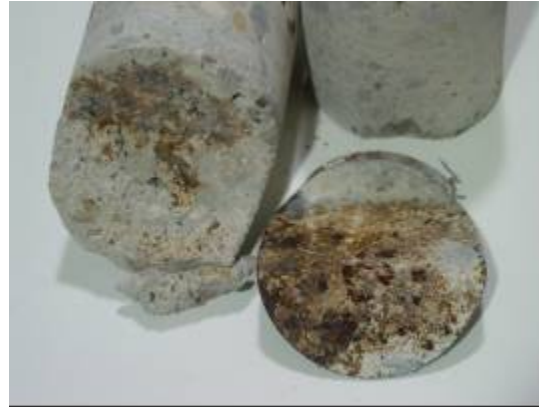
Figure 3.107. Core 6d rust on the SIPMF

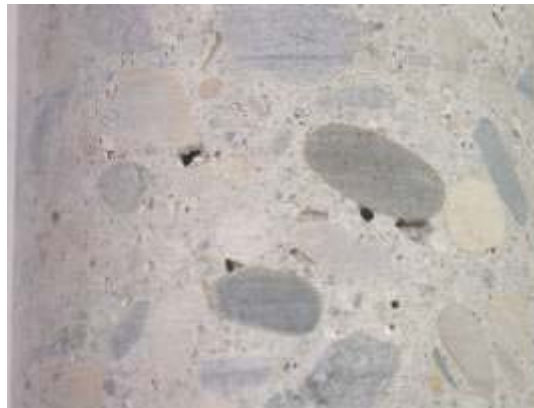
Figure 3.108. Core 6e many locations of entrapped air

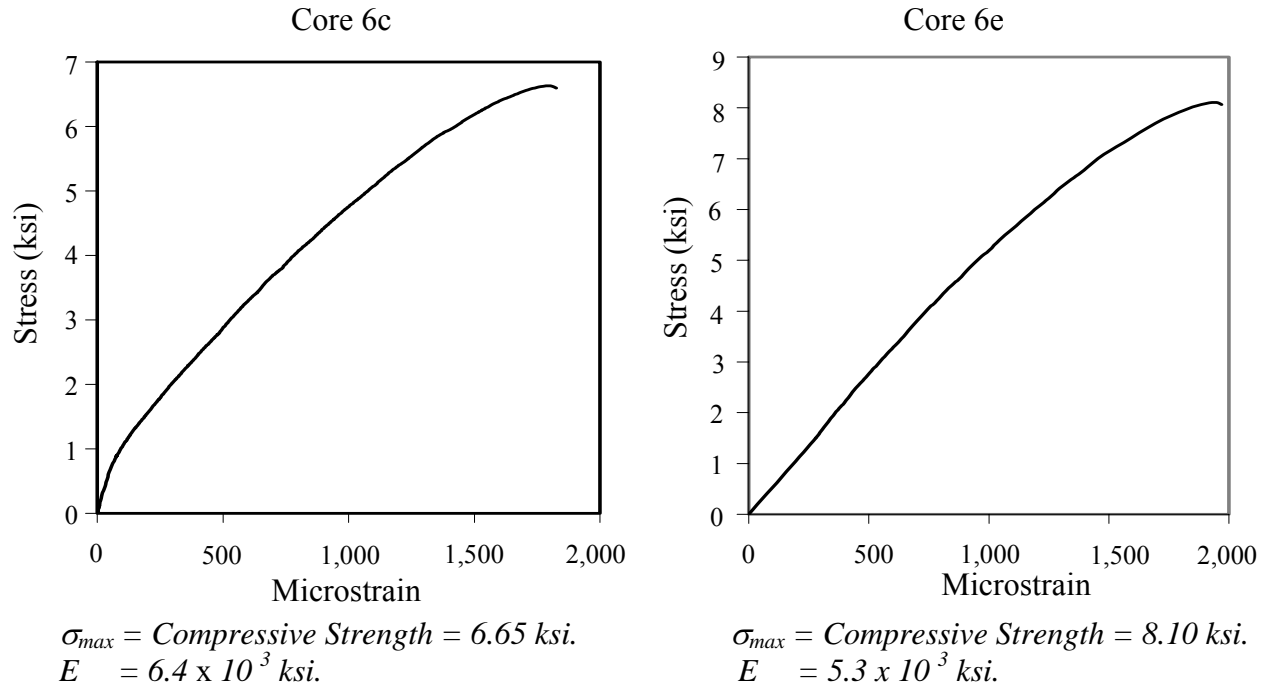
Figure 3.109. Compressive strength test results for Cores 6c and 6e (S. Washington Ave., Bridge Deck Number 6, Structure No. R01-13012, SIPMF)

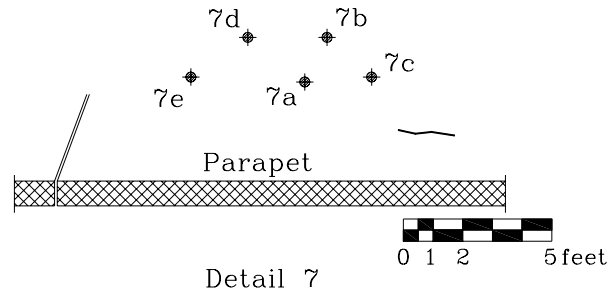
Figure 3.112. Map of cracks at coring locations for Bridge Deck Number 7 (Structure No. S03-81041)

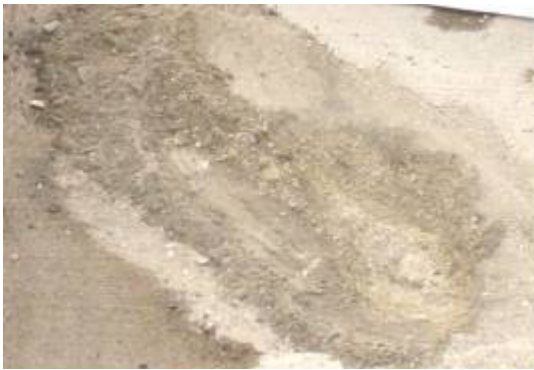
a. Large depression in bridge deck

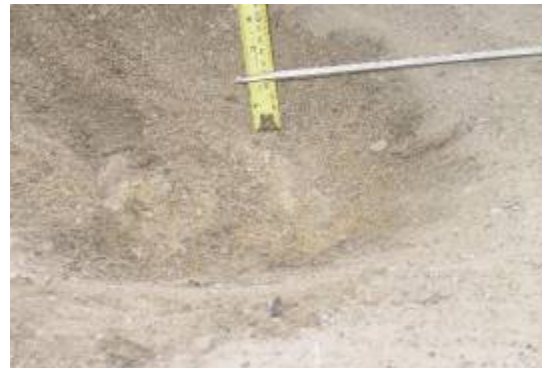
b. Depth of large depression

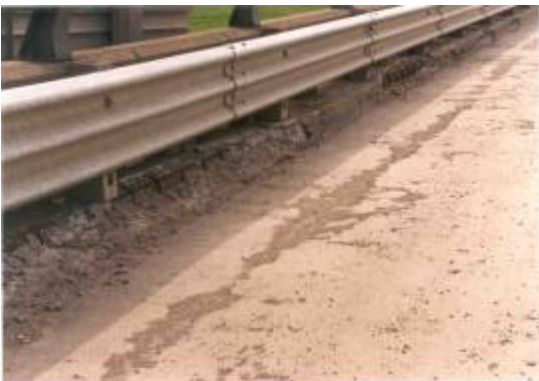
a. Severe deterioration along the curb

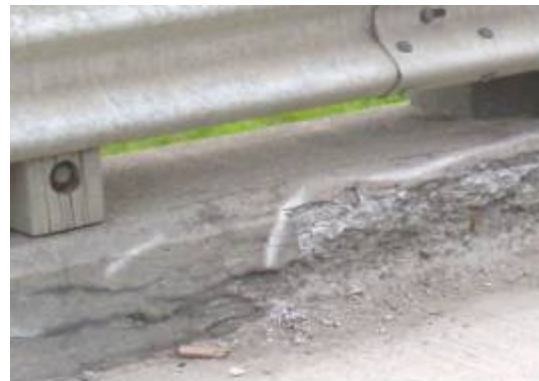
b. Deteriorated section and white traces

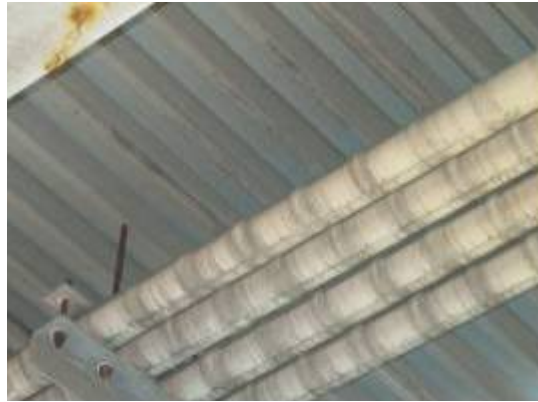
Figure 3.115. Good condition of SIPMF

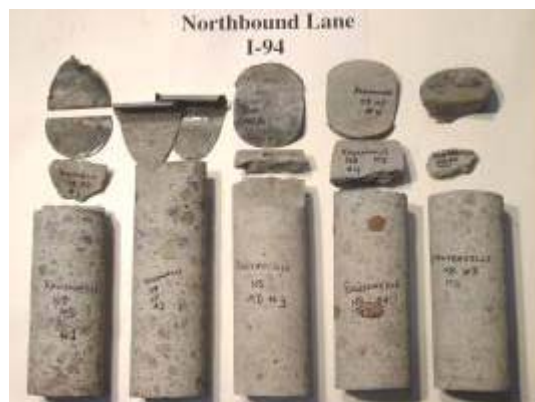
Figure 3.116. The 5 cores that were taken from Bridge Deck Number 7 (Structure No. S03-81041)

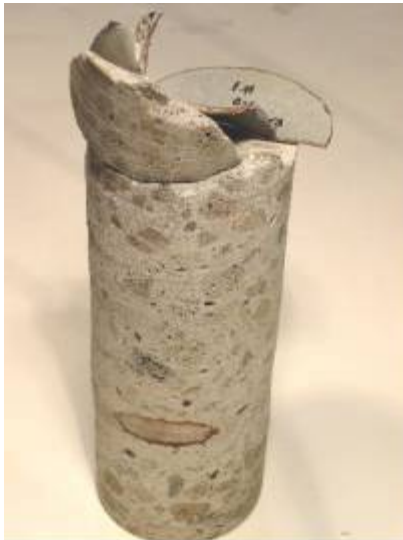
Figure 3.117. Core 7a is broken and reinforcement bar is rusted

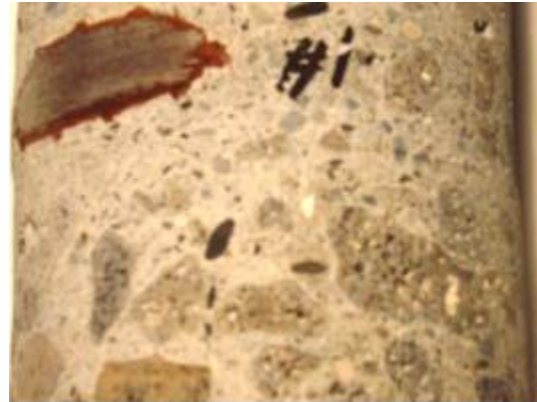
Figure 3.118. Core 7a reinforcement is rusted and concrete is porous

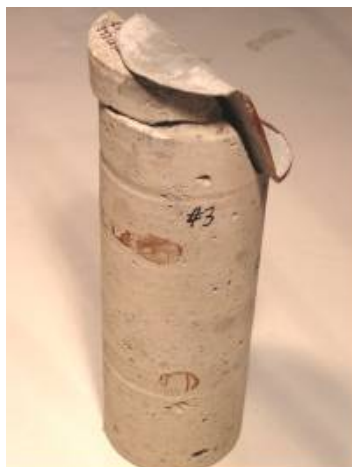
Figure 3.120. Core 7c shows the broken concrete in the region of the valley of the SIPMF and the rust in the reinforcement bars

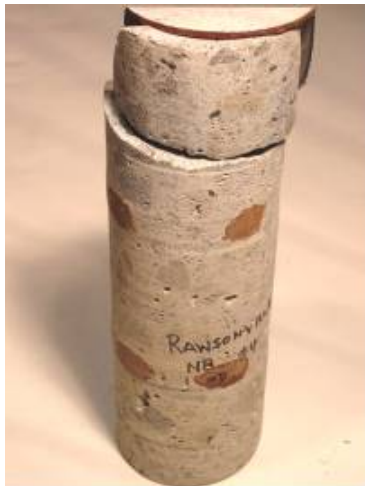
a. Broken concrete in the region of the valley of the SIPMF

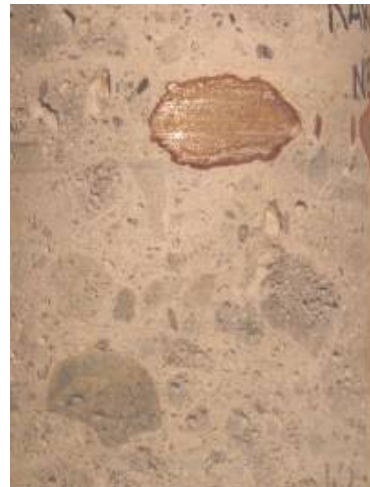
b. Rust in the reinforcement bar

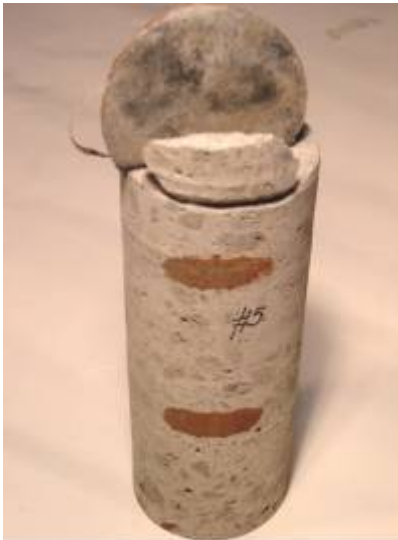
Figure 3.122. Broken concrete in the region of the valley of the SIPMF and the rust in the reinforcement bars in Core 7e

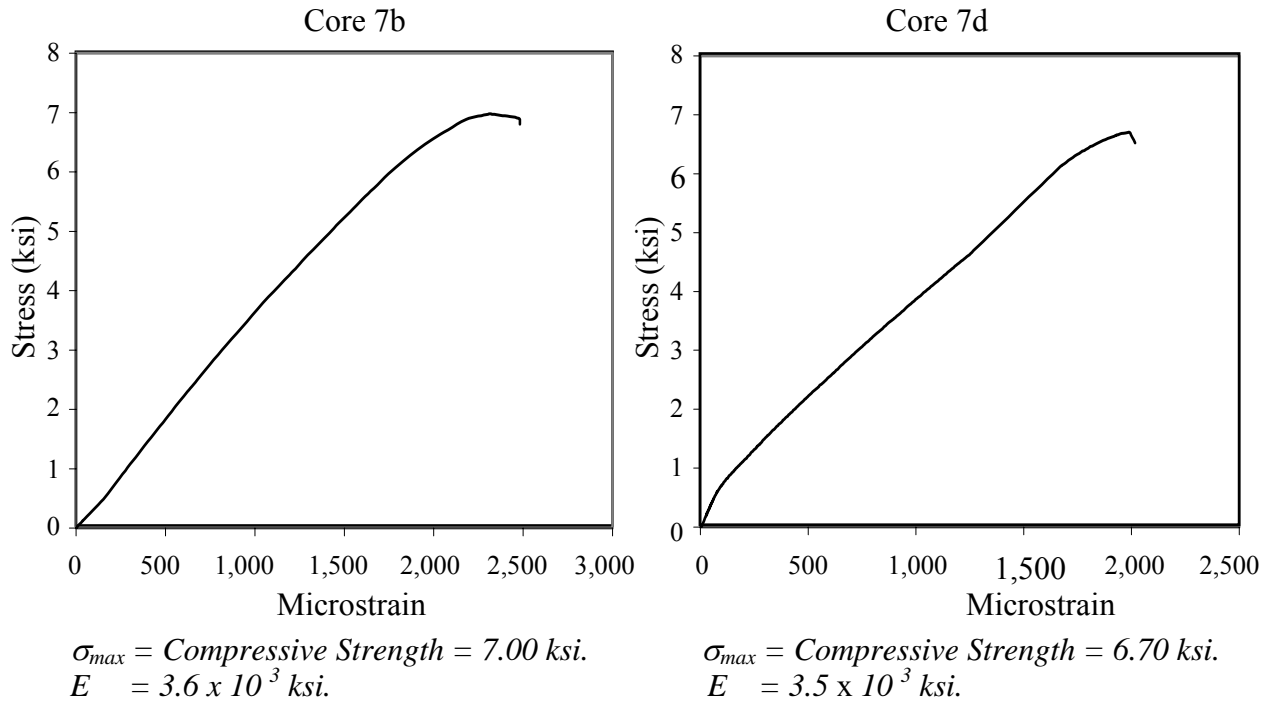
Figure 3.123. Compressive strength test results for Cores 7b and 7d (Rawsonville Rd., Bridge Deck Number 7, Structure No. S03-81041, SIPMF)

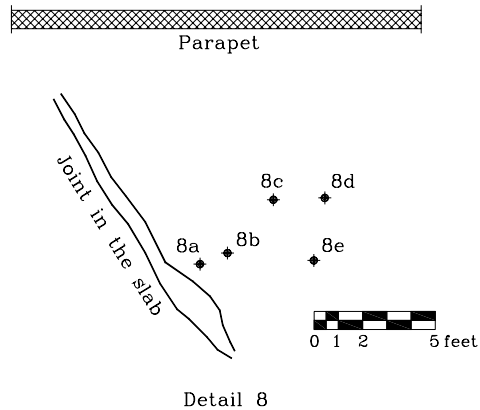
Figure 3.126. Map of cracks at coring locations for Bridge Deck Number 8 (Structure No. B01-82194)

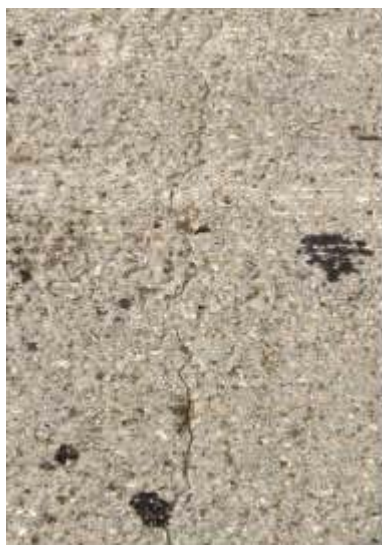
a. Longitudinal Crack

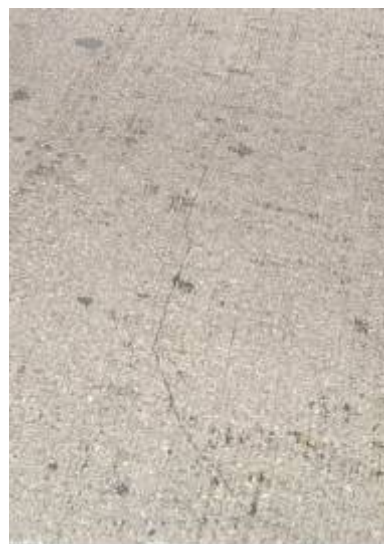
b. Diagonal and transverse cracks

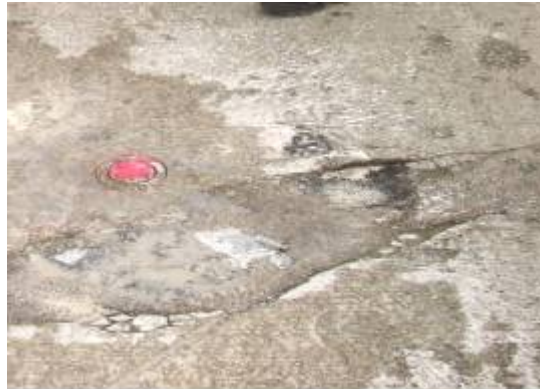
Figure 3.128. Deterioration in the joint

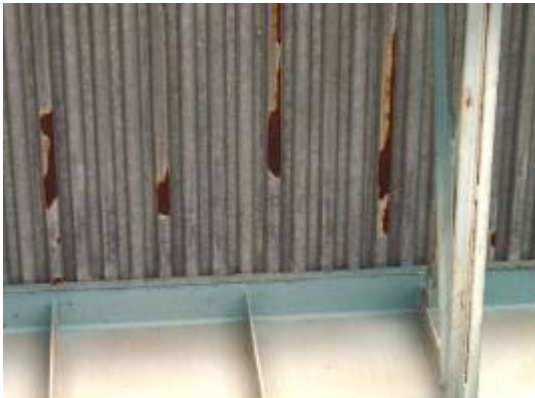
a. Rust traces in SIPMF

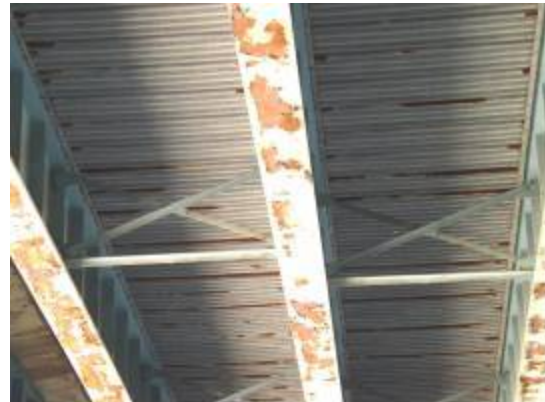
b. General view of the rusted SIPMFs

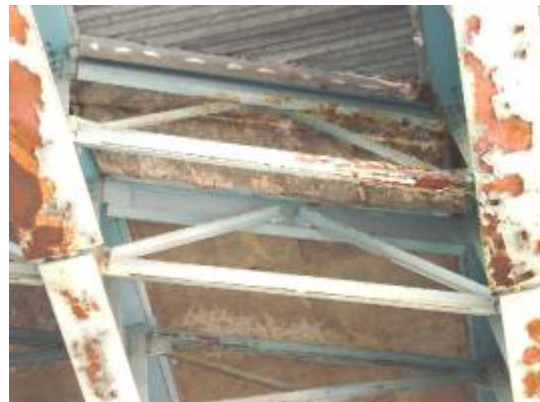
Figure 3.130. Rust in the connection between steel girders and SIPMFs

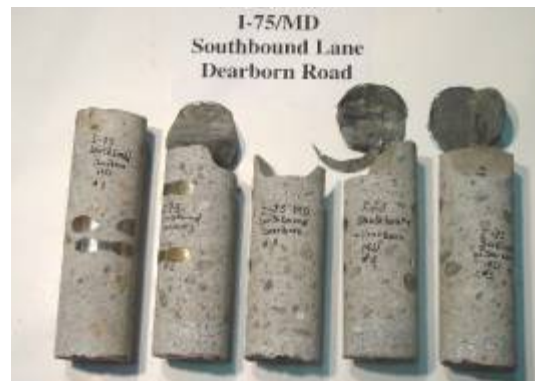
Figure 3.131. The 5 cores that were taken from Bridge Deck Number 8 (Structure No. S03-81041)

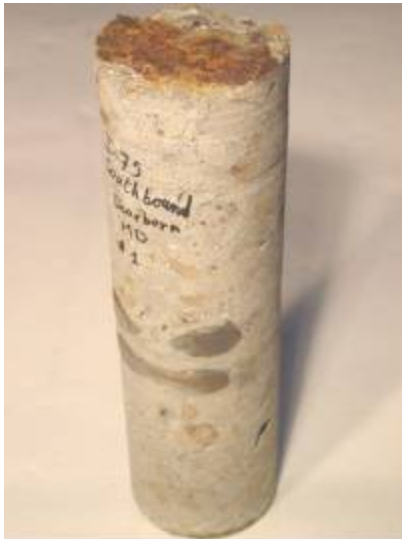
Figure 3.132. Core 8a

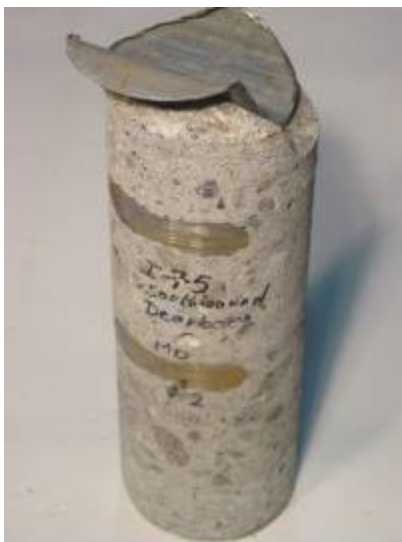
- 9.5 in. height (11.6 in. with the concrete in the region of the valley of the SIPMF).
- The concrete in the region of the valley of the SIPMF was broken during coring.
- Two longitudinal cuts in the reinforcement located 5.0 in. and 8.5 in. from top.
- One region of honeycombing of approximate width of 0.4 in. located 5.5 in. from top.
- Two large voids of average diameter 0.5 in. located 5.0 in. and 7.5 in. from top.
- The wearing surface had very high porosity and many voids of average diameter 0.3 in.
- SIPMF was separated.
- Steel reinforcement bars were in good condition.

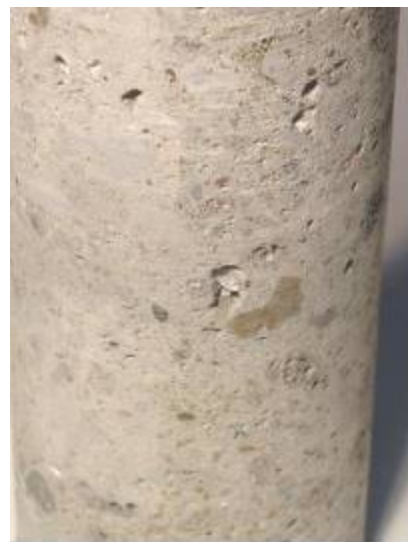
b. Large region of voids

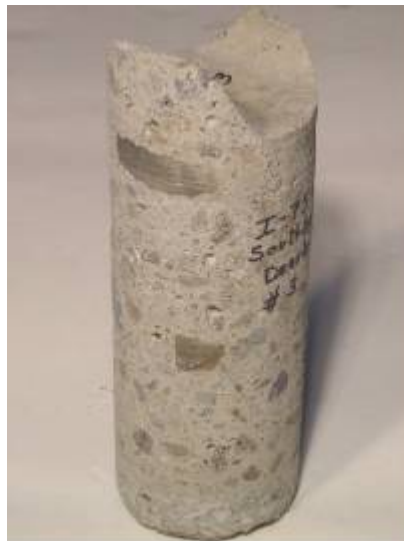
Figure 3.135. Core 8c

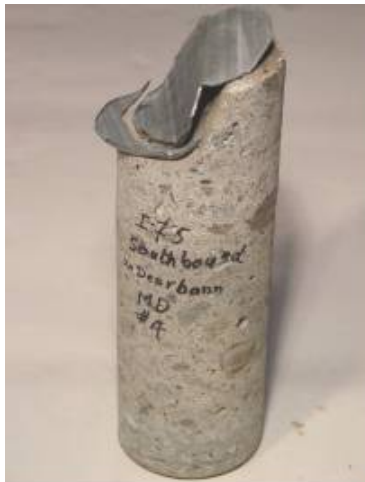
- 9.0 in. height (11.0 in. with the concrete in the region of the valley of the SIPMF).
- One longitudinal cut of reinforcement bar located 3.5 in. from the top.
- Five axial sections of reinforcement bars located 4.0, 4.5, 6.5, 6.8 and 7.5 in. from top.
- SIPMF separated from the core and cut to two parts.
- Slag was used as aggregates; and cement paste had high porosity.
- Wearing surface had entrapped air voids of average diameter 0.5 in. located 2.3 and 5.8 from top.
- Steel reinforcement bars were in good condition.

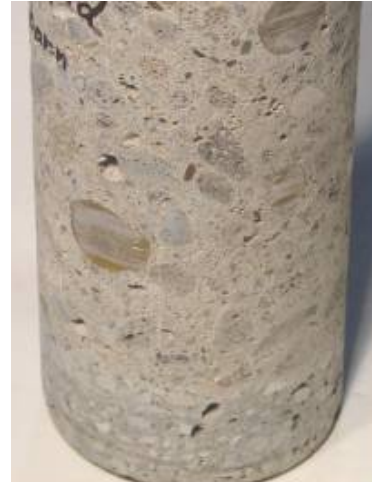
b. Entrapped air voids in the wearing surface

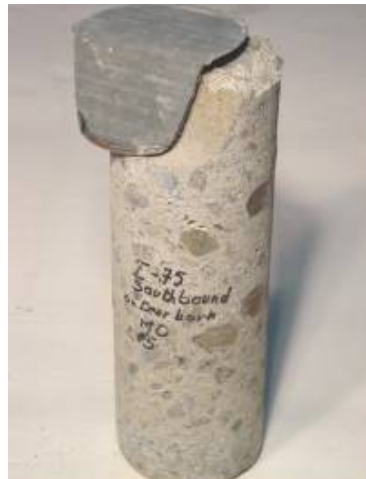
Figure 3.137. Core 8e with the broken concrete in the region of the valley of the SIPMF

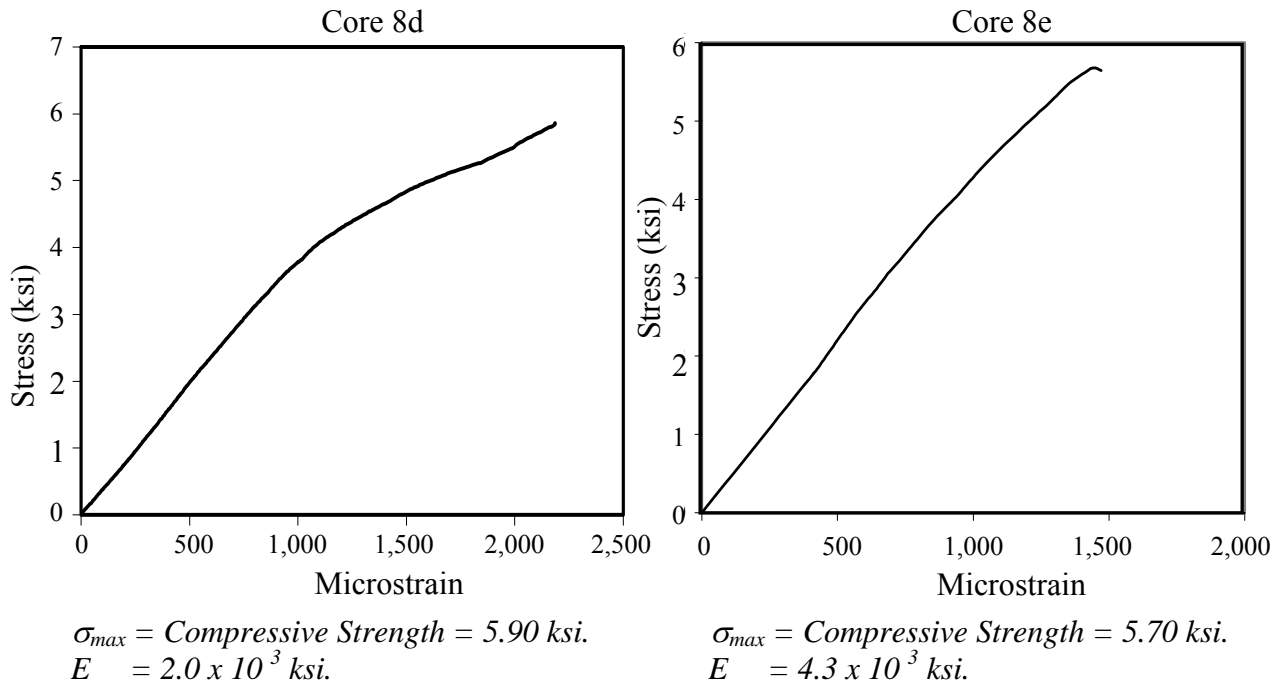
Figure 3.138. Compressive strength test results for Cores 8d and 8e (I-75, Bridge Deck Number 8, Structure No. B01-82194, SIPMF)

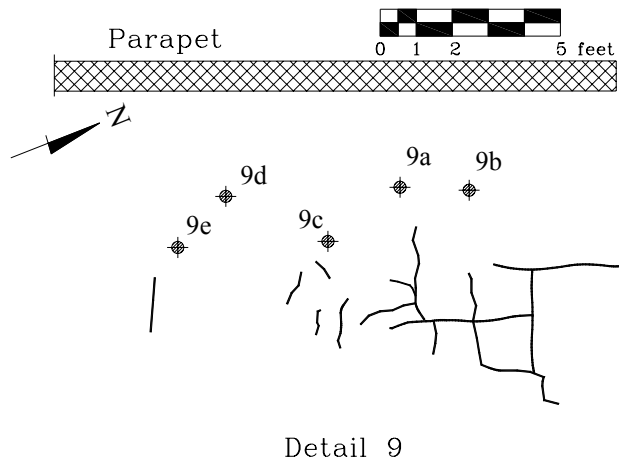
Figure 3.141. Map of cracks at coring locations for Bridge Deck Number 9 (Structure No. S10-82022)

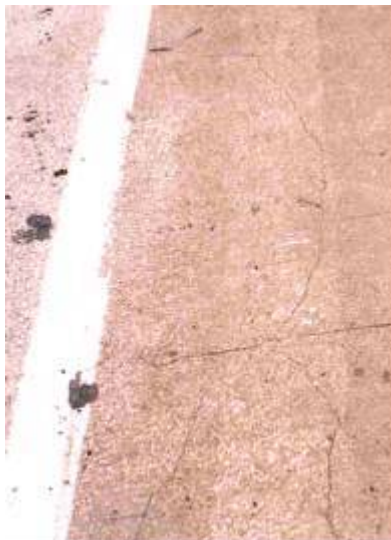
Figure 3.142. Cracks at the top surface

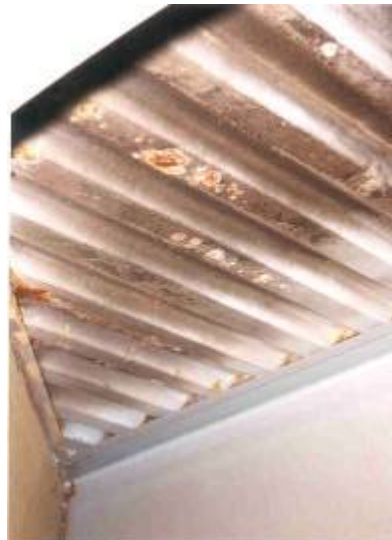
Figure 3.143. Traces of corrosion in SIPMF

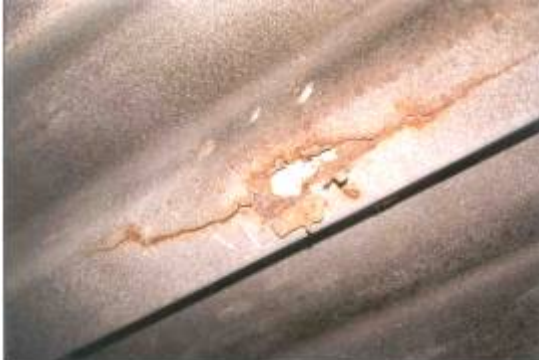
Figure 3.144. Excessive corrosion in SIPMF

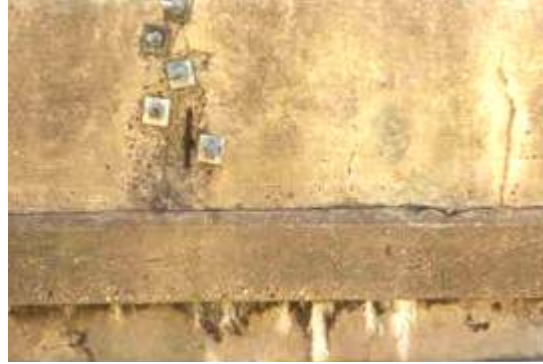
Figure 3.145. White traces and rust traces at Cracks

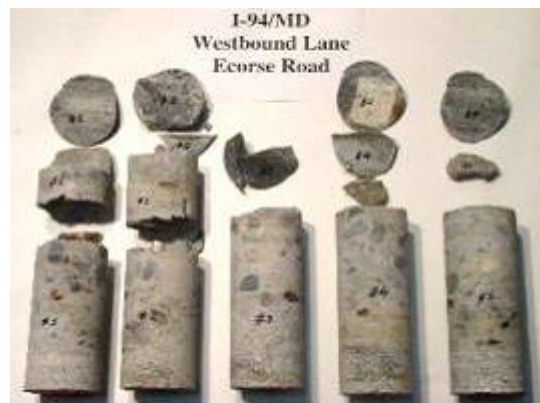
Figure 3.146. The 5 cores taken from Bridge Deck Number 9 (Structure No. S10-82022)

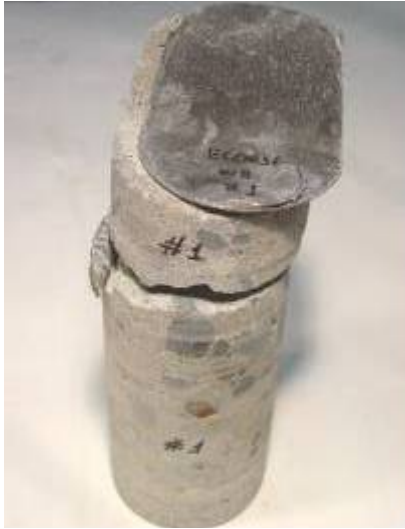
Figure 3.147. Core 9a fractured at reinforcement location

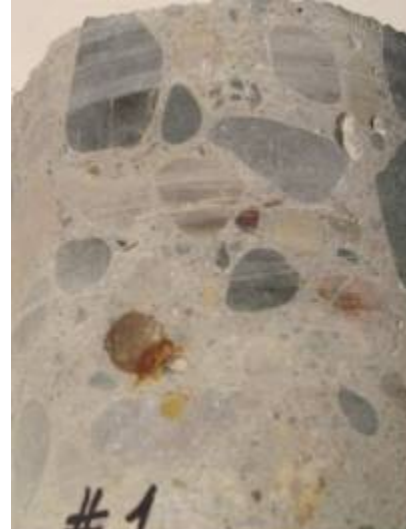
Figure 3.148. Core 9a rust in the reinforcement bar

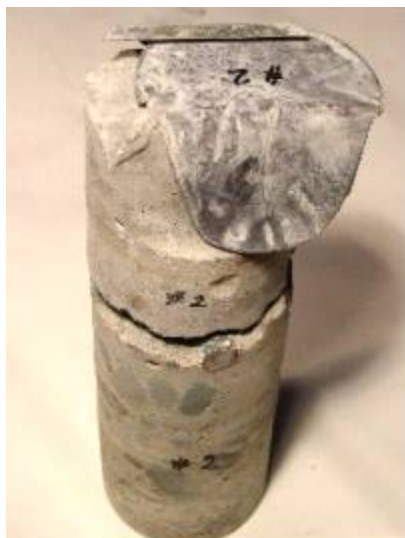
a. Broken at reinforcement location

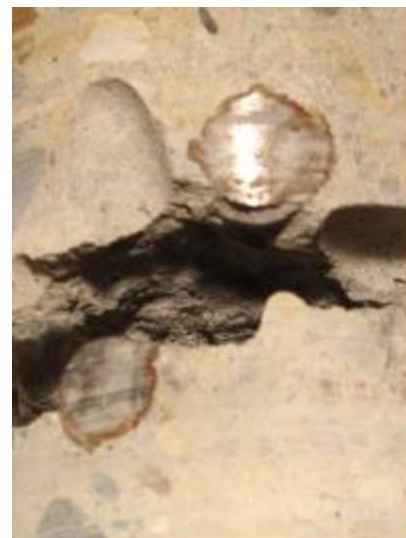
b. Rust in the reinforcing steel

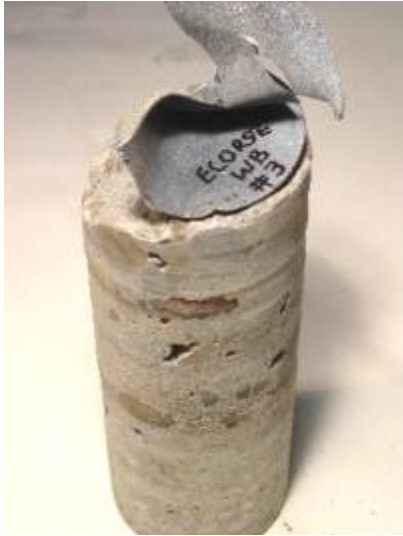
Figure 3.150. Core 9c

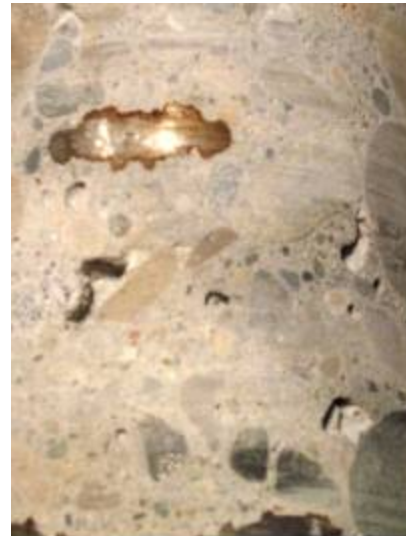
Figure 3.151. Core 9c Large voids and rust in the reinforcing steel

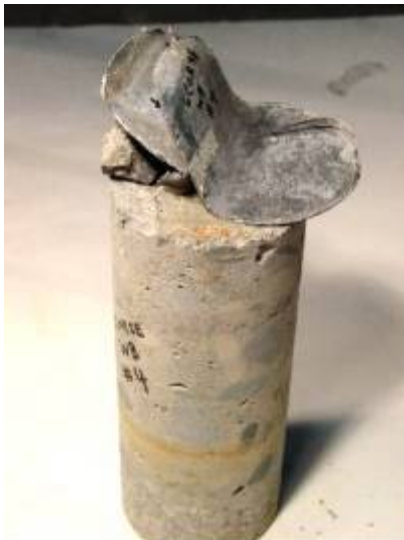
Figure 3.152. Core 9d

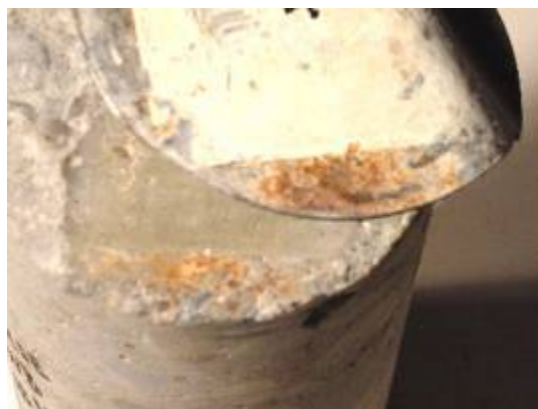
Figure 3.153. Core 9d rust traces on SIPMF and concrete

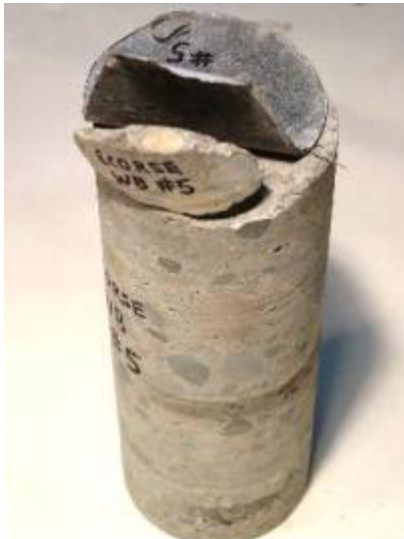
Figure 3.154. Core 9e

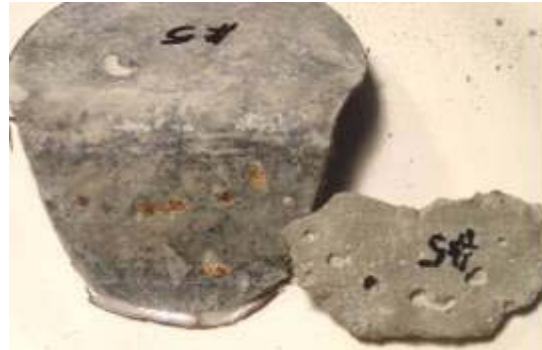
Figure 3.155. Core 9e rust traces on the SIPMF at the entrapped air voids

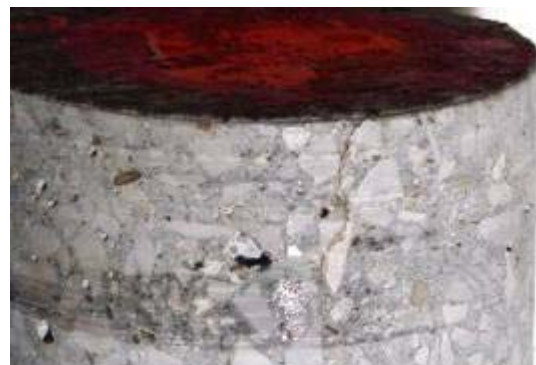
Figure 3.156. Core 9e hairline cracks at the top surface layer of the deck

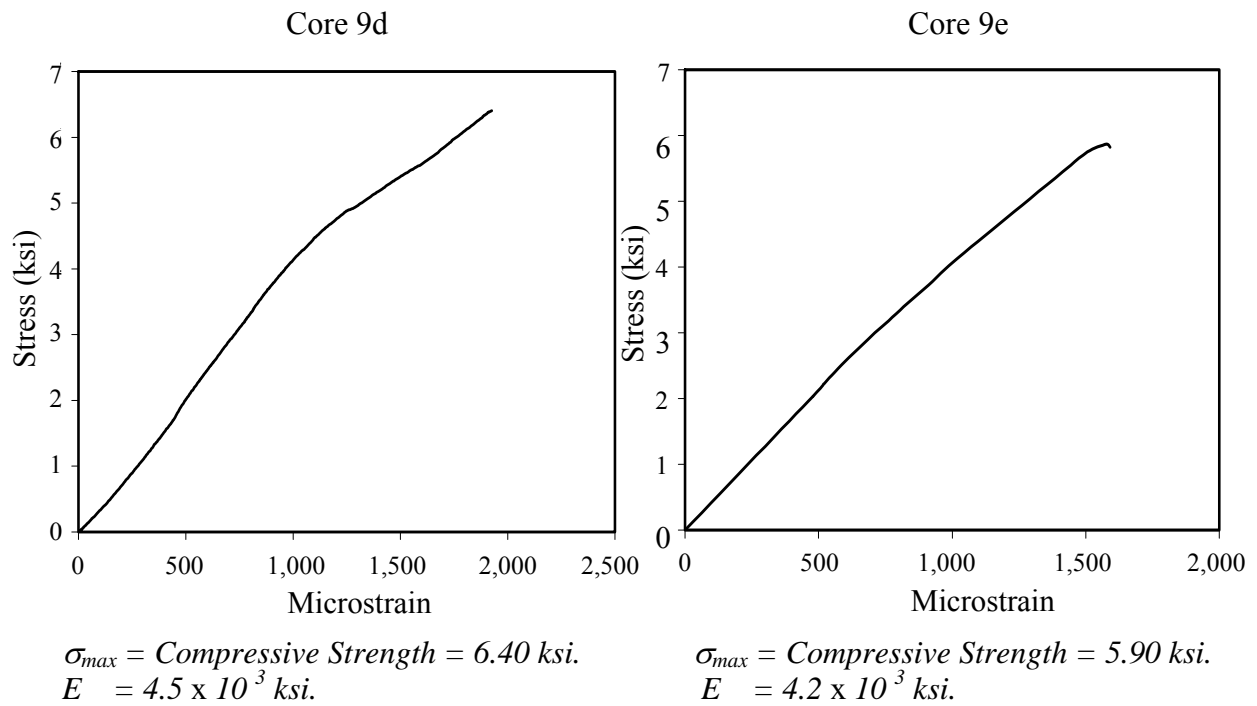
Figure 3.157. Compressive strength test results for Cores 9d and 9e (I-94, Bridge Deck Number 9, Structure No. S10-82022, SIPMF)

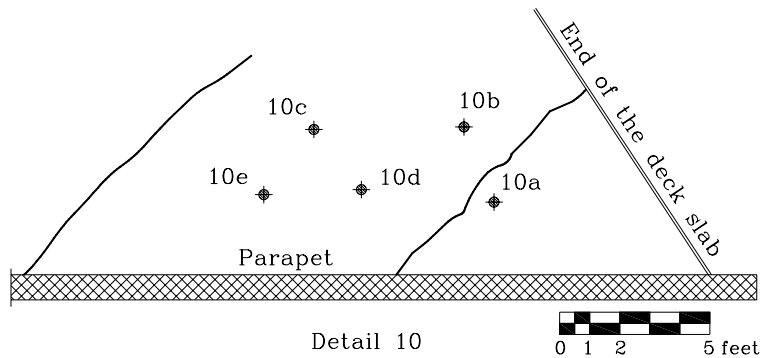
Figure 3.160. Map of cracks at coring locations for Bridge Deck Number 10 (Structure No. R03-25132)

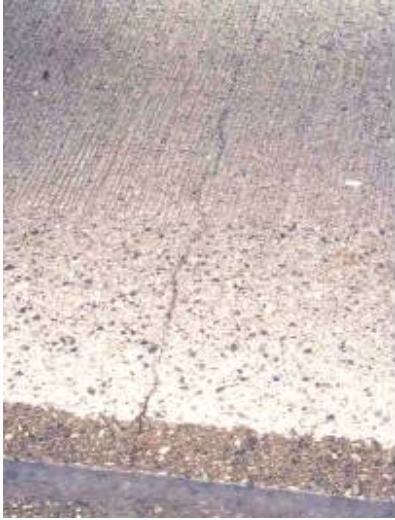
Figure 3.161. Top cracks propagated transversely in the slab

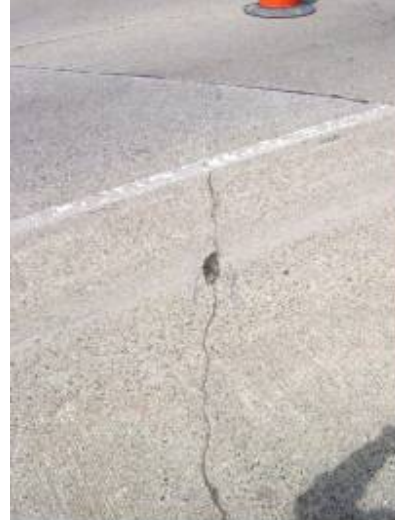
Figure 3.162. Top cracks propagated diagonally in the slab

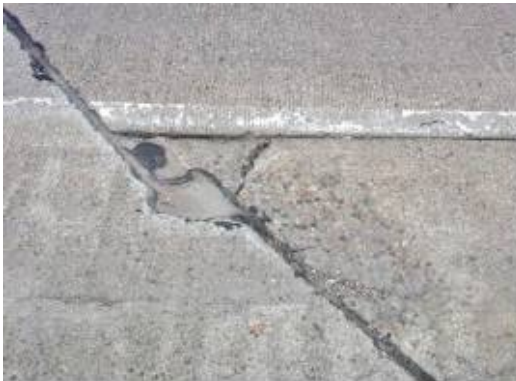
Figure 3.163. Top cracks propagated around the joint

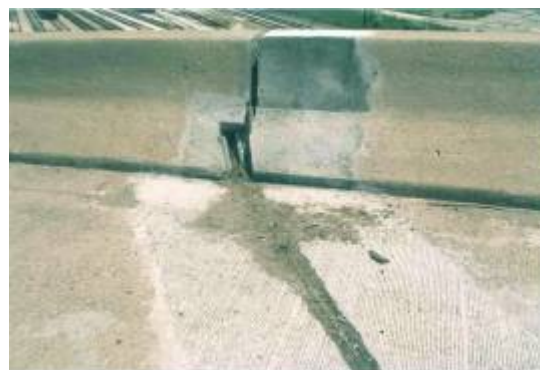
Figure 3.165. Different types of concrete around the joints
