LAWRENCE TECHNOLOGICAL UNIVERSITY

**INSPECTION AND DETERIORATION OF BRIDGE DECKS
CONSTRUCTED USING STAY-IN-PLACE METAL FORMS
AND EPOXY-COATED REINFORCEMENT**

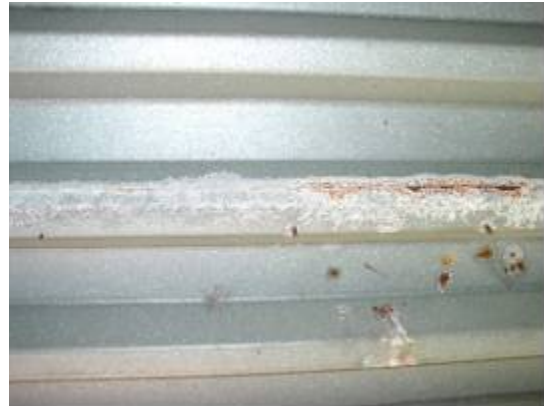
b. White and rust traces

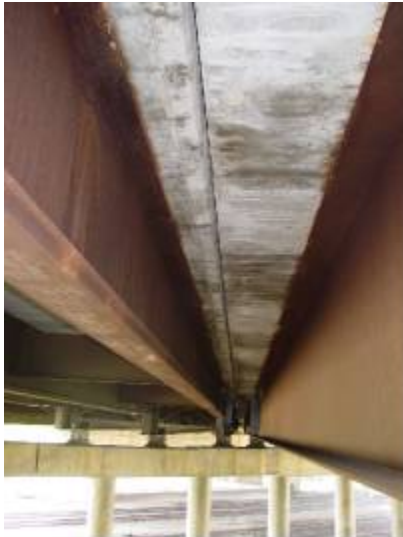
Figure 3.167. Corrosion and white traces on the bottom face of the cantilever slabs

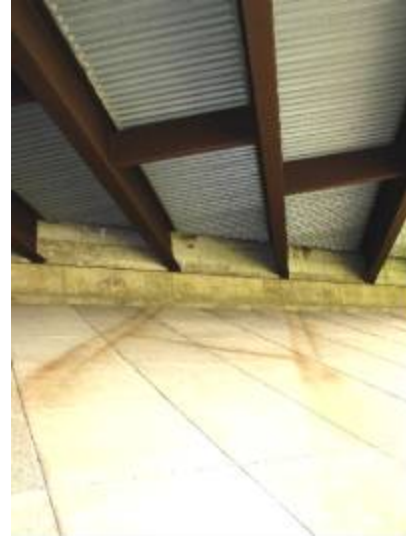
Figure 3.168. Corrosion traces underneath the steel beams

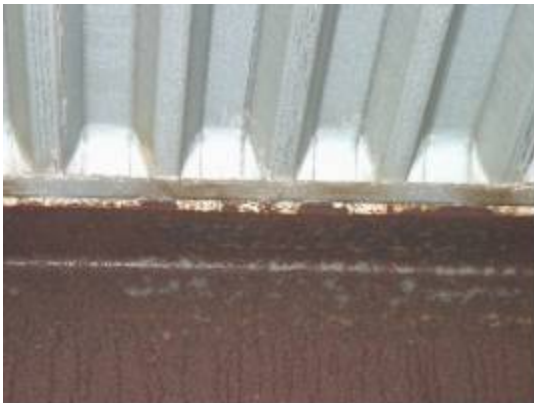
Figure 3.169. White and corrosion traces at the connection between steel beams and the SIPMF

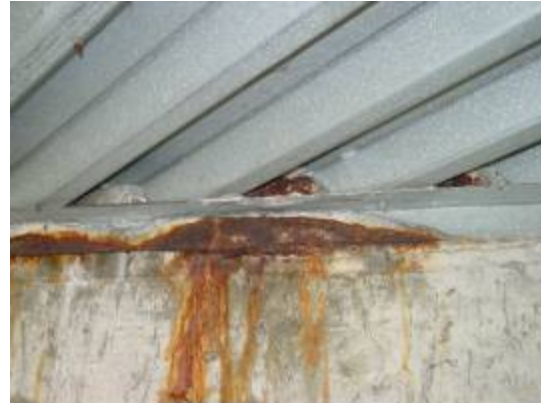
Figure 3.170. White and corrosion traces at the connection between SIPMF and the abutment

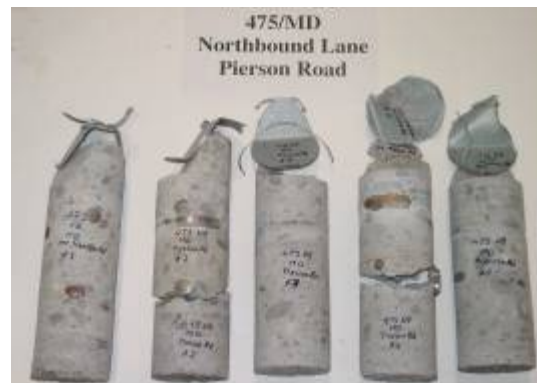
Figure 3.171. The 5 cores that were taken from Bridge Deck Number 10 (Structure No. R03-25132)

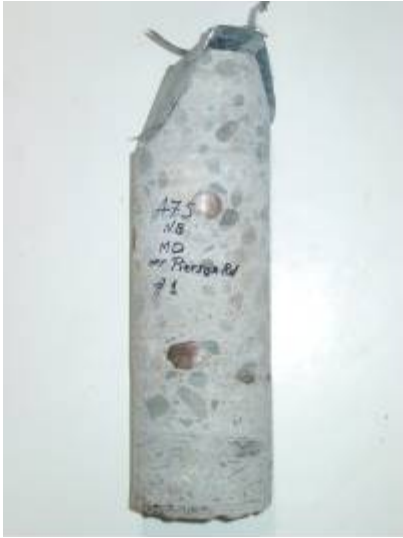
Figure 3.172. Core 10a

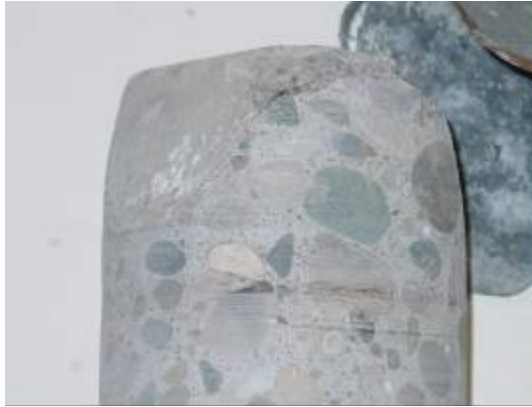
Figure 3.173. Core 10a concrete placed in the valley of the corrugation of the SIPMF partially broken

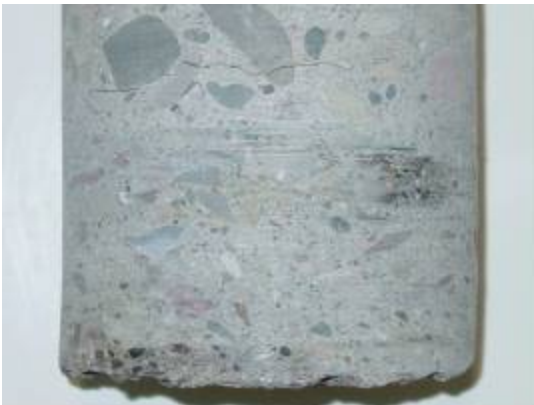
Figure 3.174. Core 10a horizontal crack.

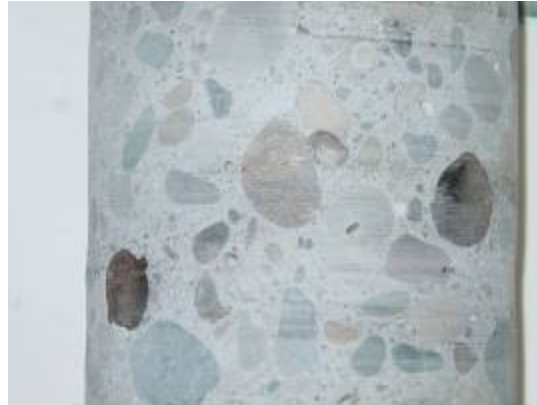
Figure 3.175. Core 10a small voids in the concrete

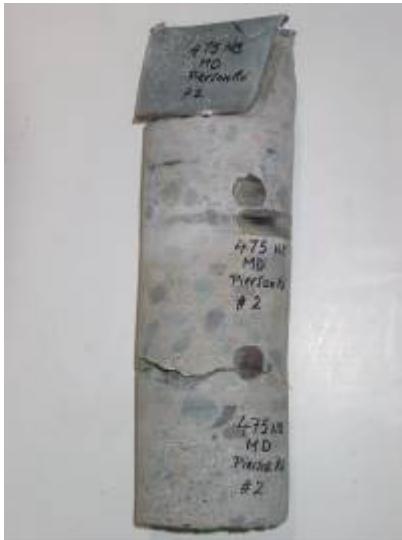
- 9.5 in. height (12.0 in. with the concrete in the region of the valley of the SIPMF).
- The core was broken during coring at reinforcement location (4.0 in. from top).
- One longitudinal cut in the reinforcement located 7.3 in. from top.
- Four axial sections in the reinforcement located 4.0 and 8.0 in. from top.
- SIPMF was separated from the core.
- Steel reinforcement bars had traces of corrosion.
- The concrete in the region of the valley of the SIPMF was partially broken.
- Small voids of 0.1 in. were observed throughout the entire core.

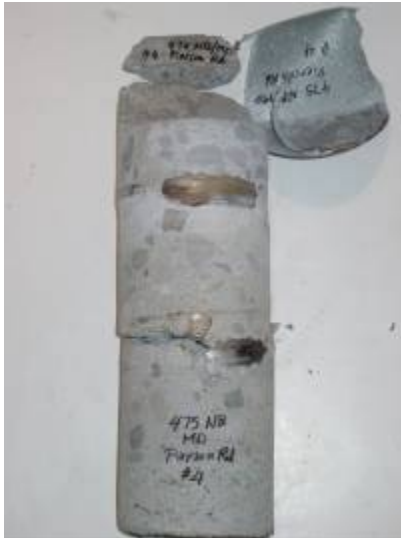
- Two longitudinal cuts of reinforcement bars: one was located 4.3 in. from the top and separated from the core and the other one was located 7.8 in. from top.
- Two axial sections of reinforcement bars located 4.8 in. from top.
- SIPMF separated from the core.
- Many small voids of average diameter of 0.1 in. were propagated at the entire surface.
- Steel reinforcement bars had traces of corrosion.
- Core was broken at 4.5 in. from top at the reinforcement location.
- One large region of honeycombing of 0.5 in. diameter located 3.5 in. from top.
- The concrete in the region of the valley of the SIPMF was broken during coring.

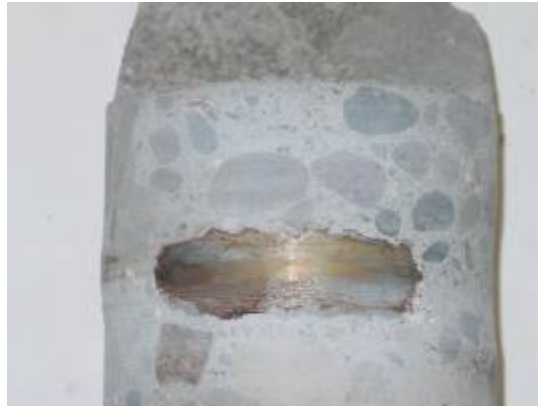
b. Reinforcement bar had traces of corrosion

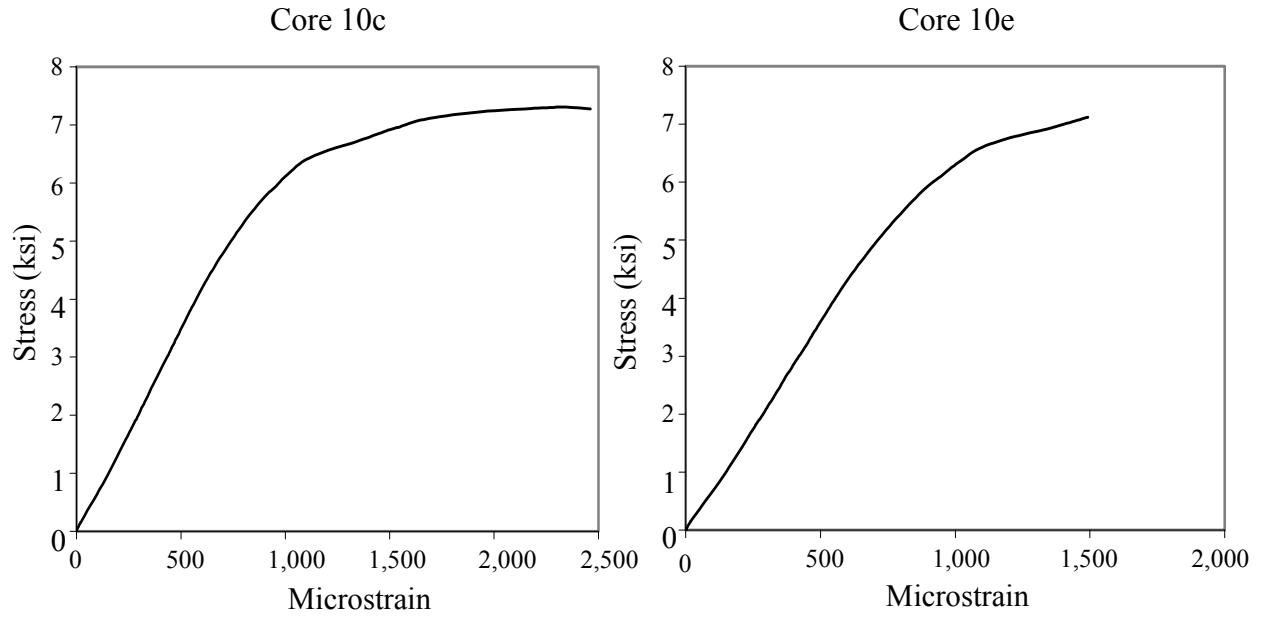
$\sigma_{max} = \text{Compressive Strength} = 6.95 \text{ ksi.}$
 $E = 3.5 \times 10^3 \text{ ksi.}$

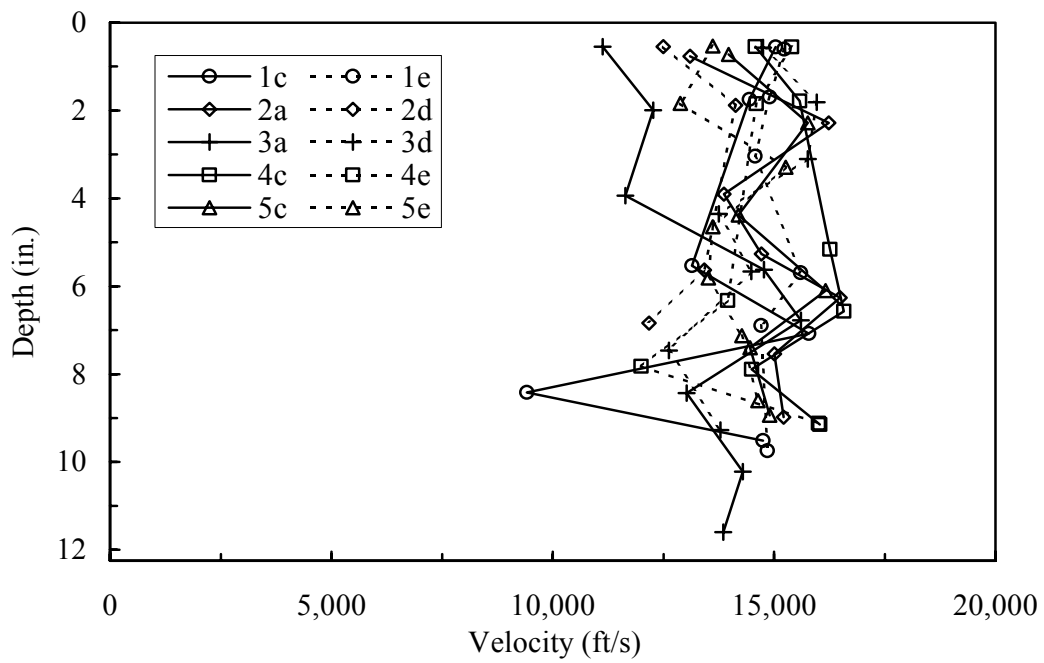
Figure 3.182. Velocity profiles for cores from bridge decks without SIPMF

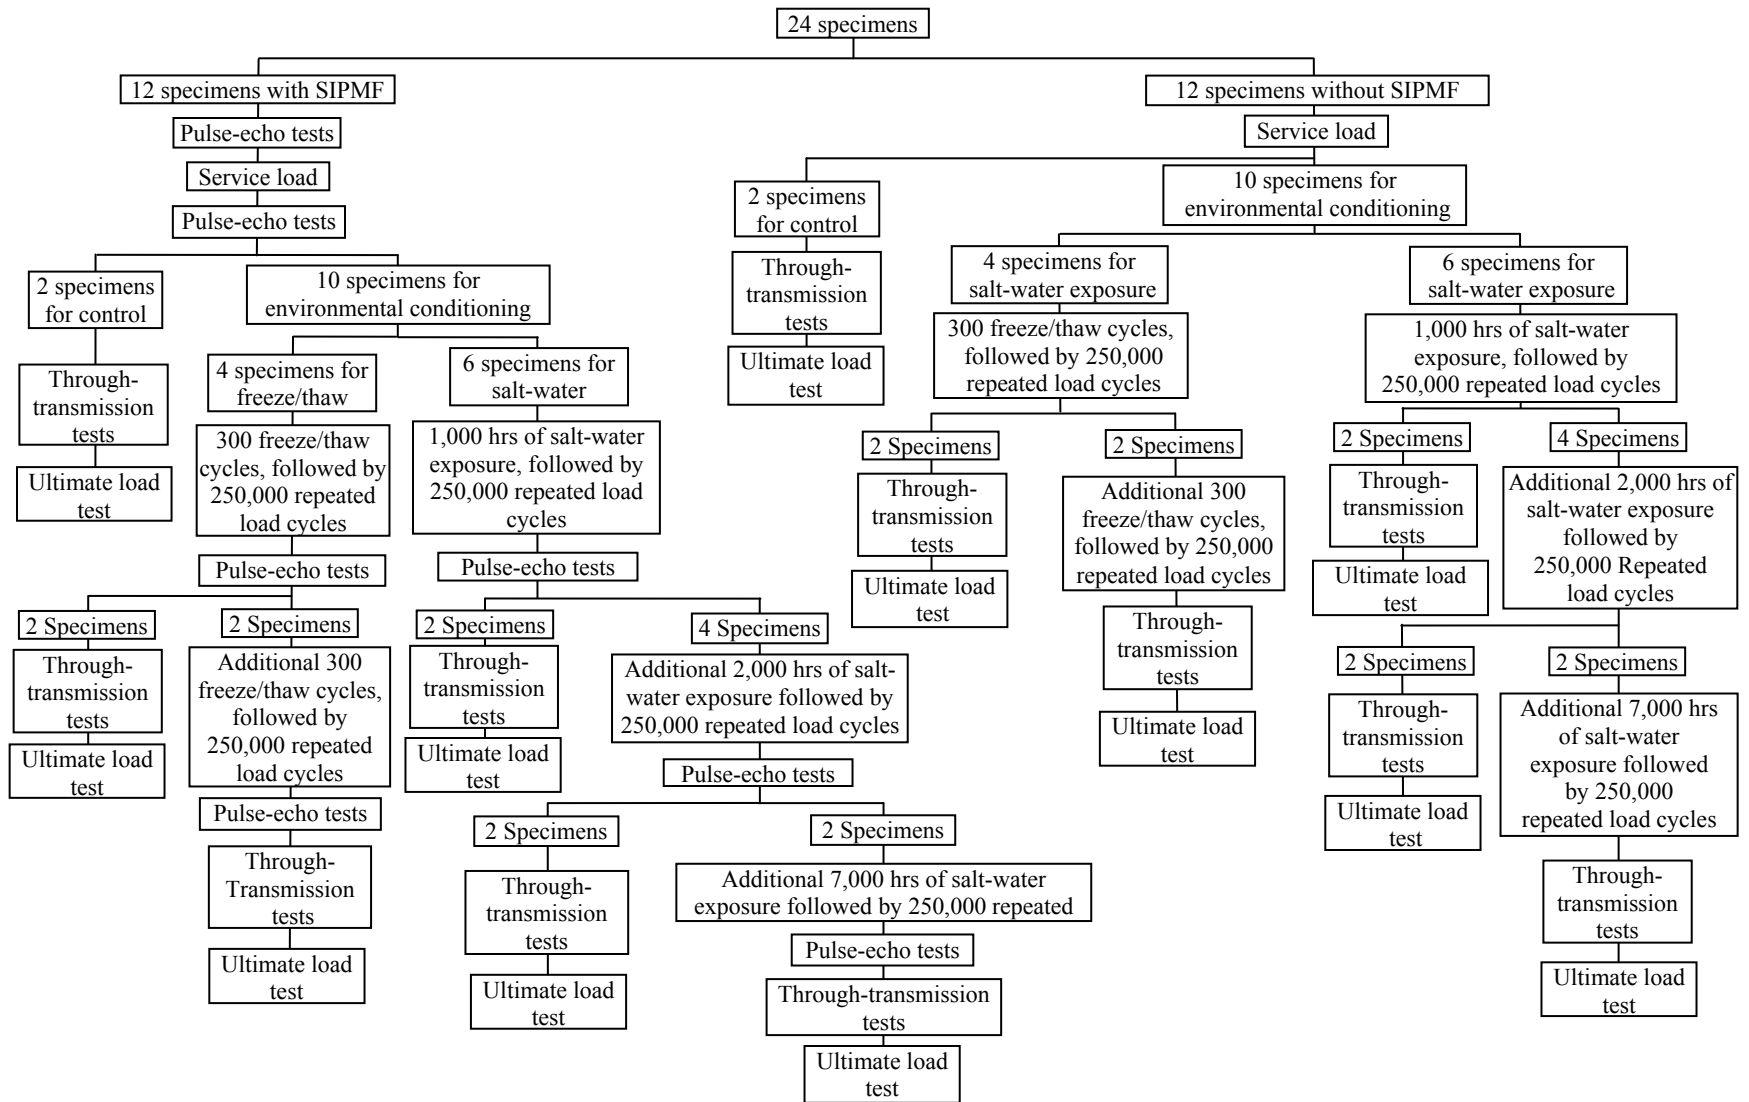
Figure 4.1. Summary flow chart for the experimental test program

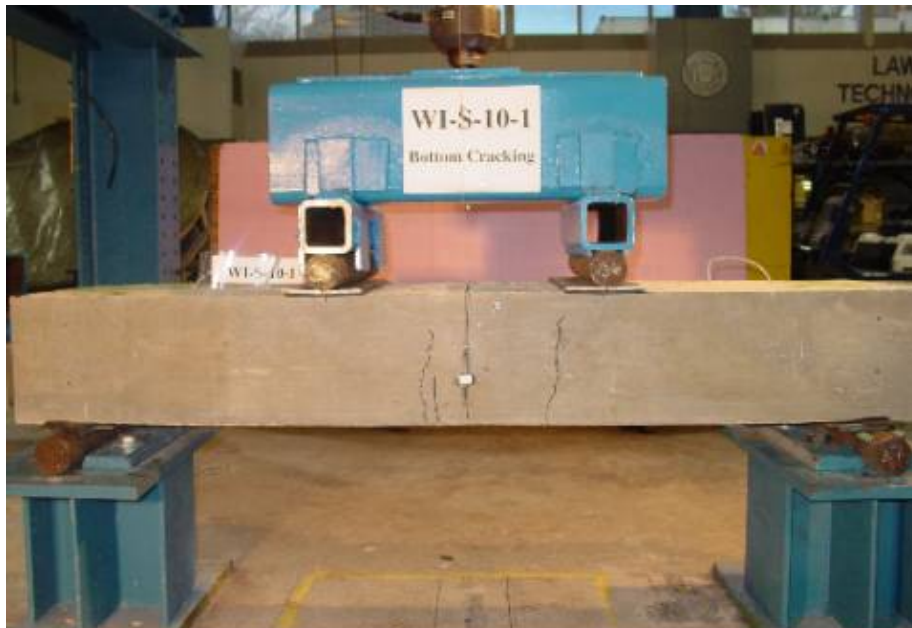
Figure 4.18. Positive moment application
(cracking along the bottom of specimen with SIPMF)

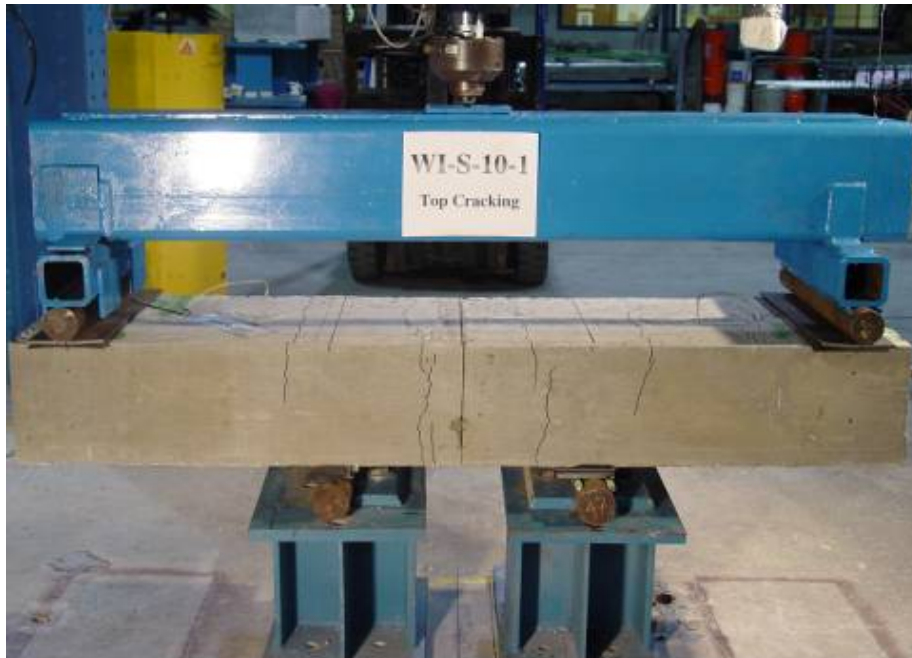
Figure 4.19. Negative moment application
(cracking along the top of specimen with SIPMF)

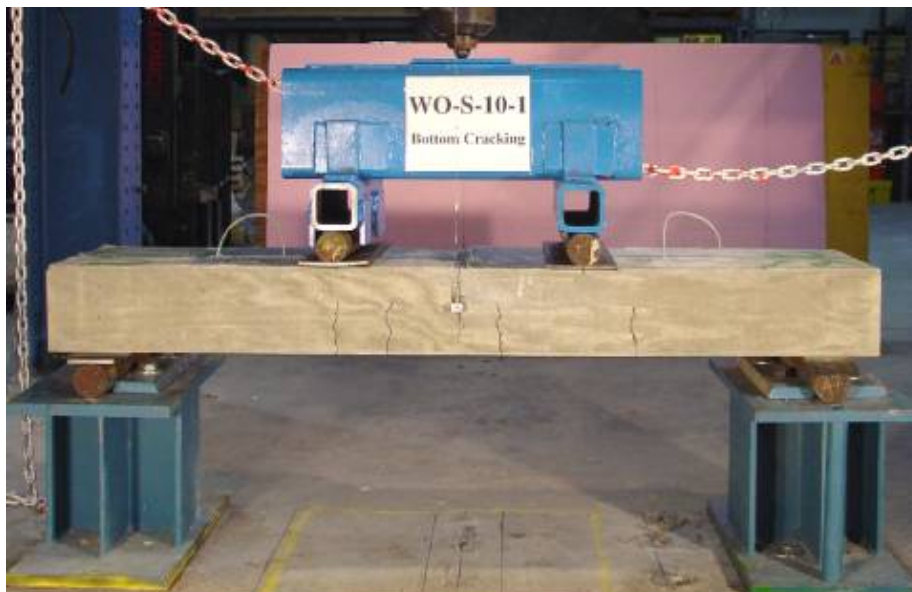
Figure 4.20. Positive moment application
(cracking along the bottom of specimen without SIPMF)

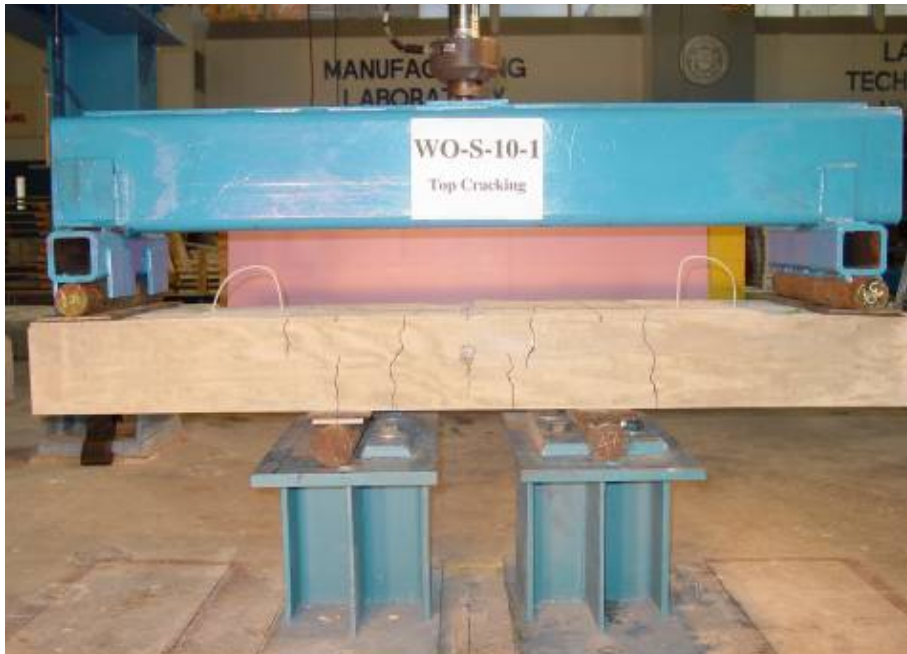
Figure 4.21. Negative moment application
(cracking along the top of specimen without SIPMF)

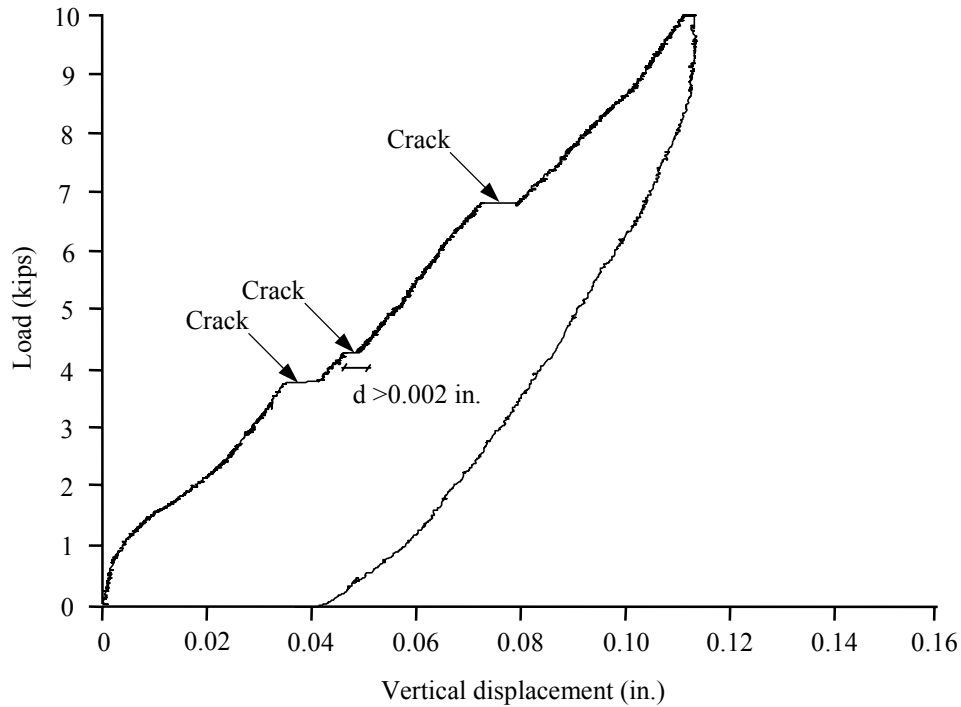
Figure 4.22. Criteria for crack determination

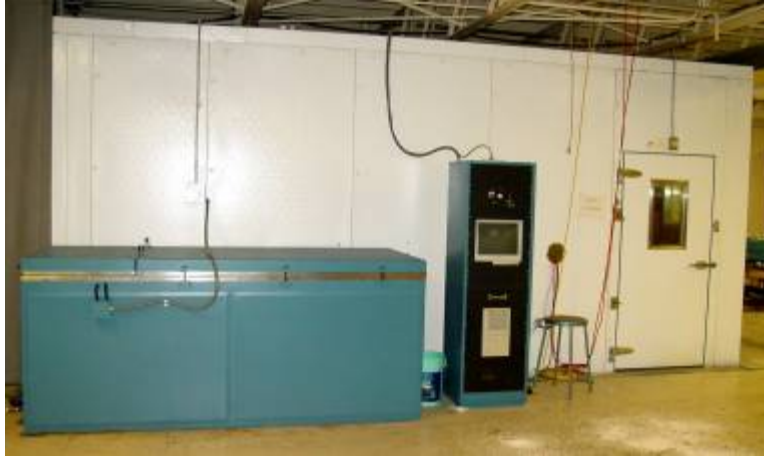
Figure 4.23. Freeze/Thaw system

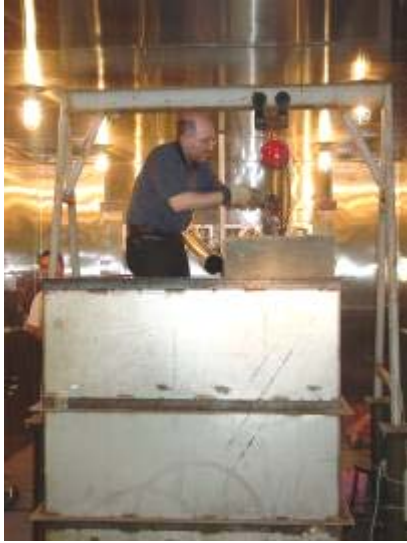
a. Custom-designed crane system

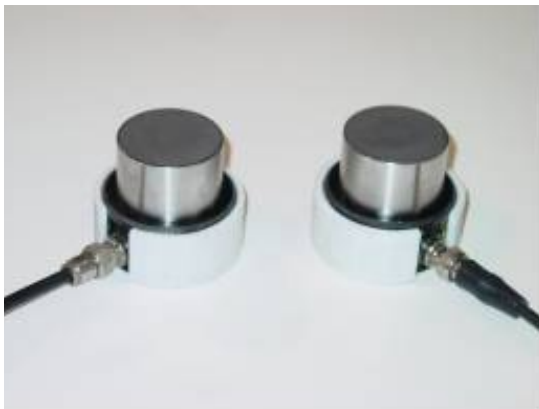
Ultrasonic through-transmission technique was used in the test program to evaluate the quality and condition of the concrete in the bridge deck specimens. The tests were used to evaluate the effects of the environmental exposure conditions on the quality of the concrete (Figure 4.47).

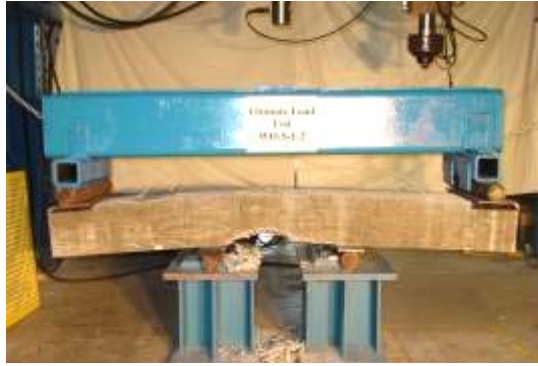
a. Flexural failure mode for a specimen

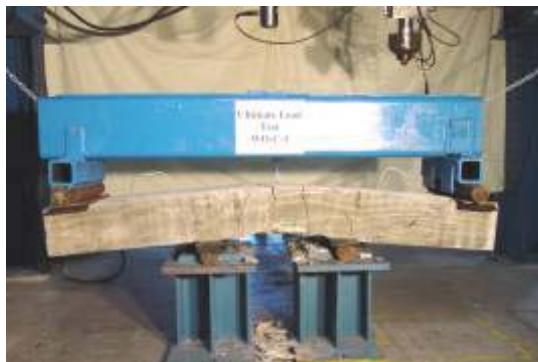
c. Combined flexural/shear failure mode

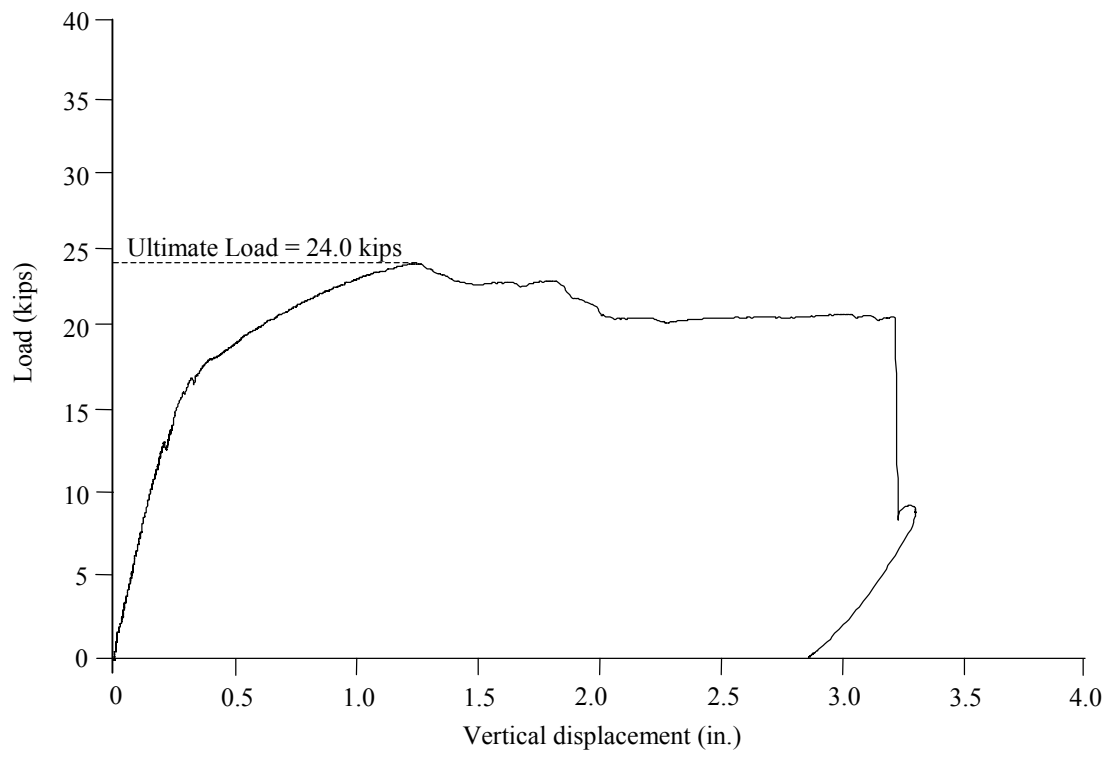
Figure 4.57. Example load-displacement curve for ultimate load test

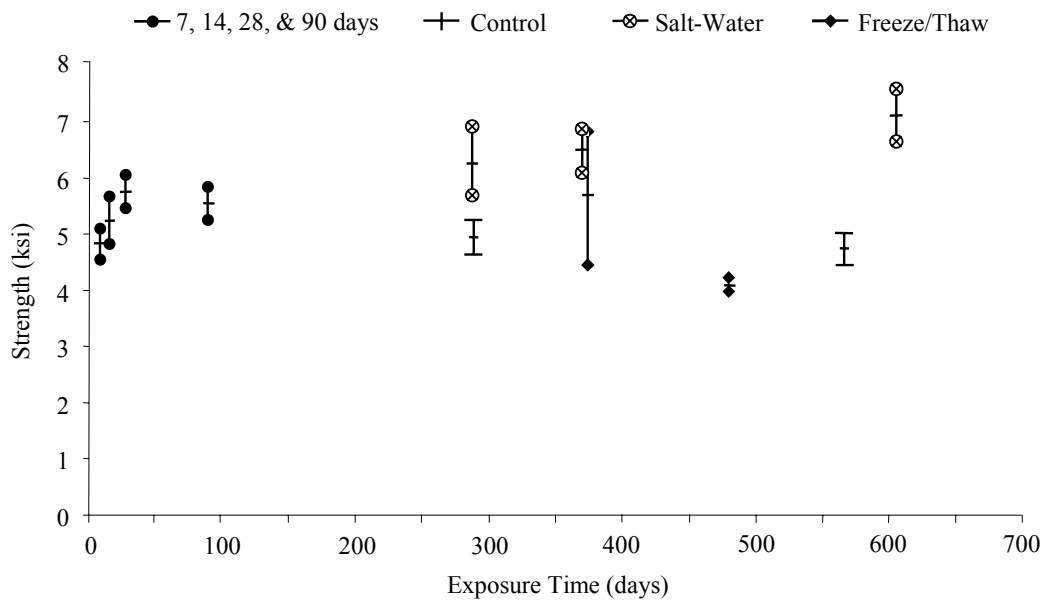
Figure 5.1. Compressive strength for cylinders

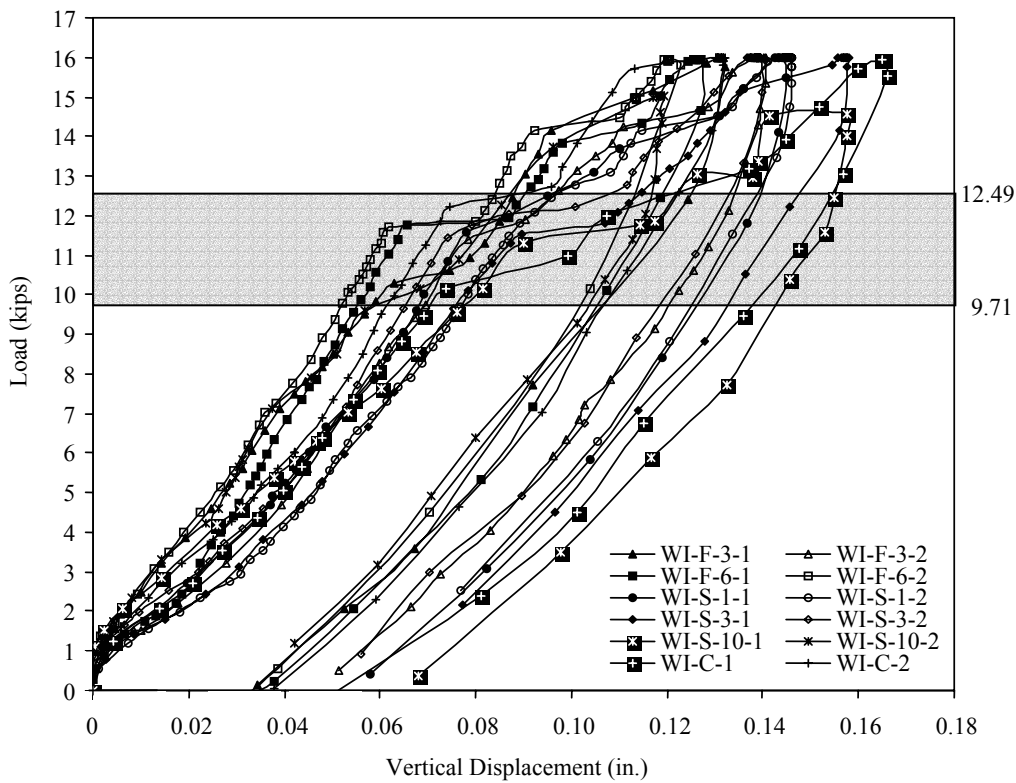
Figure 5.2. Load-displacement curves for positive moment application (bottom cracking) for specimens with SIPMF

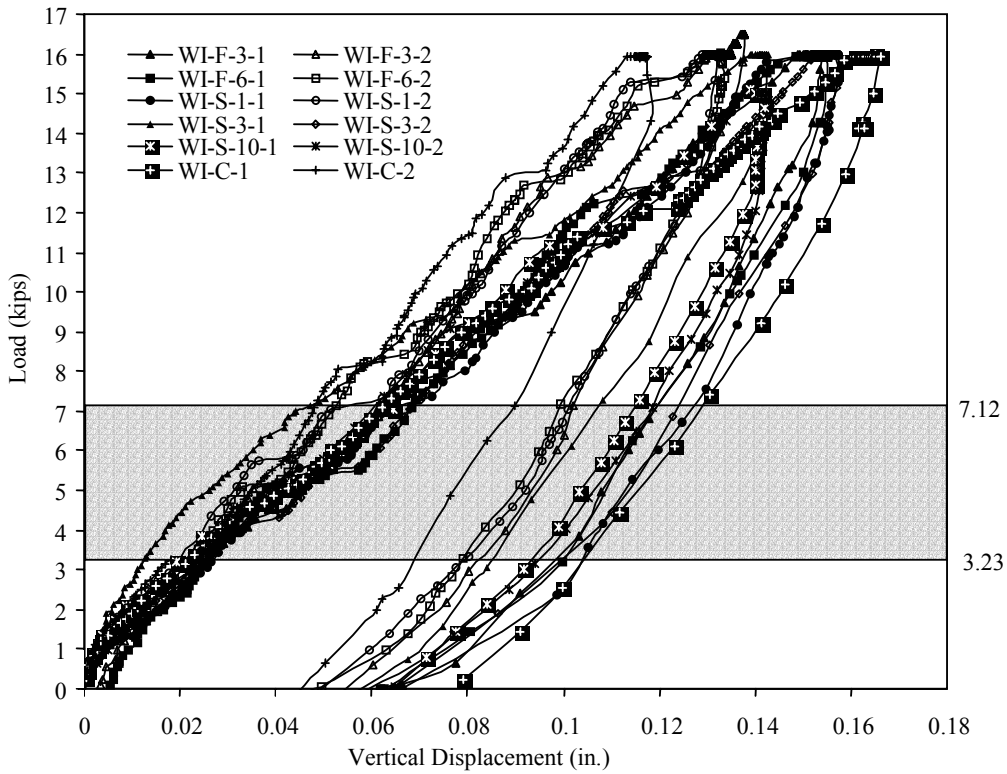
Figure 5.3. Load-displacement curves for negative moment application (top cracking) for specimens with SIPMF

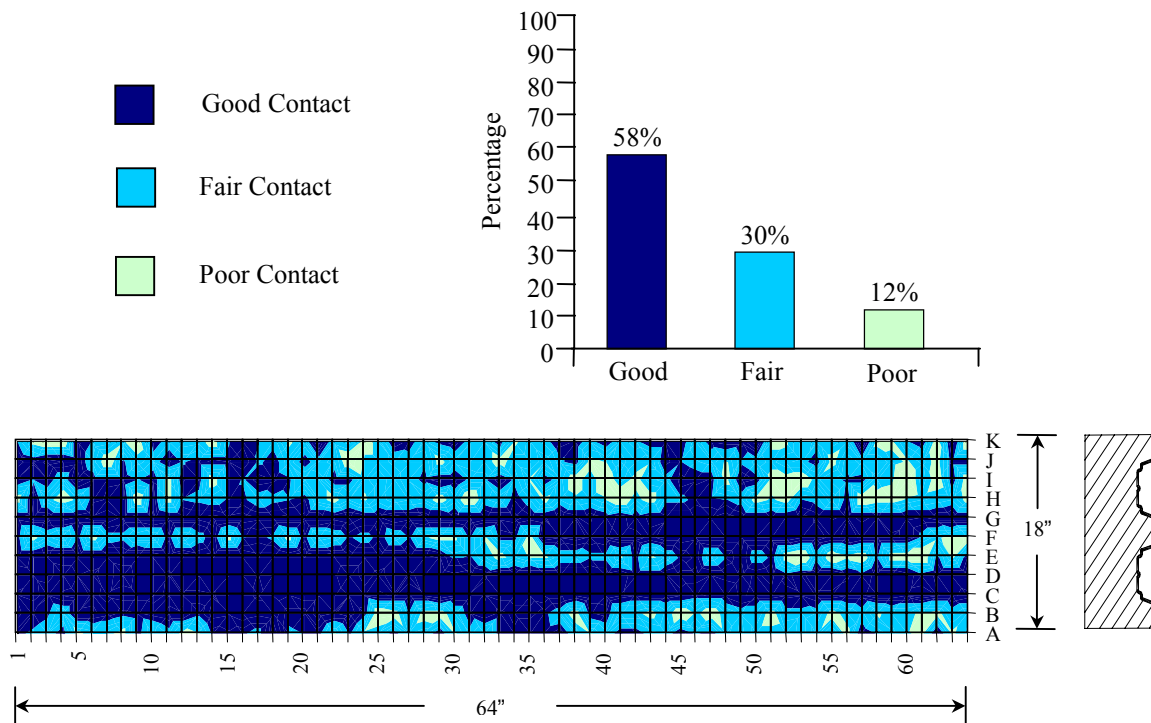
Figure 5.4. Pulse-echo contour map and bar chart for Before Cracking for specimen WI-C-1

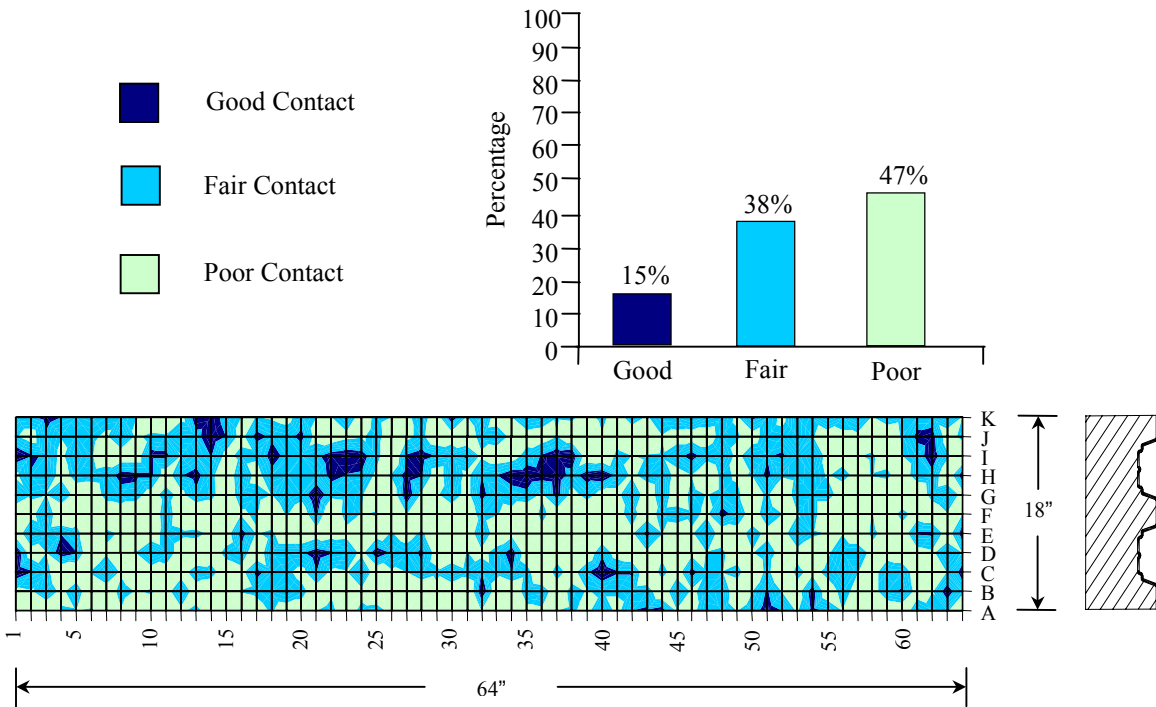
Figure 5.5. Pulse-echo contour map and bar chart for After Cracking for specimen WI-C-1

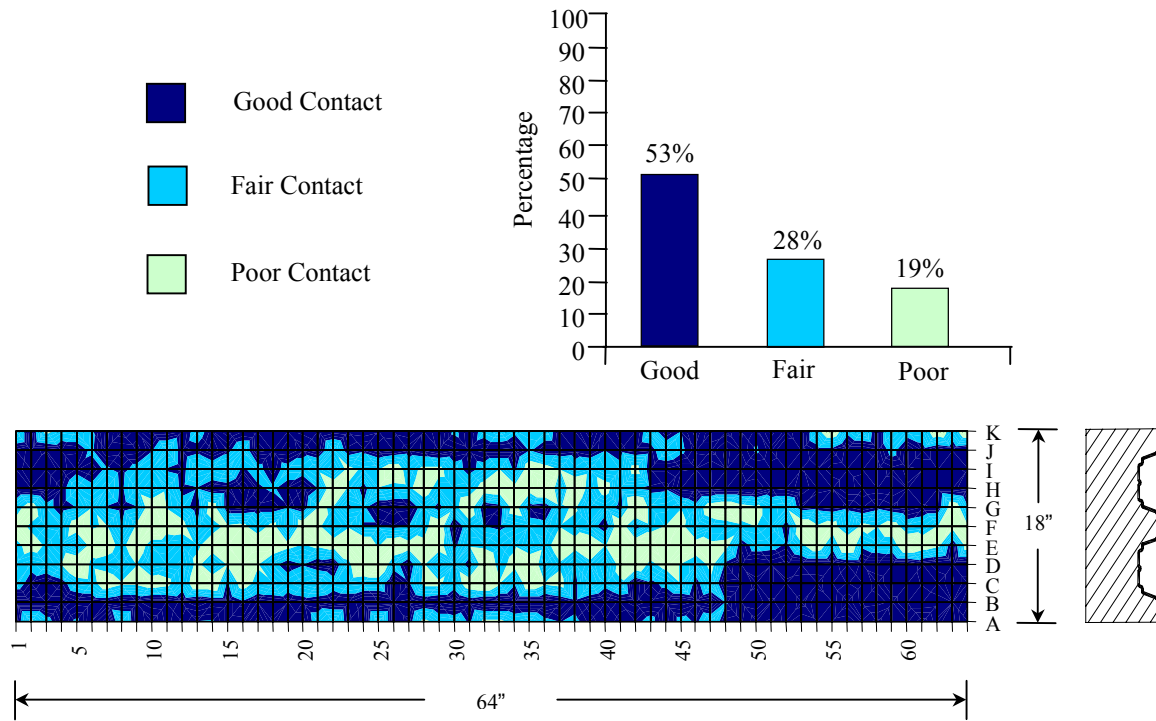
Figure 5.6. Pulse-echo contour map and bar chart for Before Cracking for specimen WI-C-2

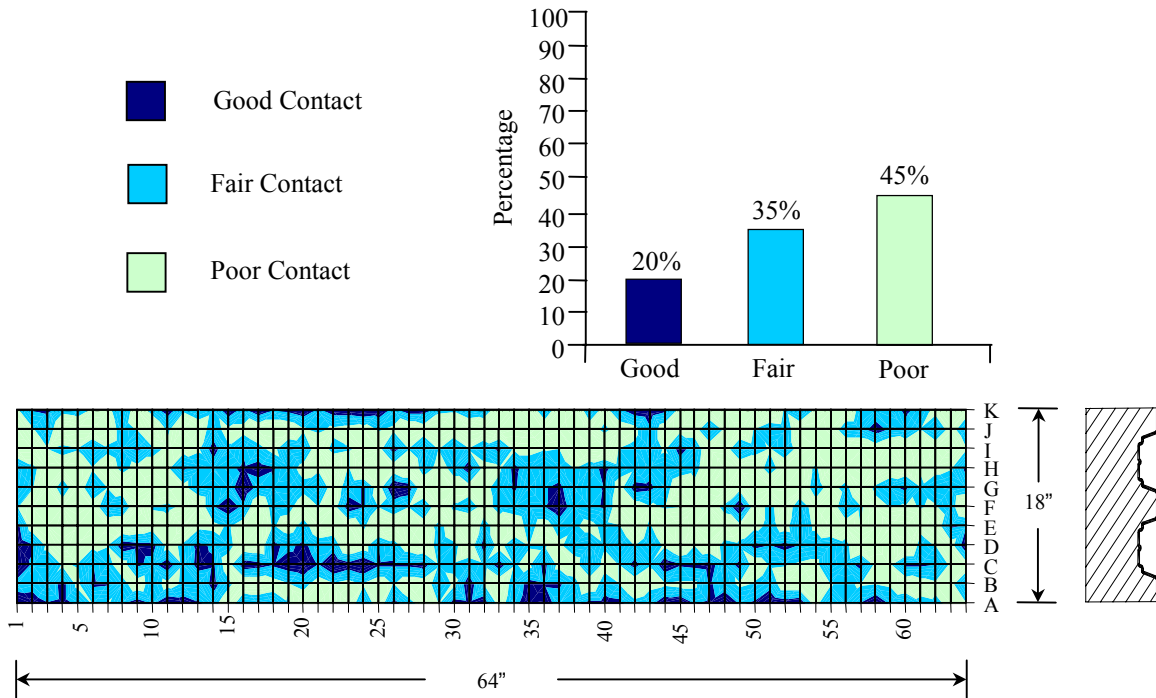
Figure 5.7. Pulse-echo contour map and bar chart for After Cracking for specimen WI-C-2

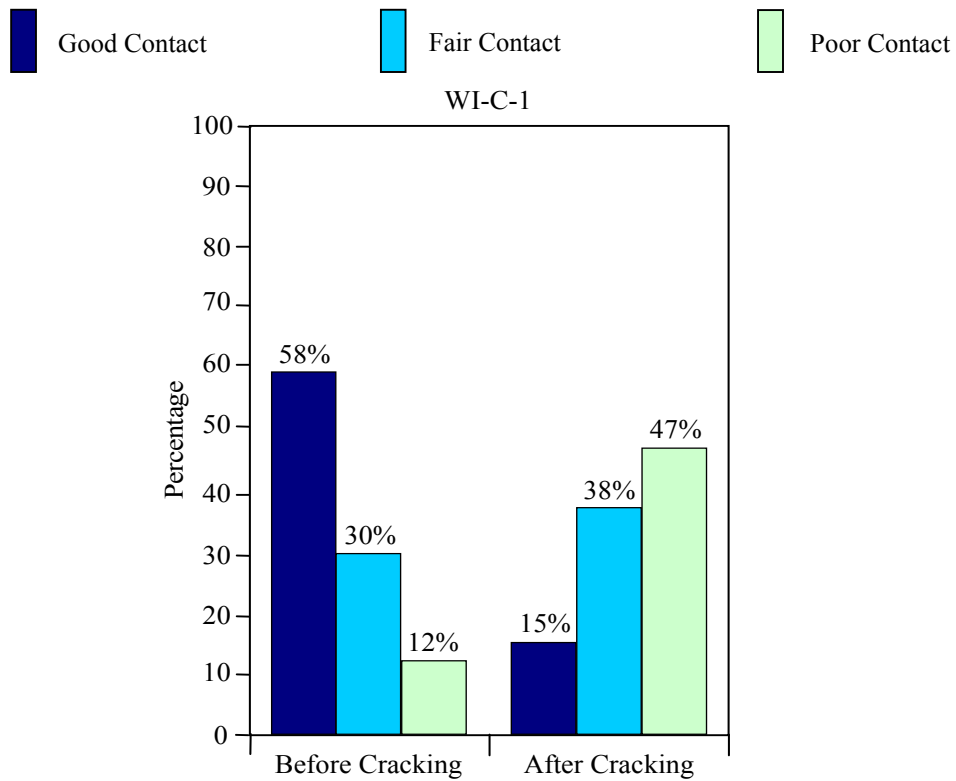
Figure 5.8. Summary of pulse-echo results for specimen WI-C-1

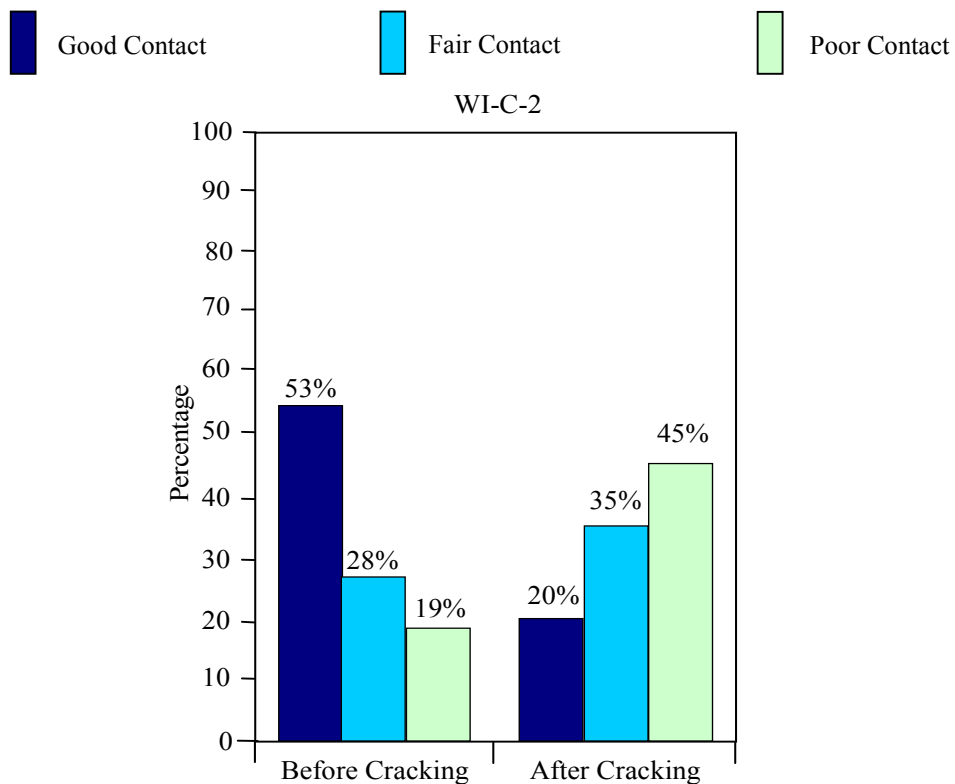
Figure 5.9. Summary of pulse-echo results for specimen WI-C-2

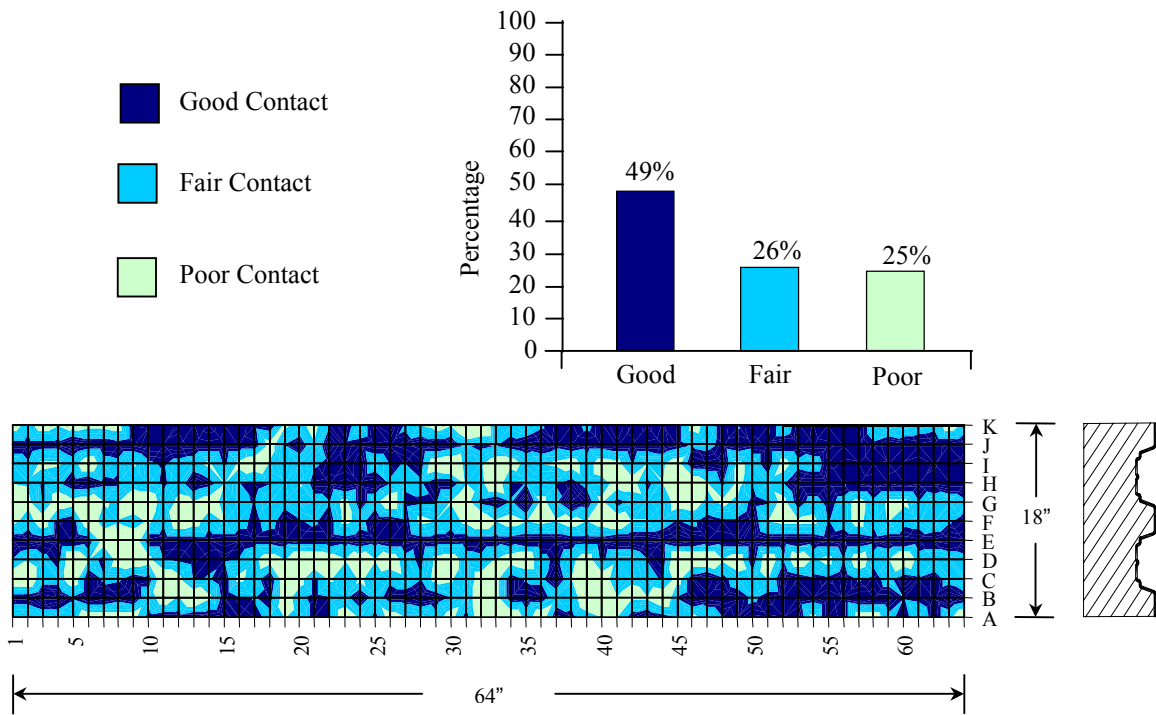
Figure 5.10. Pulse-echo contour map and bar chart for Before Cracking for specimen WI-F-3-1

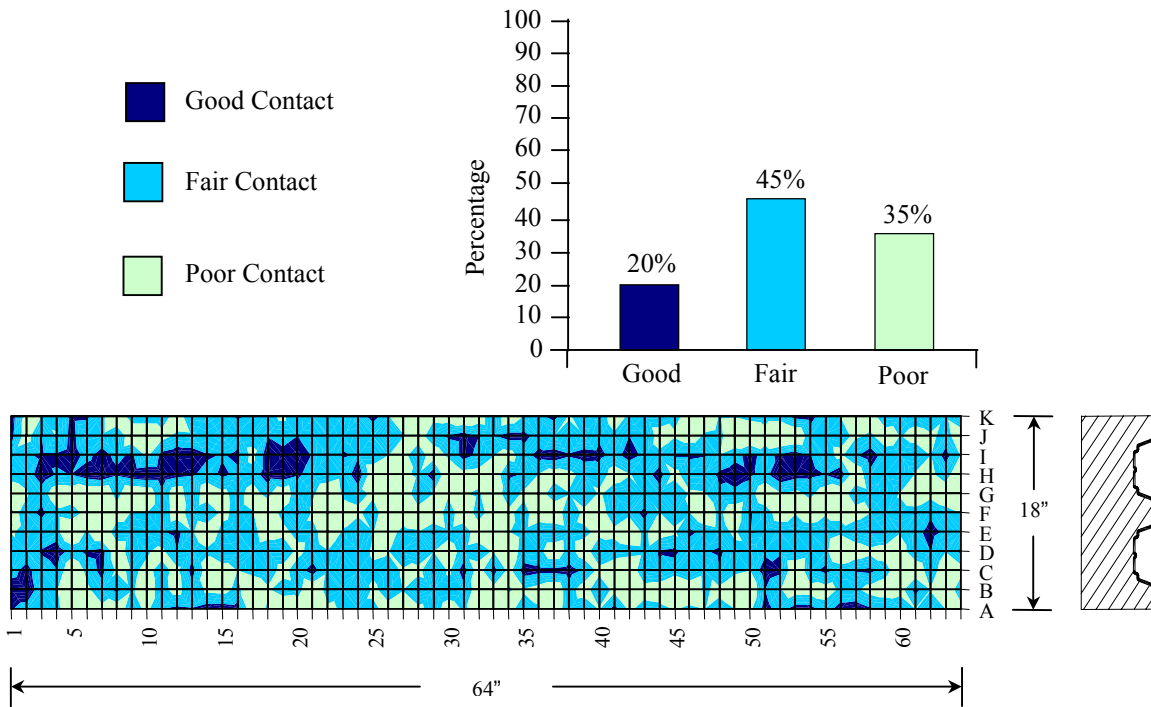
Figure 5.11. Pulse-echo contour map and bar chart for After Cracking for specimen WI-F-3-1

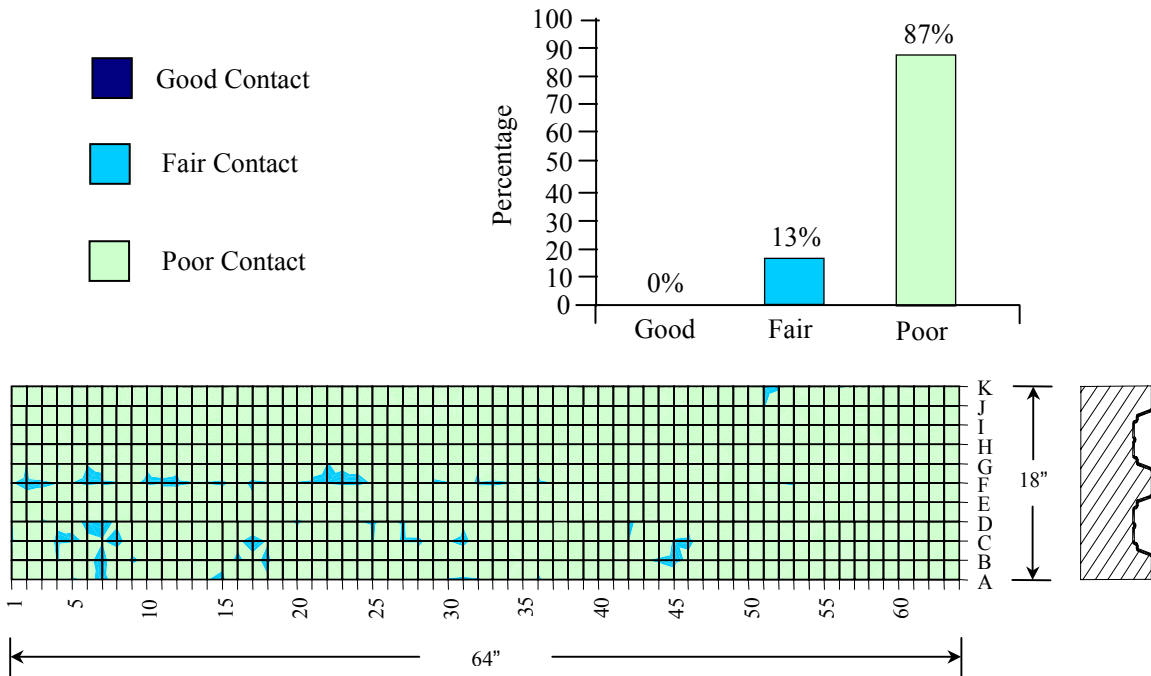
Figure 5.12. Pulse-echo contour map and bar chart for After 300 Freeze/Thaw Cycles for specimen WI-F-3-1

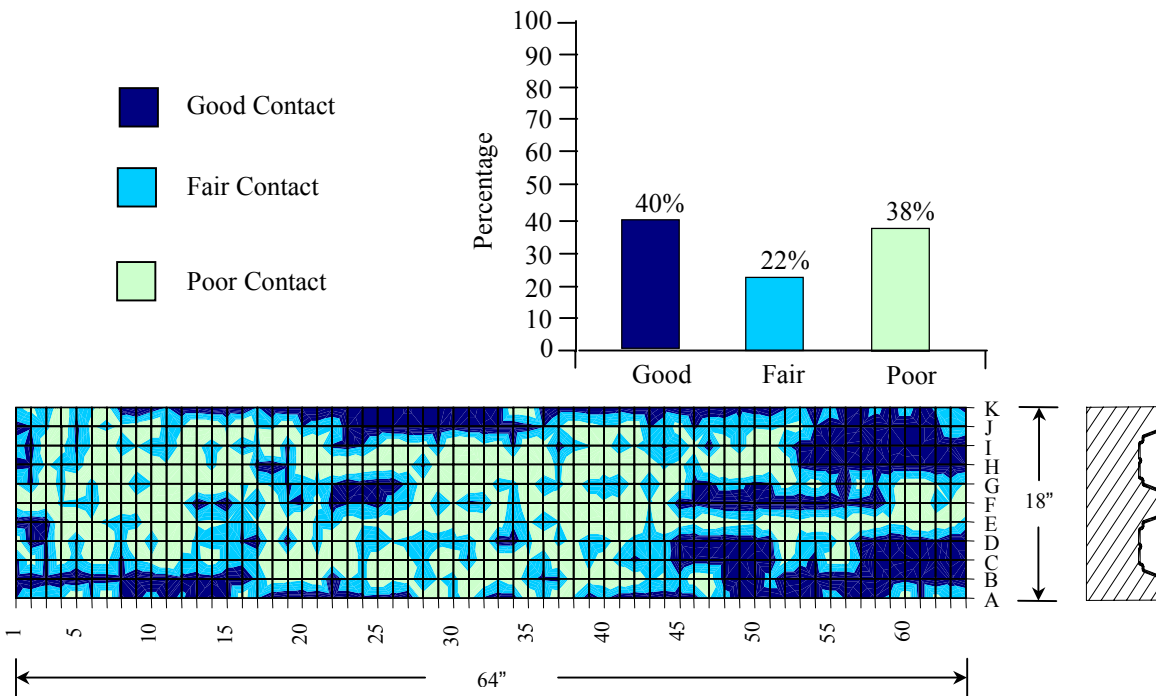
Figure 5.13. Pulse-echo contour map and bar chart for Before Cracking for specimen WI-F-3-2
