LAWRENCE TECHNOLOGICAL UNIVERSITY

**INSPECTION AND DETERIORATION OF BRIDGE DECKS
CONSTRUCTED USING STAY-IN-PLACE METAL FORMS
AND EPOXY-COATED REINFORCEMENT**

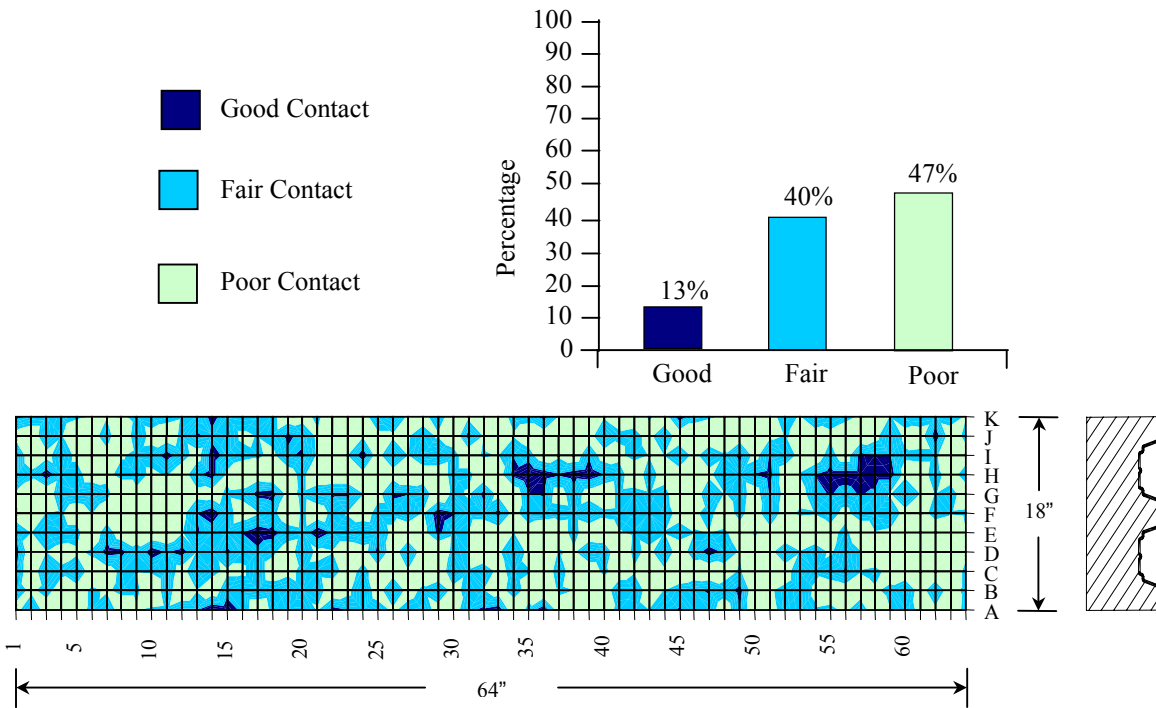
Figure 5.14. Pulse-echo contour map and bar chart for After Cracking for specimen WI-F-3-2

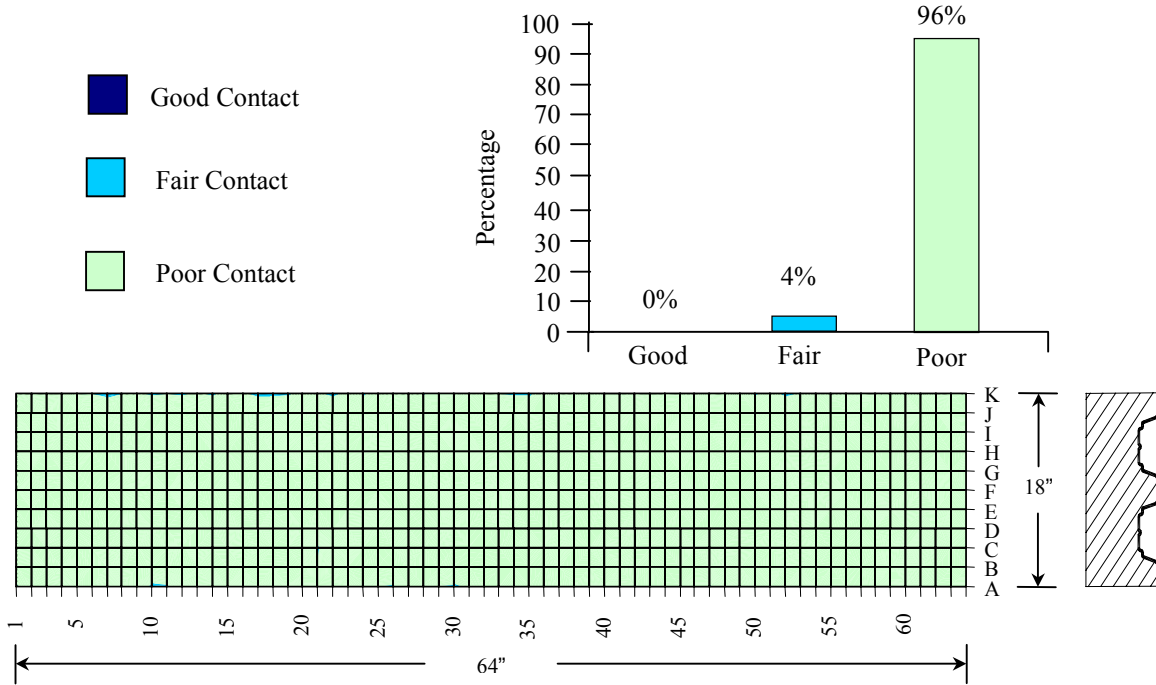
Figure 5.15. Pulse-echo contour map and bar chart for After 300 Freeze/Thaw Cycles for specimen WI-F-3-2

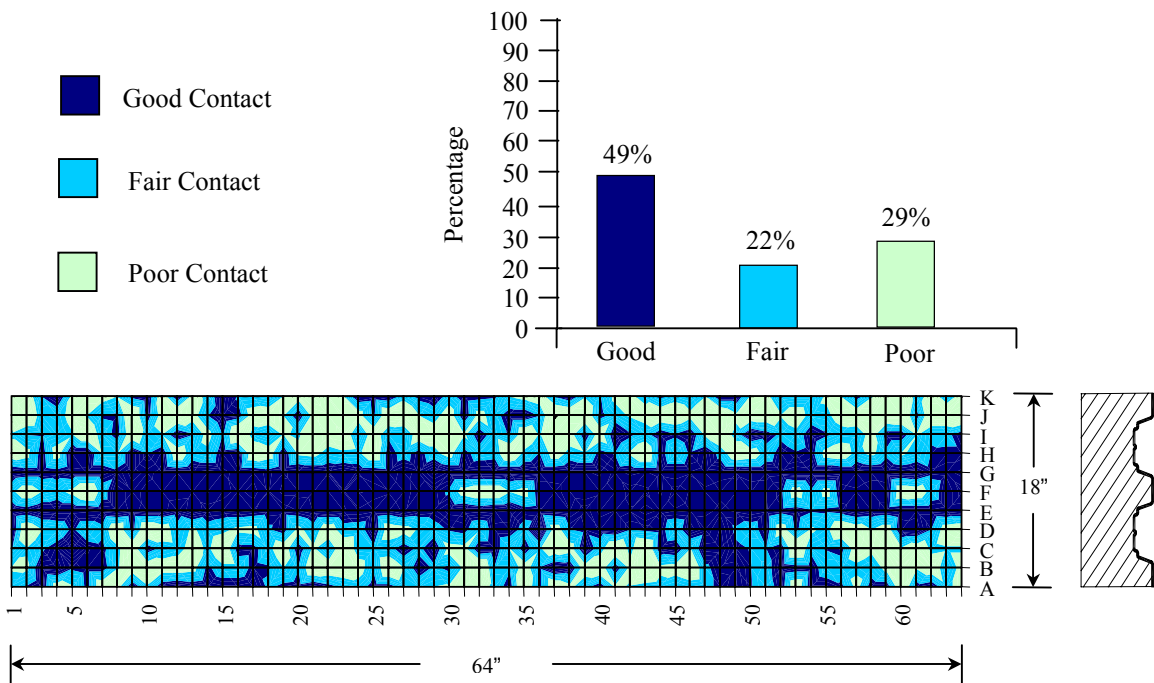
Figure 5.18. Pulse-echo contour map and bar chart for Before Cracking for specimen WI-F-6-1

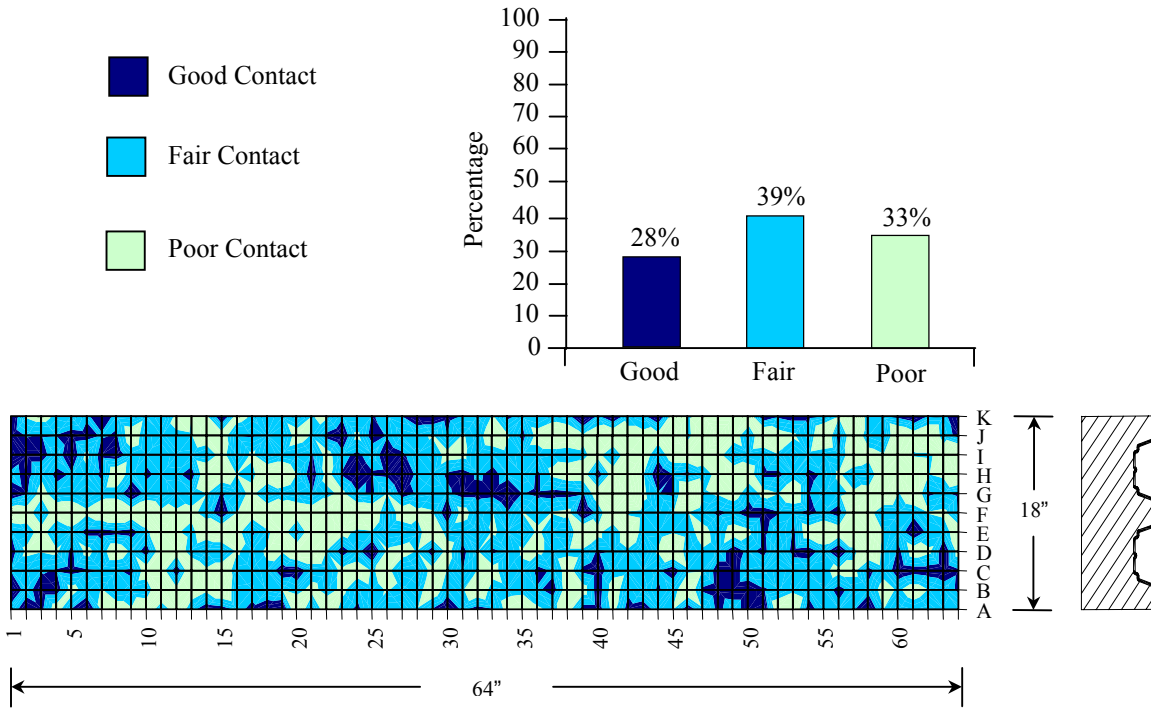
Figure 5.19. Pulse-echo contour map and bar chart for After Cracking for specimen WI-F-6-1

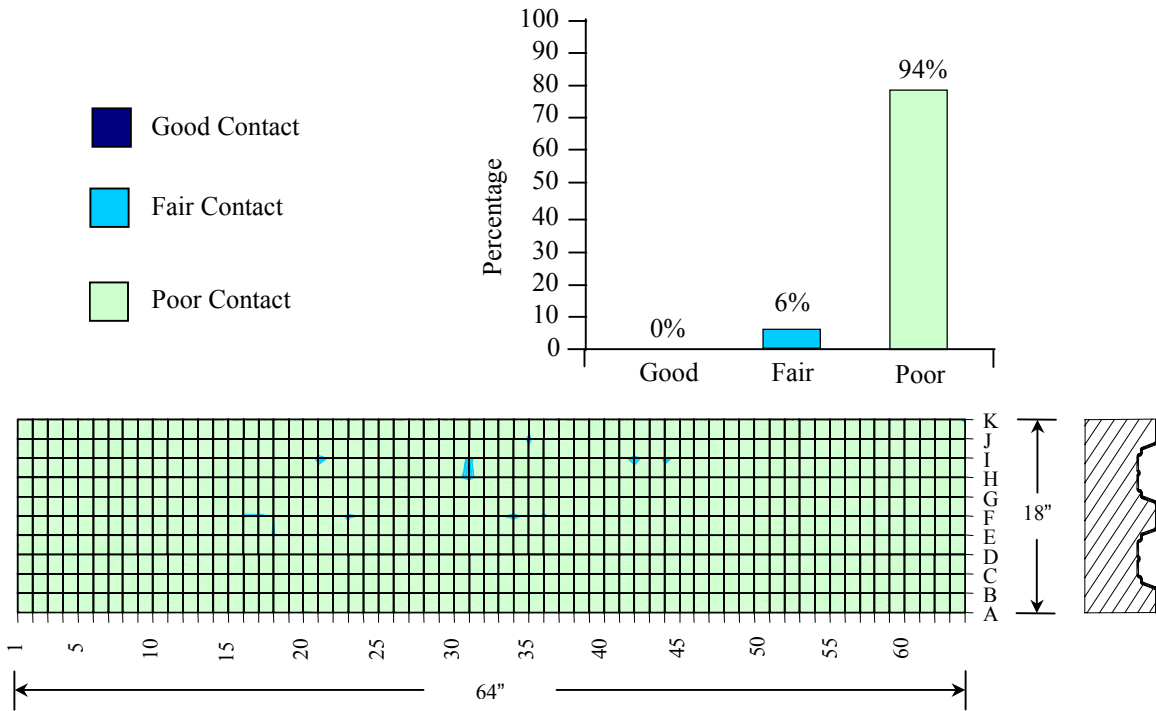
Figure 5.20. Pulse-echo contour map and bar chart for After 300 Freeze/Thaw Cycles for specimen WI-F-6-1

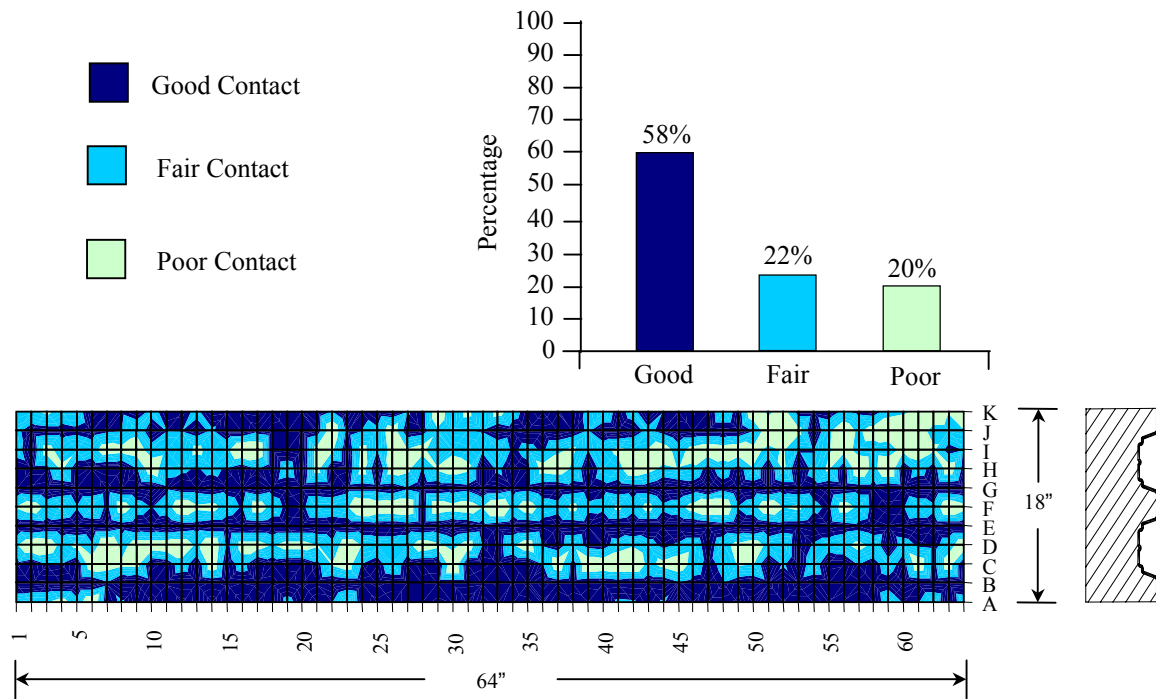
Figure 5.22. Pulse-echo contour map and bar chart for Before Cracking for specimen WI-F-6-2

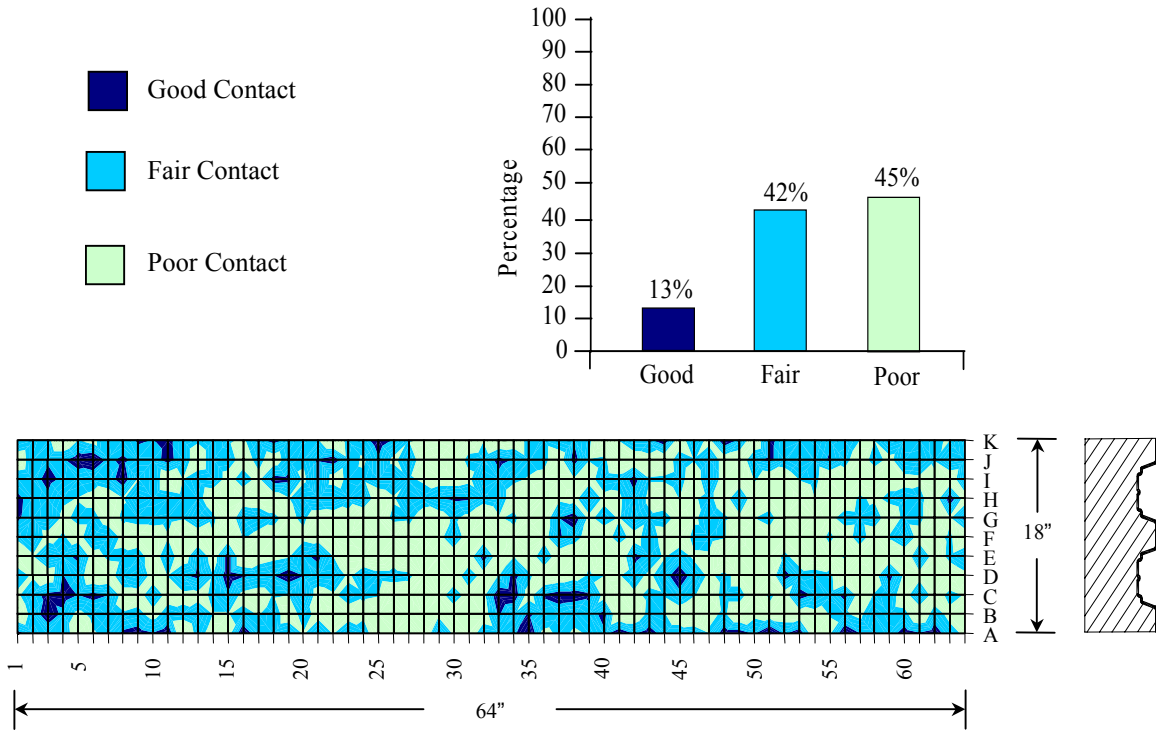
Figure 5.23. Pulse-echo contour map and bar chart for After Cracking for specimen WI-F-6-2

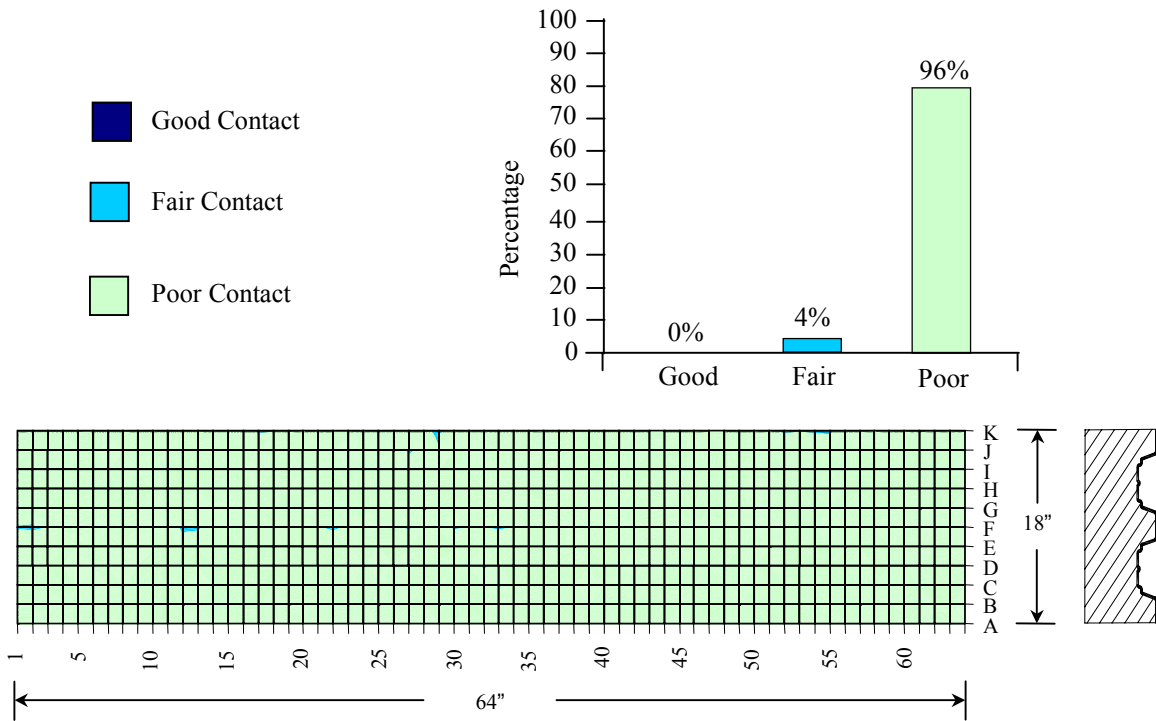
Figure 5.24. Pulse-echo contour map and bar chart for After 300 Freeze/Thaw Cycles for specimen WI-F-6-2

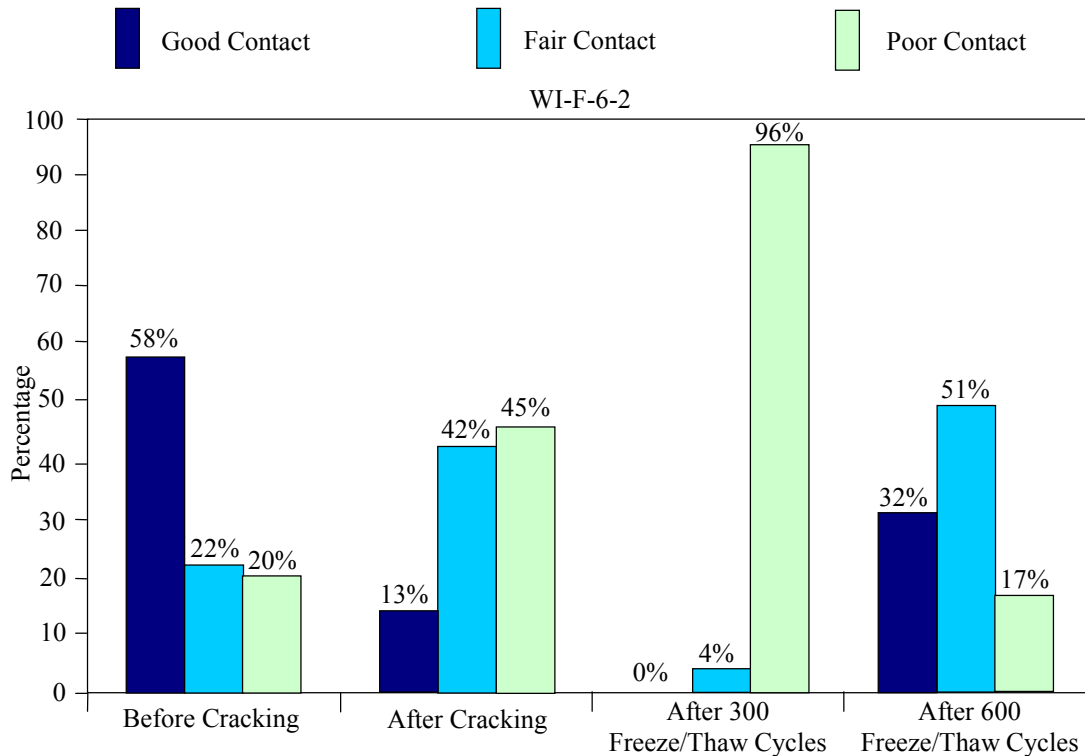
Figure 5.27. Summary of pulse-echo results for specimen WI-F-6-2

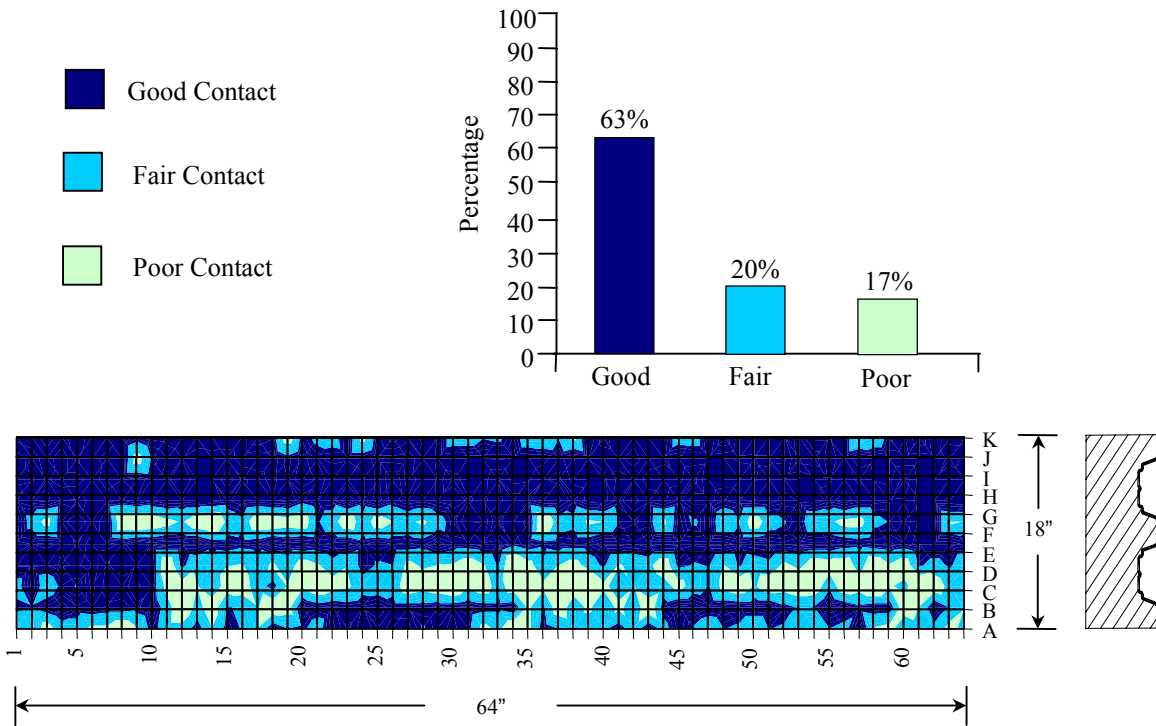
Figure 5.28. Pulse-echo contour map and bar chart for Before Cracking for specimen WI-S-1-1

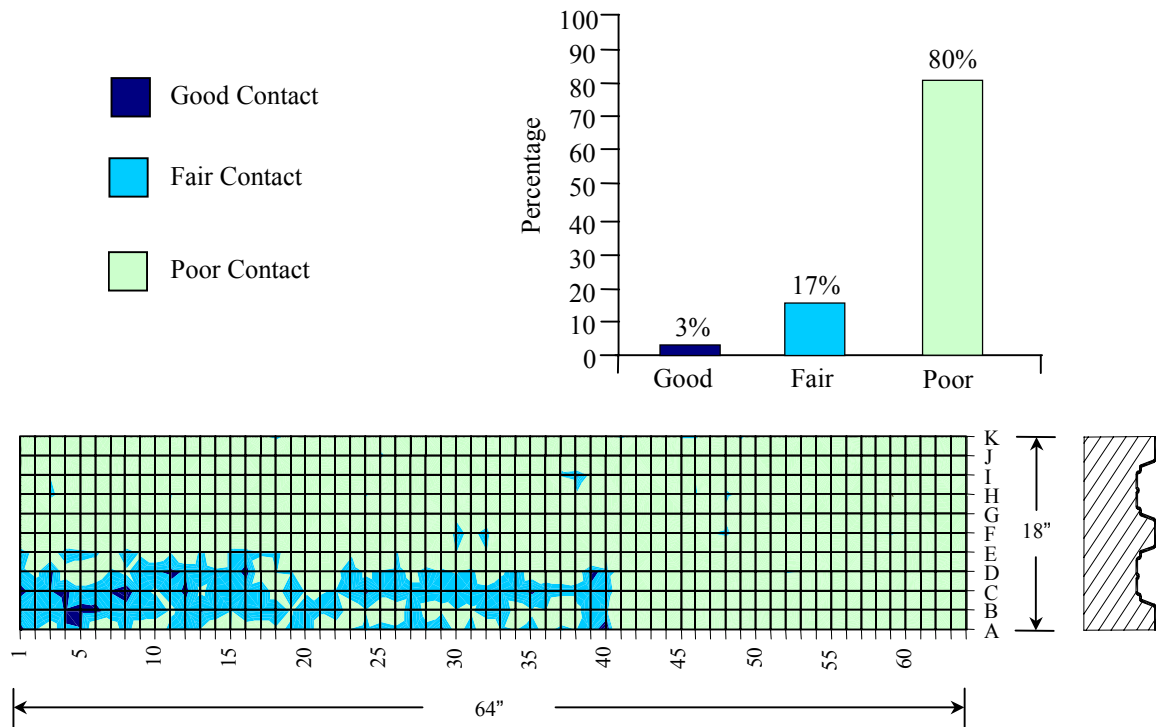
Figure 5.29. Pulse-echo contour map and bar chart for After Cracking for specimen WI-S-1-1

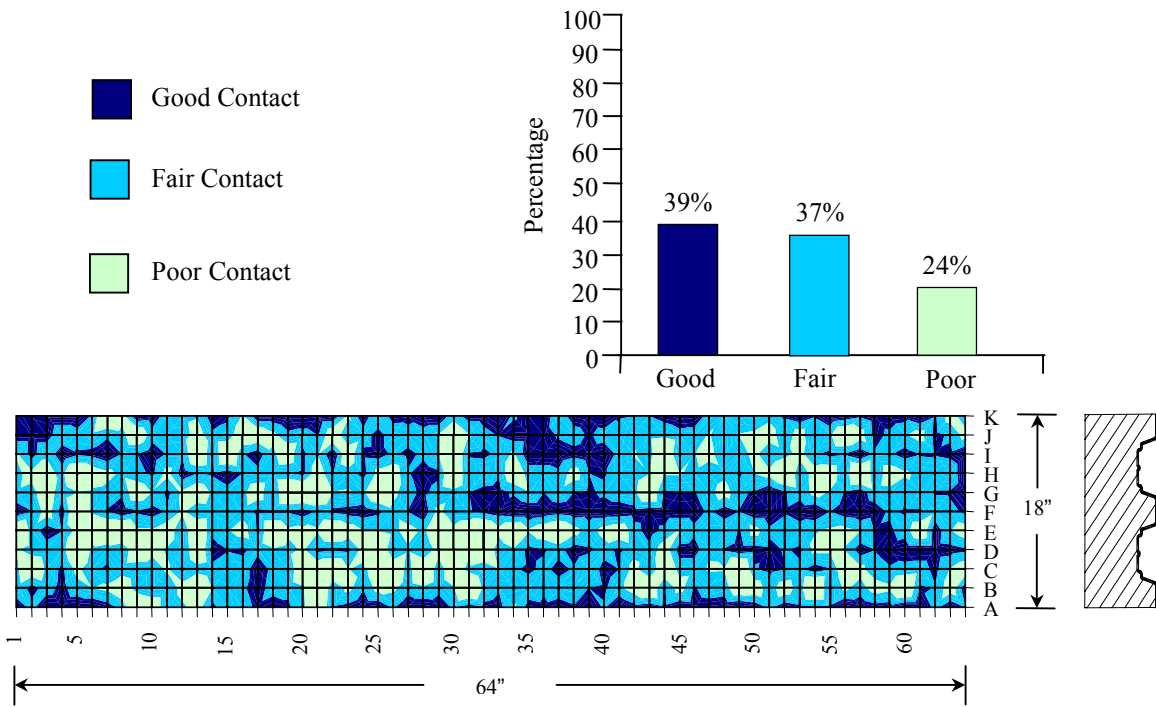
Figure 5.30. Pulse-echo contour map and bar chart for After 1,000 hrs Salt-Water for specimen WI-S-1-1

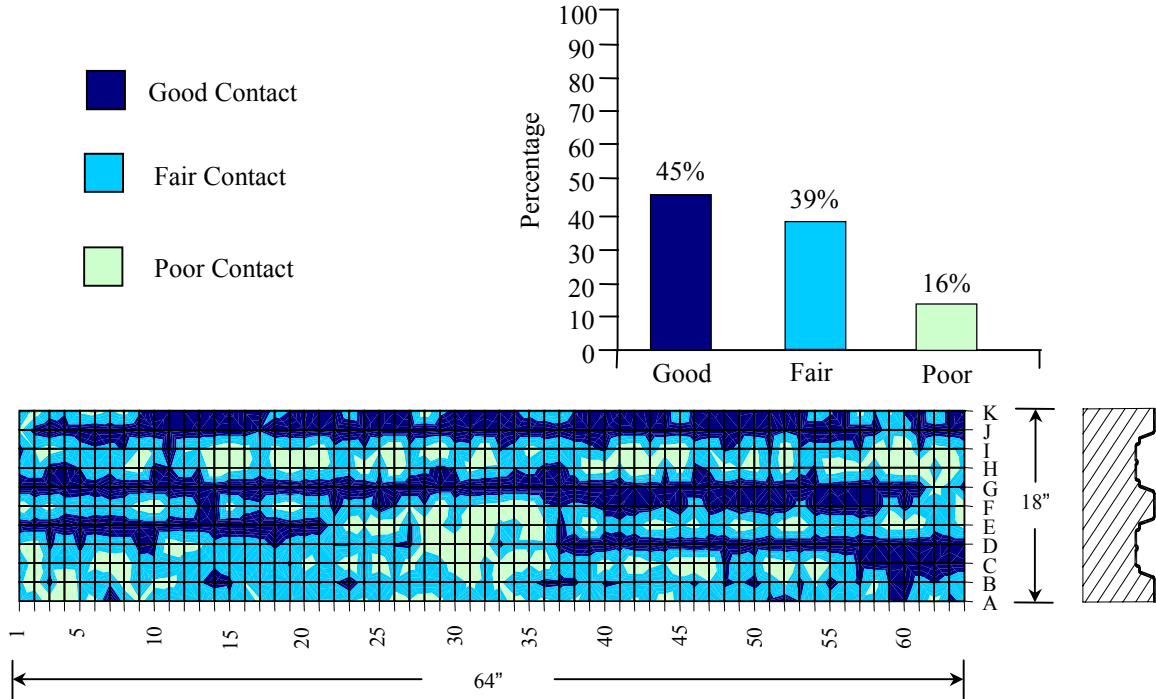
Figure 5.31. Pulse-echo contour map and bar chart for Before Cracking for specimen WI-S-1-2

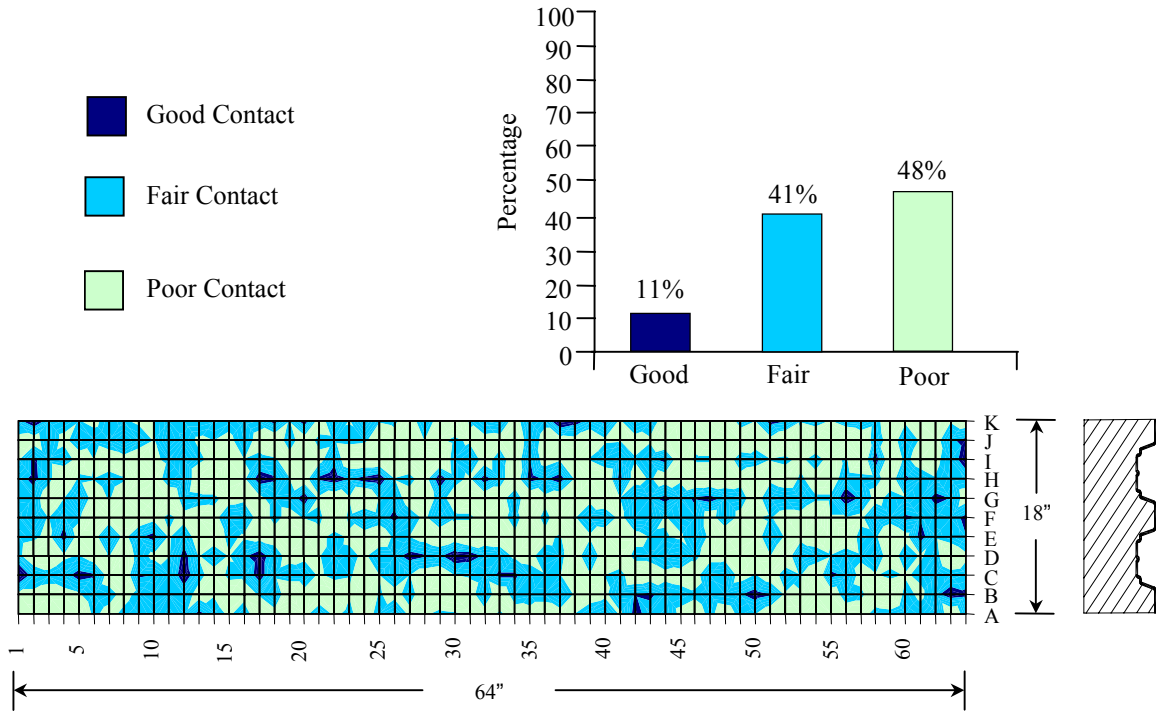
Figure 5.32. Pulse-echo contour map and bar chart for After Cracking for specimen WI-S-1-2

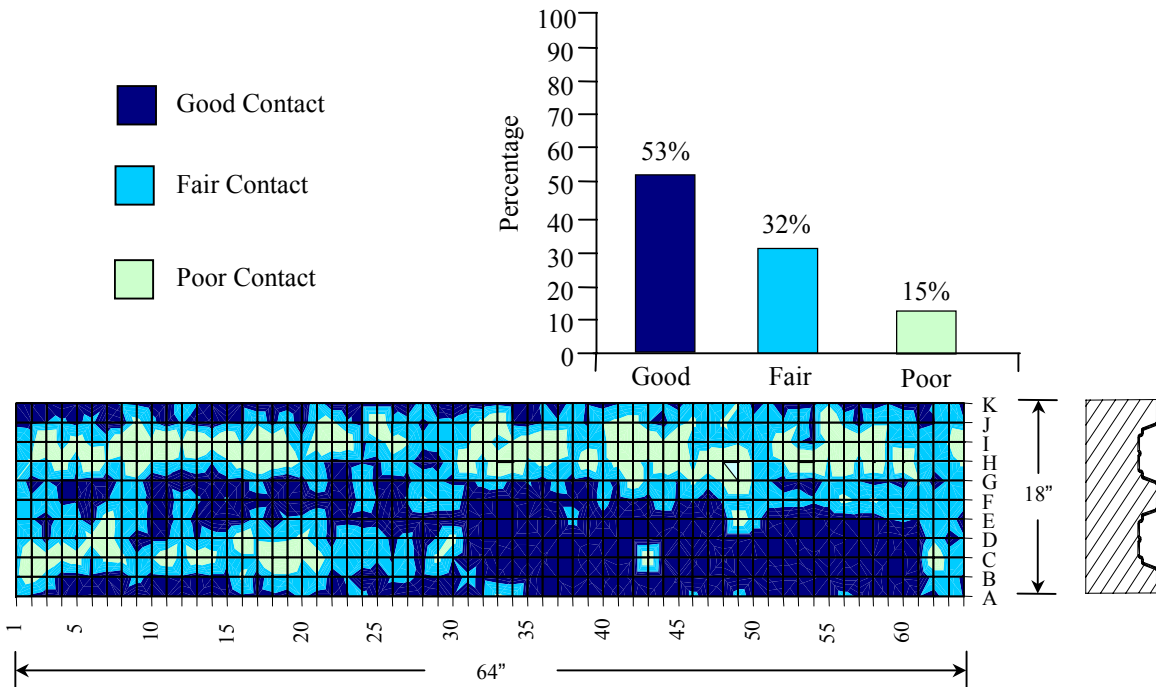
Figure 5.33. Pulse-echo contour map and bar chart for After 1,000 hrs Salt-Water for specimen WI-S-1-2

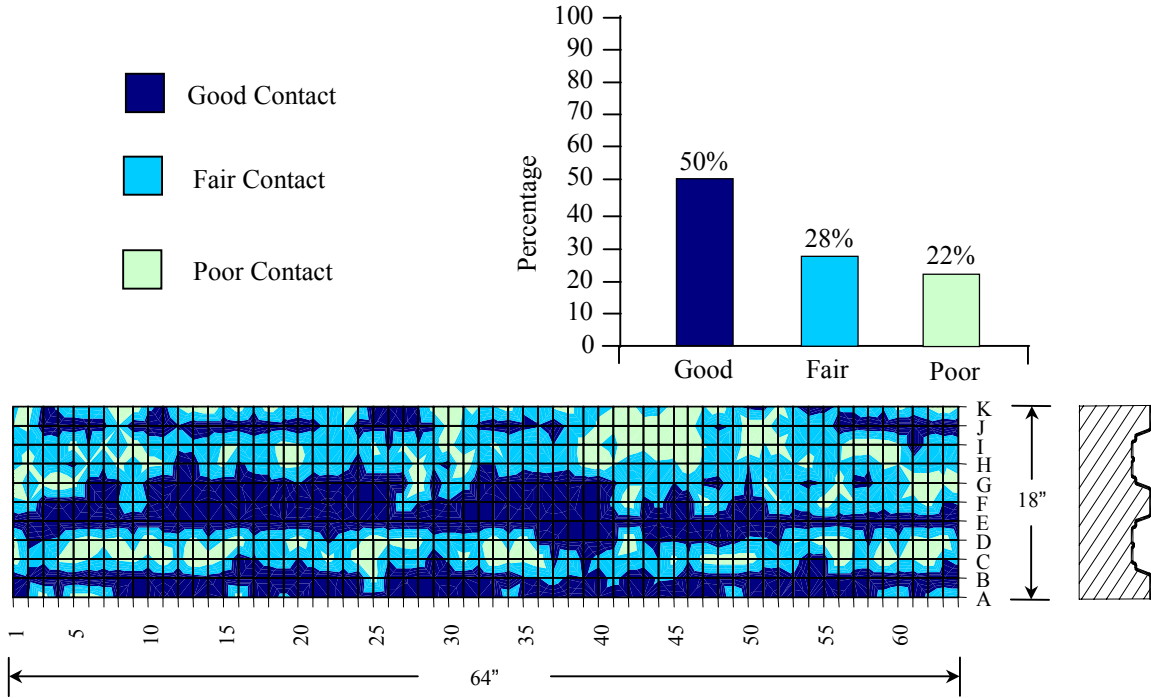
Figure 5.36. Pulse-echo contour map and bar chart for Before Cracking for specimen WI-S-3-1

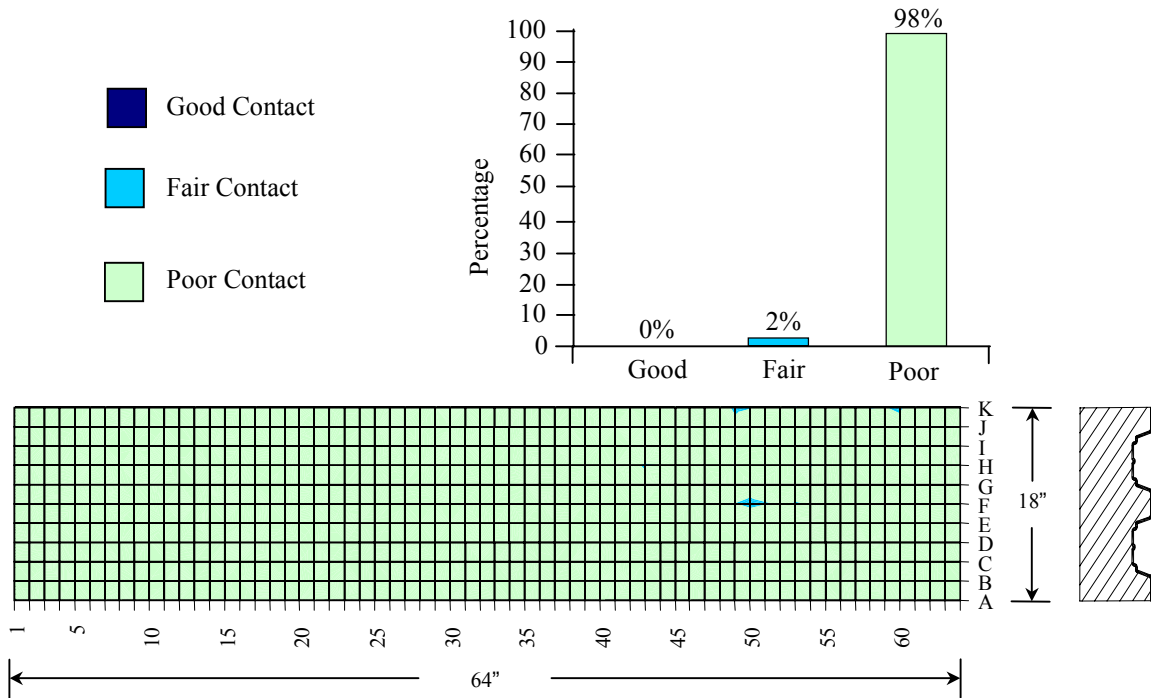
Figure 5.37. Pulse-echo contour map and bar chart for After Cracking for specimen WI-S-3-1

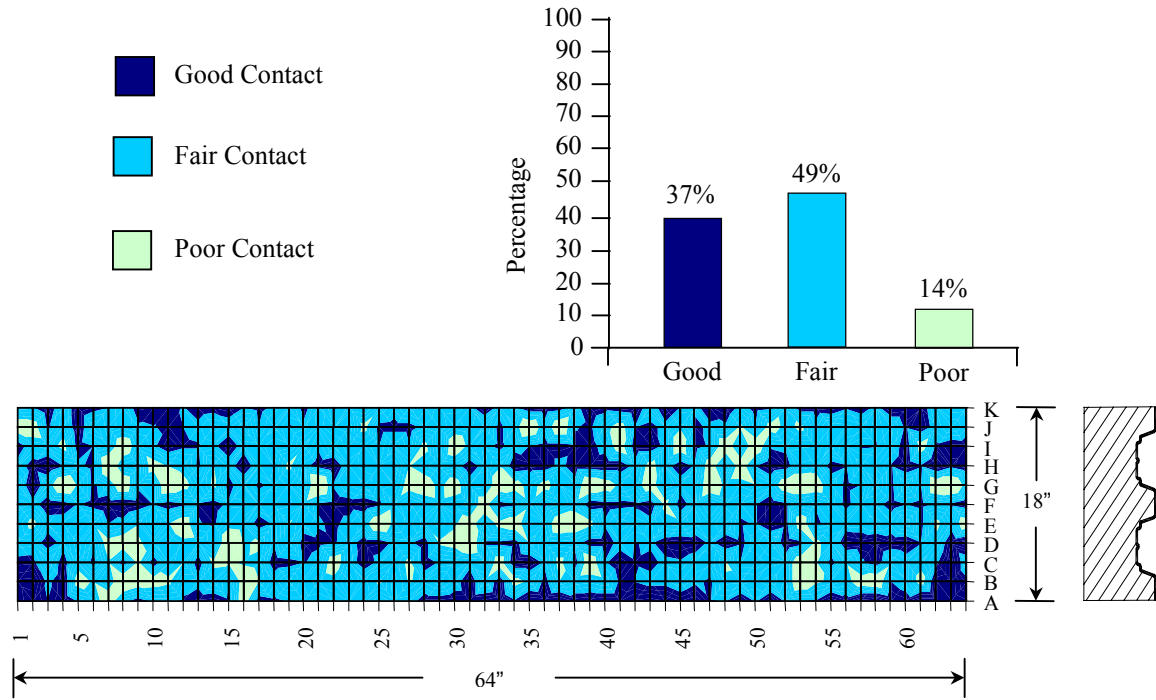
Figure 5.38. Pulse-echo contour map and bar chart for After 1,000 hrs Salt-Water for specimen WI-S-3-1

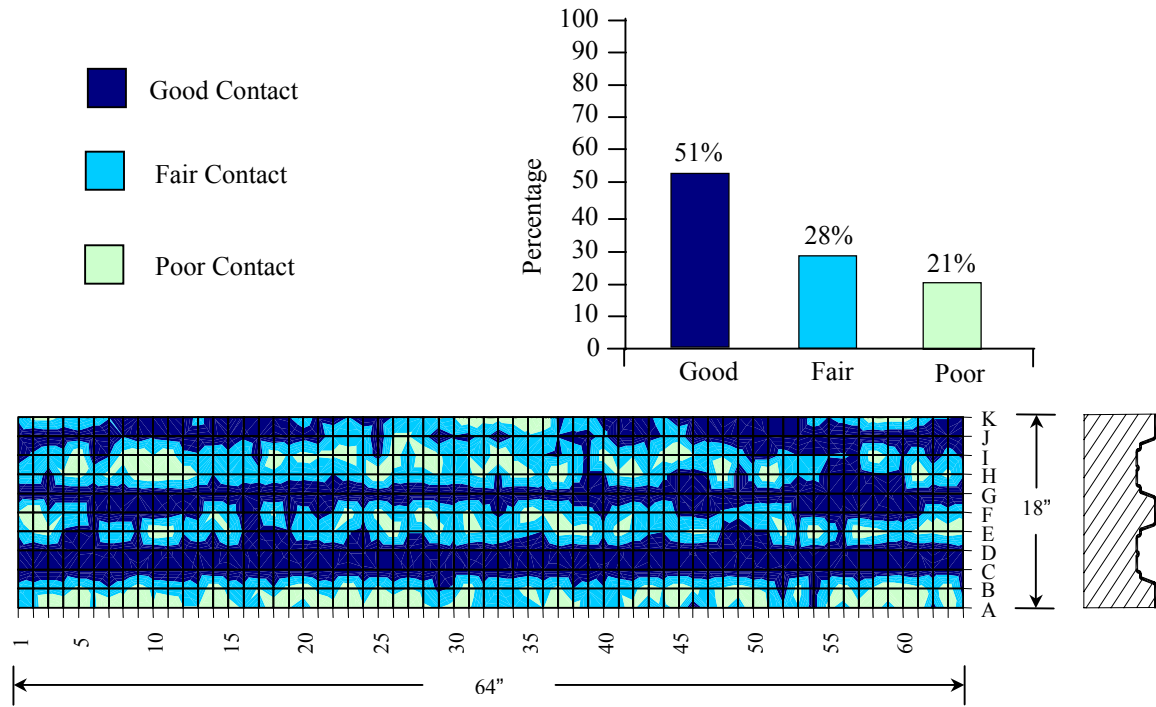
Figure 5.40. Pulse-echo contour map and bar chart for Before Cracking for specimen WI-S-3-2

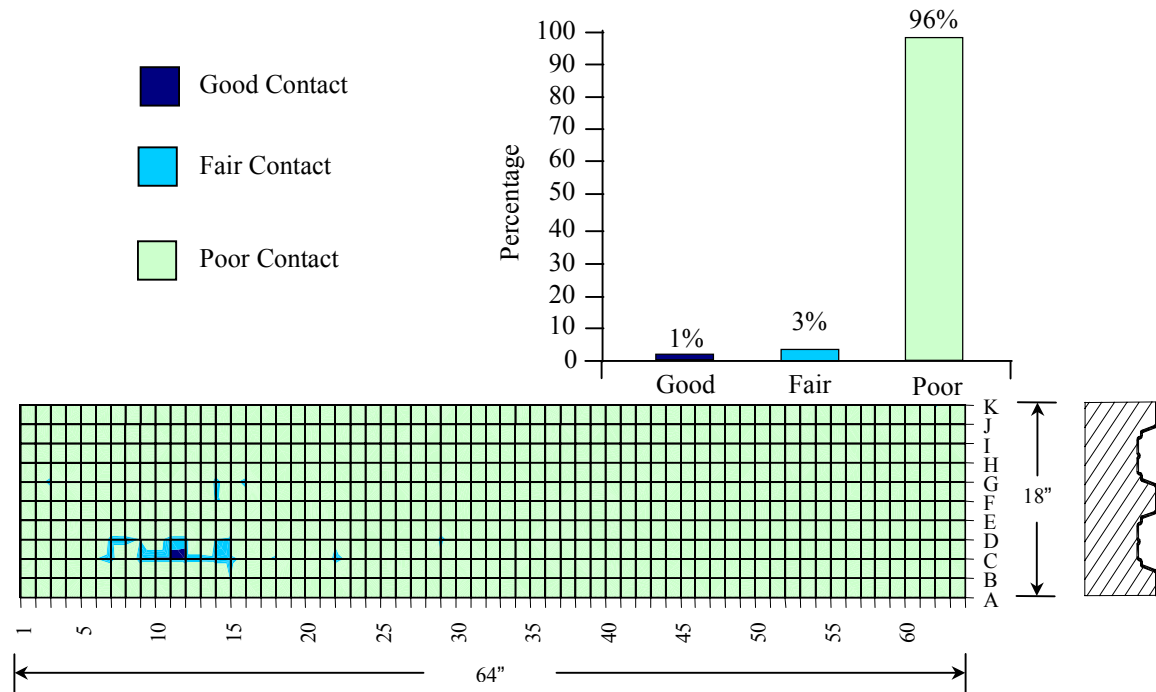
Figure 5.41. Pulse-echo contour map and bar chart for After Cracking for specimen WI-S-3-2

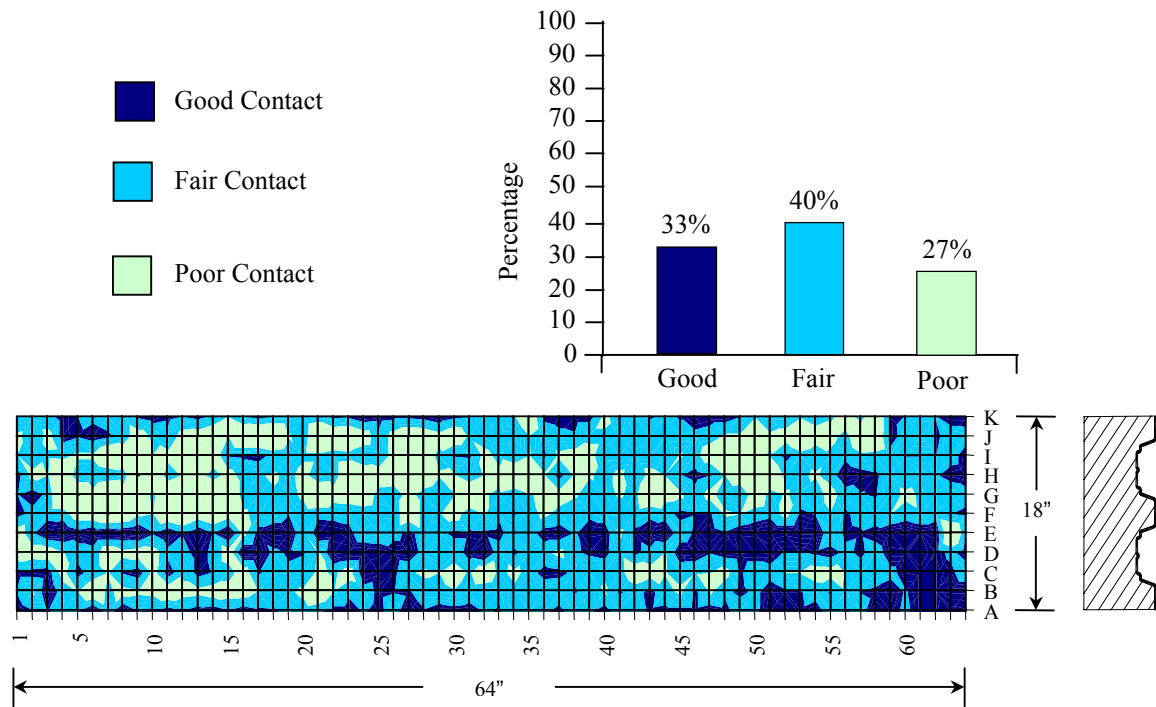
Figure 5.42. Pulse-echo contour map and bar chart for After 1,000 hrs Salt-Water for specimen WI-S-3-2

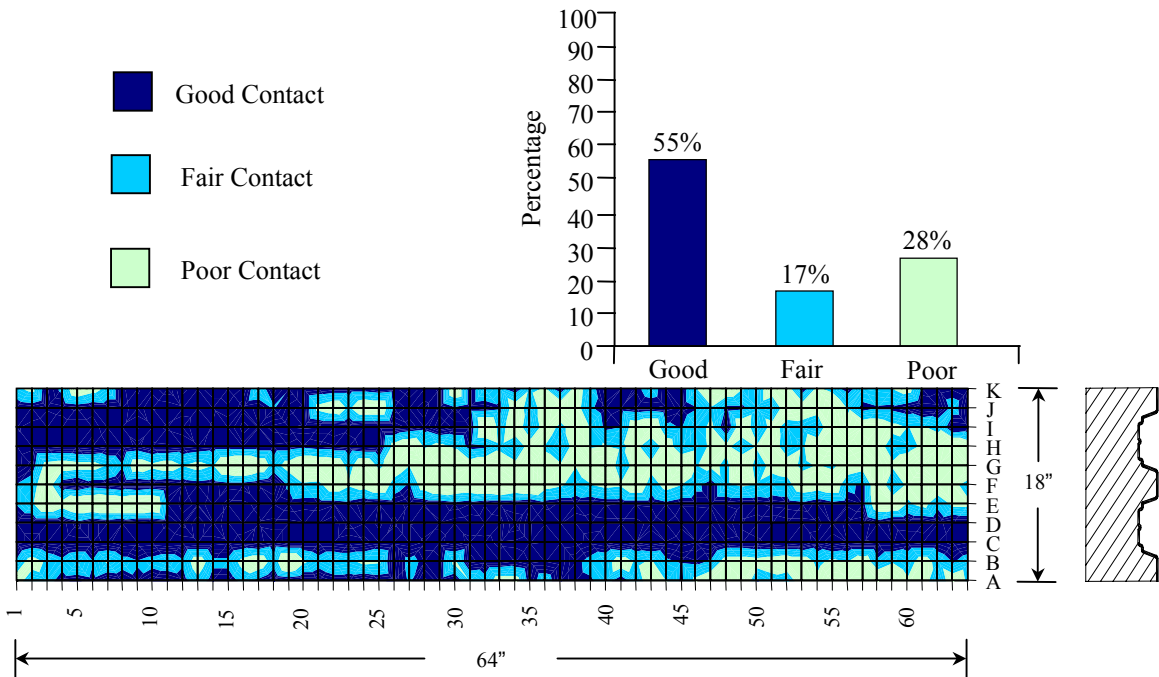
Figure 5.46. Pulse-echo contour map and bar chart for Before Cracking for specimen WI-S-10-1

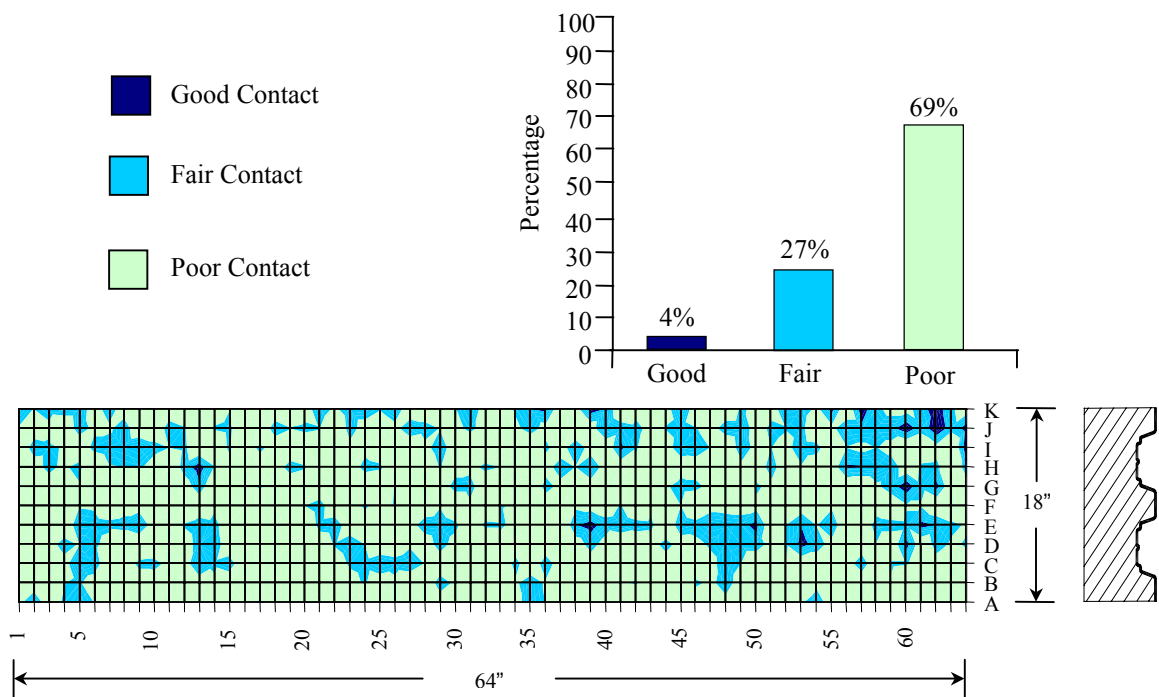
Figure 5.47. Pulse-echo contour map and bar chart for After Cracking for specimen WI-S-10-1

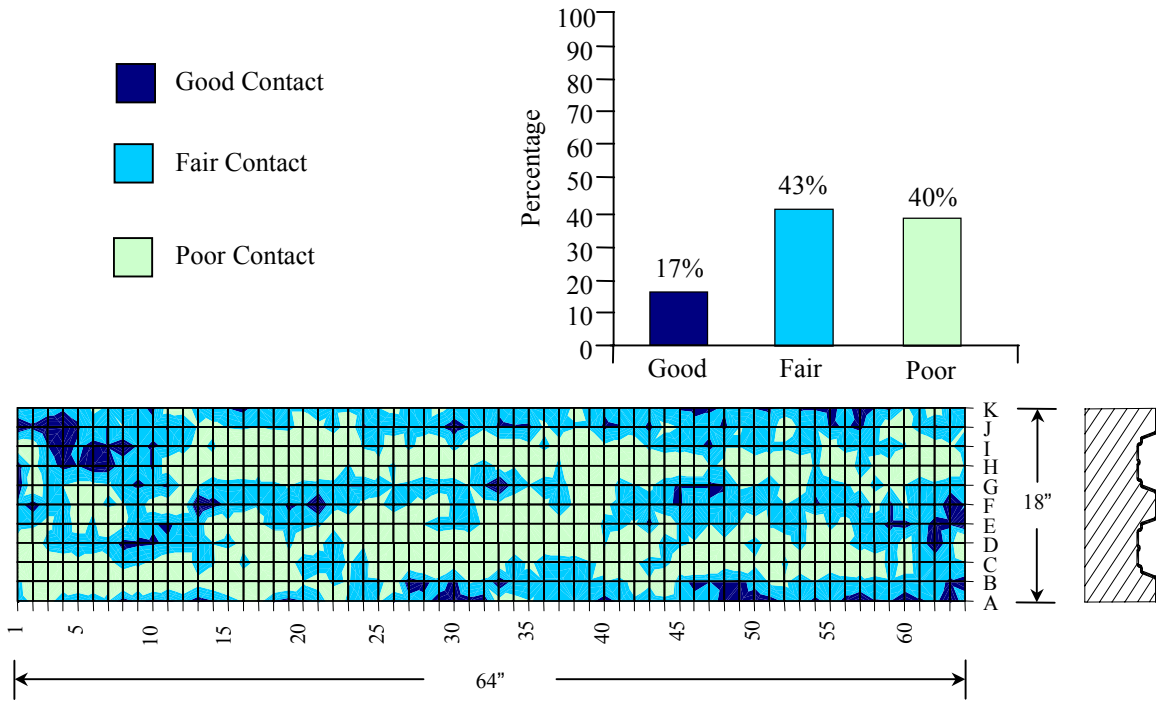
Figure 5.48. Pulse-echo contour map and bar chart for After 1,000 hrs Salt-Water for specimen WI-S-10-1

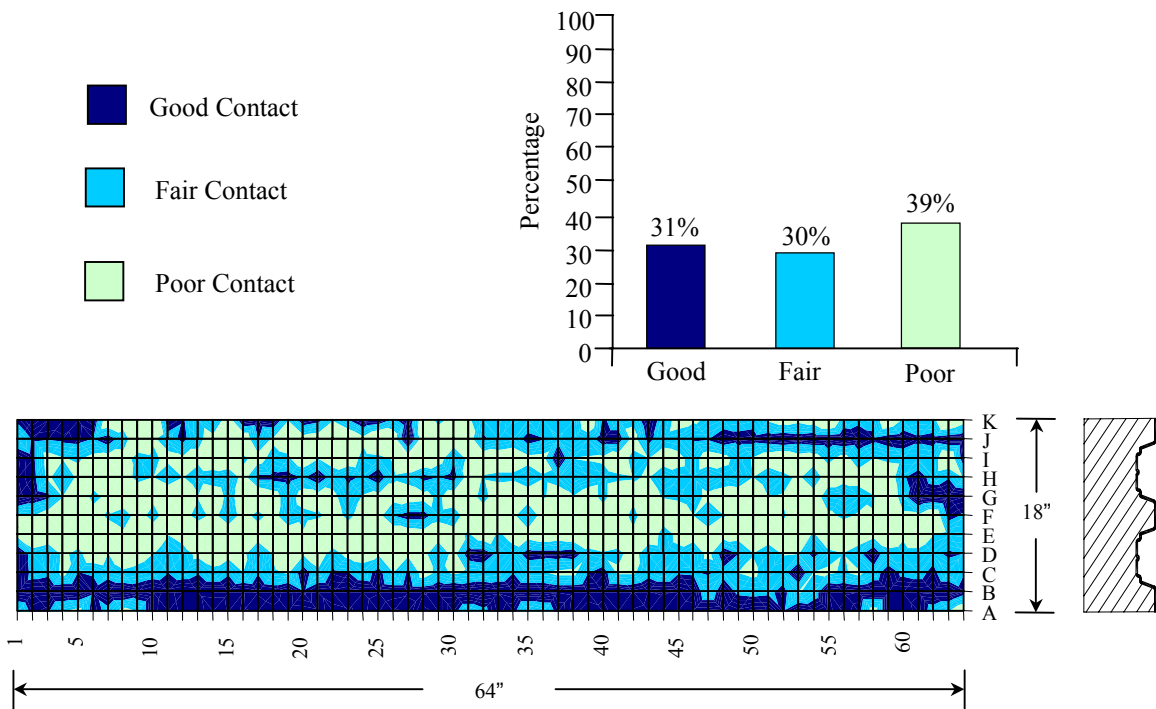
Figure 5.51. Pulse-echo contour map and bar chart for Before Cracking for specimen WI-S-10-2

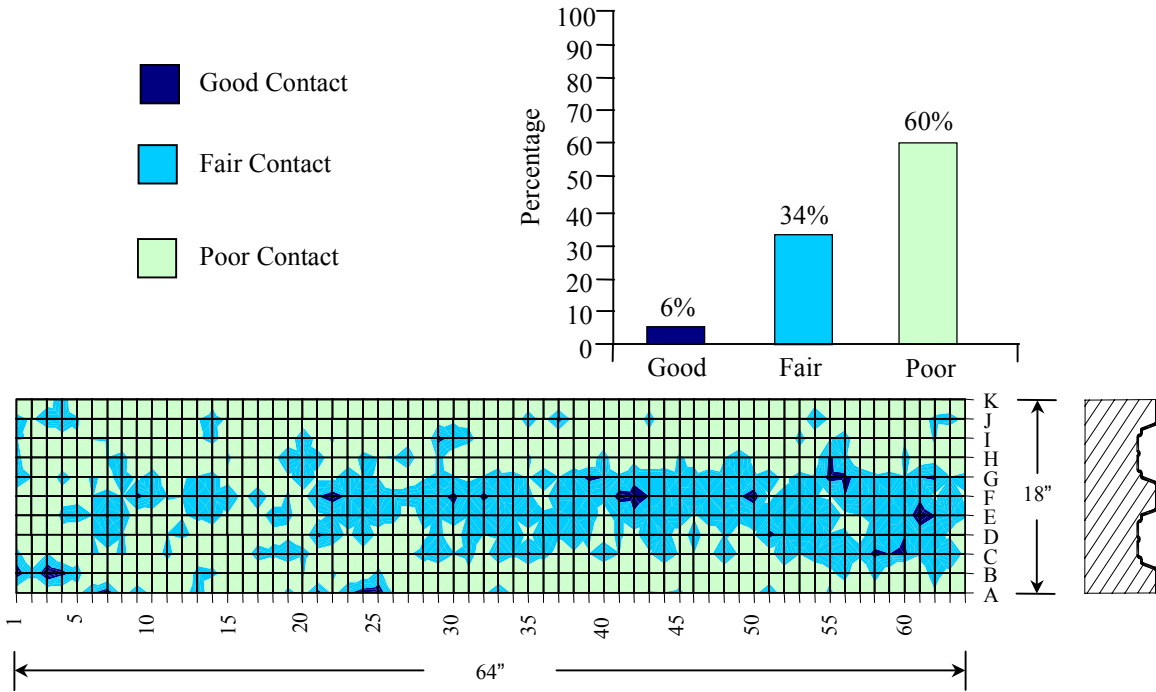
Figure 5.52. Pulse-echo contour map and bar chart for After Cracking for specimen WI-S-10-2

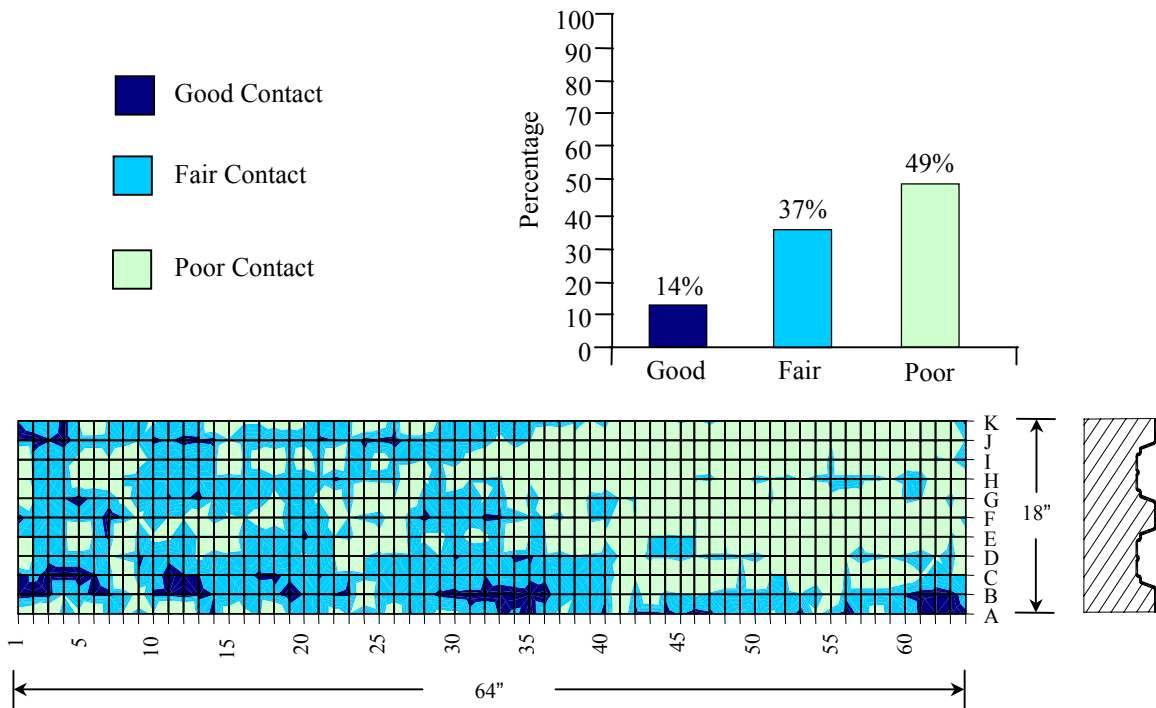
Figure 5.53. Pulse-echo contour map and bar chart for After 1,000 hrs Salt-Water for specimen WI-S-10-2
