LAWRENCE TECHNOLOGICAL UNIVERSITY

**INSPECTION AND DETERIORATION OF BRIDGE DECKS
CONSTRUCTED USING STAY-IN-PLACE METAL FORMS
AND EPOXY-COATED REINFORCEMENT**

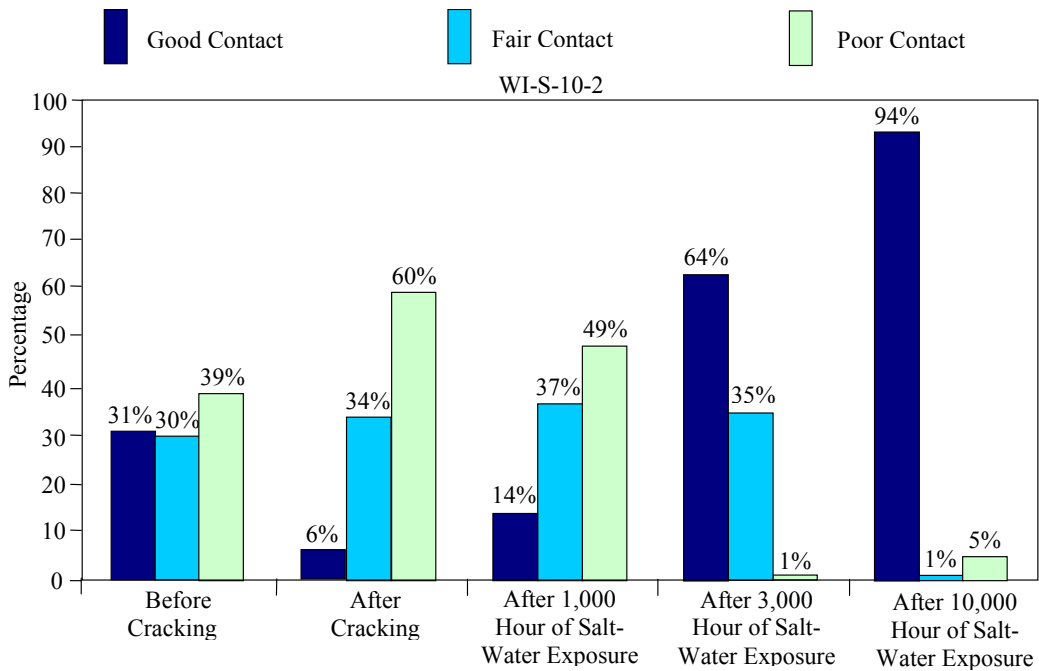
Figure 5.57. Summary of pulse-echo results for specimen WI-S-10-2

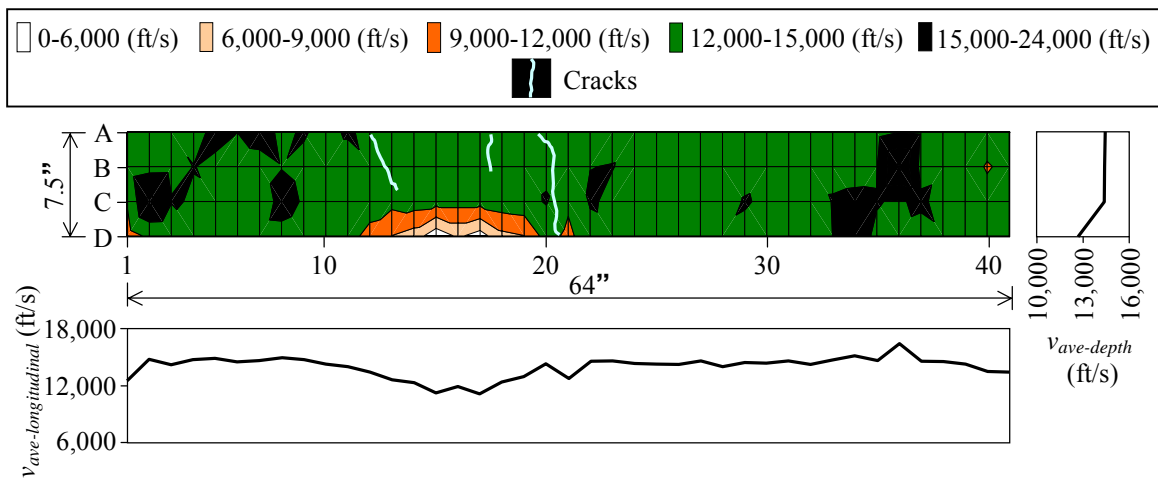
Figure 5.63. Through-transmission test results for slice from specimen WI-F-6-2

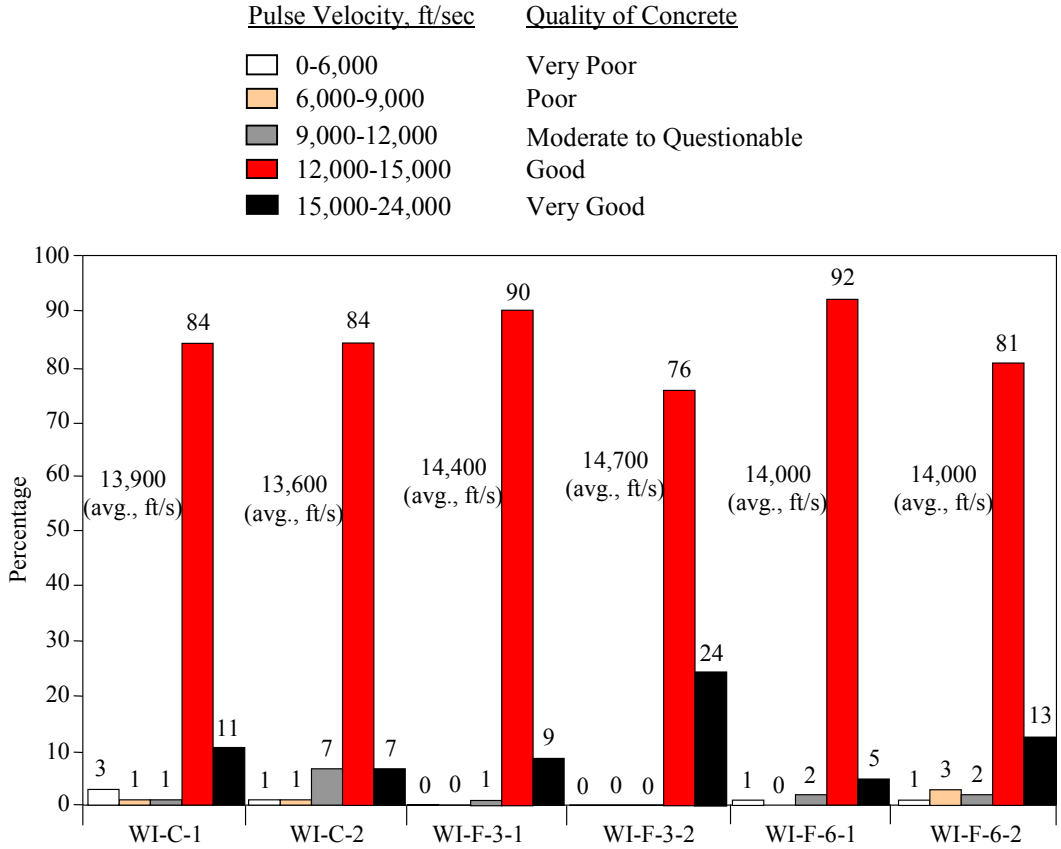
Figure 5.64. Summary of through-transmission test results for control and freeze/thaw exposure specimens with SIPMF

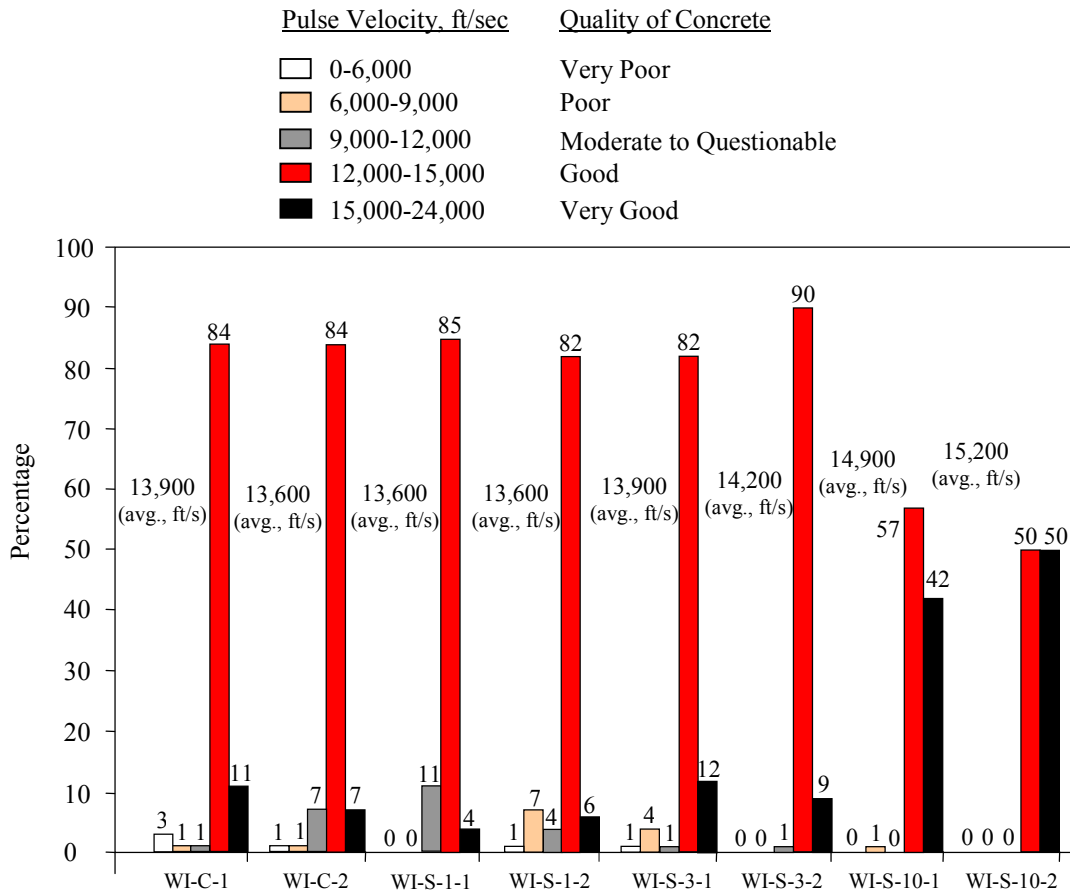
Figure 5.71. Summary of through-transmission test results for control and salt-water exposure specimens with SIPMF

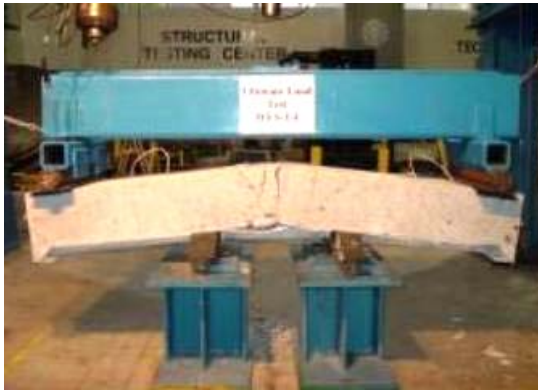
a. Flexural failure mode

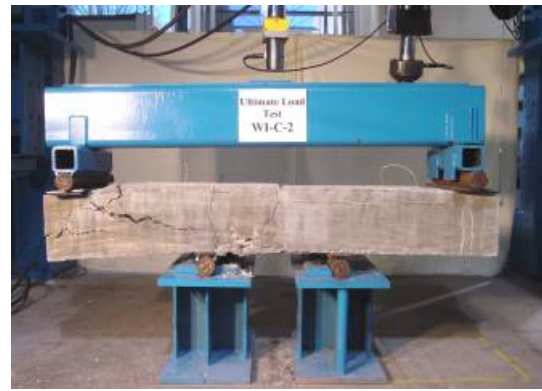
b. Shear failure mode

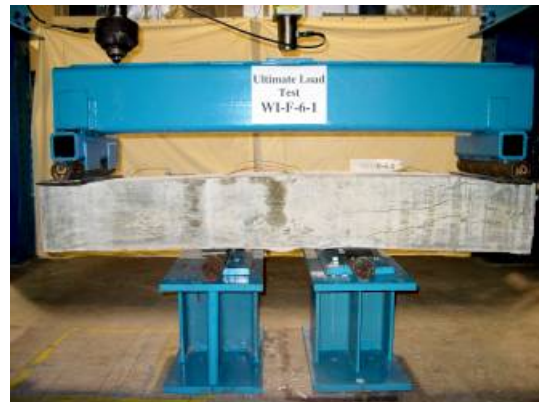
c. Flexural/shear failure mode

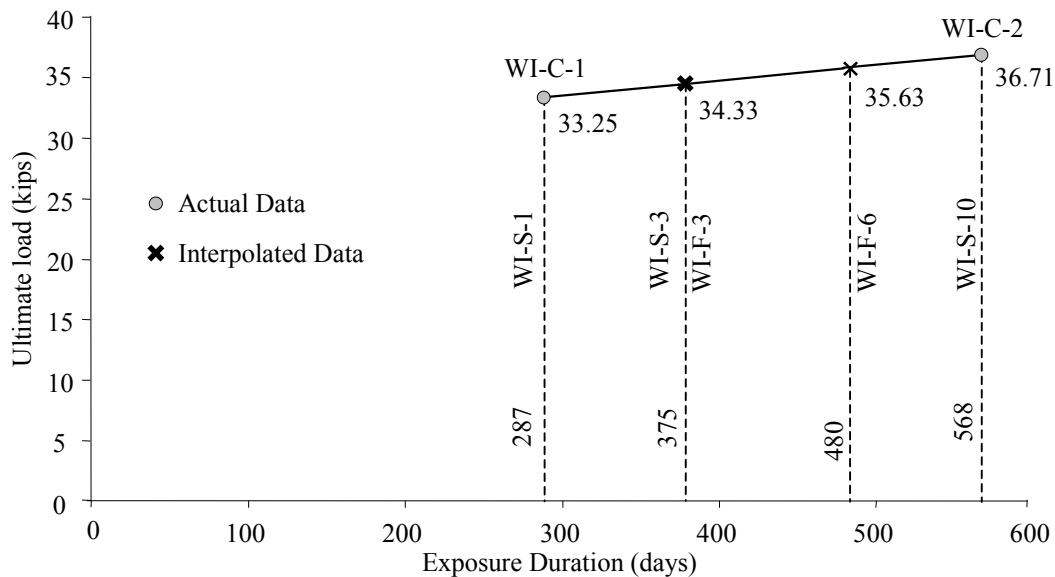
Figure 5.73. Interpolation of control values for freeze/thaw and salt-water specimens with SIPMF

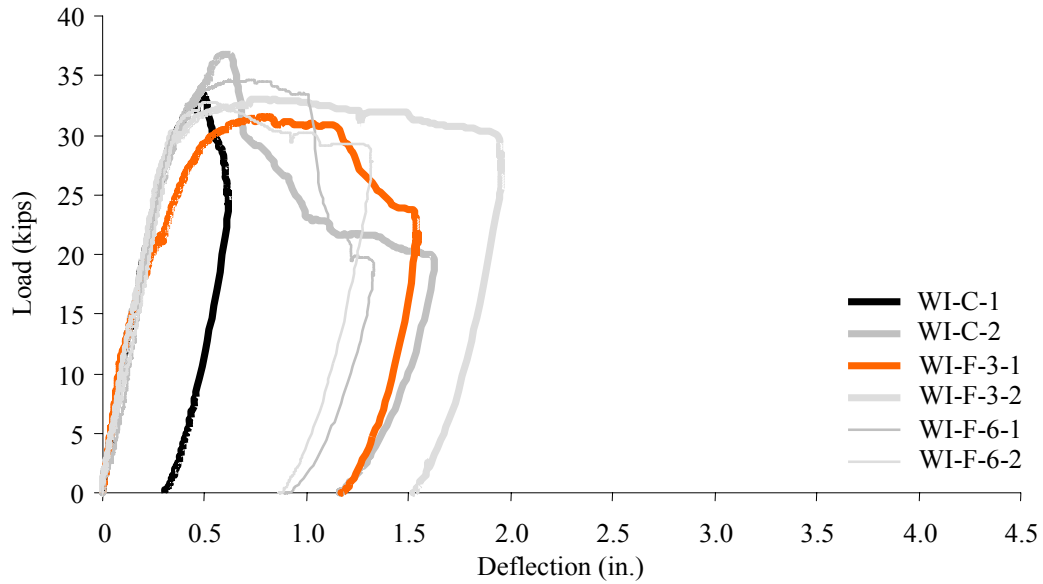
Figure 5.74. Load-deflection curves for ultimate load of control and freeze/thaw exposure specimens with SIPMF

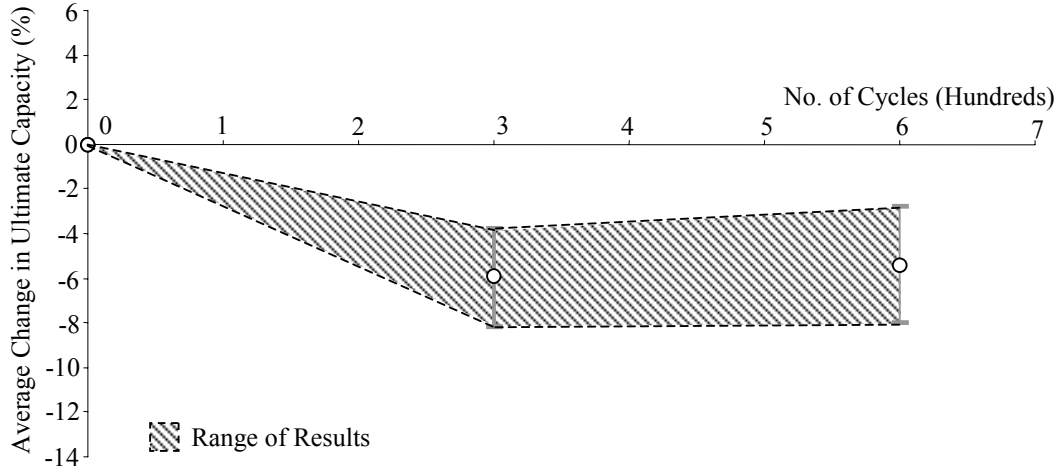
Figure 5.75. Percentage of change in ultimate load carrying capacity for freeze/thaw exposure specimens with SIPMF

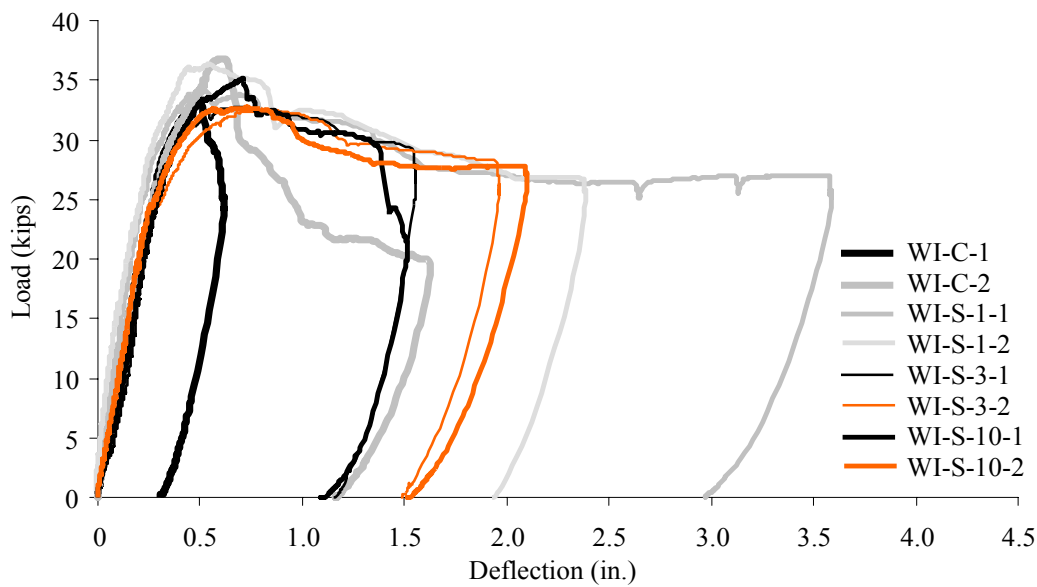
Figure 5.76. Load-deflection curves for ultimate load of 1,000-, 3,000-, 10,000-hour salt-water exposures, and control specimens with SIPMF

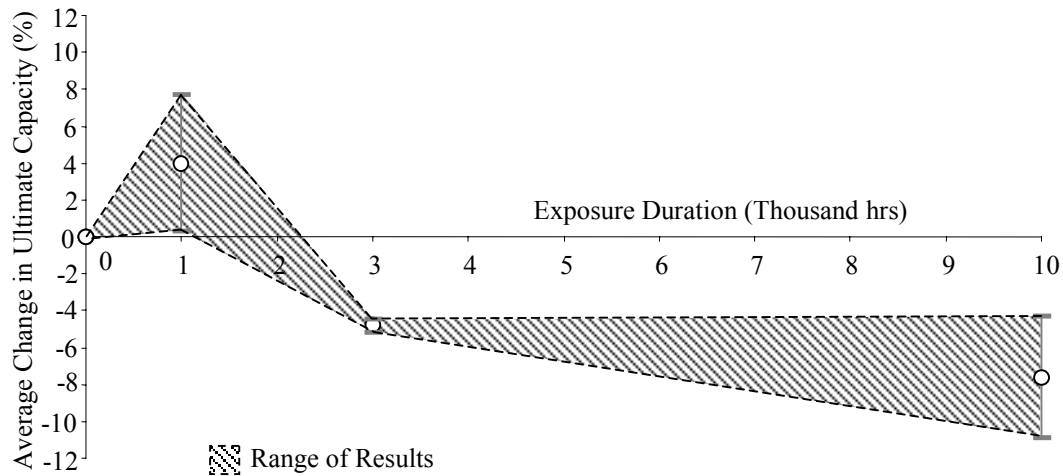
Figure 5.77. Percentage of change in ultimate load carrying capacity for salt-water exposure specimens with SIPMF

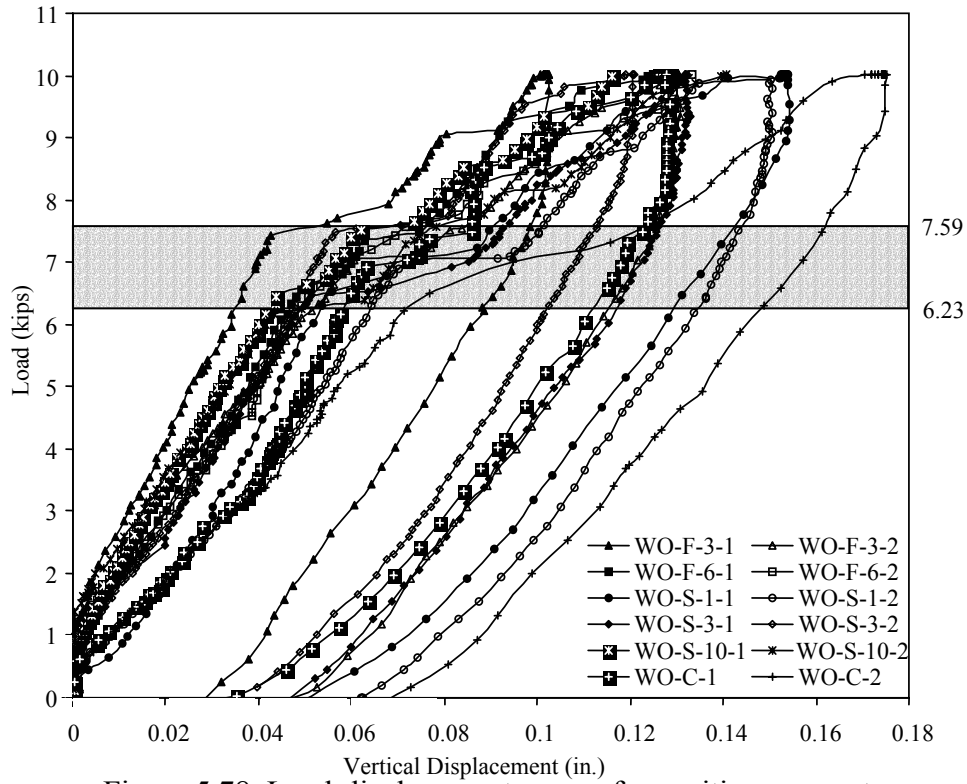
Figure 5.78. Load-displacement curves for positive moment application (bottom cracking) for specimens without SIPMF

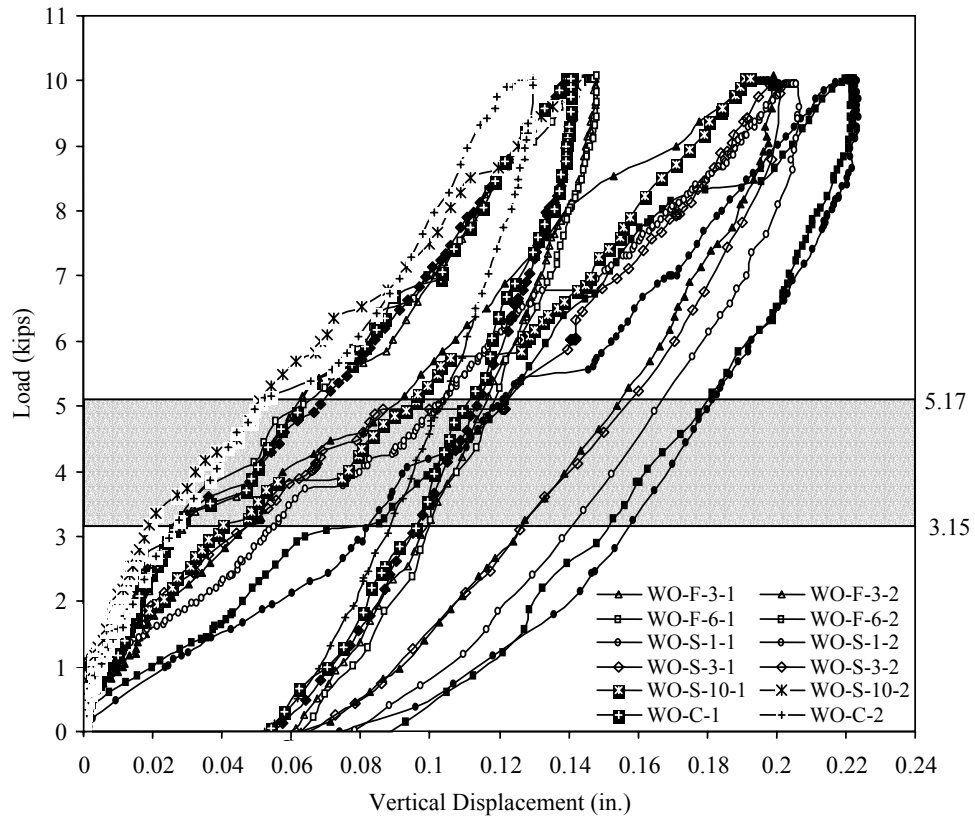
Figure 5.79. Load-displacement curves for negative moment application (top cracking) for specimens without SIPMF

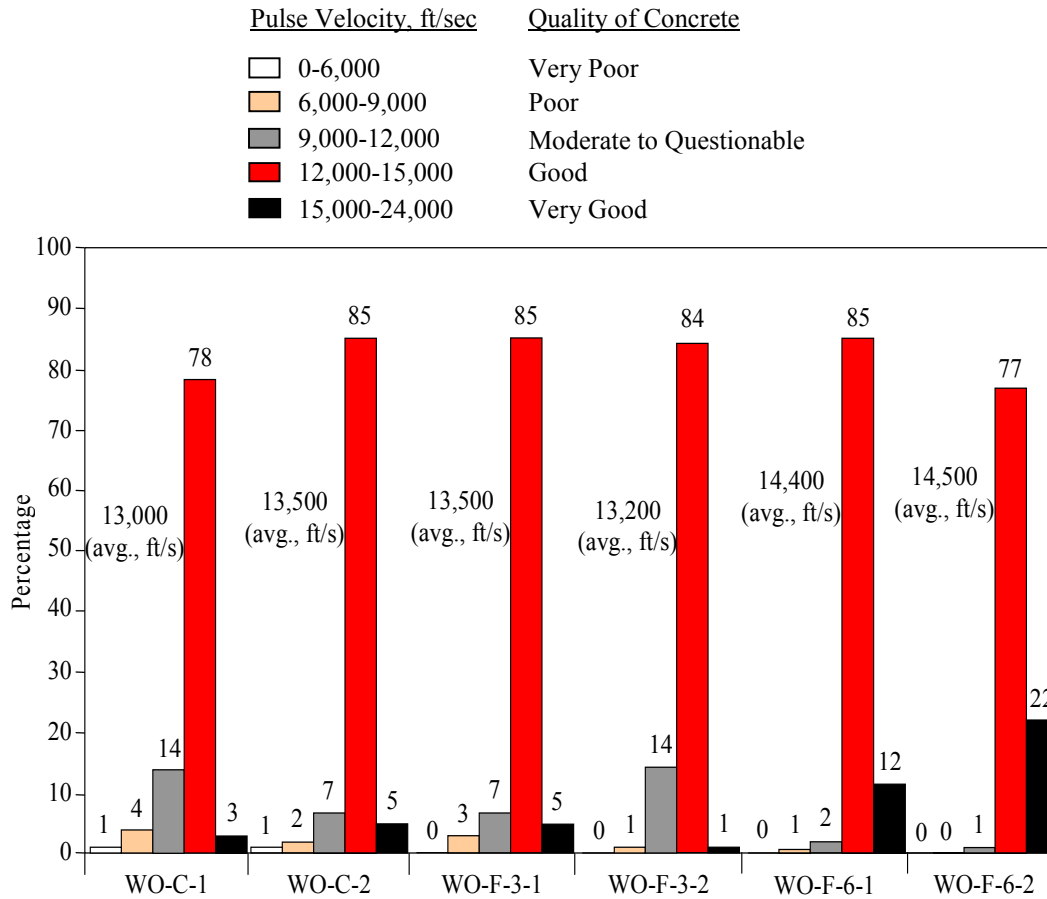
Figure 5.86. Summary of through-transmission test results for control and freeze/thaw specimens without SIPMF

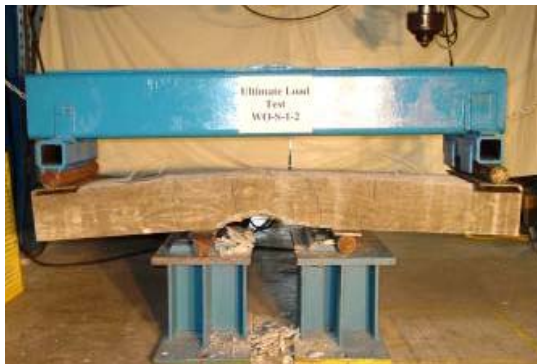
a. Flexural failure mode

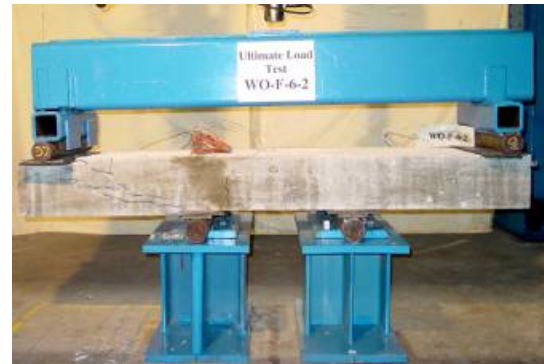
b. Shear failure mode

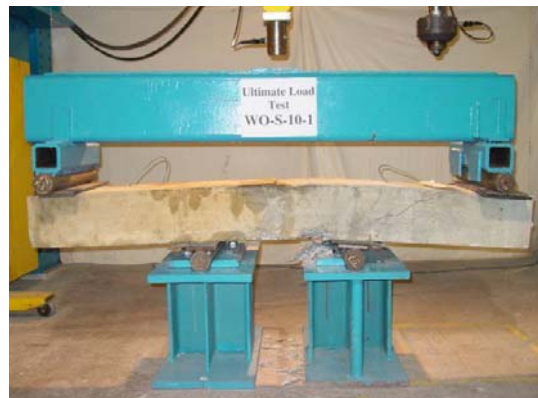
c. Flexural/shear failure mode

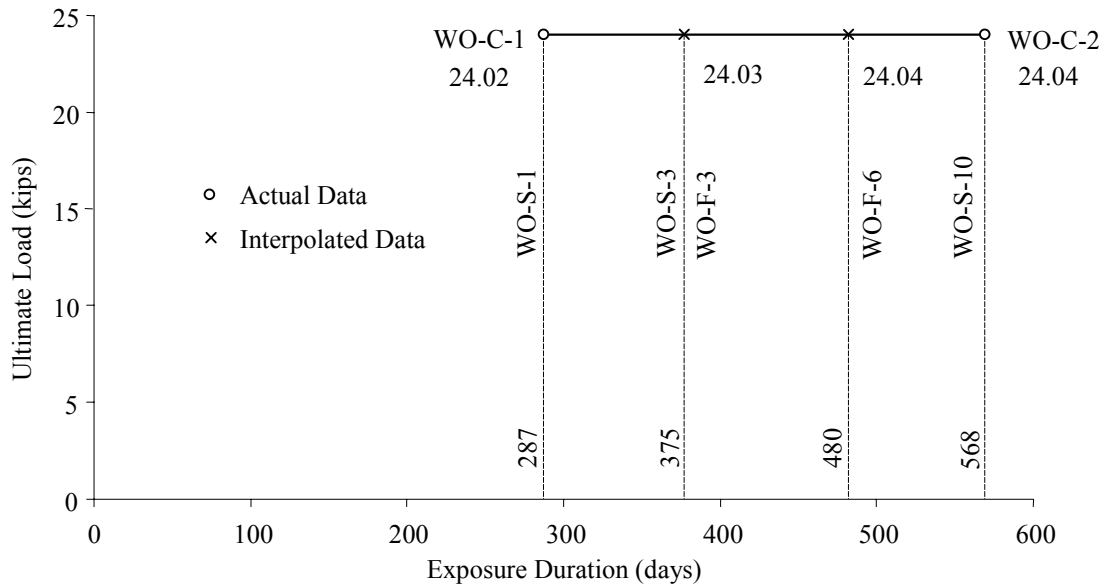
Figure 5.95. Interpolation of control values for freeze/thaw and salt-water specimens without SIPMF

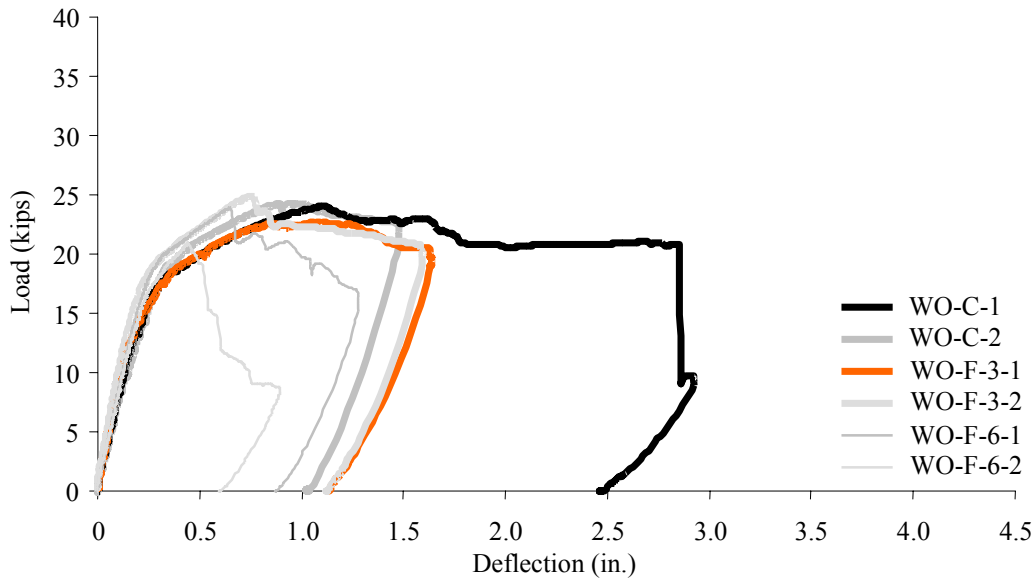
Figure 5.96. Load-deflection curves for ultimate load of 300-, 600-cycle, and control specimens without SIPMF

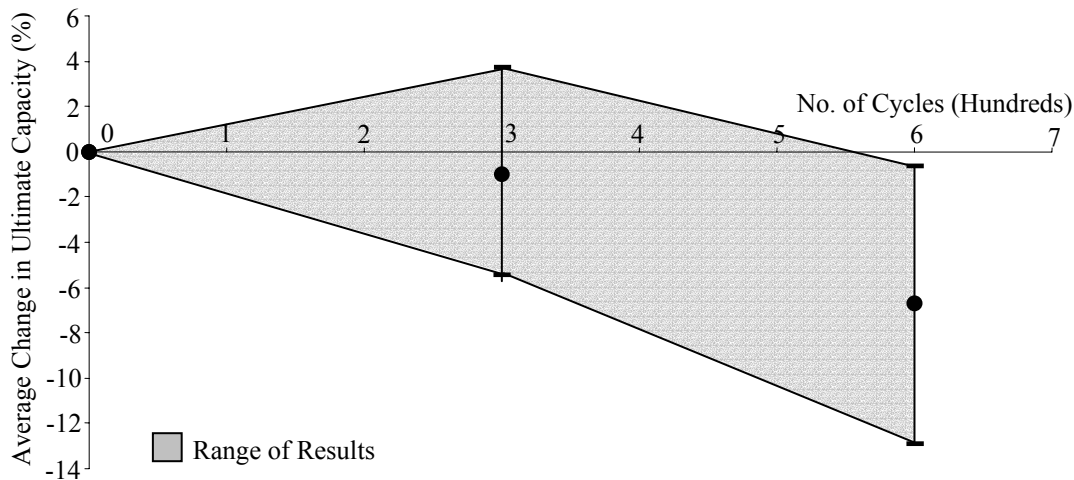
Figure 5.97. Percentage of change in ultimate load carrying capacity for freeze/thaw exposure specimens without SIPMF

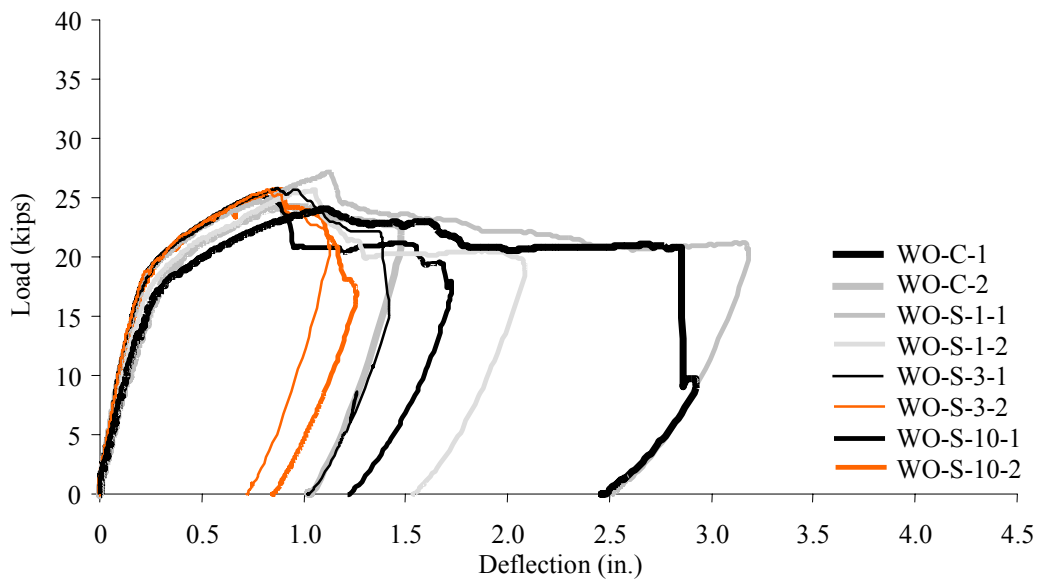
Figure 5.98. Load-deflection curves for ultimate load of 1,000-, 3,000-, 10,000-hour salt-water exposures, and control specimens without SIPMF

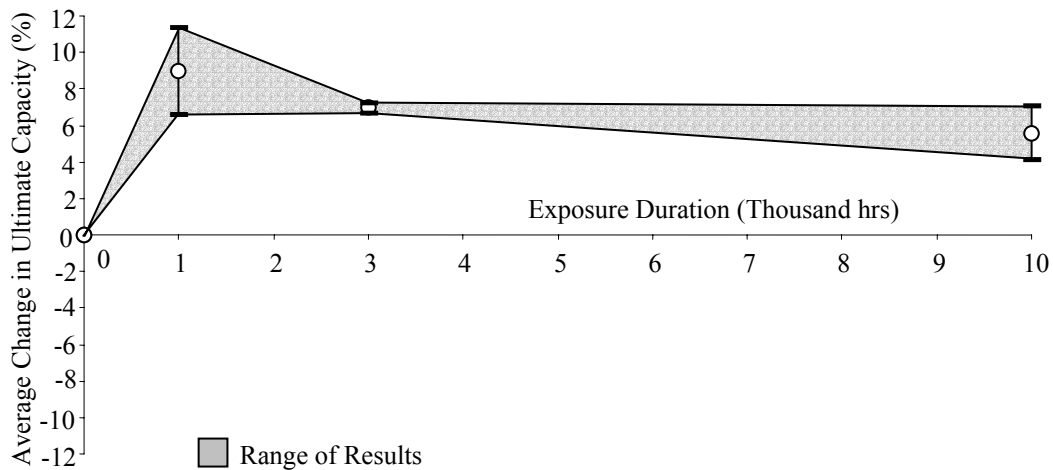
Figure 5.99. Percentage of change in ultimate load carrying capacity for salt-water exposures specimens without SIPMF

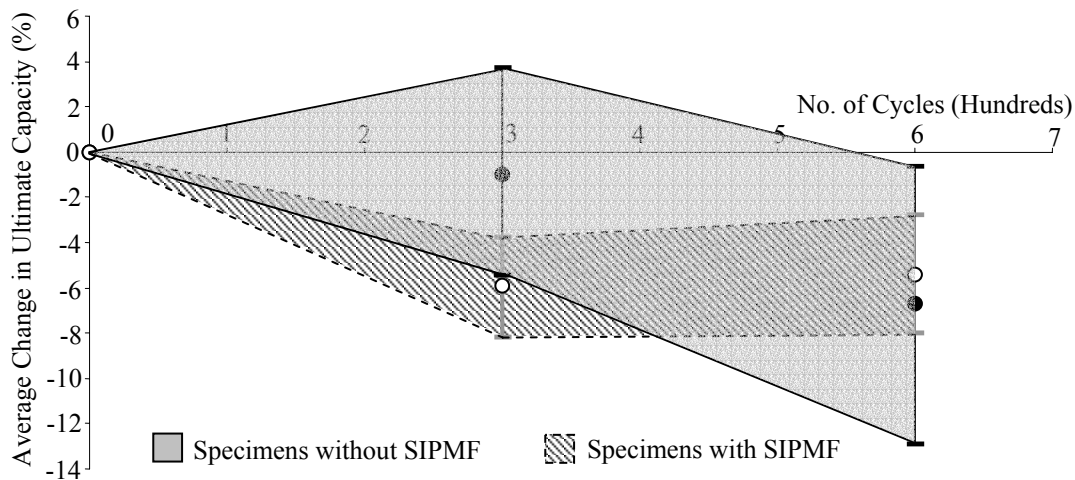
Figure 5.108. Percentage of change in ultimate load carrying capacity for freeze/thaw exposure specimens with and without SIPMF

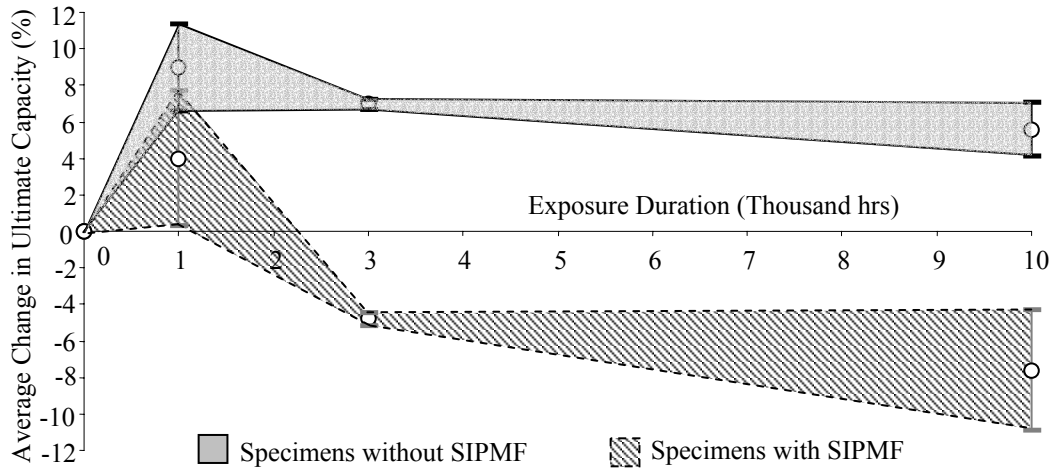
Figure 5.109. Percentage of change in ultimate load carrying capacity for salt-water exposures specimens with and without SIPMF

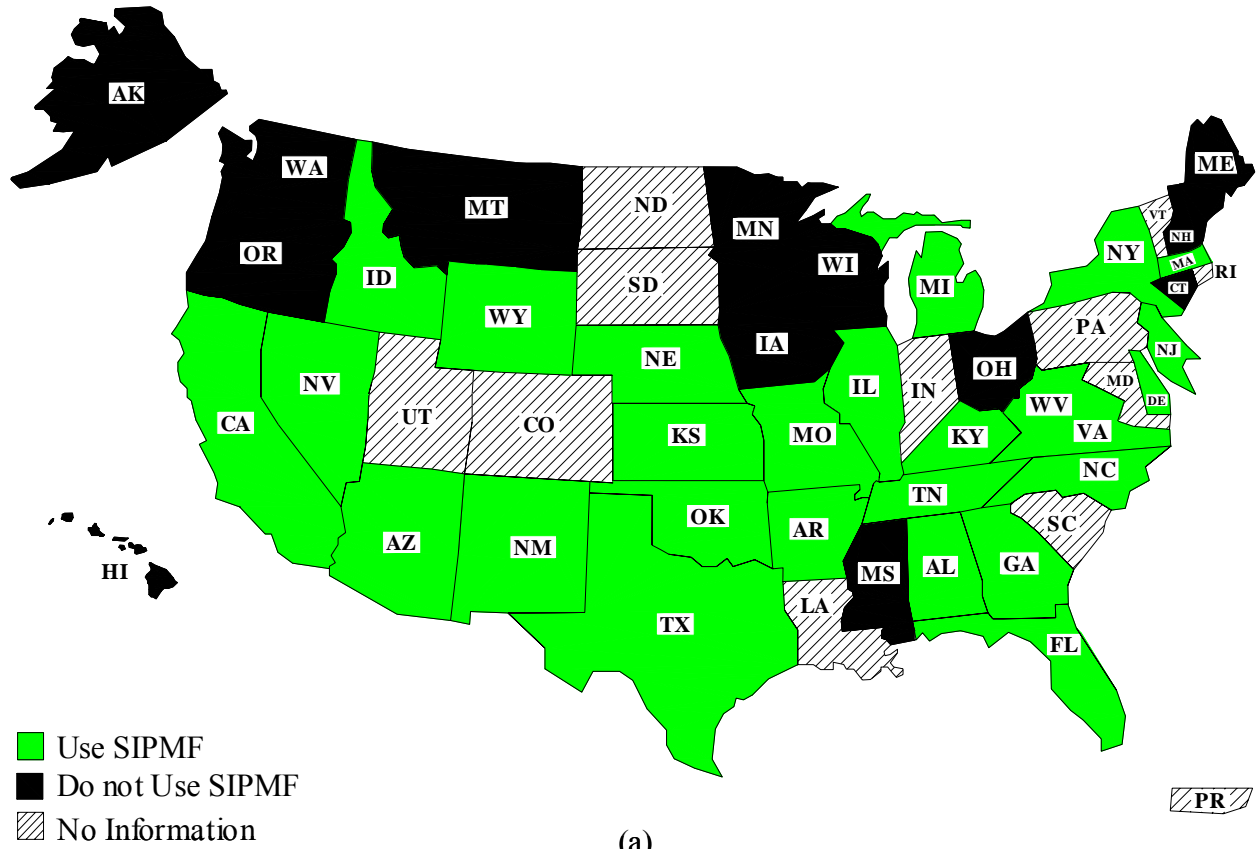
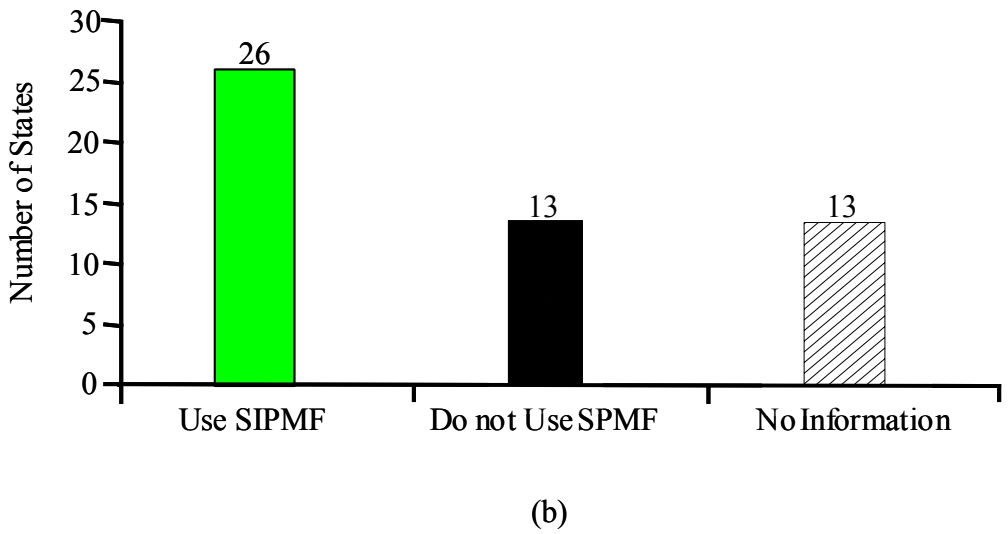
Figure 1. Does your state use SIPMFs for constructing deck slab bridges?

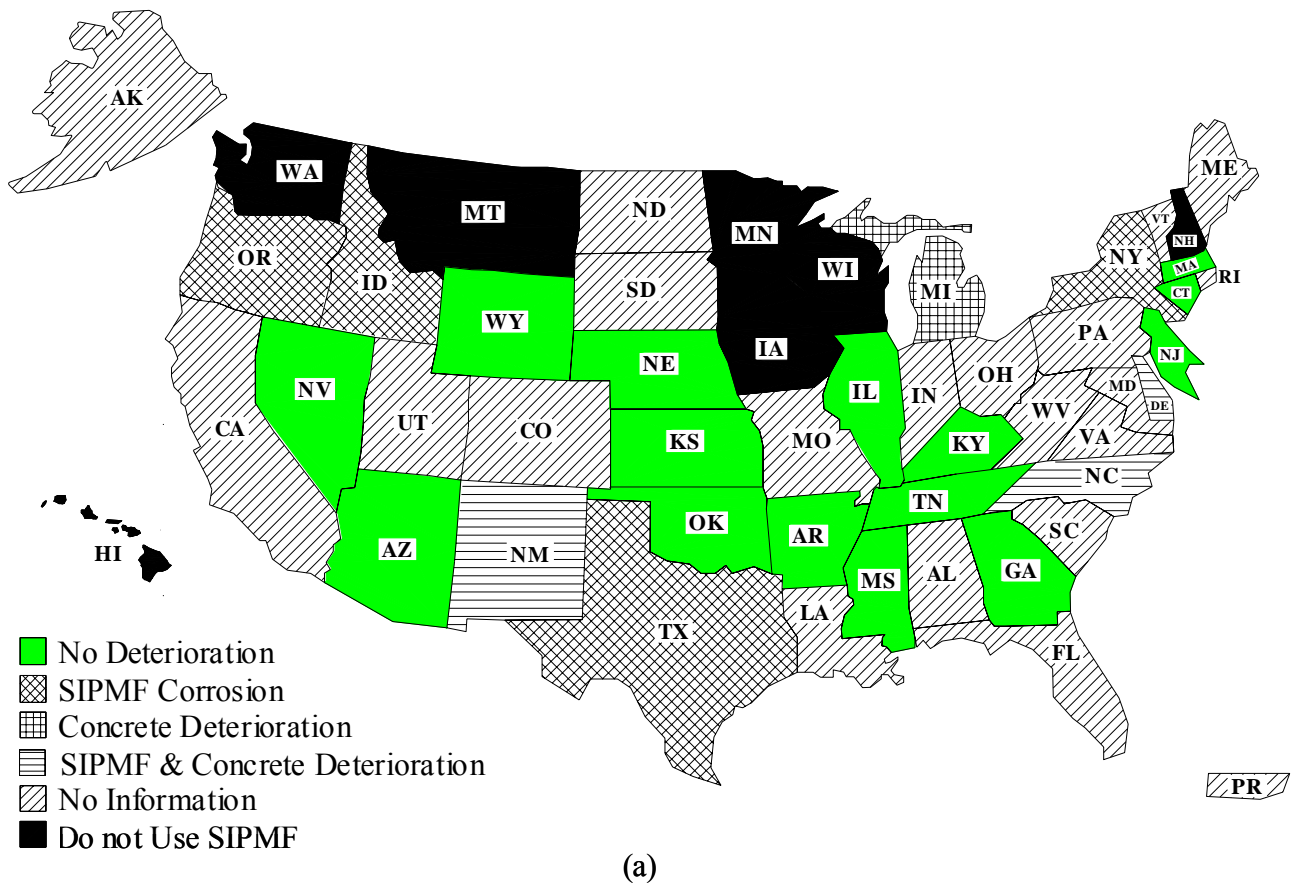
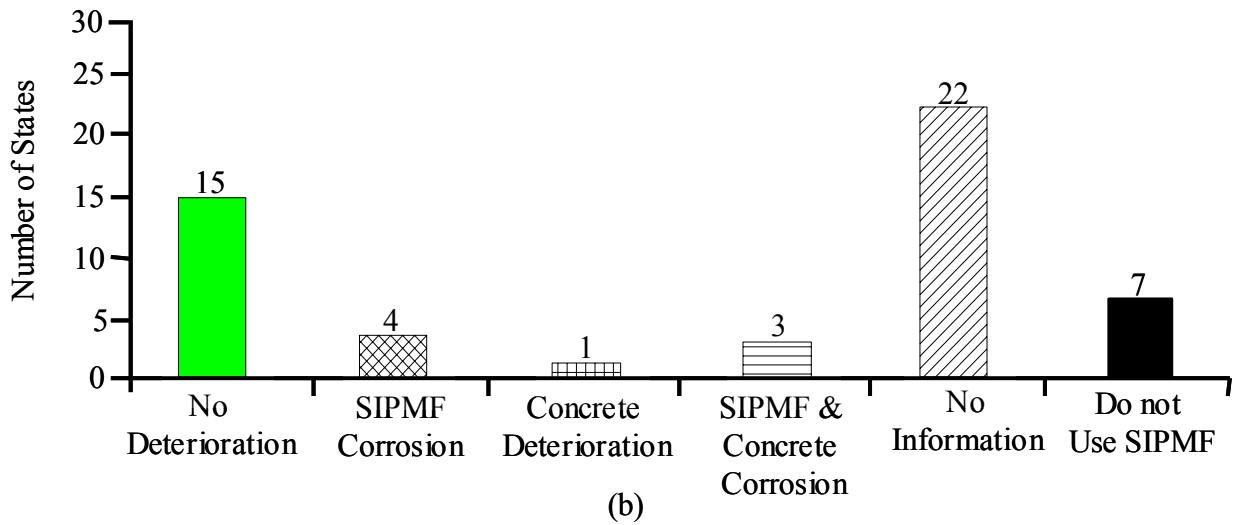
Figure 15. As a result of using SIPMF, what types of deterioration of bridge decks have been observed?

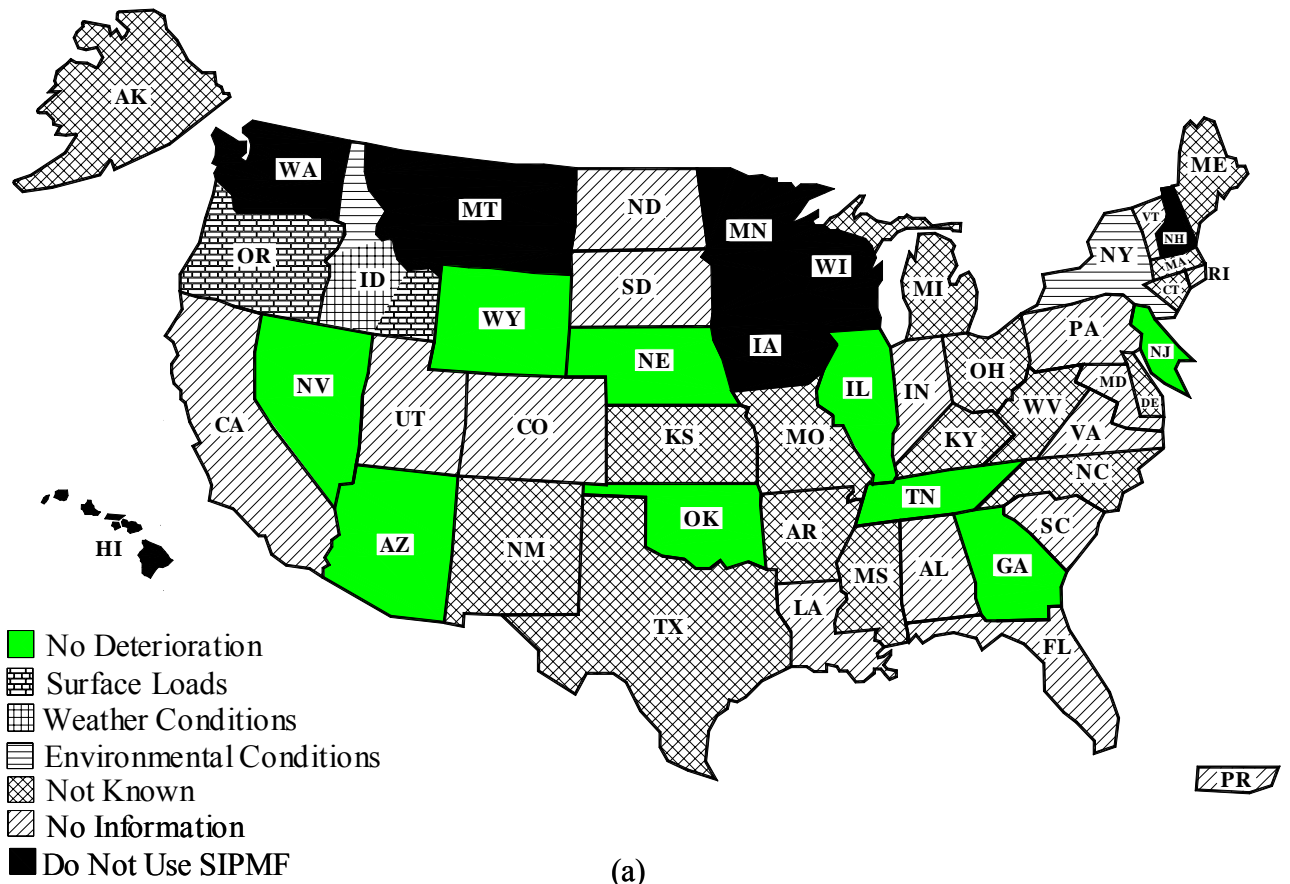
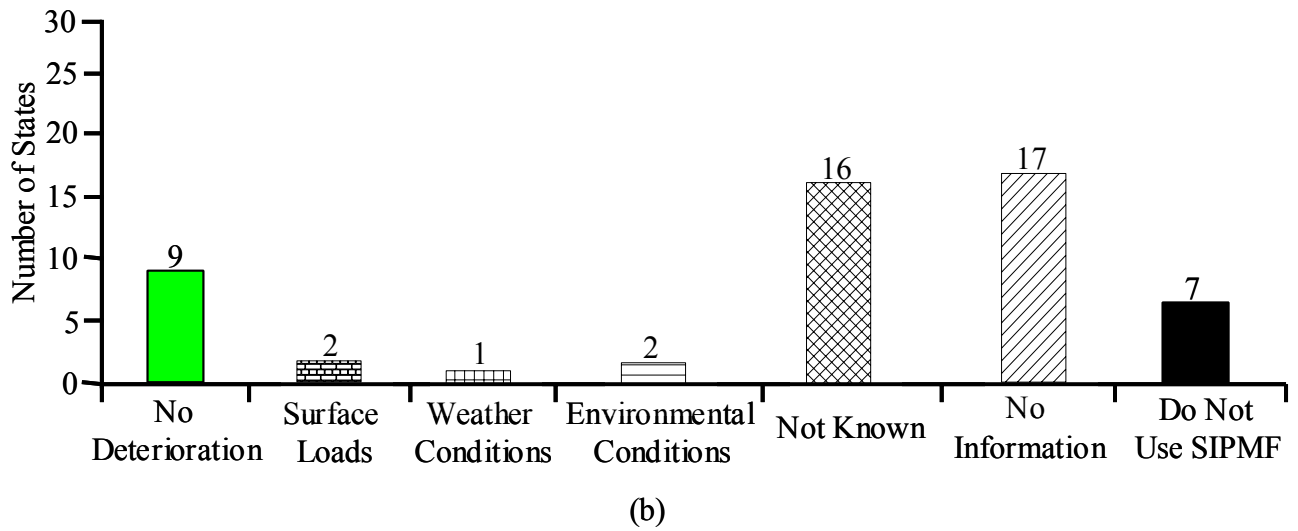
Figure 16. What is the cause of the bridge deck deteriorations when constructed using SIPMF?

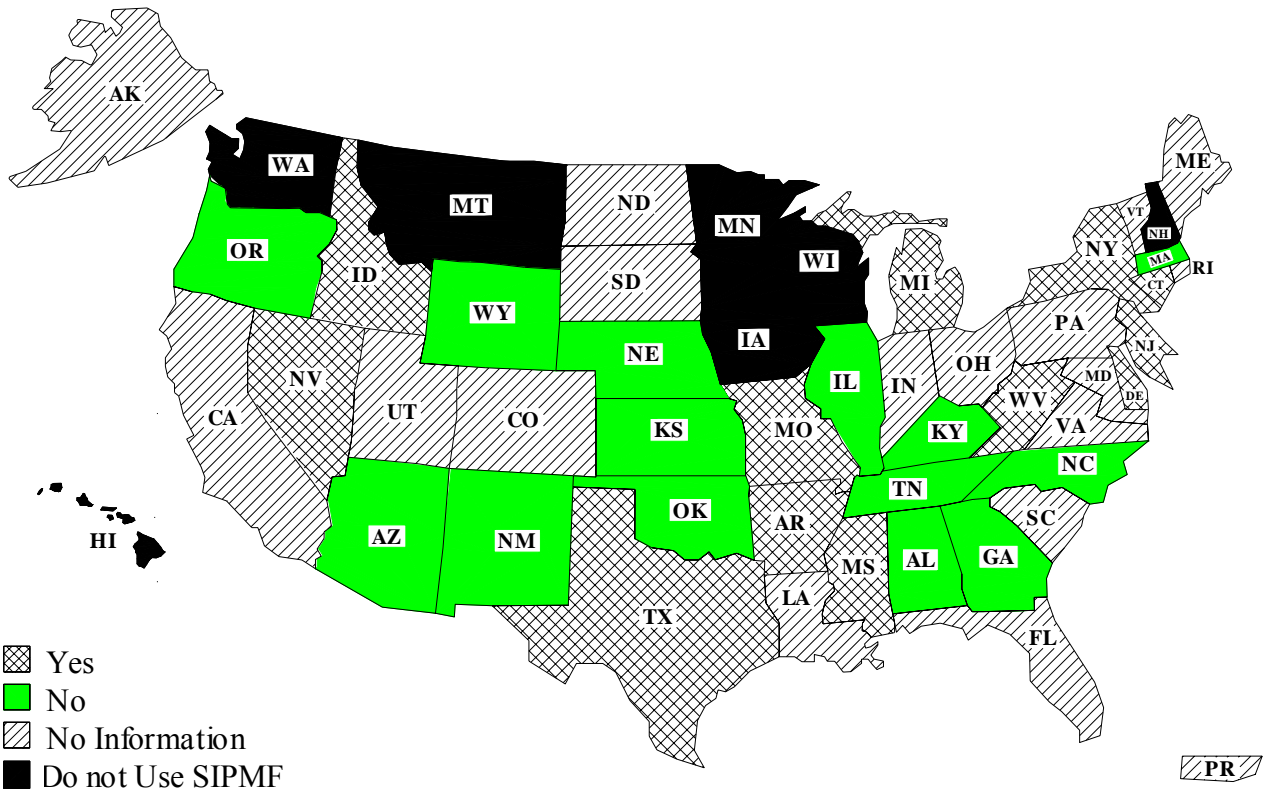
Figure 17. What is the most common type of deck cracking observed in SIPMF bridge decks?

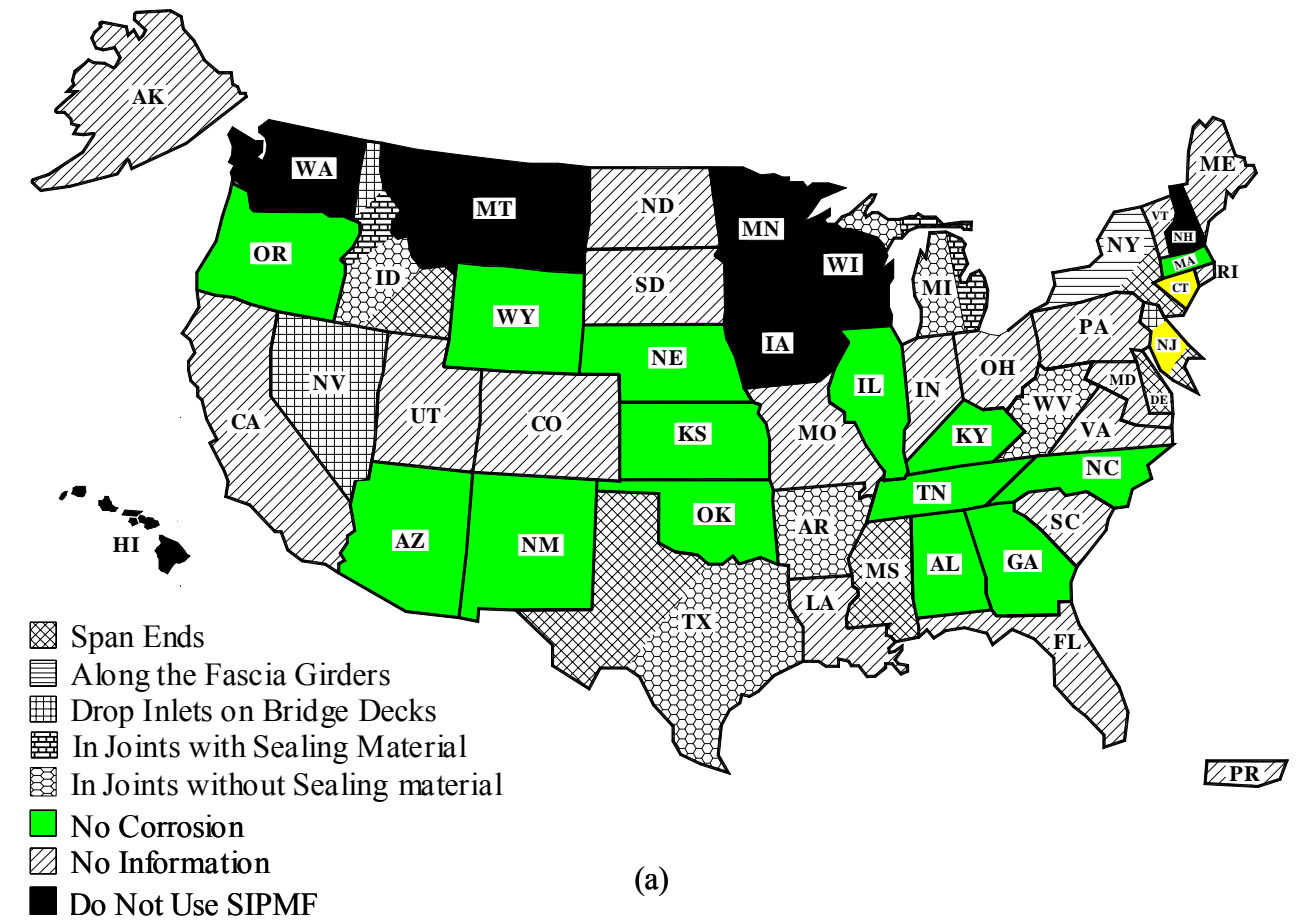
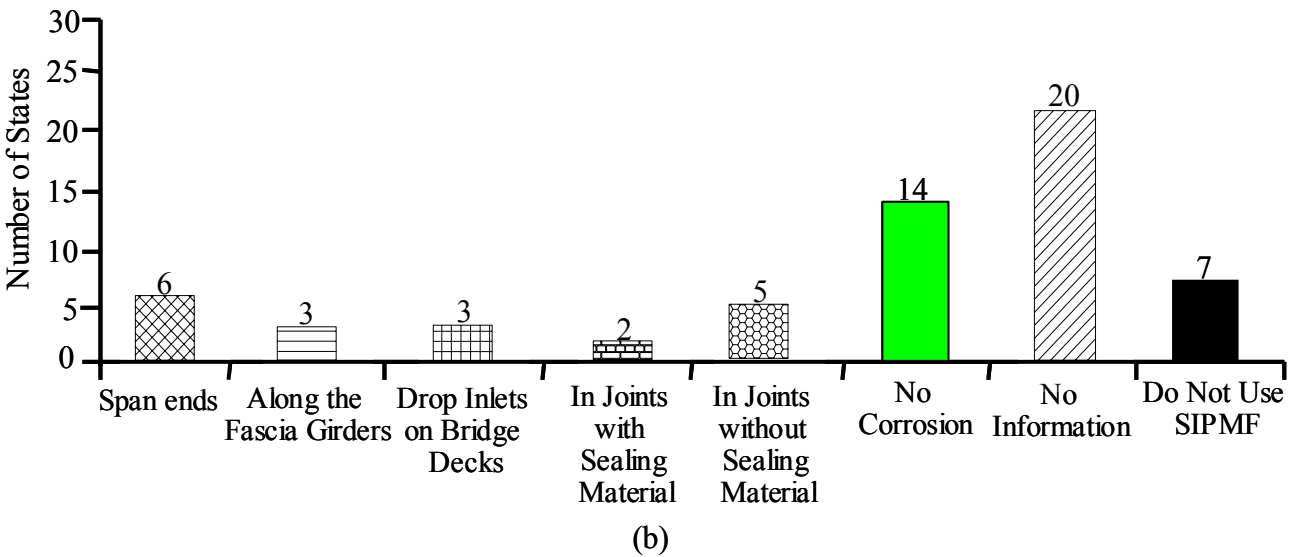
Figure 19. Where on the bridge was the most extensive corrosion of SIPMF concentrated?
