LAWRENCE TECHNOLOGICAL UNIVERSITY

**INSPECTION AND DETERIORATION OF BRIDGE DECKS
CONSTRUCTED USING STAY-IN-PLACE METAL FORMS
AND EPOXY-COATED REINFORCEMENT**

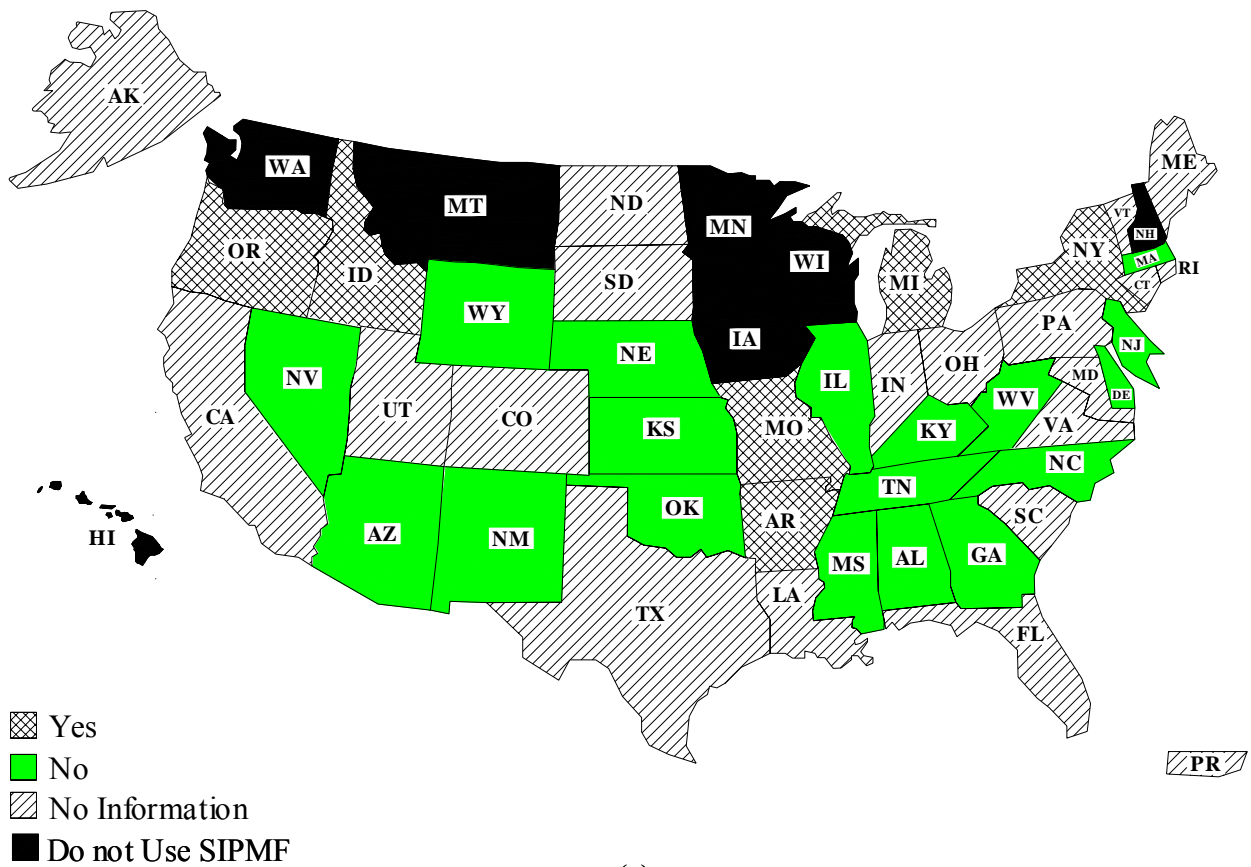
Figure 19. Where on the bridge was the most extensive corrosion of SIPMF concentrated?

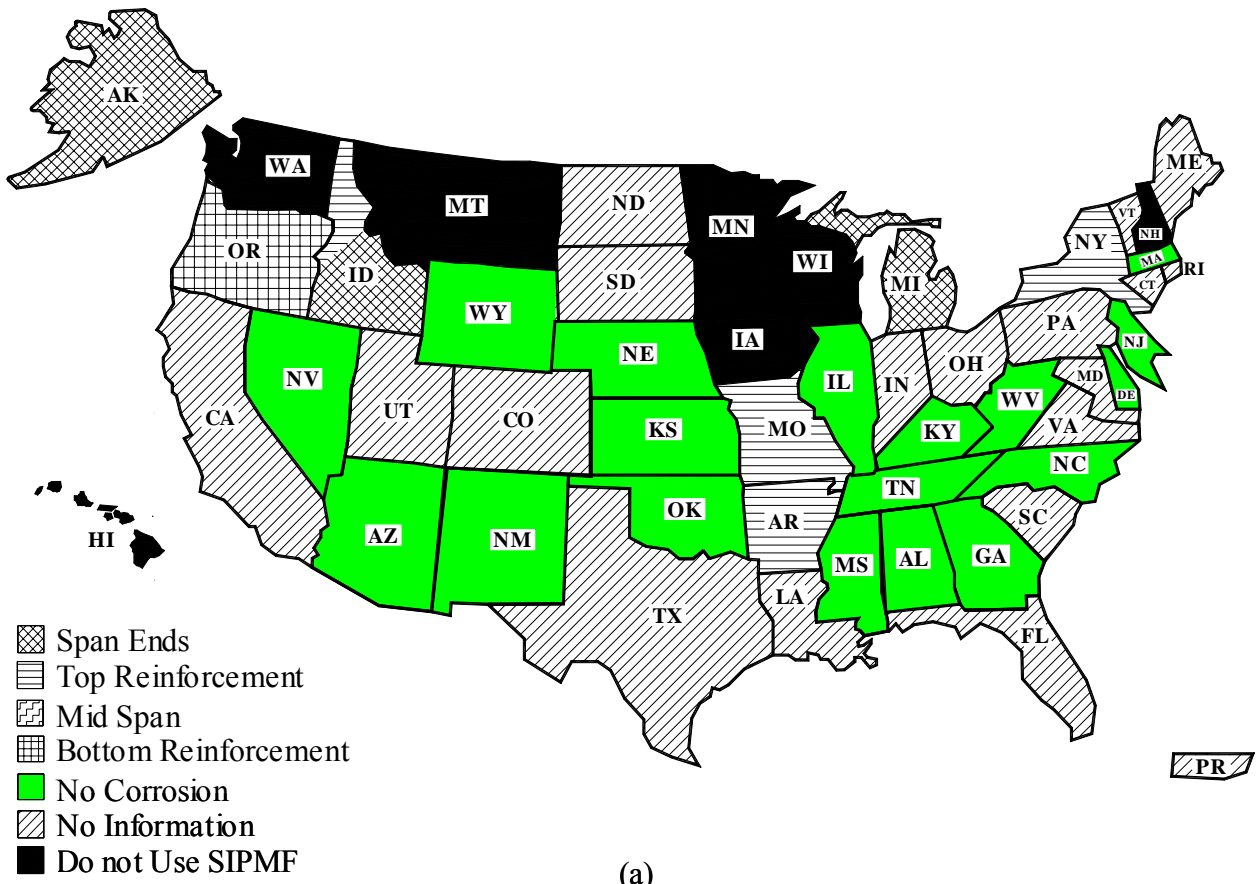
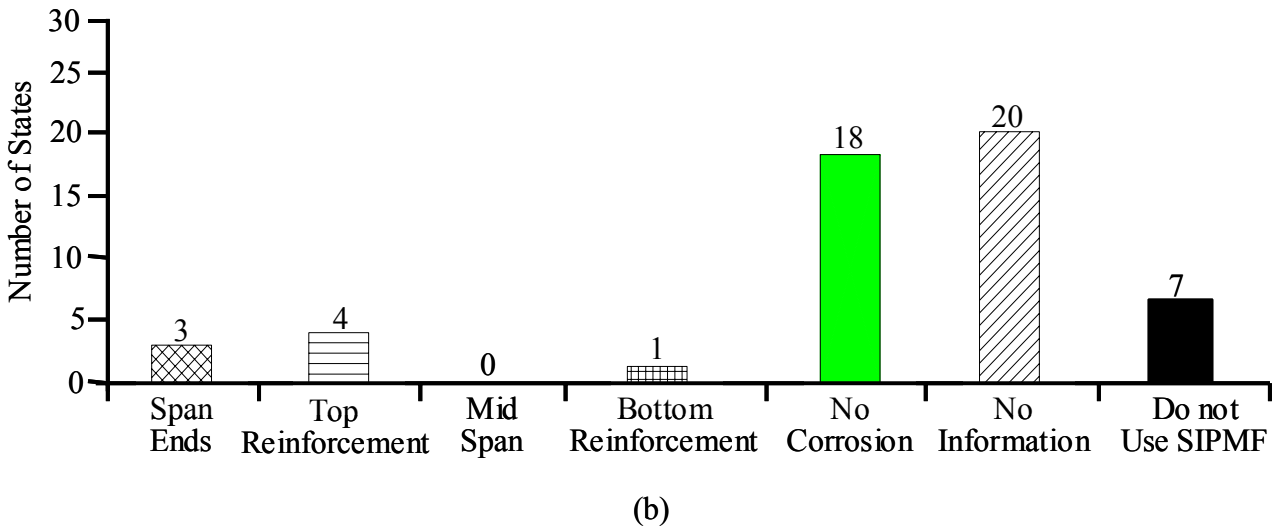
Figure 21. Where on the bridge was the most extensive corrosion of deck reinforcement concentrated?

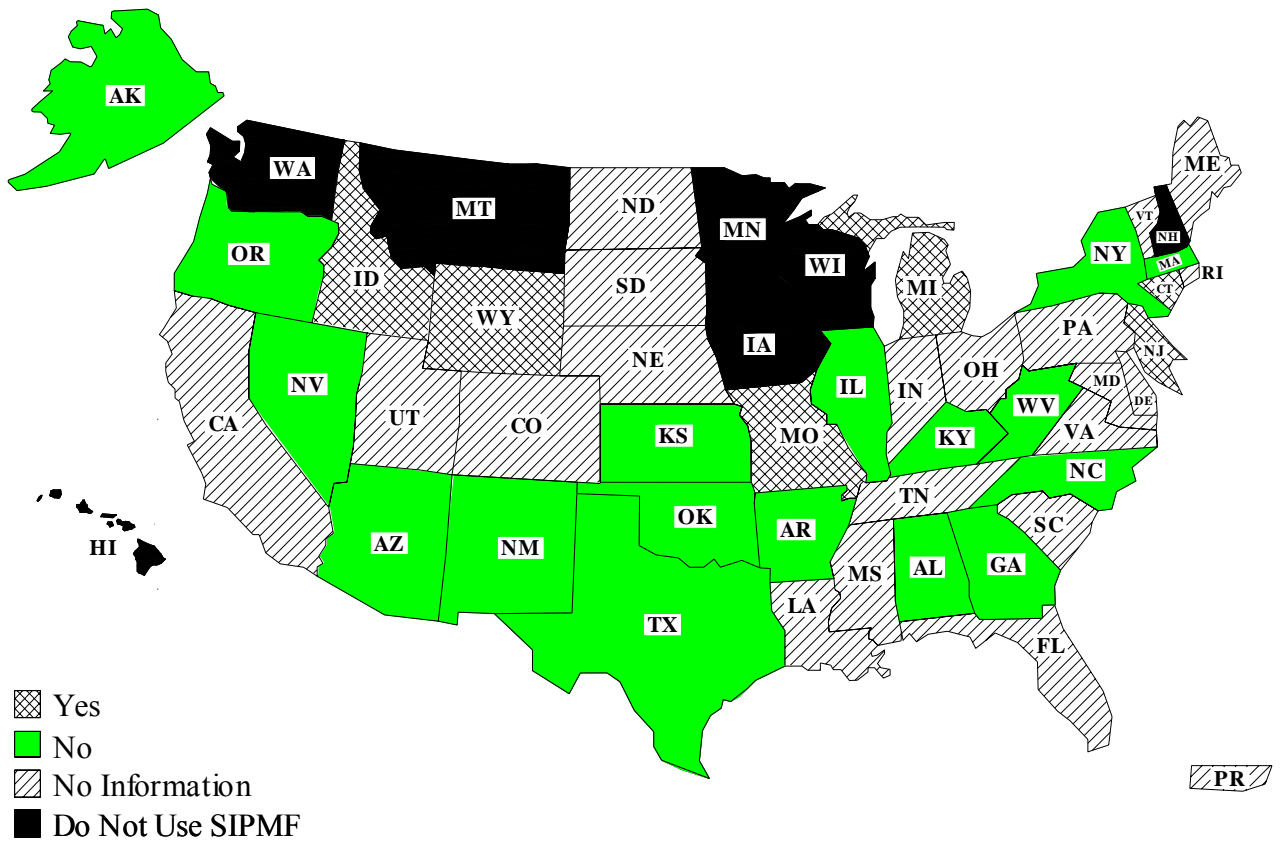
Figure 22. After how long did the extensive corrosion occur?

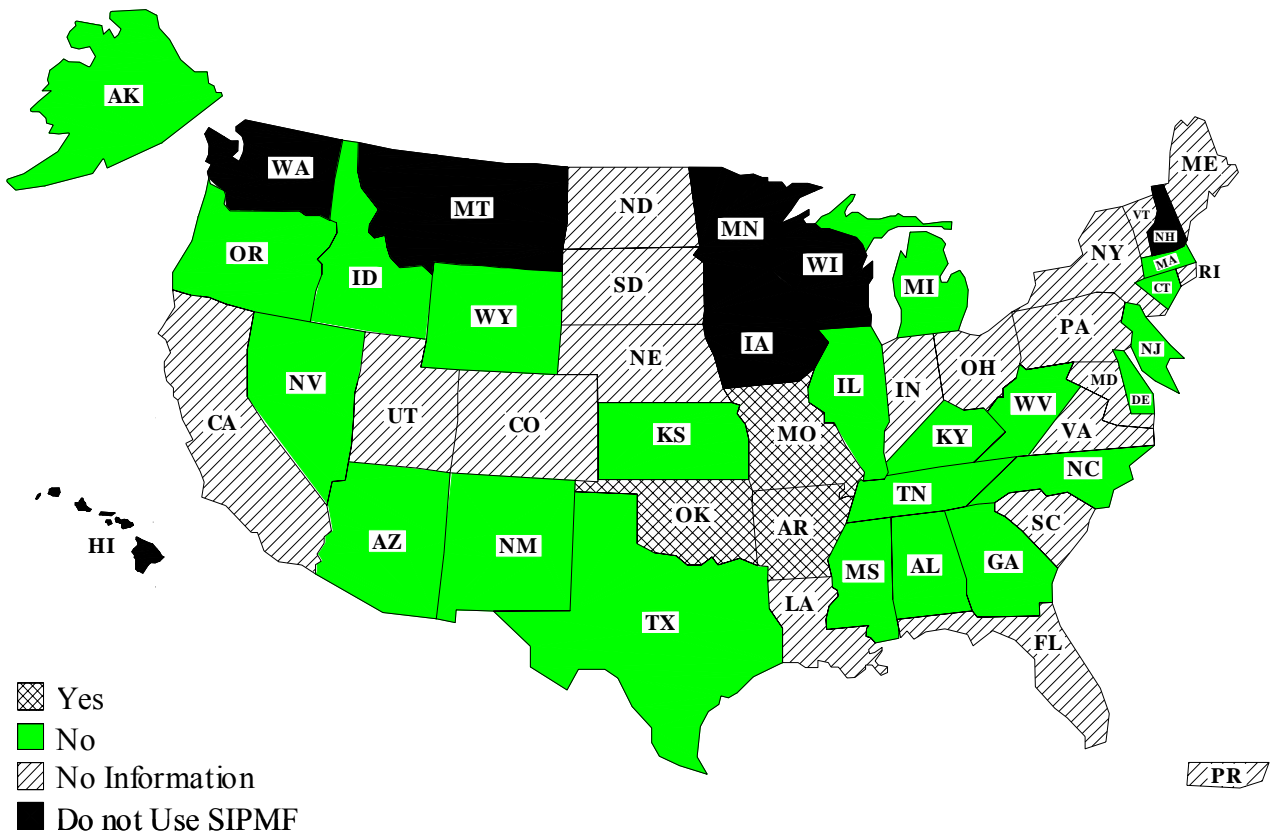
Figure 23. Has any effect of joint leakage on the SIPMF been observed?

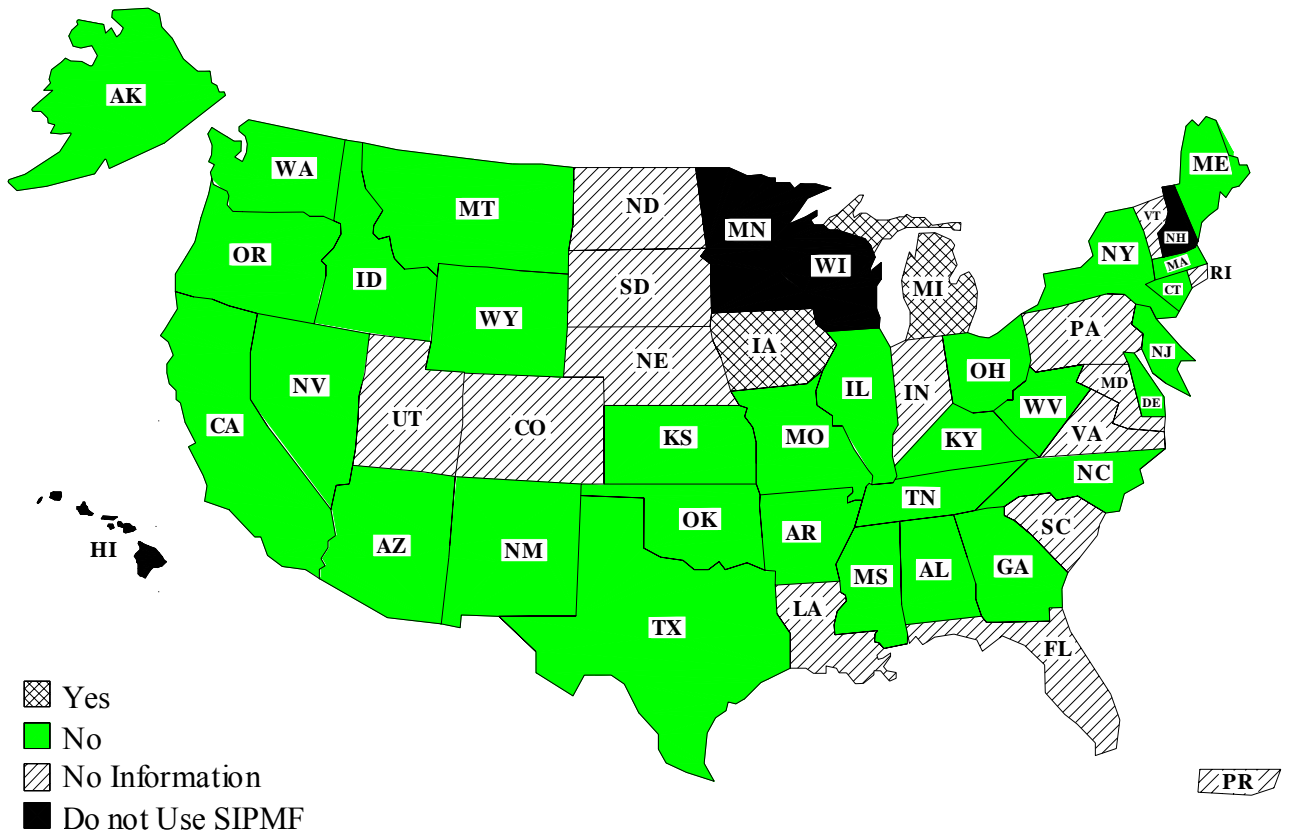
Figure 24. Were there any problems observed a direct result of using SIPMF?
