EVALUATION OF THE LATERAL STABILITY OF  
POSTS FOR DEEP BEAM GUARD RAIL

Highway Research Project  
55 F-39

Research Laboratory  
Testing and Research Division  
Report No. 230  
June 23, 1955

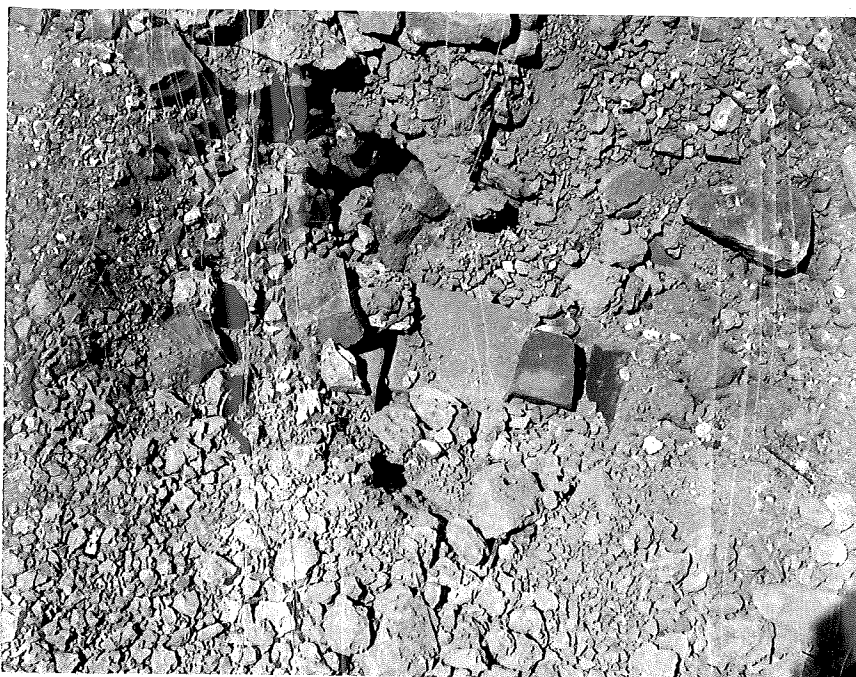
A preliminary investigation of test sites was made by Frank Skebensky, Road Project Engineer. For convenience in obtaining construction equipment, it was necessary to conduct the work in Detroit, Michigan on the right-of-way for the Edsel Ford Expressway near St. Aubin. A choice of two sites was possible, but both of these were underlain with assorted debris. As a last resort, it was decided to use the best of these two sites, the northwest corner of Wideman St. and Harper Avenue, and remove the top several feet of material in the hope that more uniform material would be encountered below this level. Even though several feet of material were removed before the posts were placed, the soil profile still consisted of approximately three feet of a mixture of cinders, broken brick, broken concrete and miscellaneous industrial debris, underlain by approximately two feet of firm clay.

Figure 3. Picture showing general condition of upper soil layer.

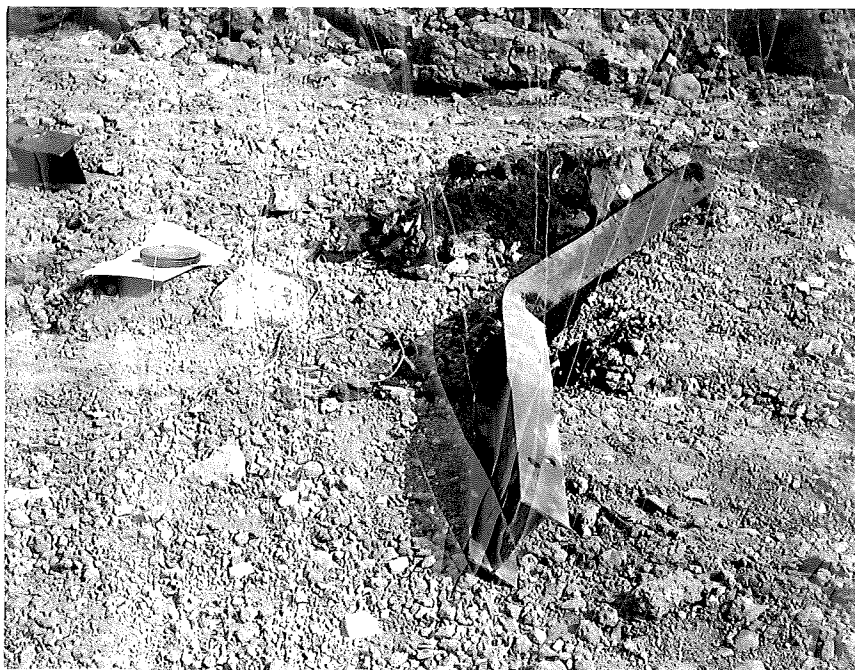
<u>POST NO.</u>	<u>POST TYPE</u>	<u>EMBEDMENT LENGTH</u>	<u>MAX. TRANSVERSE LOAD APPLIED 1'-6" ABOVE GROUND LINE</u>	<u>METHOD OF FAILURE</u>
1	steel	3'-7 $\frac{1}{2}$ "	5700#	Pulled out of soil (no structural damage)
2	steel	4'-7 $\frac{1}{2}$ "	7400#	Compression flange buckled, 1.4' below G.L.
3	oak	4'-11"	15800#	Pulled out of soil (no structural damage)
4	steel	3'-7 $\frac{1}{2}$ "	9900#	Pulled out of soil (no structural damage)
5	steel	4'-7 1/8"	10600#	Compression flange buckled 0.8' below G.L.
6	oak	4'-10 3/8"	13800#	Tensile failure (knot) 1.2' below G.L.
7	steel	3'-7 $\frac{1}{4}$ "	9100#	Compression flange buckled, 0.9' below G.L.
8	steel	4'-7"	11900#	Compression flange buckled, 0.7' below G.L.
9	oak	4'-10 $\frac{1}{2}$ "	18800#	Pulled out of soil (no structural damage)
10	steel	3'-7"	11100#	Compression flange buckled, 1.0' below G.L.
11	steel	4'-7 $\frac{1}{4}$ "	10500#	Compression flange buckled 0.7' below G.L.

Figure 4. Picture showing typical failure condition of steel post.
