STATE HIGHWAY DEPARTMENT

December 20, 1962

Subject: Trenching for Expansion Joints. Research Project R-39 F-7(14). Report No. R-407.

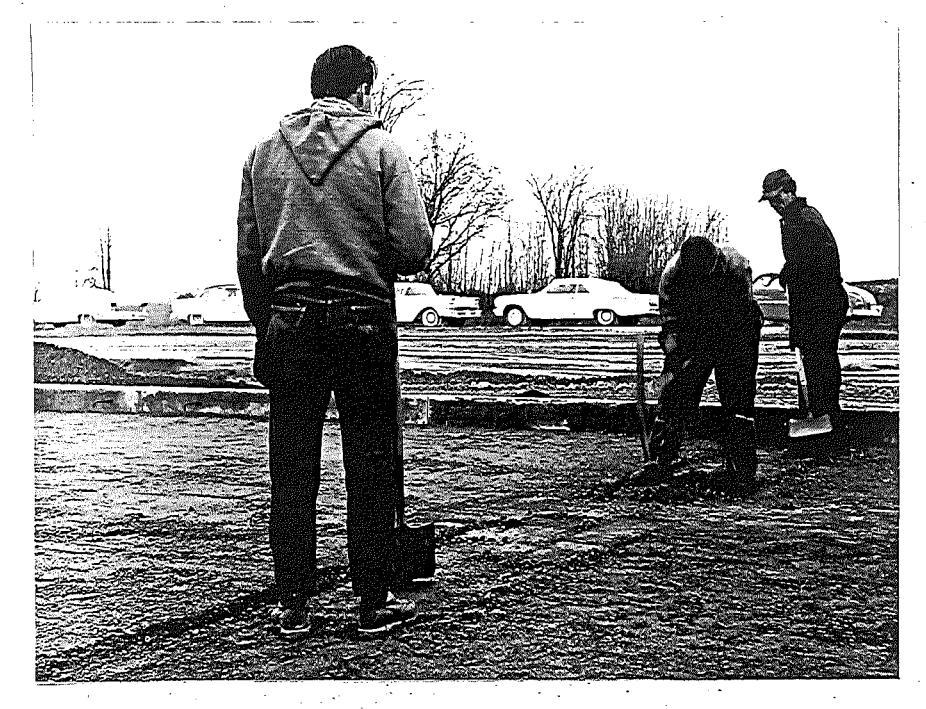
The current practice of offsetting the crown to the center of the passing lane for Interstate highways has caused problems, in that the filler and basket in the passing lane rock on the high point of the crown in the subbase, and the filler is too close to the surface either at the center of the roadway or at the outside edge of the passing lane. The remedy has been to dig out about an inch of the subbase under the entire basket assembly (Fig. 1), which lowers the high point of the filler sufficiently, but leaves too deep a groove elsewhere. Trenching also lowers the position of the dowel bars about 1 in. below their proper location.

Figure 1 (upper left). Trenching prior to installation of expansion joint.

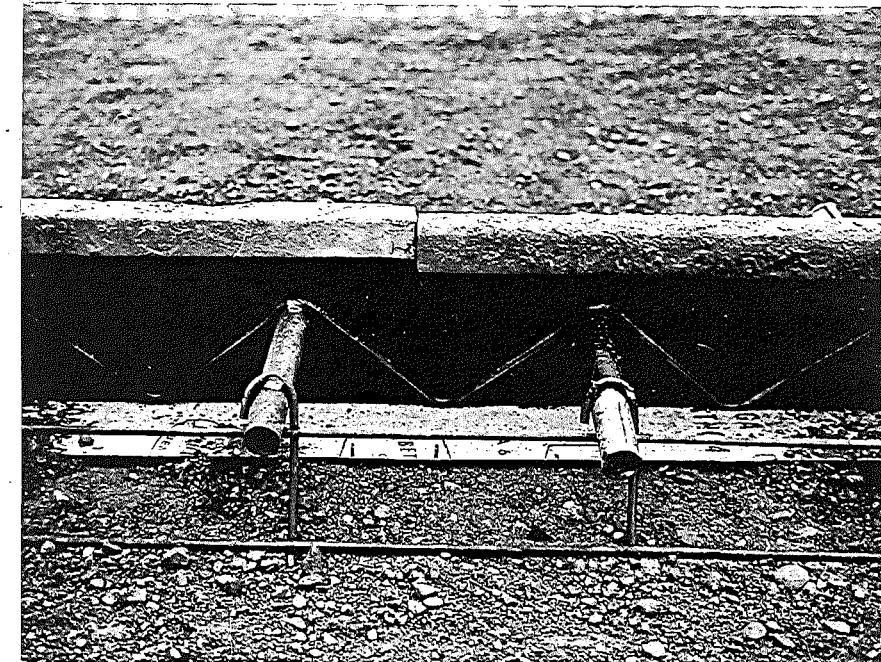
Another problem is that the metal channel cap, which is straight, cannot possibly conform to a curved or segmented filler. The channel rocks on high spots and is offset so as to form faults where channels end, as shown in Figs. 2 and 3. These metal protrusions increase the overall height of the assembly, and permit possible interference with the spreader and finishers.

Figure 2 (above). Channels rock on high points of filler, causing fault.

- 2. All fillers might be made 8-1/8 in. high and the specification changed to require a groove depth of not less than 3/4-in. nor more than 1 in. This would allow a better shaped groove for joint sealer.
- 3. The metal channel, if not shaped to the crown, could be furnished in four 6-ft sections instead of three 8-ft sections. This would allow better approximation to the crown by the straight metal pieces, and would provide a metal junction coinciding with the junction in the filler at the center of the roadway, eliminating the most prevalent fulcrum (Fig. 5).

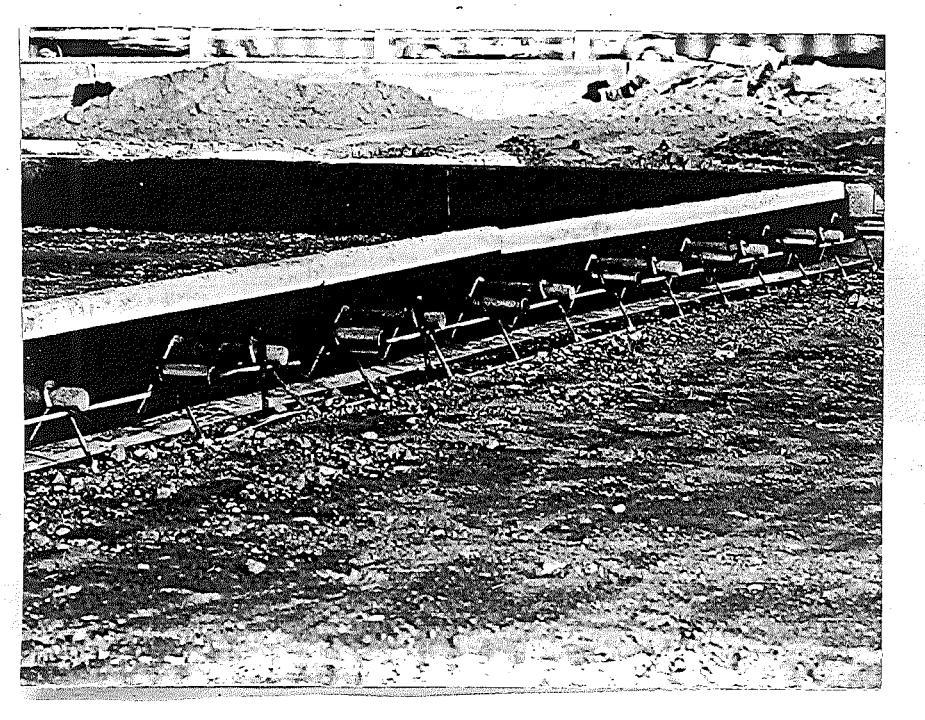
Figure 3 (left). Another fault at junction of channels.

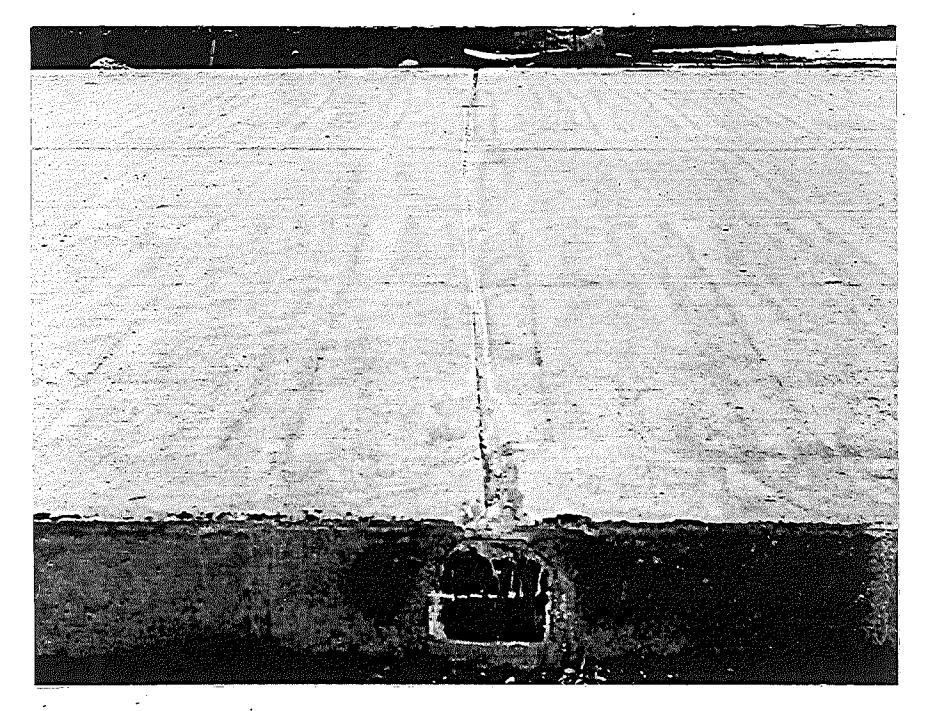
It was also observed that the filler material, and presumably the basket, in some instances have been tipped during construction operations. Figs. 6 through 8 show three finished joints, where the tilt in every case is in the direction of pour, perhaps indicating that the spreader dragged too much concrete along as it advanced over the basket assembly.

Figure 6 (upper left). Expansion joint curved in direction of pour.

It is imperative, especially in the case of an expansion joint where the joint width is at least 1 in., that the dowel bars be maintained in the plane of the pavement. Suitable hold-down devices should be employed to ensure that the proper alignment is maintained.
