Report TSD-214-73

A TRAFFIC ACCIDENT ANALYSIS OF HIGH ACCIDENT LOCATIONS IN KALAMAZOO COUNTY

January 1974

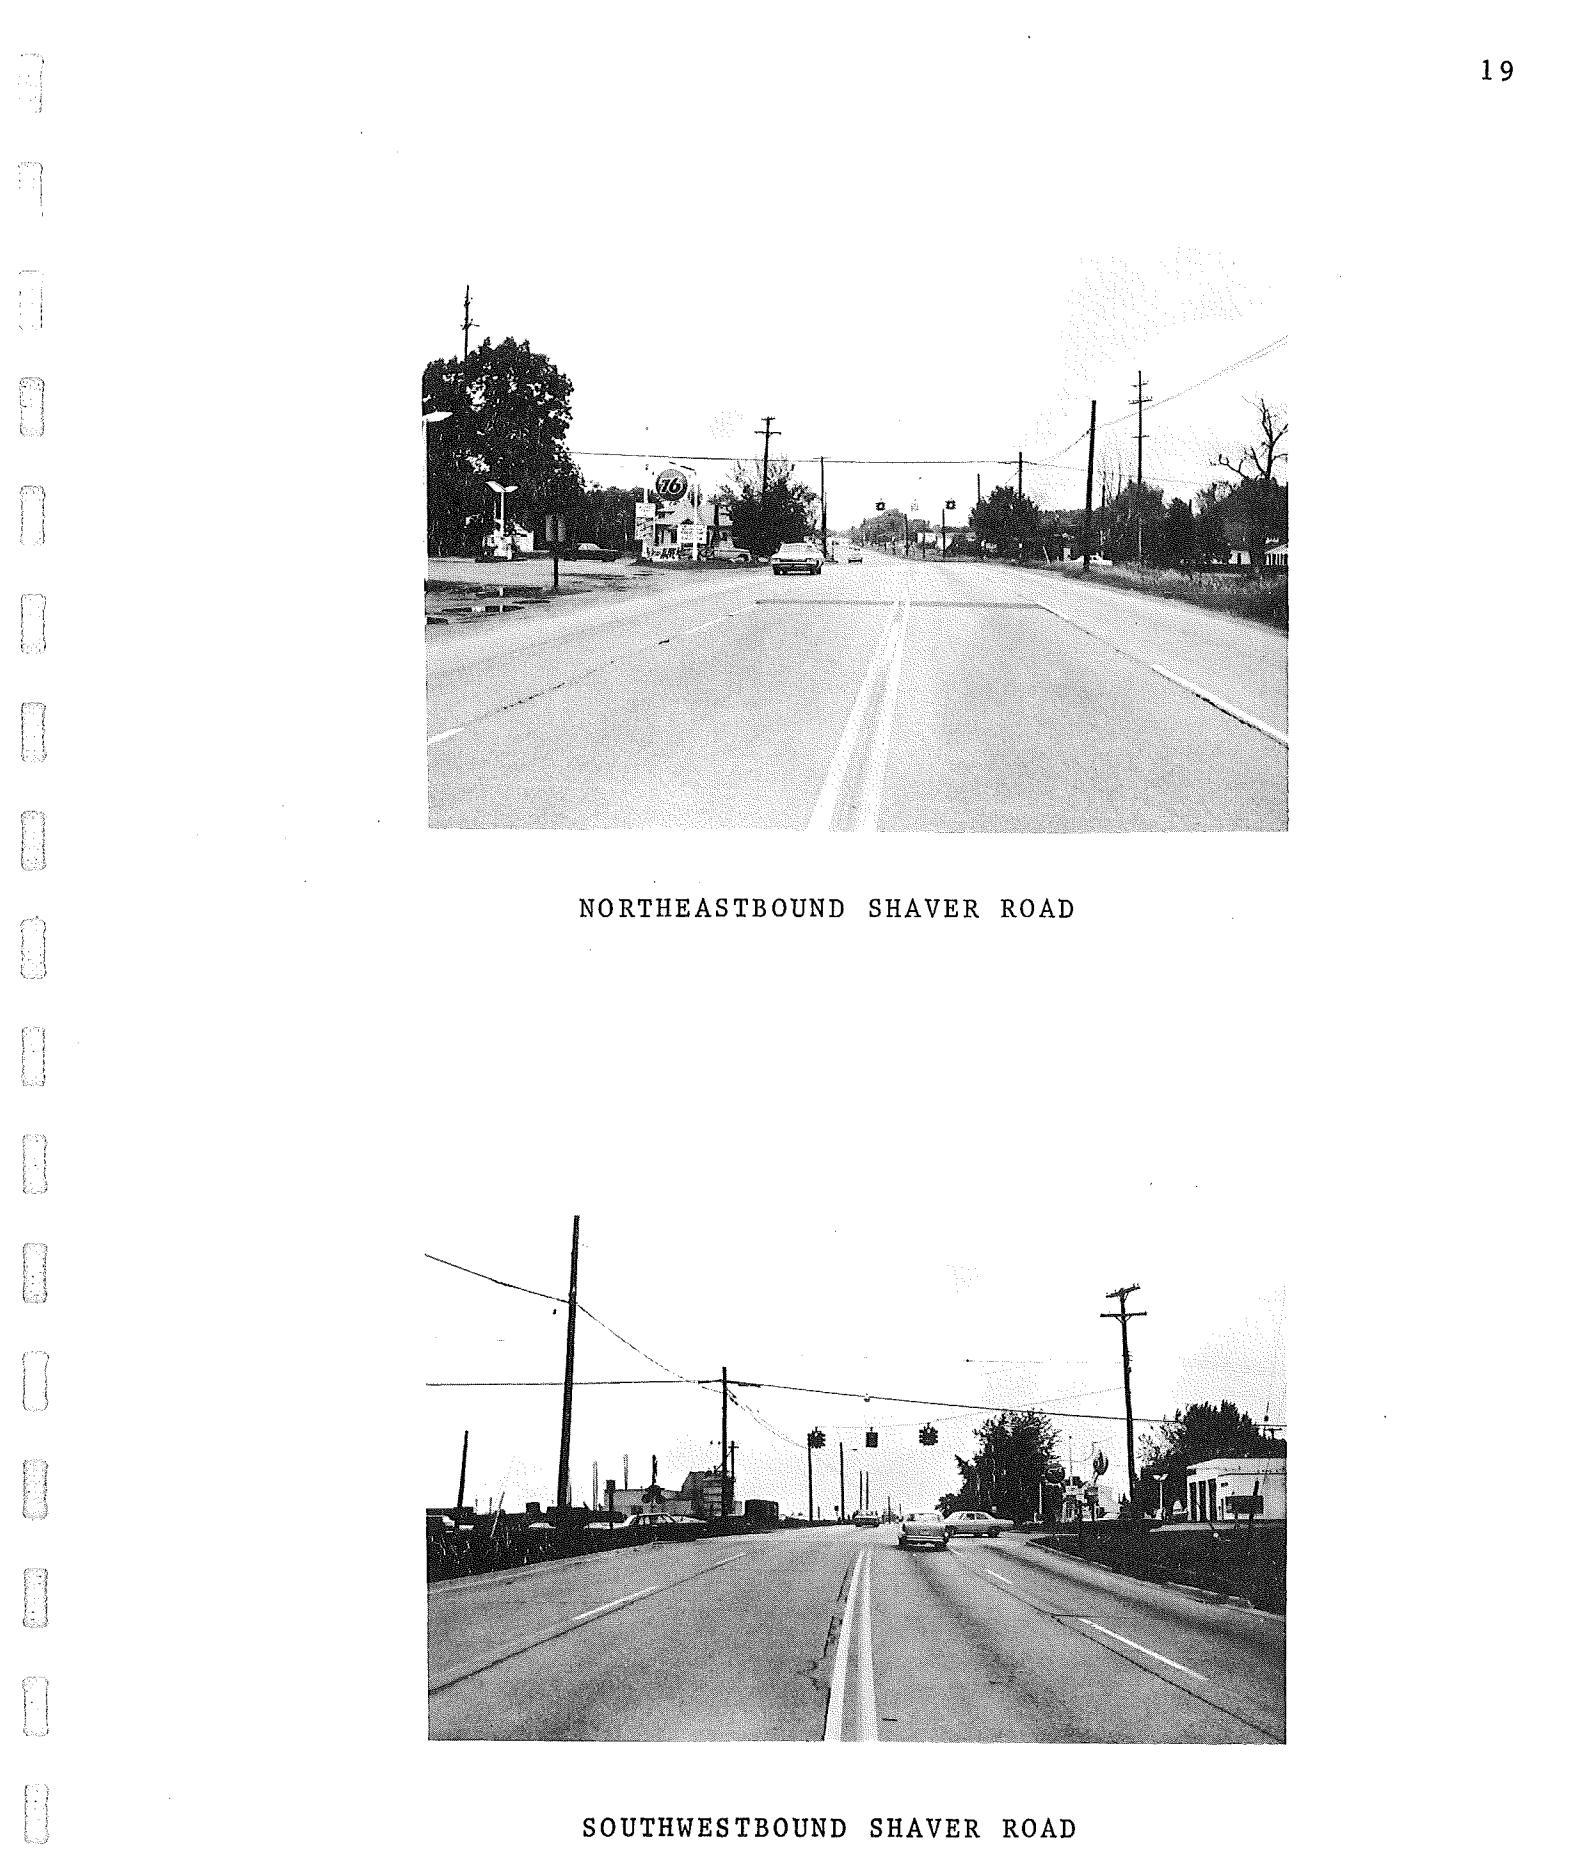
FIGURE 8

There were 12 head-on left-turn accidents that occurred from southwestbound Shaver Road. Left turns are already prohibited from northeastbound Shaver Road. Therefore, it is recommended that left turns from southwestbound Shaver Road also be prohibited. This can be accomplished by using the blank side of the existing overhead case sign. There is an alternate route approximately one-half mile north of this intersection for operators wishing to travel east on Centre Avenue. Southbound Westnedge Avenue forms a "Y" intersection with Shaver Road and intersects Centre Avenue one-half mile further south. The Westnedge Avenue-Centre Avenue intersection is only one block east of the Shaver Road-Centre Avenue intersection. A route direction sign indicating that southbound Westnedge Avenue provides access to eastbound Centre Avenue should be placed on Westnedge Avenue north of its intersection with Shaver Road (See Figure 10). The prohibition on left turns should increase the capacity on Shaver Road and reduce the number of head-on left turn and rear end accidents.

SOUTHWESTBOUND SHAVER ROAD

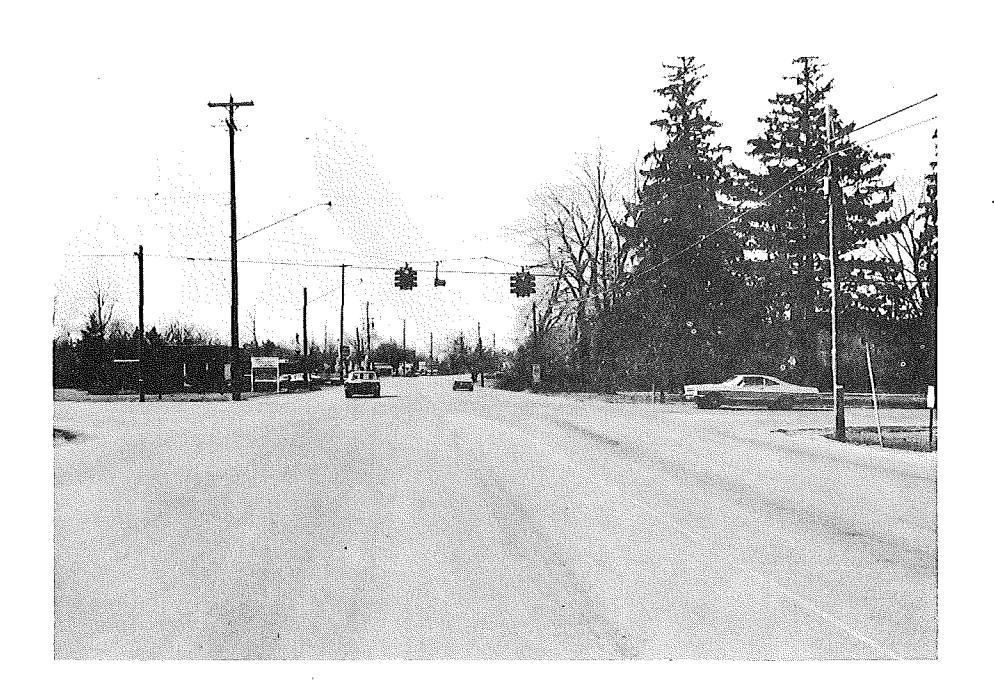
SOUTHBOUND PORTAGE ROAD

Head-on left-turn collisions accounted for 55 percent of the accidents at this location between 1966 and 1970. Eighty-three percent of these accidents happened during a left turn from north or southbound Portage Road. It is recommended that a separate signal phase be incorporated to enable north and southbound Portage Road traffic to turn left at Centre Avenue without interference from other traffic. Due to the fact that Portage Road has recently been widened, the inclusion of a separate signal phase can be accomplished by striping Portage Road for five lanes with the center lane for left turns only and employing five signal heads. A detail drawing of the five lanes and signal configuration can be found on p. 25.

Also, due to the ten sideswipe accidents that occurred at this location, it is recommended that both center lines and lane lines be applied to each leg of the intersection. Left turn arrows accompanied by the word "Only" should also be applied to the center lane on Portage Road in the immediate intersection area. If these pavement markings are employed at this location, improper lane usage would be reduced.

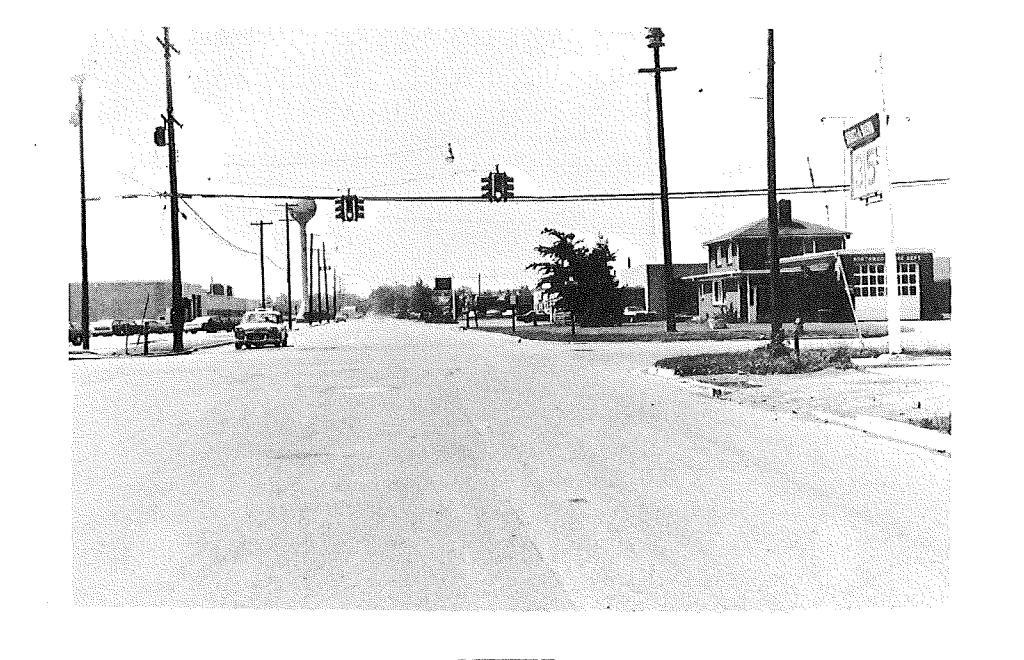
SOUTHBOUND BURDICK STREET

The two signal heads that are suspended above the Mosel Avenue-Burdick Street intersection are not centered over the intersection. One signal head is located directly over the center line for Burdick Street and the other signal head is located west of the center line. It is recommended that these two signal heads be located as close as possible to the proper position as described by the Manual. At the Mosel Avenue-Pitcher Road intersection there is a cyclone fence and brush growth in the southeast quadrant which causes inadequate visibility for northbound Pitcher Road traffic. It is recommended that this brush growth be maintained so that it doesn't interfere with the vision of motorists on northbound Pitcher Road.

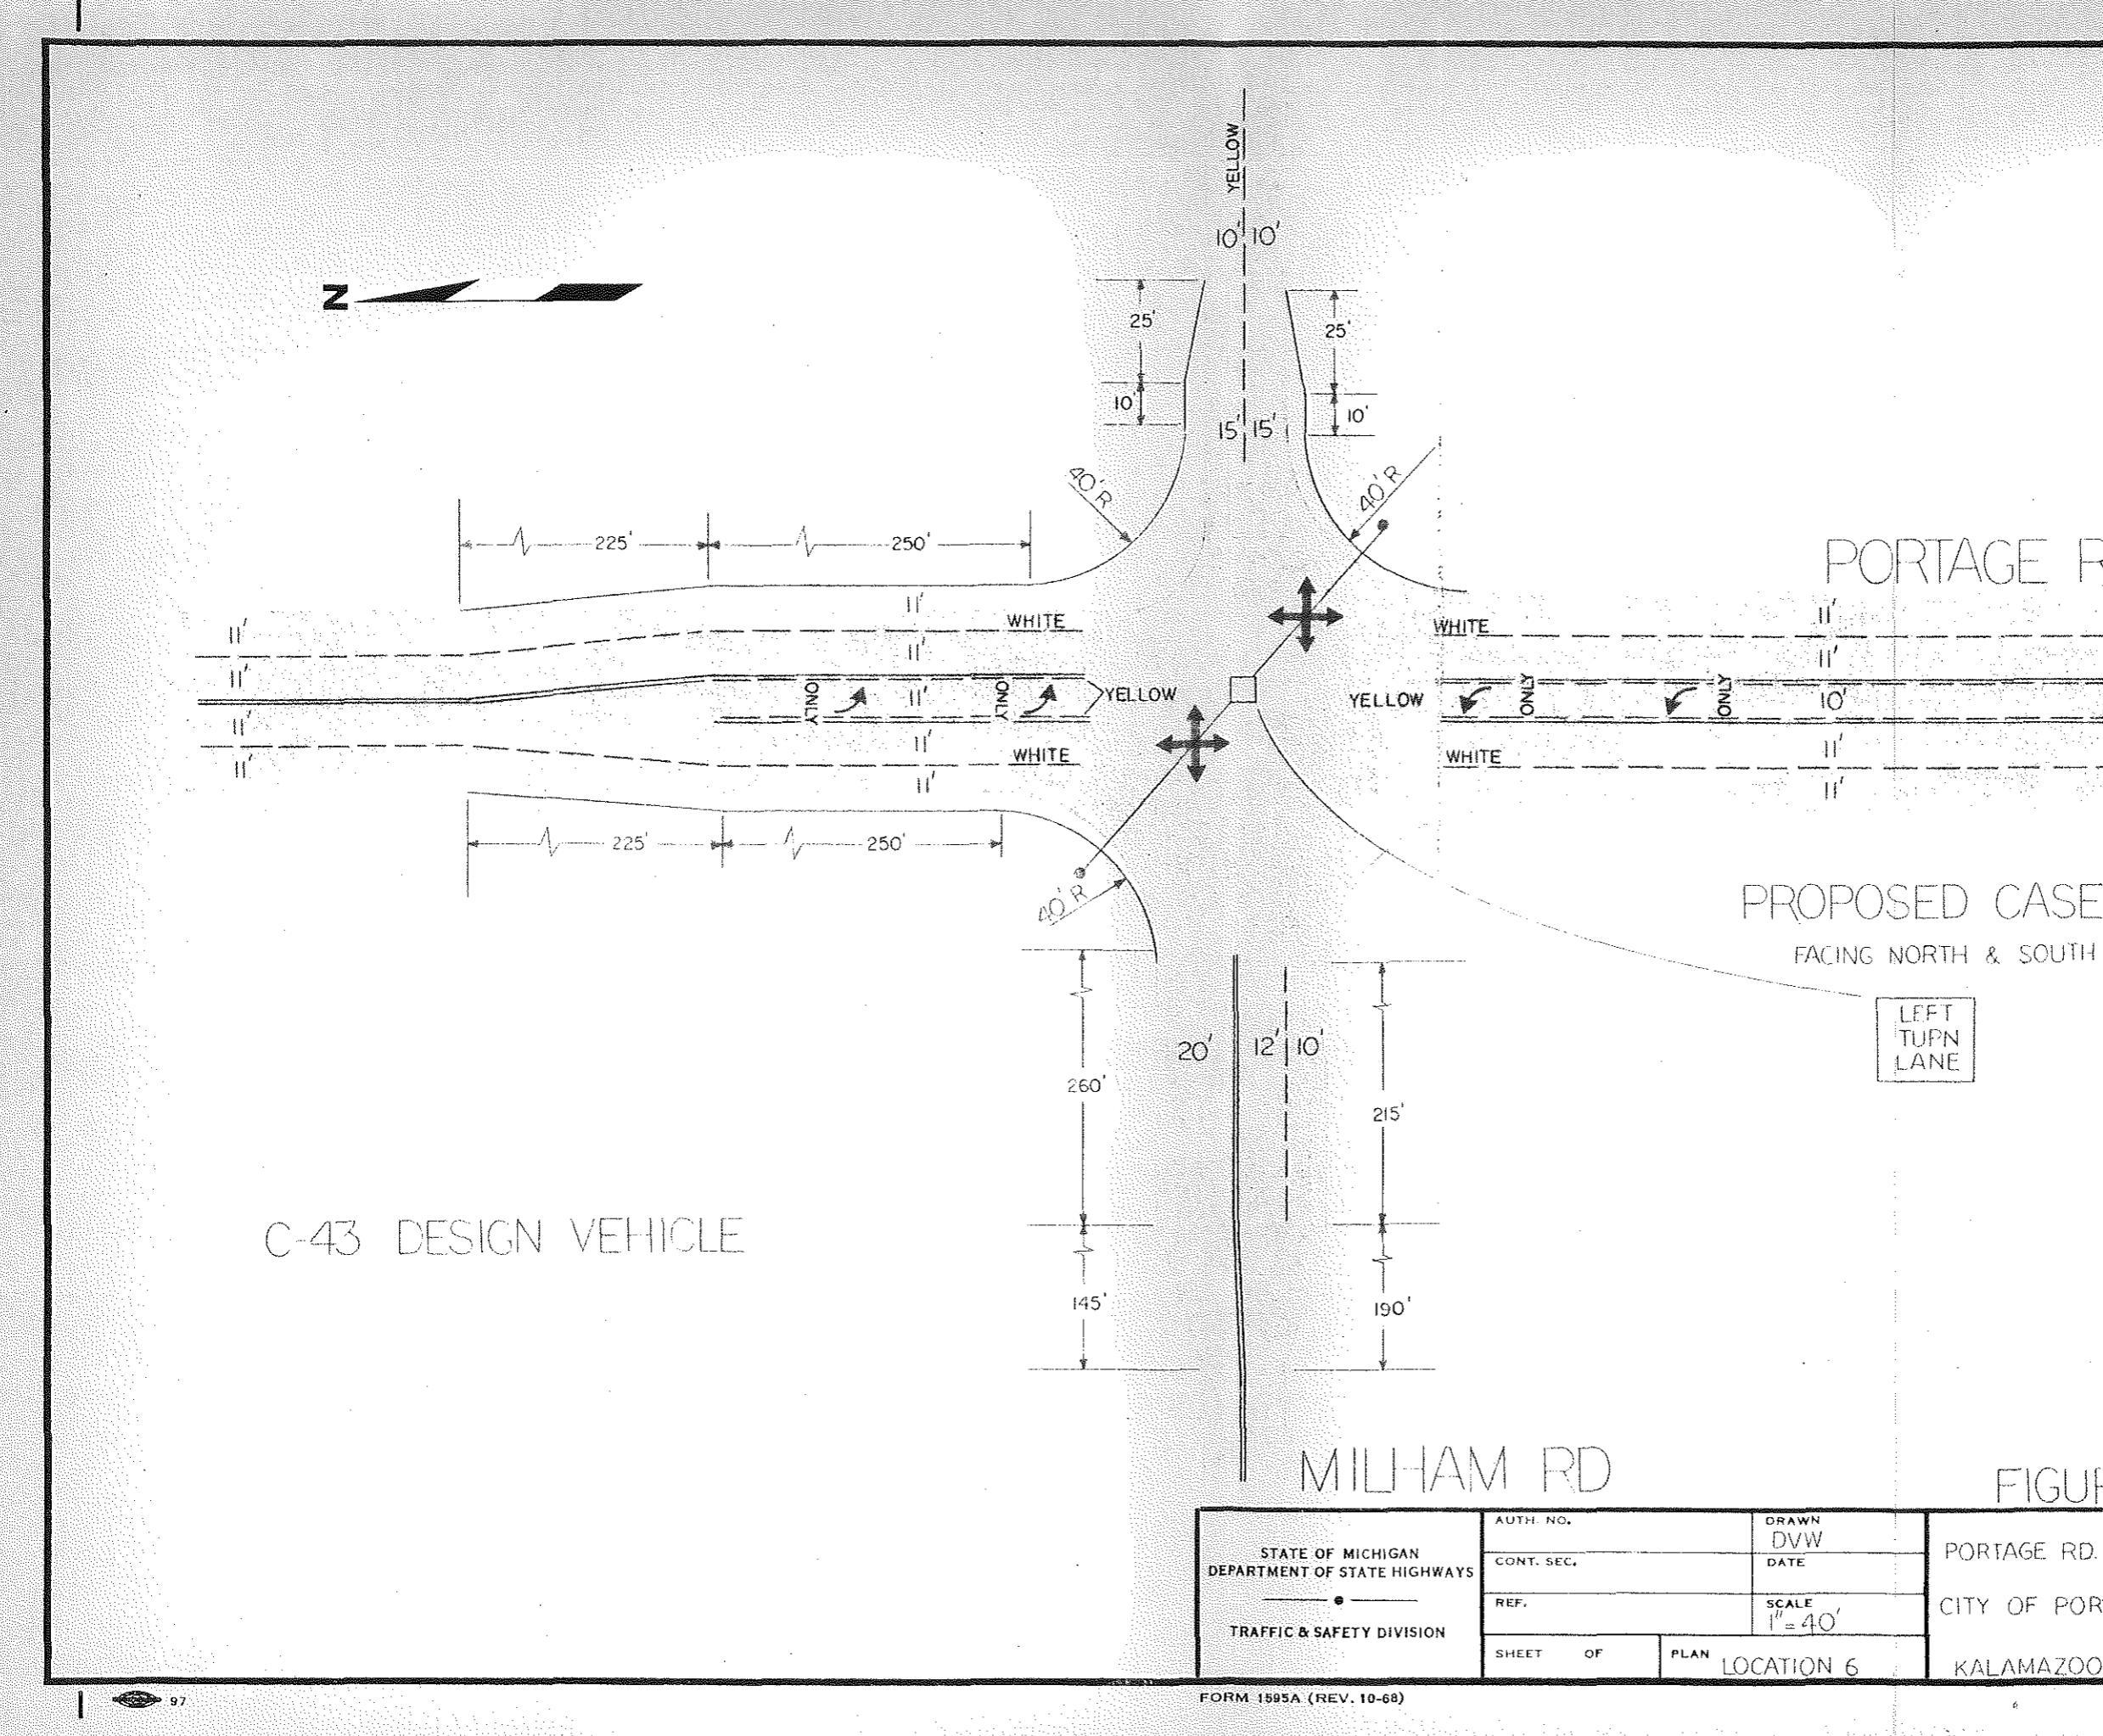
44 PROPOSED CASE SIGN FIGURE 25 PORTAGE RD. at MILHAM RD. CITY OF PORTAGE KALAMAZOO CO.

The pavement on the north leg of Portage Road is deteriorating. This conclusion is drawn from the numerous patches that make the pavement uneven. Therefore, it is recommended that consideration be given to resurfacing the north leg of Portage Road in the immediate intersection area. At the same time we recommend that the width of the north leg of Portage Road be increased from 44 ft to 55 ft and the approach road connection for the east leg of Milham Road be widened to 30 ft (Figure 25). We realize that 40

Kalamazoo County's resurfacing is scheduled on a priority basis and that the north leg of Portage Road may not have a high priority at this time. The skidometer tests, recommended previously, however, may indicate that the north leg of Portage Road be given a higher priority. In any case, it is recommended that the north leg of Portage Road be included in the construction program as soon as feasible.

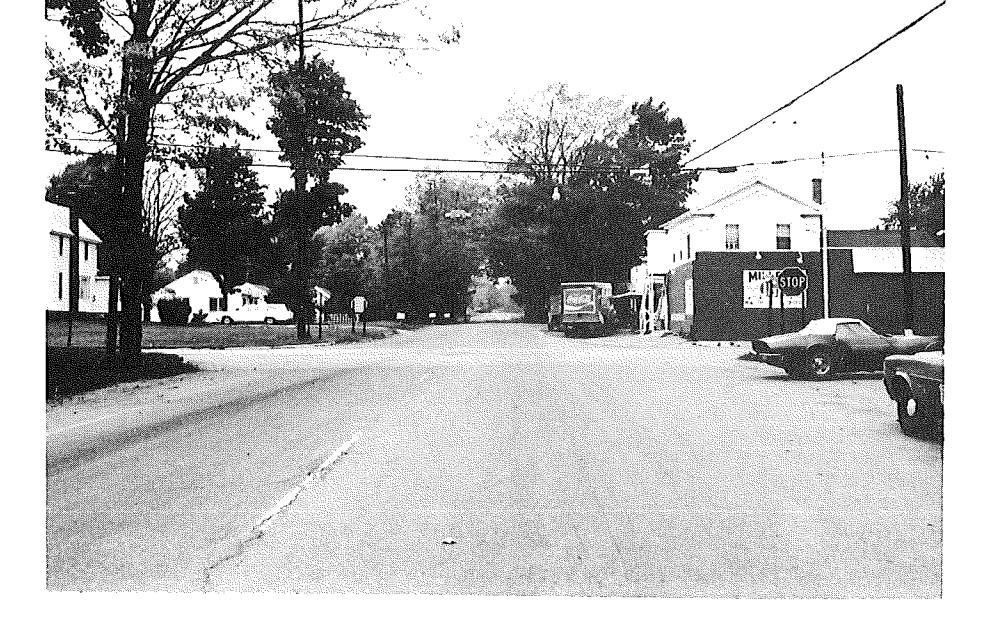
FIGURE 32

The sight distance from the east leg of "D" Avenue is inadequate. Thus, it is recommended that the bushes in the southwest quadrant be trimmed and then periodically maintained.

WESTBOUND "D" AVENUE

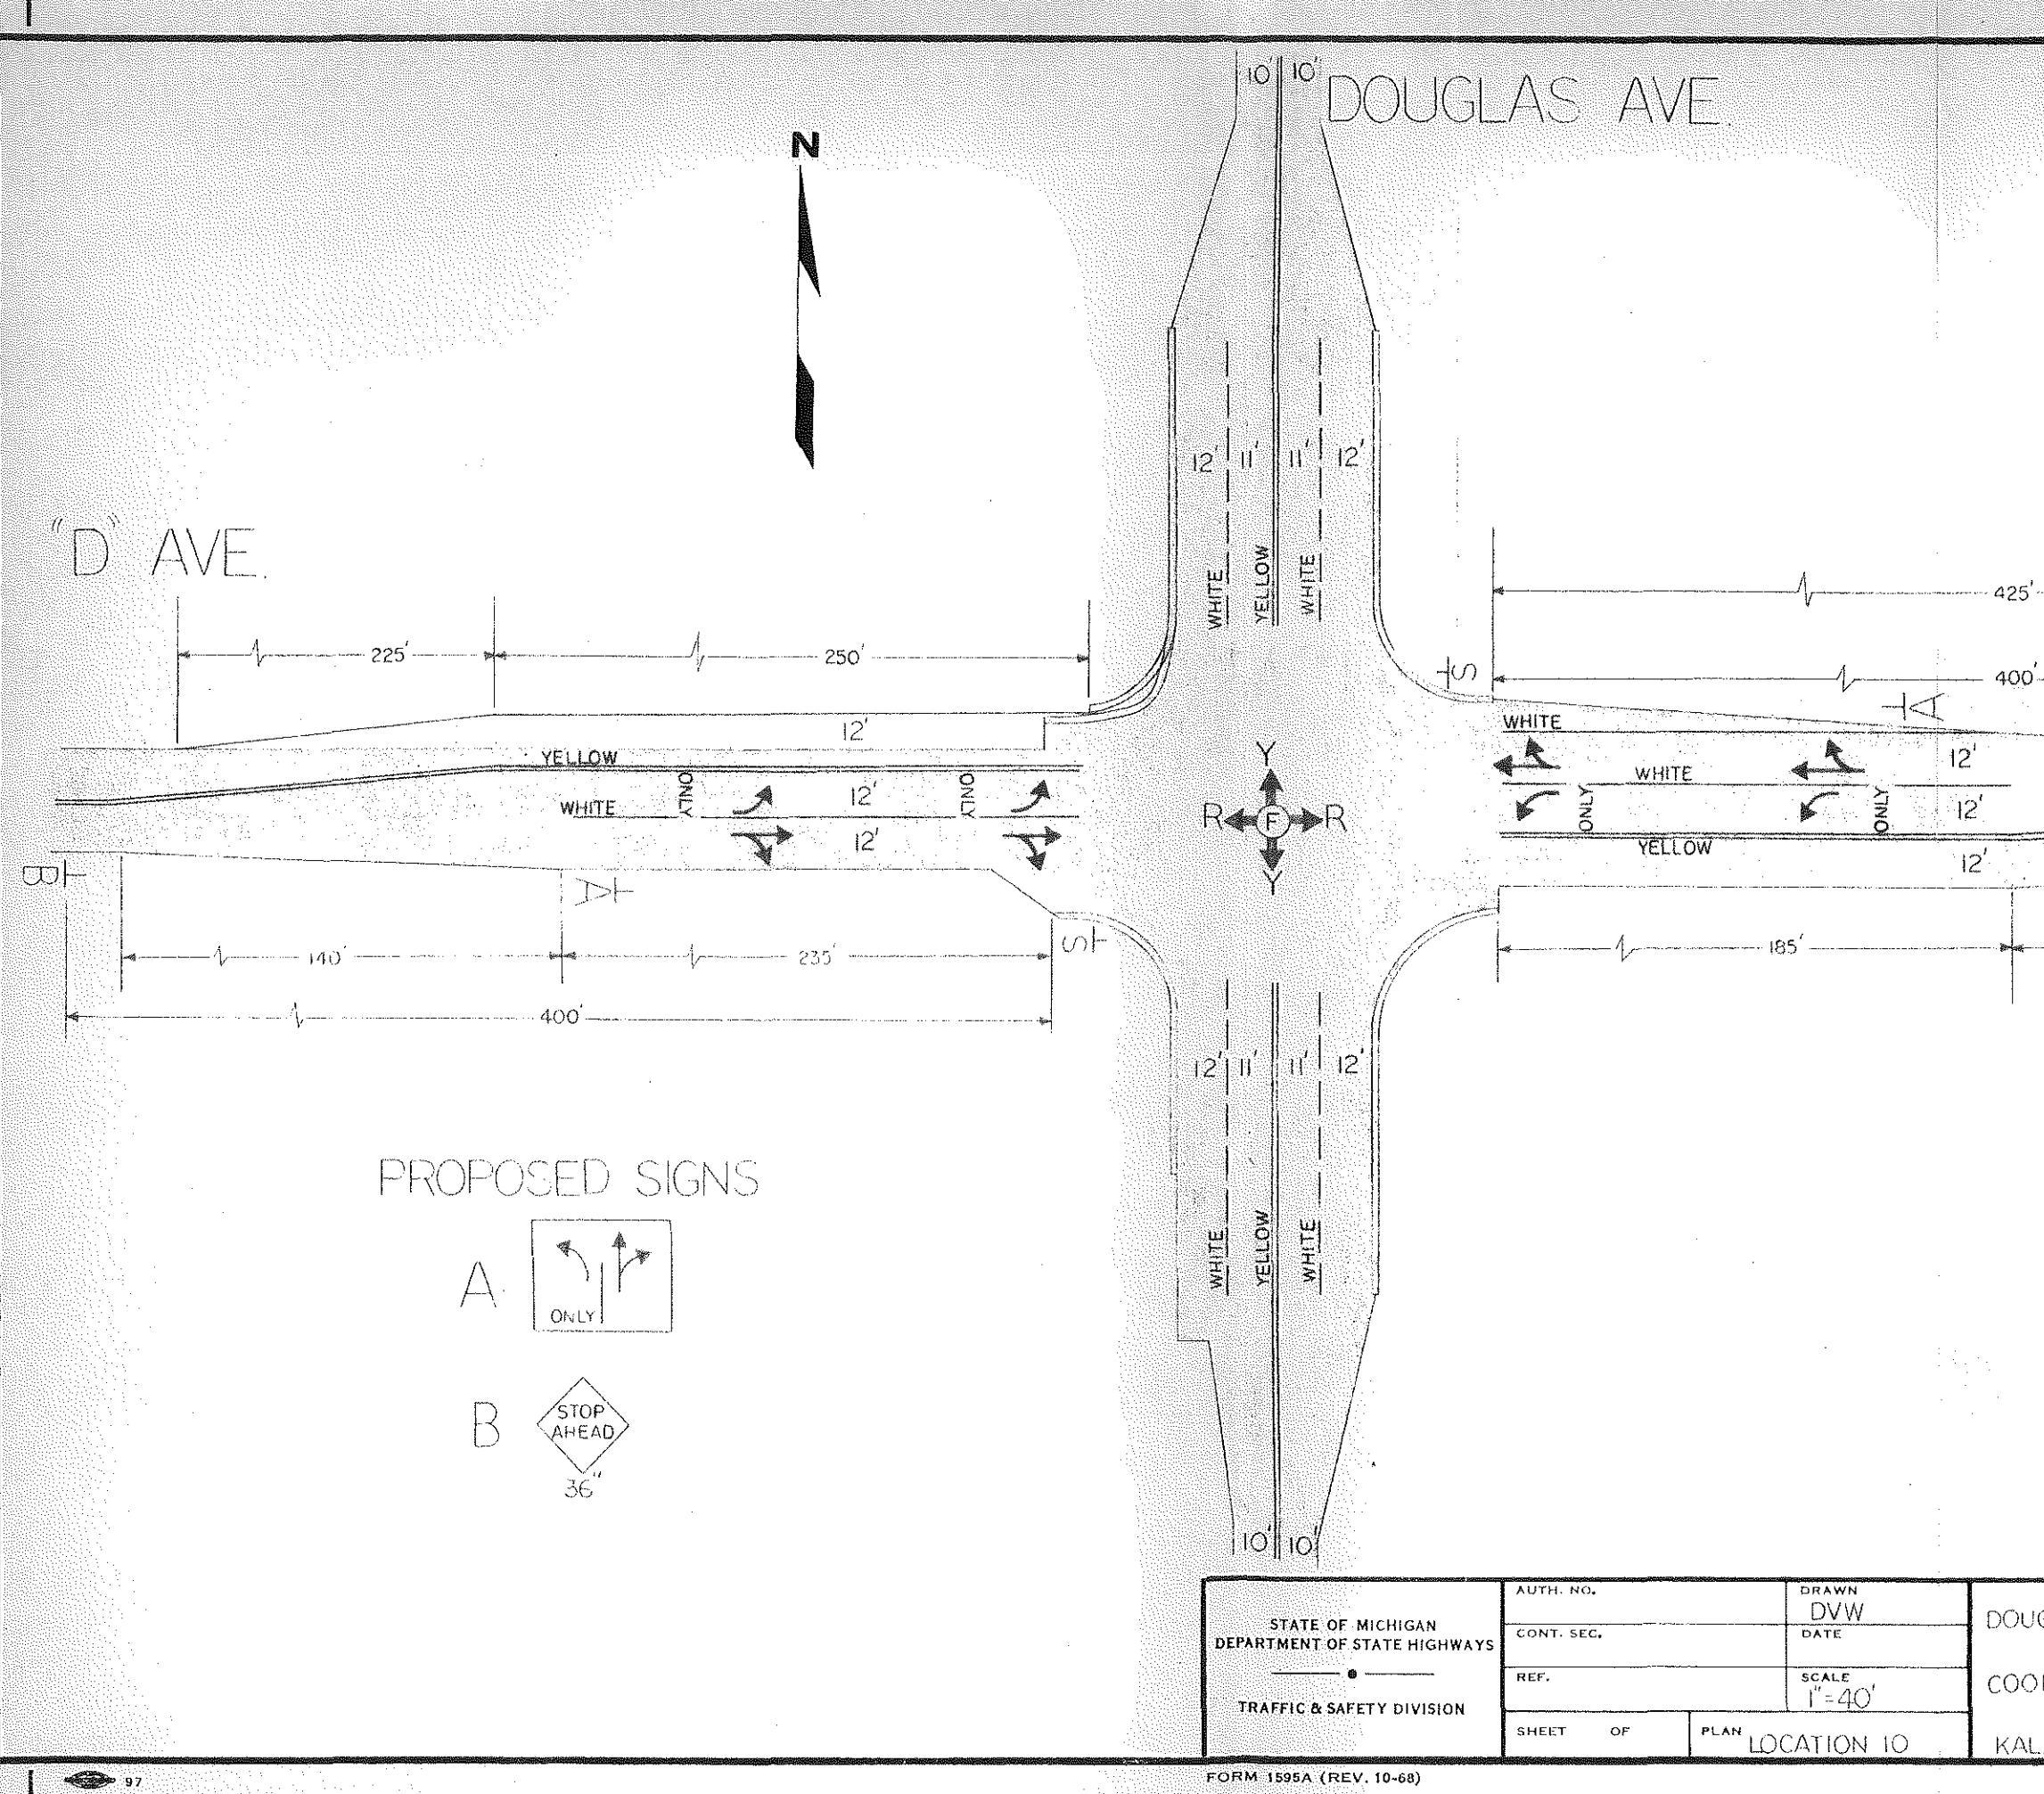
57
* -		
	- m	
FIGURE	33	
SLAS AVE. at "D" AV	Ε.	
PER TWP.		
AMAZOO CO.		
Annan and a second and a second and a second s

The traffic controls at this location consist of a 36 in. "Stop" sign for both east and westbound "D" Avenue traffic and an overhead flashing beacon. Also there are 32 in. "Stop Ahead" warning signs for both directions of traffic on "D" Avenue. The sight distance from the east leg of "D" Avenue is inadequate due to brush growth in the southeast quadrant while the sight distance from the west leg is adequate.

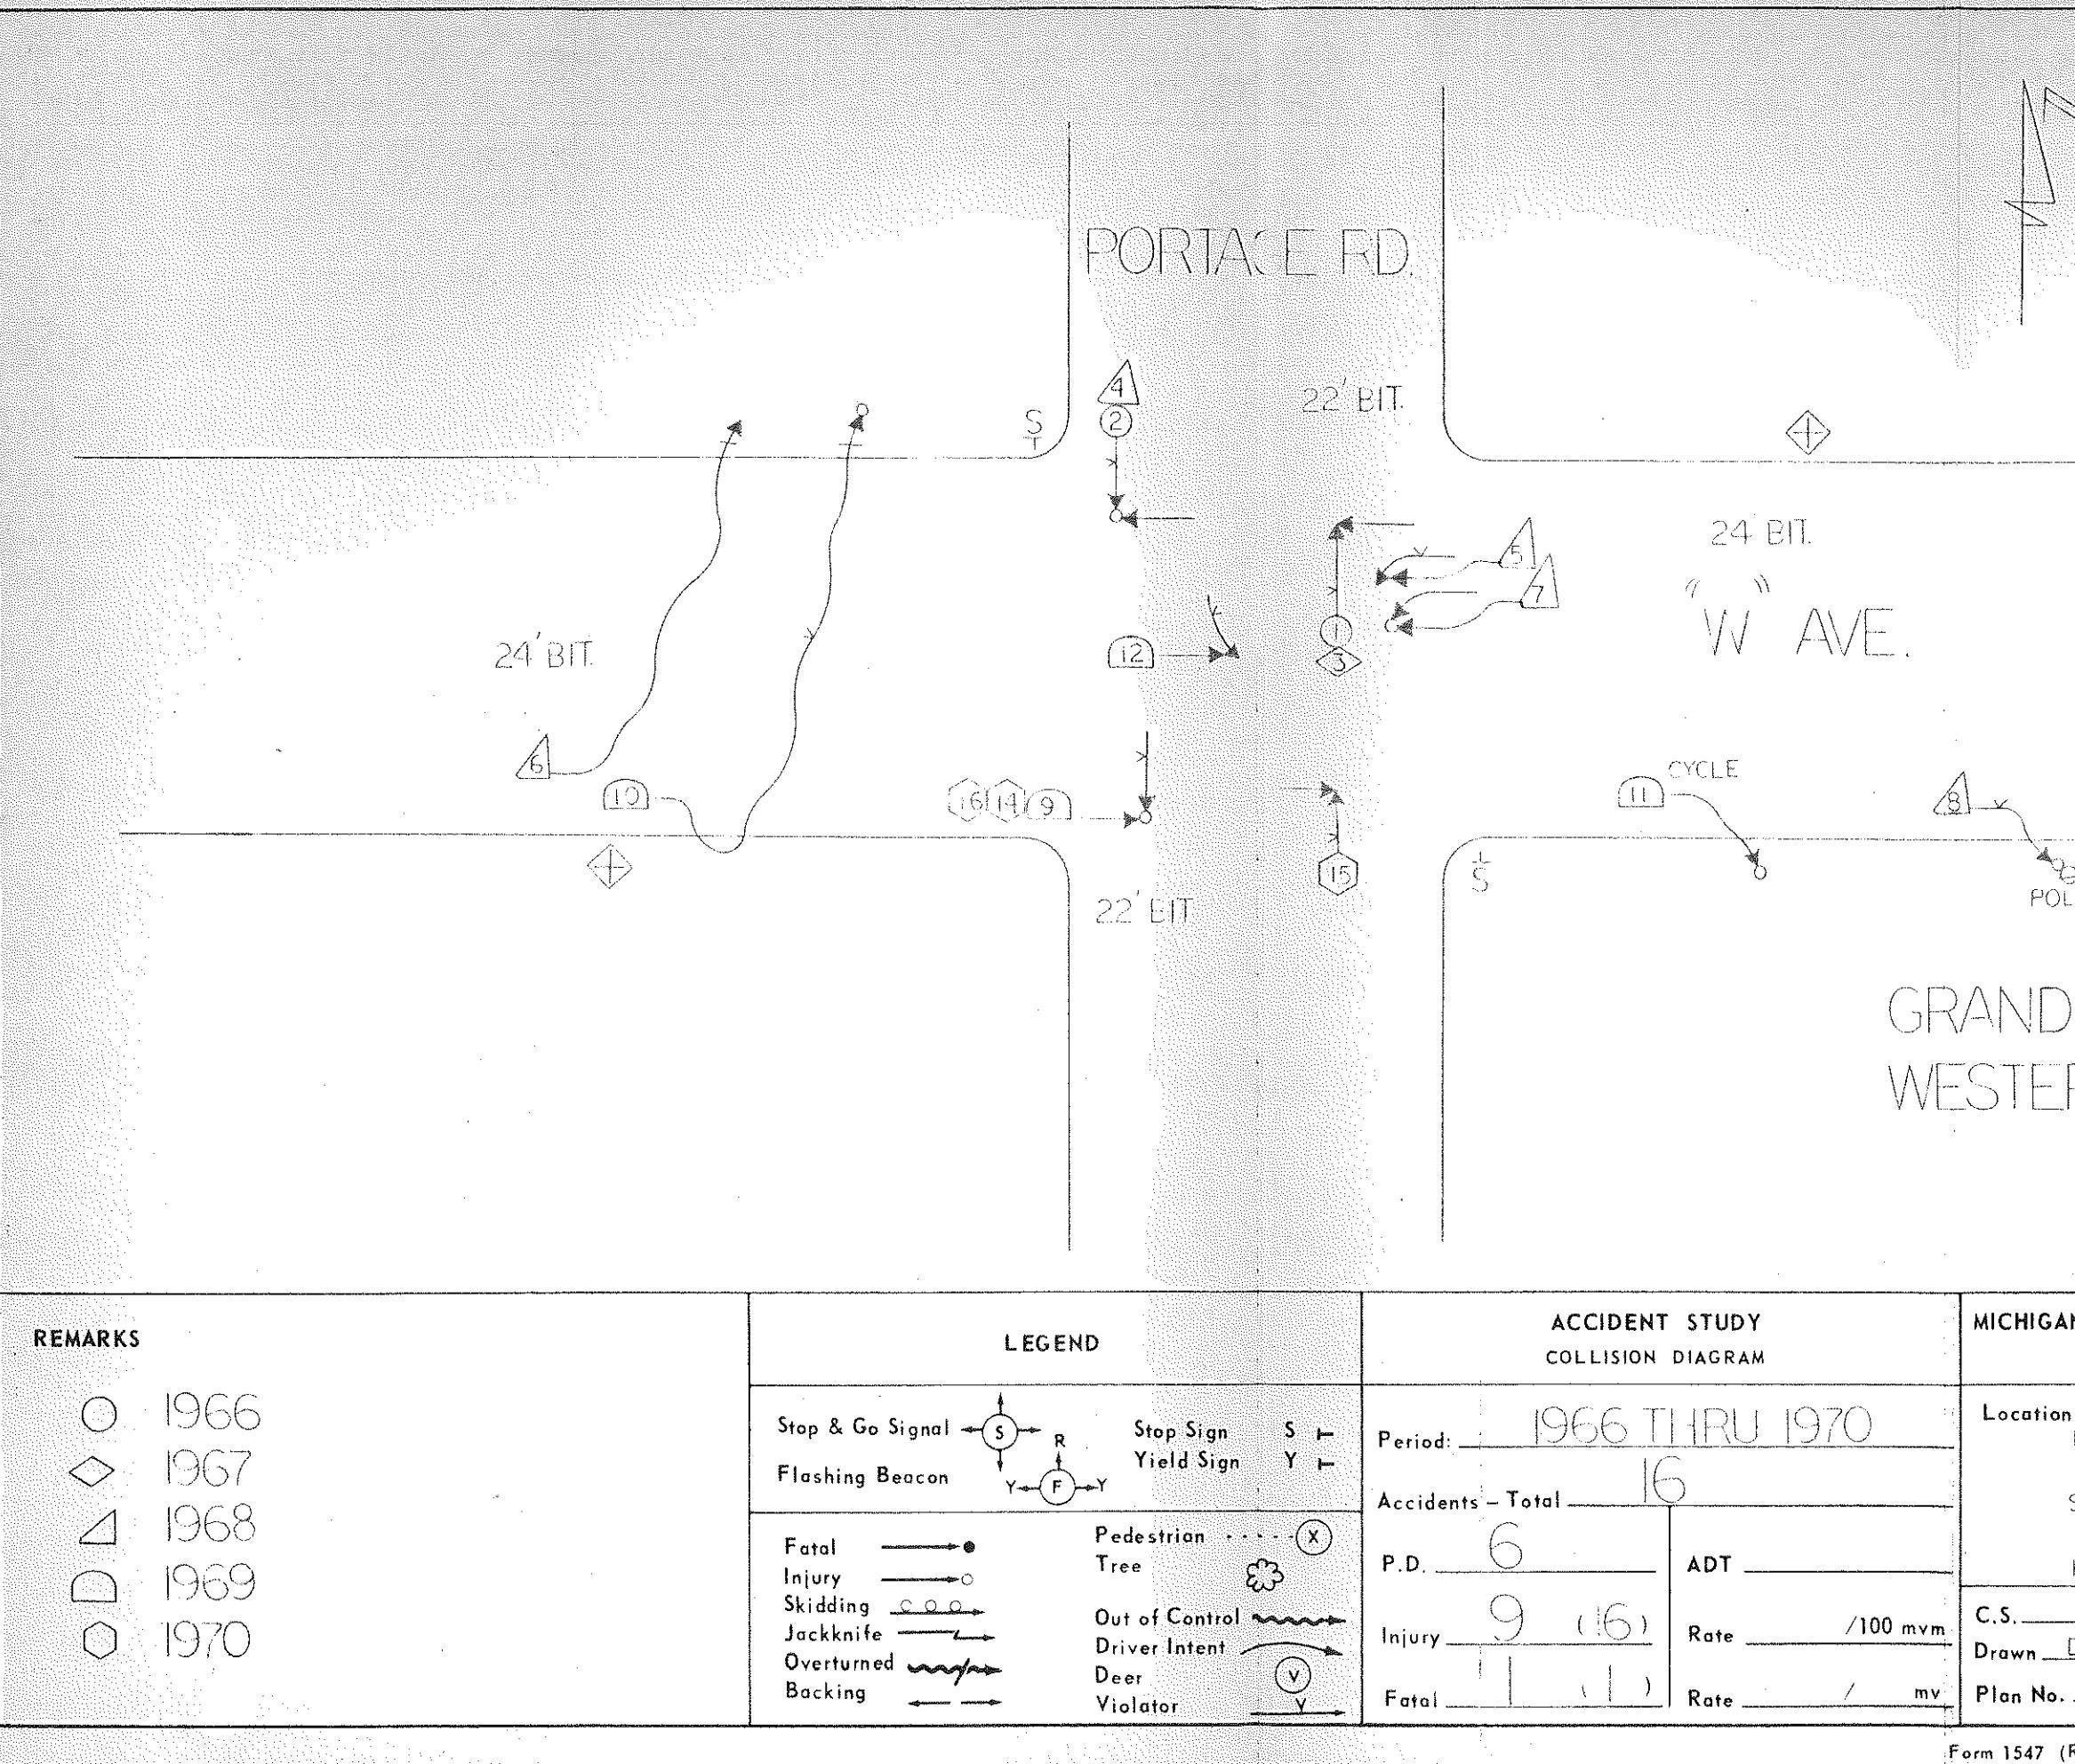
81
Į.	
141	•
14	
Ŧ	8
) TRUNK	
RN R.R.	
FIGURE 48	
· · · · · · · · · · · · · · · · · · ·	_
AN DEPARTMENT OF STATE HIGHWAYS TRAFFIC AND SAFETY DIVISION	5
n 22 No.	-
PORTAGE RD. at "W" AVE.	
SCHOOLCRAFT TWP	
KALAMAZOO CO,	_
Miles DVW Date 4-12-71	-
LOCATION 19	-
(Rev. 5/69) Sheet of	_] _

Portage Road and "W" Avenue form a four-legged intersection located in a rural area of Kalamazoo County. Portage Road has a two lane, 22 ft wide bituminous pavement, while "W" Avenue has a two lane, 24 ft wide bituminous pavement. There is a railroad crossing on "W" Avenue approximately one-quarter of a mile east of the intersection. Northbound Portage Road is the only leg of the intersection that does not have center line markings.

On all major rural highways having an even number of lanes center lines are necessary and should be applied throughout the entire length of the pavement. They should be applied on two-lane pavements 16 ft or more in width with prevailing speeds of greater than 35 mph. Thus, it is recommended that the center line be applied to northbound Portage Road.

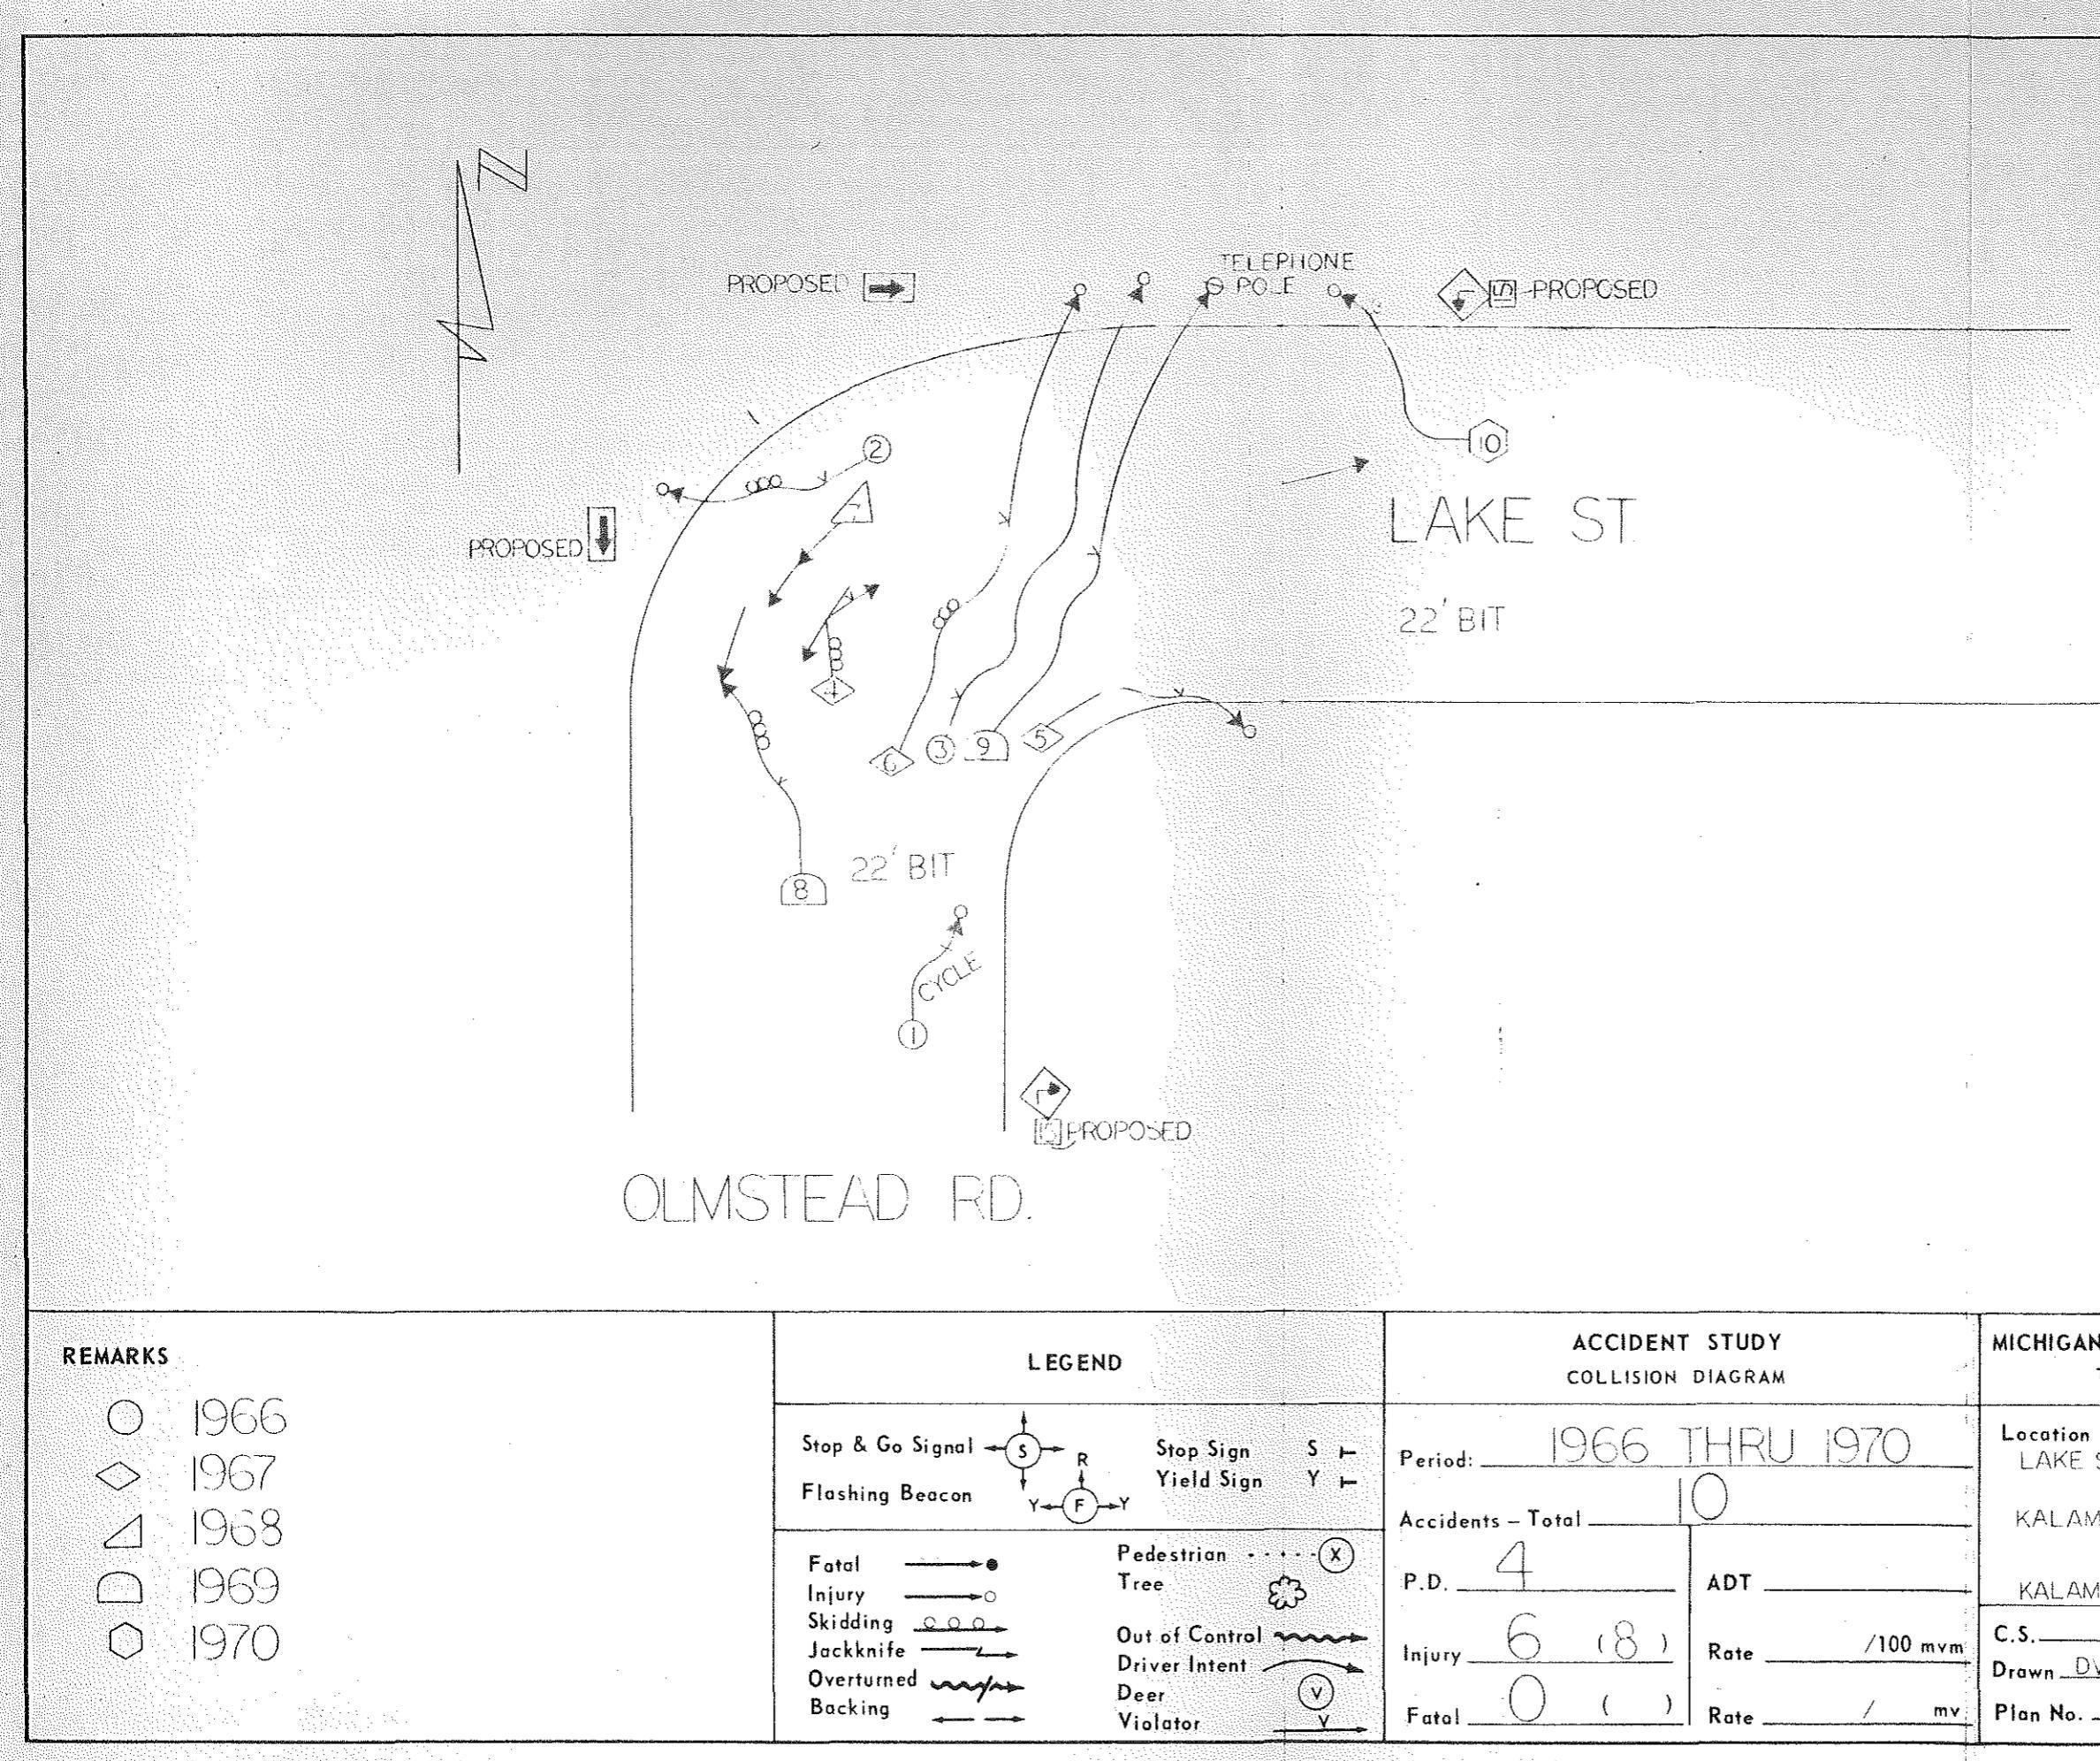
FIGURE 57	
N DEPARTMENT OF STATE HIGHWAYS TRAFFIC AND SAFETY DIVISION	
ST. at OLMSTEAD RD.	
MAZOO TWP	
MAZOO CO.	
Miles DVW Date 4-7-71	
LOCATION 22	
Rev. 5/69) Sheet of

Olmstead Road and Lake Street form a 90 degree turn. Both streets have 22 ft bituminous roadways with double yellow center line markings to prohibit passing. There are also 30 in. turn signs for both northbound Olmstead Road and westbound Lake Street.

In addition, there is a telephone pole in target position for both directions of traffic. These telephone poles are a safety hazard to the operators of vehicles that run off the roadway. Thus, it is recommended that these telephone poles be relocated so that they are not in target position.
