R-334

MICHIGAN
STATE HIGHWAY DEPARTMENT
JOHN C. MACKIE, COMMISSIONER

June 3, 1960

Subject: Study of Premolded Rubber and Polyvinyl Chloride Base Plate
for Joints. Research Project 53 G-70. Report No. 334.

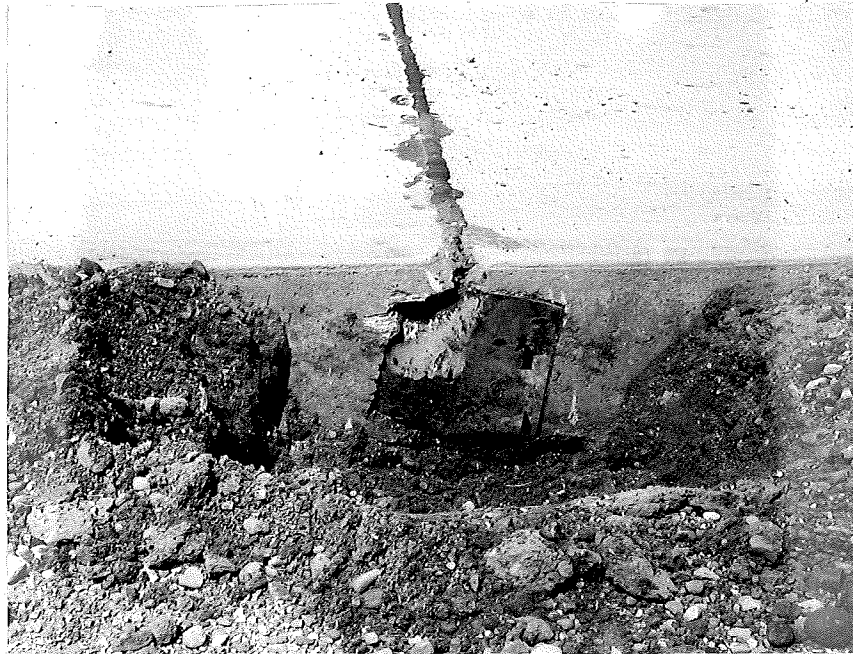
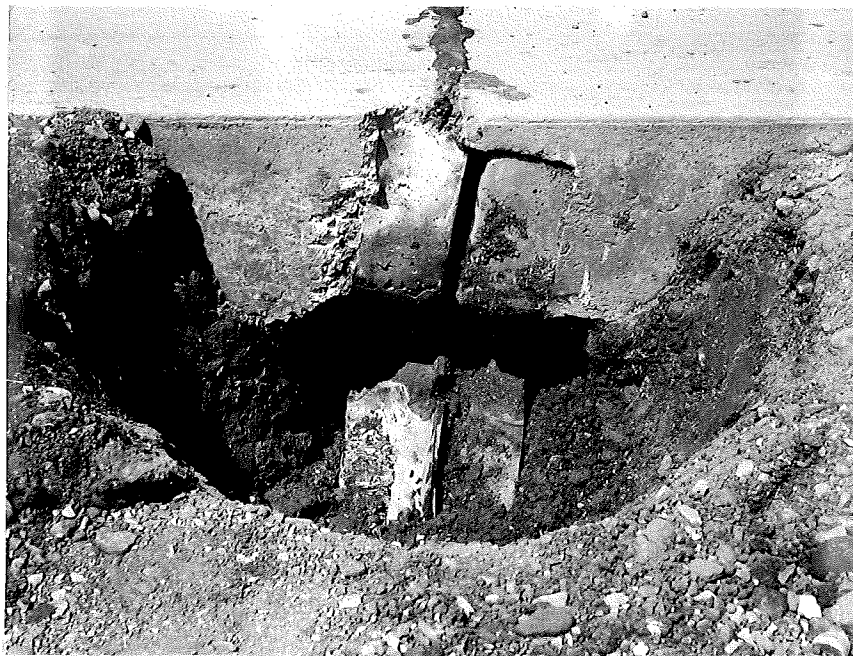
It is pertinent, however, to call attention to some of the construction difficulties associated with the use of this material, as revealed by an examination of several joints on the US 12 Kalamazoo Bypass (IN 39-40, C7 & 8), built in the fall of 1956. The attached photographs (Figs. 1 through 4) were taken in April 1958, of joints selected at random for inspection of the end plates. Three of the four showed various defects in positioning of the end plate (Figs. 1 through 3). The fourth (Fig. 4) showed good end plate positioning, but the surface groove was not centered over the base plate. Evidently considerable care must be taken to position the turned-up ends properly and to avoid displacement of these ends by the fresh concrete during pouring operations.

Figure 1. End plate twisted laterally; before (above) and after (below) bending down end plate. Sta 817+57

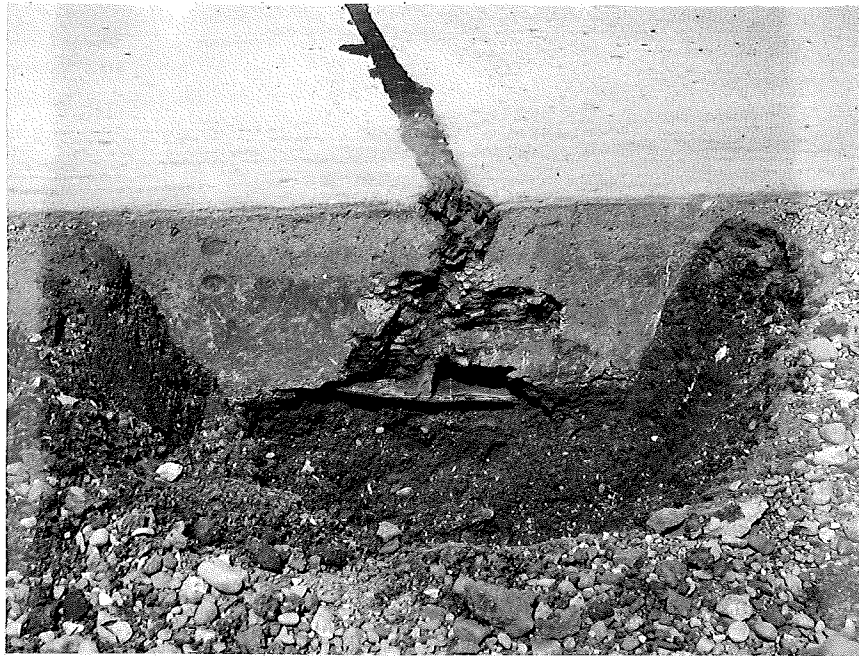
**Figure 2. Base plate too short--no material remained
for end plate. Sta 858+25**

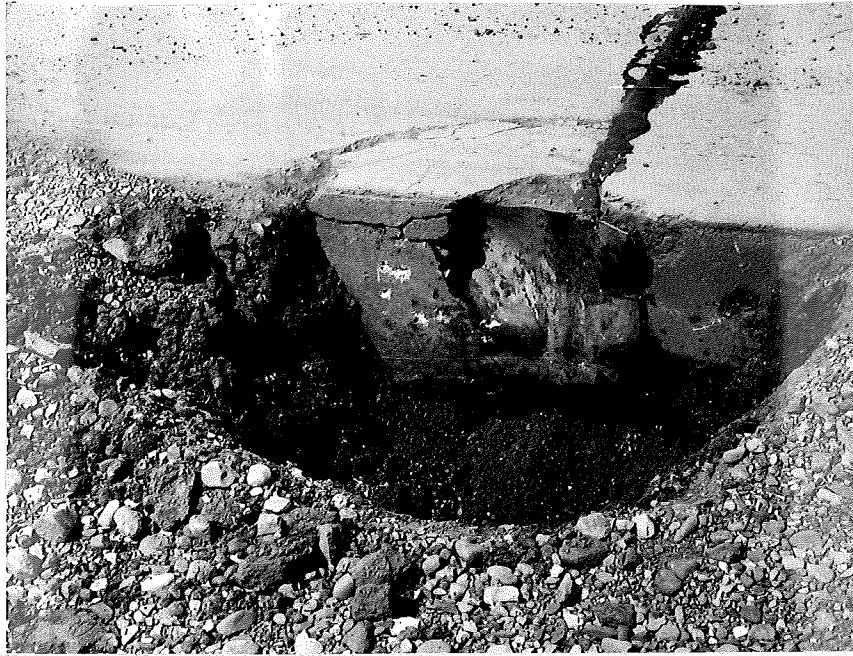
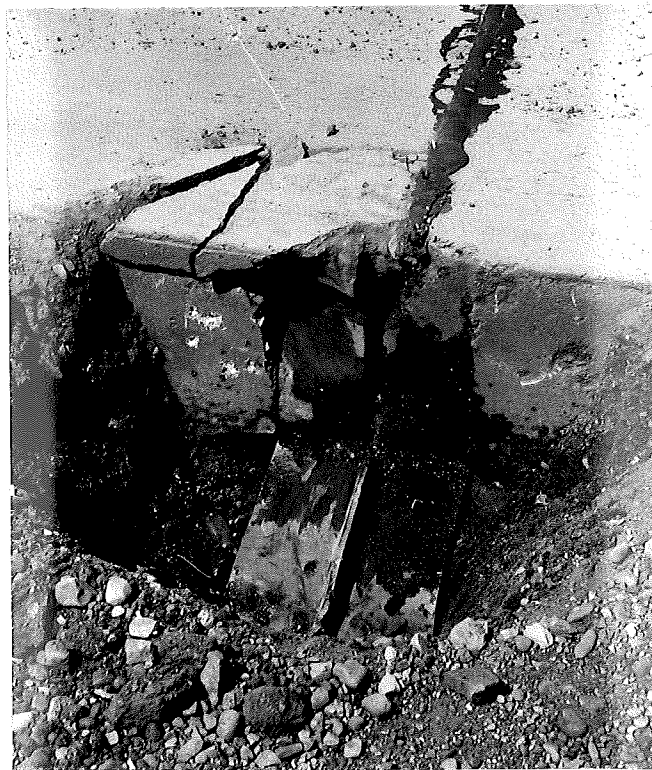
Figure 3. End plate distorted, with one corner embedded in concrete, resulting in edge break; before (above) and after (below) bending down end plate. Sta 874+10

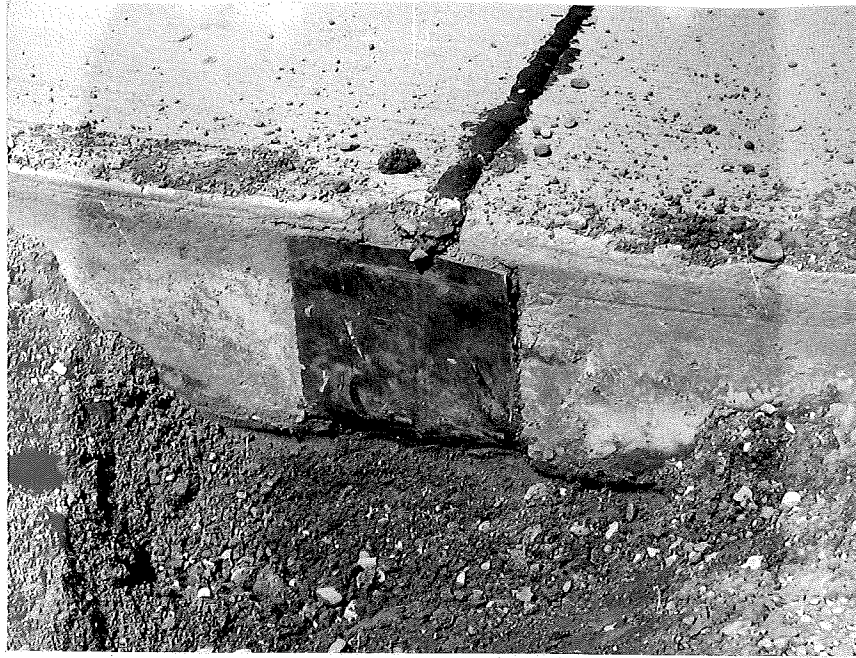
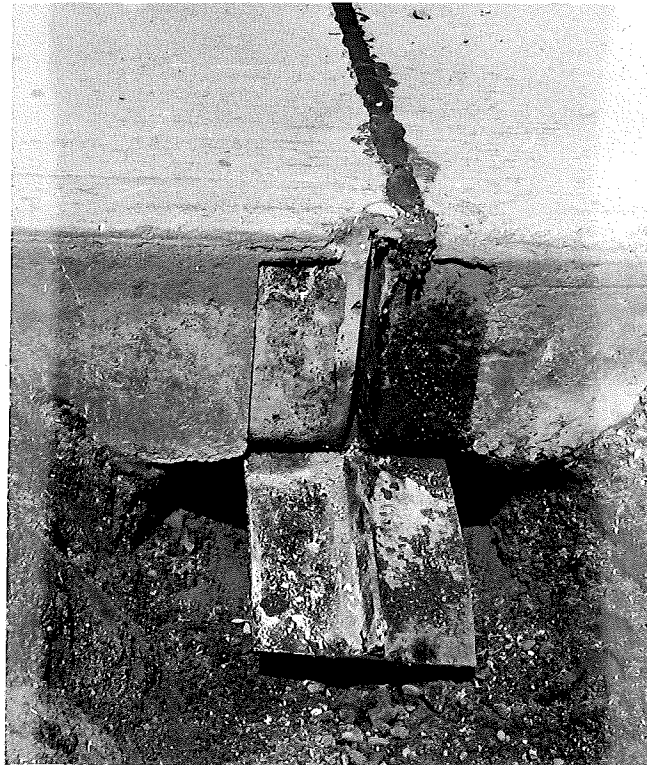
Figure 4. End plate properly positioned, but joint groove not centered over base plate; before (above) and after (below) bending down end plate. Sta 805+72
