INVESTIGATION  
of  
HINGED BAR MAT

Research Project 46 G-32

Research Laboratory  
Testing and Research Division  
Report F - 84  
June 3, 1946

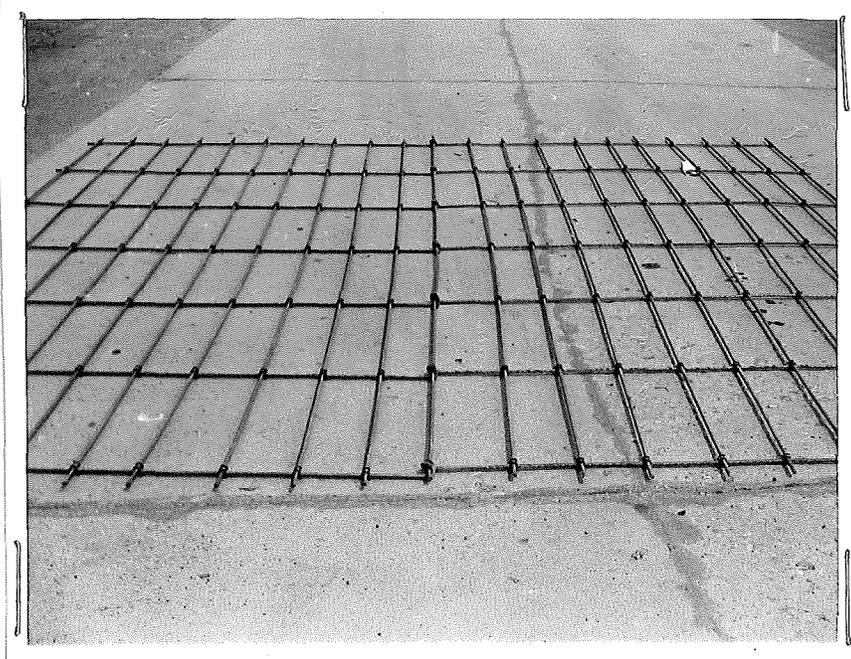
Figure 1 presents a general view of the mat showing the hinge construction through the center. When the mat is installed in the pavement the hinge would be parallel to the center-line of the pavement and in the center of each traffic lane. The bars are all uniformly spaced except the first longitudinal bars on either side of the hinge. In Figure 1 the bar on the left of the hinge is spaced at 6 inches and the one on the right is spaced at 8 inches while the remainder of the longitudinal bars are spaced at 7 inch centers. Apparently the reason for this is to allow the longitudinal bars to mismatch when folded in order to provide a thinner bundle as shown in Figure 2. As a result one half of the mat is approximately 2 inches wider than the other.

Figure 1. View showing hinge construction in center of mat.

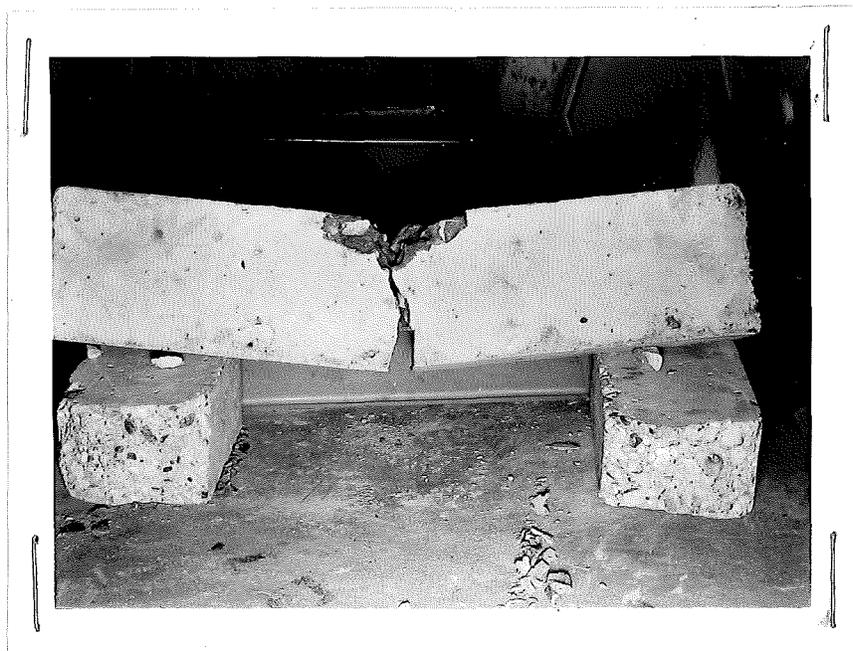
Figure 16. Specimen with continuous bar. Concrete failed in compression. Bar still unbroken.

The specimen containing the single 3/8" rod developed a crack at a total applied load of 13,700 pounds. Figures 15 and 16 show the condition of the beam at the appearance of the first crack and at ultimate failure respectively.
