MICHIGAN DEPARTMENT OF TRANSPORTATION
MDOT

CONCRETE SURFACE TEXTURING STUDY

Testing and Research Section
Construction and Technology Division
Research Project 71C-0013 (Phase 2)
Research Report No. R-1423

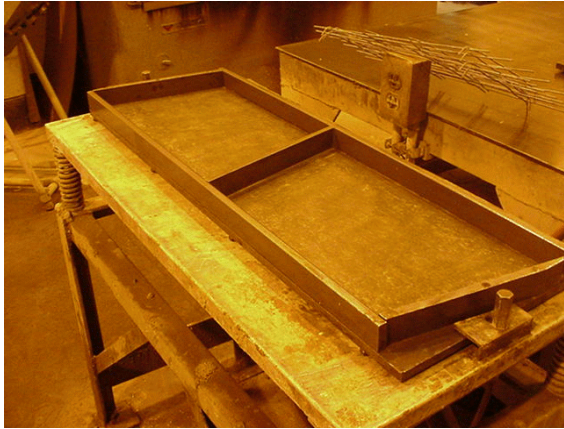
Wear track slab forms

Each slab was cast in the wear track slab forms. The sand mixes were constructed in one layer. Once the form was filled with the concrete mixture it was vibrated for consolidation and wire mesh was placed approximately at mid height of the slab. The slabs were then struck off to remove the excess concrete. Each slab was then given a smooth finish with a steel trowel. The concrete mixes containing 26A aggregate were constructed in two layers. The concrete was first placed in the form to approximately the half way point. Wire mesh was then placed on this layer. The form was then slightly overfilled and consolidated by vibration. The slabs were struck off to remove the excess concrete and then each was given a smooth steel trowel finish.

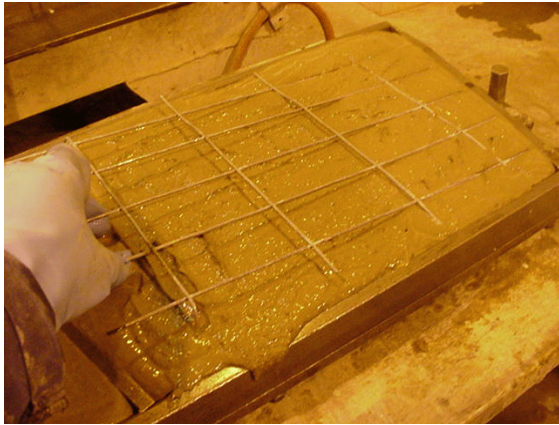
Wire mesh is placed in the filled form

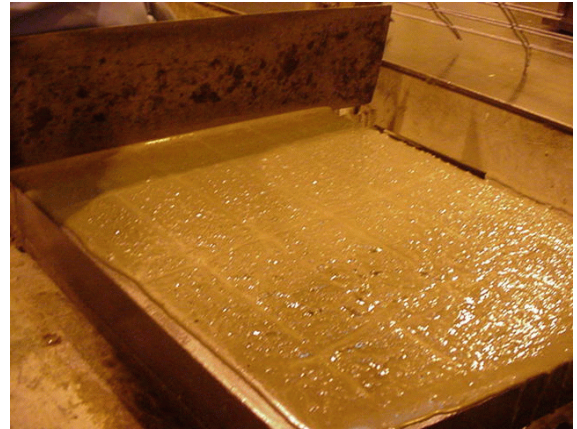
The excess concrete is struck off

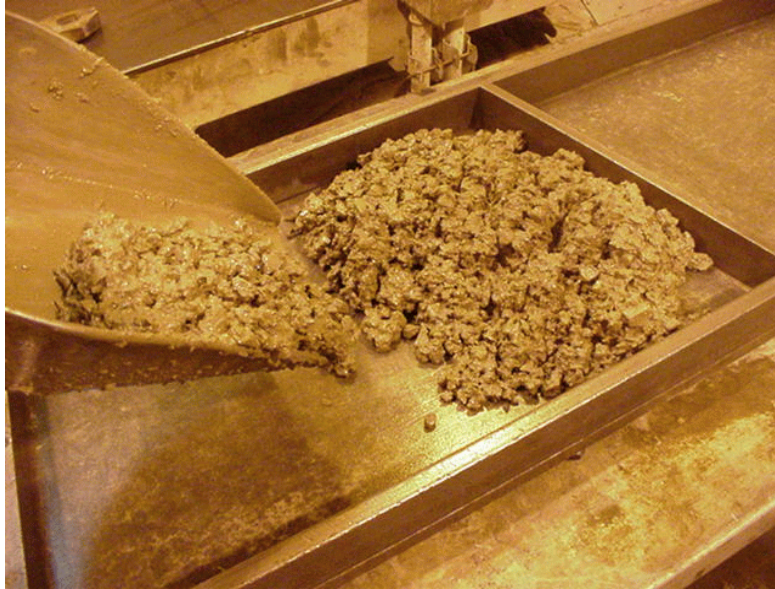
26A concrete mixture being placed in form

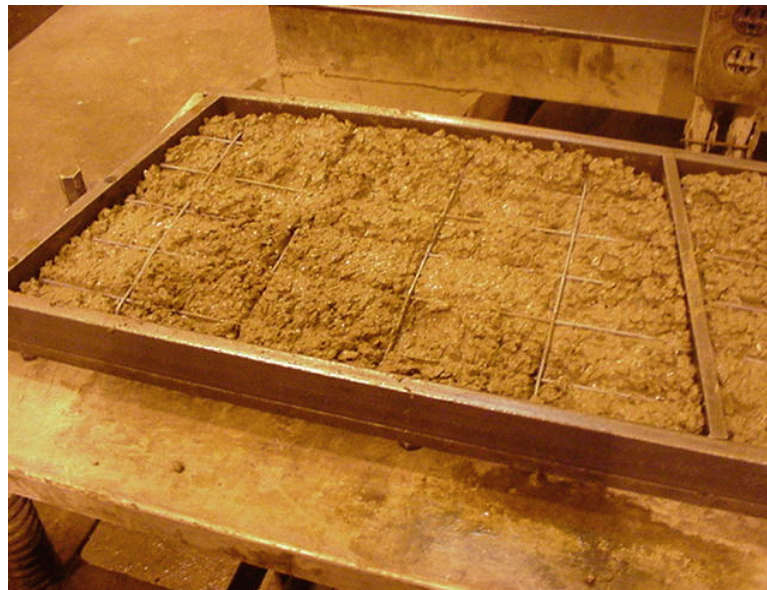
Wire mesh is placed on the first layer of concrete

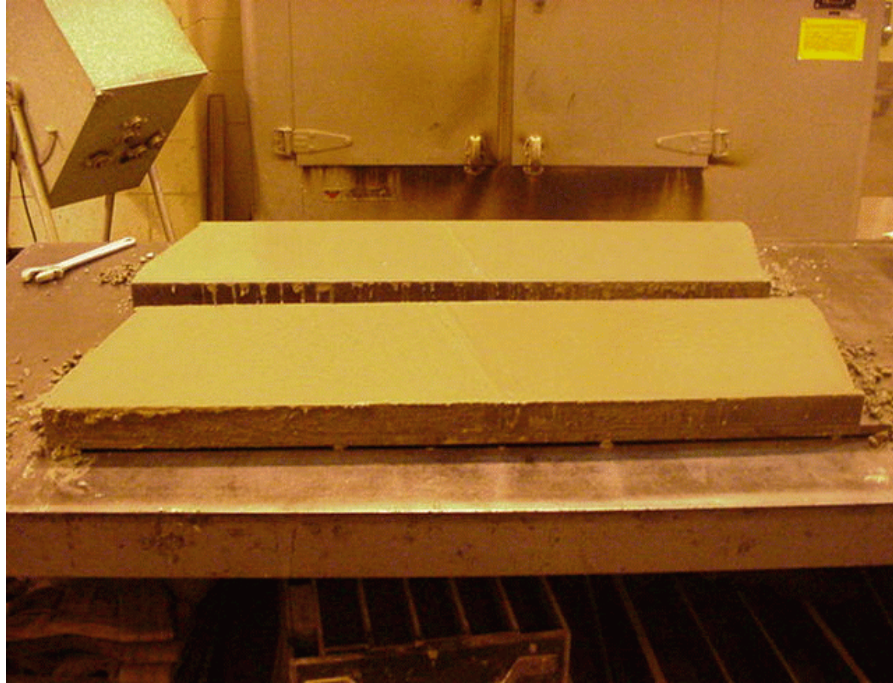
The remaining concrete is placed, consolidated, and struck off
The slabs are then given a smooth finish with a steel trowel

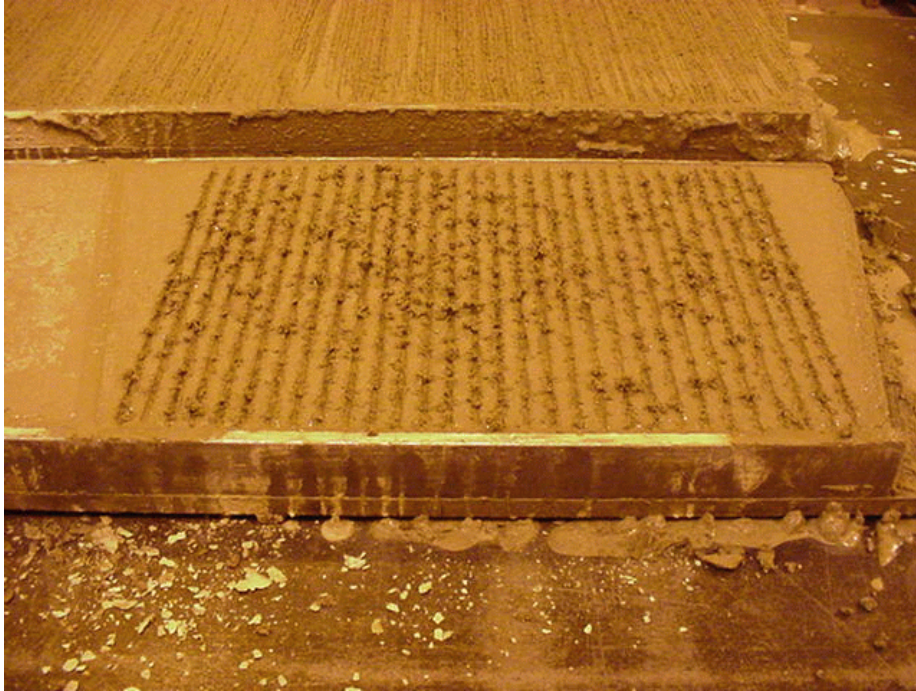
Transversely tined surface

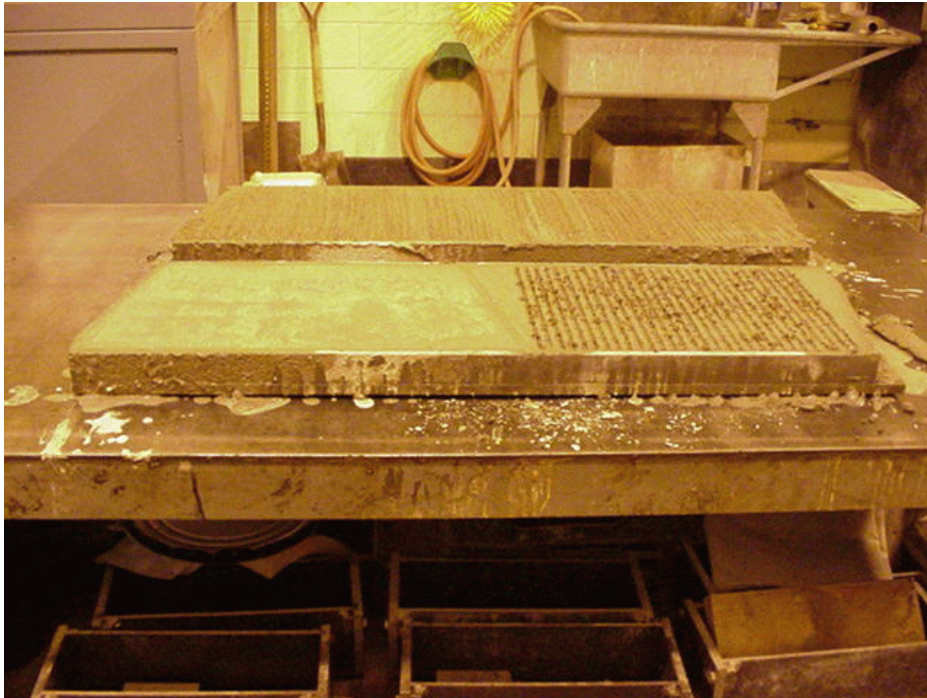
Smooth trowel finish (bottom left), transversely tined finish (bottom right), astroturf drag finish (top)

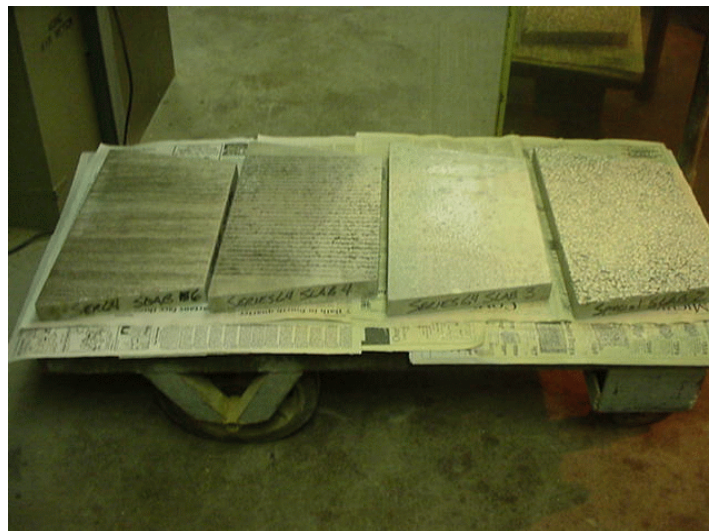
White pigmented curing compound (above) was spray applied (below) to slabs 2 through 16

The textured slabs were covered with polyethylene and allowed to cure overnight. Each slab specimen was stripped from the form after approximately twenty-four hours. The slabs were then immersed in lime saturated water for a minimum of seven days. After the seven-day immersion cure, the slabs were removed from the water, brushed off, and sprayed with fresh water to remove excess lime. Each specimen was allowed to air dry to a point where no surface moisture was present. At that point, *R.W. Meadows Sealtight Lin-Seal™ White*, white pigmented concrete curing compound was spray applied to slabs 2 through 16. Slab 1 will be the lone control slab for this wear track test series.

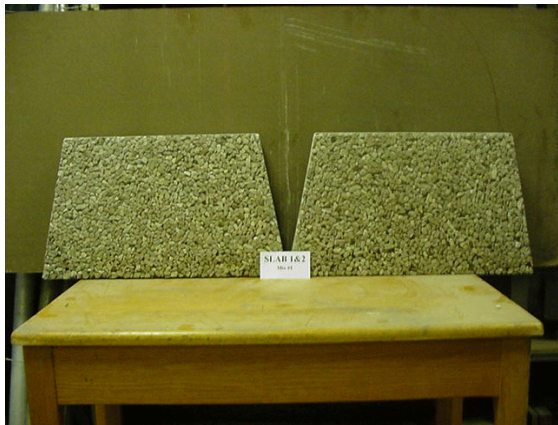
Slabs 1 & 2

Control slabs 1 and 2

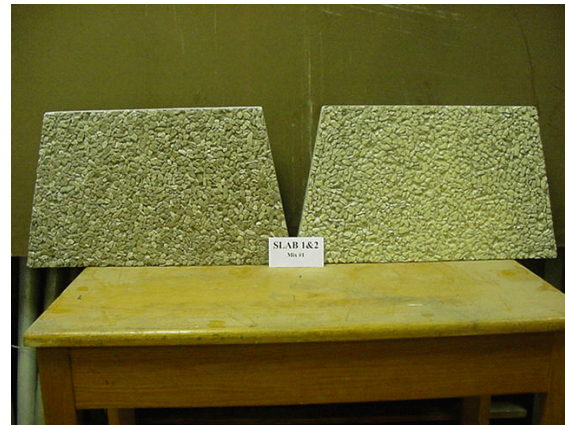
Slab 2 (right) is coated with curing compound

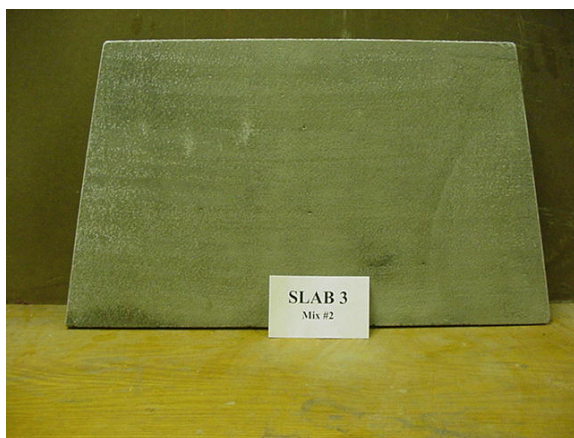
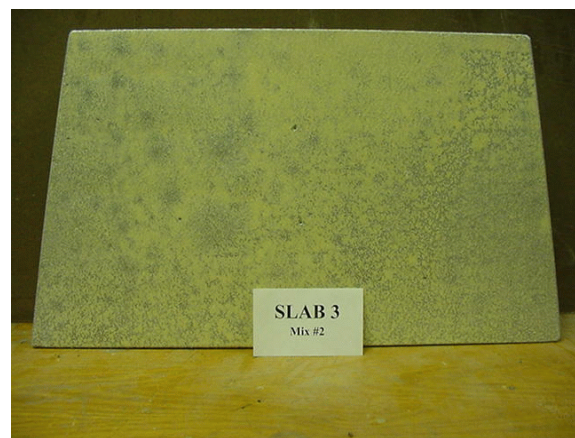
Slab 3

Photo at left shows slab 3 smooth trowel finish, at right is slab 3 with curing compound applied

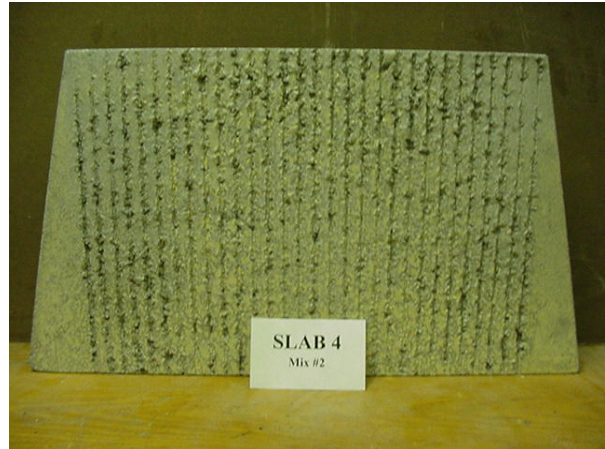
Slab 4 tined finish (left), and slab 4 with curing compound (right)

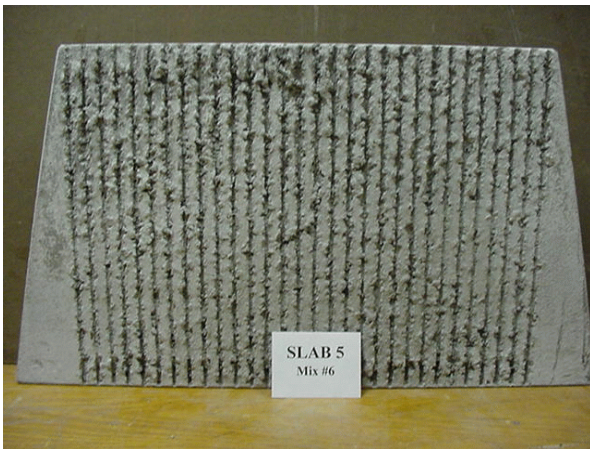
Slab 5

Tined surface texture on slab 5

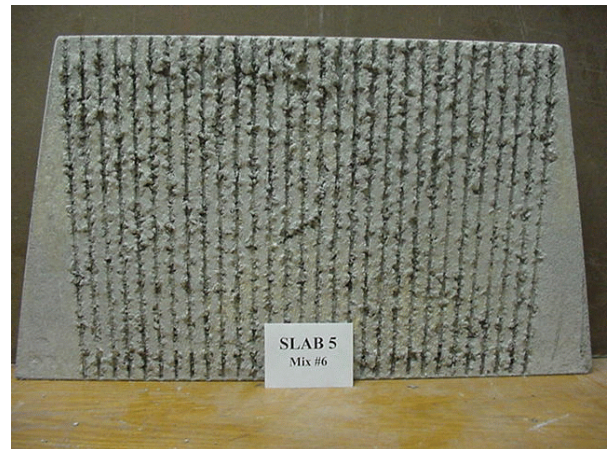
Slab 5 coated with curing compound

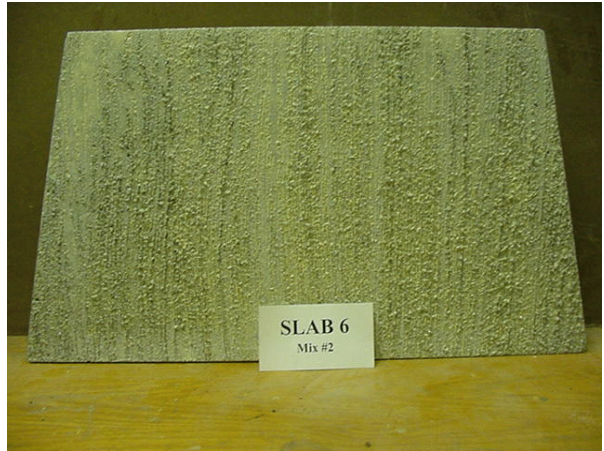
Slab 6 with astroturf drag finish (left) and coated with curing compound (right)

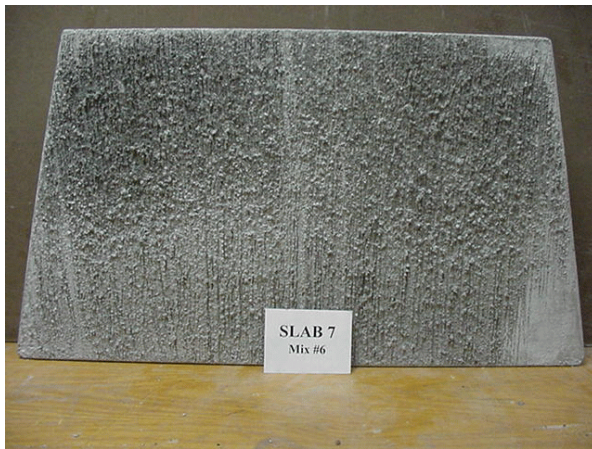
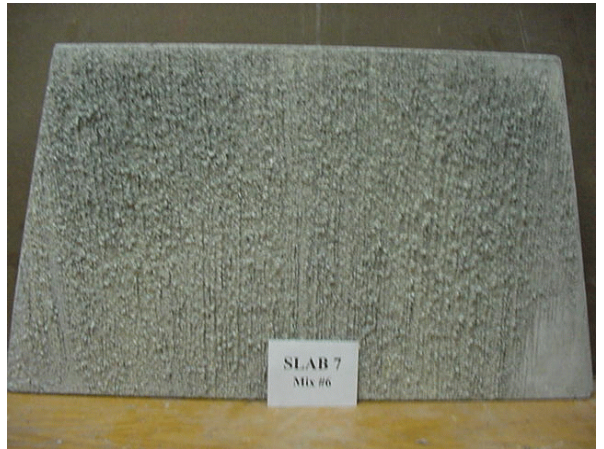
Slab 7 with transverse astroturf drag texture (left), and coated with white curing compound (right)

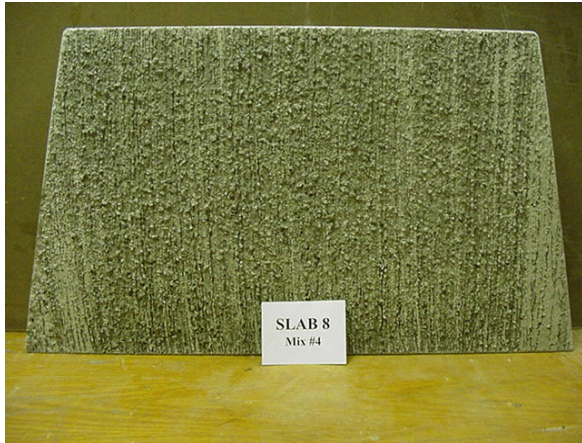
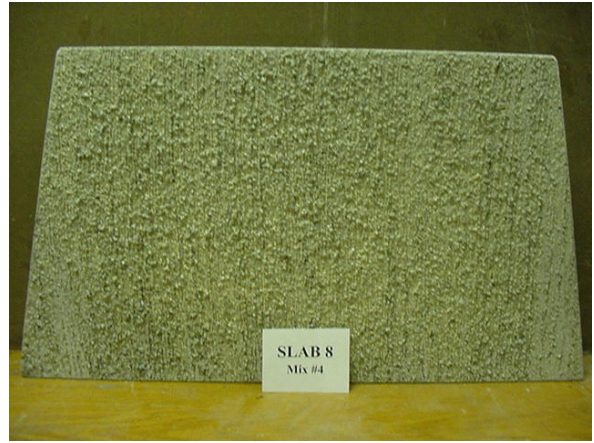
Slab 8 (left) with astroturf drag texture and coated with curing compound (right)

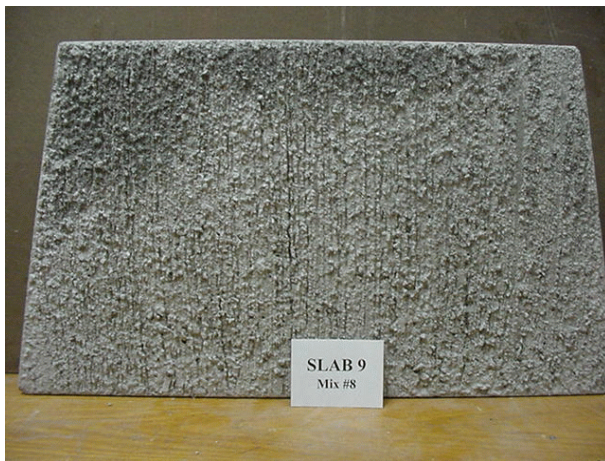
Slab 9

Astroturf drag texture on slab 9

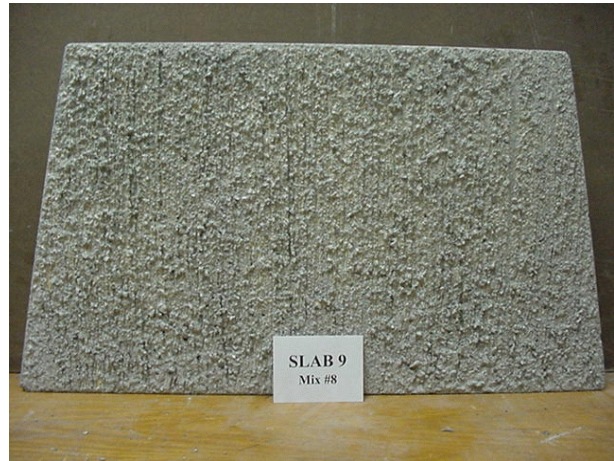
Slab 9 coated with curing compound

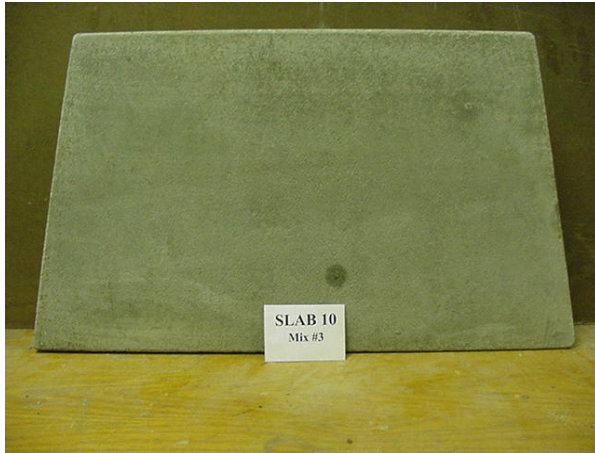
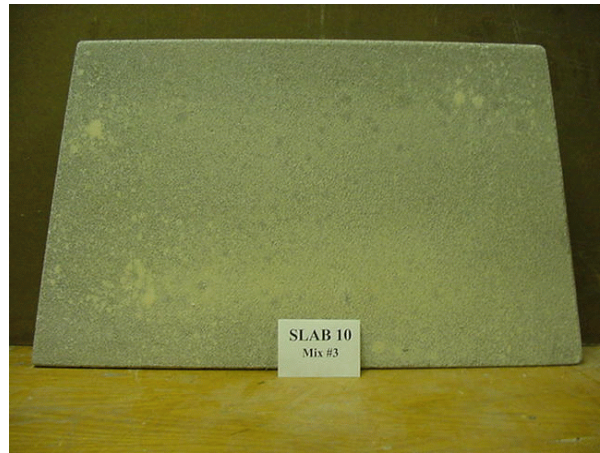
Slab10 has a smooth trowel finish (left). Slab 10 with white pigmented curing compound (right)

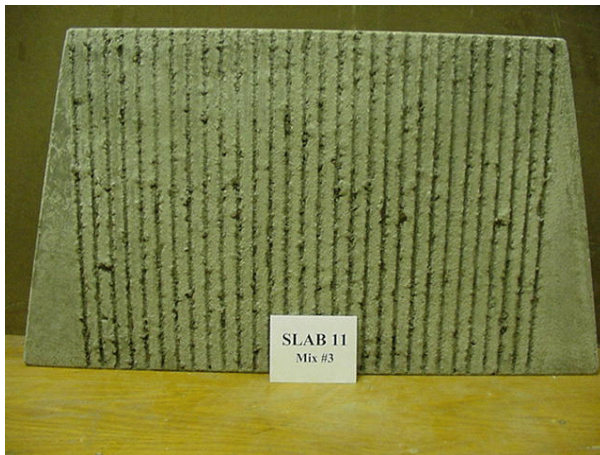
Slab 11

At left, slab 11 shows a tined surface texture, and at right, slab 11 with a coating of curing compound

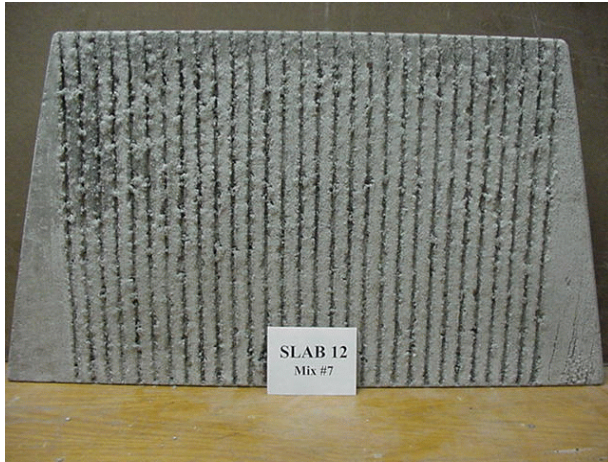
Slab 12 has a tined surface texture (left), and the same slab coated with white pigmented curing compound (right)

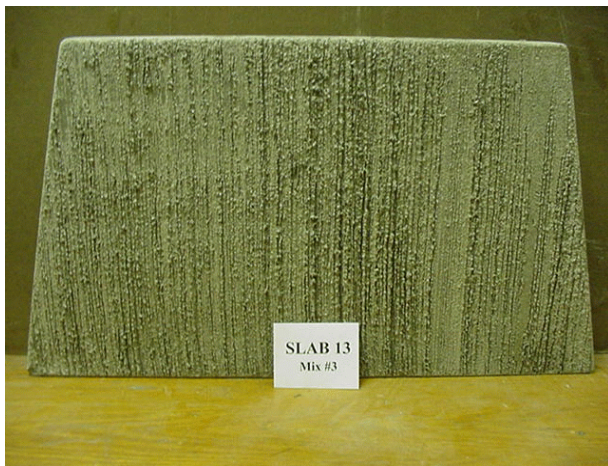
Slab 13 with astroturf drag texture

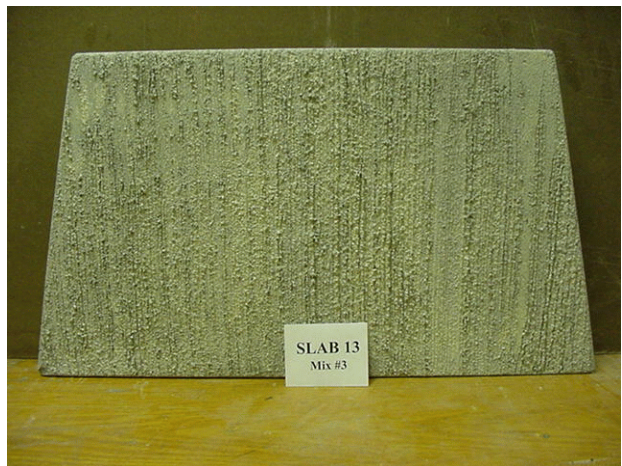
Slab 13 with white curing compound

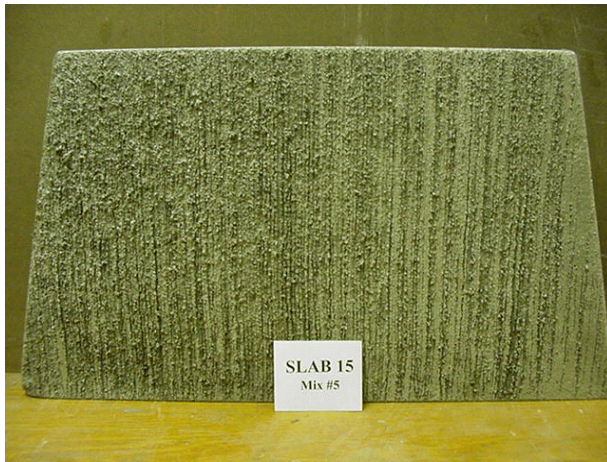
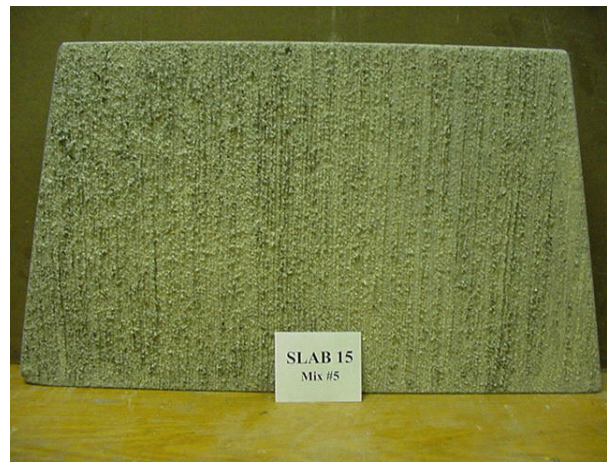
Slab 15

At left is slab 15 with an astroturf drag surface texture, and, at right, is slab 15 coated with curing compound

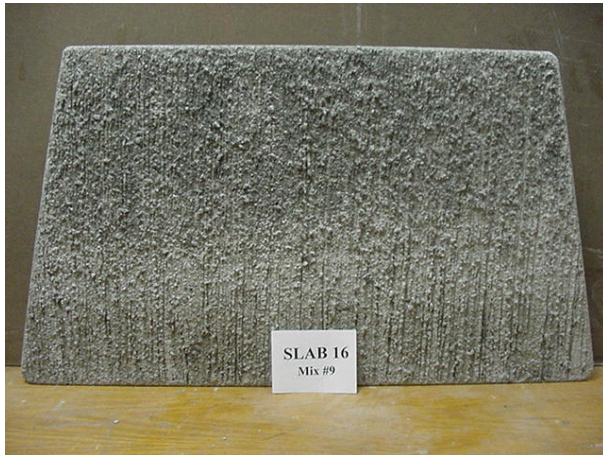
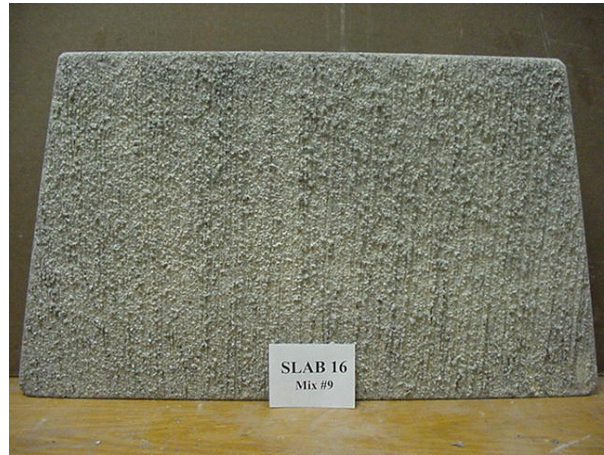
Slab 16

Astroturf drag finish on slab 16 (left), and slab 16 coated with curing compound (right)

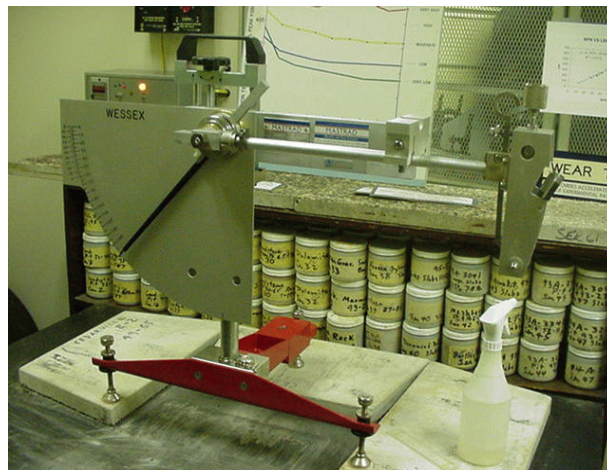
Prior to skid testing, slabs 1 through 16 were tested by the British Pendulum test method. Each slab was again tested by this method after 0.5 million wheel passes, and four million wheel passes on the wear track. Wear track testing progressed in the normal method, with slabs 1 through 16 being tested for skid resistance every 0.5 million wheel passes, until a total of four million wheel passes was reached.

British Pendulum Tester

Remarks: British Pendulum test results represent the average of five test drops on each slab, following ASTM E 303 Standard Method of Test for Surface Frictional Properties Using the British Pendulum Tester.
