Report TSD-232-73

A TRAFFIC ACCIDENT ANALYSIS
OF HIGH ACCIDENT LOCATIONS
IN THE CITY OF PORTAGE

ROBERT G. LARIVIERE
TRAFFIC ENGINEERING SERVICES

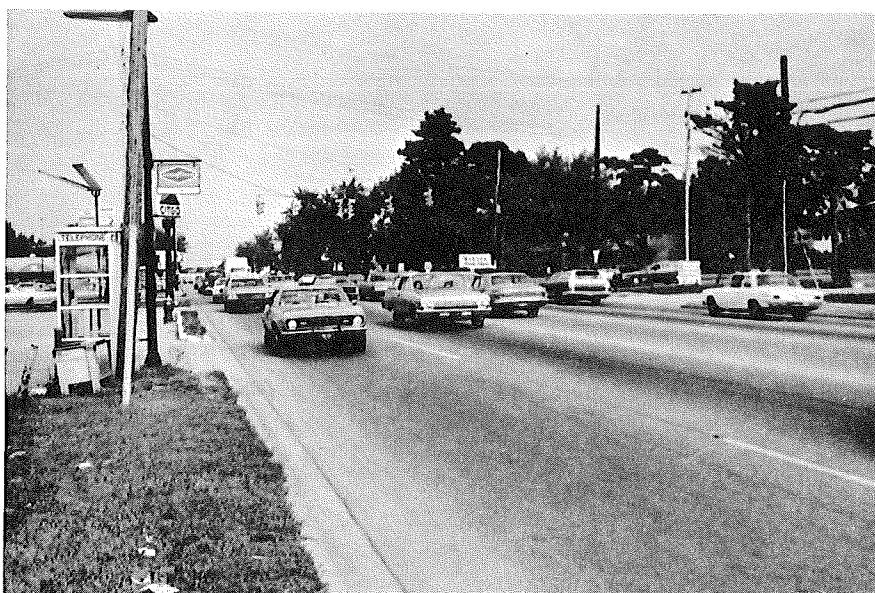
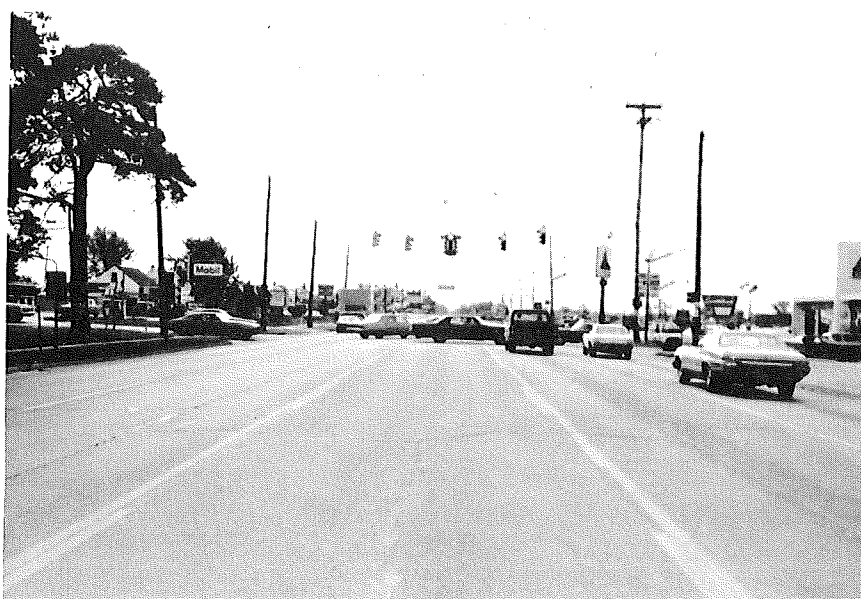
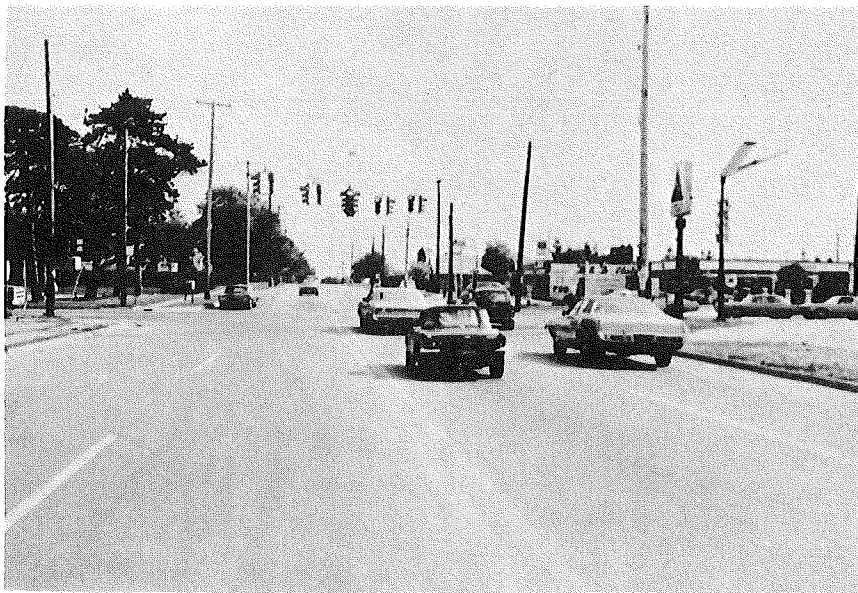
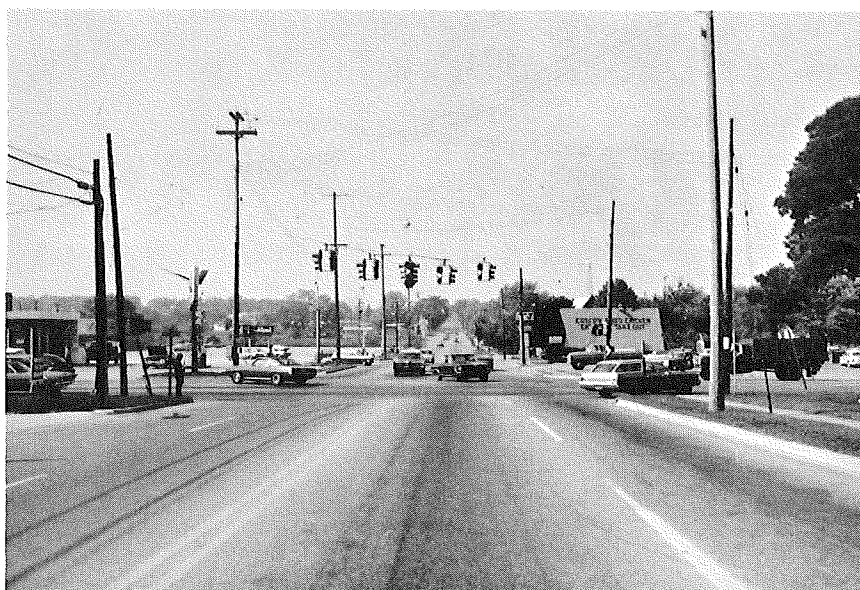
FIGURE 7

NORTHBOUND WESTNEDGE AVENUE

SOUTHBOUND WESTNEDGE AVENUE

EASTBOUND MILHAM ROAD

WESTBOUND MILHAM ROAD

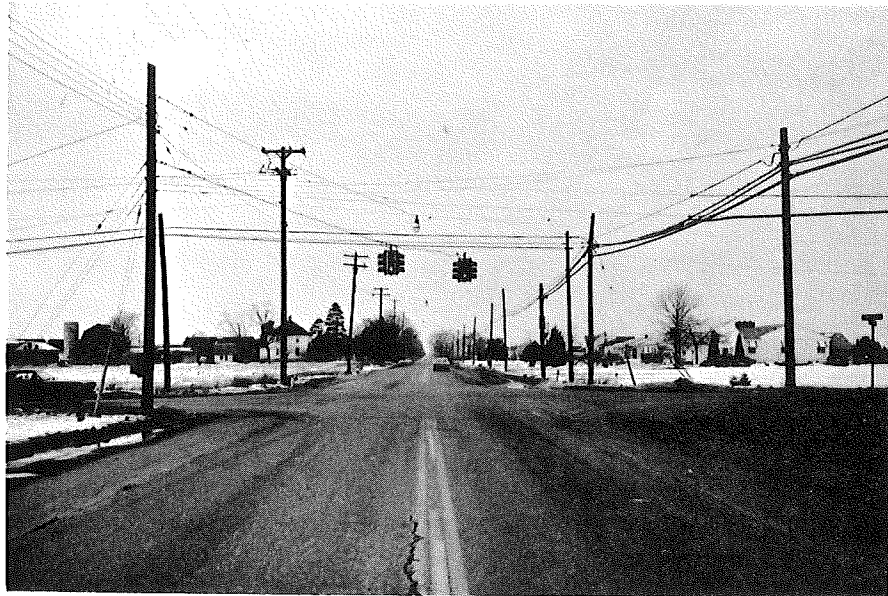
FIGURE 11

EASTBOUND MILHAM ROAD

WESTBOUND MILHAM ROAD

SOUTHBOUND OAKLAND DRIVE

NORTHBOUND OAKLAND DRIVE

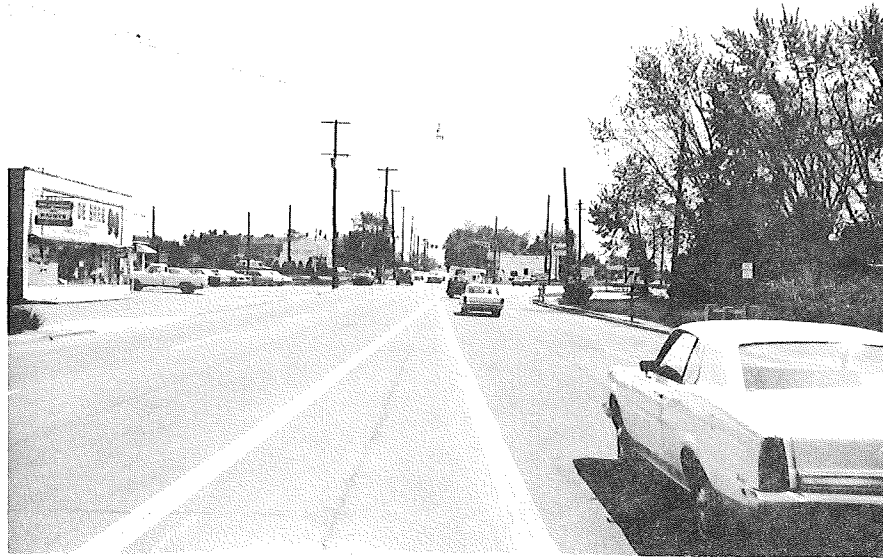
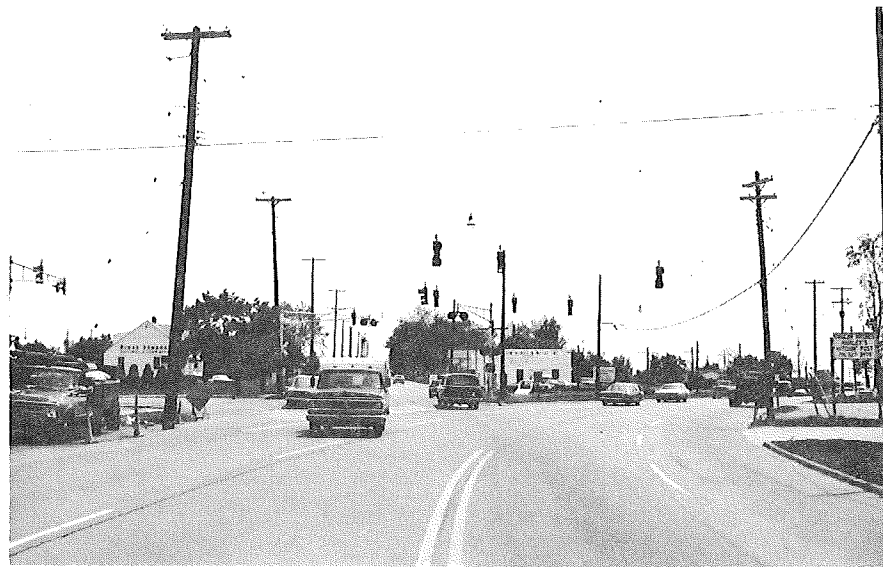
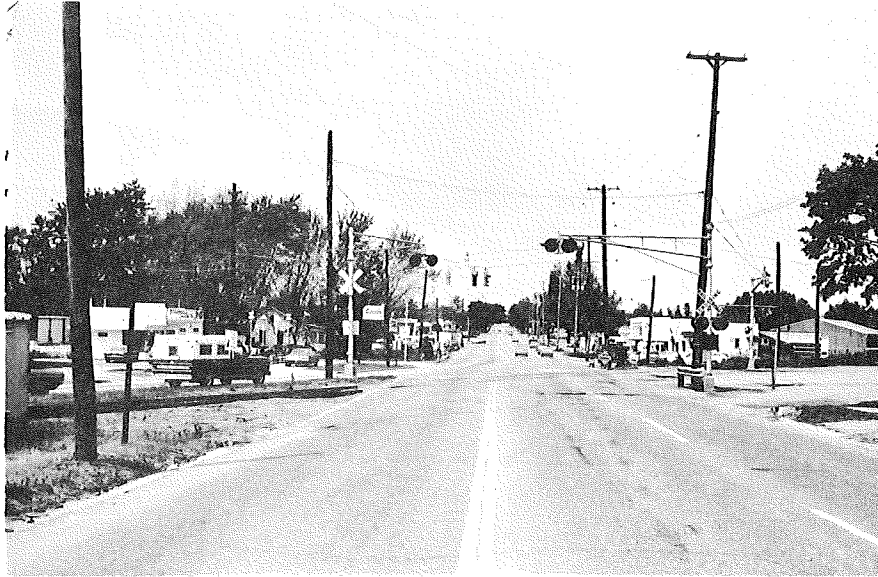
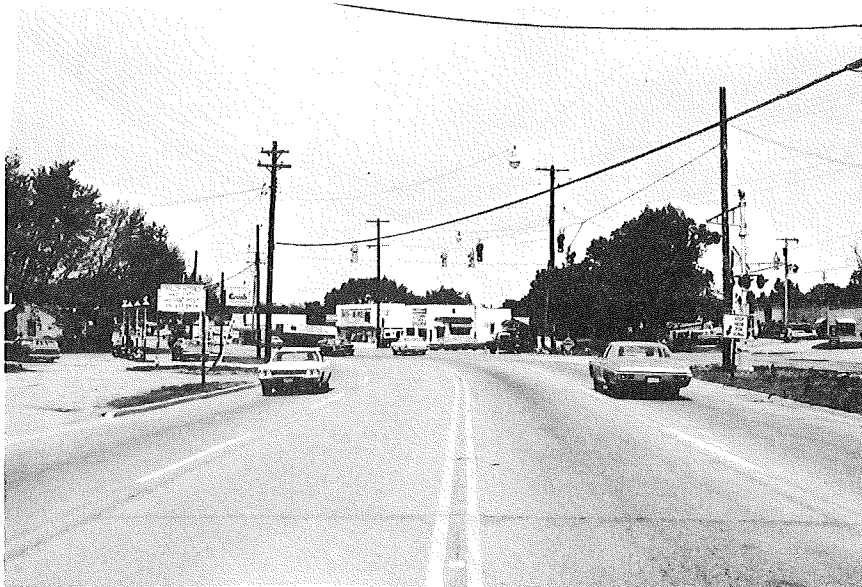
FIGURE 13

SOUTHBOUND WESTNEDGE AVENUE

NORTHBOUND WESTNEDGE AVENUE

NORTHEASTBOUND SHAVER ROAD

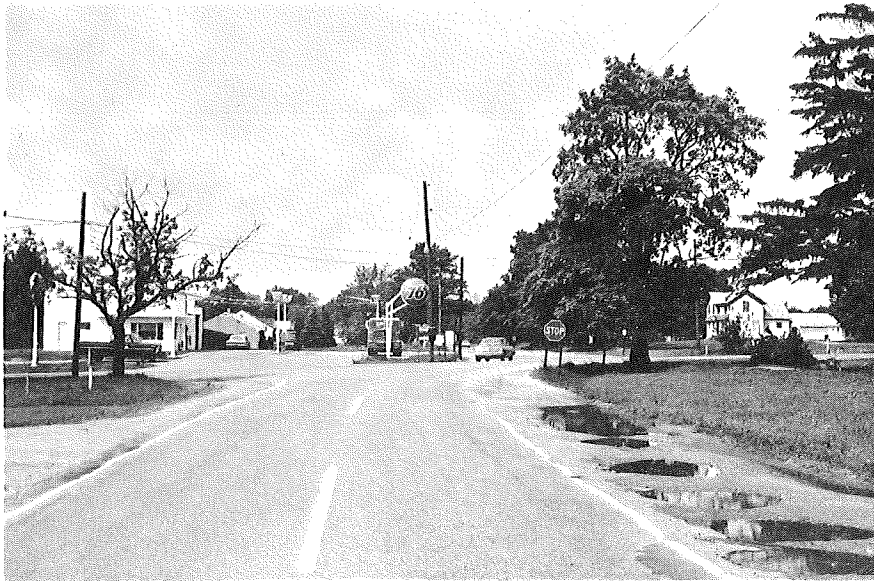
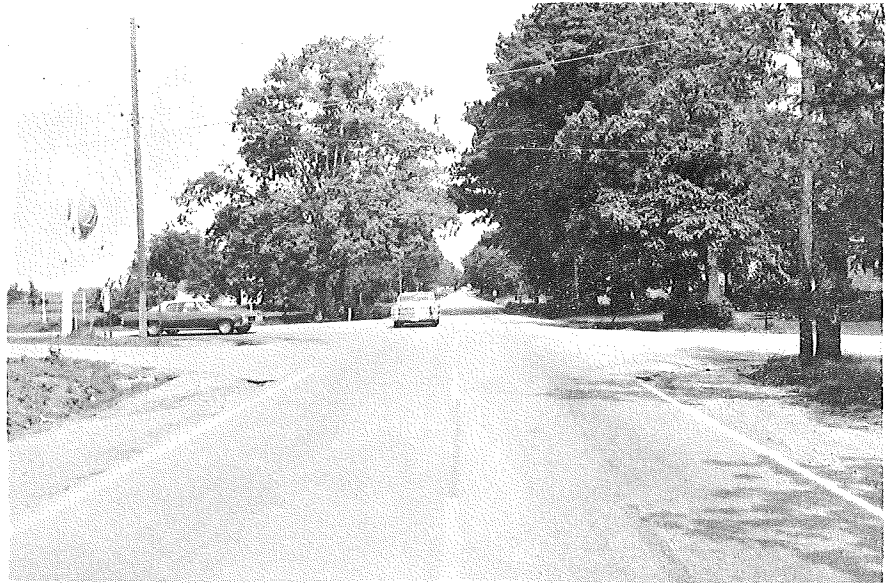
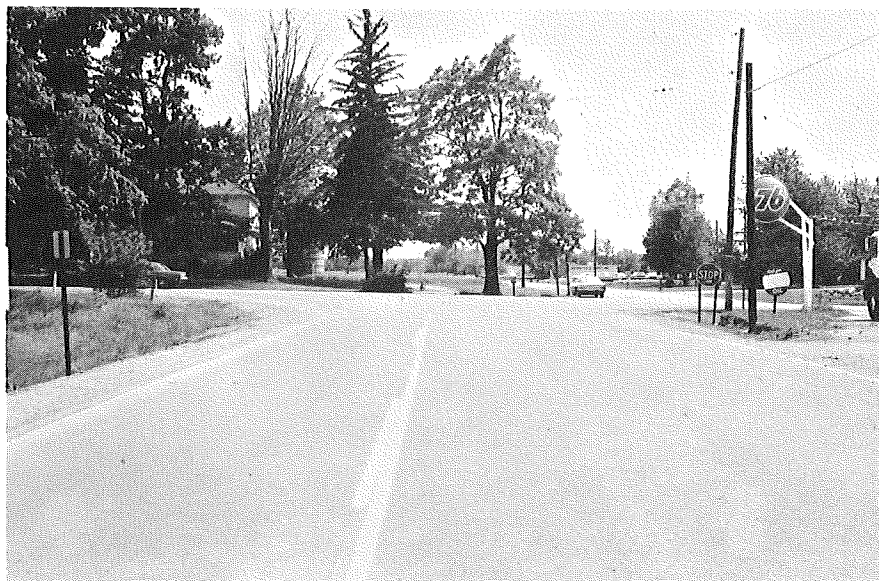
FIGURE 19

NORTHBOUND
LOVERS LANE

EASTBOUND
MILHAM ROAD

SOUTHBOUND
LOVERS LANE

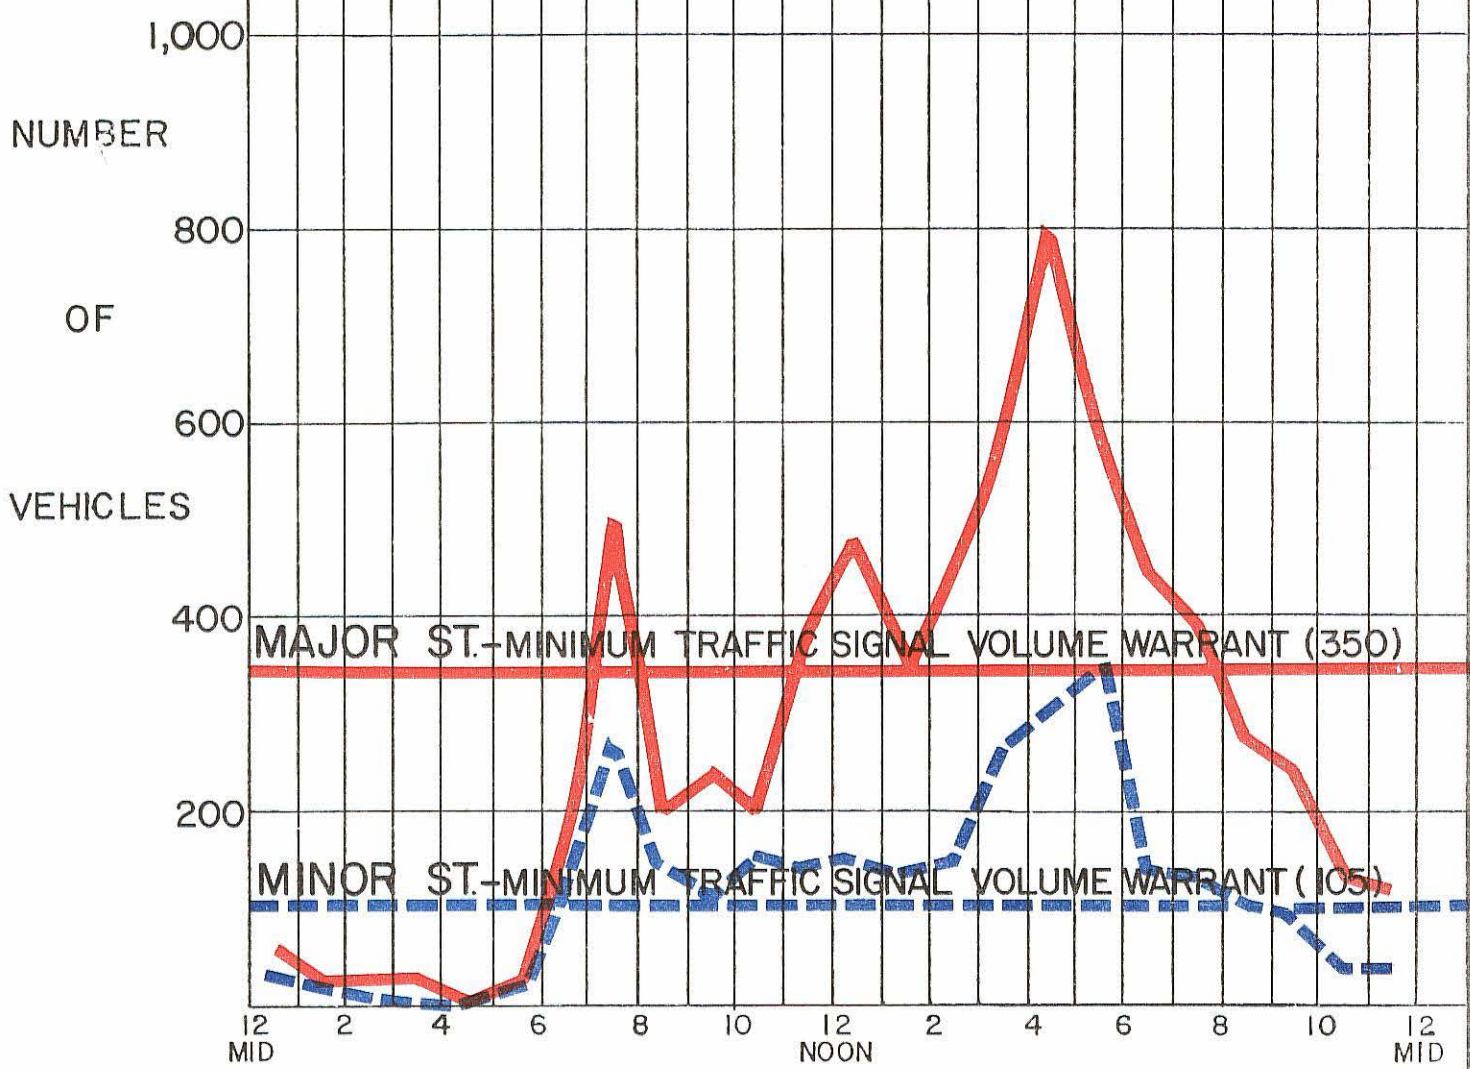
SURVEY TAKEN 3-27-73

TIME OF DAY

During the analysis at this location a Traffic Signal Warrant Graph was prepared. The results which can be found on p. 35 indicate that this intersection meets the minimum vehicular volume requirements of Warrant #1 for pretimed signals. Thus, it is recommended that two overhead signals be erected. The Lovers Lane offset should be eliminated to prevent the development of a conflict between opposing right and left turns off Lovers Lane. Furthermore, two approach lanes should be provided for each leg of the intersection to increase capacity by reducing through traffic delay caused by left turning vehicles.

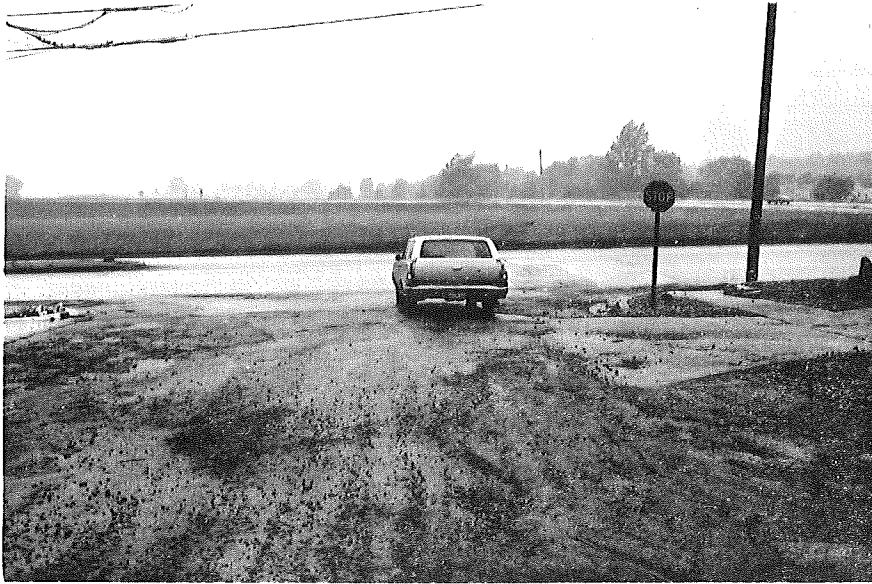
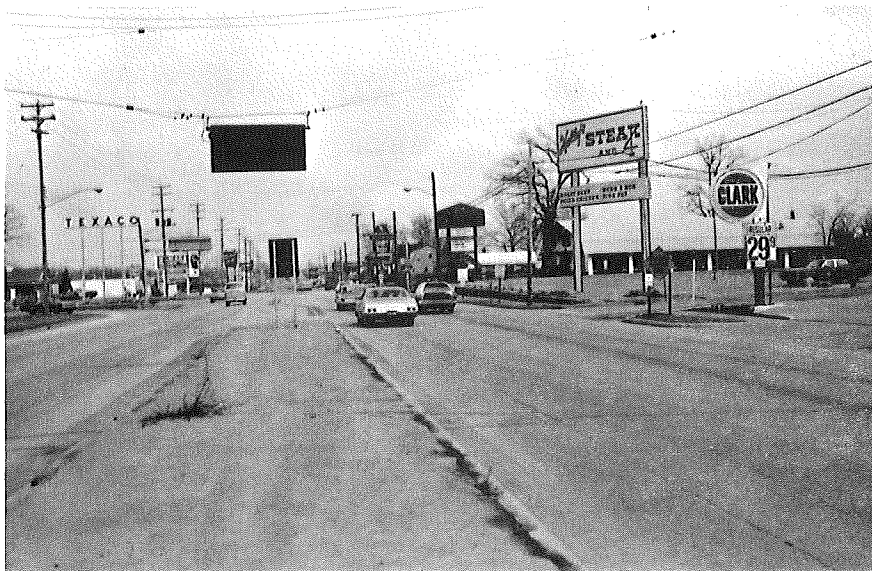
FIGURE 22

WESTBOUND
AMOS STREET

SOUTHBOUND
WESTNEDGE AVENUE

NORTHBOUND
WESTNEDGE AVENUE

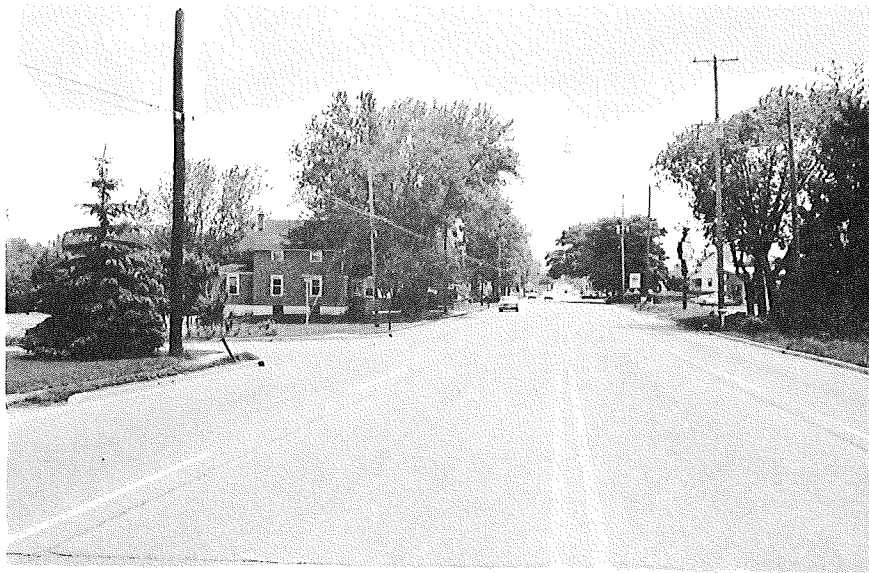
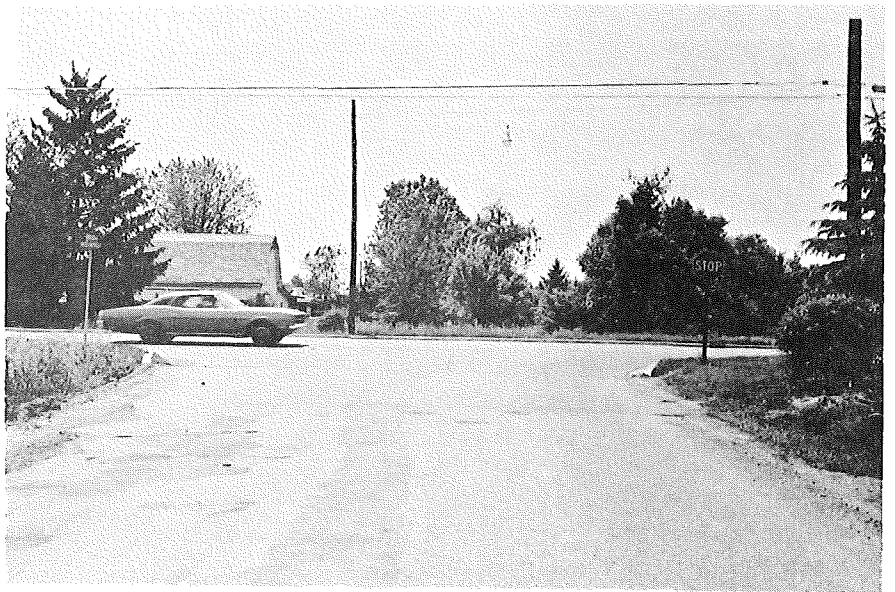
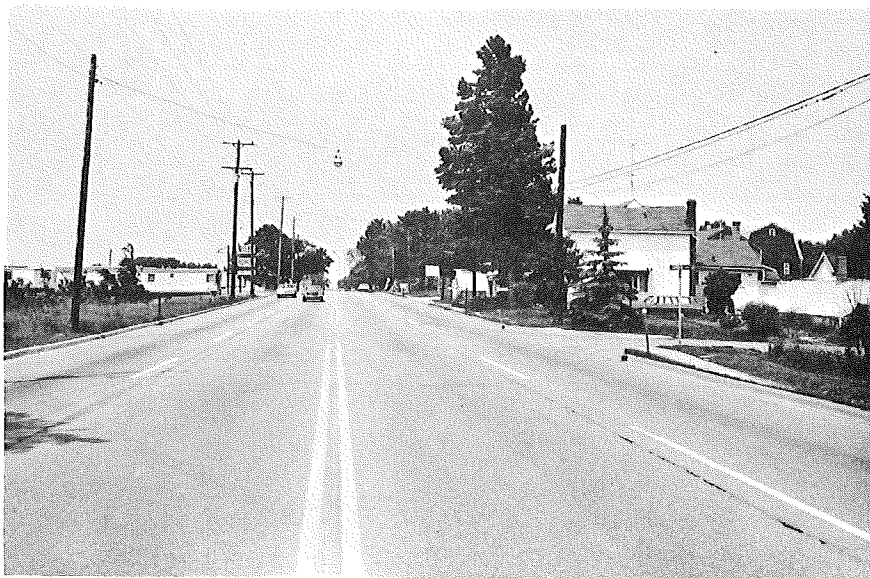
FIGURE 24

SOUTHBOUND
WESTNEDGE AVENUE

WESTBOUND
GARDEN LANE

NORTHBOUND
WESTNEDGE AVENUE

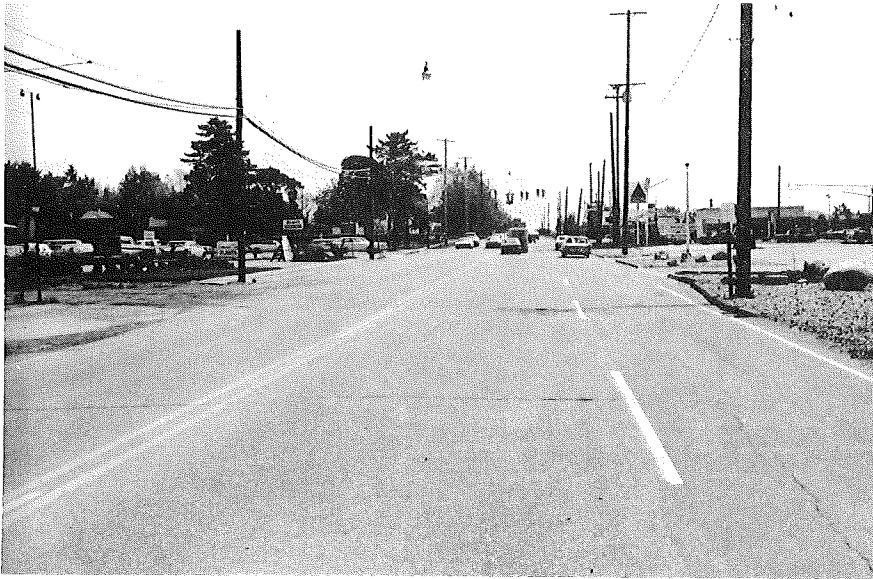
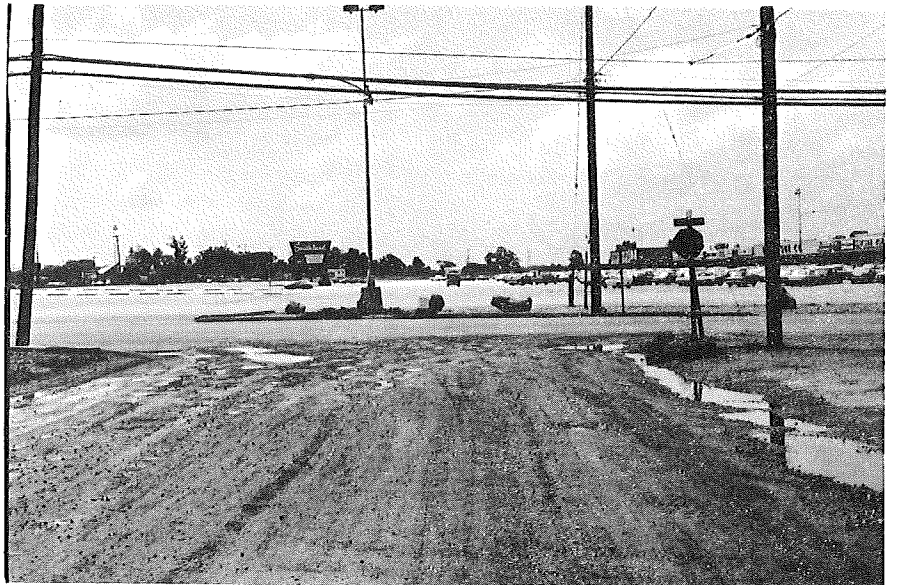
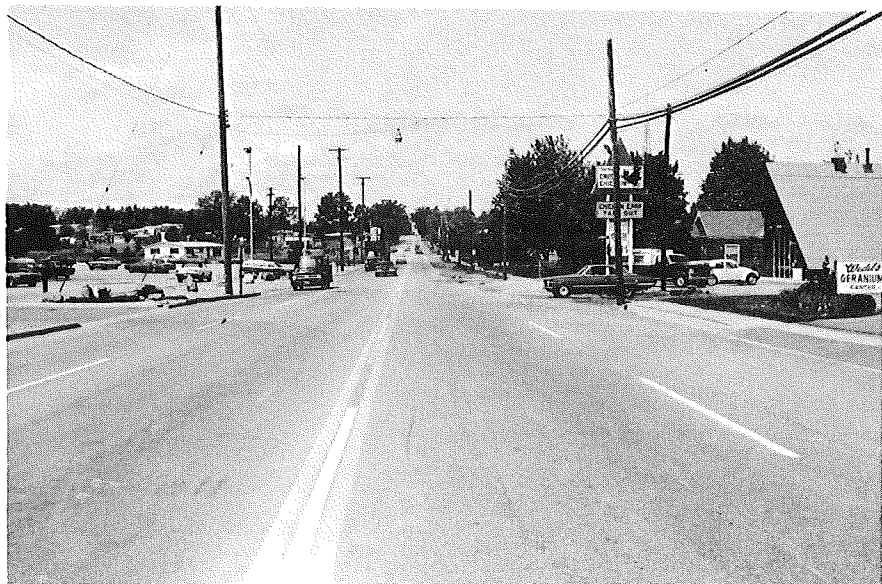
FIGURE 26

EASTBOUND
MILHAM AVENUE

SOUTHBOUND
VERMONT STREET

WESTBOUND
MILHAM ROAD
