CATATHERM THERMOPLASTIC STRIPING

Research Laboratory Division
Office of Testing and Research
Report No. 312
Research Project 47 G-36(10a)
Progress Report 1

Michigan State Highway Department
John C. Mackie, Commissioner
Lansing, April 1959

CATATHERM THERMOPLASTIC STRIPING
in 1957 Performance Tests

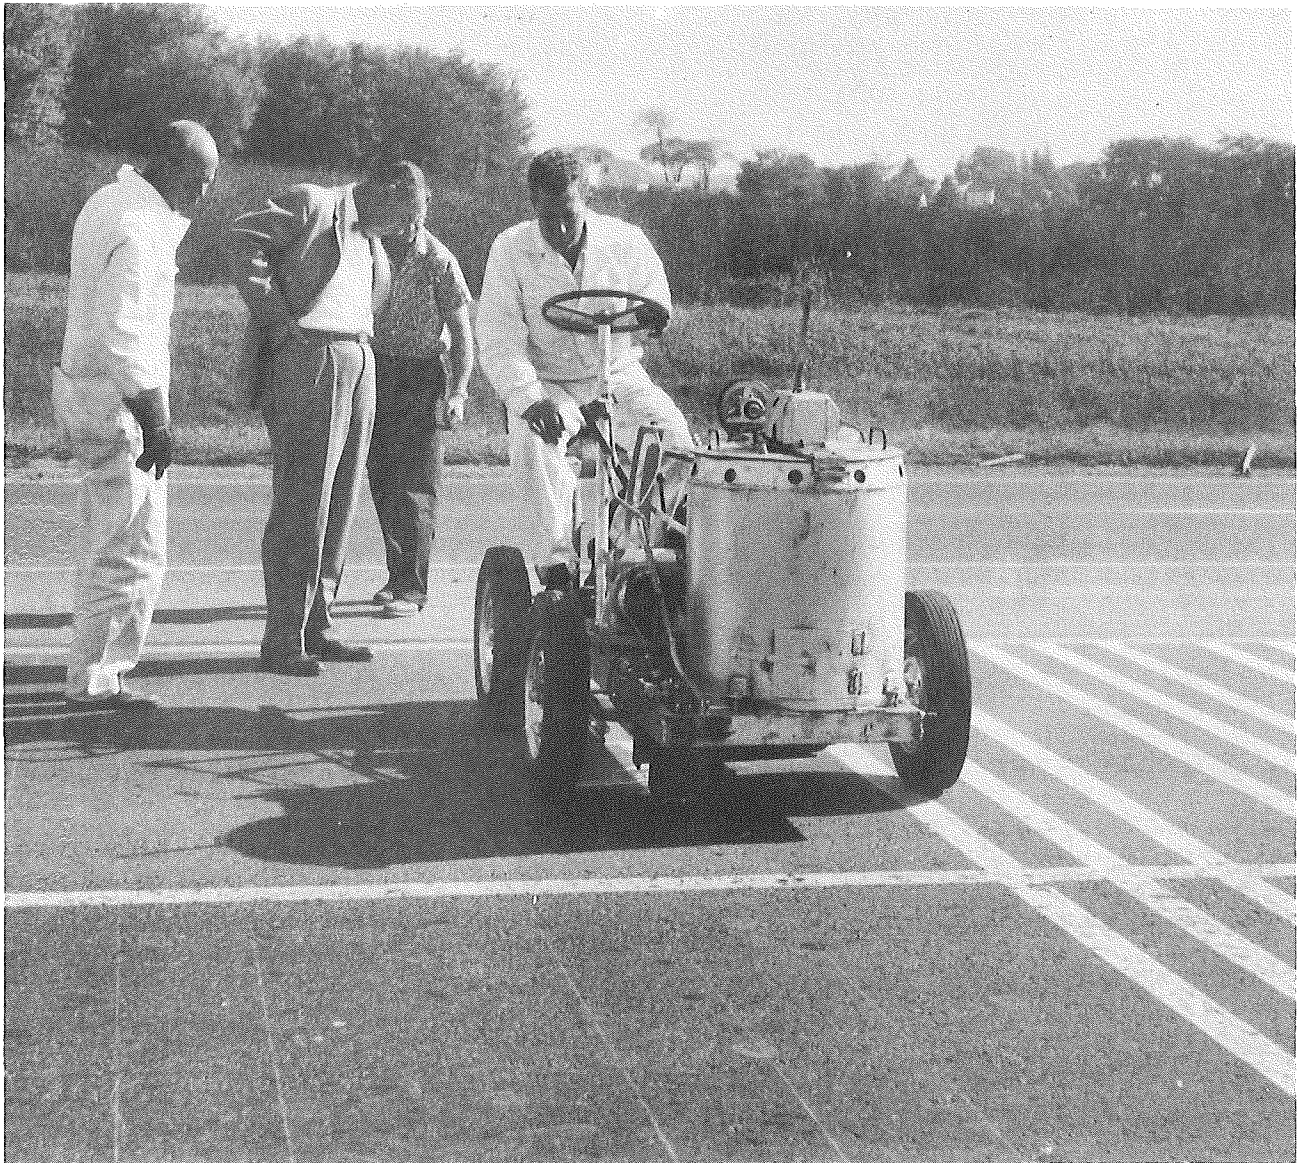
Figure 1. Producer's Equipment applying stripes in Test Area.

The white Catatherm material contained no solvents and was a solid mixture of thermoplastic resins, opacifying pigments and glass beads. Deposition of this material is effected by softening to a liquid consistency at elevated temperatures, about 375° F, in special striping equipment which flows out the liquid mixture onto the roadway to shortly congeal to a solid stripe at ambient temperatures (Figure 1).

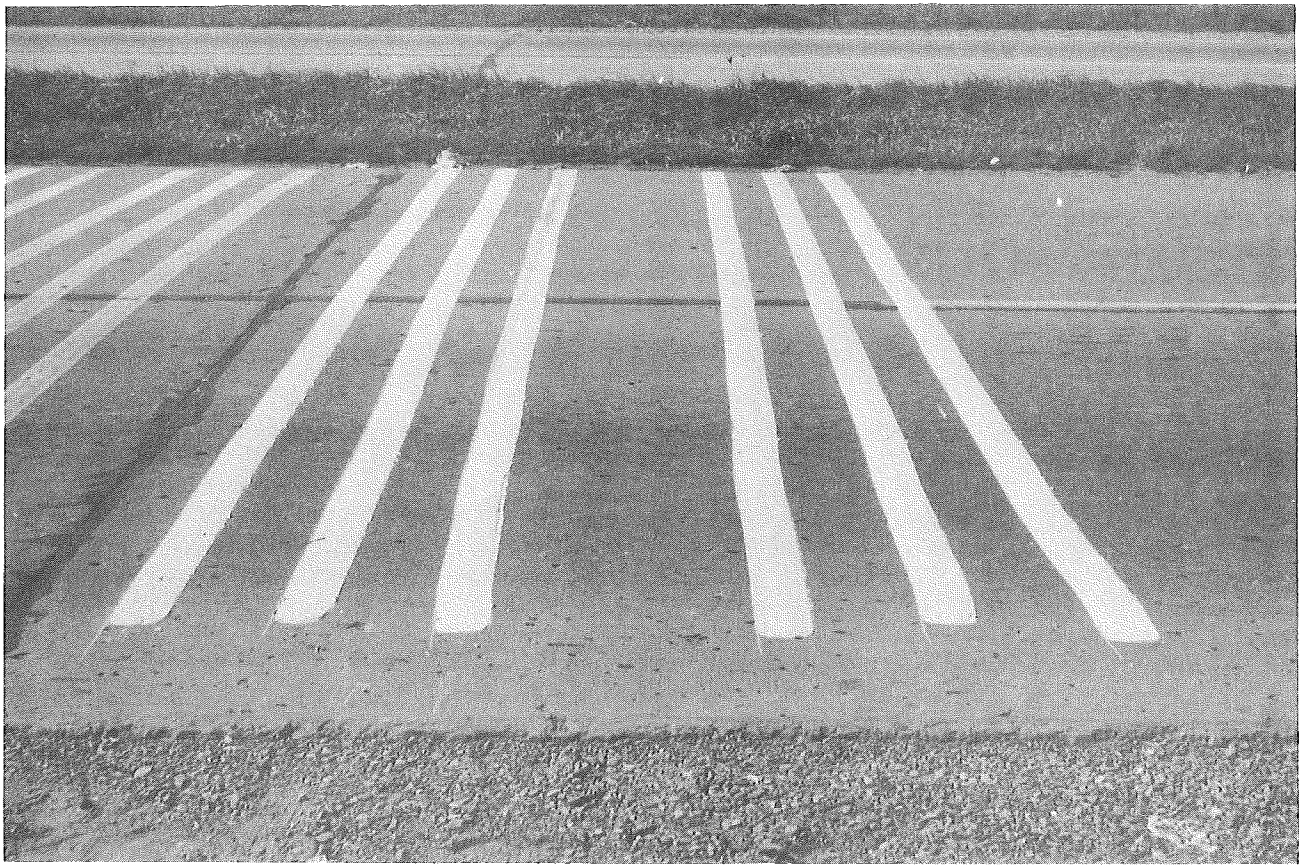
Figure 2. Catatherm Thermoplastic experimental striping on concrete of US-127, Lansing - Holt Test Area.

▲ Initial appearance of striping, October 2, 1957.

The performance of the striping can be deduced from Table I and the photographs of Figures 2 and 3. Figure 2 shows the initial appearance of the striping on concrete, as well as its condition after 150 days of exposure, and after 447 days of exposure. An examination of the values of Table I and of the photographs in Figure 2 shows that the striping failed completely in the traffic lane on concrete in the period December 1, 1957 to February 25, 1958, or in the period of 59 to 150 days exposure, respectively. However, striping in the passing lane was in fairly good condition after 150 days of exposure and did not worsen materially in an additional 300 days of exposure, up to January 21, 1959.

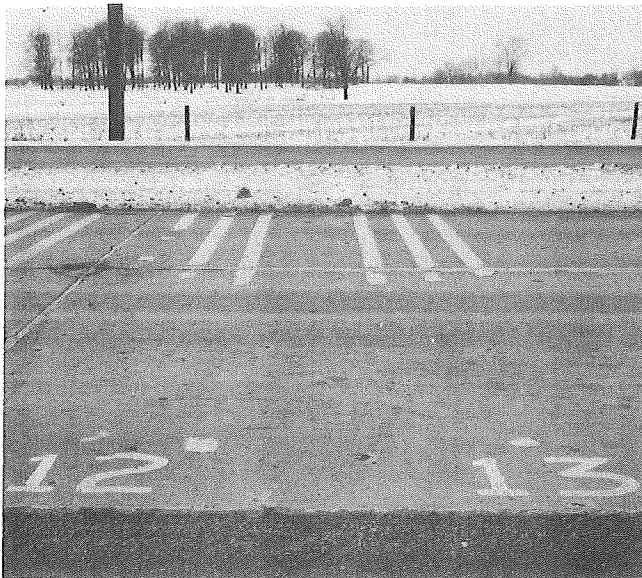
Appearance of striping
on February 25, 1958
after 150 days of exposure. ▶

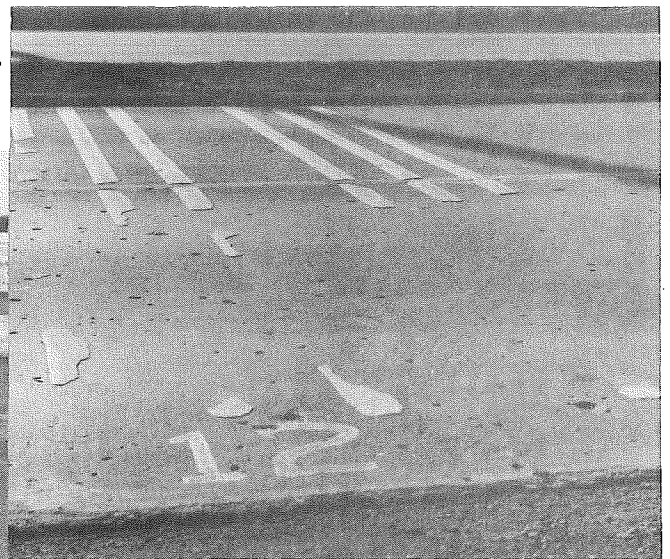
◀ Appearance of striping
on January 21, 1959
after 447 days of exposure.

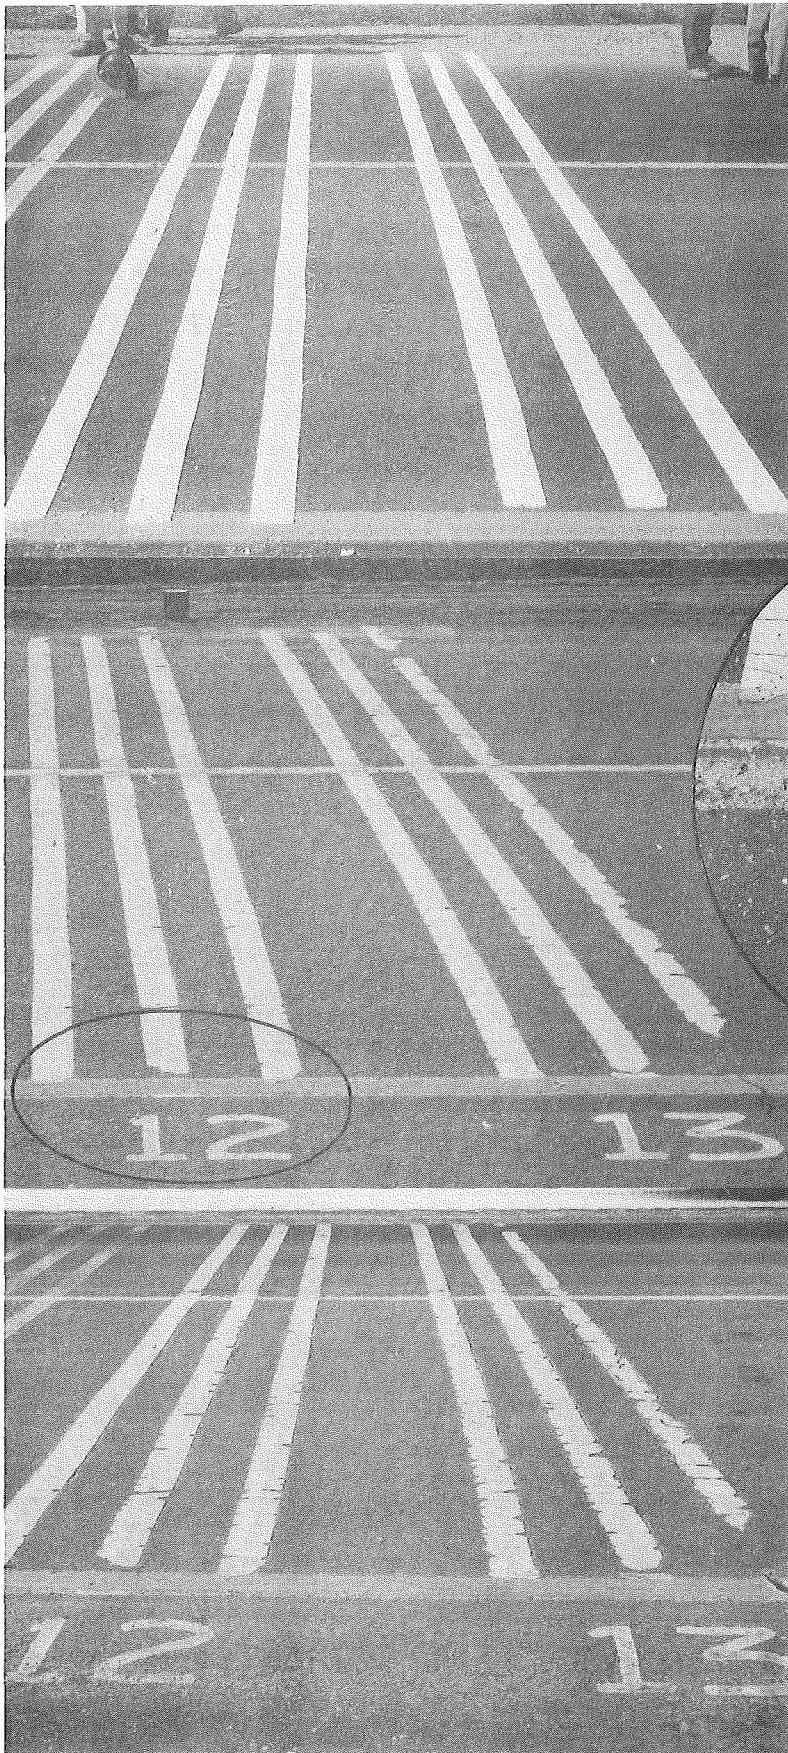
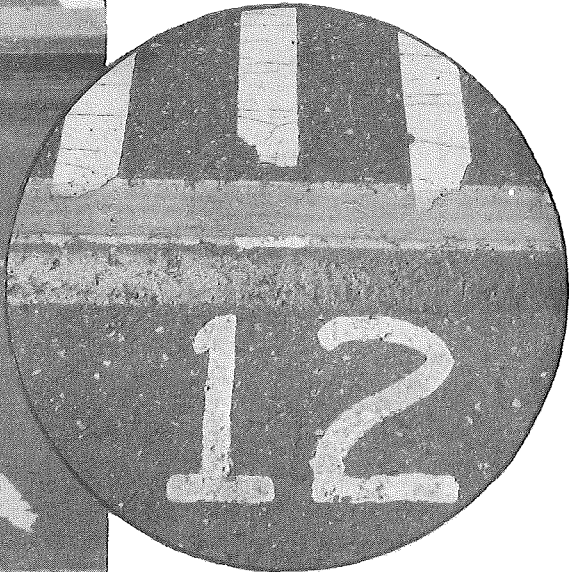
Figure 3. Catatherm Thermoplastic experimental striping on black top of US-127, Lansing - Holt Test Area.

Photos of Figure 3 illustrate the performance of the thermoplastic striping on the bituminous surface. These photos show that the striping performed much better on the black-top surface than on the concrete surface shown in Figure 2. The striping, however, is subject to a "cracking" type of deterioration with subsequent progressive fraying and loss of small segments under attrition of traffic, as shown in the photos.

Initial appearance of striping, October 2, 1957.

Appearance of striping on August 28, 1958 after 320 days of exposure.

Left - general appearance. Right - close-up, showing cracking.

Appearance of striping on January 21, 1959 after 447 days of exposure.

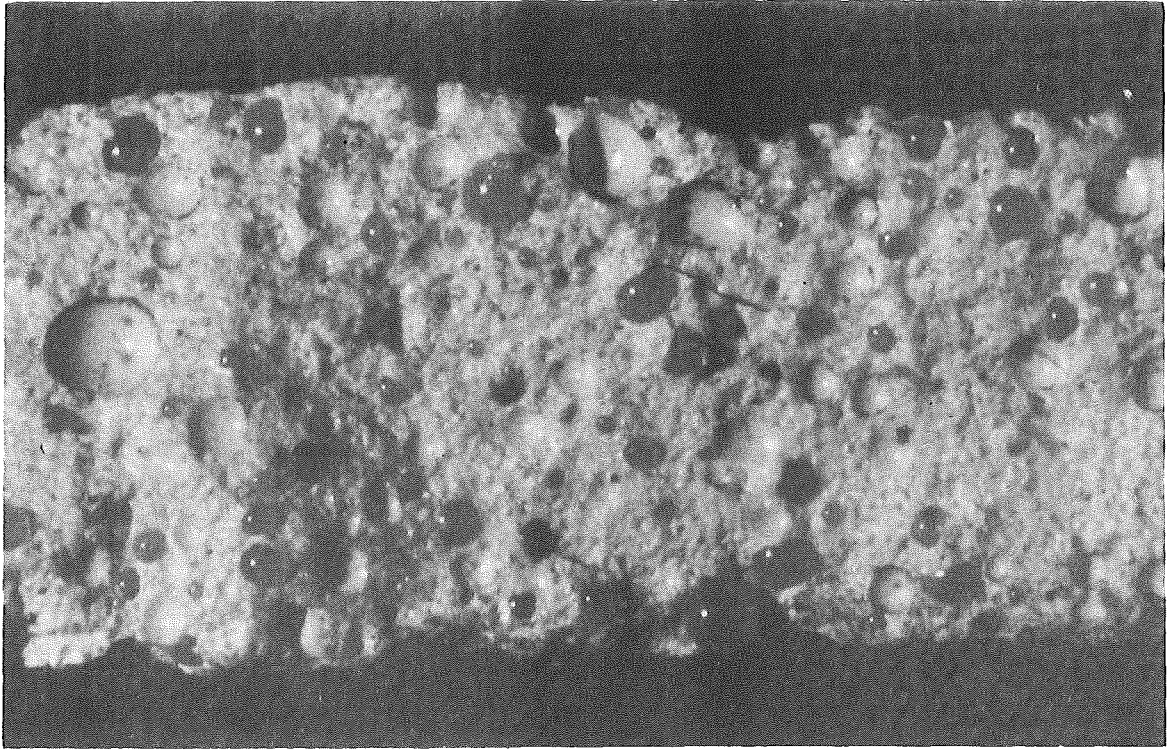
Figure 4. Side view of used Catatherm striping showing low protrusion of beads above top surface.

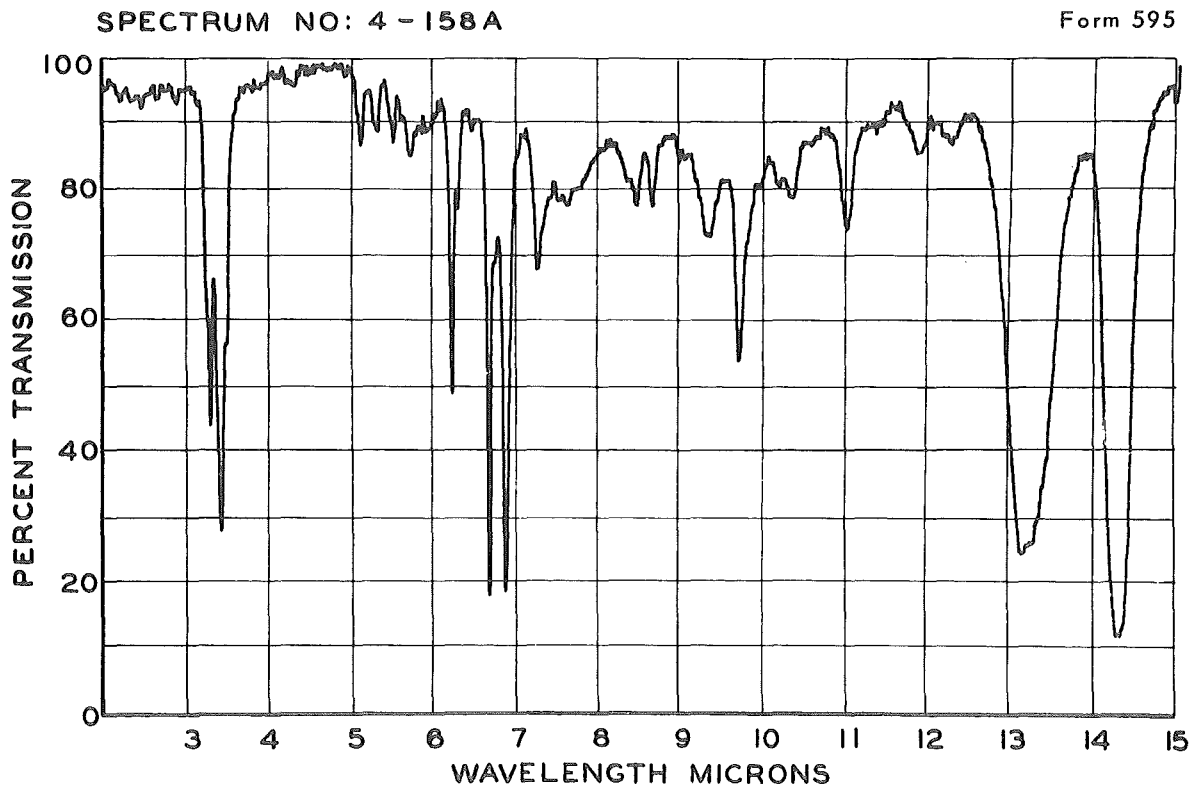
An infrared spectrum of binder and proximate analysis of striping is presented in Figure 5 and Table II. The infrared spectrum was made on plastic binder extracted from Catatherm striping. The spectral absorption bands at 3.26, 3.30, 5.12, 5.33, 5.52, 5.72, 6.23, 6.70, 9.73, 13.2 and 14.3 microns are generally interpreted as being characteristic of phenyl groups; whereas those at 3.42, 3.50, and 6.88 microns are due to CH₂ groups.

The identified chemical groupings and the general spectrum indicate a polystyrene type of plastic in the striping.

Figure 5. Infrared Absorption Spectrum for Catatherm binder.

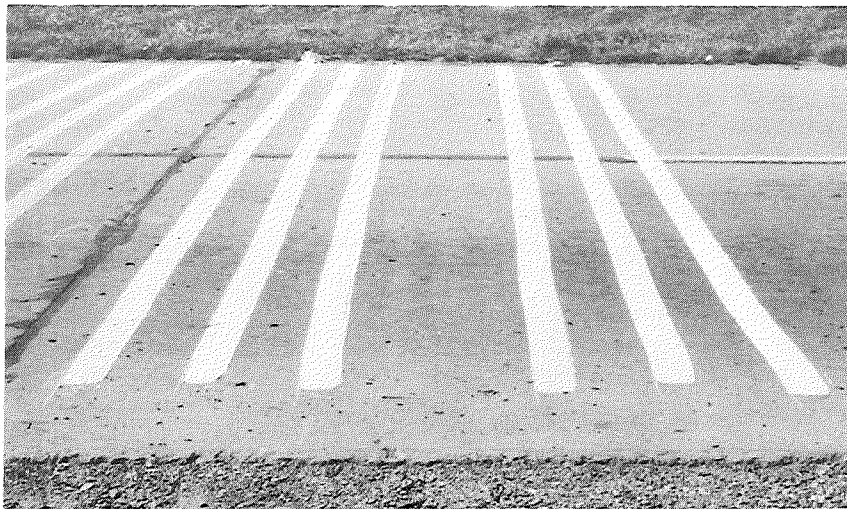
Figure 1. Progressive weathering of Catatherm thermoplastic striping being evaluated as experimental transverse stripes on concrete of US-127, south of Lansing.

▲ Appearance as applied on October 2, 1957.

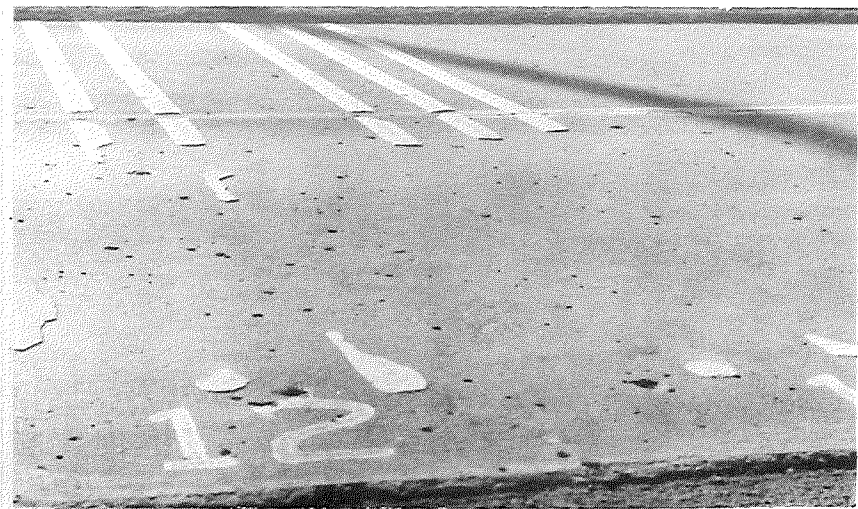
The tested striping failed completely in traffic lane on concrete during first winter of exposure as shown in photo. Partial reason for failure may have been due to snowplow damage to this thick striping. The performance of striping on passing lane of concrete and on black-top in test area was better, as shown in photos, but hardly in relation to its high cost.

▲ February 25, 1958, after 150 days exposure, showing complete loss of striping in traffic lane.

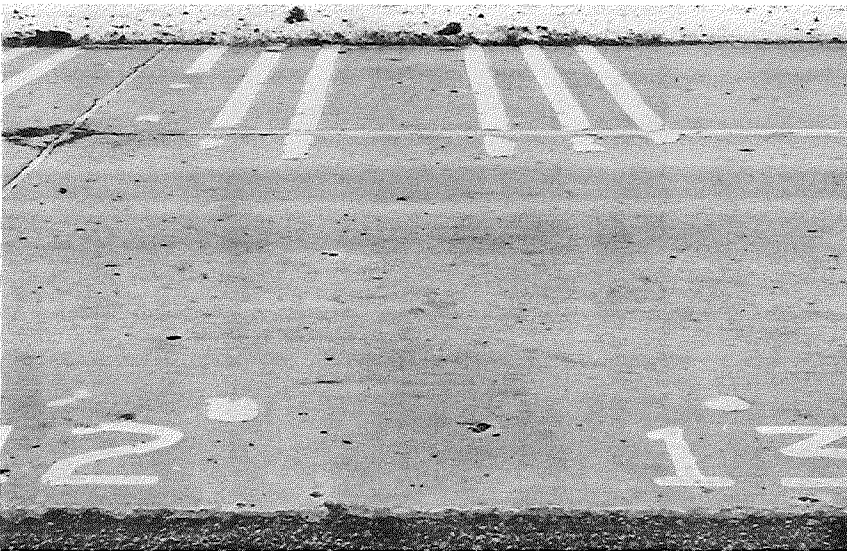
▲ January 21, 1959, after 447 days exposure, with passing lane striping exhibiting much better service than traffic lane striping.

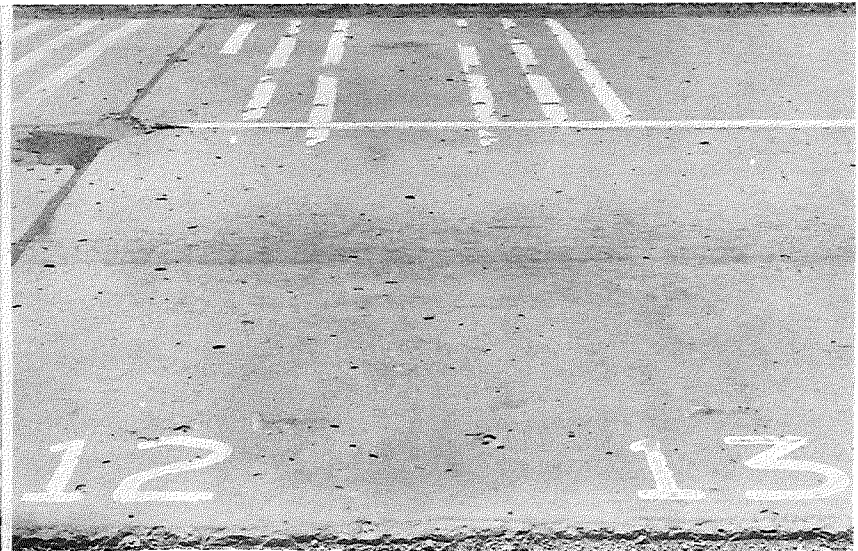
▲ February 27, 1961, after 3.4 years exposure, showing further loss of striping in passing lane.

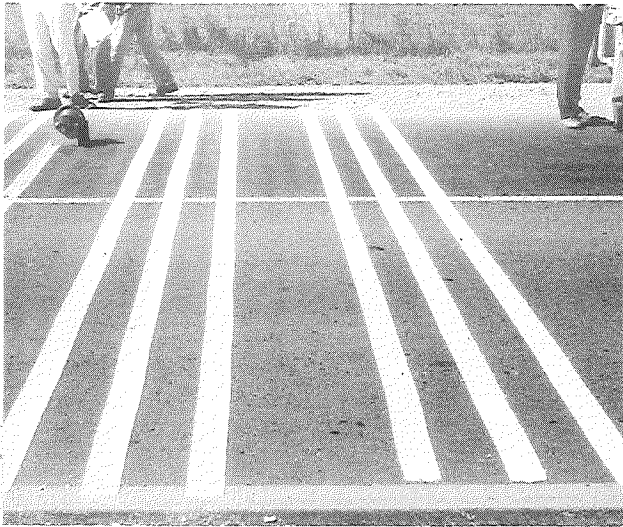
Figure 2. Progressive weathering of Catatherm thermoplastic striping being evaluated as experimental transverse stripes on black-top of US-127, south of Lansing.

▲ Appearance as applied on October 2, 1957.

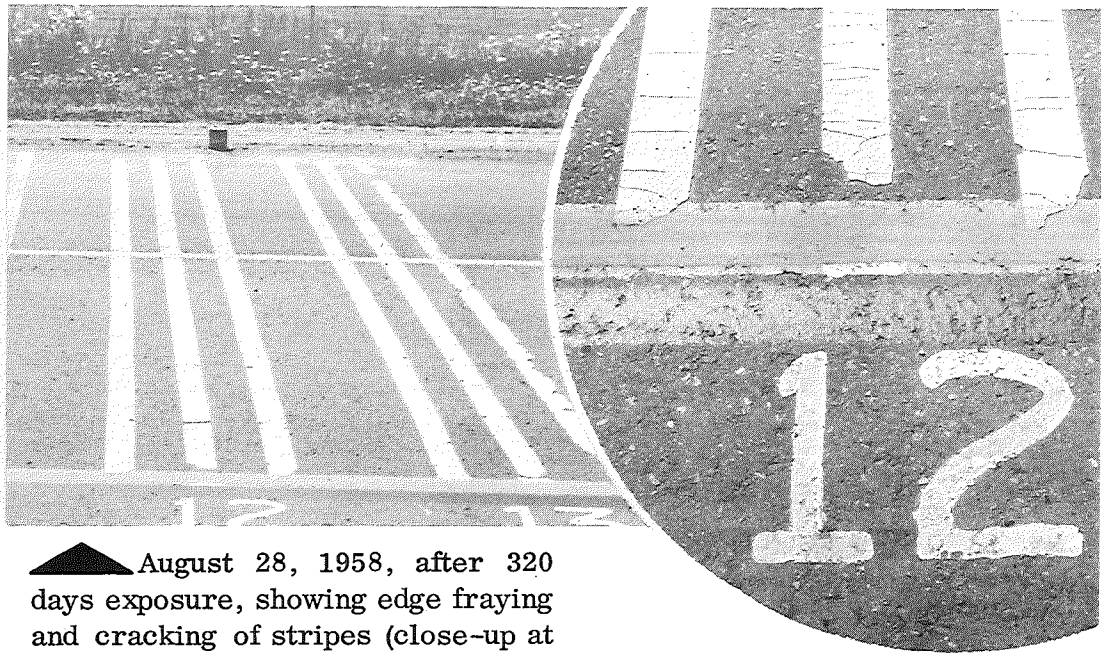
▲ August 28, 1958, after 320 days exposure, showing edge fraying and cracking of stripes (close-up at right).

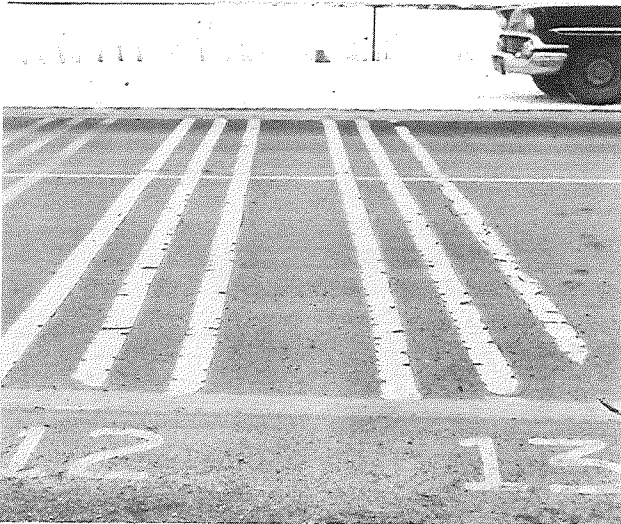
◀ January 1, 1959, after 447 days exposure, showing progressive fraying.

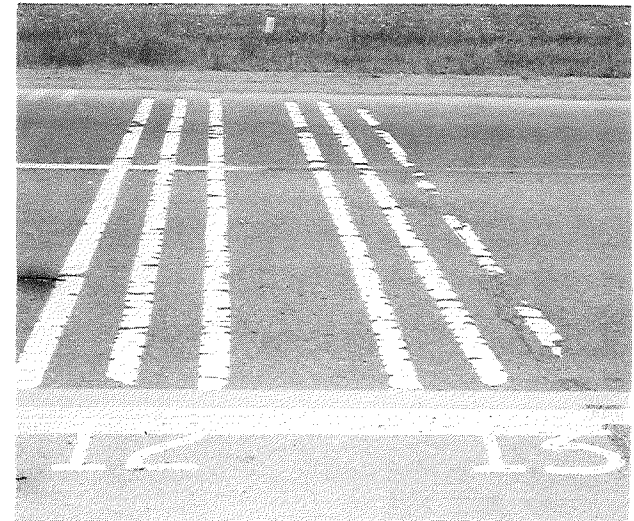
February 27, 1961, after 3.4 years exposure showing progressive fraying and loss of striping. ▶
