A TRAFFIC ACCIDENT ANALYSIS  
OF HIGH ACCIDENT LOCATIONS  
IN THE CITY OF ESCANABA  
Report TSD-SS-197-72

PREPARED BY THE  
Safety & Surveillance Section  
Traffic & Safety Division  
Bureau of Operations  
Michigan Department of State Highways

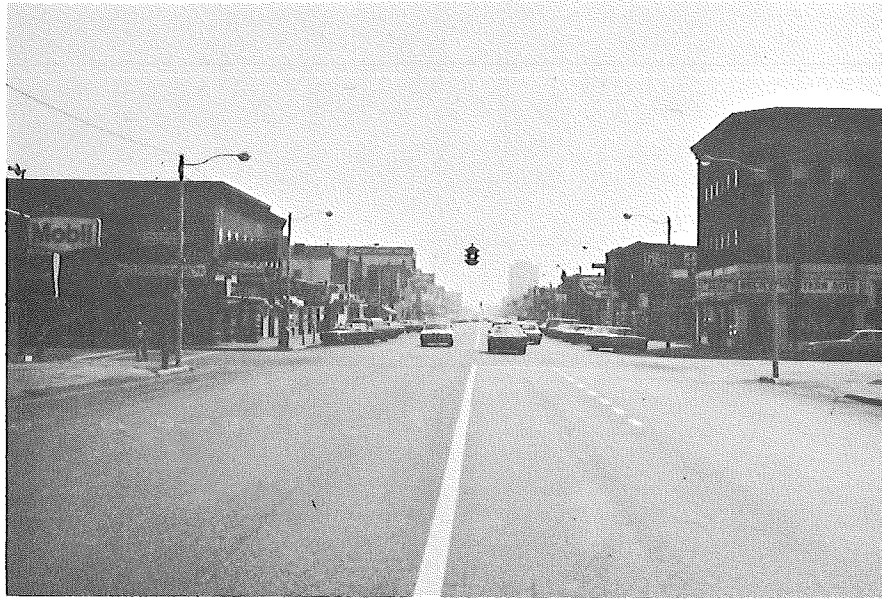
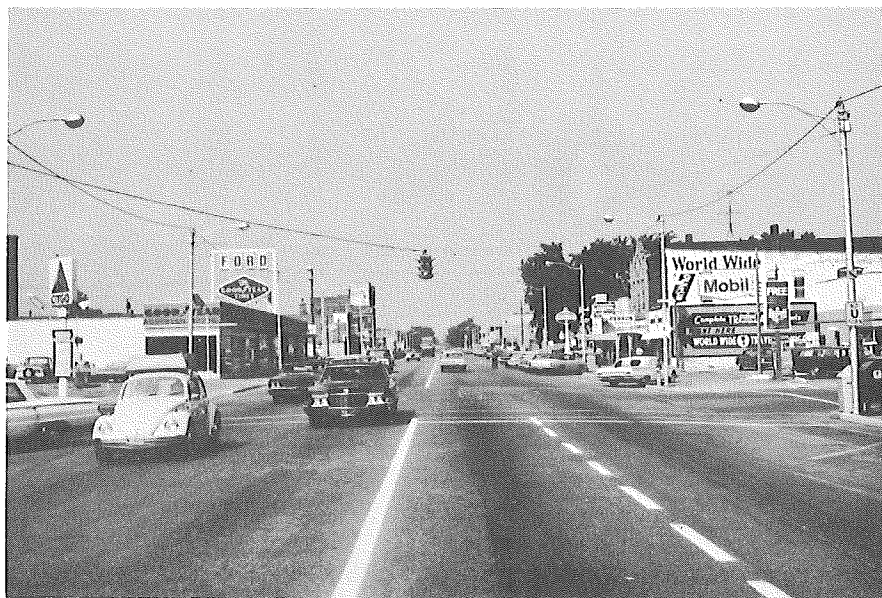
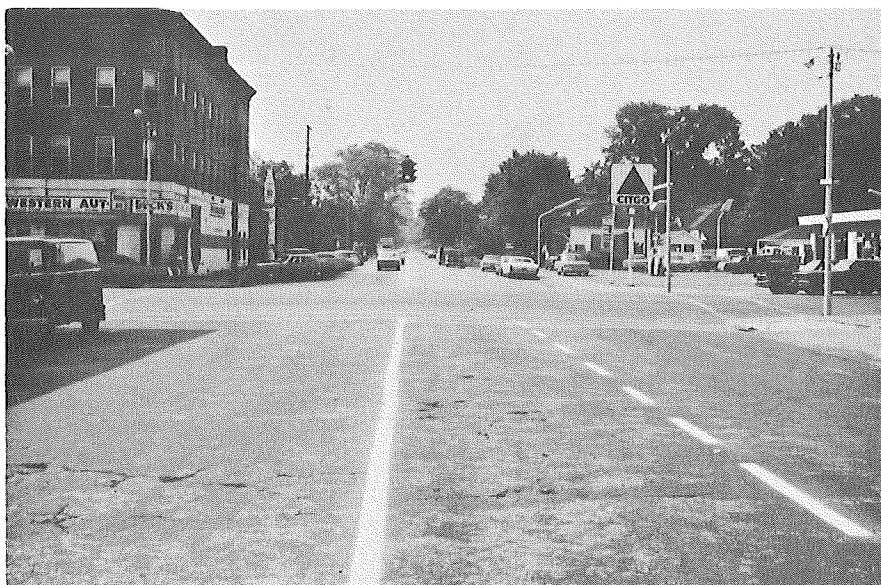
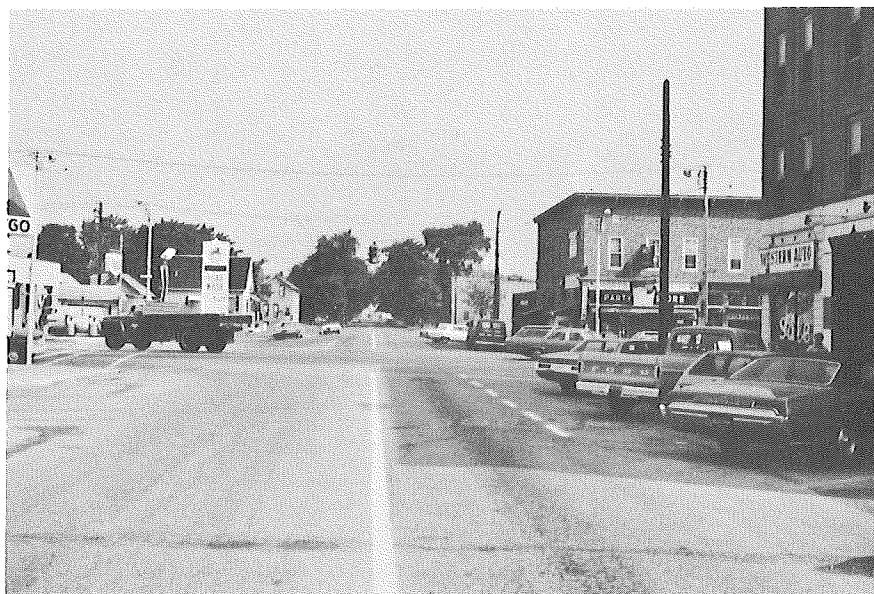
FIGURE 7

The approaches on all four legs of the intersection have two lanes into the intersection and one lane out of the intersection (See Figure 7a and 7b).

EASTBOUND  
LUDINGTON STREET

WESTBOUND  
LUDINGTON STREET

SOUTHBOUND  
14TH STREET

NORTHBOUND  
14TH STREET

Parking removal has been discussed in the TRAFFIC ENGINEERING ANALYSIS part of the report. It is also recommended that the amber time be changed from 5% to 6%. This change should help reduce the incidence of right-angle accidents and possibly some rear end accidents by increasing the clearance interval. Rear end accidents will also be reduced if the angle parking is changed to parallel parking.

Finally, it is recommended that vehicles be prohibited from angle parking on the east side of 14th Street, south of the intersection. The pavement is marked to show two approach lanes (See Figure 7b) but the parked vehicles are restricting the use of the outer lane.

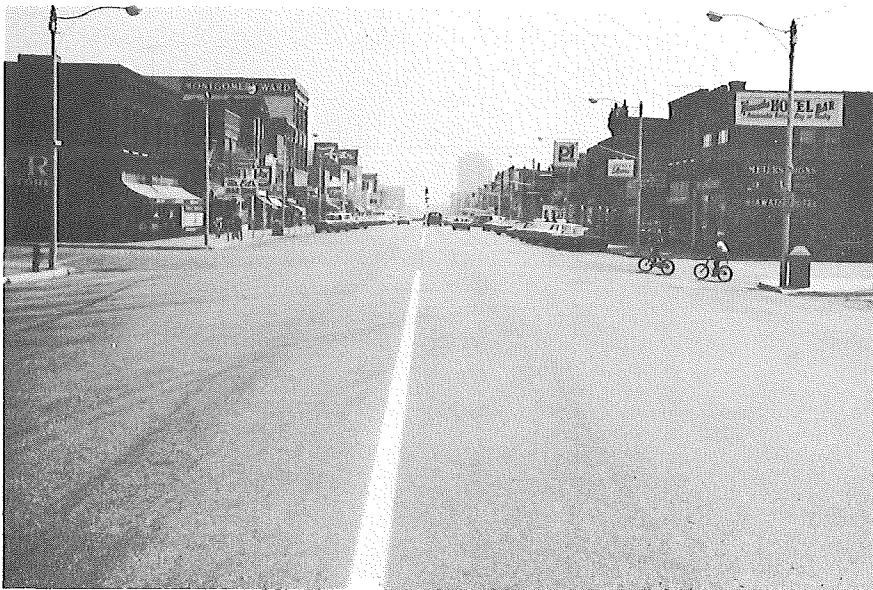
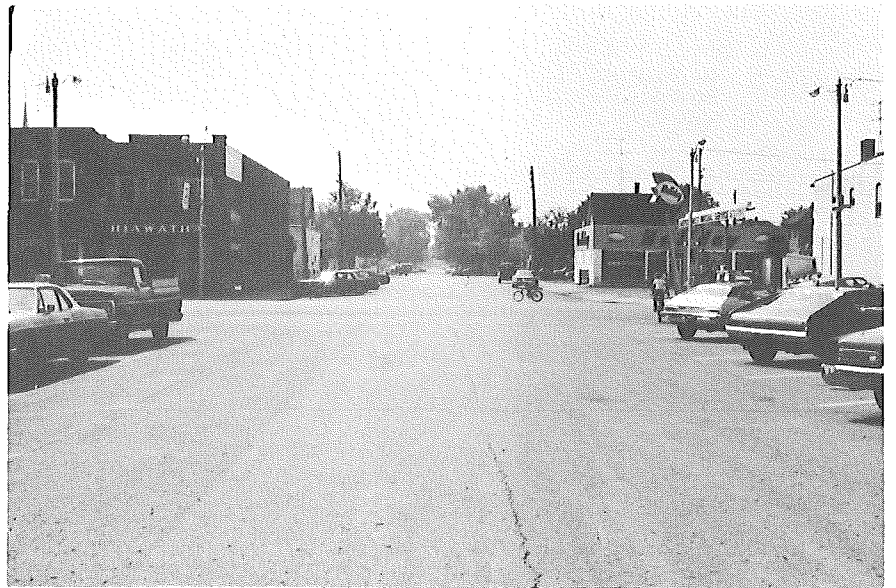
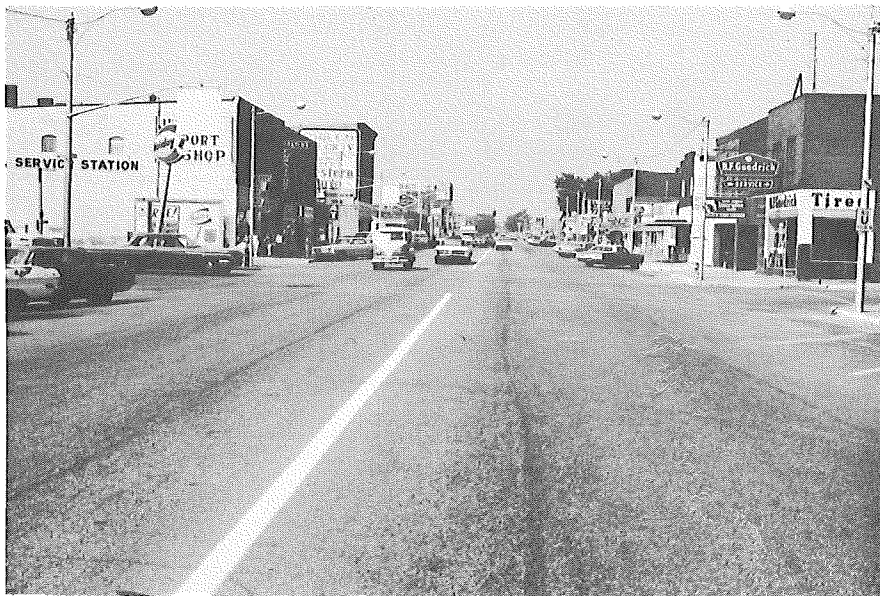
FIGURE 8

EASTBOUND  
LUDINGTON STREET

SOUTHBOUND  
13TH STREET

WESTBOUND  
LUDINGTON STREET

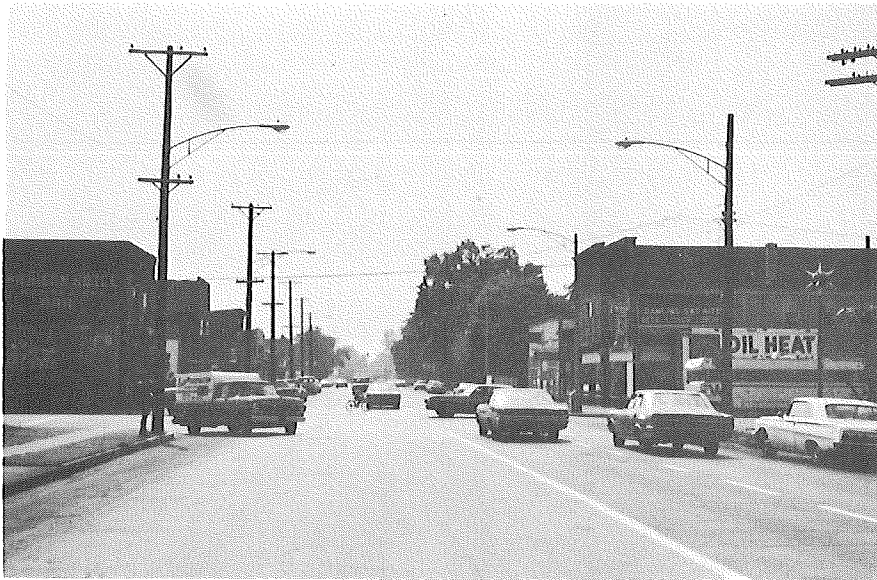
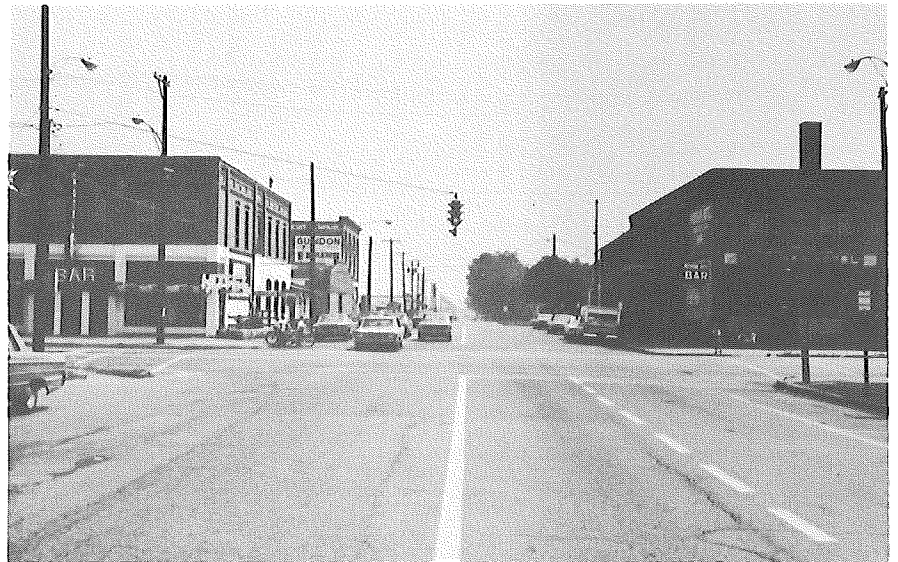
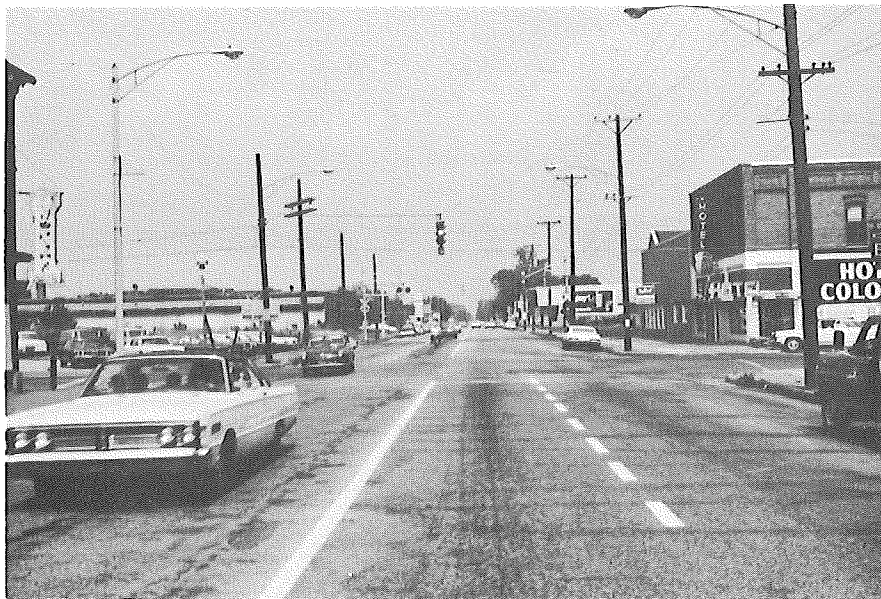
Figure 9a

SOUTHBOUND  
STEPHENSON AVENUE

EASTBOUND  
3RD AVENUE NORTH

NORTHBOUND  
STEPHENSON AVENUE

The only recommendation at this location involves changing the amber time to 6% of the total cycle length. This change should reduce the incidence of right-angle accidents at the intersection.

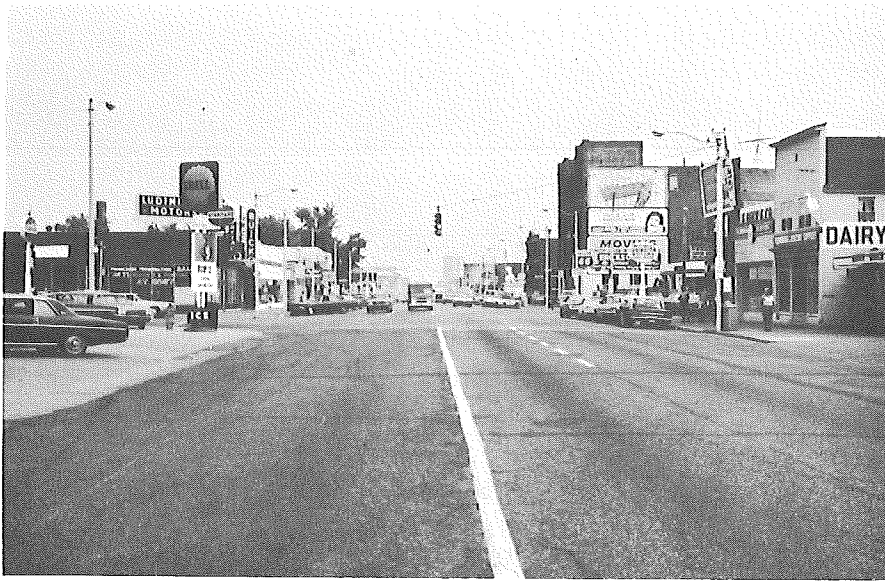
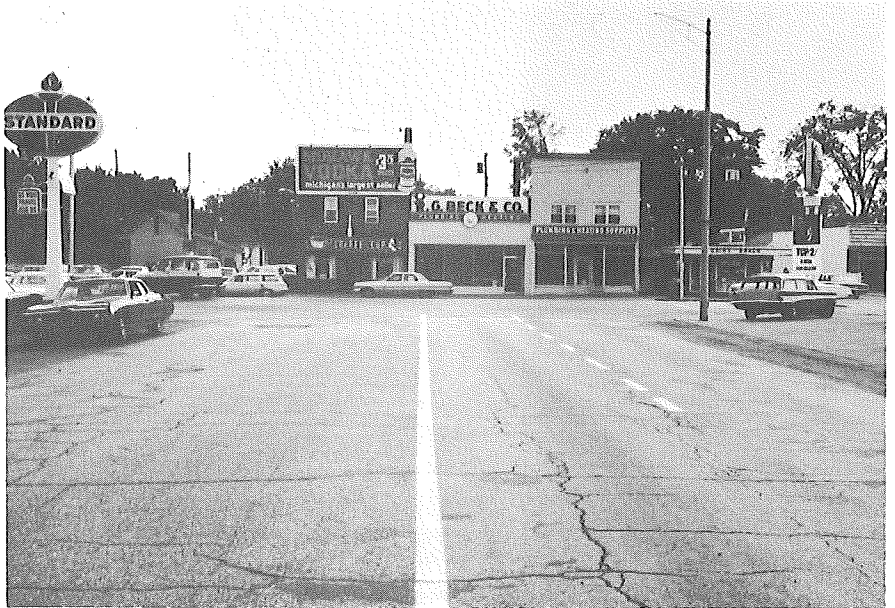
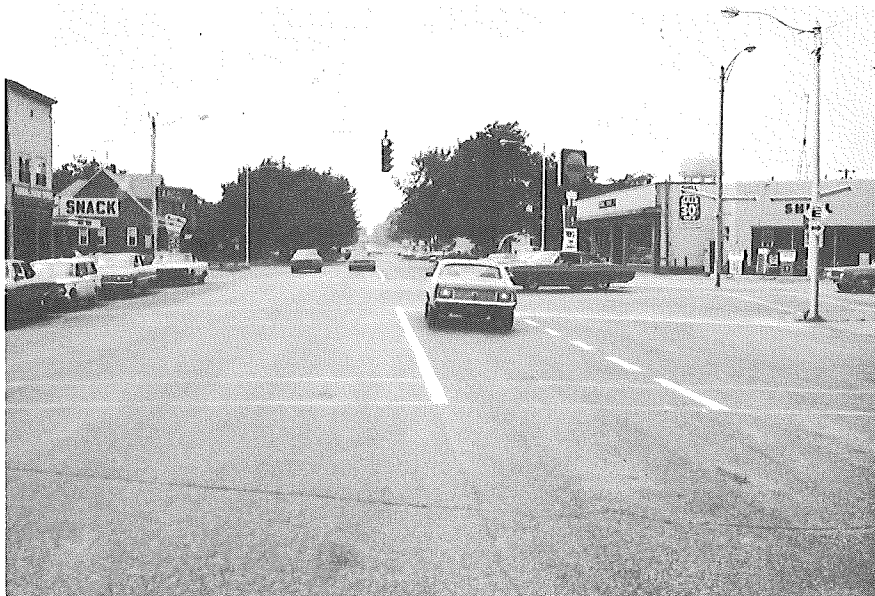
FIGURE 10

EASTBOUND  
LUDINGTON STREET

SOUTHBOUND  
STEPHENSON AVENUE

WESTBOUND  
LUDINGTON STREET

Eight of the 20 rear end accidents occurred on snowy or icy pavement; therefore, the incidence of rear-end accidents cannot be considered critical. It is recommended, however, that the amber time be increased to 6% of the cycle time. This change will coincide with the changes made at Locations 2 and 6.

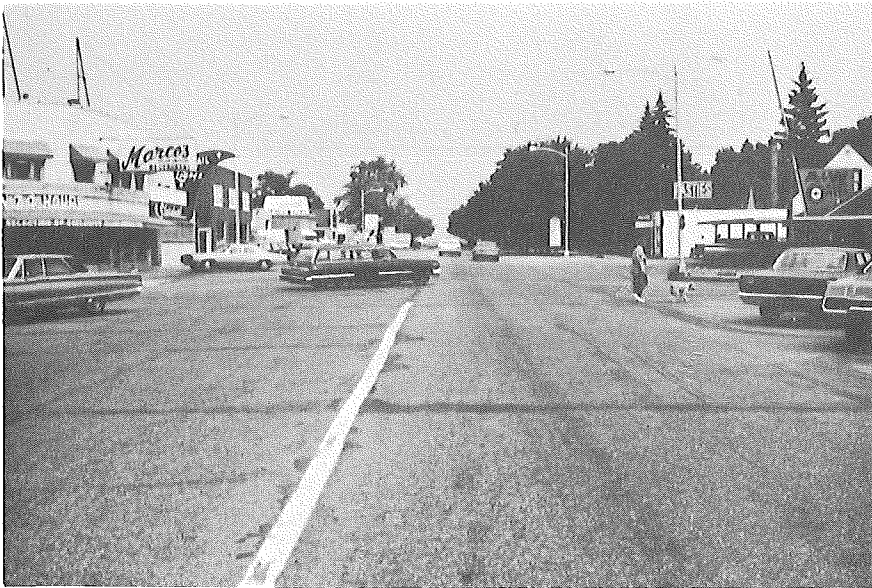
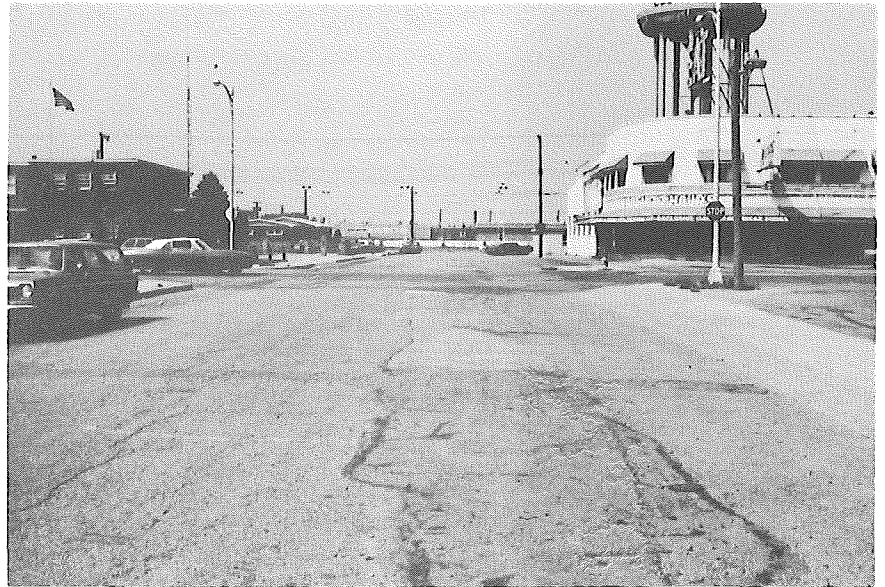
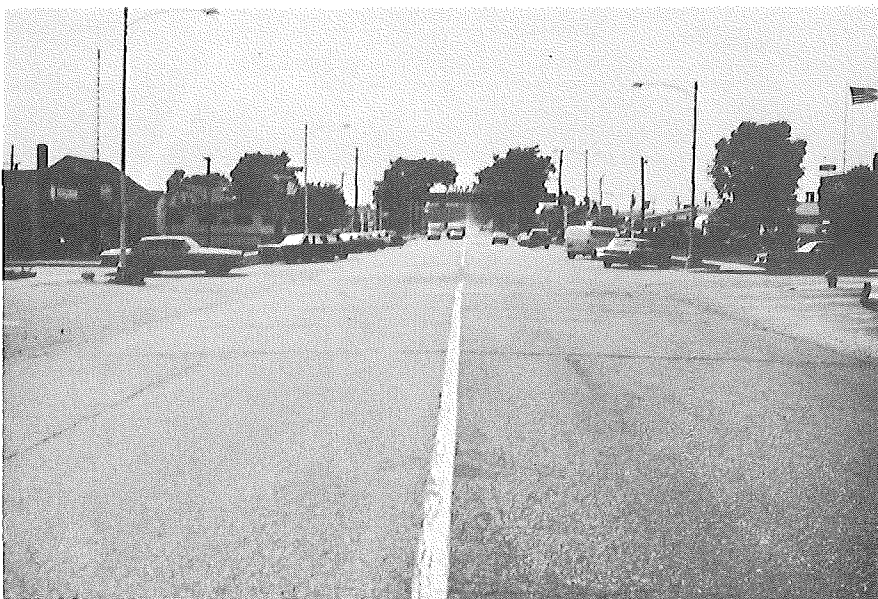
MICHIGAN DEPARTMENT OF STATE HIGHWAYS  
 TRAFFIC AND SAFETY DIVISION  
 Location LUDINGTON ST. at 22<sup>nd</sup> ST.  
 CITY OF ESCNABA  
 DELTA CO.

Traffic is controlled by two 24in. stop signs (R1-1-24, Appendix II, p.76) on 22nd Street. These stop signs are in poor condition.

EASTBOUND  
LUDINGTON STREET

NORTHBOUND  
22ND STREET

WESTBOUND  
LUDINGTON STREET

quadrant of the intersection. It is, therefore, recommended that the angle parking adjacent to the restaurant be changed to parallel.

Finally, it is recommended that the stop signs on 22nd Street be replaced, as they are in poor condition.

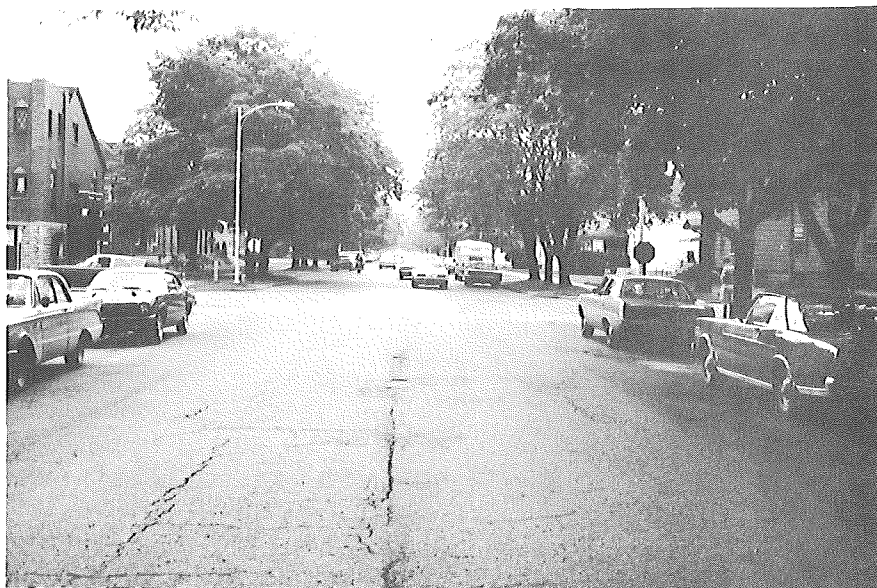
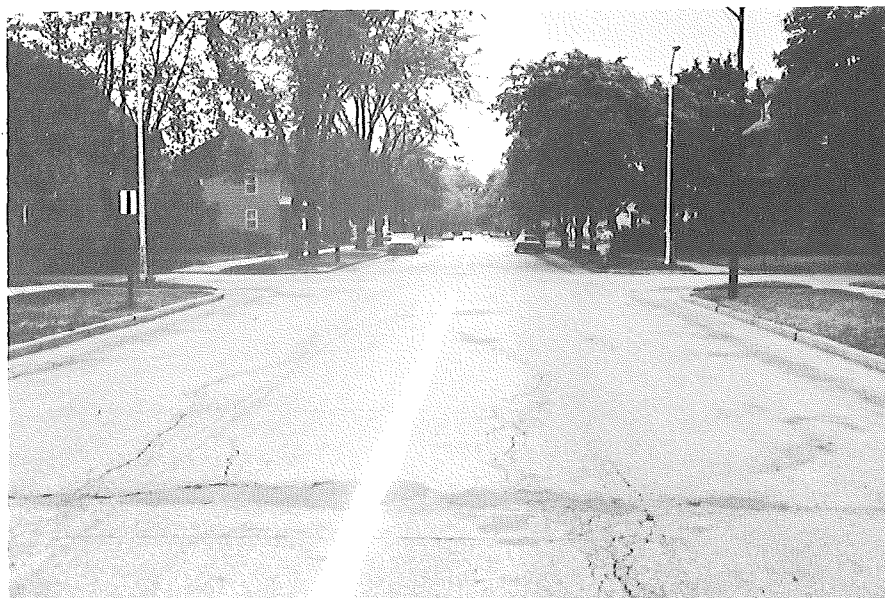
Location SOUTH 14<sup>th</sup> ST. at 1<sup>st</sup> AVE. SOUTH  
CITY OF ESCANABA  
DELTA CO.

South 14th Street has a solid white centerline, north of the intersection, and south of the intersection it has a broken white centerline. Traffic is controlled by two 24in. stop signs (R1-1-24, Appendix II, p.76) on 1st Avenue South.

EASTBOUND  
1ST AVENUE SOUTH

SOUTHBOUND  
SOUTH 14TH STREET

It is, therefore, recommended that a pre-timed dual head signal be installed at the intersection. It should operate on a 60 second cycle split 60%-40%, 1st Avenue South to South 14th Street, with a 6% amber. Since there is a signal one block (400 feet) to the north (See Location 2, p. 24), these signals should be interconnected to provide progression between the two locations.

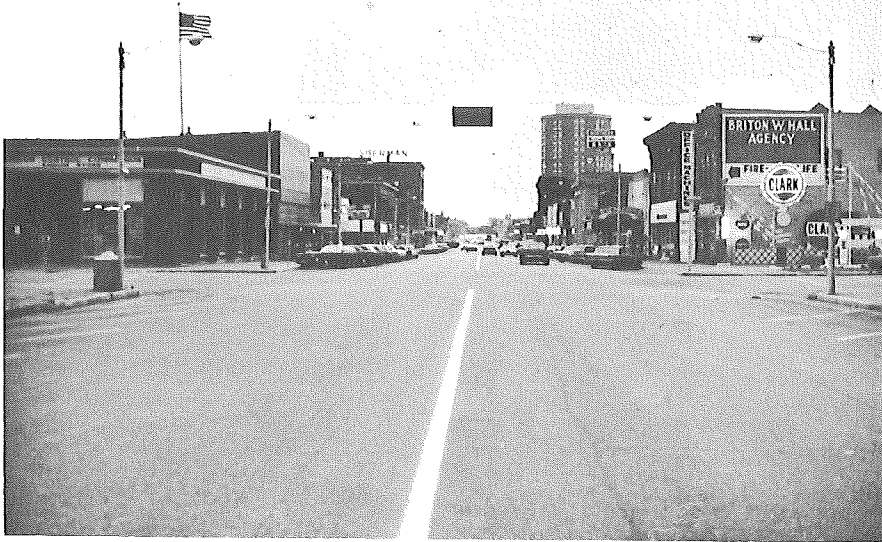
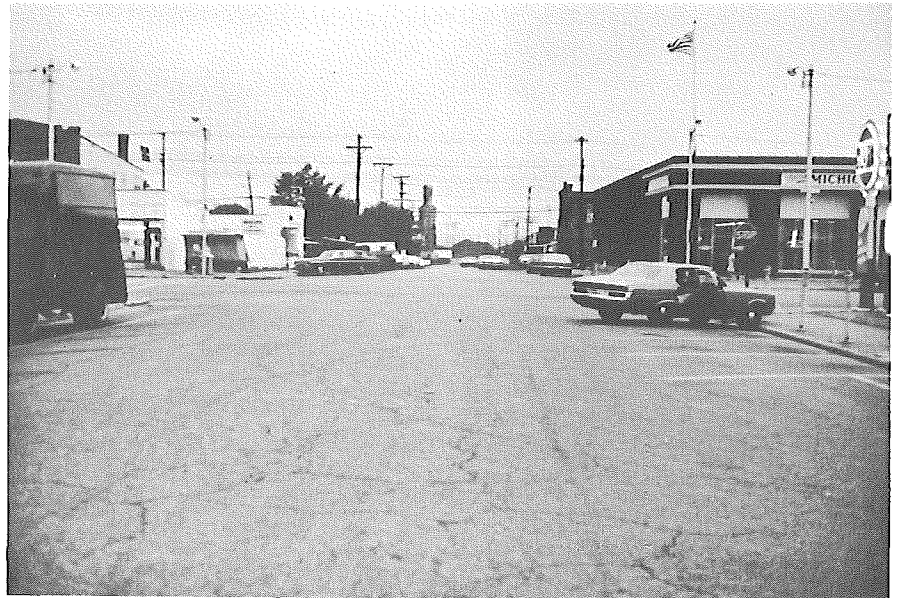
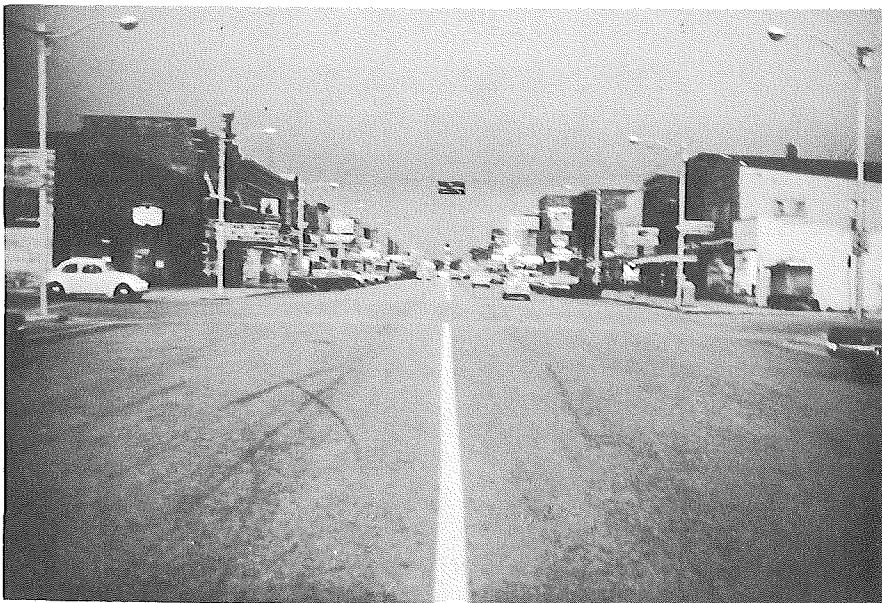
Location LUDINGTON ST. at 9<sup>th</sup> ST.  
CITY OF ESCANABA  
DELTA CO.

EASTBOUND  
LUDINGTON STREET

NORTHBOUND  
9TH STREET

WESTBOUND  
LUDINGTON STREET

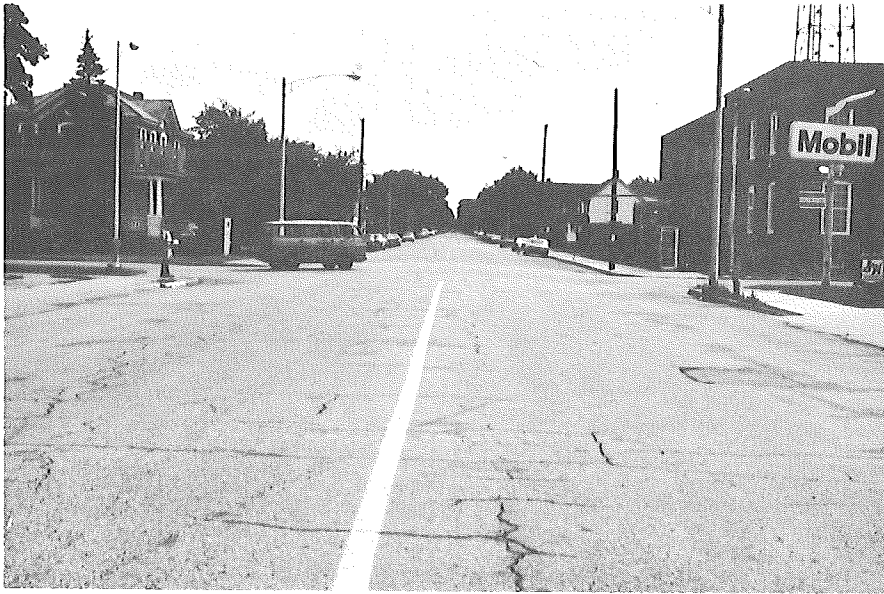
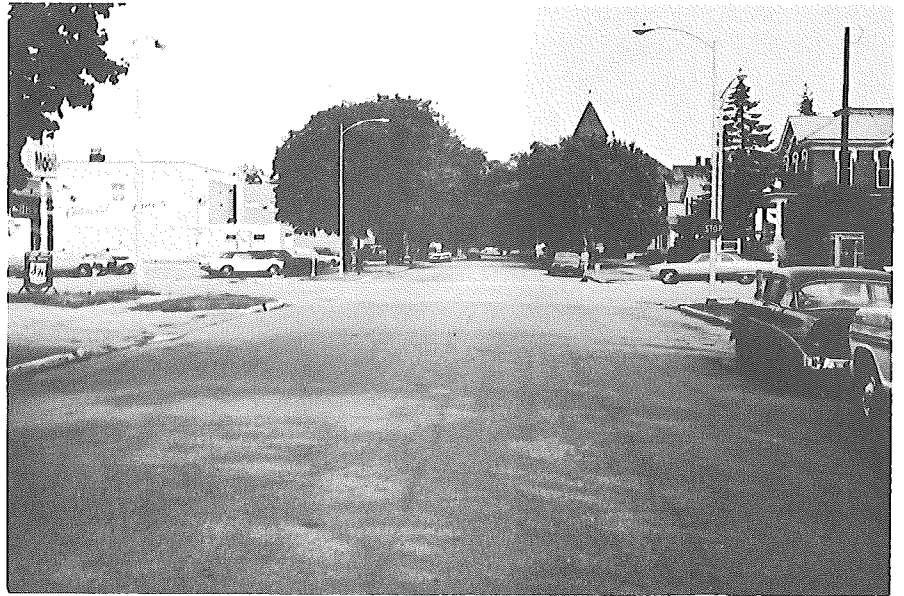
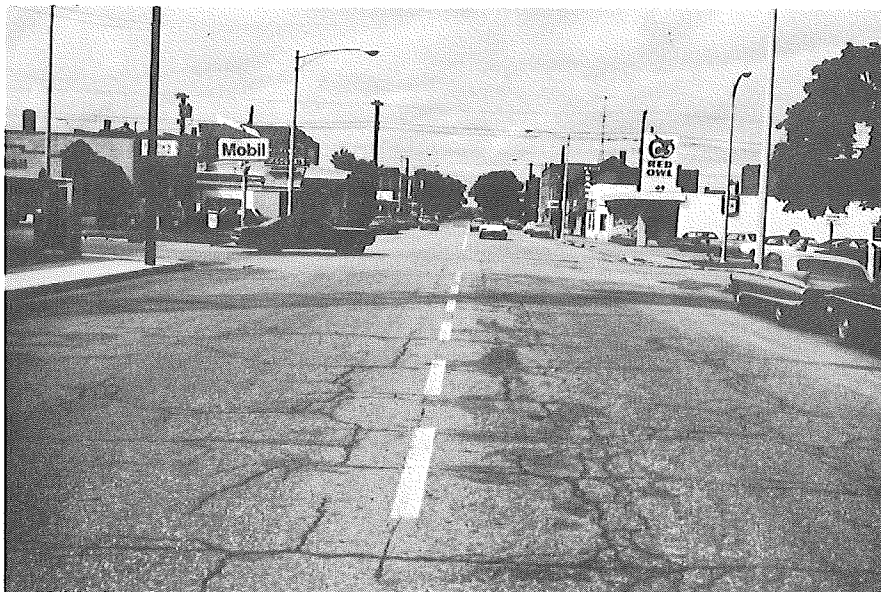
FIGURE 14

SOUTHBOUND  
SOUTH 10TH STREET

EASTBOUND  
1ST AVENUE SOUTH

NORTHBOUND  
SOUTH 10TH STREET

As a remedial measure to help reduce the incidence of right-angle accidents at this location, it is recommended that a flashing beacon be installed at the intersection.

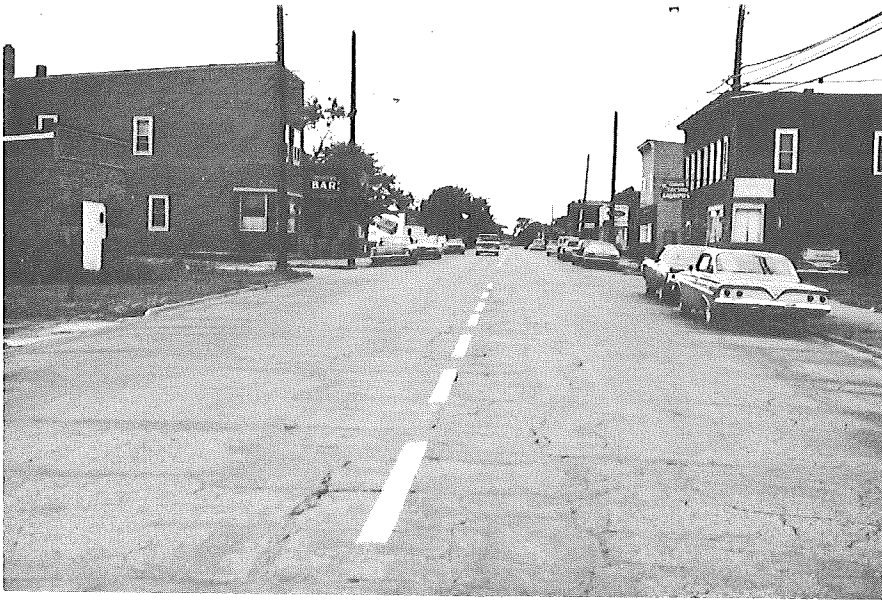
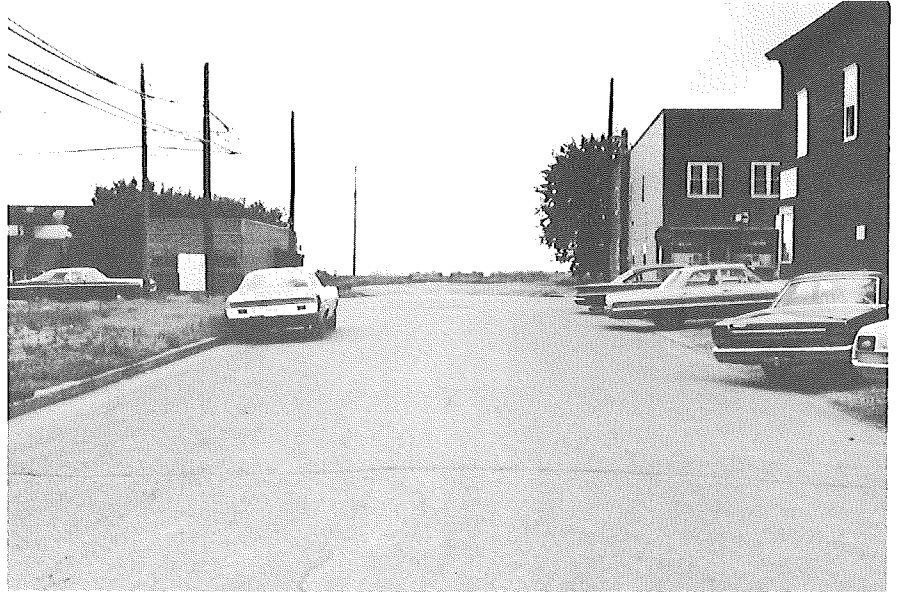
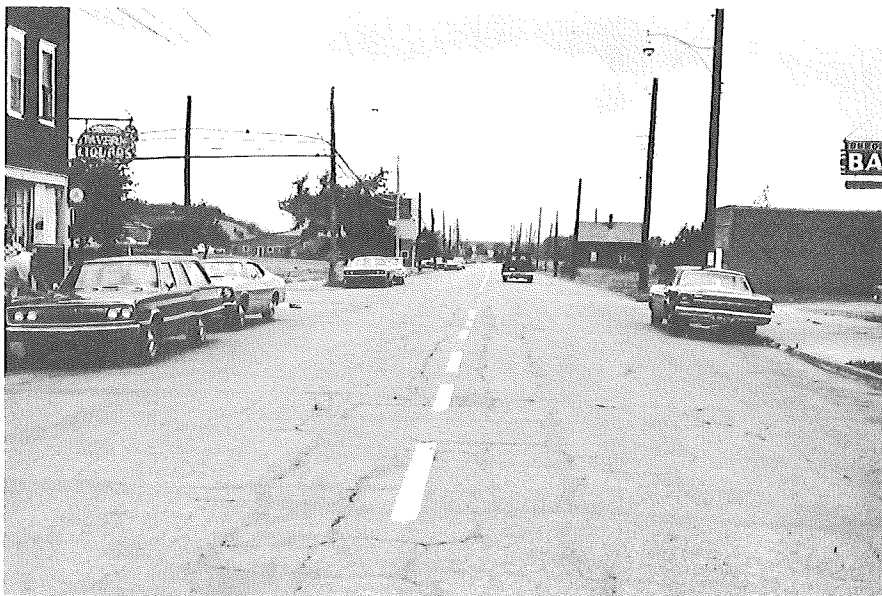
FIGURE 15

Traffic is controlled by a 24 inch stop sign (R1-1-24, Appendix II, p. 76) on 16th Avenue North for eastbound vehicles. Sheridan Avenue has broken white centerlines.

SOUTHBOUND  
SHERIDAN AVENUE

EASTBOUND  
16TH AVENUE NORTH

NORTHBOUND  
SHERIDAN AVENUE

To ease part of the problem, it is recommended that the angle parking on the south side of 16th Avenue North, west of the intersection, be replaced by parallel parking. This will eliminate the conflict between vehicles backing from the angle parking spots on the south side of the street and those vehicles parallel parked on the north side of the street.

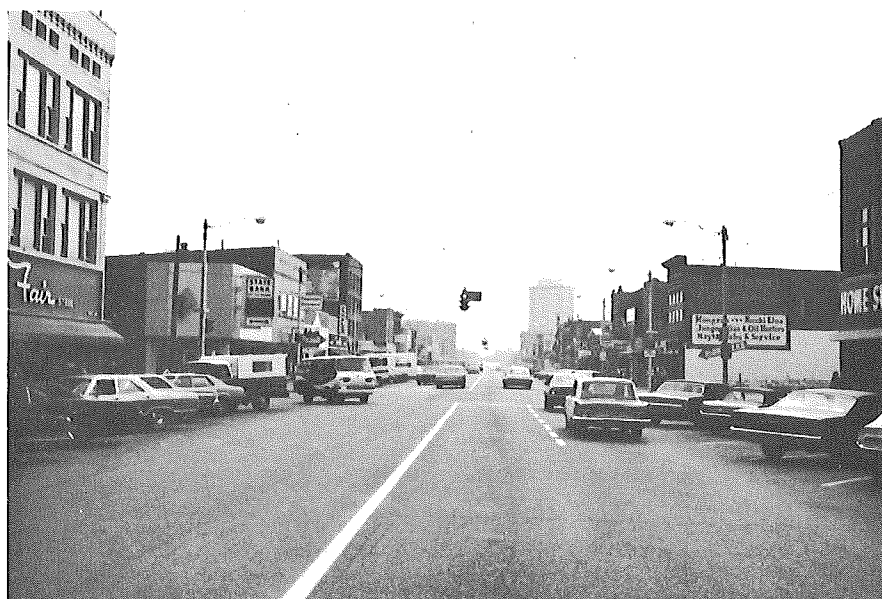
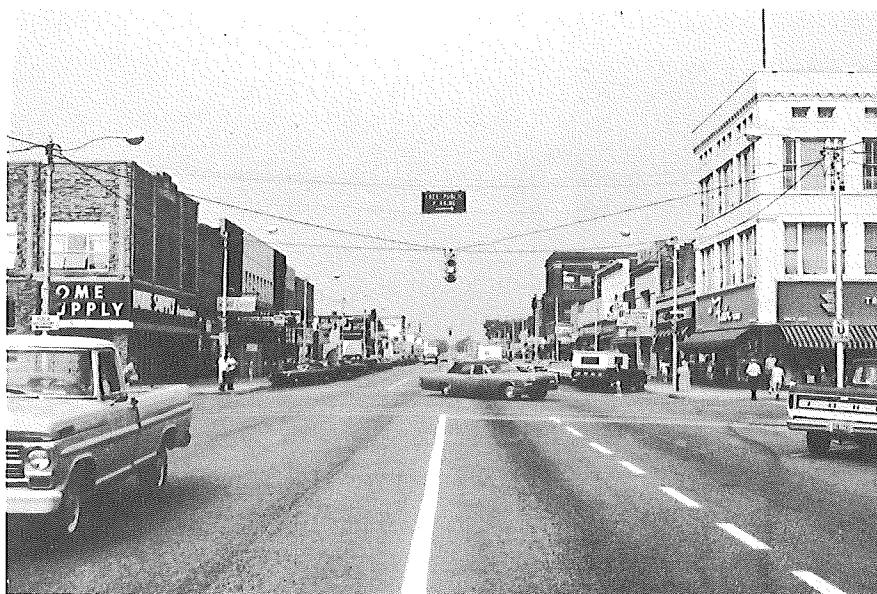
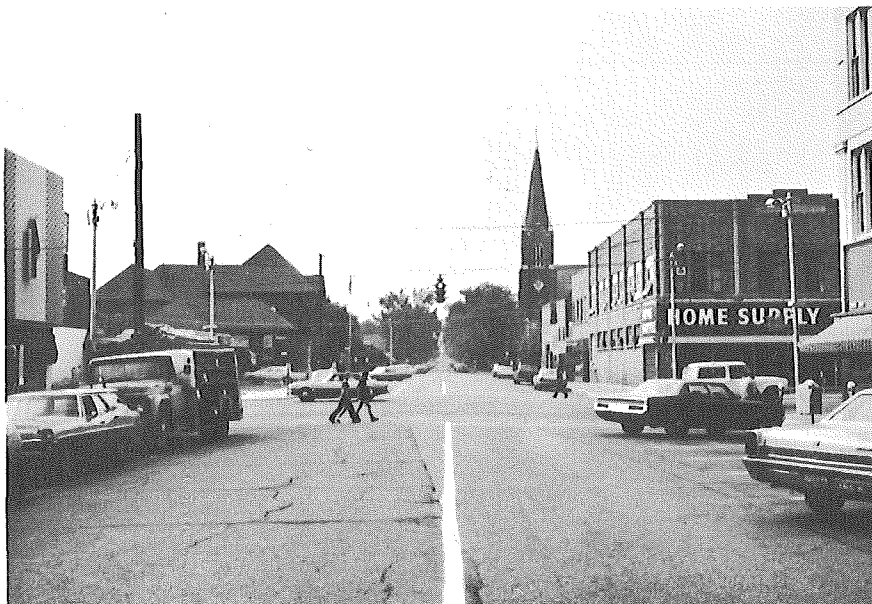
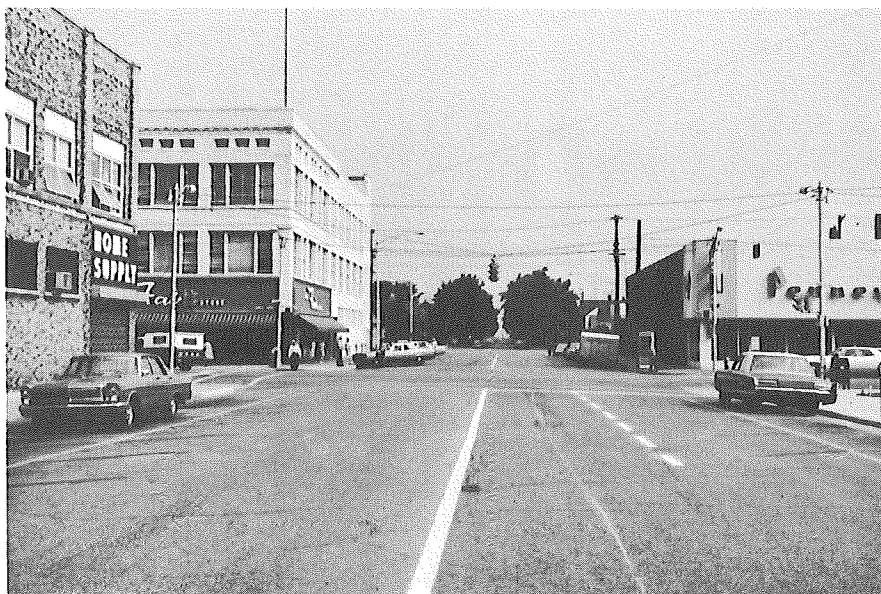
MICHIGAN DEPARTMENT OF STATE HIGHWAYS  
 TRAFFIC AND SAFETY DIVISION  
 Location LUDINGTON ST. at 11<sup>th</sup> ST.  
 CITY OF ESCANABA  
 DELTA CO.

EASTBOUND  
LUDINGTON STREET

WESTBOUND  
LUDINGTON STREET

SOUTHBOUND  
11TH STREET

NORTHBOUND  
11TH STREET

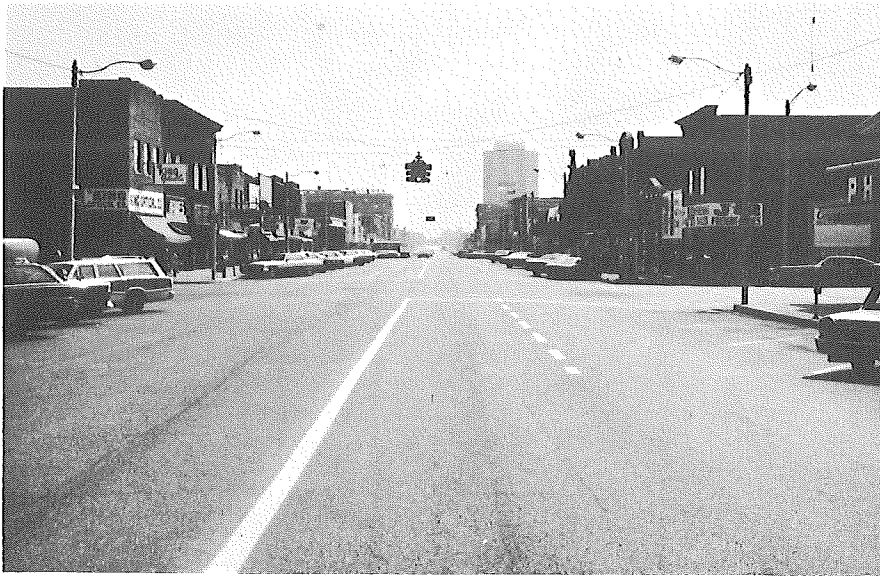
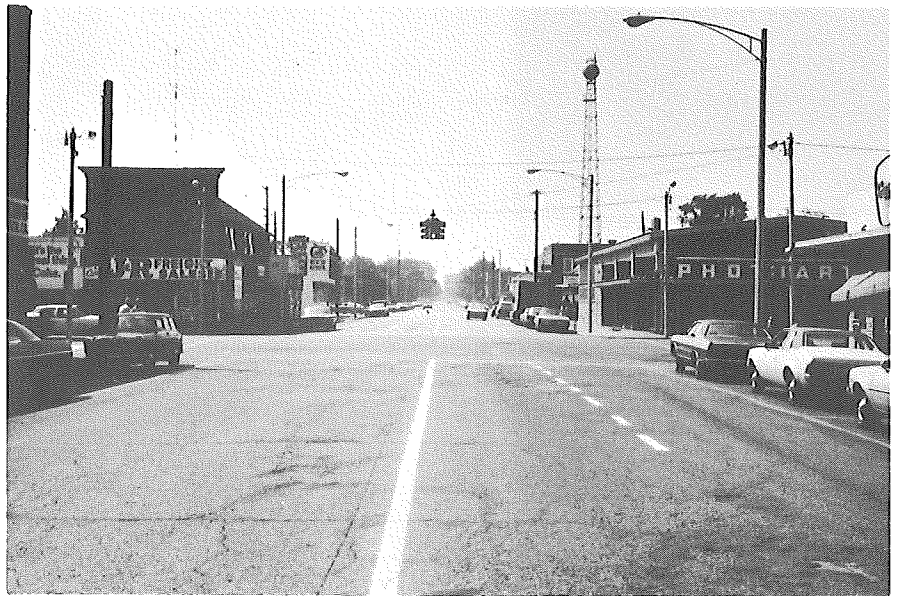
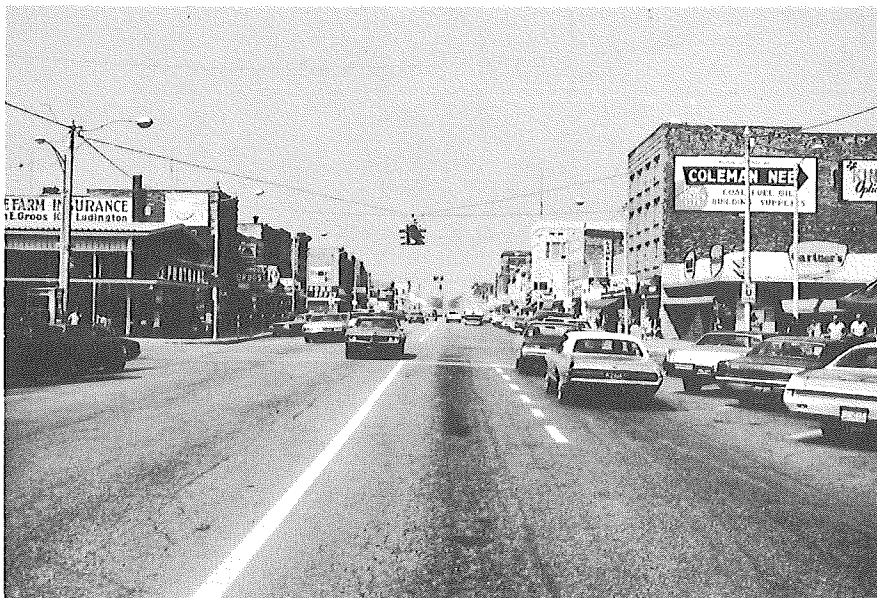
Figure 17a

EASTBOUND  
LUDINGTON STREET

SOUTHBOUND  
10TH STREET

WESTBOUND  
LUDINGTON STREET

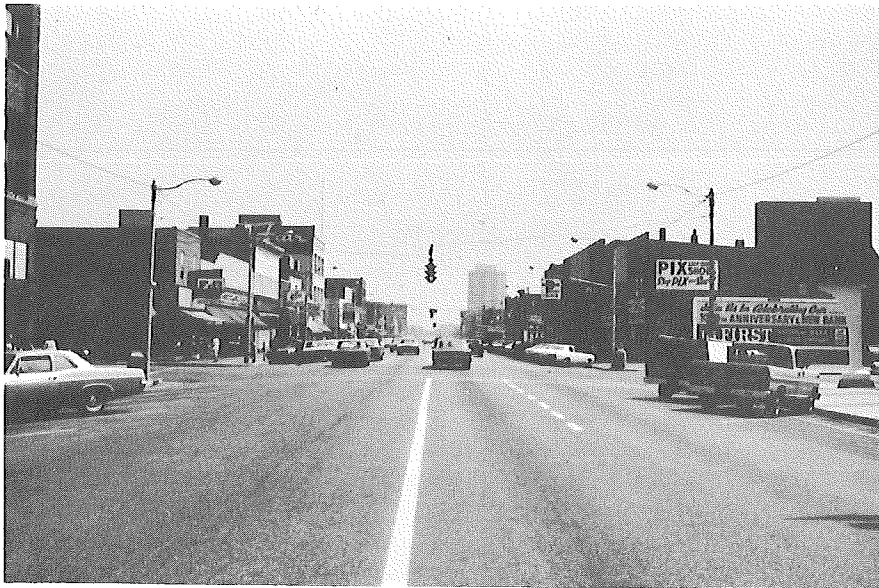
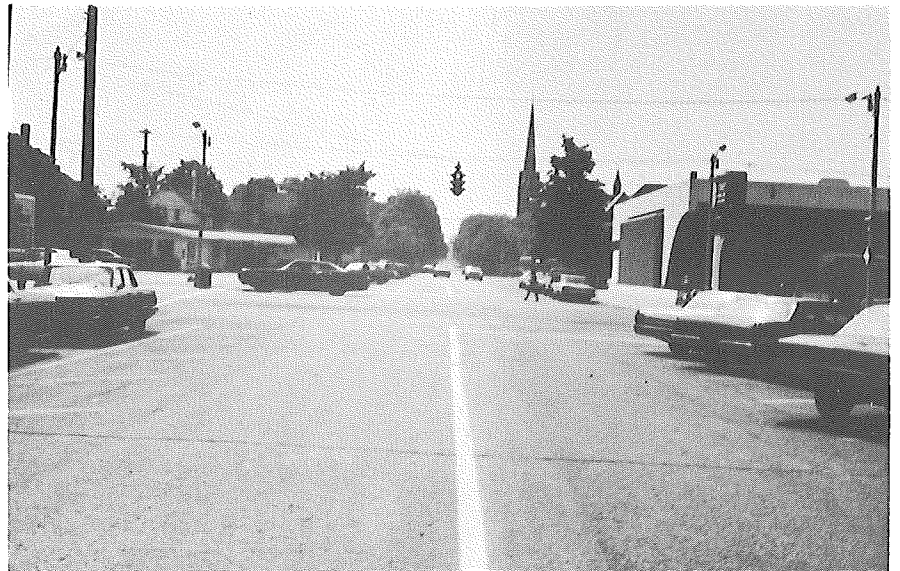
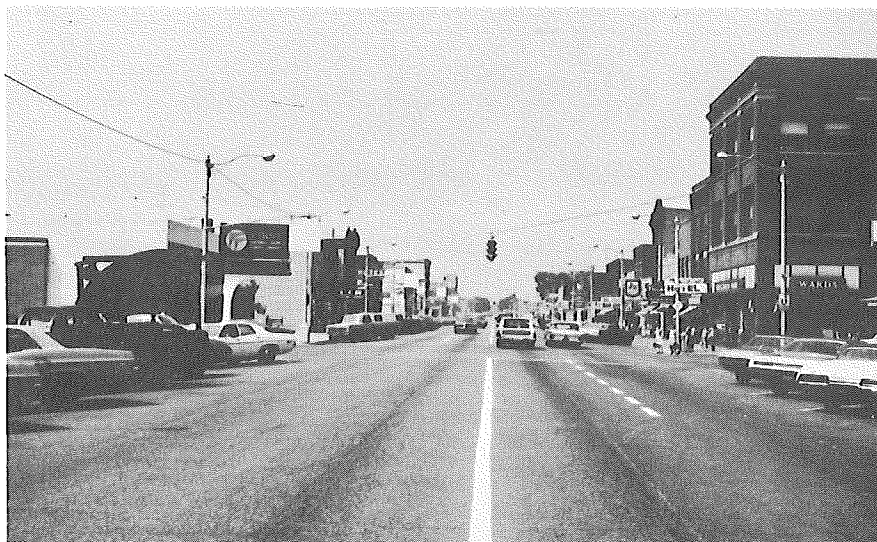
FIGURE 18

EASTBOUND  
LUDINGTON STREET

SOUTHBOUND  
12TH STREET

WESTBOUND  
LUDINGTON STREET

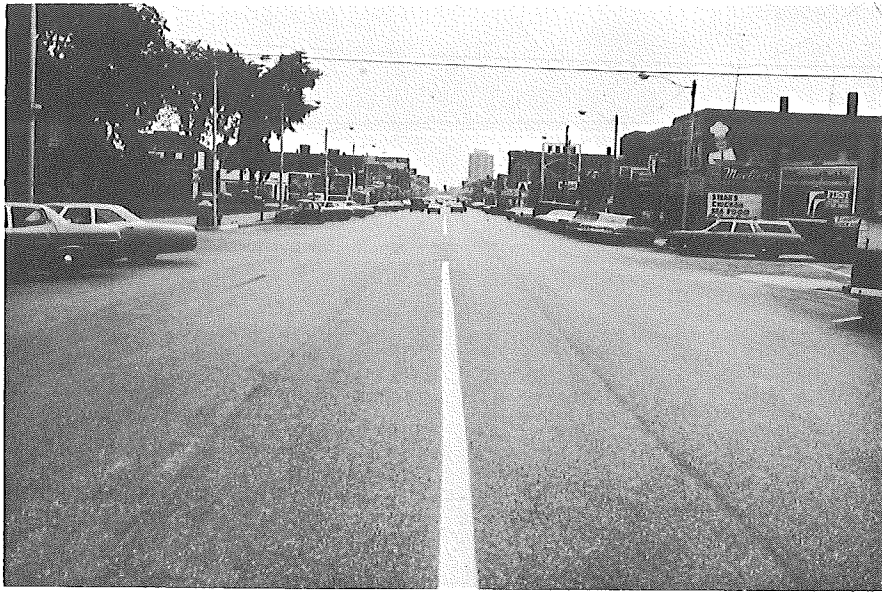
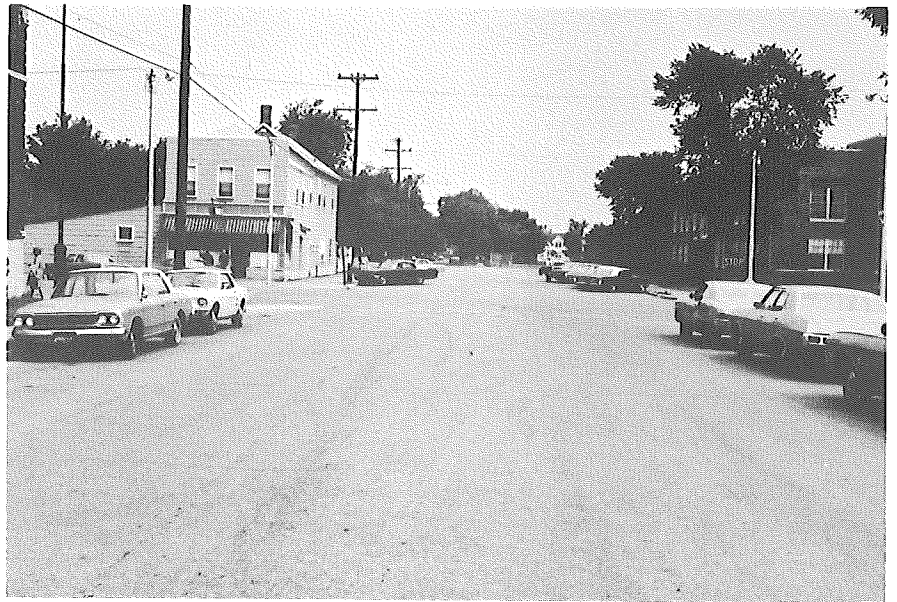
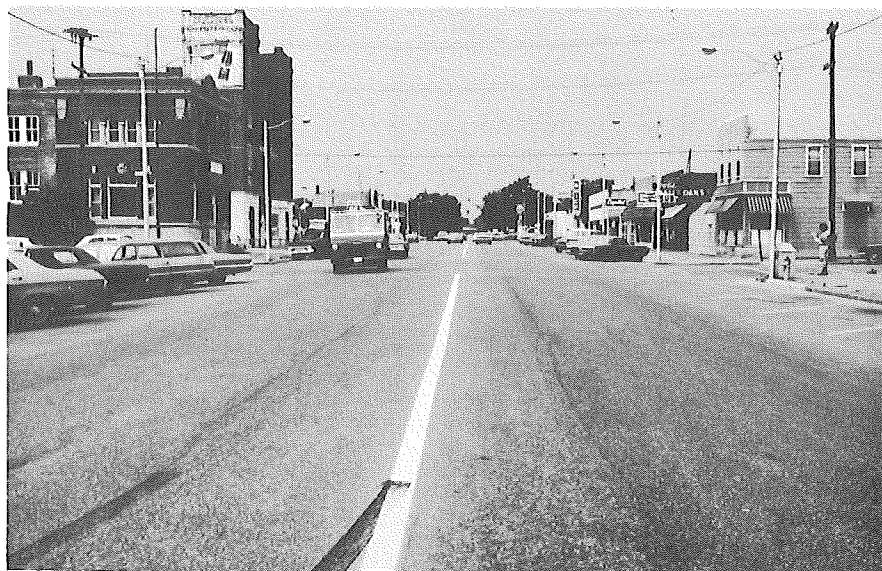
FIGURE 19

EASTBOUND  
LUDINGTON STREET

NORTHBOUND  
16TH STREET

WESTBOUND  
LUDINGTON STREET
