A TRAFFIC ACCIDENT ANALYSIS  
OF HIGH ACCIDENT LOCATIONS  
IN THE CITY OF ESCANABA  
Report TSD-SS-197-72

PREPARED BY THE  
Safety & Surveillance Section  
Traffic & Safety Division  
Bureau of Operations  
Michigan Department of State Highways

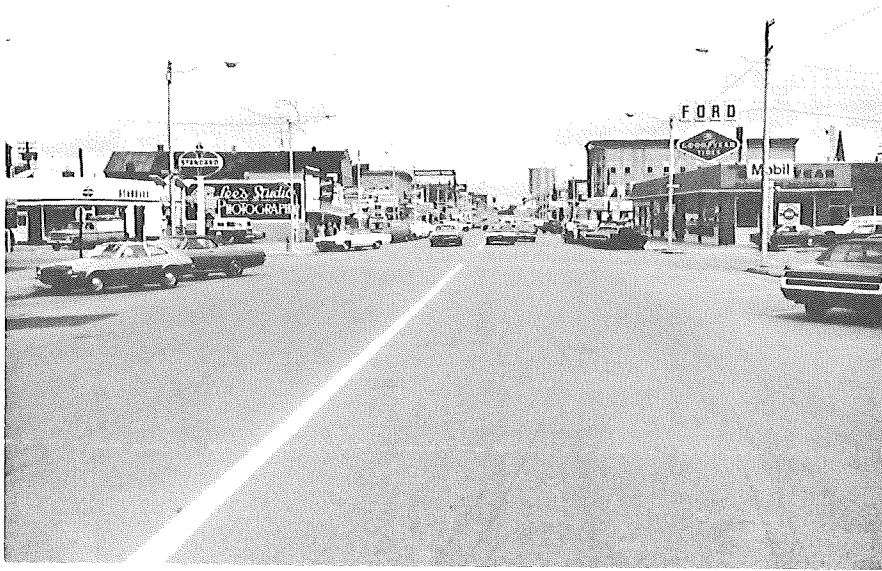
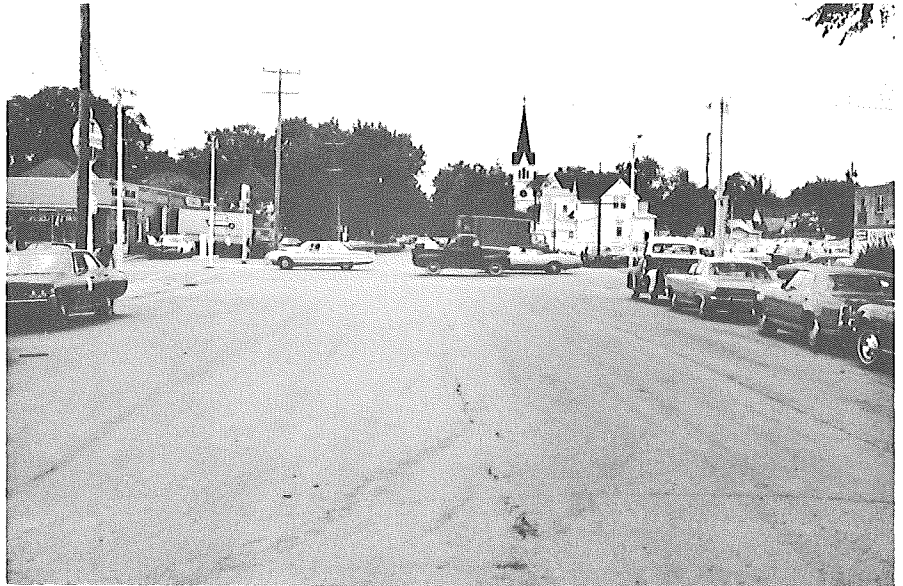
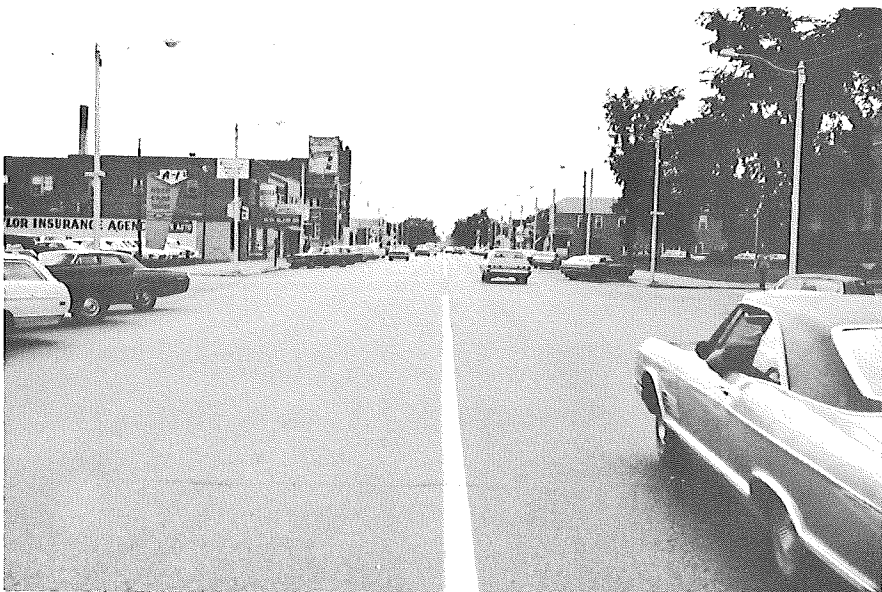
FIGURE 20

EASTBOUND  
LUDINGTON STREET

SOUTHBOUND  
15TH STREET

WESTBOUND  
LUDINGTON STREET

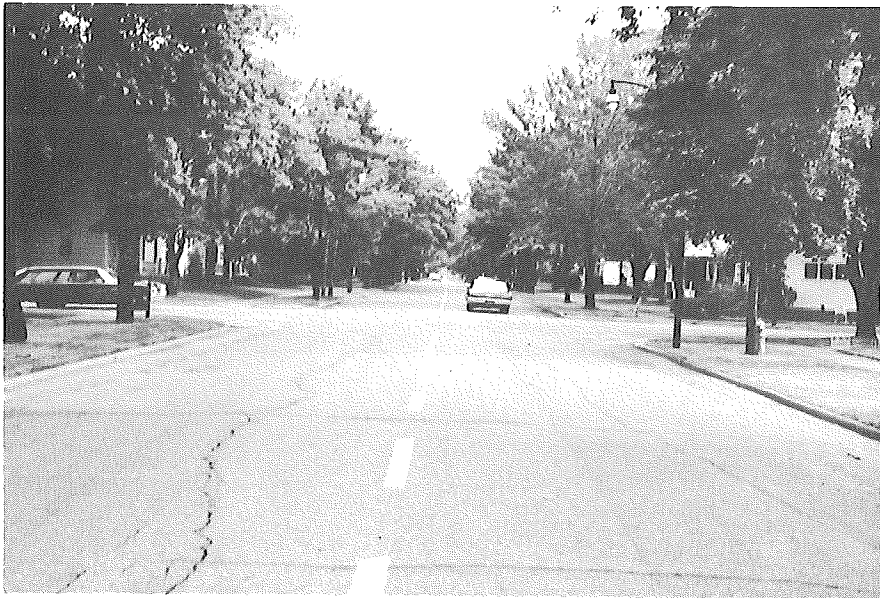
Location SOUTH 14<sup>TH</sup> ST. AT 5<sup>TH</sup> AVE. SOUTH  
CITY OF ESCANABA  
DELTA CO.

SOUTHBOUND  
SOUTH 14TH STREET

EASTBOUND  
5TH AVENUE SOUTH

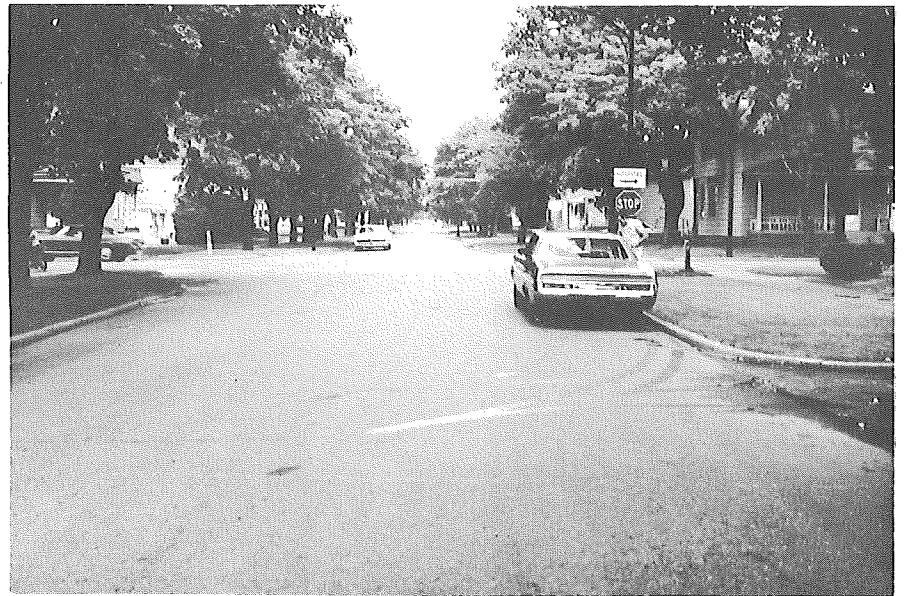
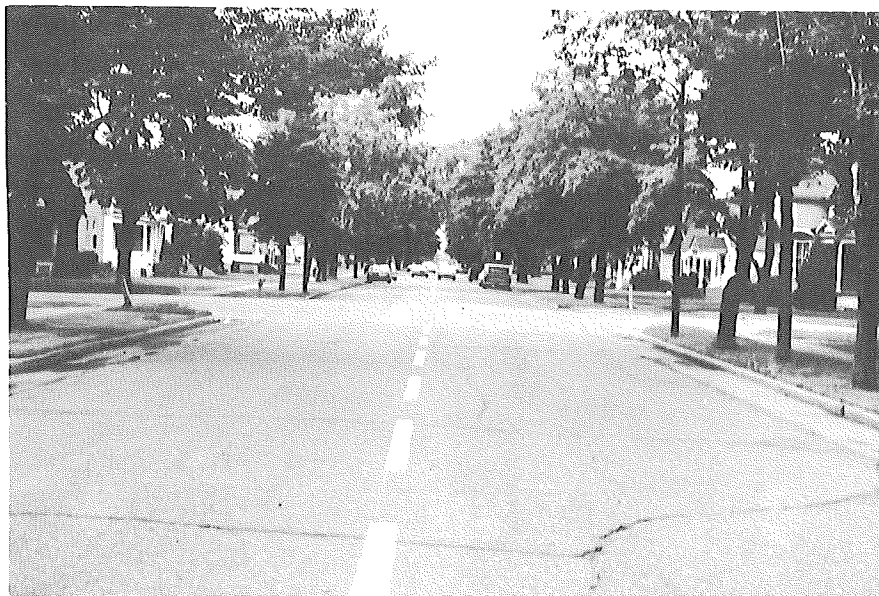
NORTHBOUND  
SOUTH 14TH STREET

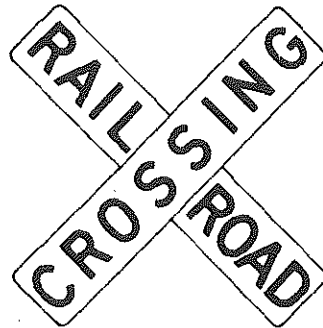
W10-2 (5½" and 4" letters)

## RAILROAD CROSSING SIGN

Reflectorized

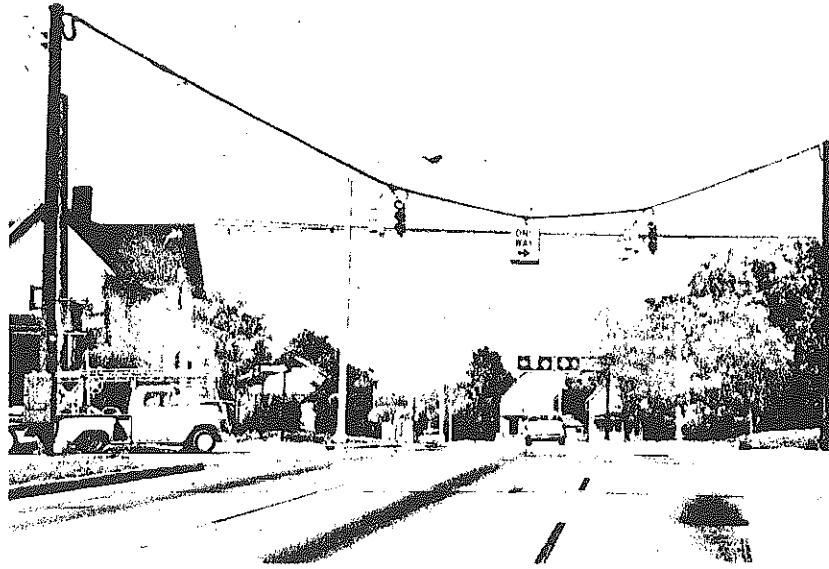
Figure 4-2. Traffic control signal installation with illuminated case sign.
