A TRAFFIC ACCIDENT ANALYSIS
OF HIGH ACCIDENT LOCATIONS
IN ST. JOSEPH COUNTY

Report TSD-SS-140-70

**DEPARTMENT OF STATE HIGHWAYS
STATE OF MICHIGAN**

February, 1971

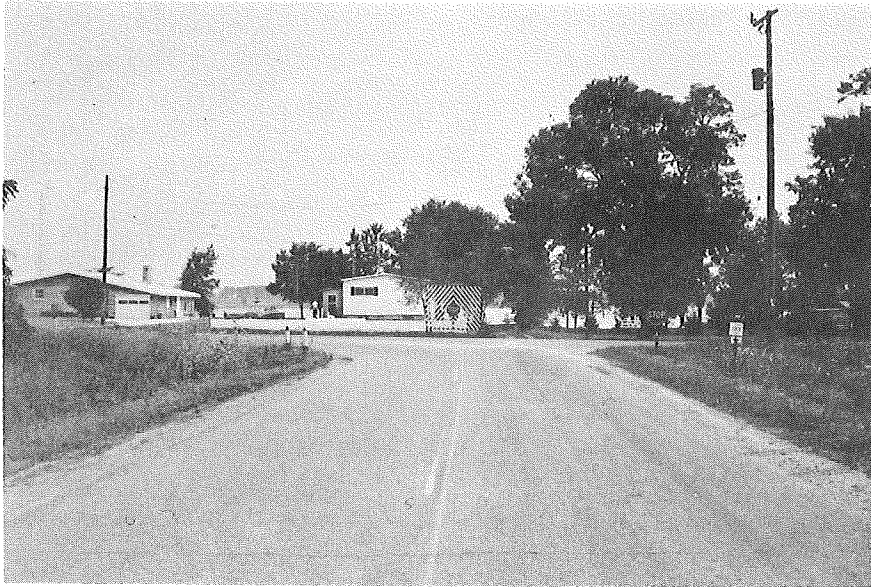
NORTHBOUND SILVER STREET
AT MICHIGAN AVENUE
(EAST INTERSECTION)

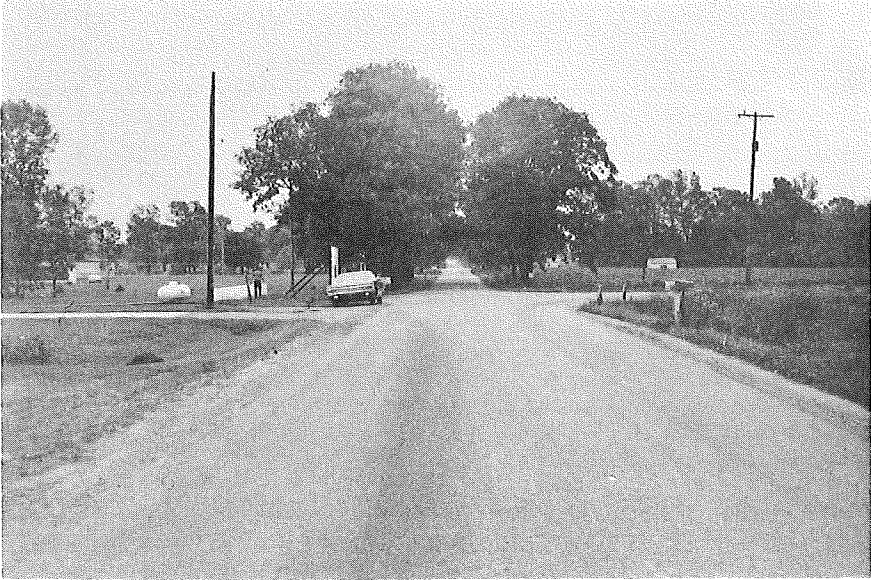
EASTBOUND MICHIGAN AVENUE
AT SILVER STREET
(EAST INTERSECTION)

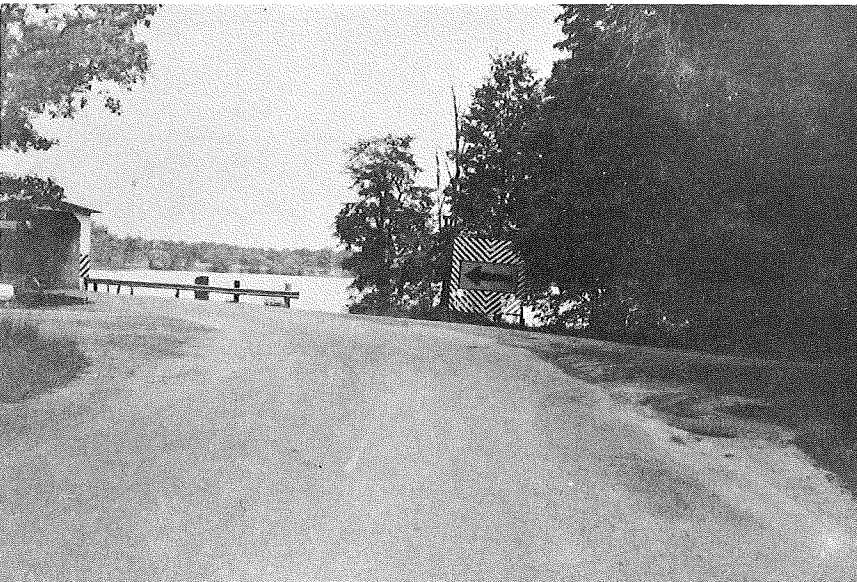
NORTHBOUND
COVERED BRIDGE ROAD
AT THE CURVE

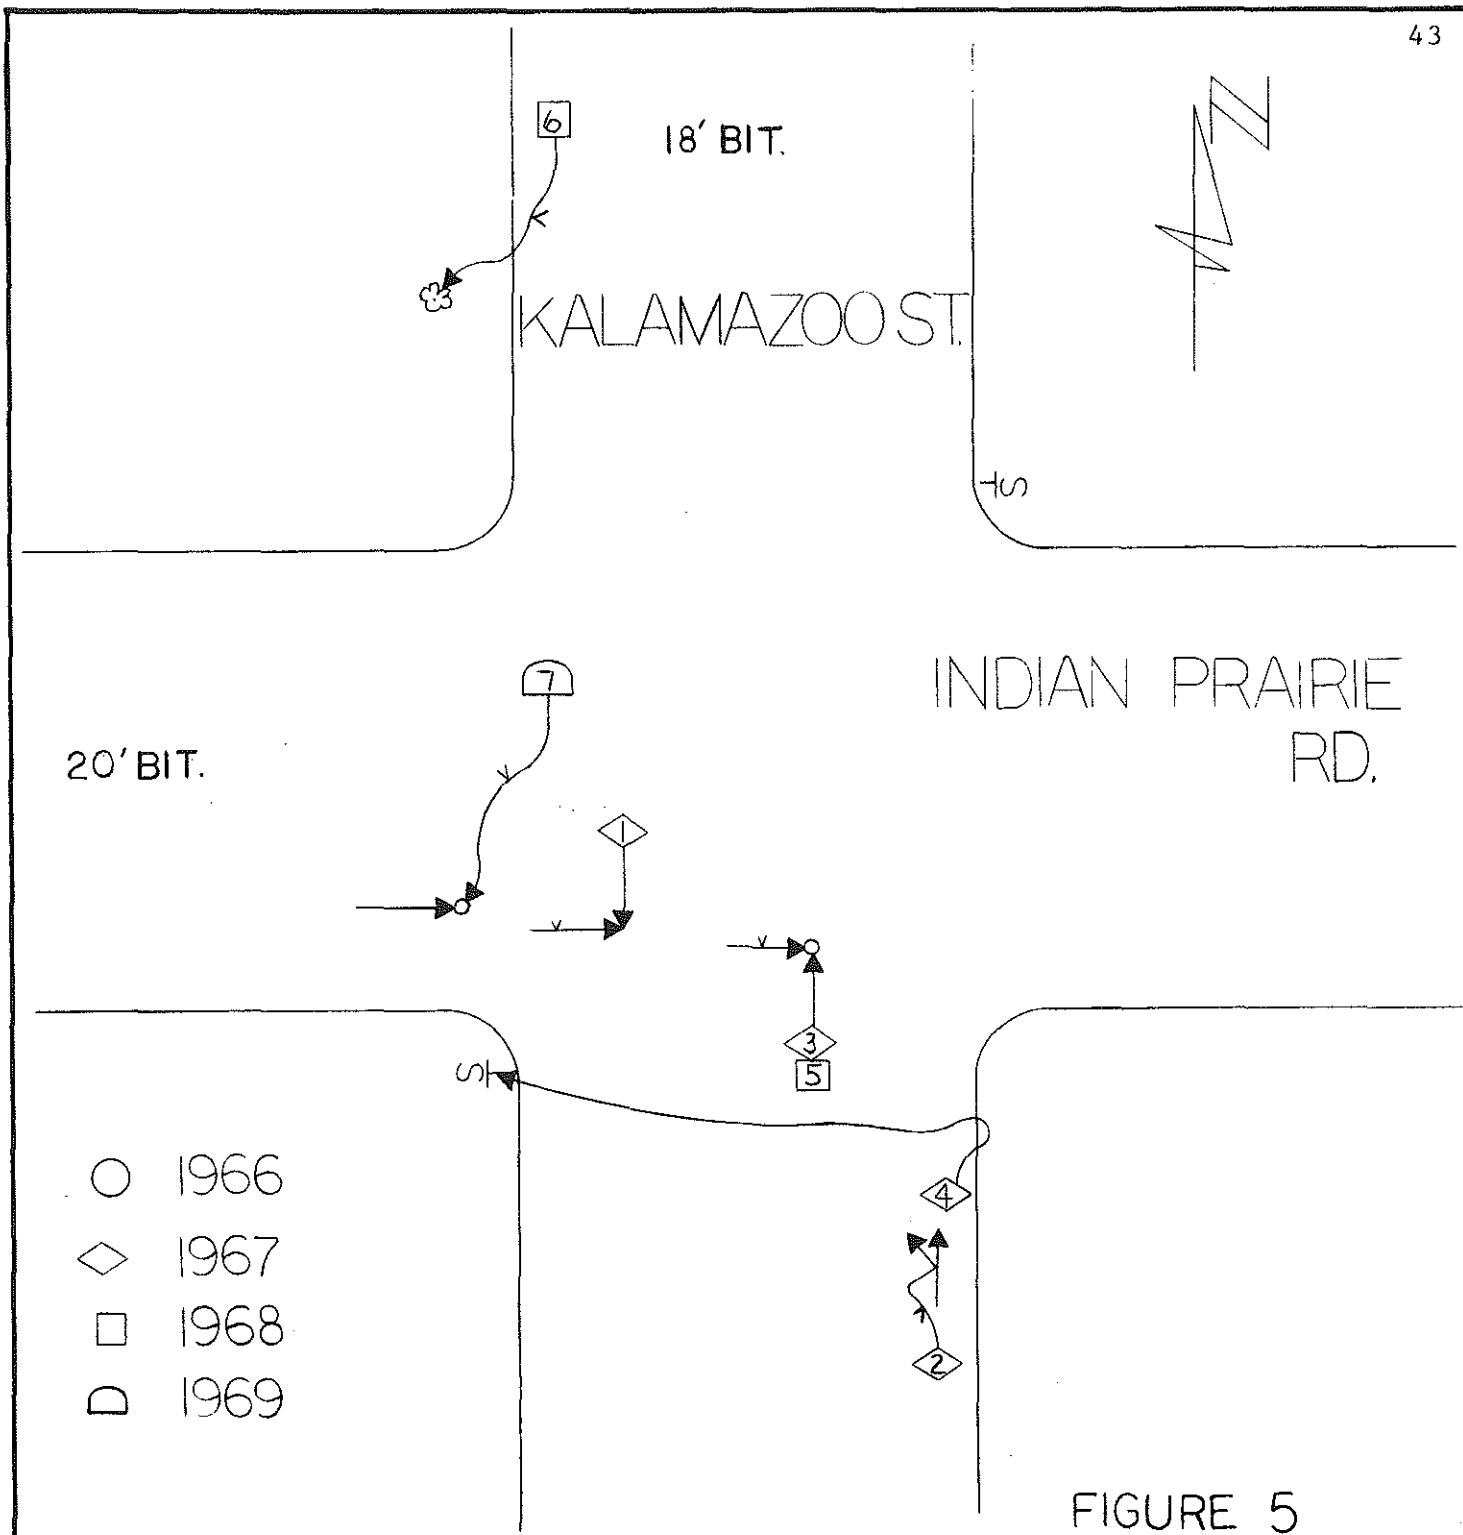
Plan No. LOCATION 5

During the study period 1966-1969 there were seven accidents at this location. Three of the accidents were violations of the stop sign for eastbound Indian Prairie Road traffic and two of them resulted in serious injuries. The intersection is visible from all approaches. However, due to high rural speeds, traffic on Indian Prairie Road may not realize the presence of the stop sign in time to take appropriate action.

We recommend that stop ahead warning signs (W3-1-36, Appendix II, p. 109) be erected for each direction of traffic on Indian Prairie Road.

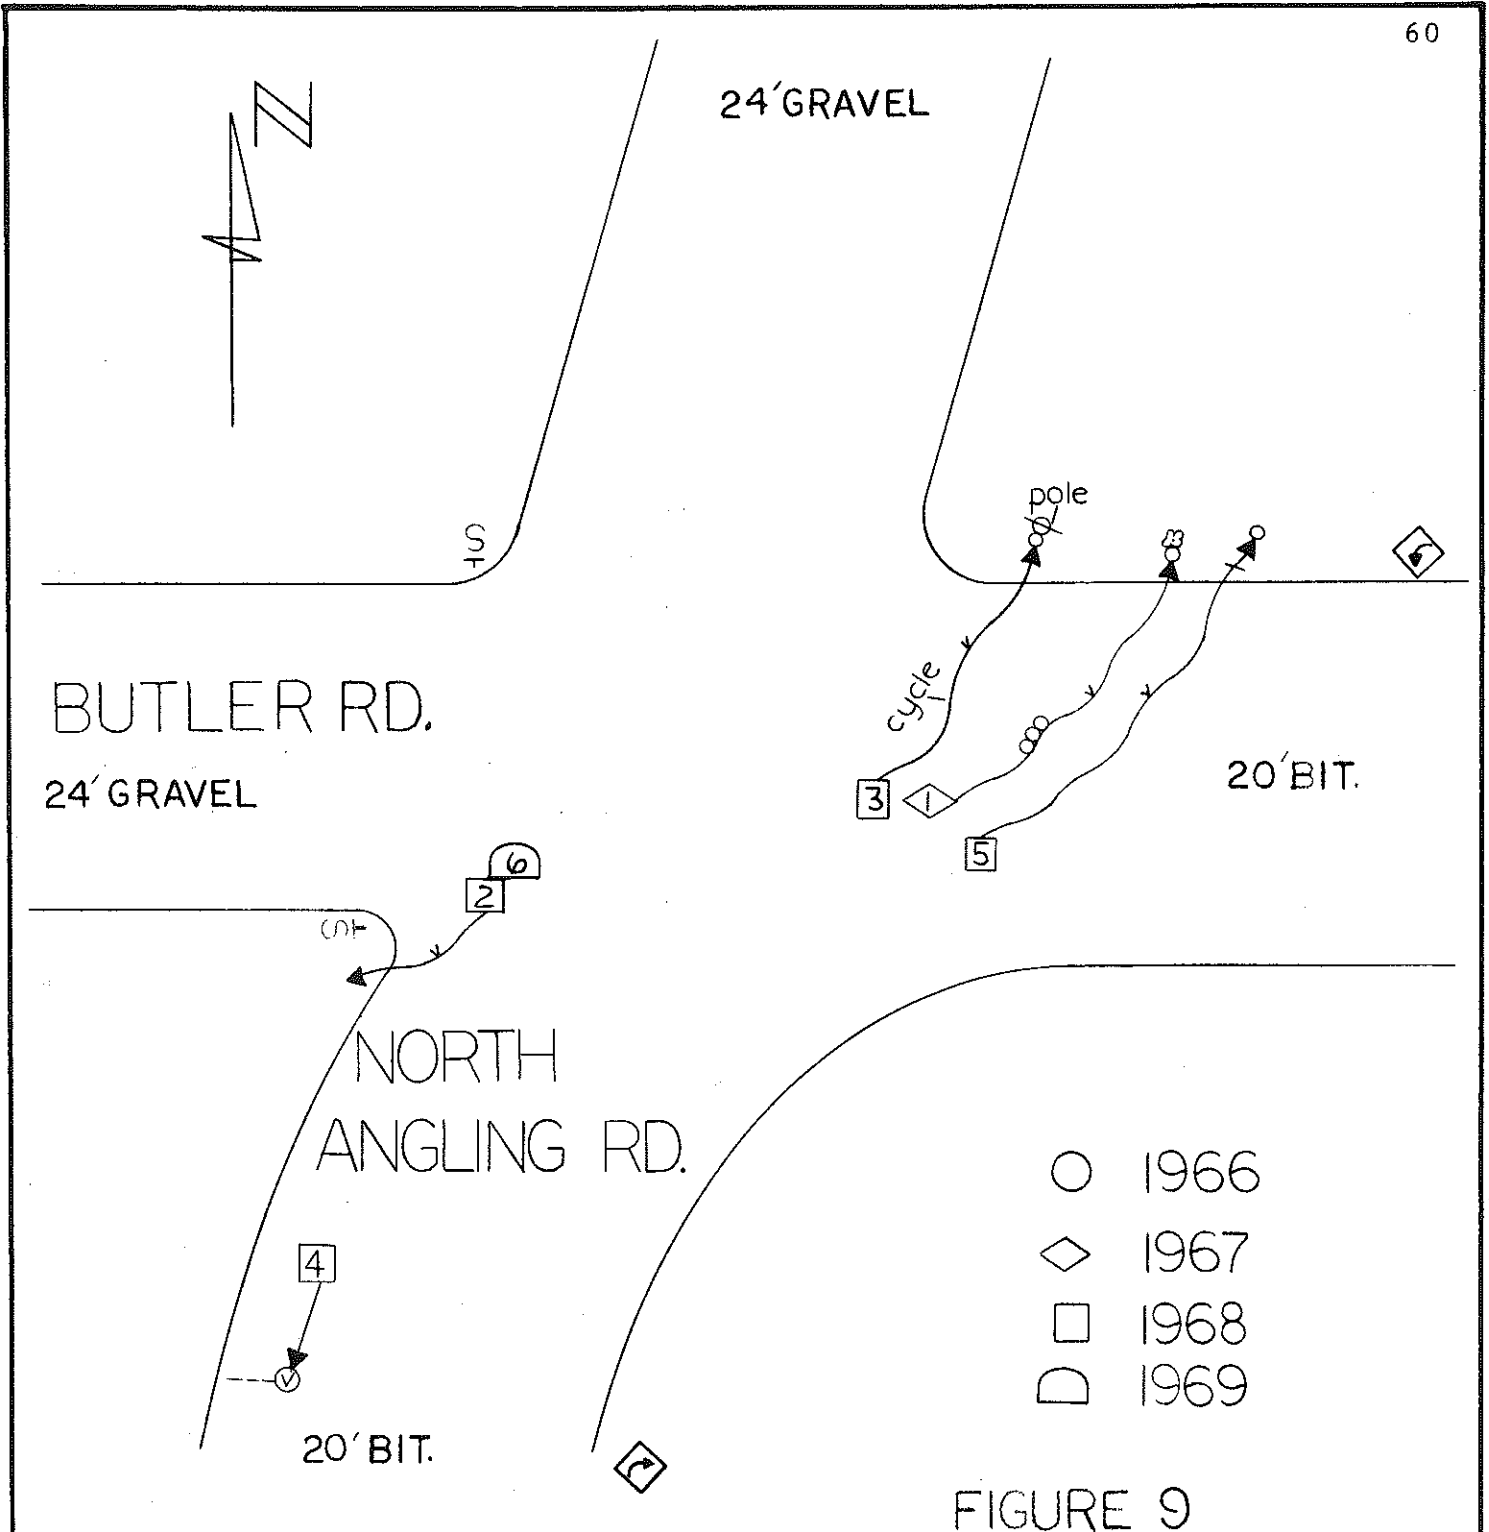
FIGURE 9

North Angling Road intersects Butler Road on a skew. The major traffic movements are from the southwest to the east and from the east to the southwest. The south portion of North Angling and the east portion of Butler Road are 20 ft wide bituminous surfaces with three foot shoulders. The other two legs of the intersection are gravel roadways in good condition.

At the time of the field investigation, the traffic control present for southbound North Angling Road and eastbound Butler Road was a yield sign for each roadway. However, the yield signs have been replaced by 24 in. stop signs.

We recommend that the existing curve signs for northbound North Angling Road and westbound Butler Road be

replaced by turn signs (W1-1-30, Appendix II, p. 99).

Based on the field data and the theory outlined in Appendix II, pps. 111 - 112, we recommend that the new turn signs be supplemented with 25 mph advisory curve speed panels (W12-1-21, Appendix II, p. 111). We also recommend that a target arrow (W1-6-48, Appendix II, p. 104) be erected in target position for northbound North Angling Road.

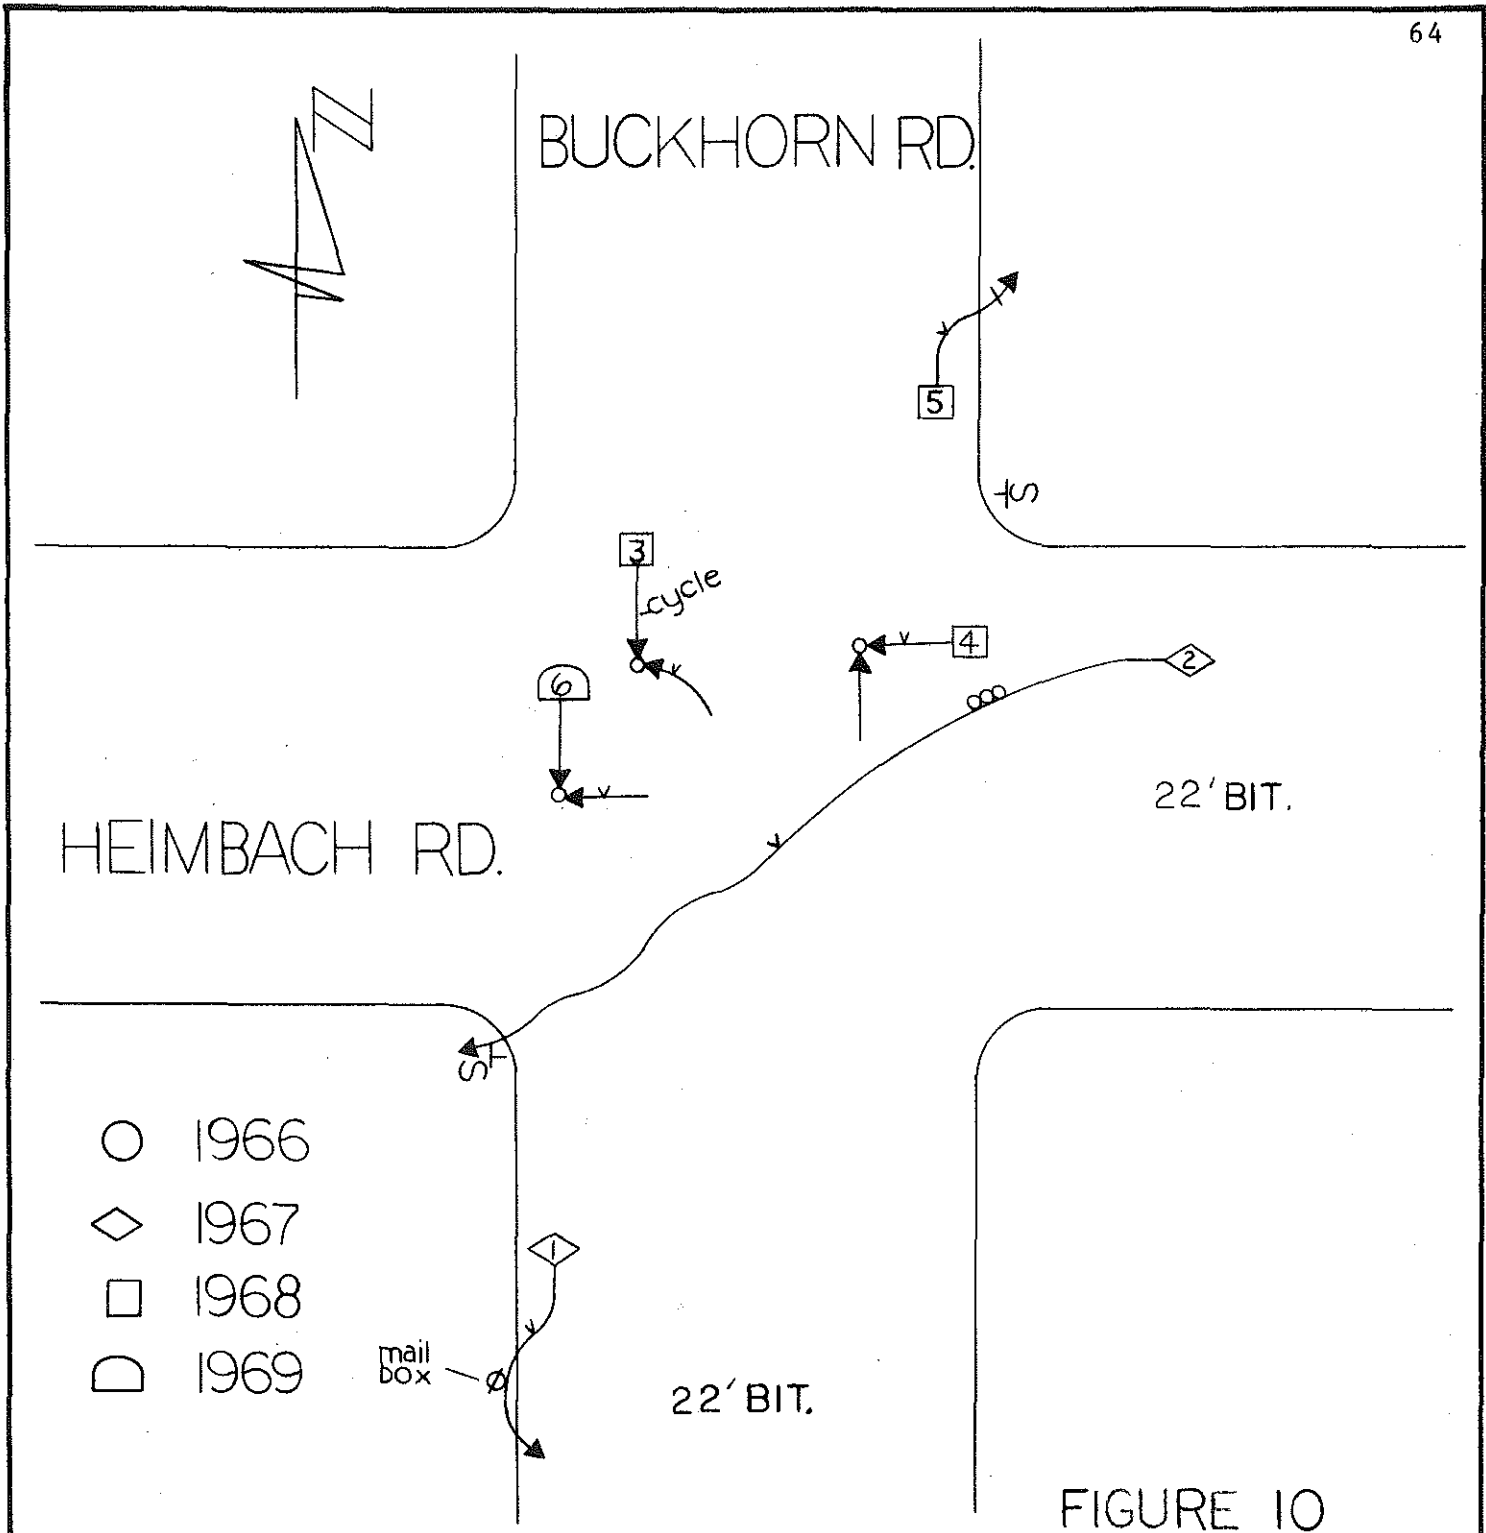
FIGURE 10

This is a right angle intersection with both legs of Heimbach Road under stop control. Heimbach Road is a 22 ft bituminous roadway which has been recently sealed and is in good condition. Heimbach Road has no shoulders and at the present time doesn't have any centerline markings.

The traffic control is a 24 in. stop sign for each direction of traffic on Heimbach Road. There was a total of six accidents at this location over the study period 1966 through 1969. Westbound traffic on Heimbach Road failed to yield the right of way causing three of the reported accidents. Overall visibility at the intersection is very good.

We recommend that stop ahead signs (W3-1-30, Appendix II, p.109) be erected for each direction of traffic on Heimbach Road.

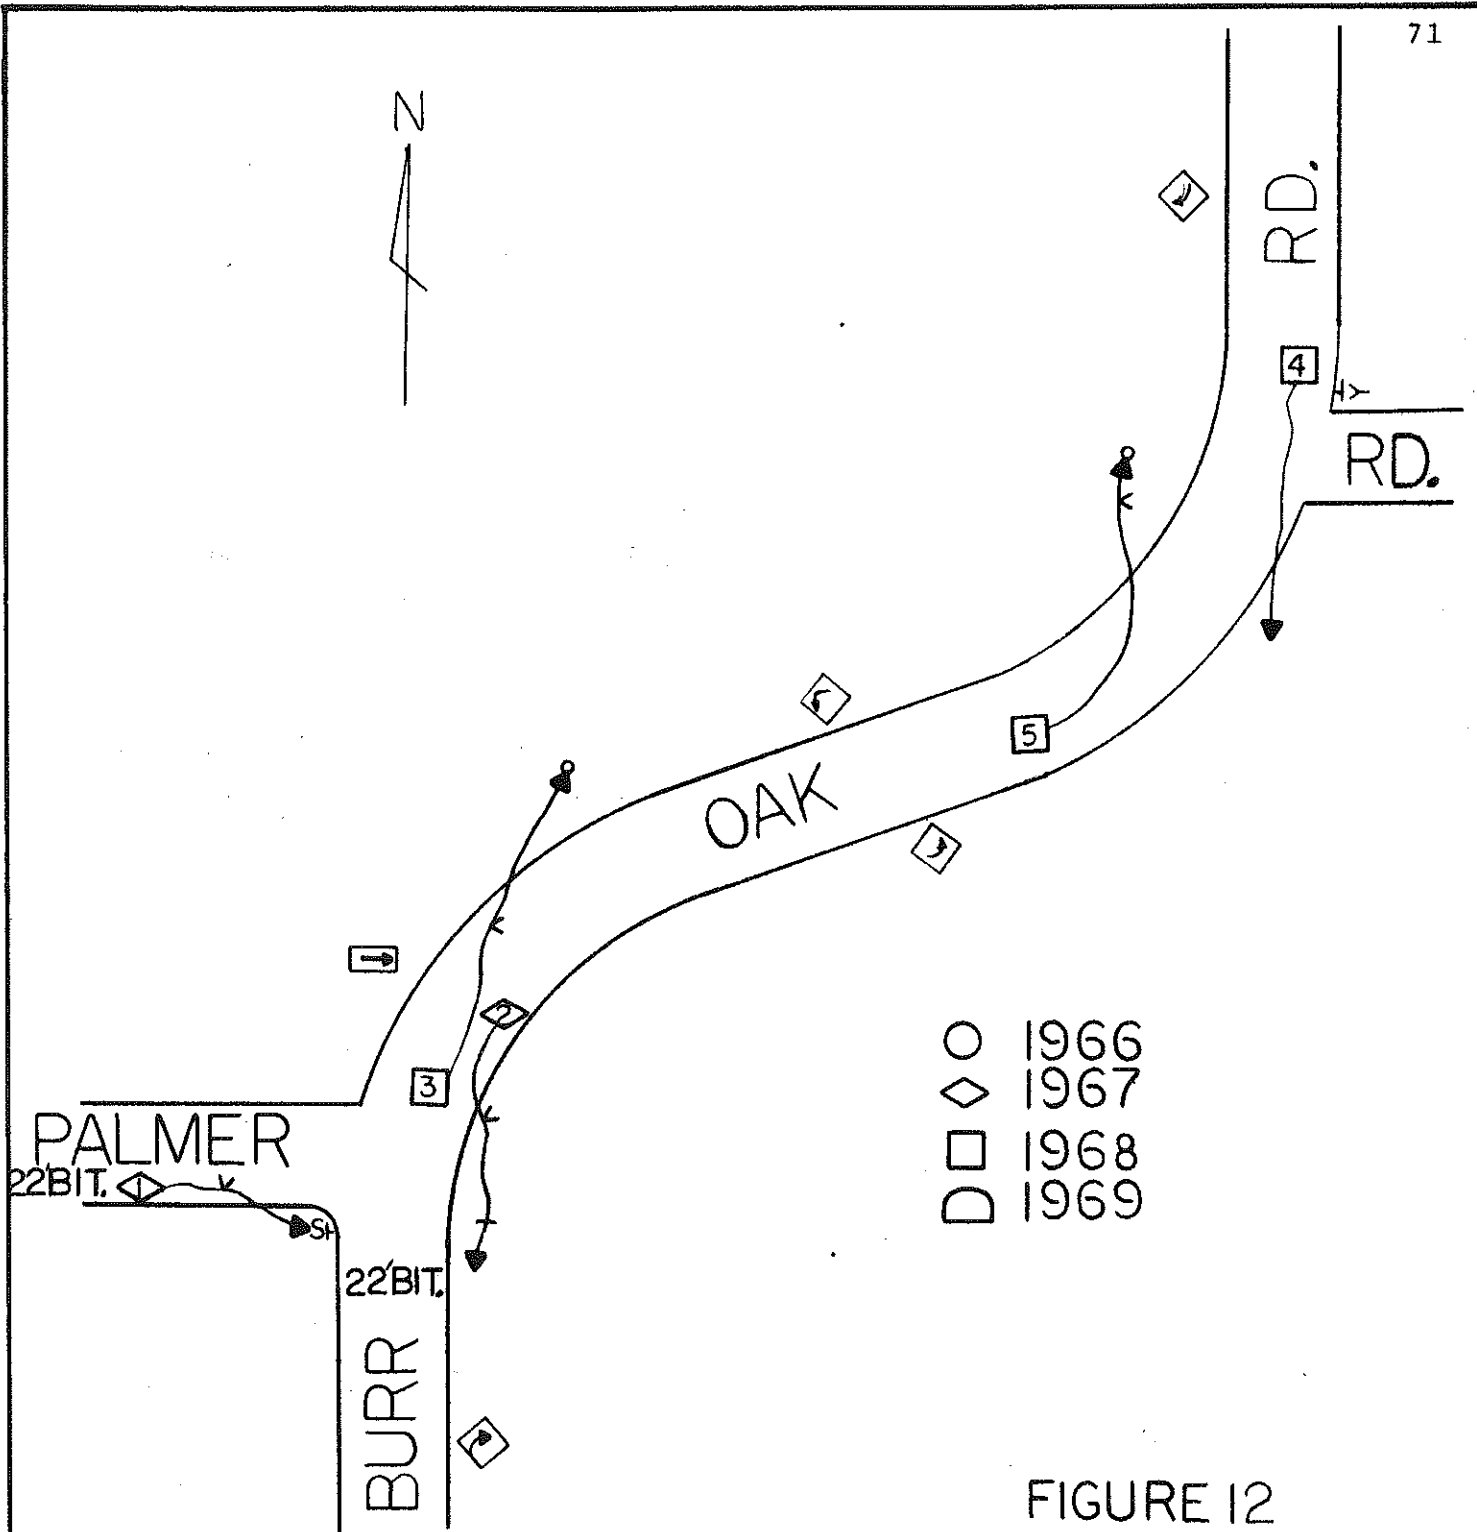
FIGURE 12

Traffic controls for Palmer Road are a 24 in. stop sign for the west leg (eastbound traffic) and a 30 in. yield sign on the east leg (westbound traffic). The 30 in. yield sign is smaller than the minimum size required by the Manual and consideration should be given to bring this sign to standards whenever the condition of the sign requires its replacement. Traffic controls for northbound Burr Oak are a 30 in. curve sign and a 24 in. x 48 in. target arrow for the first curve encountered by northbound traffic. The second curve encountered by northbound traffic has a 30 in. curve sign.

There were five accidents at this location over the study period 1966 through 1969. One accident resulted in personal injury and the others in property damage.

We recommend that a 24 in. x 48 in. target arrow (W1-6-48, Appendix II, p. 104) be erected in target position for the first curve encountered by southbound Burr Oak traffic (east junction).

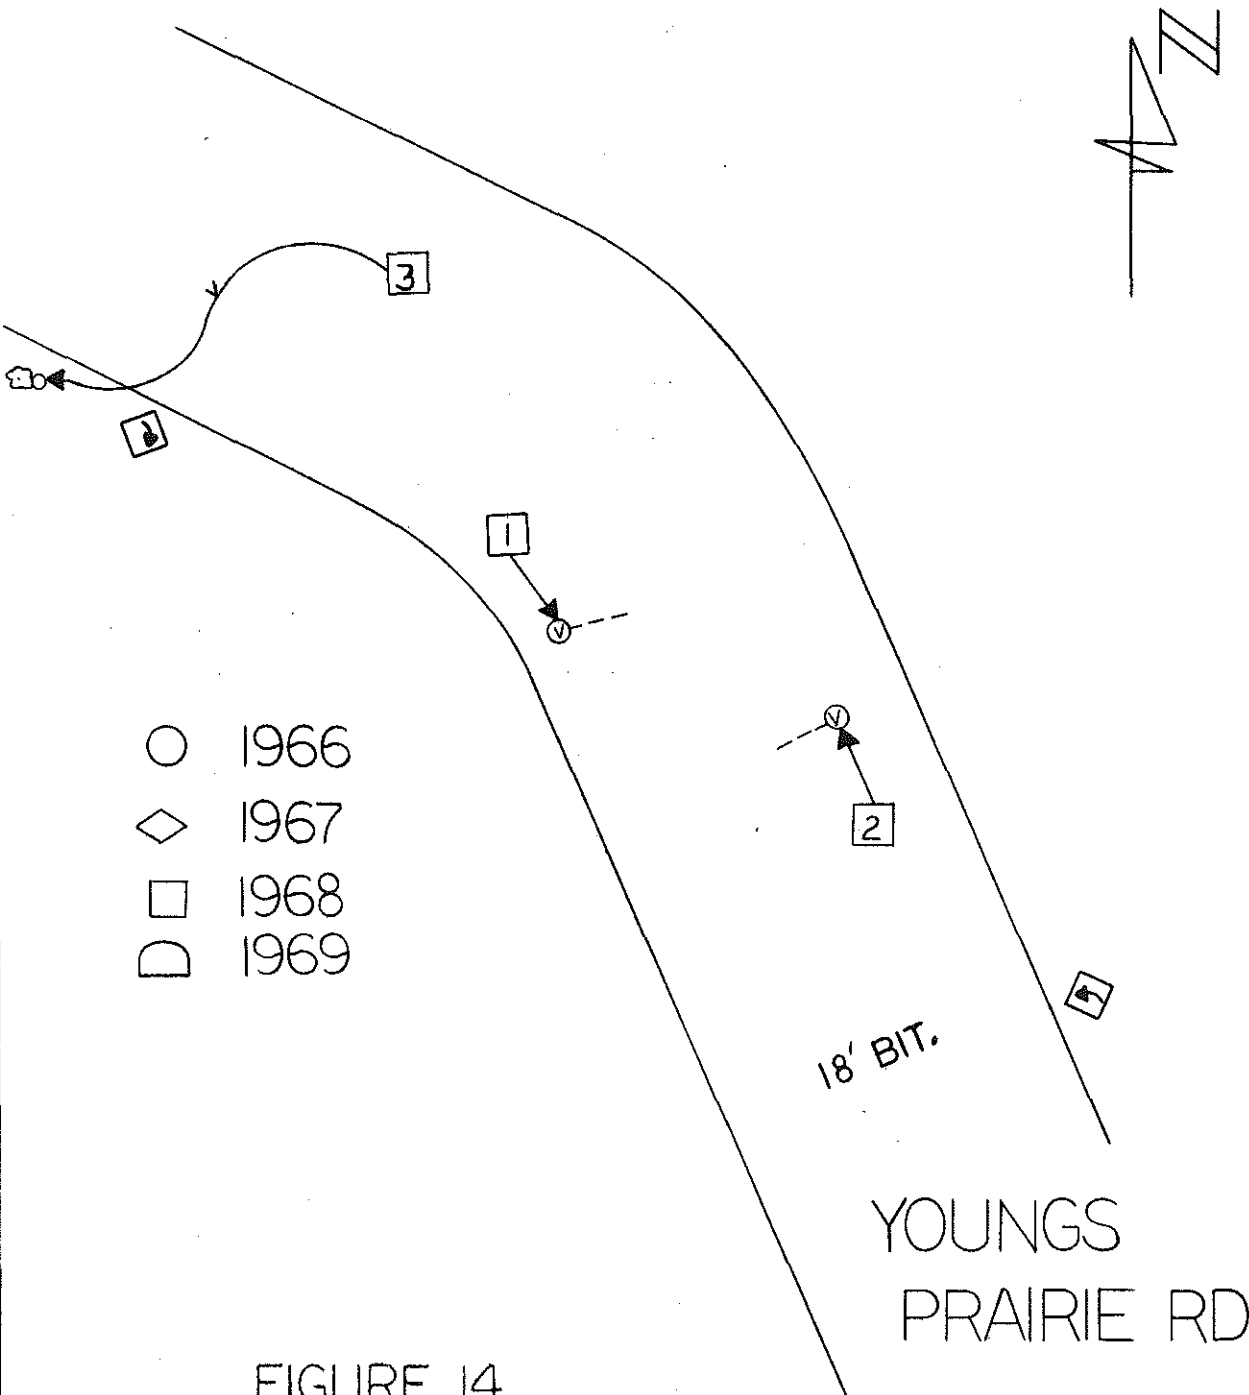
FIGURE 14

Judging by the current accident picture and the existing signing, no recommendations are being made for this location.
