MDOT Research Report RC-1425

**A STUDY OF MATERIALS-RELATED  
DISTRESS (MRD) IN MICHIGAN'S  
PCC PAVEMENTS—PHASE 2**

**Final Report**

**Transportation Materials Research Center  
Michigan Technological University  
Dept. of Civil and Environmental Engineering  
1400 Townsend Drive  
Houghton, MI 49931**

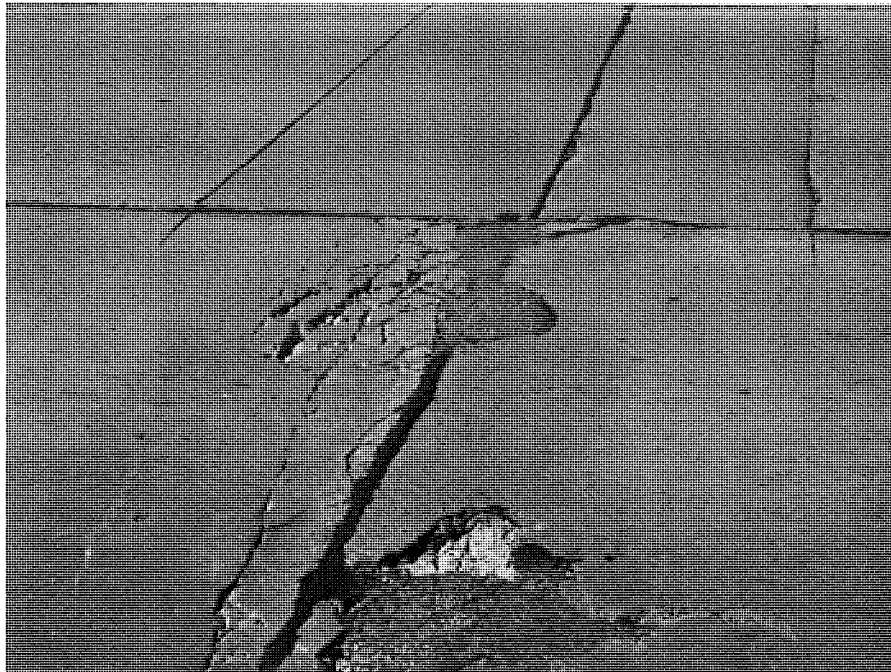
Figure 2. Cracking, staining, and spalling at joint.

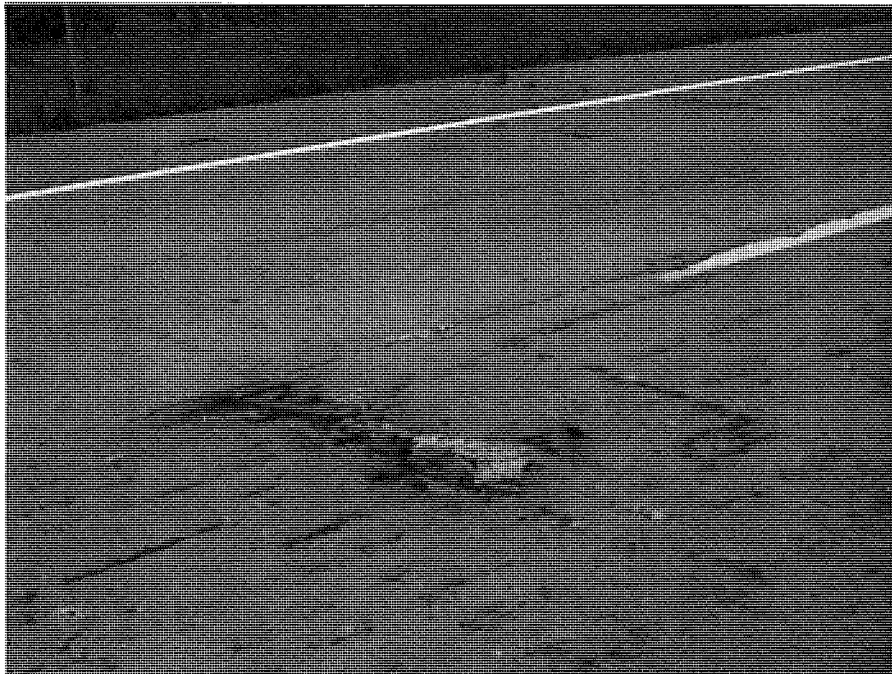
Figure 4. Corrosion of embedded steel.

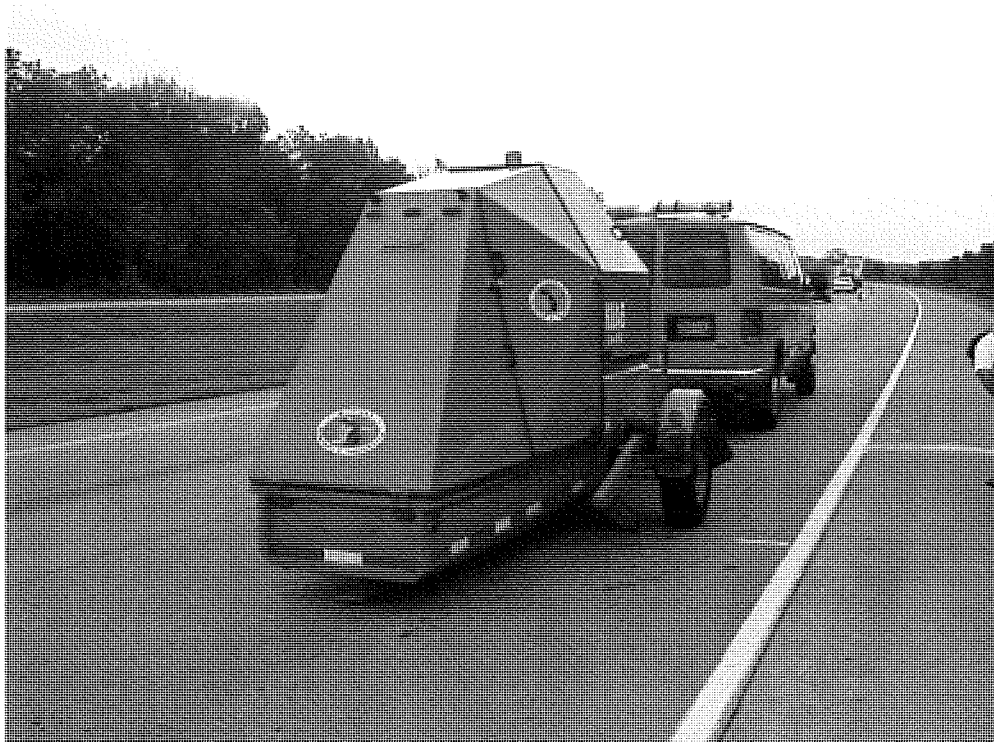
Figure 7. MDOT's FWD testing at Site 4A, US-23 SB.

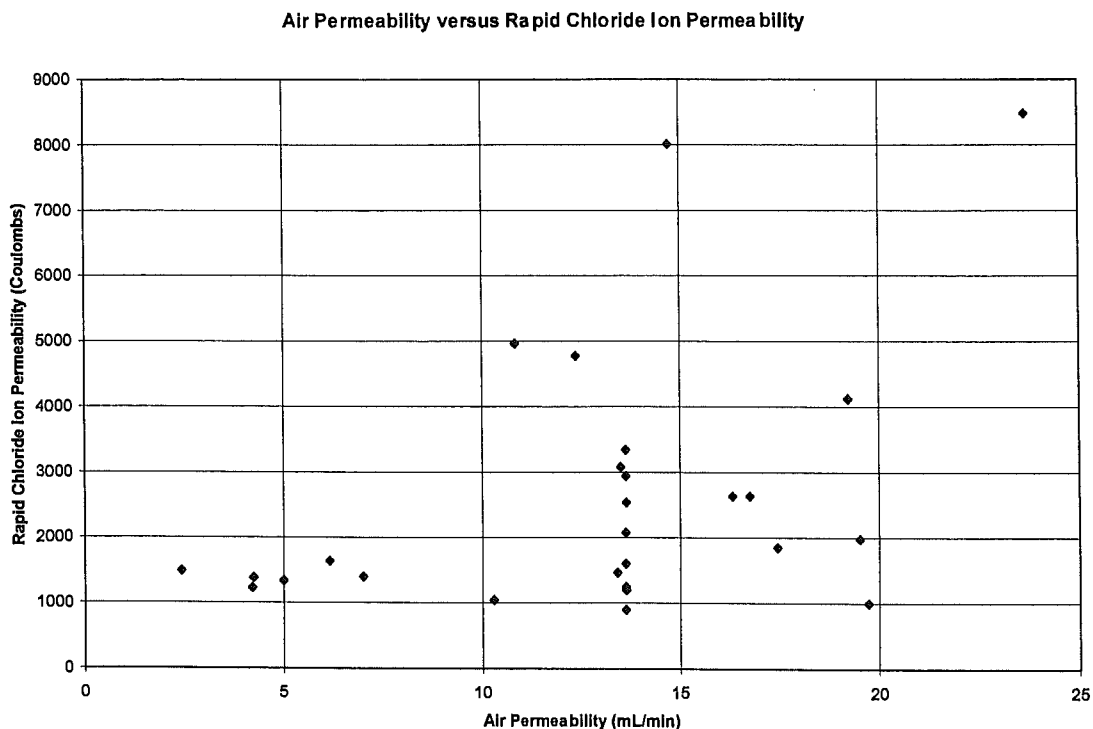
Figure 10. Plot of air permeability versus rapid chloride ion permeability.

One interesting observation is that although no readily observable trend exists between the aggregate type and the rapid chloride ion permeability test, this is not the case with the air permeability test. The three of the four highest air permeability measurements were made on concrete having slag coarse aggregate, including the non-distressed test site (Site No. 1). All of the slag sites tested (air permeability was not conducted on Site No. 19) had an average air permeability rating of “permeable” whereas only one of the sites constructed with natural aggregate (Site No. 3) received such a high rating. Similar trends were not observed with the rapid chloride ion permeability test.

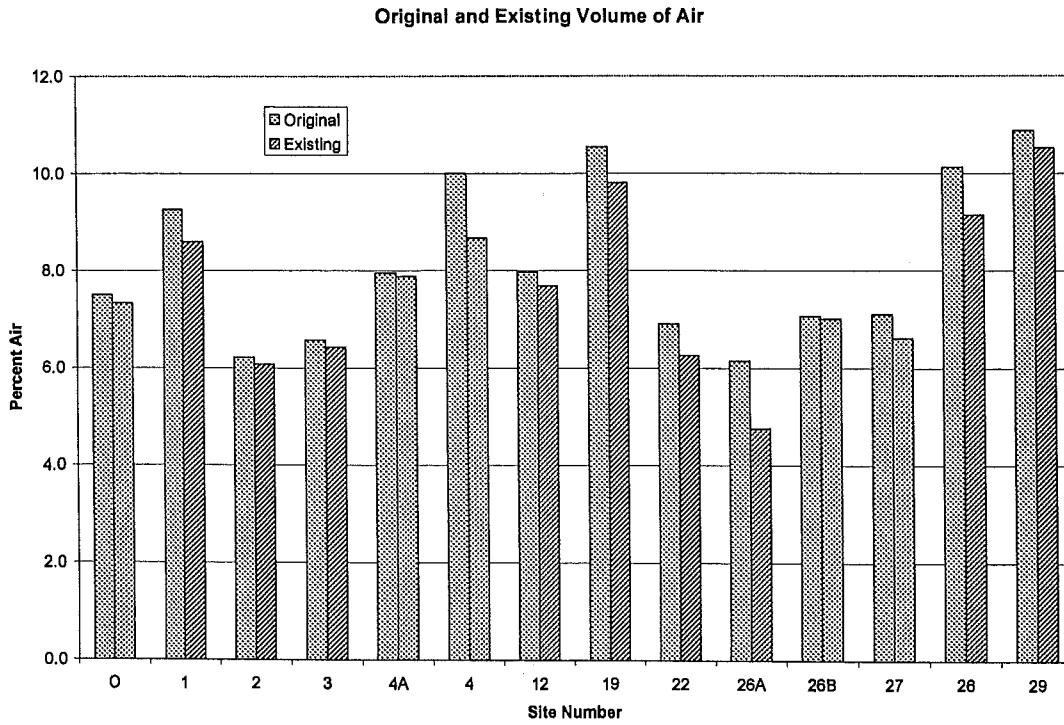
Figure 11. Original and existing air content from ASTM C457.

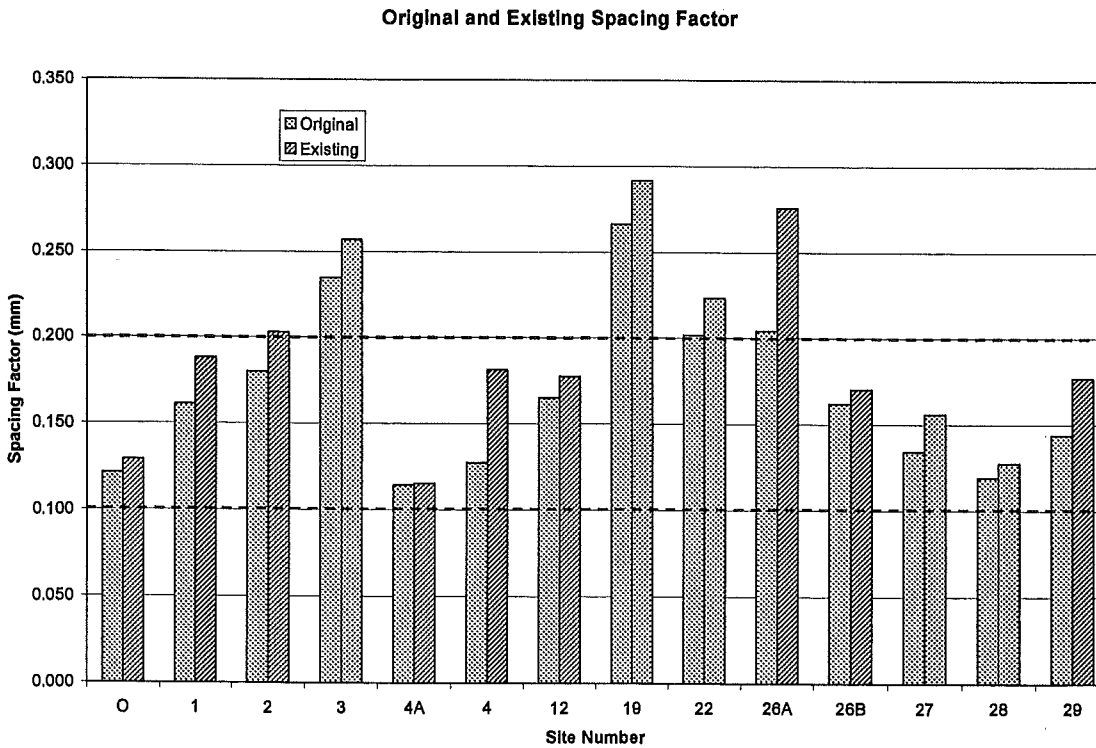
Figure 12. Original and existing spacing factor from ASTM C457.

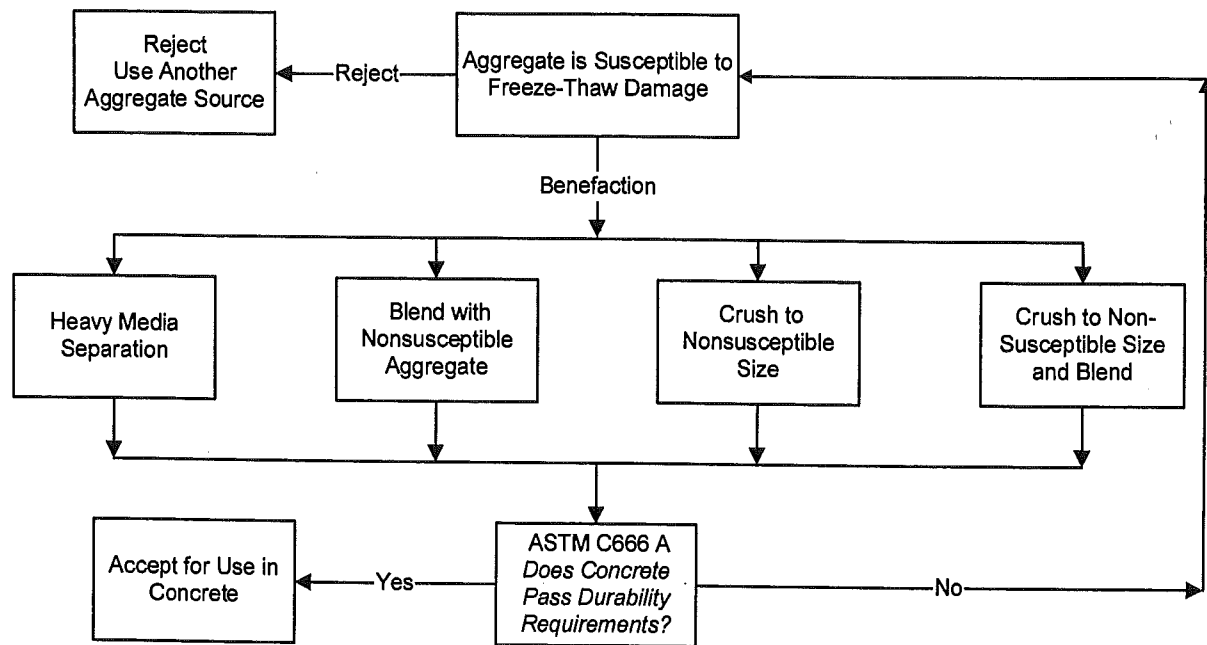
Figure 20. Benefaction techniques for mitigation of aggregate freeze-thaw deterioration (Van Dam et al. 2002a).

Therefore, it has been necessary for these marginal aggregate sources to undergo benefaction to reduce the susceptibility to this MRD. Benefaction generally takes four many forms as illustrated in Figure 20, with three methods having been used with variable success. The first method attempts to separate susceptible aggregate from nonsusceptible aggregate using the aggregate bulk specific gravity. This method is frequently used in Michigan to separate out lighter aggregate particles that are generally deleterious and have been implicated in popouts and spalling. It has been found in some cases that aggregates having lower bulk specific gravities were less resistant to freeze-thaw deterioration and that this difference could be used to separate aggregate using heavy-media separation (Schwartz 1987). With the elimination of the lighter aggregate particles, the remaining aggregates are more resistant to freeze-thaw deterioration.
