Durability Study of the US-23 Aggregate Test Road and Recent JPCP Projects
with Premature Joint Deterioration

Final Report

Submitted to
MICHIGAN DEPARTMENT OF TRANSPORTATION
Construction and Technology Division
Lansing, Michigan

Final Report prepared for
Michigan Department of Transportation
December 2010

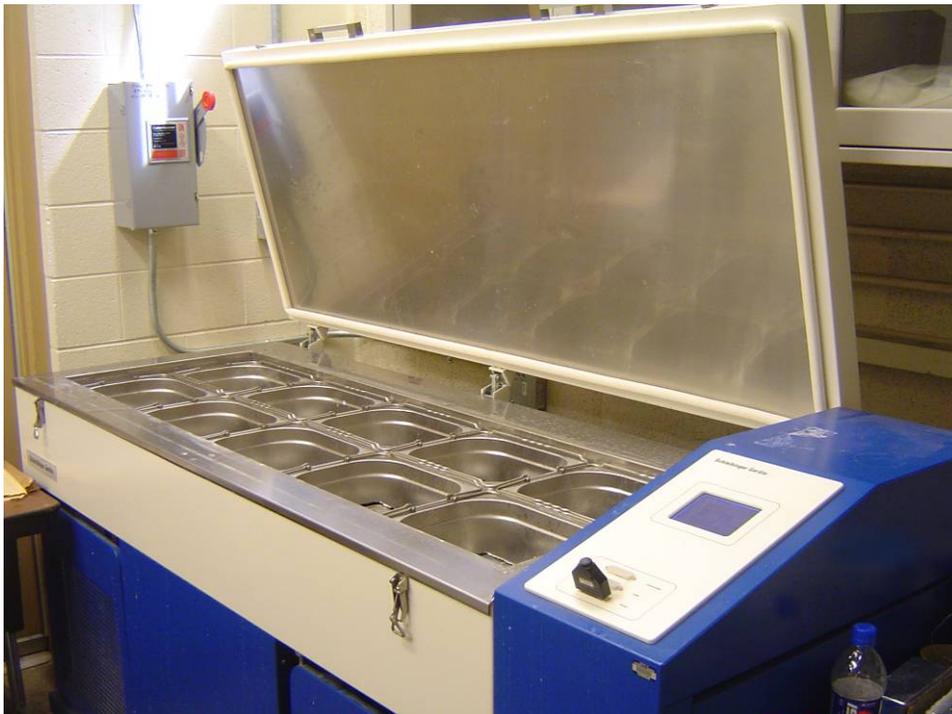
A freeze-thaw cycle has a 12 hour duration, consisting of a linear temperature lowering from 68 °F (20 °C) to – 4 °F (-20 °C) at a rate of 18 °F/hour (10 °C/hour), followed by a constant temperature of – 4 °F (-20°C) for 3 hours, then a heating rate of 18 °F/hour (10 °C/hour) for 4 hours. The specimen surface in contact with the liquid is subjected to this temperature profile. The temperature is kept at 68 °F (20 °C) for 1 hour before commencement of the next freeze-thaw cycle. During this time measurements are made. The freeze-thaw machine is shown in figure 2.2 with 10 stainless steel-bowls, each containing one specimen.

Figure 2.2 Freeze-Thaw Machine (www.schleibinger.com)

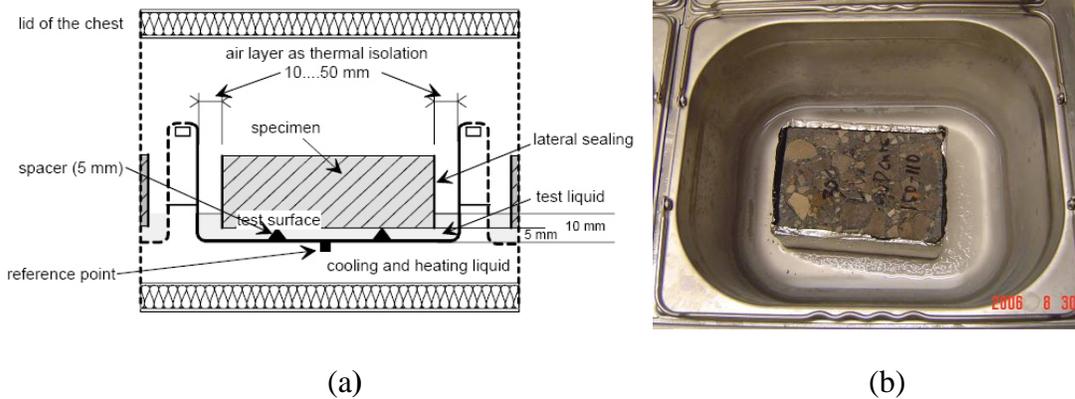
Each specimen is sitting on spacers so that the bottom test surface is in contact with the test liquid (either water or 3% NaCl solution) as shown in figure 2.3 a and b.

Figure 2.3 Close-up of specimen test (a) and actual test specimen with bottom test surface in contact with liquid, in this case in a frozen condition (b).

To prevent liquid uptake and scaling from the lateral surfaces the specimens are sealed using aluminum foil lined with butyl rubber (figure 2.3b) on the inside. Mass-loss from surface scaling and internal damage are determined after 4 to 6 consecutive freeze-thaw cycles.

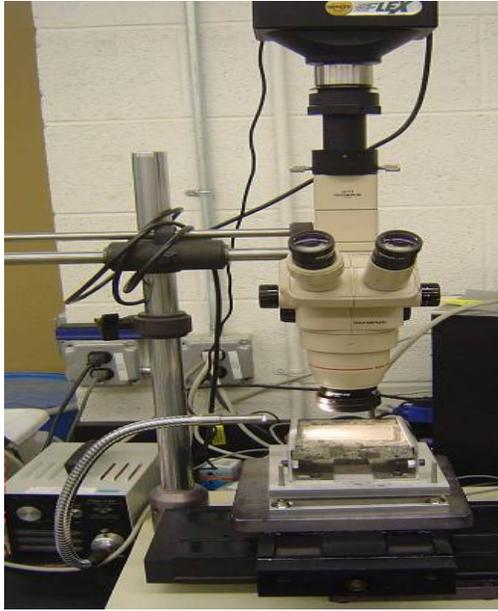
In order to understand the damage mechanisms associated with freeze-thaw, the specimen surface and the scaled material were analyzed periodically in the digital microscope, figure 2.4.

Figure 2.4 Digital microscope setup.

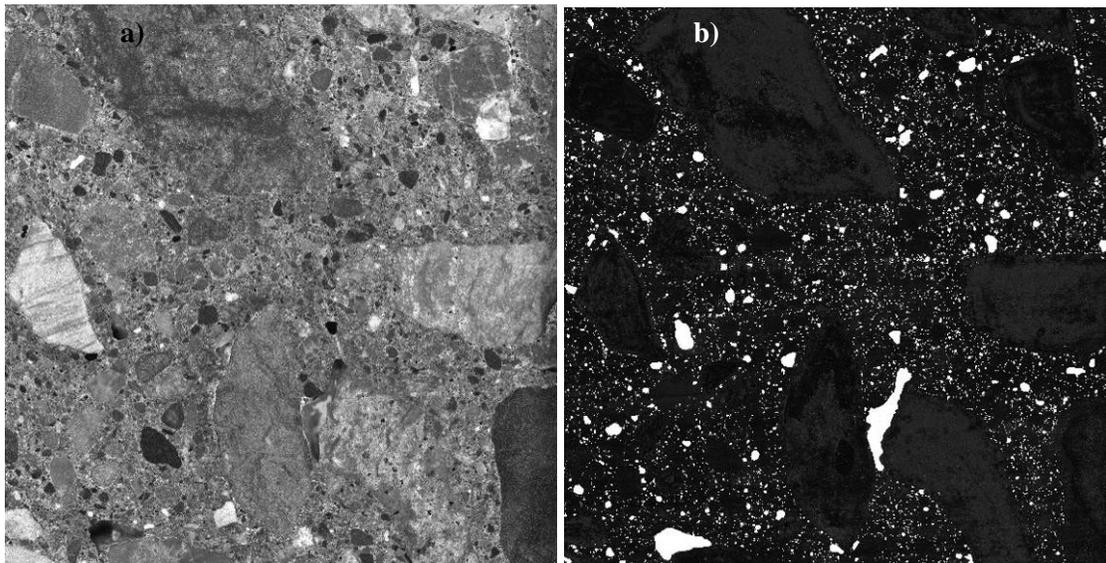
Point count analysis for paste, total air and aggregate content and infilling of air was conducted on the polished concrete samples (Figure 2.7a). Air-void chord-size distribution was determined by an automated procedure (RapidAir 457 Air Void Analyzer) which required contrast enhancement. Air-voids were filled with white particles ($BaSO_4$) and the surface was colored with black ink (Figure 2.7b).

Figure 2.6 Sample surface after polishing (a), and the same surface after contrast enhancement (b).

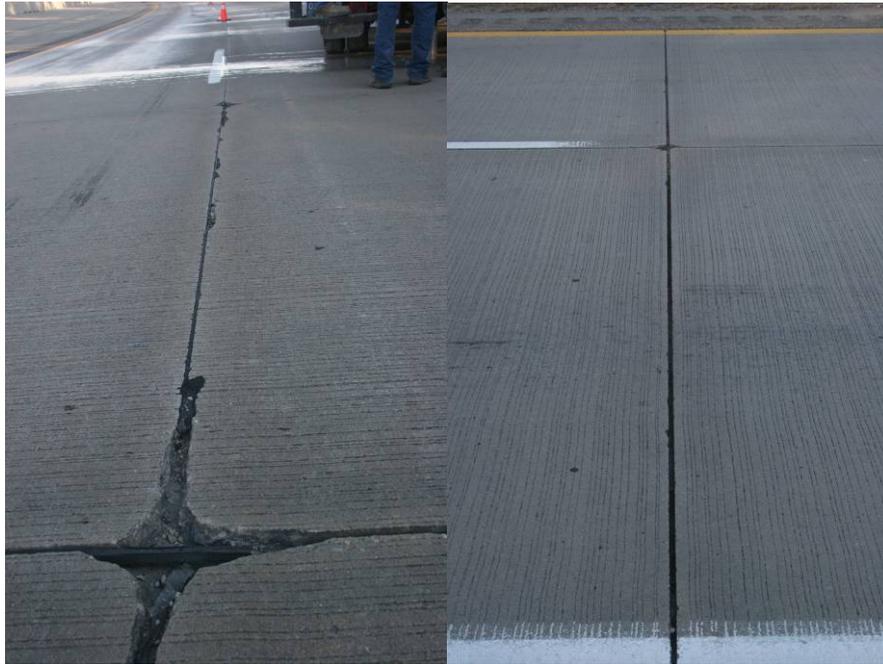
Field observations show that joint associated distress is most pronounced at the joint corners and additional joint spalling develops in the longitudinal joints (figure 3.1). Transverse joint staining was found to be associated with this type of distress (figure 3.2). Occasional transverse joint spalling was found near the outside shoulder away from wheel-load area. This is likely a water accumulation problem due to the pavement cross slope (figure 3.2).

Figure 3.1 Joint associated distress (EB, M-14, Ann Arbor).

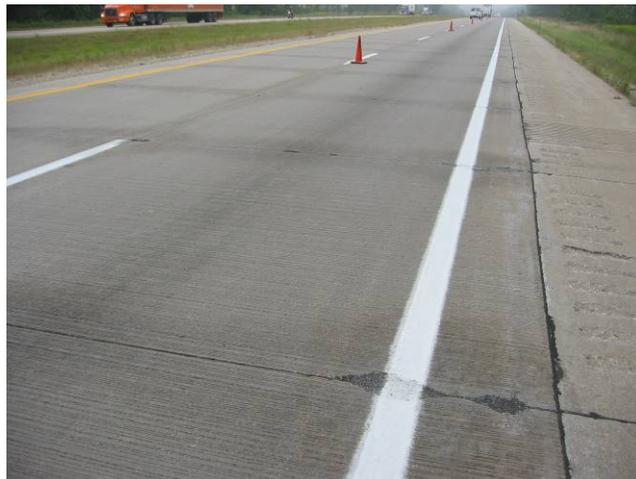
Figure 3.2 Transverse joint staining and spalling near outside shoulder (WB, I-94, Lawrence, MI).

Ensure that the base and subsurface is sufficiently drained so that water and deicer solutions are not permitted to accumulate at or beneath joints or other discontinuities in the concrete pavement surface. Ensuring adequate drainage will reduce the likelihood that the

surrounding concrete at joints will become critically saturated, thus, reducing the risk for MRD and premature deicer-related freeze-thaw deterioration.

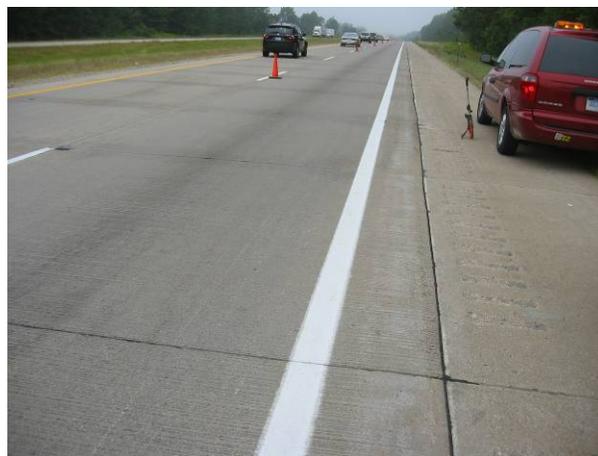
A unique situation exists on WB, I-94, Lawrence, where a small part of the section at time of investigation (August, 2008) has no joint associated distress (i.e. no spalling and joint staining) while the remaining section has developed distress (figure 3.3). Additional transverse joint spalling was associated with longitudinal cracks running in a straight line between transverse joints. The crack pattern was typical for vibrator trails due to over-vibration of the concrete during paving operation. No vibrator trails were observed in the section without distress. These crack intercepts at the transverse joints were points of spall initiation just below the tined surface (figure 3.4 and 3.5). In figure 3.5 coring on one side of the joint spall show that joint deterioration has developed only in the top few inches. Figure 3.6 is another example of transverse joint deterioration outside the wheel-path, showing that concrete deterioration is due to erosion of the mortar. Extensive longitudinal joint associated distress has developed for both the M-14 and the I-94 projects. Coring on the I-94 project demonstrated that water was trapped in the joint due to tight crack opening (figure 3.7). Core samples were obtained from midslab and joint areas for freeze-thaw testing and air-void analysis.

Figure 3.3 WB I-94, Lawrence, MI, showing end of section without joint distress and the beginning of the section with distress.

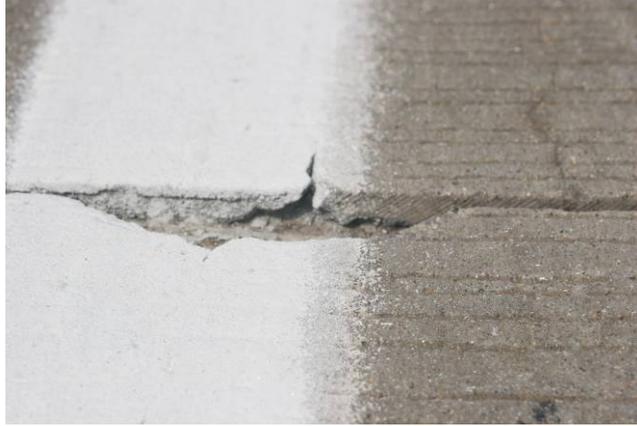
Figure 3.4 Longitudinal cracks at transverse joints initiate joint associated distress just below the tined surface.

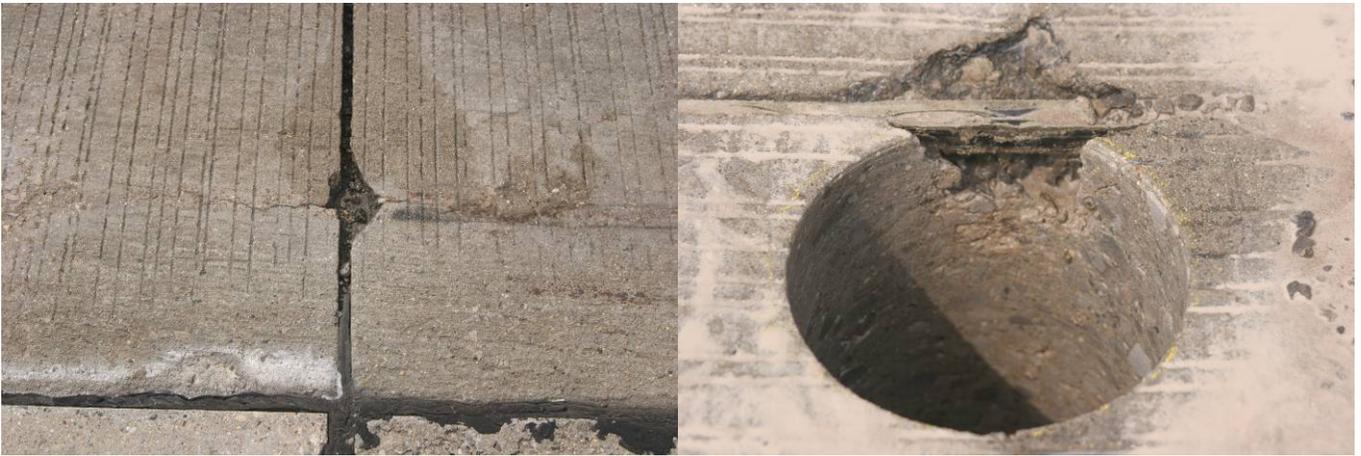
Figure 3.5 Close-up of joint deteriorated concrete (WB, I-94, Lawrence, MI).

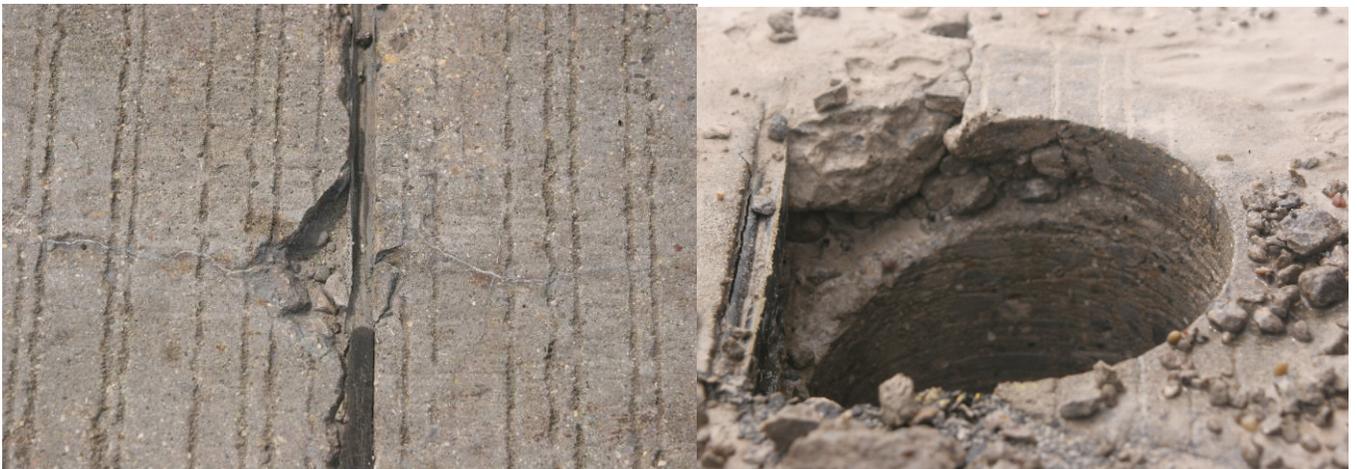
Figure 3.6 (a) WB, I-94, transverse joint spalling deterioration at intercept of longitudinal crack from vibrator trails, and (b) deterioration initiation just below the tined surface from mortar erosion.

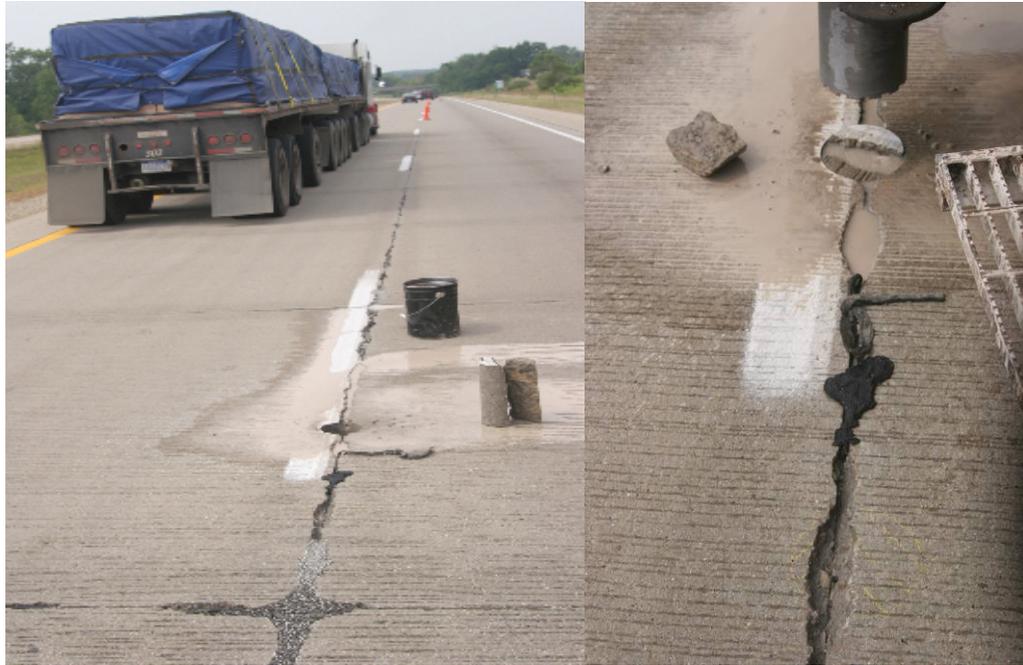
Figure 3.7 WB I-94, Lawrence, MI, with longitudinal joint deterioration (a), and (b) poorly draining joint.

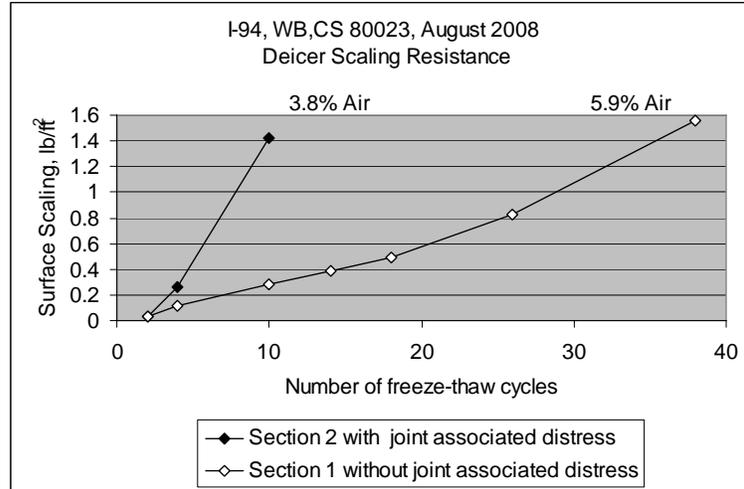
Results in figure 3.8 corroborate field observations for the WB, I-94, Lawrence, project, where one section has no distress while the adjoining section has extensive joint associated distress. The concrete from the distressed area failed quickly (< 10 cycles) in the deicer scaling test while the concrete without any field distress had substantially better deicer scaling resistance with 75% less surface scaling for same number of freeze-thaw cycles. Photos (figure 3.9) of the specimen exposure surfaces illustrate extensive erosion of the mortar phase after only 10 freeze-thaw cycles while the erosion is limited in the concrete without any field distress. The major factor for the poor laboratory frost resistance is insufficient air content. The concrete with poor freeze-thaw resistance and field distress has 3.8% total air content, while the field concrete with no distress has 5.9% air (ASTM C457).

Figure 3.8 WB, I-94 test results for two different sections.

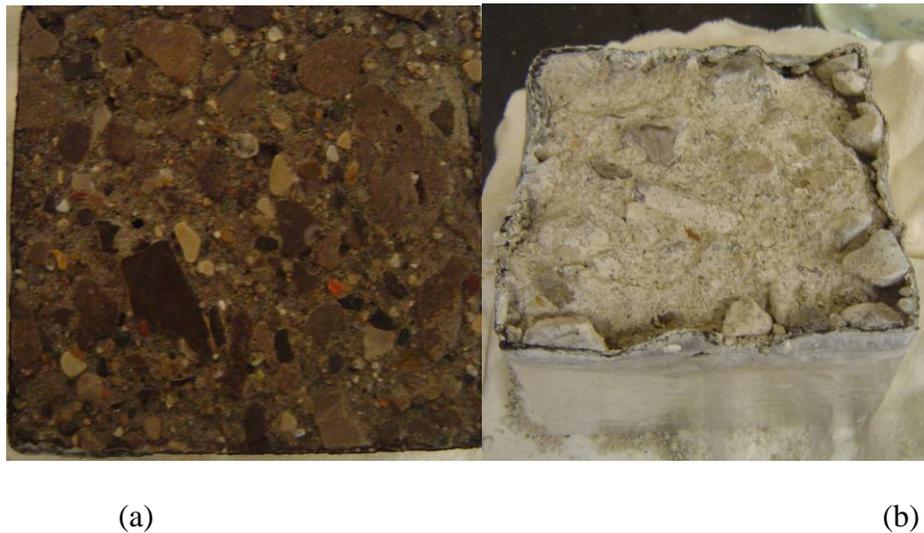
Figure 3.9 Concrete exposure surface from WB I-94, Lawrence, without associated joint distress (a) after 12 freeze-thaw cycles, and (b) from the distressed area after 10 freeze-thaw cycles.

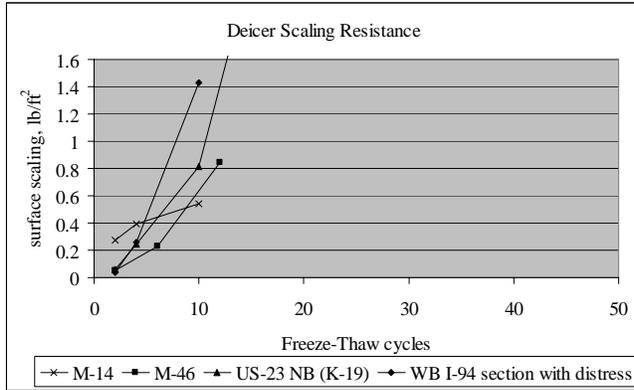
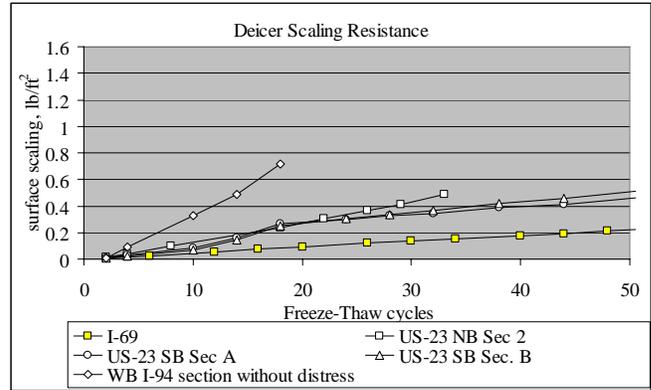
Scaling resistance for the field concrete can be divided into two distinctly different groups as seen in figure 3.10. One group, consisting of the concrete pavements with distress (M-14, M-46, US-23 NB (K-19), I-94), has rapid scaling of the mortar and extensive mortar erosion within 5 to 10 freeze-thaw cycles (figure 3.10a), while the group without distress has 5 to 10 times lower scaling. These concrete projects include one section on WB I-94 discussed above which has no joint associated distress at time of this investigation (August 2008). Despite the higher air-content (5.8%) this concrete has twice the scaling rate as compared to the other projects in this group.

Figure 3.10 Laboratory deicer scaling results for field concrete projects with (a) and without (b) joint associated distress

The scaling development is approximately linear with number of cycles (figure 3.10). This is consistent with findings from another study by Pinto and Hover (2001) based on a ponding test (ASTM C672). Therefore, the scaling rate ($\text{lb/ft}^2/\text{cycle}$) can be considered an inherent concrete property of resistance to deicer salt exposure during freeze-thaw cycle. For similar water-cement ratios and mix designs, which is typical for highway concrete, improved resistance to frost in general is achieved through air-entrainment. Typically, total air is used in specifications due to the ease of measurement of air in fresh concrete. Thus, scaling rate and air content, as a first measure, may provide insight into field resistance of hardened concrete. Results in figure 3.11 show a strong correlation between scaling rate and total air content. Closed symbols refer to pavements with joint associated distress while open symbols are for projects without distress. The results are for each specimen per test and thus shows for some test sections considerable variation in scaling resistance between two different core samples (M-14, M-46), which is attributed to paste in homogeneity. The concrete with premature joint associated distress have higher scaling rates due to lower total air content (entrained plus entrapped air), while the concretes without field distress have lower scaling rates and higher air content, consistent with expectations.

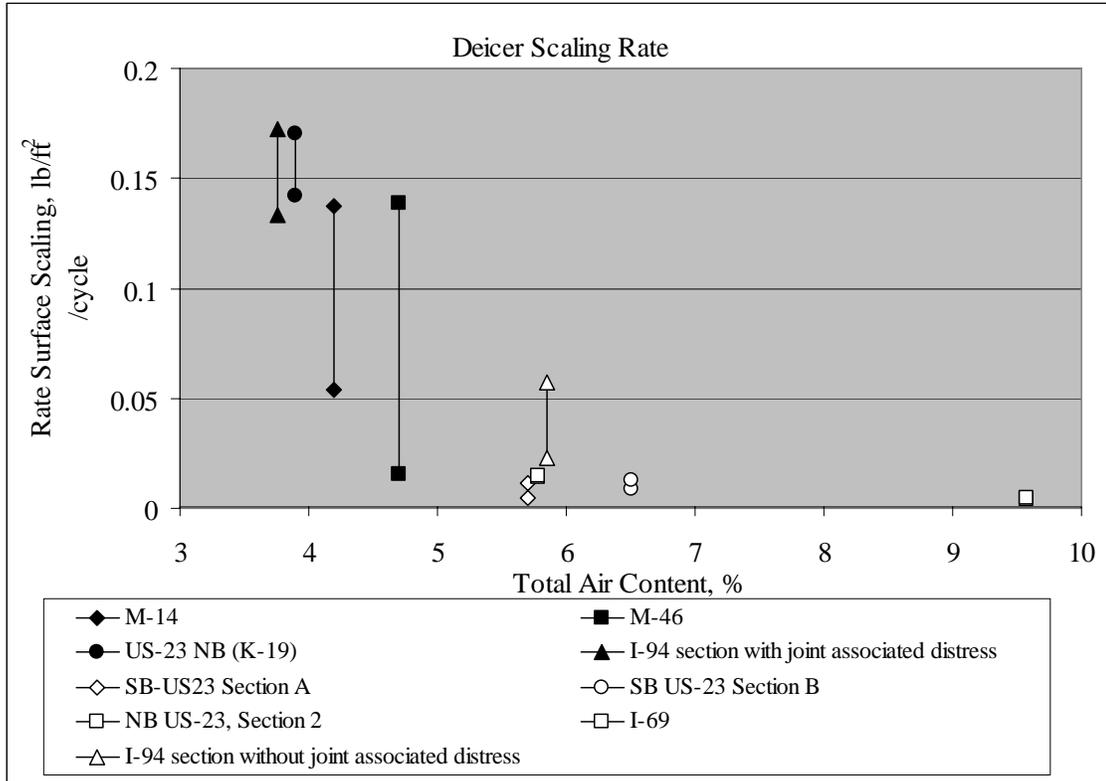
Figure 3.11 Deicer scaling rate for field concrete versus air content.

The results here suggest that total air exceeding about 5.8% can result in frost resistant concrete for a severe exposure condition (i.e. salt frost attack). From Table 3.1, an average value for infilling is 18.9% of total. This translates into a minimum recommended fresh air content of slightly over 7%, when taking into account that infilling of air-voids over time can be expected in the joint area.

The results here suggest that if the minimum recommended fresh air content is slightly over 7%, the net remaining air content after about 10 years in service, when taking into account that infilling of air-voids over time can be expected in the joint area, is sufficient for field resistance to deicer salt and freeze-thaw.

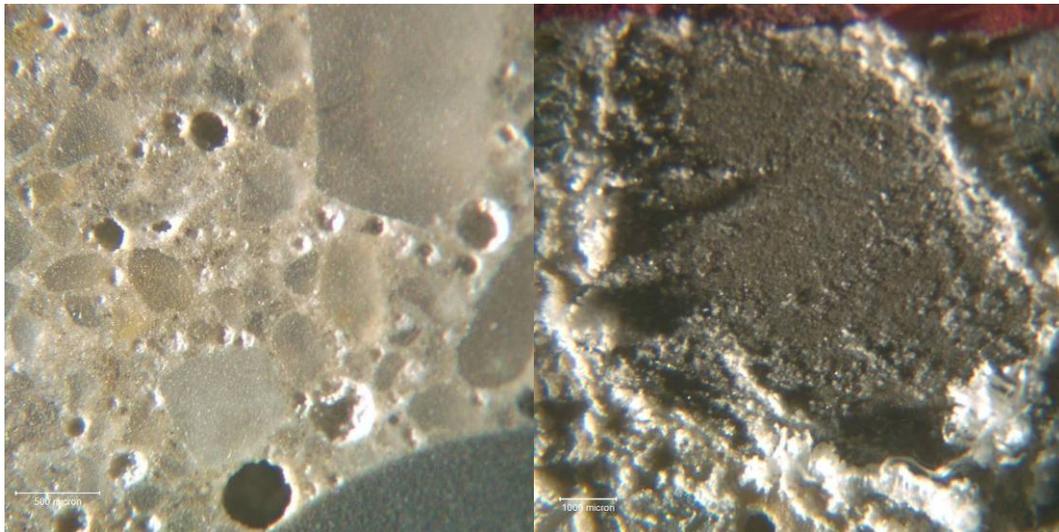
An example of infilling is shown in Figure 3.12. The white powder seen inside the air-voids is most likely salt since water-sorption tests on dried field-samples showed presence of salt. During water absorption test of freeze-thaw specimens, salt crystallization in the porous interface between coarse aggregate and the paste was common for the I-94 concrete (figure 3.12b). The I-94 section had received substantial amounts of road-salt during winter periods.

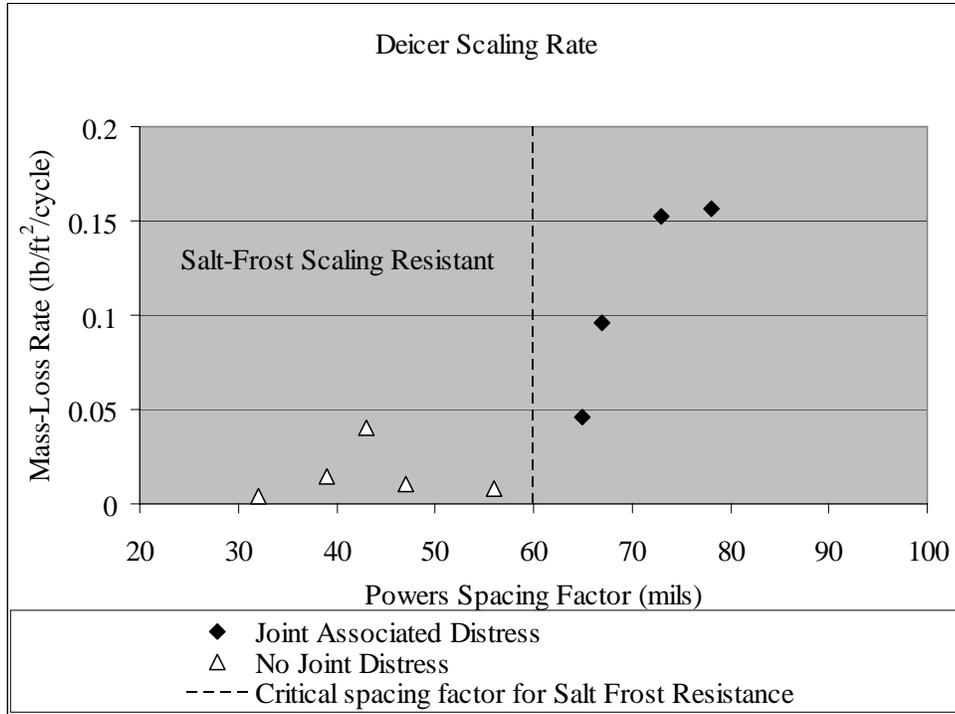
Powers spacing factor is typically used as a fundamental indicator of concrete frost resistance when exposed to water during a freeze-thaw test. The results in this study suggest that field concrete for Michigan environmental conditions and mix proportion the critical spacing factor is about 59 mils (0.150 mm) for deicer salt exposure (figure 3.13). The critical spacing factor for water exposure is typically 98 mils (0.250 mm). A lower spacing factor requires more air entrainment and thus greater total air content. Fagerlund (2004) has suggested a spacing factor in the range of 63 mils (0.160 mm) to 77 mils (0.200 mm) for salt-frost resistant concrete. Spacing factor values are listed in table 3.2. Excellent agreement was obtained for total air content based on the manual point-count method (Table 3.1) and the automated linear traverse (Table 3.2) method. Linear traverse measurements further show that entrapped air ranges from 0.5% to 2.1%, which is also consistent with expected values (PCA, 2003).

Figure 3.13 Deicer scaling rate versus Powers Spacing Factor

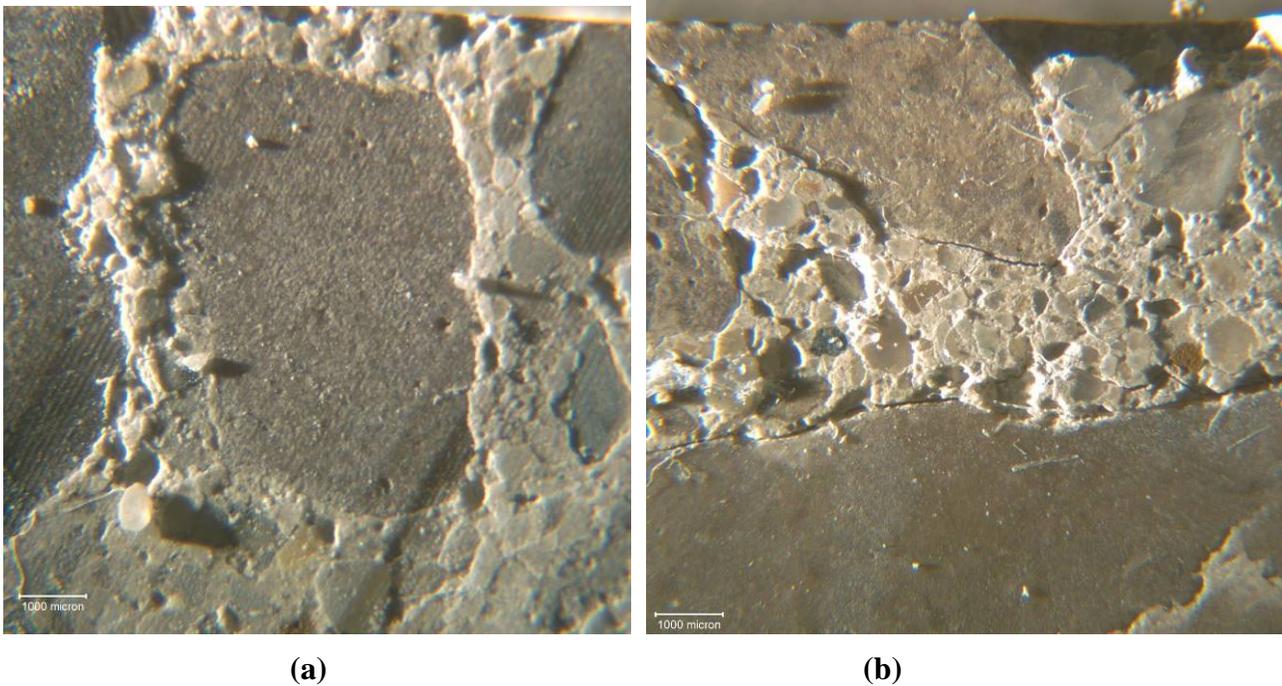
A closer examination of the deteriorated surfaces of the I-94 concrete by optical microscopy revealed that freeze-thaw deterioration was the result of cracking within the portland cement paste consistent with a poor air-void system (figure 3.14). Cracking is the result of excessive pore-pressure associated with freezing and associated expansion. A unique feature of freezing with a salt solution on the surface is that part of the salt solution remains liquid after freezing starts in the pores within vicinity of the surface. This condition creates a cryogenic suction pump and rapid pore-filling during the entire freezing cycle. Once a surface layer consisting of mortar has peeled off the process continues. Therefore, scaling increases linearly with number of freeze-thaw cycles, as long as the paste below the surface has similar properties. Microscopic evaluation of the scaled concrete surface showed no deterioration within the coarse aggregate for any of the pavements investigated in this study.

Figure 3.14 (a and b) I-94 section 2 joint concrete surface following 3 freeze-thaw cycles in 3%NaCl solution.

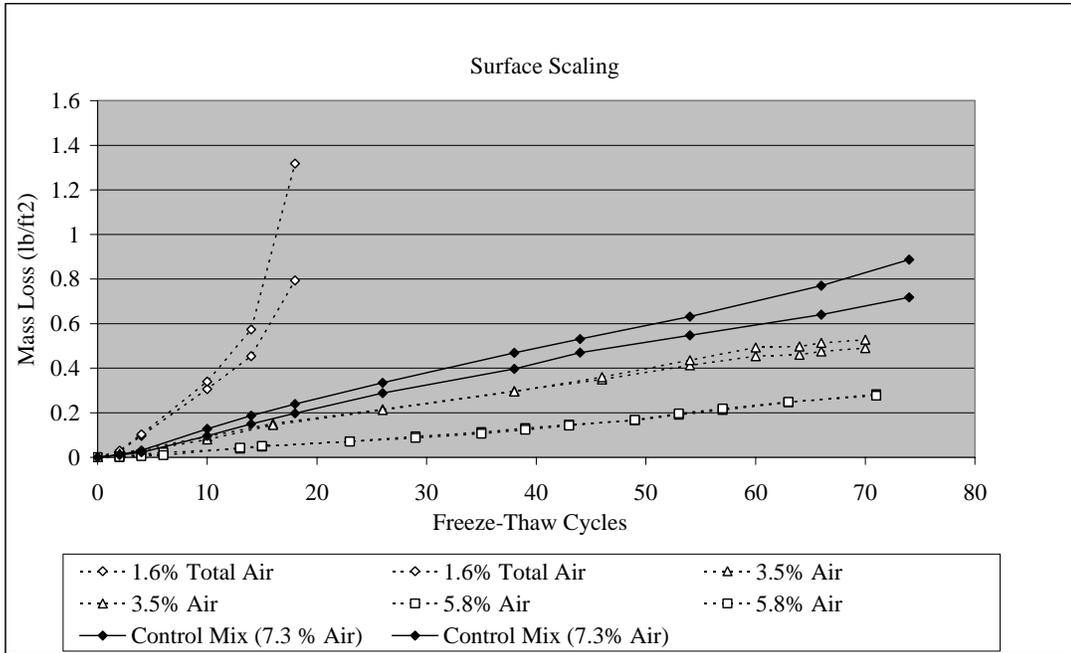
Three slag cement concretes of increasing air contents, based on the P-1 MOD mix and materials used for an ongoing overlay project (US-131), were tested for deicer scaling resistance. The slag cement concretes are lab mixes using field materials. One lab control mix (i.e. without slag cement) containing target air content of 6.5% was tested for comparison. Duplicate specimens were used and results are plotted for each specimen in figure 3.15. These concretes were water cured for 28 days, then dried for two weeks and re-saturated prior to freeze-thaw testing. Average scaling rates are plotted in figure 3.16 for the lab concretes along with the field concrete. The slag cement systems have markedly improved scaling resistance for same air content. Scaling in control concrete is more pronounced around coarse aggregate (figure 3.17 a) while paste scaling in slag cement concrete is uniform (Figure 3.17 b). This is attributed to an improved interface zone without tendency for agglomeration of air-voids (figure 3.18) embedded within a more porous paste (i.e. higher local water-cement ratio), typical for the control concrete system (figure 3.19). Consequently, a better air-void distribution is achieved in the slag cement concrete, which in turn improves salt frost scaling resistance for same total air content as a control concrete.

Figure 3.15 Mass loss of various air content concrete in de-icing solution

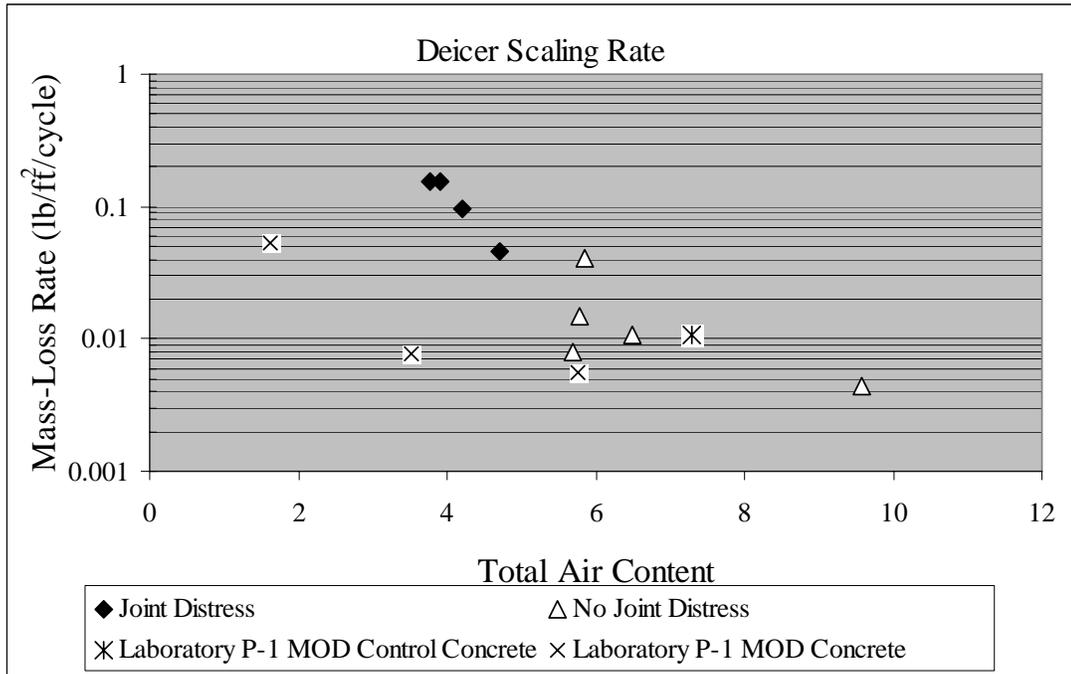
Figure 3.16 Scaling rate for P-1 MOD lab concrete and field concrete

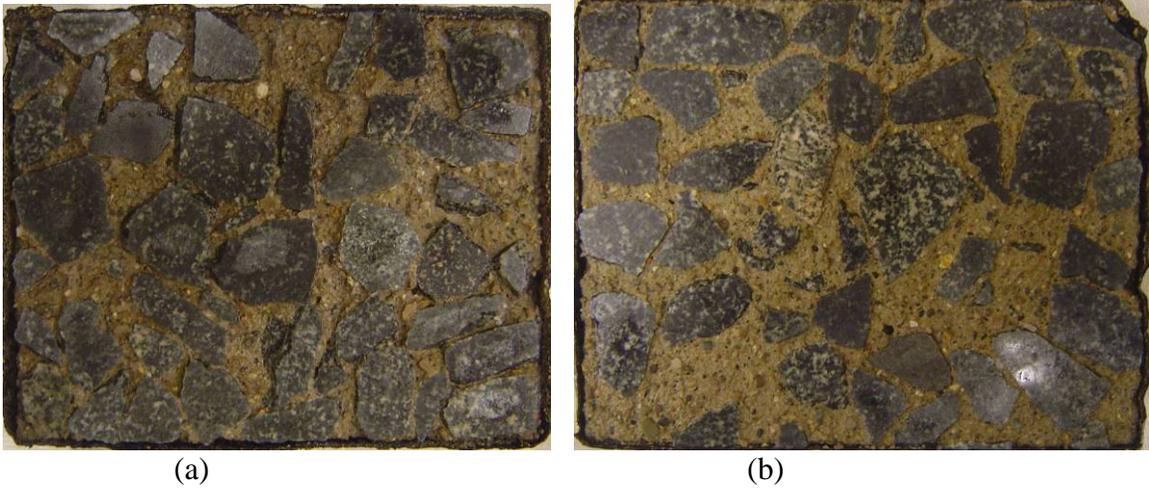
Figure 3.17 Control concrete with 7.3 % air (a), and slag-cement concrete with 5.8 % air after 42 freeze-thaw cycles in salt solution

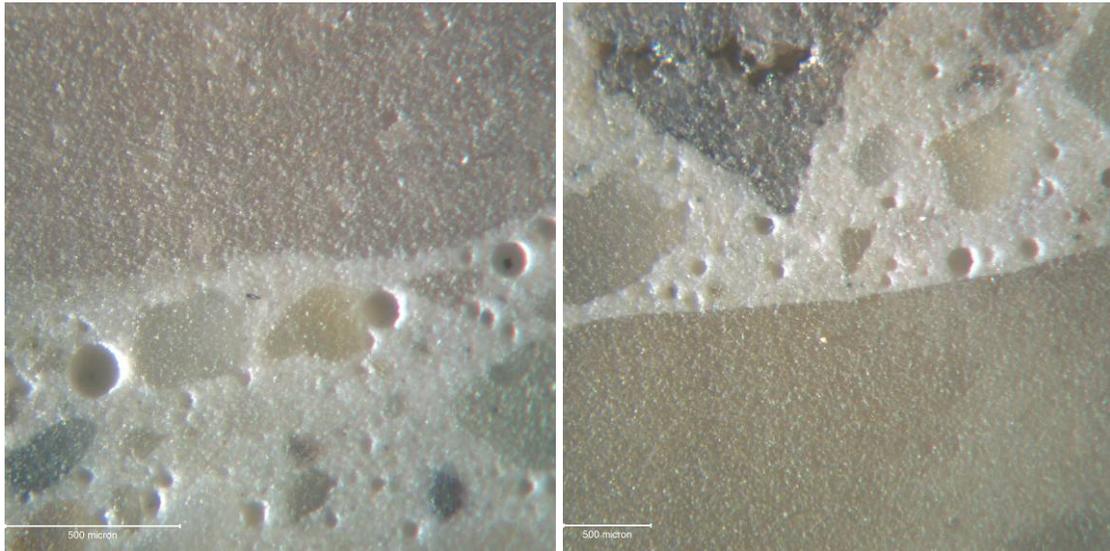
Figure 3.1 Typical interface zone in slag cement concrete

- MDOT's P-1 MOD concrete containing slag cement had improved deicer frost resistance as slag cement improves the paste-aggregate interface zone, which reduces water sorptivity rate and amount of water uptake as compared to a control concrete. Air-void agglomeration around the coarse aggregate was common in the field concrete and absent in the slag cement concrete. These factors have a major impact on frost resistance.

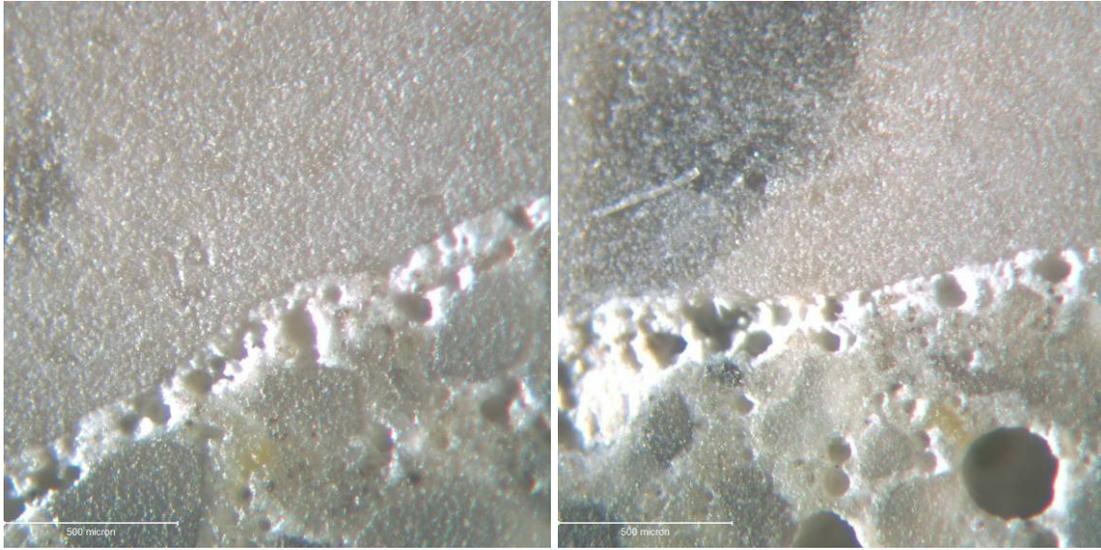
Figure 3.19 Highly porous interface zone (agglomeration of air-voids) around the coarse aggregate in the control concrete.
