Report TSD-253-74

A TRAFFIC ACCIDENT ANALYSIS  
AND TRAFFIC CONTROL DEVICES  
INVENTORY IN THE CITY OF MOUNT CLEMENS

**MICHIGAN DEPARTMENT OF STATE HIGHWAYS  
AND TRANSPORTATION**

September, 1976

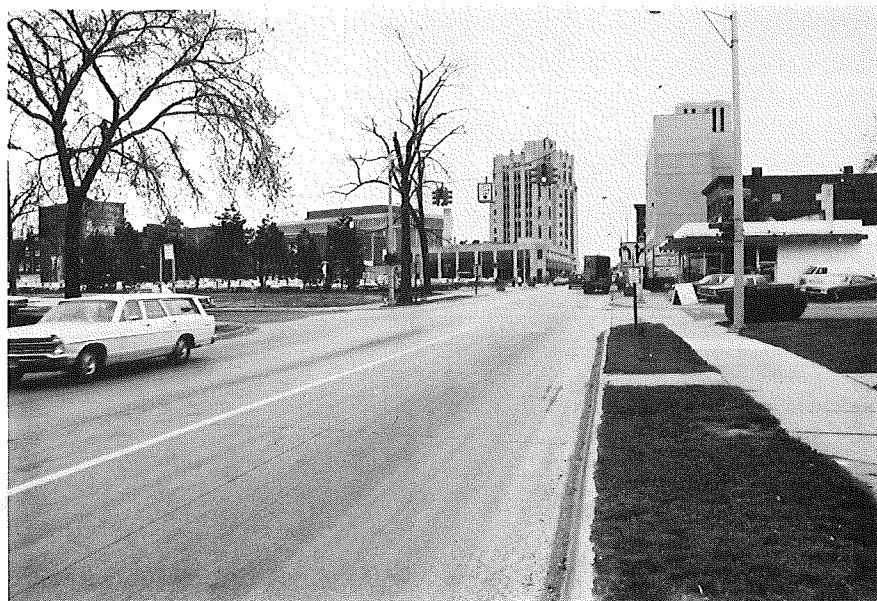
EASTBOUND CASS AVENUE

1. Yellow clearance intervals should have a duration of between 4 and 4.5 seconds to be effective. For this reason it is recommended that the clearance interval be increased to 7 percent which would be 4.2 seconds. \$ 50

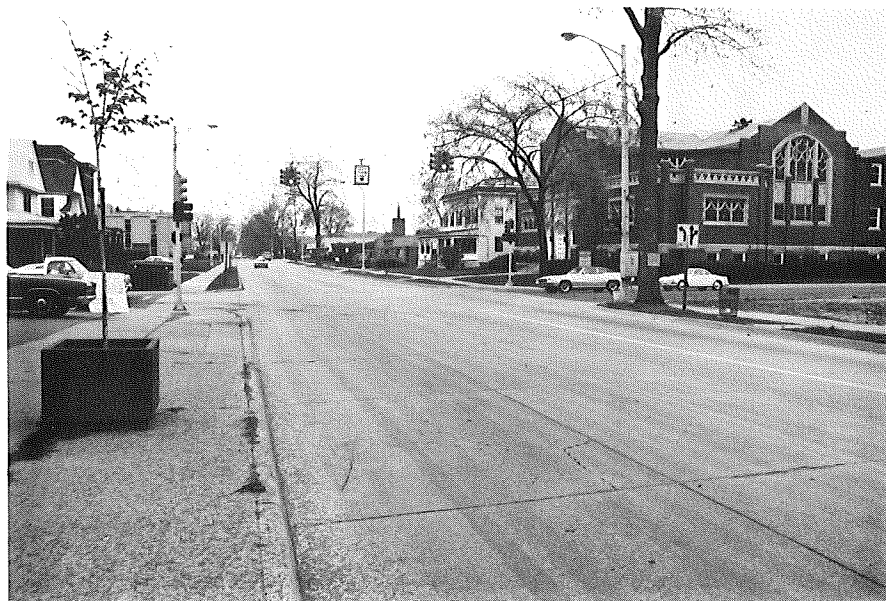
WESTBOUND CASS AVENUE

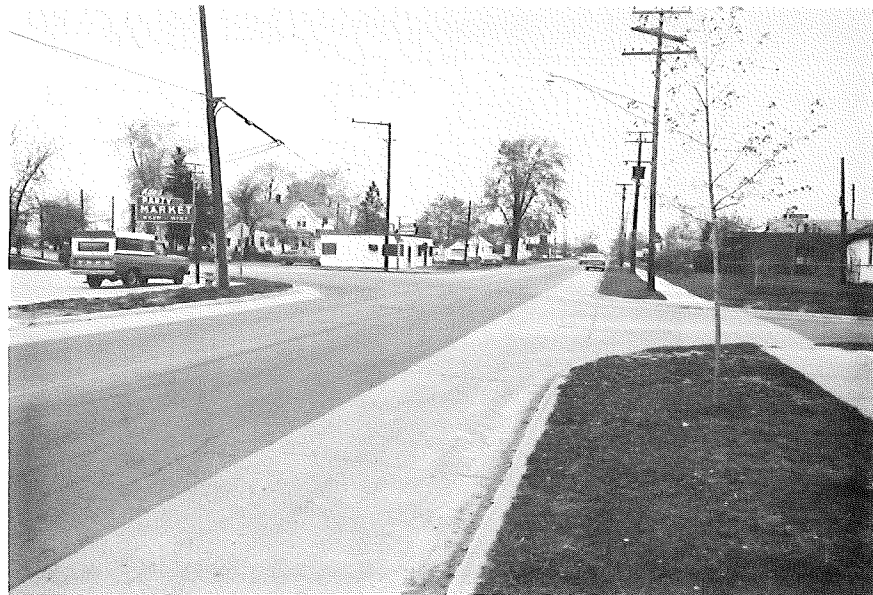
NORTHBOUND NORTH AVENUE

| 2. | Eight of the vehicle operators involved in the right-angle accidents indicated that they did not see the vehicle they struck. The parked cars on North Avenue are causing a visibility problem. We recommend that the parking on North Avenue be prohibited 75 feet from all four corners of the intersection. | \$ 75 |

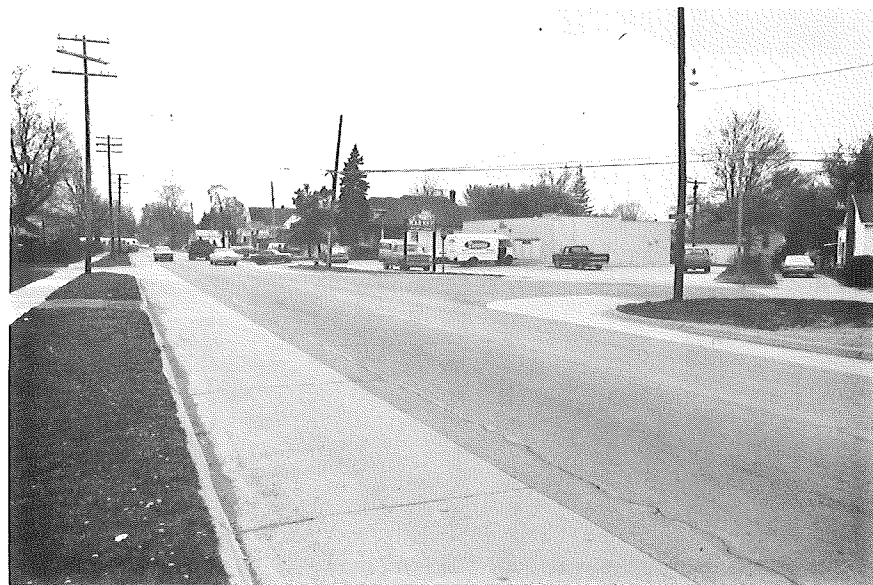
SOUTHBOUND NORTH AVENUE

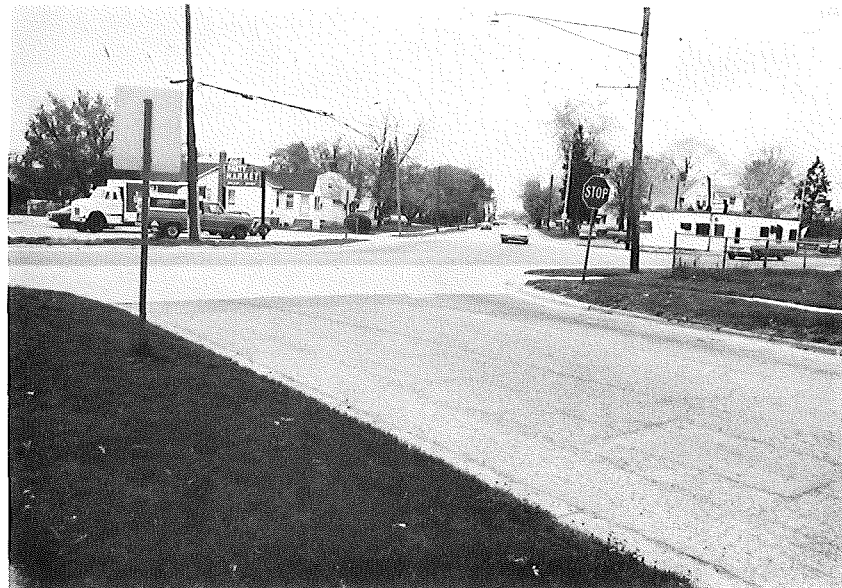
WESTBOUND CLAIR AVENUE

| 1. | The standard size "STOP" sign shall be 30 inches by 30 inches except at the intersection of low-volume local streets and secondary roads with low approach speeds where a 24-inch sign may be used. Due to the traffic volumes experienced at this location we recommend that the 24-inch "STOP" sign on Clair Avenue be replaced by a 30-inch sign. | \$ 30 |
| 3. | A further visibility problem exists for motorists on westbound Clair Avenue due to a hedge located in the southeast quadrant. It is recommended that this hedge be removed so that northbound North Avenue traffic can be seen from the east leg of Clair Avenue. The removal of the hedge along with the parking removal on North Avenue will reduce the right angle problem. | \$ 50 |

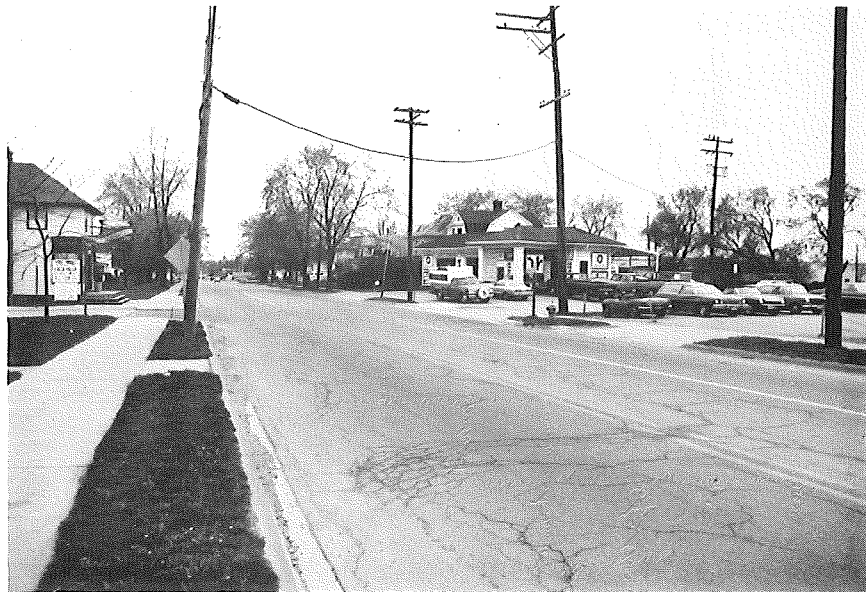
WESTBOUND CASS AVENUE

| 3. | The Lane-Use Control signs on Cass Avenue should be supplemented by pavement word and symbol markings. The left-turn lane should be marked with two sets of left-turn arrows each including the word "ONLY". Two sets of thru or right-turn arrows should be placed on the outside approach lanes. | \$420 |

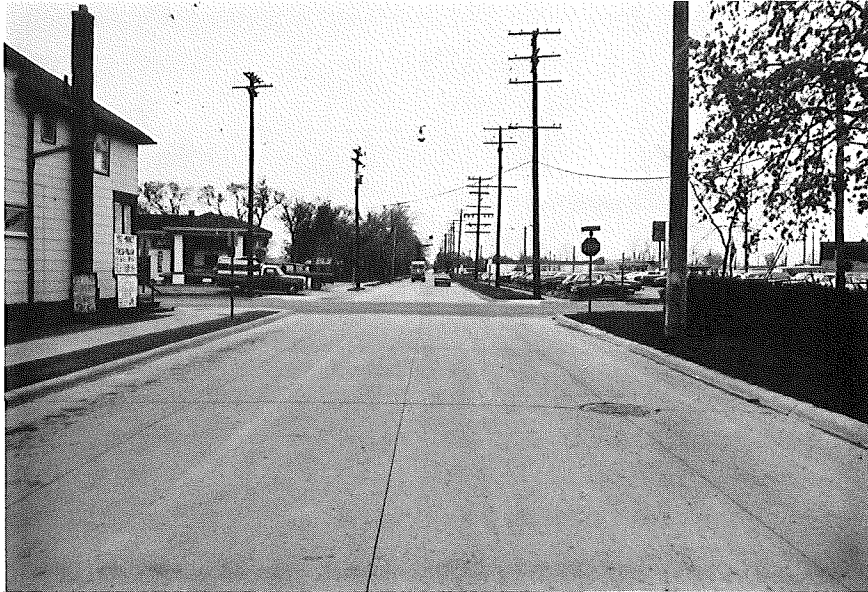
NORTHBOUND ROSE STREET

| 1. | It is recommended that the 24-inch "STOP" signs on Rose Street be replaced by 30-inch signs because of the traffic volumes experienced at this intersection. | \$ 60 |

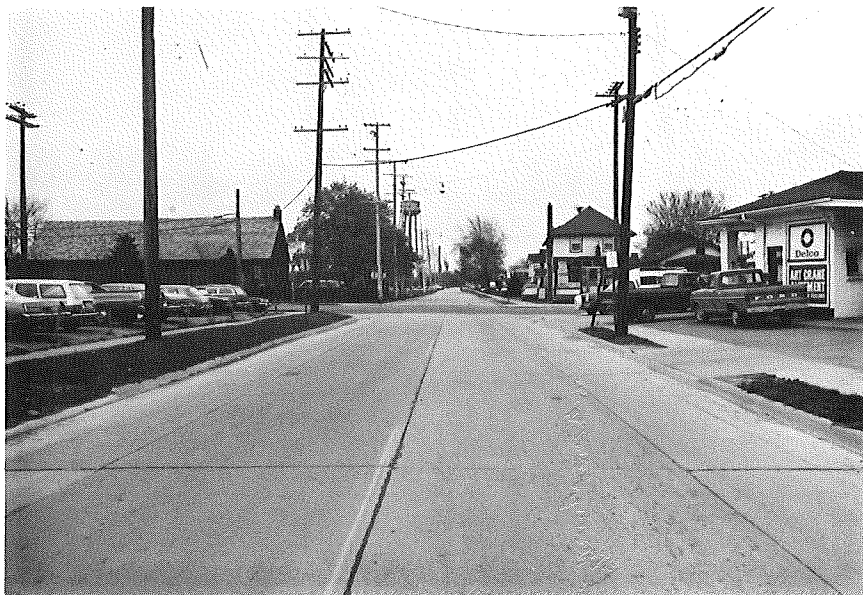
SOUTHBOUND ROSE STREET

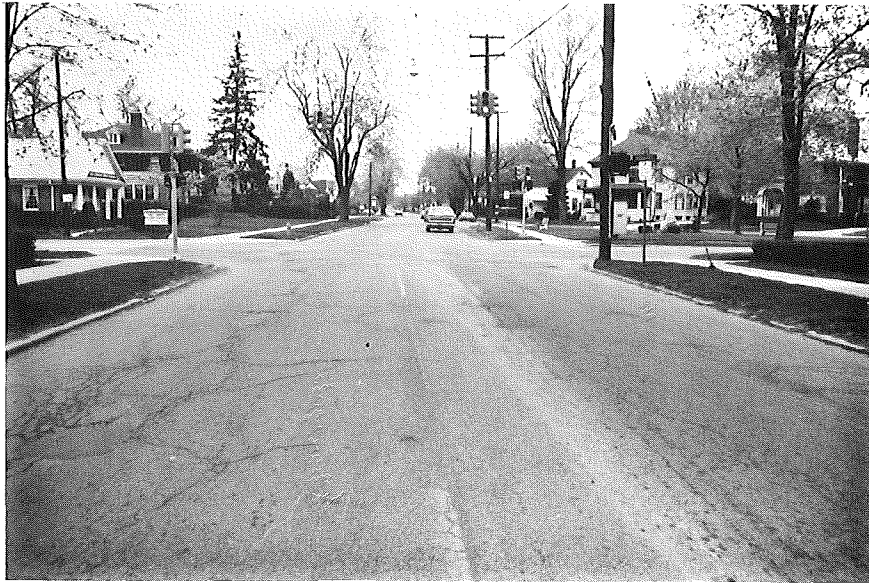
NORTHBOUND NORTH AVENUE  
AT HUBBARD AVENUE

| 2. | In all 10 of the right-angle accidents at the North Avenue-Hubbard Avenue intersection, the motorist at fault disregarded the red signal indication. Seven of these operators were traveling on north or south-bound North Avenue. We recommend that a 3 percent (1.8 seconds) all-red clearance interval be incorporated in the cycle length to follow the North Avenue yellow clearance interval. | \$ 50 |

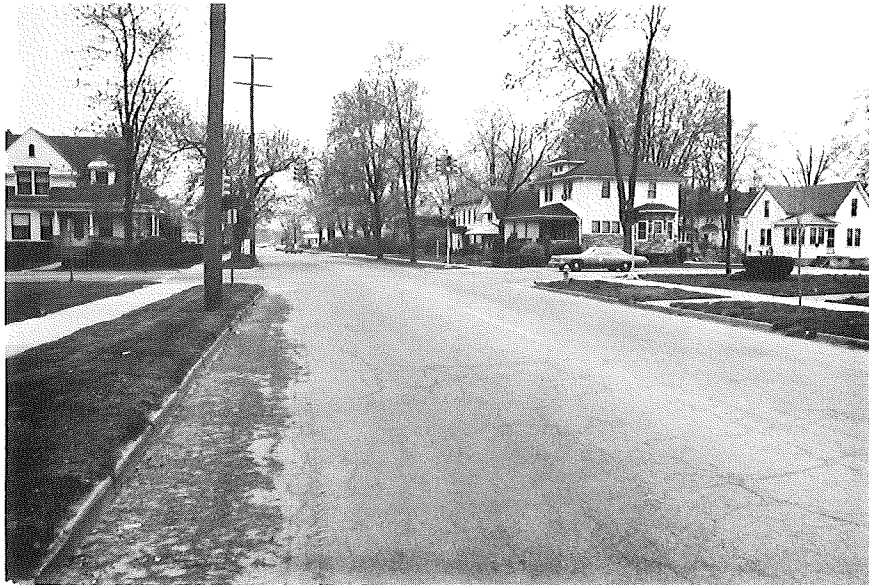
SOUTHBOUND NORTH AVENUE  
AT HUBBARD AVENUE

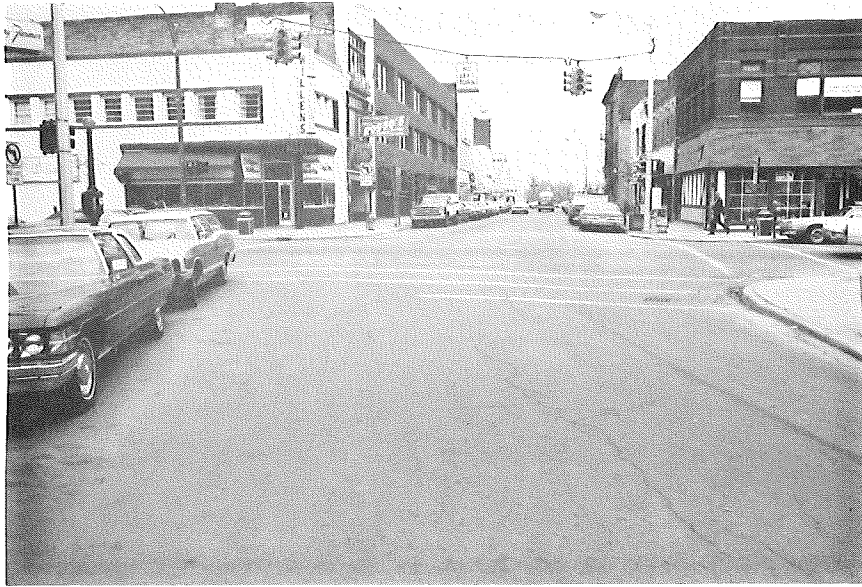
NORTHEASTBOUND WALNUT STREET

| 3. | Centerline markings should be applied to both Macomb and Walnut Streets. | \$ 50 |

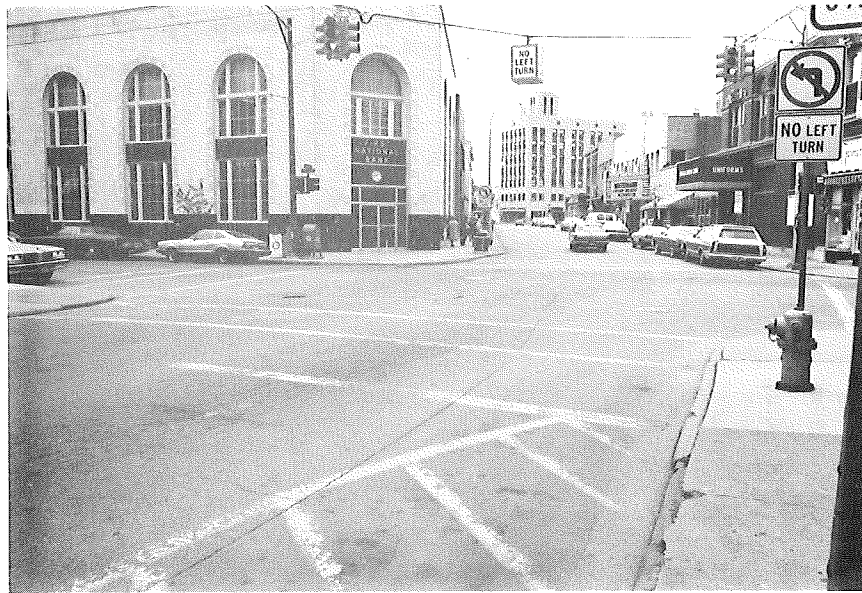
SOUTHWESTBOUND WALNUT STREET

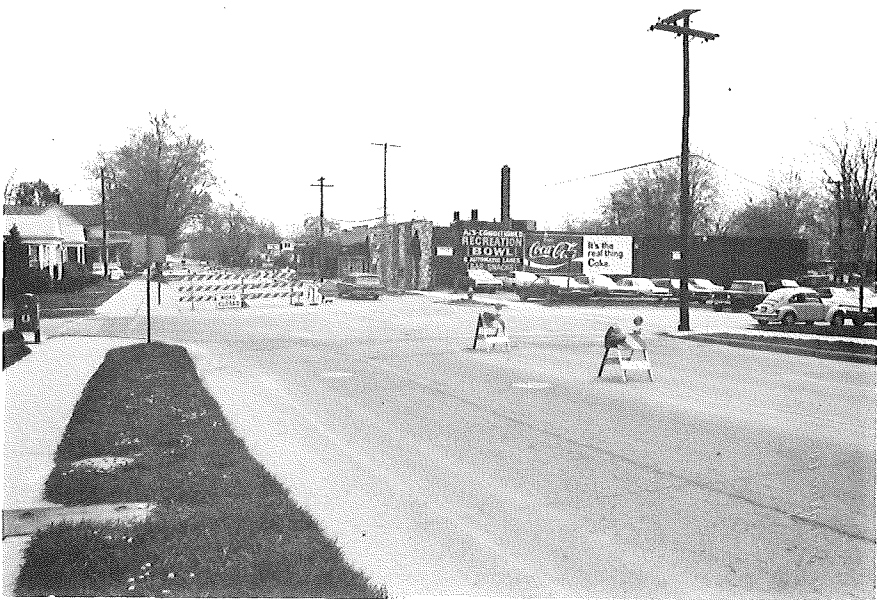
SOUTHEASTBOUND CROCKER BOULEVARD

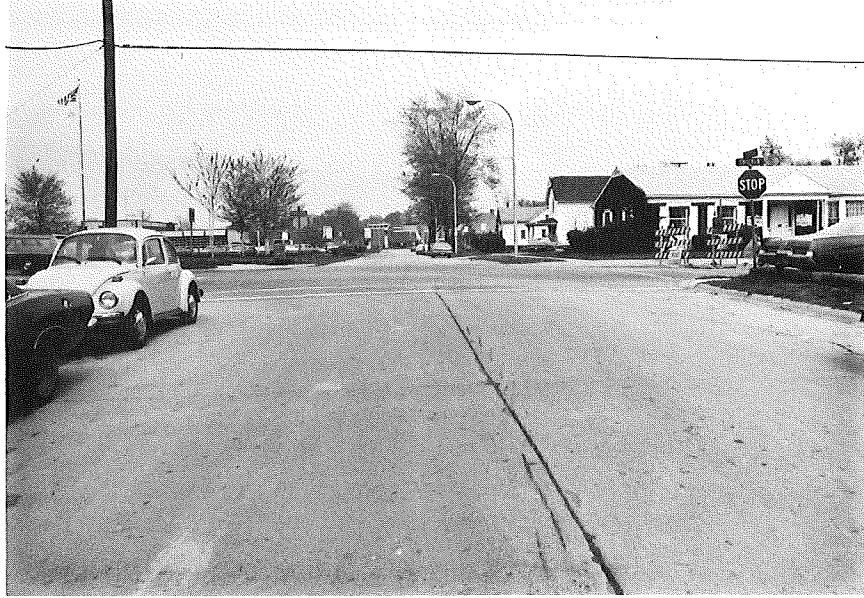
NORTHEASTBOUND FIRST STREET

| 2. | It is recommended that the existing 24-inch "STOP" sign on First Street be replaced by a 30-inch sign. First Street carries a little more than twice the Average Daily Traffic of Amvet Drive and approximately one-fourth the Average Daily Traffic of Crocker Boulevard. Furthermore First Street provides access to the city of Mount Clemens Municipal offices. A 24-inch "STOP" sign can be used only at the intersection of low-volume local streets and secondary roads with low approach speeds. | \$30 |
