MDOT RC-1527

**CONDITION ASSESSMENT AND METHODS
OF ABATEMENT OF PRESTRESSED
CONCRETE BOX-BEAM DETERIORATION**

Phase II

**FINAL REPORT
VOLUME I**

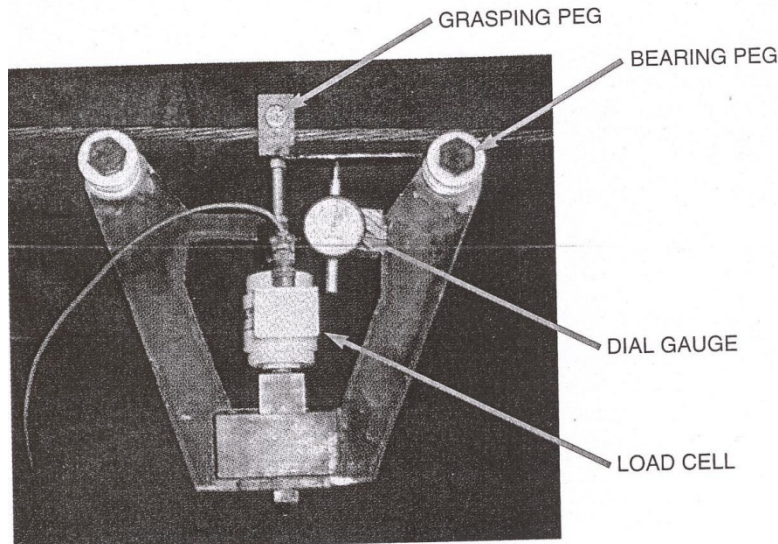
Civjan et al. (1998) developed a mechanism to estimate the remaining prestress of exposed strands (Figure 2-1). His estimates are useful for evaluating the remaining prestress of existing bridges for accurate estimation of load carrying capacity.

Figure 2-1. Instrument for measuring remaining prestress of exposed strands

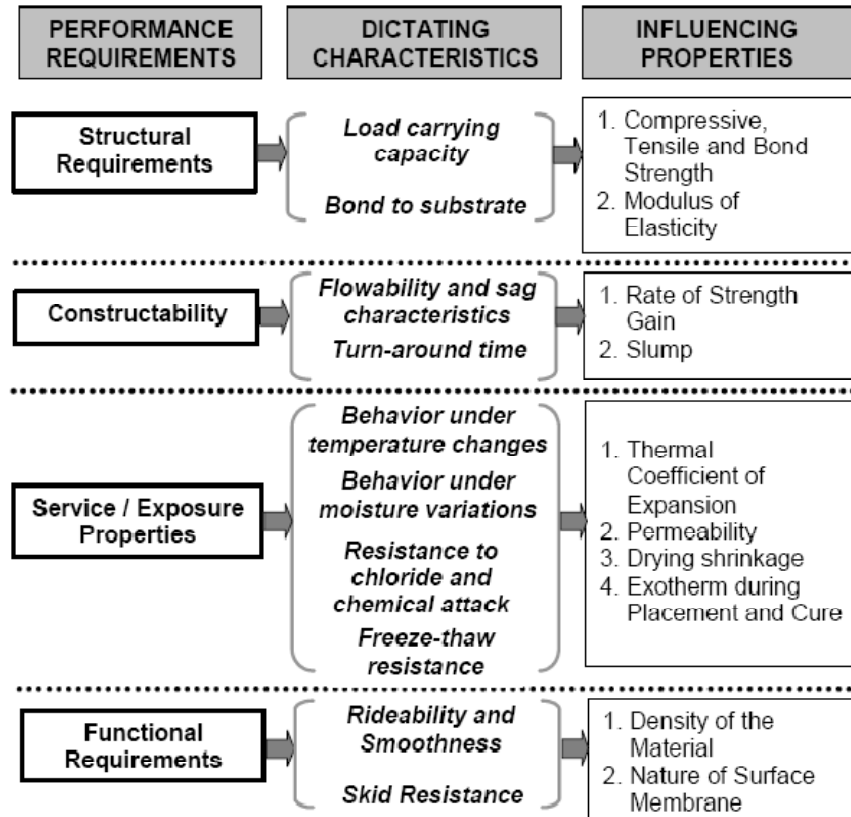
The characteristics of a repair material for long-term performance of repaired concrete under service conditions are illustrated in Figure 2-2.

Figure 2-2. Characteristics of an ideal repair material (Parameswaran 2004)

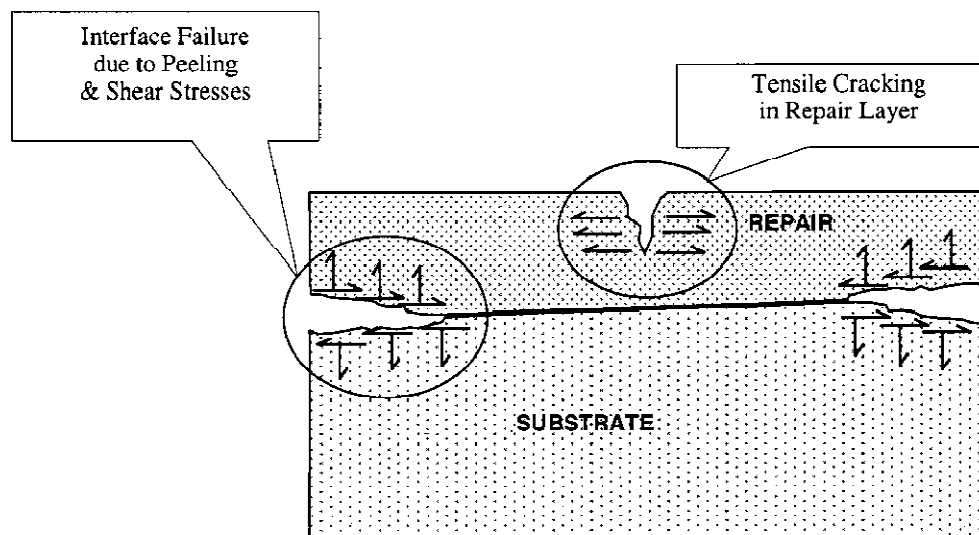
Figure 2-3. Modes of failure in patch repair (Baluch et al. 2002)

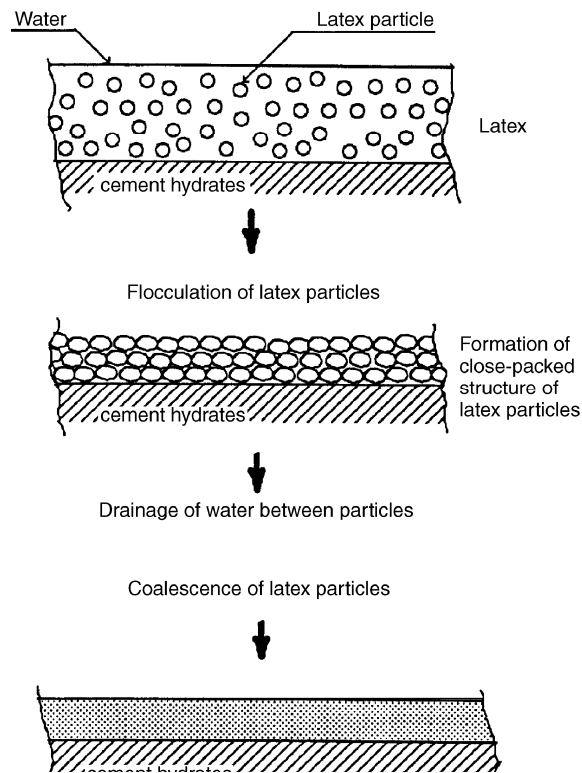
Figure 2-4. Simplified model of formation of polymer film on cement hydration (ACI 2005)

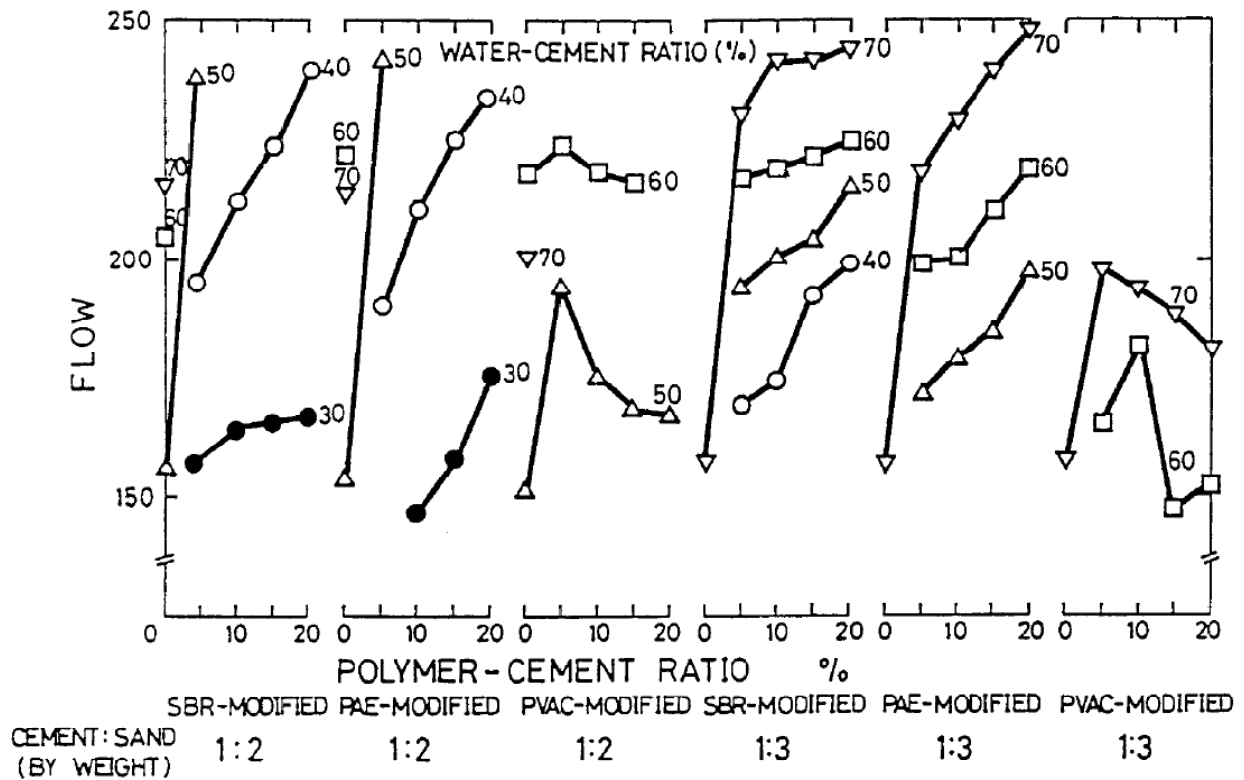
Figure 2-5 and Figure 2-6 show the effect of unit water content and polymer cement ratio on the consistency of latex modified mortars and concretes respectively (Ohama 1995a). The flow of the latex modified mortars increase as both, the water cement ratio and the polymer cement ratio increase.

Figure 2-5. Effects of water-cement ratio and polymer-cement ratio on flow of latex modified mortars (Ohama 1995a)

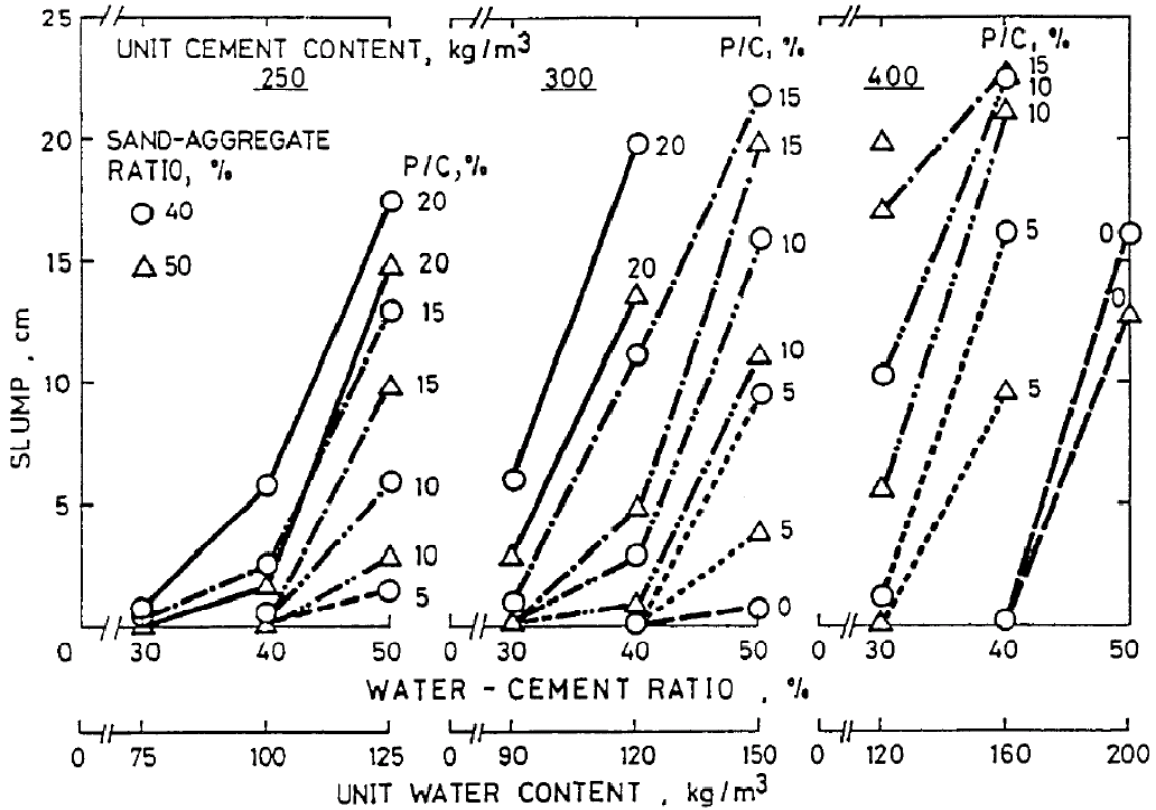
The slump of the latex-modified concretes tends to increase with rising unit water content (or water-cement ratio) and polymer-cement ratio, and at each unit water content, a rise in the polymer-cement ratio causes an increase in the slump. This tendency is more significant at smaller sand-aggregate ratios and at large unit cement contents (Ohama 1995a).

Figure 2-6. Effects of unit water content (water-cement ratio) and polymer-cement ratio on slump of SBR modified concrete (Ohama 1995a)

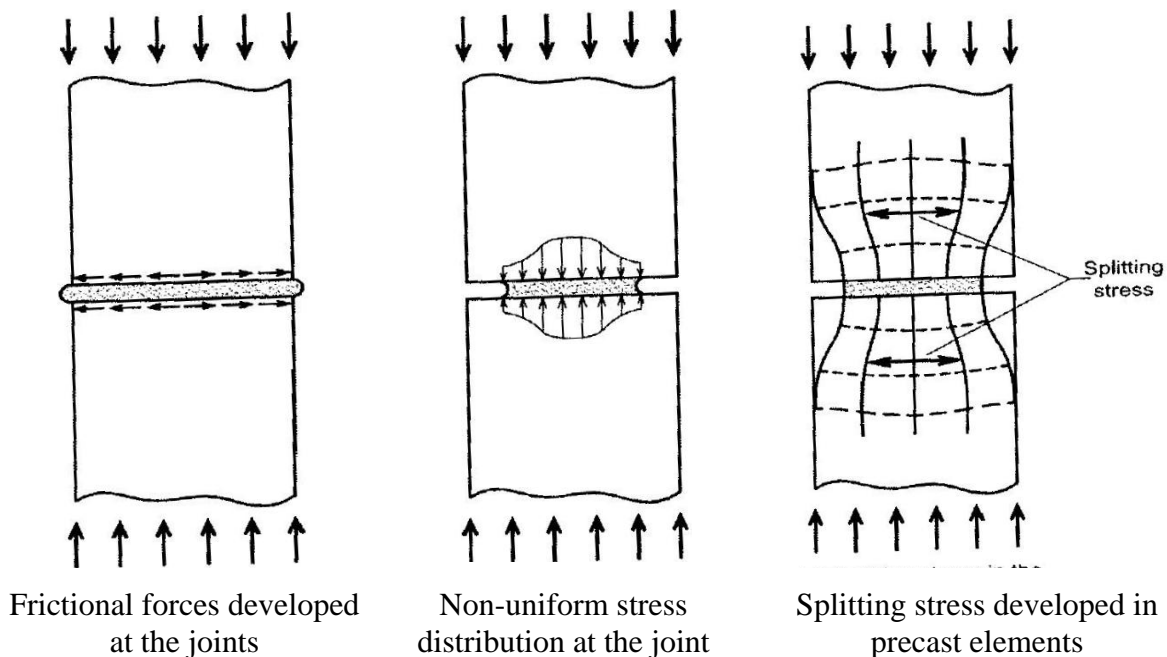
Barboza et al. (2006) studied the bearing capacity and compressive strength of mortar joints between precast elements. The bearing capacity is typically governed by the splitting stress of precast elements. Splitting stresses are developed due to flow of compressed grout to the border that develops frictional forces and “pulls” the precast element apart or the redistribution of stresses at the joint. The hypotheses for these behaviors are illustrated in Figure 2-14.

Figure 2-14. Stresses developed at the joints and in the precast elements (Barboza et al. 2006)

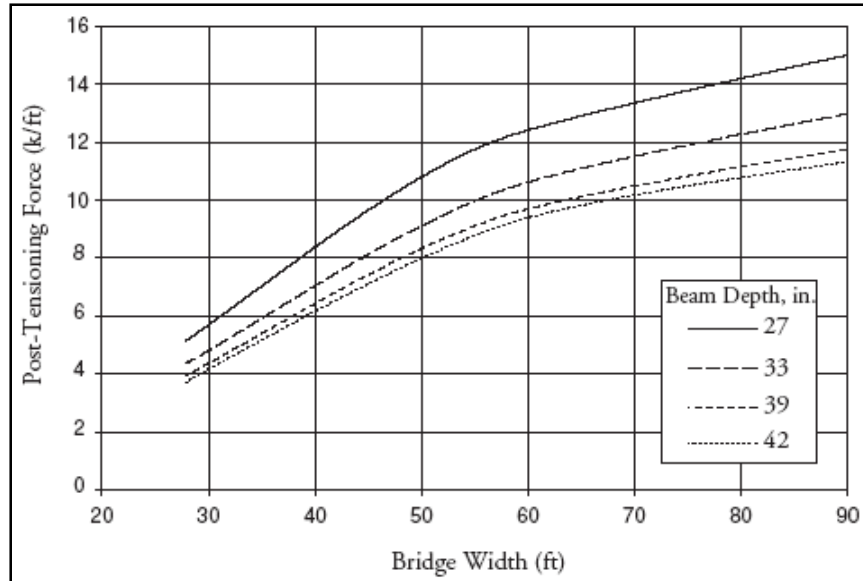
The required posttension force also depends on bridge width (Figure 2-18). According to El-Remaily et al. (1996), the grillage analysis can be performed for calculating the force demand at the diaphragm locations.

Figure 2-18. Posttension force variation with bridge width and beam height (El-Remaily et al. 1996)

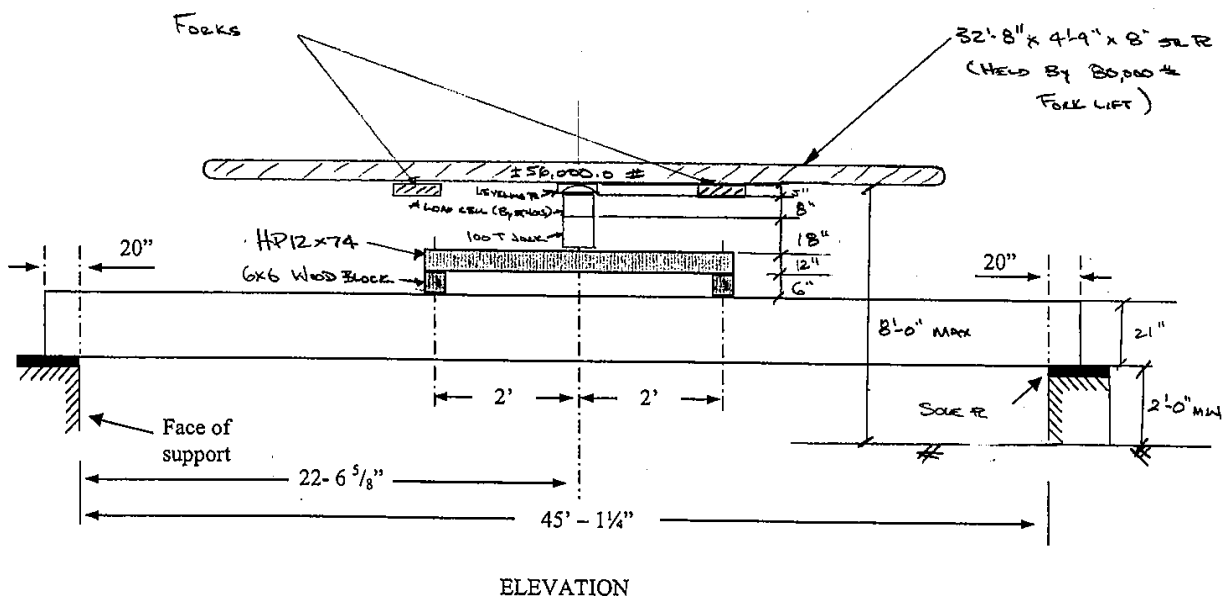
Figure 3-4. Load configuration developed by the contractor

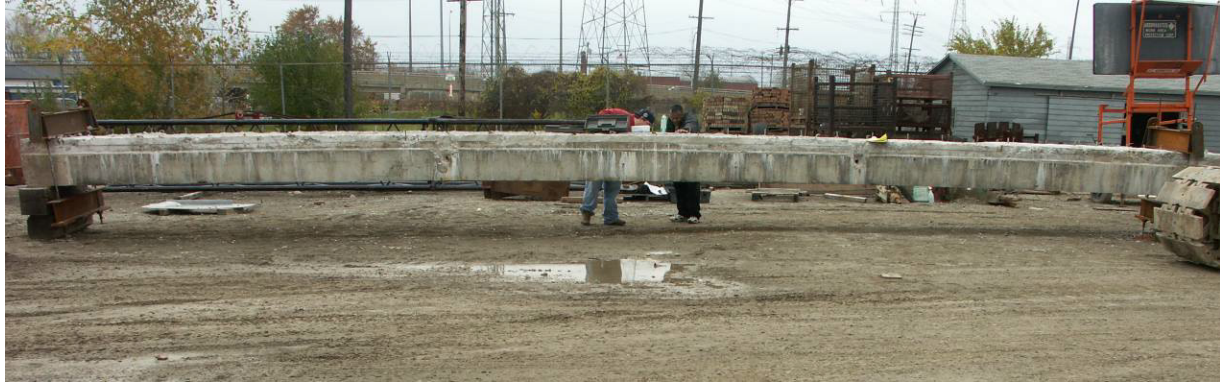
Photo 3-11. Box-beam camber

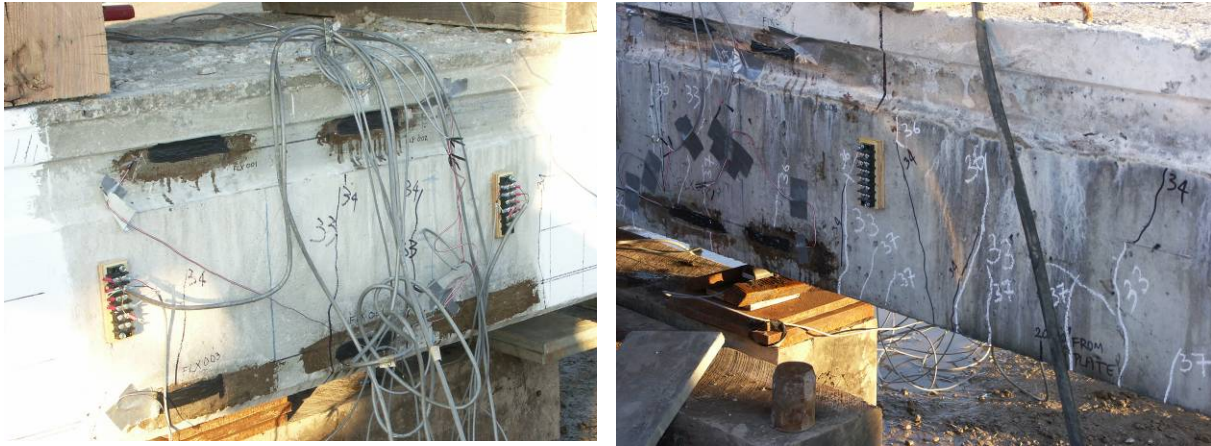
As shown in Photo 3-12, two flexural strain gauges were attached to the bottom flange on each face of the beam at the mid-span. During load testing flexural cracks were documented as formed and marked on the beam faces near the mid-span bottom flange of the beam (Photo 3-12). Even though cracking sounds were heard during load application, the first flexural crack could not be noticed until the applied load reached 33 kips.

Photo 3-12. Flexural cracking at mid-span

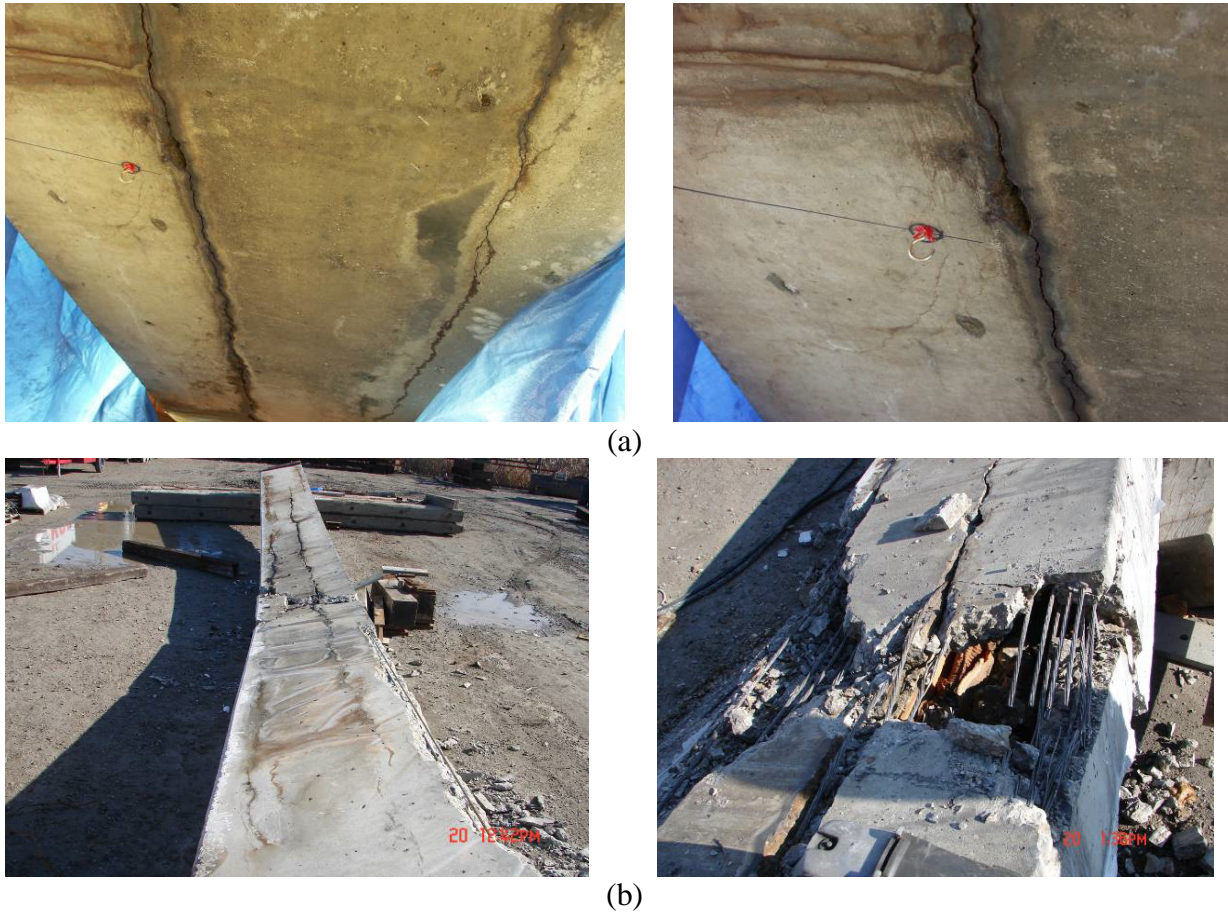
Corrosion stains were visible in the vicinity of the cracks at the bottom flange as seen in Photo 3-13a. Upon the completion of the load testing, the concrete was chipped away within the vicinity of cracks. There were no severed strands due to corrosion (Photo 3-13b).

Photo 3-13. Beam bottom flange condition (a) before and (b) after the testing was performed

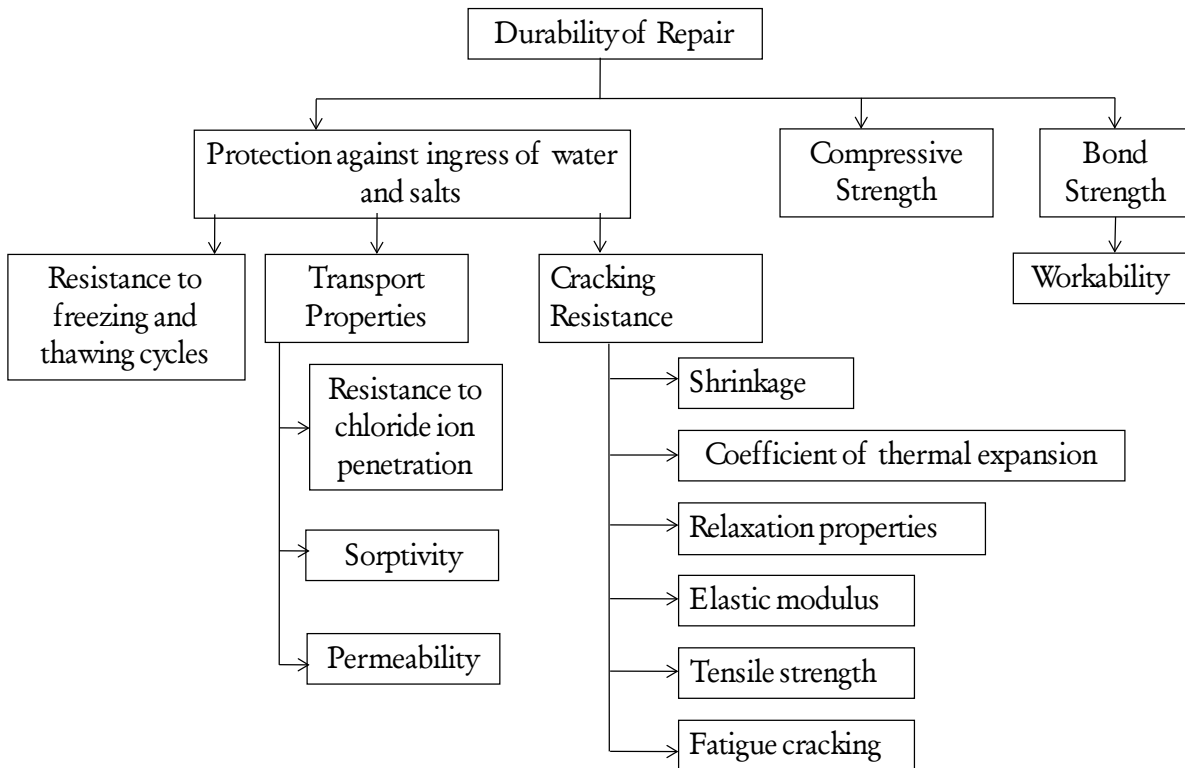
Figure 4-1. Characteristic material properties required for durable concrete repair

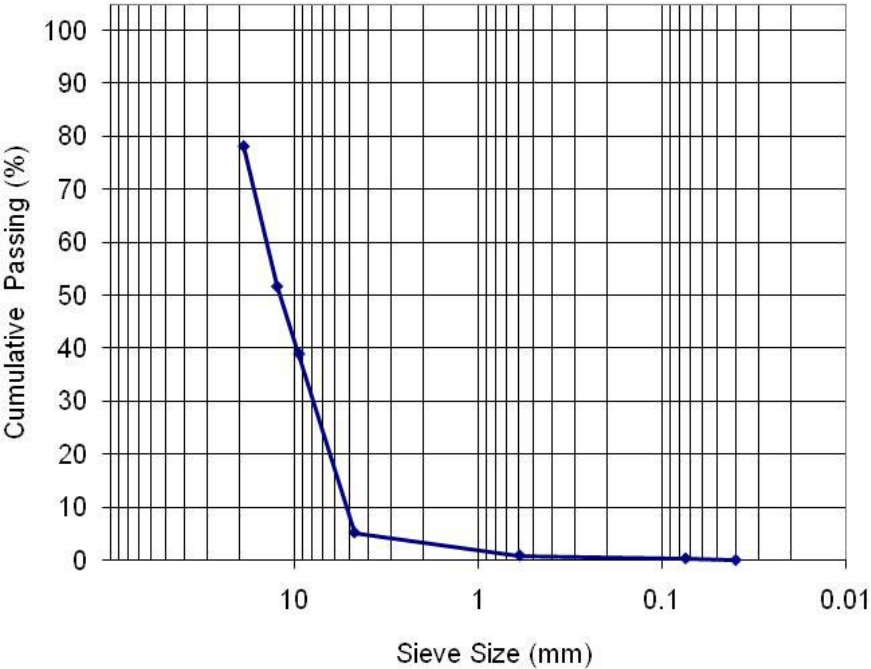
Figure 4-2. Gradation of coarse aggregates

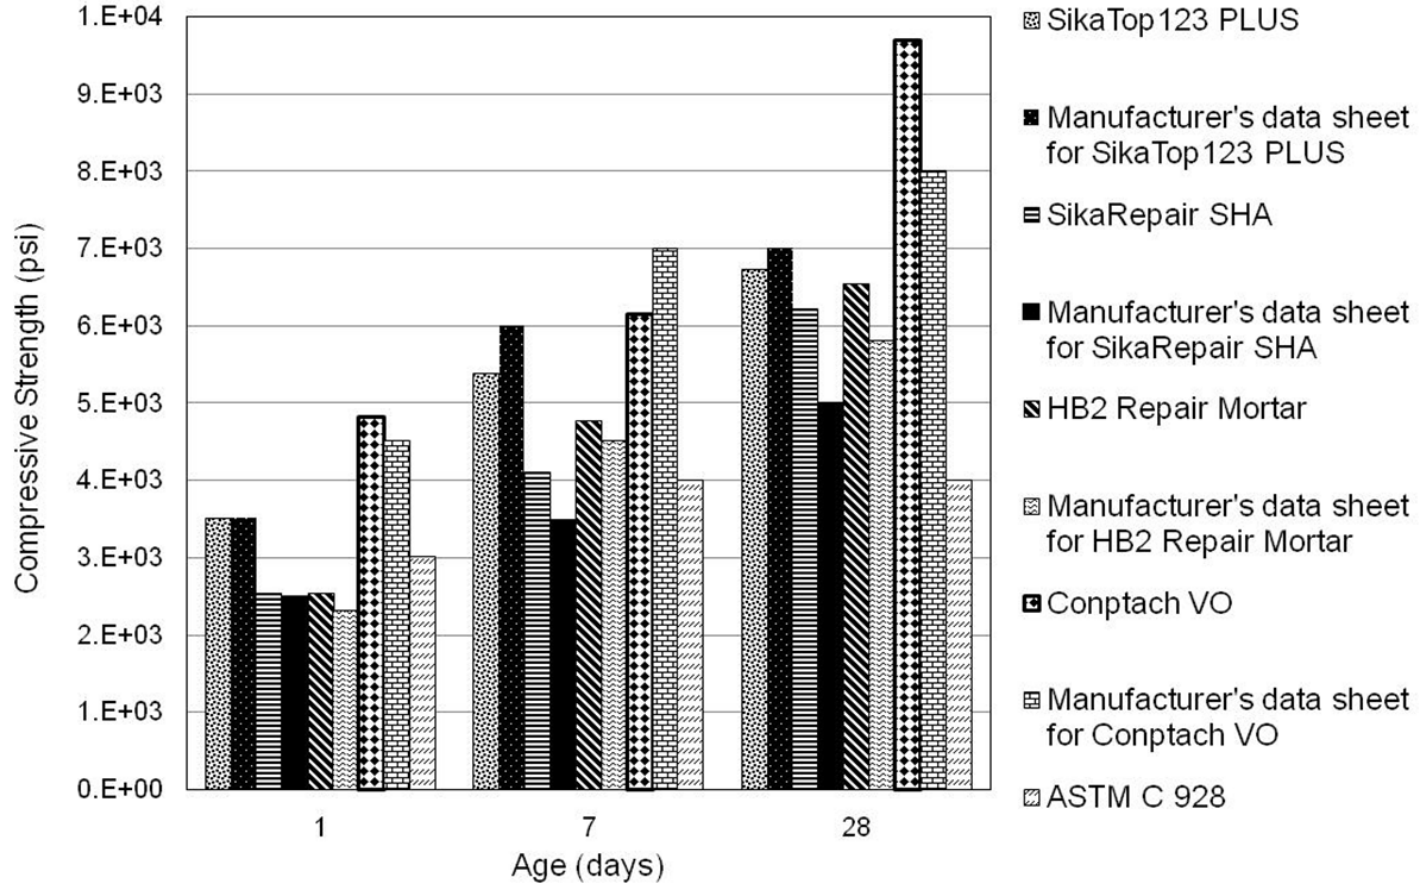
The rate of compressive strength gain was measured for repair materials as well as shear key grouts at the ages of 1, 7 and 28 days. Six samples were tested for each age for each repair material and shear key grout. Individual results are supplied in Appendix C, whereas the analysis of mean compressive strengths is provided in this section. The mean compressive strength was calculated as per ASTM C 109 whereas the acceptance criteria adopted was as per ASTM C 109. Figure 5-1 shows a comparison of the compressive strength results at various ages for all repair materials with respect to the manufacturer’s data sheet as well as ASTM C 928 minimum.

Figure 5-1. Compressive strength at various ages for repair materials

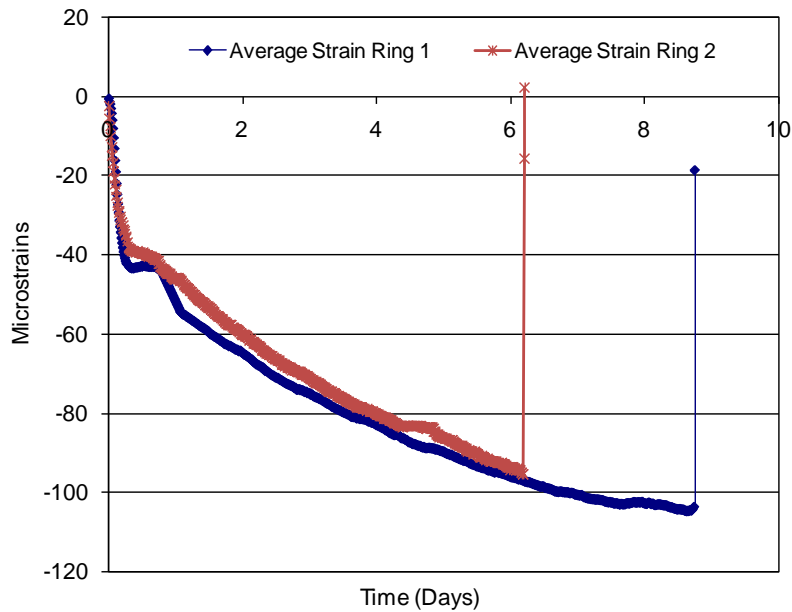
The variability in the age of cracking for the two specimens can be related to the batch variation and consolidation of the repair mortar in the specimen mold. Due to the large volume of mortar required, the mold was filled with 7 batches of mortar of 0.1 cu. ft each. The rapid-setting nature of the repair mortar at times made the process of consolidation slightly difficult leading to presence of voids in the specimen.

Figure 5-9. Cracking susceptibility of Sika Top[®]123 PLUS

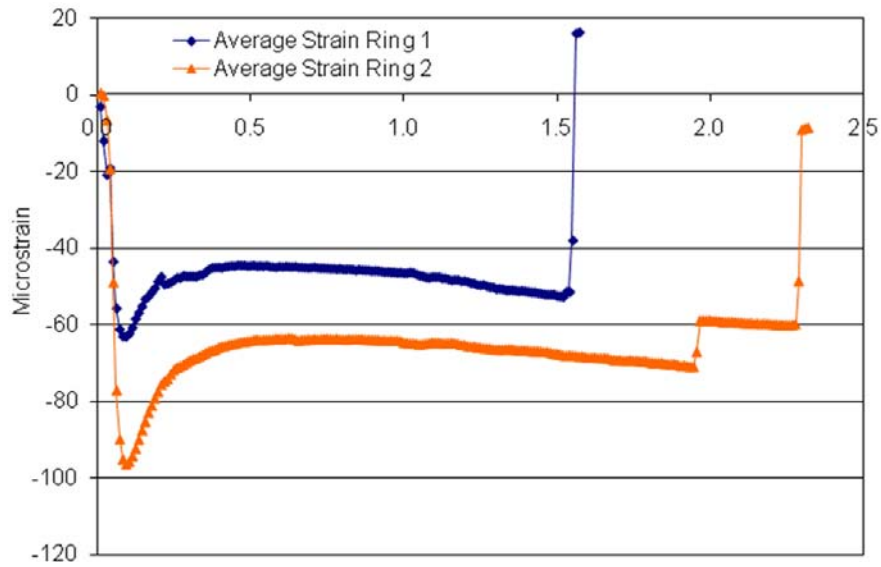
Figure 5-11 represents the development of tensile strains in ring specimens for Conpatch VO. The first ring developed a crack at the about 1.6 day since the addition of water whereas the second ring cracked at about 2.3 days since addition of water. Both rings exhibited a rapid rise in strains within the first two hours of casting the specimens followed by a drop in strains immediately after a time period of two hours. This behavior was not observed in any of the other repair materials. At the same time it has to be noted that this behavior was also observed at a later age (about 0.3 days) for free shrinkage specimens of Conpatch VO stored at 100 % RH (refer Figure 5-8). As mentioned earlier the mixing liquid used for mixing of Conpatch VO is water unlike the other repair materials. The initial increase in the strain values could be related to the increase in stress in capillary pores which eventually was reduced as the cement hydrated.

Figure 5-11. Cracking susceptibility of Conpatch VO

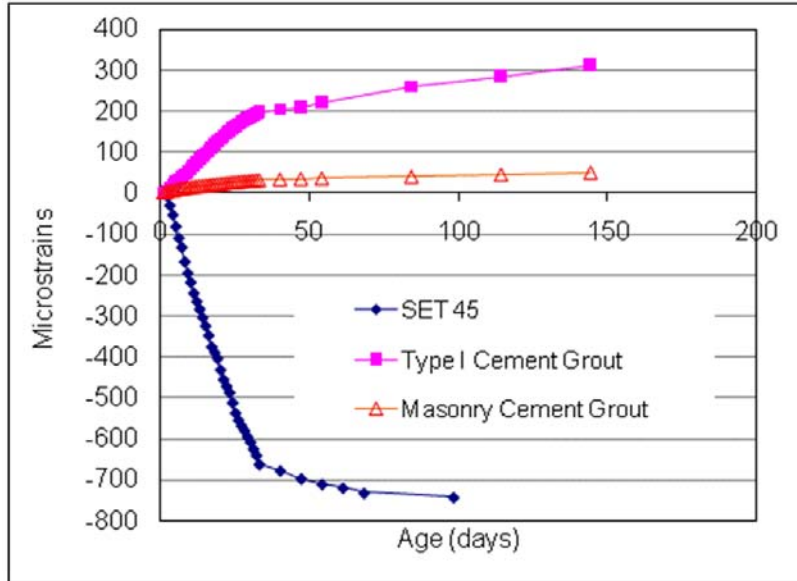
Figure 5-13 presents the development of free shrinkage strains in three shear key grouts stored in 100% RH. The manufacturer of SET 45 clearly states in the data sheet that SET 45 should not be water cured. In order to maintain an identical environment for all specimens, the SET 45 free shrinkage specimens were also stored at 100% RH. The evidently different behavior of SET 45 under these environmental conditions can be noted in Figure 5-12. Set 45 samples exhibited contraction rather than expansion as observed in the Type I cement grout and Masonry cement grout specimens. Overall, masonry cement grout exhibited minimal expansion at the end of 150 days.

Figure 5-13. Free shrinkage strains in shear key grouts for samples at 100% RH

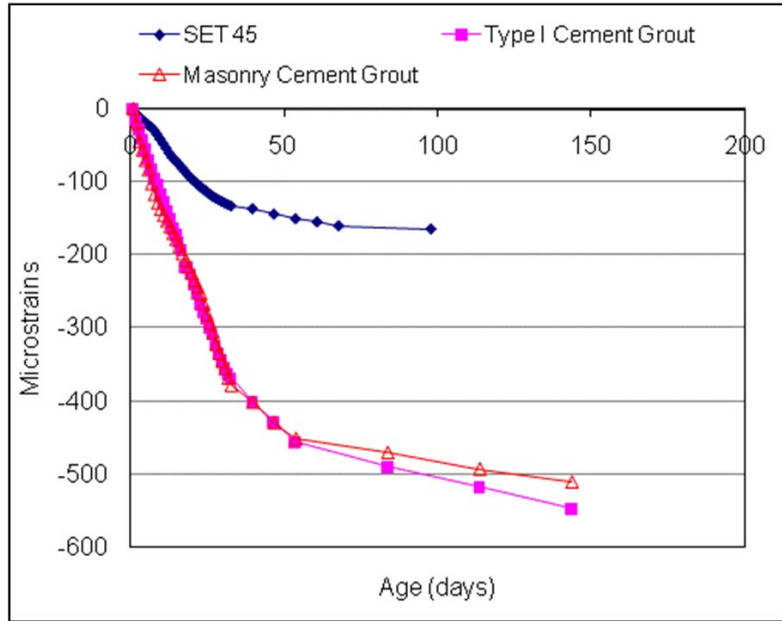
When free shrinkage specimens were stored in 50% RH it was observed that SET 45 exhibited the least contraction and the lowest development of free shrinkage strains as shown in Figure 5-14. The free shrinkage strains in both grouts are high ($\sim 525\mu\epsilon$ at the end of 150 days). Due to the low humidity and high water to cement ratio of both cement grouts, the rate of diffusion of water from the specimen to the surrounding environment is high, leading to high negative strain value. In cement based system, between the relative humidity of say about 95% to 85%, typically water is lost predominantly from large capillary pores or commonly referred as macropores. As the humidity lowers (between 85% to 50%) water is lost concomitantly from both the mesopores and micropores, i.e. from fine capillary pores as well as from the calcium silicate hydrate. The grout mixtures examined in this study have high water to cement ratios as well as intrinsic high porosity leading to a higher tendency for water loss from the different sized pores, resulting in high strain values.

Figure 5-14. Free shrinkage strains in shear key grouts for samples at 50% RH and 73°F

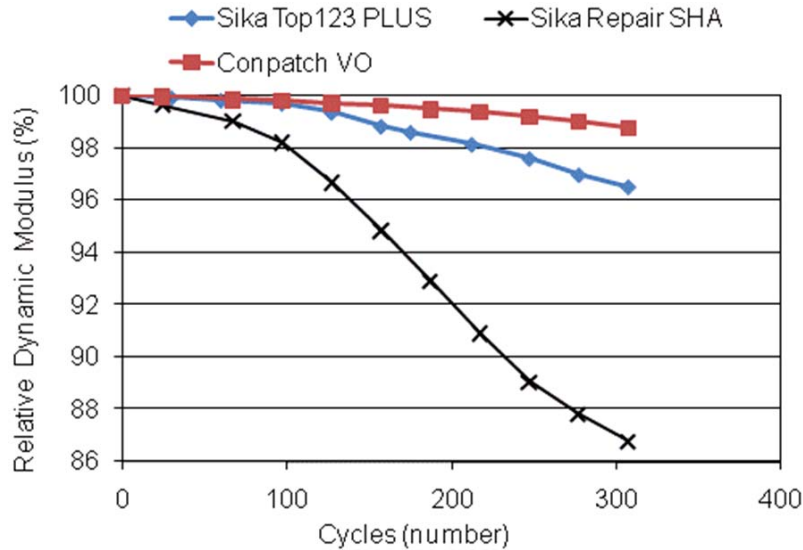
As per ASTM C 666, the relative dynamic modulus at the end of 300 cycles should not be below 60% for a material to be considered to have good resistance to freezing and thawing. All the repair materials evaluated exhibited good resistance to freezing and thawing cycles. Sika Repair® SHA exhibited the highest loss in relative dynamic modulus of 86.5% at 300 cycles. Sika Top123 PLUS and Conpatch VO have excellent resistance to freezing and thawing cycles and exhibit a very low loss in relative dynamic modulus at the end of 300 cycles.

Figure 5-15. Relative dynamic modulus of repair materials over 300 cycles of freezing and thawing

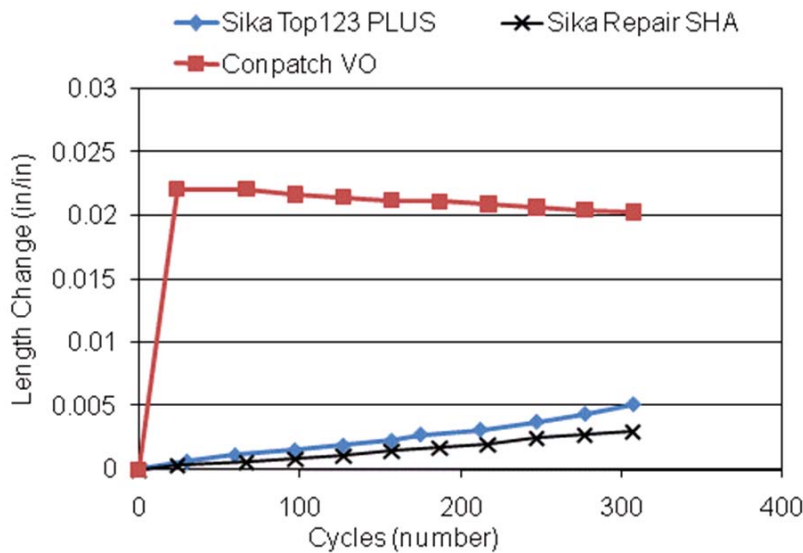
Figure 5-16. Change of repair materials over 300 cycles of freezing and thawing

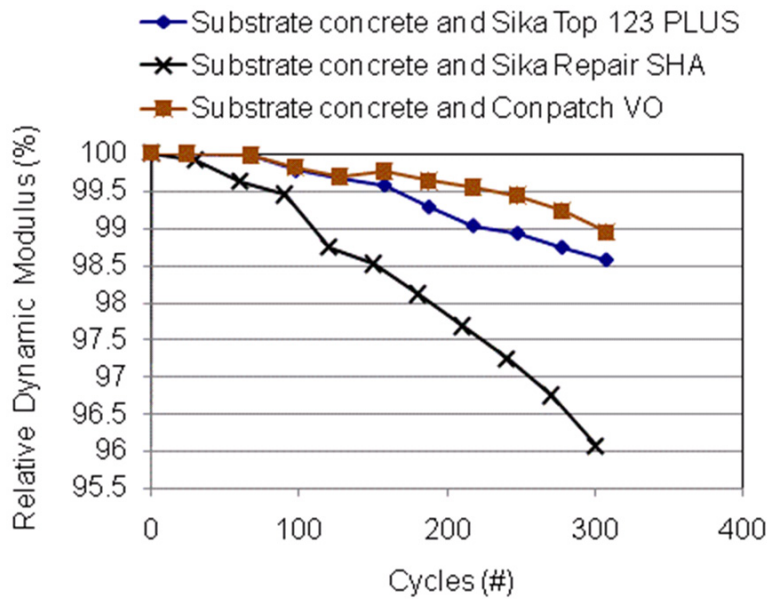
Figure 5-19. Change in relative dynamic modulus of composite specimens of substrate concrete and repair material over 300 cycles of freezing and thawing

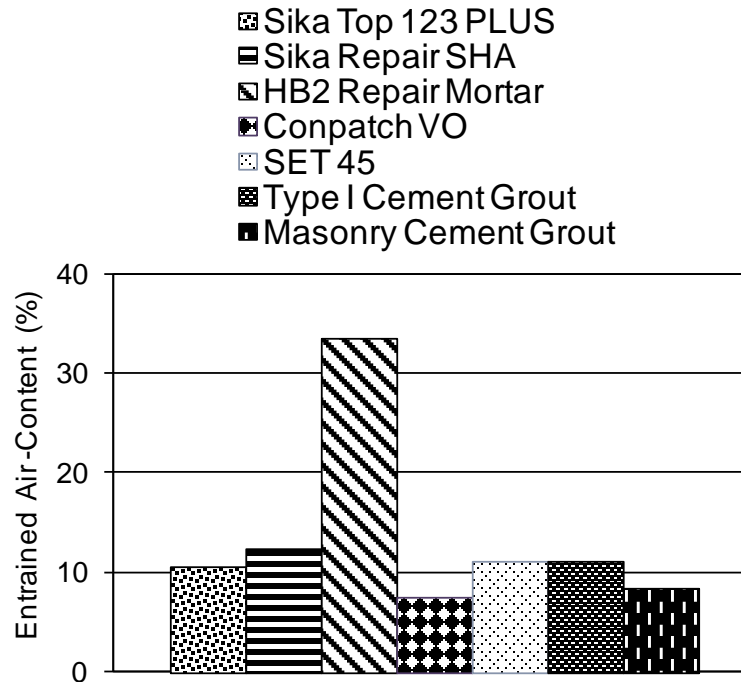
Figure 5-20. Air content in hardened repair mortar and shear key grouts

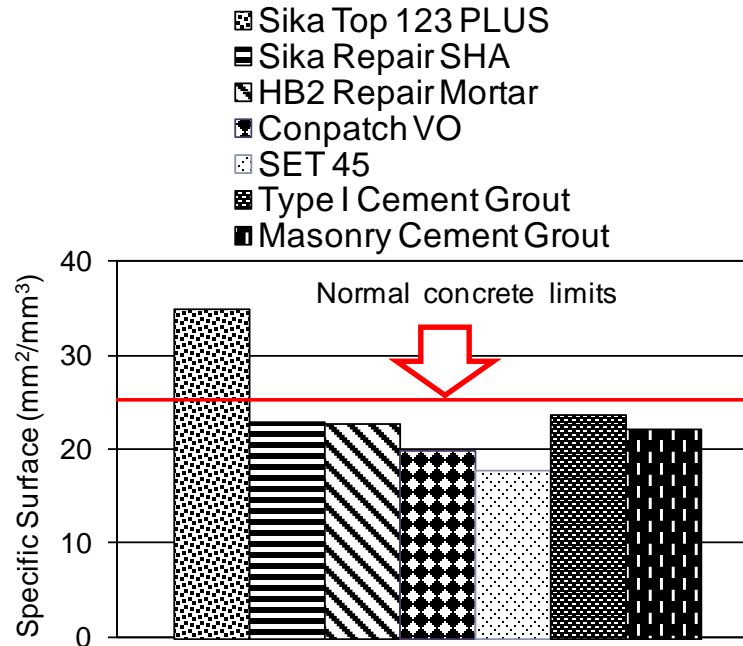
Figure 5-21. Specific surface area of repair mortars and shear key grouts

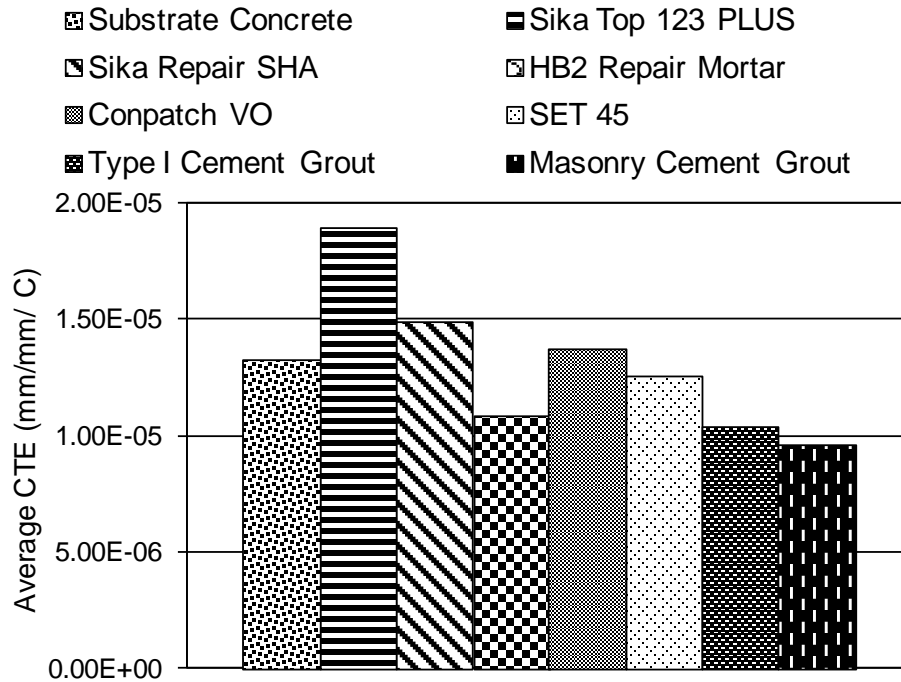
Figure 5-22. Average coefficient of thermal expansion of repair mortars and shear key grouts

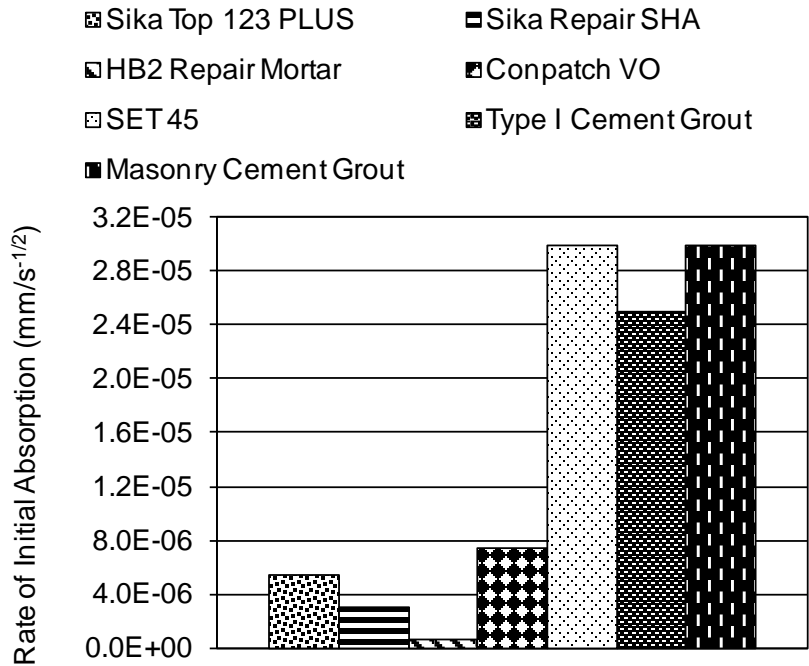
Figure 5-23. Comparison of rate of initial absorption of repair mortars and shear key grouts

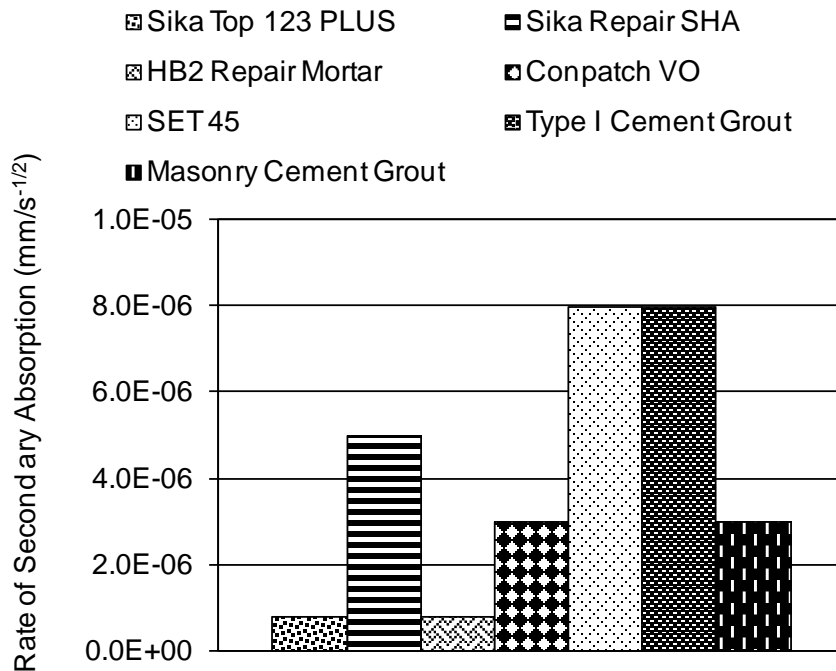
Figure 5-24. Comparison of rate of secondary absorption of repair mortars and shear key grouts

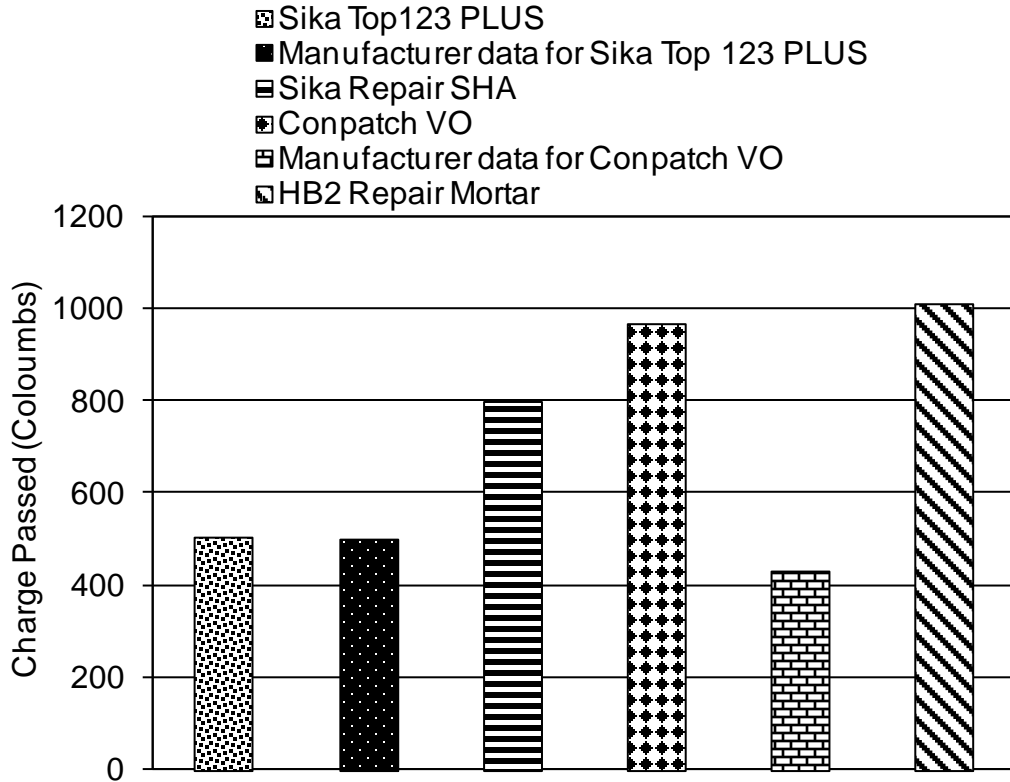
Figure 5-25. Comparison of chloride permeability for repair materials

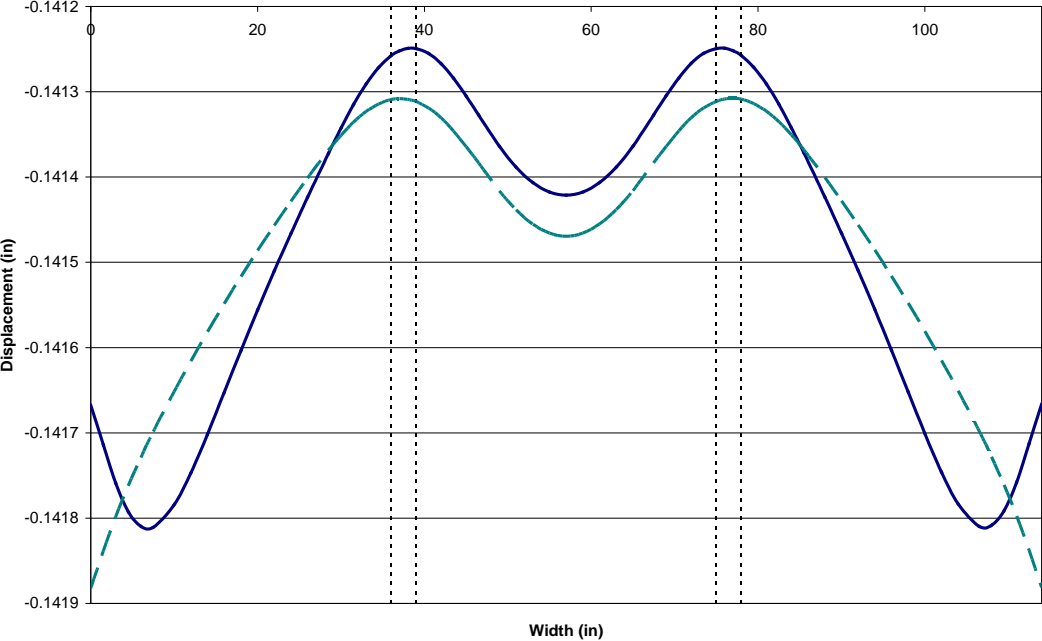
Figure 7-5. Deflection profile of the mid-span transverse section bottom fiber under concentrated load.
 (Note: solid – with posttension and dash – without posttension)

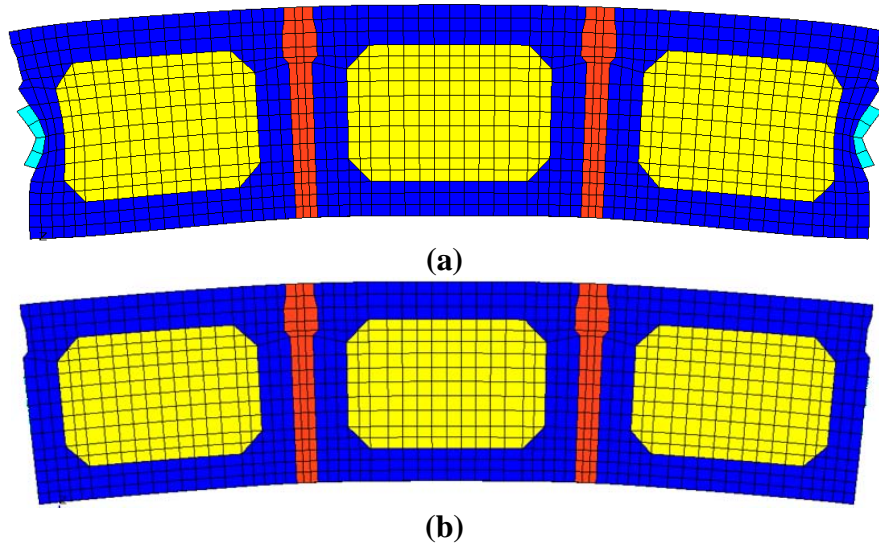
Figure 7-9. Deformed shape of mid-span transverse section under dead load: (a) with posttension and (b) without posttension

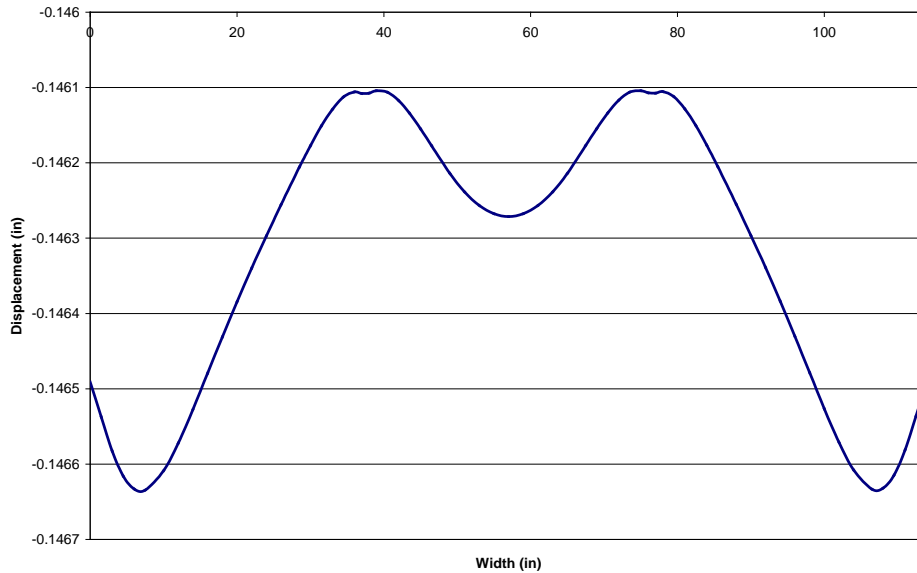
Figure 7-10. Deflection plot of the bottom fiber under concentrated load at mid-span transverse section for three diaphragm configuration

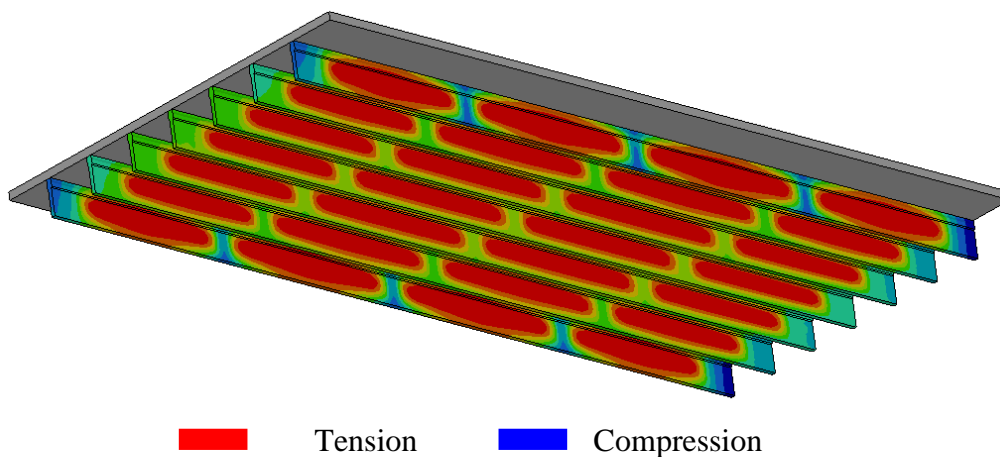
Figure 8-8. Clamping stress distribution in grout layers after posttension application (note: deck is still free from stresses)
