MDOT RC-1527

**CONDITION ASSESSMENT AND METHODS
OF ABATEMENT OF PRESTRESSED
CONCRETE BOX-BEAM DETERIORATION**

Phase II

**FINAL REPORT
VOLUME I**

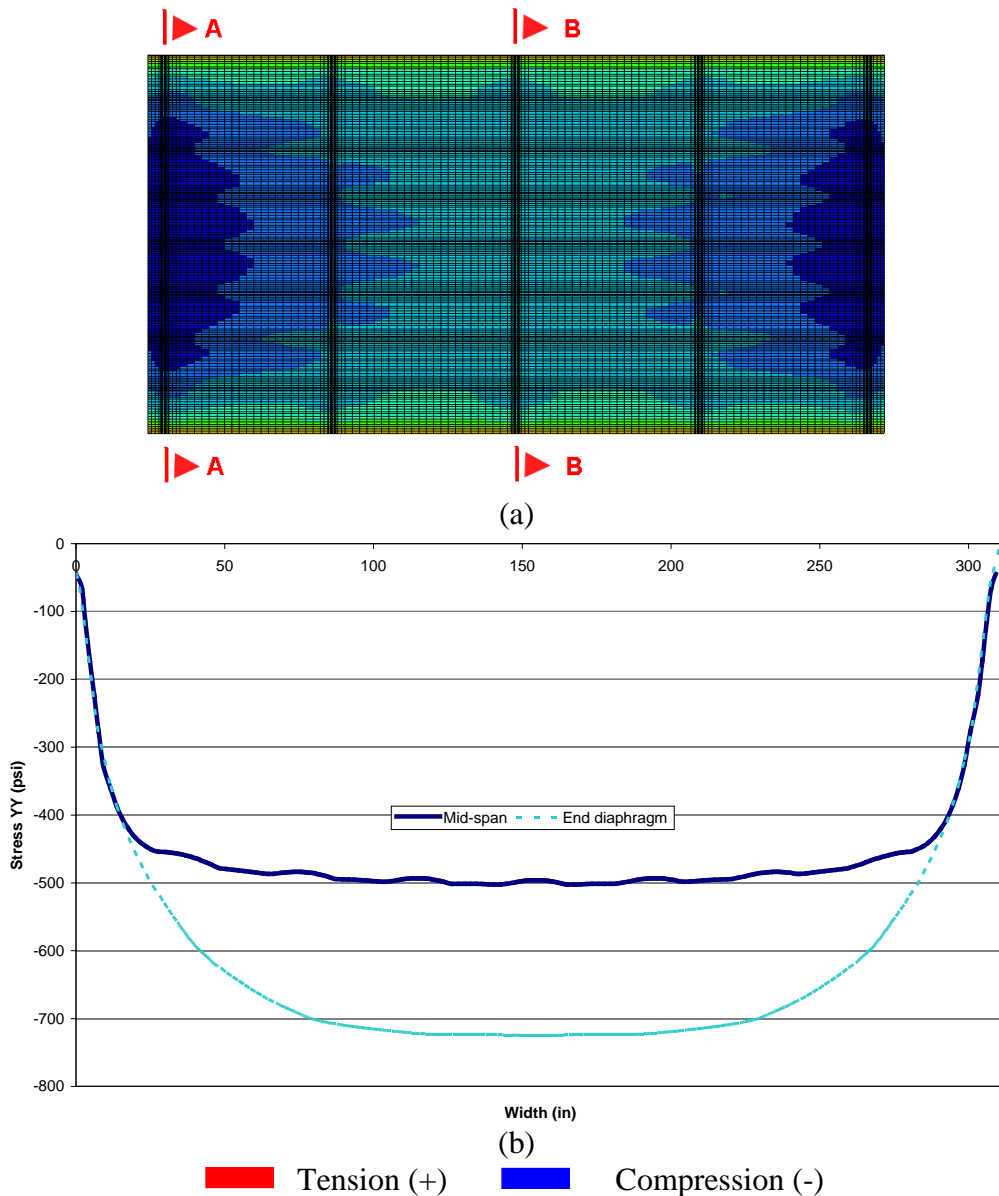
Figure 8-13. Transverse stress distribution (a) at the top surface of the deck and (b) along the width of the deck top surface over mid-span (Section B-B) and end-diaphragm (Section A-A) under Service I load combination 2

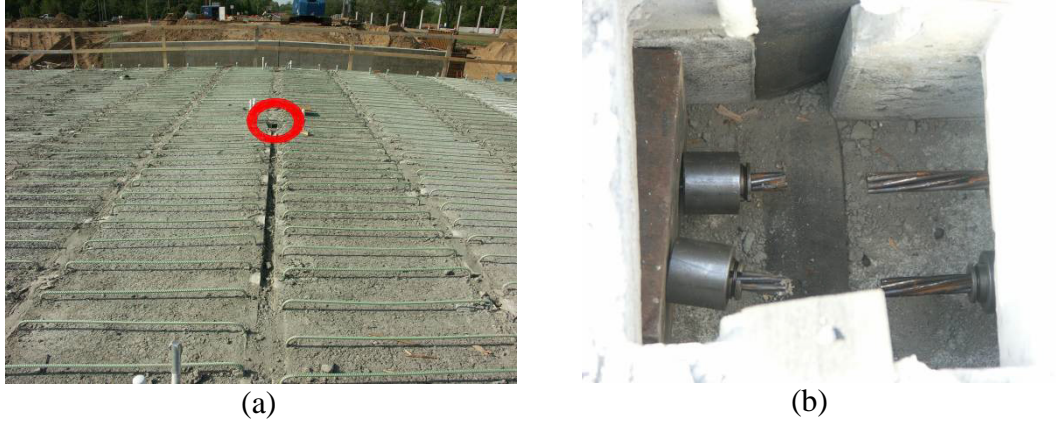
Figure 9-2. (a) Shear-key between beams 11 and 12 and (b) discontinued top posttension strands

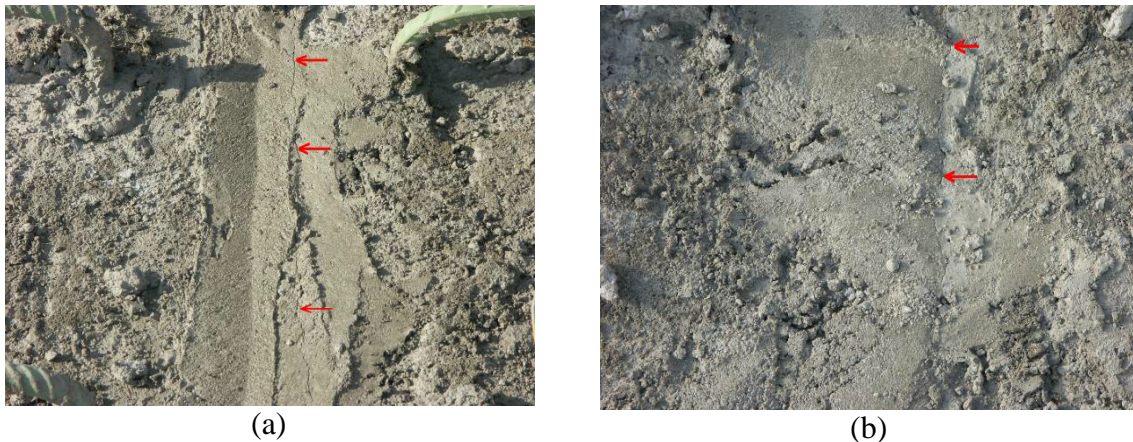
Figure 9-3. Shear-key interface cracking observed on May 14th (a) before and (b) after posttension

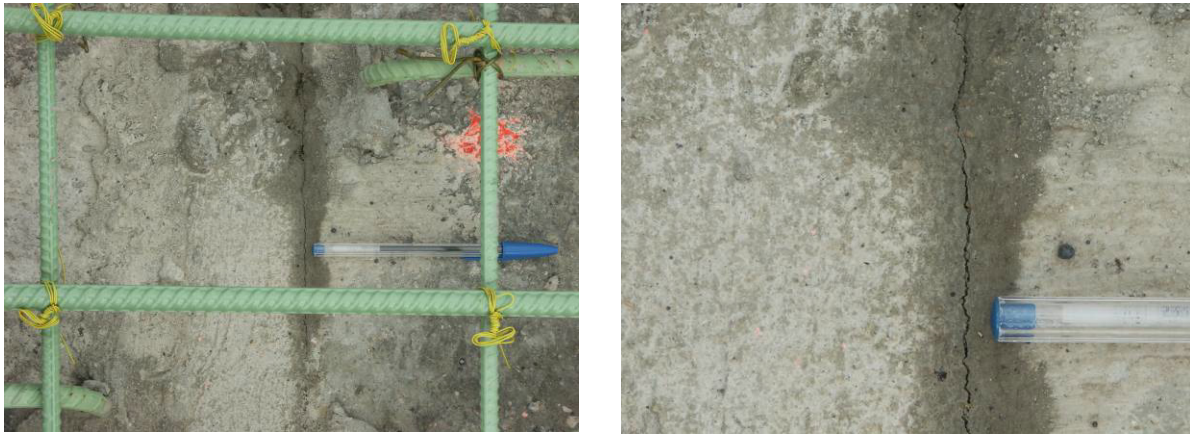
Figure 9-4. Shear-key interface cracks observed on June 4th

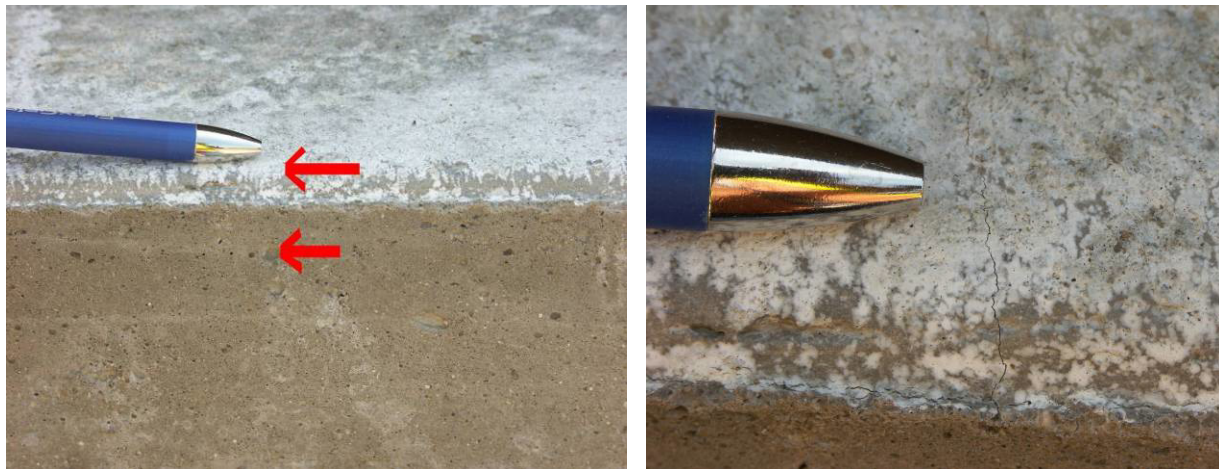
Figure 9-5. Deck cracking observed on June 22nd

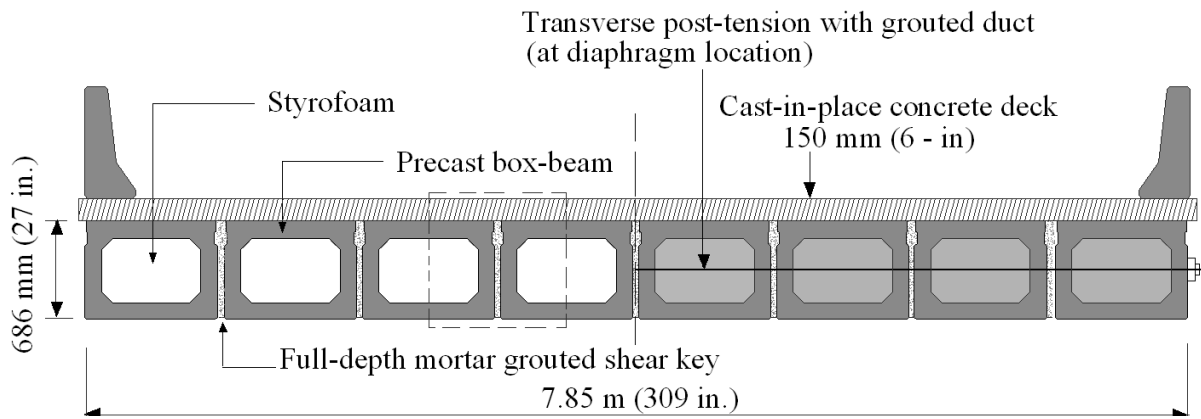
Figure 9-8. Side-by-side box-beam configuration

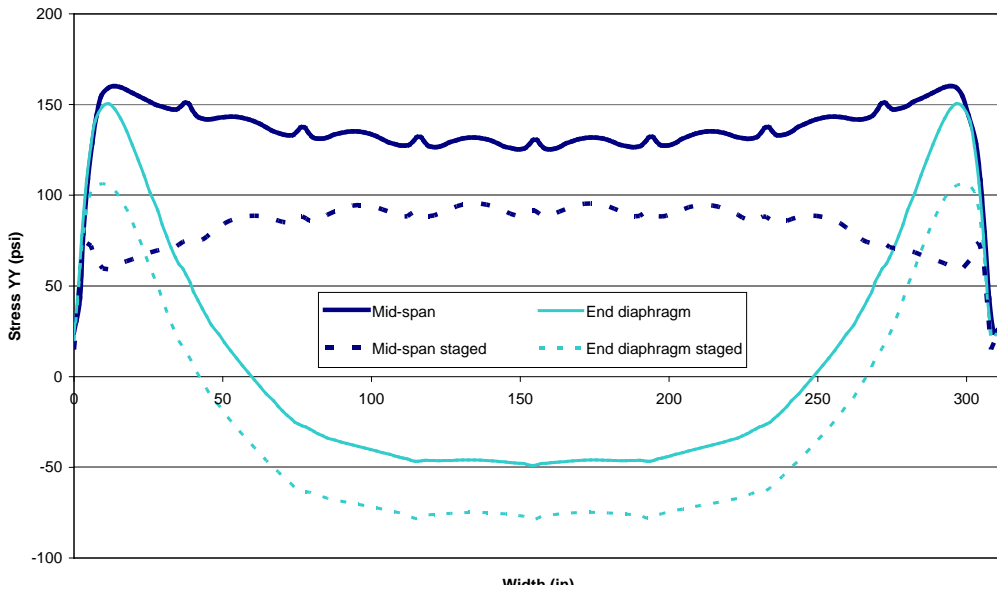
Figure 9-29. Transverse stress distribution along the width of the 6-in cast-in-place concrete deck bottom surface with and without staged posttension under service I load combination 2

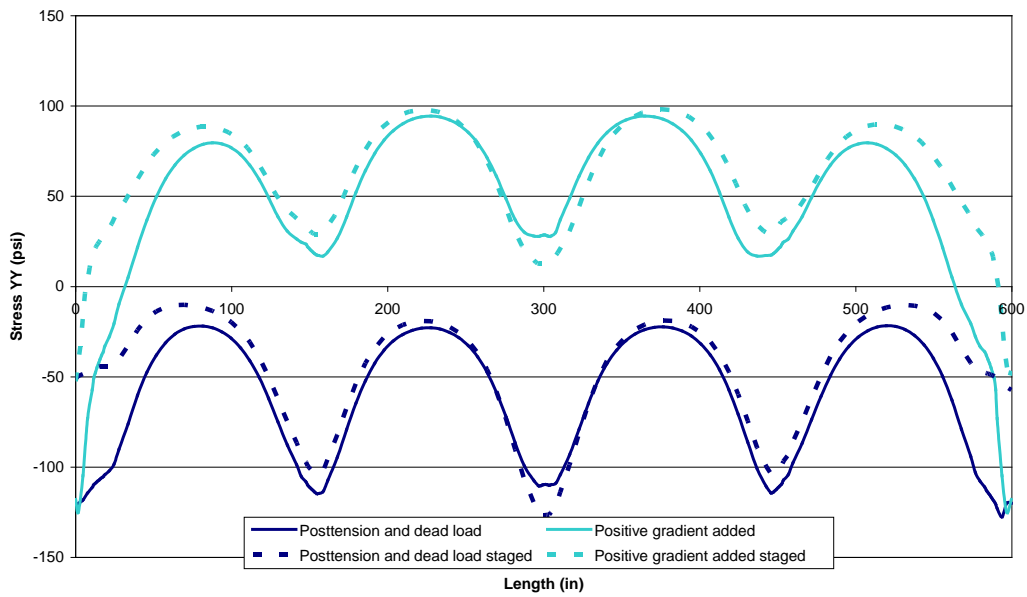
Figure 9-32. Clamping stress distribution along the length of the shear key top surface with and without staged posttension under positive gradient loading

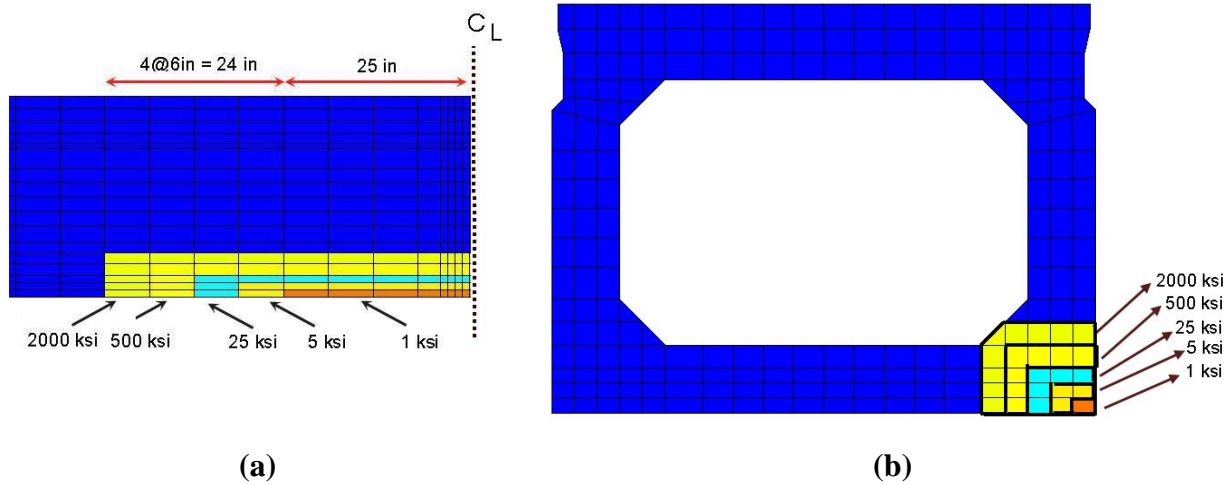
Figure 10-1. Finite element model of distress levels 2 and 3: (a) enlarged view of half of the distressed zone along length and (b) section view of the distressed zone (note: broken strands are not visible)

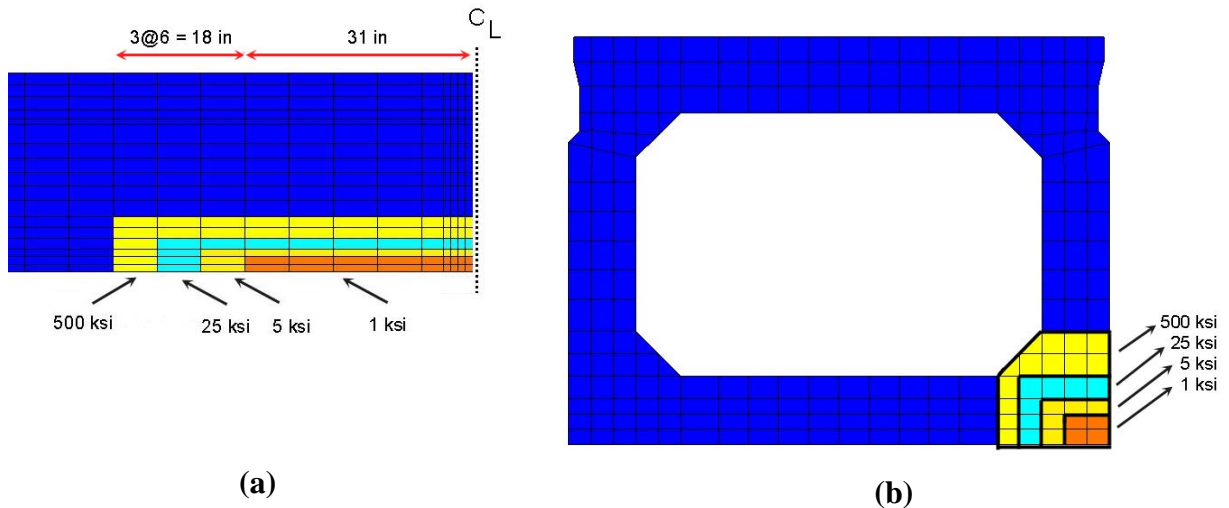
Figure 10-2. Finite element model of distress level 4: (a) enlarged view of half of the distressed zone along length and (b) section view of the distressed zone (note: broken strands are not visible)

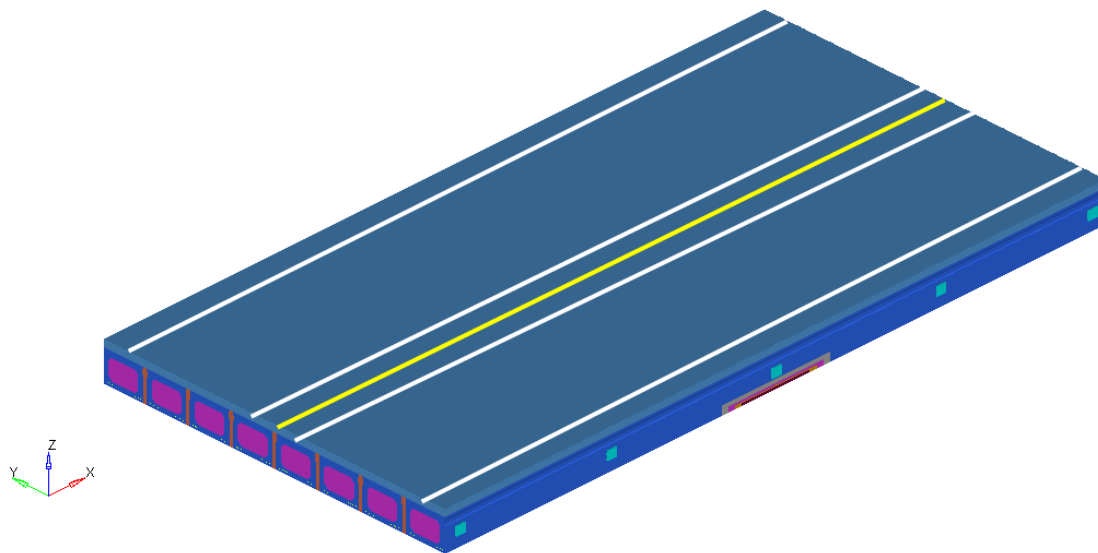
Figure 10-9. 3D view of the model showing distress on fascia beam and design lanes

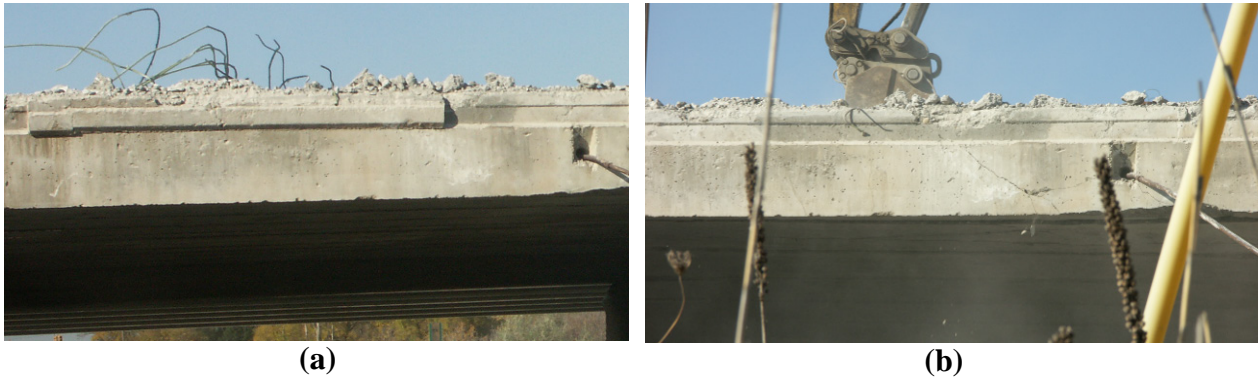
Figure 10-10. a) A portion of shear key grout remain intact with the beam and (b) beam surface after shear key grout cleanly fall off

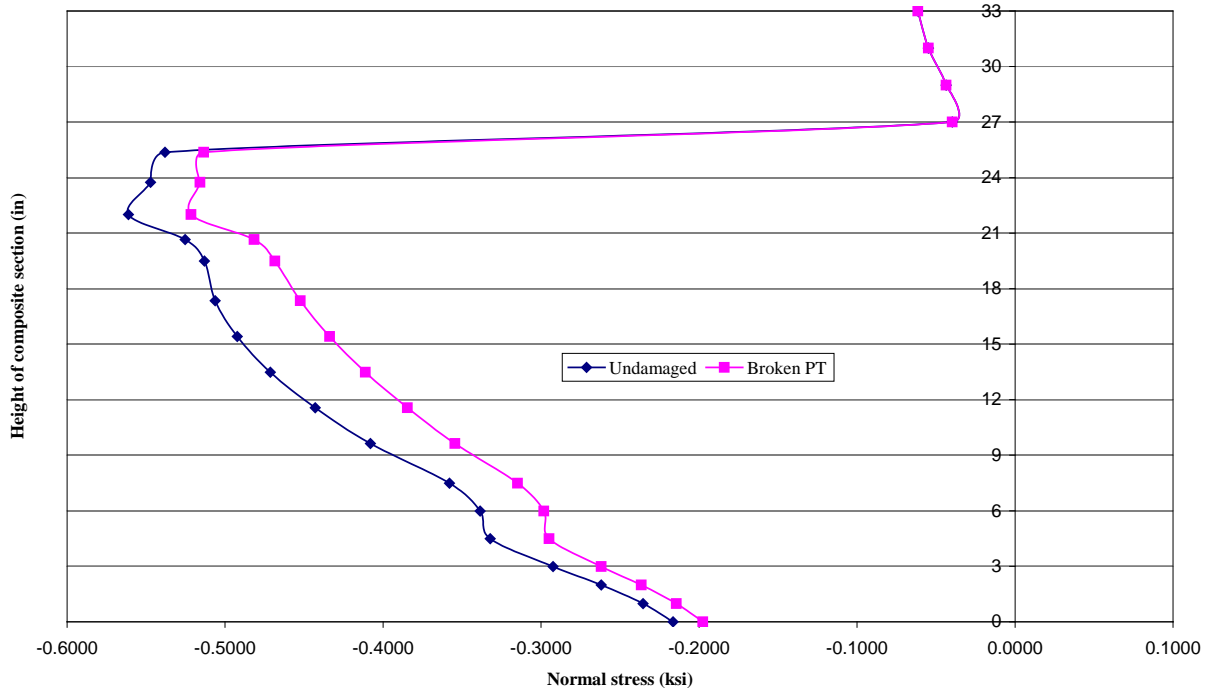
Figure 10-14. Normal stress distribution through the depth of deck-beam composite cross-section under dead load + prestress (tensile +; compression -)

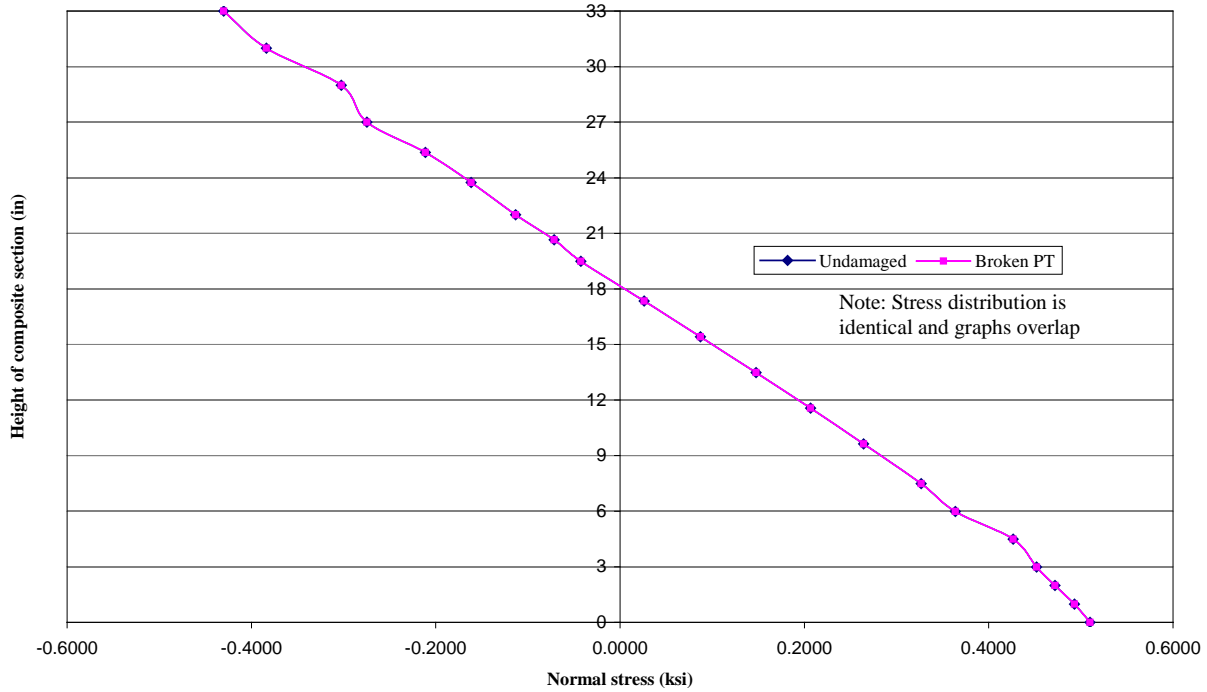
Figure 10-16. Normal stress distribution through the depth of deck-beam composite cross-section only under 100 percent live load (Tensile +, Compressive -)

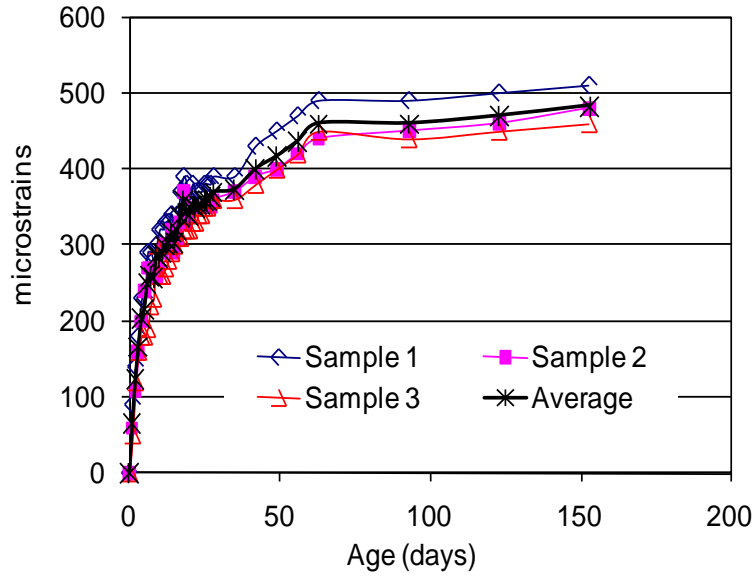
Figure E-1. Development of free shrinkage in Sika Top®123 PLUS in 100 % RH

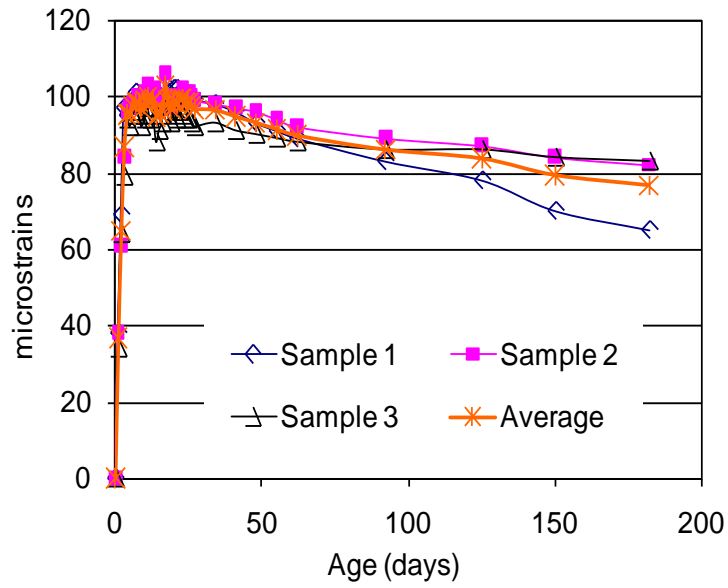
Figure E-3. Development of free shrinkage in Sika Repair[®] SHA in 100 % RH

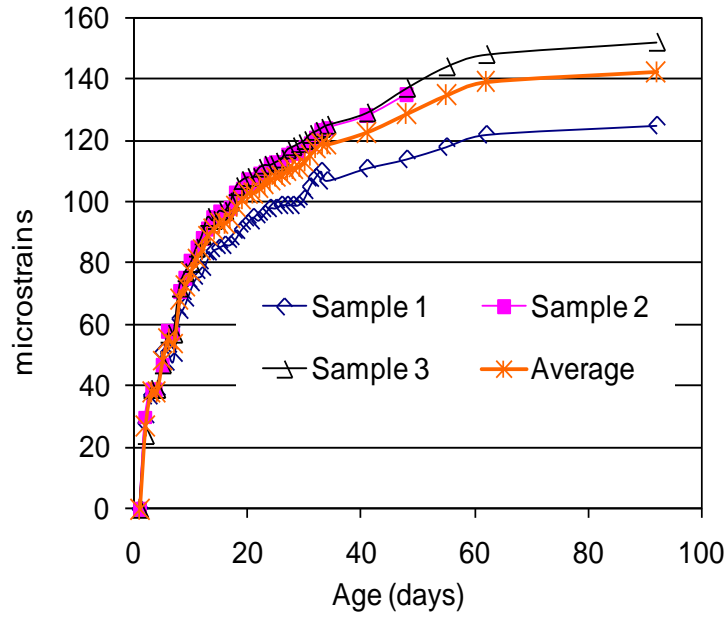
Figure E-5. Development of free shrinkage in HB2 Repair Mortar in 100 % RH

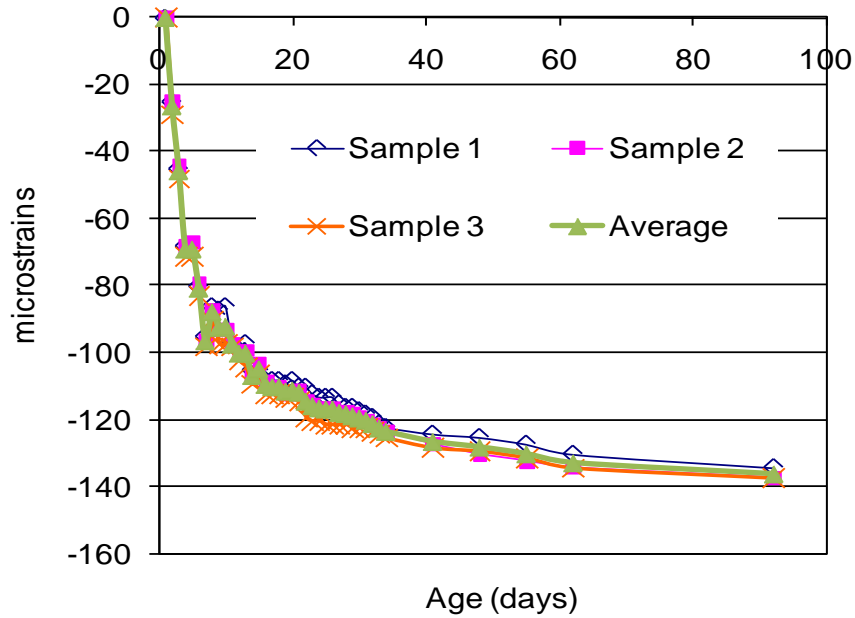
Figure E-6. Development of free shrinkage in HB2 Repair Mortar in 50 % RH

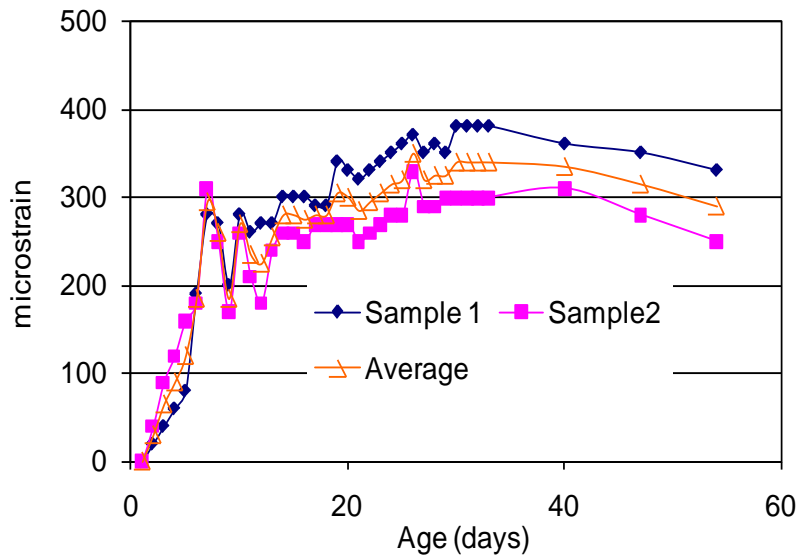
Figure E-7. Development of free shrinkage in Conpatch VO in 100 % RH

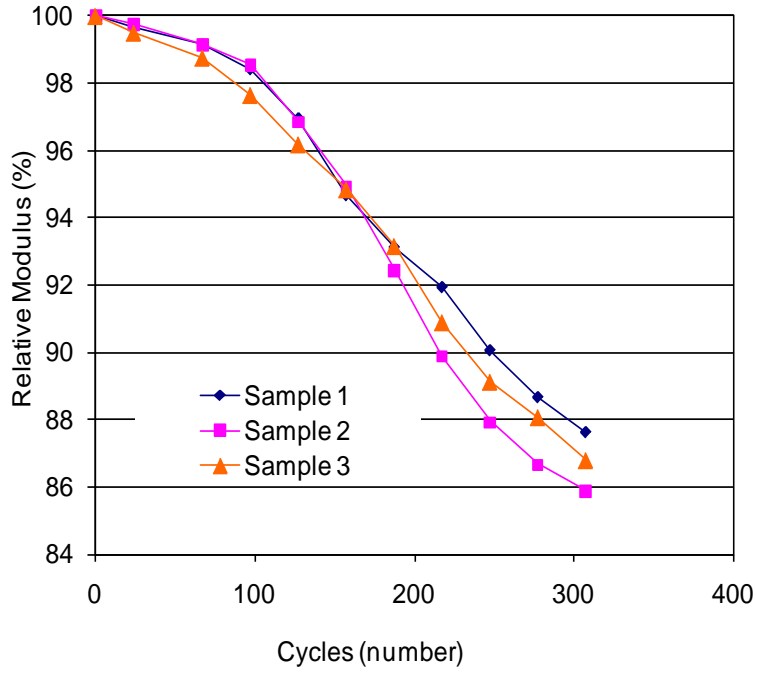
Figure F-3. Relative Dynamic Modulus of Sika Repair[®] SHA over 300 cycles

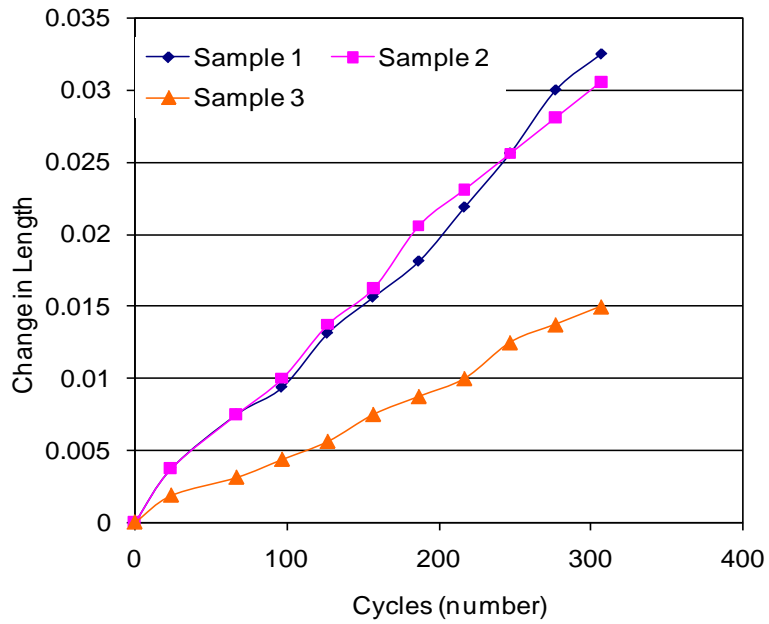
Figure F-4. Length Change in Sika Repair[®] SHA over 300 cycles

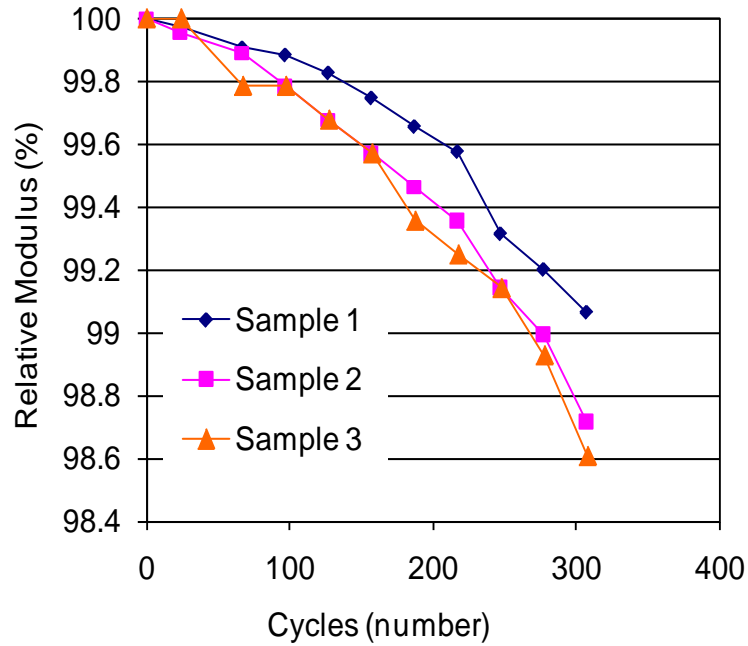
Figure F-5. Relative Dynamic Modulus of Conpatch VO over 300 Cycles

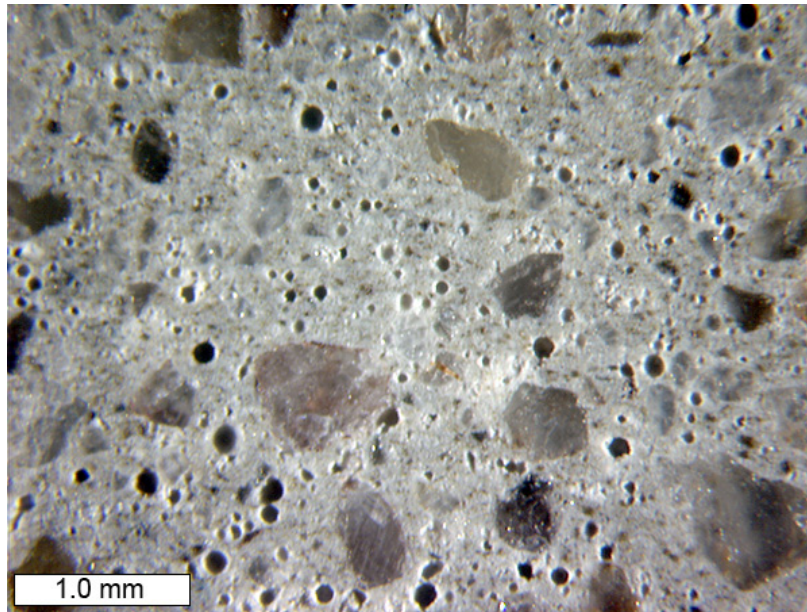
Figure G-1. Stereo Image of Sika Top 123 PLUS Mortar

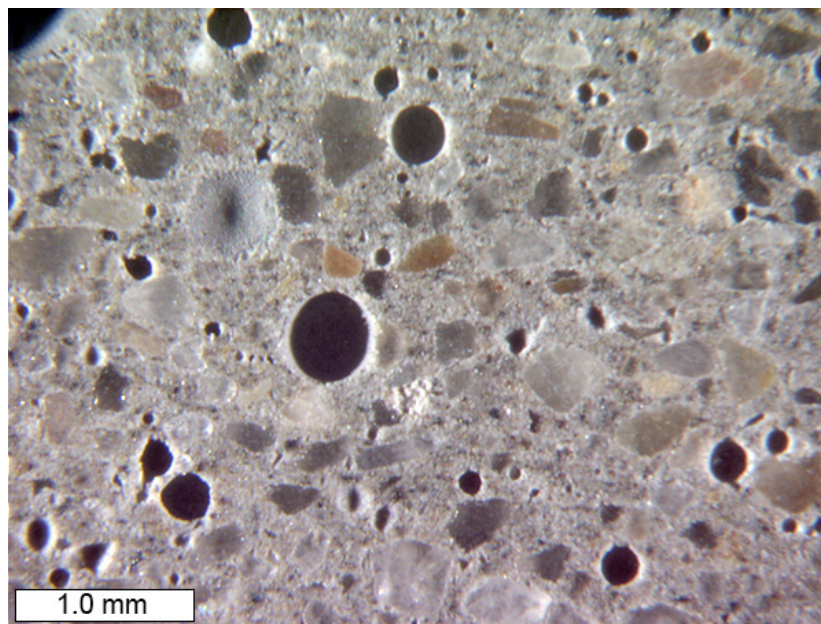
Figure G-2. Stereo Image of Sika Repair SHA Mortar

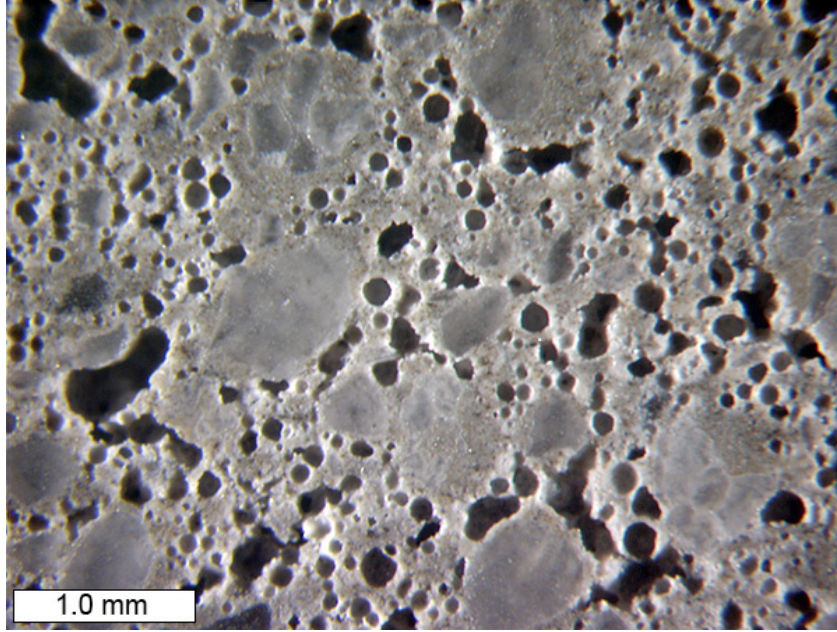
Figure G-3. Stereo Image of HB2 Repair Mortar

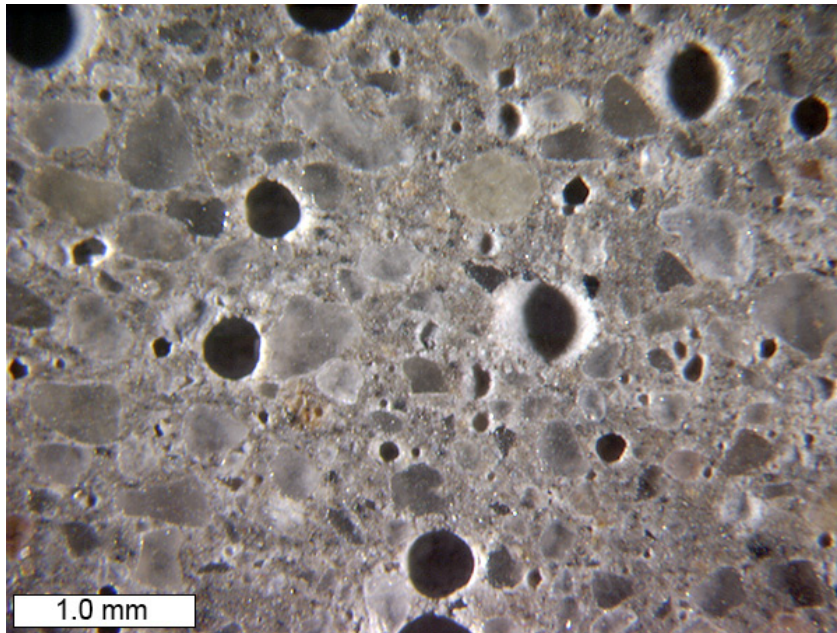
Figure G-4. Stereo Image of Conpatch VO Mortar

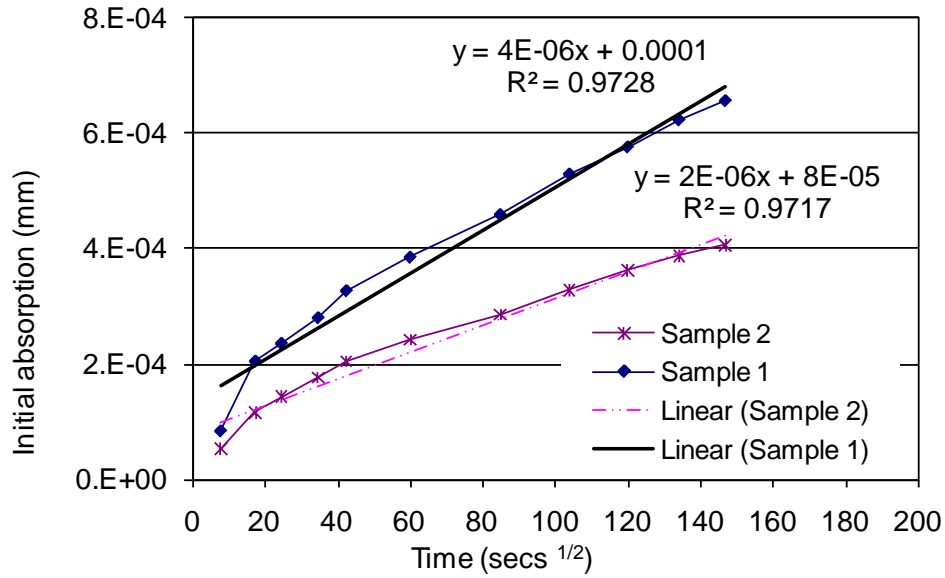
Figure I-3. Initial Absorption Curves for Sika Repair SHA

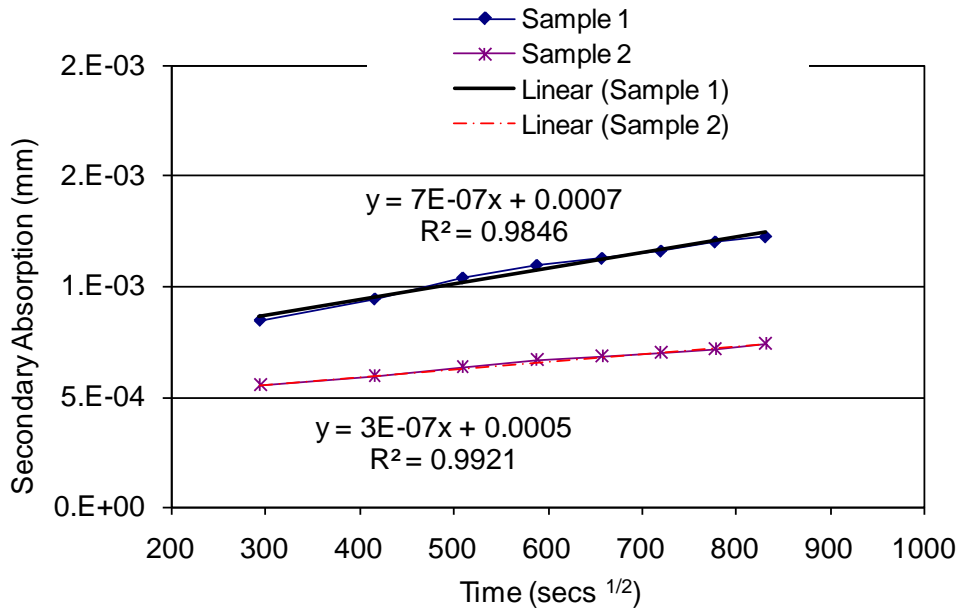
Figure I-4. Secondary Absorption Curves for Sika Repair SHA

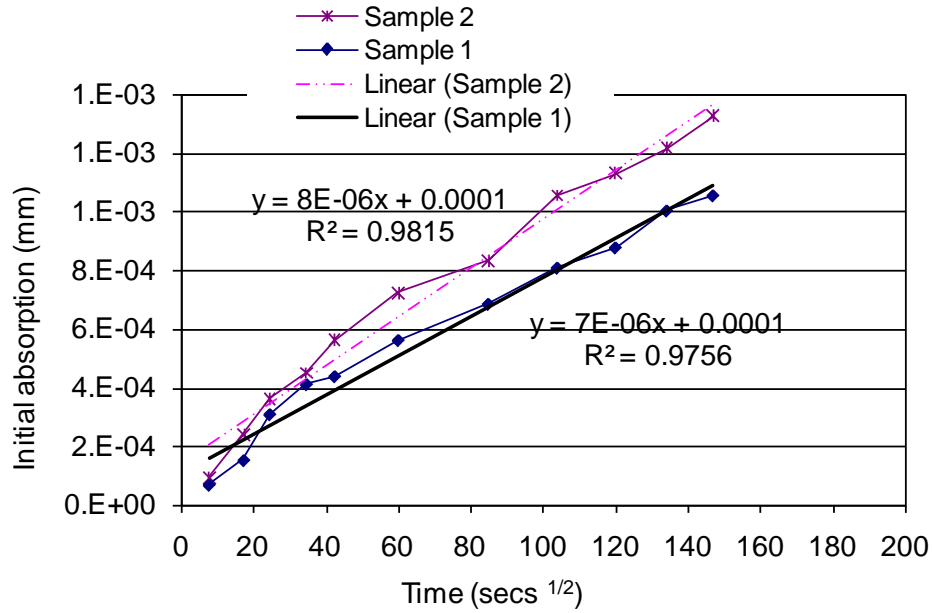
Figure I-5. Initial Absorption Curves for Conpatch VO

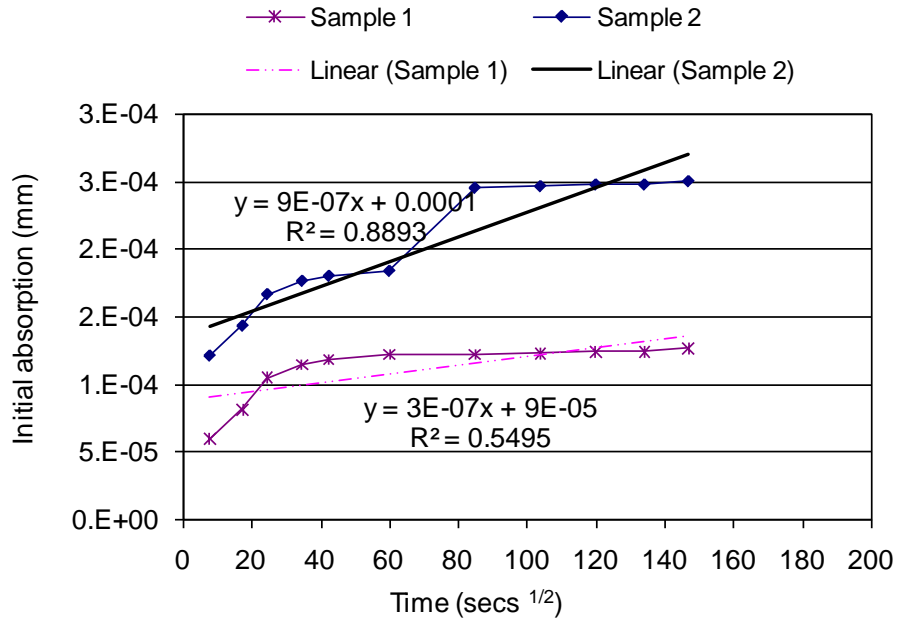
Figure I-7. Initial Absorption Curves for HB2 Repair Mortar

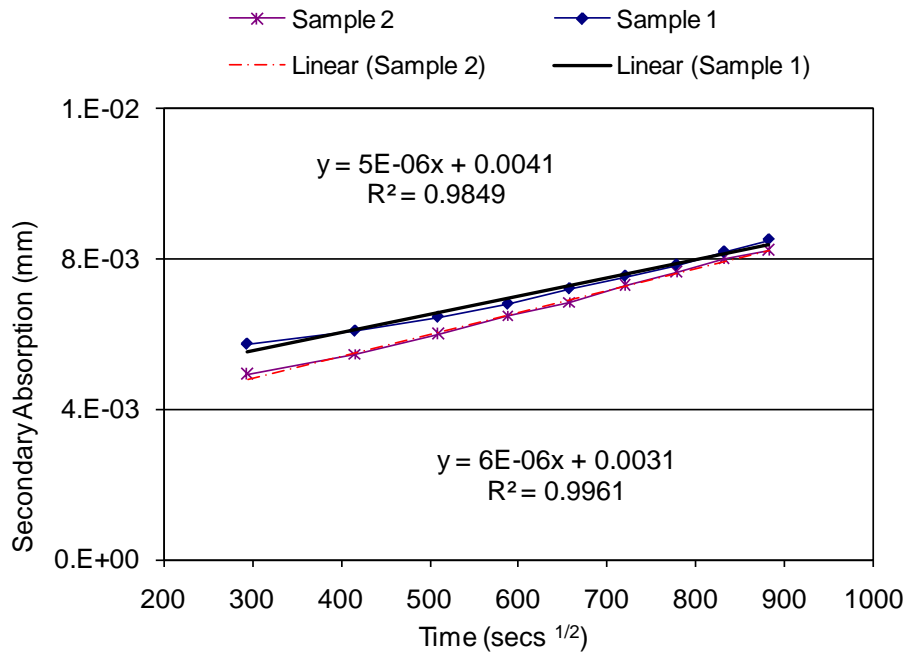
Figure I-8. Secondary Absorption Curves for HB2 Repair Mortar

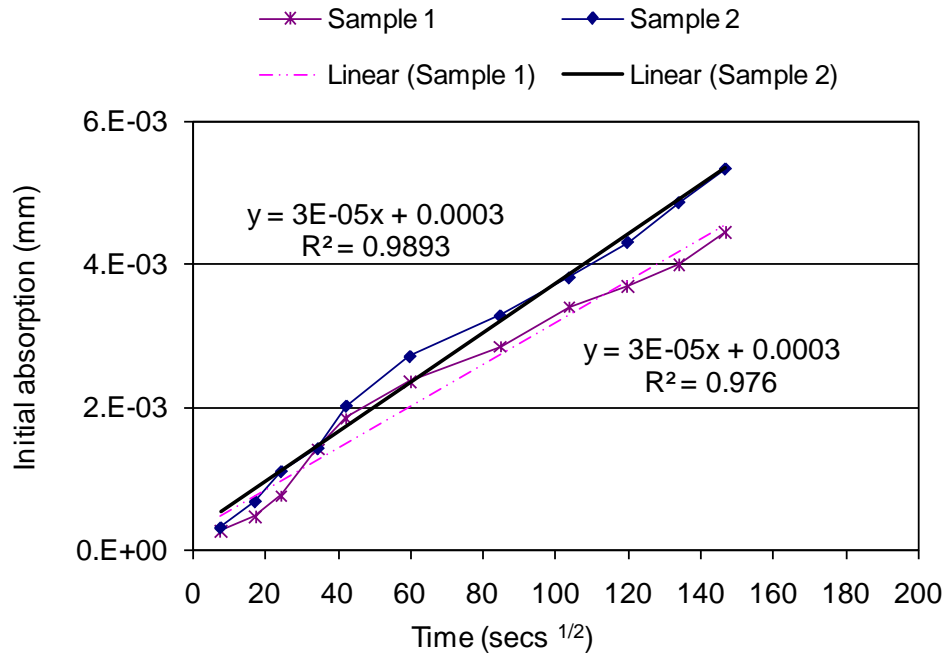
Figure I-9. Initial Absorption Curves for SET 45
