A STUDY OF COLD PLASTIC
PAVEMENT MARKING MATERIALS

TSD-0-118 (I)-69

Interim Report

Reflective Devices Unit
Operations Section
Traffic and Safety Division

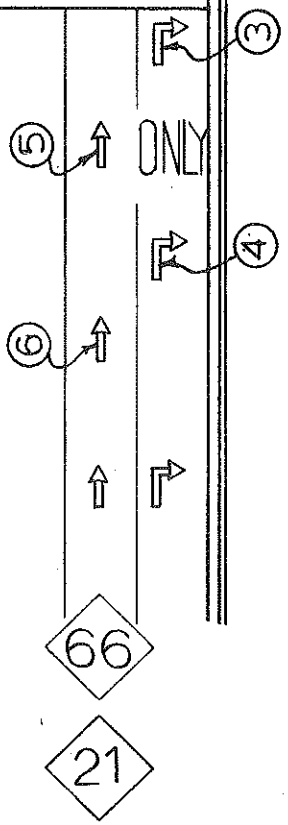
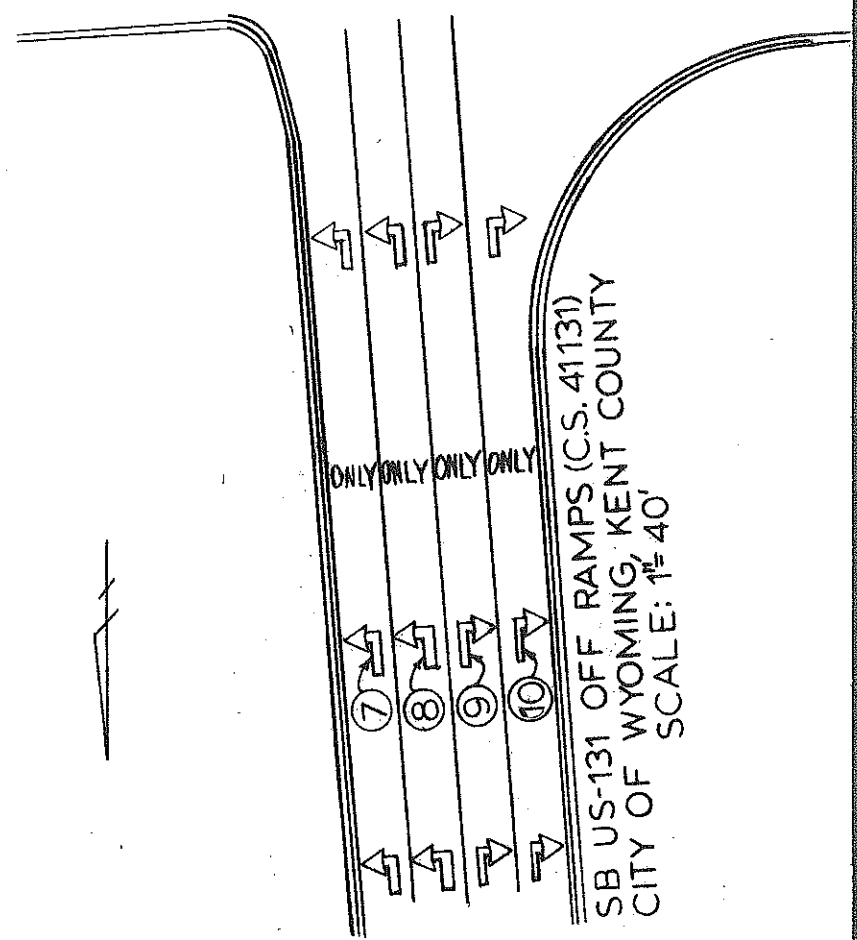
WEST INTERSECTION M-66 & M-21
 IN CITY OF IONIA (C.S. 34033)
 IONIA COUNTY
 SCALE: 1"=30'

SB US-131 OFF RAMP (C.S. 41131)
 CITY OF WYOMING, KENT COUNTY
 SCALE: 1"=40'

Ten Holland-Suco Presslab arrows were installed on October 14, 1968. Six arrows were placed at the intersection of the west junction of M-66 and M-21 in the City of Ionia, and four arrows were installed at the southbound US-131 off-ramp to M-11 in the City of Wyoming. Figure #1 depicts these locations and provides an identifying number for each arrow. The characteristics of the arrows are as listed in the following table:

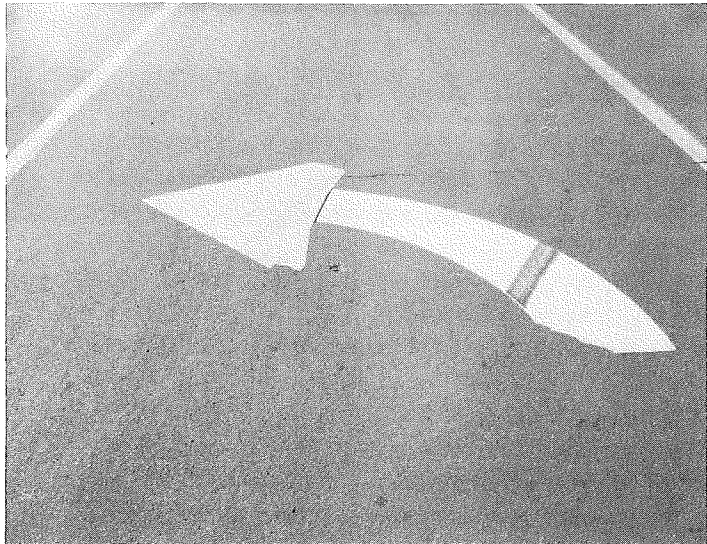
Figure #2

HOLLAND-SUCO PRESSLAB
LEFT TURN ARROWS
INSTALLED SEPT. 20, 1967

FIRST ADVANCE CENTERLANE
ARROW ON WB. SAGINAW (M-43)
@ WAVERLY RD. (3-18-69)

A survey was made of the Holland-Suco Presslab Arrows at the M-43 - Waverly Road intersection on March 18, 1969. After one and one-half years (two seasons of winter maintenance activity), these Presslab arrows showed very little loss of material. Tire marks were visible on each arrow, however (Figure #2).

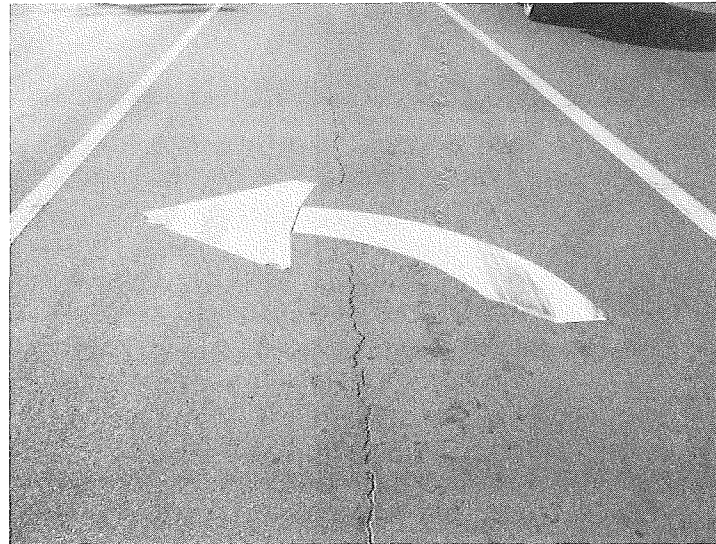
SECOND ADVANCE CENTERLANE
ARROW ON WB. SAGINAW (M-43)
@ WAVERLY RD. (3-18-69)

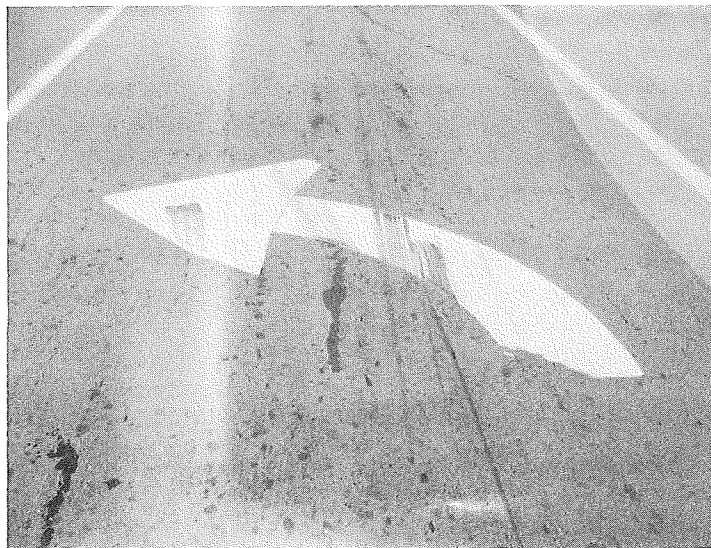
ADVANCE CENTERLANE ARROW
ON EB. SAGINAW (M-43)
@ WAVERLY RD. (3-18-69)

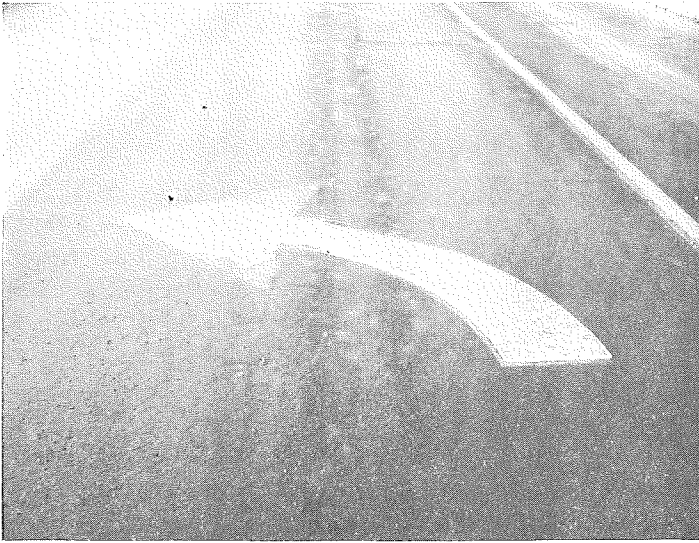
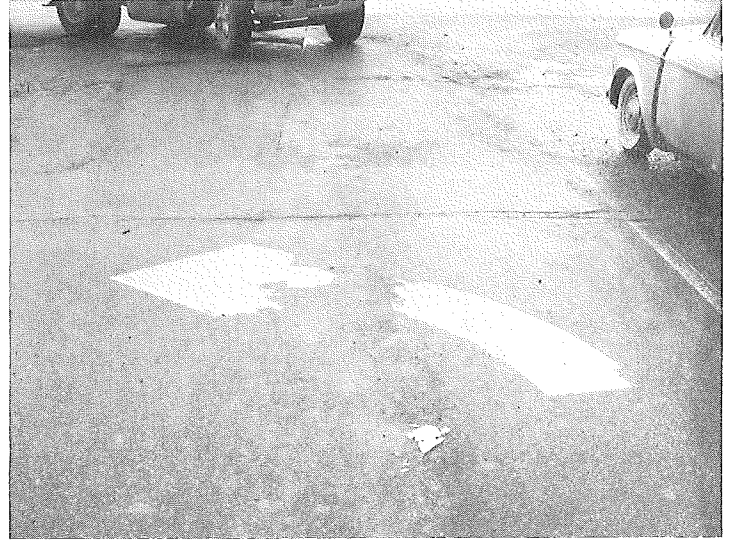
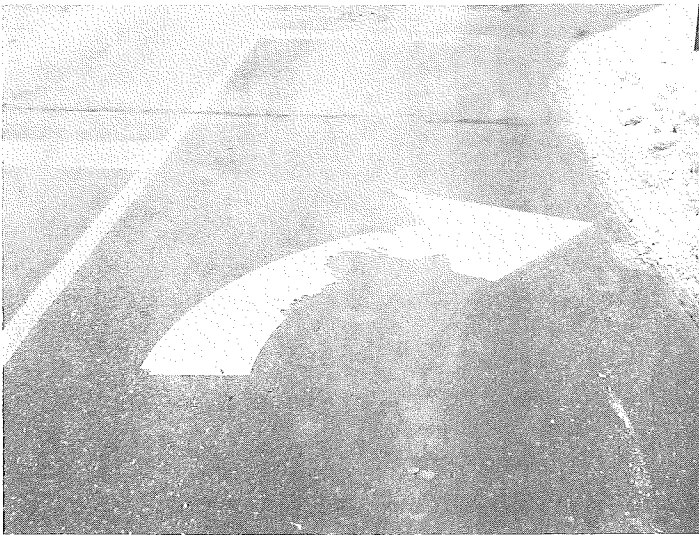
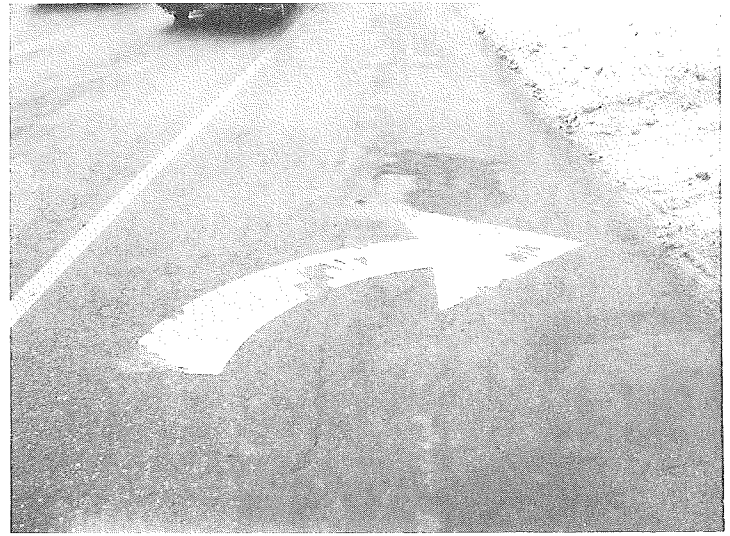
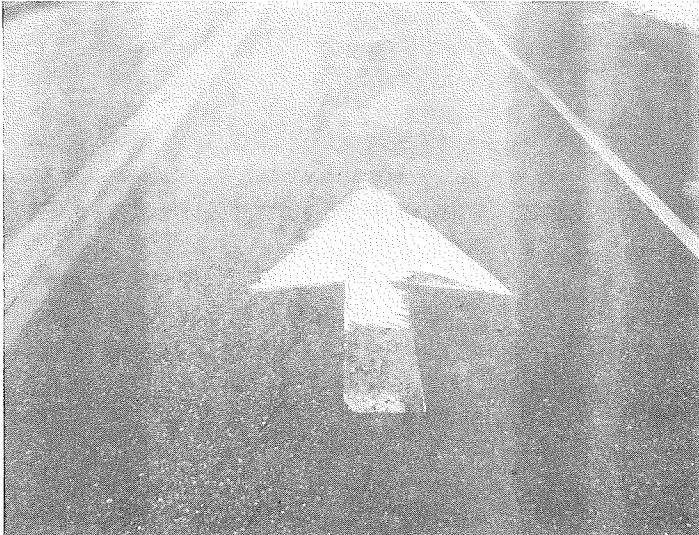
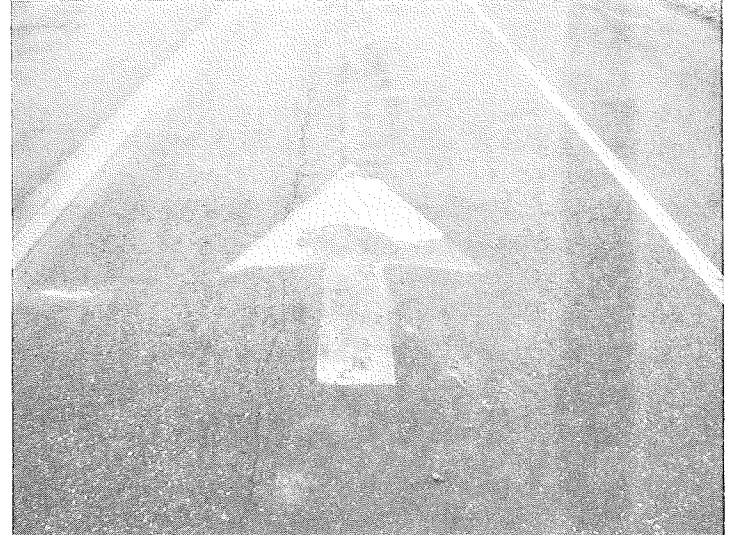
Figure #3
HOLLAND-SUCO PRESSLAB ARROWS
INSTALLED OCTOBER 14, 1968
W. JCT. M-66 & M-21, CITY OF IONIA

The Presslab arrows in the cities of Ionia and Wyoming were inspected on December 30, 1968. At the time of this inspection, arrows #1 through #10 had been subjected to winter maintenance activity resulting from snow and ice storms. The arrows in the City of Ionia (arrows #1 through #6) had lost large amounts of the plastic material and, in some instances, it was difficult to determine the original form of the pavement markings (Figure #3). The four arrows placed on the freeway off-ramp (City of Wyoming) fared better with only the leading edges of the Presslab material being removed. However, some tire marks were visible on the arrows (Figure #4).

Our experience to date with cold plastic pavement marking materials has been rather limited. It is apparent, from analyzing the test arrows, that the plastic material is breaking away, rather than wearing away. The critical parameter in the service life of the cold plastic arrow seems to be its bonding strength to the pavement, and the bonding strength is dependent upon the nature and condition of the surface to which it is bonded. Snow plow activity and high traffic volumes appear to be the worst enemies to the pressure-sensitive bond.

Our tests to date have revealed that cold plastic arrows applied to new bituminous surfaces or to smooth portland cement surfaces have performed rather well and seem to be quite durable. Those arrows installed on an older, rough bituminous surface have had a shorter life than a conventionally painted arrow on the same surface.

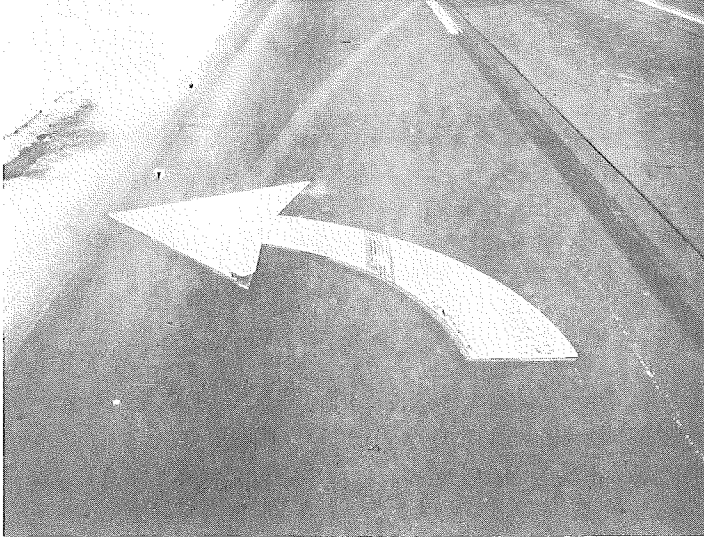
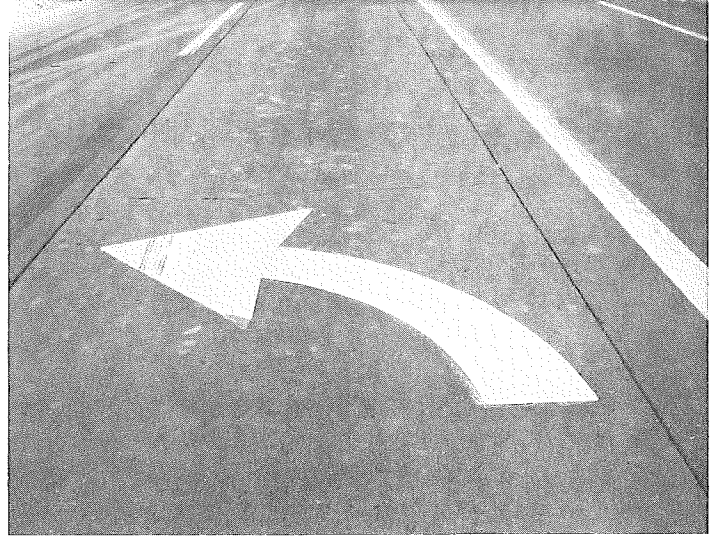
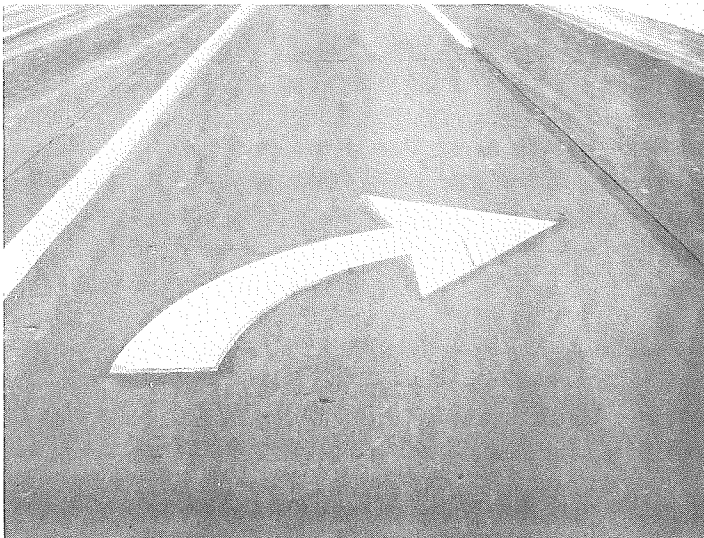
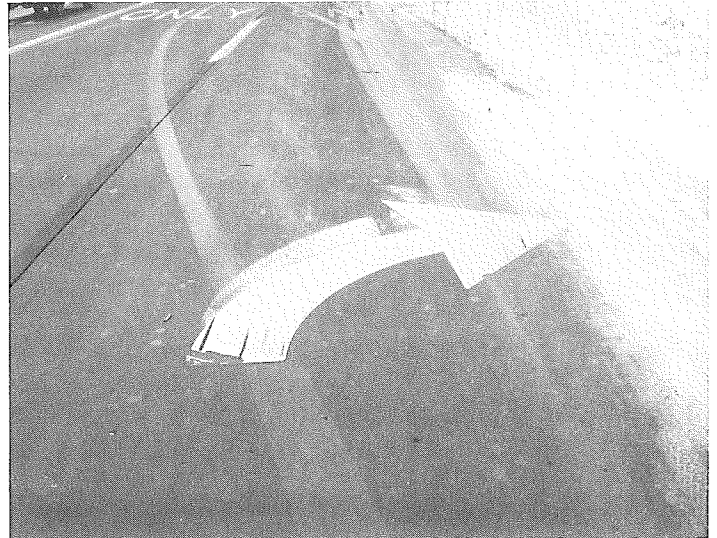
Figure #4

HOLLAND-SUCO PRESSLAB ARROWS
INSTALLED OCTOBER 14, 1968
S.B. US-131 OFF RAMP TO 28th ST.
CITY OF WYOMING

Tire marks visible on many of the cold plastic test arrows indicates that occasional cleaning might be desirable. However, the fact that the arrows do not become completely tire marked indicates that they may be self-cleaning to some extent. The short life of the conventionally painted arrow, if not properly maintained, results in an ineffective traffic control device and thereby increases accident potential and reduces highway capacity. It is recommended that consideration be given to further testing of cold plastic pavement marking materials to determine the conditions (surface type, surface age, traffic volumes, climate, etc.) for which the use of cold plastic pavement marking materials could be justified from a standpoint of economy and safety.

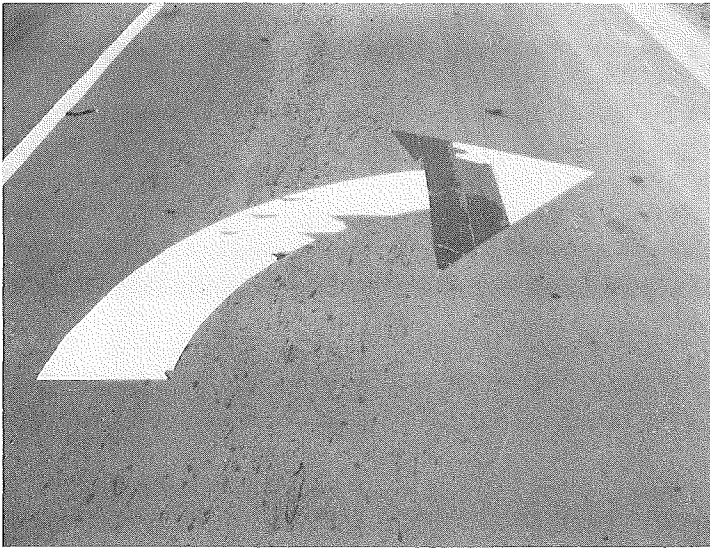
Figure #5

The two Prismo right-turn arrows on US-27 north of Lansing were inspected on March 18, 1969. The Prismo arrows were not tire-marked, but large amounts of the plastic material had been lost from the arrow at State Road. Except for a tar splatter, the arrow at Sheridan Road was not damaged (Figure #5).

RIGHT TURN LANE ON
N.B. US-27 @ STATE RD.
(3-18-69)

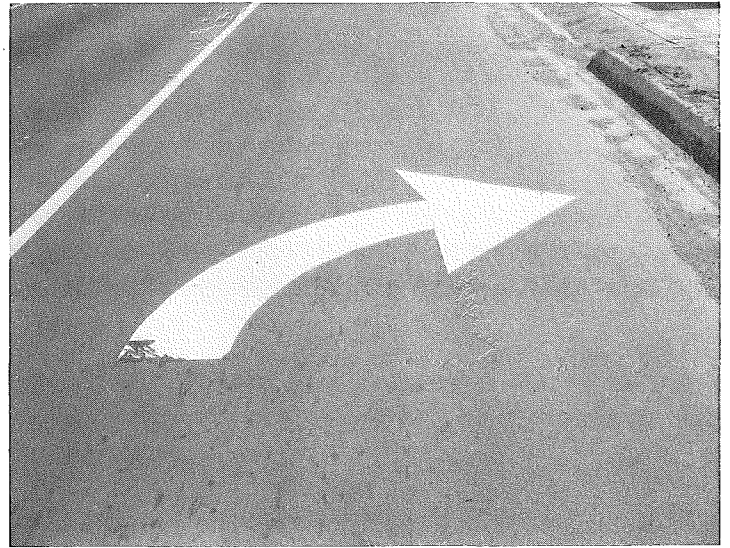
RIGHT TURN LANE ON
N.B US-27 @ SHERIDAN RD.
(3-18-69)
