STUDIES OF CORROSION RESISTANCE OF DOWEL BARS

Research Laboratory Division
Office of Testing and Research
Research Project 52 G-64
Research Report R-497R

Michigan State Highway Department
Lansing, May 1965

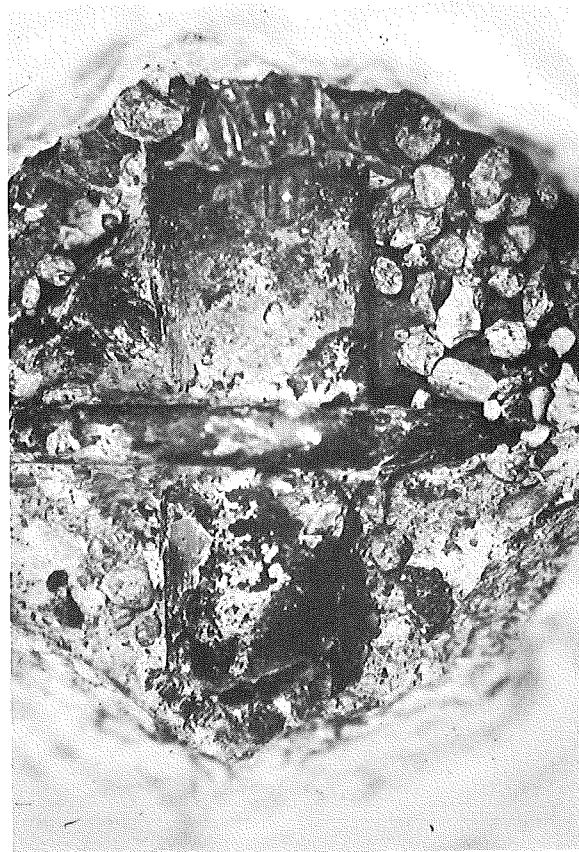
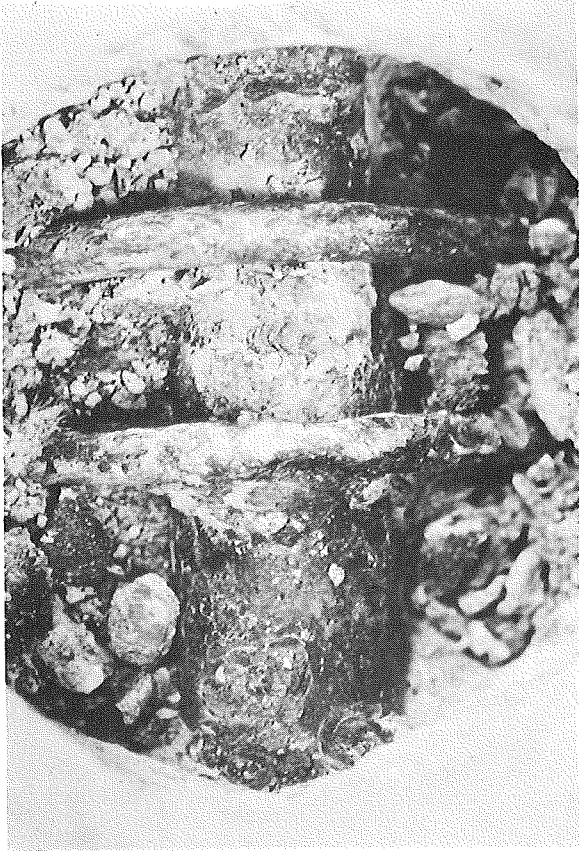
Figure 9 (above). Badly corroded standard hot-rolled steel dowels from one expansion joint assembly (Sta. 1127+30 WB), located first from pavement edge (left) and fifth from pavement edge (right).

In a thorough field survey on October 27-28, 1964, these experimental dowels received their closest inspection in seven years of service. Figs. 6 and 7 show dowels in open expansion joints with sealant removed prior to resealing. For Figs. 8, 9, and 10, an impact hammer was used to expose selected dowels of various types in expansion and contraction joints. The inspection indicated that the nickel plated dowels, the Monel sleeved dowels, and dowels sleeved in three types of stainless steel have been superior in durability in this installation to standard hot-rolled steel dowel bars installed at the same time.

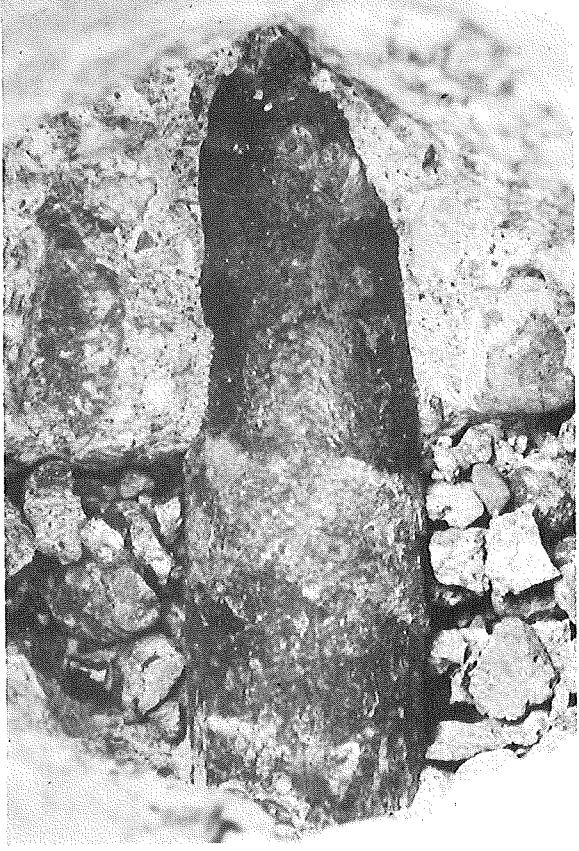
Figure 10 (below). Badly corroded standard hot-rolled steel dowels from one expansion assembly (Sta. 1130+00 WB), located first (left) and fifth (right) from pavement edge.
